# **Summary Building Condition Survey Report**

**Logie Primary School**

**Dunphail IV36 2QG**

**7<sup>th</sup> October 2021**

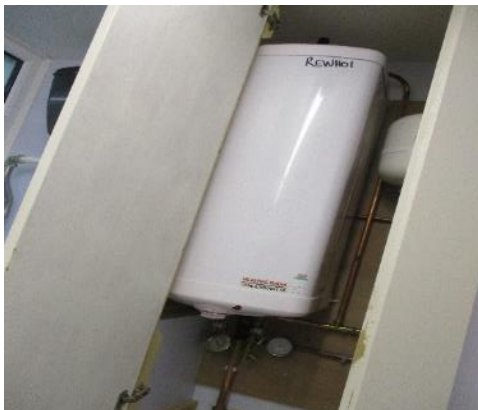
27. Boys toilet multipoint water heater

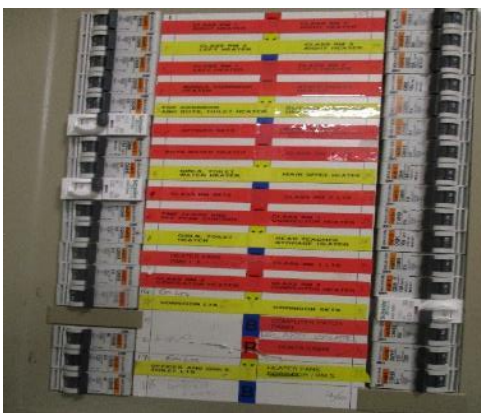
29. Main school distribution board

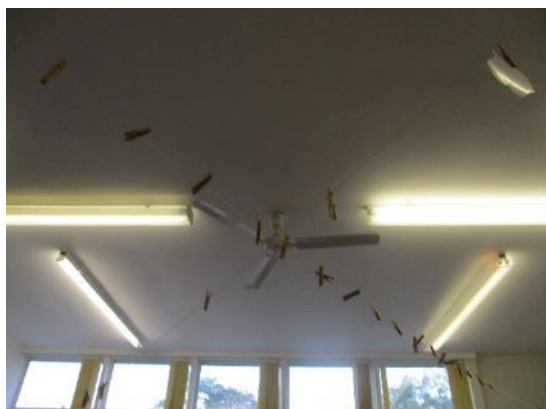
33. Main school class lighting

- Replacement of HORSAs hut with purpose built dining hall and storage facilities.
- Replacement of lighting systems with LED light fittings and energy saving automatic controls.
- Installation of modern intruder alarm system.
- Upgrade CCTV security system to cover wider areas of site for increased security.

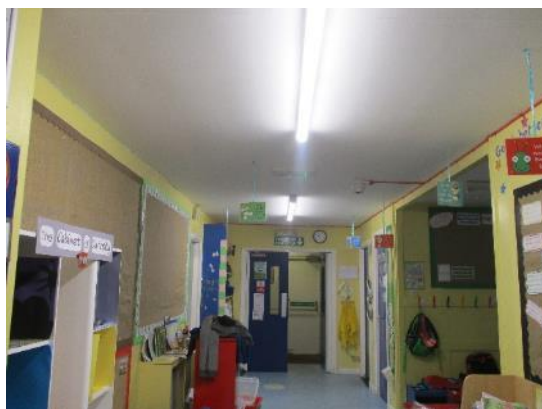
34. Main school corridor lighting

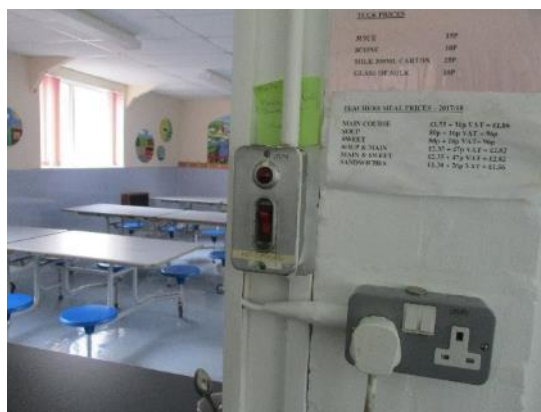
74. Kitchen sockets and switches
