# **Summary Building Condition Survey Report**

**Pilmuir Primary School  
Pilmuir Road, Forres IV36 1HD**

**30<sup>th</sup> & 31<sup>st</sup> March 2022**

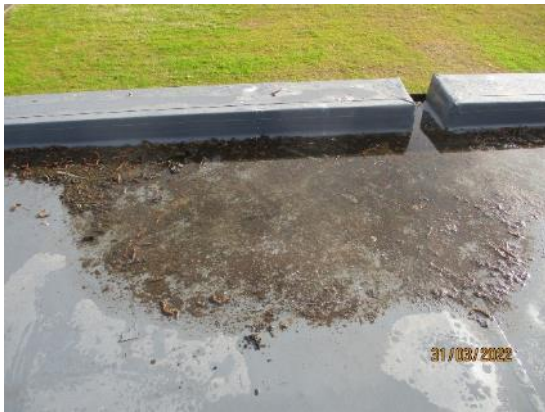
- Roof insulation loose and moving below single ply membrane.
- Rainwater ponding on flat roof.
- Silt and debris blocking rainwater downpipes.
- Carpet tiles lifting in Classroom 3.

7. Part blocked rainwater outlets

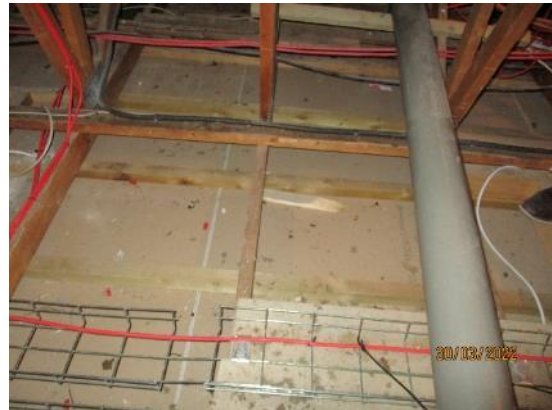
- External walls cracked and roughcast boss in a number of areas.
- Windows, glazing and ironmongery in poor condition.
- Inadequate roofspace insulation.

10. Lack of insulation

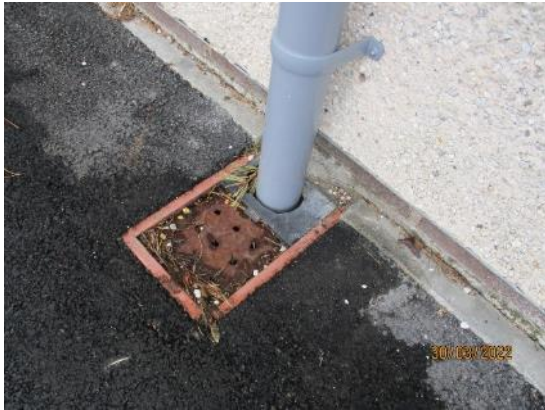
13. Downpipes to back inlet gullies

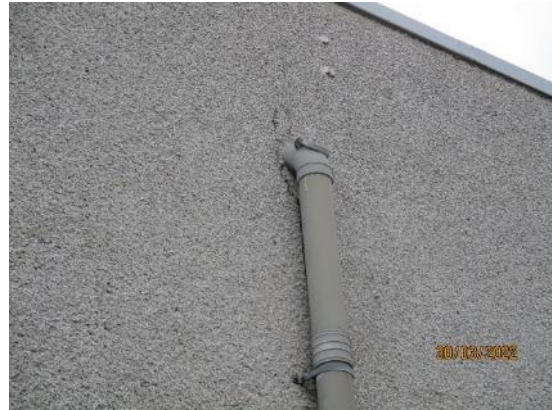
14. Games Hall downpipes

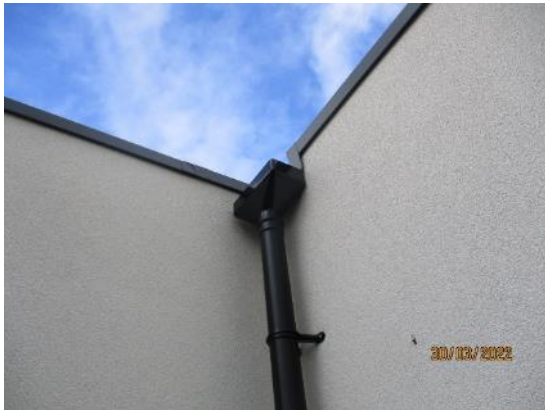
15. Annexe hopper heads & downpipes

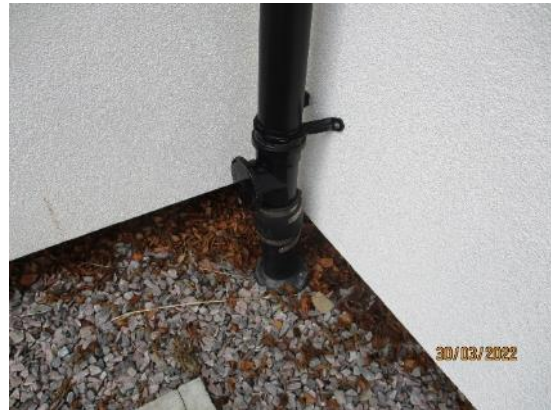
16. Discharging below ground

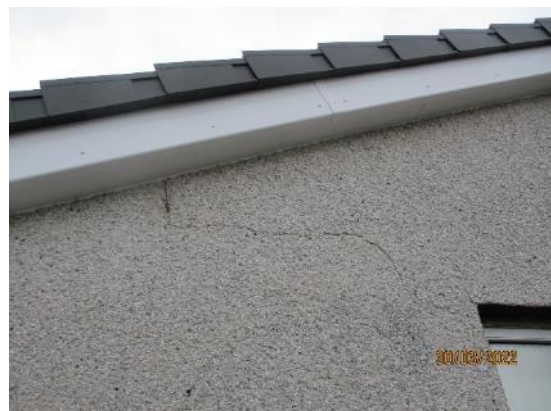
18. Cracks in masonry

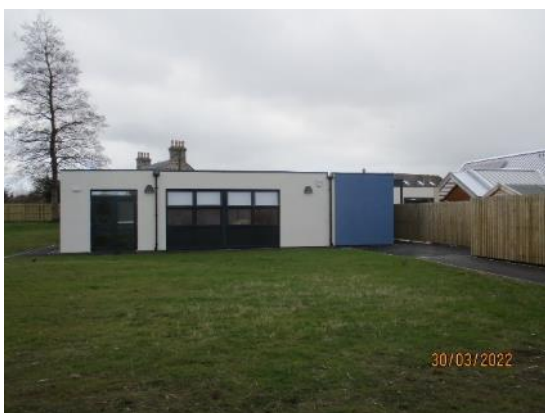
23. Annexe external walls

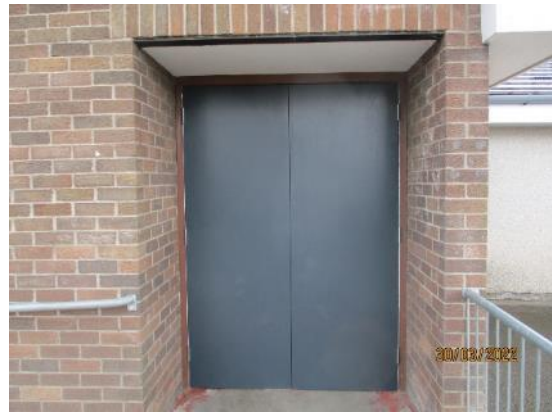
26. Fire exit doors

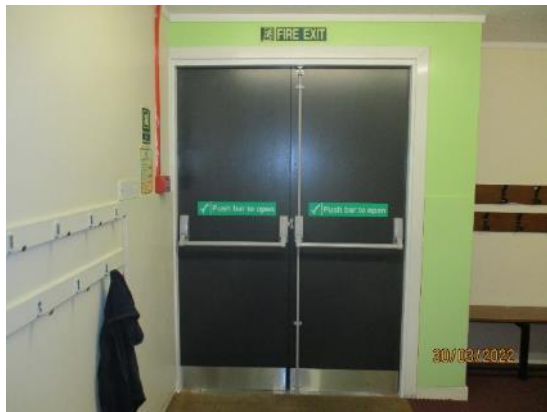
27. Fire exit doors internally

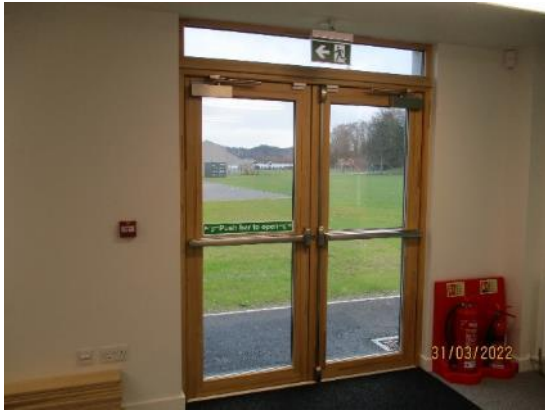
31. Fire exit ironmongery

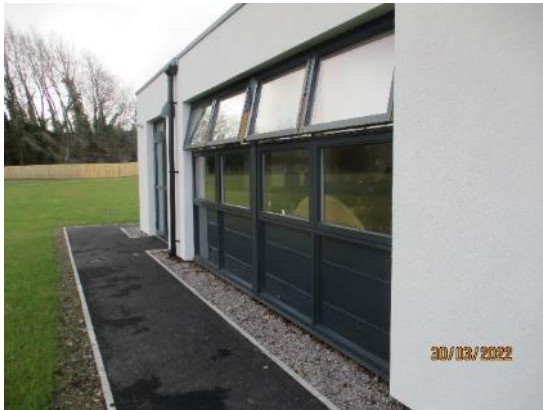
39. Large screen windows

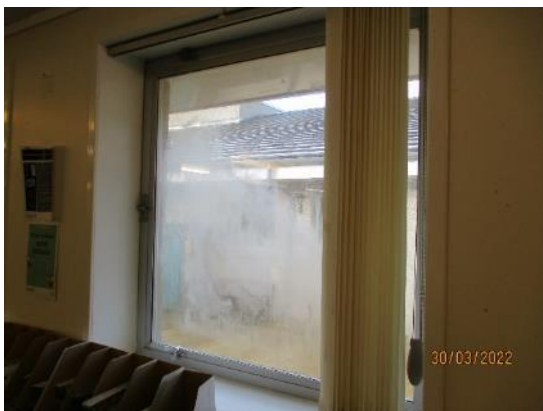
41. Blown double glazing – Primary School

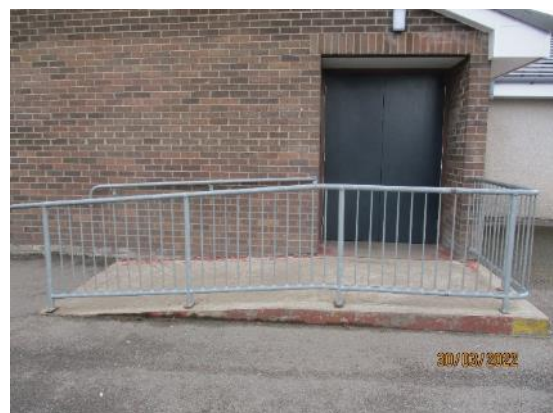
48. Concrete ramp and galvanised guardrail

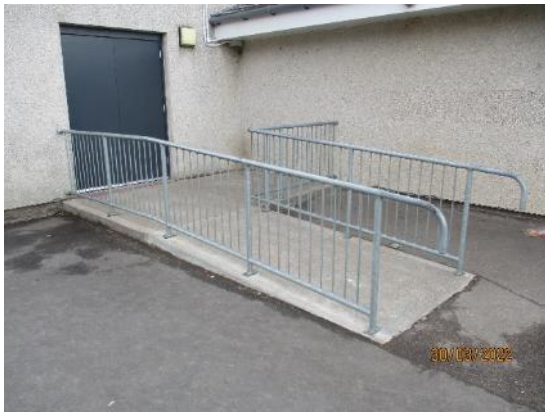
49. Ramped fire exit and galvanised guardrail

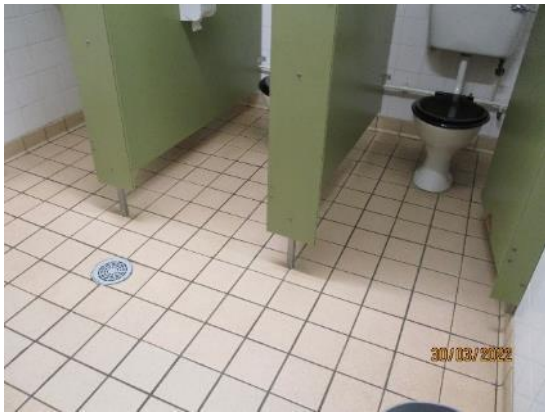
54. Quarry tiles in toilets

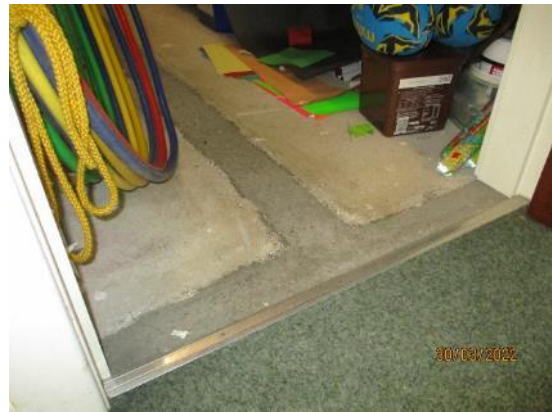
55. Concrete screed in cupboards

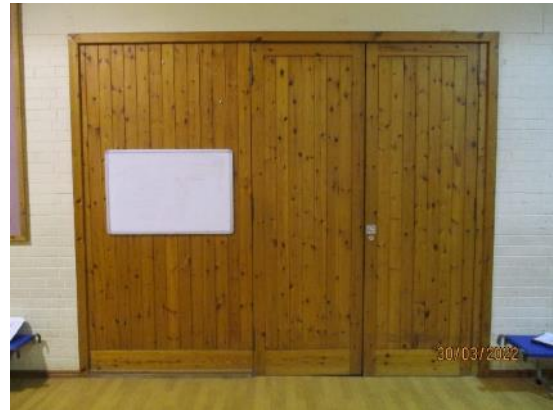
75. Timber lined doors in Gym Hall

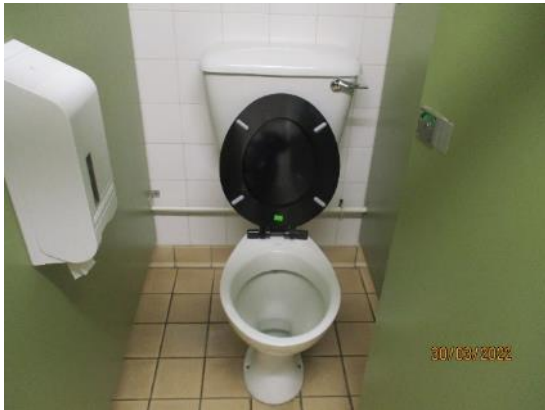
80. Typical Primary WC

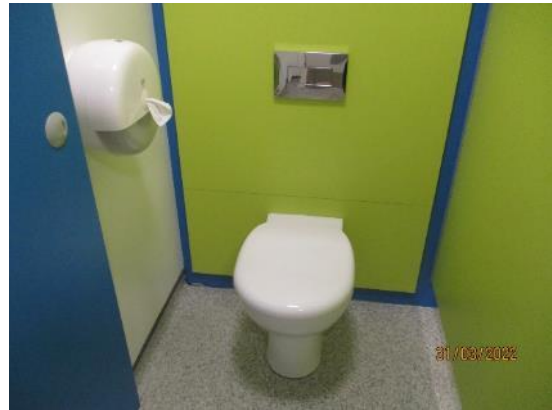
81. Typical Annexe WC

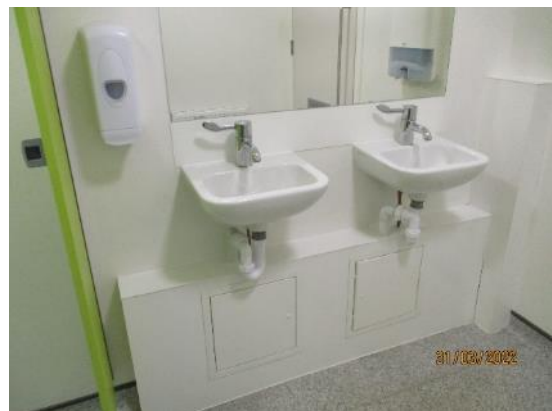
83. Typical Annexe wall hung basins

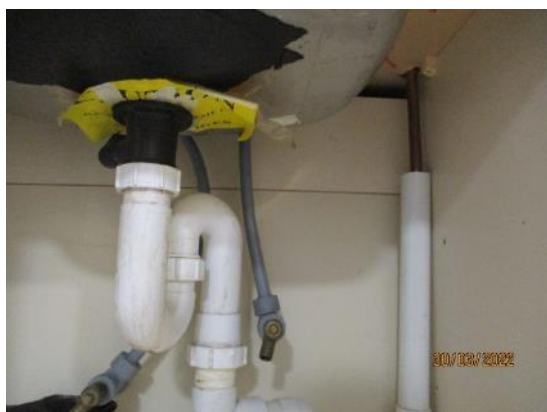
84. PVC waste pipes

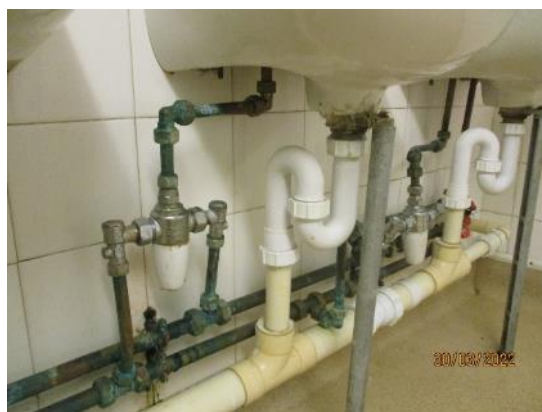
85. PVC waste pipes faded and discoloured

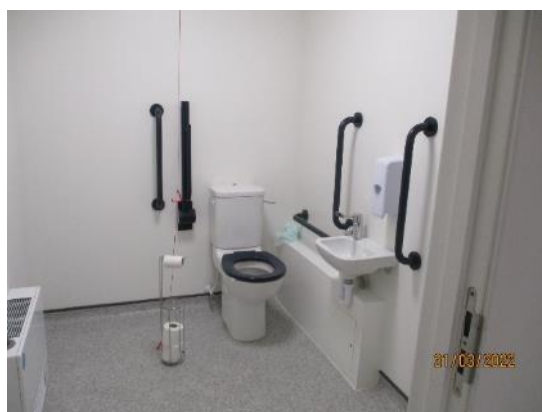
87. Annexe accessible toilet

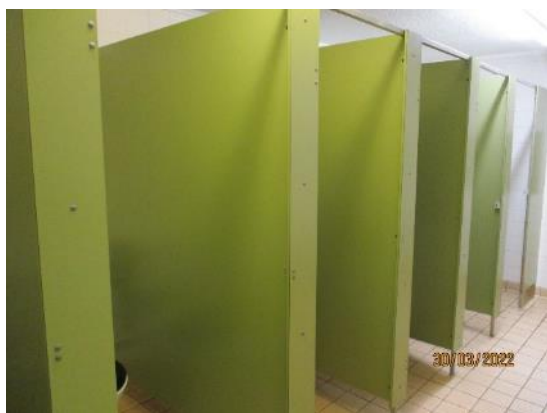
- Watermarked ceilings and taped joints failing.
- Floor finishes worn and soiled.
- Sanitary ware dated, cubicle partitions laminating.
- Existing lighting is dated throughout and should be considered for upgrade to LED type with energy saving controls.

88. Primary cubicle partitions

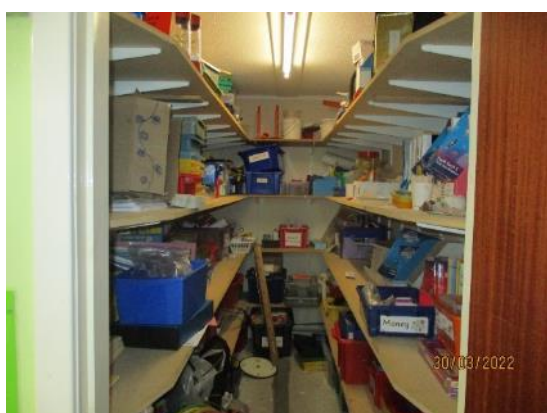
94. Cupboards lined with chipboard shelving

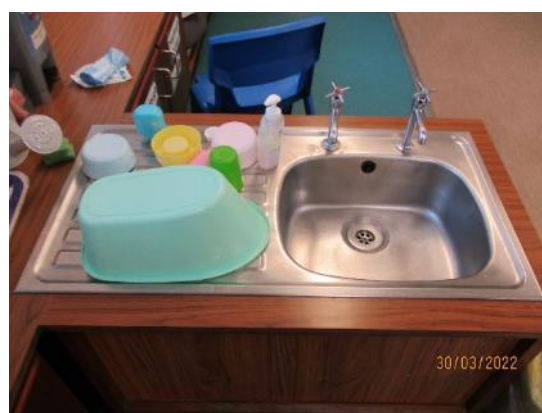
95. Stainless steel sinks with pillar taps

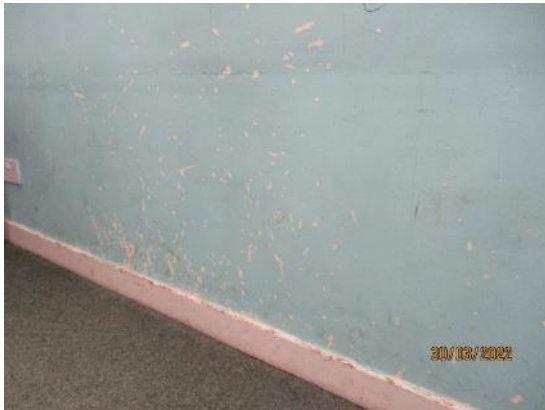
98. Chipped and peeling internal decoration

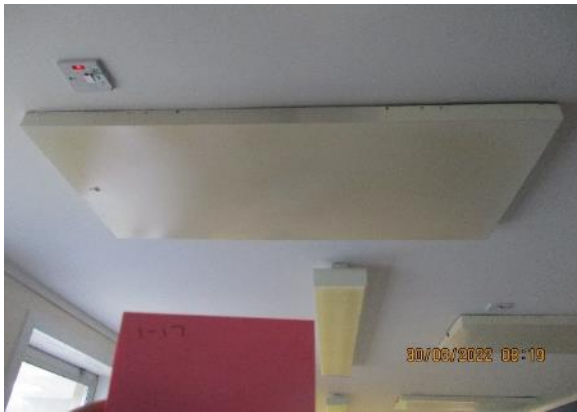
- Domestic hot and cold water pipework supplies are reaching the end of their useful life and should be considered for replacement.
- Existing electric ceiling heating panels and electric convector heaters are reaching the end of their useful life and should be considered for replacement or upgrade to alternative energy efficient heating system.

107. Electric ceiling radiant heater panels circulation.

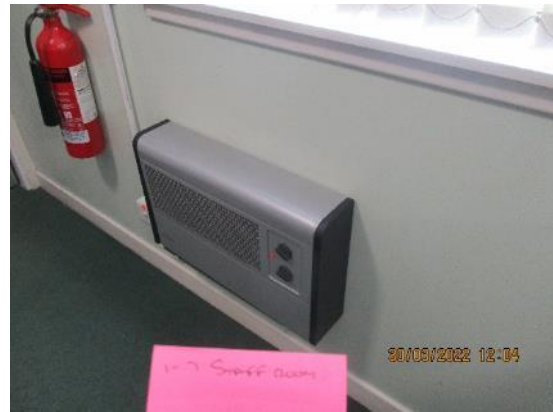
108. Electric convector heater – staff room.

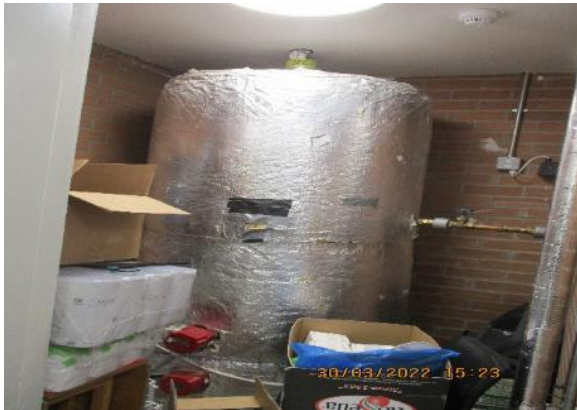
109. Hot water storage calorifier

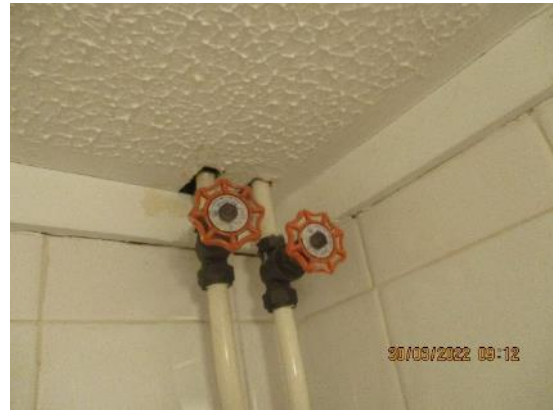
110. Hot water pipework typical

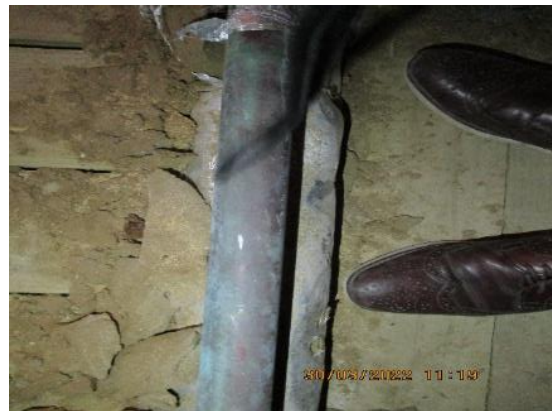
112. Cold water pipework attic space

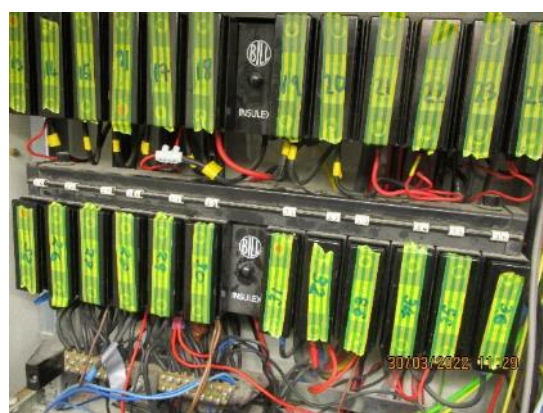
- Electrical installation – wiring, switches and distribution boards are reaching the end of their useful life and should be considered for replacement/upgrade.

118. Distribution board – switchgear room

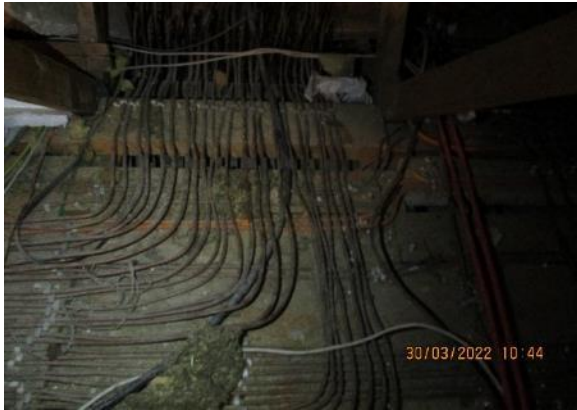
119. General wiring – attic space

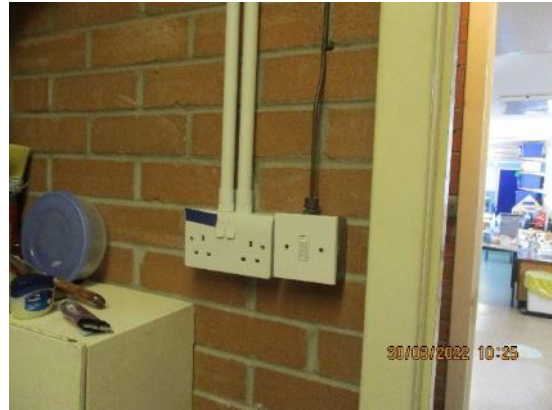
120. Switches and sockets typical

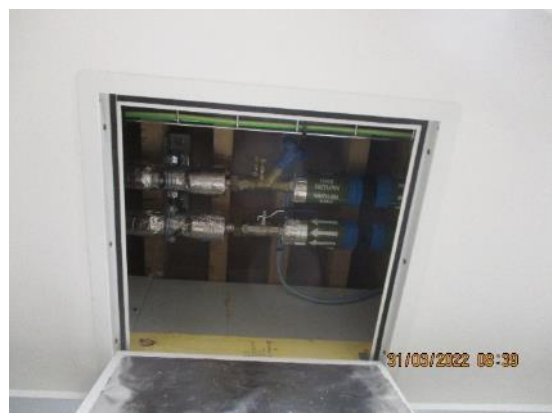
142. Hot and cold water domestic pipework

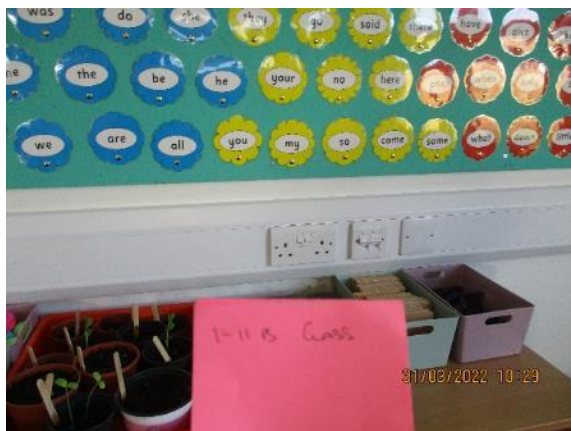
147. Sockets and switches

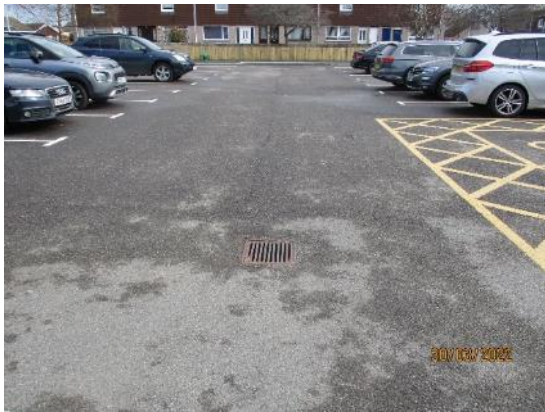
- Stone wall to East boundary crumbling, requires repair and repointing.
- Concrete posts to chain link fence leaning and require stabilised.
- Access road and car park, tarmacadam breaking up and potholed.

167. Tarmacadam car park

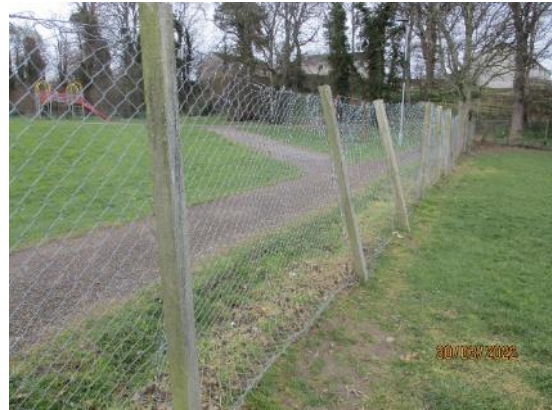
174. Leaning concrete posts to playing field

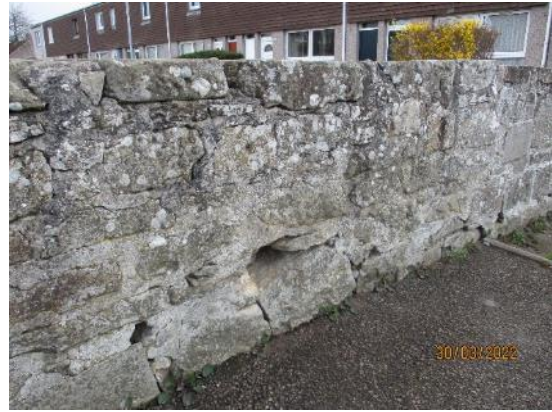
180. Stone wall to East boundary
