# **Summary Building Condition Survey Report**

**Cluny Primary School  
South Pringle Street, Buckie AB56 1PX**

**25<sup>th</sup> and 26<sup>th</sup> April 2022**

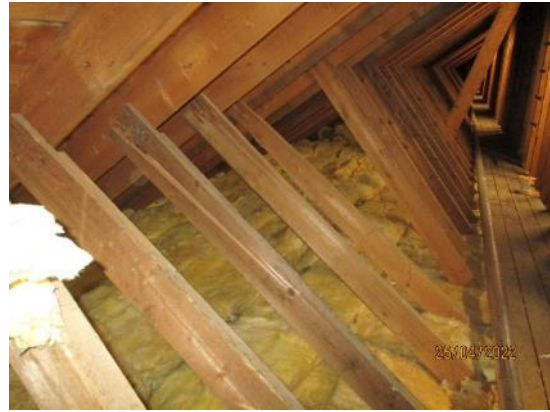
2. Displaced rafter supports

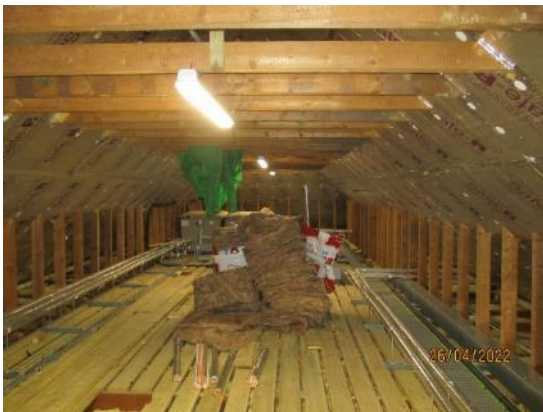
3. Dining Hall roof structure

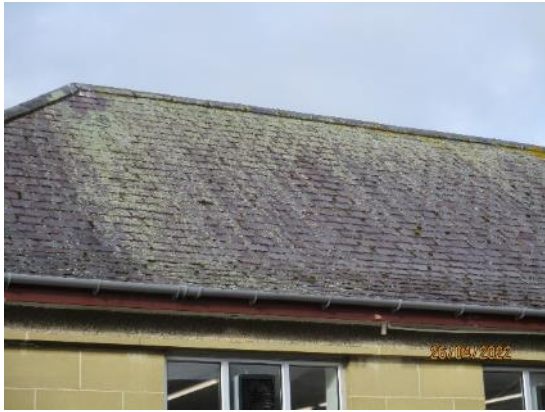
7. Dining Hall slate roof

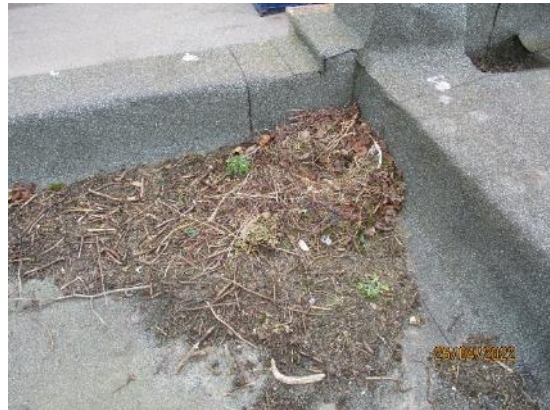
10. Vegetation and debris on flat roofs

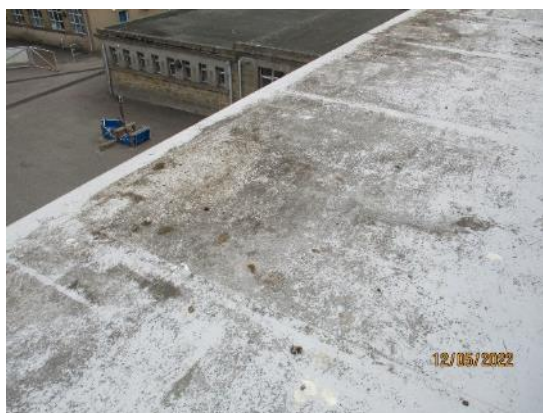
17. Soiled surface of single ply membrane

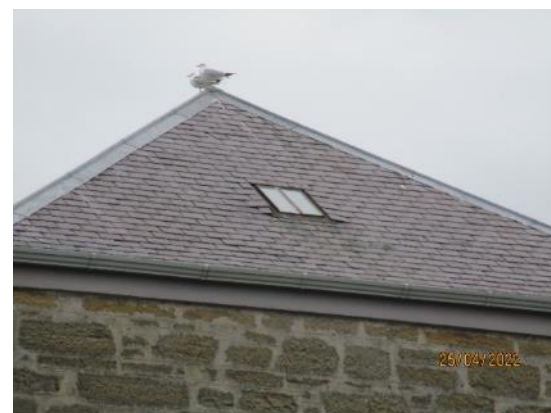
18. Skylight to main school roof

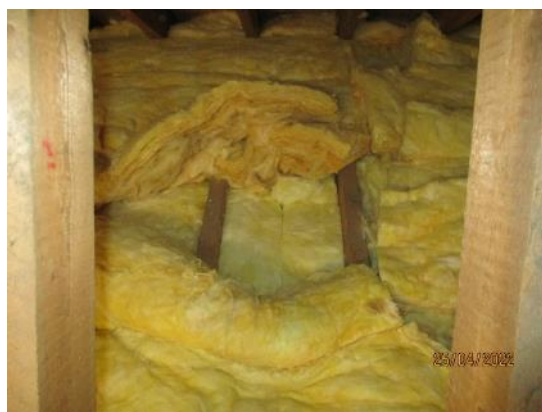
20. Insulation disturbed in main school roof

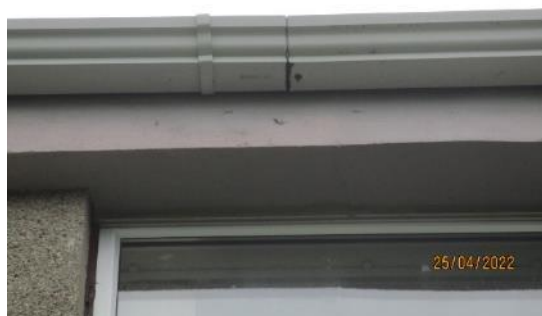
- Felt roofing has exceeded its useful life.
- Flat roof outlets are small and frequently block.
- Cast iron ogee gutter leaking at the joints.
- Isolated double glazed units have failed seals and have become fogged.
- A large proportion of window ironmongery has failed or is missing.
- Timber fire escape doors have extensive rot to the bottom edge.
- Internal doors and ironmongery, damaged and have exceeded their useful life.
- Carpets are worn and heavily soiled.

24. Leaking gutter joints

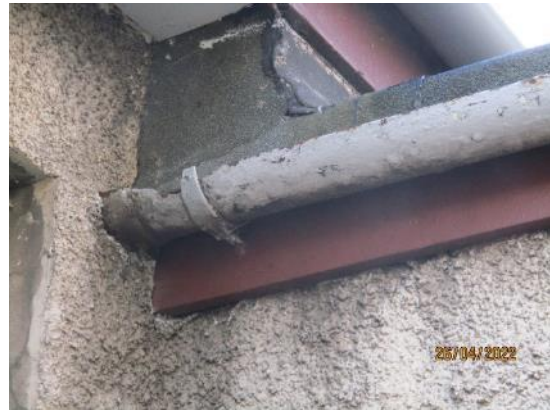
28. 1/2 round cast iron gutter to Dining Hall

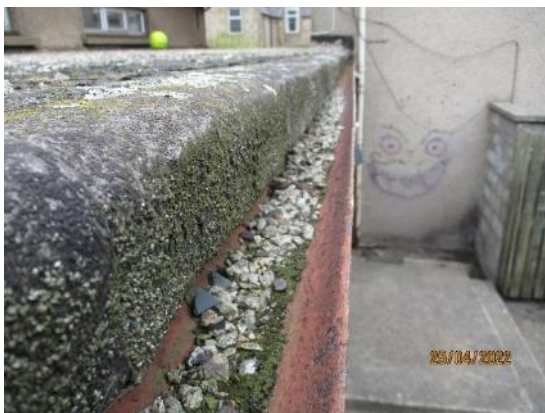
29. 1/2 round cast iron gutter to Dining Hall

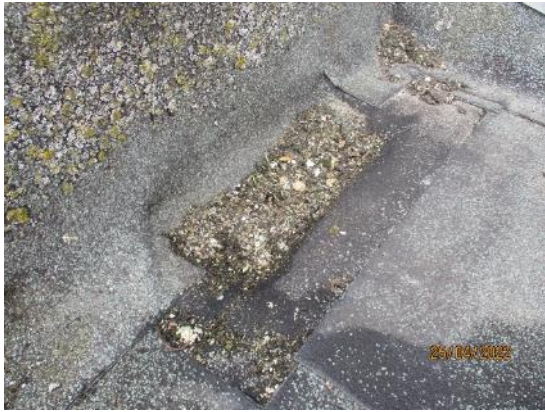
31. Blocked outlets to felt roofs

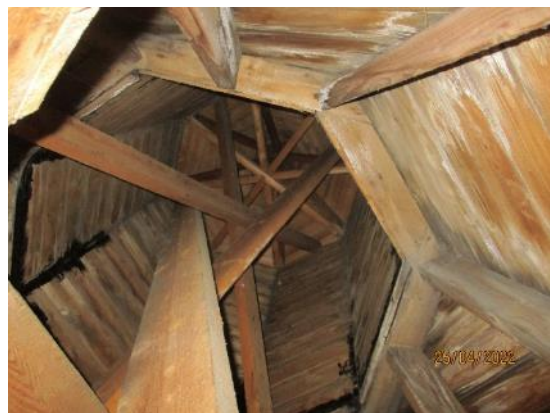
36. Tower's timber structure

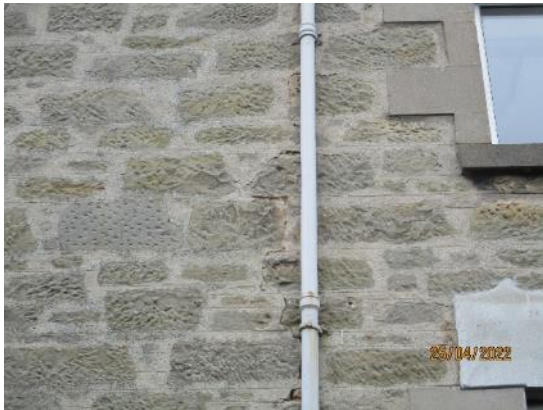
39. Isolated cracking, pointing required

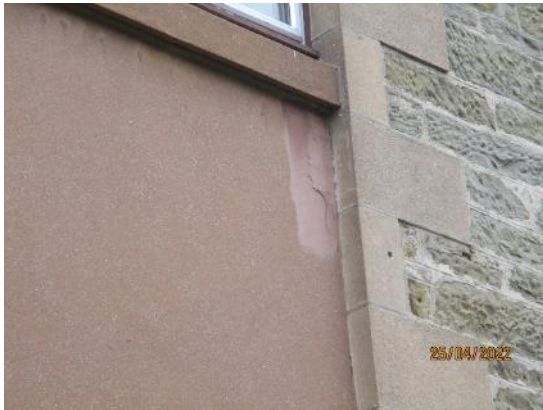
45. Isolated spalling of render panels

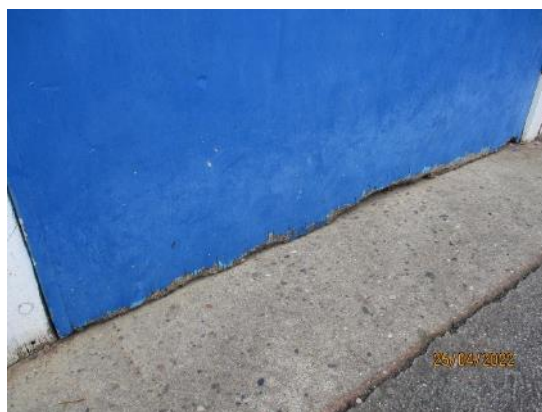
50. Timber wet rot

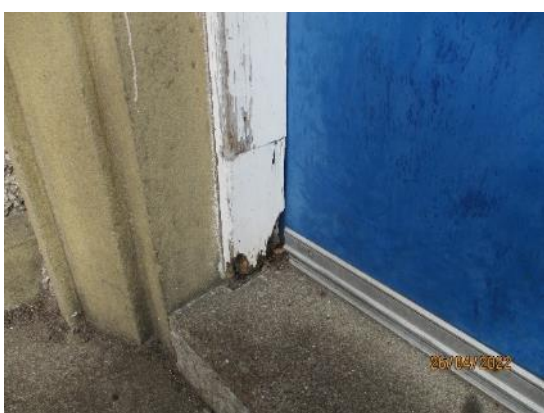
53. Wet rot in door frames

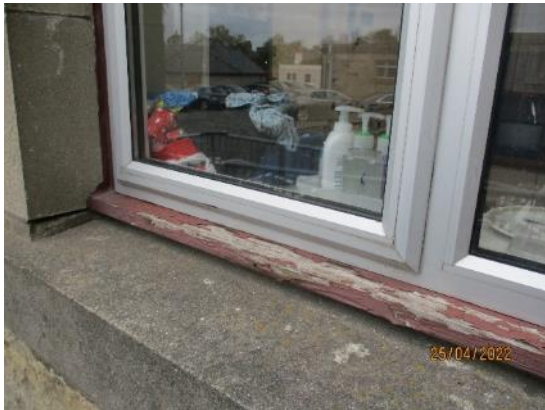
57. Timber window sills

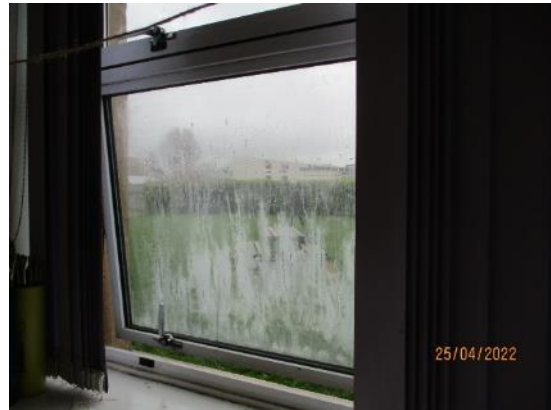
58. Defective double glazed units

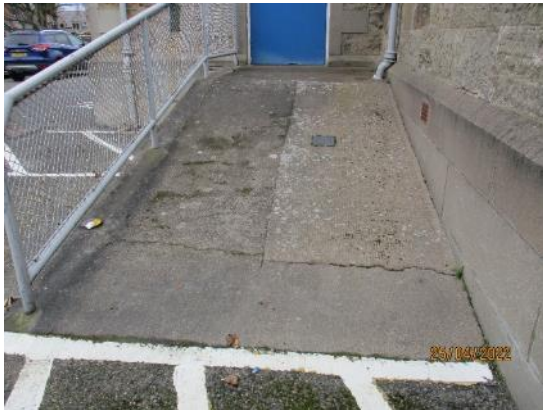
74. Cracked concrete ramps

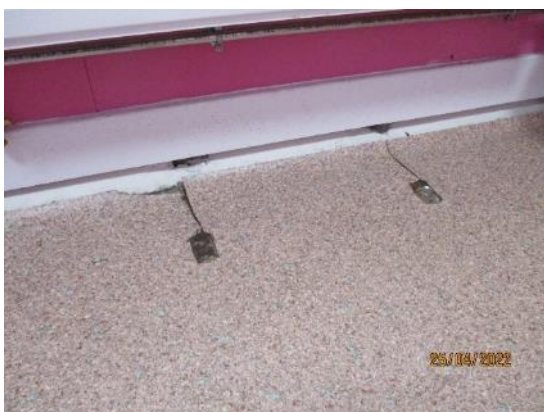
78. Holes in sheet vinyl

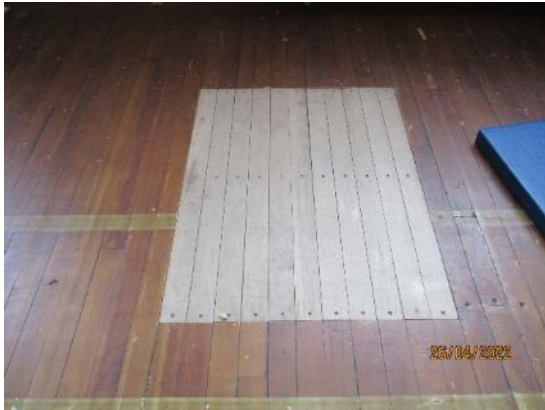
84. Timber flooring repairs

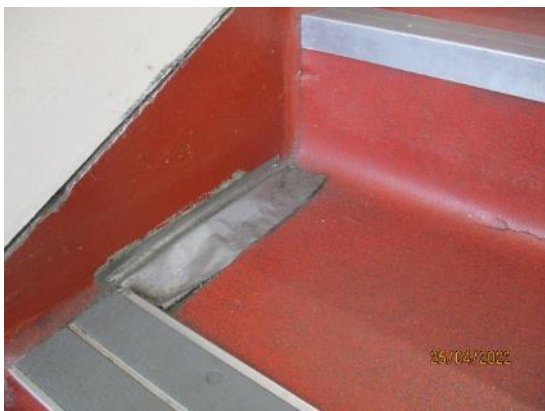
88. Vinyl taped repairs

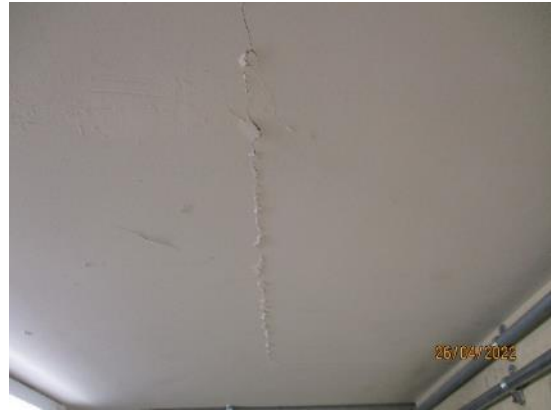
96. Failed taped joints

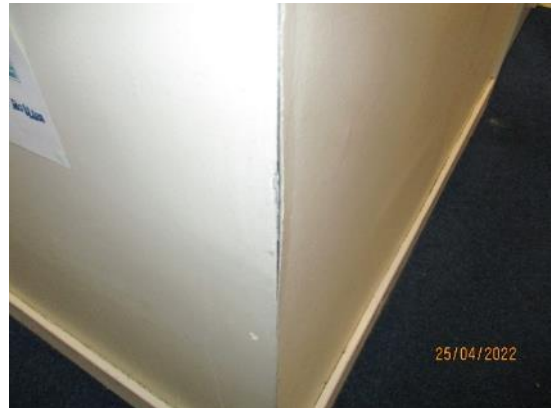
104. Damaged plasterboard walls

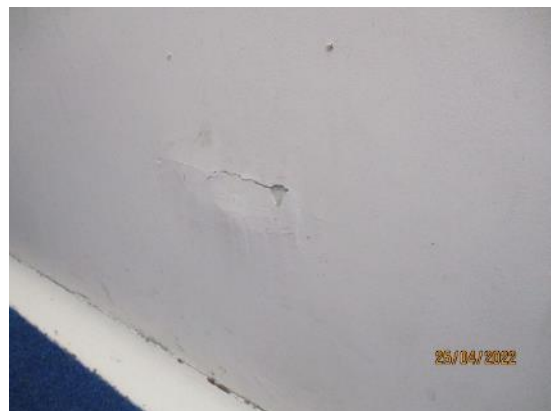
106. Fibreboard linings damaged

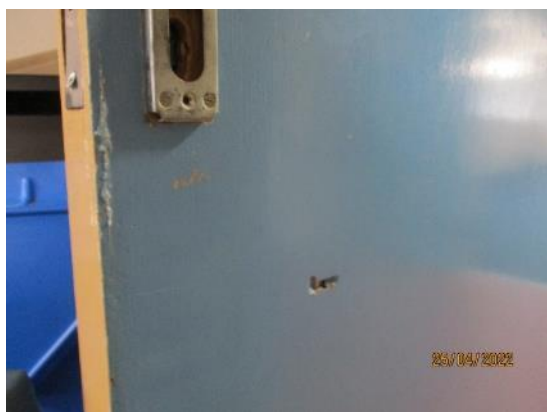
113. Damaged timber doors

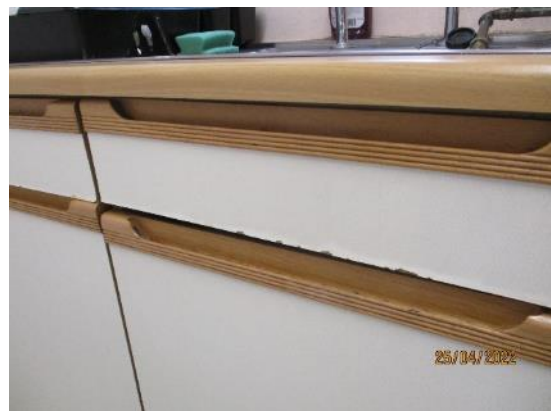
130. Damage to base units

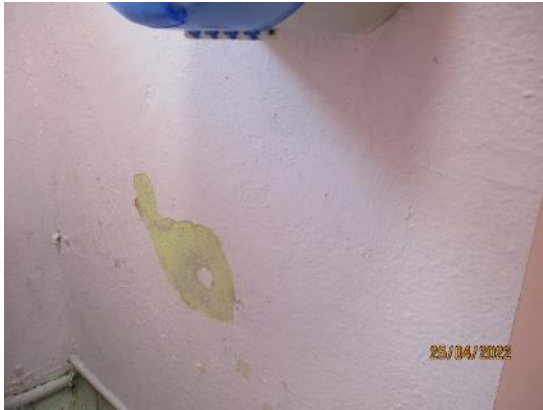
136. Peeling and flaking decoration

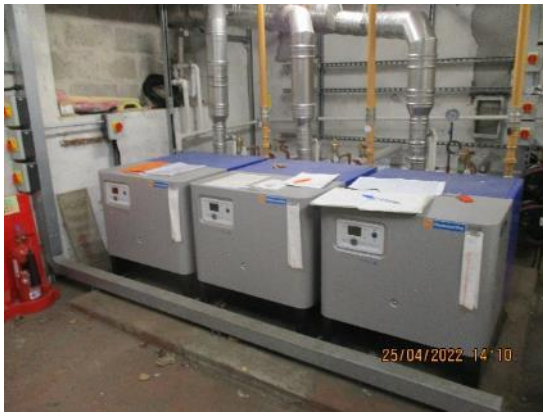
141. Natural gas condensing boilers. 0/1 Boilerhouse.

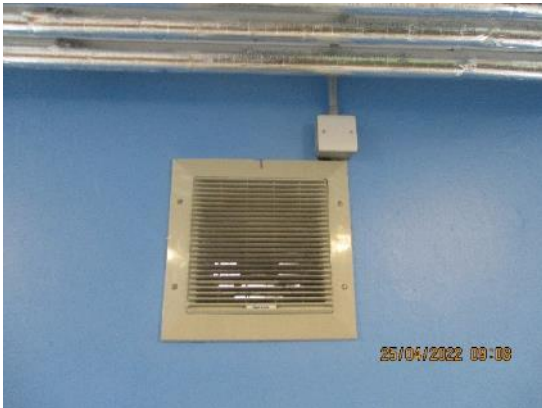
155. Extract fan – boys toilets 1/21.

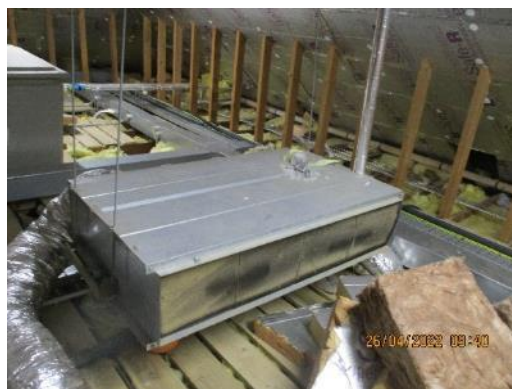
- The extract fan in the male staff toilets 1/23a – main school is defective.
- The extract fan in the disabled shower room 1/30 is defective.
- 3 of 4 extract fans within the main kitchen in the dining block are defective.

201. Extract fan – kitchen windows. 1-42

- Installation of mechanical extract fans to dining block toilets.
- Installation of purpose designed extract canopy in main kitchen to exhaust cooking fumes/steam and excess heat from island cooking appliances.
- Consideration could be given to the installation of a fixed fire-fighting or sprinkler system to improve resilience in the event of fire.
- Carry out review of inadequate car park drainage.

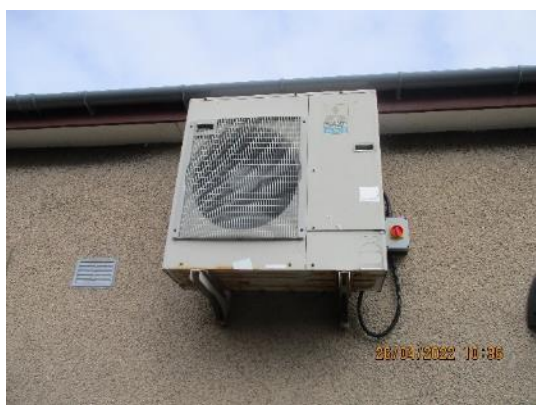
- Air conditioning unit serving the kitchen urgently requires cleaning and work to repair ductwork.
- The staff, boys and girls toilets in the dining block have no extract fans installed.

202. Air conditioning unit – indoor. Serves kitchen 1/42.

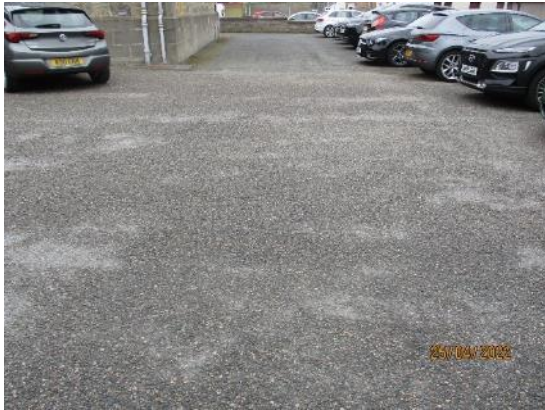
219. Tarmacadam car park

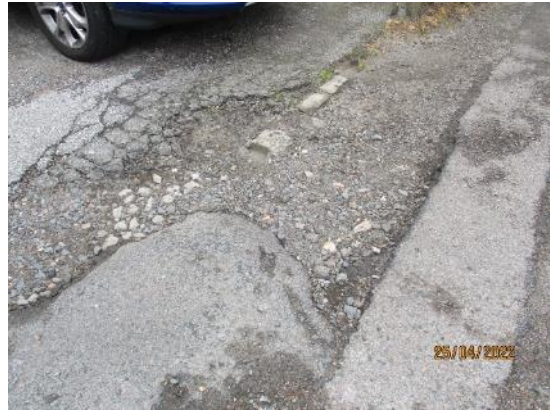
- Tarmacadam car park breaking up and pot holed.
- Concrete post and panel fence has exposed reinforcement and missing panels.
- Blockwork wall cracked and leaning, adjacent to trees.
- Natural stone walls have eroded and missing pointing.
- Gates have extensive corrosion.

220. Surface breaking up and potholed

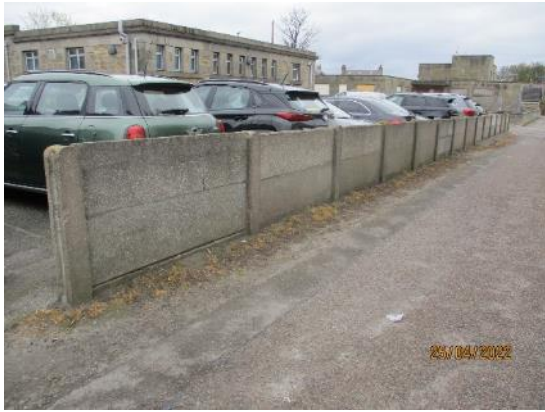
225. Concrete post and panel fence

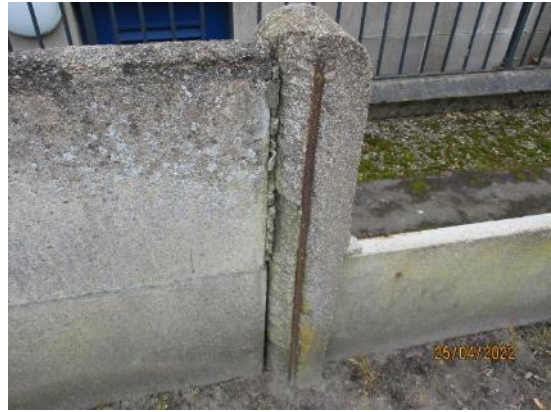
226. Exposed, corroding reinforcement

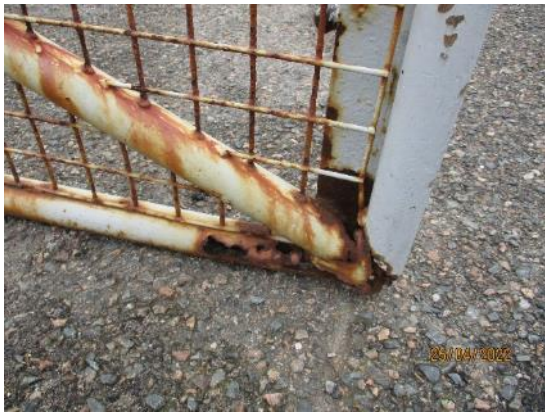
231. Corrosion of tubular gates

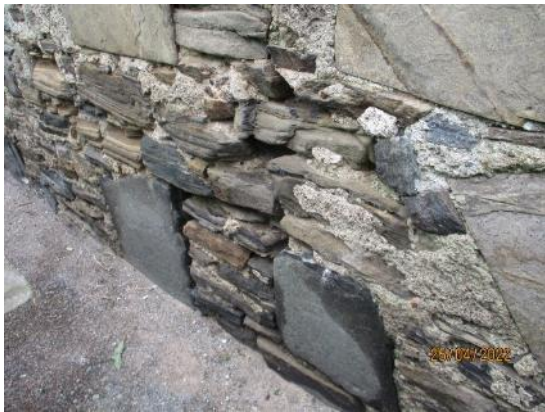
237. Repointing of stone walls required

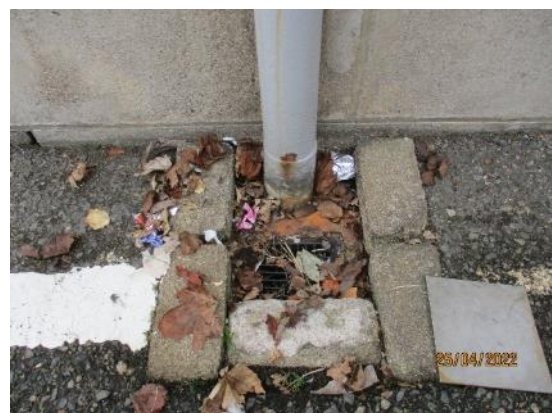
242. Back inlet gullies, partially blocked

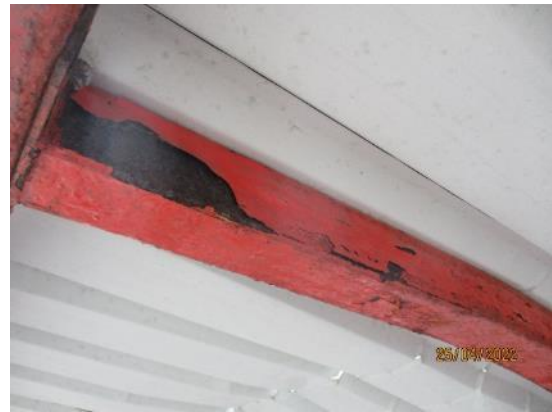
244. Corrosion of the steel frame
