# **Summary Building Condition Survey Report**

**Cullen Primary School  
Old Church Road, Cullen AB56 4UZ**

**7<sup>th</sup> June 2022**

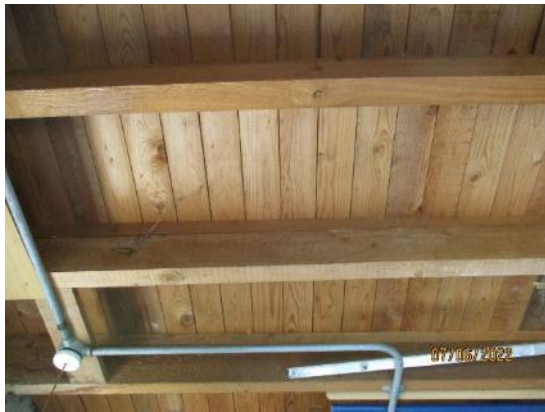
1. External store roof

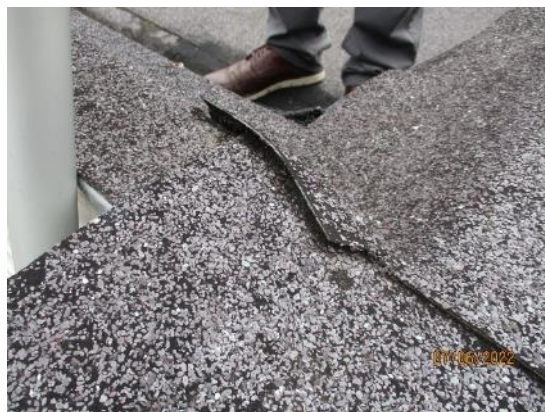
6. Open joints in felt roofing

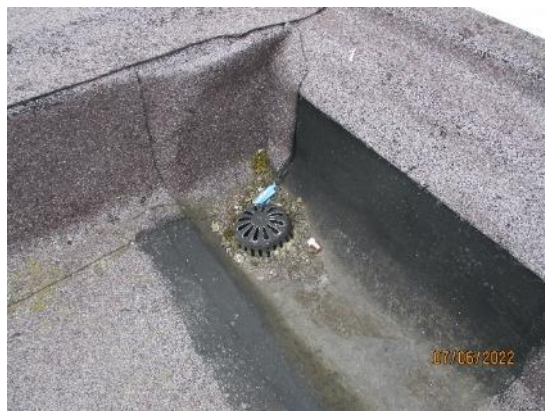
12. Deep box gutters

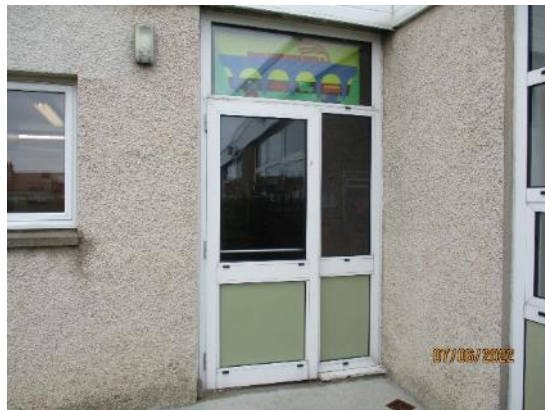
22. Fire escape door

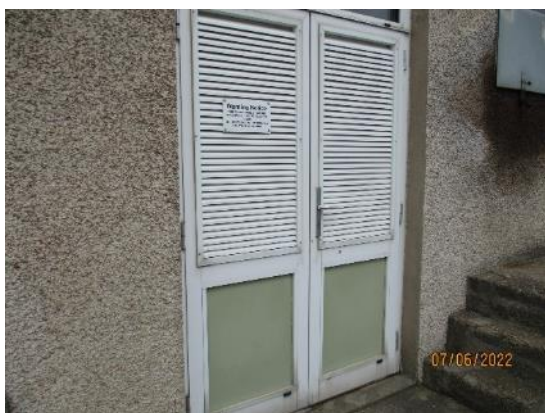
23. Boiler house double doors

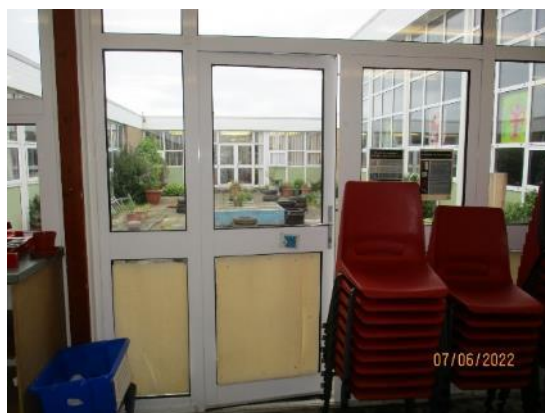
24. Courtyard door and screen

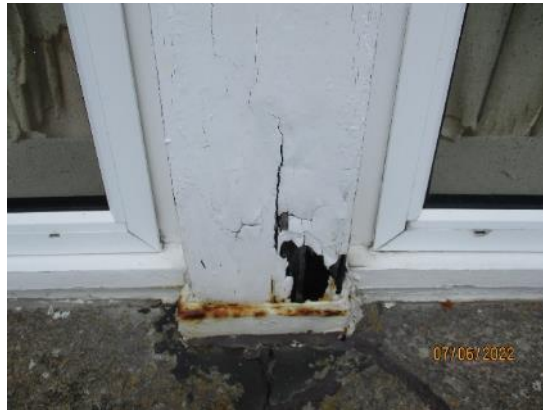
- Felt roofing is blistering and reaching the end of its useful life.
- Timber sills to windows and doors have extensive rot.
- Timber framework to high level Gym Hall windows, have extensive wet rot.
- Several windows have defective double glazed units.
- Several water marked ceiling tiles.
- Internal door ironmongery is slack and worn.
- Sanitary ware is very dated although functional.

34. Rotten timber frame

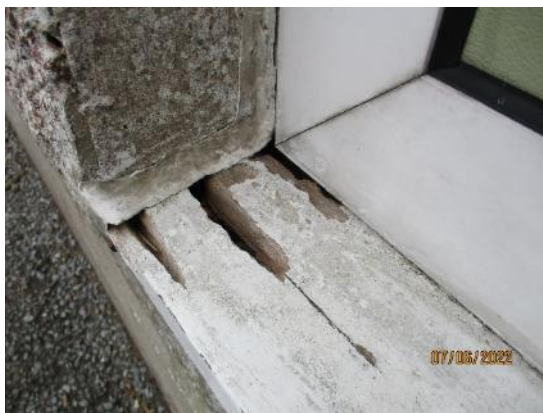
36. Rotten timber sills

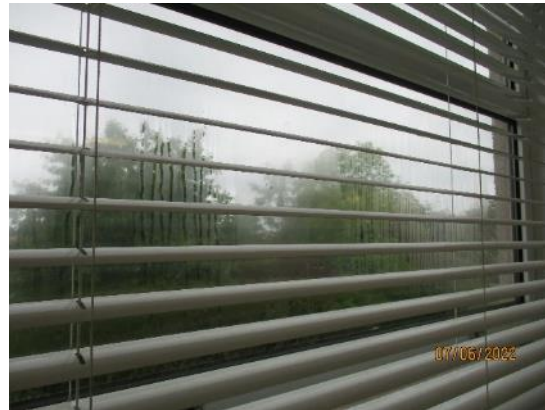
40. Blown double glazing units

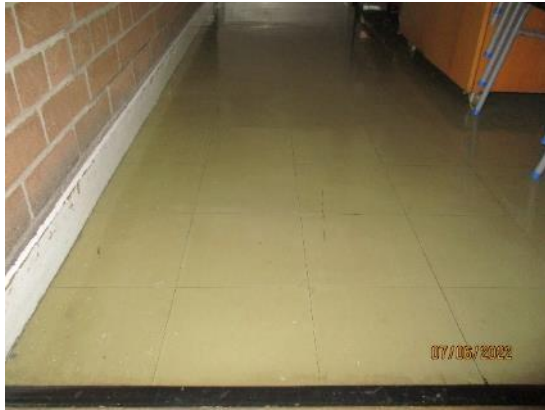
49. Vinyl tiles to corridor

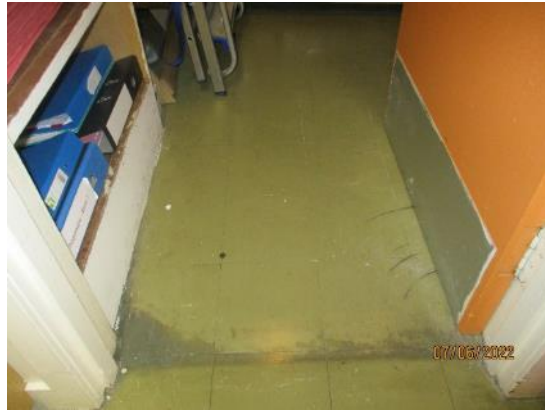
50. Vinyl tiles to cupboards

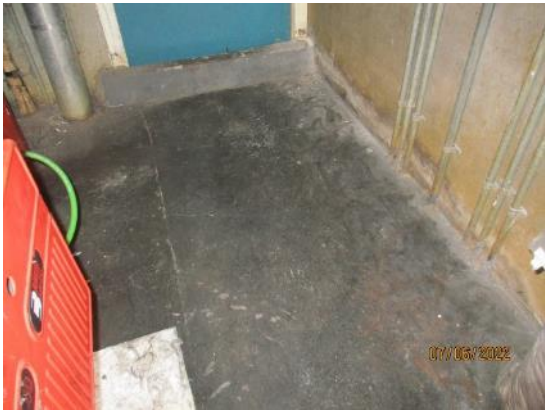
57. Concrete screed to boiler room

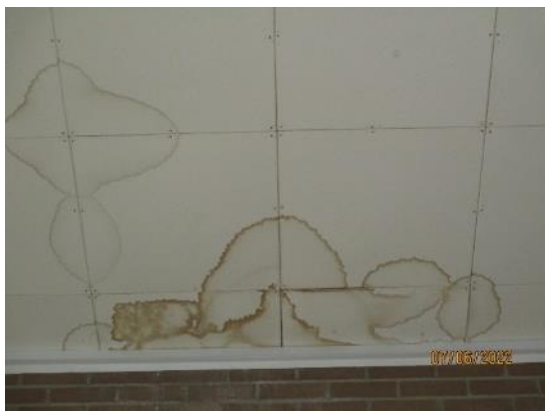
58. Watermarked ceiling tiles

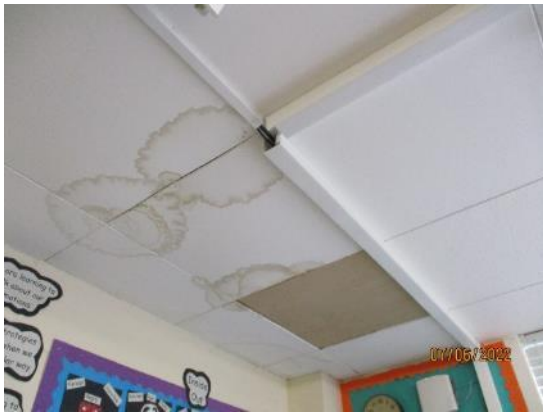
60. Watermarked ceiling tiles to classrooms

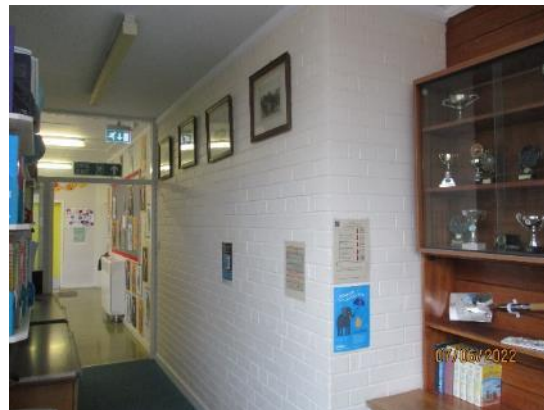
63. Painted brick walls

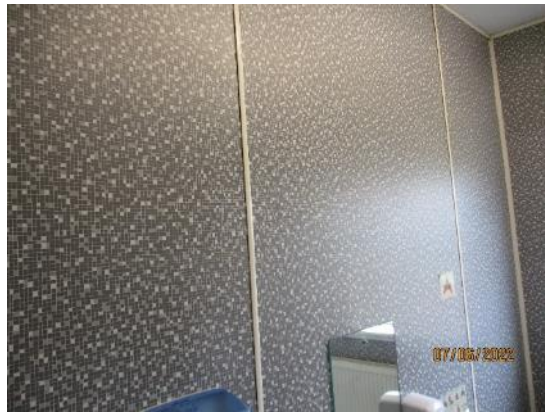
67. Wetwall in toilets

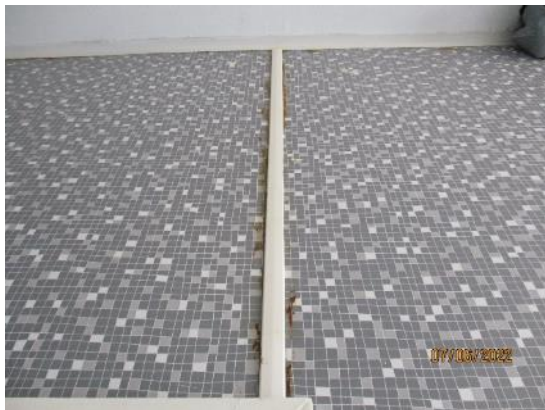
68. Soiled wetwall joints

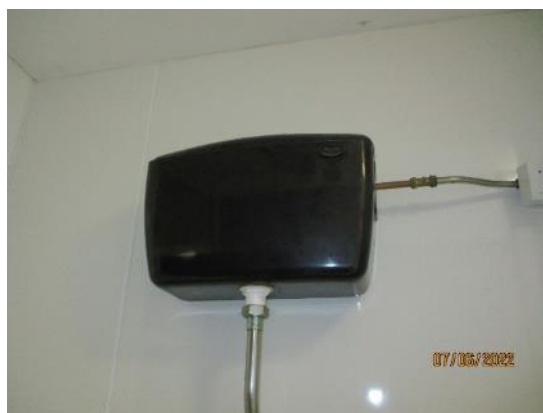
82. High level composite cistern

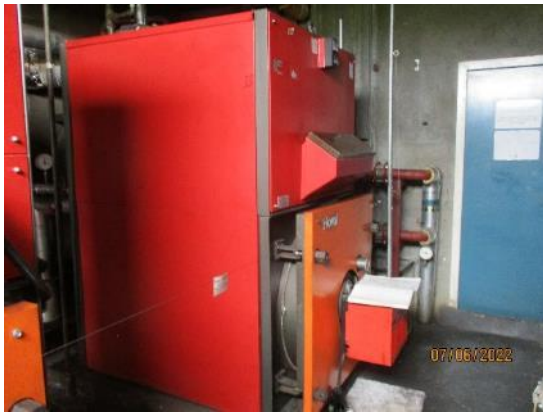
- Heating source, controls, pipework and heat emitters are in poor condition and reaching the end of their useful life.
- General internal lighting is in poor condition and reaching the end of its useful life.

101. Oil shell and tube boiler. Boilerhouse 1/19

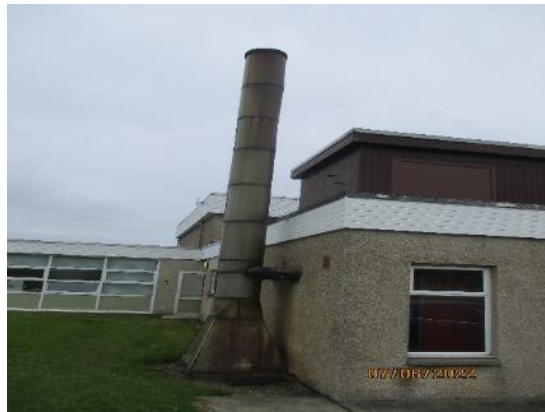
102. Boiler common chimney. 1-19 External.

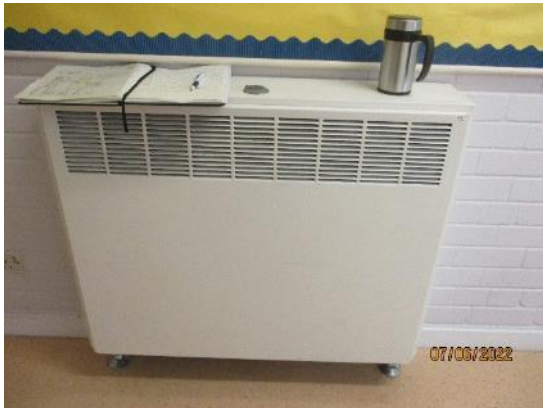
103. Convector heater – heating system typical.

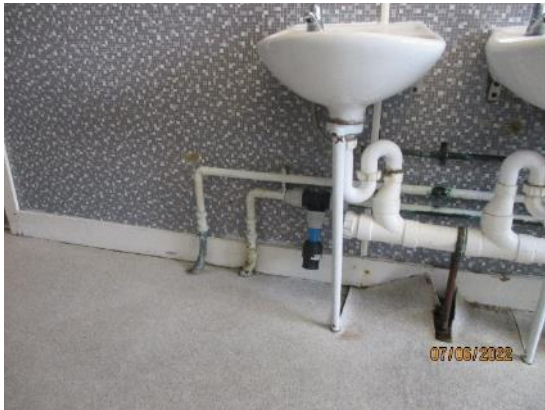
- Heating and hot water pipework is only partly insulated.
- The kitchen appliance extract canopy and fan unit is in poor condition.

108. Heating system pipework. Typical

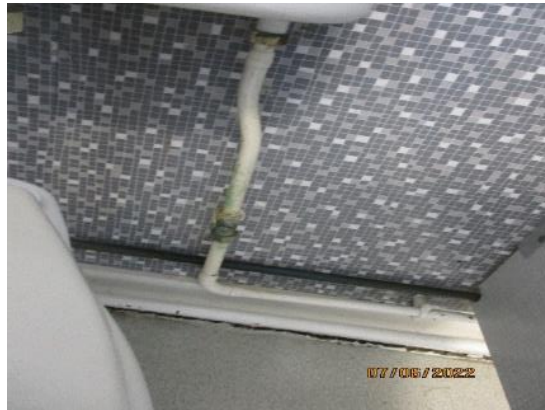
- External building lighting is in poor condition and reaching the end of its useful life.
- Hot and cold water distribution pipework is in poor condition and reaching the end of its useful life.

109. Hot water pipework. Girls toilets 1-25

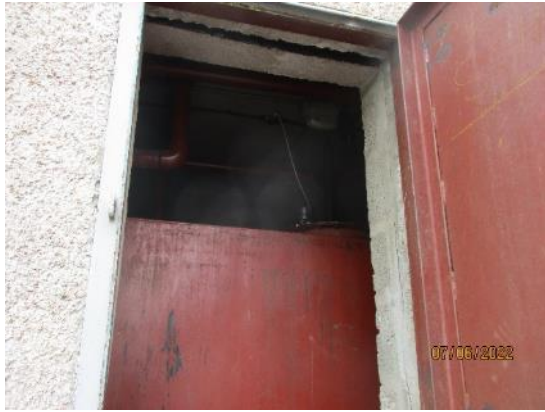
112. Cold water feed pipework from tank – 1/20

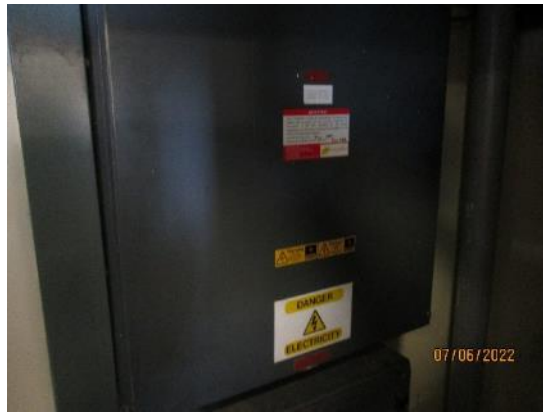
- General power distribution wiring, sockets, switches and distribution boards are in poor condition and reaching the end of their useful life.
- There is no intruder alarm installed in the building.

119. Distribution board – power. Store 1/3

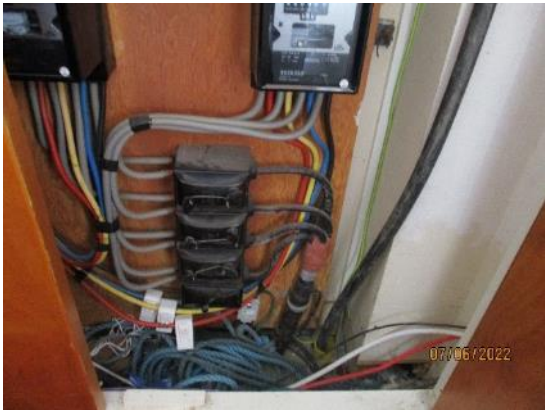
120. Distribution board – kitchen. Store 1-18

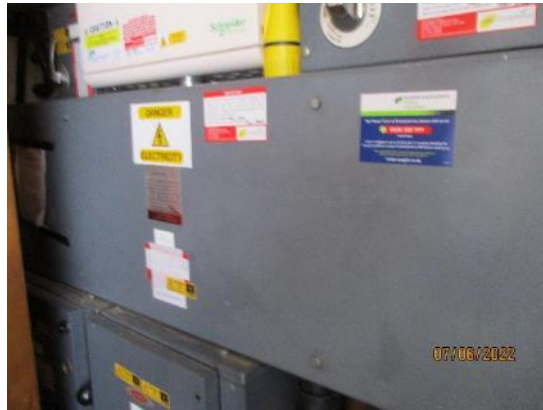
121. Incoming power supply and main fuses. Store 1/3

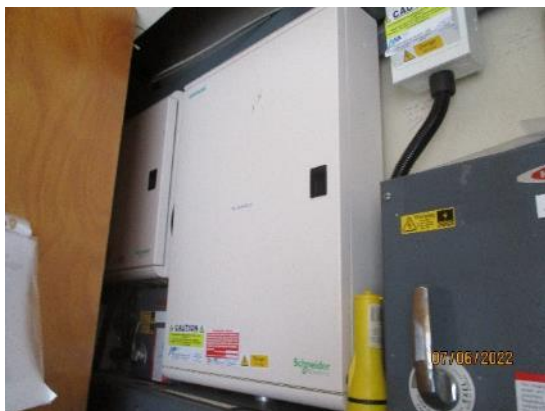
122. Main busbar – store 1/3.

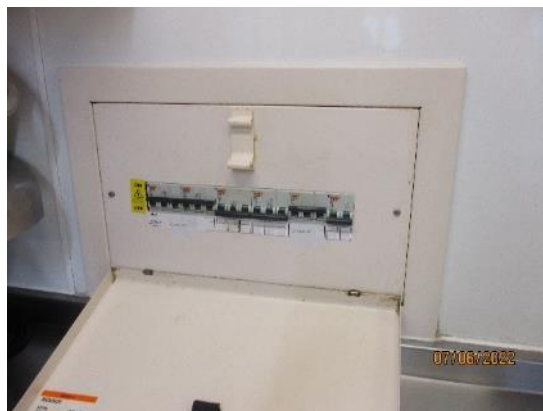
123. Distribution board power. LP1 – Store 1/3

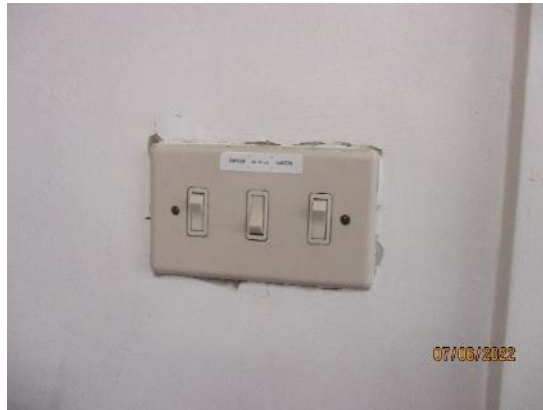
127. Light switch – external store.

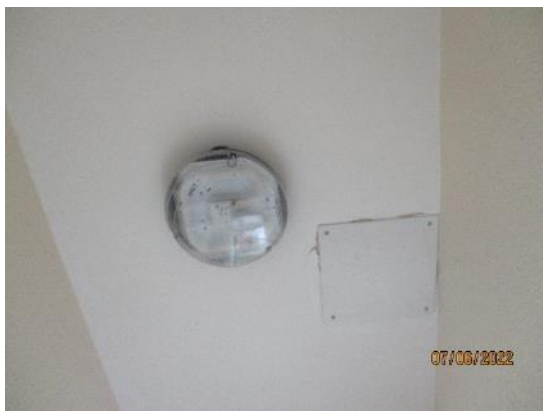
129. Lighting – typical class and circulation.

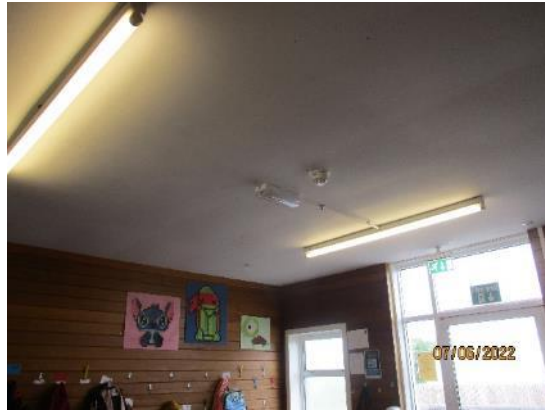
131. Lighting – store example.

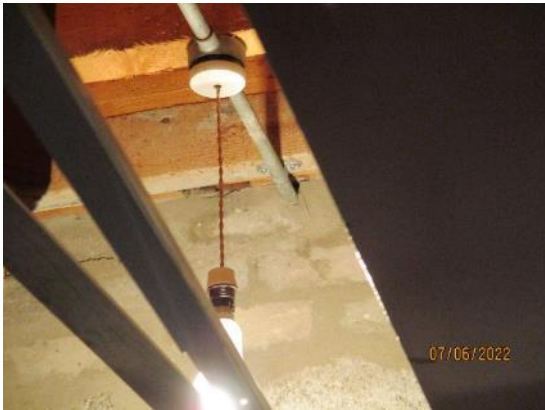
132. Lighting – cloakroom example.

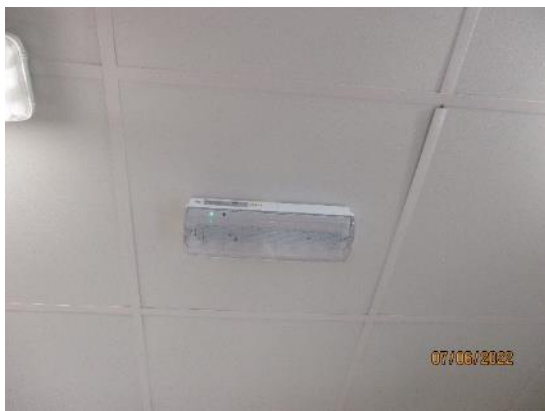
134. Lighting – class store cupboard example.

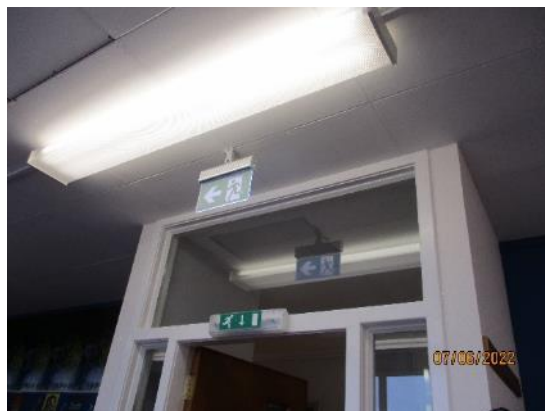
135. Emergency lighting. Typical – kitchen 1/17

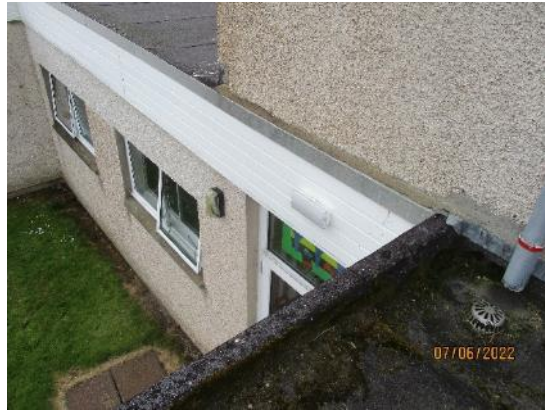
137. External lighting typical.

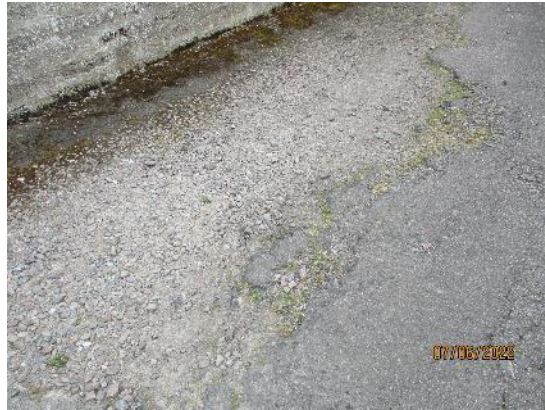
- Tarmacadam car park and rear access road is potholed and breaking up.
- Areas of concrete footpaths are breaking up.
- Precast concrete slab footpaths are damaged and uneven.
- Masonry wall to front has several open cracks.
- Timber sheds are dilapidated.

156. Surface erosion and potholes

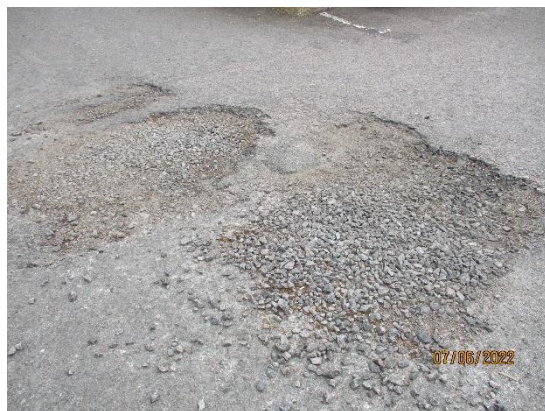
160. Surface erosion and potholes
