# **Summary Building Condition Survey Report**

**Findochty Primary School  
Burnside Street, Findochty AB56 4QW**

**11<sup>th</sup> & 12<sup>th</sup> July 2022**

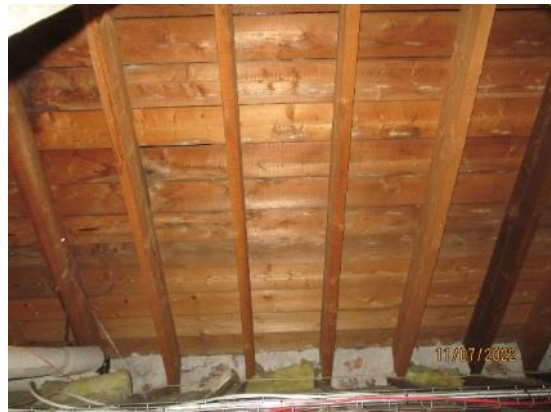
2. Timber sarking boards

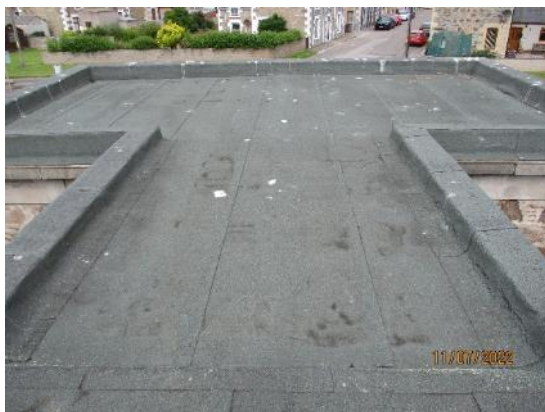
5. Felt roof above toilets

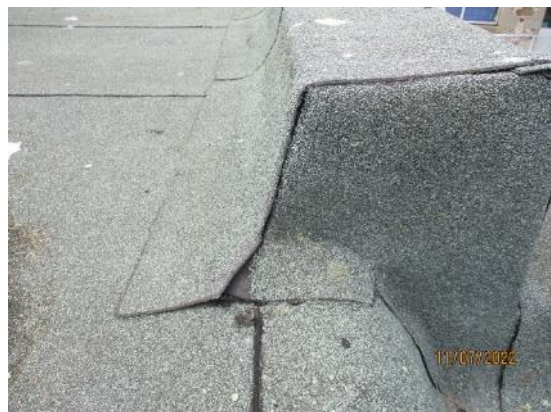
- The felt roof coverings are reaching the end of their useful life.
- The cast iron gutters appear to be in poor condition.
- Cast iron downpipes and SVP's have cracks and extensive surface corrosion.
- Stone walls of the school require isolated areas of re-pointing.
- Windows are reaching the end of their useful life, and double glazing is failing.
- Timber and aluminium external doors are rotten and twisted.
- Internal walls are cracked and damaged by rainwater penetration.
- Timber suspended floors are noisy and uneven.
- Concrete floors are uneven in the ground floor corridor.
- Internal doors are reaching the end of their useful life.
- Woodworm identified in isolated areas.

6. Open joints in felt roofing

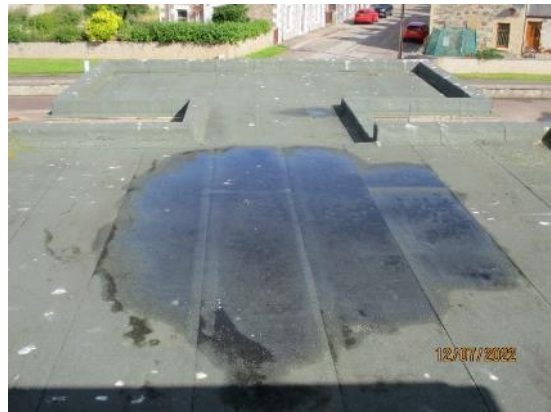
8. Ponding following overnight rain

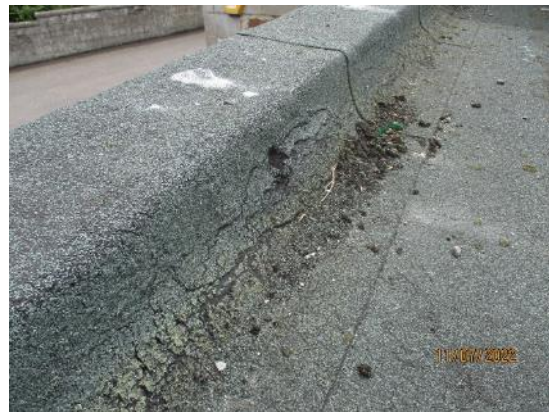
10. Cracking and blistering

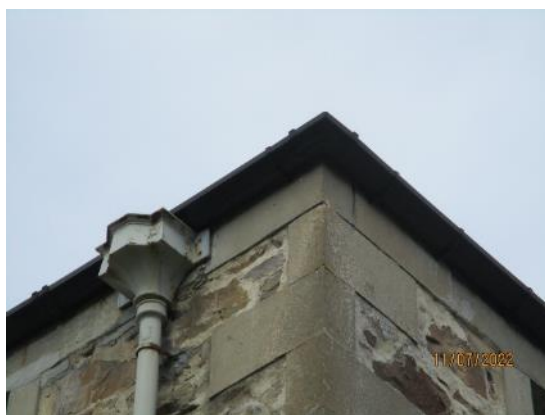
14. UPVC ogee gutter to main building

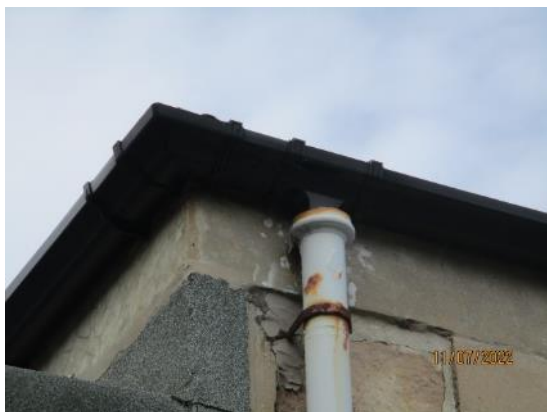
15. UPVC ogee gutter to Games Hall

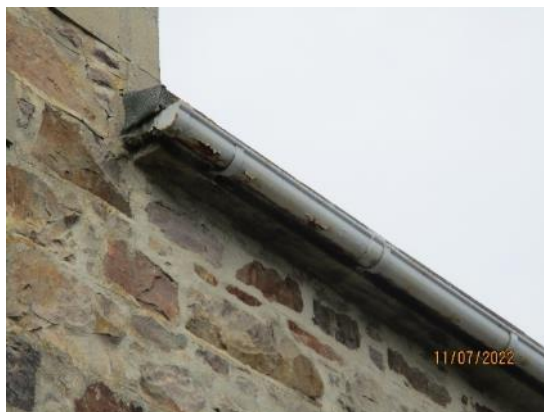
16. Cast iron gutter to first floor corridor

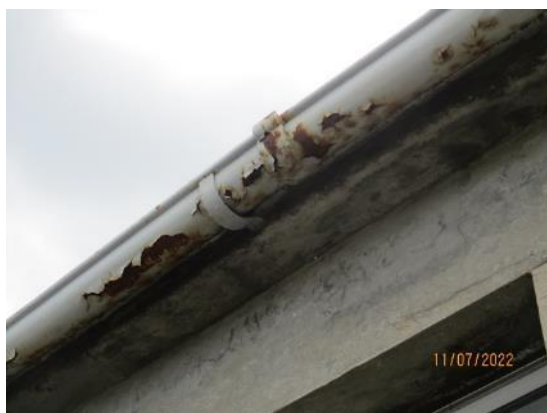
17. Extensive surface corrosion

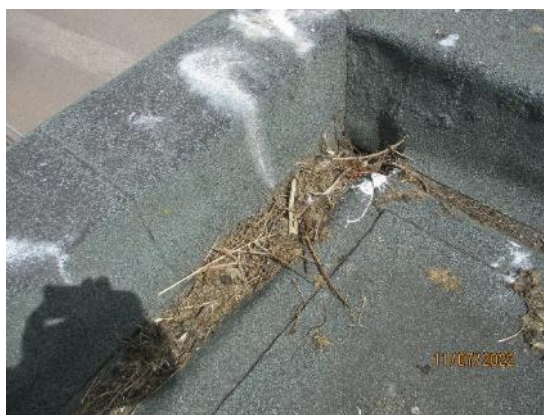
20. Outlets blocked with nesting material

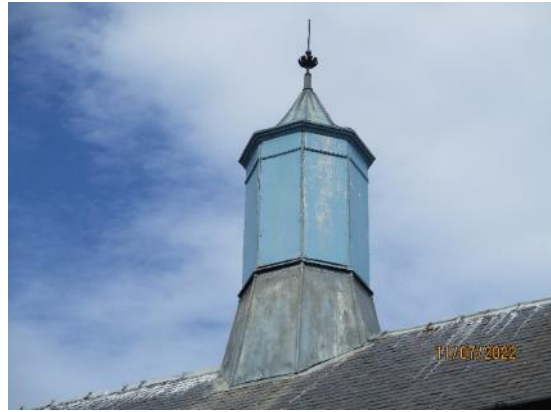
26. Octagonal bell tower with metal capping and skirt

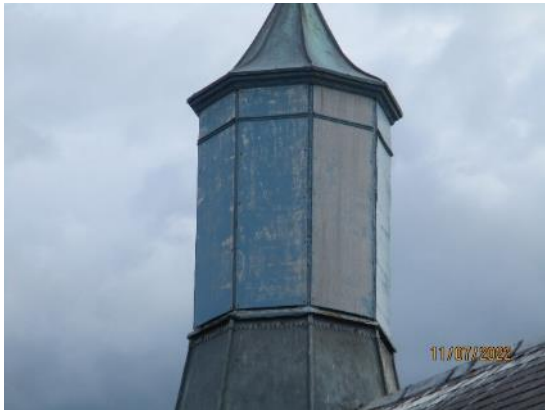
27. Timber cladding to belltower

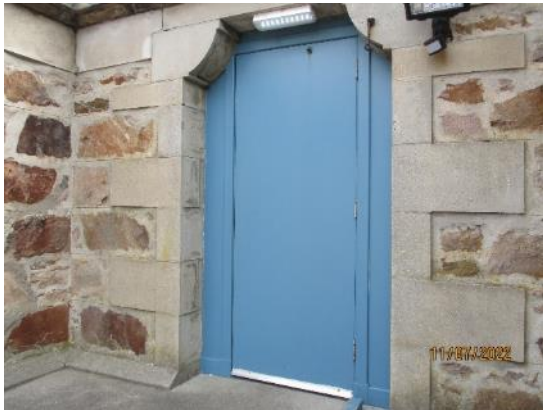
38. Timber fire escape doors

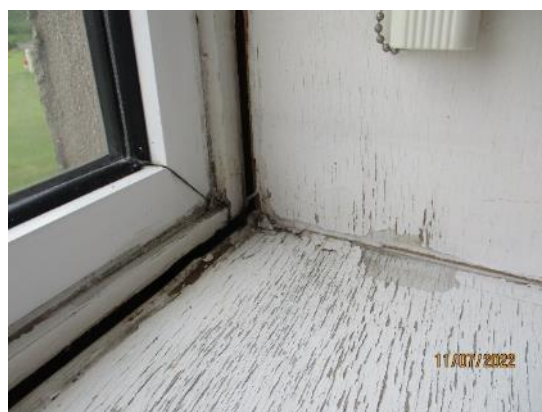
45. Gap between windows and internal frame

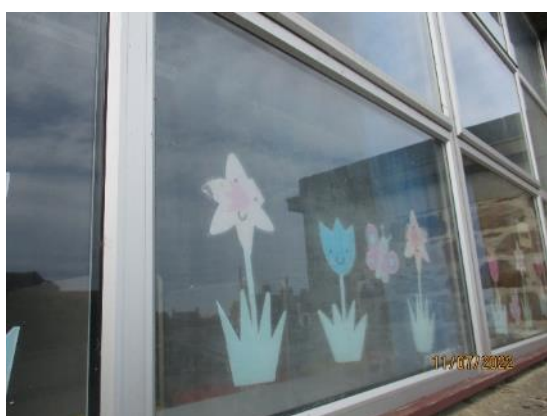
46. Fogged double glazing units

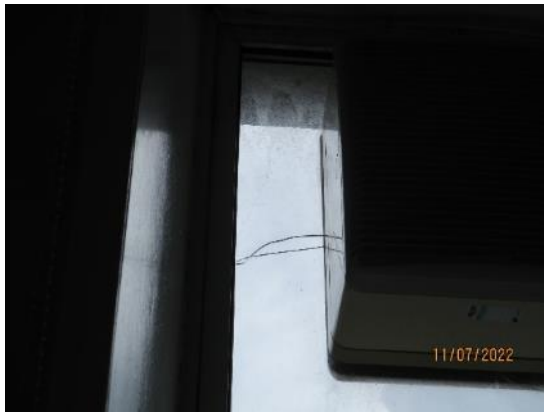
48. Broken double glazing unit

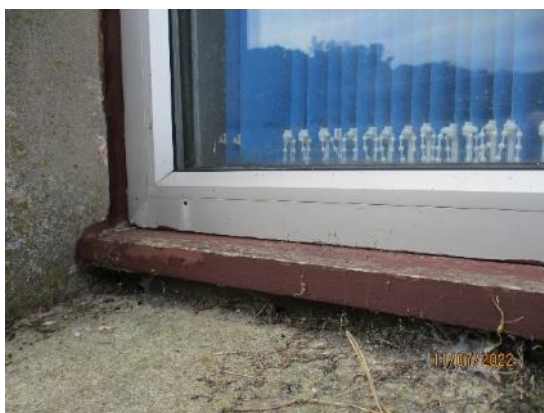
52. Timber window sills

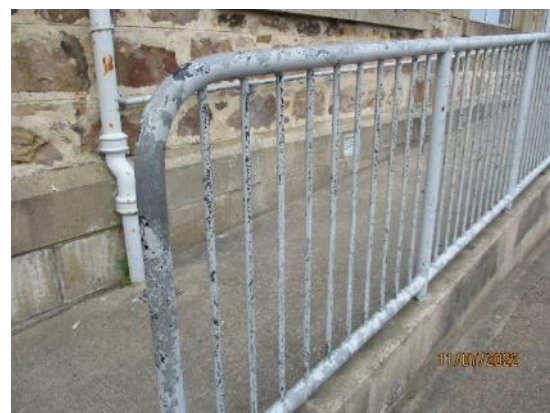
53. Railings and guard rails

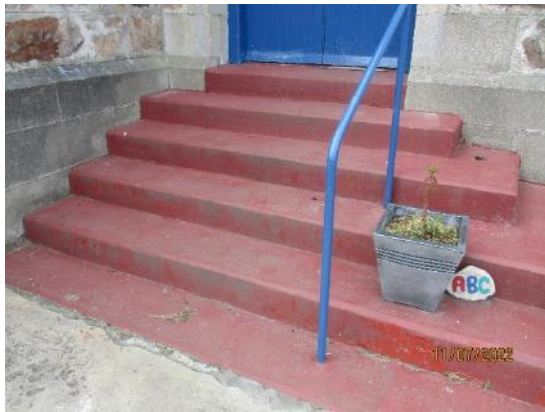
54. Concrete steps to front entrance

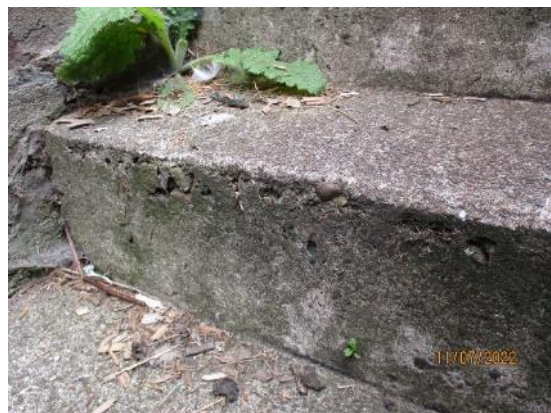
59. Minor surface erosion

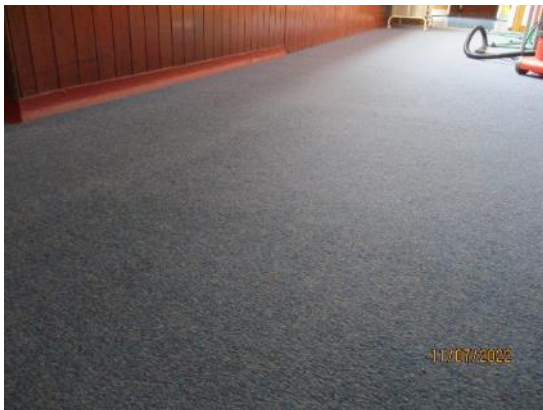
62. Concrete ground floor with raised ridge

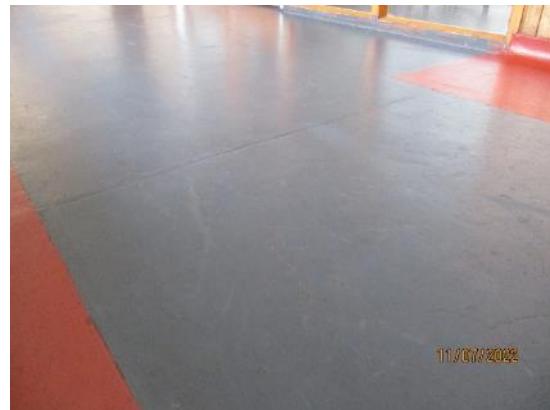
63. Concrete first floor with paint finish

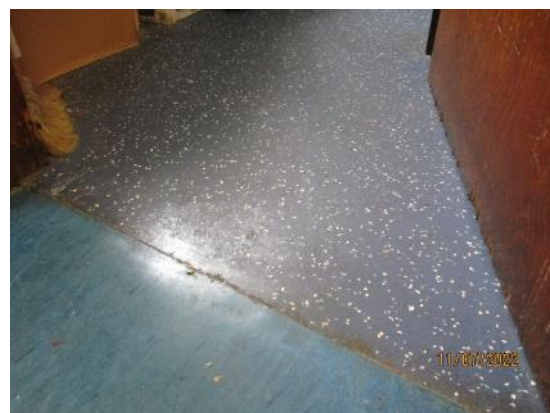
65. Sheet vinyl flooring, worn

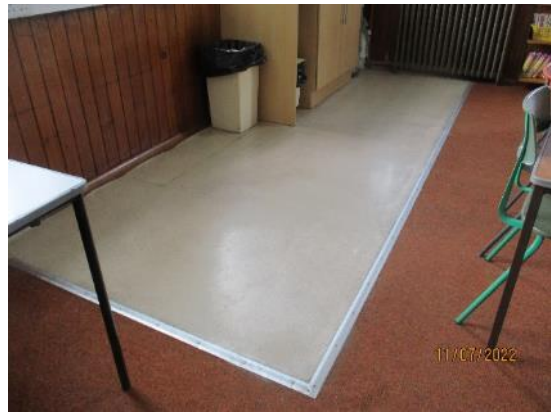
67. Sheet vinyl to kitchen sink areas

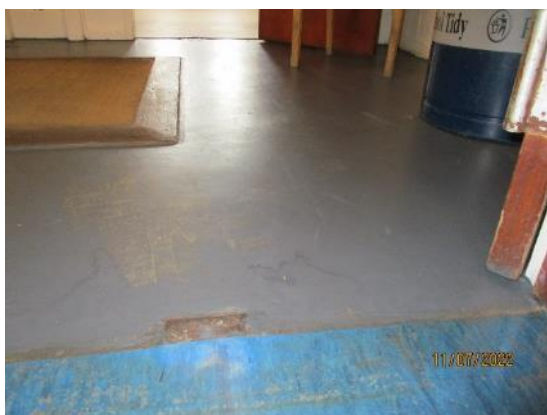
72. Painted concrete floors

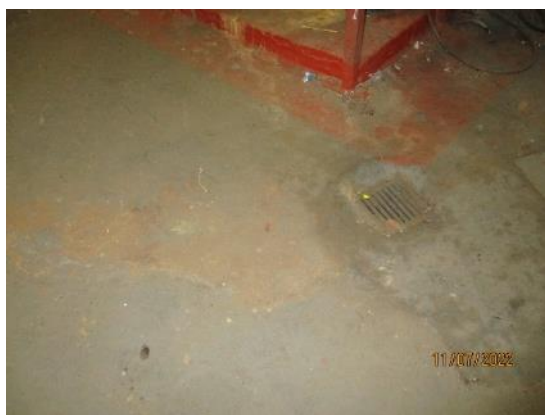
73. Boiler House concrete floor

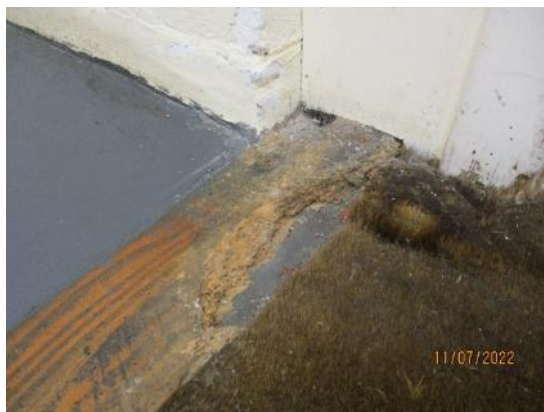
75. Extensive woodworm damage

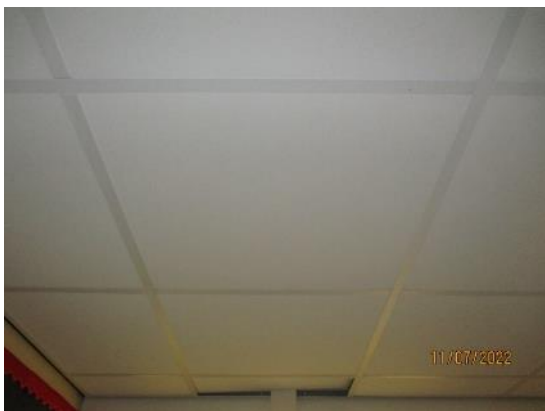
82. Suspended ceiling tiles

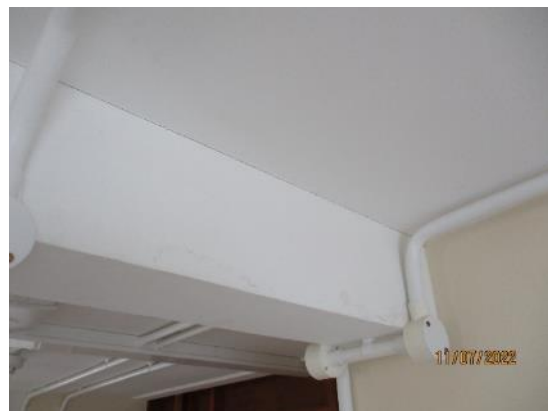
83. Plastered ceilings with concrete beams

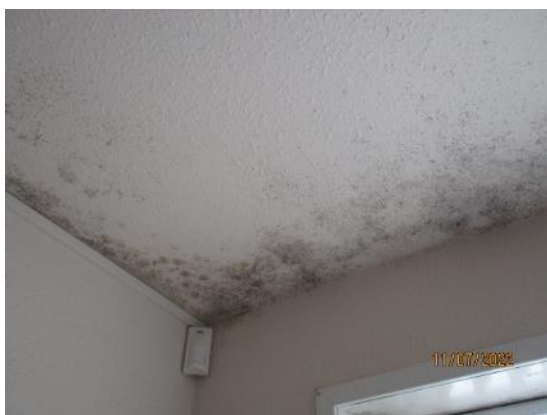
84. Plastered ceilings with mould growth

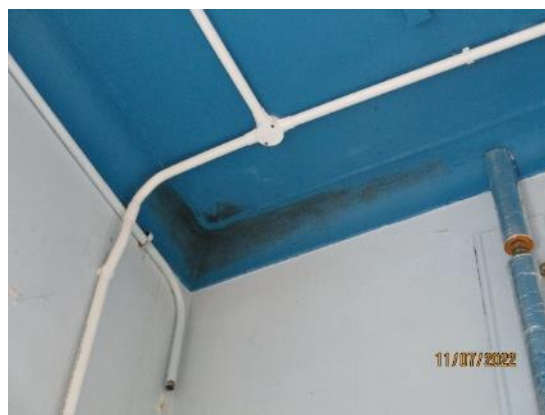
85. Lath & plaster ceilings with mould growth

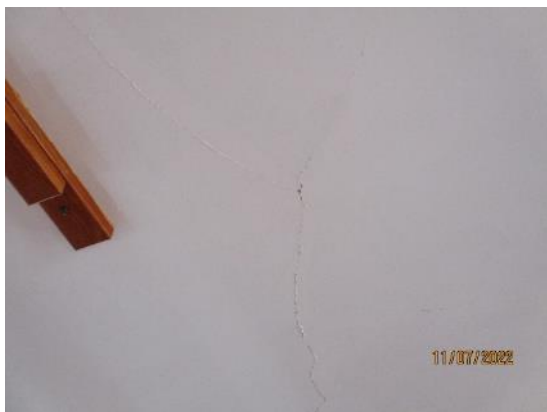
86. Cracked lath & plaster ceilings

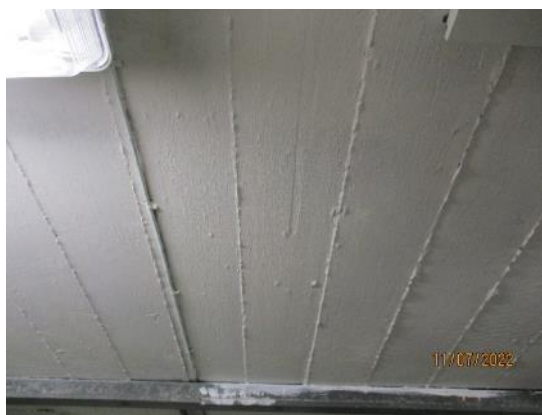
89. Concrete ceiling in Boiler House

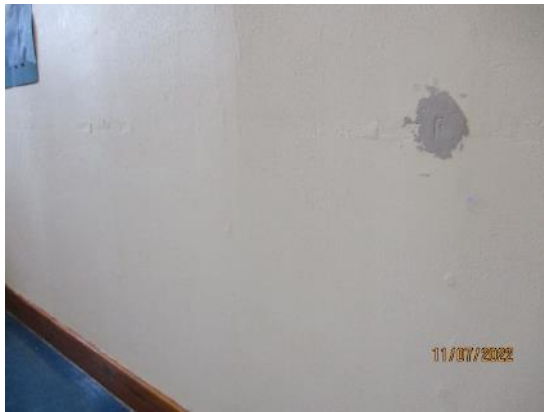
90. Repairs to plasterboard walls

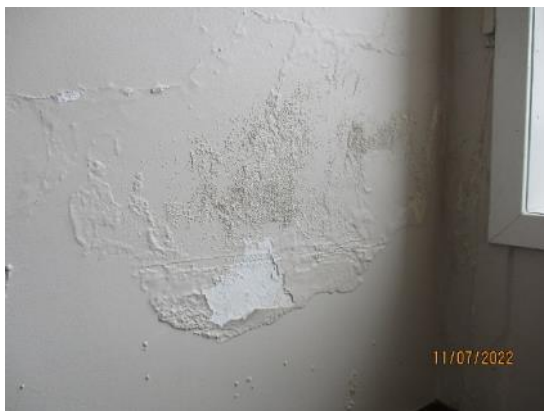
94. Damp to plastered walls

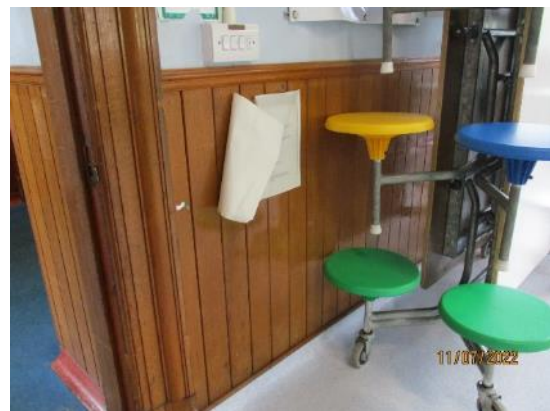
95. Timber linings to dado level

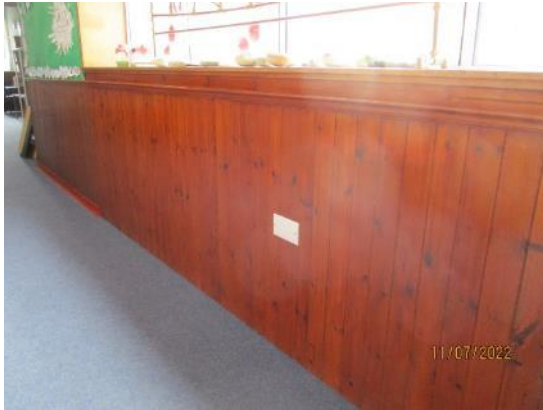
96. Timber linings to corridors

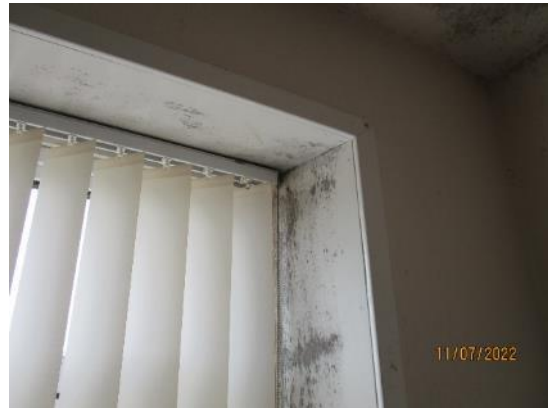
99. Plywood window reveals

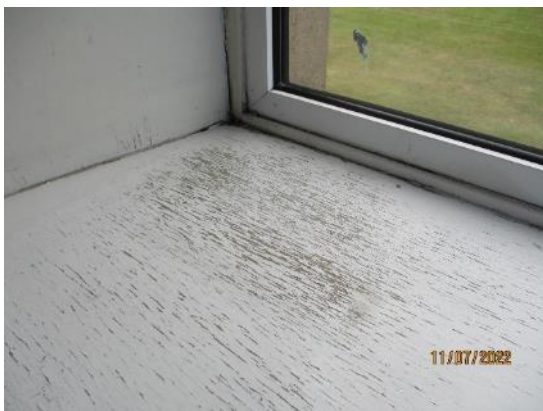
100. Plywood window sills

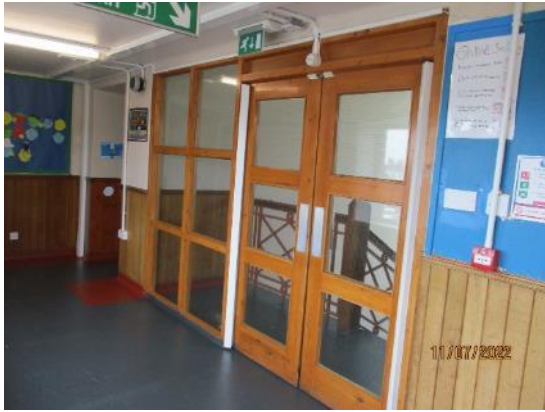
102. Timber doors and screens to stairs

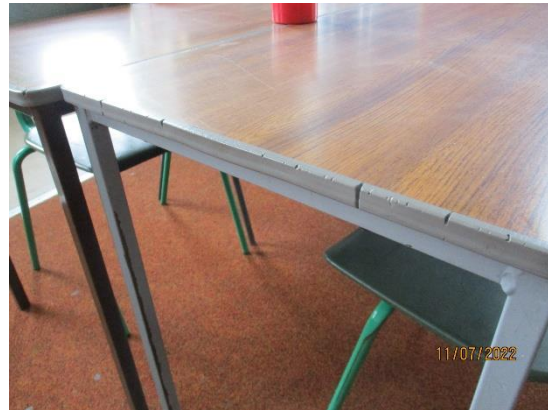
135. Typical damage to desks

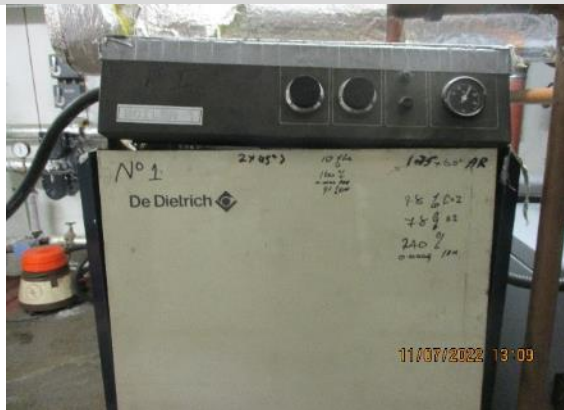
- Heating system heat emitters are in poor condition and life expired as per CIBSE guide M for life expectancy.
- Boiler no.1 is in poor condition and life expired as per CIBSE guide M for life expectancy.

137. Oil Boiler no.1 – Basement boilerhouse 0-41

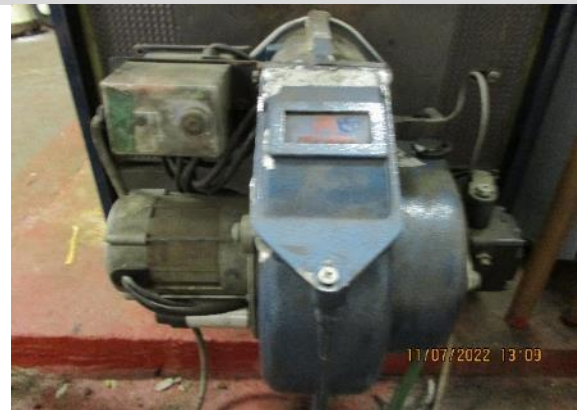
138. Boiler no.1 Burner assembly

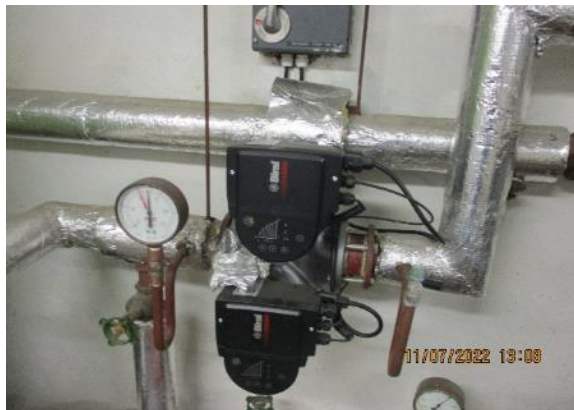
139. Pumps – Primary boilerhouse 0/41

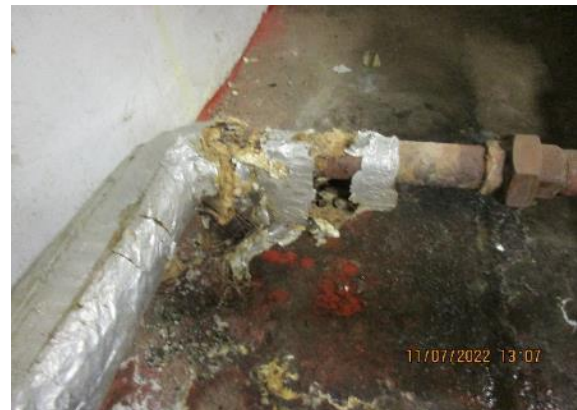
- Heating system pipework including feed and expansion tank is in bad condition, only partly insulated and at risk of serious imminent failure, particularly under floor.

140. Pipework – Heating system boilerhouse 0/41

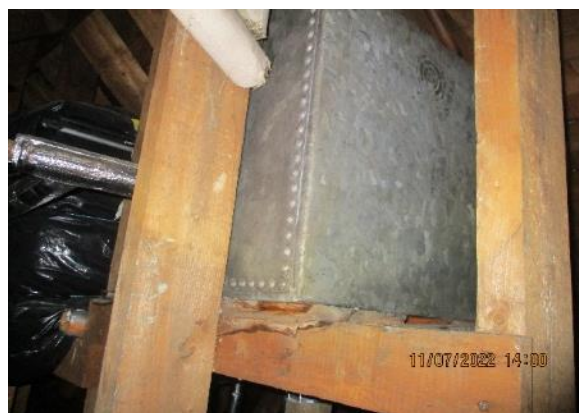
141. Heating system feed and expansion tank. Attic.

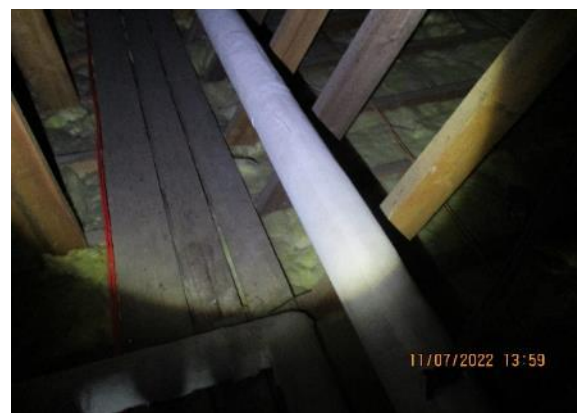
142. Heating pipework – attic space.

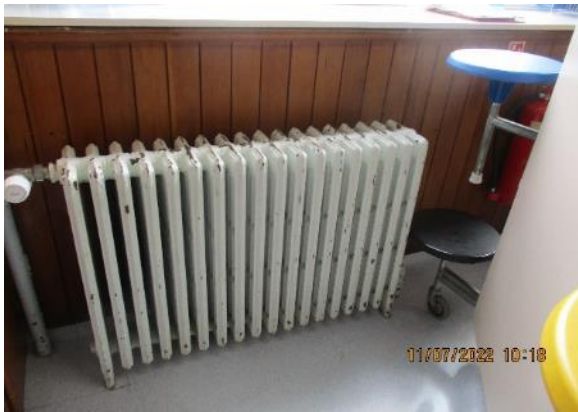
143. Radiator – heating system. Kitchen / cast iron.

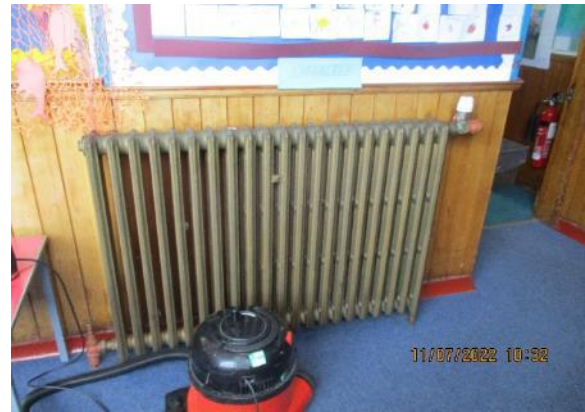
144. Radiator – heating system typical.

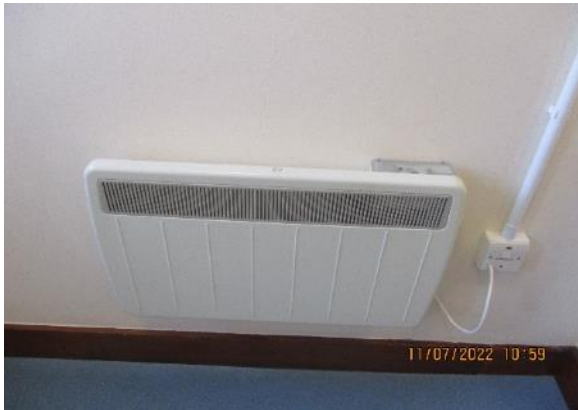
- External lights are showing signs of corrosion and approaching the end of their useful life.
- Electric point of use water heaters are in poor condition and approaching the end of their useful life.
- Electric convector heaters in the boys and girls toilets are in poor condition.

145. Electrical Convactor heater – Girls toilet. 1/8

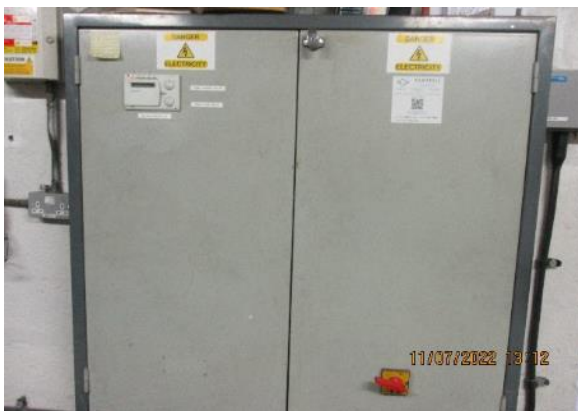
- Heating system control panel and controls are poor and could be improved to aid energy efficiency and performance.
- Hot and cold water pipework is in poor condition and life expired as per CIBSE guide M for life expectancy. It is also only partly insulated.

147. Heating control panel – boilerhouse 0/41

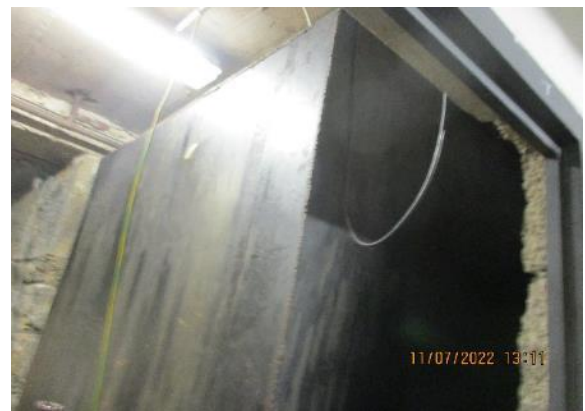
148. Oil storage tank – boilerhouse 0/41

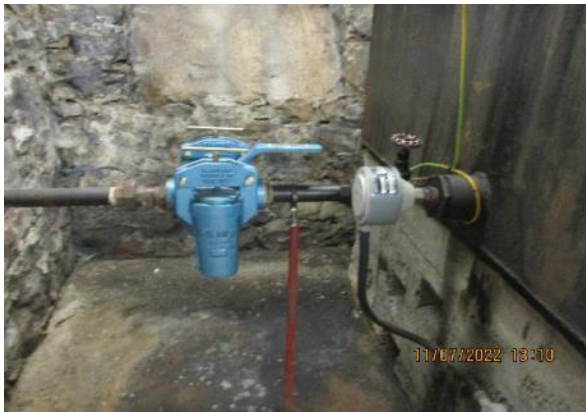
149. Oil pipework and control devices. Boilerhouse 0/41

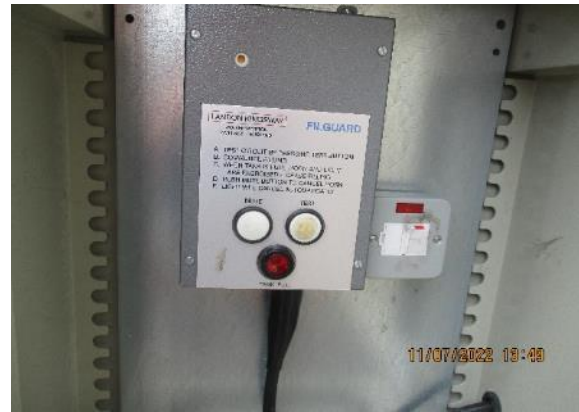
150. Oil tank overfill alarm device – external.

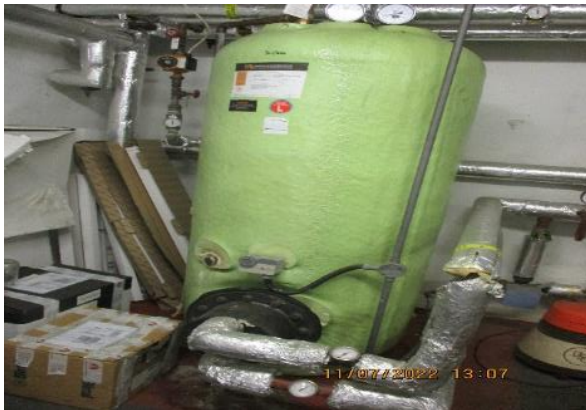
151. Hot water storage calorifier. Boilerhouse 0/41

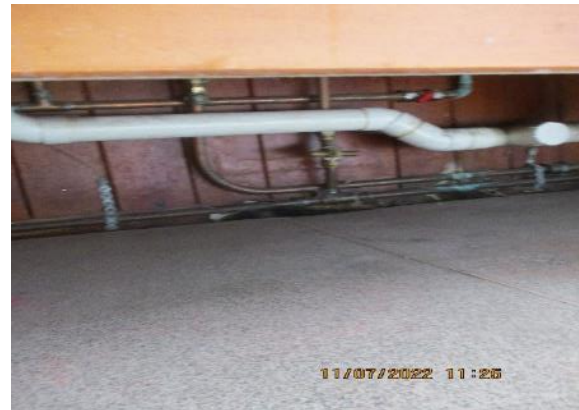
152. Pipework – hot water class 1/25.

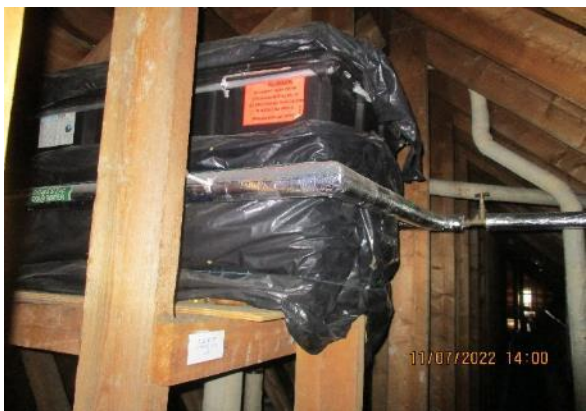
153. Cold water storage tank. Attic.

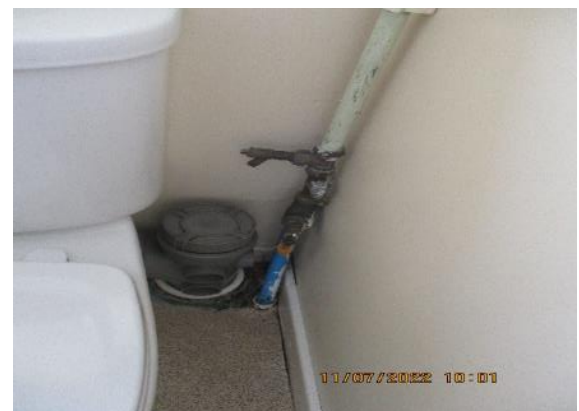
154. Cold water supply pipework. Girls toilet 1/8

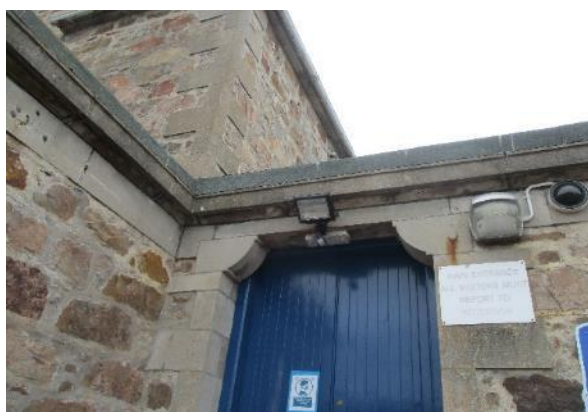
169. External lighting. Bulkhead and flood. Main entrance

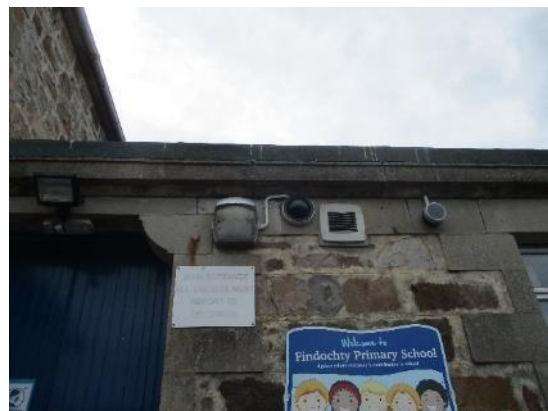
184. CCTV camera. Main entrance.

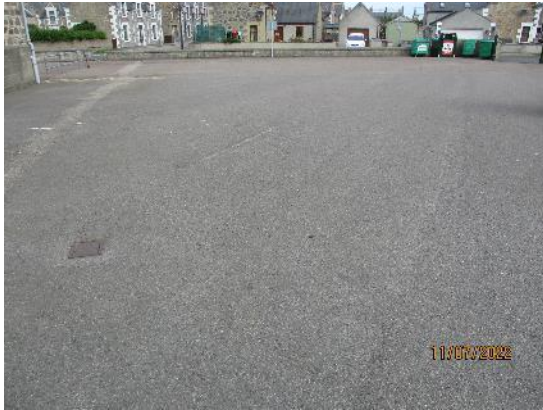
185. Tarmacadam car park

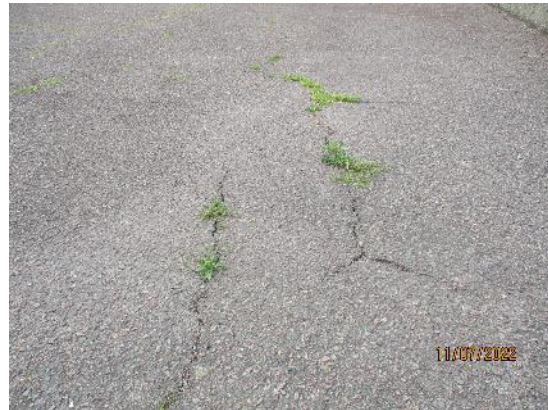
188. Surface cracking and vegetation

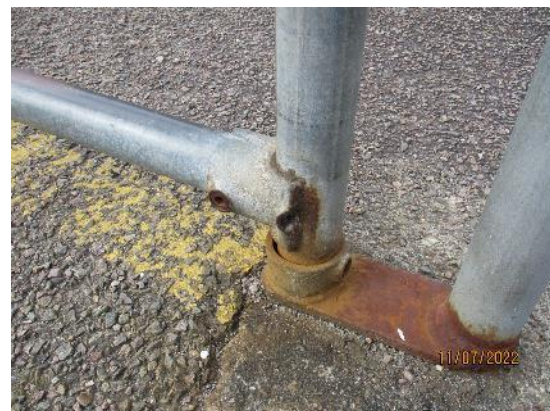
196. Surface corrosion and damage

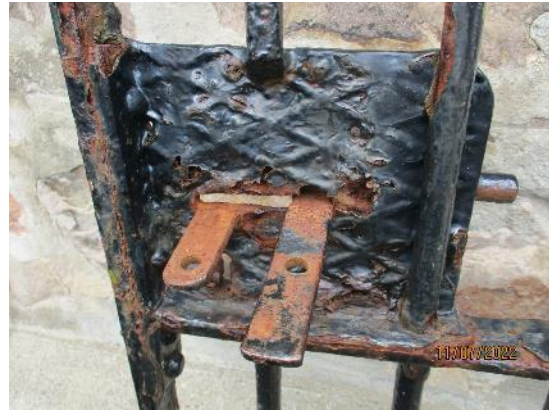
200. Extensive penetrating corrosion

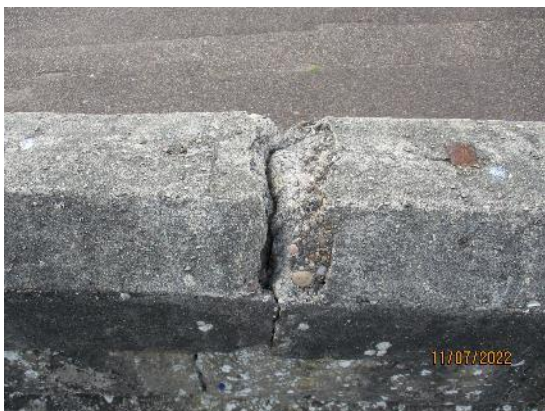
- The HORSIA hut is boarded up, is no longer in use and has exceeded its useful life.
- The concrete coping to the front wall is cracked and spalling.
- The cover of the inspection chamber in the playground is corroded and raised.
- The basketball stands are corroded and the backboards are laminating.
- There are large depressions in the surface of the sports field, at the goal mouths.

203. Damage to concrete coping

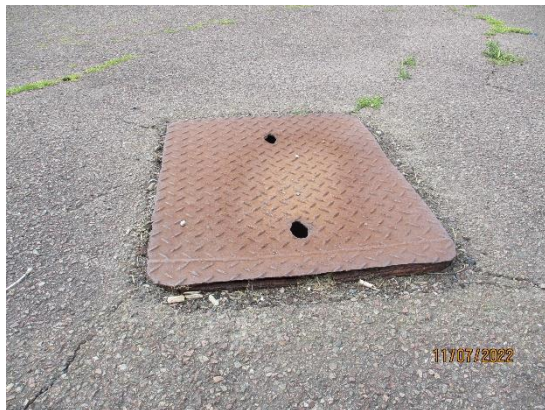
207. Raised playground inspection chamber

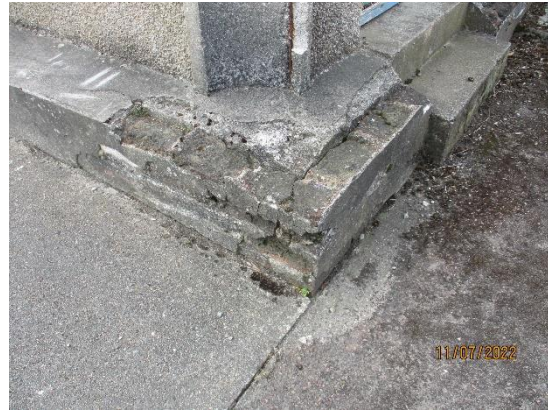
212. Brick plinth, breaking up

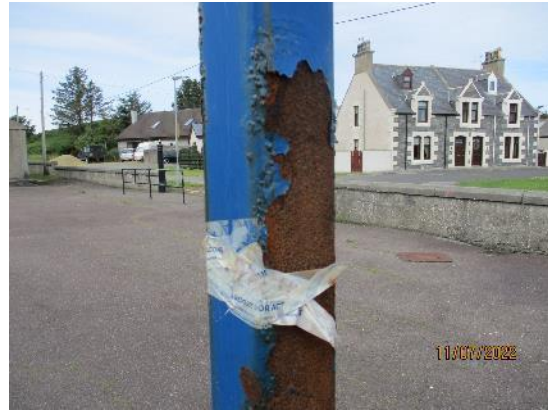
218. Steel stands with surface corrosion
