# **Summary Building Condition Survey Report**

**Millbank Primary School  
McWilliam Crescent, Buckie AB56 1LU**

**18<sup>th</sup> & 19<sup>th</sup> July 2022**

Z00445 / ADC & NS

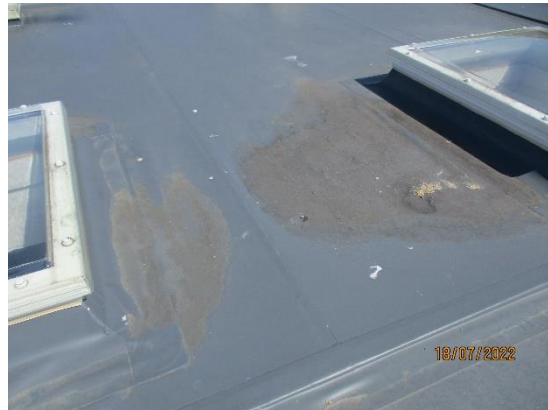
4. Areas of ponding

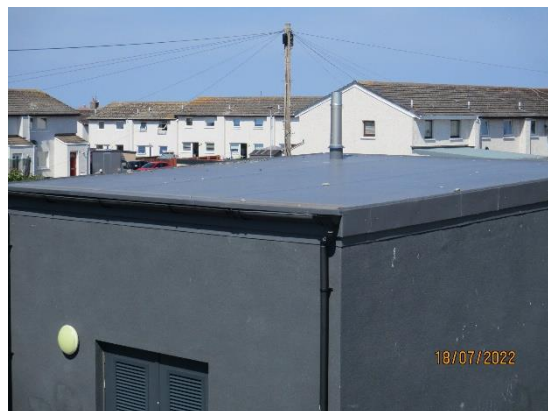
6. Boiler house single ply membrane

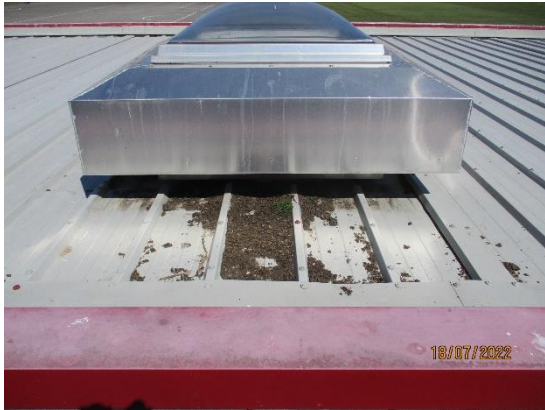
7. Roof cleaning required

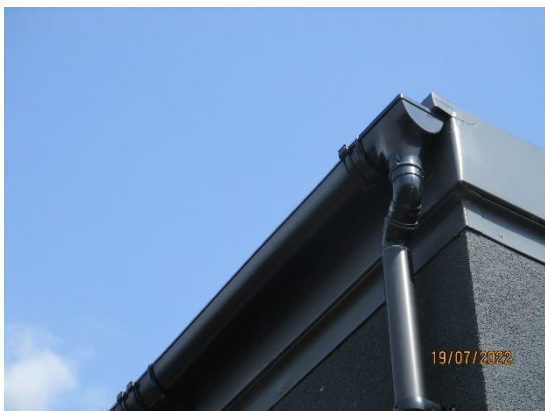
11. Gutter to boiler house

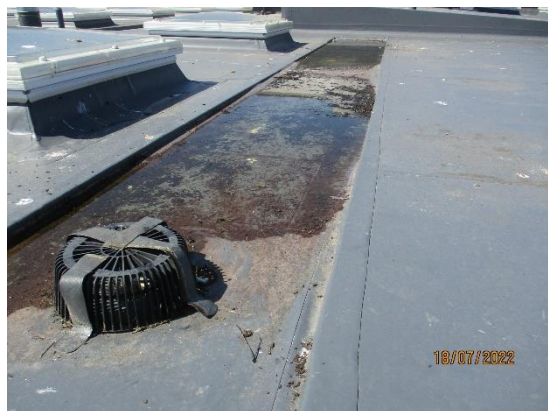
12. Flat roof gutters ponding

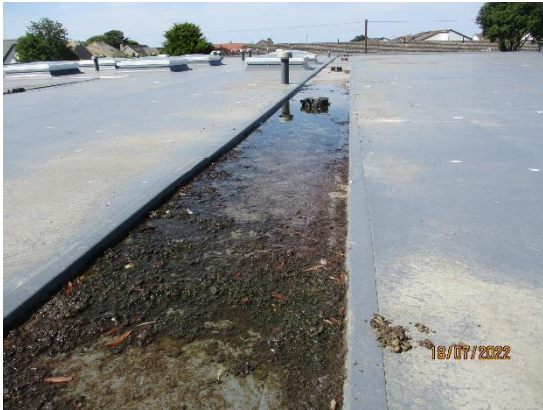
13. Partially blocked gutters

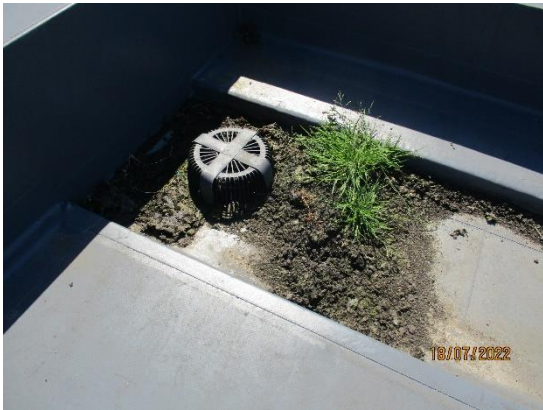
15. Partially blocked gutters

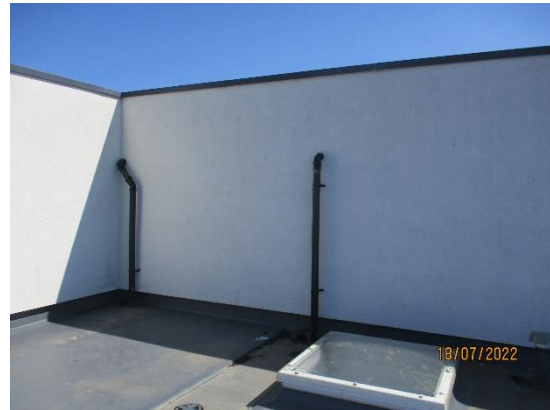
16. Downpipes from Games Hall roof

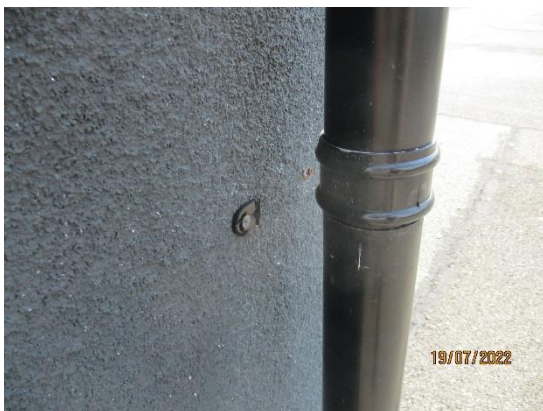
17. Boiler house downpipes – broken brackets

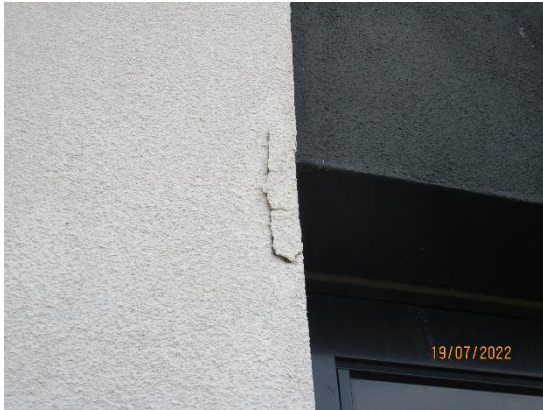
25. Damage to external insulation

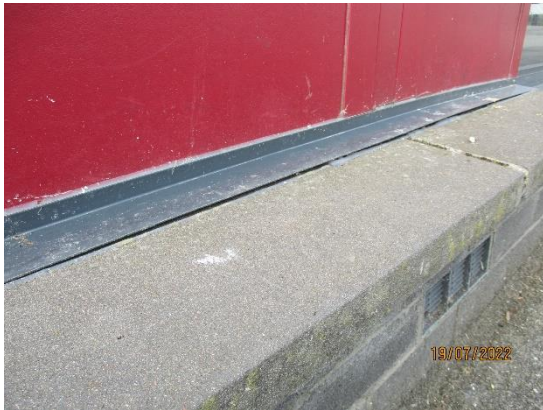
27. Poor sill detail

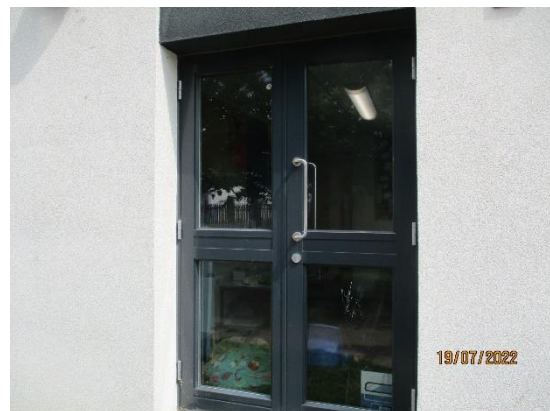
30. Fire exit double, glazed doors

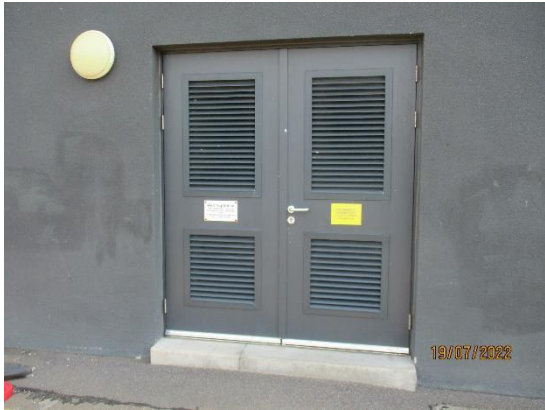
31. Boiler house timber louvred doors

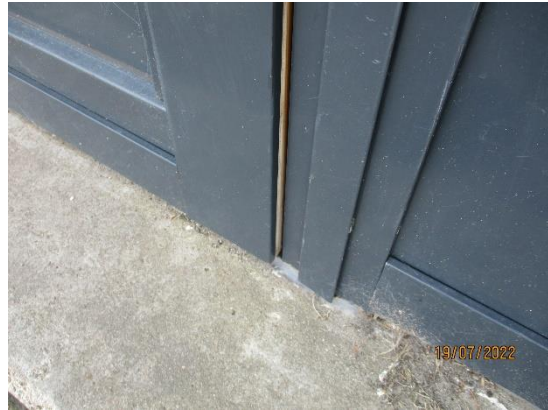
32. Poor fitting fire escape doors

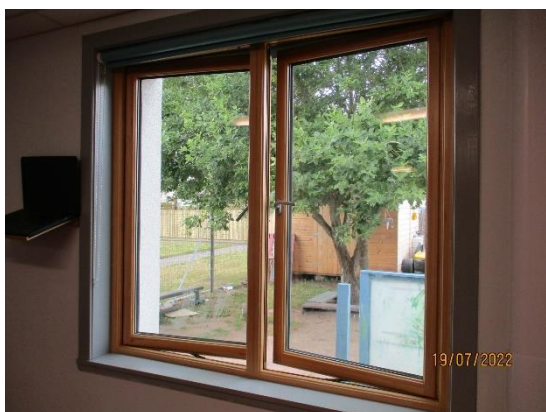
37. Typical window (internally)

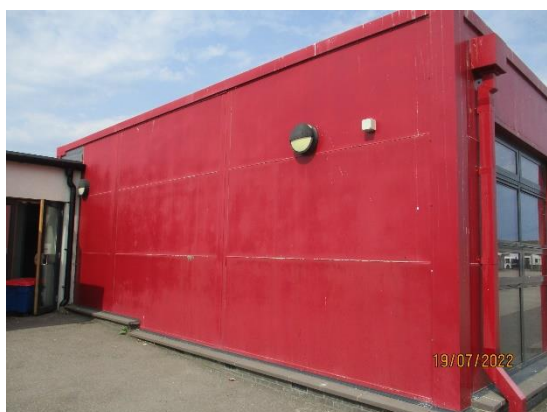
39. Smooth cladding to pods extension

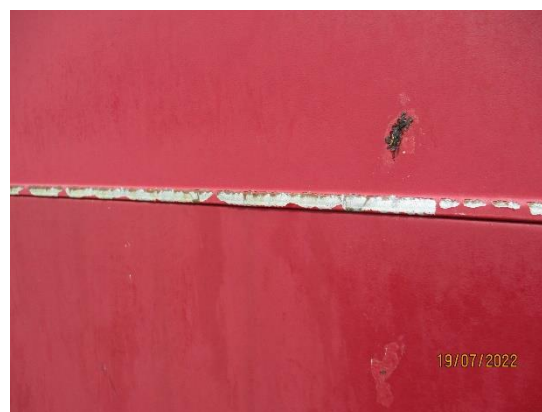
40. Peeling and flaking paint

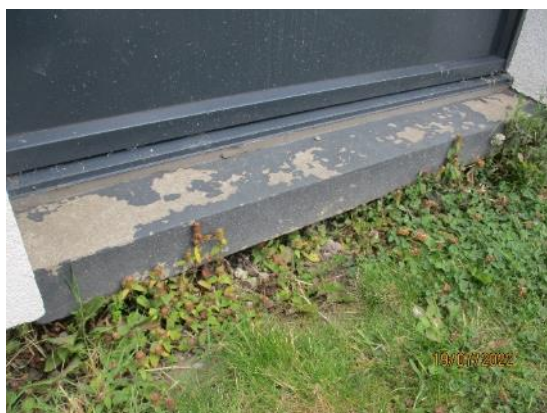
41. Painted concrete sills

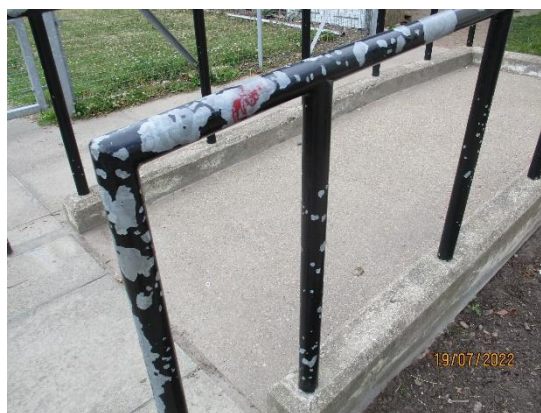
42. Peeling paint to guardrails

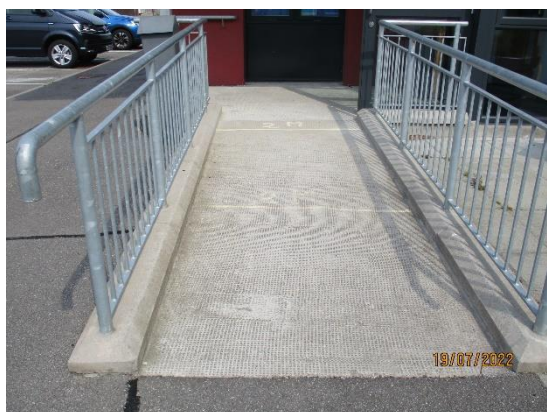
43. Concrete ramp to main entrance

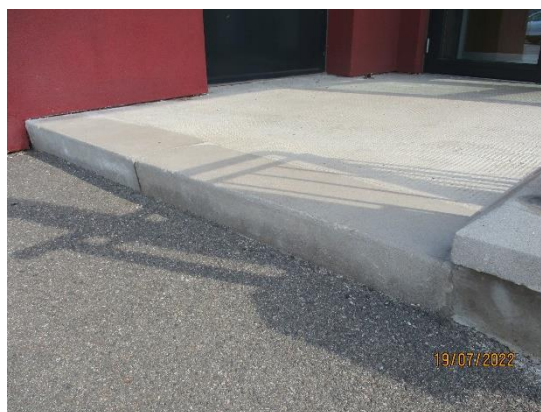
44. Concrete step to main entrance

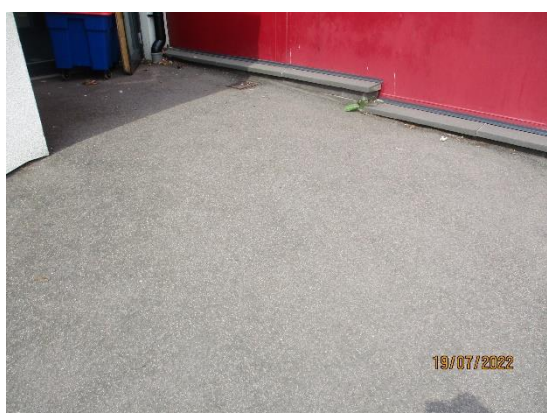
47. Tarmac ramp to fire exits

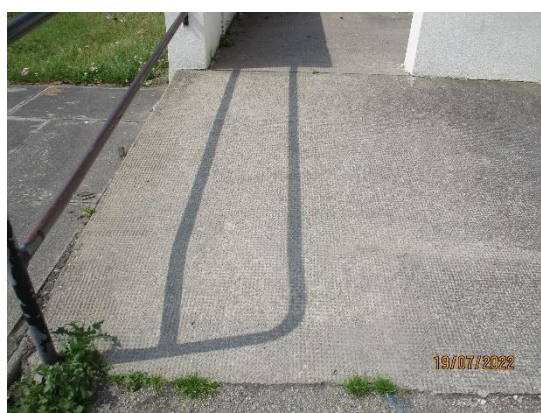
48. Concrete ramps to fire exits

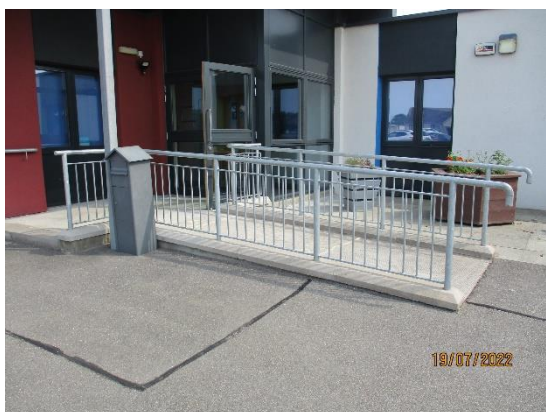
49. Tubular guard rail to front entrance

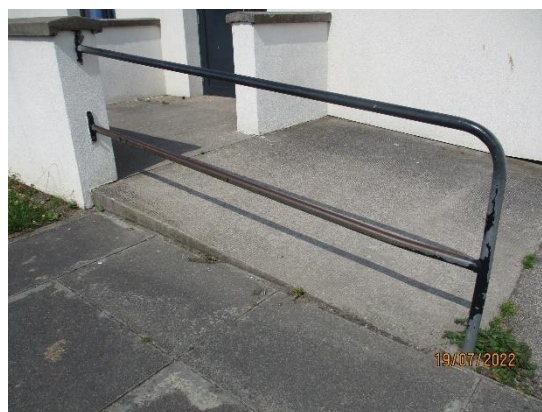
50. Tubular guard rail to fire exits

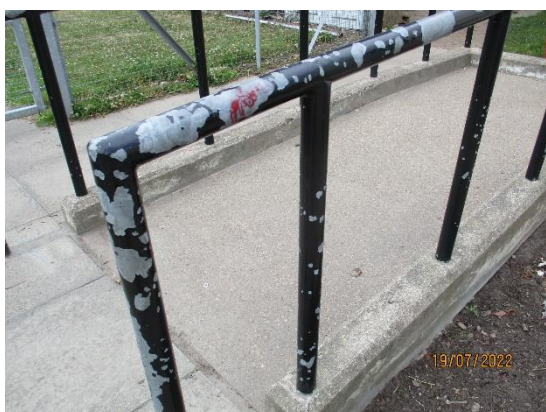
51. Tubular guard rail to Nursery

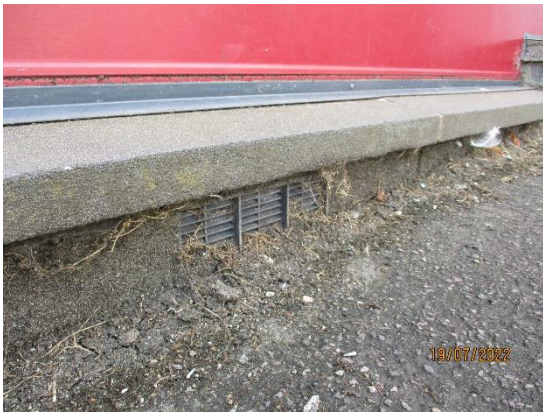
54. Ventilation below suspended timber floor

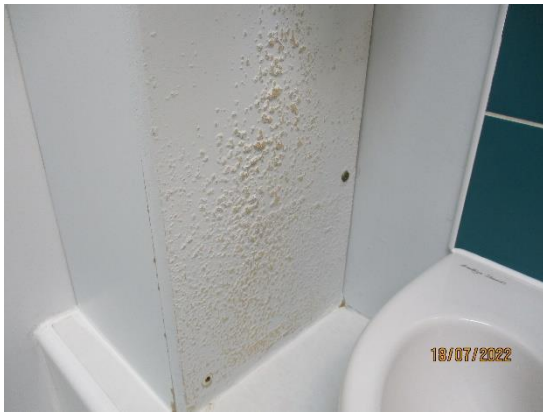
110. Blistering paint to pipe boxes

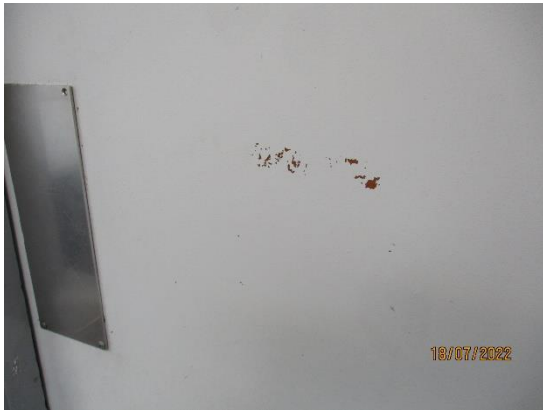
112. Chipped paint to timber doors

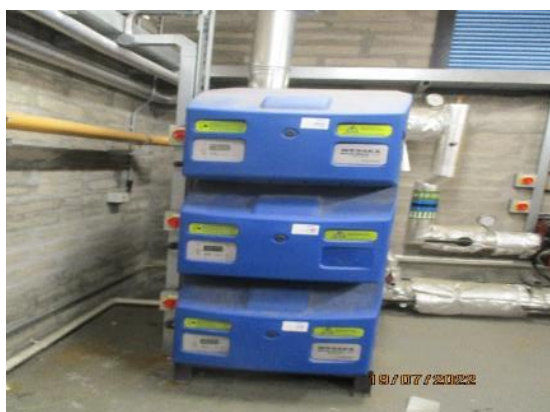
124. Natural gas modular boiler unit – 3 modules

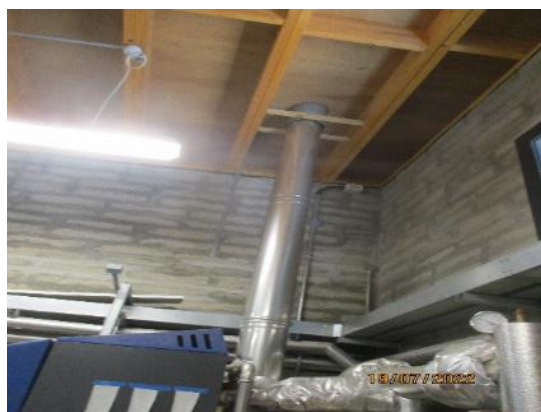
125. Gas boiler stainless steel flue. Plant room.

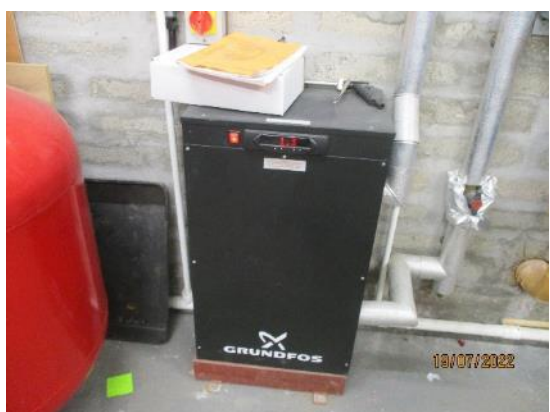
126. Pressurisation unit heating system – plant room.

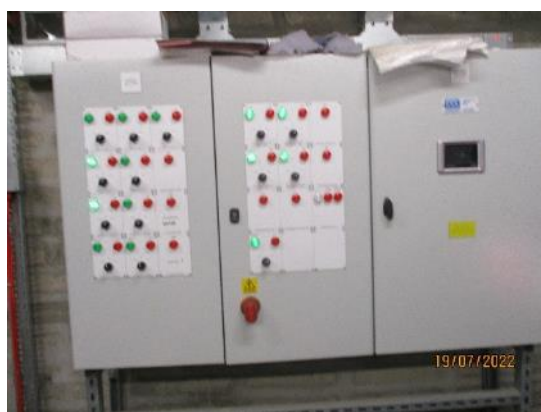
127. BMS heating control panel. Plant room.

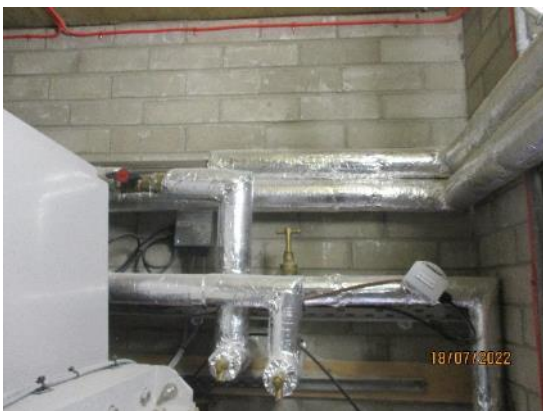
139. Cold water storage tank – above hall cupboard.

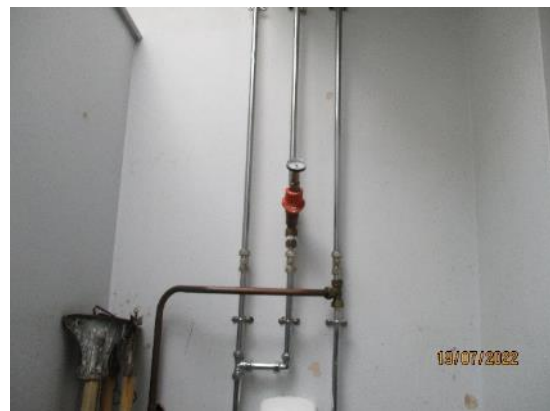
140. Pipework – cold water distribution at tank.

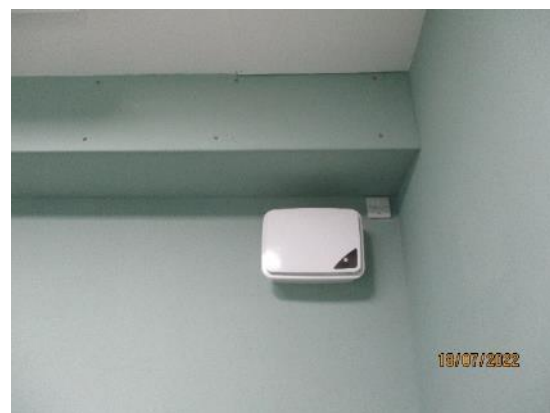
146. Extract fan – boys toilets.

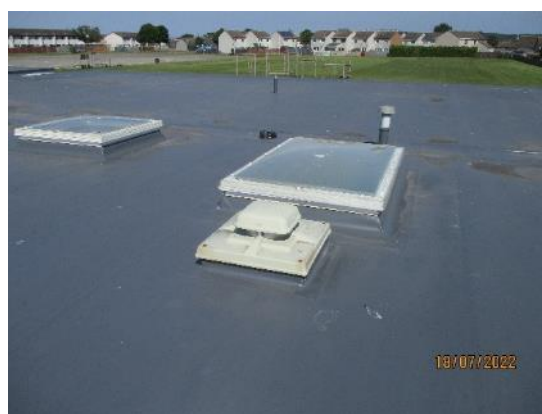
148. Extract fan – roof mounted. Kitchen roof.

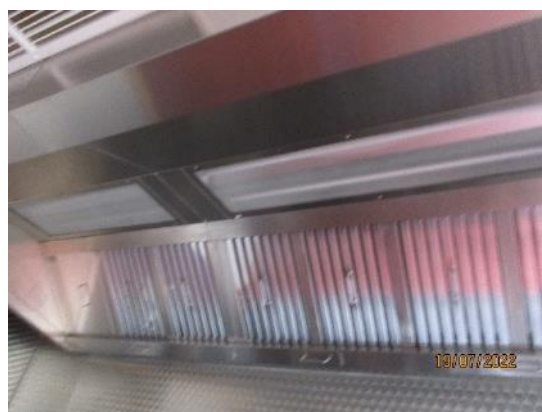
150. Extract fan and canopy. Main kitchen/dishwasher.

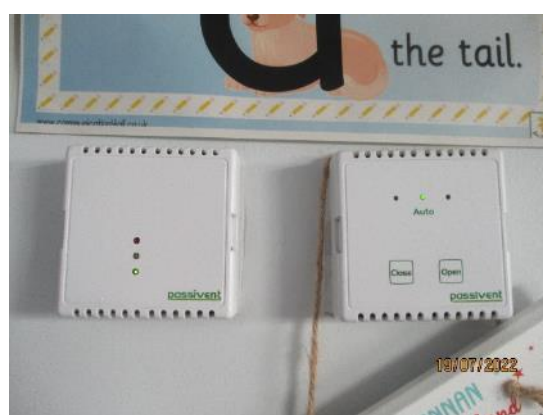
152. Passivents – modular classrooms. Typical.

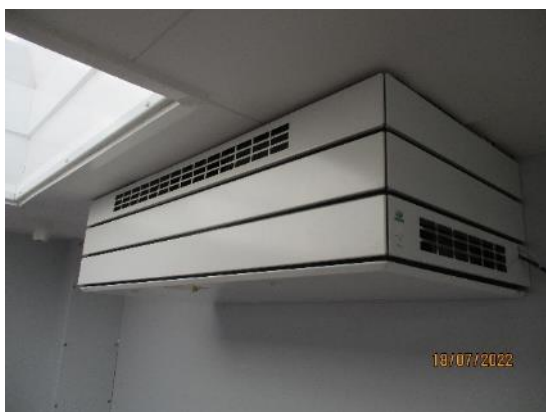
153. Passivent controls. Modular classrooms. Typical.

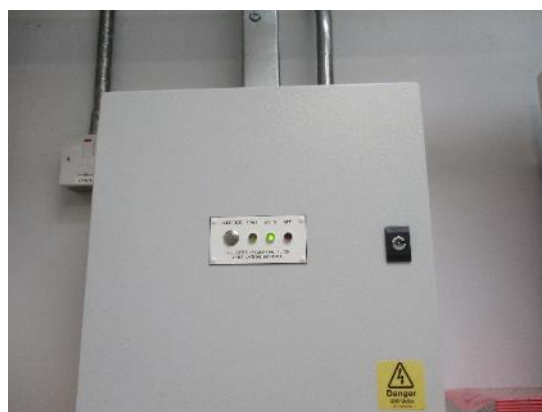
156. Electrically operated windows. Modular classrooms.

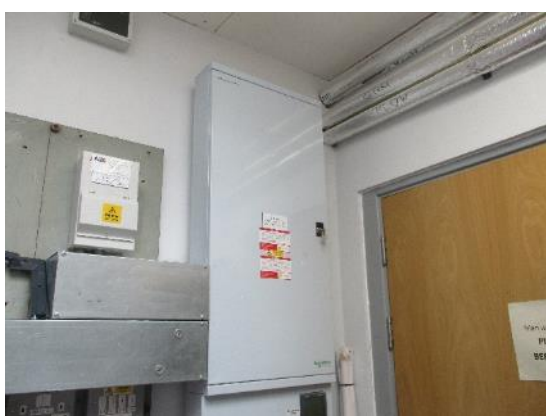
157. Hall ventilation units control panel.

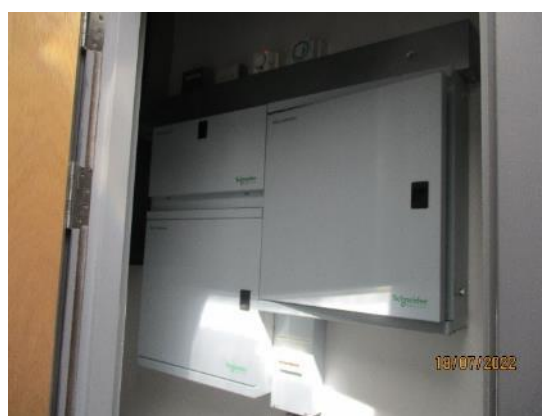
158. Electrical distribution board – switch room

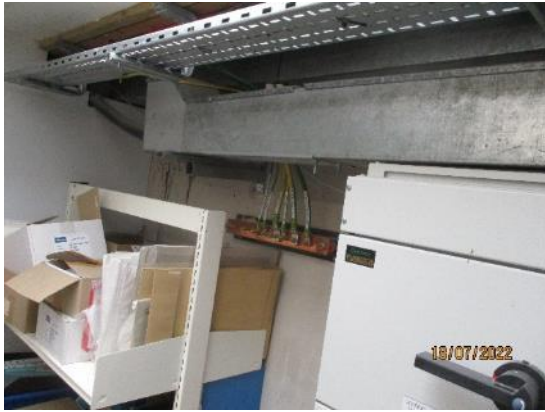
159. Electrical distribution boards – lighting and power

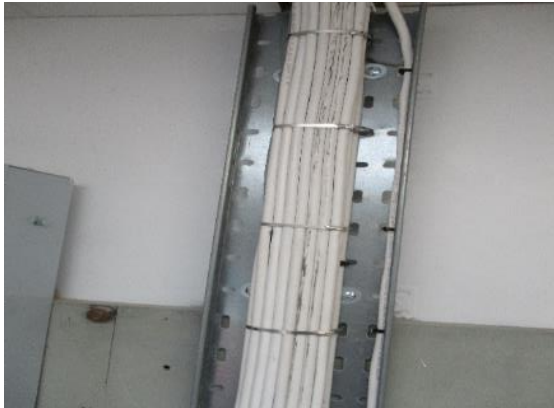
161. General wiring – switch room.

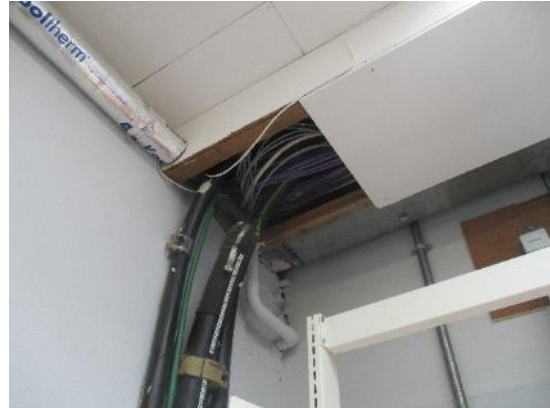
162. General wiring – circuit distribution. Switch room.

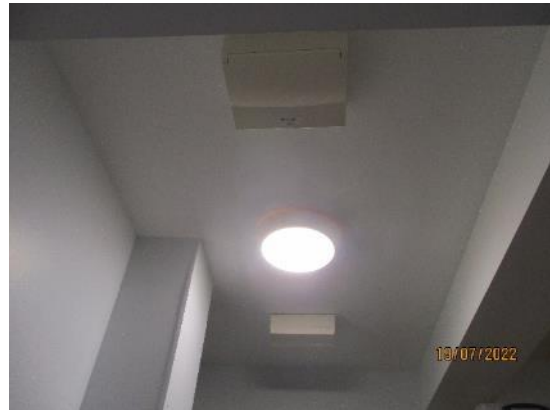
168. Lighting main school classroom.

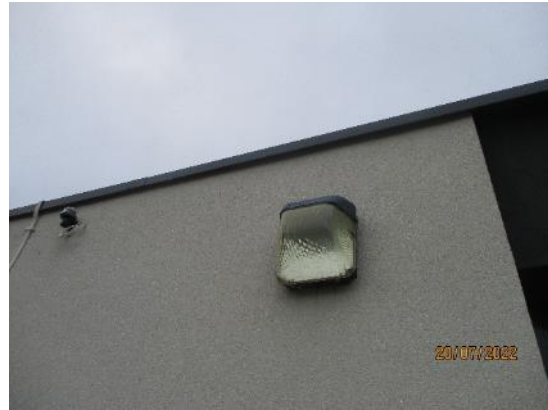
172. External Lighting main school typical.

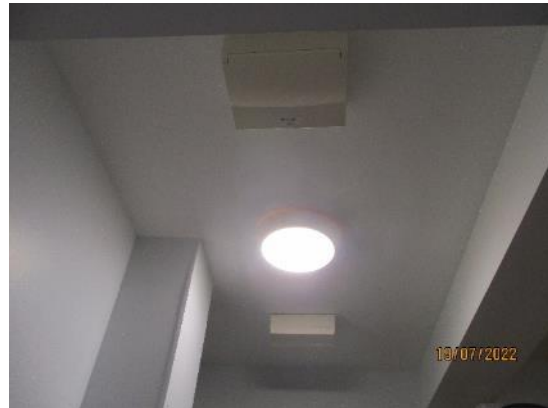
174. Lighting main school classroom.

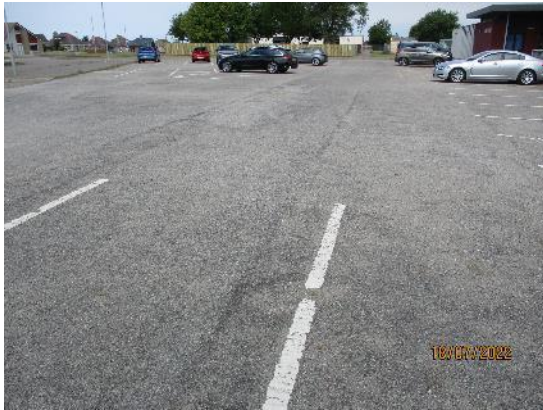
196. Tarmacadam car park

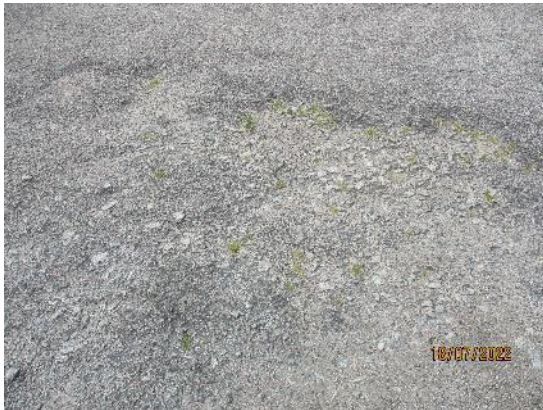
- Tarmacadam car park – surface erosion, potholes and surface vegetation.
- Car park drainage, partially blocked.
- Playground surface – previous repairs, cracking and surface vegetation.
- Playground drainage, partially blocked.
- Nursery grass playground, worn and missing grass.
- Holes in Nursery paving slabs.
- Sunken tarmacadam in Nursery playground.

198. Eroded surface and potholes

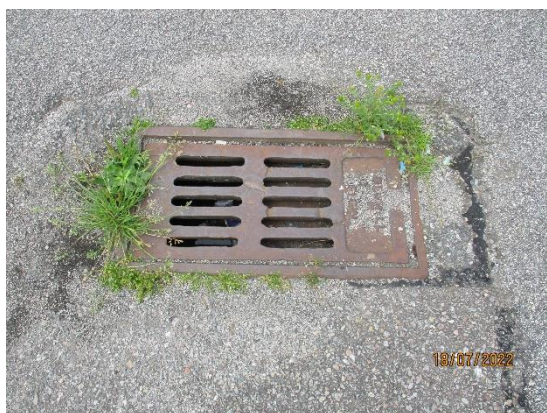
218. Partially blocked playground drainage

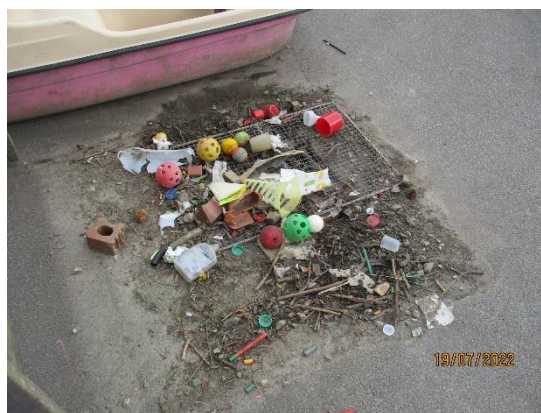
219. Partially blocked Nursery drainage

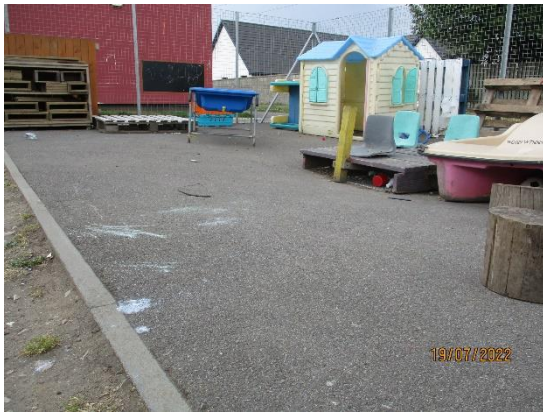
220. Sunken Nursery playground/drainage
