# **Summary Building Condition Survey Report**

**Portessie Primary School  
School Road, Portessie AB56 1TN**

**24<sup>th</sup> & 25<sup>th</sup> August 2022**

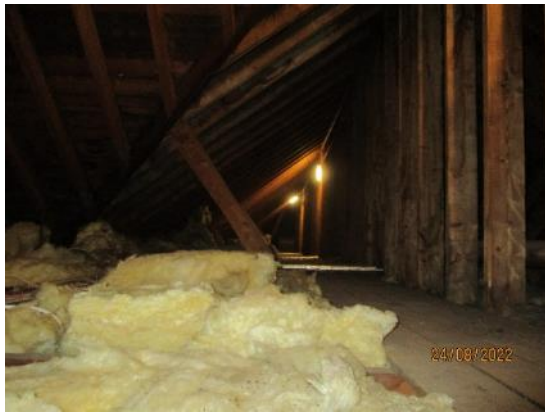
1. Main school trussed roof

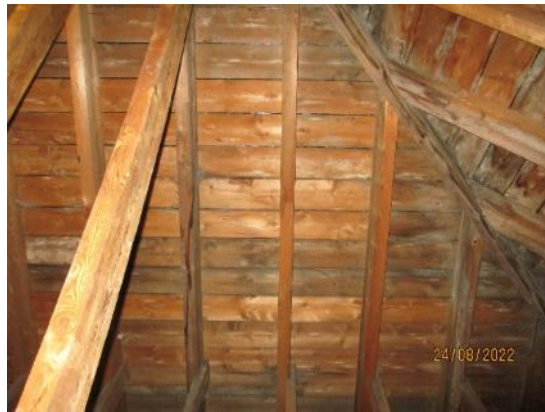
2. Timber sarking boards

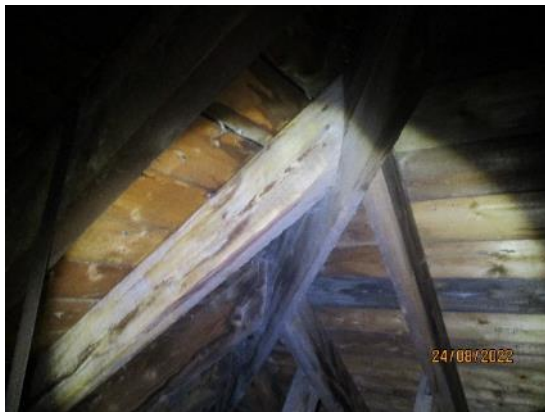
3. Evidence of previous water penetration

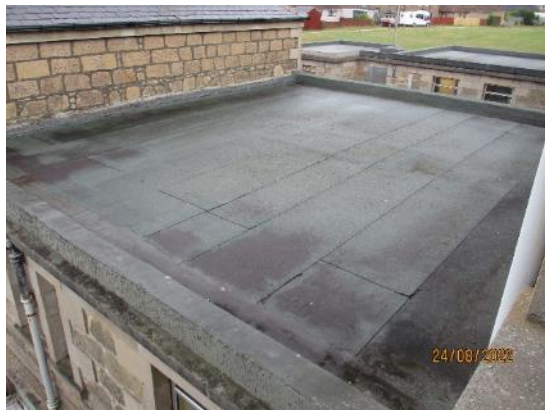
9. Silt on felt roofs

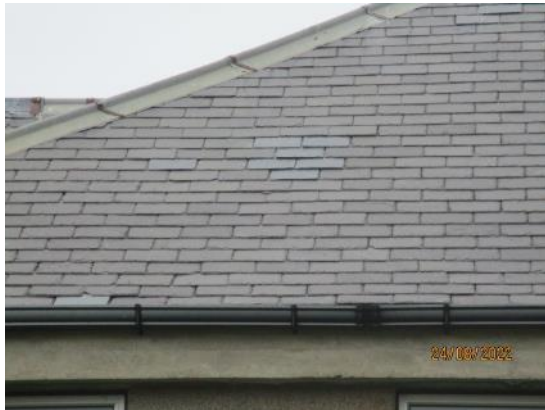
15. UPVC ogee gutters

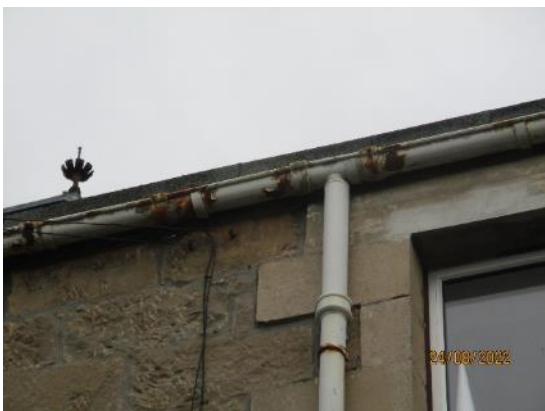
17. Cast iron gutters to first floor corridor

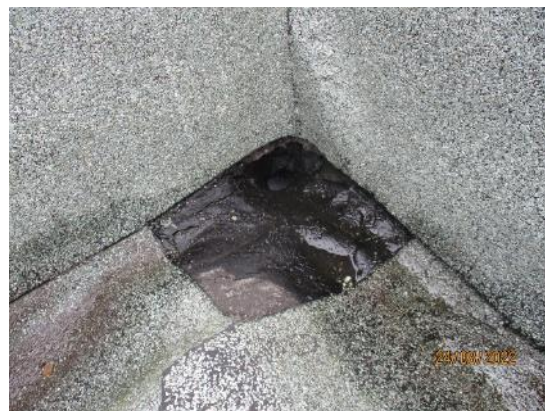
18. Felt lined box gutters

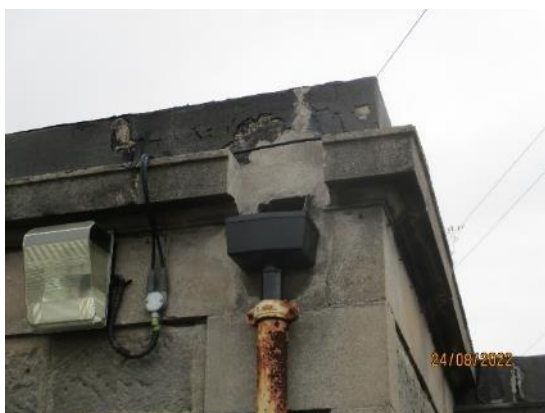
23. Replacement upvc hopper heads

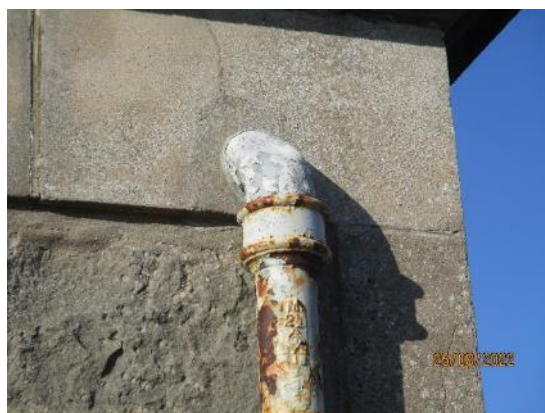
24. Lead outlet to cast iron downpipes

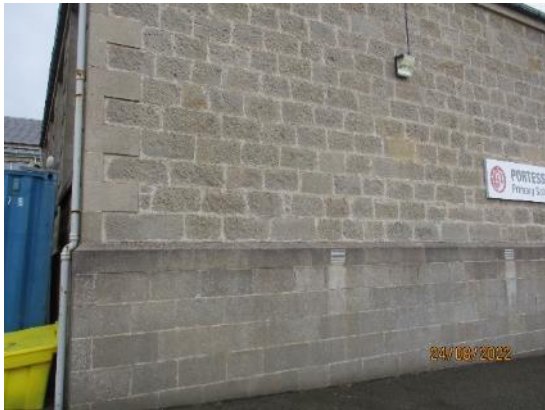
27. Natural stone walls

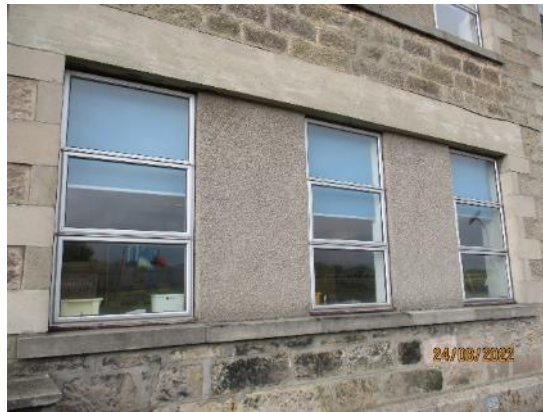
32. Roughcast panels between windows (south)

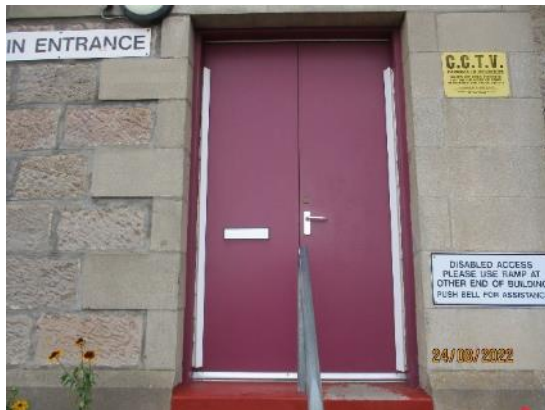
33. Timber entrance doors

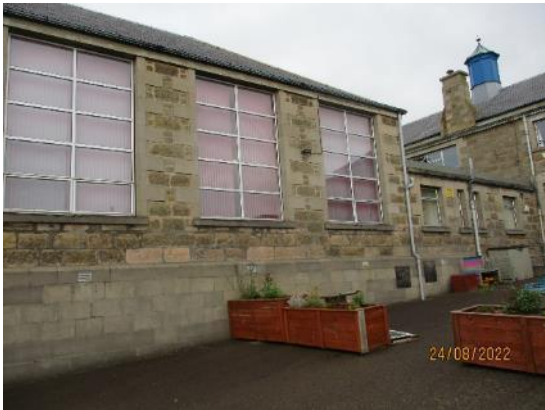
39. Large aluminium framed windows

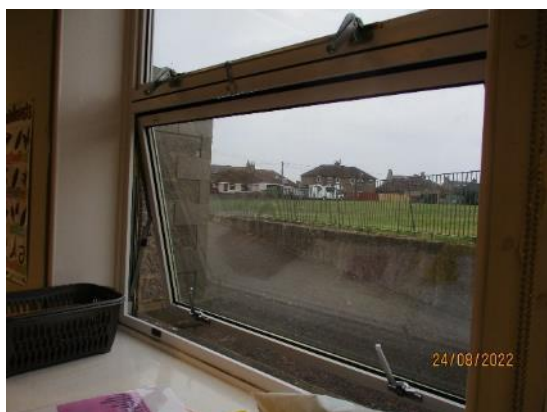
43. Aluminium windows internally

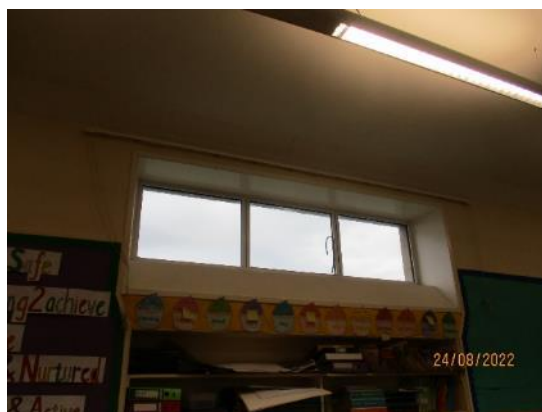
44. High level windows on 1<sup>st</sup> floor

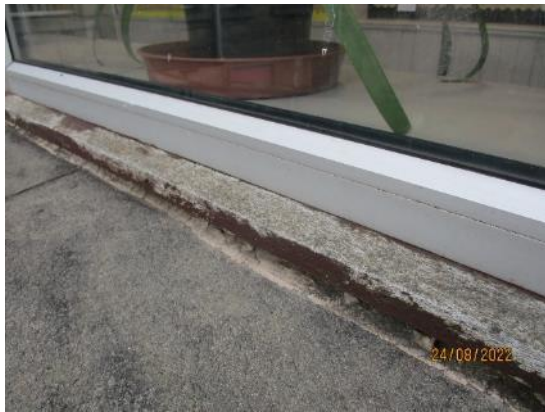
55. Timber window sills

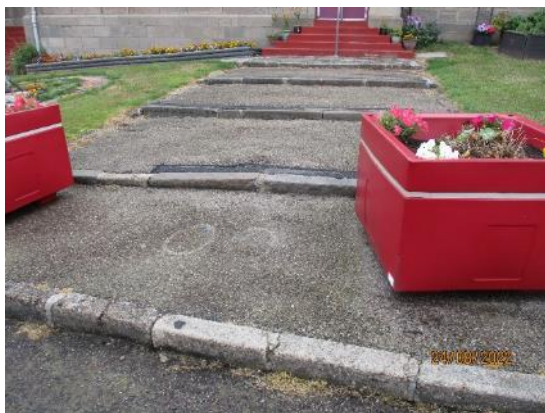
60. Steps to front entrance

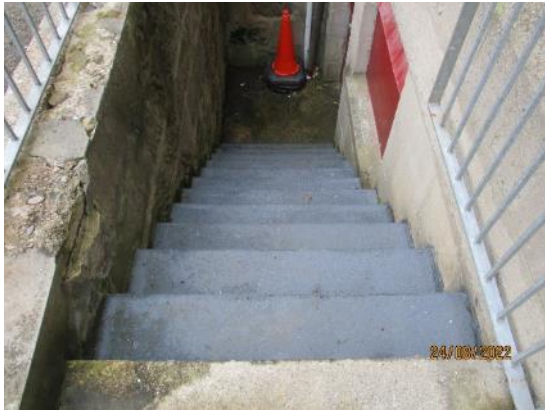
62. Concrete steps to Boiler House

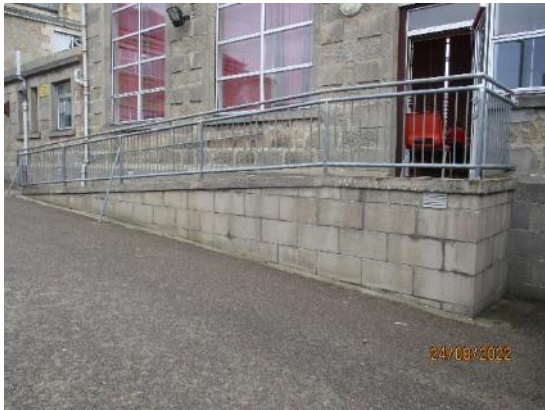
64. Fire escape ramps

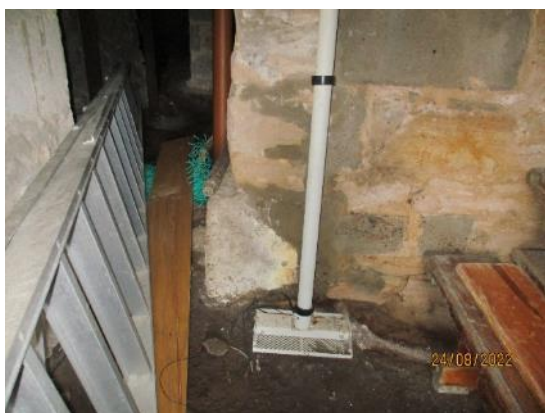
73. Temporary support bearing on the floor

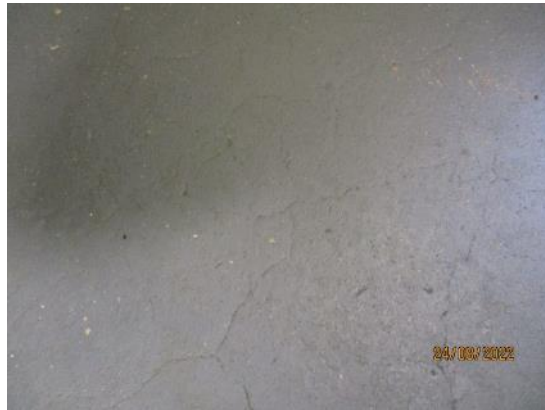
83. Crazed concrete floor

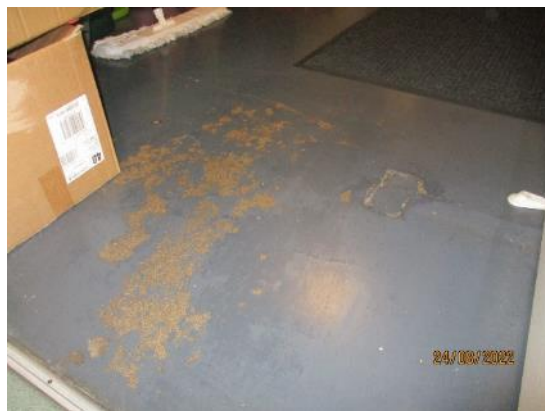
85. Uneven concrete floor

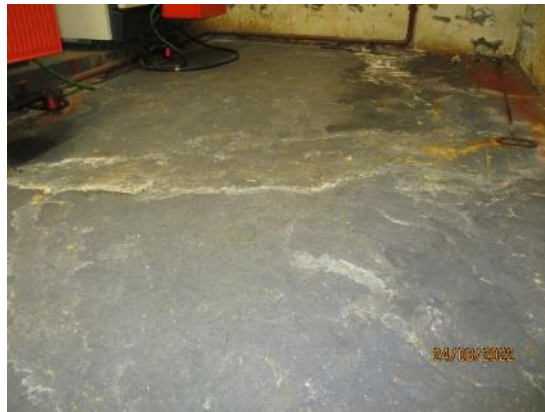
87. Uneven boiler house concrete floor

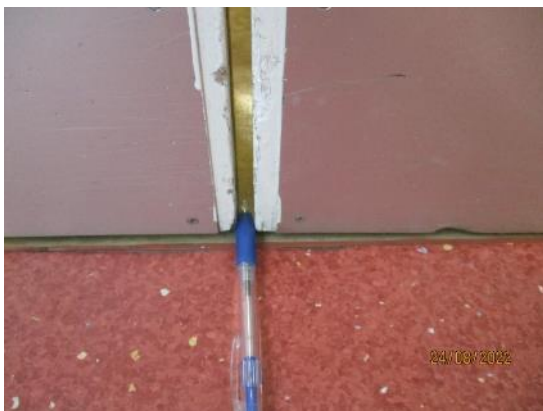
131. Large gaps between fire doors

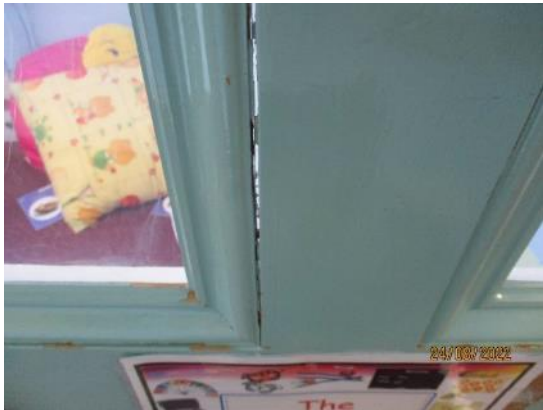
135. Gaps to glazed panels

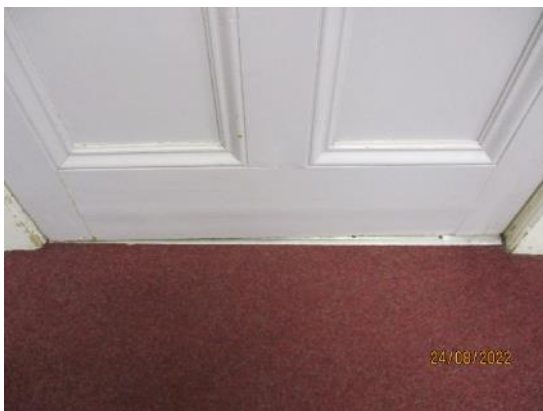
137. Doors twisted within frames

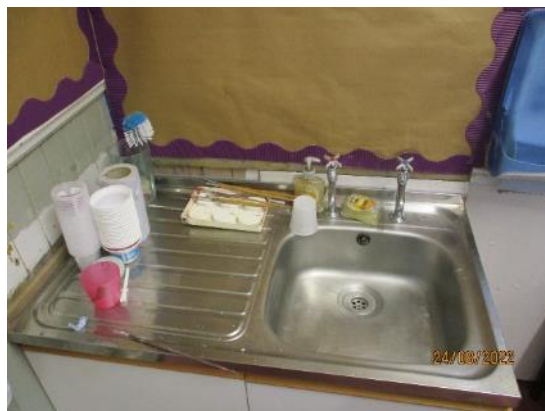
168. Typical sink with pillar taps

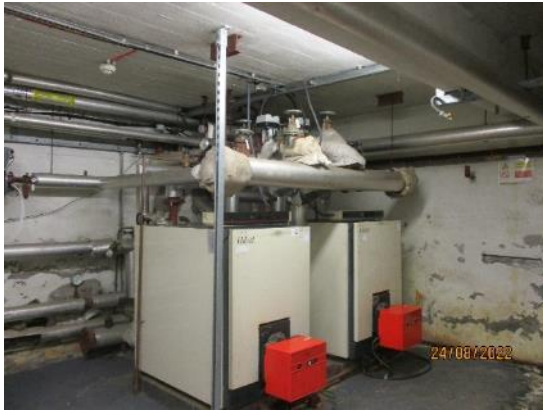
184. Gas boilers – boiler house.

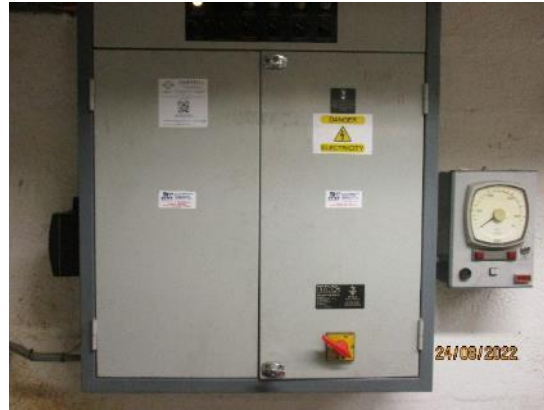
- Heating system is in poor condition and life expired as per CIBSE guidance doc M.
- Hot and cold water pipework is reaching the end of its useful life and is only partly insulated.

185. Heating system control panel. Boiler house.

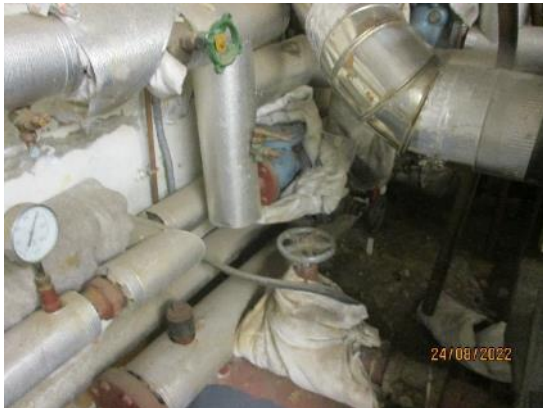
186. Heating system pipework. Boiler house.

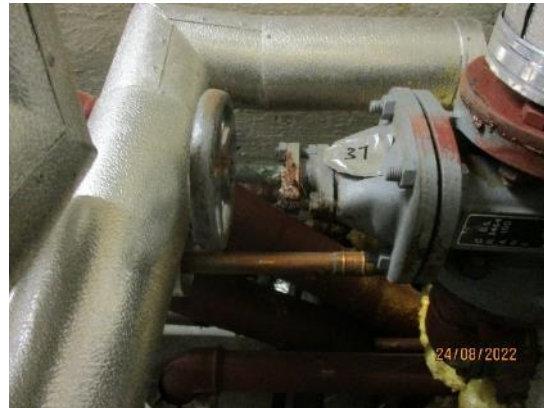
187. Heating system pipework and valves. Boiler house.

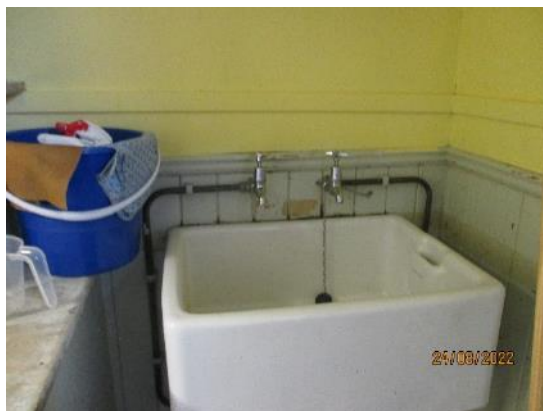
194. Pipework – hot water. Copper / cleaners room.

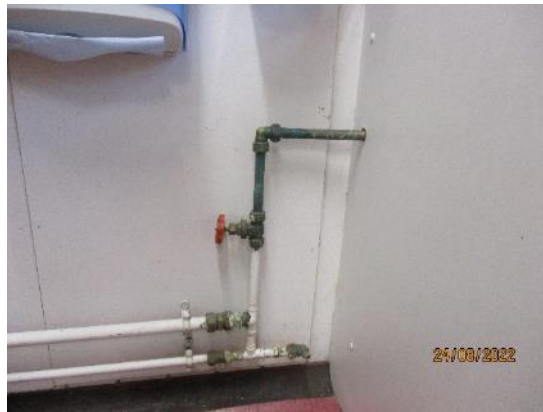
197. Pipework – cold water distribution.

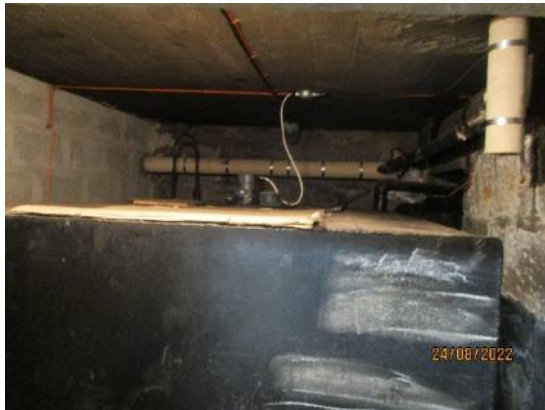
Heating fuel oil is stored in a steel tank located in the basement within a bunded room next to the boilerhouse. Oil pipework and control valves are dated and in poor condition. An electronic warning system for tank overfilling and also a tank oil level monitoring system are installed.

- Heating fuel oil pipework, storage tank and controls are life expired and should be considered for replacement.
- The intruder alarm system is dated and nearing the end of its useful life.

198. Oil storage tank. Basement 0/36

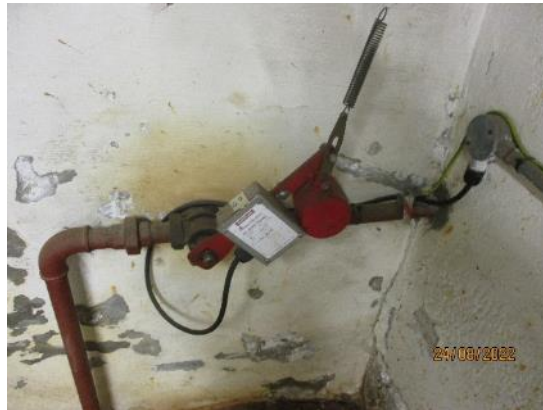
199. Oil pipework / safety shut off valve.

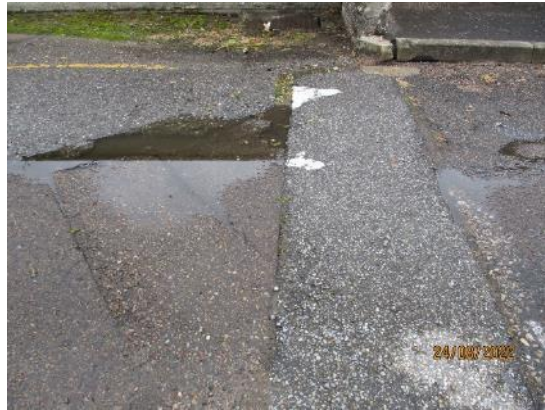
- Tarmacadam access road and car park is potholed and cracked.
- Car park drainage partially blocked.
- Concrete steps are chipped and broken.
- Concrete post fence, north of sports field, has no wire.

233. Potholes and ponding water

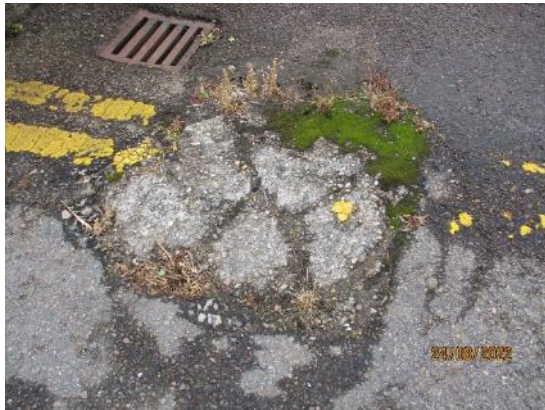
234. Surface patched and breaking up

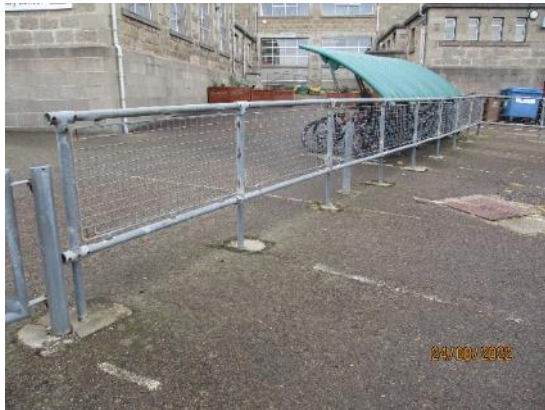
239. Tarmacadam footpaths

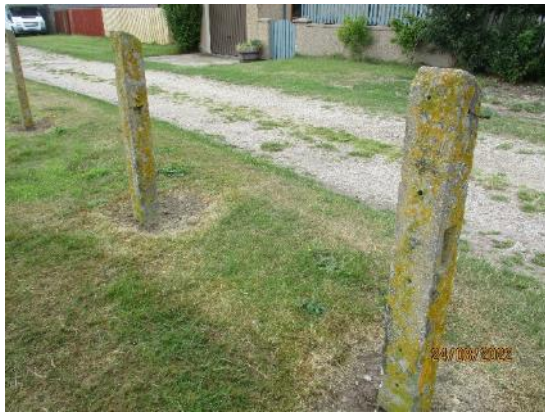
243. Concrete post fence

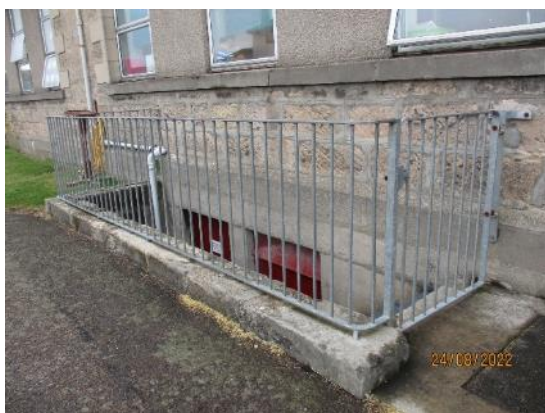
247. Galvanised railings above blockwork walls

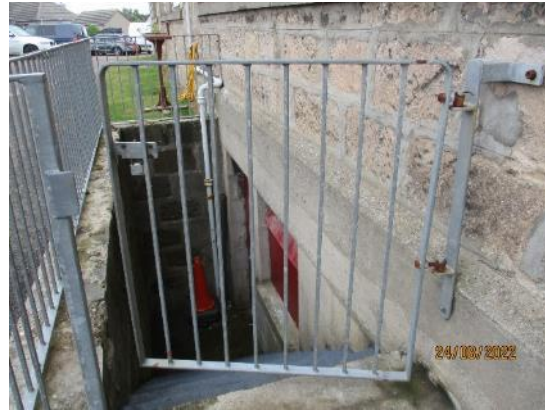
250. Tubular rail personnel gate

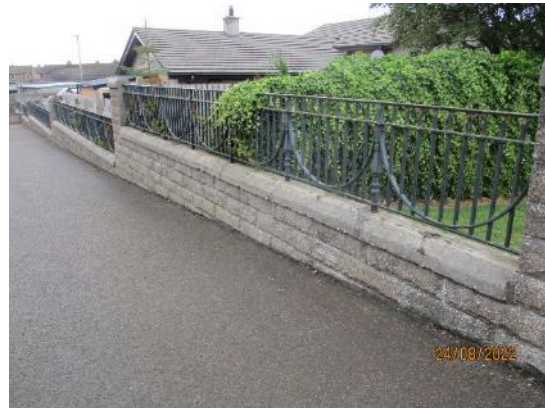
252. Blockwork wall to north

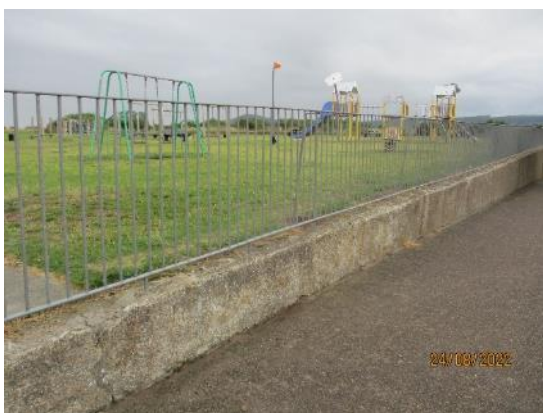
253. Block walls to playground

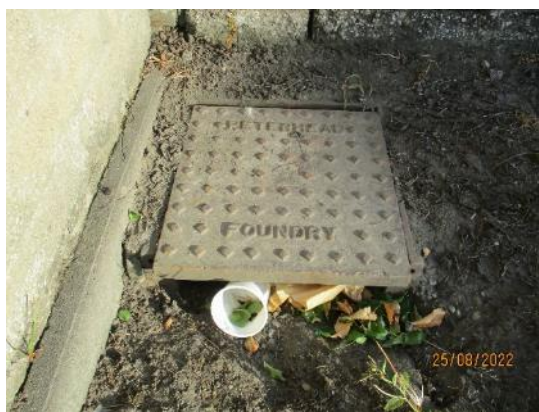
257. Surface water drainage

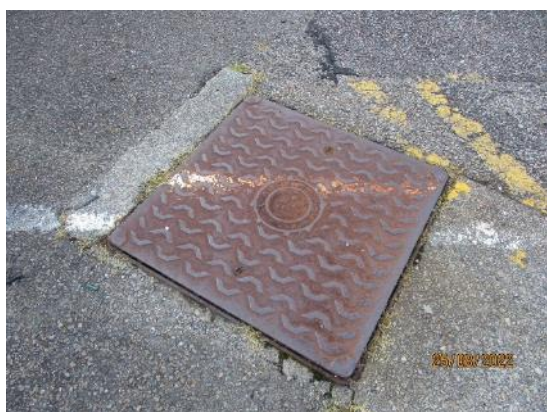
258. Partially blocked drainage
