# **Summary Building Condition Survey Report**

**Portgordon Primary School  
Richmond Terrace, Portgordon AB56 5RA**

**13<sup>th</sup> September 2022**

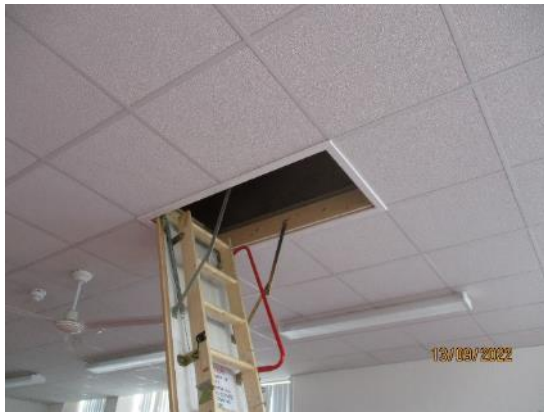
1. Roof space access above P1, 2 & 3

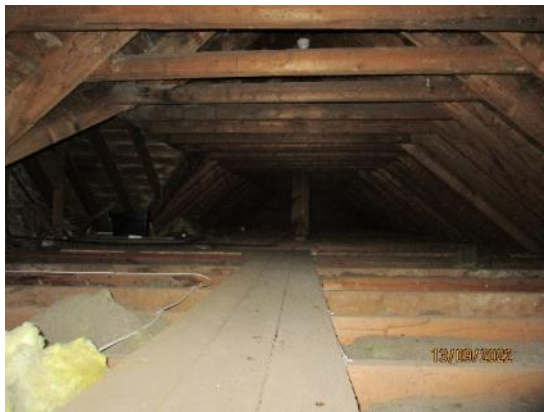
3. Roof structure, south pitch

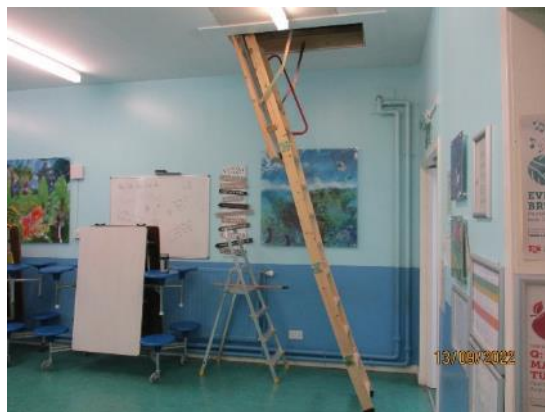
6. Roof space access above Dining Room

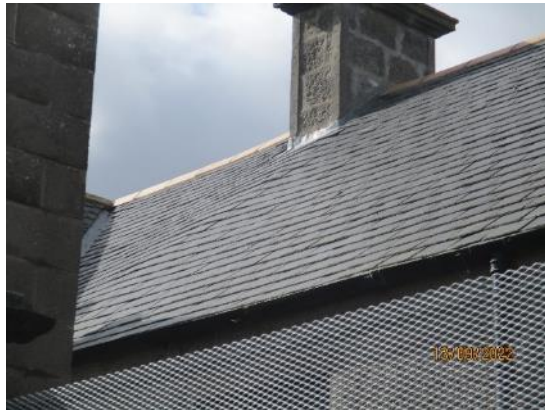
9. Irregular roof surface

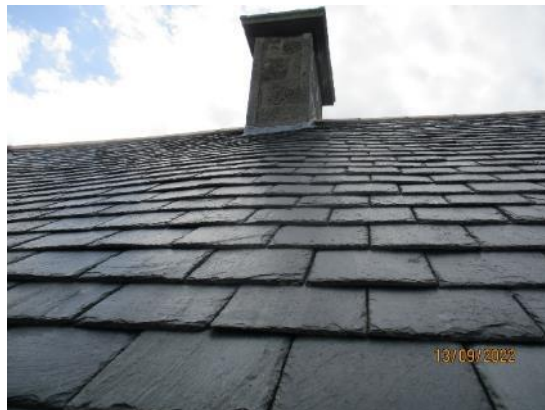
10. Raised roof surface

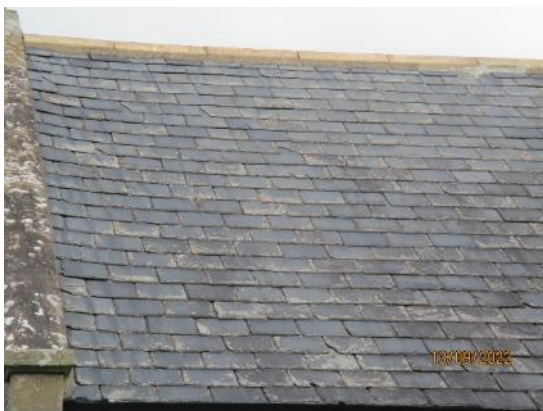
- Several slipped and broken slates.
- Broken ridge tiles and missing pointing.
- Felt roofing is reaching the end of its useful life.
- Surface corrosion of cast iron rainwater goods.
- Significant cracking to most elevations of external walls.
- Several double glazed units are blown and fogged with moisture between the panes.
- Plaster and lath & plaster ceilings are cracked.
- Plaster and lath & plaster walls are cracked.
- Suspended timber floors creak and are uneven.
- Carpets are soiled, stretched and wrinkled.
- Linoleum floor finishes are cracked and breaking up.

11. Slipped and broken slates

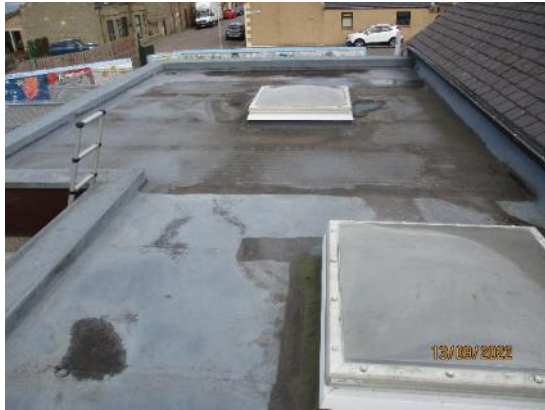
19. GRP roof, soiled

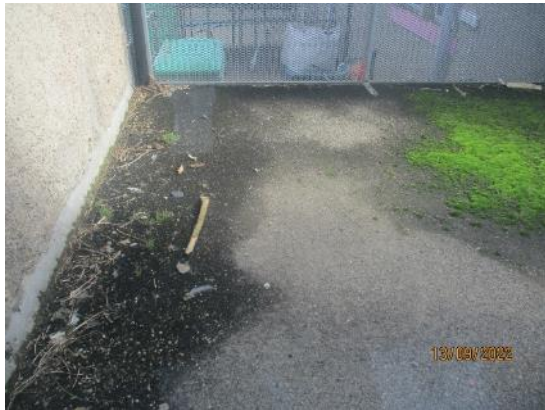
21. Felt roof – debris and vegetation

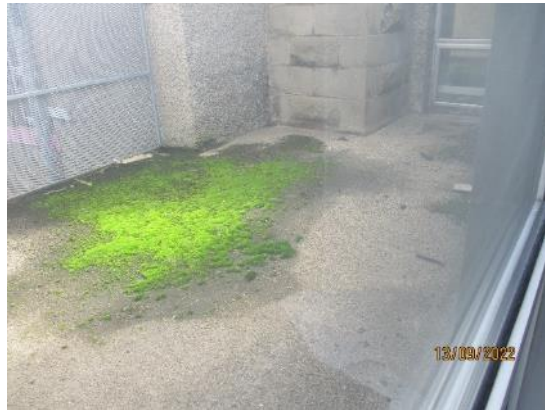
22. Moss on felt roof

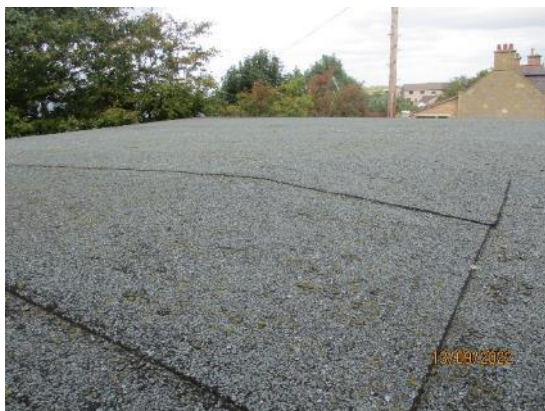
23. Falls on felt roof

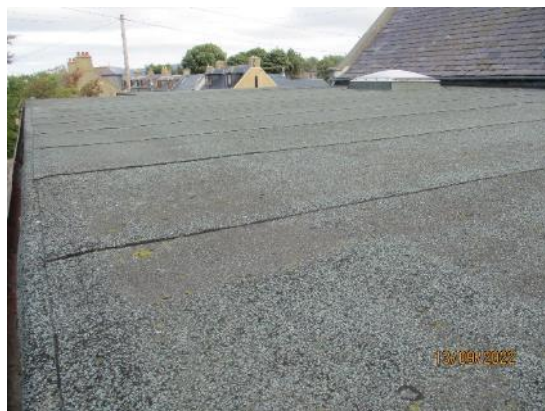
24. Surface erosion of felt roofs

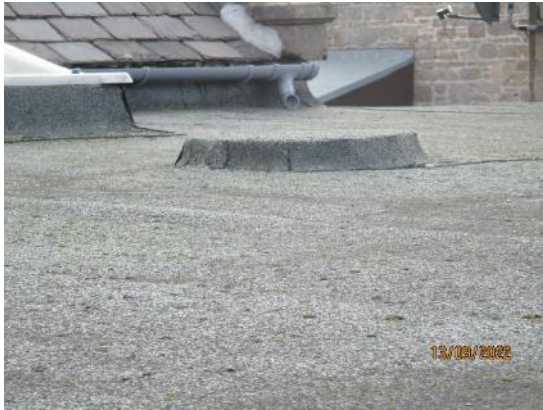
25. Vent cap above staff toilet

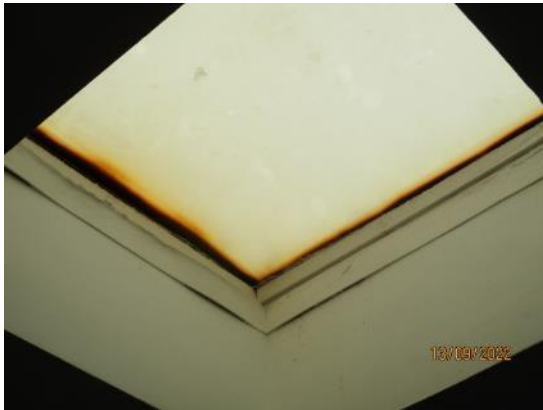
27. UV degradation of domed rooflights

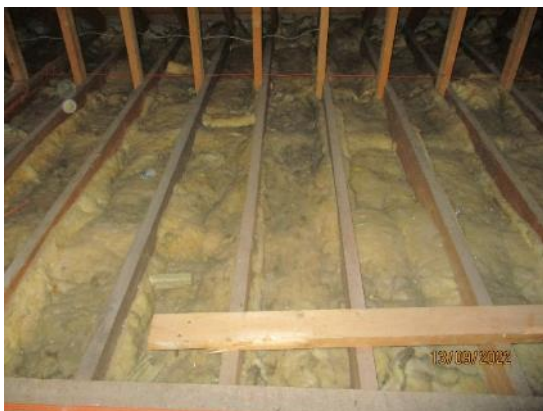
29. Insulation to south pitched roof

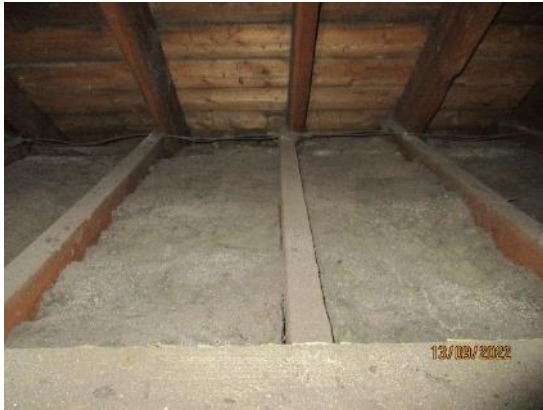
31. Insulation above Dining Hall

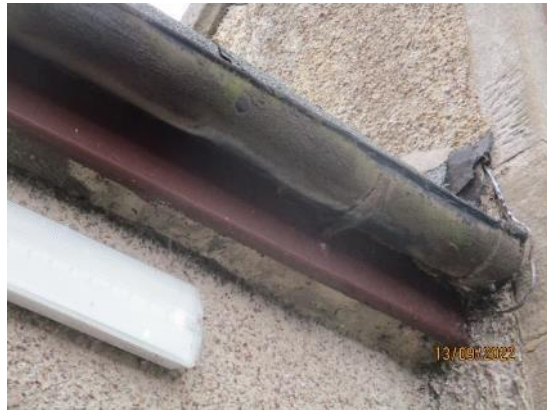
34. Cast iron gutters

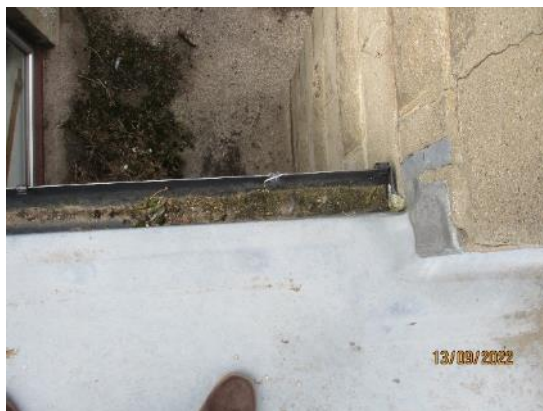
35. Some gutters require cleaning

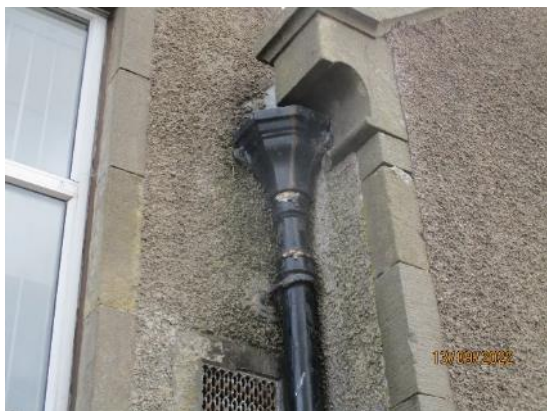
36. Cast iron hopper heads and downpipes

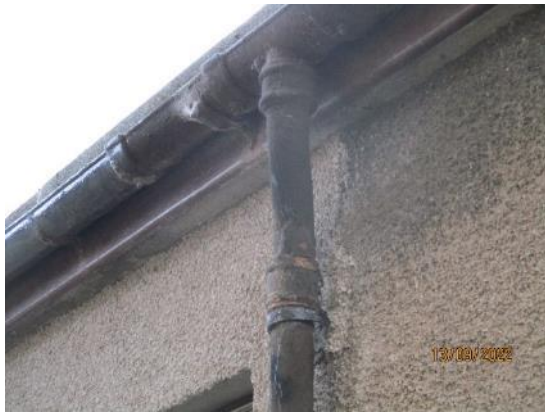
37. Cast iron downpipes

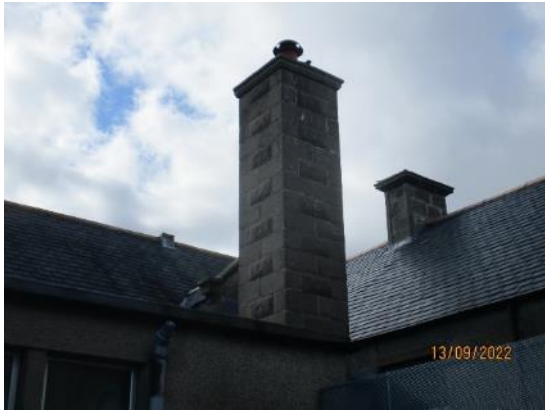
43. Boiler House chimney

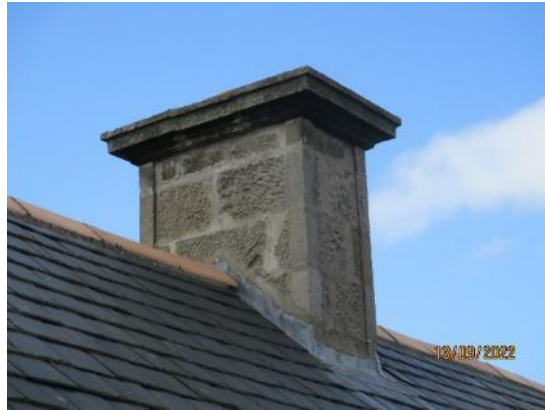
44. Redundant stone chimneys

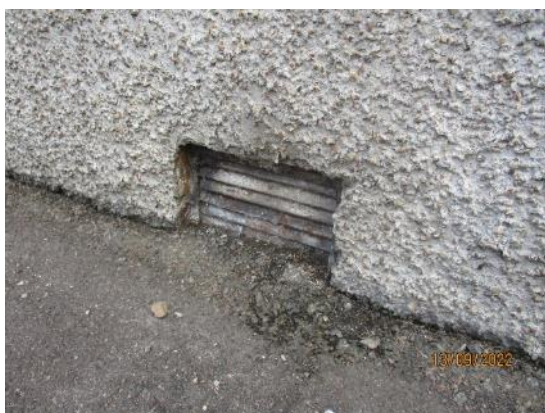
53. Some underfloor vents at ground level

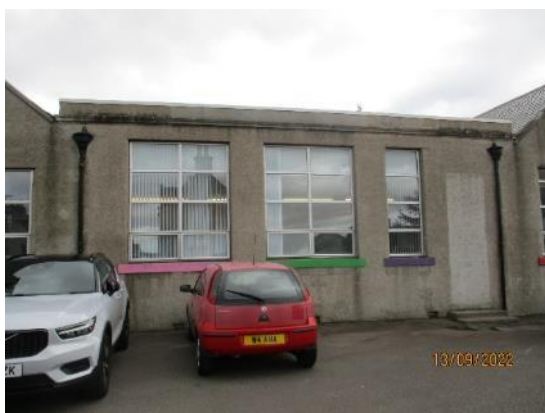
54. Roughcast external walls

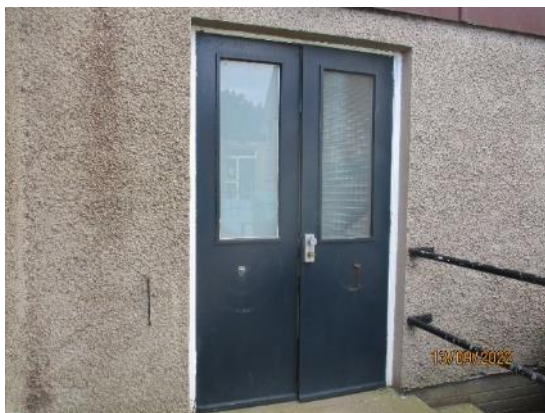
58. Missing roughcast at bellcast bead

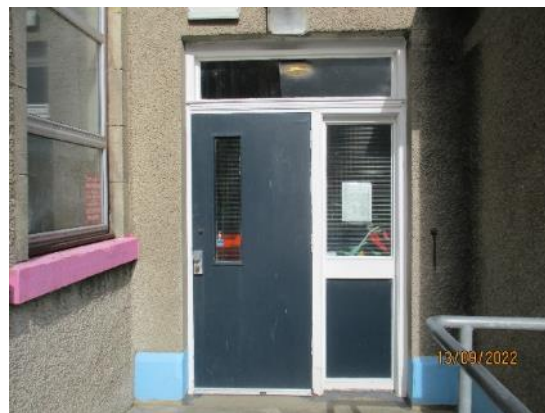
59. Timber doors to Nursery

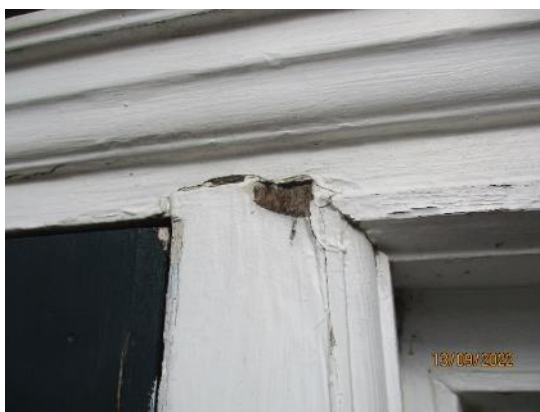
61. Previous repairs to timber door frame

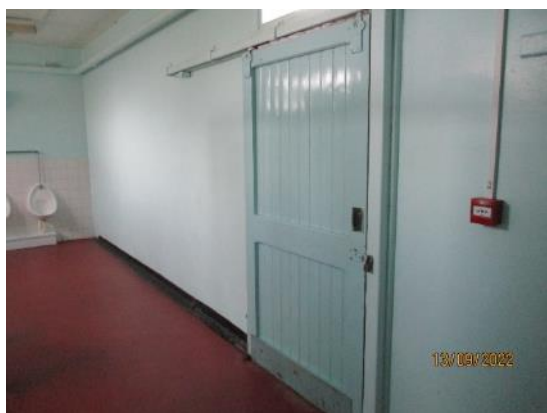
64. Timber back door

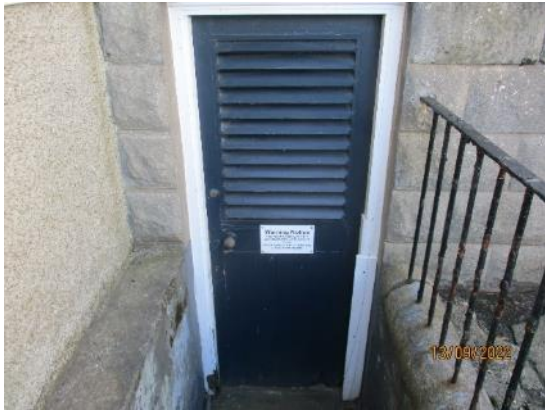
66. Paper packing around door

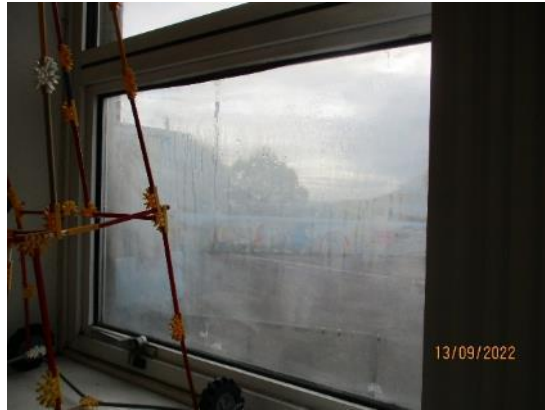
79. Double glazing to aluminium windows

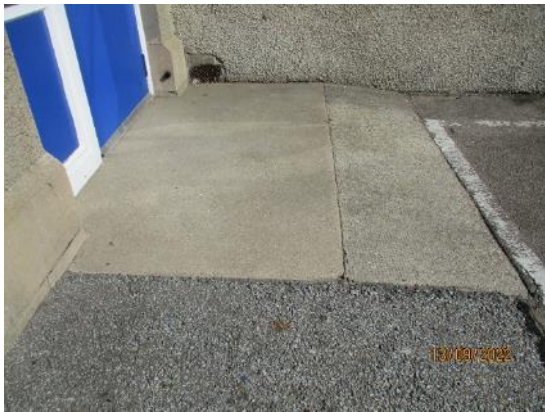
90. Steps to Boiler House

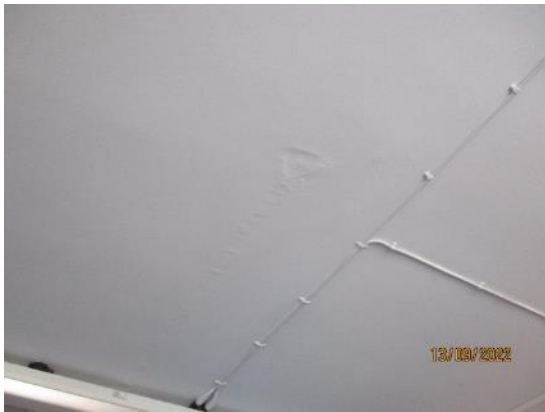
125. Redundant vent in Staff Toilet ceiling

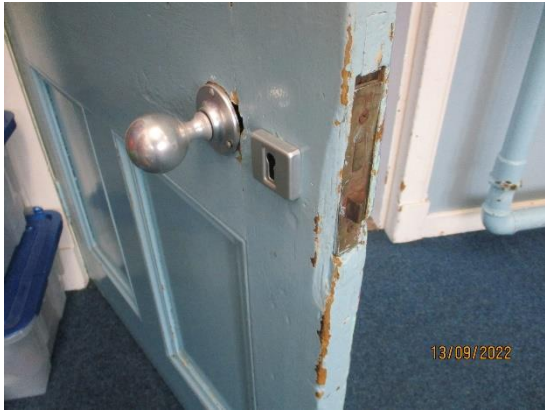
157. Wear and damage to classroom doors

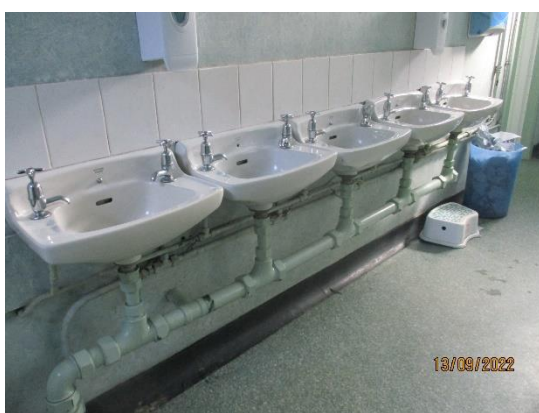
174. Basins in Girls Toilet

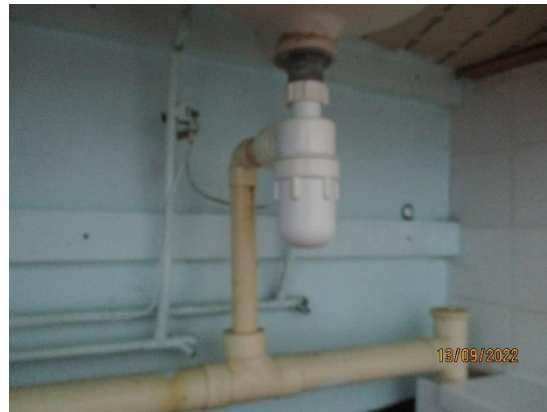
176. PVC waste pipes

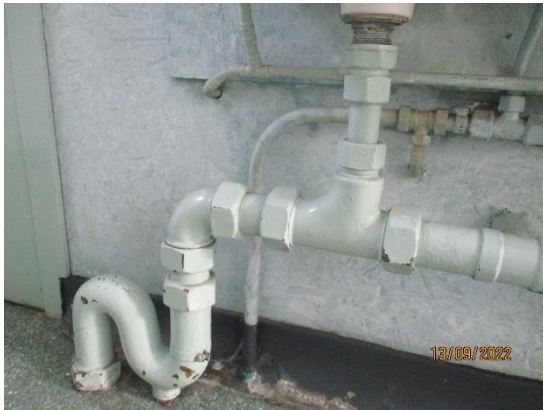
177. Copper waste pipes (Girls Toilet)

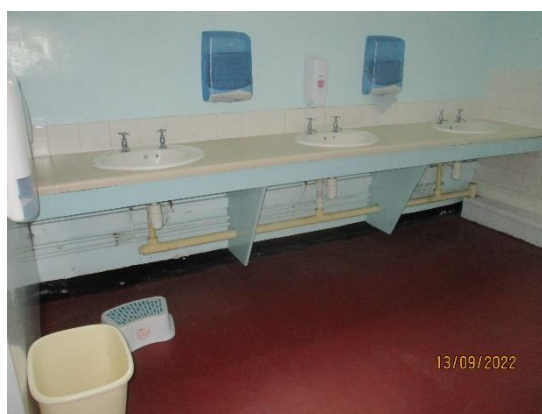
182. Vanity basin worktop (Boys Toilet)

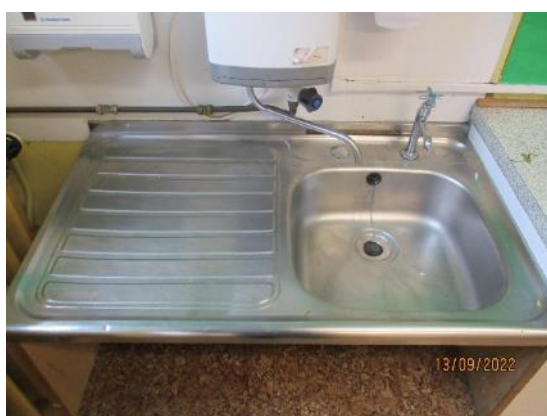
185. Stainless steel classroom sinks

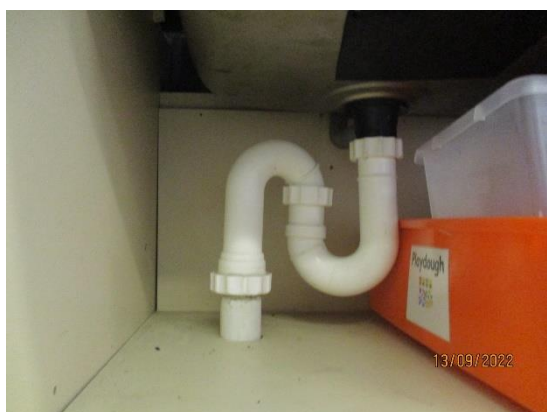
189. PVC waste pipes

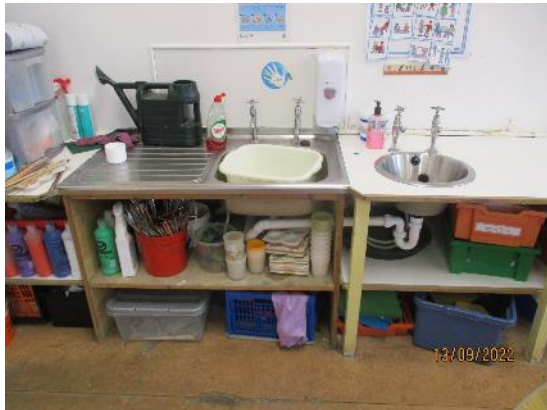
201. Worktop only, no base units

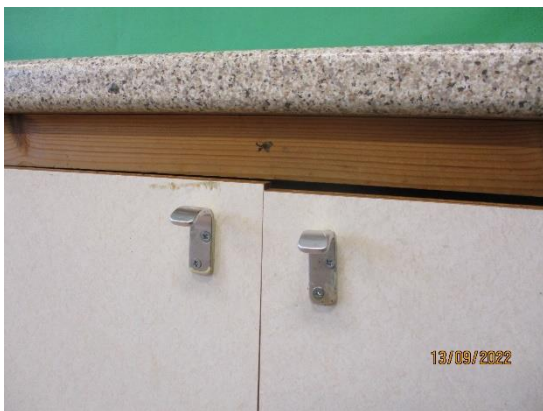
202. Missing handles, damaged base units

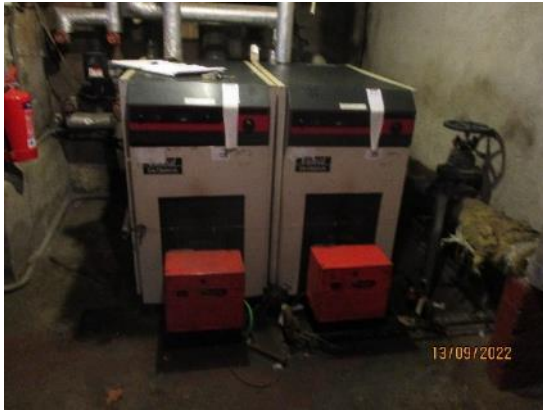
- Boilers and heating system are life expired as per CIBSE doc M and in poor condition.
- Internal lighting is life expired as per CIBSE doc M and in poor condition.

204. Oil fired boilers. Plant room 0/1

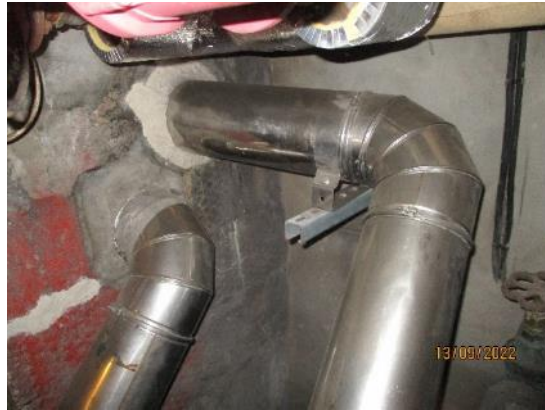
205. Boiler flues into brick chimney. Plant room 0/1

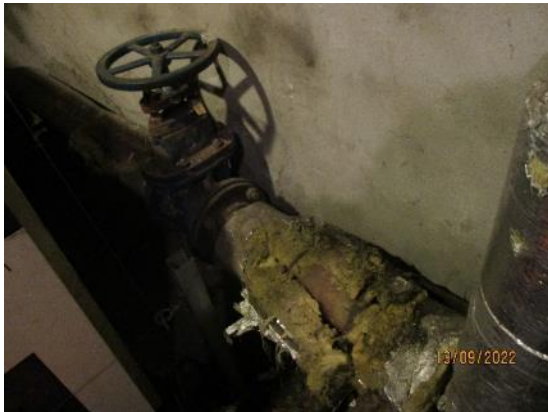
206. Pipework – heating system. Plant room 0/1

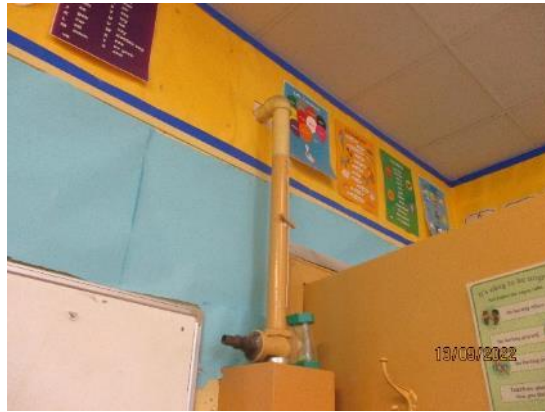
207. Pipework – heating distribution. Typical.

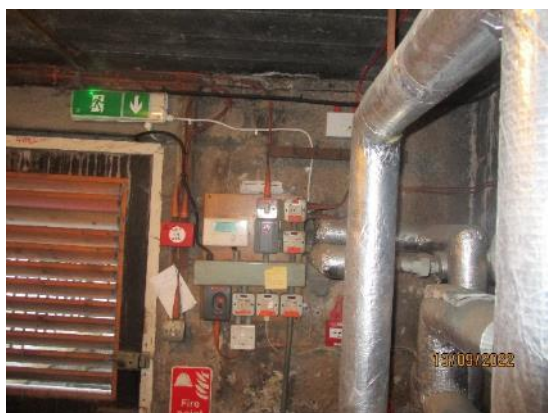
208. Heating controls – plant room 0/1

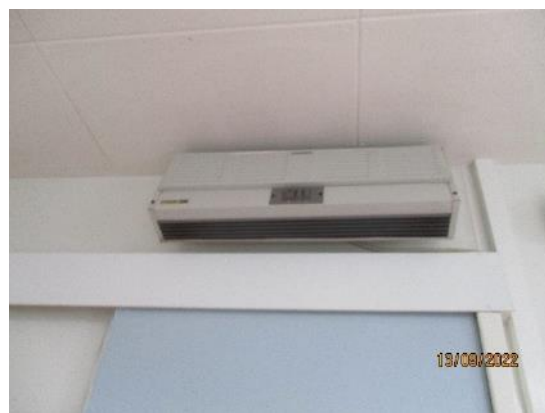
209. Electric fan heater - kitchen

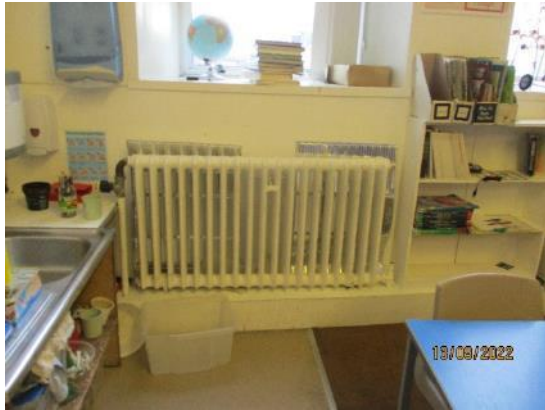
210. Radiator – cast iron column. Classroom

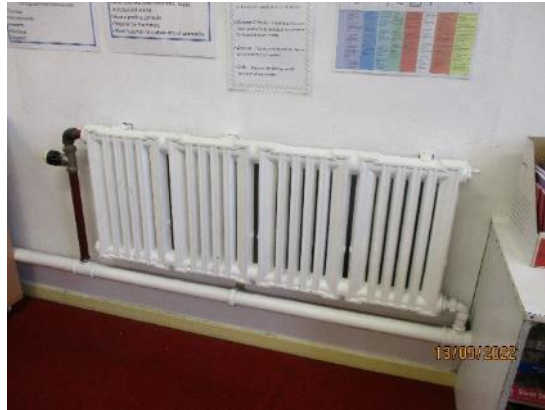
211. Radiator – cast iron section classroom

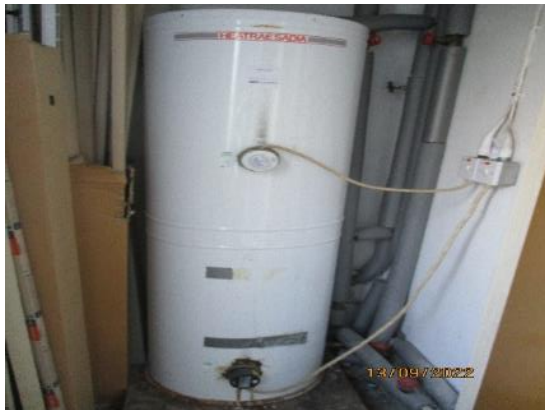
212. Hot water storage cylinder. Kitchen cupboard

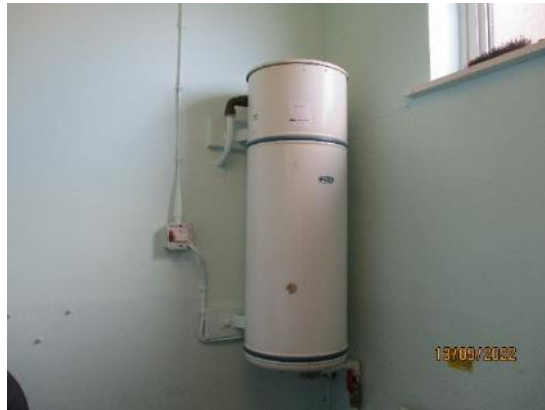
213. Hot water storage cylinder. Cleaners/boys toilets.

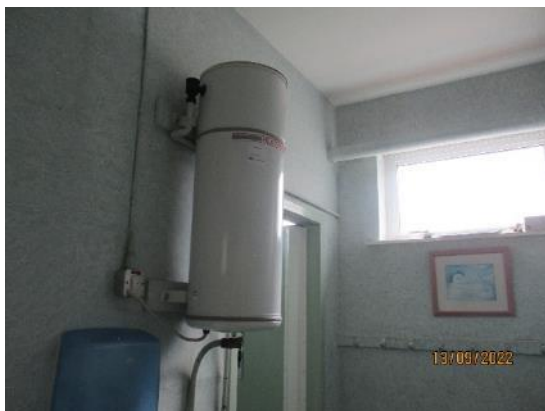
214. Hot water storage cylinder – Girls toilets.

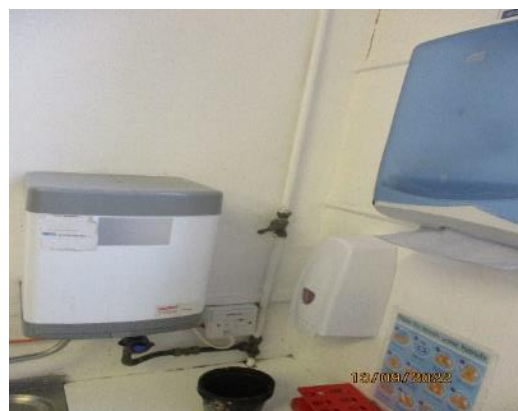
215. Point of use hot water heater. Typical.

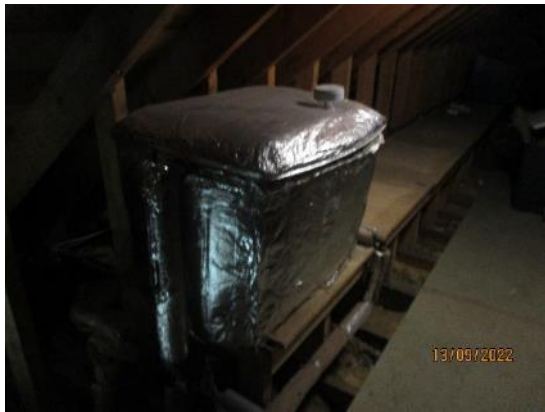
216. Cold water storage tank. Above dining hall.

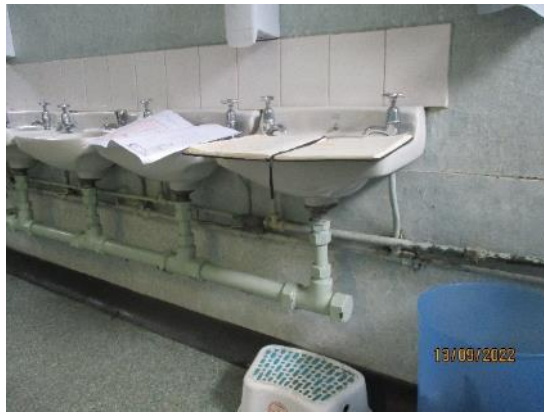
- Hot and cold water pipework is only partly insulated.
- Hot and cold water pipework is reaching the end of its useful life due to age and condition.
- Oil supply pipework and safety controls are life expired as per CIBSE doc M and in poor condition.

217. Pipework – cold water. Girls toilets.

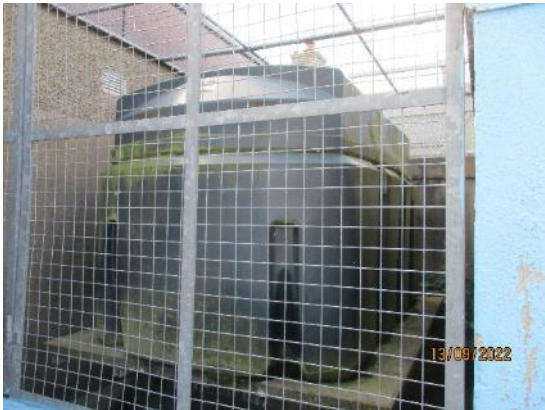
218. Oil storage tank in external bunded secure store.

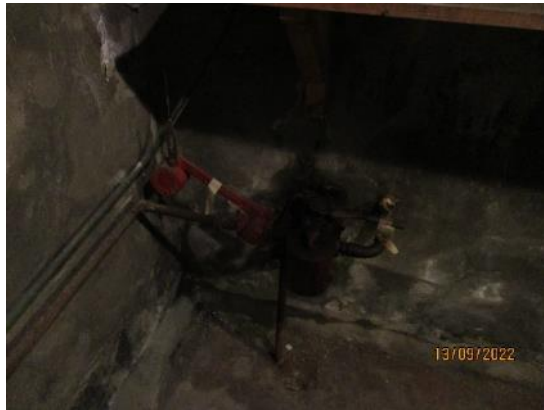
219. Oil supply auto shut off valve and pipework.  
0/1

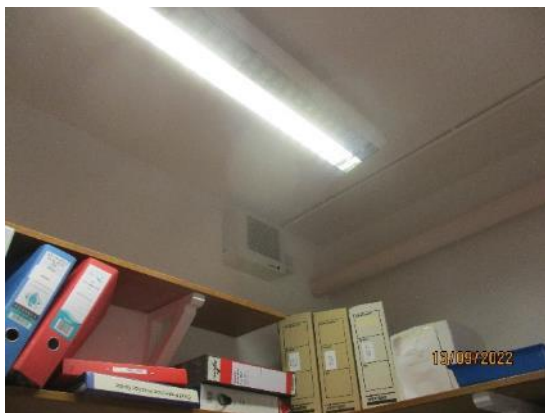
220. Extract fan – reception office.

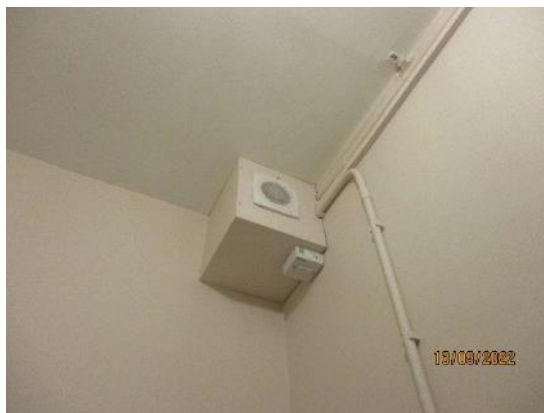
221. Extract fan – staff toilets.

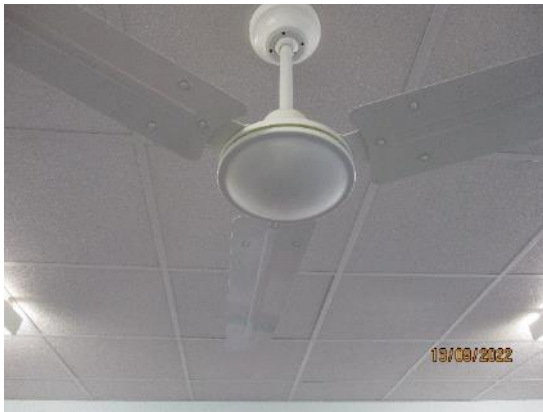
222. De stratification fan - classroom

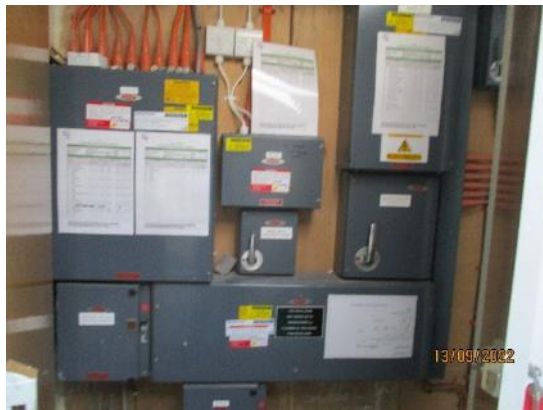
- Extract fans are not automatically operated by motion or humidity sensor.
- Electrical wiring and distribution boards are life expired as per CIBSE doc M and in poor condition.

224. Switchgear and distribution boards.

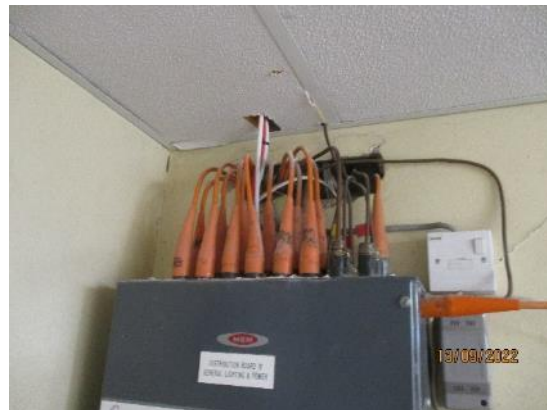
225. Distribution board and supply general wiring.

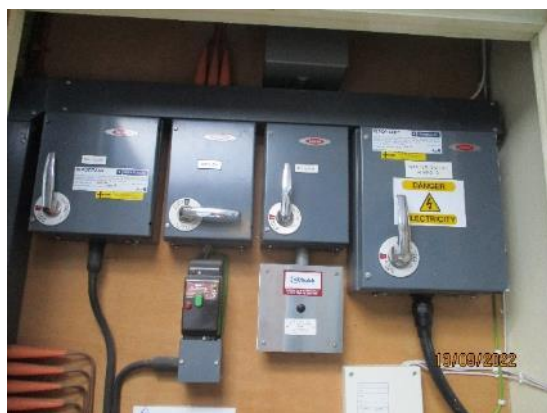
227. Fused isolators. Switchgear.

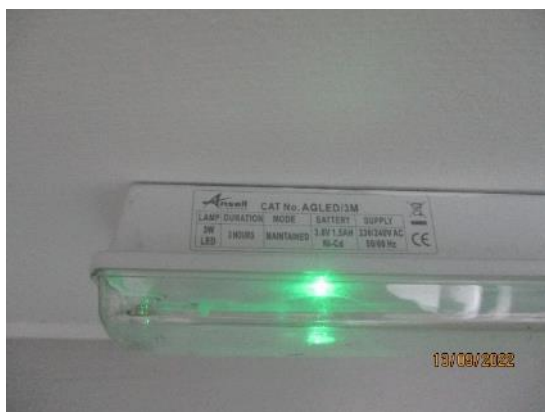
234. Emergency lighting – typical.

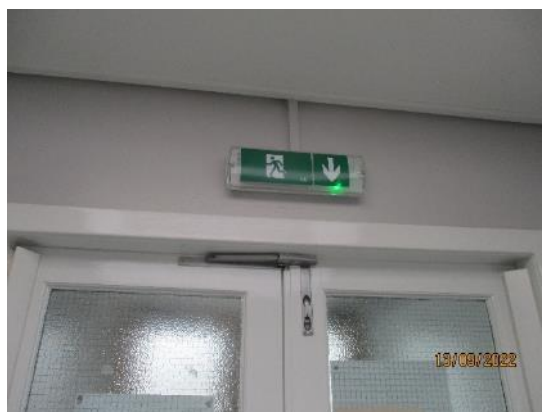
235. Emergency exit sign lighting. Typical.

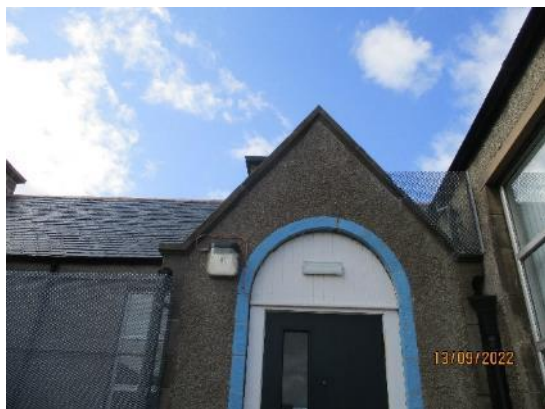
- Electrical accessories are life expired as per CIBSE doc M and in poor condition.
- External building lighting is life expired as per CIBSE doc M and in poor condition. External lighting also has no automatic lux control sensors to operate lighting automatically according to external light levels.

236. External lighting – typical.

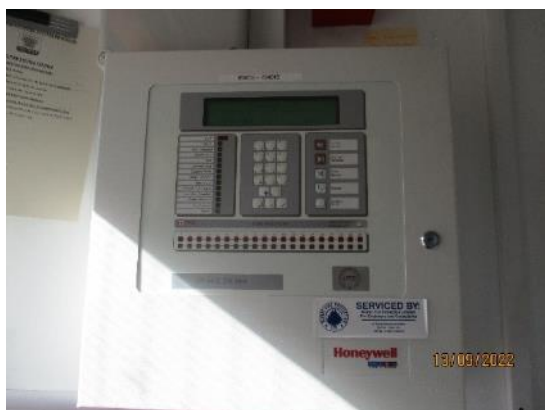
238. Fire alarm system control panel. Entrance lobby.

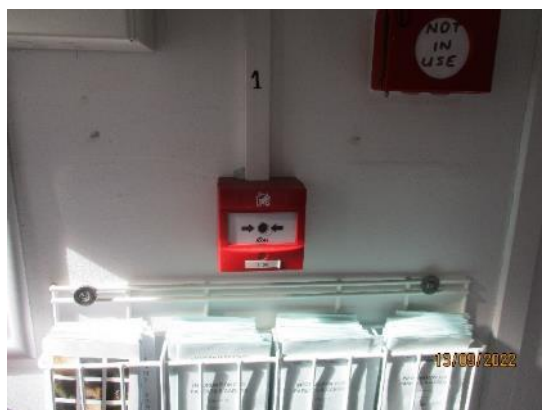
239. Fire alarm system call point. Typical.

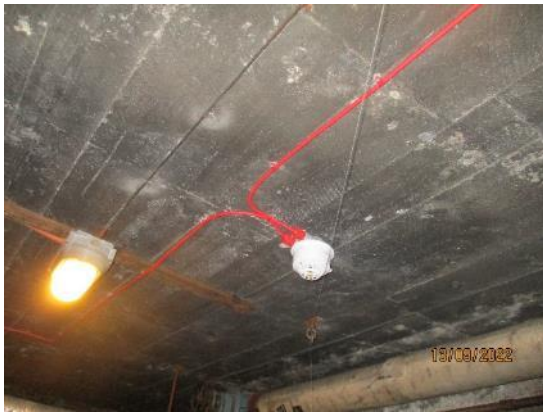
240. Fire alarm system wiring and detector head.  
0/1

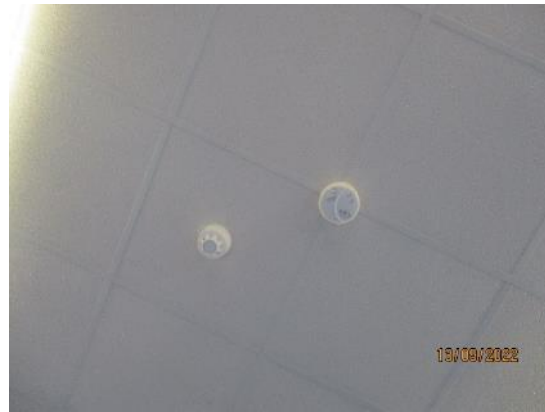
241. Fire alarm system detector head. Classroom.

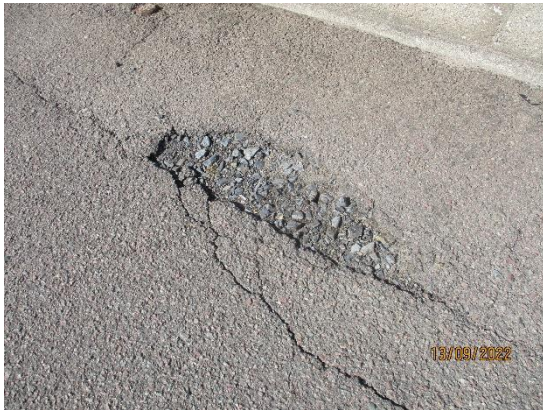
- Cracks, potholes and surface erosion of tarmacadam car park and playground.
- Cracked, spalling render and missing pointing, to perimeter walls.

254. Surface erosion and potholes

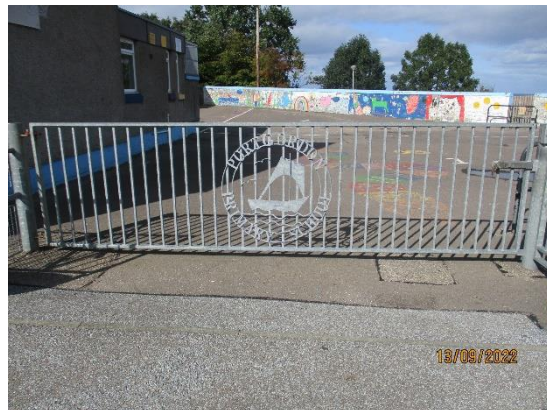
266. Extensive corrosion

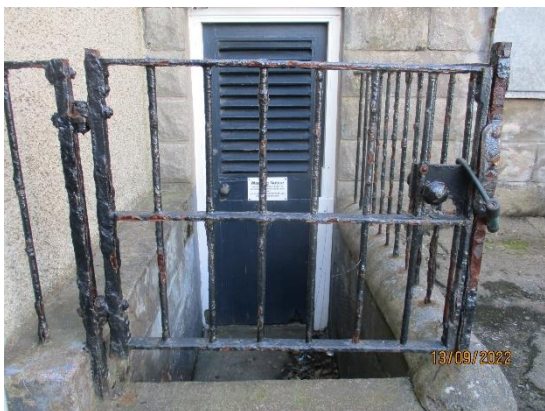
274. Metal railing gate with extensive corrosion
