# **Summary Building Condition Survey Report**

**Portknockie Primary School**  
**King Edward Terrace, Portknockie AB56 4NX**

**3<sup>rd</sup> & 4<sup>th</sup> October 2022**

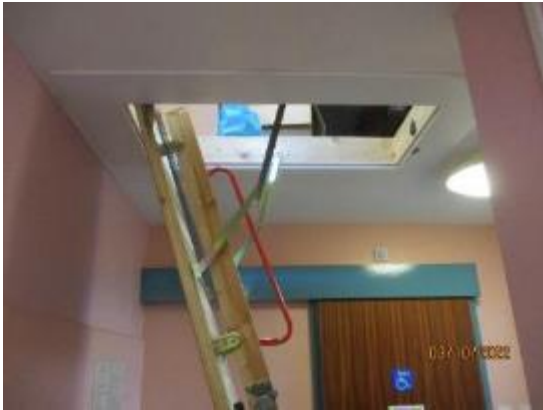
1. Roof access above toilets

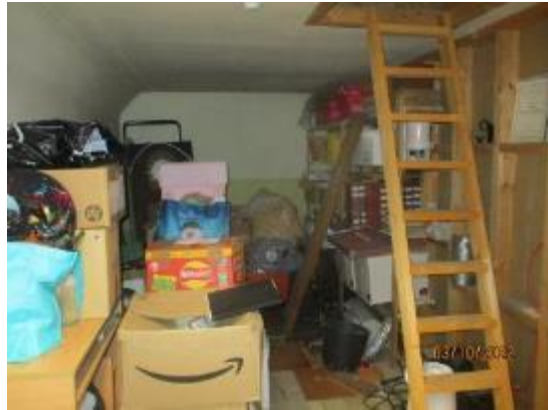
2. Storage roof space

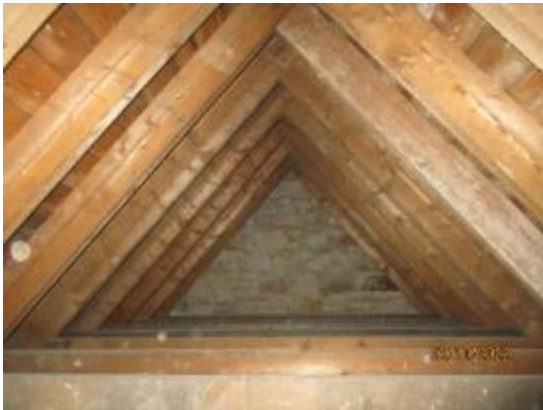
3. Timber roof trusses

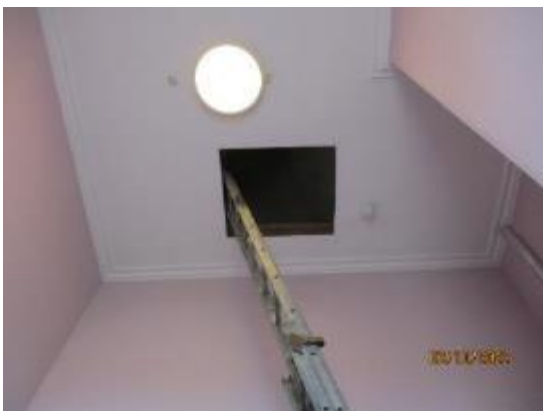
5. Roof access above staff toilets

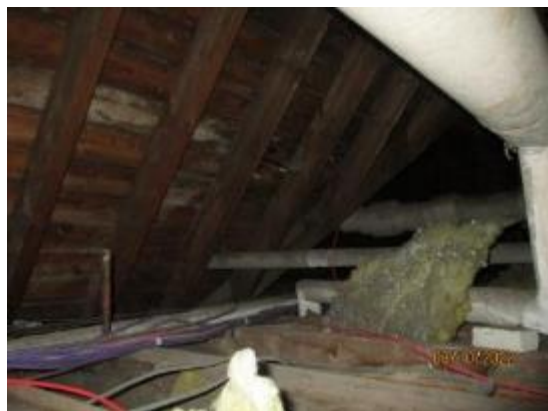
6. Timber roof trusses

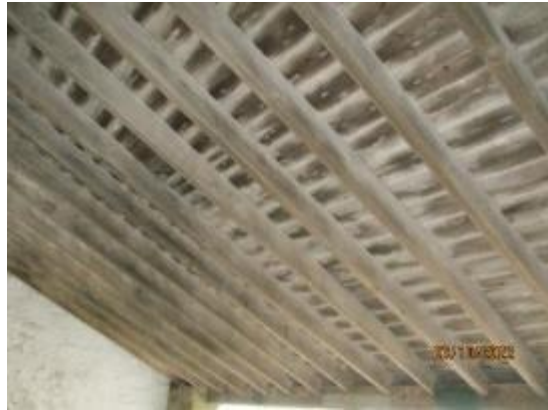
8. External store roof structure

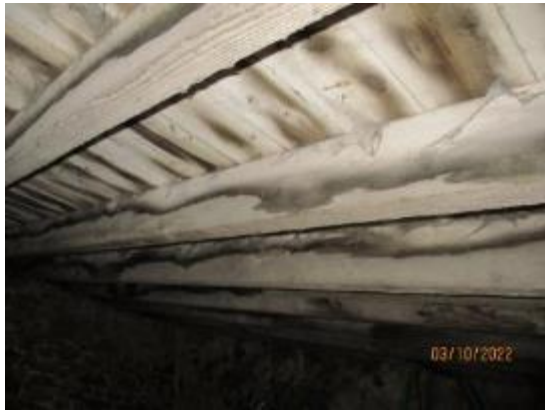
9. Watermarked roof timbers

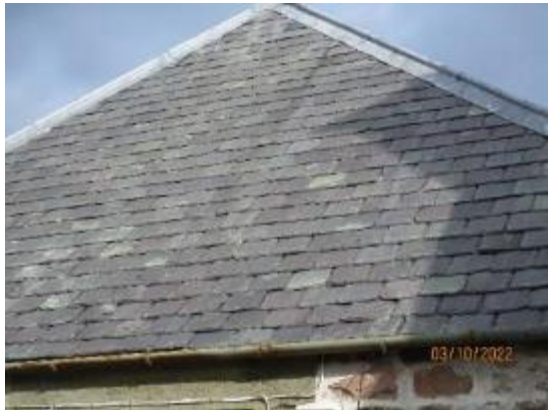
10. Slated roof to main school

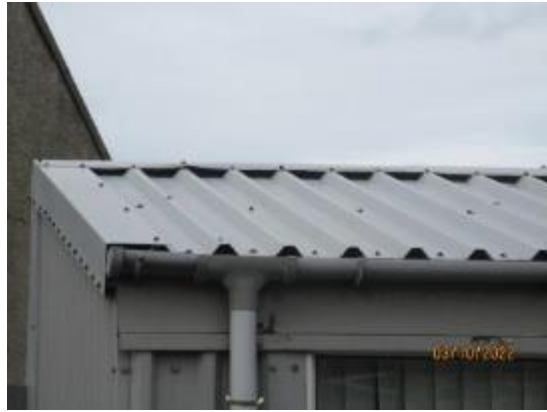
14. Metal profile to Nursery extension

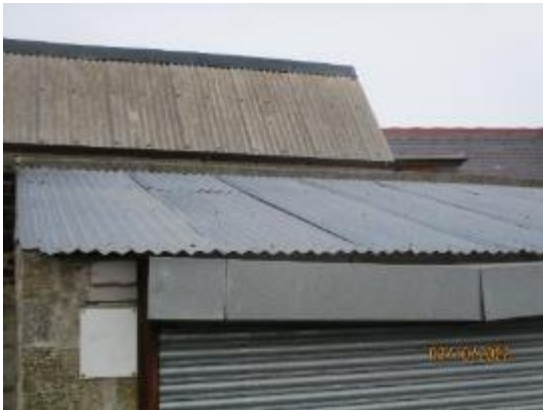
15. Corrugated iron to Nursery external stores

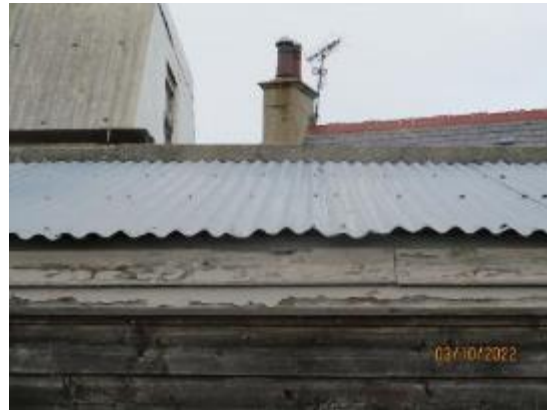
16. Uneven roof surface, no rainwater goods

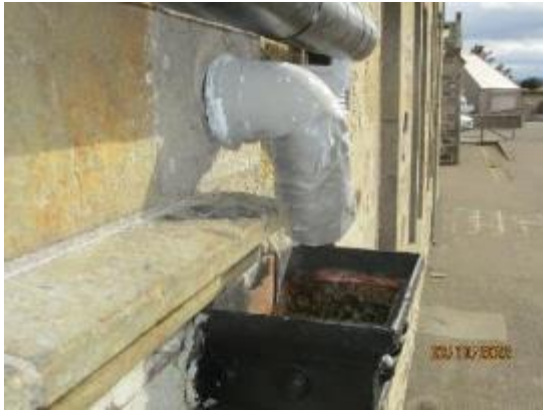
31. Damaged rainwater outlets

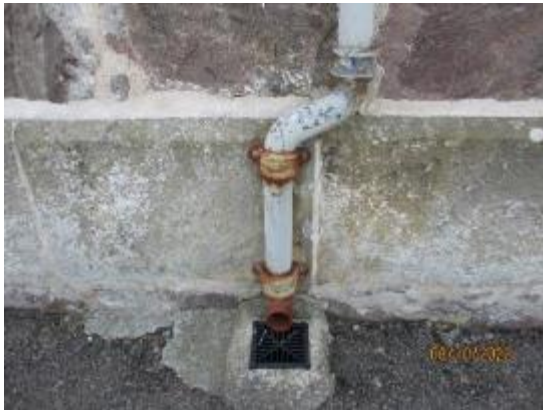
33. Downpipes to surface gullies

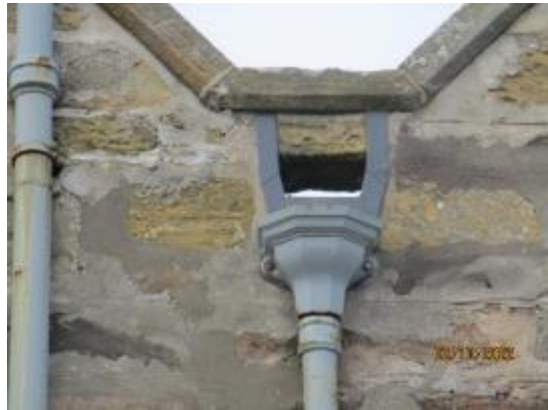
34. Cast iron hopper heads to valley drainage

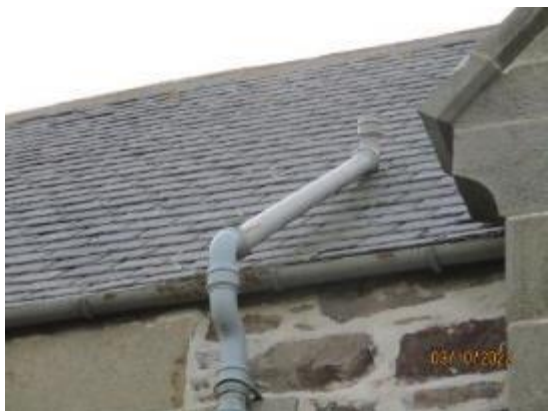
36. Cast iron soil vent pipes

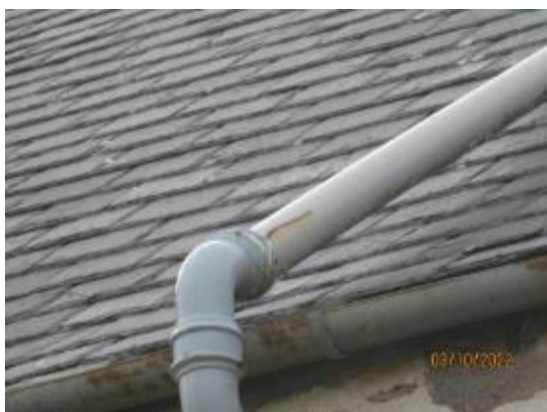
37. Cracked soil vent pipes

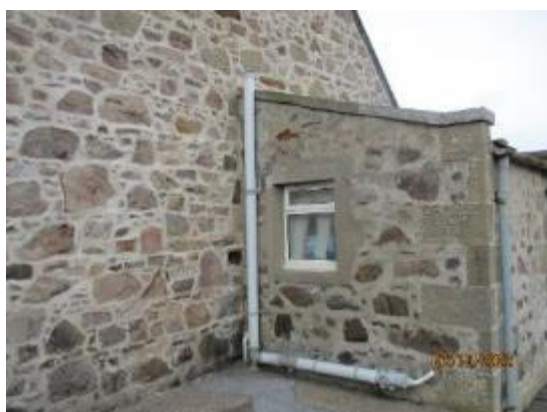
39. UPVC soil vent pipes to Nursery

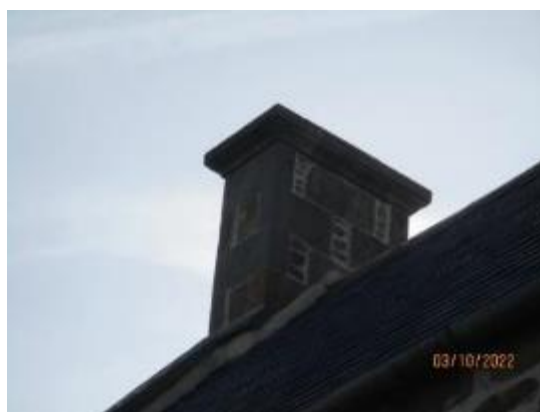
40. Stone chimneys to school

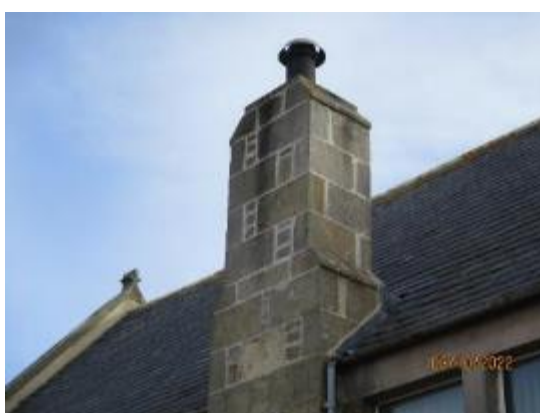
42. Stone chimney to Boiler House

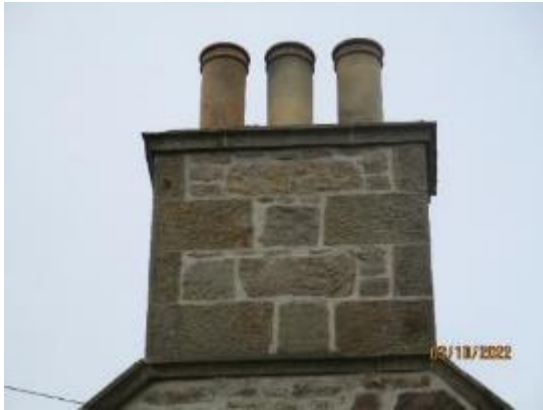
43. Stone chimney to Nursery

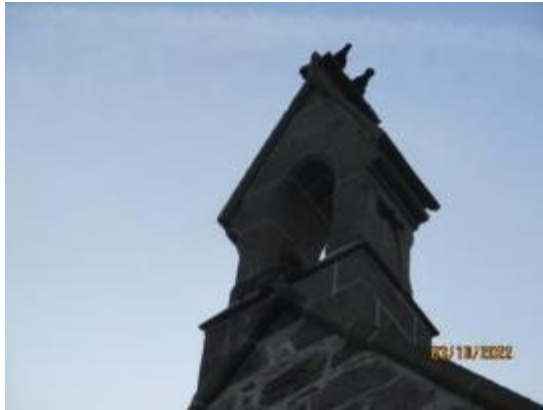
44. Stone bell tower to school

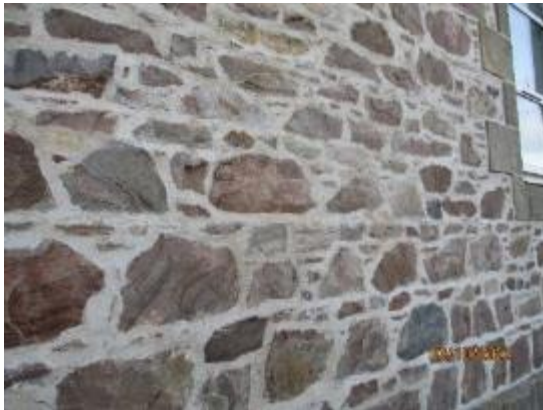
45. Natural stone external walls

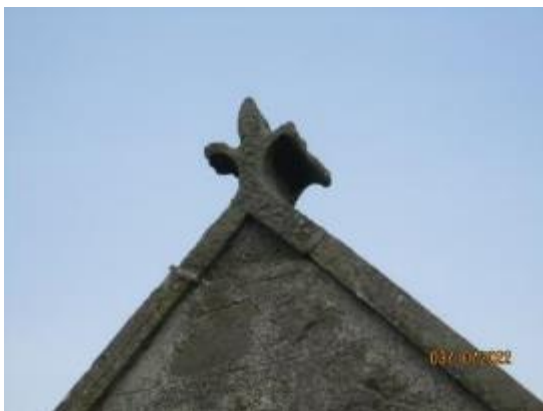
- Stone finials are heavily eroded and require regular monitoring.
- Cast iron rainwater goods have surface corrosion.
- External ground level is above floor level in the south west corner.
- Lath and plaster ceilings are cracked in many locations.
- Lath and plaster walls are cracked and watermarked in several locations.
- Timber linings boards to walls are reaching the end of their useful life.
- Timber window sills, and surrounds are swollen and watermarked.
- Timber suspended floors creek and are uneven.
- Carpets are worn, wrinkled and soiled.
- Linoleum flooring is cracked and worn.
- Internal timber doors are worn and damaged and have exceeded their useful life.
- Kitchen units and worktops have exceeded their useful life.

47. Stone finial – poor condition

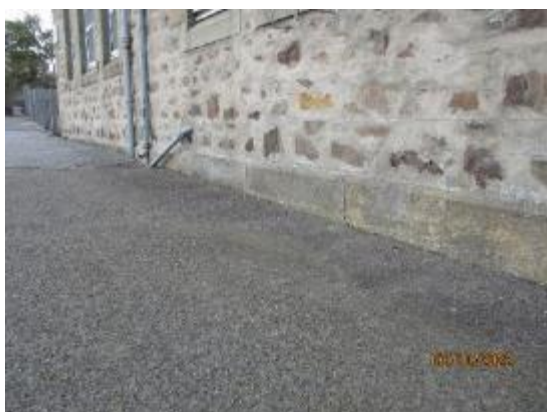
49. Ground level high in SW corner

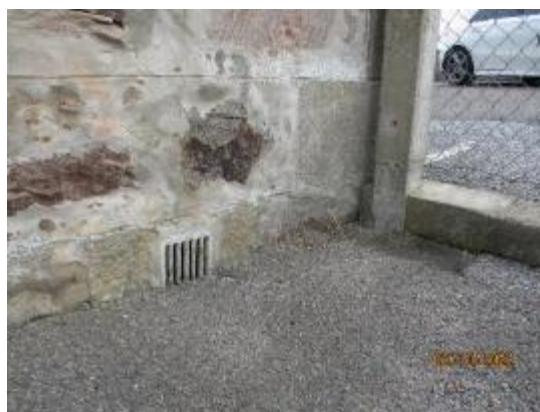
50. Ground level breaching sub-floor ventilation

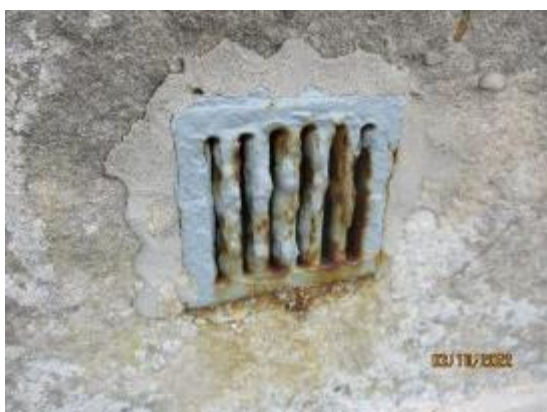
51. Corroded sub-floor vents

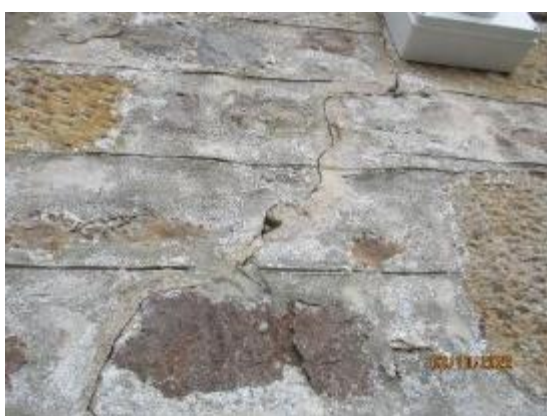
53. Pointing required to isolated cracking

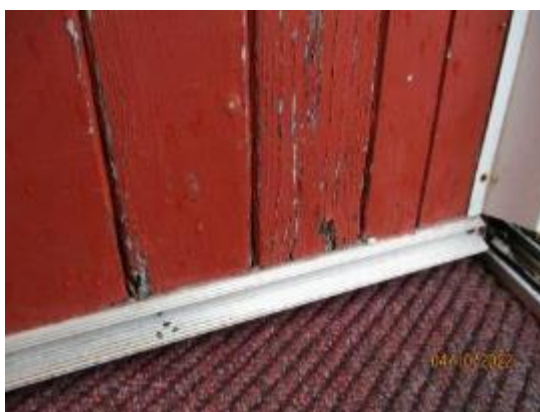
58. Wet rot in timber door to Nursery

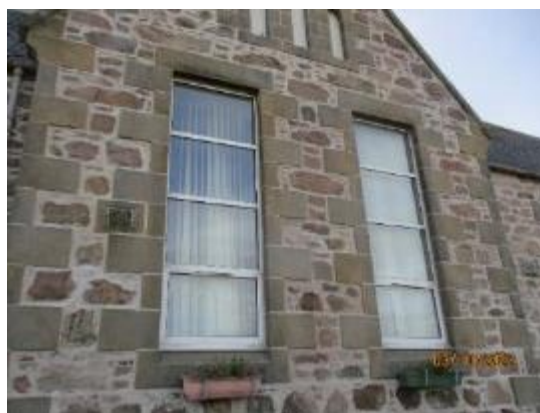
60. UPVC windows to school

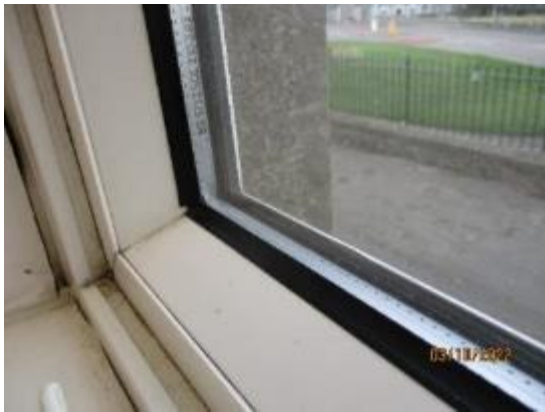
67. Double glazing to all windows

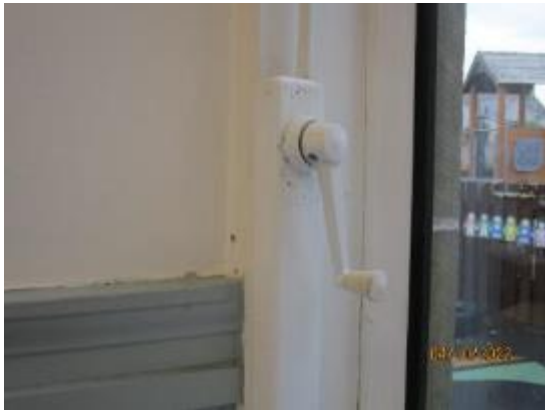
69. Faulty window winders to Nursery windows

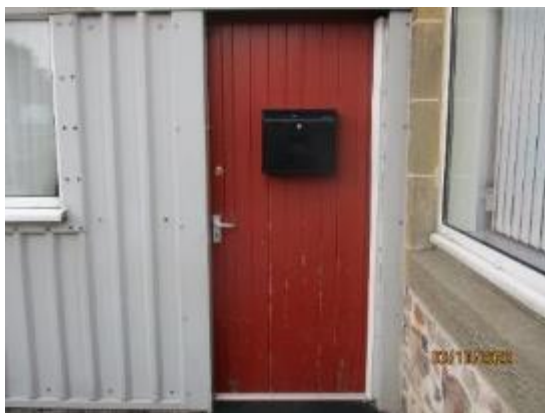
70. Timber external doors

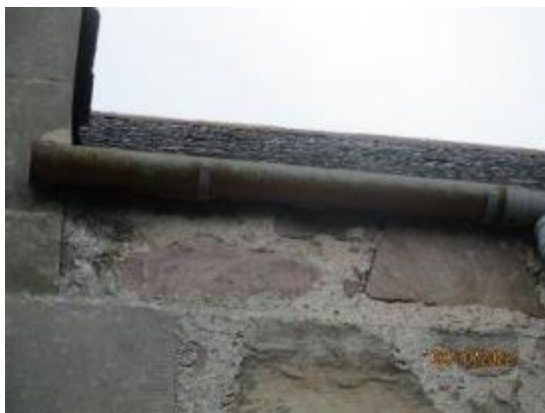
- Cast iron rainwater goods have surface corrosion.
- Cast iron gutters to the west elevation are not aligned with the roof surface.
- External ground level is above floor level in the west elevation.
- Lath and plaster ceilings are cracked in many locations.
- Lath and plaster walls are cracked and watermarked in several locations.
- Timber window sills, and surrounds are swollen and watermarked.
- Carpets are worn and soiled.
- Internal timber doors are worn and damaged and have exceeded their useful life.
- Kitchen units and worktops have exceeded their useful life.

71. Cast iron rainwater goods

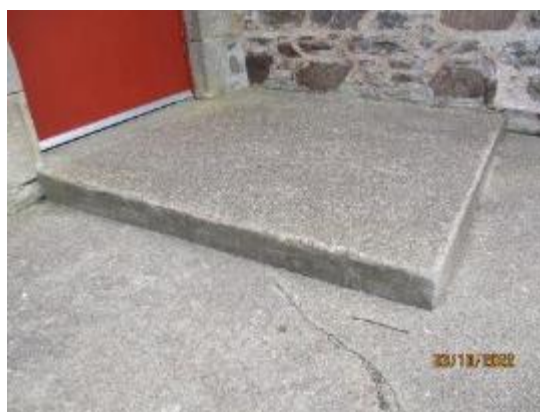
75. Concrete step to back door

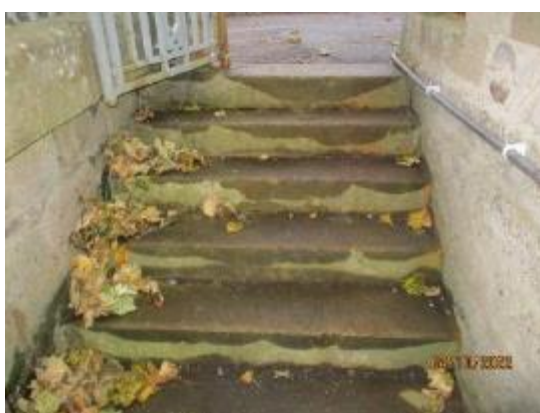
77. Concrete steps to Boiler House

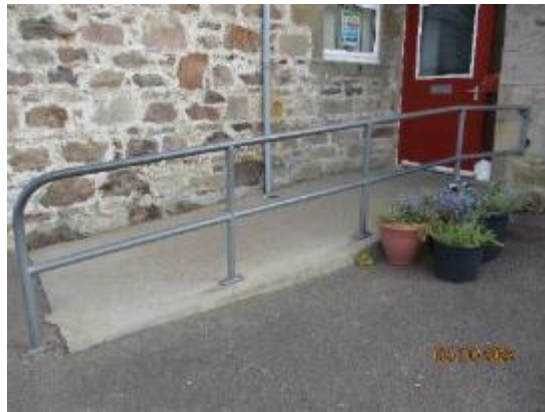
79. Galvanised handrail to ramp

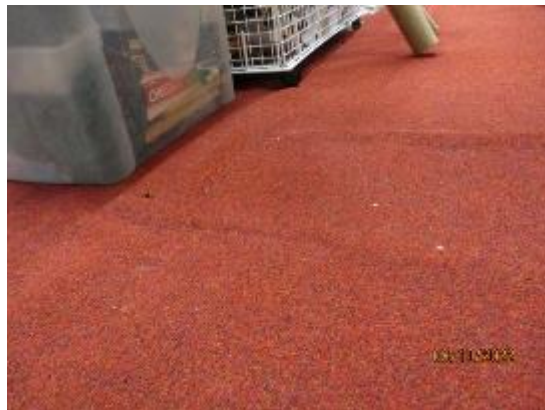
81. Eneven floor boards

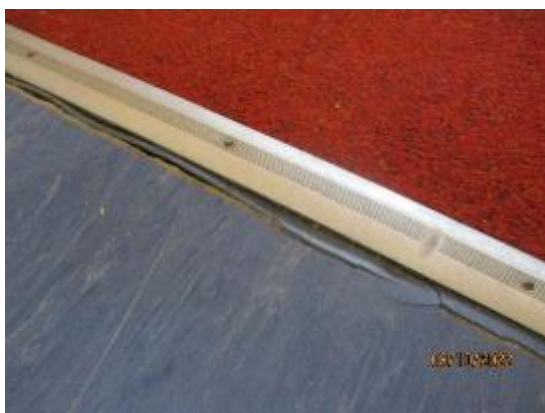
88. Linoleum cracked and worn

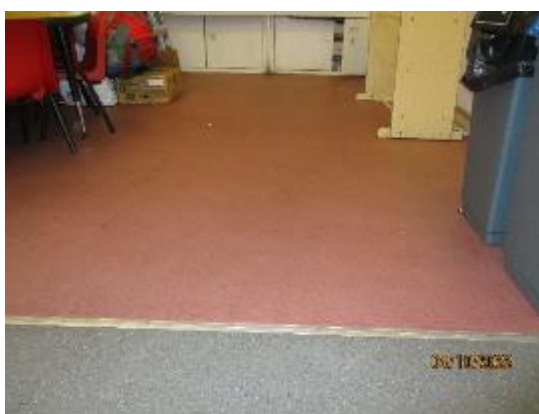
91. Sheet vinyl floors in the Nursery

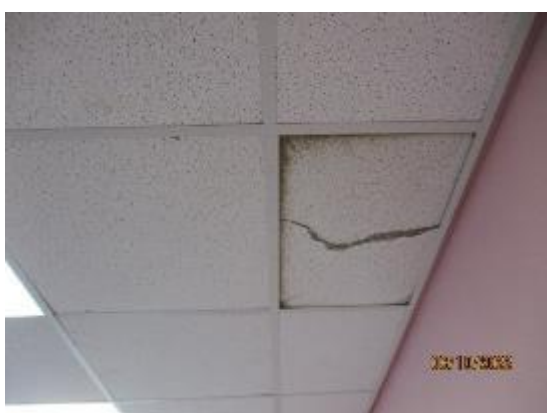
94. Suspended ceiling tiles

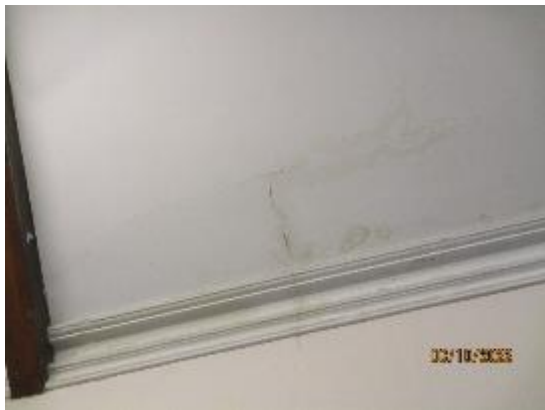
98. Lath & plaster ceilings – cracking

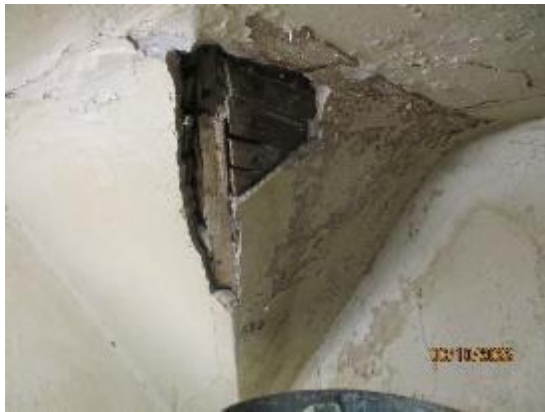
102. Lath & plaster ceilings

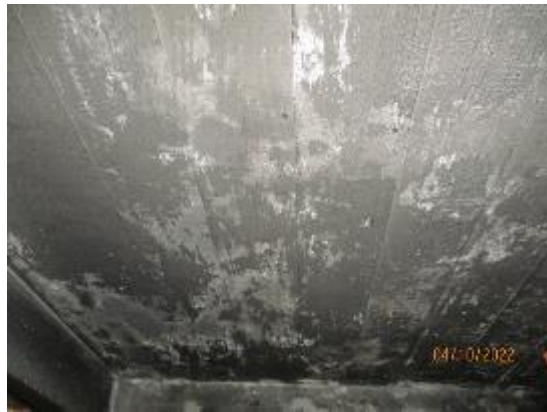
103. Concrete ceiling to Boiler House

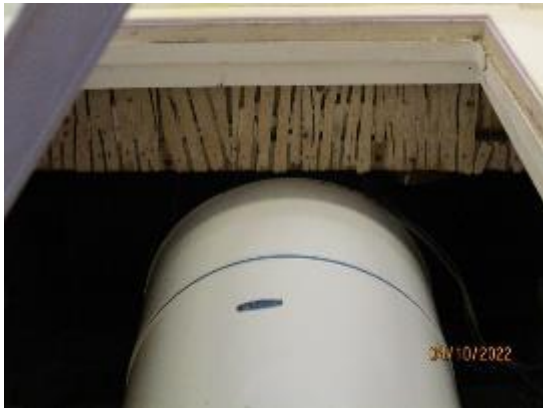
104. Lath & plaster ceilings to Nursery

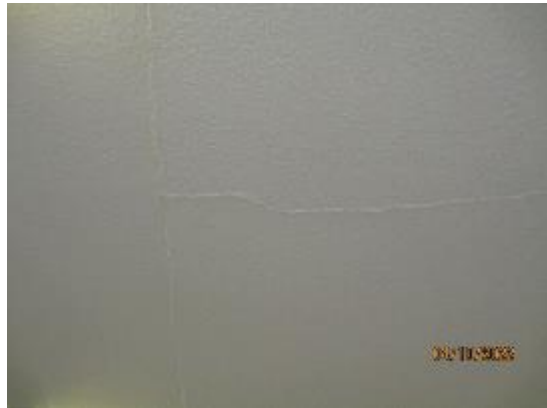
105. Cracked lath & plaster ceilings

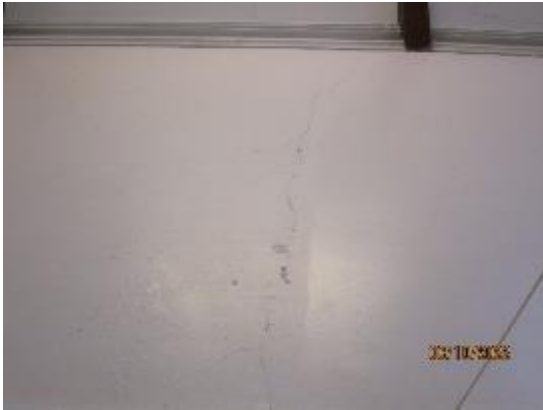
107. Lath & plaster walls cracked

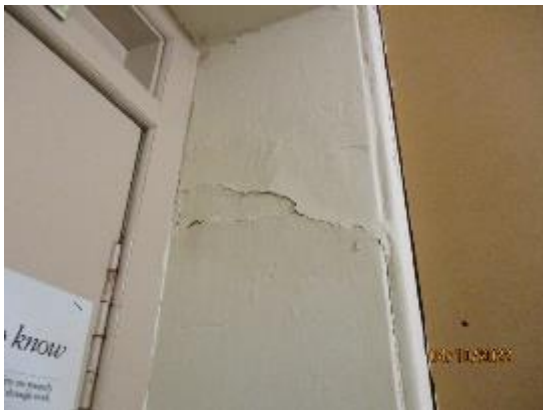
115. Lath & plaster in the Nursery

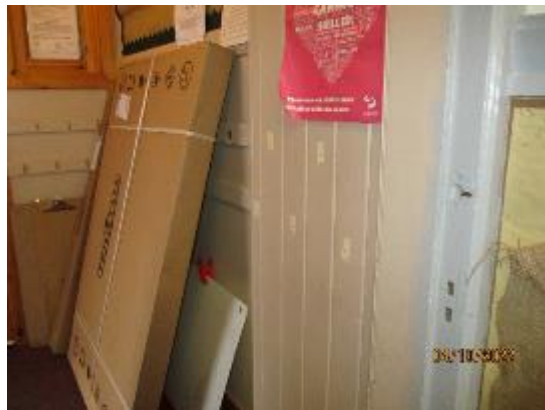
116. Timber linings to walls in the Nursery

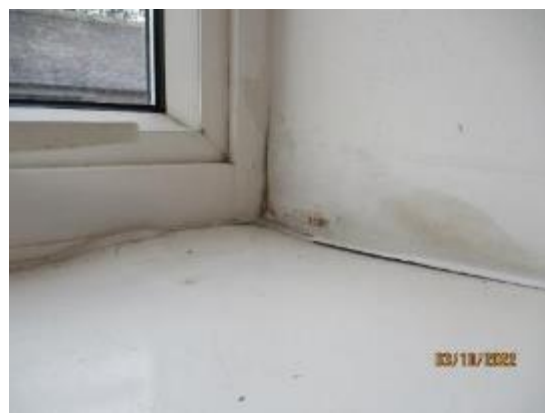
118. Window linings warped and water marked

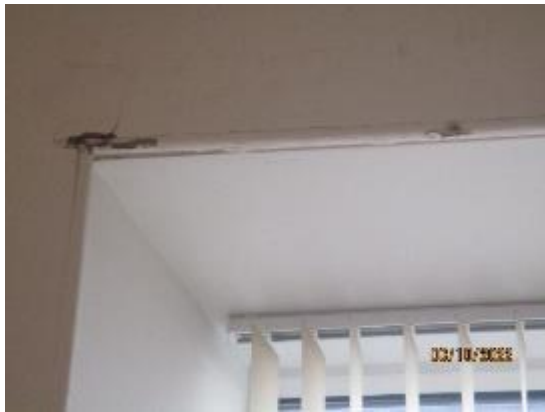
119. Damage to window linings

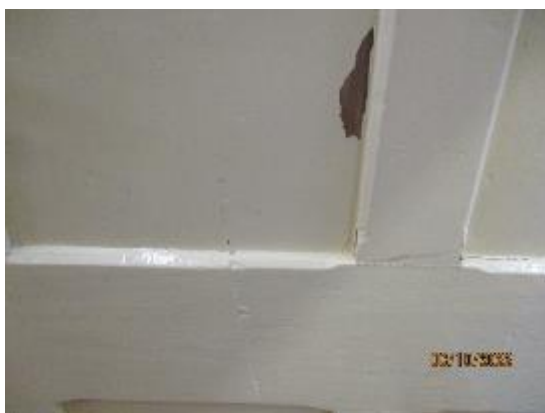
123. Damaged timber doors

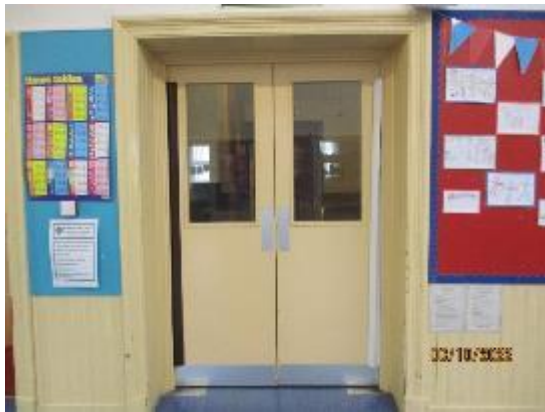
125. Timber double doors

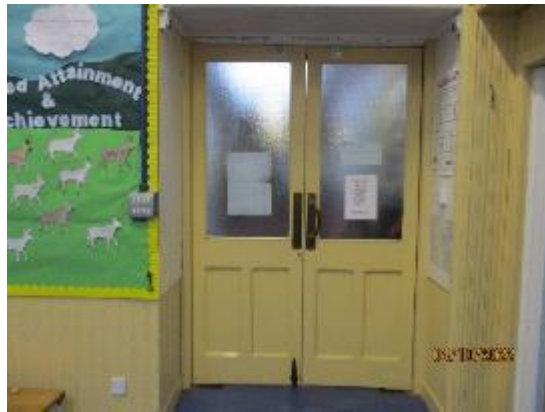
126. Timber panelled double doors

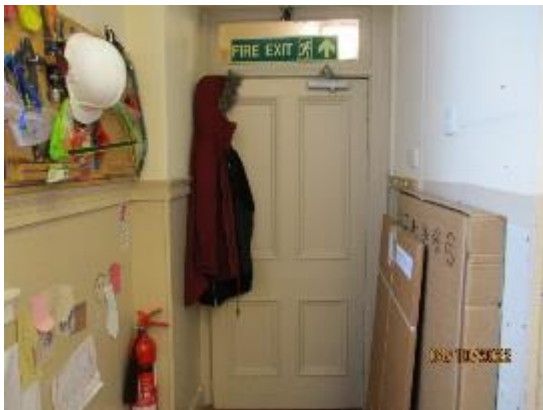
127. Timber panelled doors in the Nursery

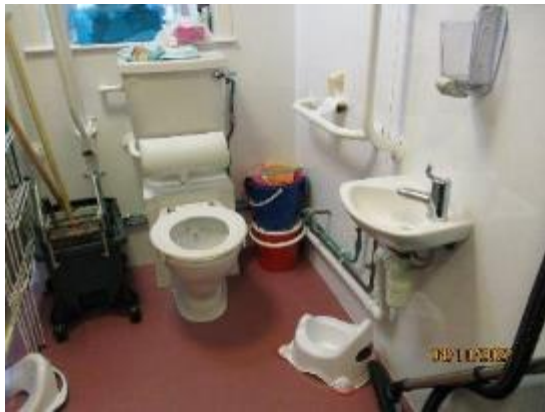
152. Accessible toilet in the Nursery

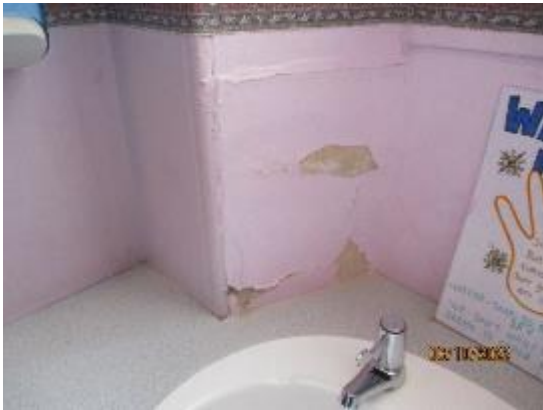
166. Lath & plaster walls

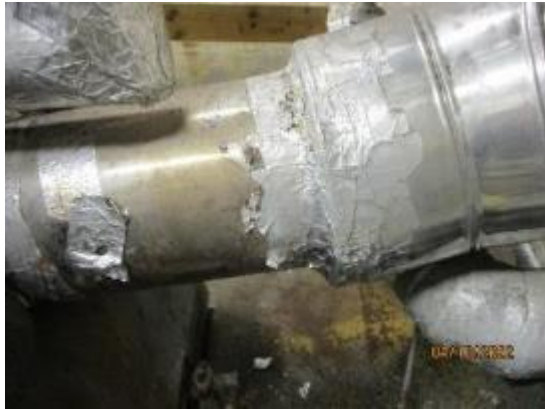
177. Boiler flue / chimney 0/26

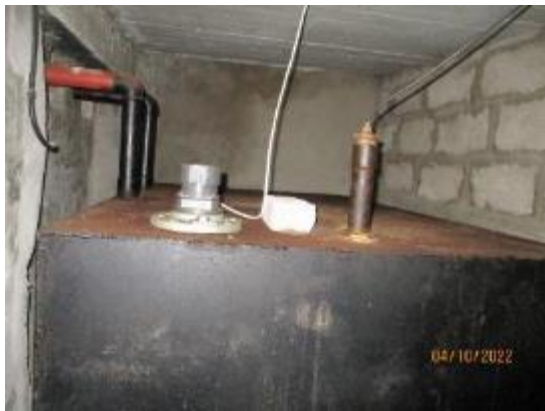
- Oil storage tank and associated supply pipework to boiler are in poor condition and have exceeded their useful life.
- Classroom point of use water heaters have exceeded their useful life.

179. Oil storage tank – plant room 0/26

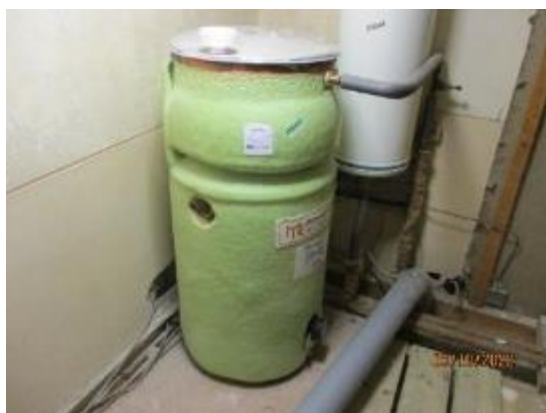
185. Hot water cylinder – PE store.

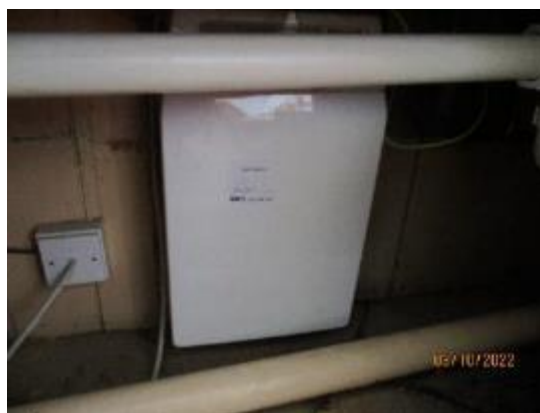
186. Hot water cylinder above staff room.

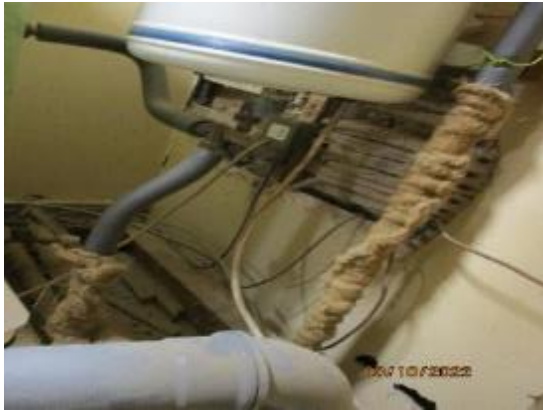
187. Classroom point of use water heater. Typical.

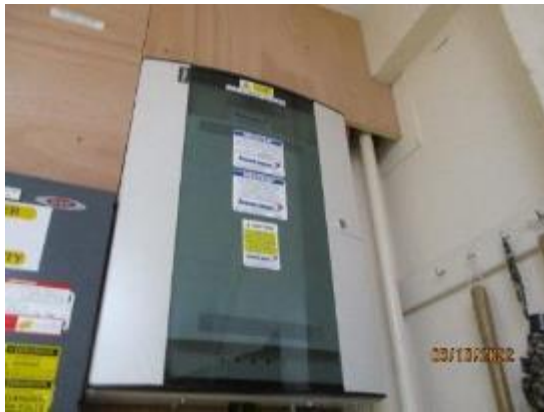
193. Extract fan kitchen. 1/23

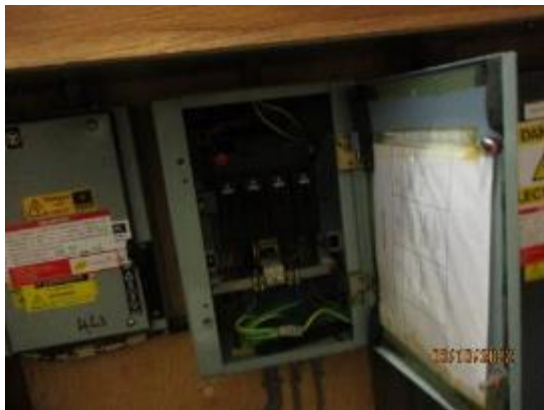
195. DB – East. Cupboard 1/22

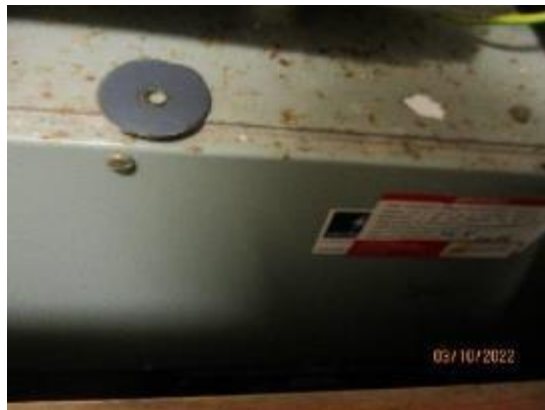
196. DB – Essential lighting cupboard 1/22

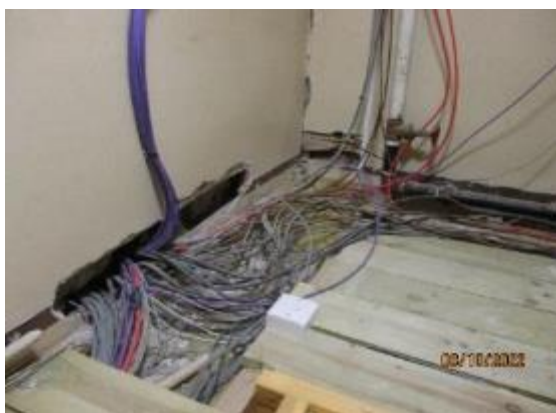
197. Main busbar. Cupboard 1/22

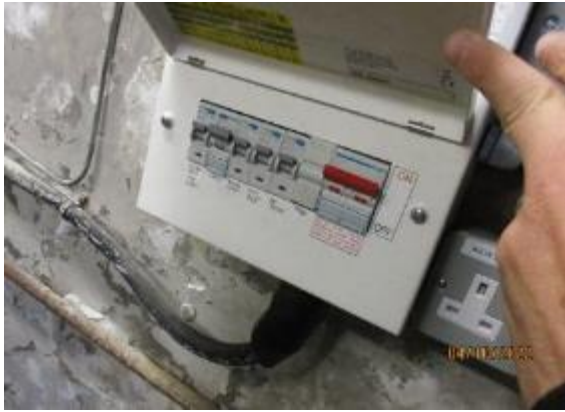
199. Consumer unit. Cupboard 1-22

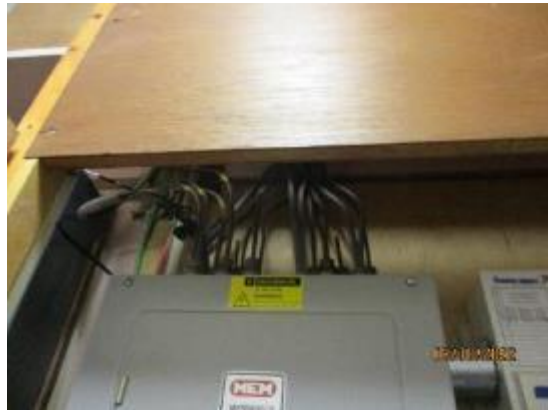
202. Sub mains cabling cupboard 1/22

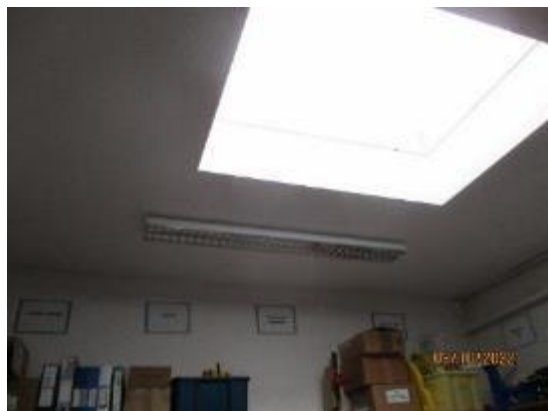
204. Lighting – library. Typical.

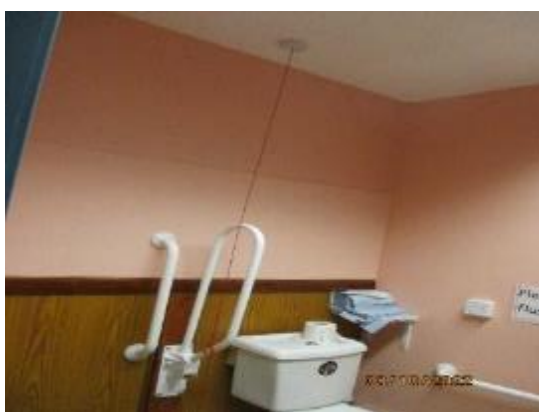
218. Disabled toilet alarm system panel. 1/12

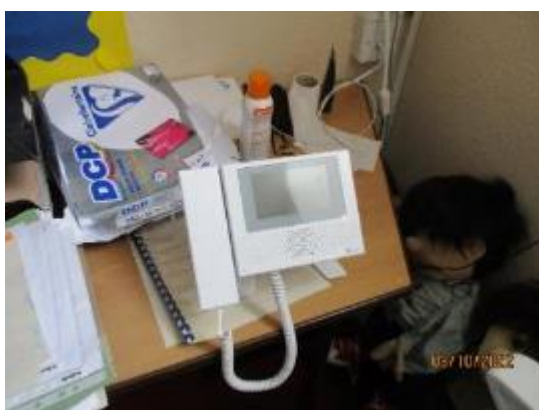
220. Security door entry intercom system with camera 1/1a

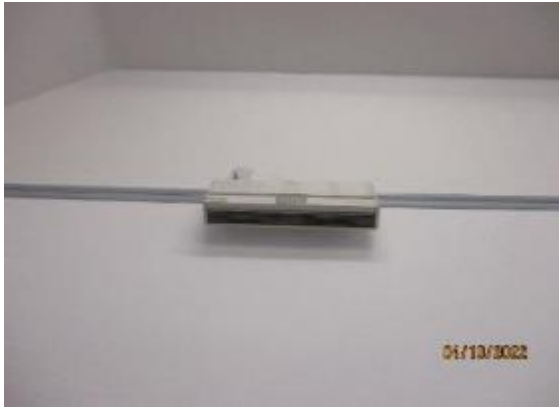
224. Electric fan convactor heater. Main classroom.

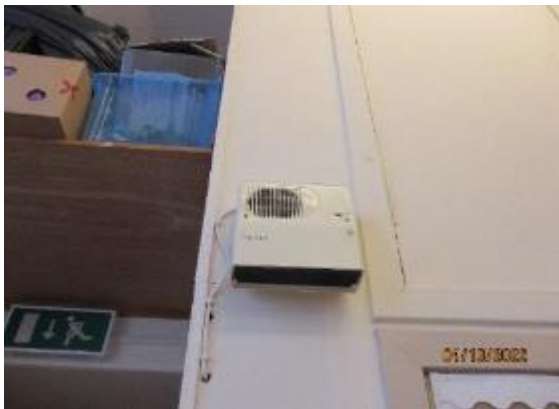
225. Electric convactor heater. Disabled WC.1/B3

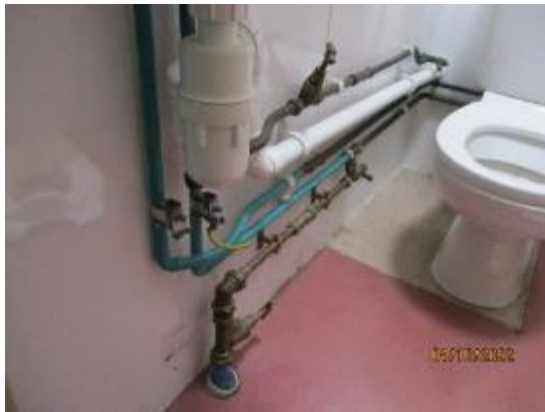
230. Cold water mains pipework. Cupboard 1/B4

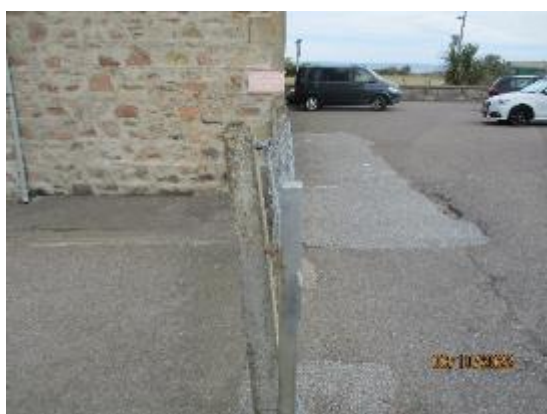
253. Concrete post and chain link fencing

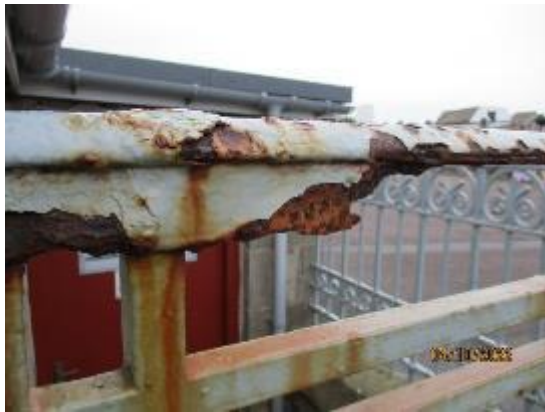
- Natural stone walls require repointing.
- Metal railings have considerable surface corrosion.
- Boiler House gate – corroded with sharp edges.
- Surface water drainage to the west playground is poor.

260. Metal gate to Boiler House

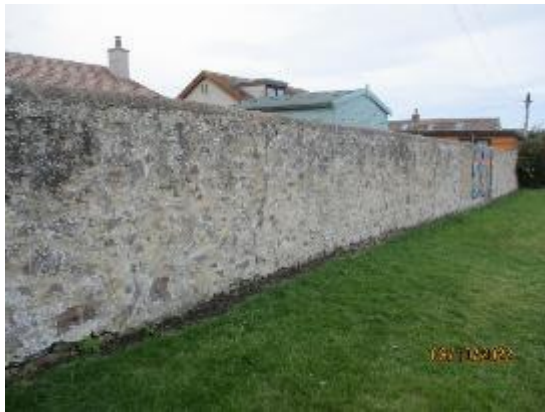
272. Stone wall to sports field

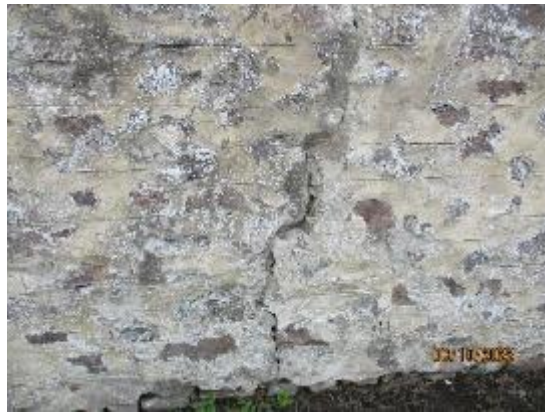
273. Cracks to perimeter wall

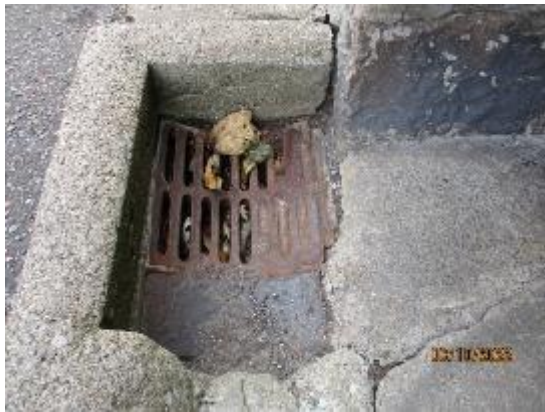
278. Part blocked road gully

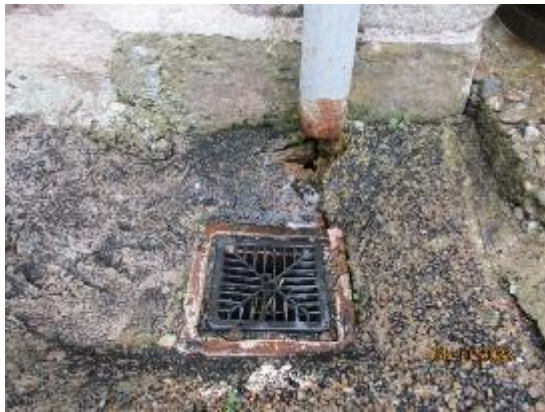
279. Cracked surround to drainage gully

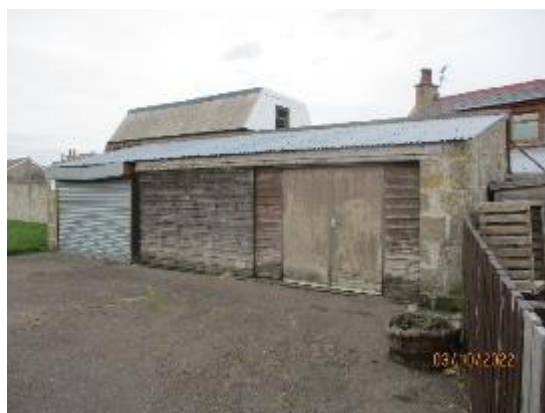
283. Nursery external stores

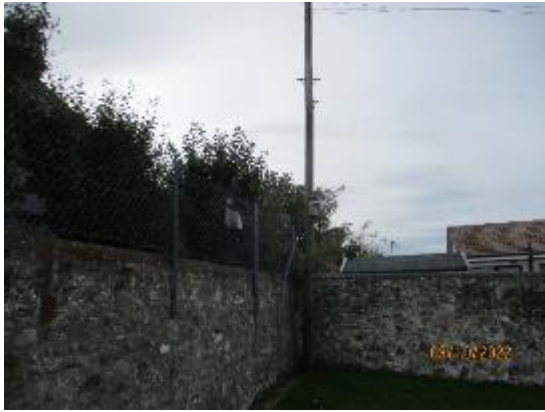
284. Utility pole in corner of sports field

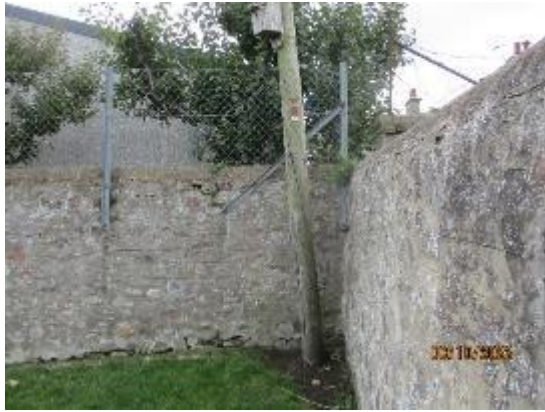
285. Leaning utility pole
