# **Summary Building Condition Survey Report**

**St Peter's Primary School  
37 St Peter's Terrace, Buckie AB56 1QN**

**13<sup>th</sup> December 2022**

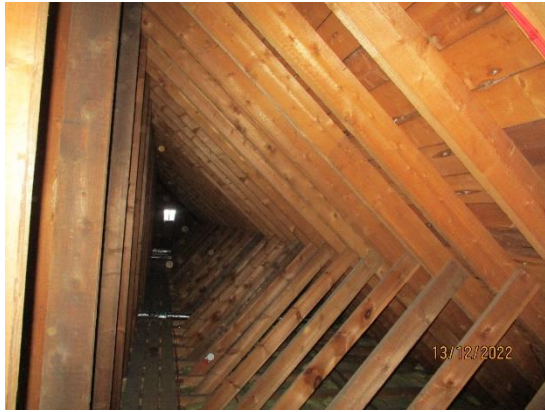
1. Timber roof trusses

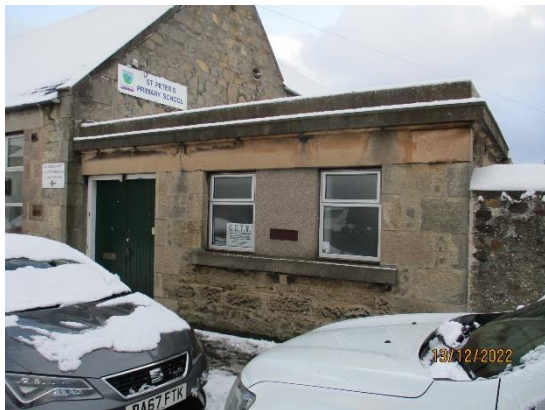
10. Flat roof west

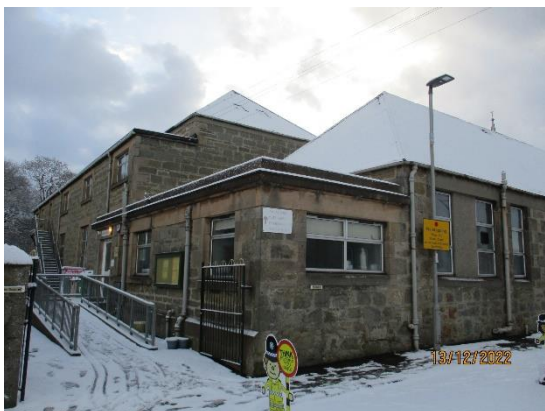
11. Flat roofs east

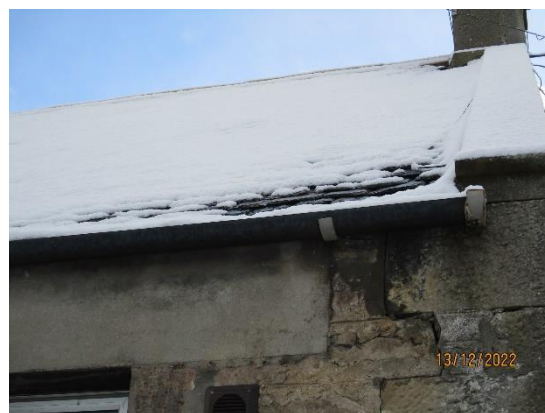
18. Cast iron gutters

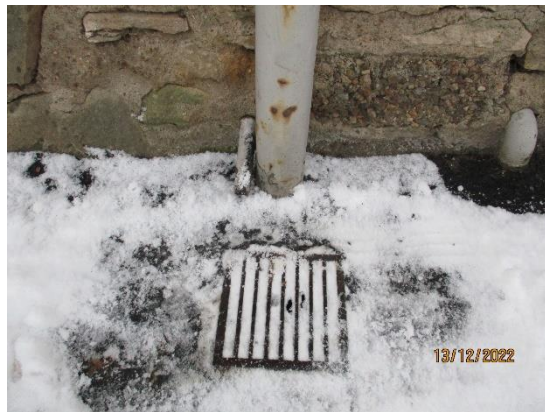
22. Back inlet gullies

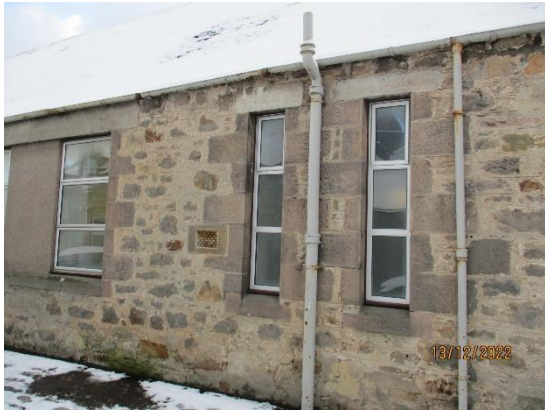
25. Cast iron soil vent pipes

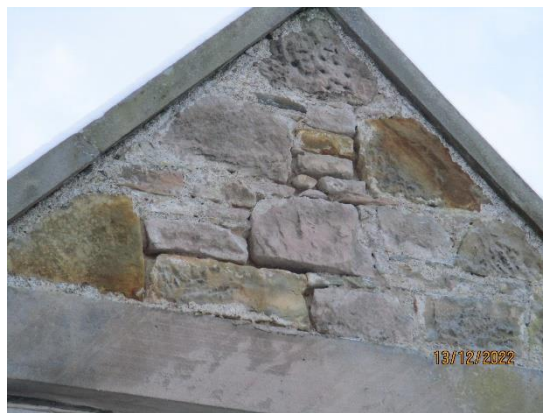
30. Isolated repointing required

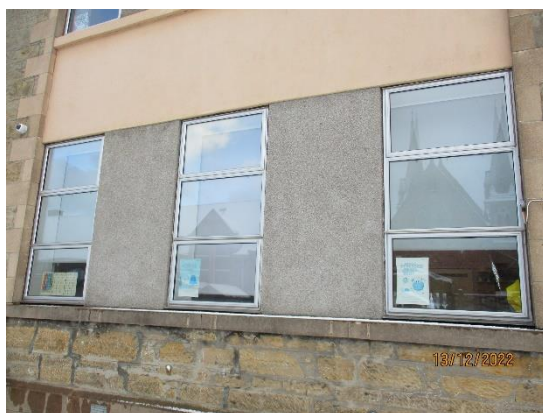
35. Roughcast panels between windows

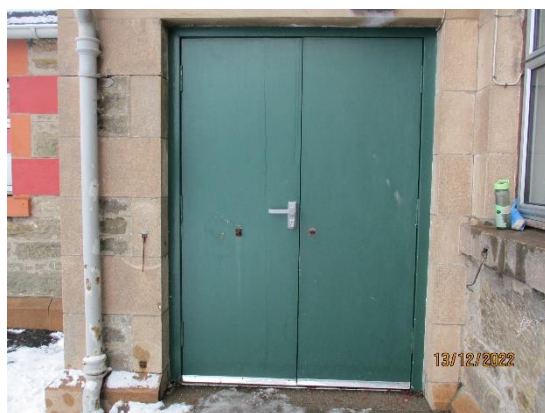
36. Solid core timber doors

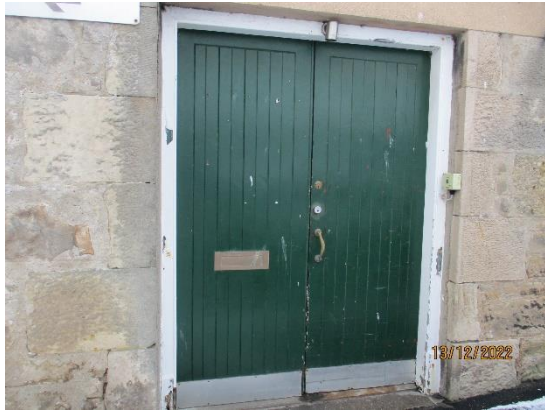
37. Timber TG&V doors

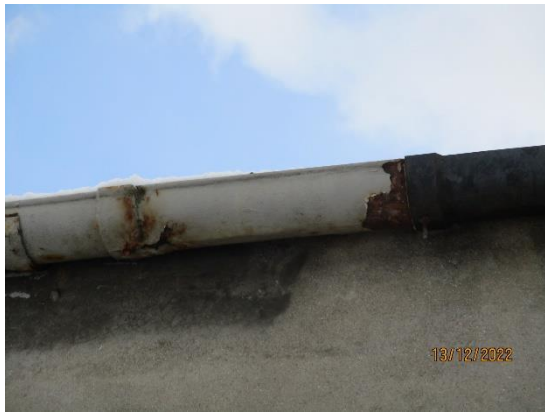
55. Cast iron rain water goods

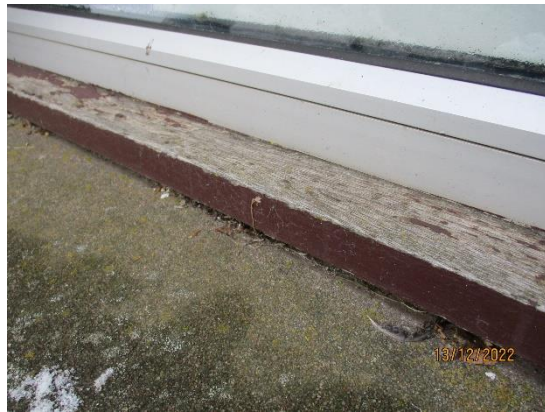
56. Timber window sills

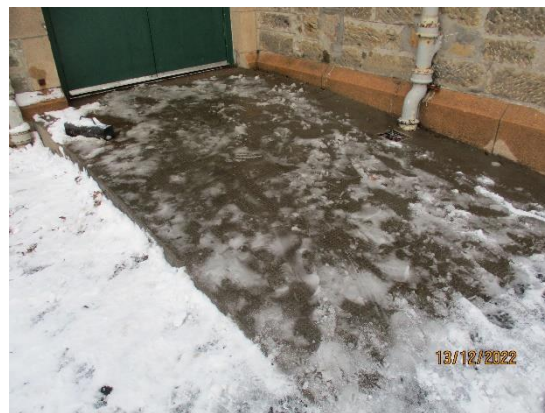
60. Concrete ramps to playground

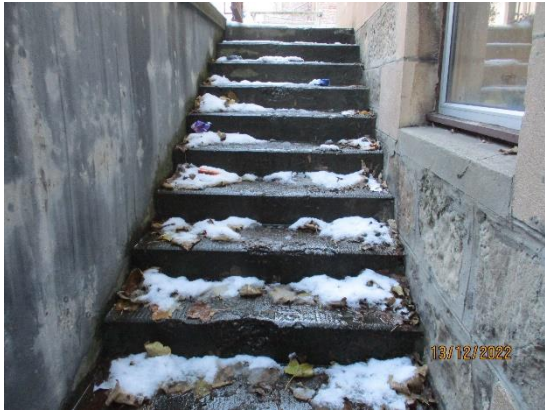
61. Steps to Boiler House

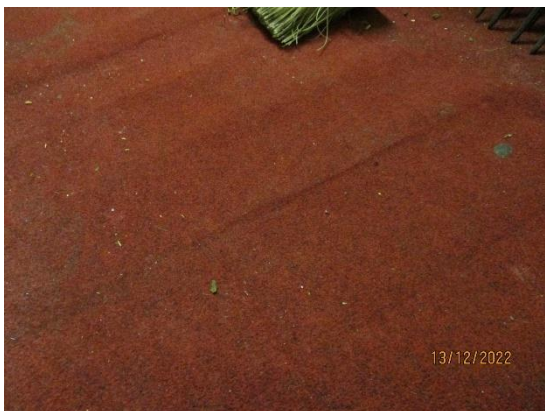
65. Uneven floor boards

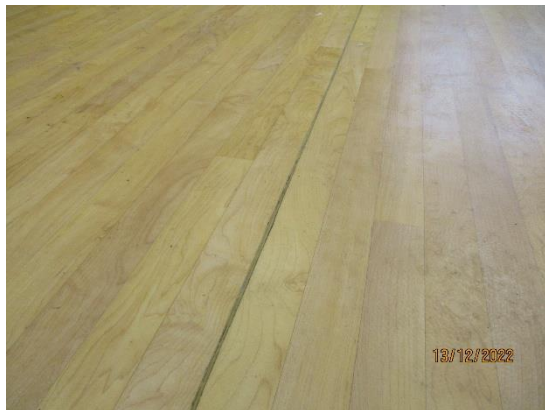
69. Open joints in vinyl flooring

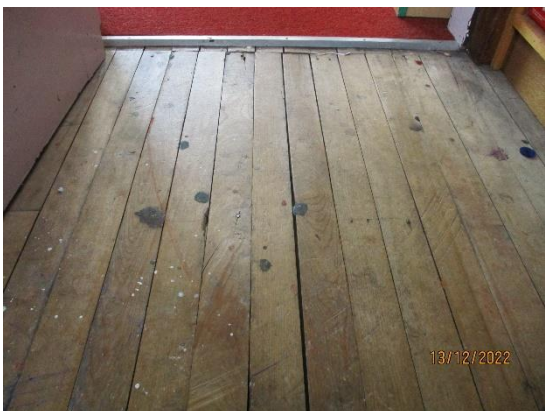
77. Timber boarded floors

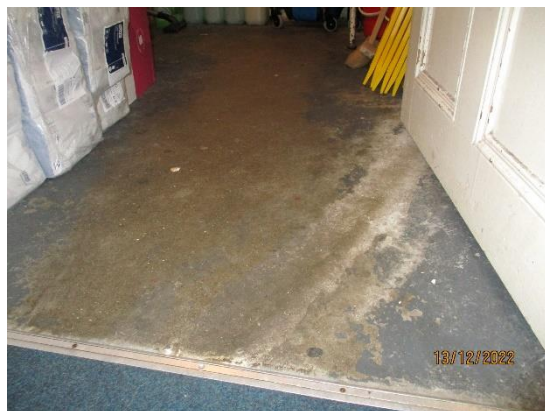
78. Painted concrete floor

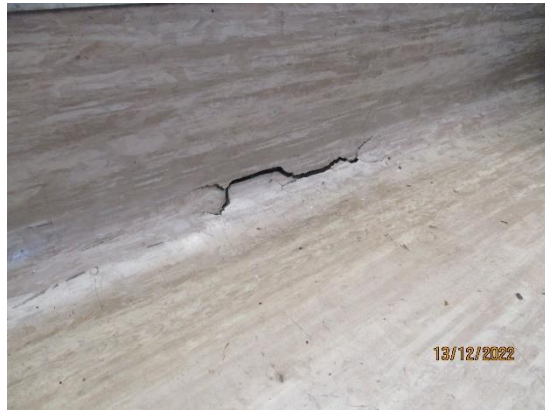
82. Torn vinyl to stairs

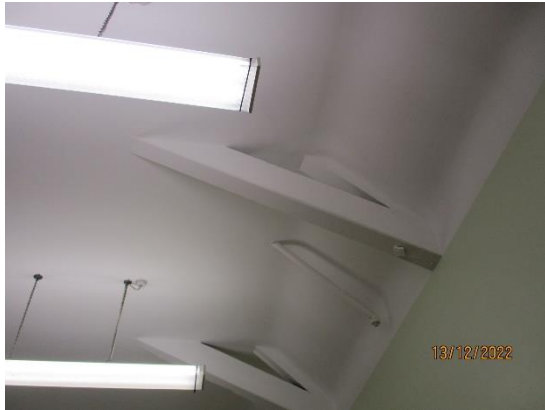
85. Lath & plaster ceilings

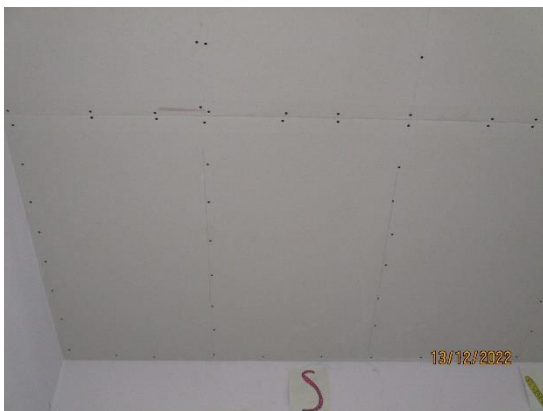
95. Plasterboard ceilings (not taped or filled)

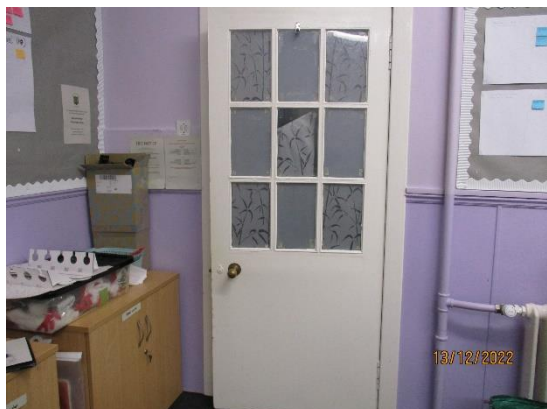
110. Timber panelled classroom doors

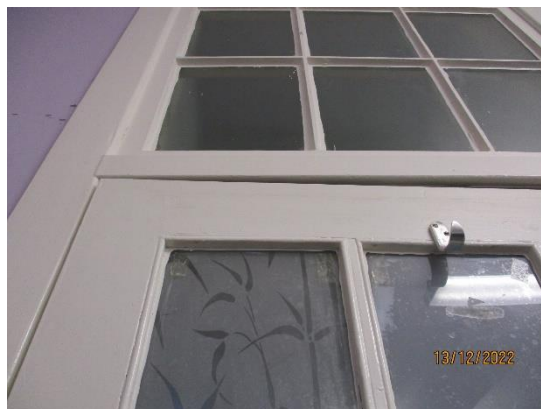
111. Twisted timber doors

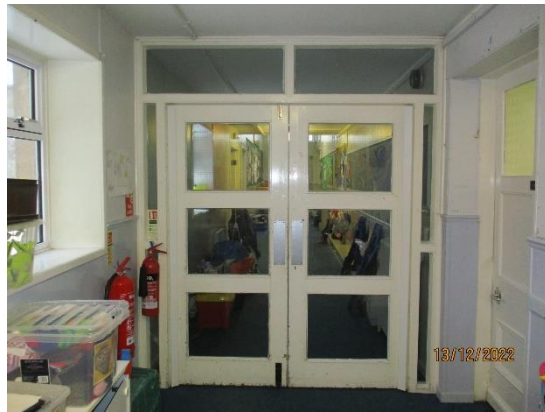
121. Timber doors and glazed screens

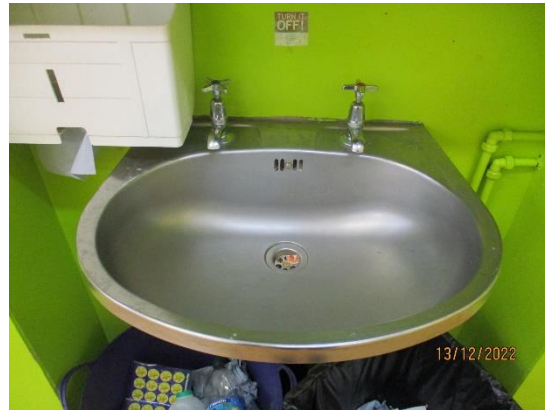
135. Stainless steel wash hand basin

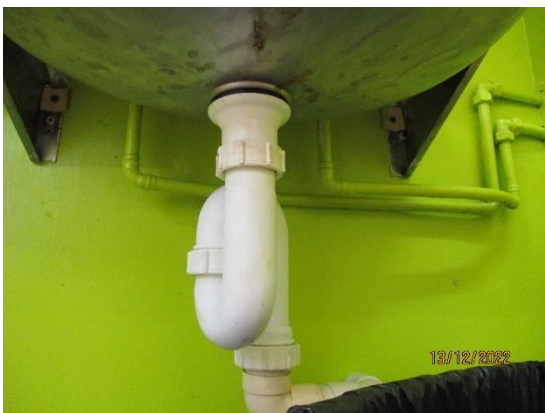
136. PVC waste pipes

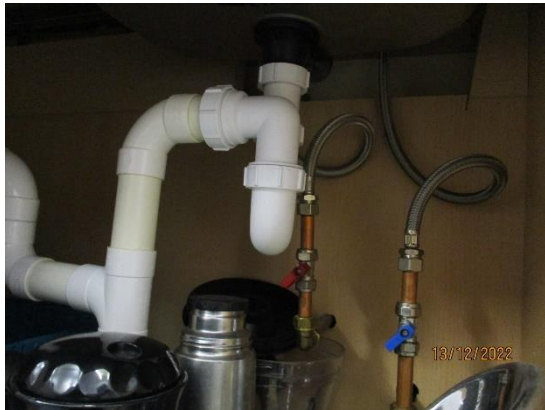
146. PVC waste pipes

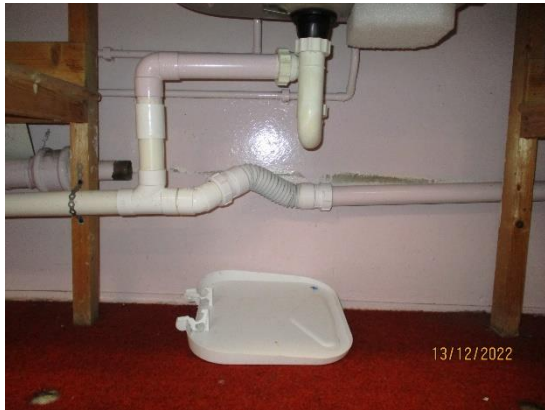
147. Poor fall on waste pipes

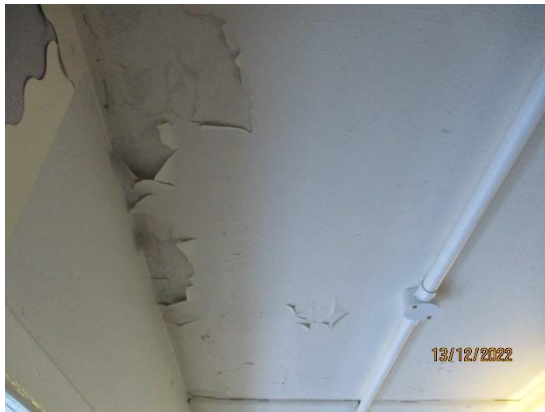
149. Ceilings – peeling paint

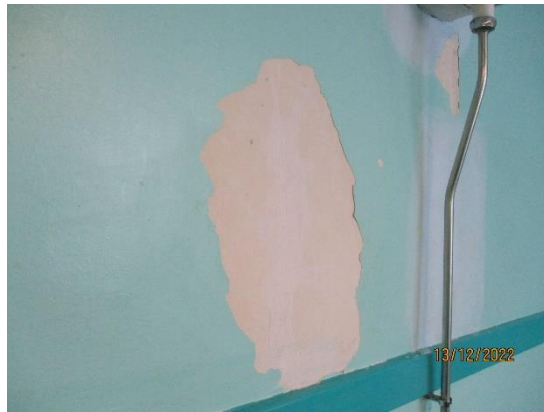
150. Walls – peeling paint

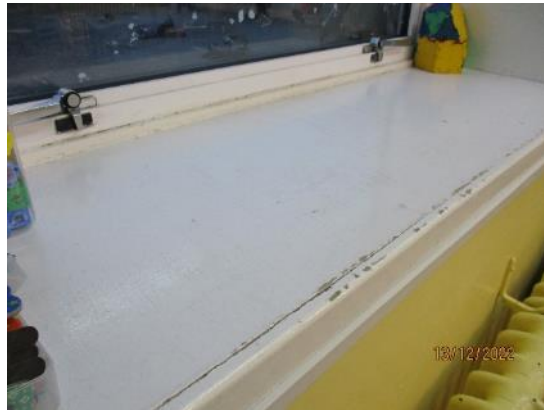
152. Timber window sills

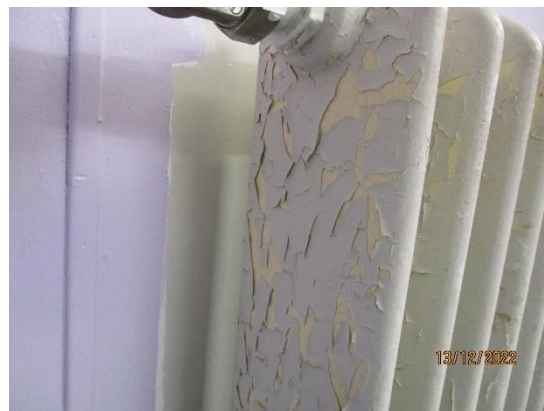
154. Cast iron radiators

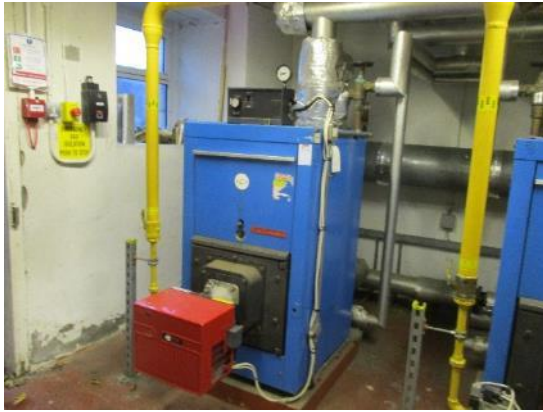
- Gas boilers are life expired as per CIBSE Guide M and in poor condition.
- Heating distribution pipework and heat emitters are life expired as per CIBSE guide M and in poor condition.

161. Boiler 1 – Plant room 0/3

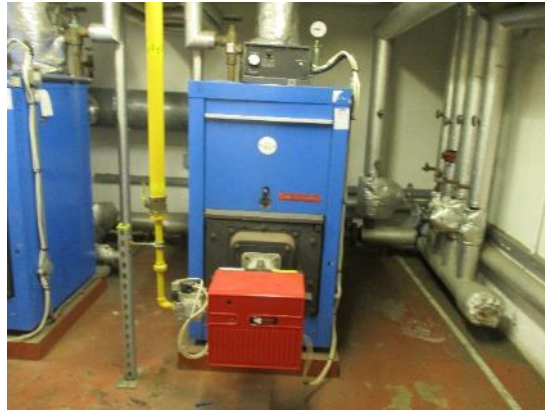
162. Boiler 2 plant room 0/3

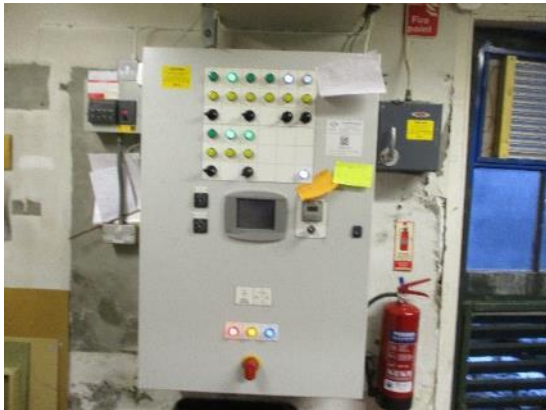
- Heating system controls are life expired as per CIBSE guide M and in poor condition.
- Hot water distribution pipework and main storage calorifier are life expired as per CIBSE guide M and in poor condition.

163. Control Panel – Plant room 0/3.

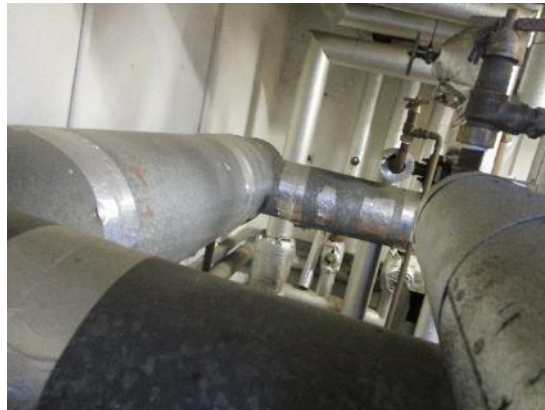
164. Flue system – boilers. 0/3 Plant room

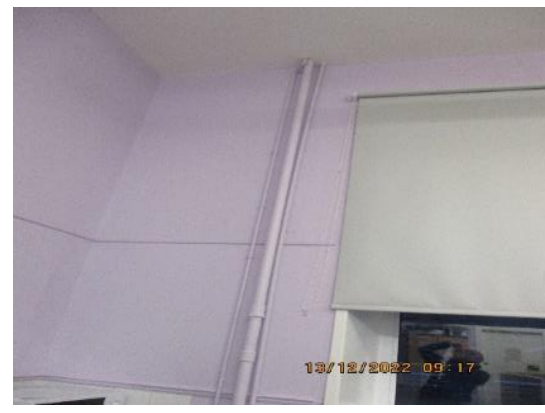
166. Pipework – heating distribution in school rooms.

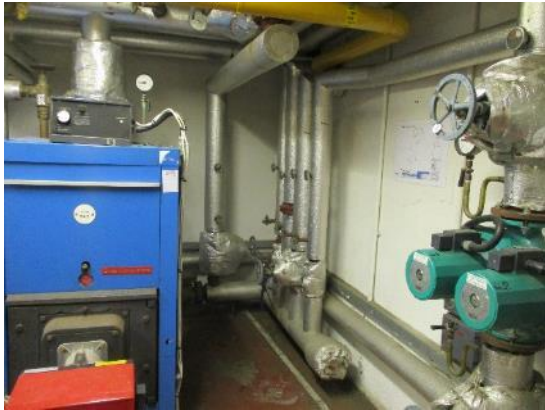
167. Pipework – heating distribution in plant room.

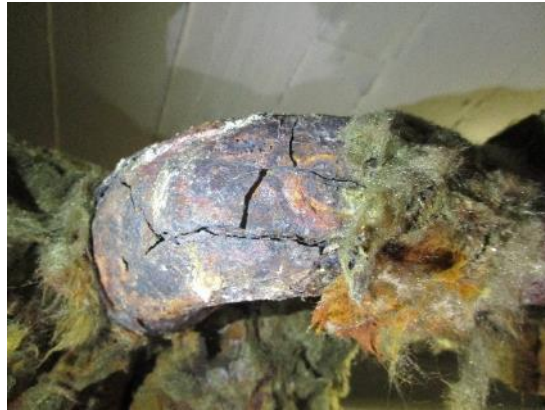
168. Pipework – heating system. Plant room.

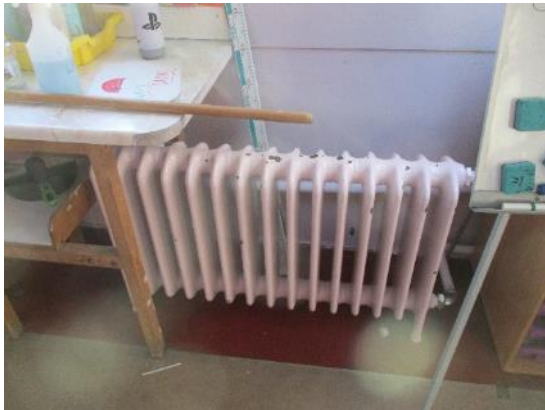
169. Radiators – cast iron section. Classroom typical.

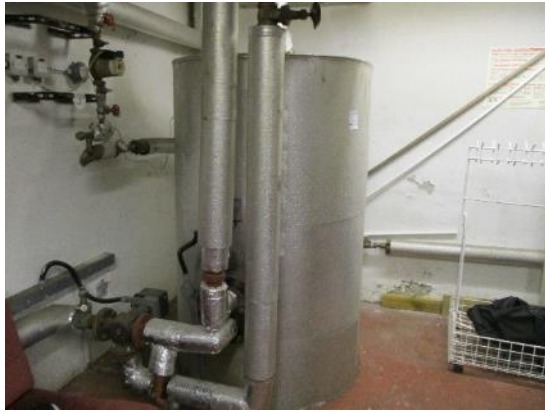
173. Calorifier. Main school hot water storage 0/3 plant room.

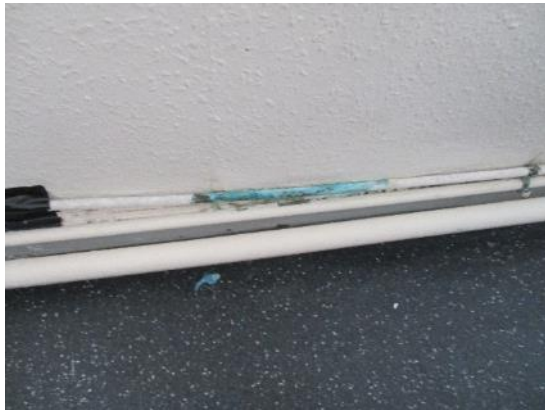
175. Pipework – hot water distribution typical.

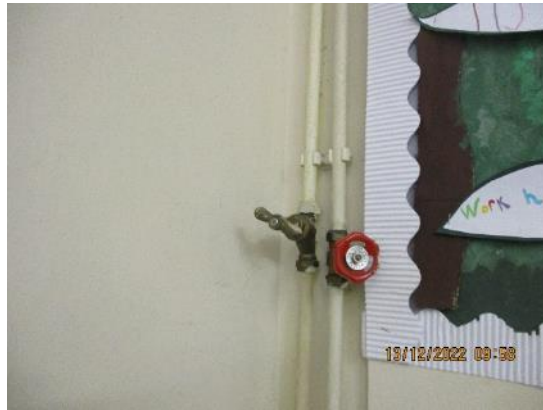
176. Pipework – hot water distribution.

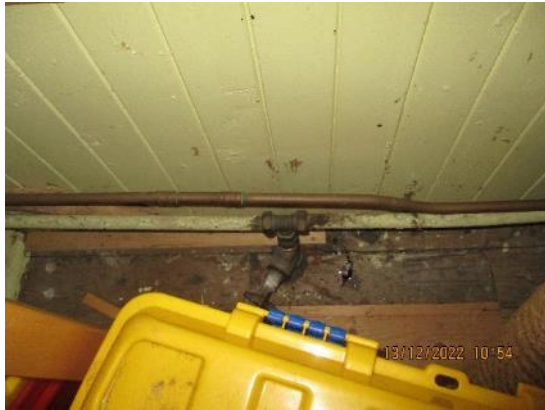
- Cold water distribution pipework is life expired as per CIBSE guide M and in poor condition.
- Mechanical ventilation – extract fans are generally in poor condition and approaching the end of their useful life. Controls for these fans could also be improved to aid energy consumption.

179. Pipework – cold water mains supply 1/14 typical.

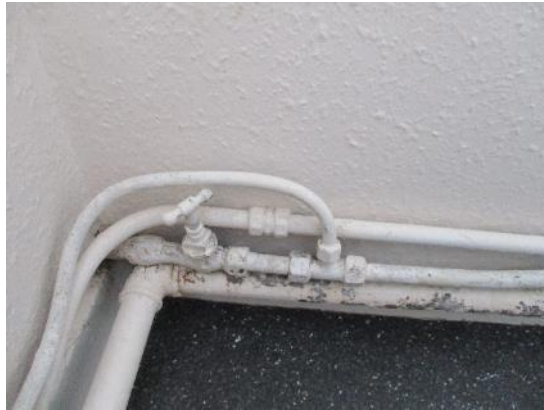
180. Pipework – cold water supply 1-18

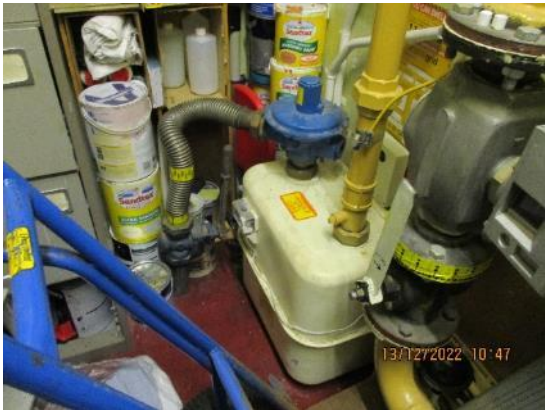
181. Gas meter and distribution pipework janitors room 1/11

- Provide adequate access to front elevation and Games Hall, pitched roof-spaces.
- Move gas supply pipe, gas meter and distribution gas pipe to external of main building.
- Install greater scope of emergency lighting.
- Options appraise to plan replacement of heating system in order to reduce boiler carbon emissions and increase energy efficiency.
- Consider replacing traditional hot water storage calorifiers with instantaneous plate heat exchanger or individual point of use water heaters to limit storage of water.
- Upgrade lighting systems to LED types.

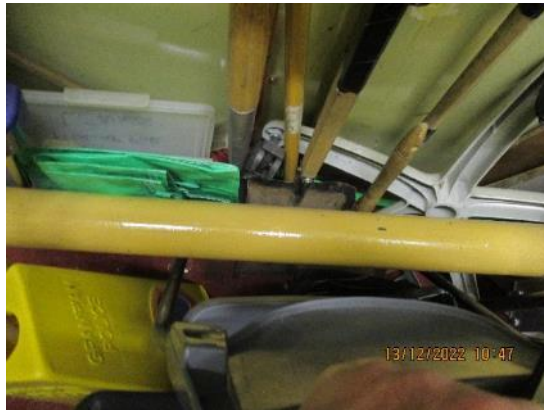
182. Gas distribution pipework room 1/11

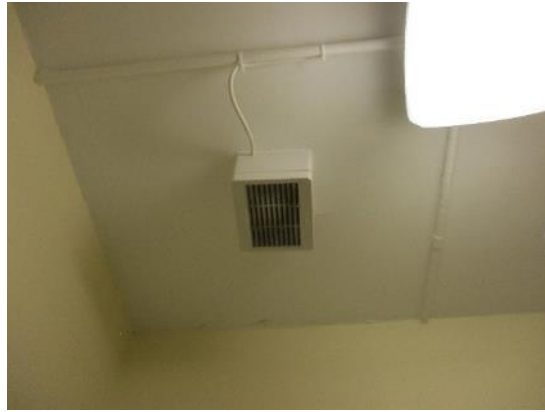
185. Extract fan – kitchen 1/21

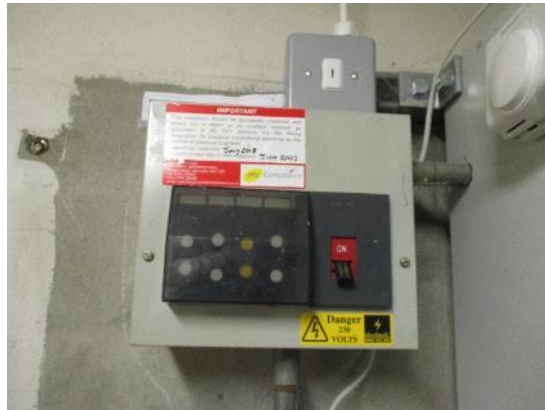
187. Distribution board 1/14

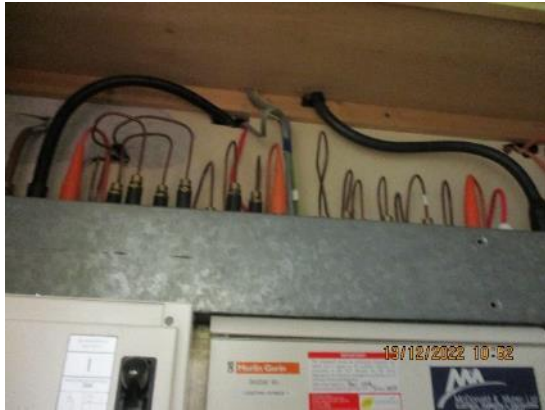
190. DB – 2/27 Class

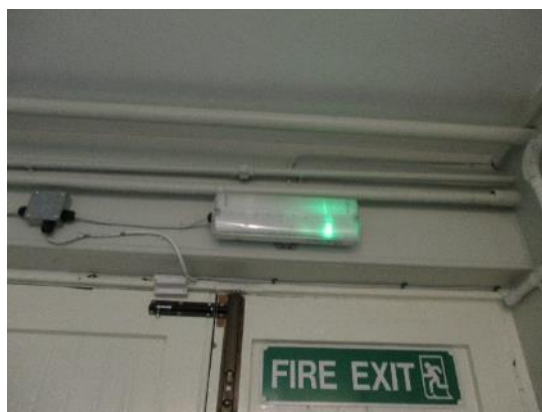
197. Emergency light fitting - classroom

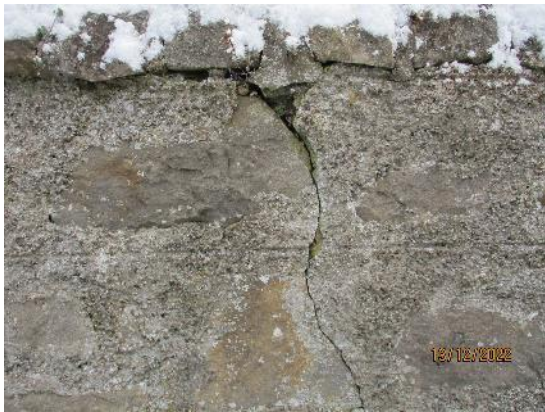
233. Pointing required to stone wall
