# **Summary Building Condition Survey Report**

**Bishopmill Primary School  
Morrison Road, Elgin IV30 4DY**

**8<sup>th</sup> & 10<sup>th</sup> August 2023**

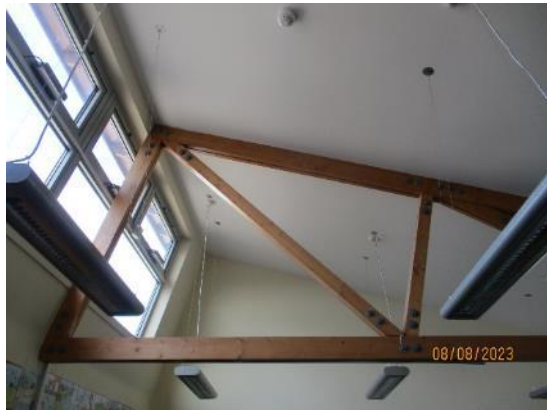
- Brush seals to external doors have failed, resulting in open gaps.
- Plasterboard walls are water damaged at exposed trusses.
- The Games Hall timber floor is lifting and uneven.
- Internal decoration is overdue.

10. Exposed roof trusses

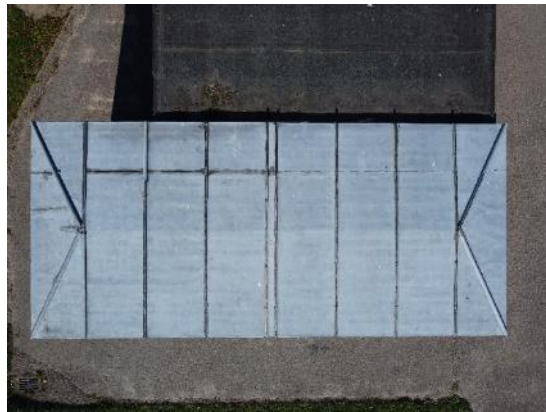
32. Zinc roof to external stores

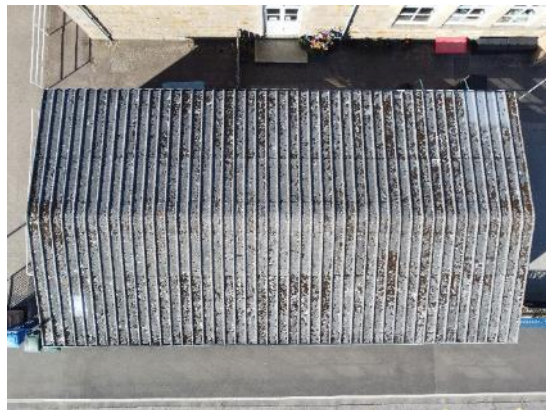
- The corrugated asbestos roof covering has areas of damage and previous repair.
- The UPVC gutters are leaking at the joints.
- The timber fascia and barge boards have areas of rot and surface damage.
- The external timber cladding has evidence of timber rot.
- External decoration is overdue.
- The surface water drainage in the play area is inadequate resulting in flooding.

34. Asbestos roof to Nursery

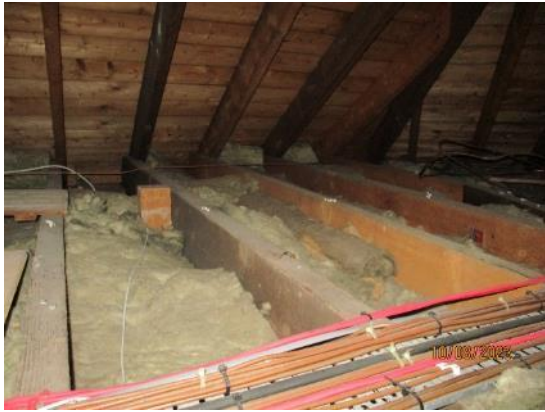
43. Thin insulation above the original school

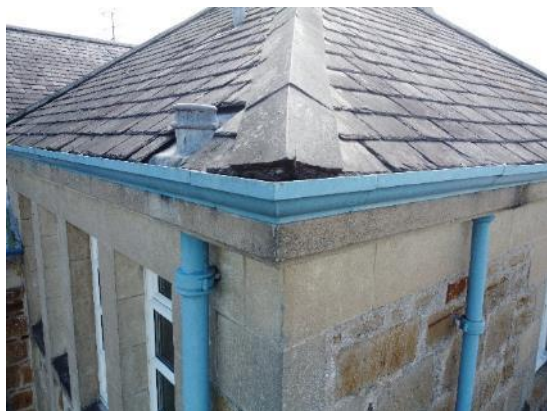
48. Cast iron ogee gutters

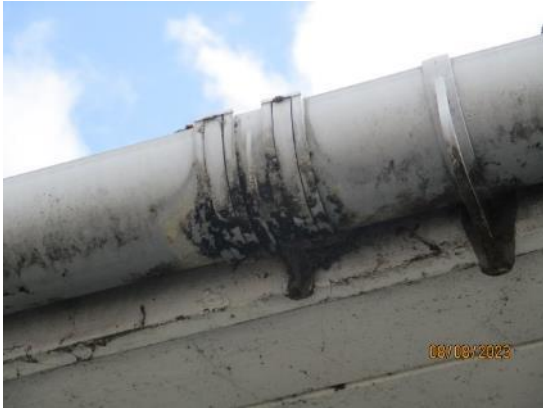
51. UPVC gutters leaking

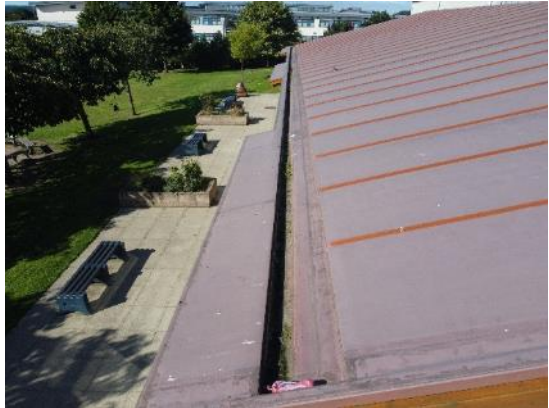
52. Single ply membrane secret gutters

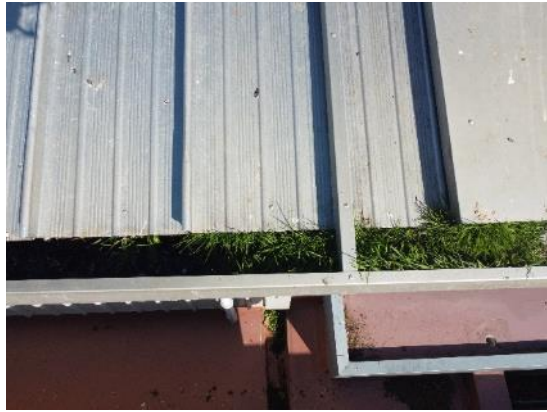
56. Blocked with vegetation

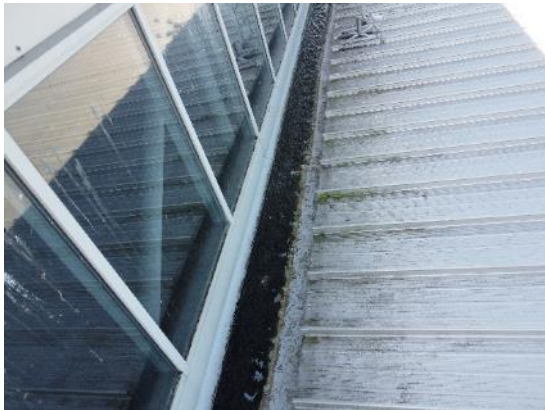
57. Blocked with silt

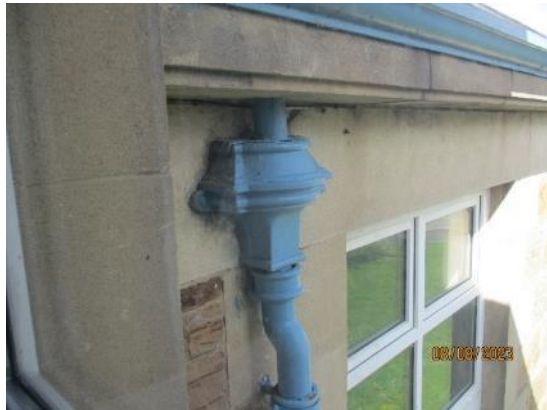
58. Cast iron downpipes

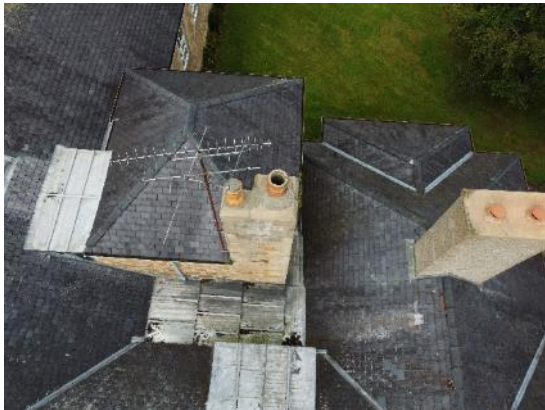
63. Open, uncapped chimney flues

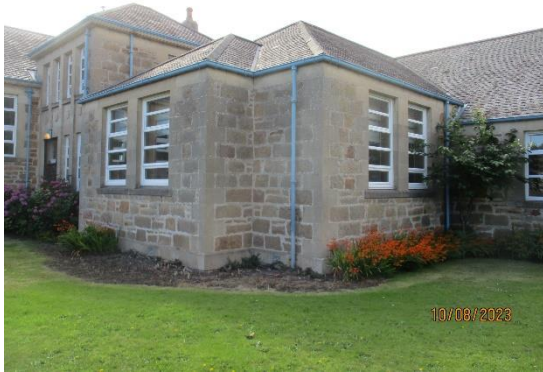
67. Stone external walls

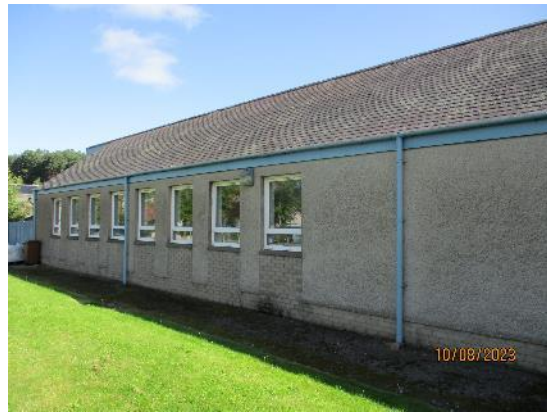
68. Brickwork external walls

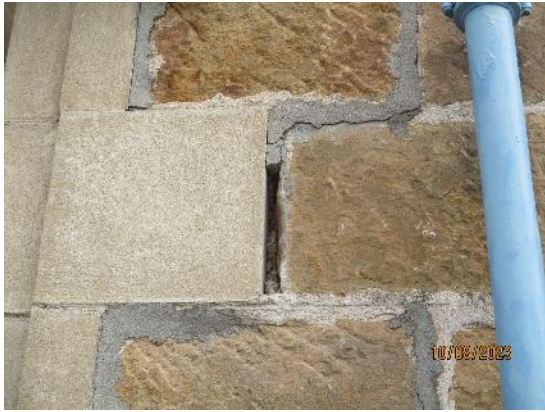
73. Isolated repointing required

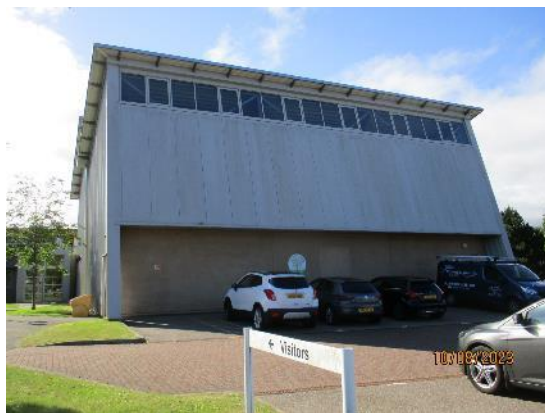
78. Metal profile walls to Games Hall

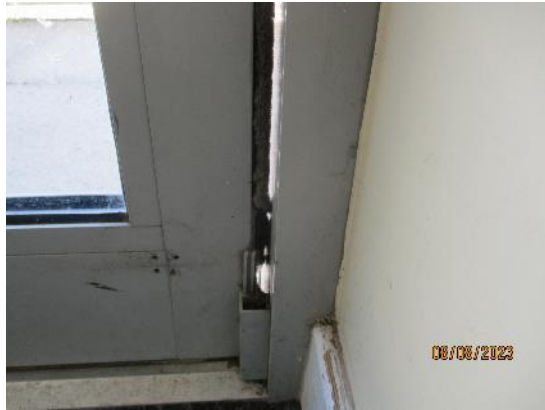
104. Gap between door and frame

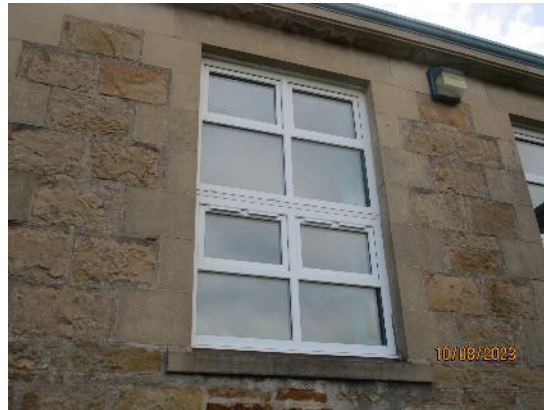
111. Windows screwed shut

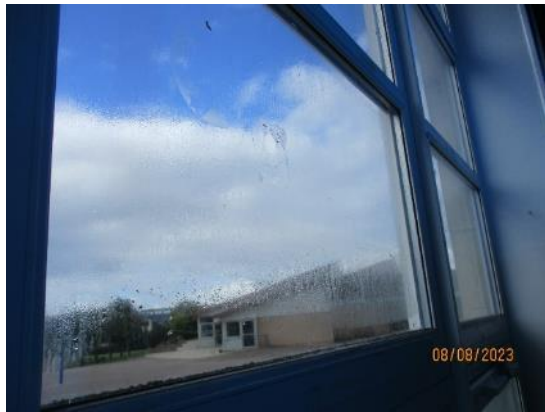
127. Condensation within double glazing

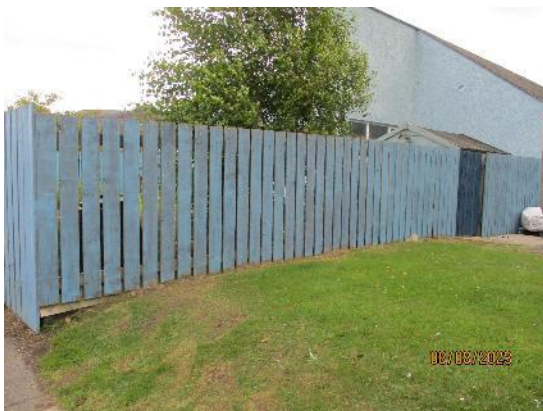
137. Timber fencing and gates

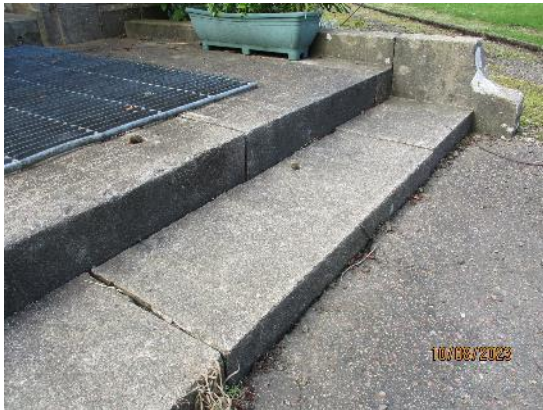
141. Pointing and levelling to concrete steps

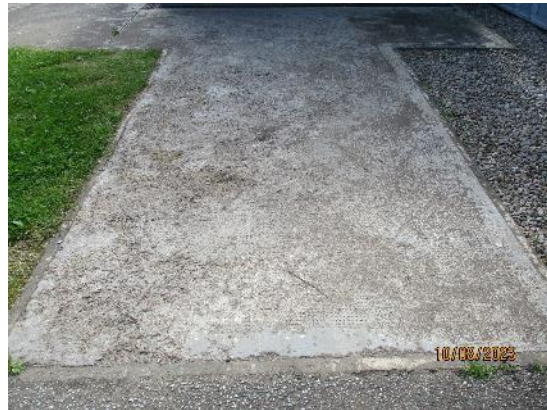
142. Eroded concrete ramp surface

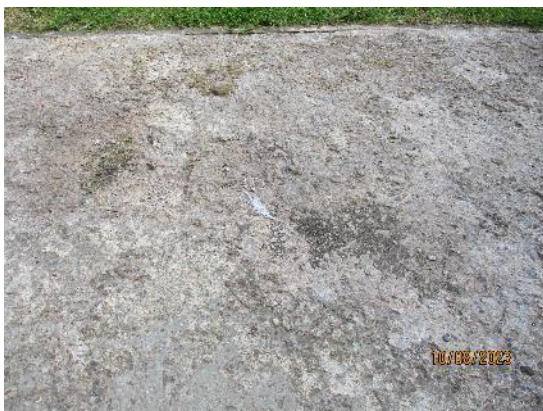
143. Eroded ramp surface

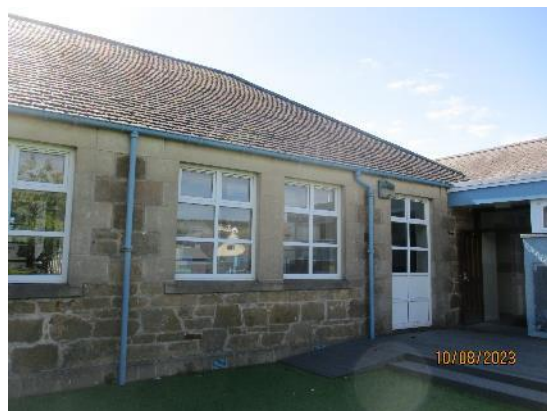
144. Composite ramp and decking

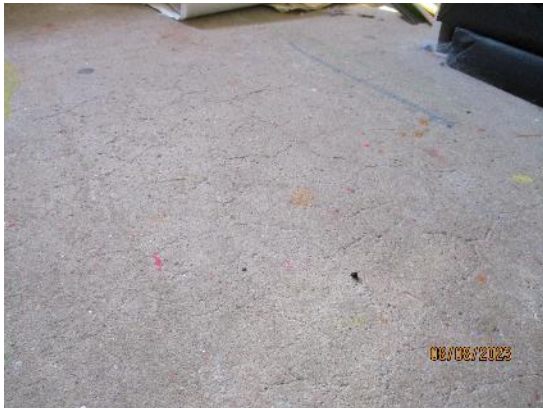
147. Concrete floors with hairline cracking

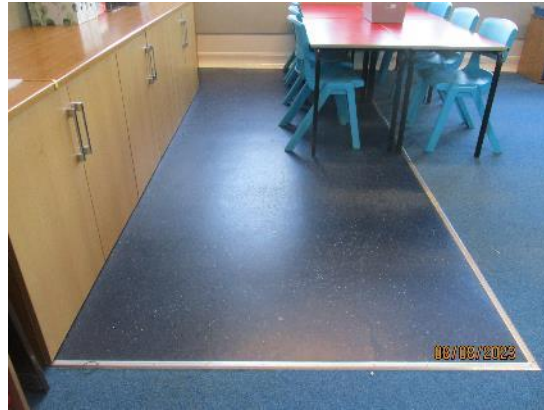
152. Sheet vinyl to sink areas

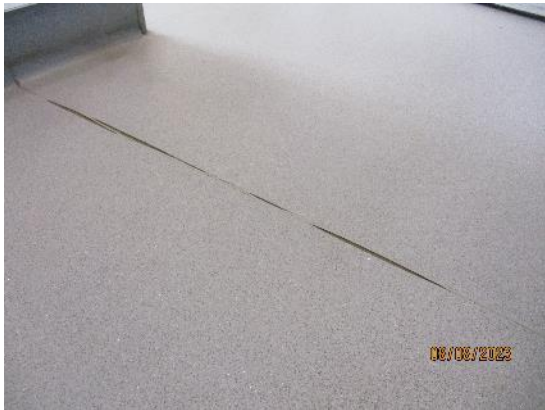
153. Open joints in vinyl flooring

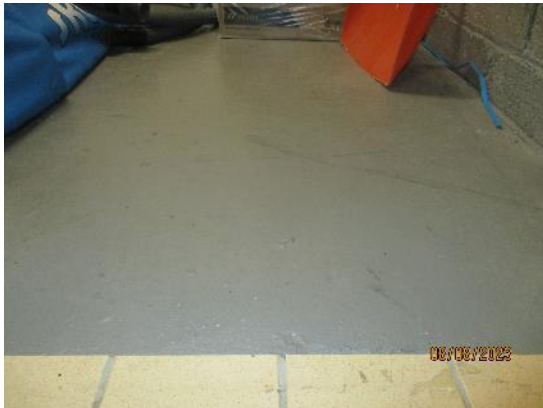
159. Painted concrete floors

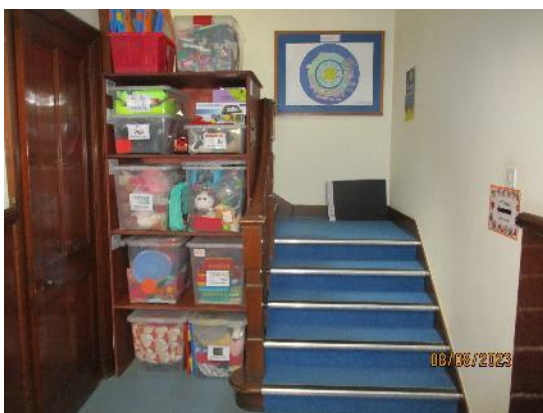
161. Timber stairs to first floor

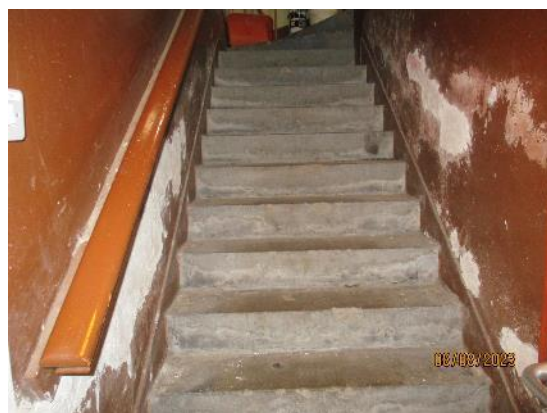
162. Concrete stairs to basement

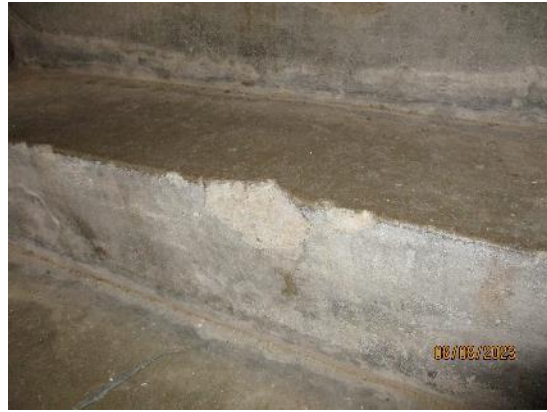
164. Chipped nosings to basement

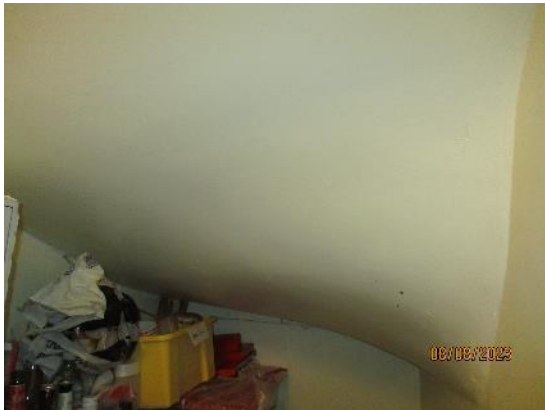
165. Plaster soffits to timber stairs

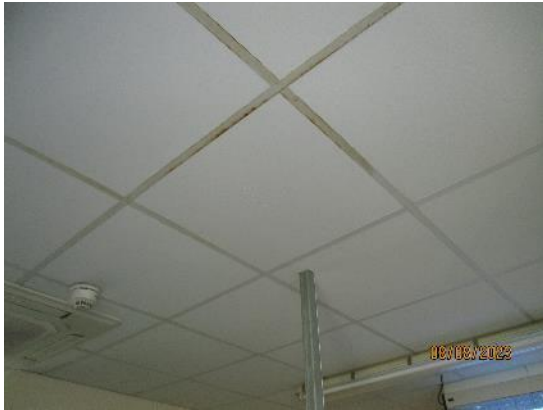
168. Suspended ceiling tiles in the Kitchen

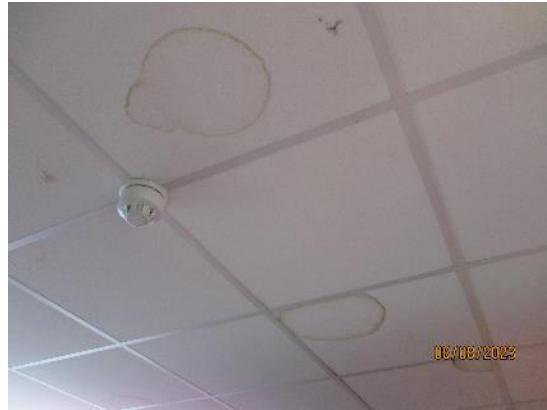
169. Suspended ceiling tiles in Classrooms

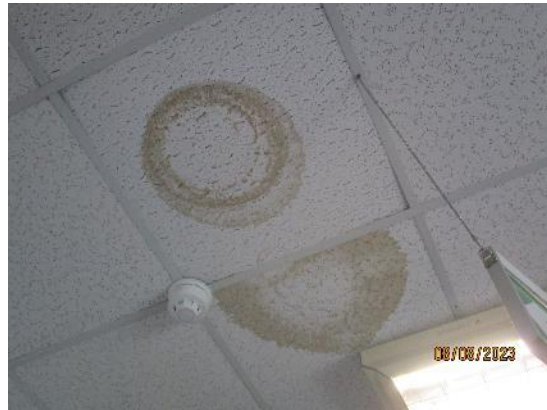
171. Watermarked suspended ceiling tiles

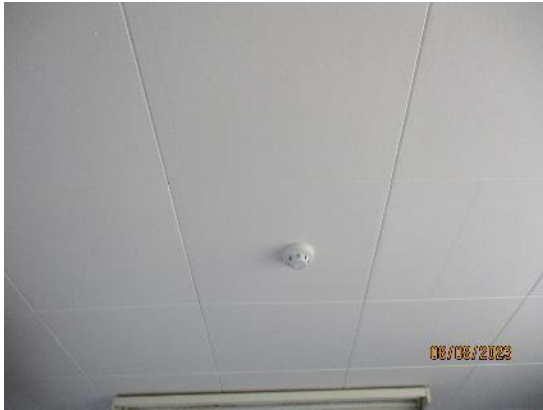
174. Asbestos ceiling tiles

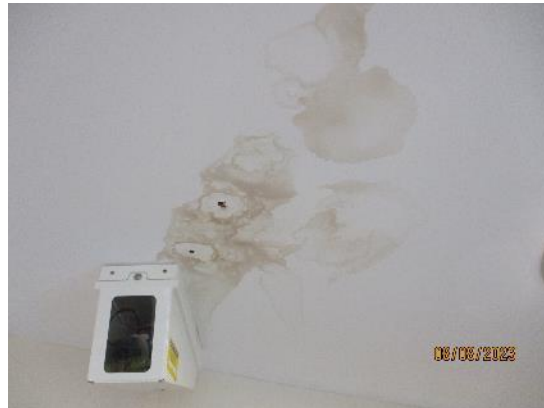
177. Water damaged plasterboard

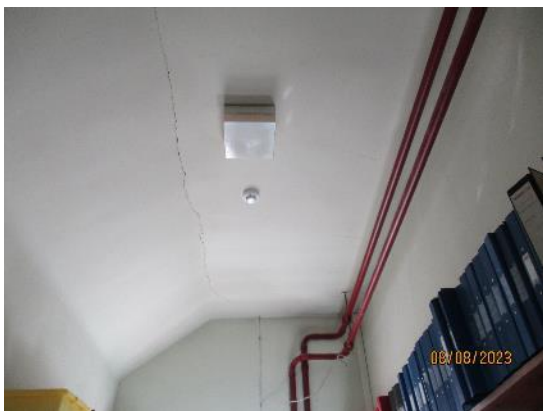
178. Lath & plaster ceilings

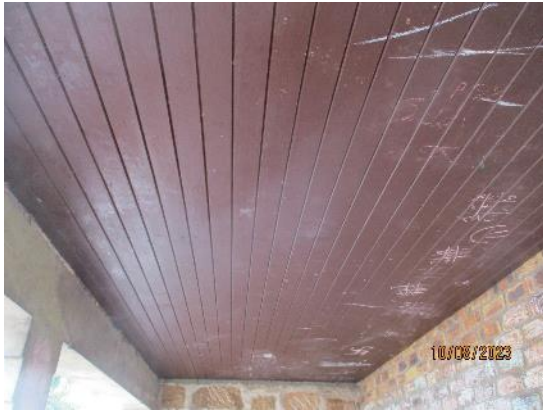
180. Timber linings to external stores

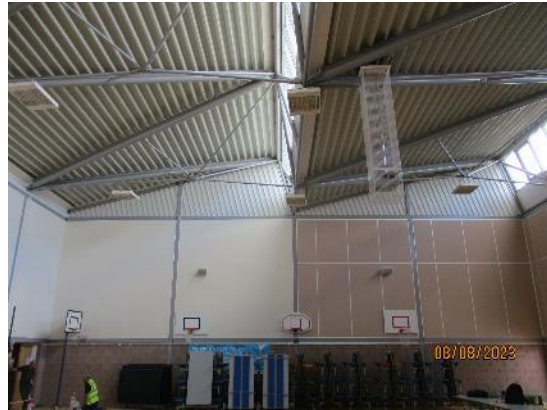
181. Metal profile sheets to Games Hall ceiling

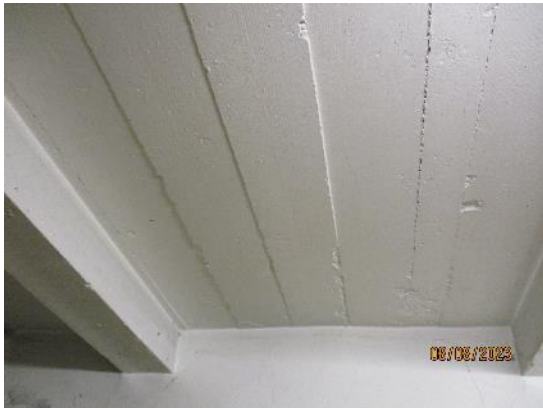
182. Concrete ceiling to Boiler Room

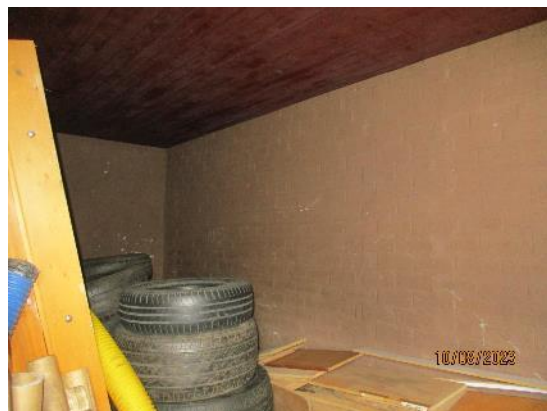
190. Brickwork to external stores

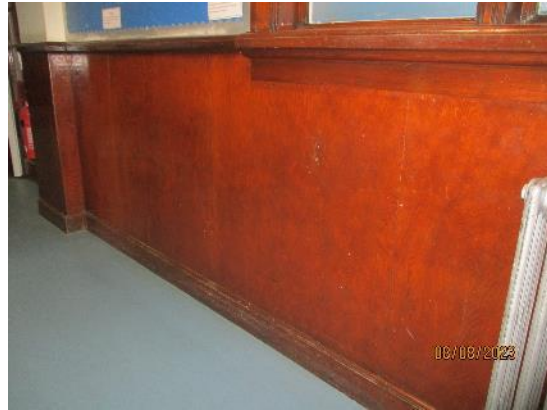
192. Plywood linings at low level

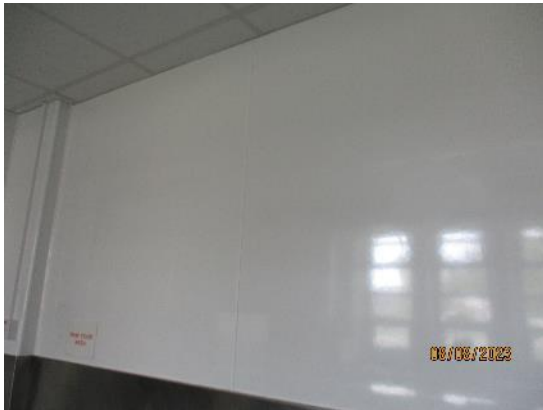
193. Wetwall to Kitchen

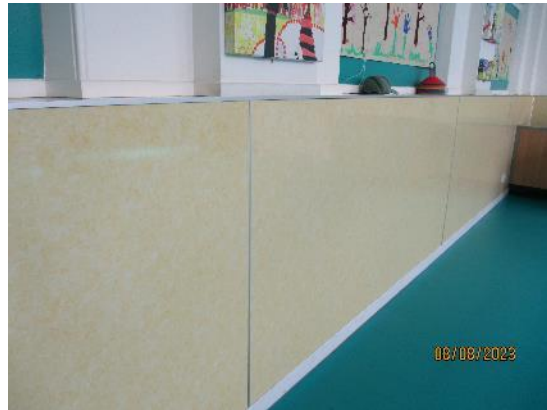
194. Wetwall in Hall

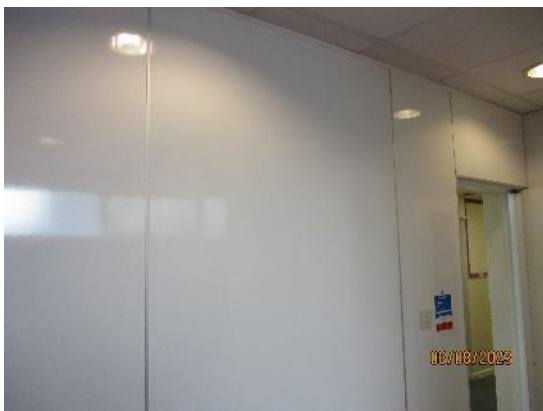
195. Wetwall in Toilets

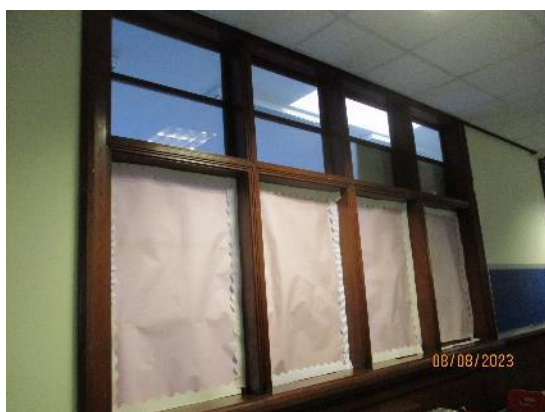
199. Timber borrowed lights in corridors

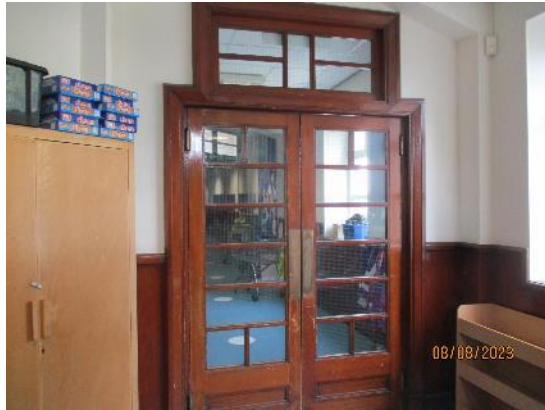
204. Timber panelled double doors

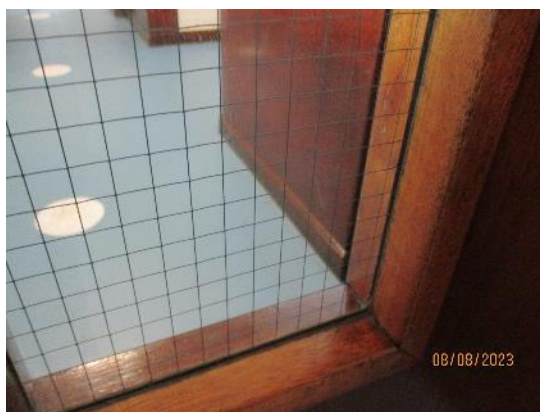
216. Georgian wired glass to internal doors

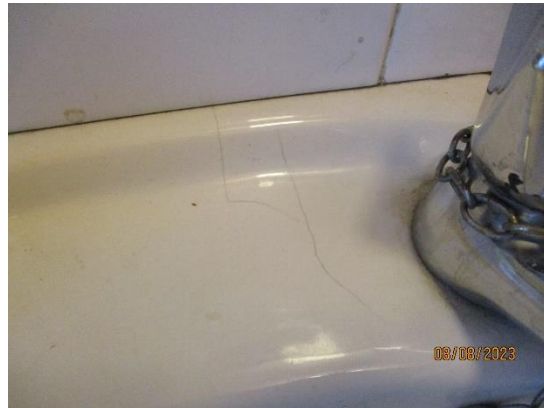
230. Hairline cracks in basins

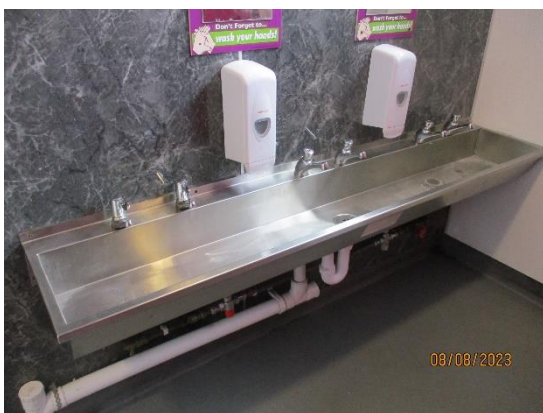
231. Stainless steel trough basins in 1975 extension

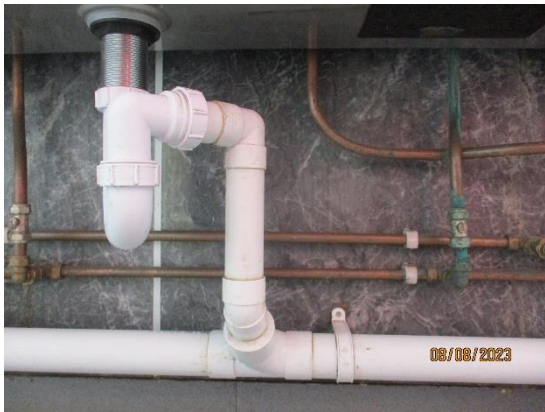
233. UPVC waste pipes

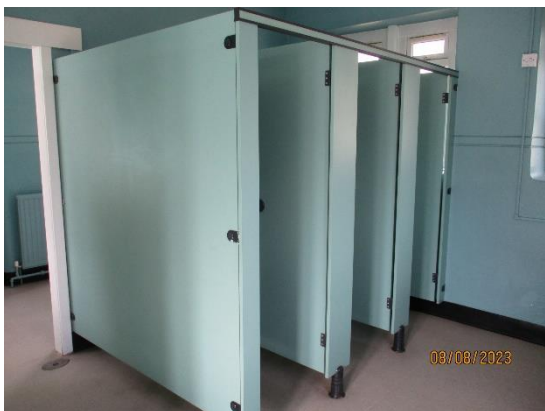
237. Composite panel toilet cubicles

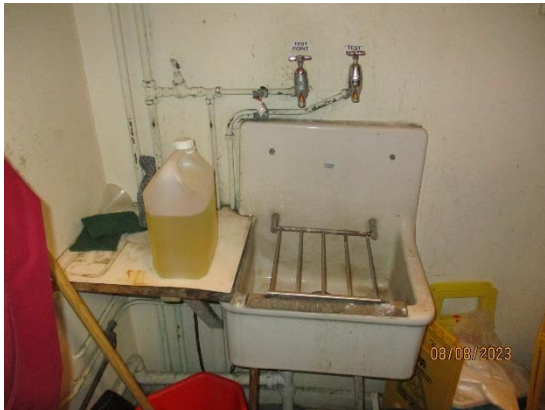
247. Cleaners Butler sinks

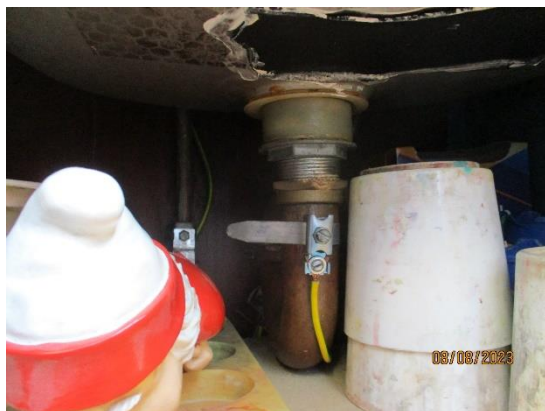
250. Copper waste pipes to classroom sinks

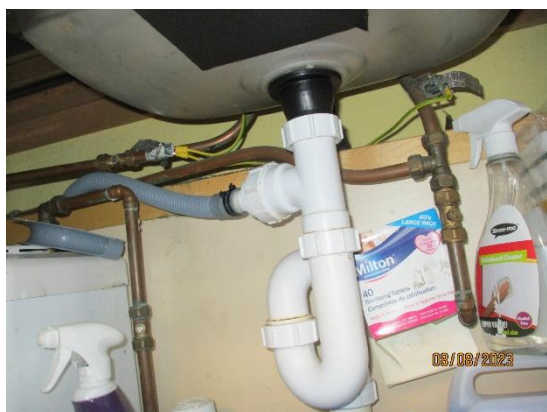
251. UPVC waste pipes to classroom sinks

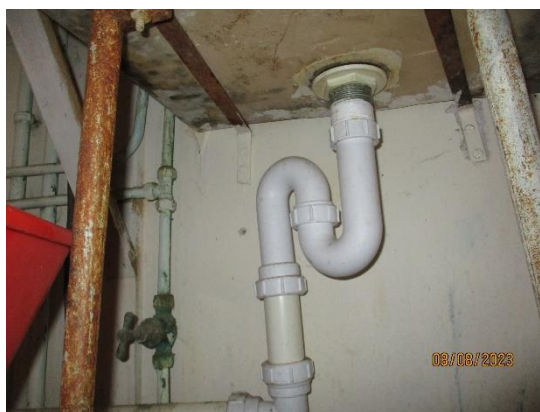
252. UPVC waste pipes to cleaners sinks

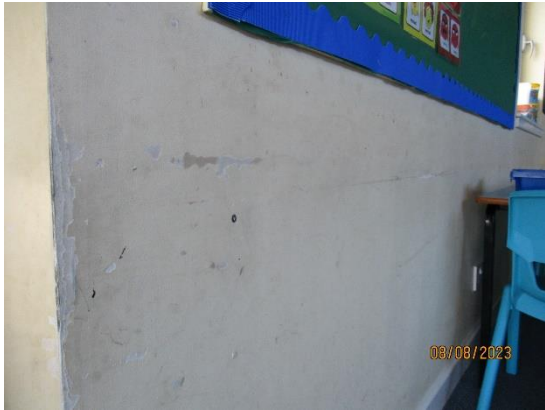
257. Painted plasterboard walls

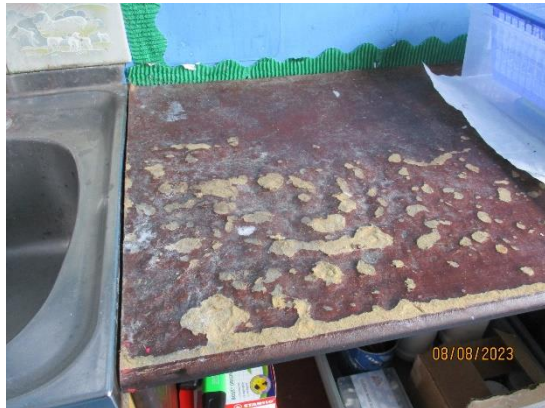
265. Water damaged worktops

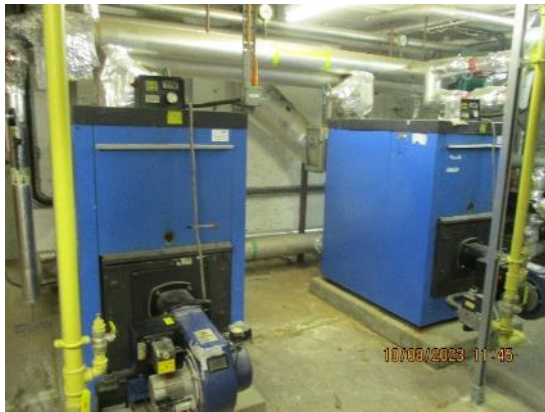
272. Natural gas boilers main school basement.

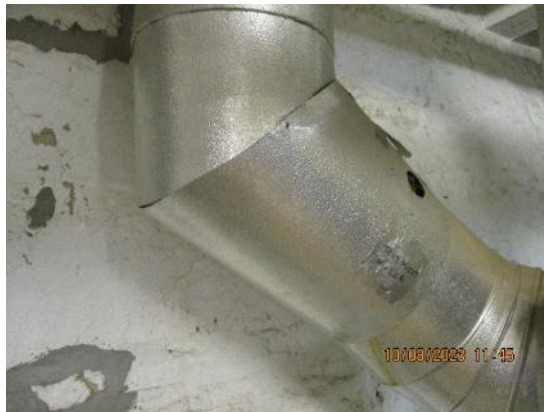
273. Boiler steel flue into brick chimney.

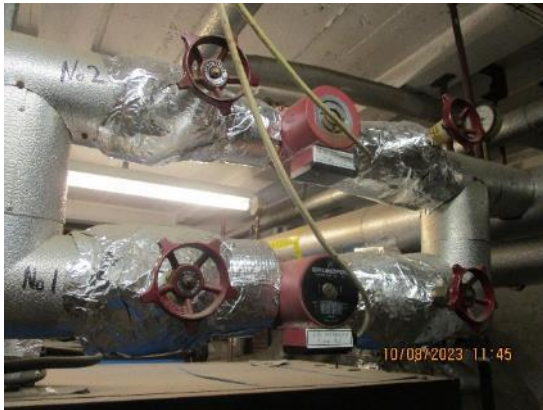
274. Heating system pipework – boilerhouse.

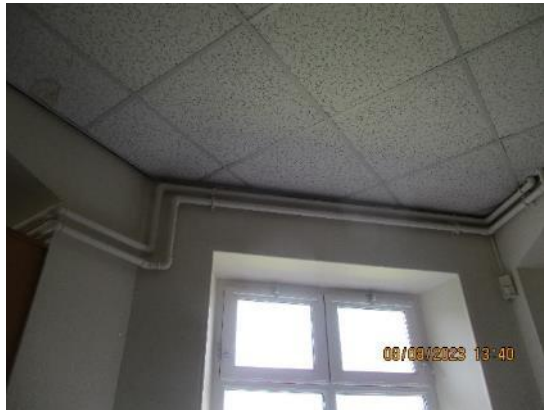
275. Heating pipework – main school.

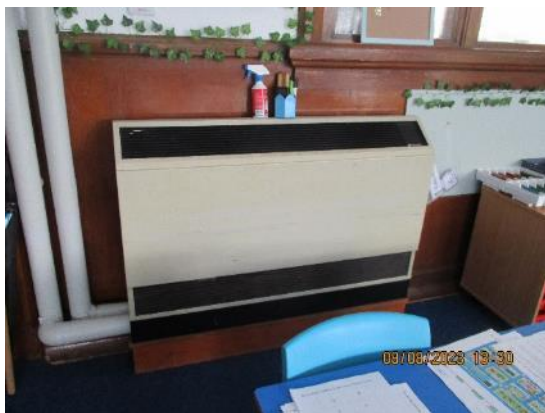
276. Fan convactor heater – classroom typical.

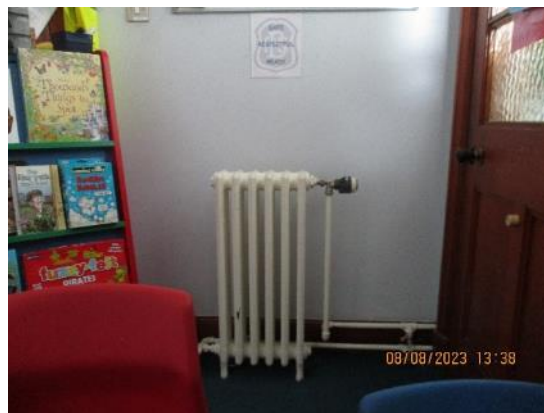
277. Cast iron radiator – original school typical.

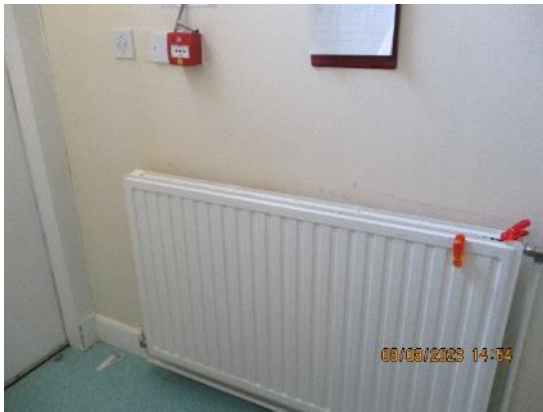
278. Steel panel radiator main kitchen corridor.

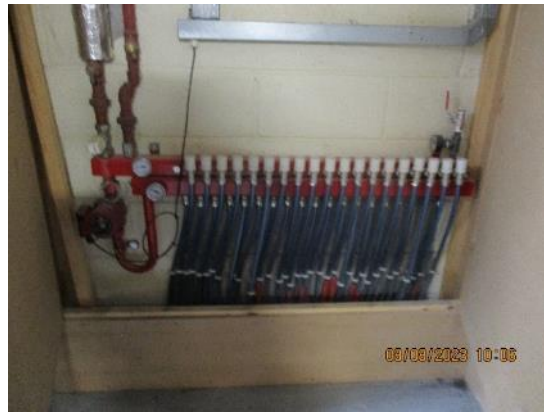
279. Underfloor heating – extension hall 1/77.

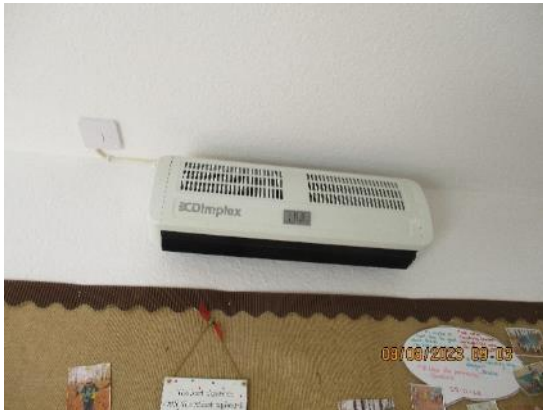
280. Electric fan heater – nursery building.

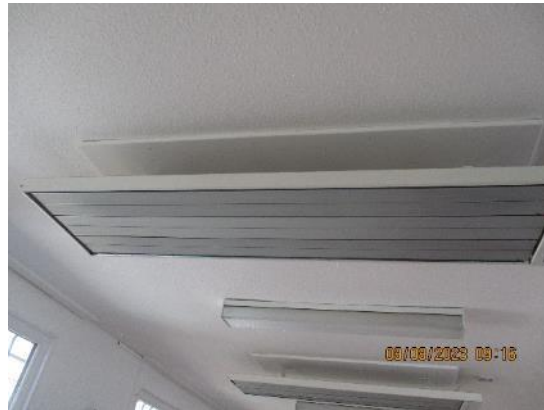
281. Electric radiant panel ceiling heater – nursery.

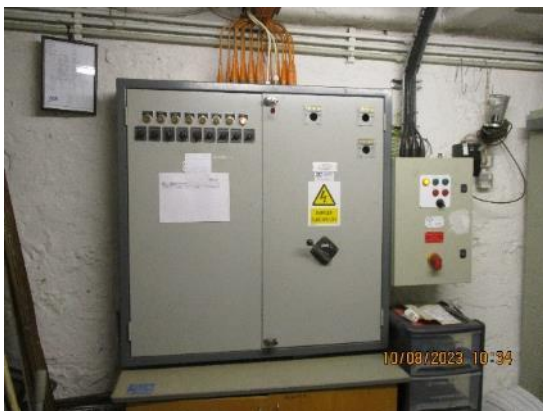
282. Heating control panel – school basement.

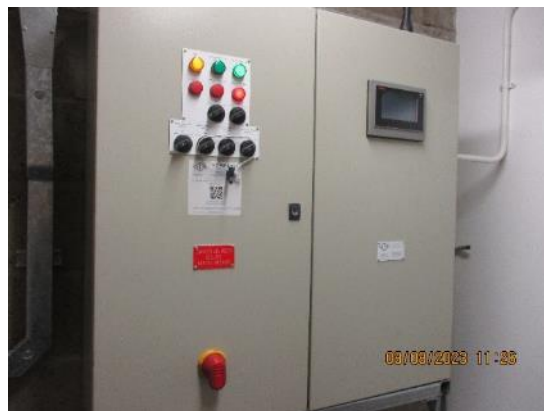
283. Heating and ventilation control panel 2008 extension.

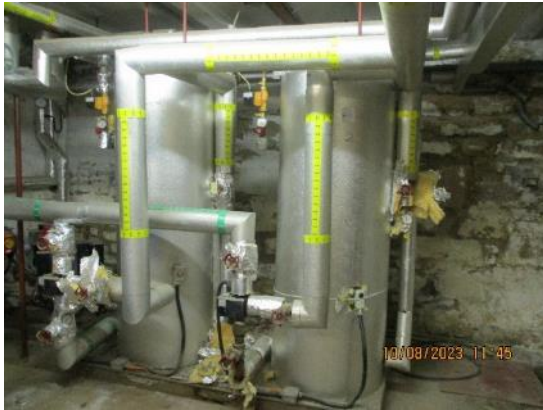
284. Calorifiers 1 and 2 – school basement.

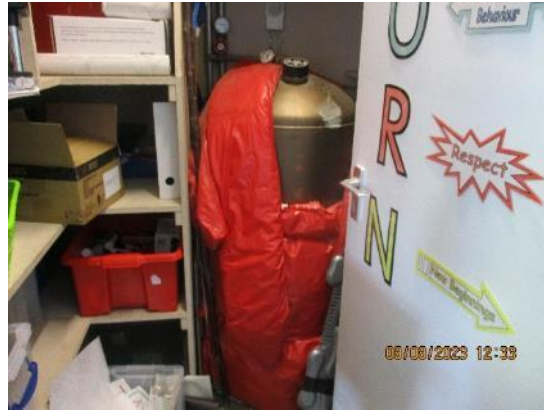
285. Hot water cylinder – main school 1/37a cupboard.

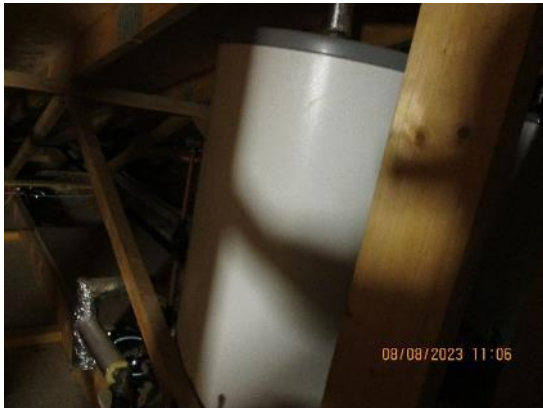
286. Hot water cylinder (1 of 2) 2008 extension attic.

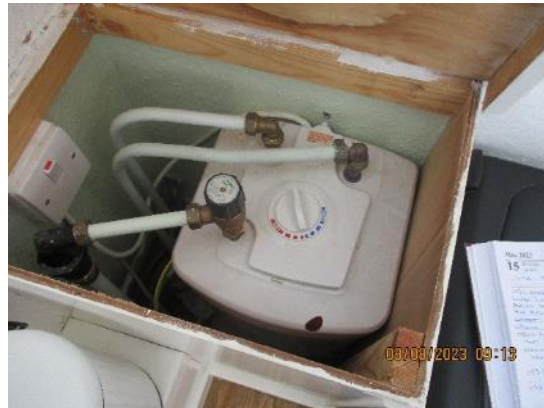
287. Point of use electric water heater – nursery.

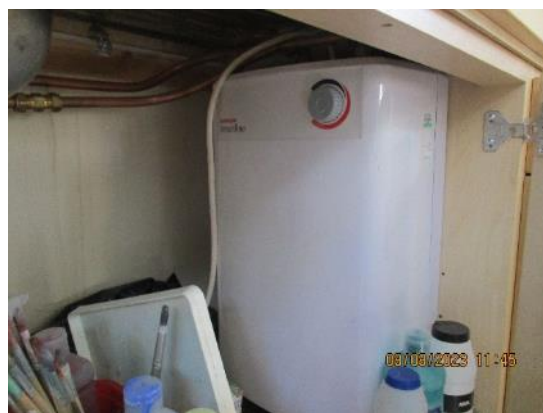
288. Point of use electric water heater 2008 extension.

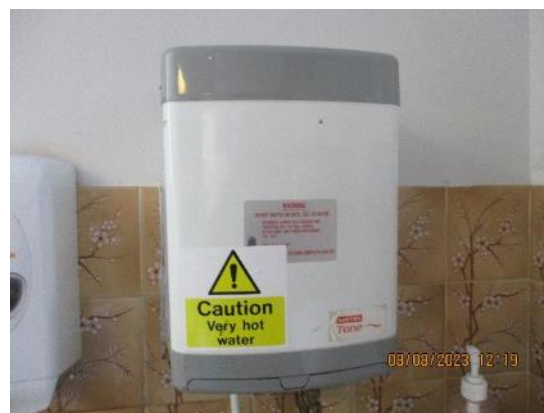
289. Point of use water heater - main school classroom.

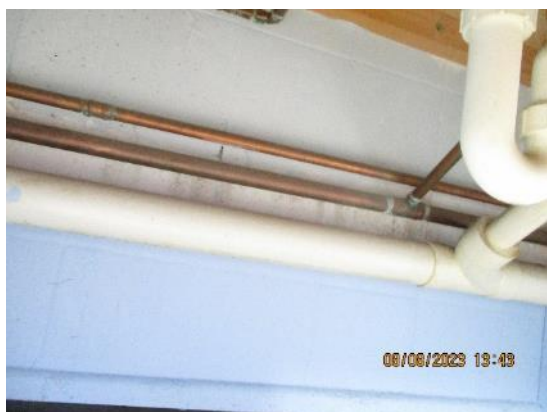
290. Hot water pipework 1975 extension.

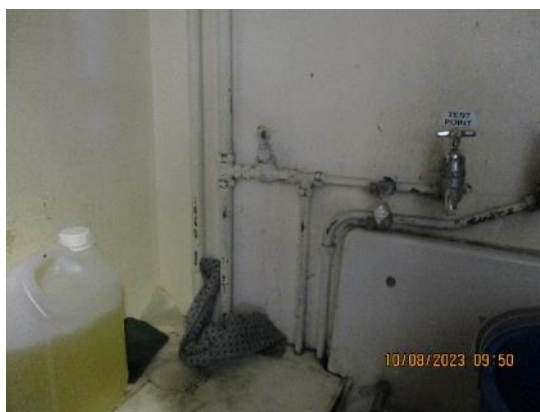
291. Hot water pipework – original school.

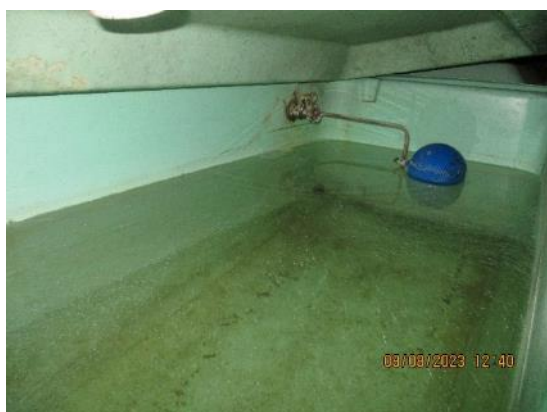
292. Cold water tank attic above 1/37a. - Main school.

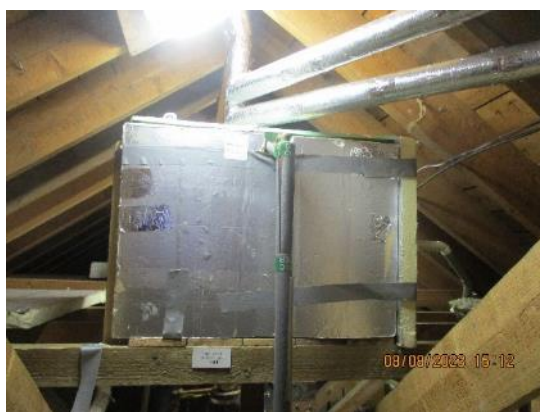
293. Cold water tank attic above 1/30. - Main school.

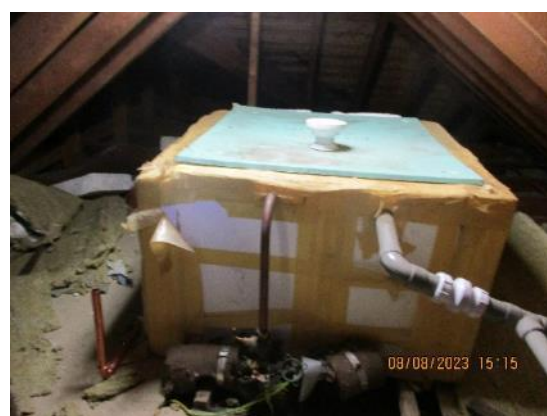
294. Cold water tank – kitchen cold supply main school.

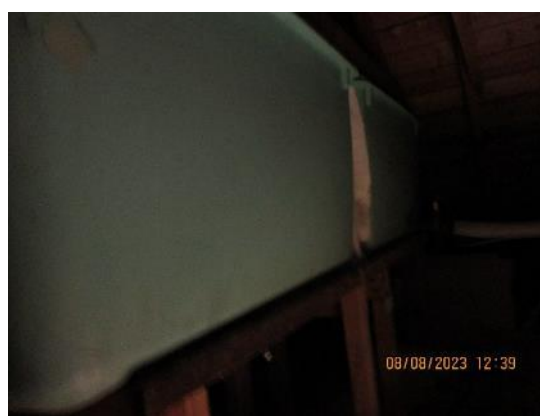
295. Cold tanks 1 and 2 above 1/37a.

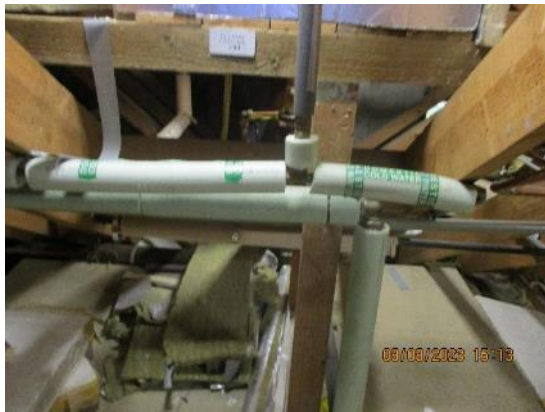
296. Cold water pipework – main school attic.

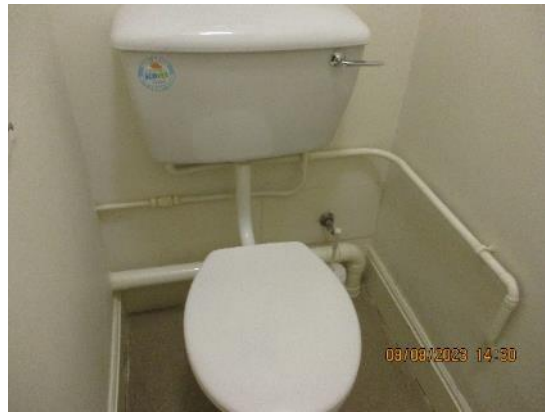
297. Cold water pipework - toilet 1/25a.

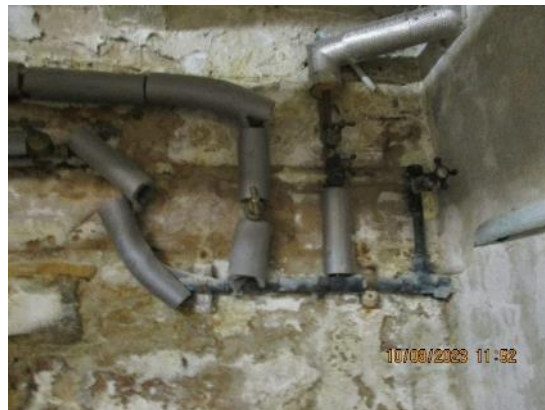
299. Cold water pipework – school basement.

- Investigate, trace and remove the damaged cast iron pipe in the basement.
- Increase the field of CCTV systems in the main school and nursery.
- Install smoke/heat detectors in the nursery building.

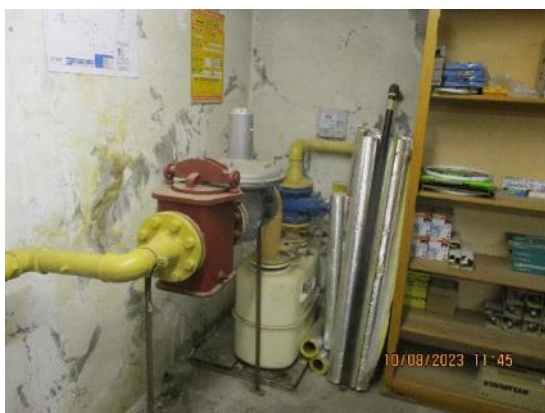
300. Gas supply pipework and meter – school basement

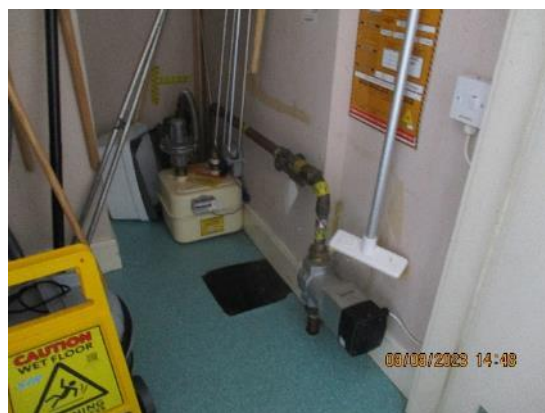
301. Gas pipework and solenoid valve - kitchen store.

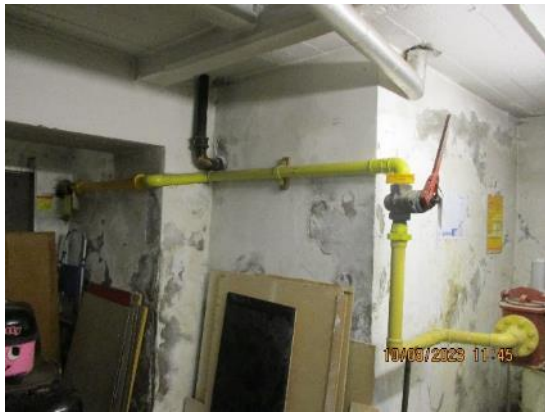
302. Gas pipework incoming to basement - main school.

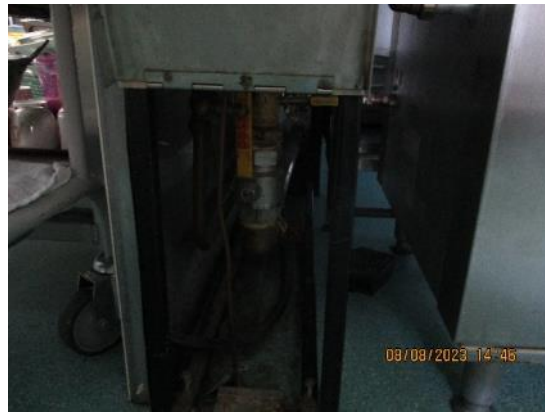
303. Gas pipework behind cooking appliances - kitchen.

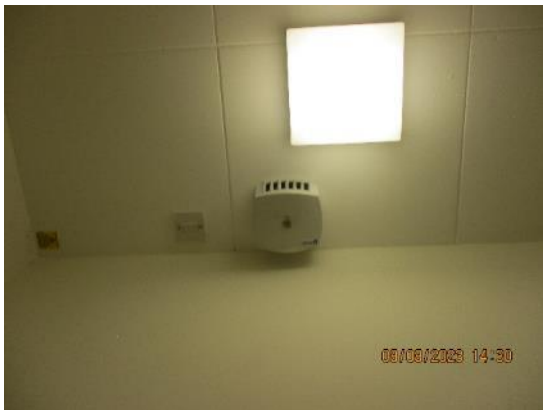
304. Extract fan – main school staff toilet.1-25a

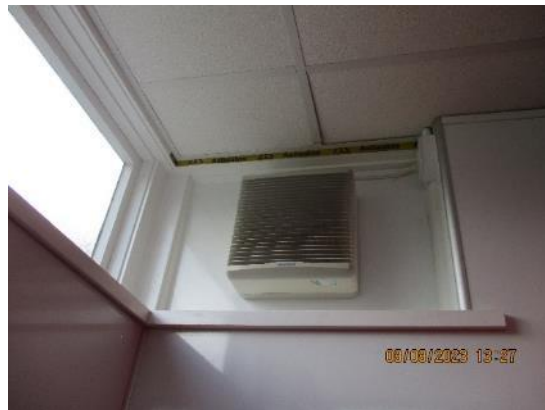
305. Extract fan boys toilet 1-35. – Main school.

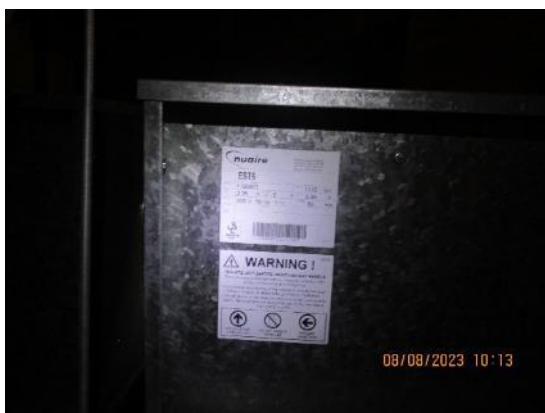
306. Centralised ventilation system (1) unit 2008 extension attic space.

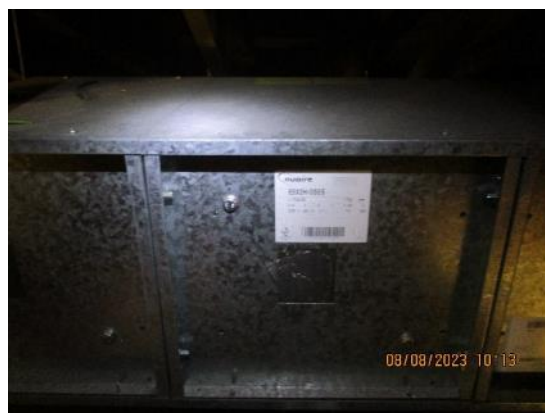
307. Centralised ventilation system unit (2) 2008 extension attic space.

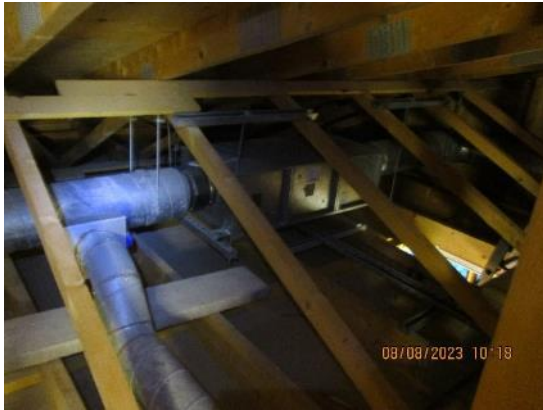
308. Centralised ventilation system ductwork 2008 extension attic space.

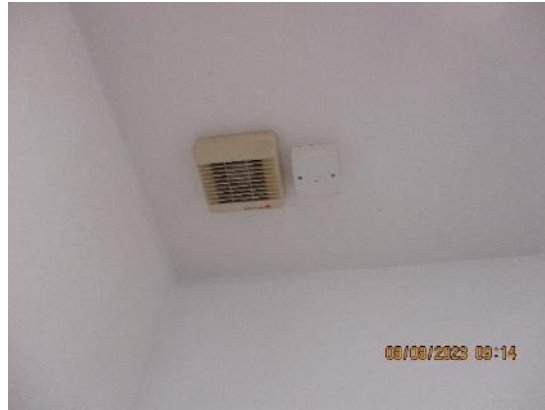
309. Extract fan staff toilet – nursery building.

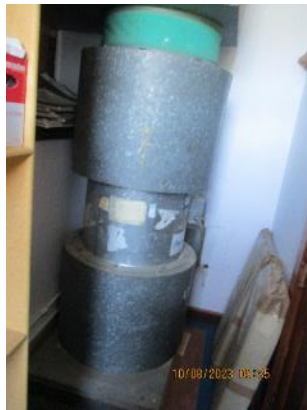
310. Kitchen cooking extract fan and ductwork 2/45b.

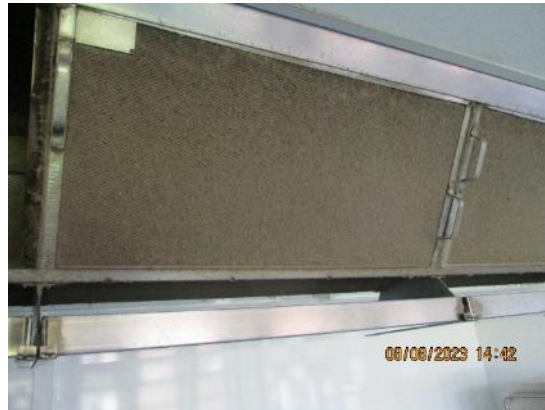
311. Kitchen extract system – filter bank (no canopy).

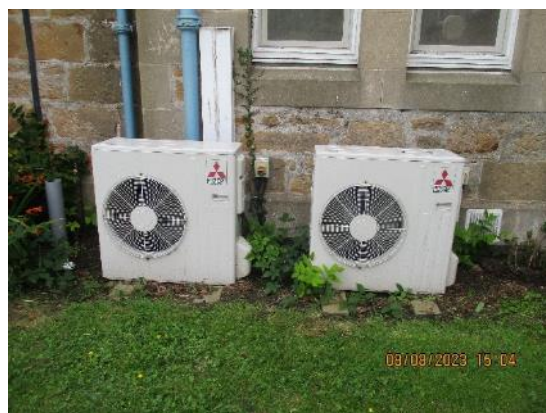
312. Air conditioning outdoor units – kitchen.
