# **Summary Building Condition Survey Report**

**Bishopmill Primary School  
Morrison Road, Elgin IV30 4DY**

**8<sup>th</sup> & 10<sup>th</sup> August 2023**

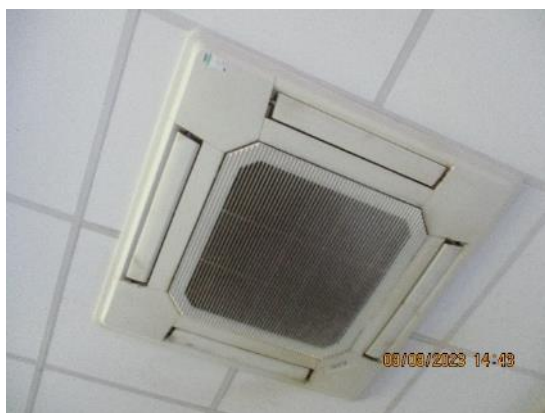
313. Air conditioning unit (1 of 2) Kitchen.

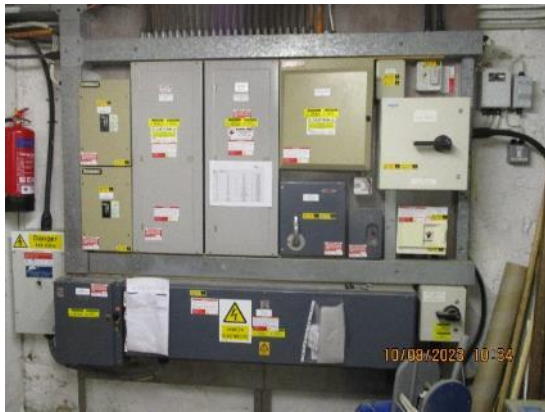
314. Main busbar and incoming power basement.

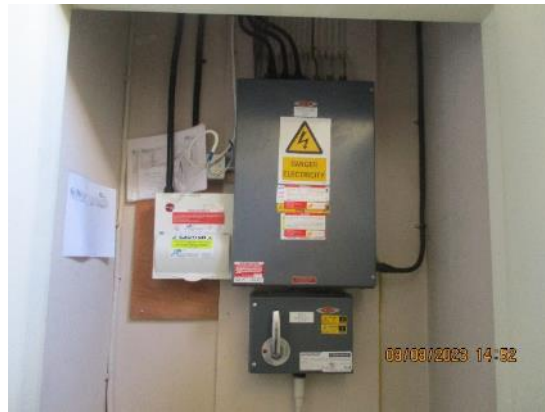
315. Distribution board – kitchen store.

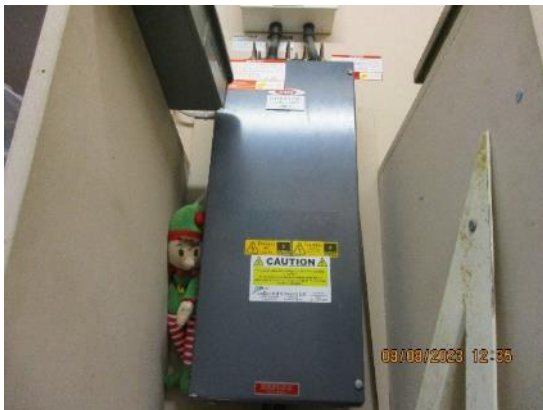
316. Distribution board – 1/37a cupboard.

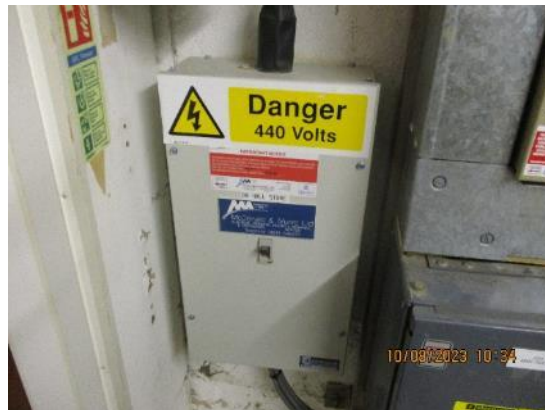
317. Distribution board hall store – basement.

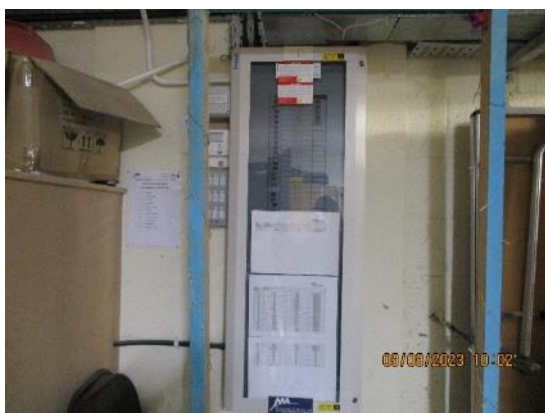
318. Distribution board – 2008 extension gym store.

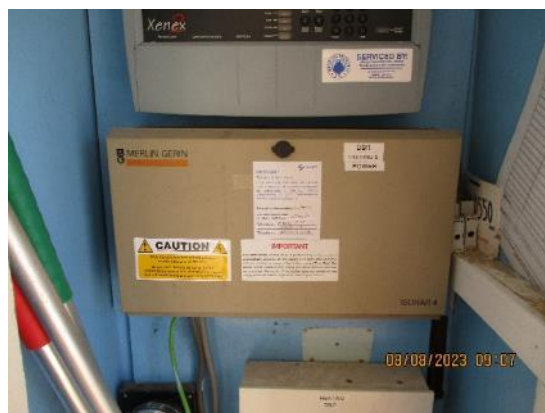
319. Distribution board L+P – nursery.

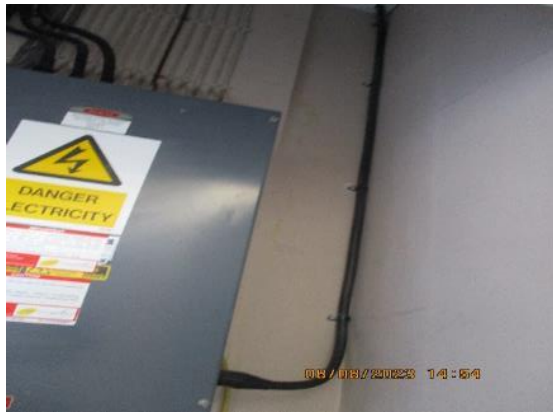
320. Sub mains cabling 1/42e original school.

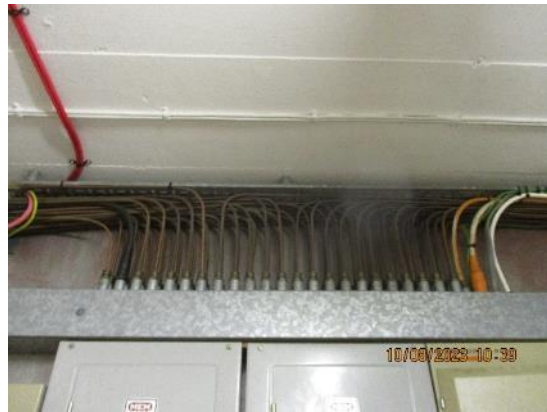
321. General wiring – basement distribution boards.

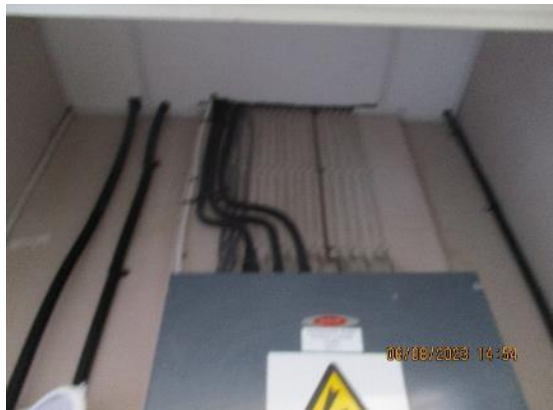
322. General wiring DB 1/42e

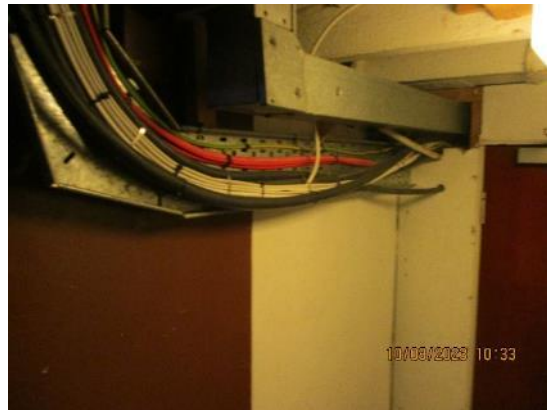
323. General wiring exiting basement boilerhouse.

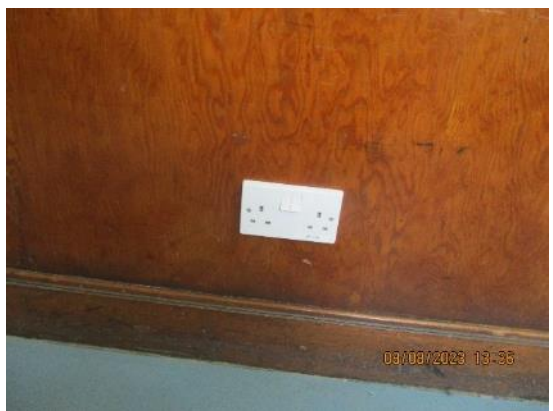
324. Flush socket – original school typical.

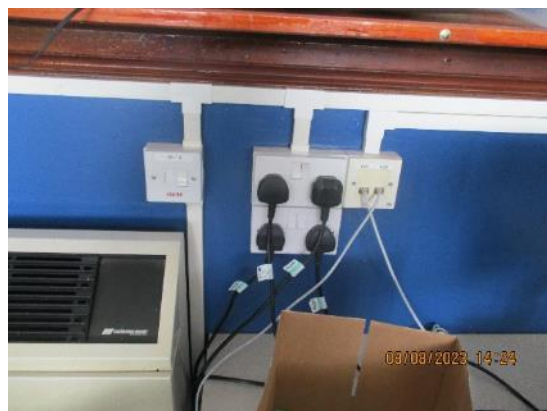
325. Sockets computer room 1/18.

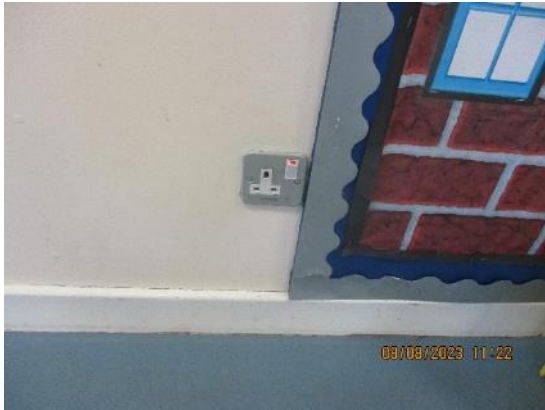
326. Socket – 2008 extension corridor 1/71.

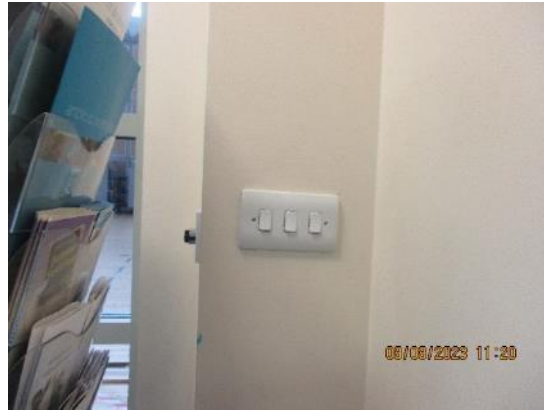
327. Light switch – 2008 extension typical.

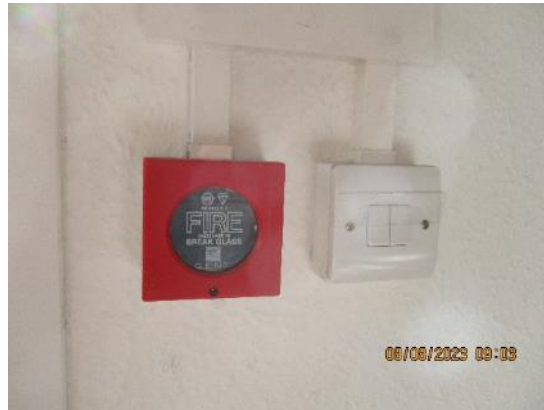
329. Light switch – nursery building typical.

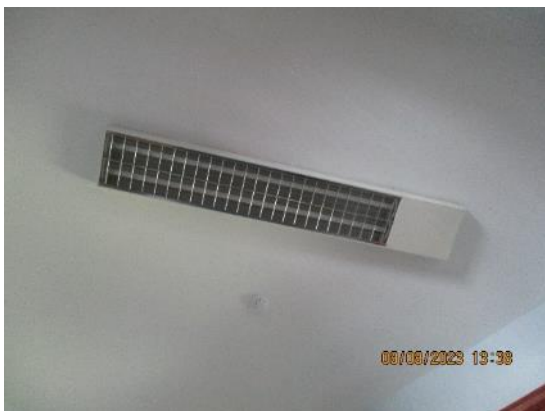
330. Lighting – original school classroom.

- Upgrade general lighting to LED types with automatic control.
- Upgrade external building lighting to LED types with lux sensors.
- Appraise cold water systems at replacement date, with intent of reducing number of cold water storage tanks to reduce cyclical maintenance and reduce potential water hygiene issues.

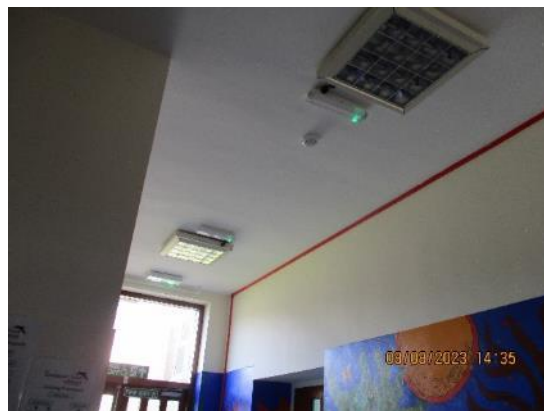
331. Lighting – original school corridor.

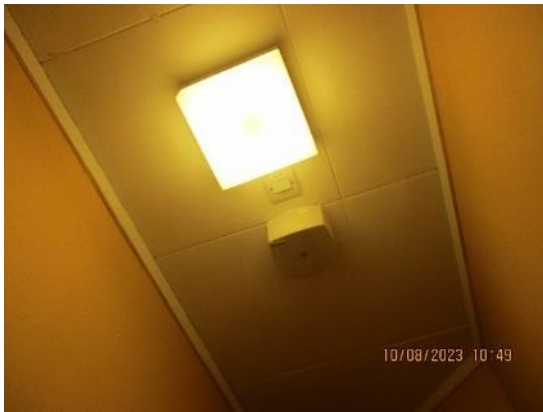
332. Lighting – original school toilet typical.

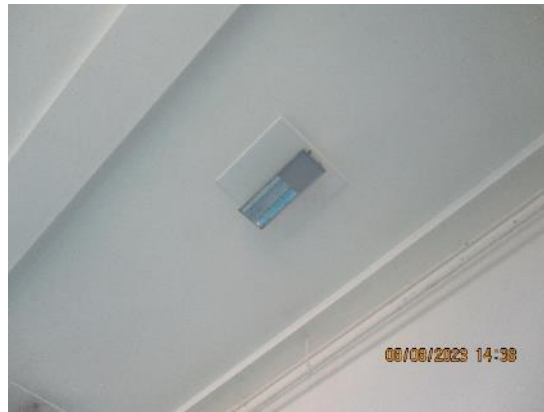
333. Lighting – original school hall.

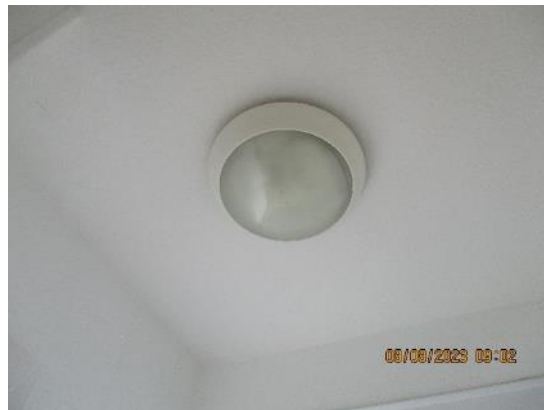
335. Lighting – nursery toilet.

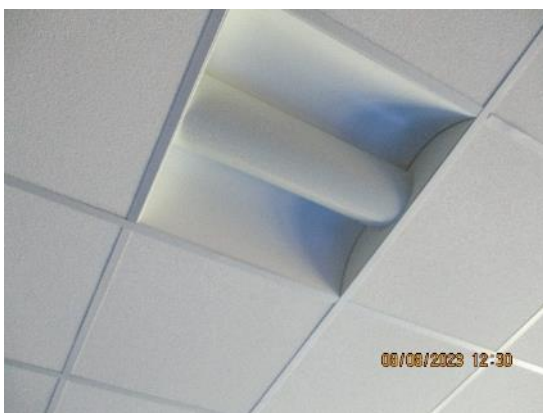
336. Lighting – 1970s extension classroom.

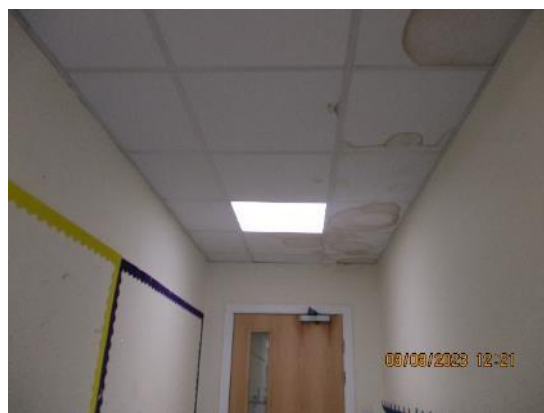
337. Lighting – 1970s extension corridor.

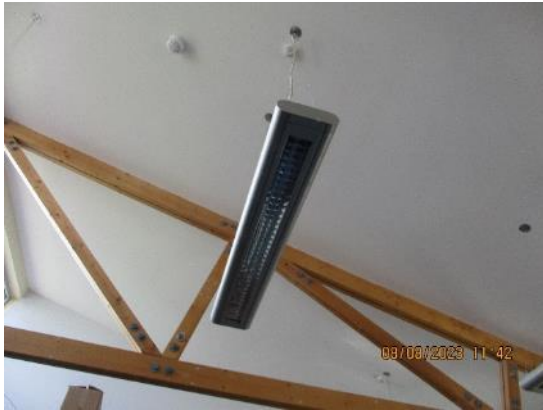
338. Lighting – 2008 extension classrooms.

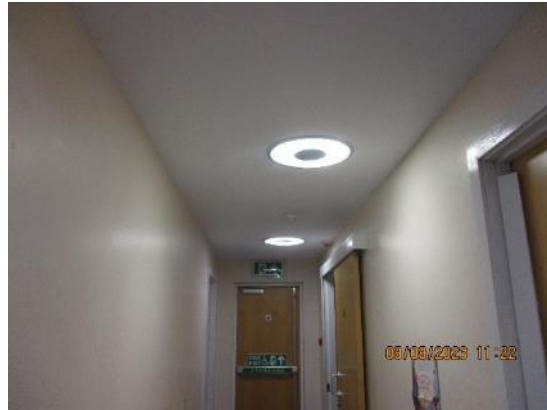
339. Lighting – 2008 extension corridor.

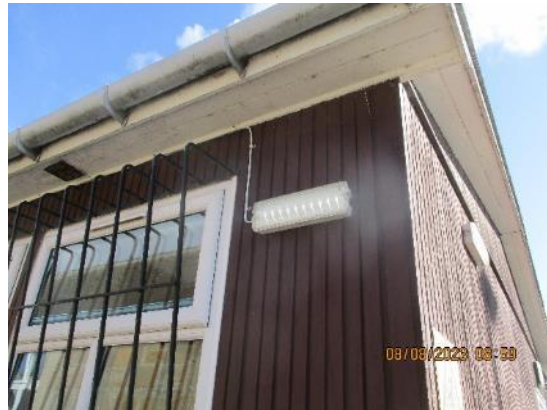
341. External lighting – nursery building.

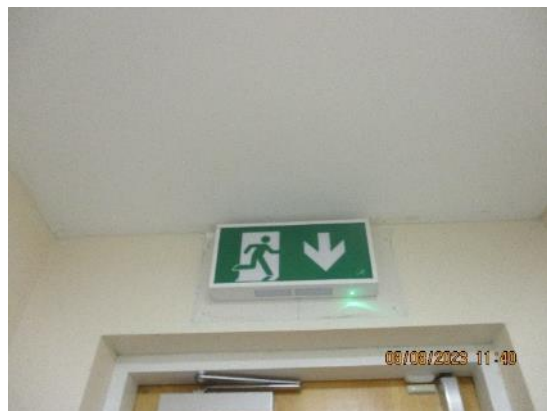
343. Emergency lighting – 2008 extension.

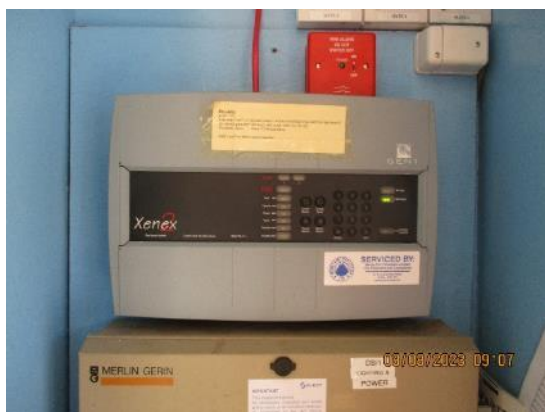
344. Fire alarm control panel – nursery building.

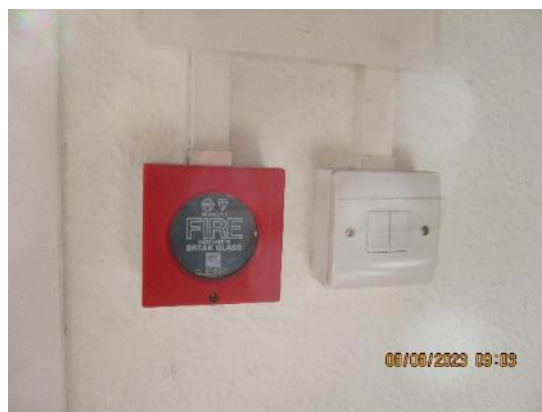
345. Fire alarm call point – nursery building.

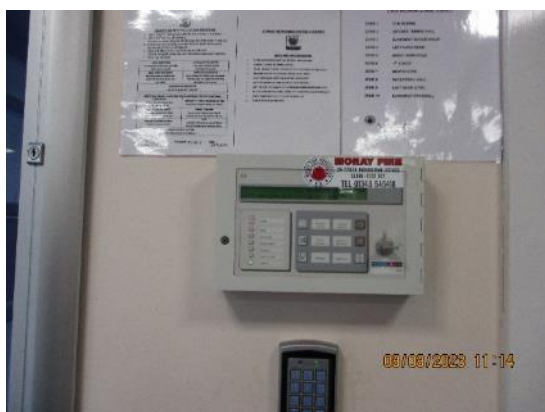
346. Fire alarm repeater panel 2008 extension 1/71.

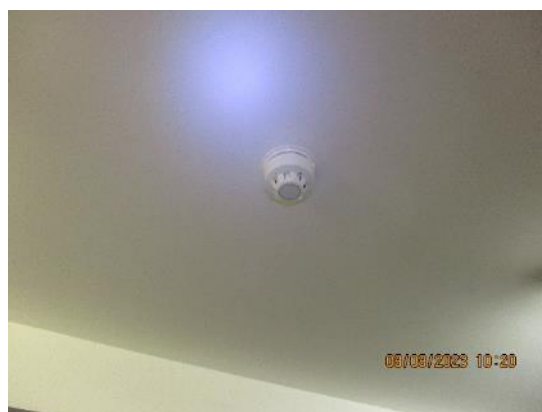
347. Smoke detector 2008 extension typical.

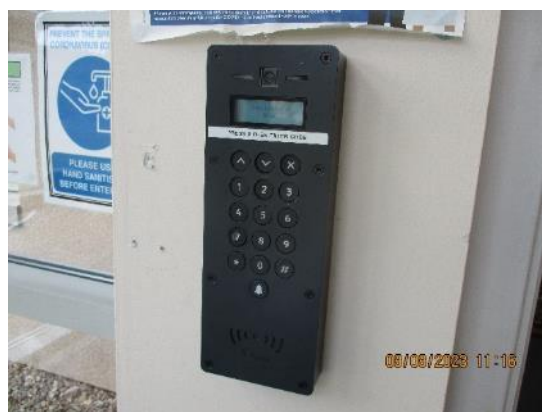
352. Door access keypad – 1/1a internal door.

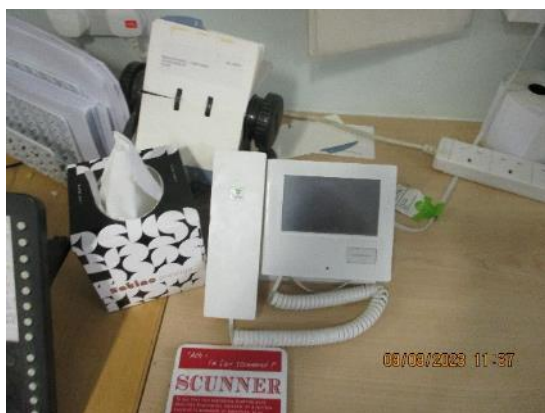
353. Door access unit – 2008 extension 1/71

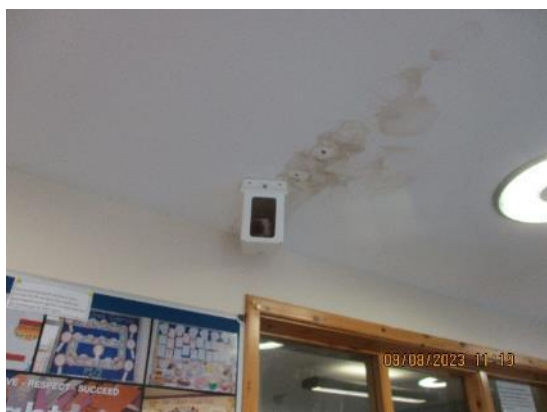
355. Door access card reader 1/71.

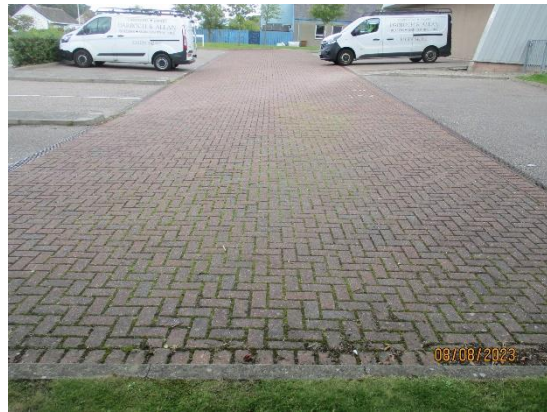
363. Brick pavior car park

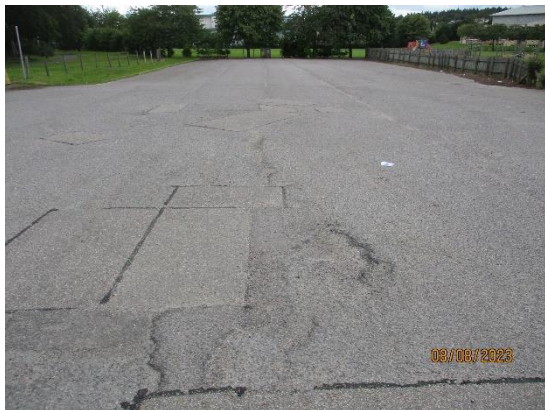
364. Tarmac staff car park

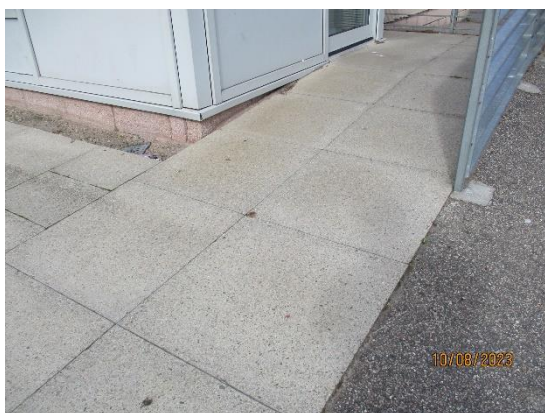
372. Paving slab footpaths

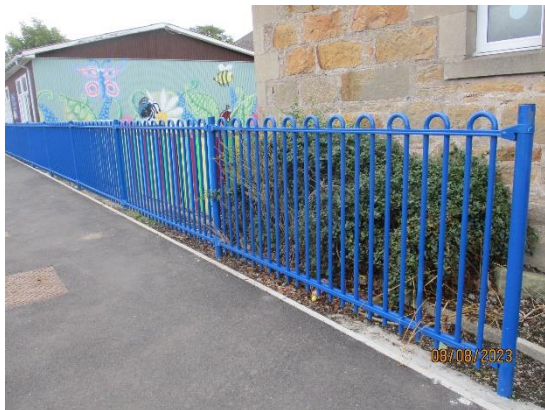
382. Tubular rail fence to Nursery

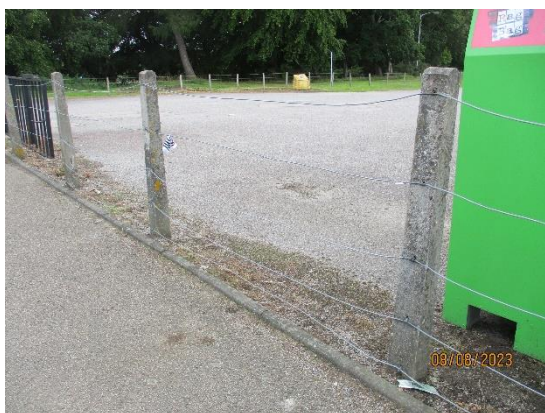
384. Concrete post and wire fence

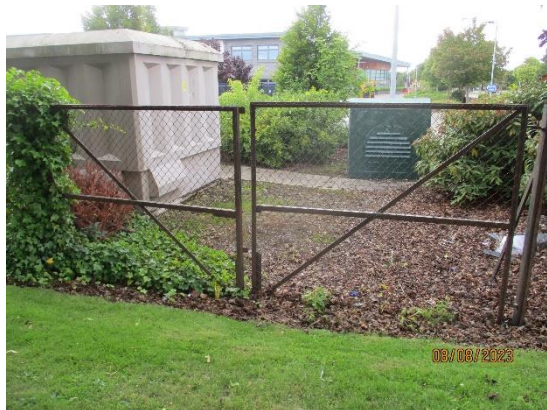
395. Chain link double gate to sub station

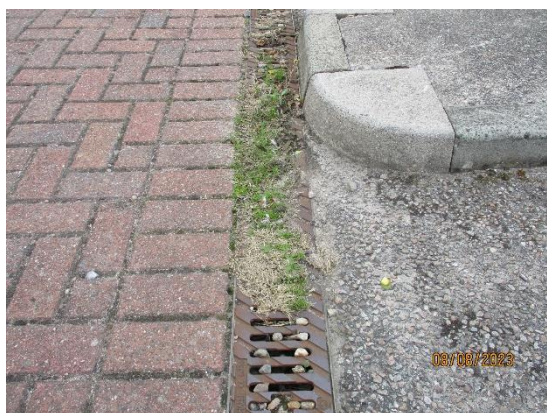
397. Car park drainage channel blocked
