# **Summary Building Condition Survey Report**

**East End Primary School  
Institution Road, Elgin IV30 1PR**

**10<sup>th</sup> & 11<sup>th</sup> April 2023**

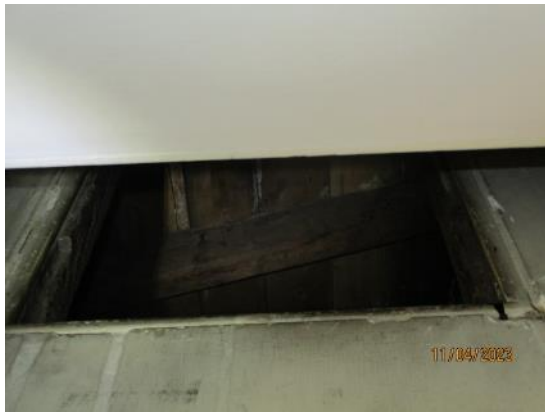
1. Block 1 – Timber trusses

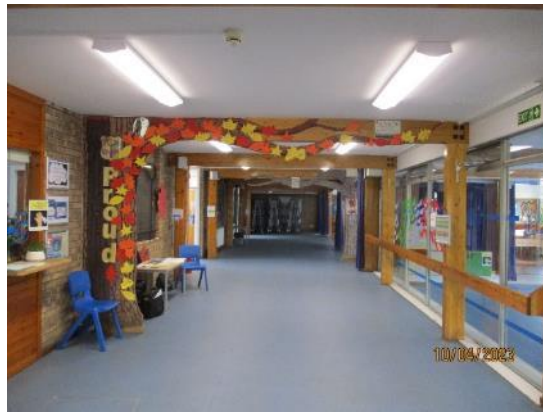
2. Block 2 – Glulam beams

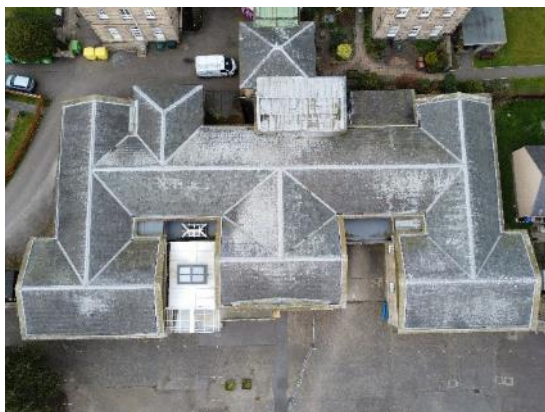
5. Block 1 – Roof overview

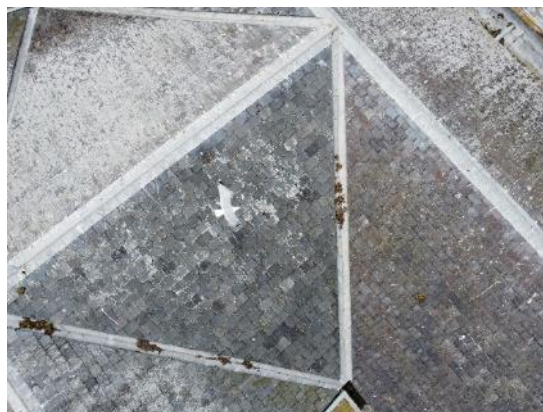
6. Debris in lead valleys

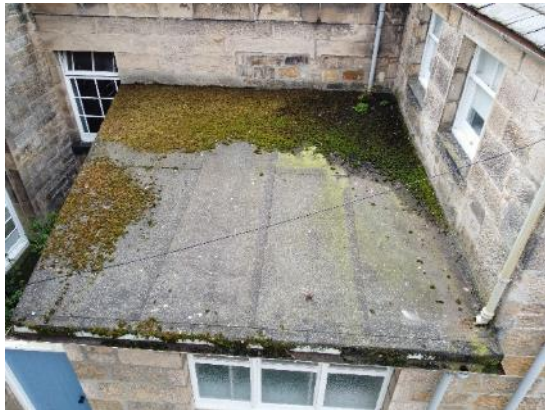
10. Felt roof with extensive moss growth

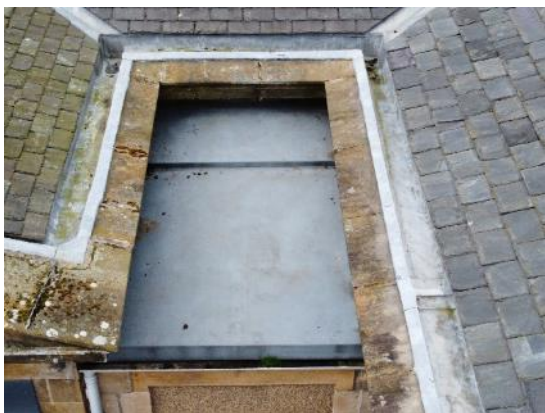
11. Single ply membrane and lead secret gutters

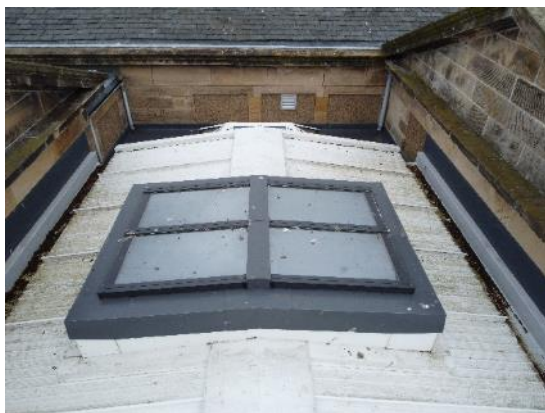
12. Block 1 – skylight over entrance

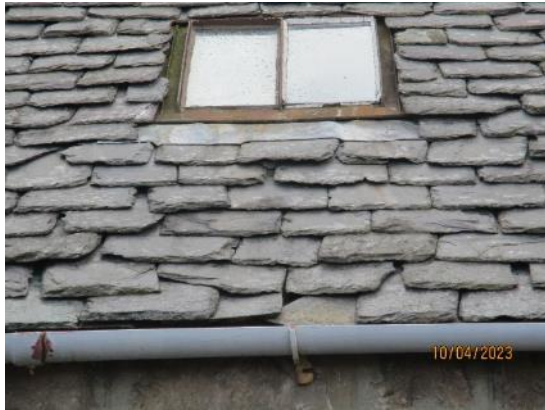
13. External shelter – poor slate

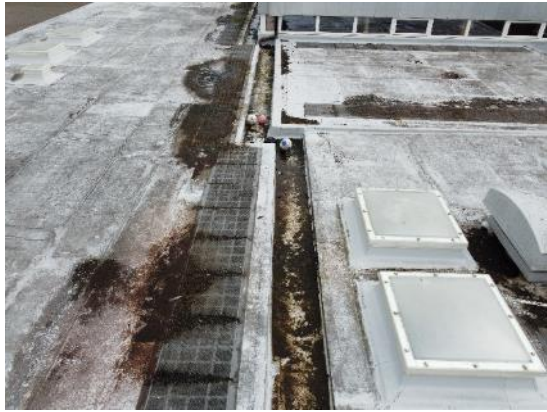
19. SPM box gutters

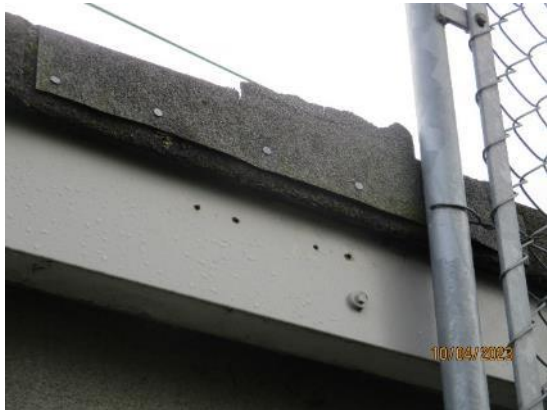
21. External store (former felt roof)

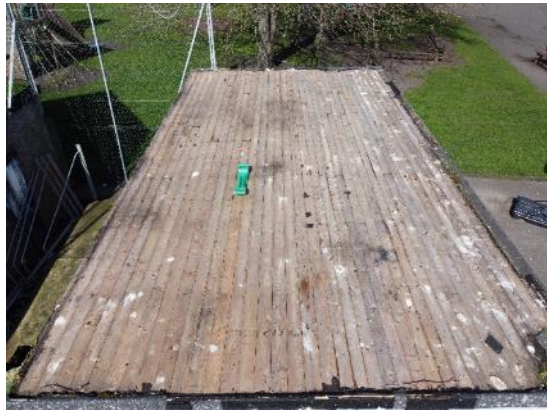
22. Felt stripped exposing timber boards

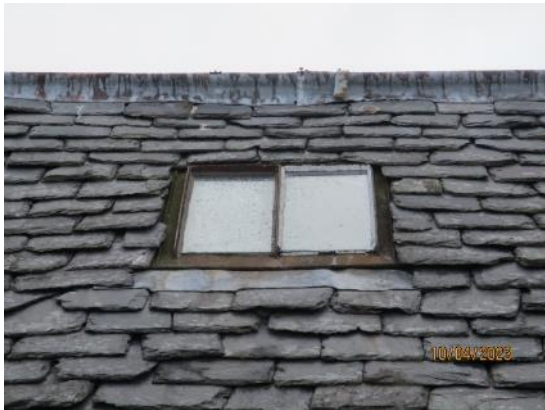
33. External shelter metal skylight

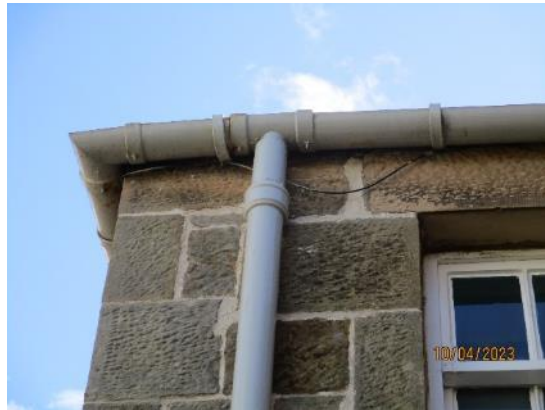
- Cast iron gutters and downpipes are damaged and partially blocked.
- Evidence of rainwater penetration to be investigated.
- Timber suspended floors to first floor have sagged and slope, investigate condition.
- Timber panelled doors are life expired.

34. Half round cast iron gutters

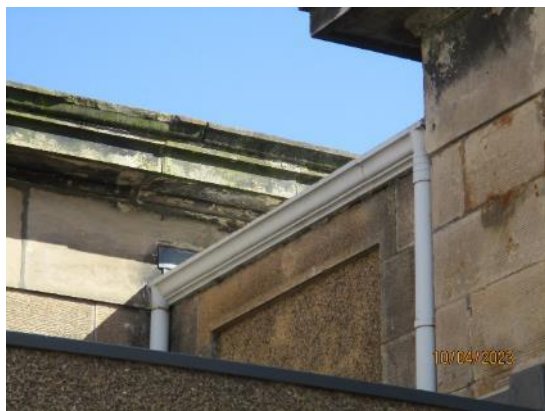
35. Cast iron ogee gutters

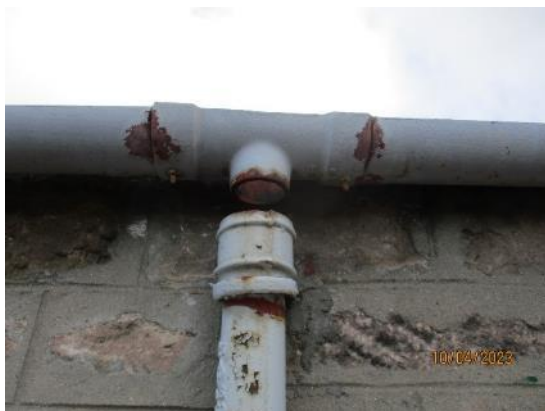
36. Cast iron downpipes

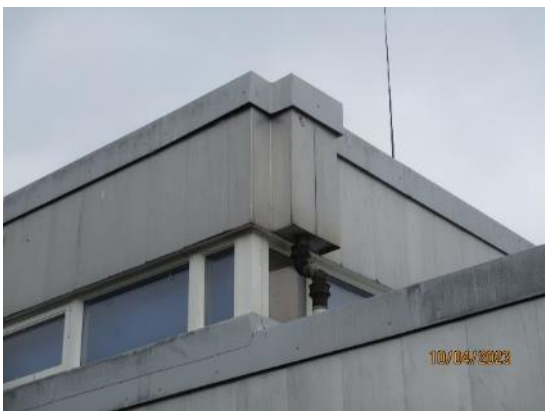
41. Block 2 – Cast iron internal downpipes

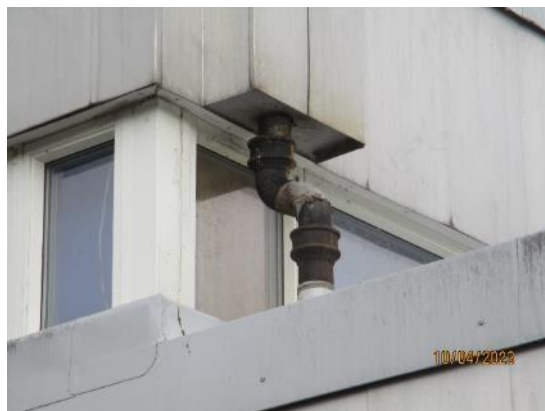
42. Poor condition downpipes

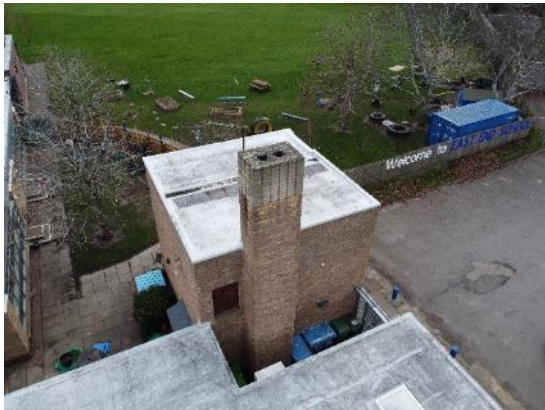
45. Brick boiler flue

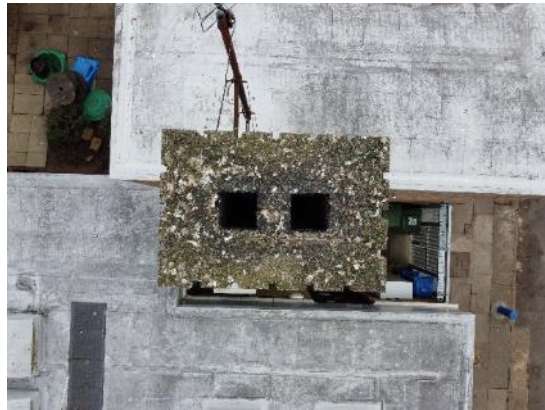
46. Concrete cap to boiler flue

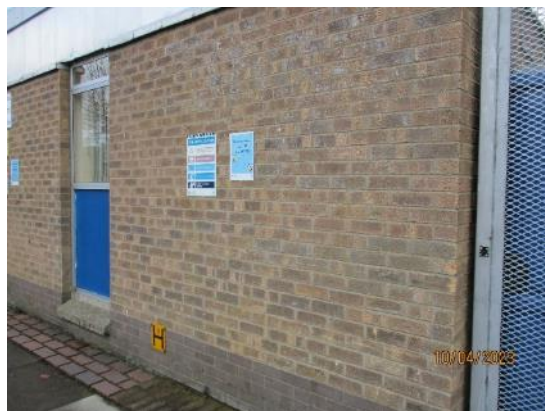
48. Block 2 – Brick walls

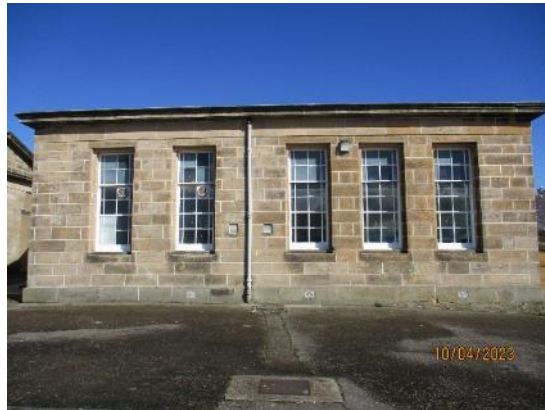
71. Block 1 – Timber sliding sash windows

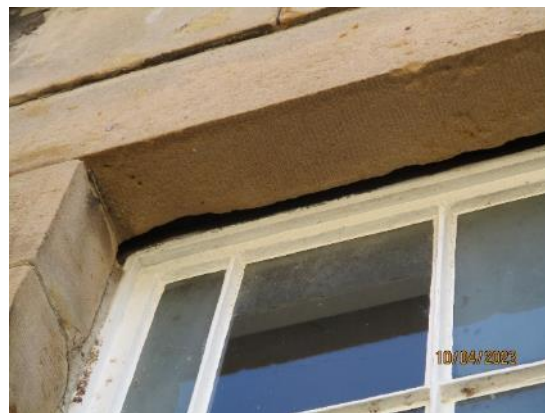
73. Gaps around windows

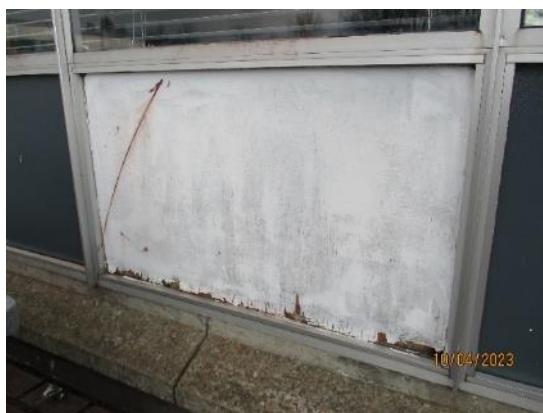
78. Defective panel below windows

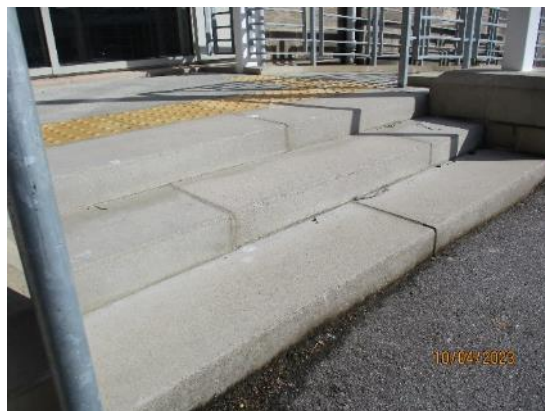
101. Block 1 – Concrete steps

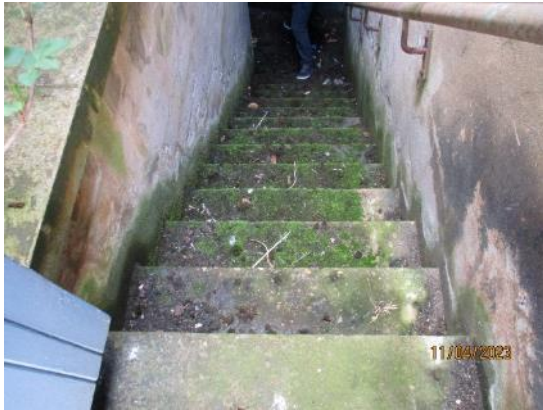
102. Concrete steps to Boiler Room

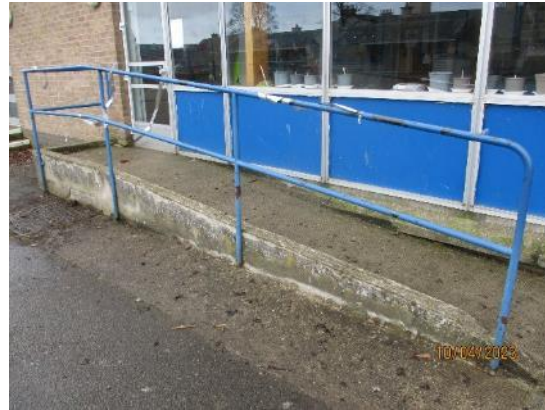
103. Tubular metal handrails

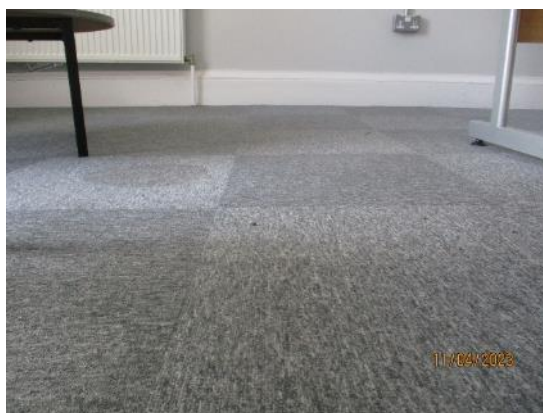
106. Block 1 – Sloping timber suspended floors

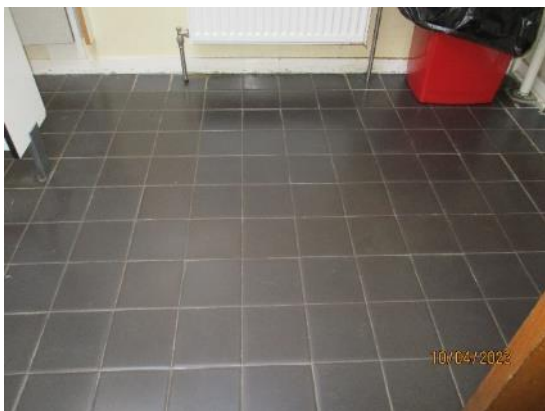
118. Quarry tiles in toilets

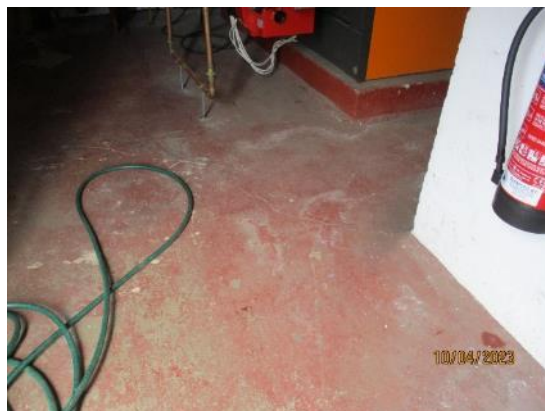
119. Painted concrete floor

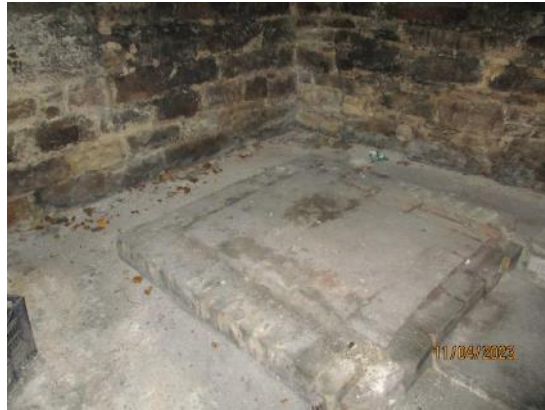
121. Concrete floor and plinths – old Boiler Room

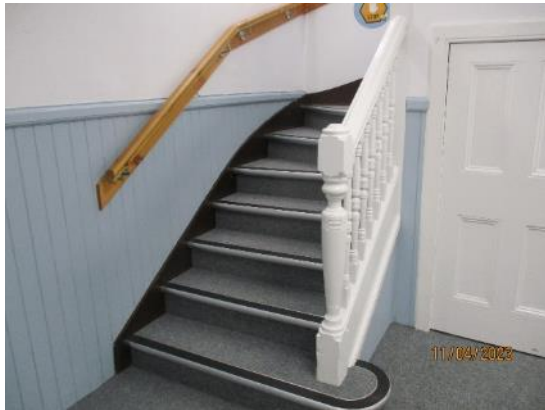
122. Block 1 – Timber staircase

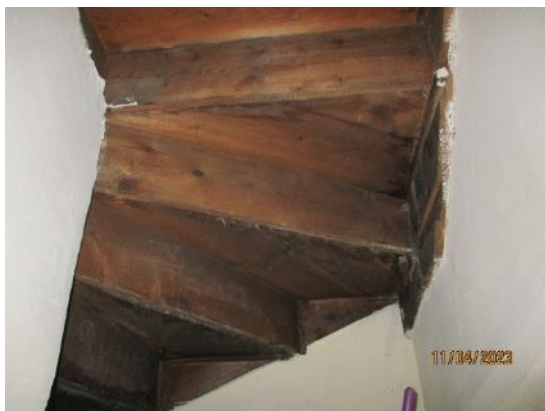
124. Underside of timber staircase

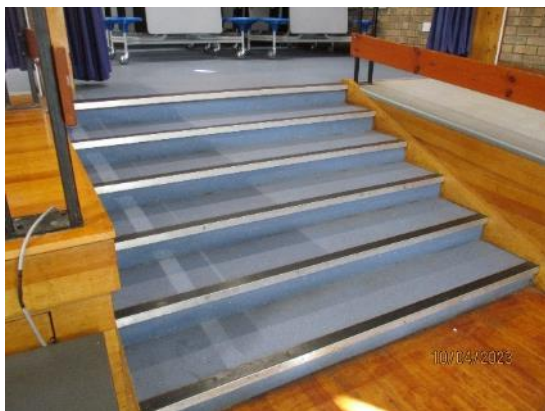
125. Block 2 – Timber stair

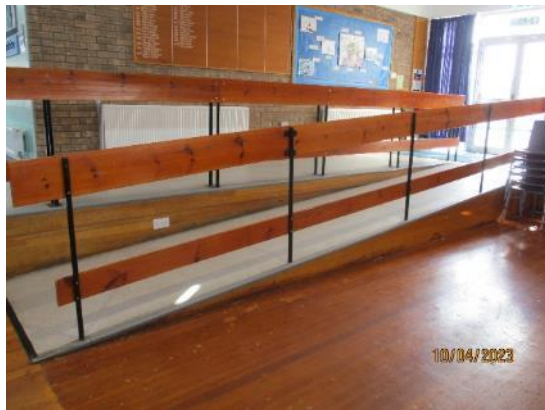
128. Block 2 – Timber handrails

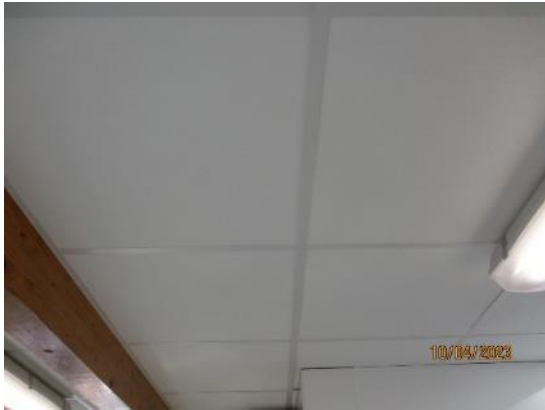
131. Suspended ceiling tiles

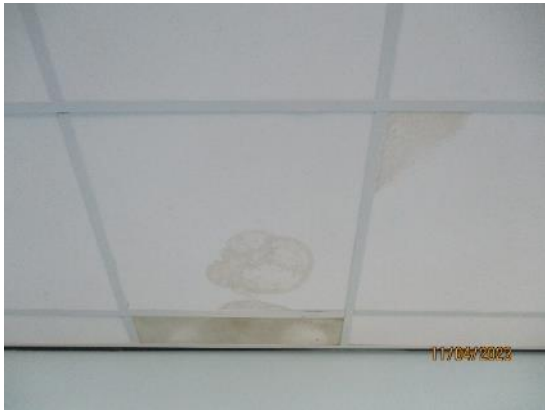
133. Isolated water marking

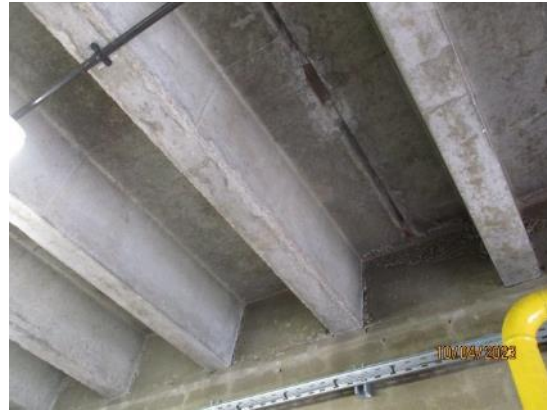
138. Concrete beam ceiling

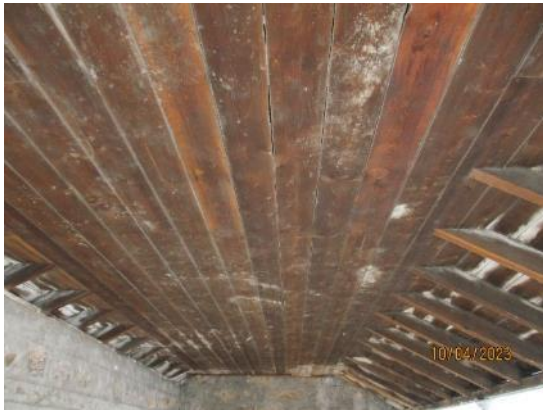
139. External shelter – Timber linings

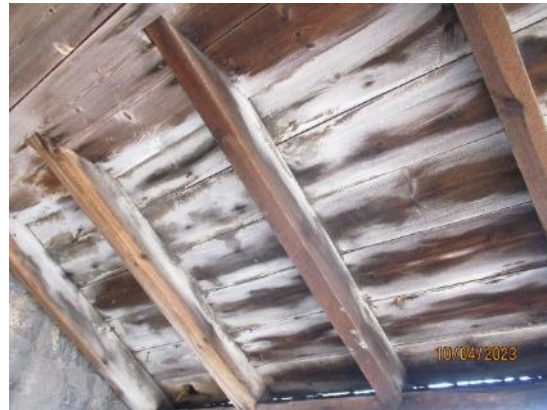
140. Evidence of rainwater penetration

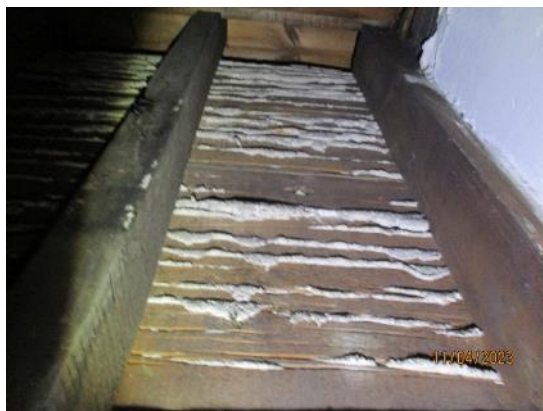
141. Block 1 – Lath & plaster walls

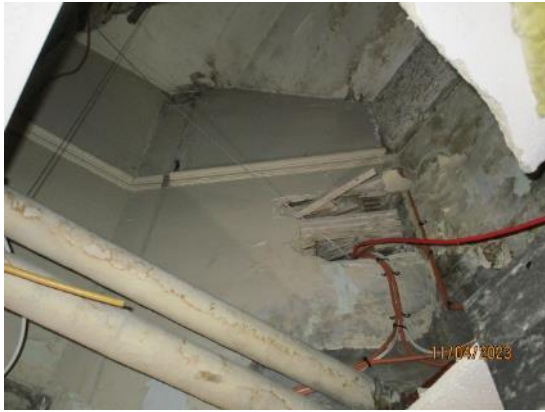
143. Lath & plaster walls

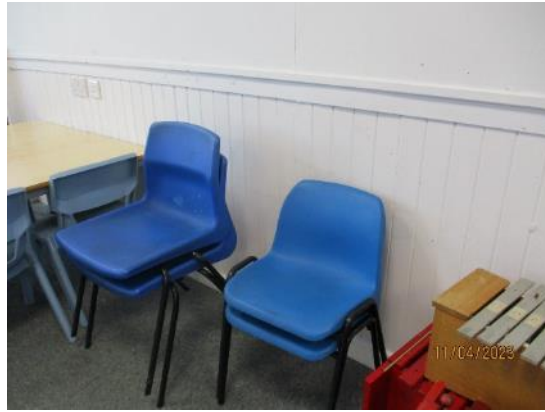
144. Block 1 – Timber linings

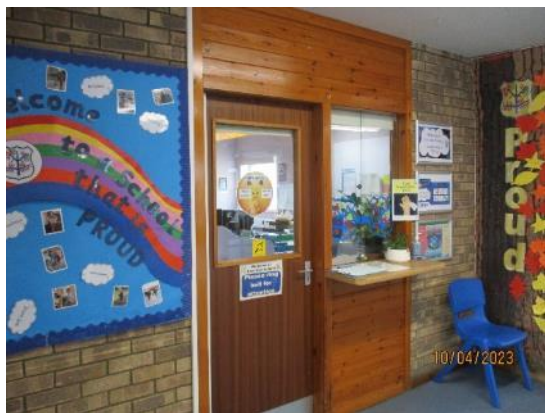
147. Block 2 – Brick walls

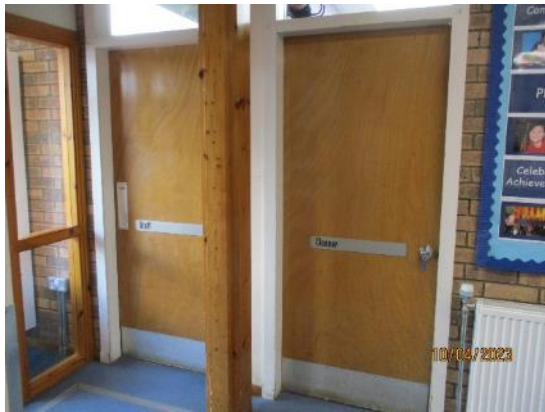
155. Block 2 – Varnished timber doors

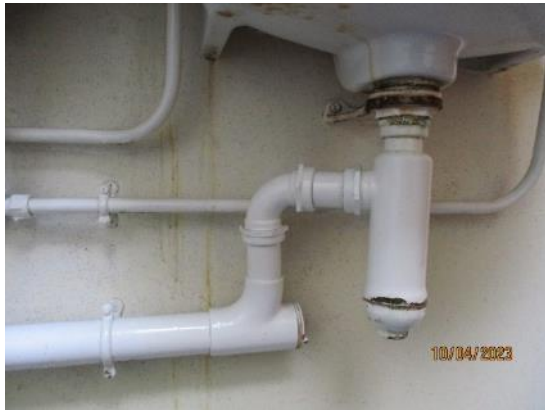
181. Copper waste pipes

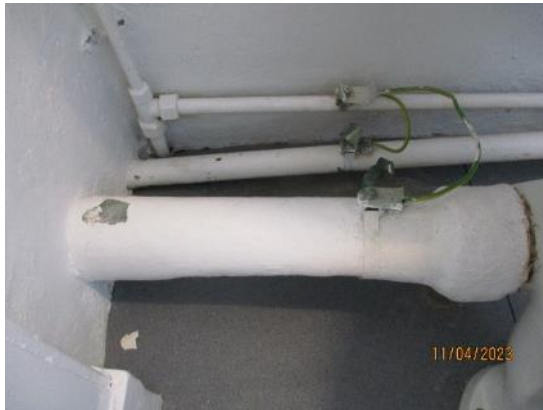
182. Lead waste pipes (Block 1)

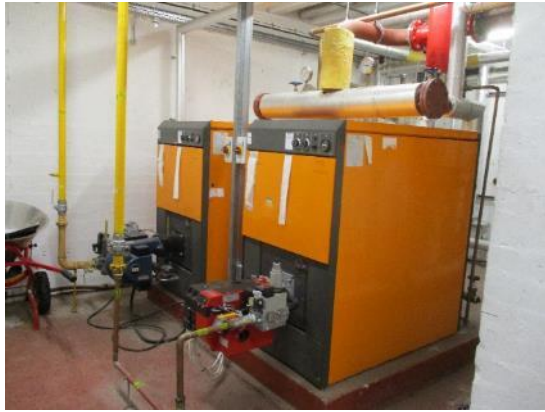
- The gas boilers, associated flues and heating header tank in block 2 are in poor condition and are life expired.
- Heating pipework in block 1 – annexe is in poor condition and life expired.

208. Natural gas boilers 1/33 block 2.

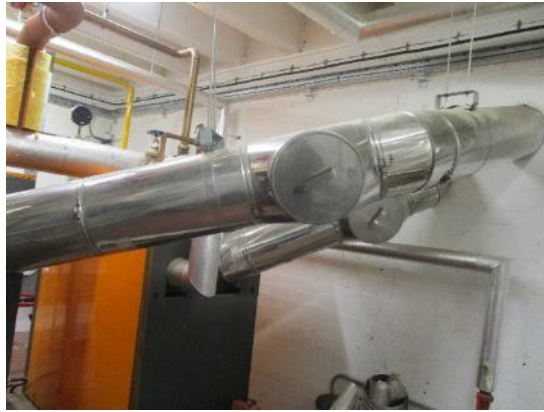
209. Boiler flues into brick chimney. 1/33 block 2.

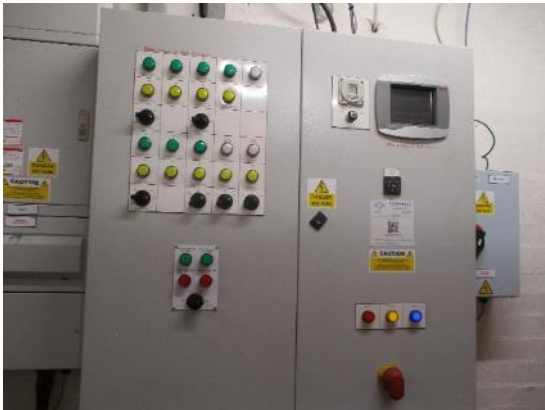
210. Heating control panel 1/33 block 2.

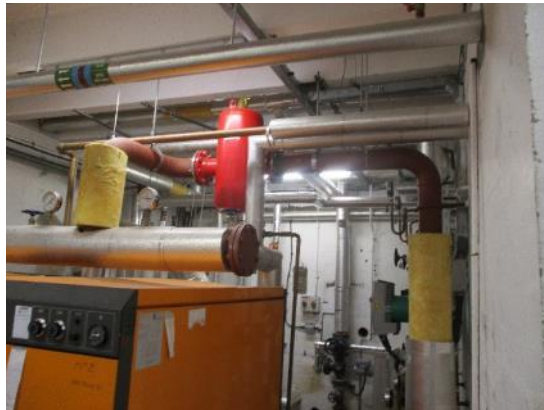
211. Heating pipework 1/33 block 2.

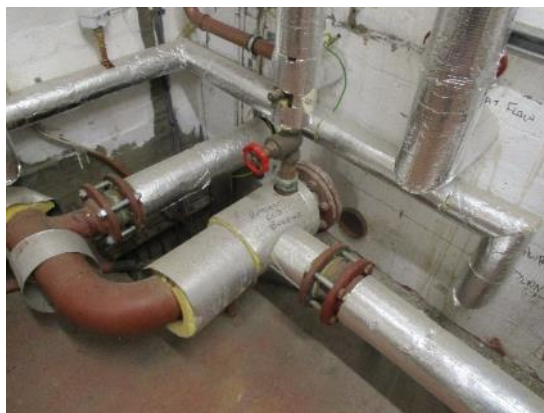
213. Heating pipework 1/33 block 2.

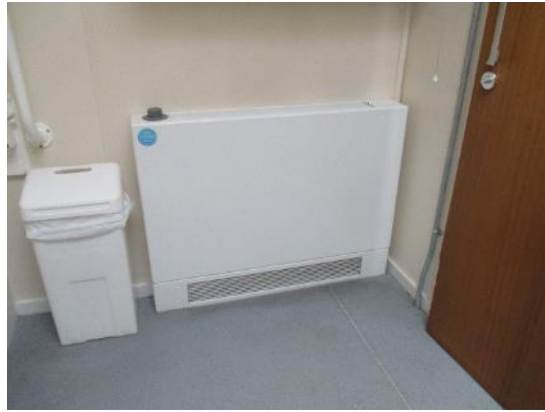
215. Radiator in access toilet 1/23 block 2.

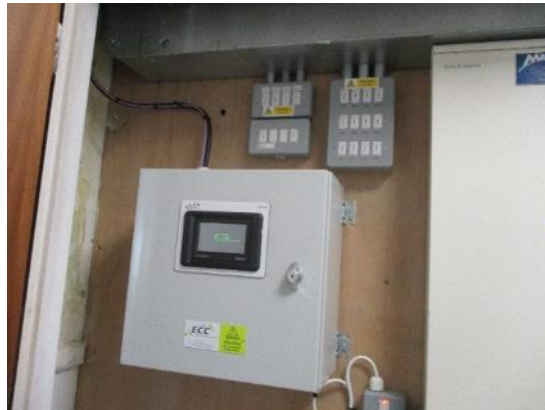
217. BMS Heating control panel block 1 annexe.

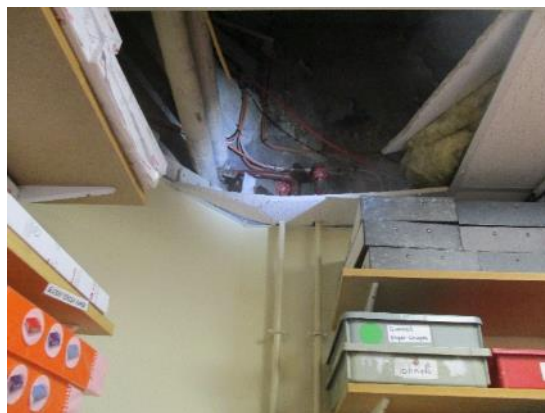
219. Heating pipework block 1 annexe above ceiling.

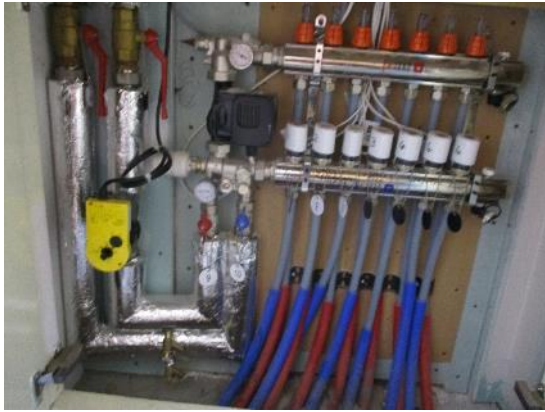
220. Underfloor heating manifold – nursery GO2.

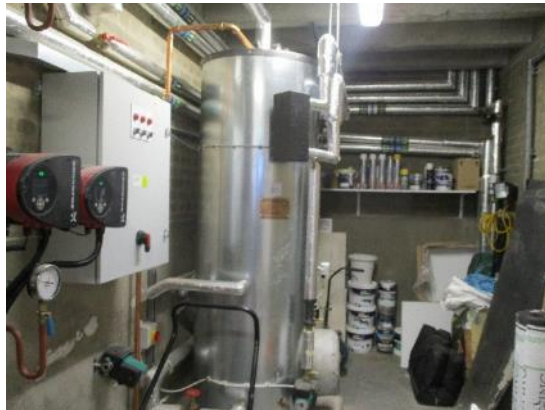
222. Hot water calorifier 1/33a – Block 2.

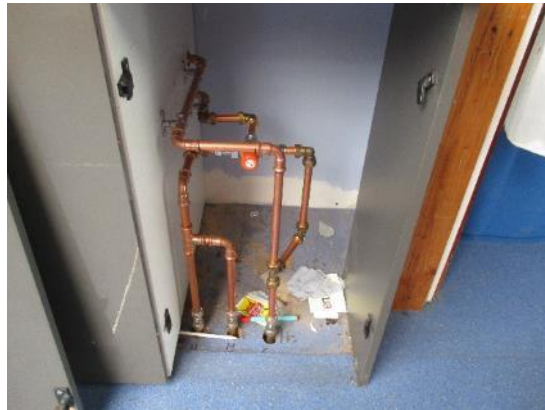
223. Hot water pipework – block 2 typical.

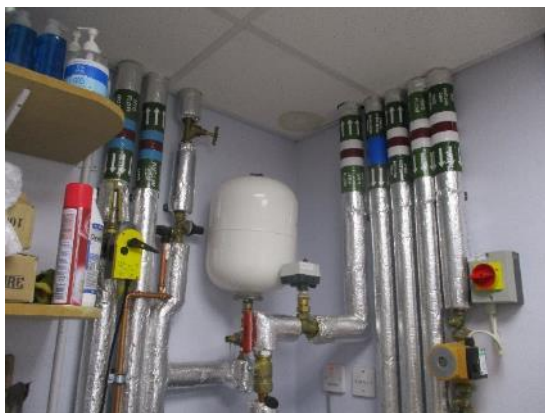
225. Hot water pipework – nursery GO2.

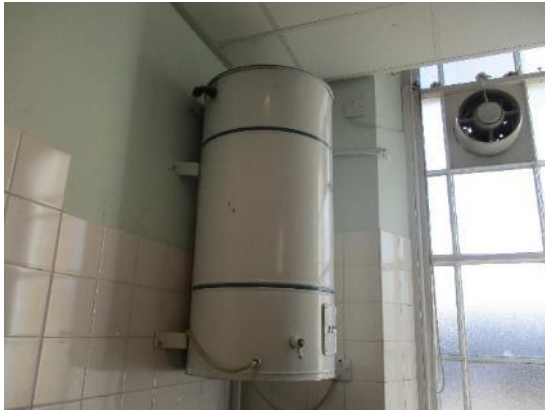
- 2 water heaters in 1/1 and 1/19 in block 1 are functional but life expired.
- Hot water calorifier in block 1, 1/3 Girls toilet, is in poor condition and life expired.

226. Hot water calorifier girls 1/2 block 1 annexe.

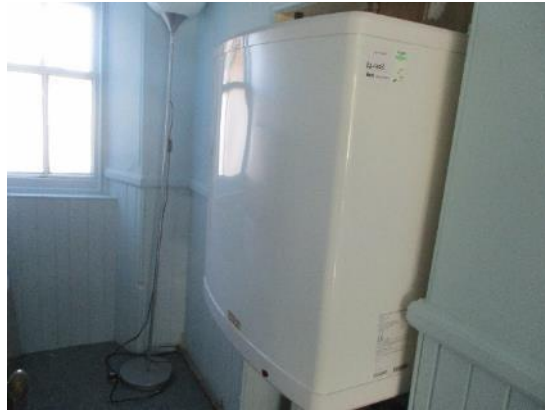
227. Point of use water heater (75L) 2/13 Block 1 annexe.

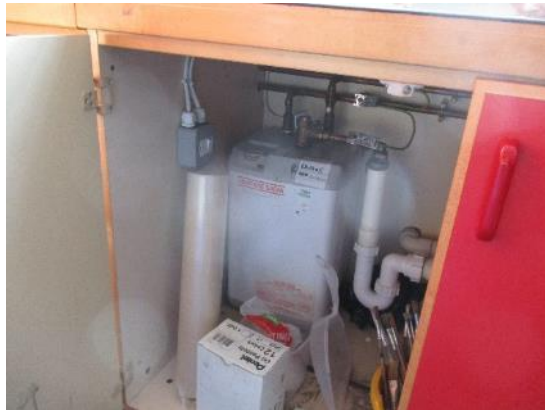
228. Point of use undersink water heater – block 1 annexe. Room 1/19

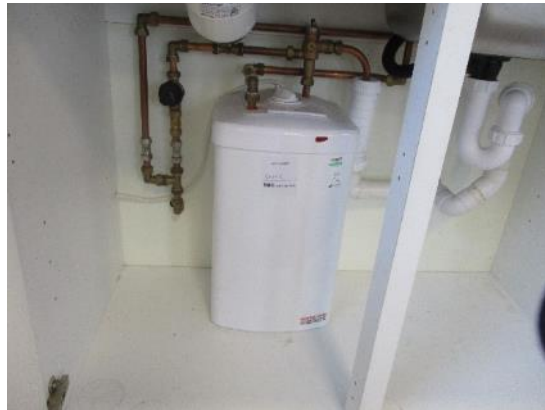
229. Point of use water heater block 1 annexe typical.

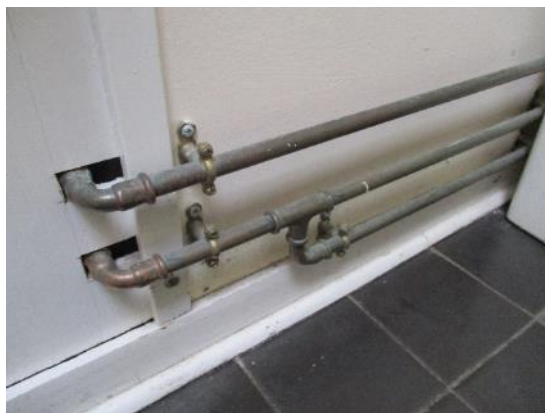
230. Cold water pipework – block 2 1/32 typical.

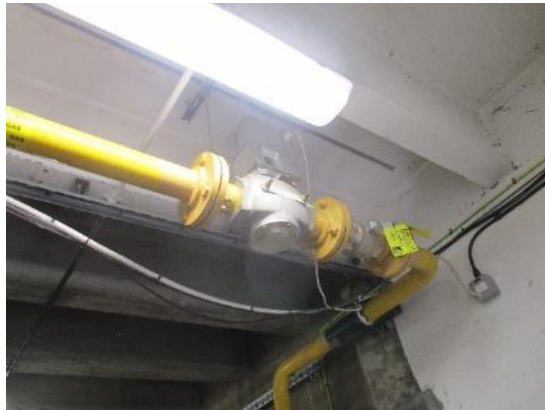
234. Gas supply solenoid valve 1/33 block 2.

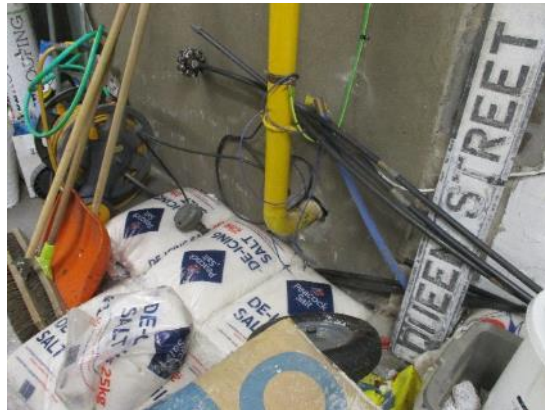
235. Gas pipework 1/33 block 2.

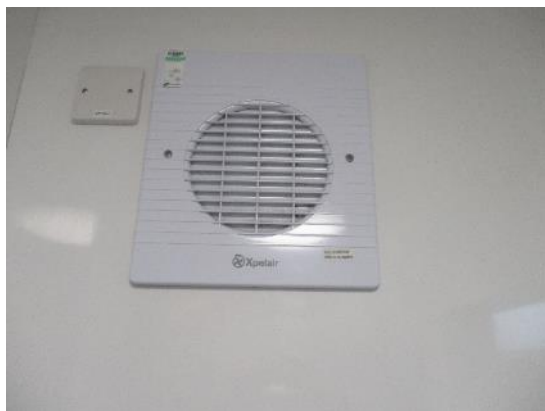
236. Extract fan – kitchen store block 2. 1/2

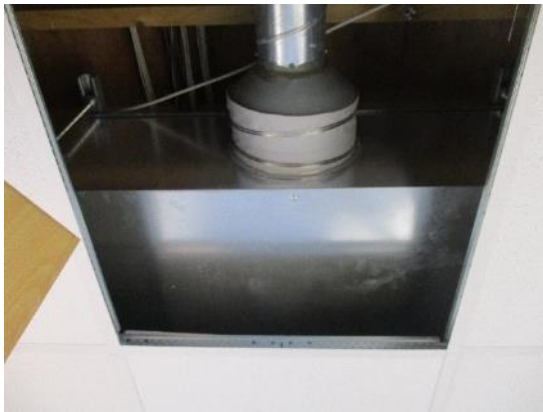
238. Ventilation unit – Nursery above GO3 access WC.

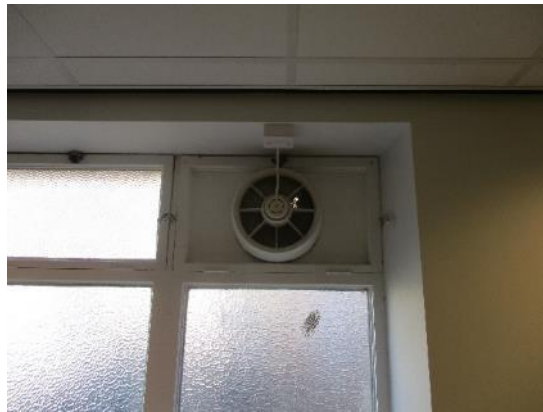
239. Extract fan toilets 1/11 block 1 annexe.

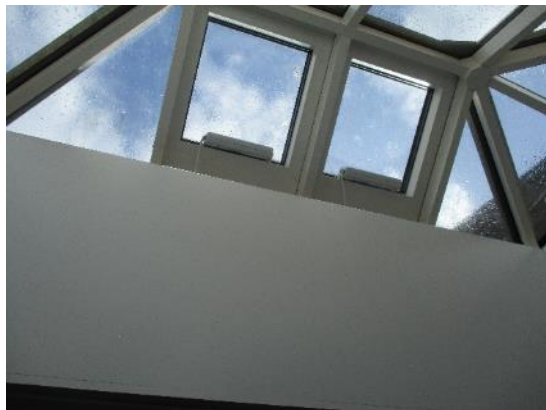
240. Electric windows – 1-21 Block 1 annexe.

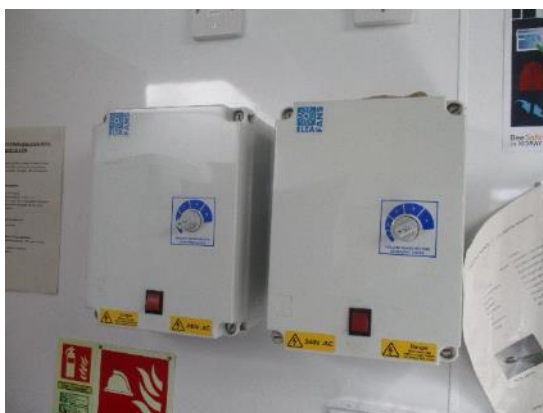
243. Extract canopy fan controls. 1/3 kitchen block 2.

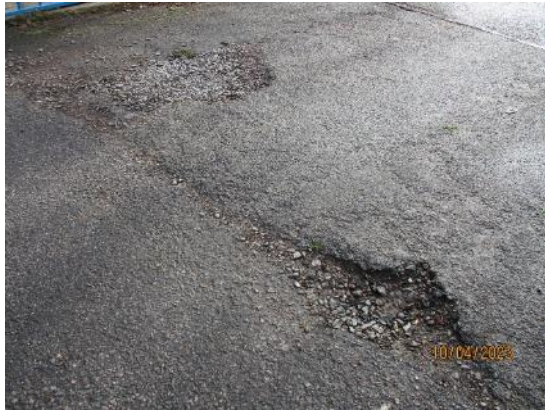
- Tarmacadam access road and car park, sunken and potholed.
- Tarmacadam playground cracked and uneven.
- Timber benches have timber rot and sections missing.
- Precast slab footpaths are broken and uneven.
- Fencing above stone walls is damaged.
- All pedestrian and vehicle entrance gates are seized.
- Stone perimeter walls are cracked, eroded and damaged.
- All surface water drainage to the car park and playground are blocked.
- The roof of the playground shelter is in poor condition, woodworm, slipped slates, water ingress etc.

298. Tarmacadam access road - potholes

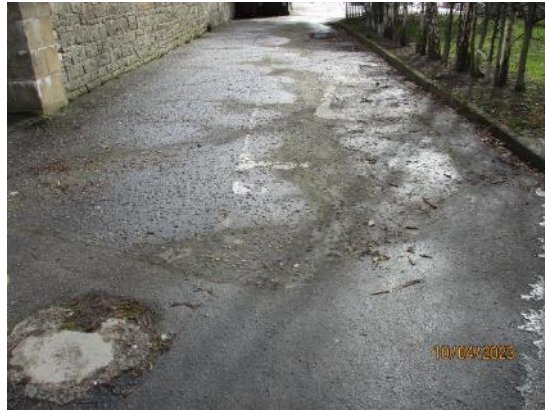
299. Access road subsiding

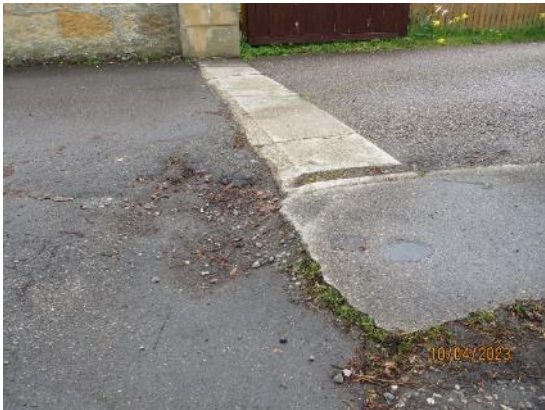
300. Access road - uneven

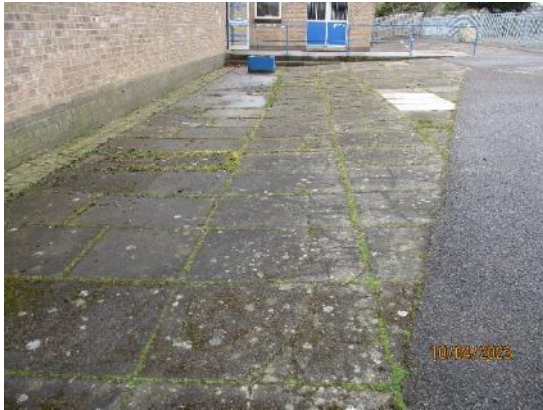
304. Paving slabs to playground

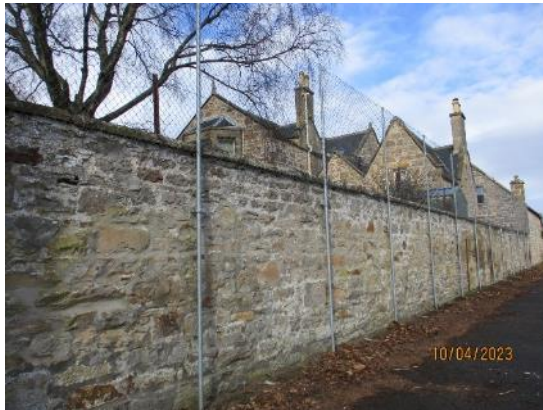
313. High chain link fencing

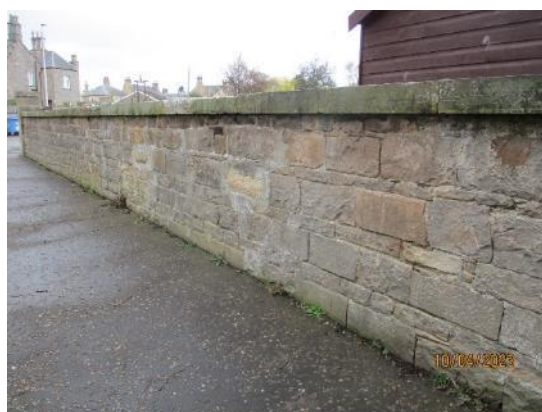
325. Natural stone walls

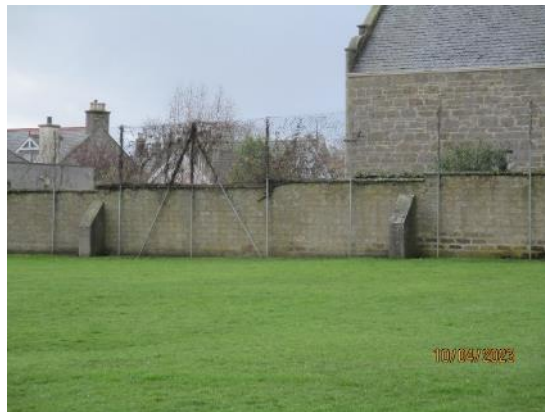
331. Concrete block walls with buttressing

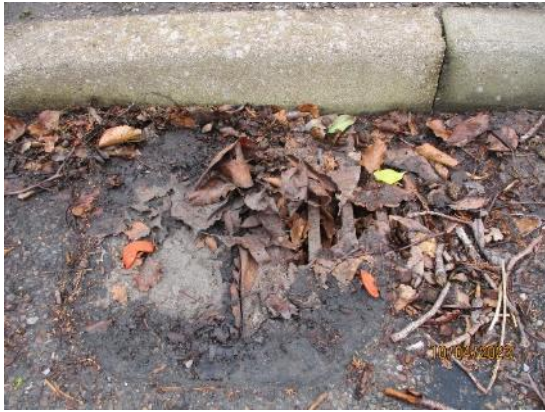
334. Blocked drainage to access road

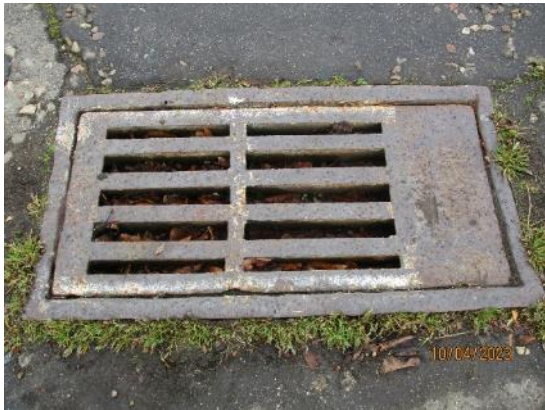
336. Blocked drainage to playground

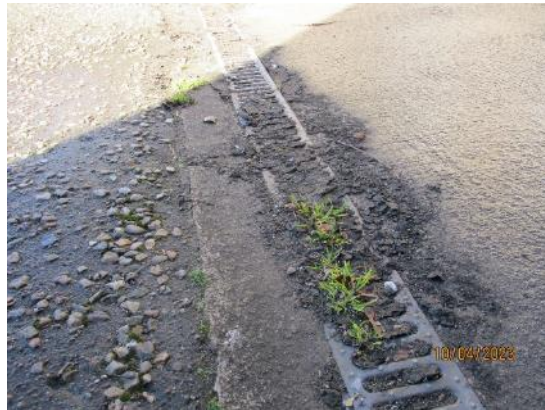
337. Blocked channel drain to Block 1

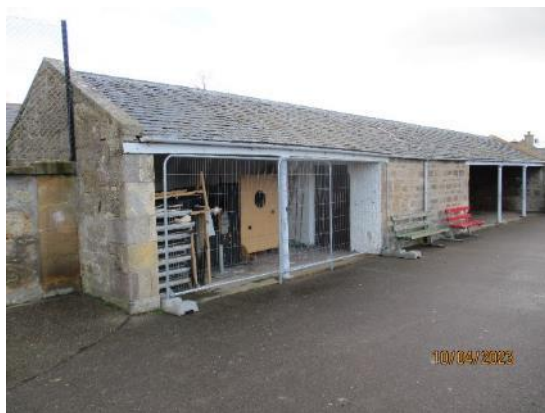
338. External shelter with Heras security fencing

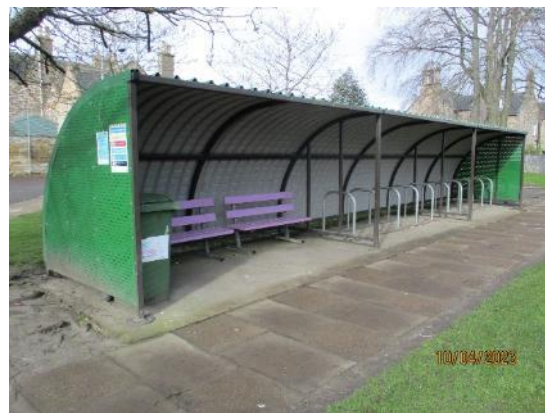
339. Steel framed bike shelter

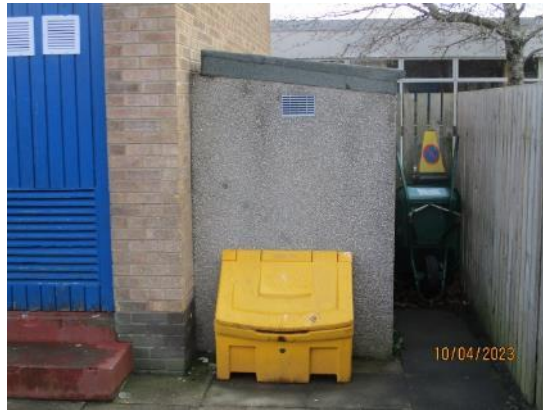
343. Gas meter housing (Block 2)

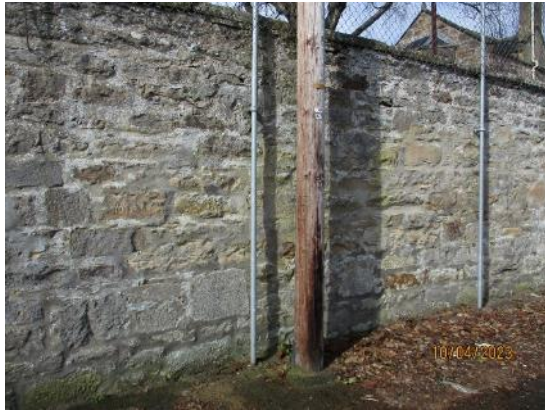
346. Utility pole in car park
