# **Summary Building Condition Survey Report**

**Seafield Primary School  
Deanshaugh Terrace, Elgin IV30 4ES**

**24<sup>th</sup> to 26<sup>th</sup> May 2023**

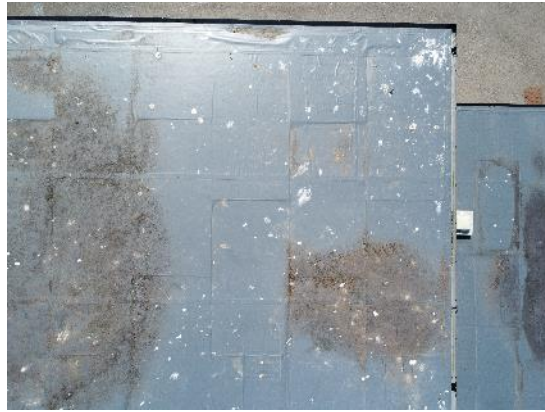
2. Single ply membrane (insulation sheets visible)

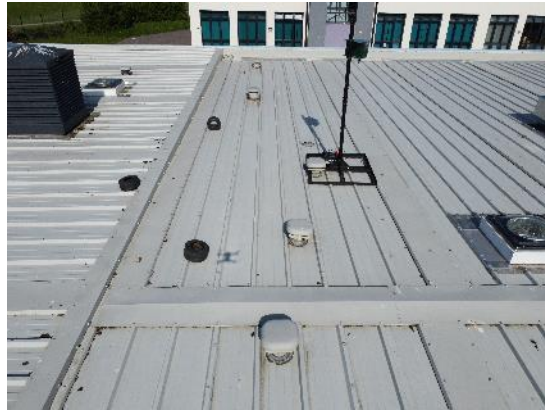
8. Metal standing seam roof with bird scarer

- Protection of the external insulation is recommended in the car park area.
- Consider additional bird deterrents, 4 gull nests found on roofs.
- Confirm operational condition of bird scarer on nursery roof.

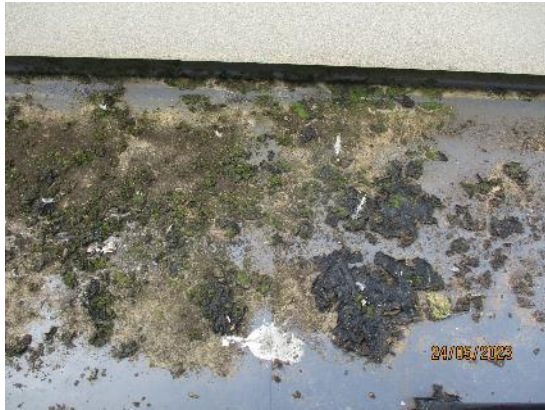
13. Bird droppings and vegetation

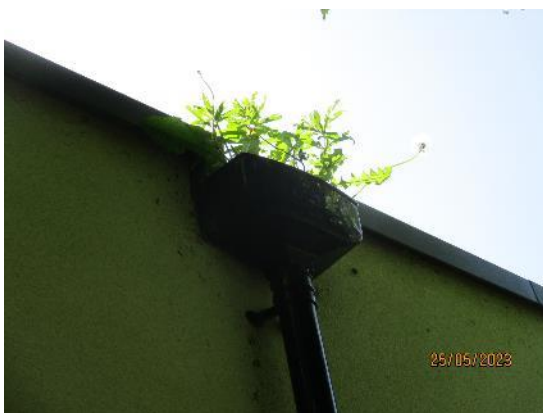
29. Hopper heads, partially blocked with vegetation

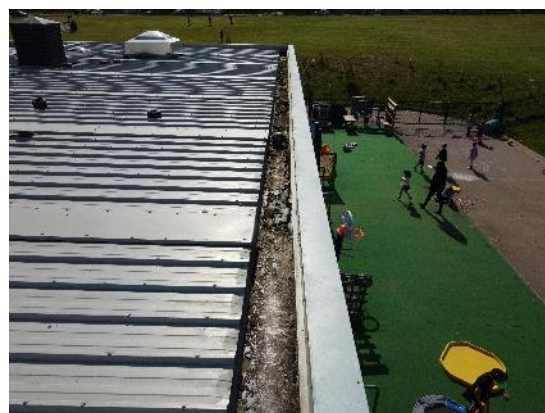
30. Metal roof box gutters, partially blocked

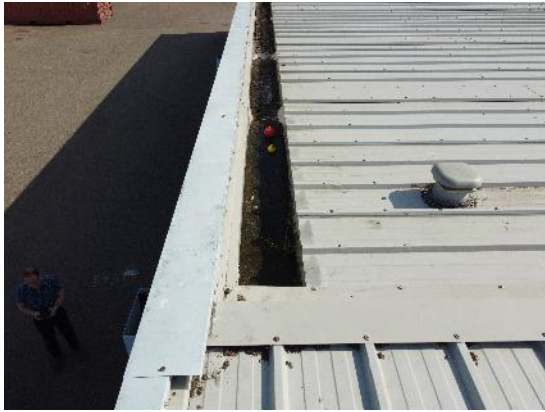
31. Box gutters with standing water

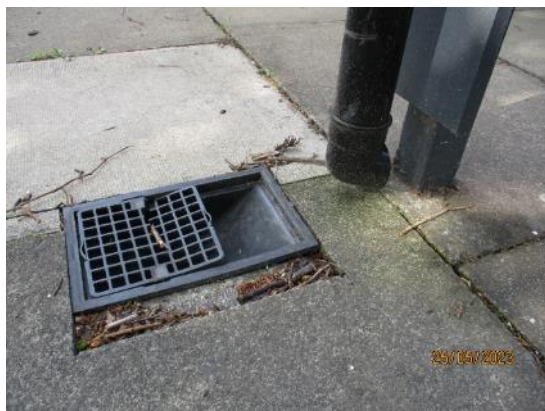
35. Downpipes not discharging to drainage

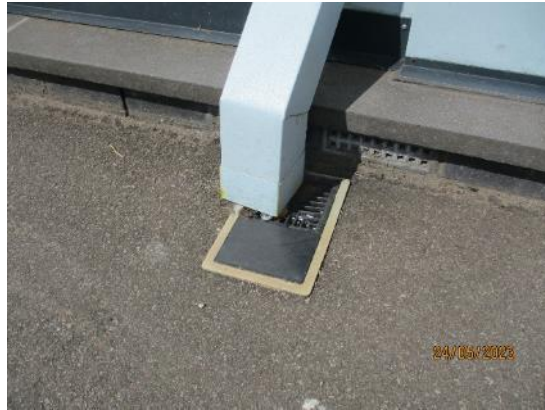
38. Downpipes miss-aligned with drainage

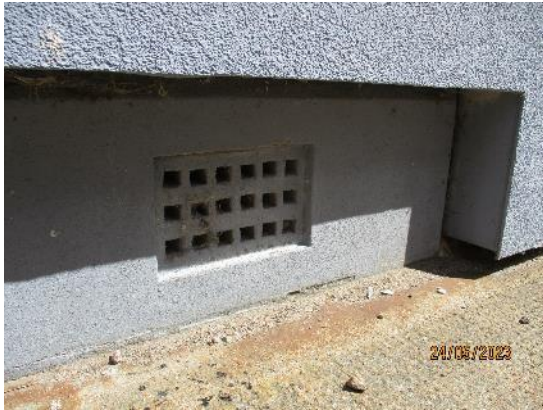
43. Primary school underfloor ventilation

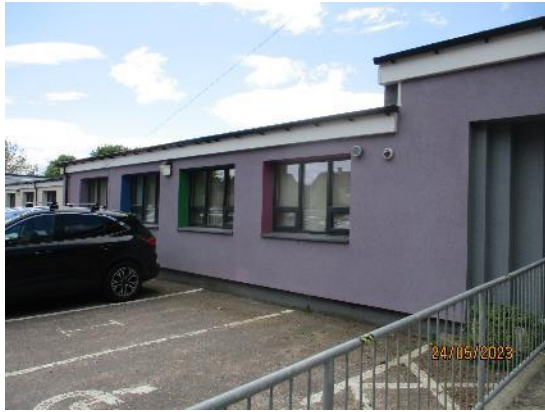
49. Primary school external insulation

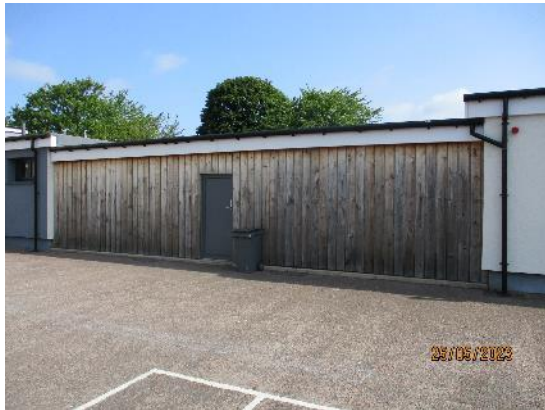
51. Timber lining boards

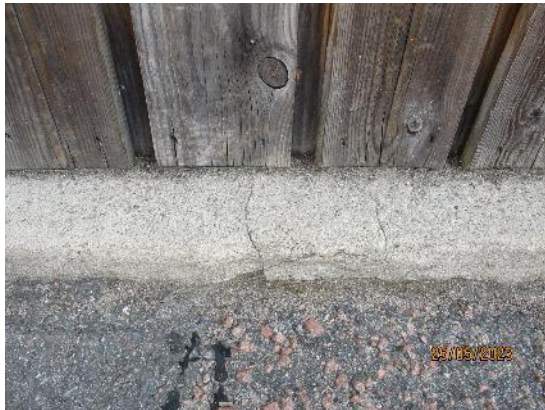
52. Boards close to concrete slab

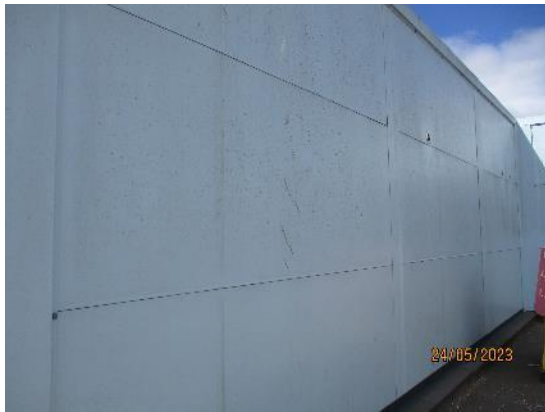
55. Nursery – Metal composite panel walls

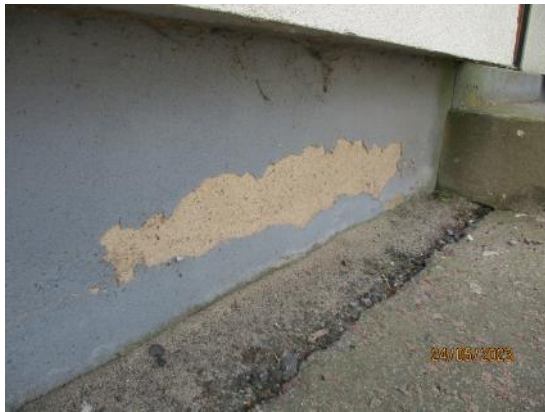
73. Peeling paint to base course

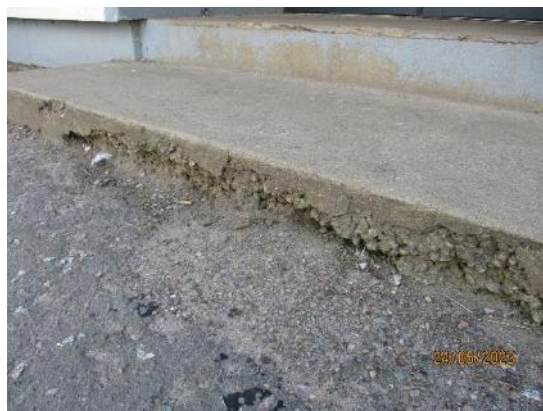
- Tarmacadam car park and access road are breaking up and pot holed.
- External concrete steps and ramps are cracked and eroded.
- Tarmacadam and paving slab footpaths are cracked and uneven.
- Damage and corrosion to metal gates and chain link fencing.

78. Eroded concrete steps

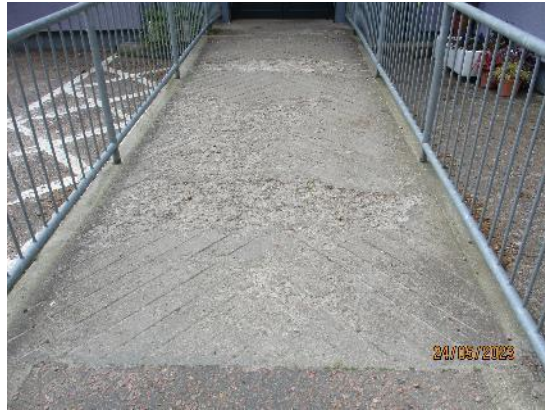
80. Eroded concrete entrance ramp

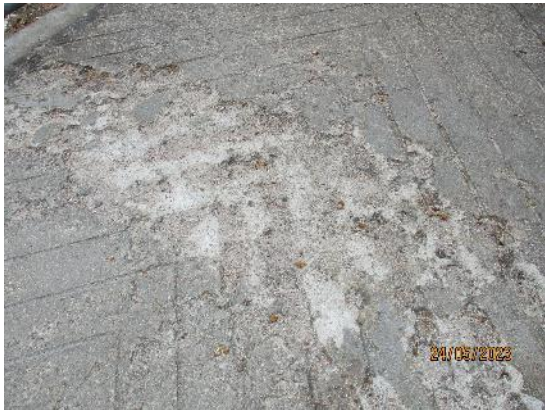
81. Surface breaking up

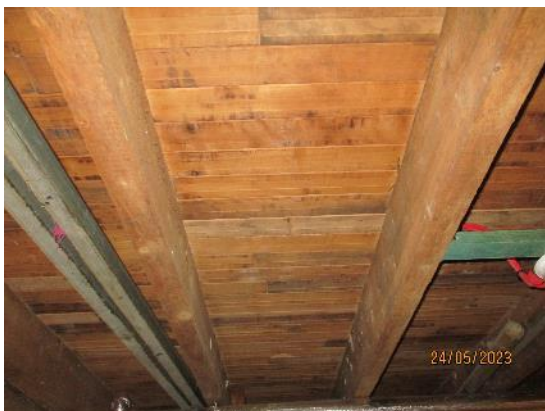
83. Timber suspended floor of the stage

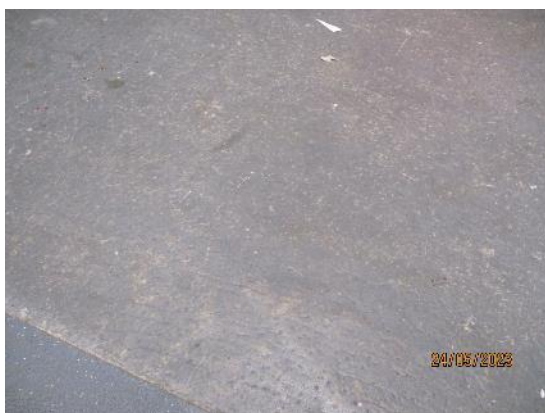
90. Painted concrete floors

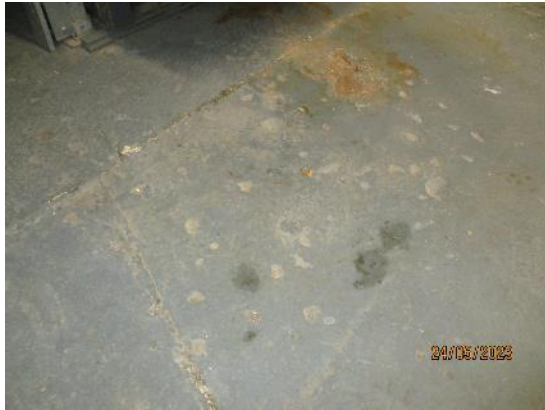
91. Boiler room painted concrete floor

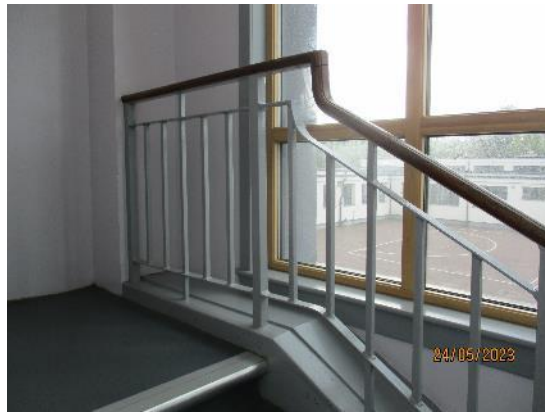
104. Metal balustrades with timber handrails

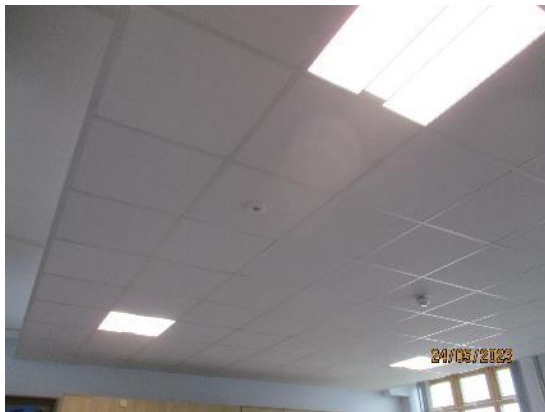
105. Primary school suspended ceiling tiles

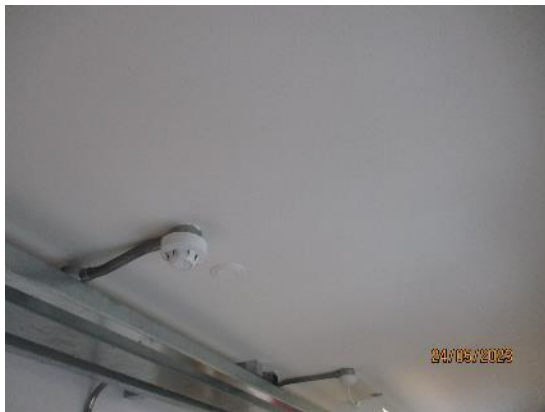
106. Primary school plastered ceilings

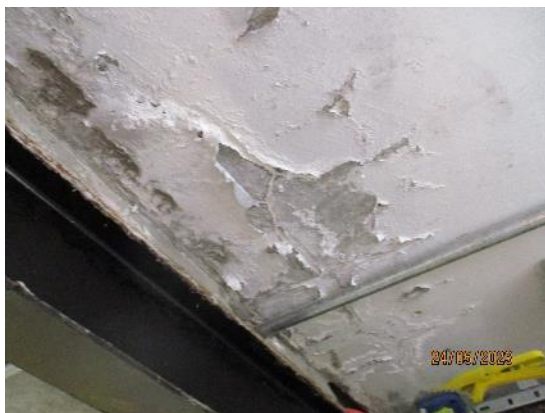
107. Concrete ceiling, peeling paint

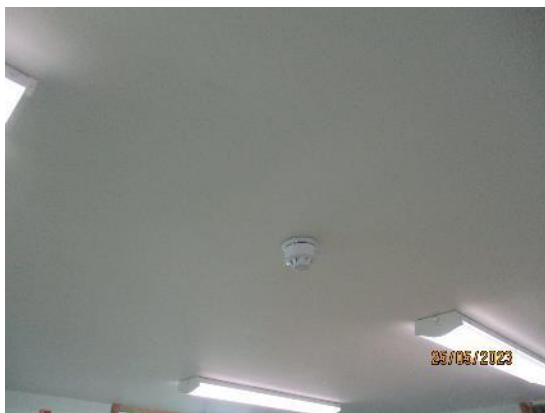
108. Plasterboard ceilings in The Hub

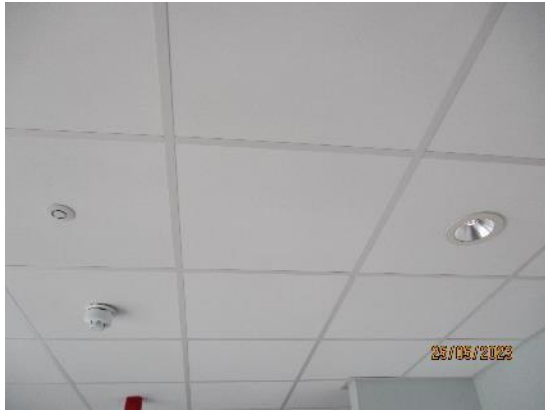
109. Nursery suspended ceiling tiles

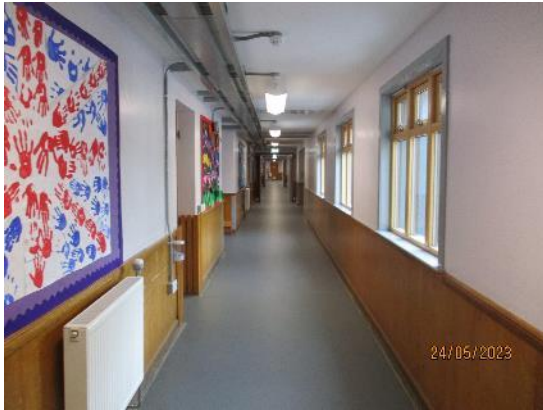
114. Timber wall panelling in the primary school

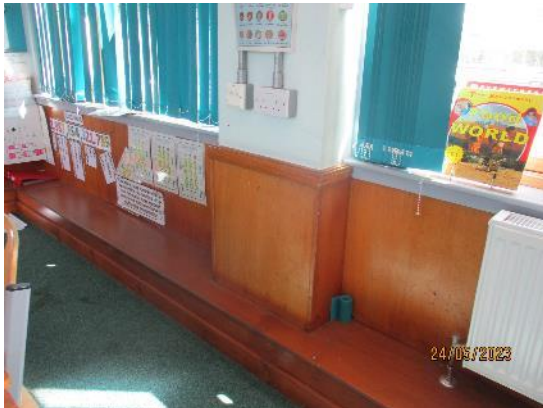
116. Panelling to classroom walls

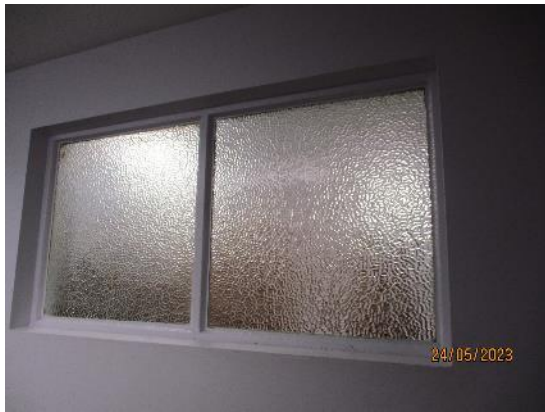
120. Internal borrowed lights (toilets)

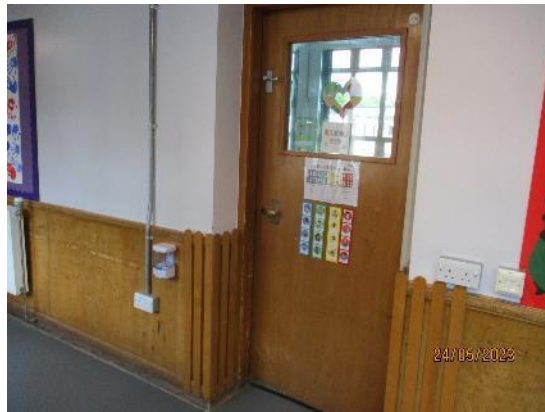
121. Typical timber hollow core door

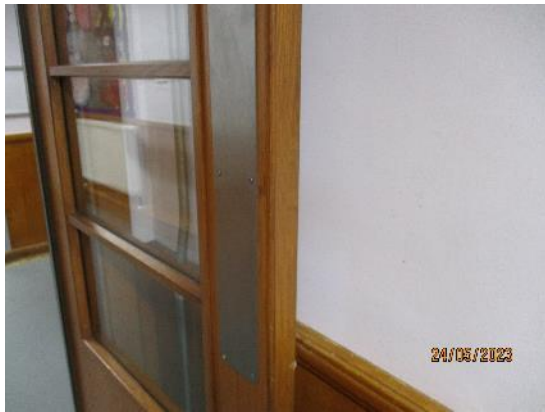
126. Not all are fire doors

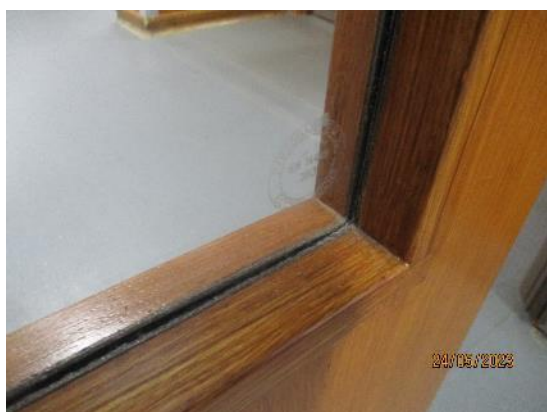
134. Safety glass to replacement doors

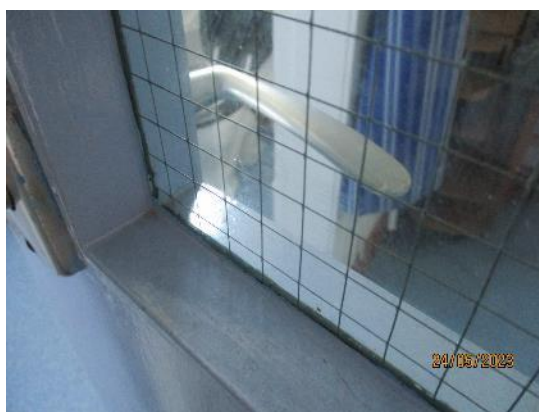
135. Georgian wired glass to some doors

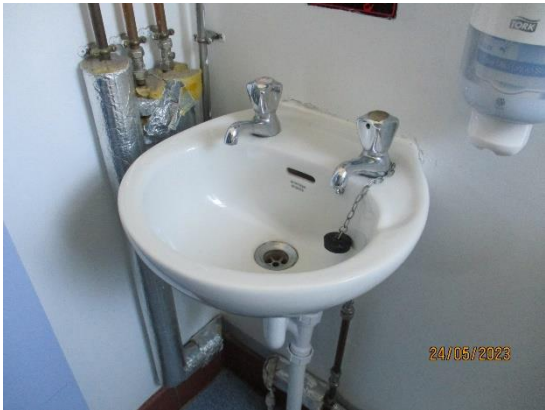
146. Wall hung wash hand basin

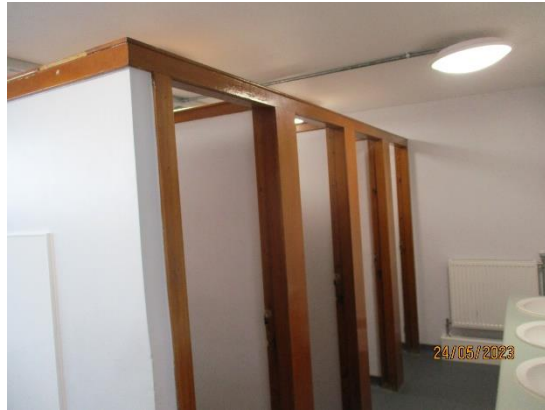
151. Stud wall cubicle partitions

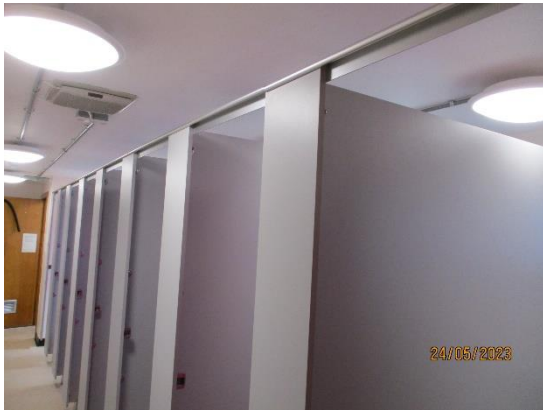
152. Composite panel cubicle partitions

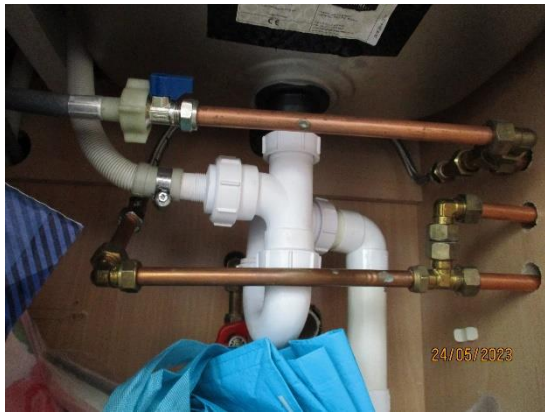
162. PVC waste pipes

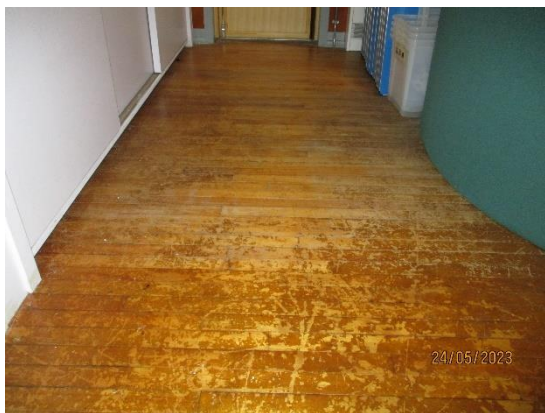
165. Timber floor boards

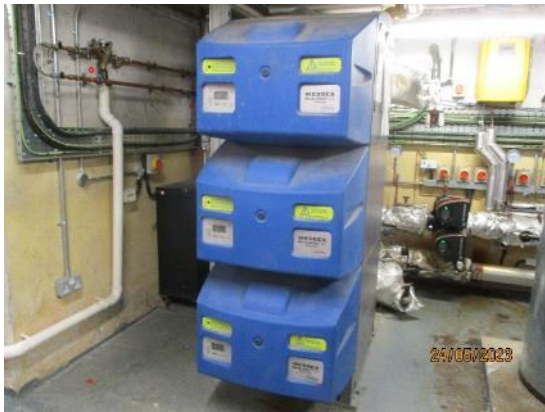
178. Main school and modular building boilers.

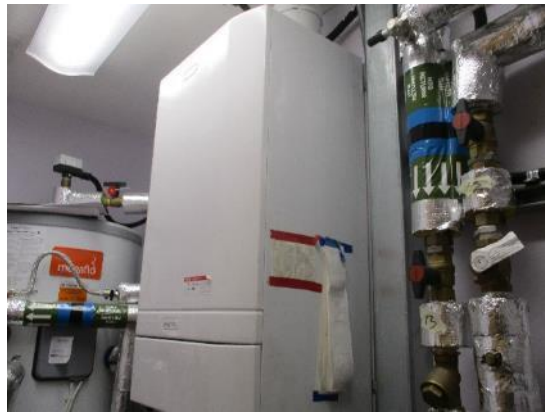
179. Hub building gas condensing boiler.

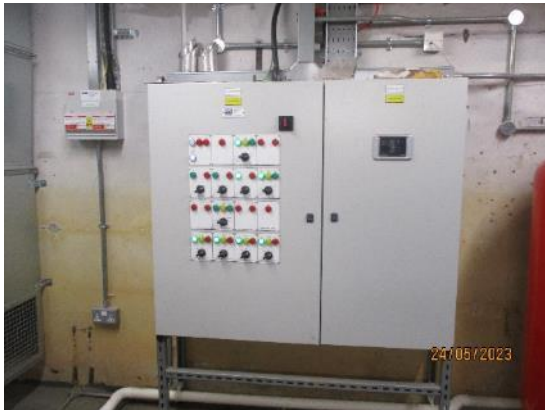
180. Control panel main school boilerhouse.

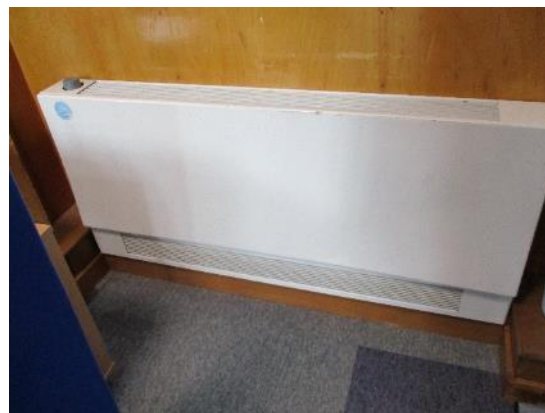
182. Radiator – typical throughout.

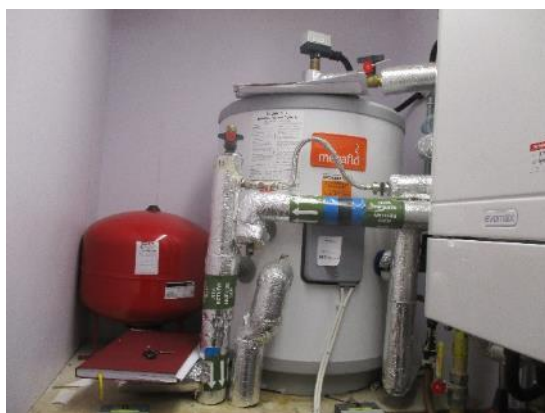
187. Hot water calorifier – main school boiler house.

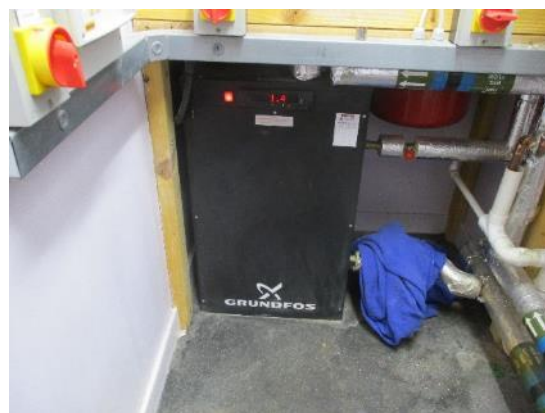
188. Hot water storage tank – hub building.

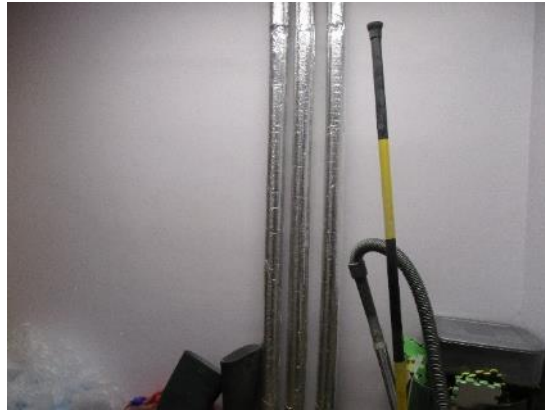
190. Pipework – hot and cold main school typical.

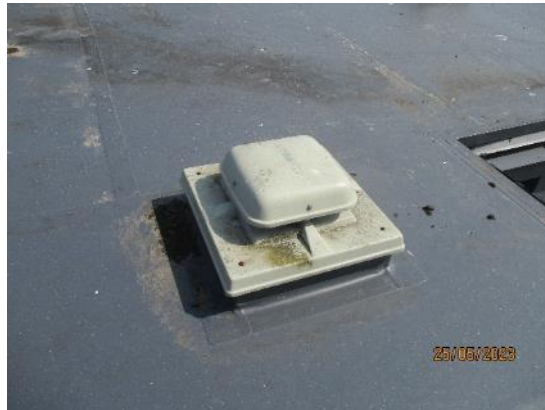
192. Extract fan main school roof mounted. Girls toilets.

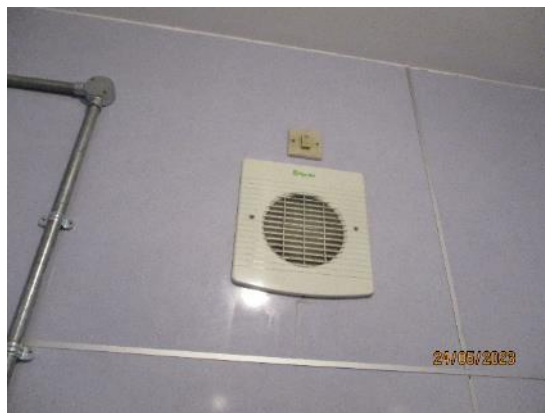
194. Extract fan – typical throughout all 3 buildings.

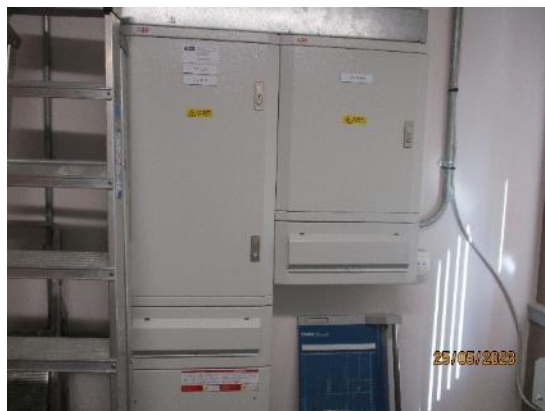
200. Main panel board – main school.

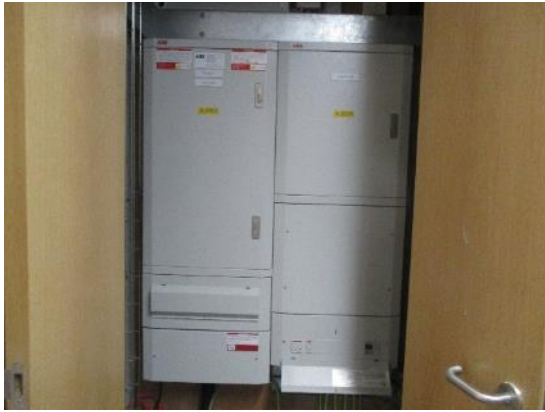
201. Distribution board LP1 main school.

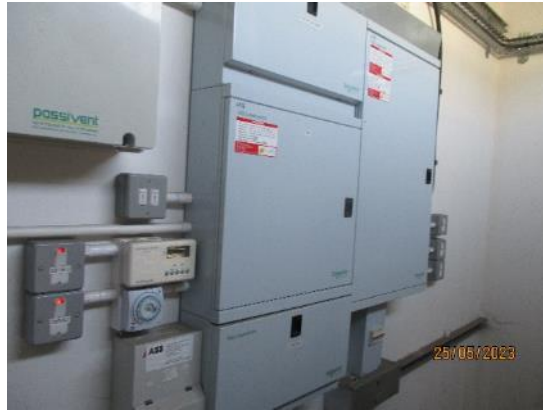
202. Distribution boards – Hub building.

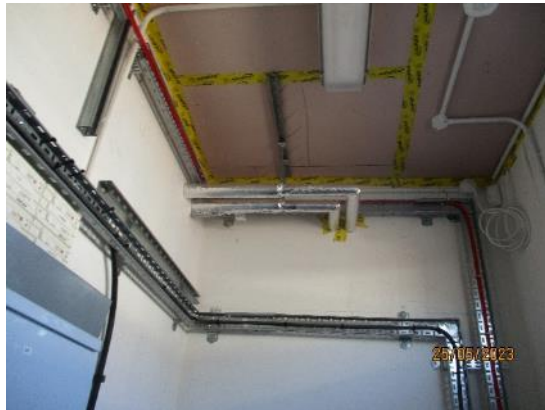
203. Distribution boards – modular nursery building.

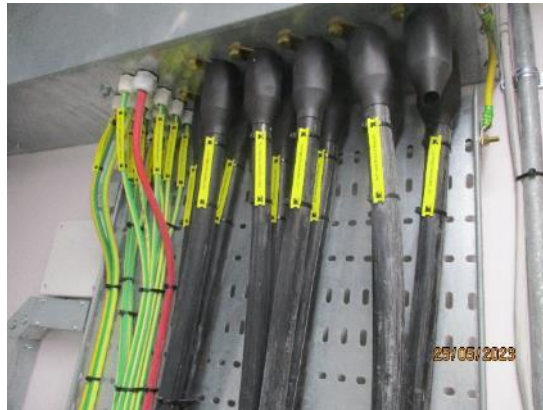
204. Sub mains cabling – modular nursery plant room.

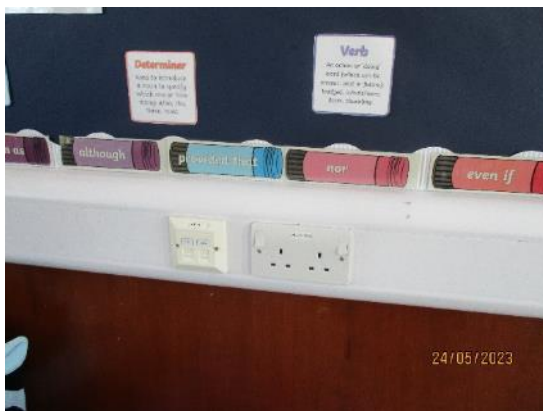
206. General wiring – main school.

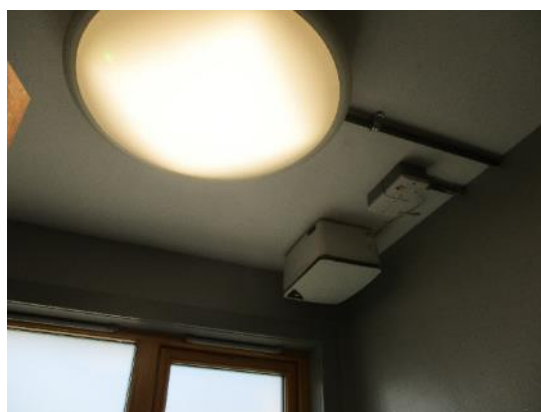
216. Lighting – classroom typical main school.

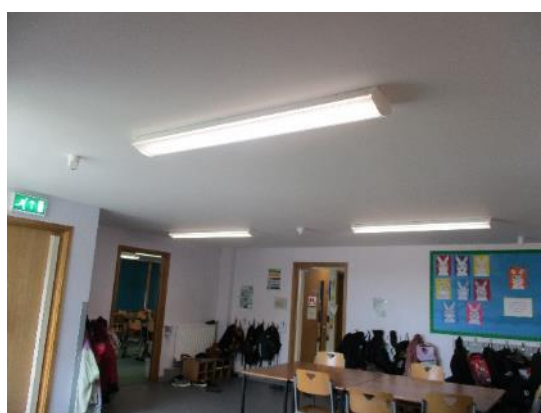
218. Lighting – PIR control main school typical.

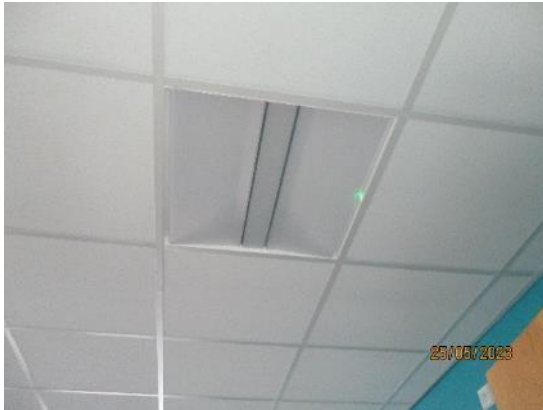
219. Lighting – Hub classroom.

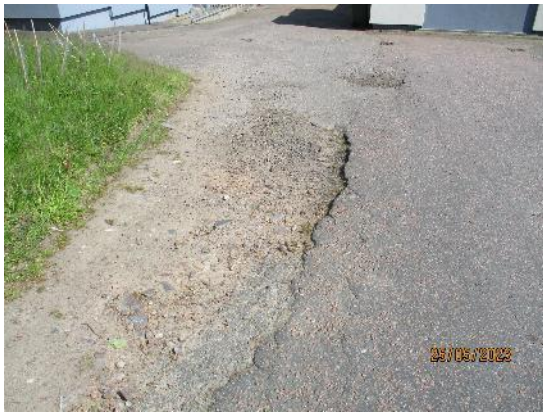
238. Access road to Kitchen breaking up

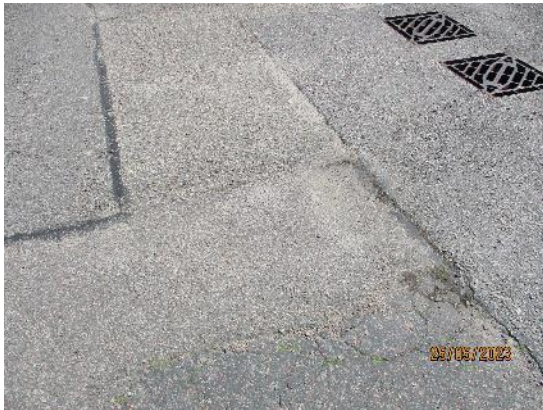
240. Tarmacadam car park

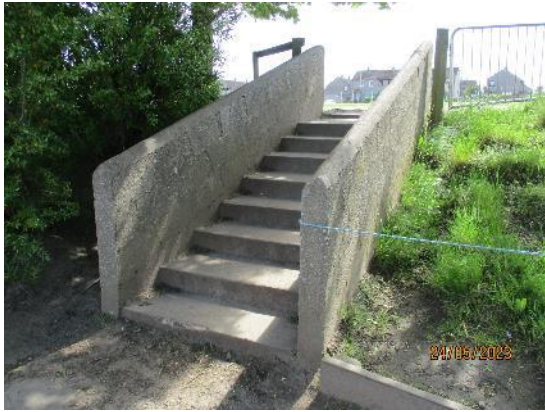
250. Concrete staircase to playing field

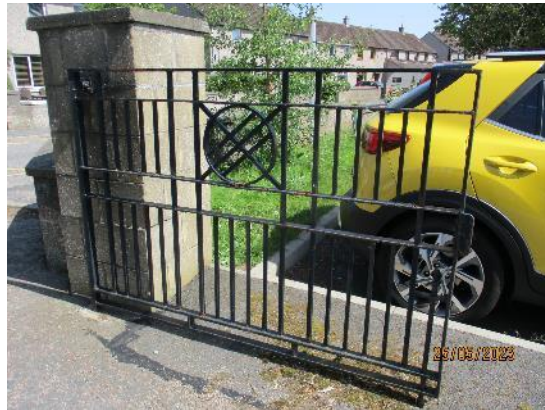
259. Metal bar vehicle gates

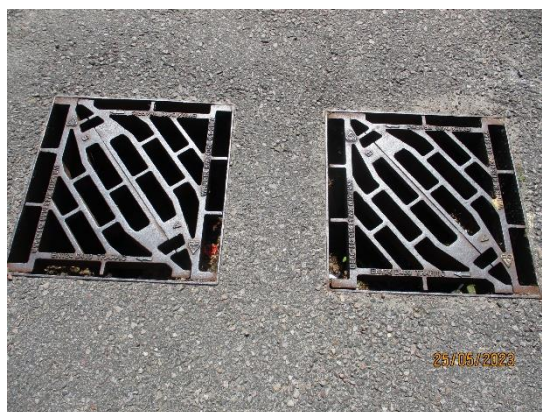
275. Car park and playground drainage

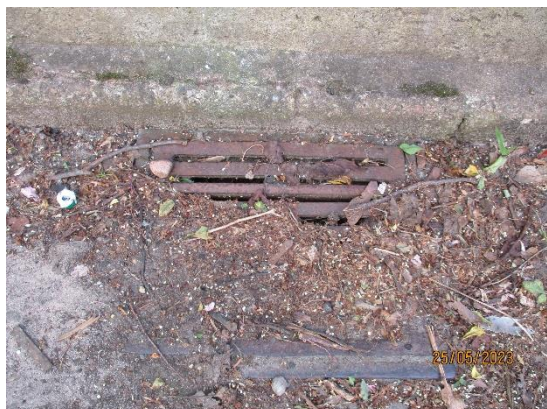
276. Blocked surface water drainage

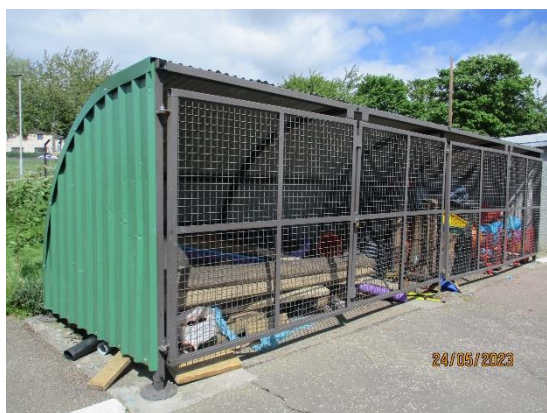
278. Metal profile and caged enclosure

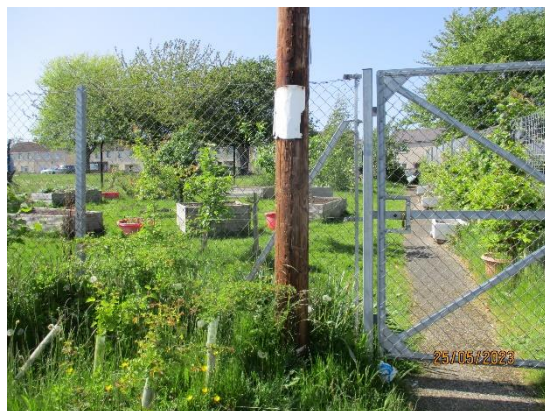
285. Timber utility pole

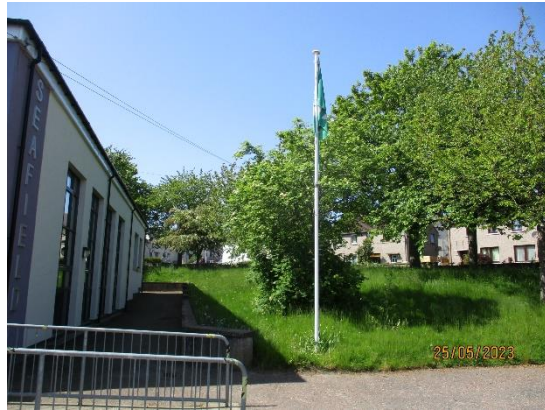
287. Timber flag pole
