# **Summary Building Condition Survey Report**

**St Sylvesters Primary School  
Abbey Street, Elgin IV30 1DA**

**26<sup>th</sup> & 27<sup>th</sup> June 2023**

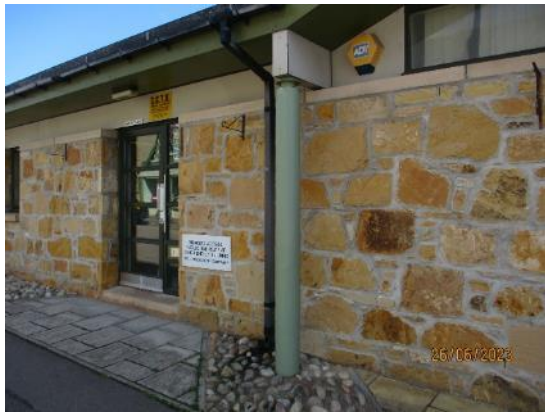
1. Steel frame externally

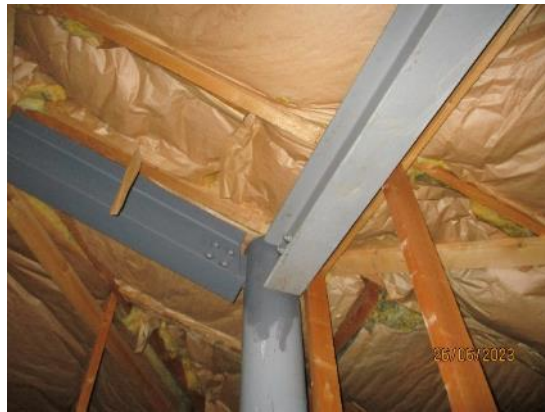
2. Steel columns & beams within roof space

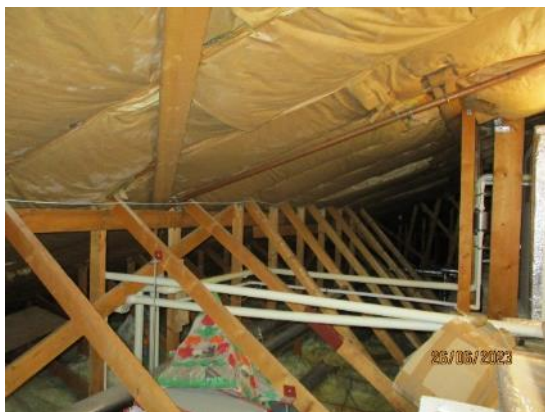
5. Timber trussed roof

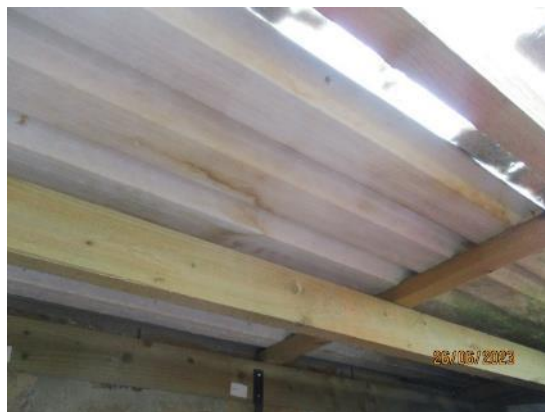
6. External store timber joists

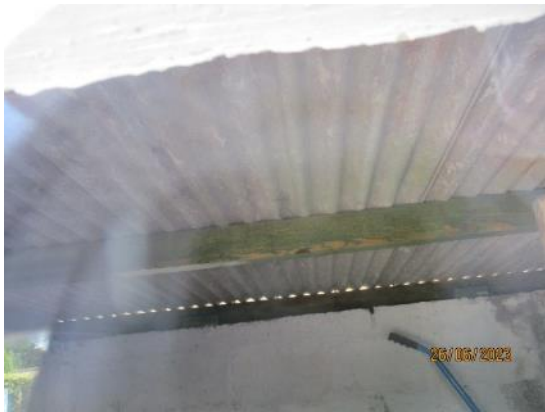
7. Salt store timber joists

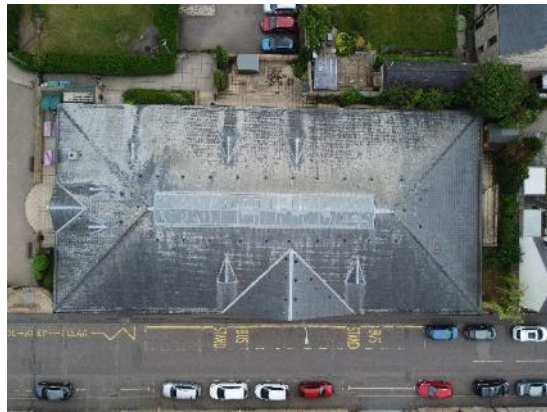
8. Overview of slated roof

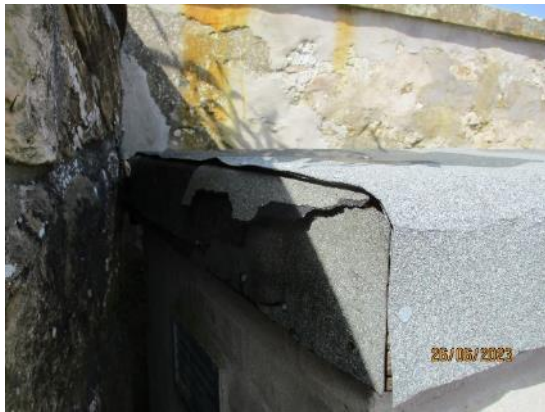
13. Felt roof to gas meter house

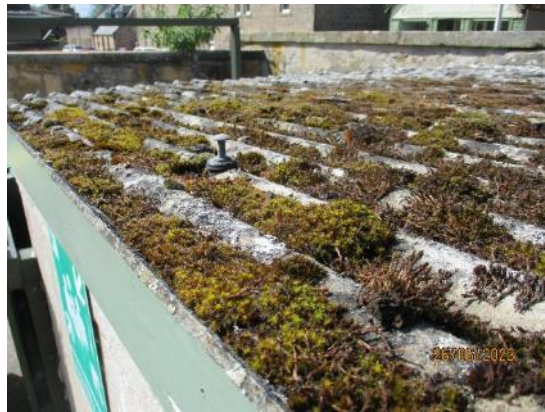
14. Corrugated asbestos roof (salt store)

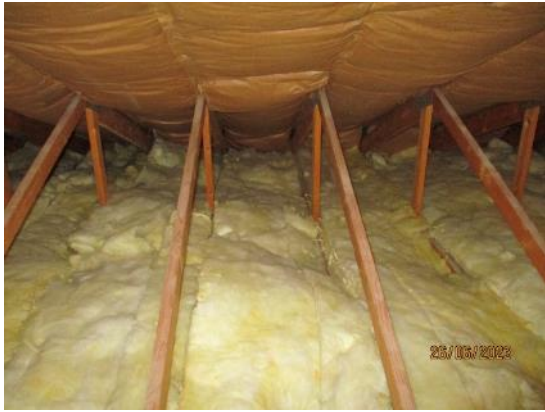
25. Mineral fibre insulation laid on ceilings

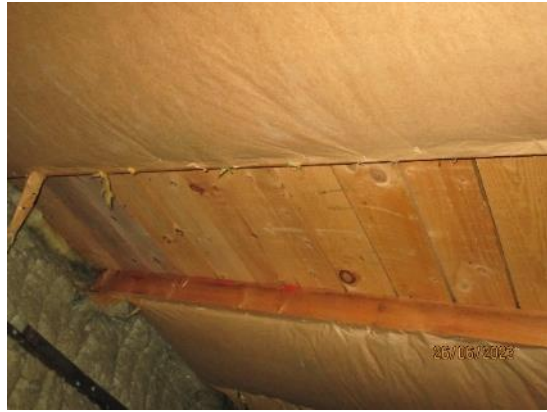
26. Insulation roll collapsed from sarking

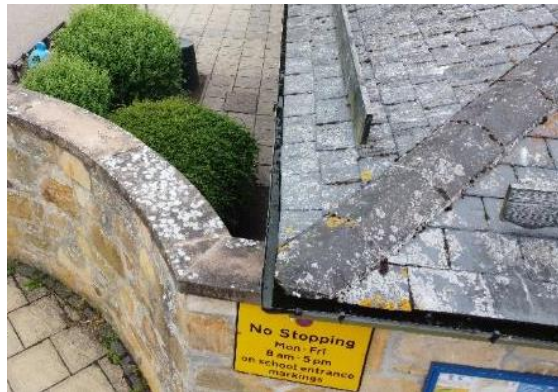
28. UPVC gutters with standing water

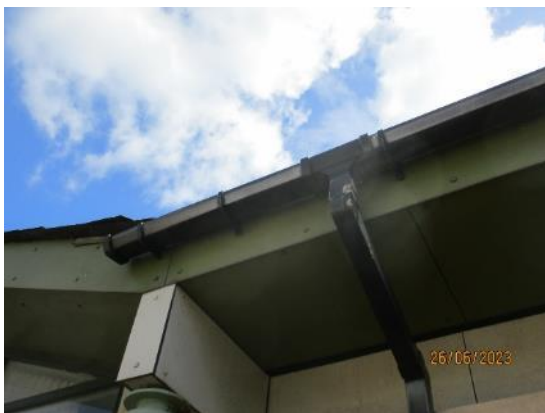
29. UPVC gutters and downpipes

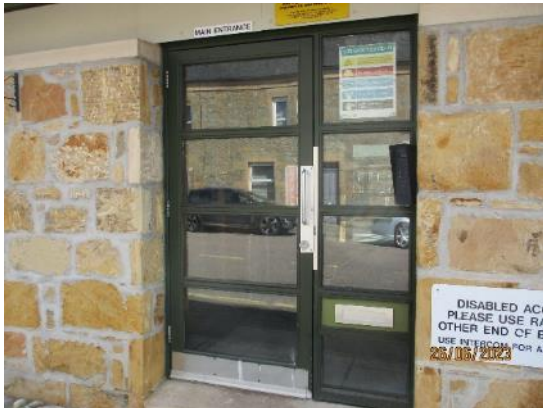
33. Timber glazed entrance door

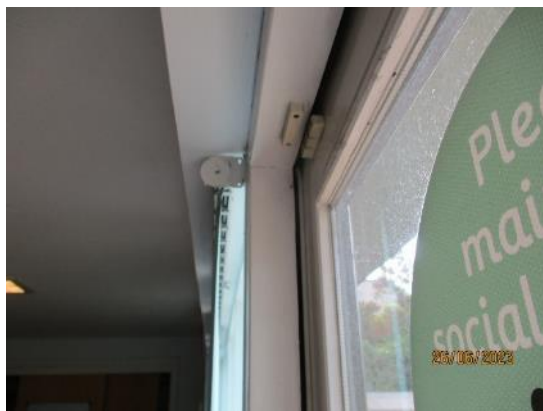
35. Doors twisting, poor fit in frame

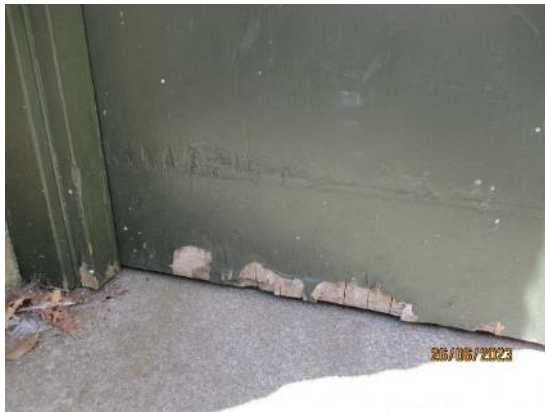
37. Damage to face of doors

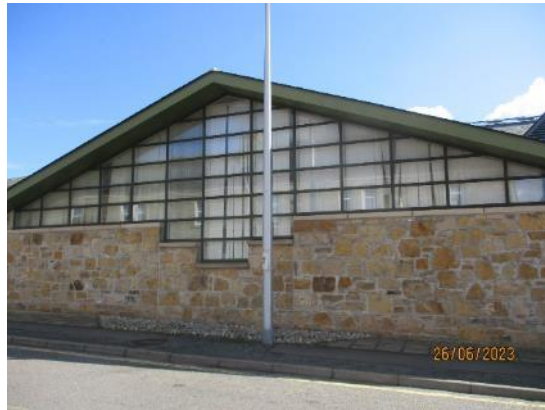
40. Large timber glazed screen

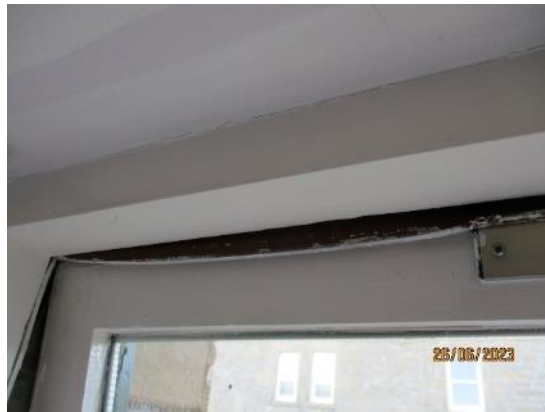
44. Seals to frames failing

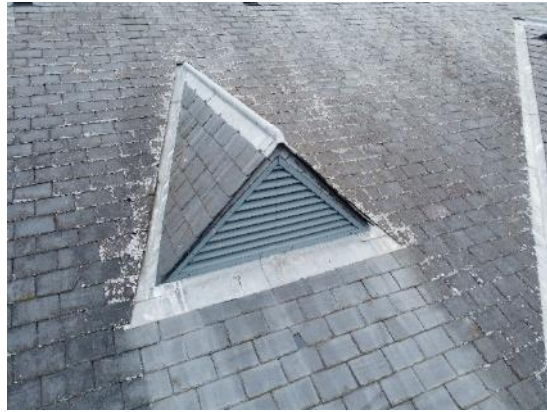
49. Timber roof ventilation grills

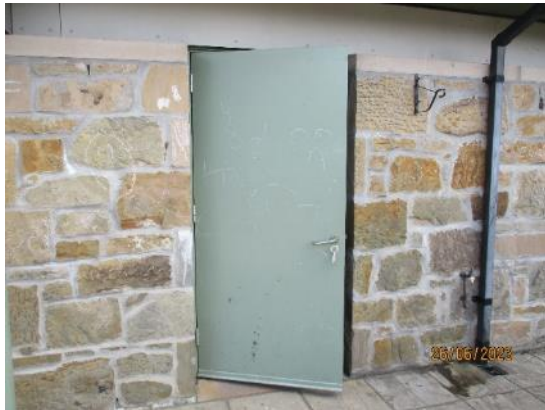
50. Timber external doors

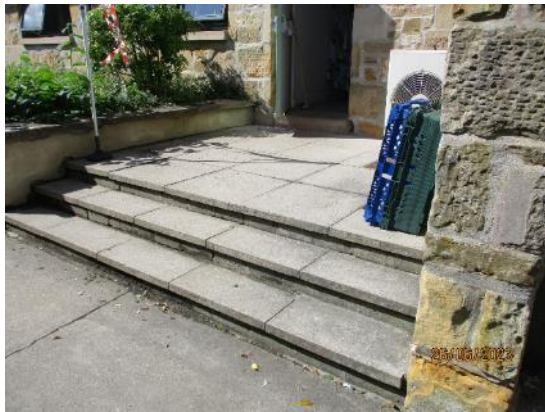
54. Paving slab steps

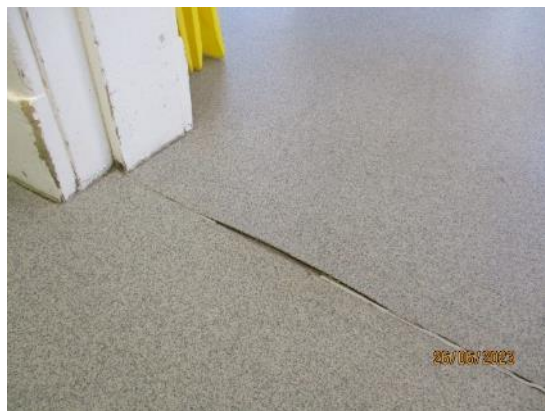
59. Edges lifting, seam joints failed

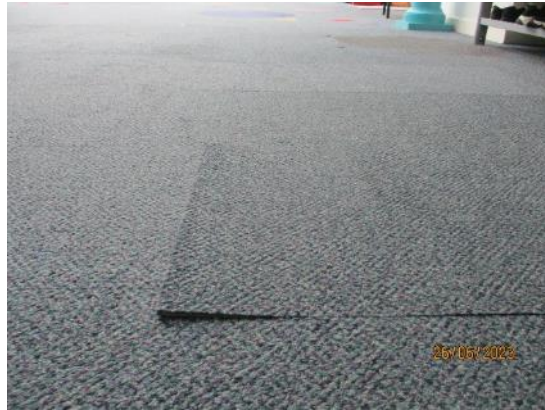
61. Carpet tiles lifting

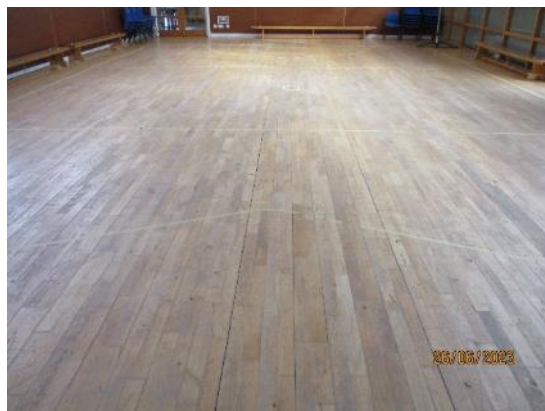
65. Timber sports floor

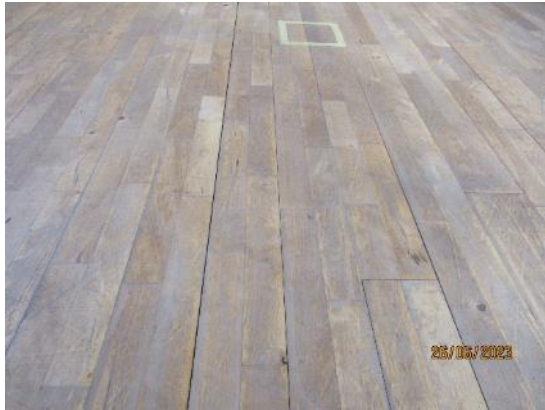
66. Timber boards worn

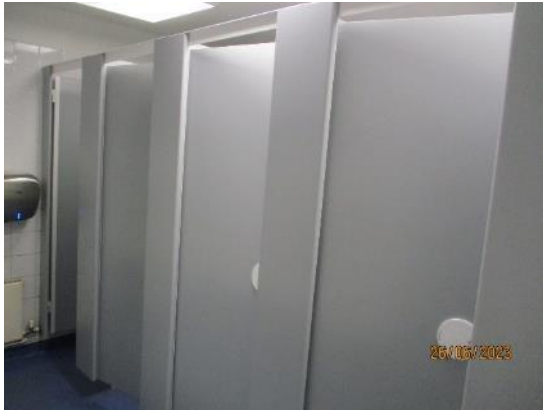
111. Lock mechanism

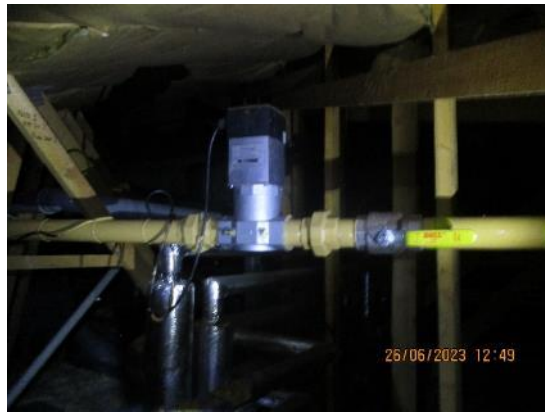
147. Gas pipework plant room typical.

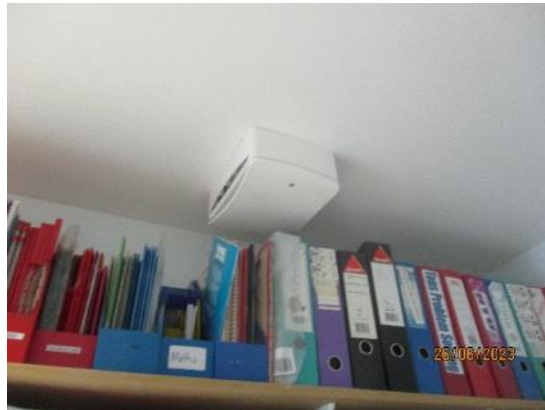
149. Extract fan – kitchen store.

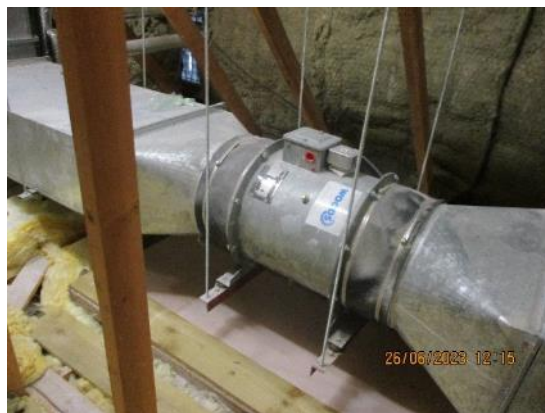
151. Extract hood – kitchen.

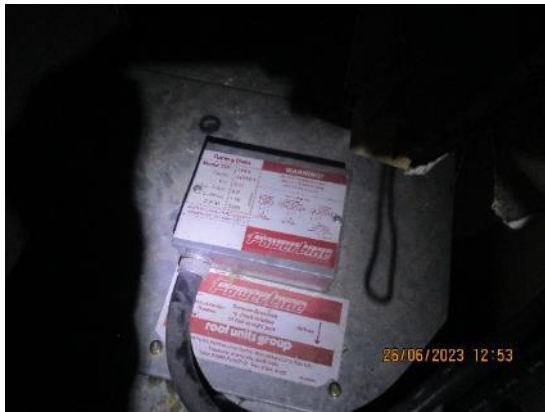
152. Toilet extract fan system attic space.

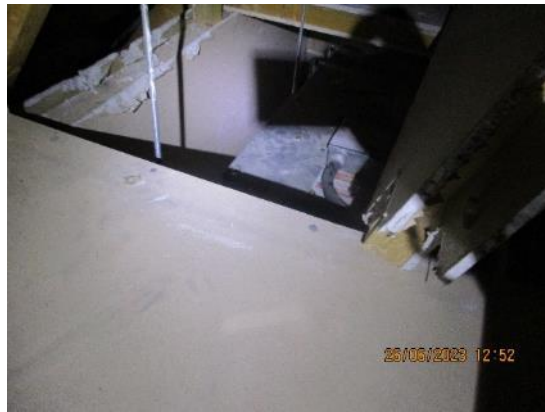
153. Air handling unit attic space.

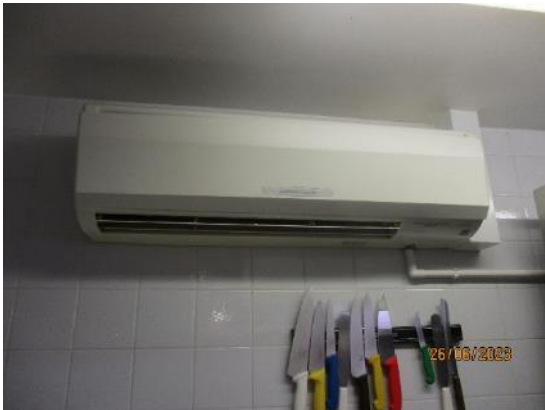
154. Kitchen air handling unit attic space.

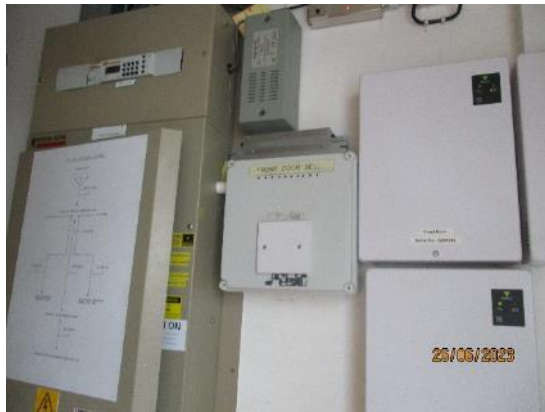
158. Electric windows 1-11 open area.

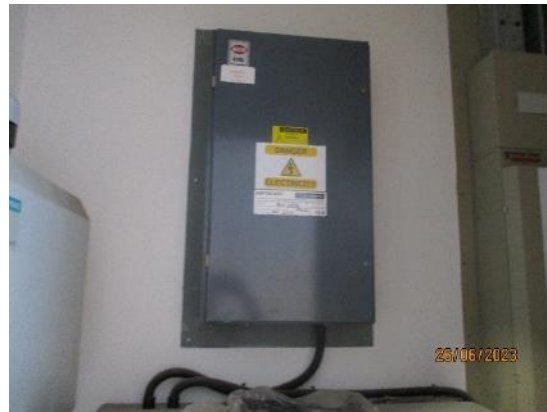
159. DB LP 1 – Electric cupboard 1/11a

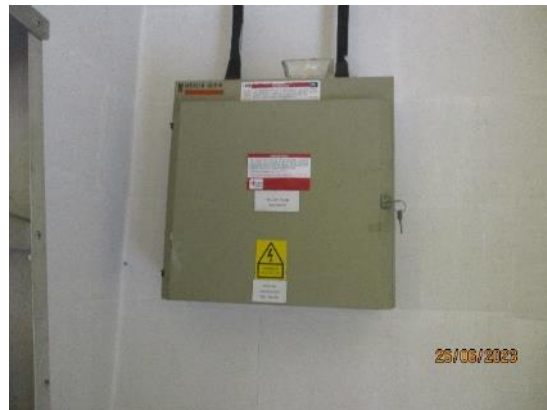
161. DB – LP kitchen

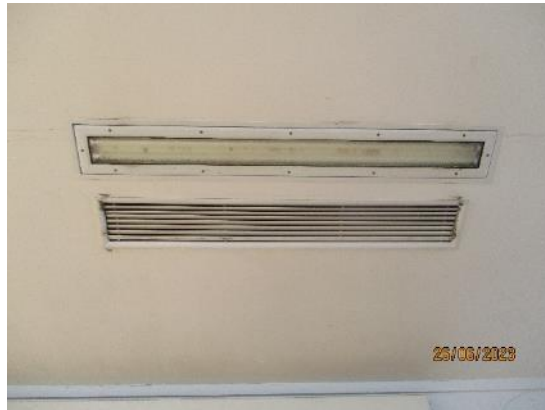
167. Lighting – classrooms and circulation typical.

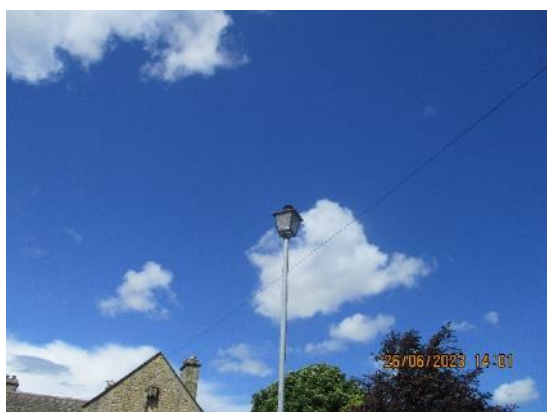
172. Lighting – circulation areas typical.

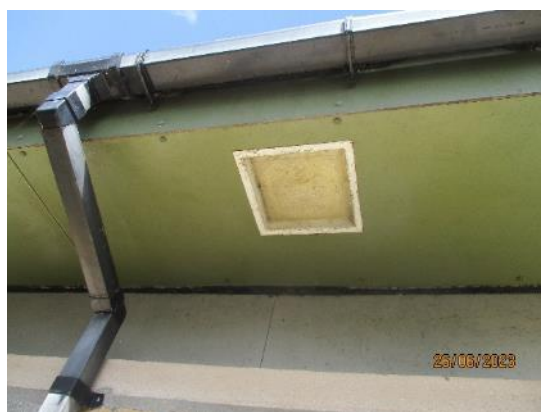
173. External car park lighting.

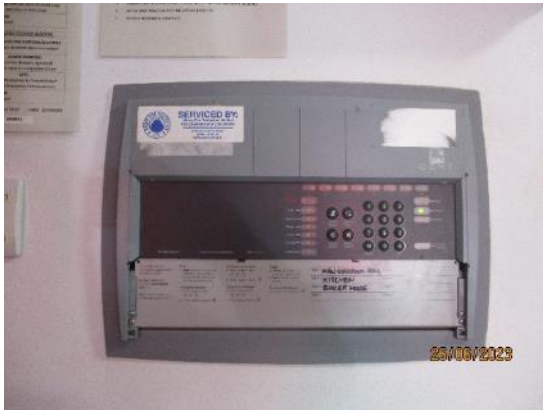
179. Fire alarm system control panel.

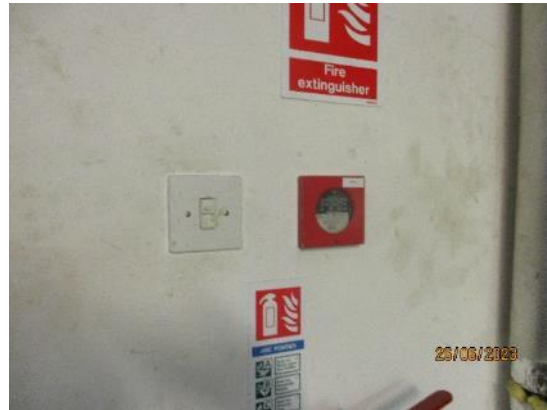
180. Fire alarm system call point typical.

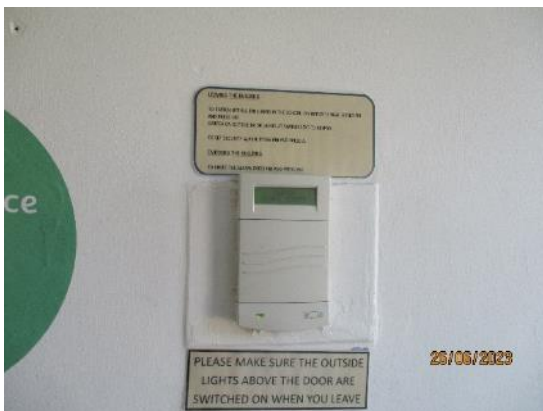
181. Intruder alarm system user control unit.

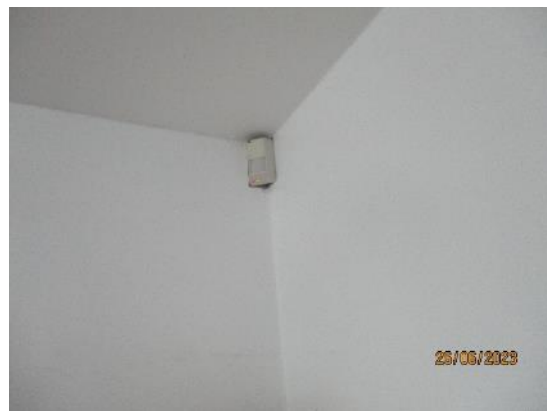
182. Intruder alarm system PIR.

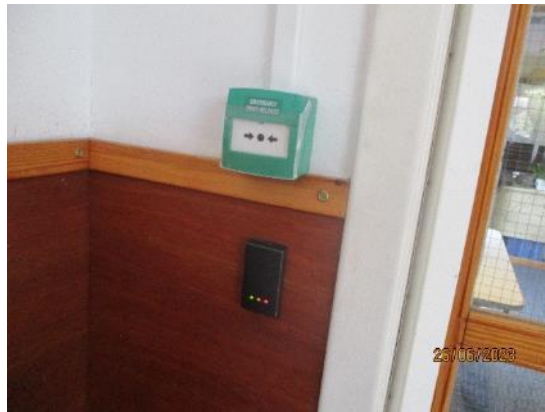
184. Security door card reader and emergency release unit typical.

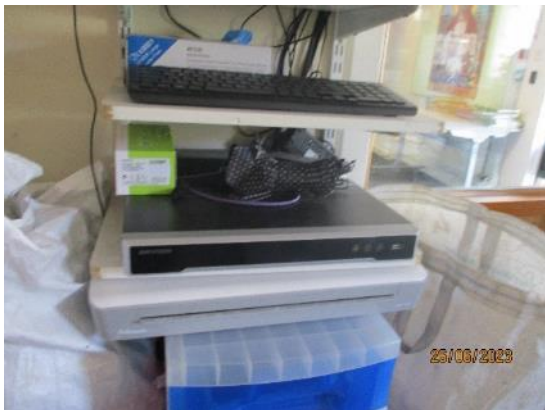
185. CCTV recorder and processor 1/24 office.

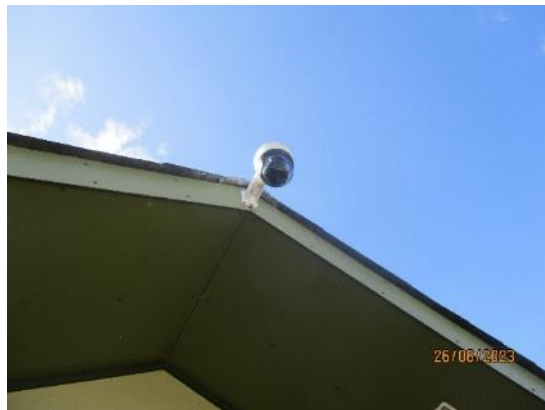
186. CCTV camera south end entrance.

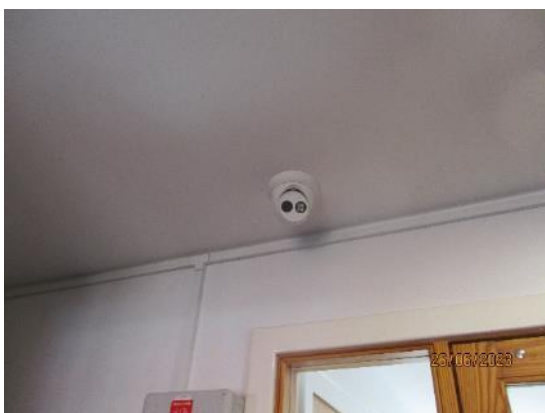
187. CCTV camera internal.

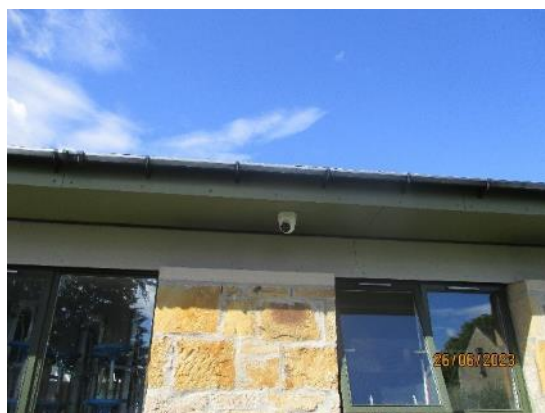
188. CCTV camera East end entrance.

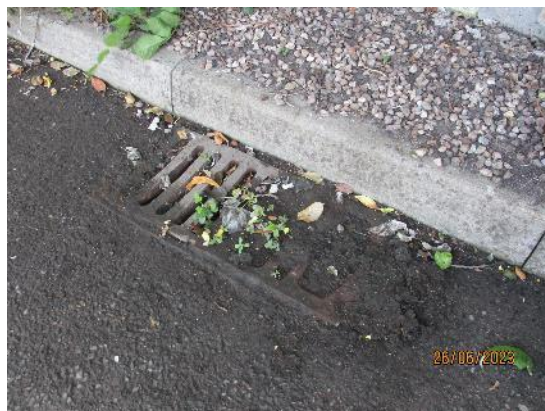
- Access road is potholed and breaking up.
- Stone walls missing stones and surface/render erosion.
- Timber fences and gates are damaged and have minor rot.
- Car park drainage is blocked.
- Playground drainage damaged and blocked.

224. Car park road gully blocked
