# **Summary Building Condition Survey Report**

**West End Primary School  
Mayne Road, Elgin IV30 1PA**

**12<sup>th</sup> & 13<sup>th</sup> July 2023**

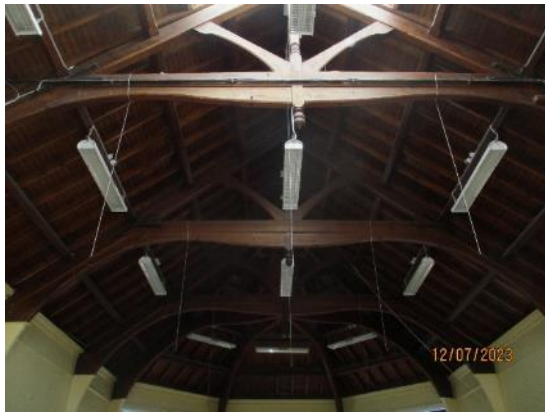
1. Exposed trusses in Hall

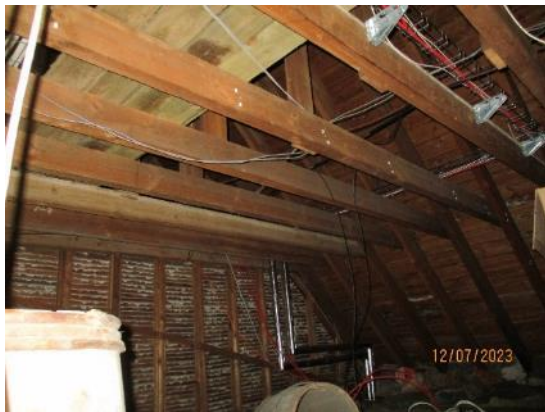
3. Timber trusses in school roofspace

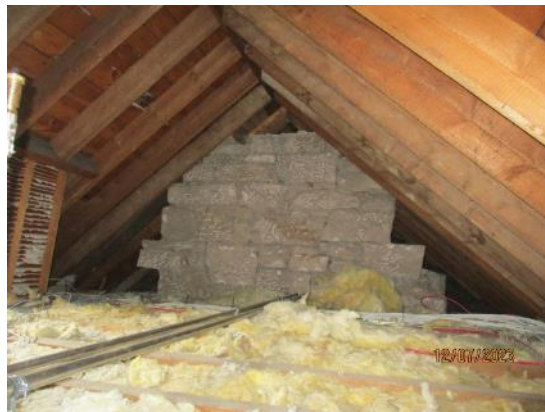
4 Stone chimney breast.

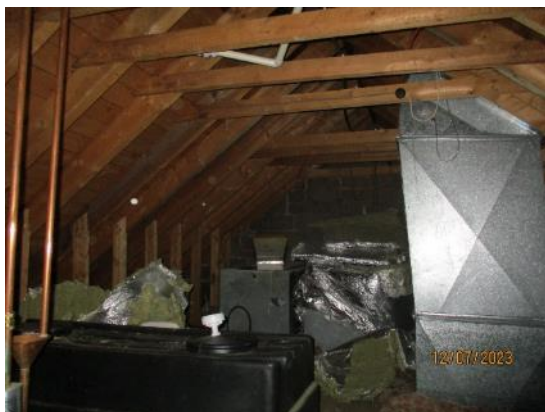
5. Timber roof trusses over Dining Hall

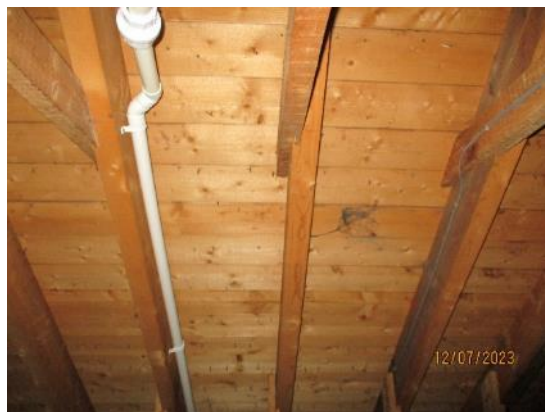
6. Timber sarking boards

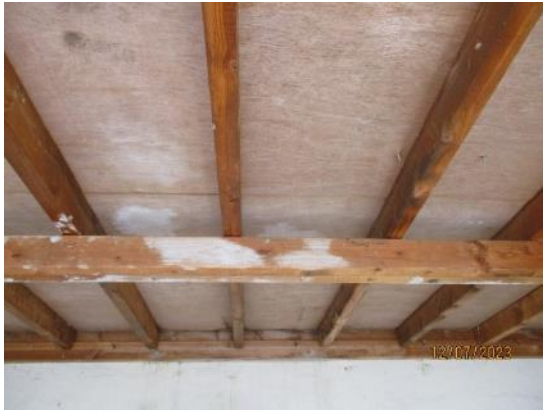
7. Timber rafters to External Stores

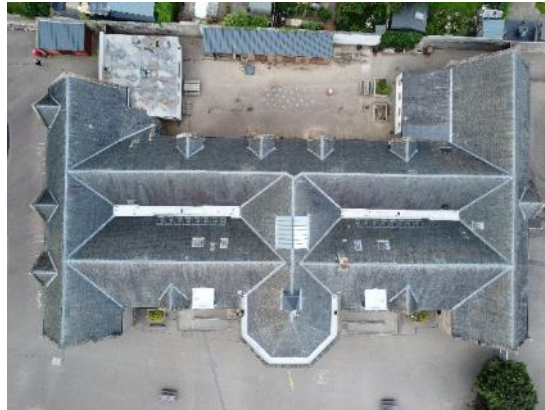
8. Main school overview of slated roof

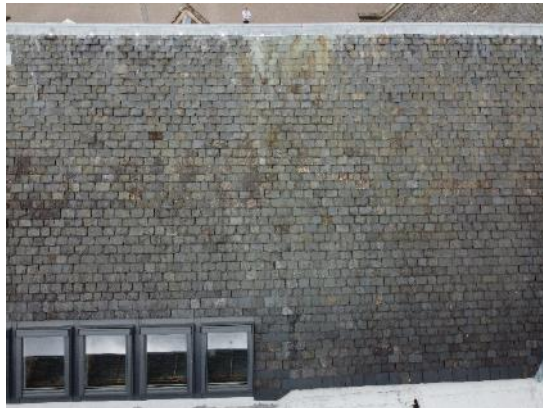
9. Slates are dated but in fair condition

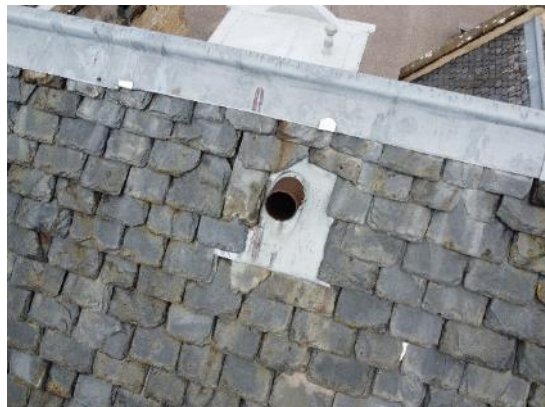
- Isolated slates are slipped and broken.
- Soil vent pipe not sealed adjacent to the ridge.
- Skylights are corroded have missing putty and broken glass.

10. Isolated missing/damaged slates

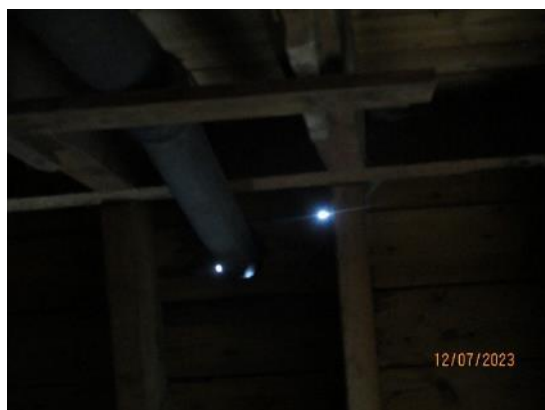
12. Daylight visible around vent pipe (see 10)

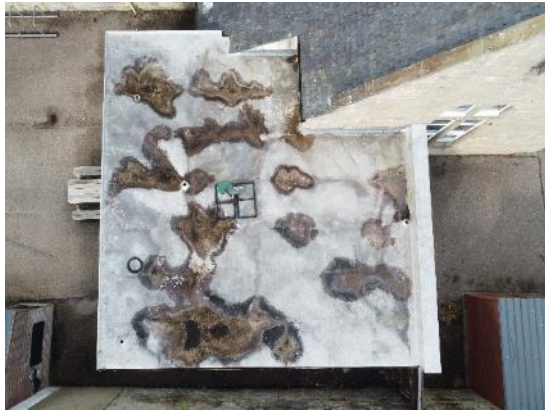
13. GRP roof over Girls toilet

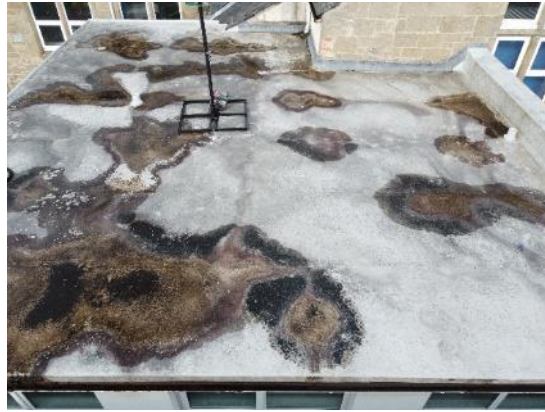
14. GRP blistered and uneven

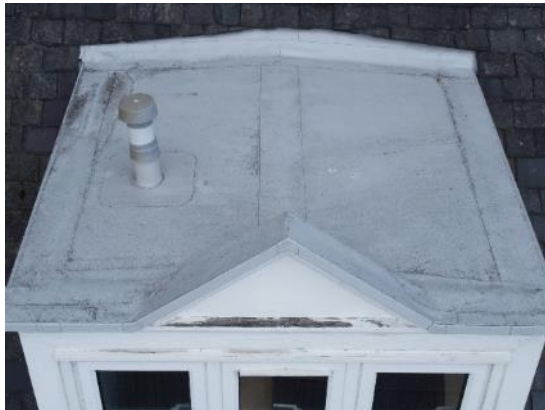
15. Single ply membrane to dormer roofs

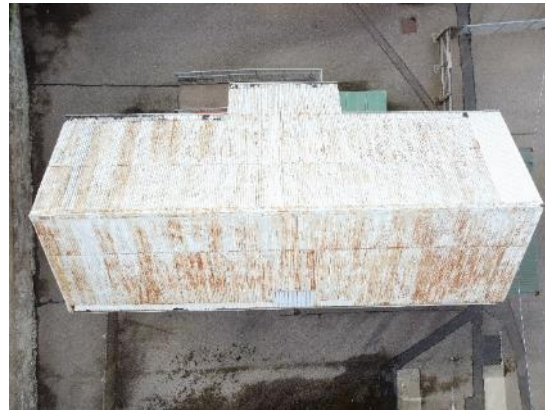
16. Hut corrugated iron roof - overview

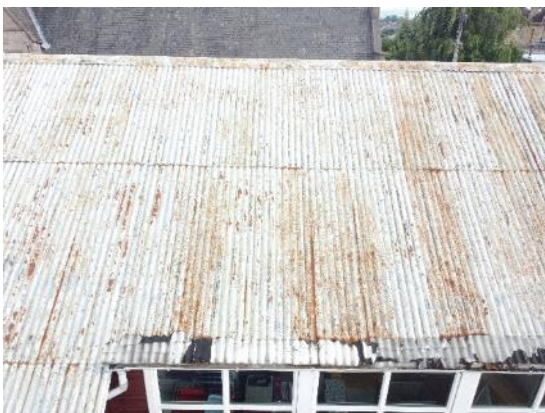
- Generally in poor condition outside and inside – Life expired.
- Corrugated iron roof is in very poor condition with corrosion, damage to the sheets and evidence of previous repairs.
- UPVC gutters are broken, leaking and inadequately supported.
- Cast iron downpipes are cracked, blocked and leaking.
- Timber cladding to external walls have rot, damage and missing sections.
- Ground level is too high at south corner and breaches the DPC.
- The timber frame to the external door has rot at the base.

17. Corroded and damaged corrugated iron

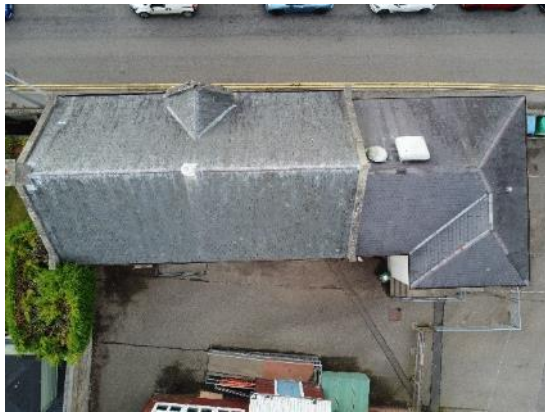
19. Dining block – overview of slated roof

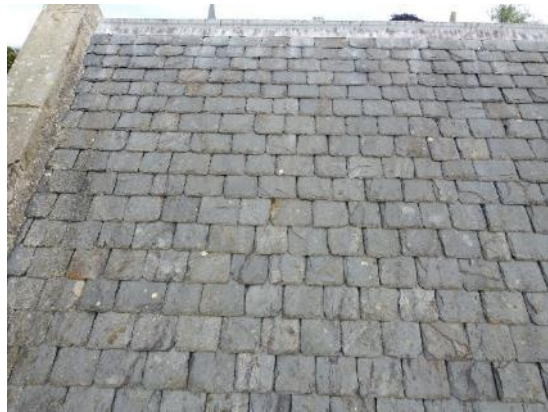
20. Chipped and broken slates

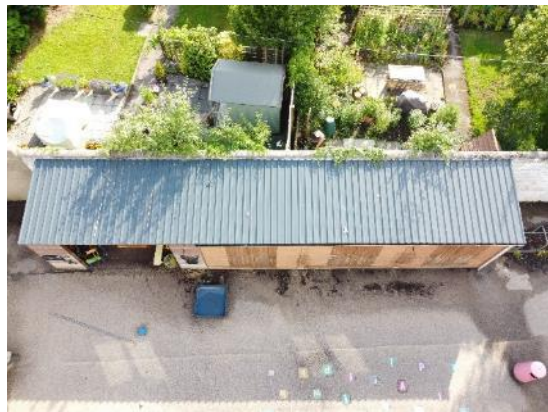
22. External stores – overview of metal profile roof

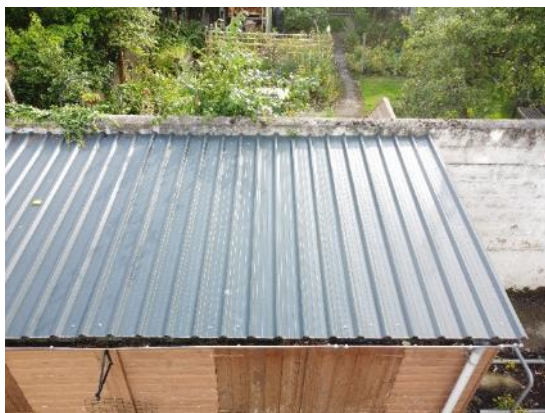
23. Metal profile roof

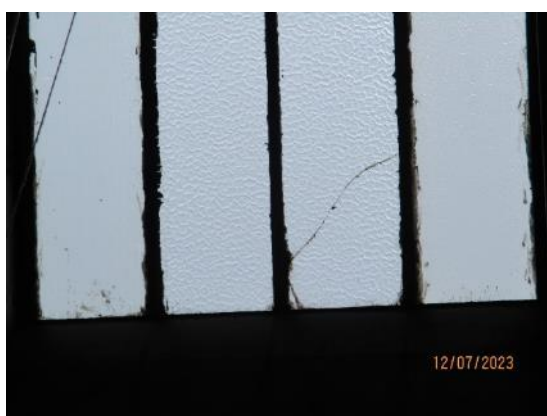
29. Metal skylights with broken glass

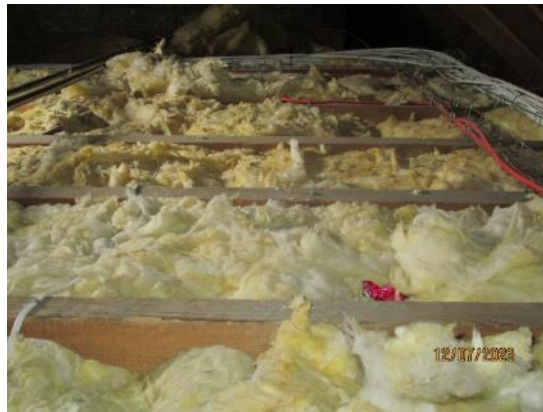
32. Insulation to school roofspace

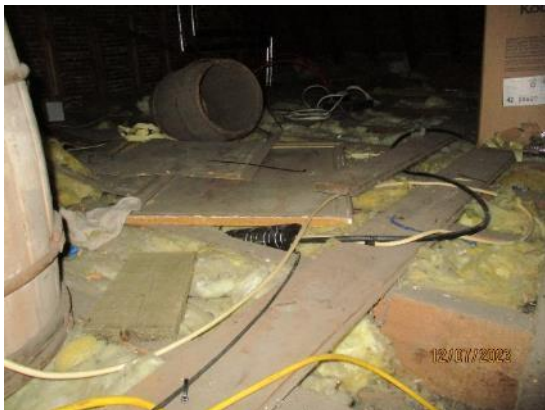
- Concrete steps to the basement are chipped and irregular.
- Window vents missing and ironmongery failing.
- Roof space insulation has isolated areas missing and disturbed.

33. Displaced mineral fibre insulation

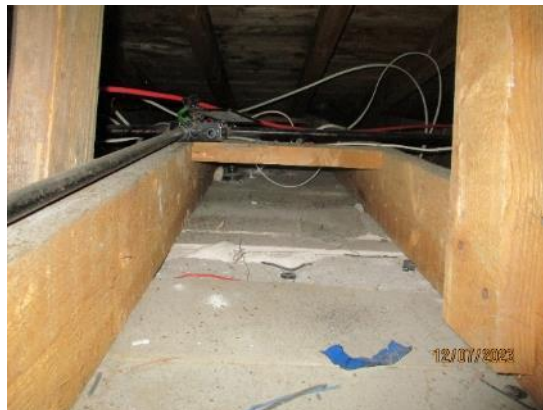
34. No insulation above Boys toilet

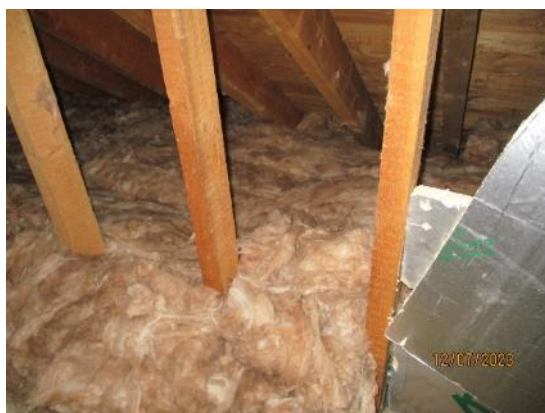
35. Insulation above Dining Hall

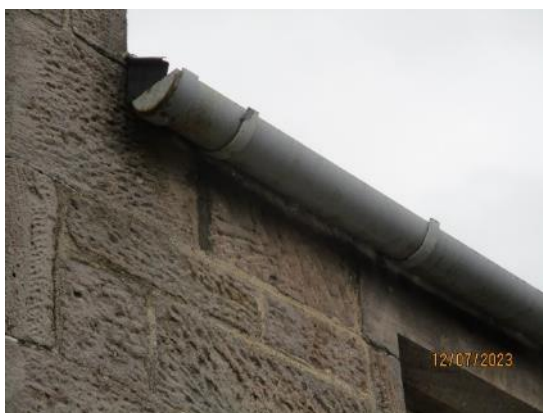
36. Cast iron gutters to school building

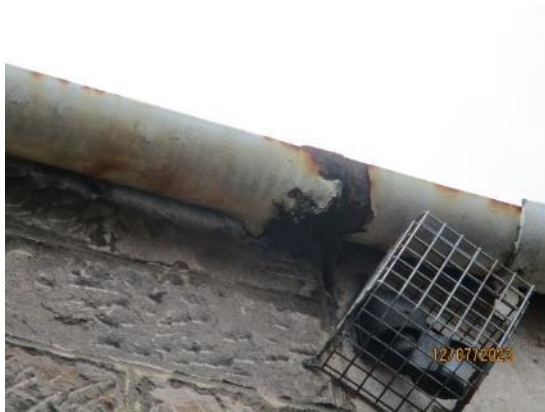
- Cast iron gutters and downpipes are cracked and leaking.
- Stone walls require isolated repairs and repointing.
- Masonry walls are cracked to the toilet extensions.

37. Leaking cast iron gutters

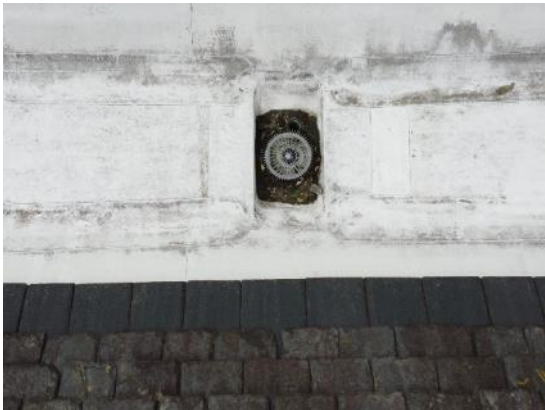
39. Valley gutter outlets

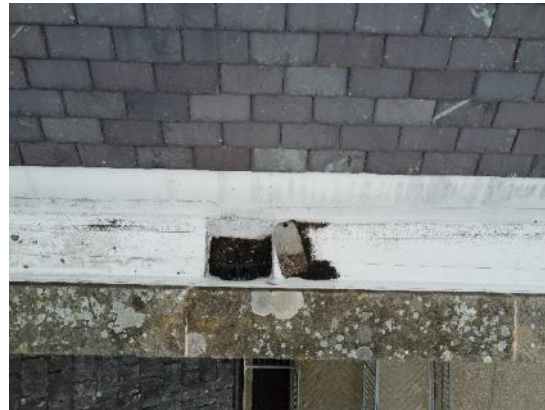
40. Slipped slate and blocked outlet above Games Hall

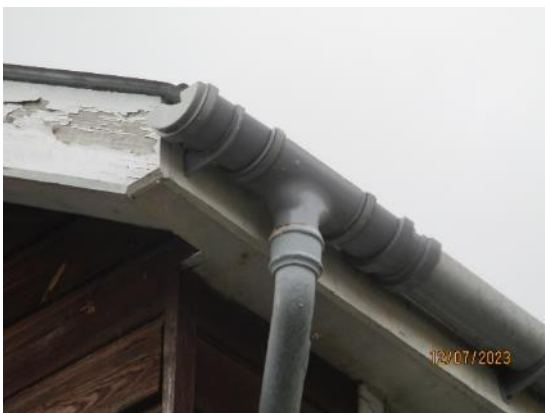
41. UPVC gutters to Hut

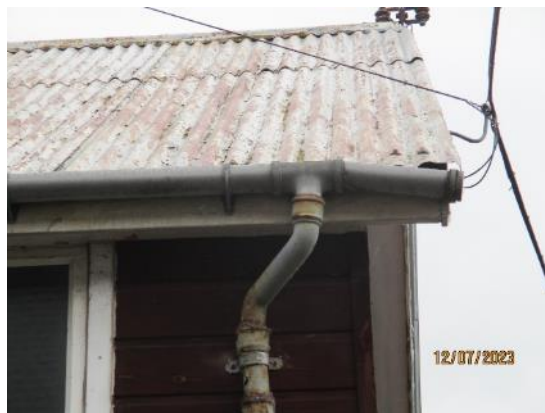
42. Unsupported upvc gutter

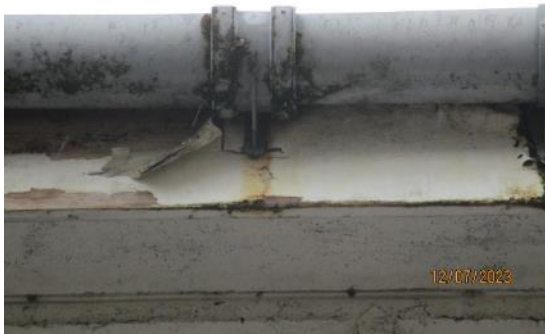
43. Leaking upvc gutters

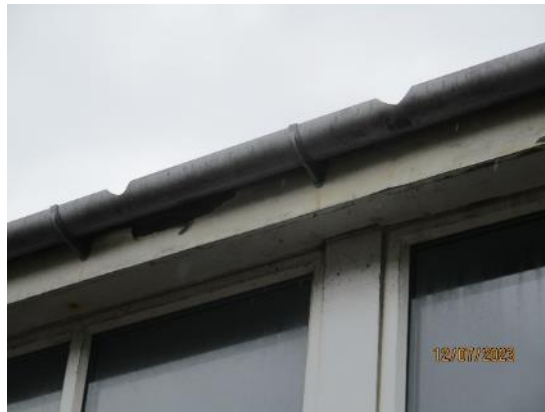
44. Broken upvc gutter

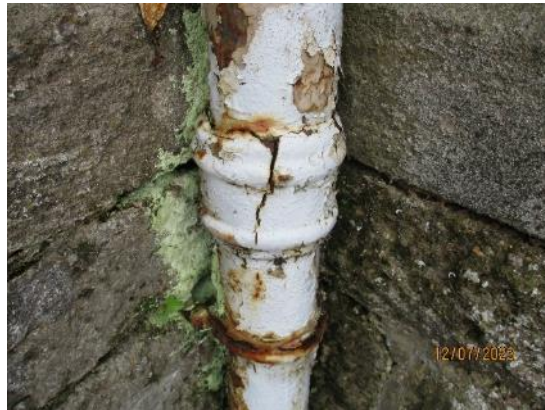
46. Cracked, leaking cast iron downpipes

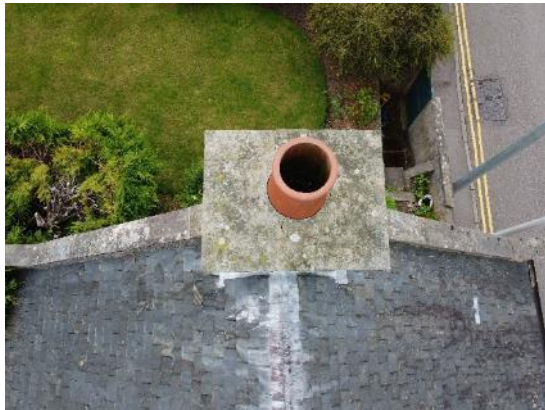
- Clay ridge and hip pieces are cracked and have missing pointing.
- The chimney is not capped which could lead to internal dampness.
- Cast iron gutters and downpipes are cracked and leaking.
- Natural stone walls have surface erosion and some loose pointing.
- The smooth render base course is cracked and spalling.
- Ground level is too high at south corner and breaches the DPC.
- Lath & plaster ceilings have hairline cracking.

57. Clay pot not capped and vented

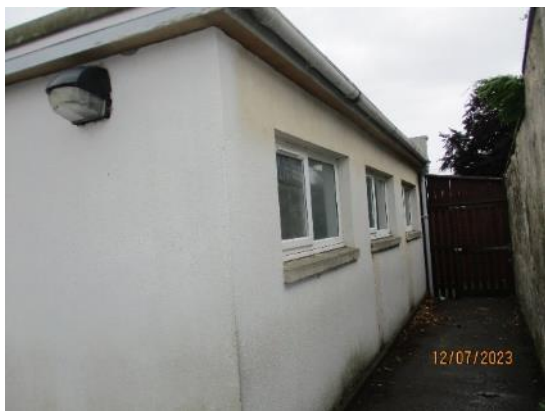
65. Cracked masonry walls

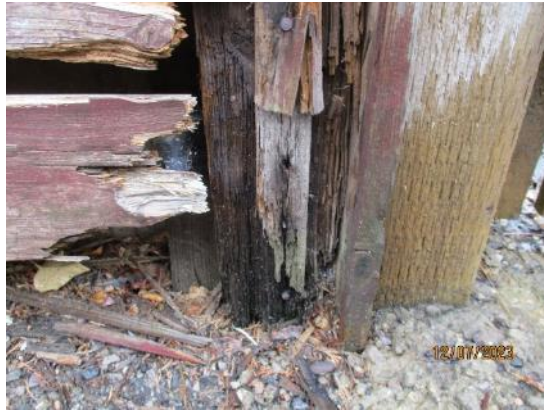
67. Rot in timber frame to Hut

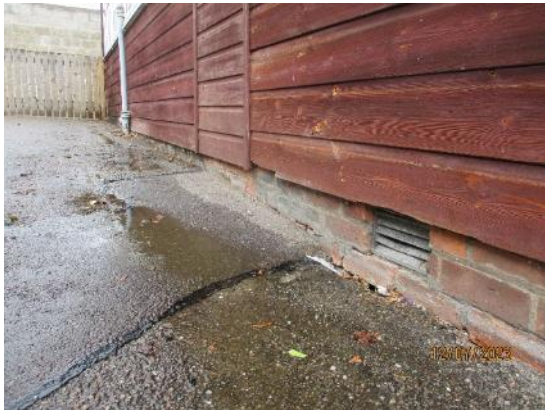
74. Reduced ground level to Hut

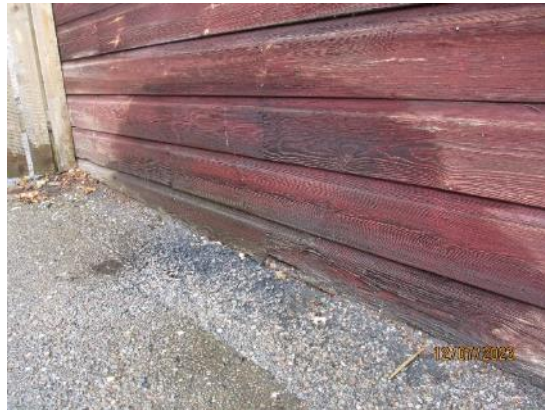
75. Ground level too high

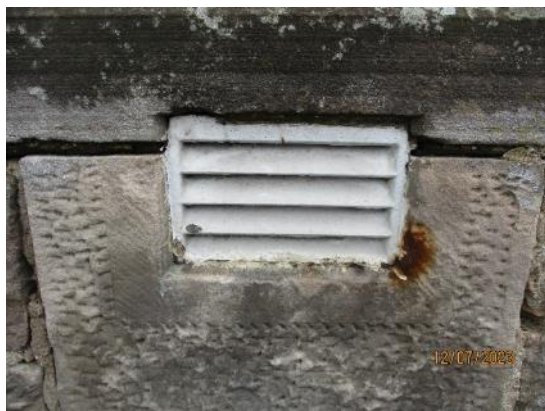
76. Underfloor ventilation to Dining Hall

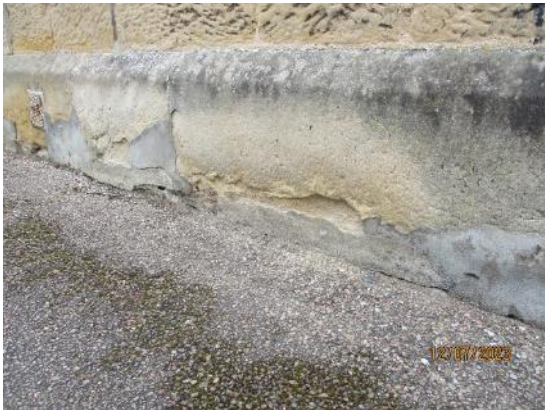
81. Cracked roughcast to school

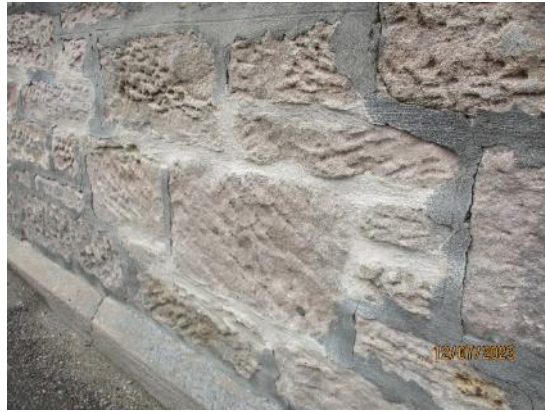
85. Poor pointing and erosion to Dining Hall

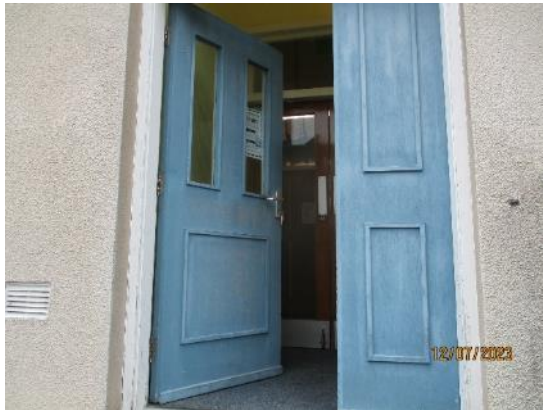
92. Timber Hut entrance door

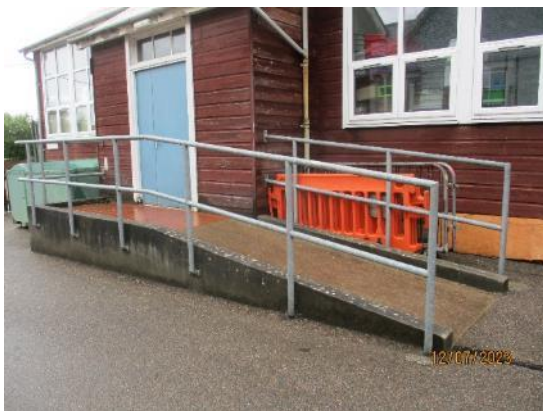
112. Steep concrete ramp to Hut

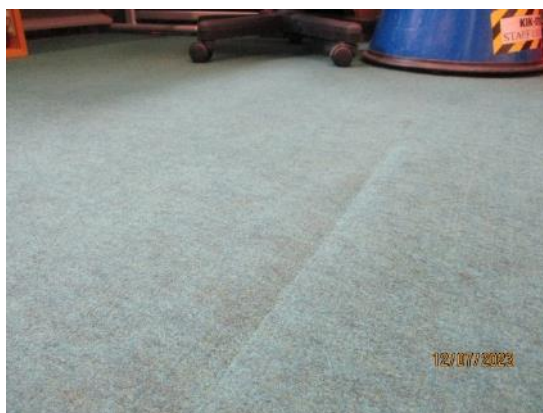
118. Uneven timber floor boards

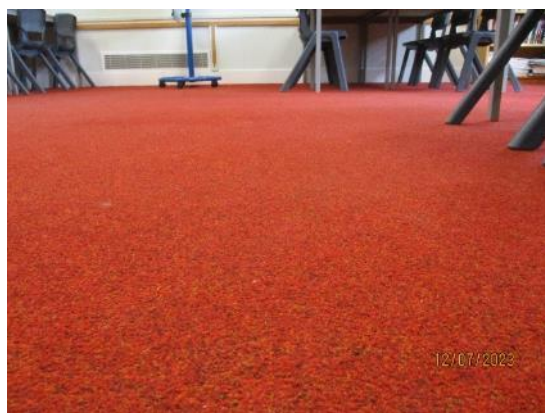
119. Uneven timber floors

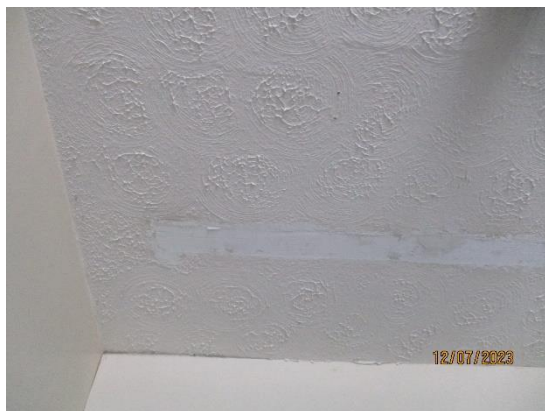
141. School – textured finish on lath & plaster

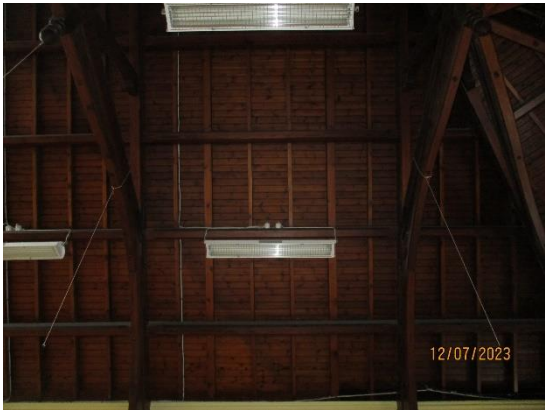
145. Timber linings to Games Hall

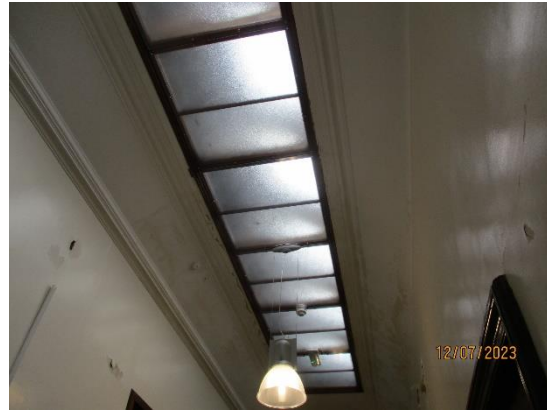
150. Borrowed lights below velux windows

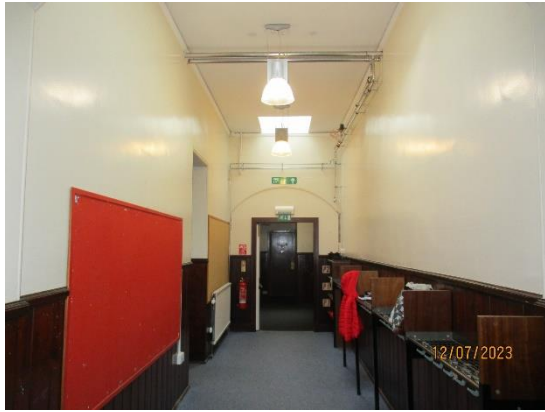
154. Lath & plaster walls

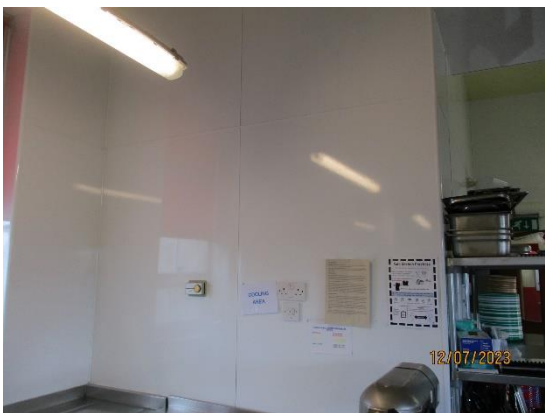
164. Wetwall in Kitchen

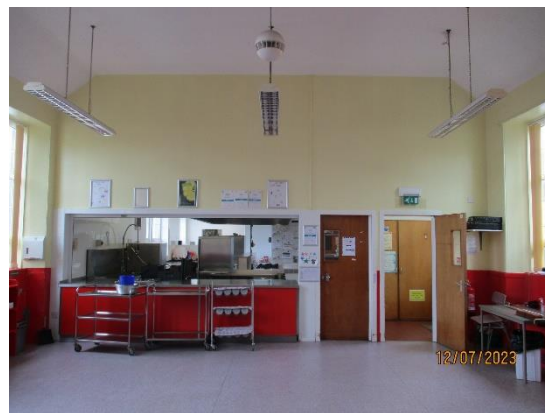
165. Lath & plaster in Dining Hall

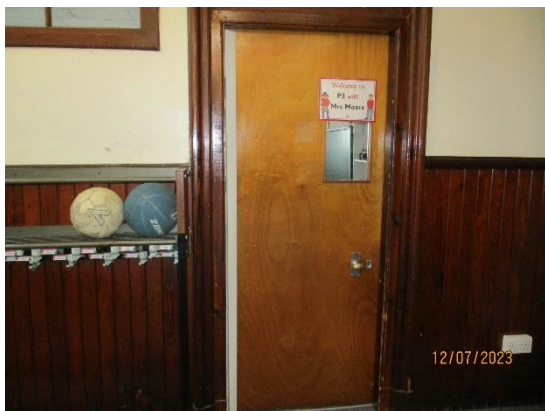
170. School – Timber hollow core doors

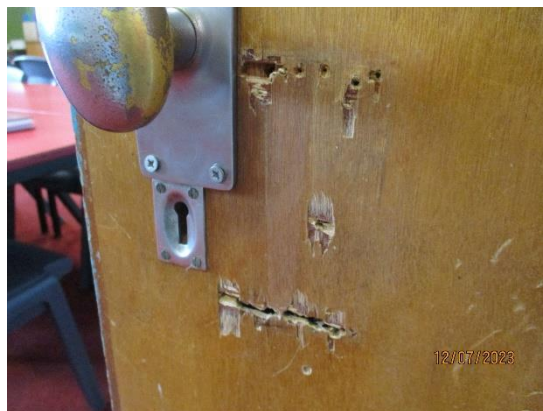
171. Damaged timber hollow core doors

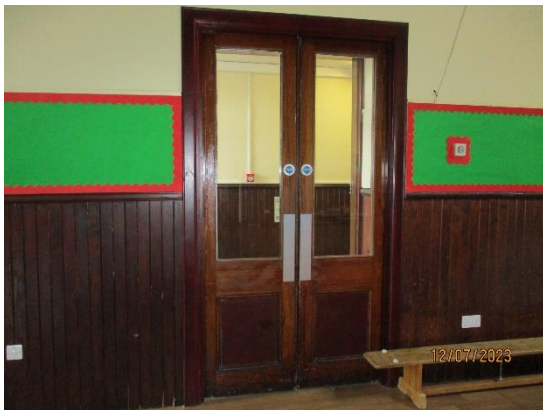
174. Timber panelled double doors

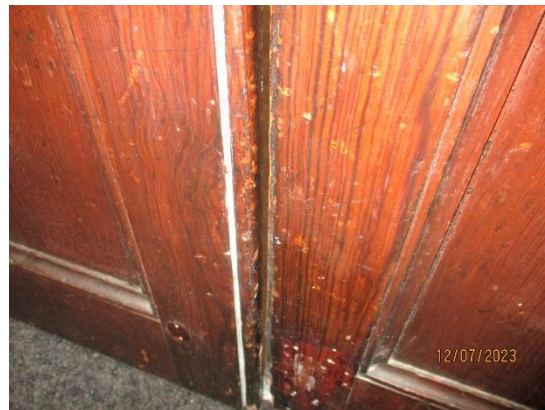
175. Gaps between door leaves

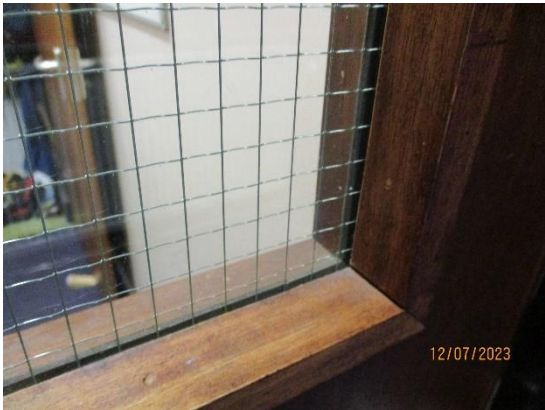
186. Georgian wired glass to fire doors

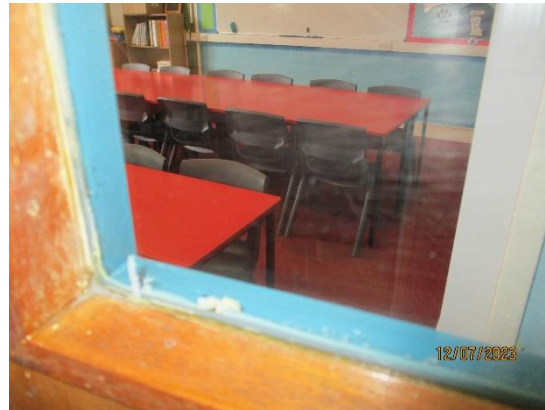
187. Plain glass to classroom doors

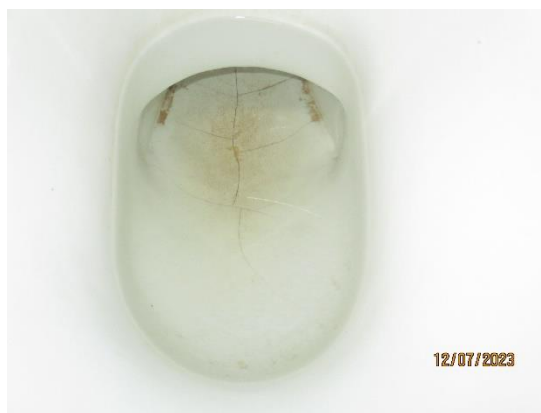
195. Cracked sanitary ware

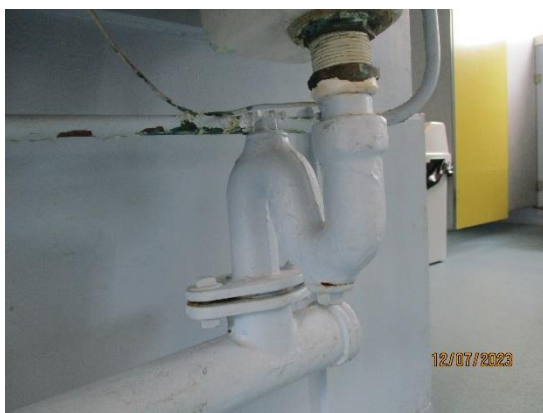
201. Cast iron waste pipes (Girls toilet)

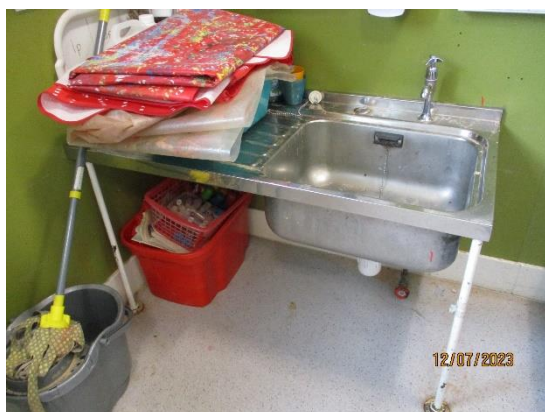
208. Stainless steel classroom sinks

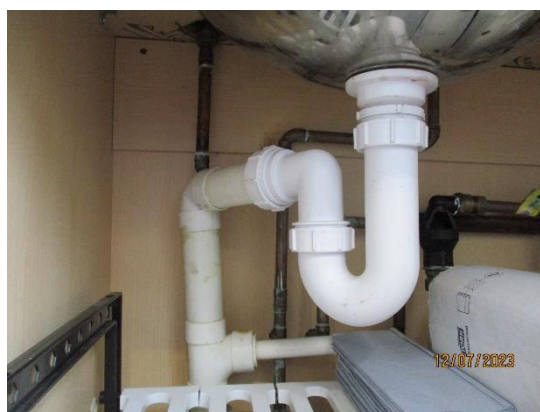
211. PVC waste pipes

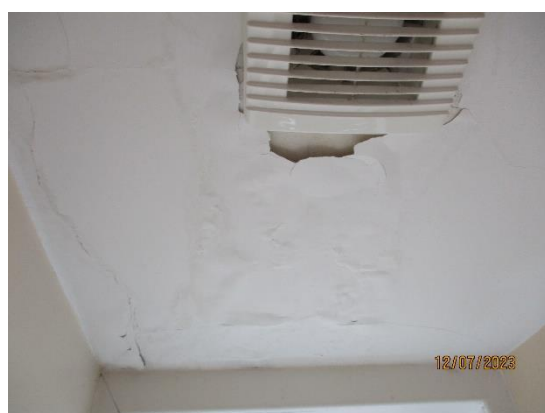
212. Peeling paint to ceilings

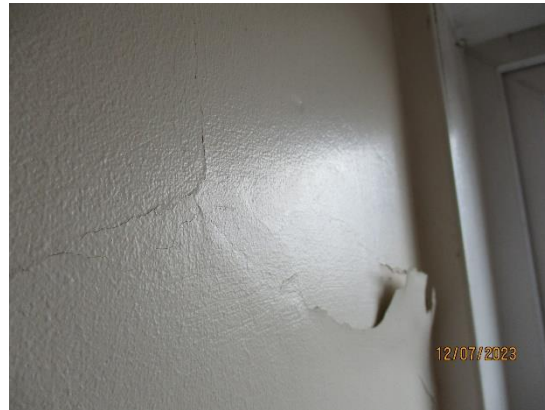
217. Peeling paint to lath & plaster walls

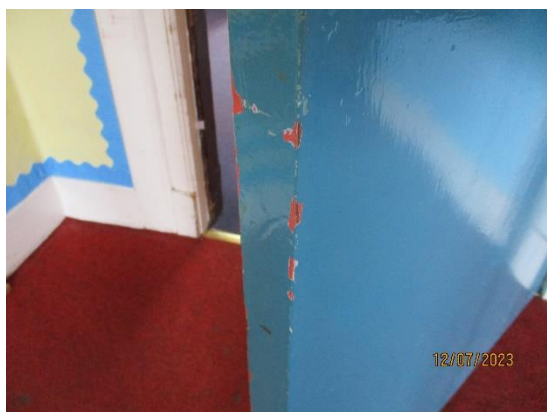
220. Chipped paint to timber doors

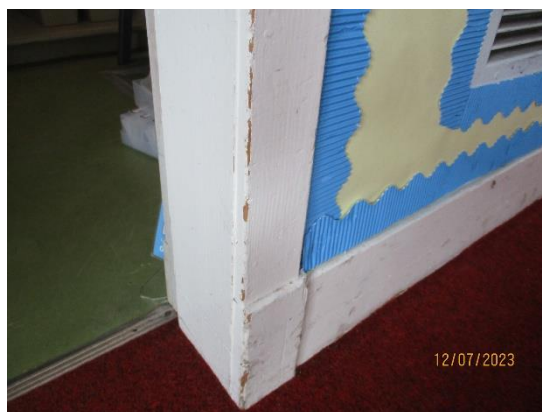
221. Chipped paint to joinery items

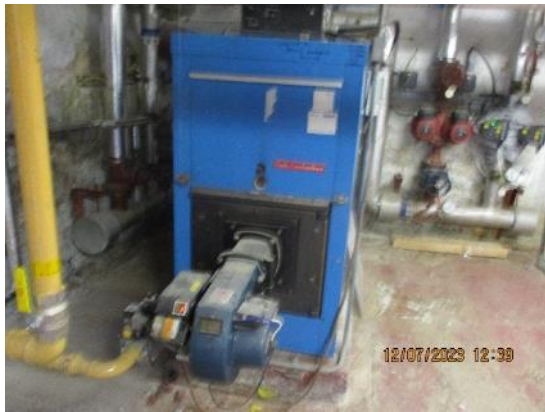
228. Gas boiler – basement plant room. 0/1

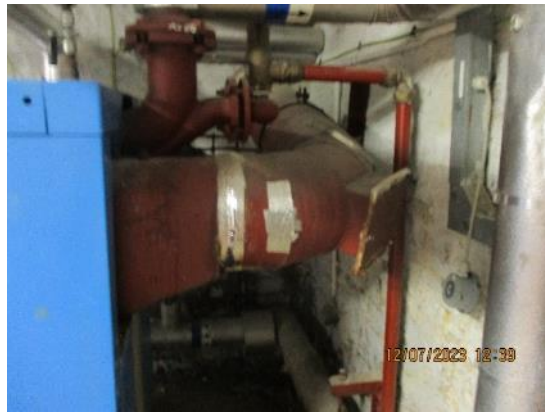
229. Boiler flue into brick chimney 0/1

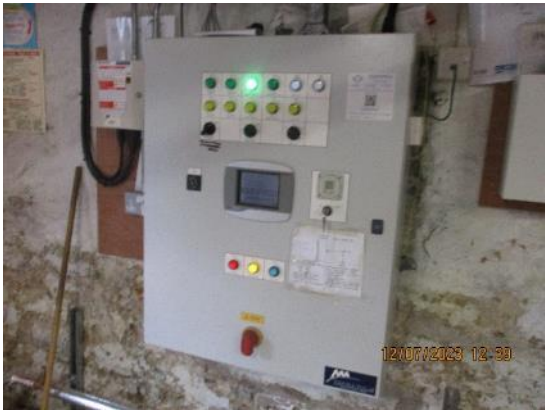
230. Heating control panel 0/1

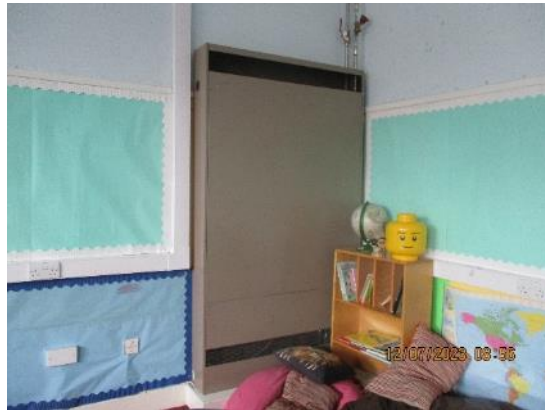
231. Heating system fan convector heater.

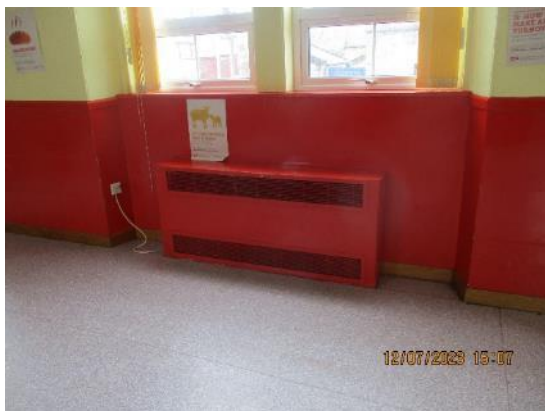
232. Heating system fan convector dining room.

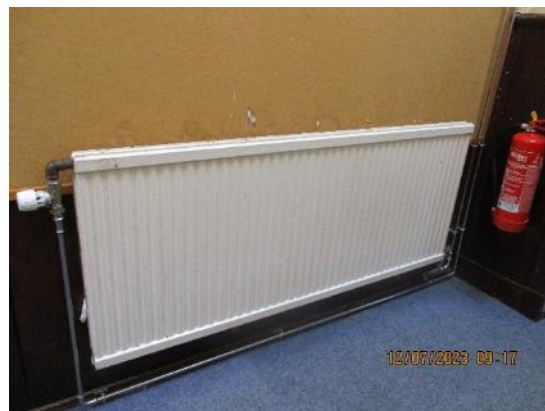
233. Radiator – steel panel typical.

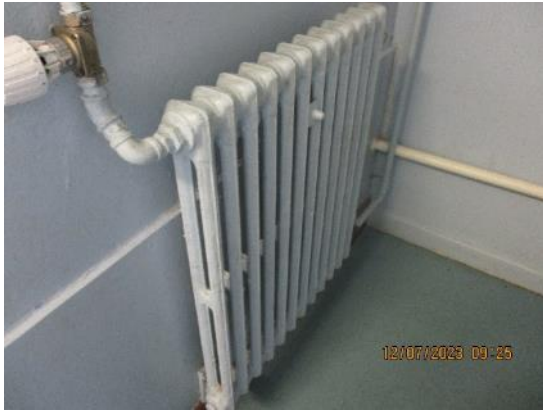
234. Radiator cast iron – boys toilets.

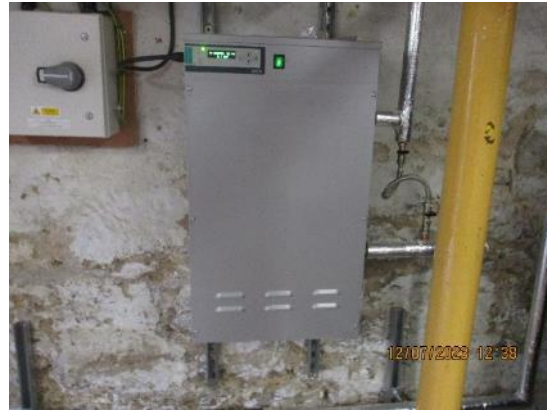
235. Heating system pressurisation unit 0/1

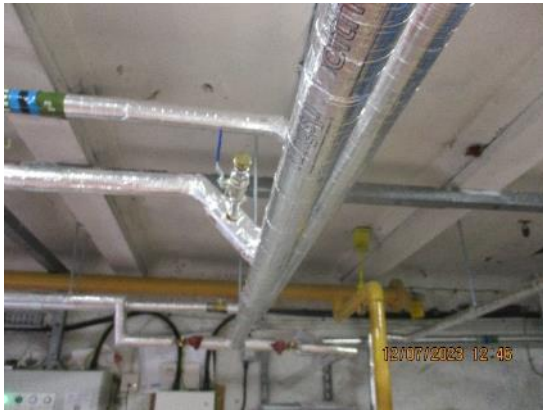
236. Pipework – heating system 0/1

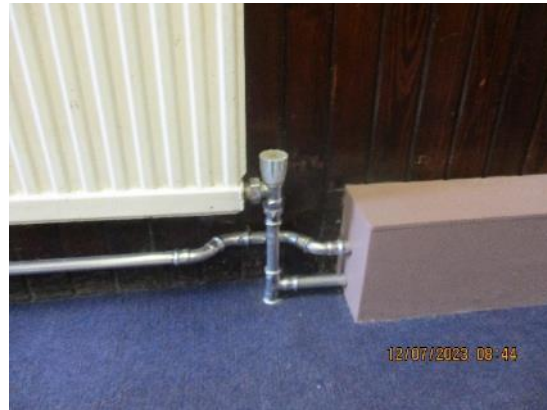
- Hot and cold water distribution pipework is in poor condition throughout both buildings and nearing the end of useful life.
- Cold water tanks in the kitchen block are nearing the end of their useful life.

237. Pipework – heating system.

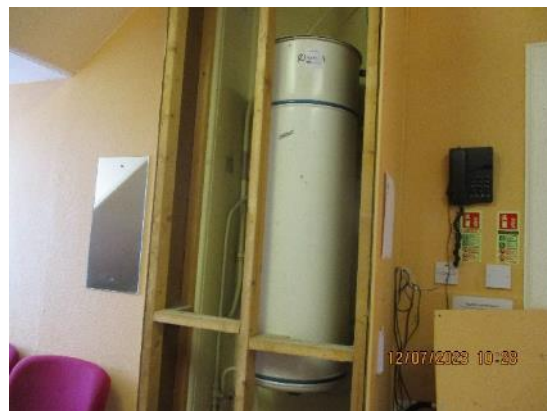
- Electric hot water storage tanks in the main school building are life expired as per CIBSE guidelines and showing evidence of significant corrosion.
- Electric point of use water heaters are life expired in the main school as per CIBSE guidelines.

239. Hot water storage tank staff room.

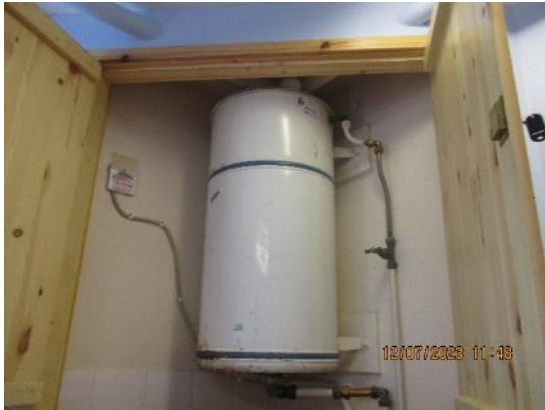
240. Hot water storage tank boys toilets 1/28.

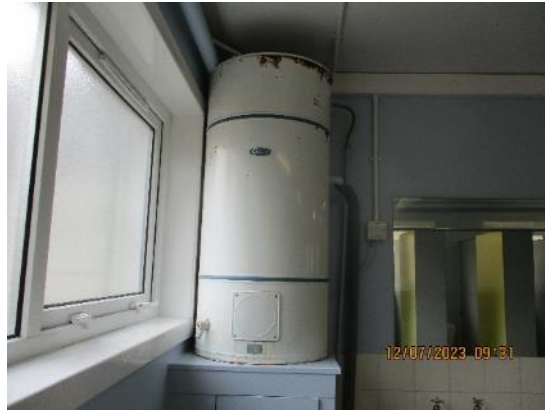
241. Hot water storage tank girls toilets.

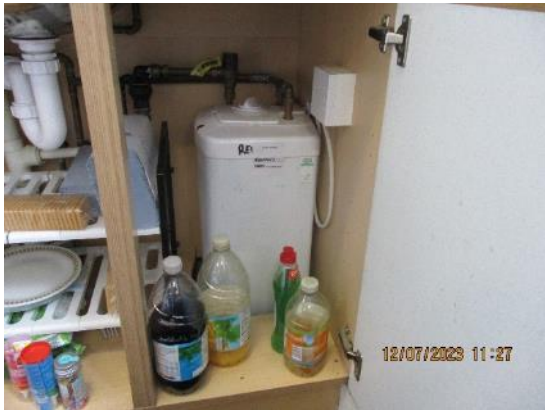
242. Point of use water heater. Main school.

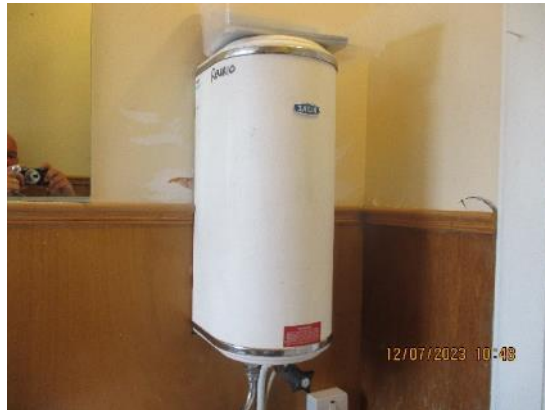
243. Point of use water heater upstairs toilet.

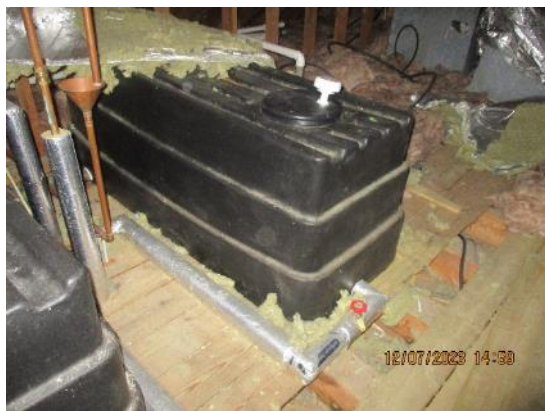
244. Cold water storage 2 tank kitchen attic.

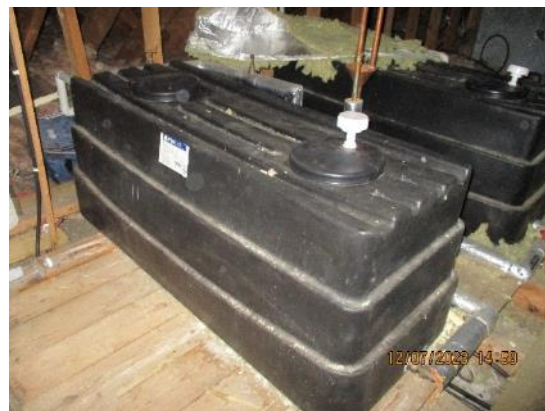
245. Cold water storage tank 1 kitchen attic.

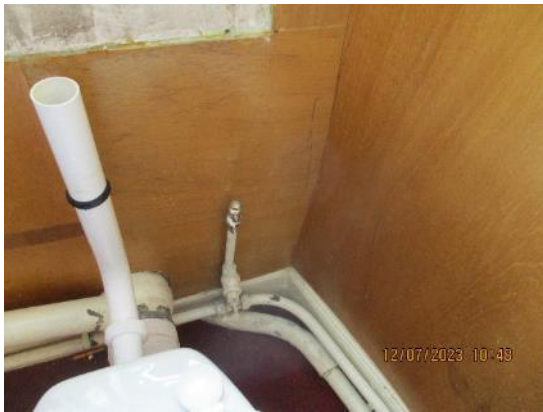
246. Pipework – cold water upstairs toilet.

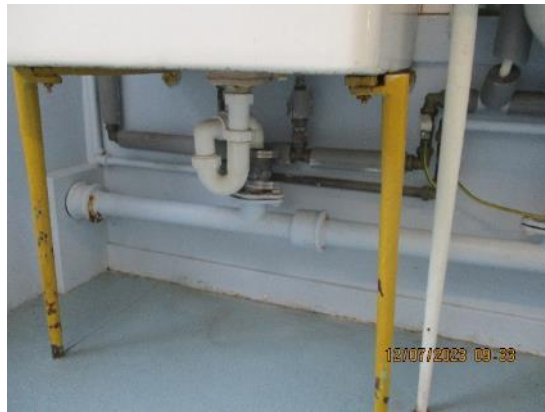
247. Pipework – hot and cold girls toilet.

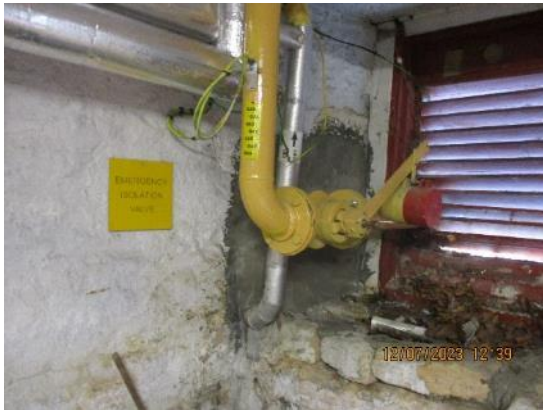
248. Gas pipework and shut off valve main school O/I.

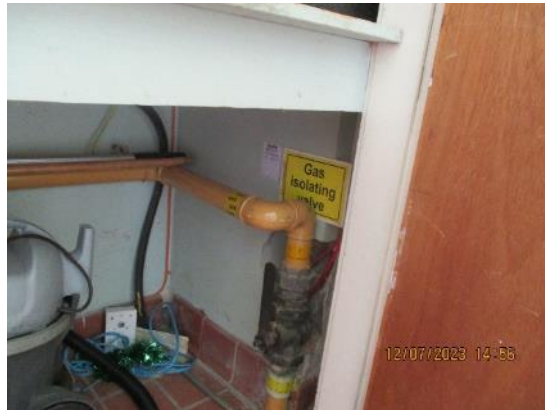
249. Gas pipework – kitchen incoming supply.

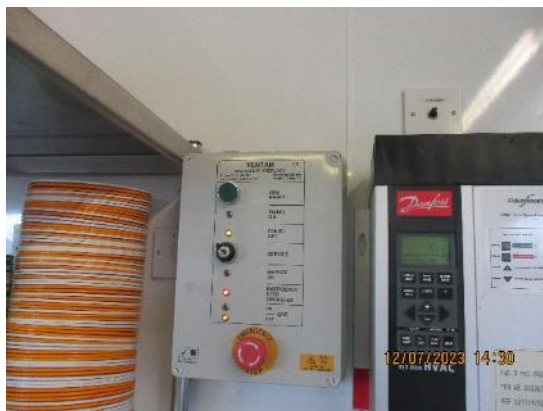
250. Gas safety control panel – kitchen interlock.

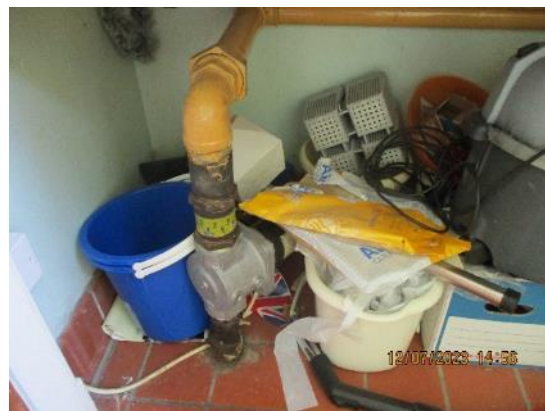
251. Gas solenoid valve. Kitchen supply.

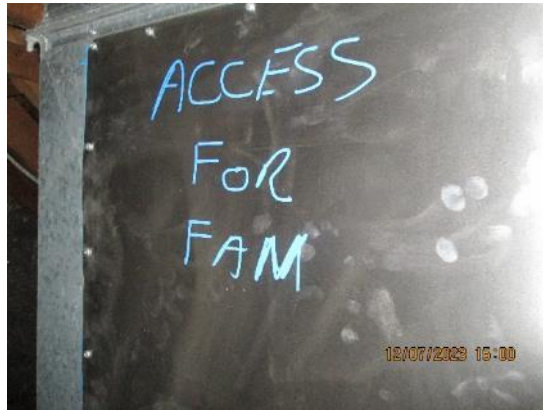
255. Kitchen canopy extract fan in ductwork in kitchen attic.

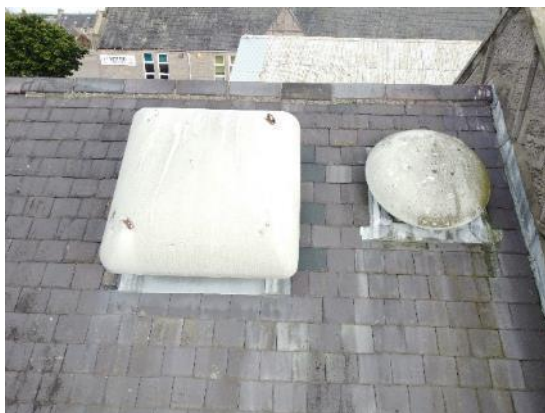
256. Kitchen canopy fan terminal on roof.

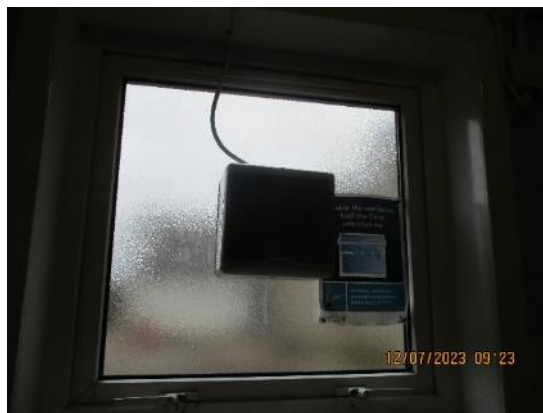
257. Extract fan boys toilet.

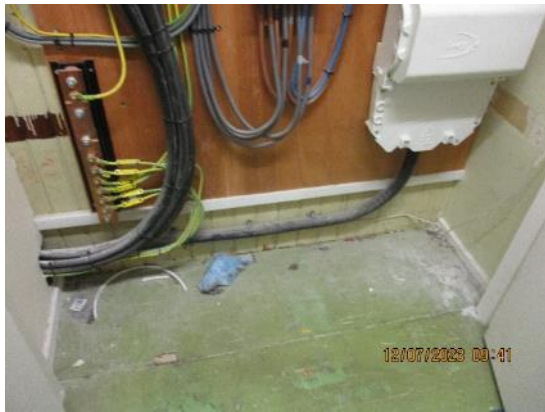
258. Electrical incoming supply and hydro fuses.

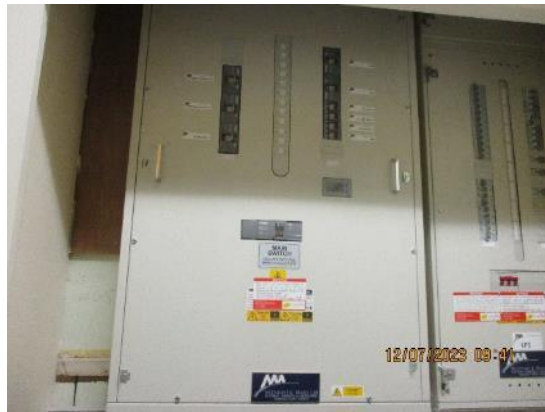
259. Electrical main DB – 1/10.

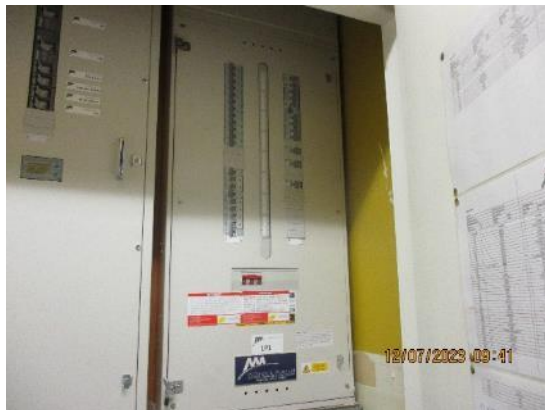
260. Electrical DB LP1 – 1/10

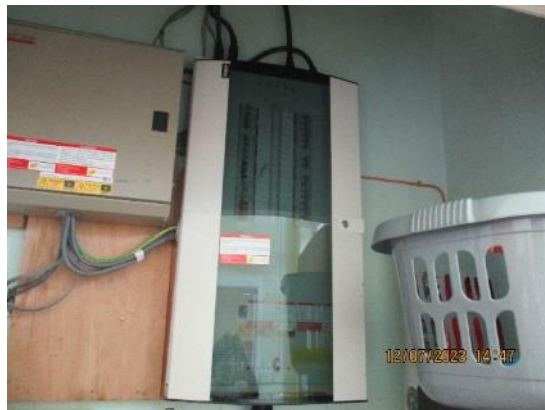
261. Electrical DBs – kitchen block cupboard.

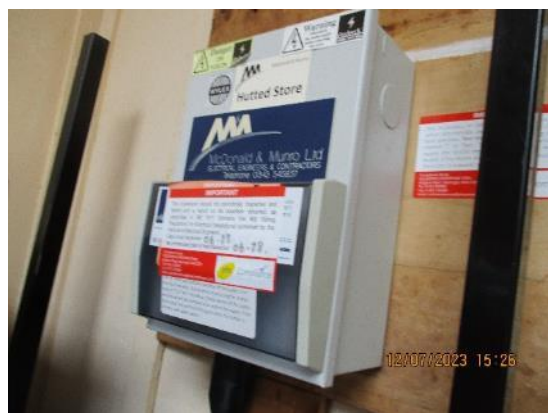
262. Electrical consumer unit hutted store.
