# **Summary Building Condition Survey Report**

**West End Primary School  
Mayne Road, Elgin IV30 1PA**

**12<sup>th</sup> & 13<sup>th</sup> July 2023**

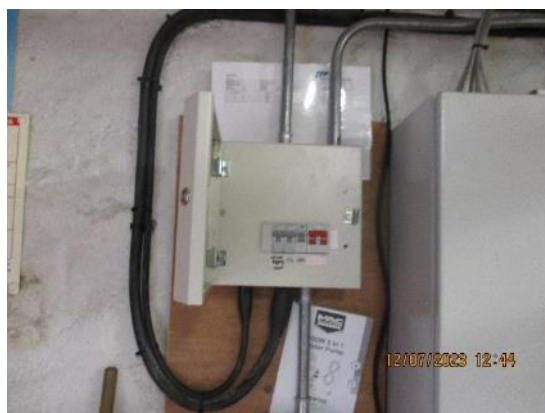
263. Electrical – DB basement plant room.

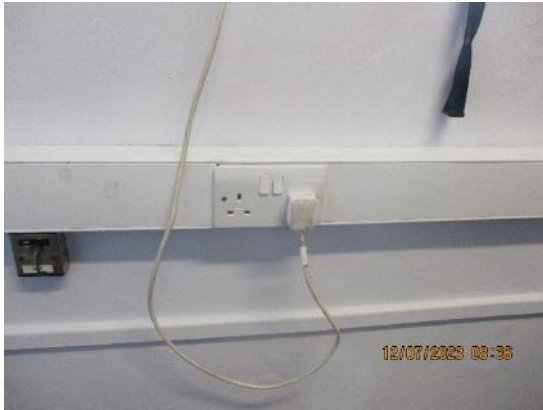
264. Socket and dado trunking typical.

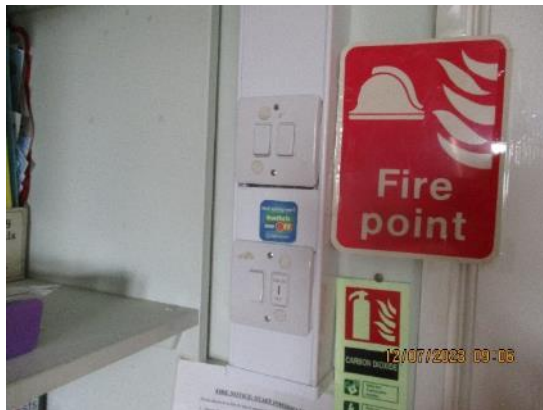
266. Light switches typical.

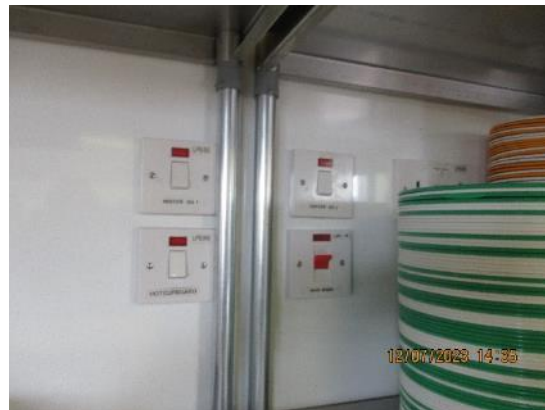
267. Isolation switches – kitchen.

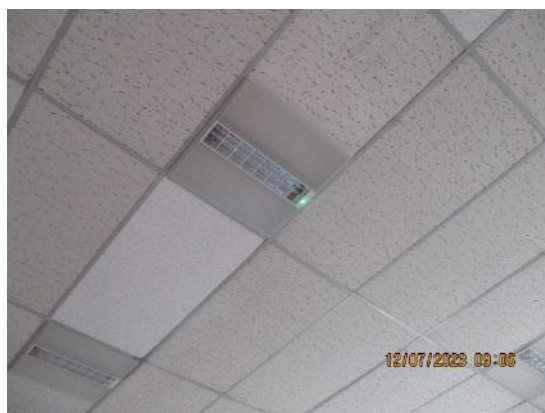
269. Lighting – classroom typical.

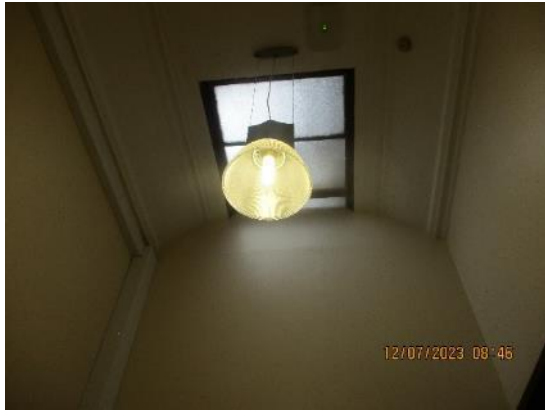
270. Lighting – corridor typical.

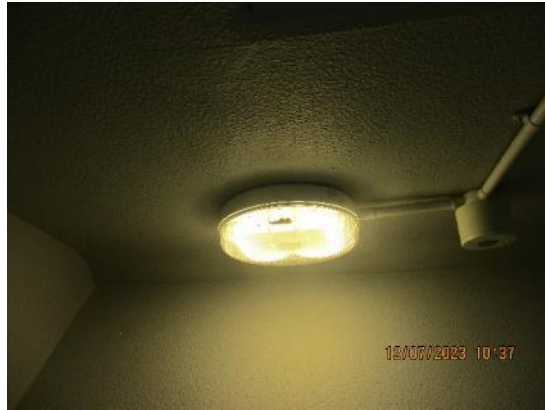
271. Lighting – stores typical.

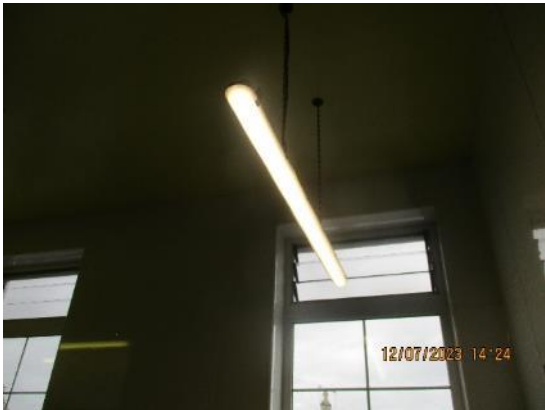
272. Lighting – main kitchen.

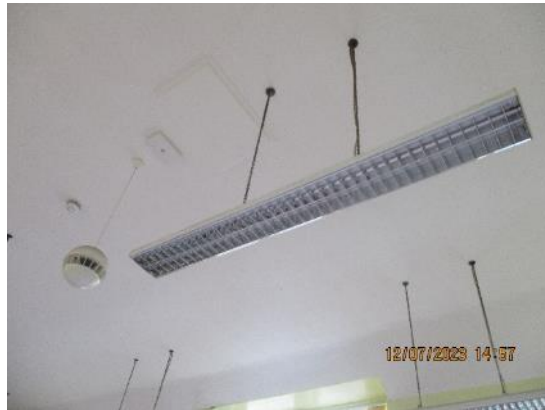
273. Lighting – dining room.

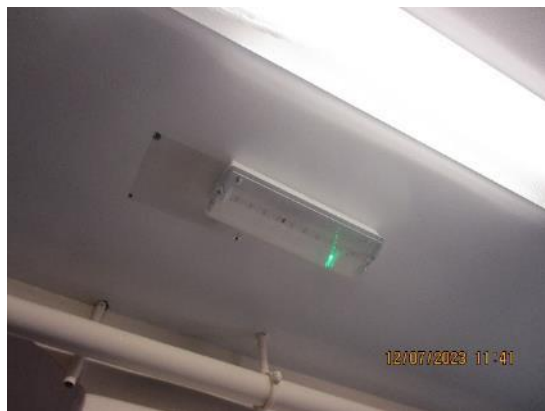
275. Emergency lighting dedicated bulkhead. LED

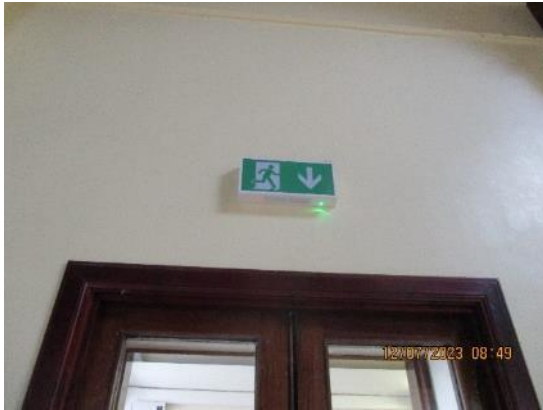
276. Emergency exit sign light typical.

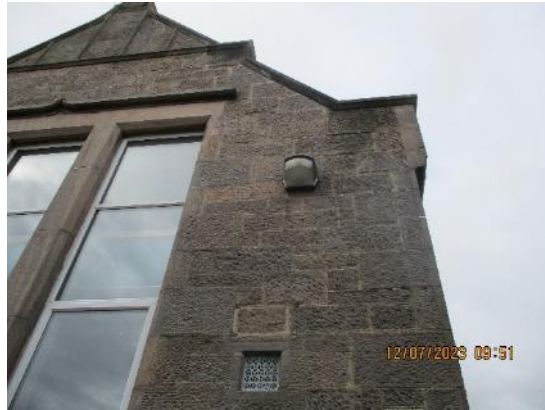
277. External building lighting typical.

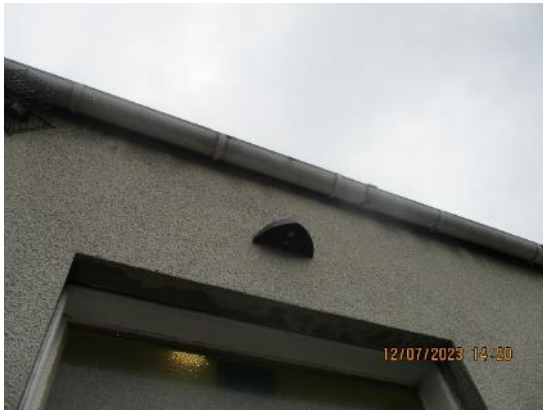
278. External building lighting kitchen block.

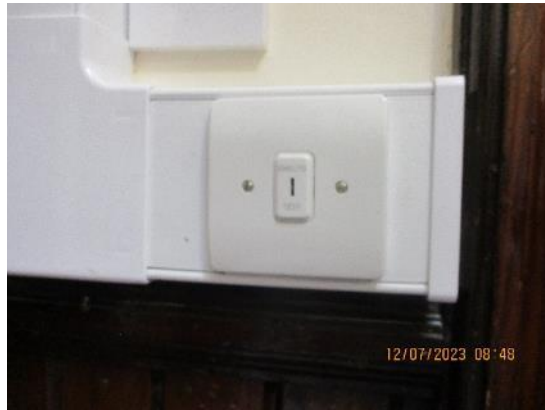
279. Emergency light test switch typical.

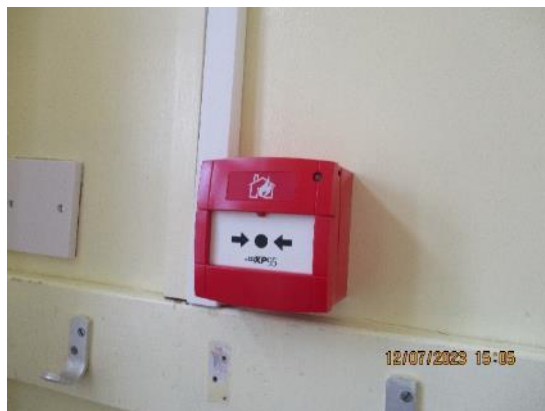
281. Fire alarm call point.

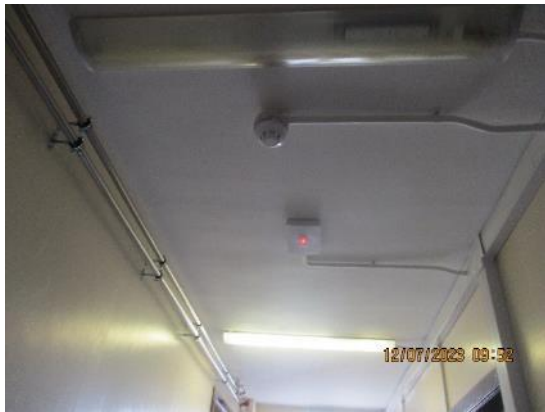
282. Smoke detector/sounder typical.

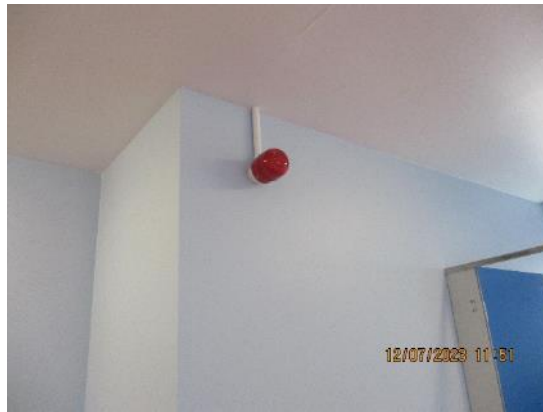
283. Fire alarm strobe boys toilet.

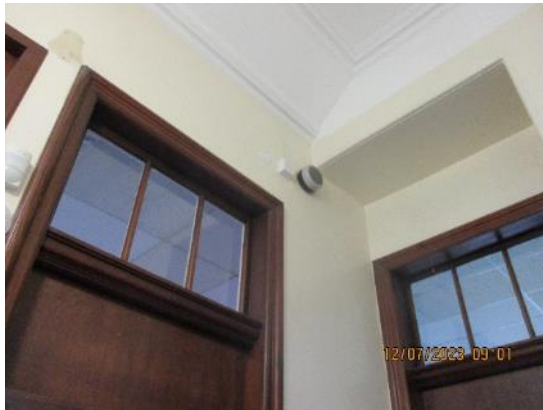
285. Period bell – corridor typical.

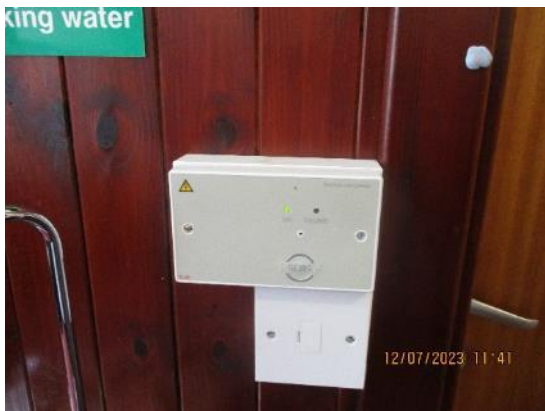
286. Disabled toilet alarm system DPT 1/27.

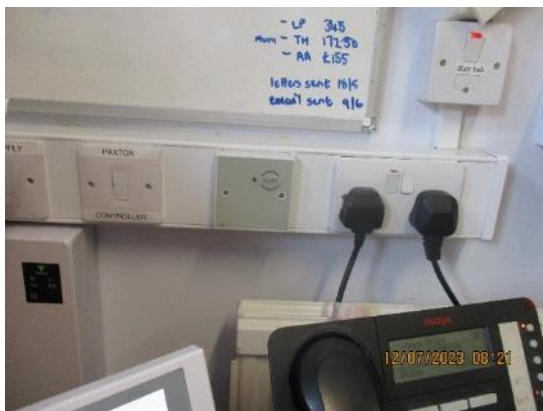
287. Disabled toilet alarm system alert panel in reception office 1/3 from 1/27.

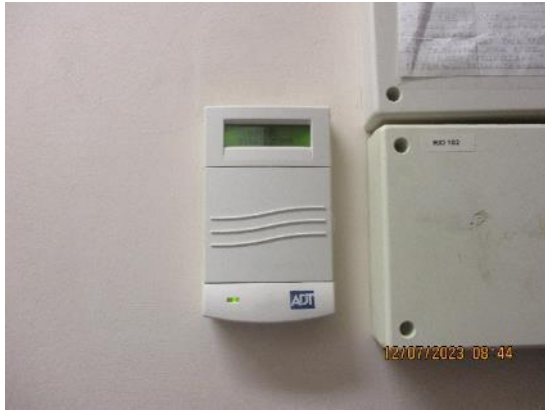
288. Intruder alarm user control keypad.

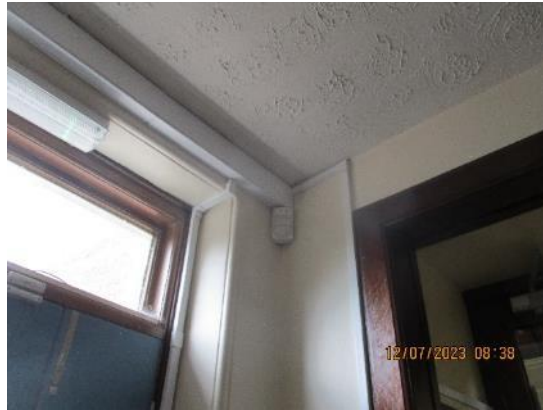
289. Intruder alarm system motion sense detector.

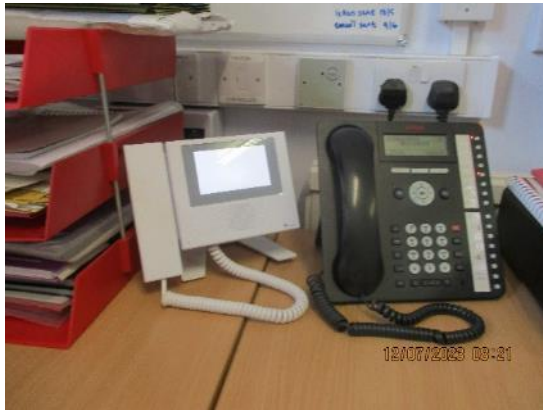
291. Paxton main entrance door security monitor and control handset reception office 1/3.

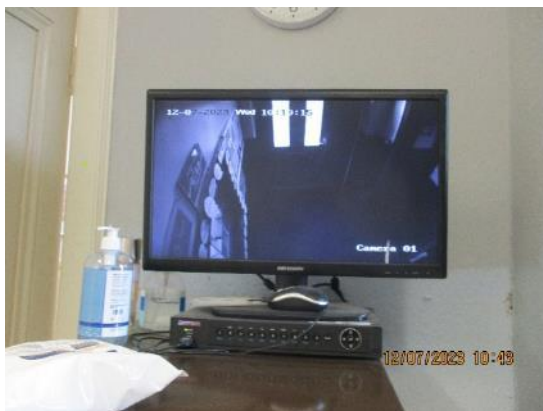
293. CCTV monitor and recorder HT office.

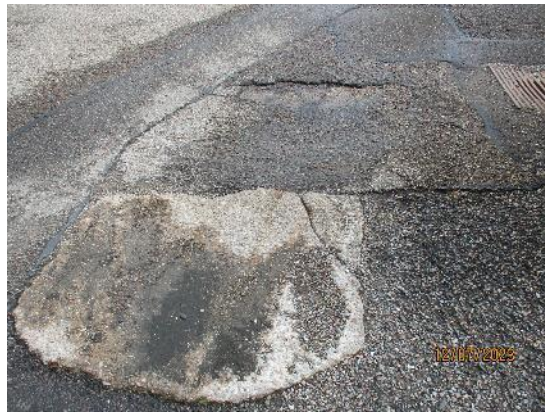
- The tarmacadam car park has surface damage and potholes.
- The tarmacadam playgrounds are cracked and raised by tree roots.
- The car park and playground surface water drainage is blocked.
- The chain link fence to the sports field is corroded and has damage to the north.
- The chain link fence on top of the stone walls is corroded.
- The stone retaining wall to the south east boundary is cracked, has dislodged stones and a considerable lean towards Forteath Avenue.
- The blockwork retaining wall with 4 Young Street is cracked horizontally.
- Concrete ramps are eroded with surface damage.
- Concrete steps to the north playground are cracked and damaged.
- Brick planters and tree surrounds are cracked and damaged by tree roots.

295. Potholes and patches

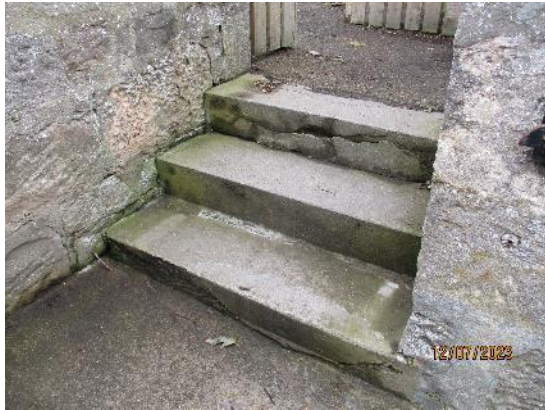
306. Concrete steps (North entrance)

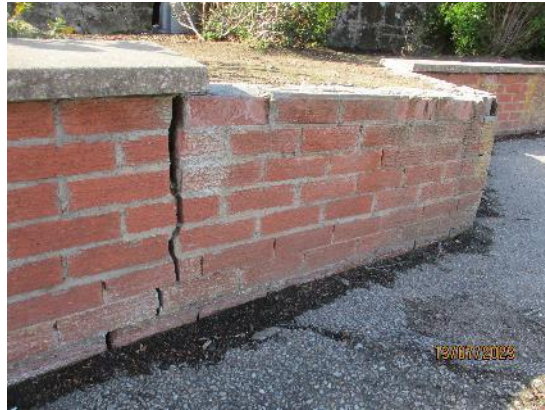
313. Damaged raised beds

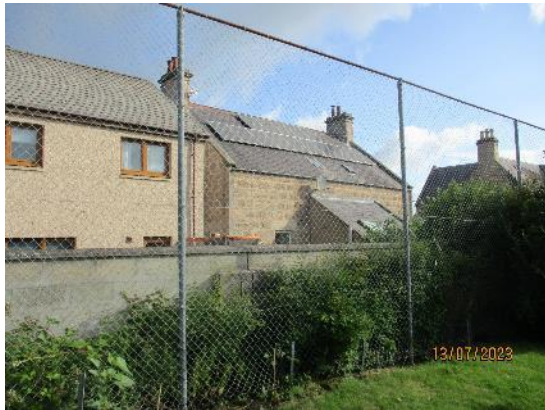
314. Damaged chain link fencing

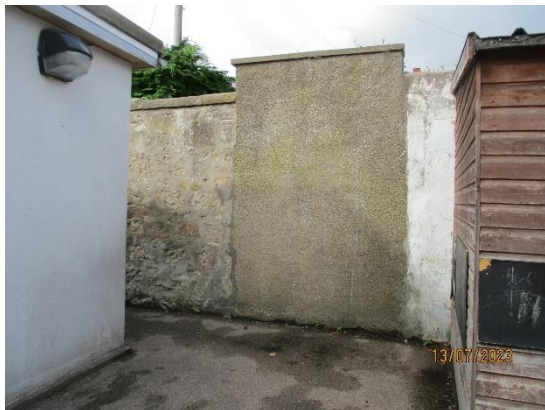
331. Missing pointing

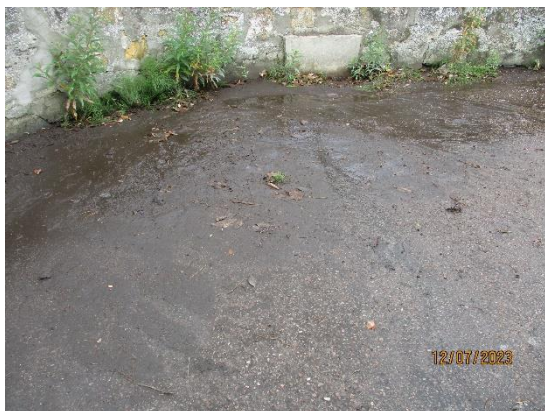
339. Blocked playground drainage

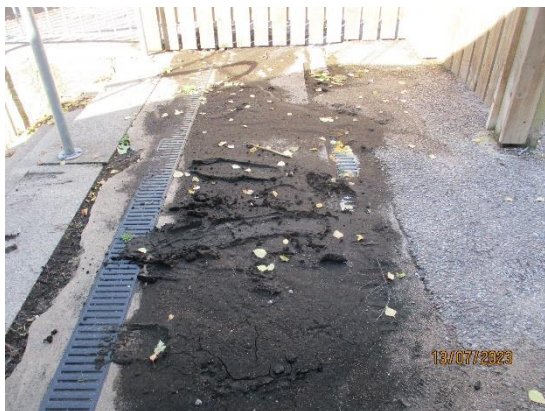
340. Silt from surface flooding
