# **Summary Building Condition Survey Report**

**New Elgin Primary School  
Bezack Street, Elgin IV30 6DP**

**18<sup>th</sup> & 19<sup>th</sup> January 2023**

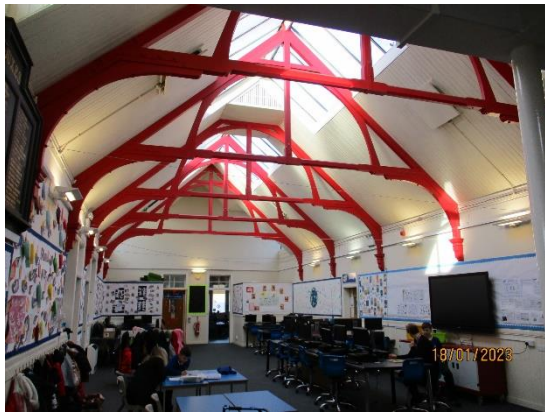
1. Old school central timber trusses

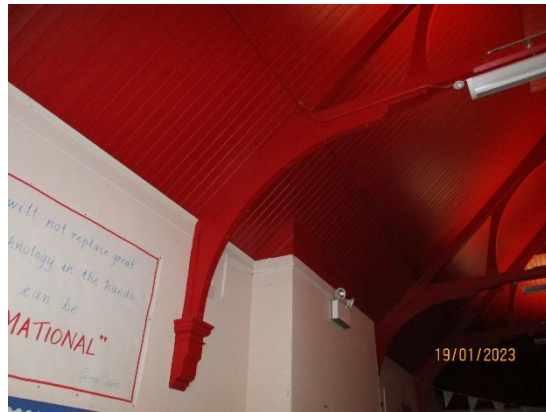
2. Trusses resting on stools

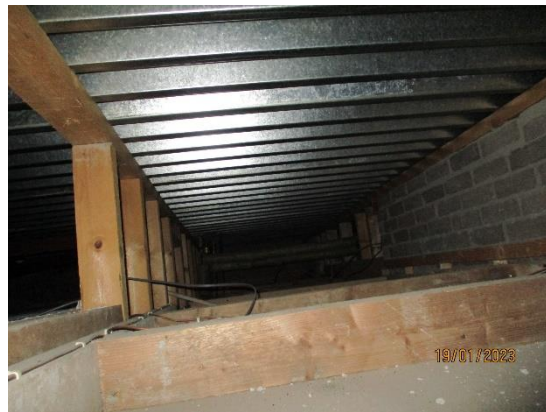
4. Decking below concrete slab roofs

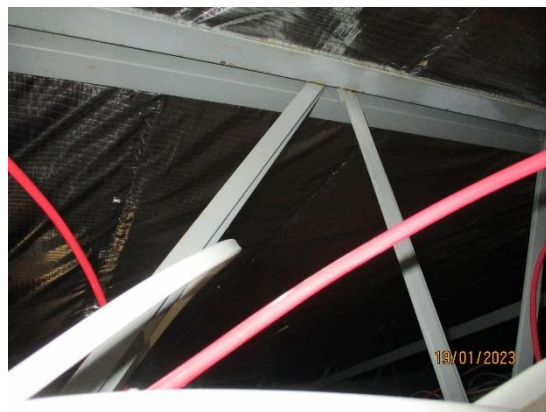
6. Steel roof joists to ASN building

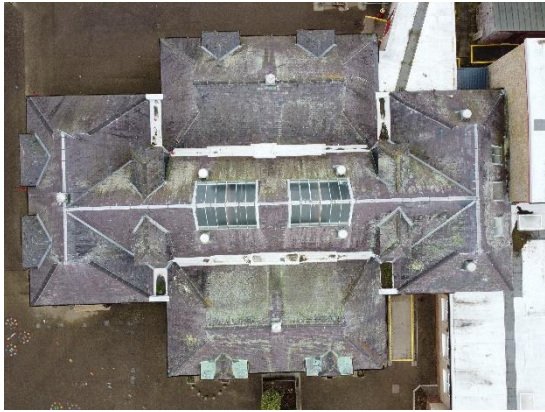
7. Natural slate to old building

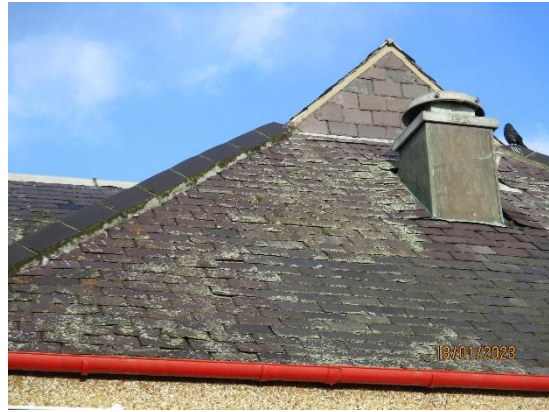
8. Slipped and broken slates

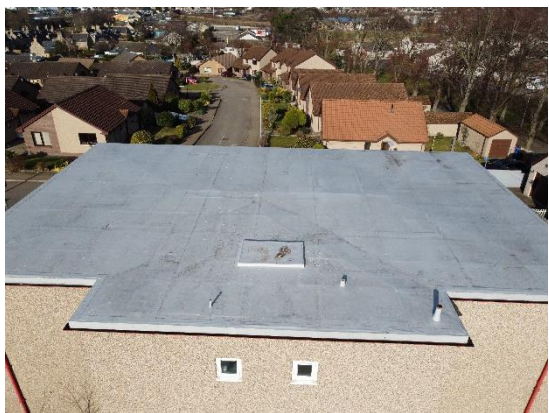
12. SPM to two storey building

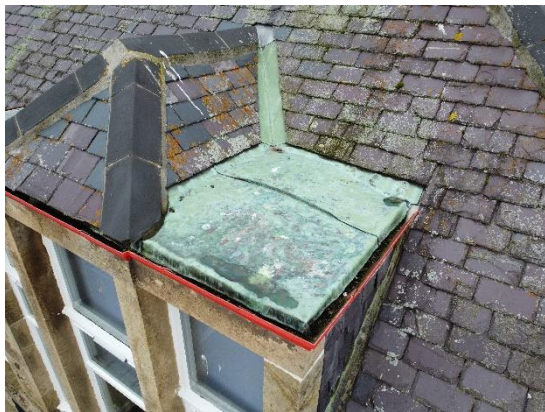
15. Copper to dormer roofs

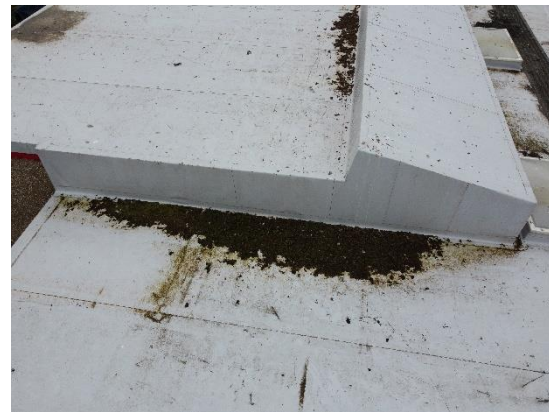
16. Debris on flat roofs

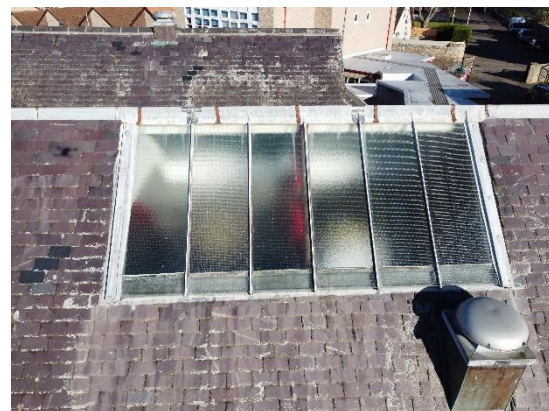
18. Skylights to old hall

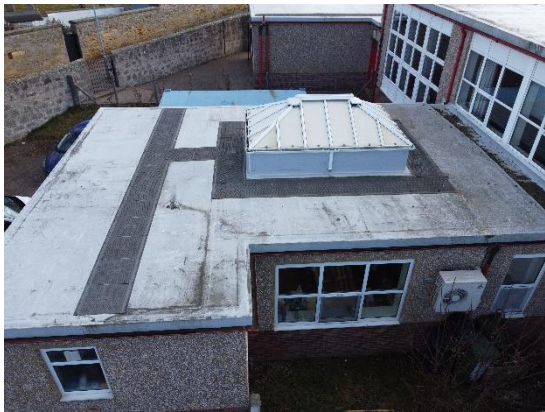
25. PVC cupola above Kitchen

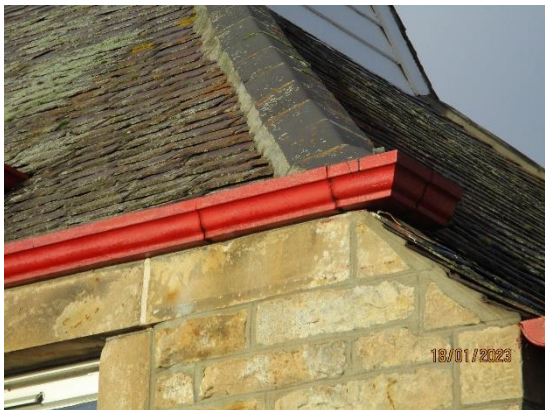
27. Cast iron ogee gutters

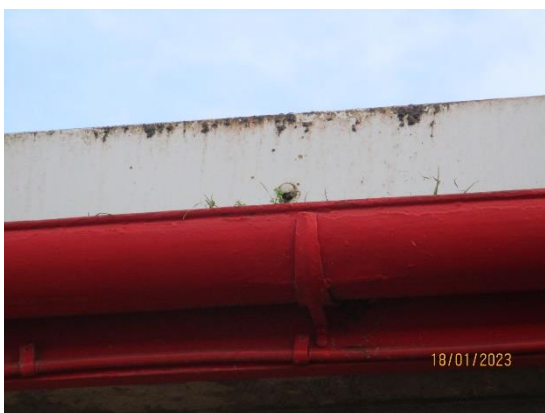
29. Vegetation in gutters

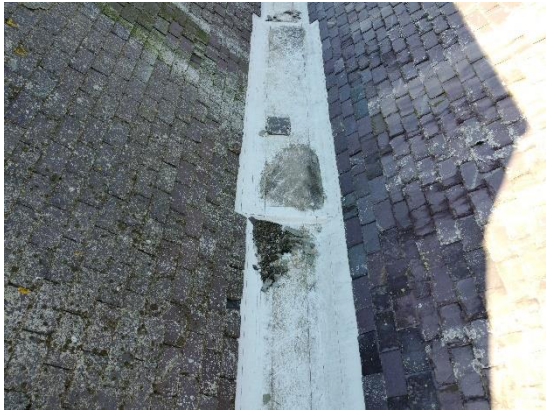
31. SPM valley gutters

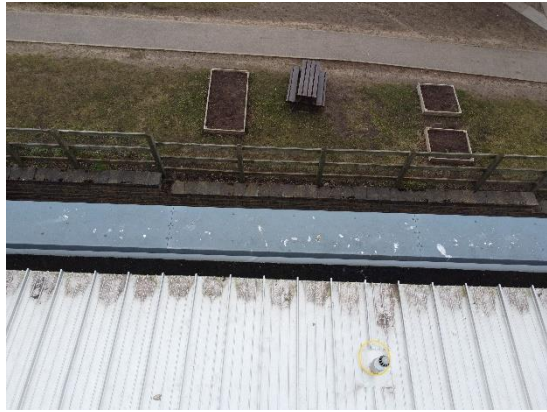
32. Part blocked gutter to New Nursery

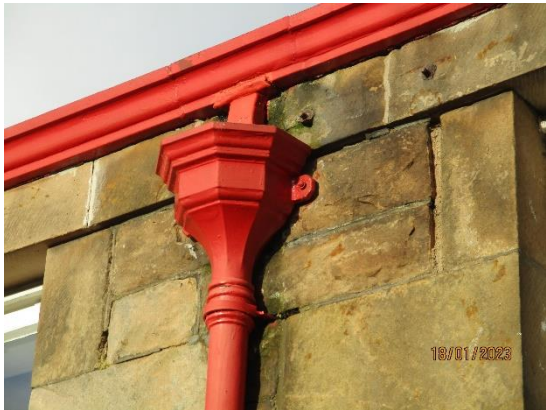
33. Cast iron hopper heads and downpipes

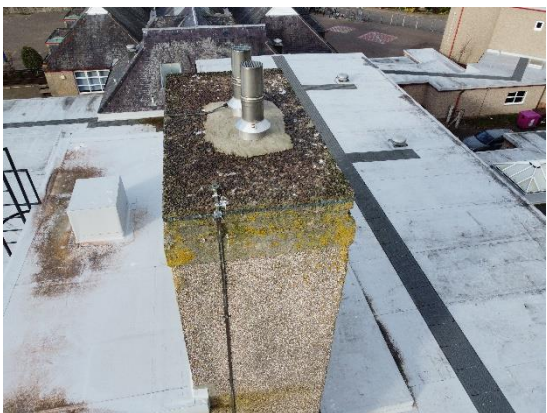
36. Water tank tower and boiler chimney

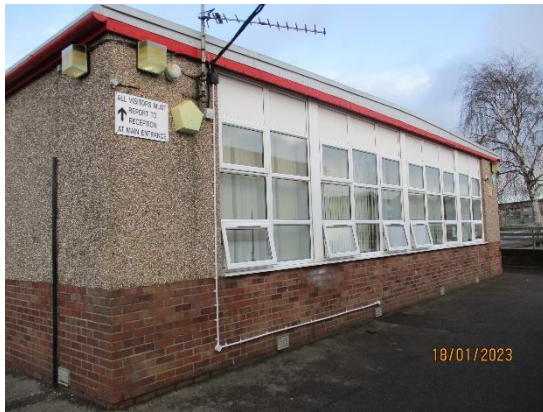
37. Brickwork external walls

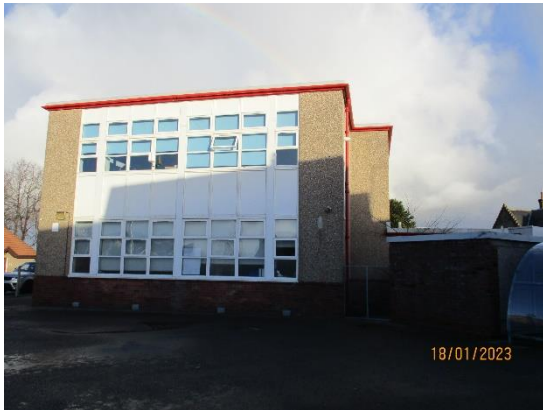
39. Concrete framed masonry walls

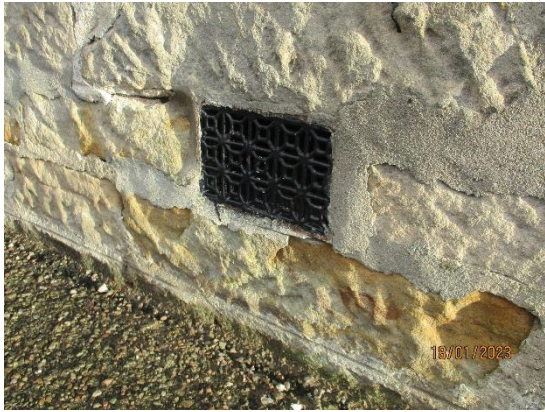
43. Ventilation to stone building

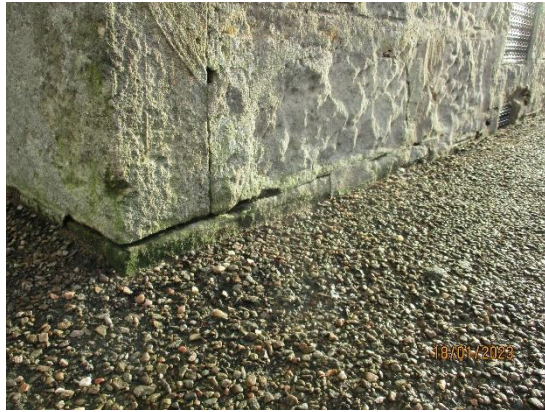
44. Ground level close to DPC

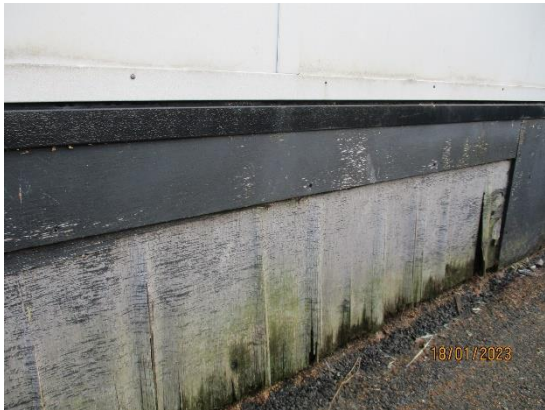
- Irregular fall on gutter.
- Missing/damaged rainwater downpipes.
- Plywood underbuilding screen damaged by rainwater penetration and wet rot.
- Guardrails to external ramps suffer from wet rot.

45. Plywood screening below ASN building

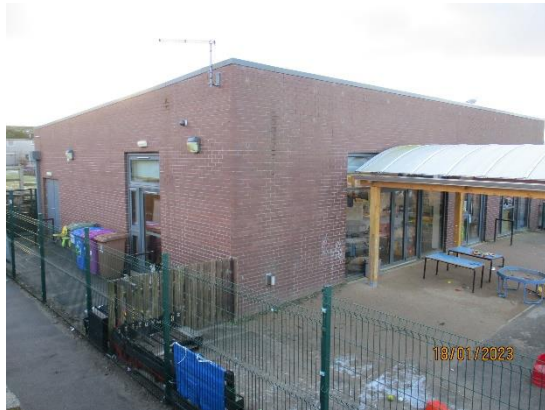
46. Brick walls to New Nursery

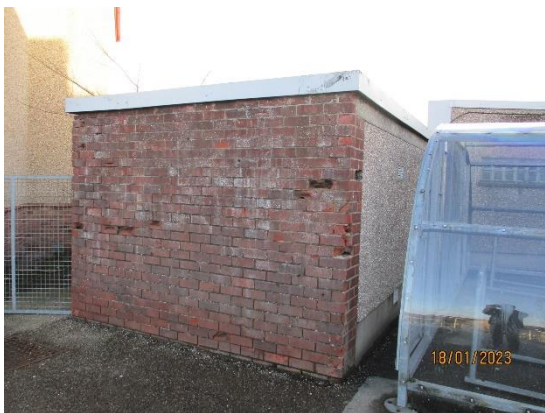
47. Brickwork to external store

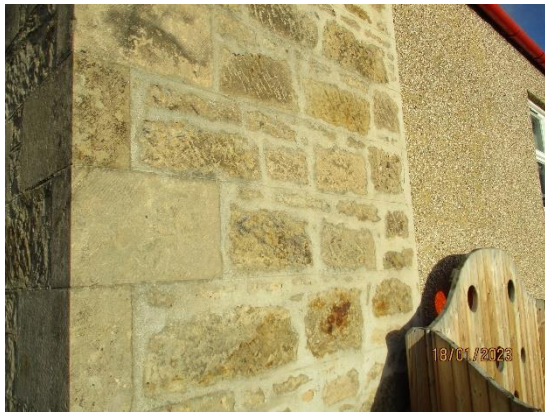
49. Stone walls to old building

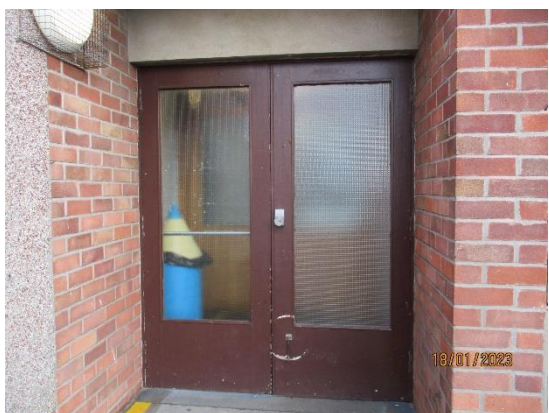
54. Timber glazed fire exits

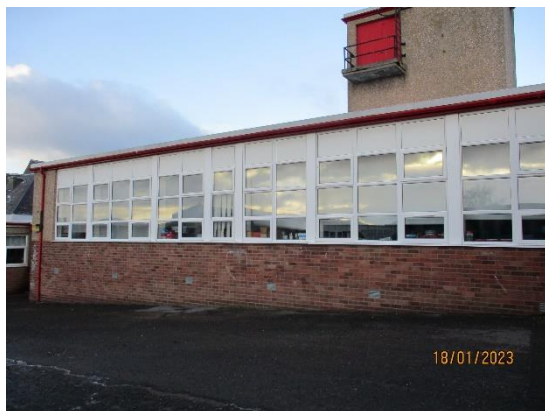
65. UPVC windows to school building

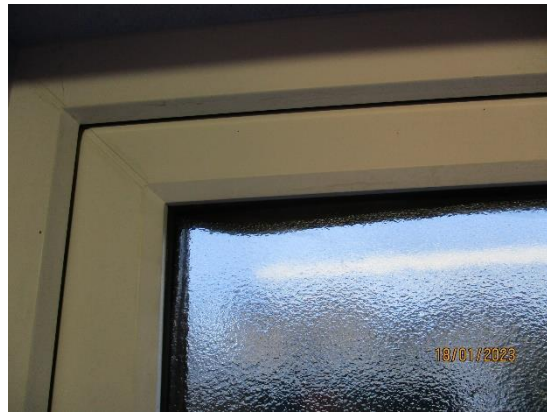
67. Glazing seals failing

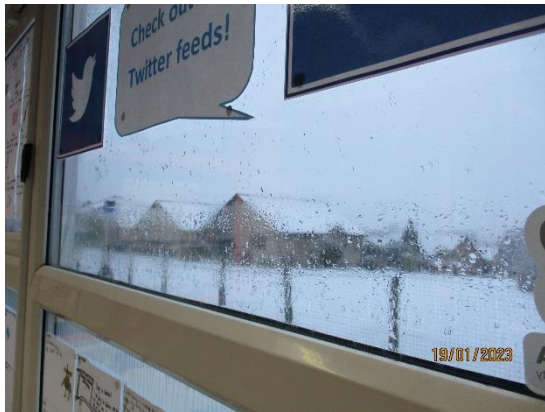
72. Blown double glazing units

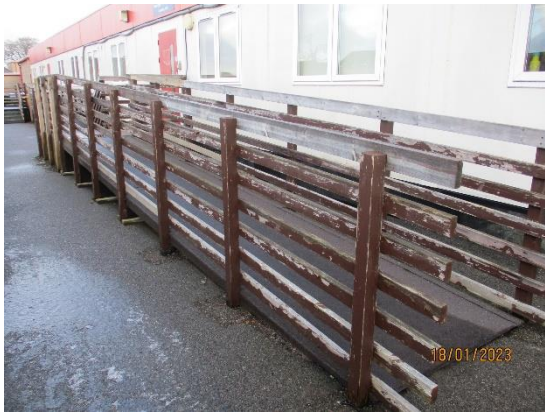
78. Timber guardrails and fencing

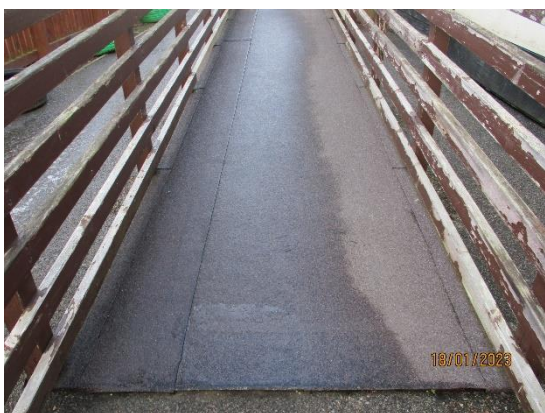
82. Timber ramps (ASN building)

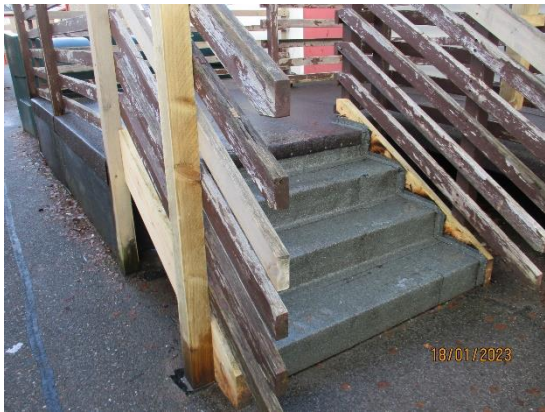
84. Timber steps (ASN building)

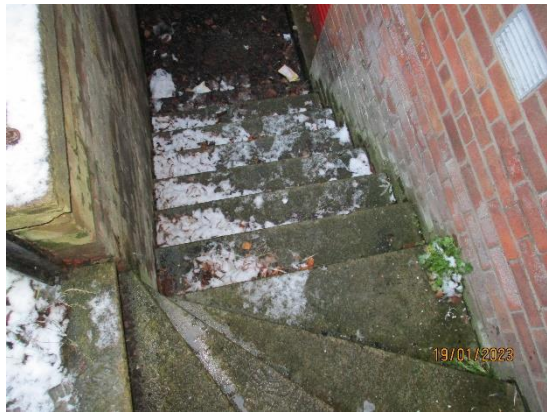
85. Concrete steps to Boiler House

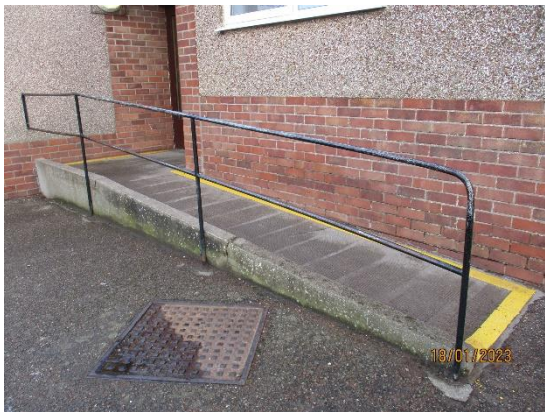
86. Metal tubular guard rail

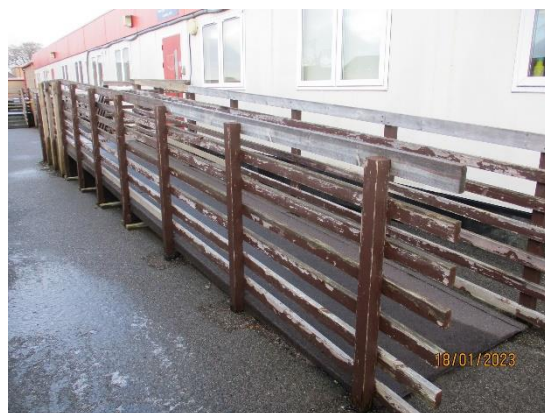
88. Timber guard rail

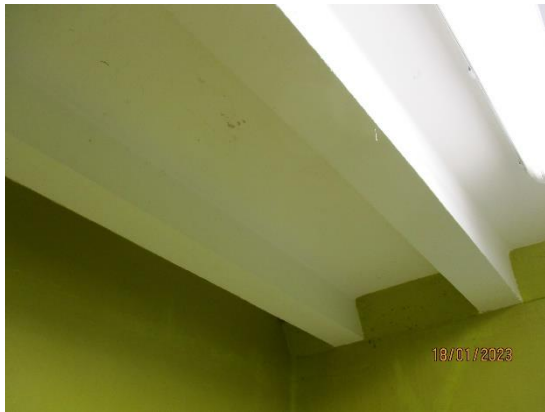
90. Concrete beam floors

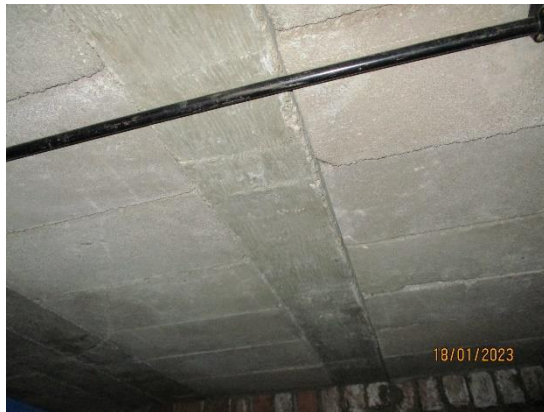
91. Beam & block floors

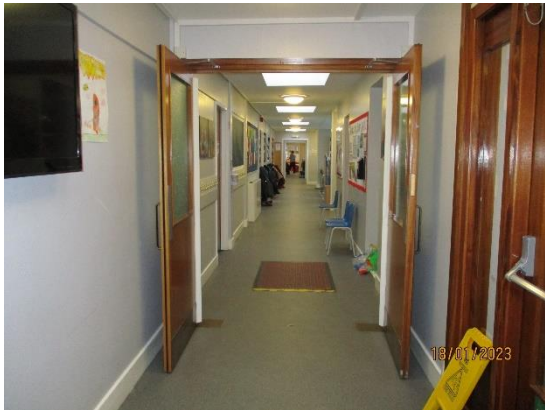
82. Sheet vinyl flooring to corridors

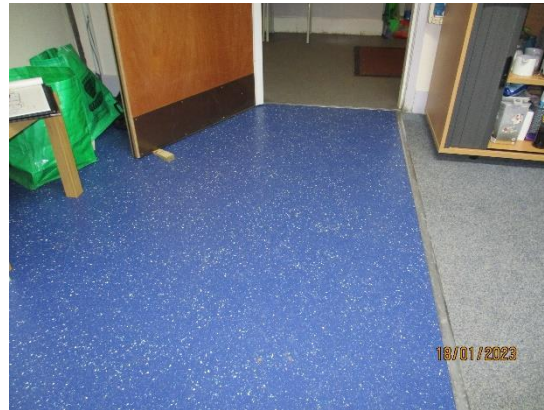
83. Sheet vinyl flooring to classrooms

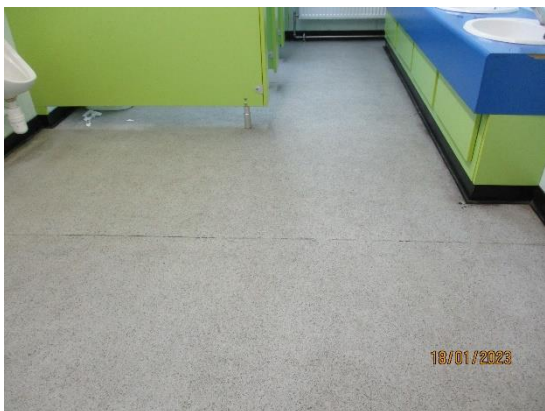
84. Sheet vinyl flooring to toilets

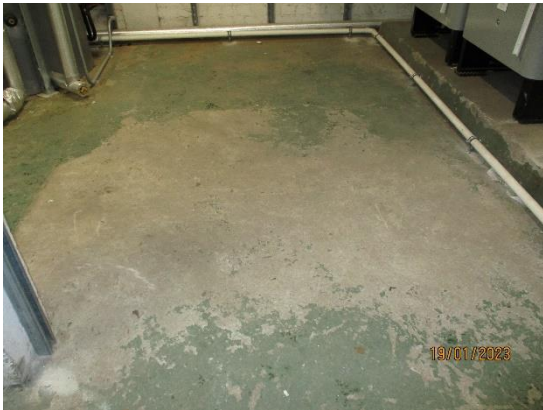
100. Painted concrete floors

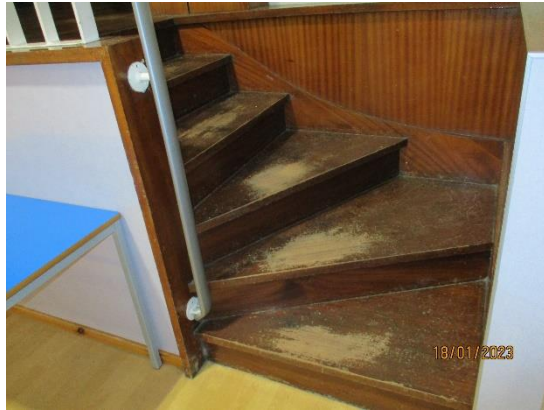
105. Timber stairs (Stage)

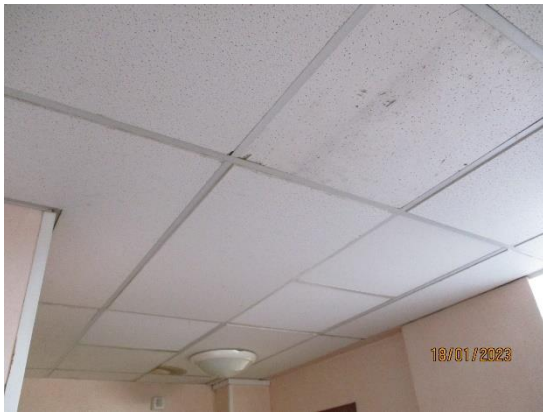
109. Suspended ceiling tiles

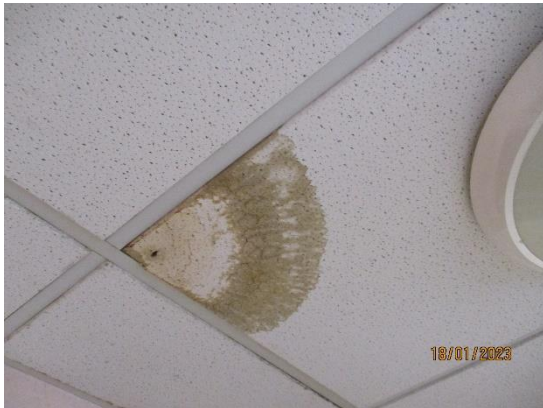
111. Watermarked ceiling tiles

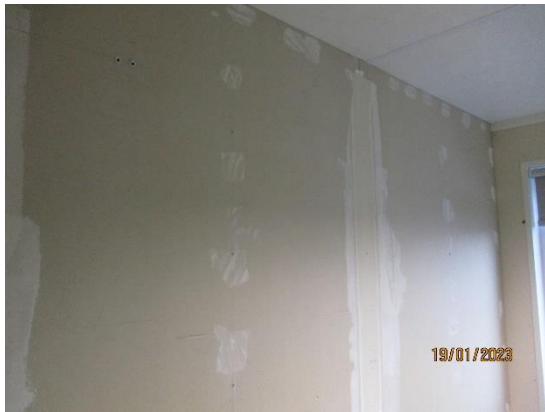
133. Plasterboard walls with no decoration

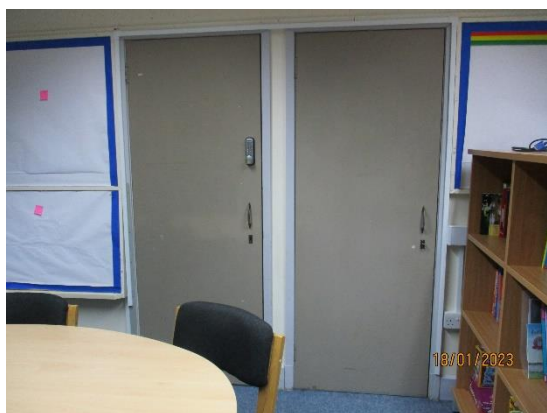
143. Timber hollow core cupboard doors

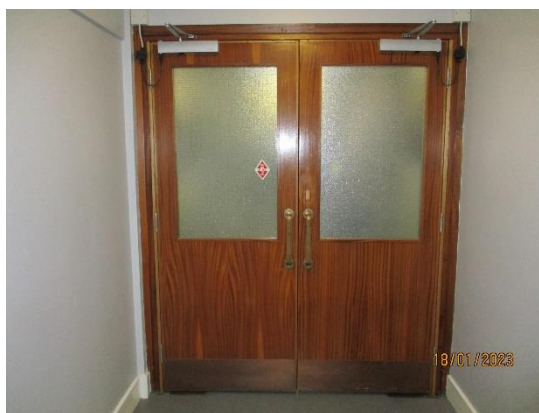
144. Double timber fire doors

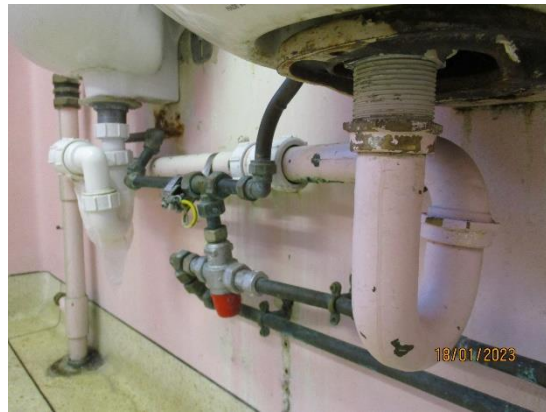
169. Composite trough basins

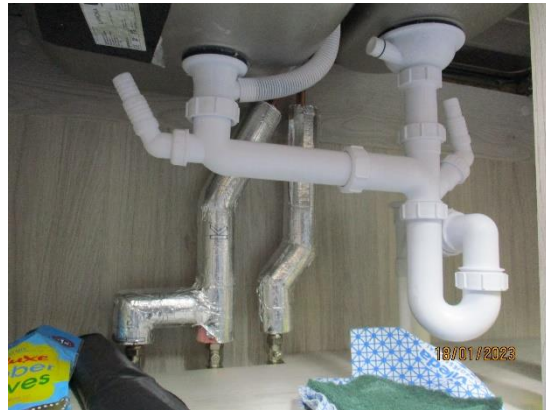
183. Cleaners butler sinks

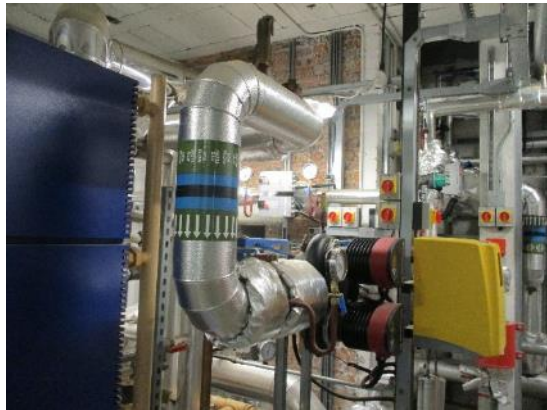
203. Pressurisation unit – heating – 0/71

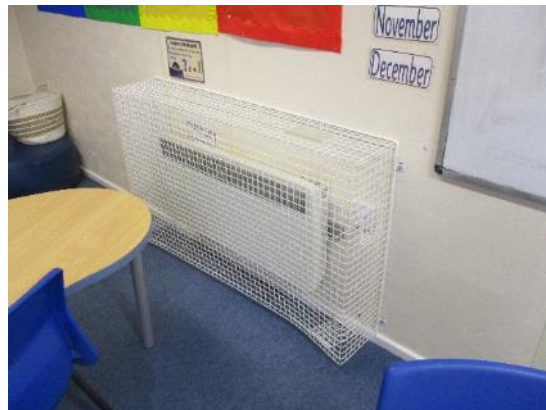
209. Electric convector – ASN building.

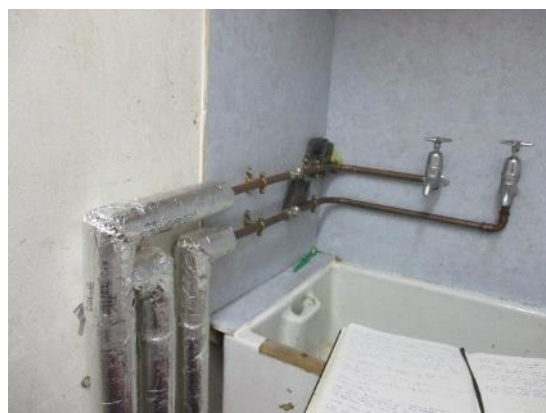
211. Calorifier – hot water storage. Main school 0/71

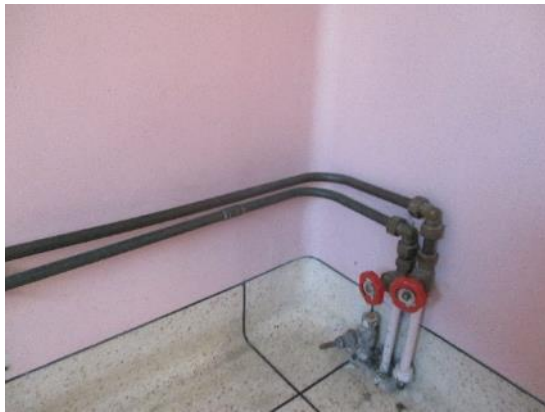
212. Pipework – hot and cold new. Main school 1/39

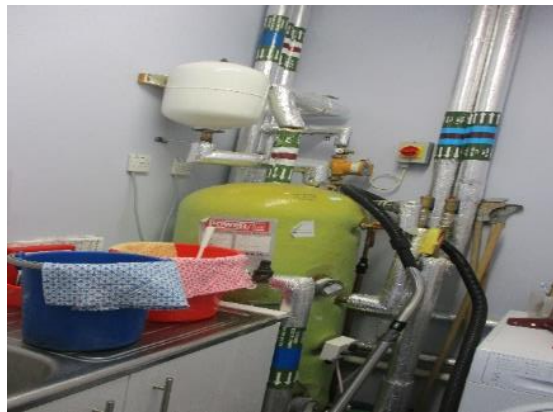
213. Pipework – hot and cold existing. Main school 1/63

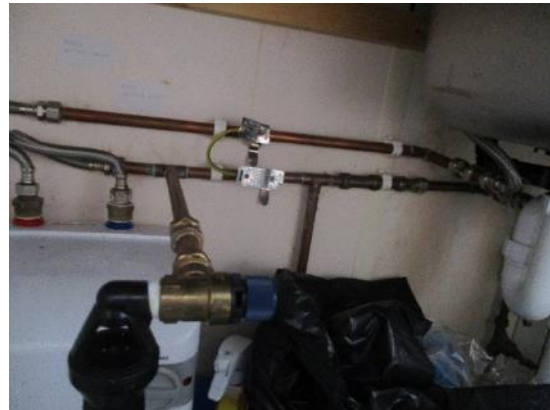
215. Point of use hot water storage unit. ASN building

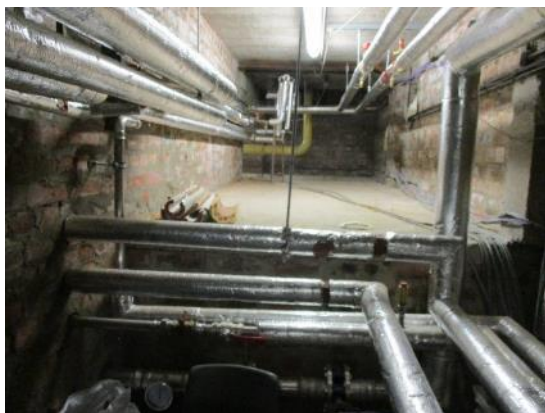
216. Pipework – hot and cold in ASN building typical.

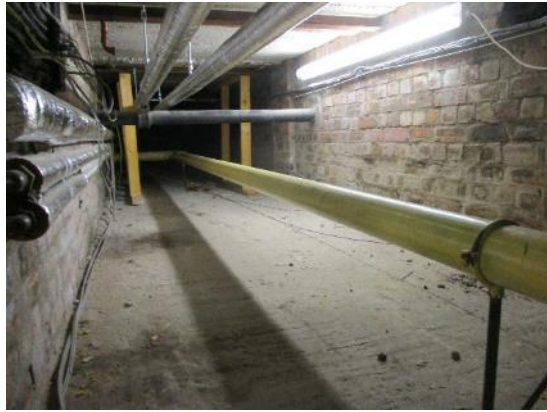
219. Gas pipe supply to plant room 0/71 in service duct under main school floor.

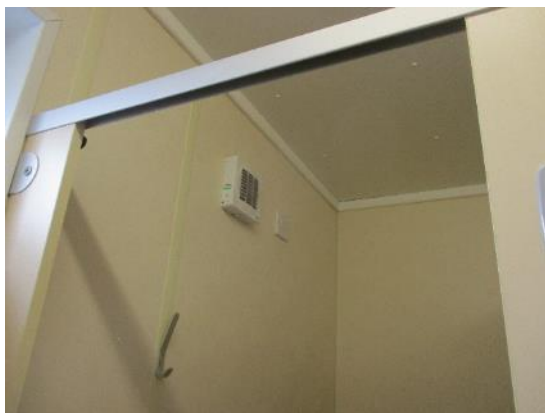
222. Extract fan above cookers main school kitchen1/44

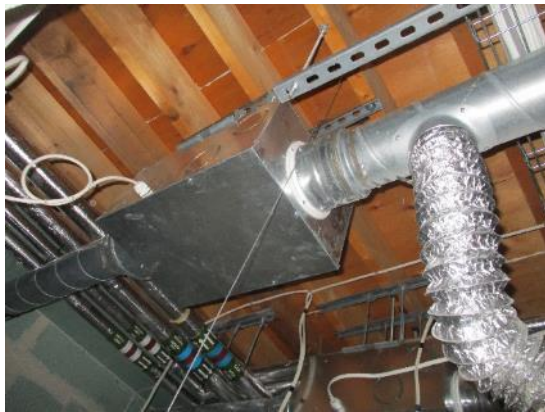
224. Extract fan nursery – Utility GO2 room

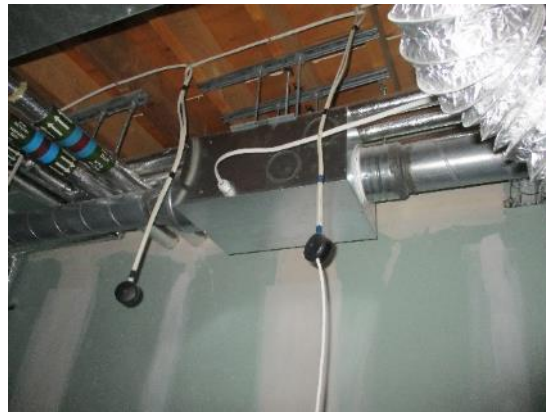
225. Heat recovery ventilation unit. Nursery toilets G05

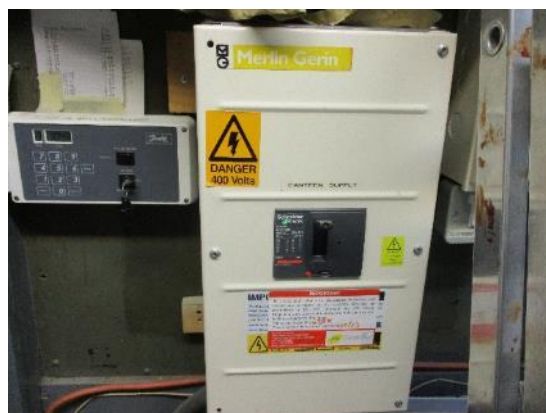
229. Distribution board main school 1/3 typical.

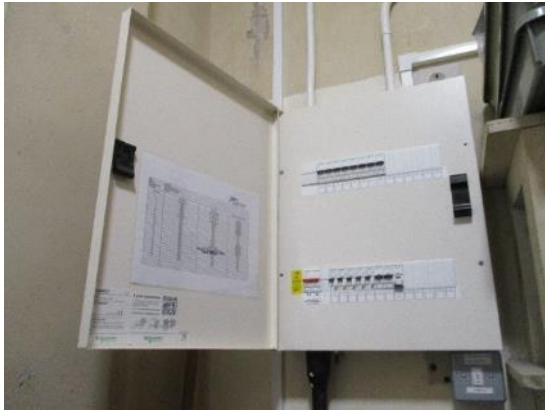
230. Main switch for canteen. Main school 1/3

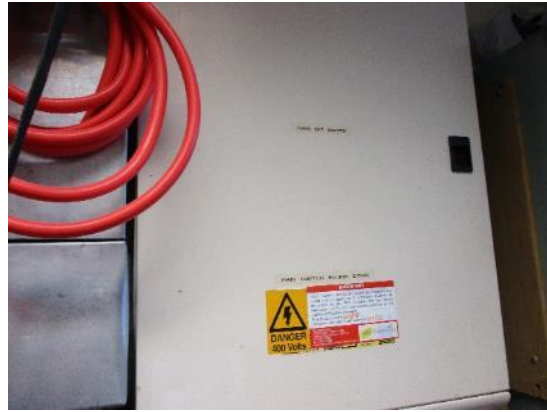
231. Distribution board main school 1/60

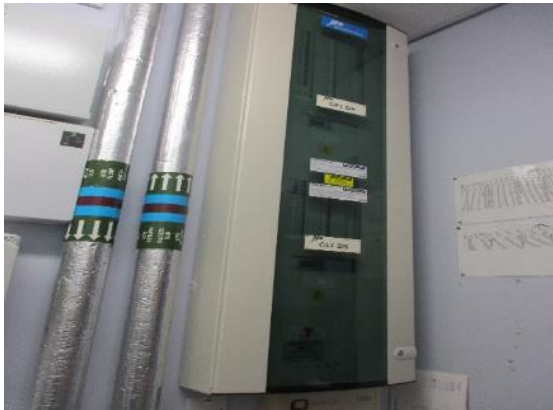
232. Distribution board main school 1/3

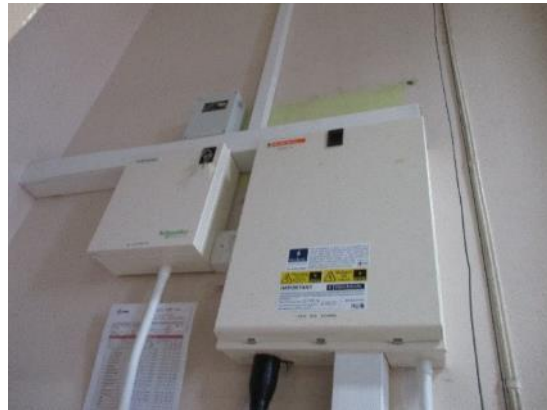
233. Distribution board nursery utility room GO5

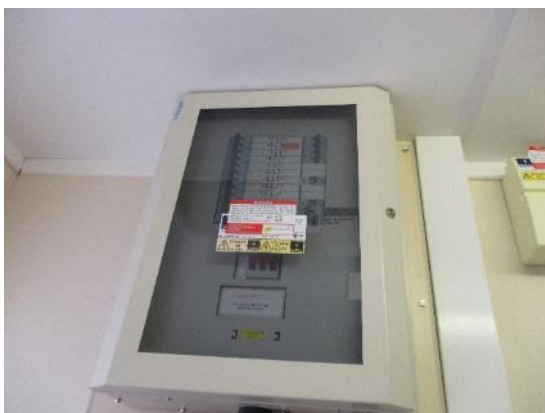
234. Distribution board – Nursery utility room GO5

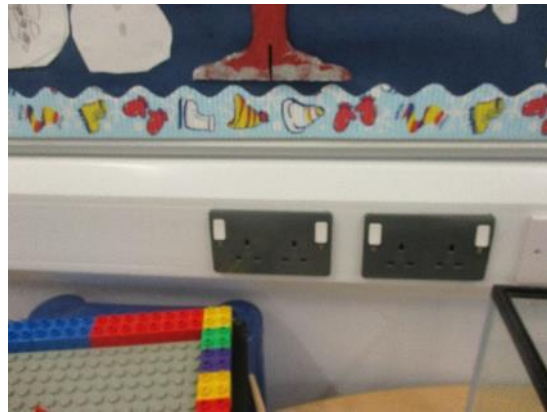
237. Sockets main school typical

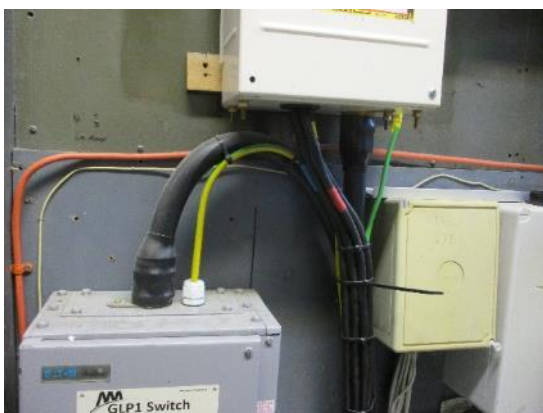
240. General and controls wiring main school 0/71

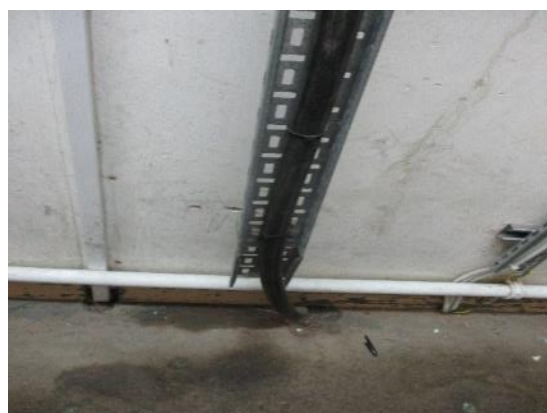
241. LV cabling – 1/3 meter cupboard main school

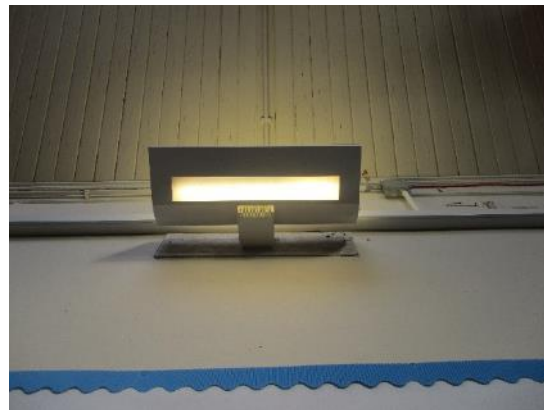
245. Lighting main school dining hall 1/41

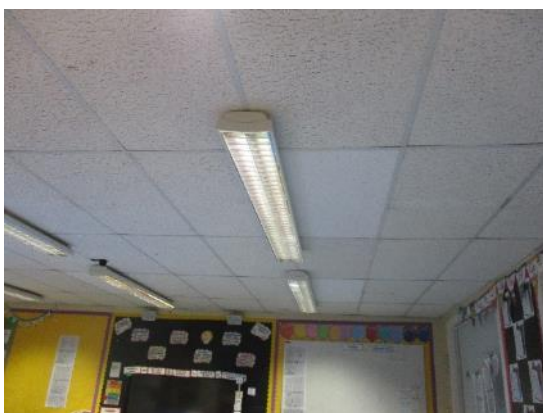
246. Lighting main school hall 1/33

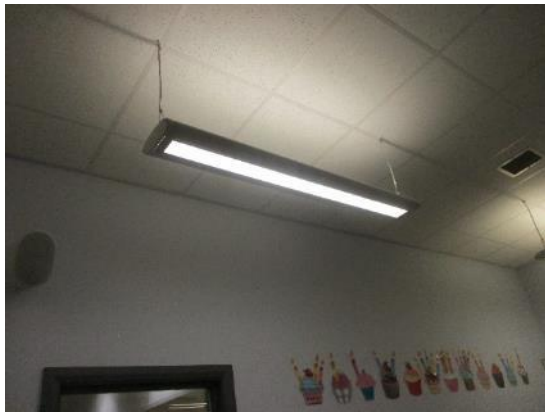
249. Lighting – nursery large room GO9

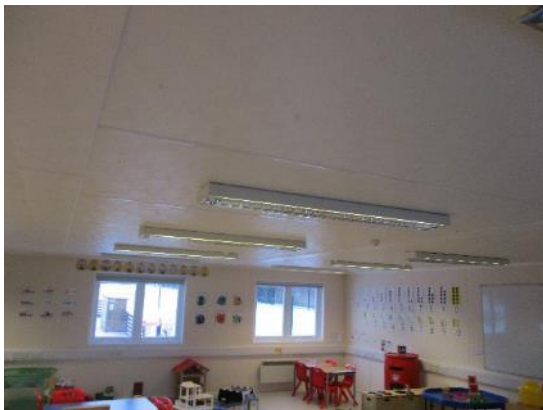
251. Lighting ASN building typical classroom

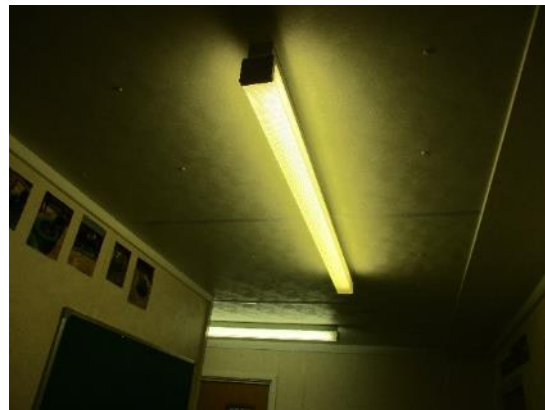
252. Lighting – ASN corridors typical

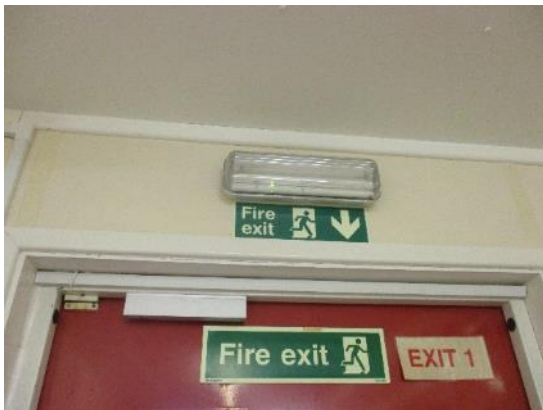
257. Emergency lighting ASN building typical exit.

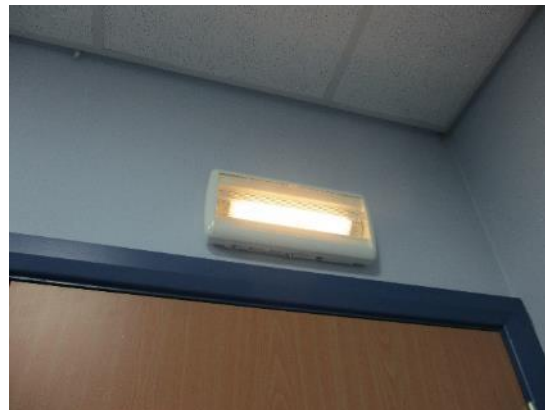
258. Emergency lighting (maintained) nursery.

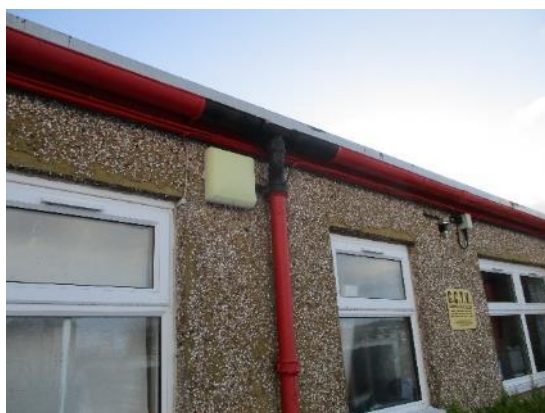
260. External emergency light main school entrance

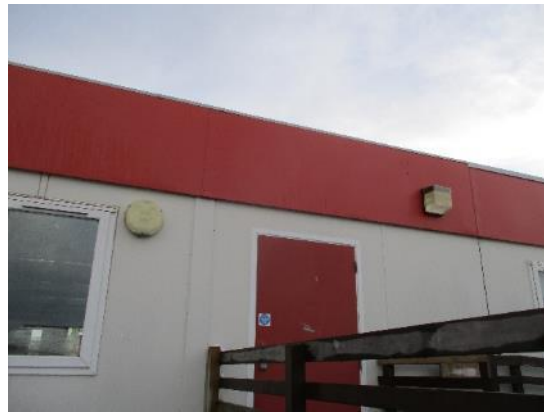
262. External lighting – ASN building example

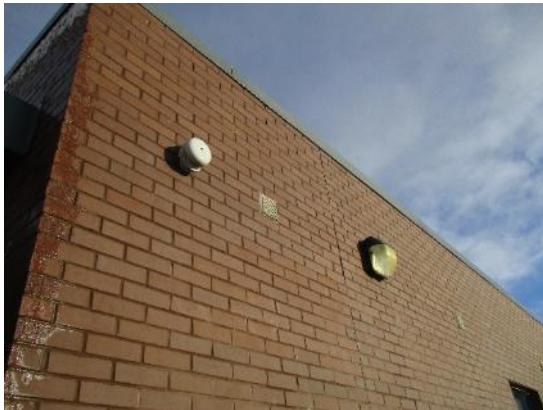
263. External lighting – nursery extension.

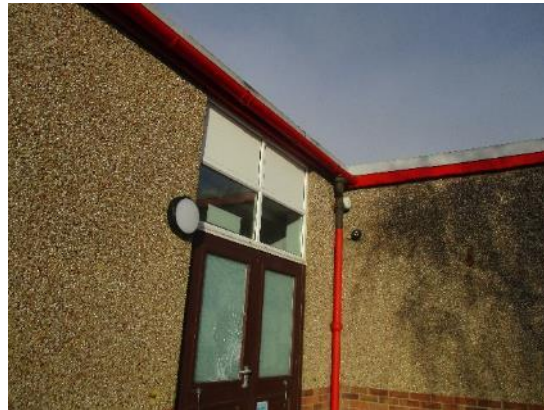
264. External lighting main school

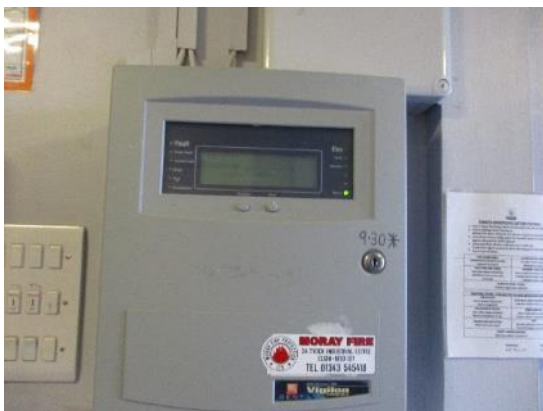
265. Fire alarm control panel main school 1/1

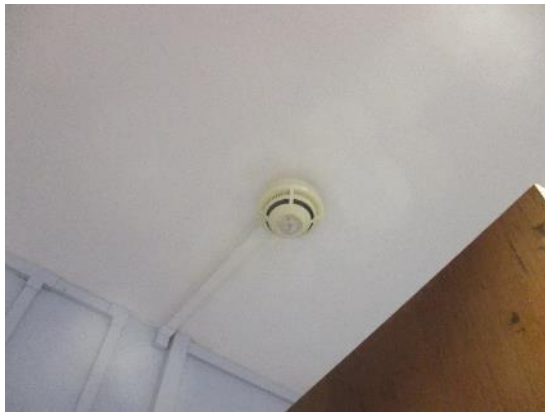
267. Fire system detection head – main school and ASN building typical

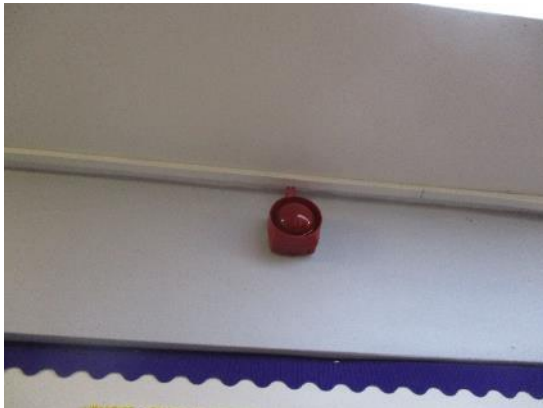
269. Fire detection system – strobe device typical.

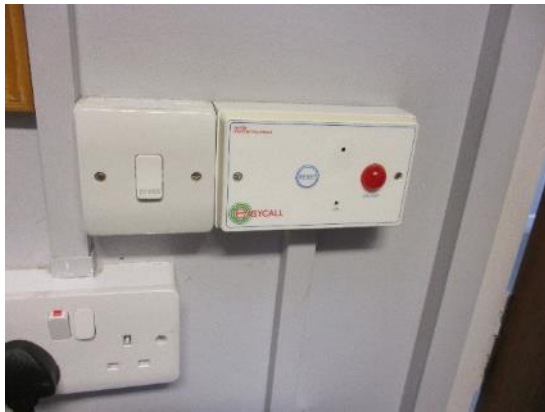
273. Disabled alarm system remote indicator. Main school reception office

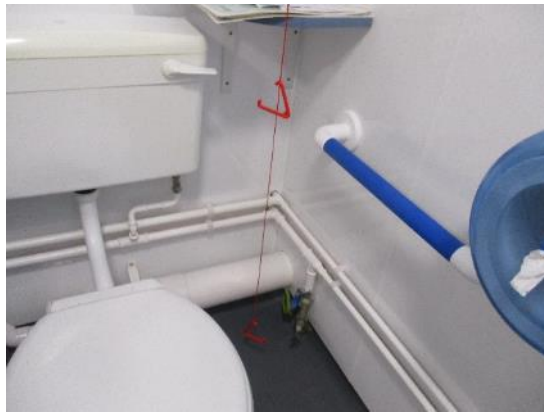
274. Disabled alarm system pull chord activation. ASN building – typical.

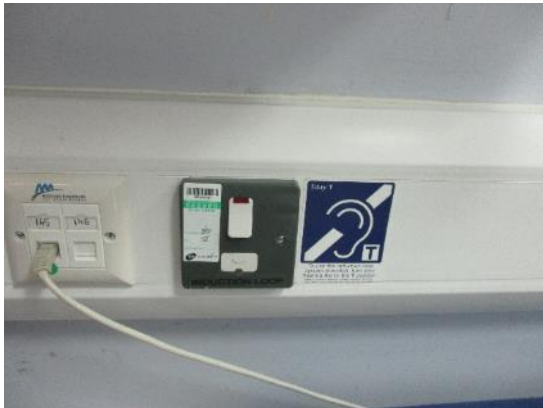
275. Induction loop system. Nursery extension

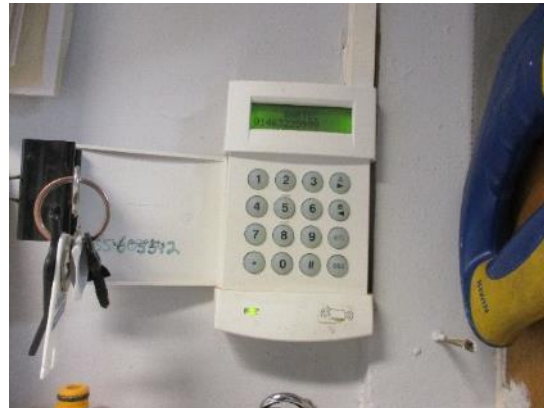
276. Intruder alarm keypad main school room 1/2

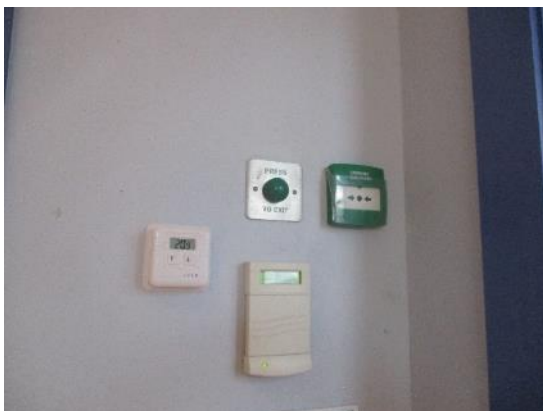
277. Intruder alarm keypad – Nursery extension.

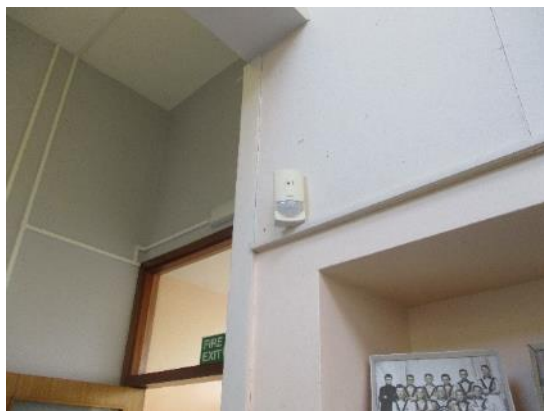
278. Intruder alarm PIR main school typical.

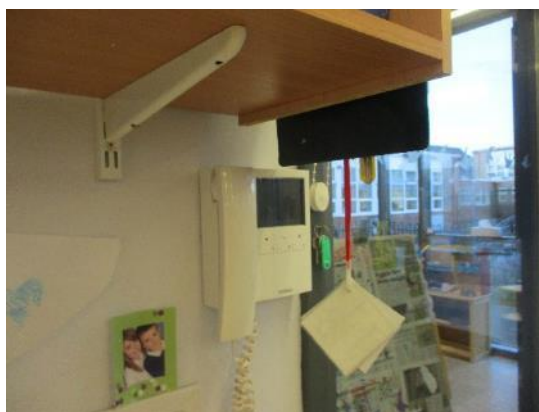
280. Door access control handset – nursery.

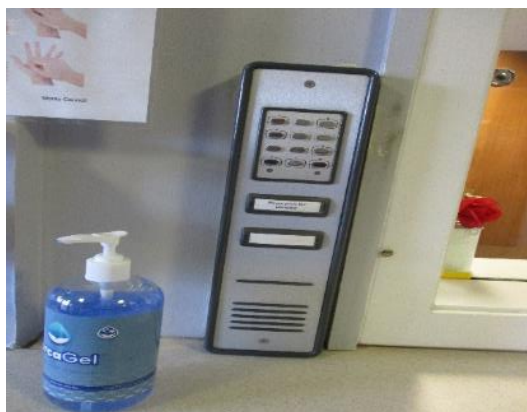
281. Door access intercom – Main school reception for internal entrance door.

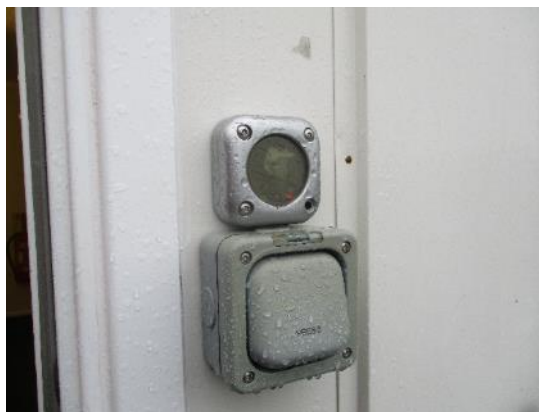
282. Door access fob reader – ASN building main entrance.

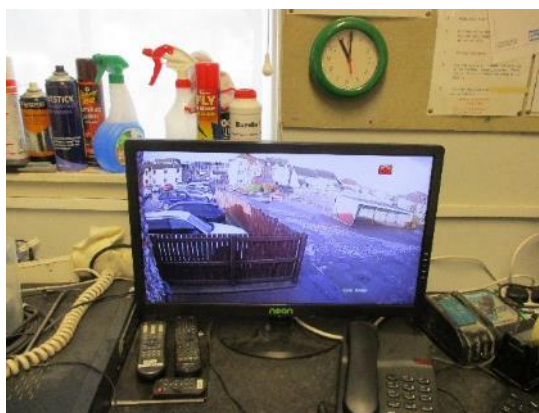
284. CCTV monitor and recorder main school 1/2

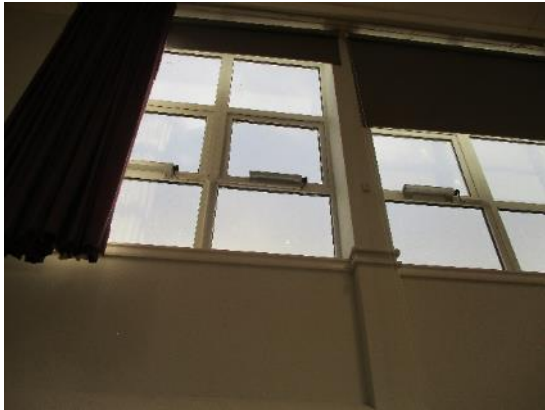
285. Electric window opening motors main school 1/41

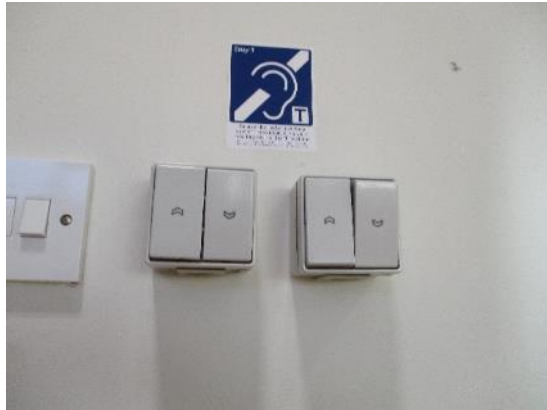
286. Electric window controls main school 1/41

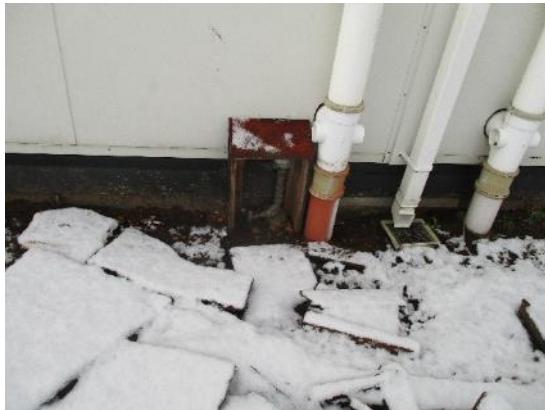
287. Cold water supply pipework ASN building.

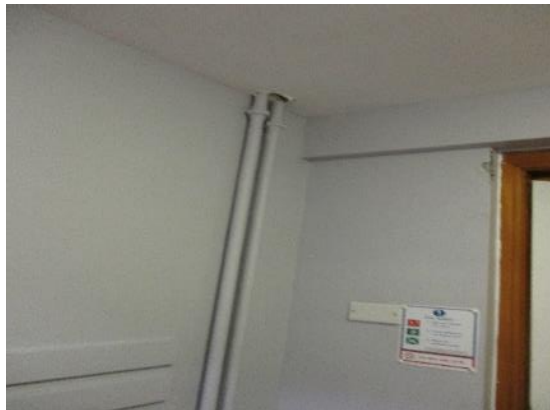
288. Pipework – heating system.

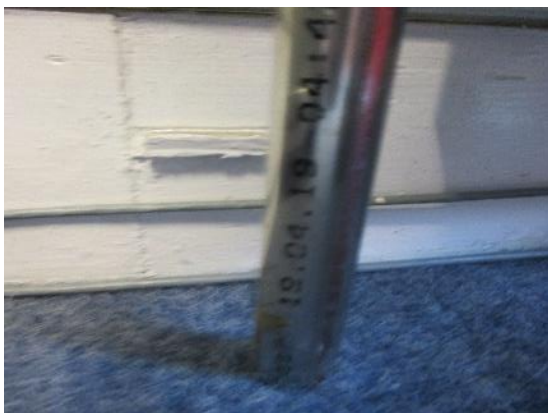
289. Pipework – new heating system.
