# **Summary Building Condition Survey Report**

**New Elgin Primary School  
Bezack Street, Elgin IV30 6DP**

**18<sup>th</sup> & 19<sup>th</sup> January 2023**

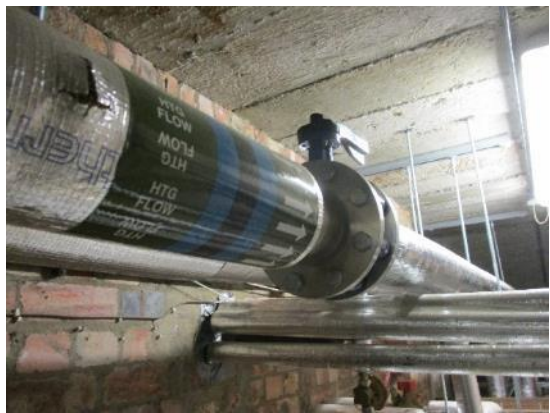
290. New heating pipework under school floor.

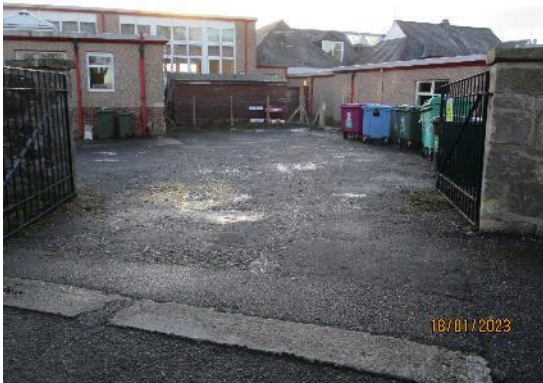
291. Rear tarmacadam car park

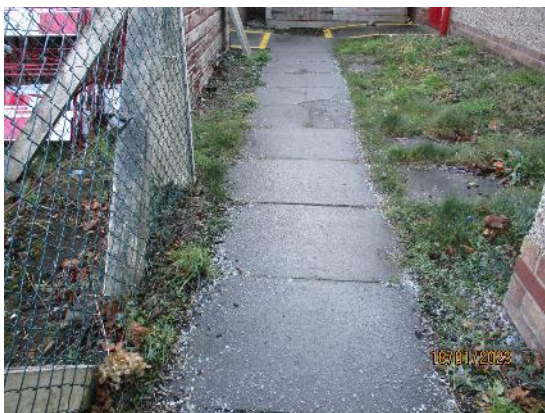
- Paving slab footpaths cracked and broken.
- Playground drainage is blocked.
- Playground shelter requires concrete and brickwork repairs.

295. Paving slab footpaths

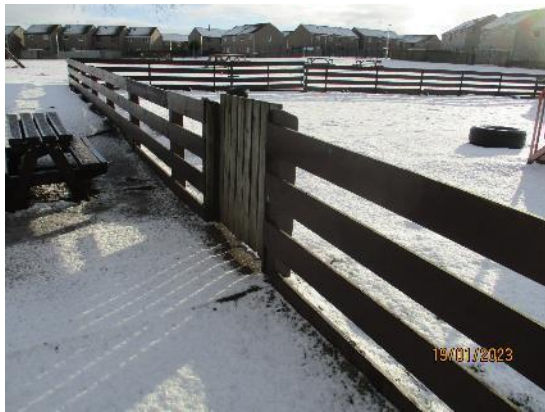
297. Timber post and rail fencing

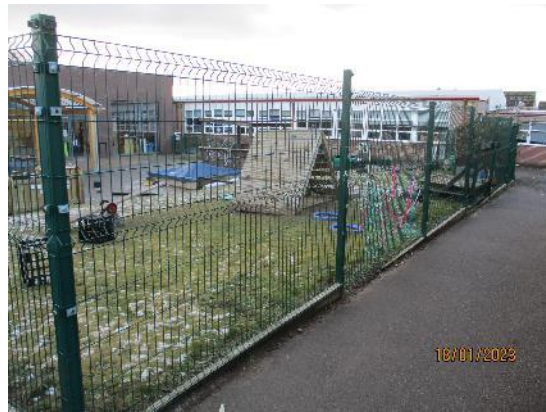
298. Security mesh fencing

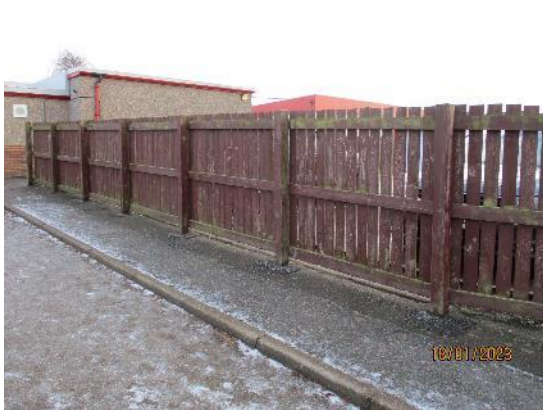
305. Timber boarded fencing

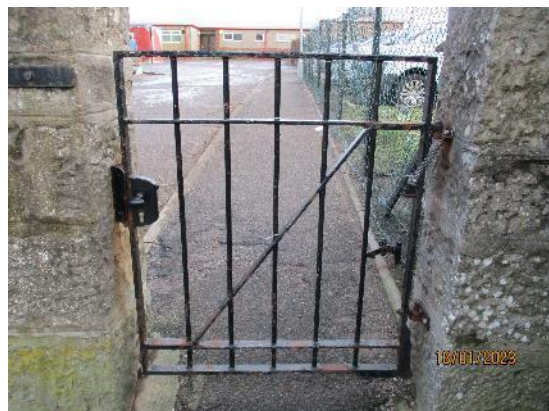
308. Metal bar gates

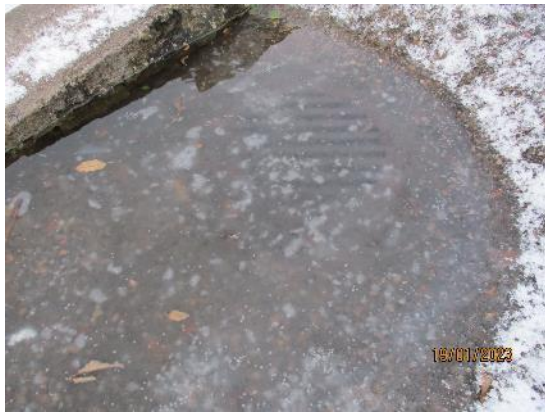
315. Blocked, flooded drainage
