# **Summary Building Condition Survey Report**

**Mosstowie Primary School**  
**Miltonbrae, Milntonduff, Elgin IV30 8TY**

**3<sup>rd</sup> April 2023**

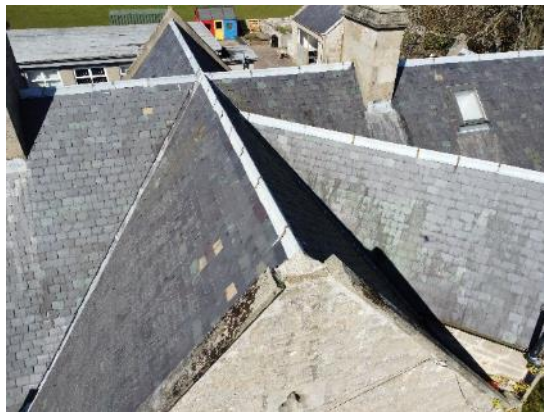
4. Slate roofs and zinc ridge

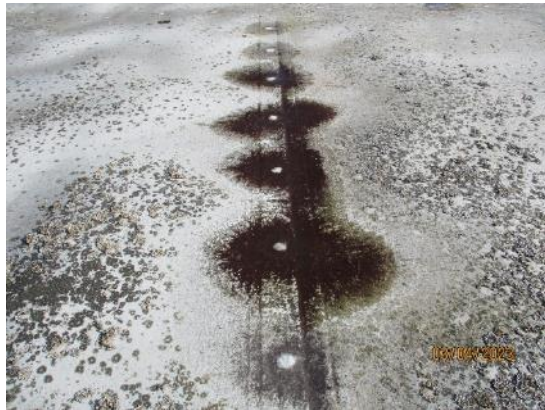
9. Fixings are raised and pronounced

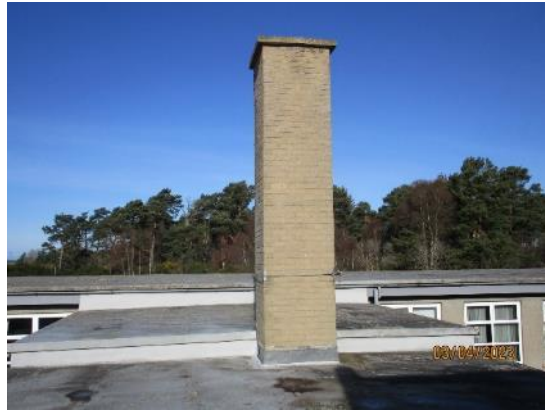
26. Brick boiler flue

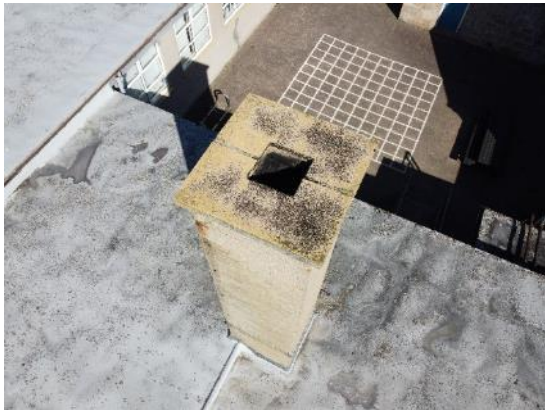
27. Concrete coping to boiler flue

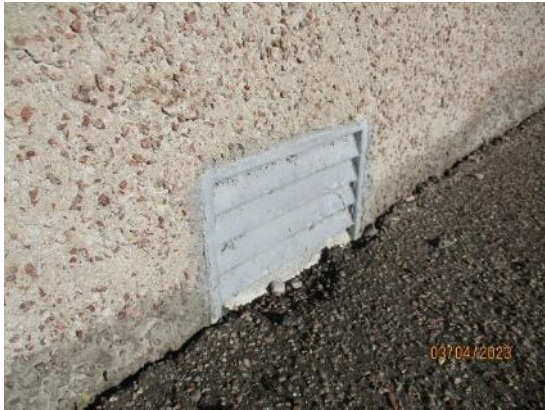
30. Under floor vents

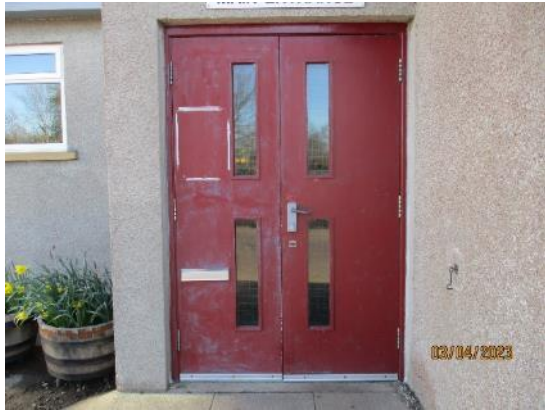
36. Timber front entrance doors

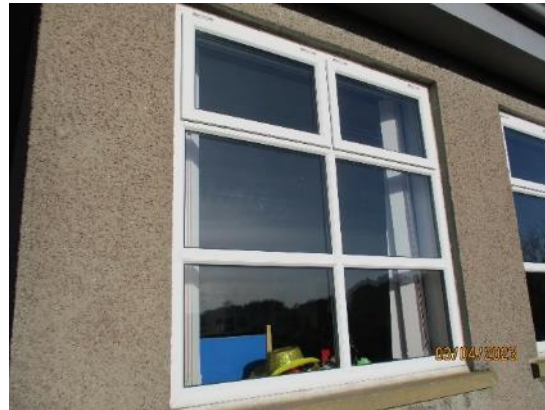
39. Large UPVC windows

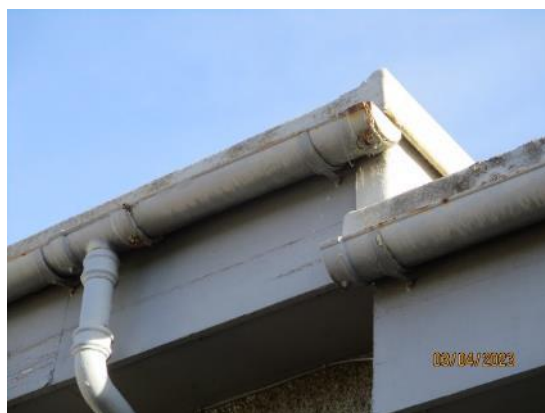
47. Cast iron rainwater goods

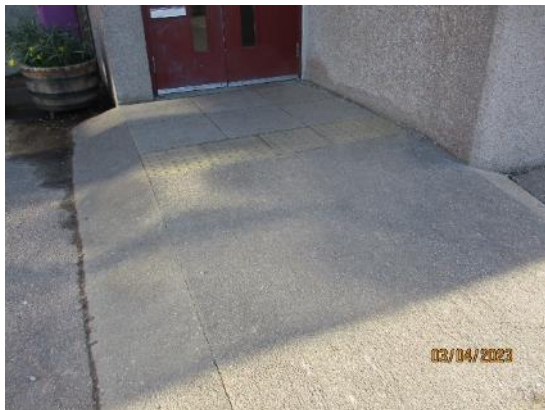
49. Concrete ramp to front entrance

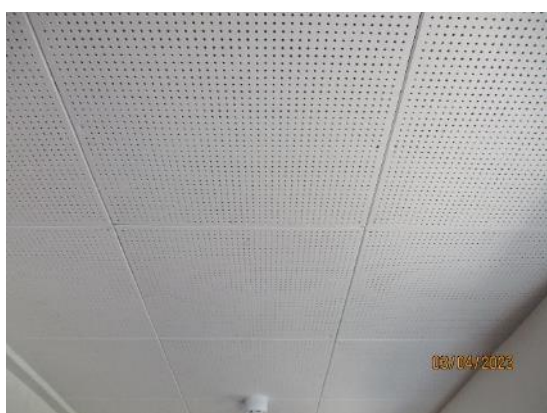
63. Fixed fibre tiles to most areas

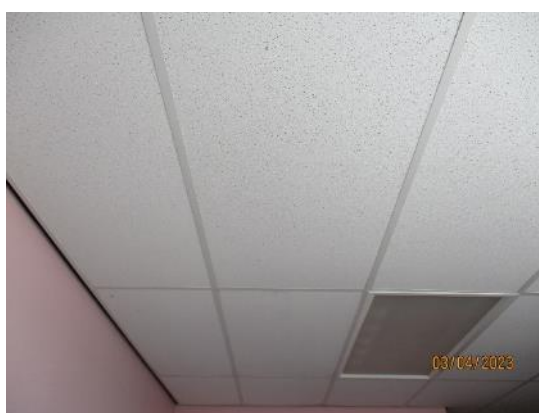
64. Suspended ceiling tiles to pupil toilets

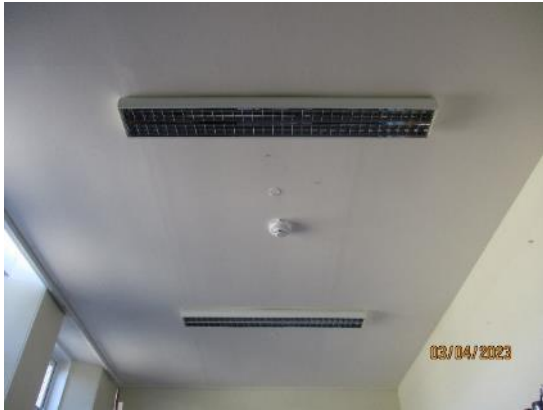
65. Lath and plaster ceilings in the old building

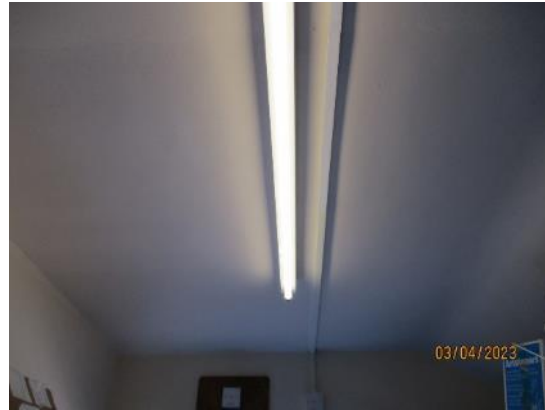
66. Lath and plaster ceiling in the external store

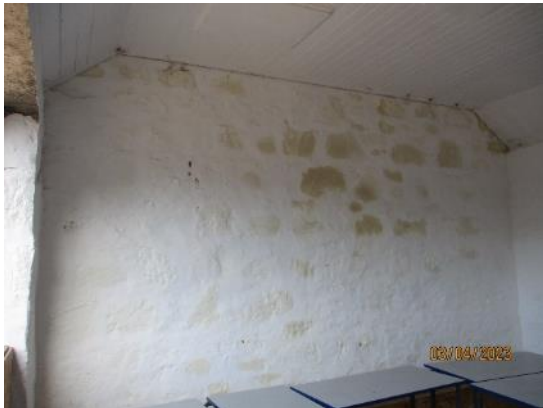
67. Timber linings to the ceiling in the external shelter

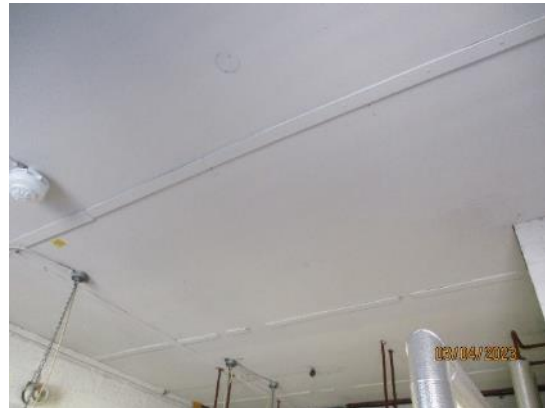
68. Sheeting with asbestos content in the Boiler Room

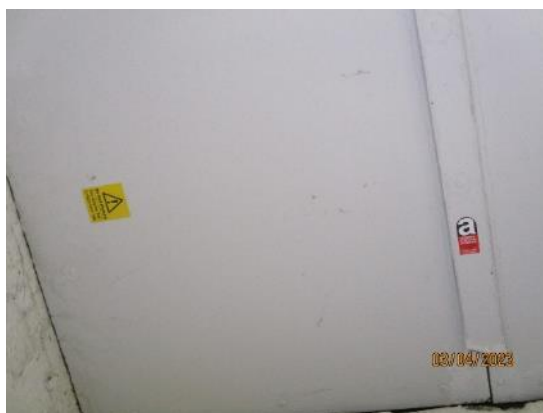
69. Labelling on ACM sheeting in the Boiler Room

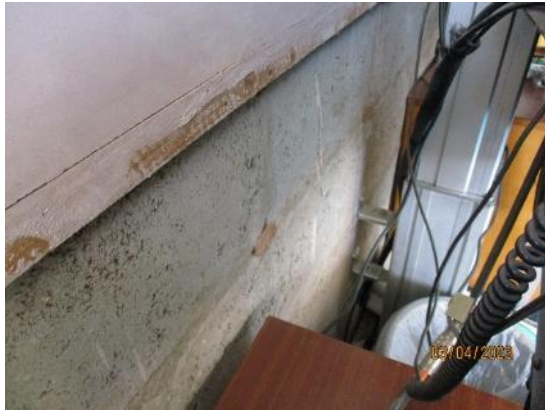
71. Blockwork internal walls

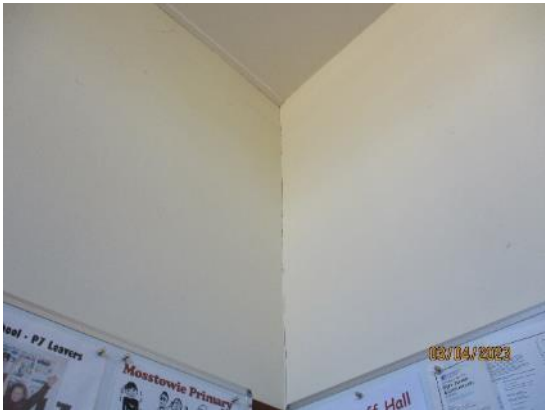
73. Lath and plaster walls

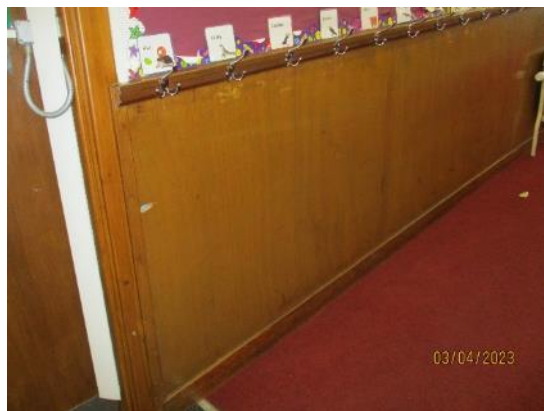
76. Timber panelling at low level

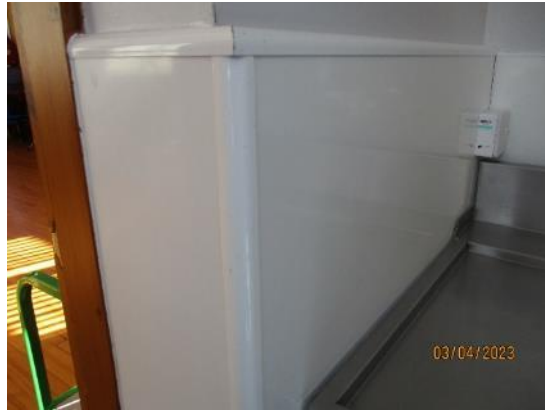
78. Wetwall in commercial kitchen

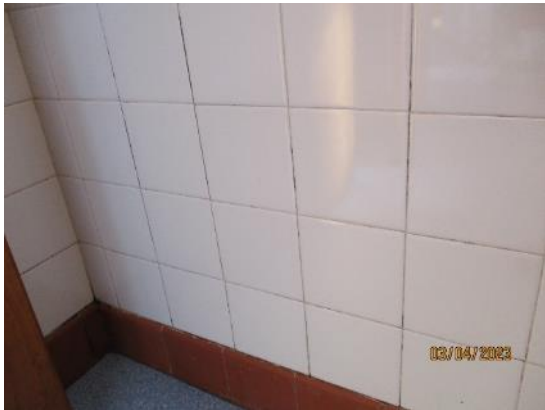
79. Ceramic tiles with soiled grouting

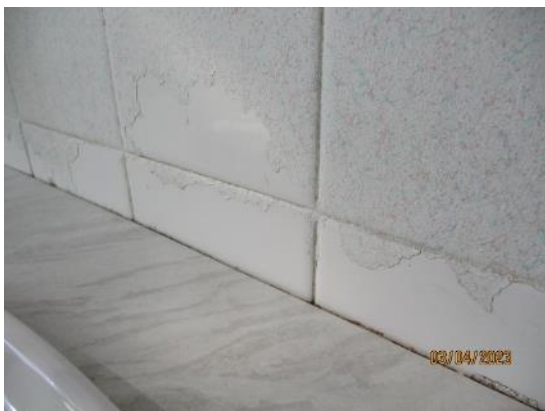
81. Ceramic tiles with paint finish peeling

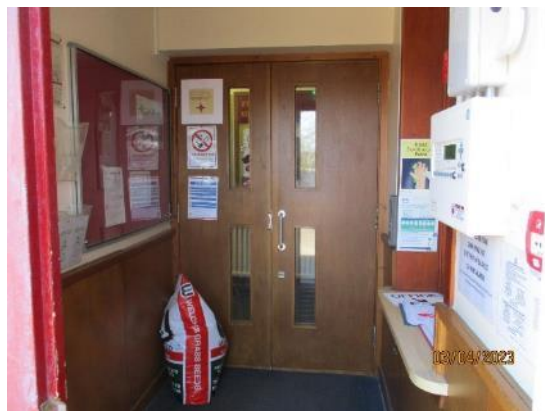
82. Timber double doors in corridor

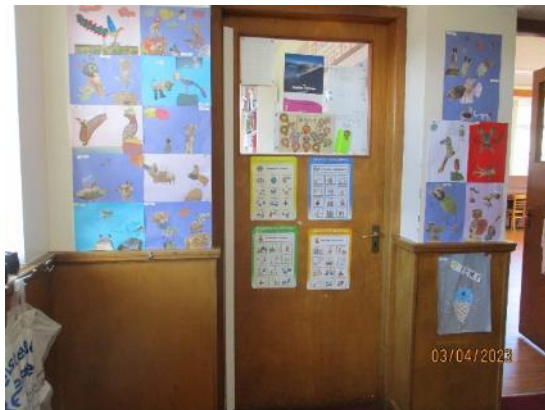
85. Timber hollow core classroom door

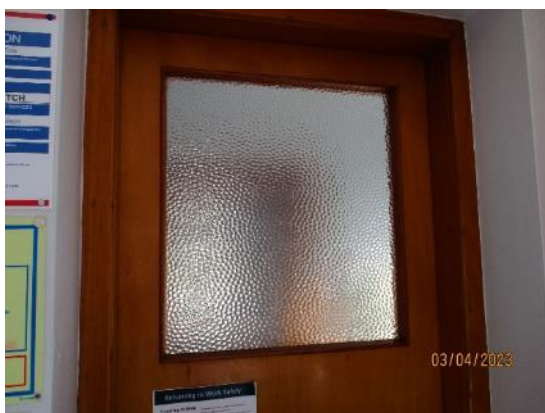
87. Glazing to classroom doors

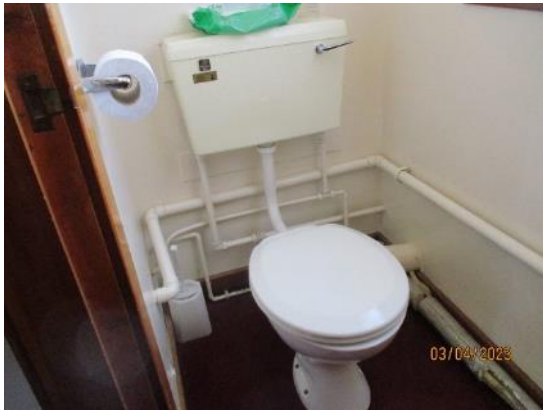
91. Staff WC with plastic cistern

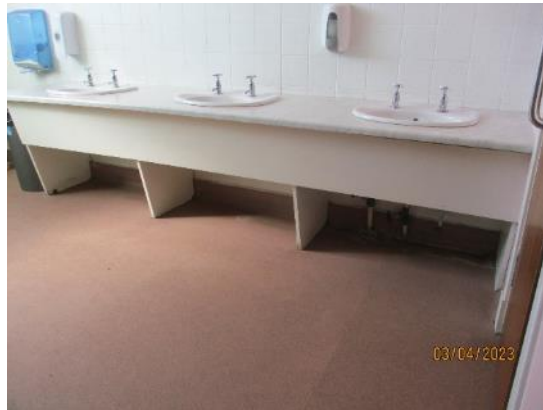
98. Basin vanity units

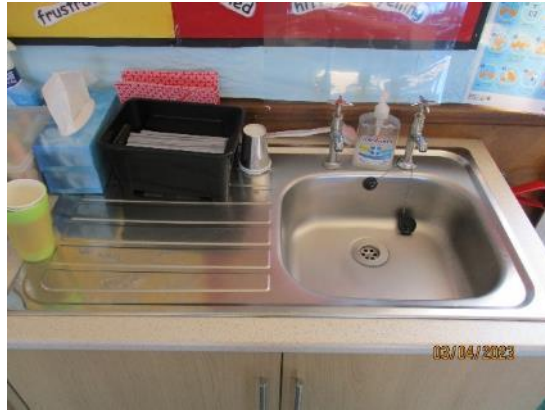
102. Stainless steel sinks in classrooms

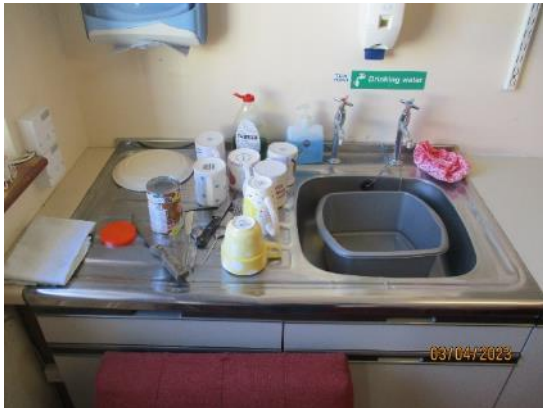
103. Stainless steel sink in Staff Room

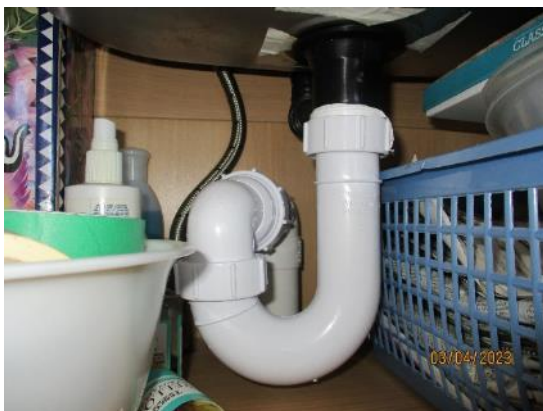
105. PVC waste pipes

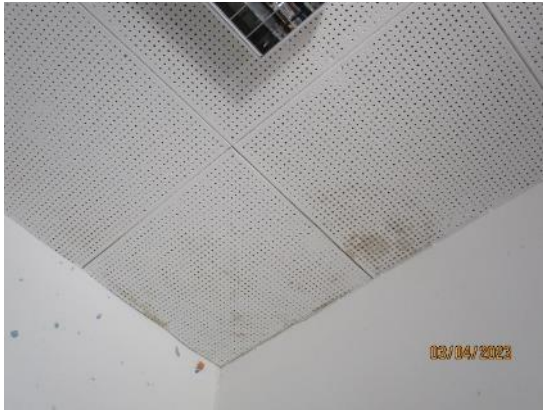
106. Water marked ceiling tiles

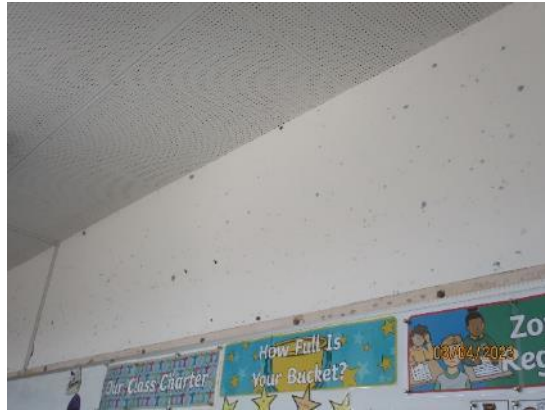
107. Marked plaster walls

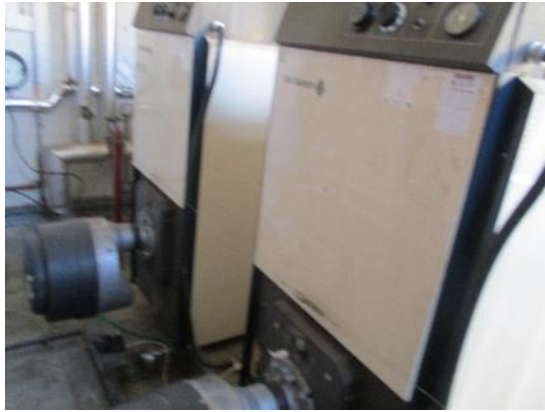
112. Oil fired boilers – Boiler house 0/14

- The heat sources and heating system are life expired and should be considered for replacement.
- Heating system controls are life expired and should be considered for replacement.

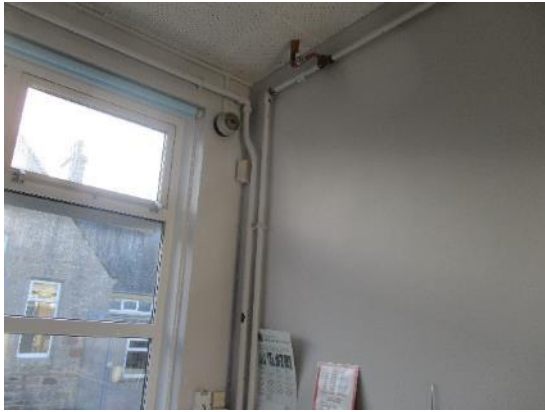
124. Pipework – hot water distribution kitchen 1/11

- Oil tank, related pipework and controls are life expired and should be considered for replacement.
- Hot and cold water distribution pipework is life expired and should be considered for replacement with all pipework being insulated.

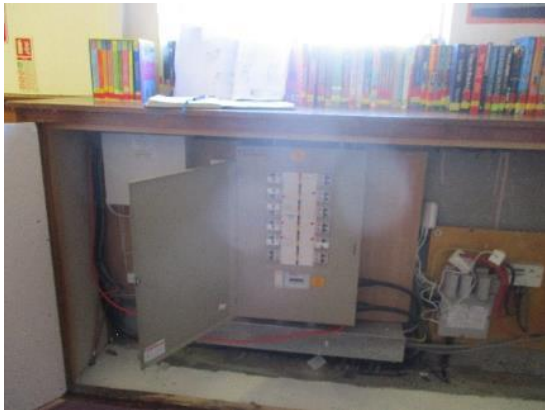
132. DB (main) Corridor 1/2 cupboard

- The electrical installation, comprising distribution boards, sub mains and general wiring and accessories are life expired and should be considered for replacement.

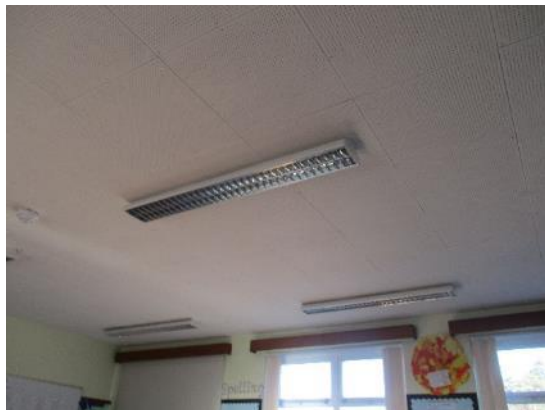
138. Lighting – Classroom typical

- A significant percentage of the lighting is life expired and should be considered for replacement. All other existing lighting should be considered for upgrade to LED fittings and energy saving automatic controls.

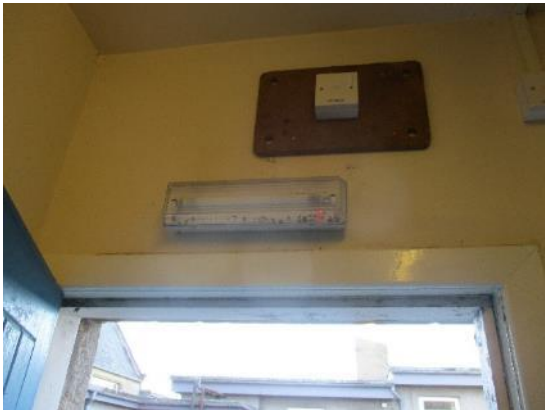
144. Emergency light 1-15a Store

- Emergency lighting only provides a small amount of coverage of the building internal spaces and is recommended to be reviewed via the fire risk assessment.

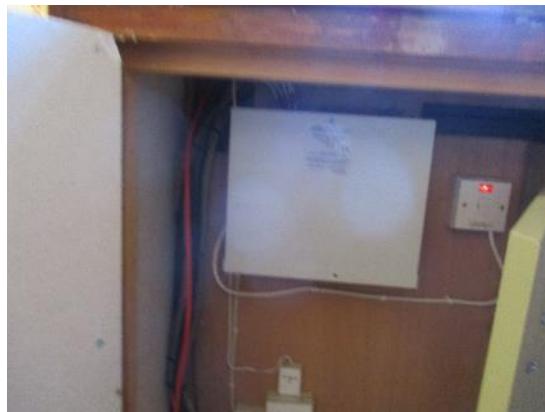
151. Intruder alarm control panel 1/2 cupboard.

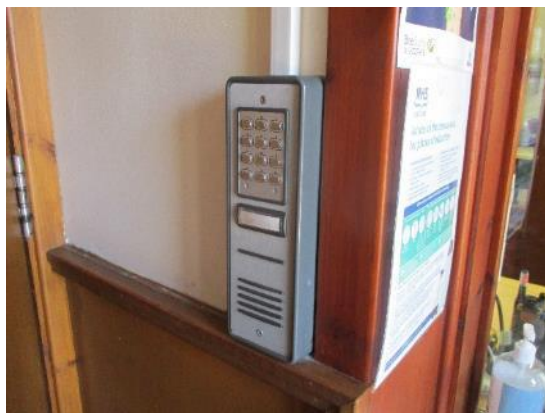
152. Door access audio and keypad 1/1 lobby.

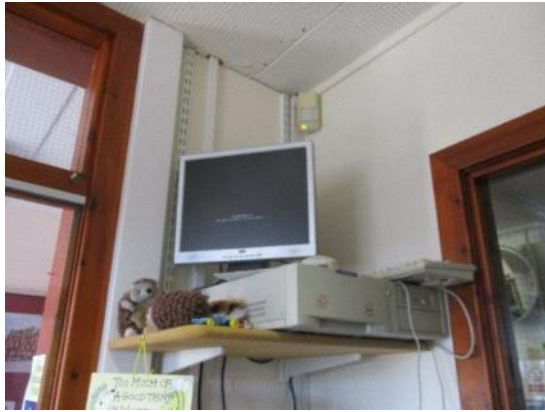
154. CCTV Monitor and processor office 1/8

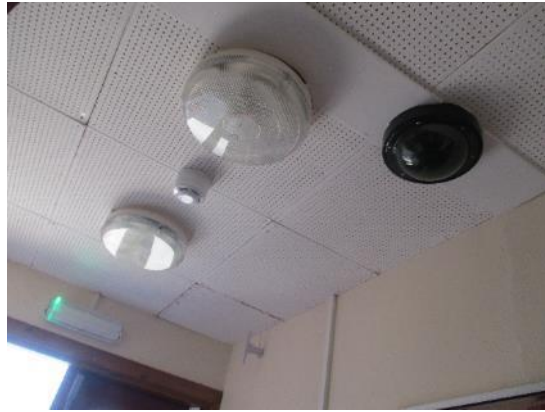
155. CCTV fixed camera 1/1 entrance lobby.

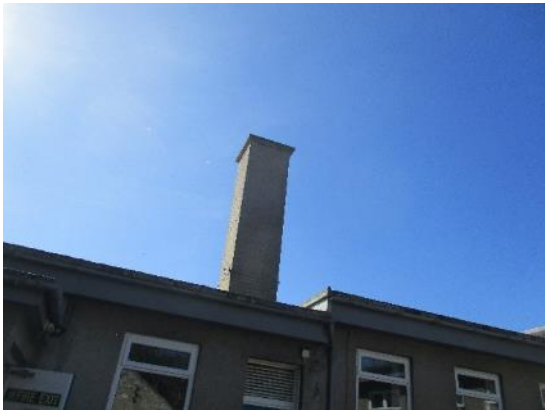
156. Boiler chimney – side view.

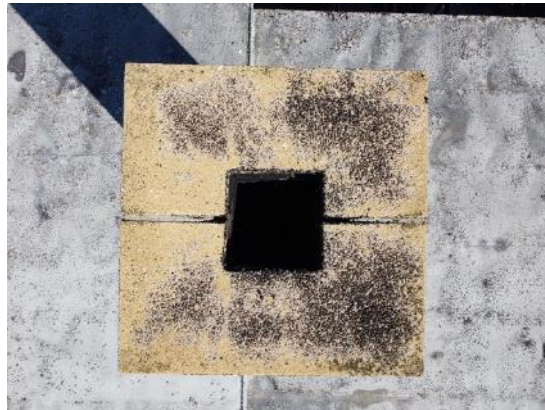
157. Boiler chimney termination. Aerial view from drone

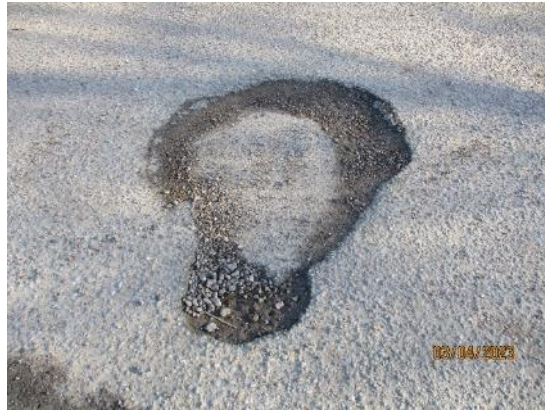
161. Potholes in tarmacadam

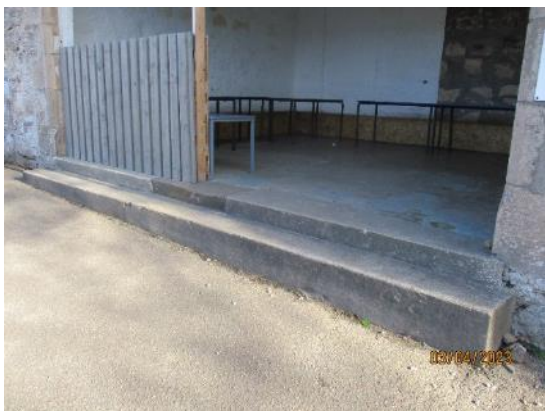
170. Concrete steps to external shelter

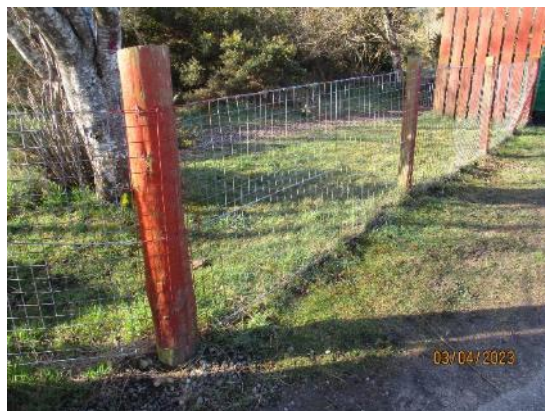
171. Timber post and wire mesh fencing

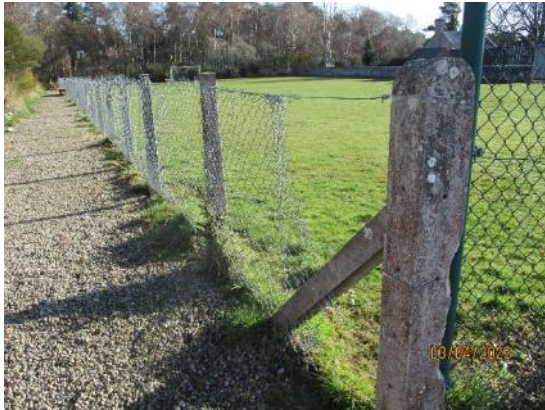
172. Concrete post and chain link fencing

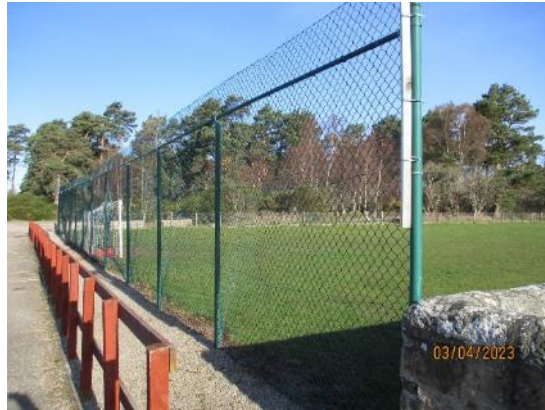
173. High chain link fencing

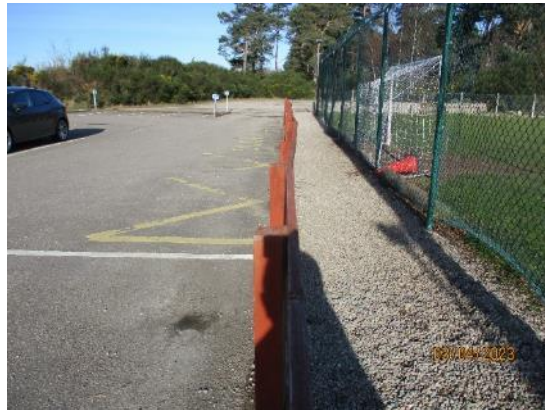
175. Some posts leaning

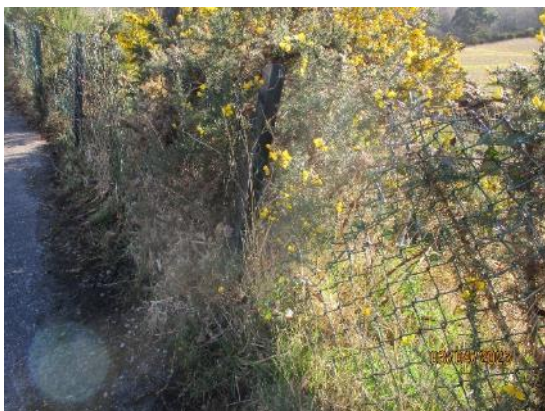
176. Galvanised post and chain link fence

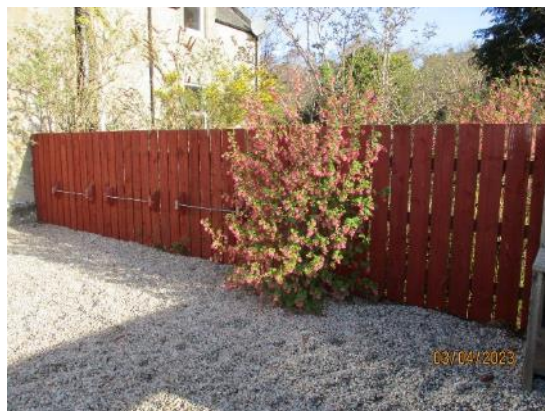
177. Timber boarded fence

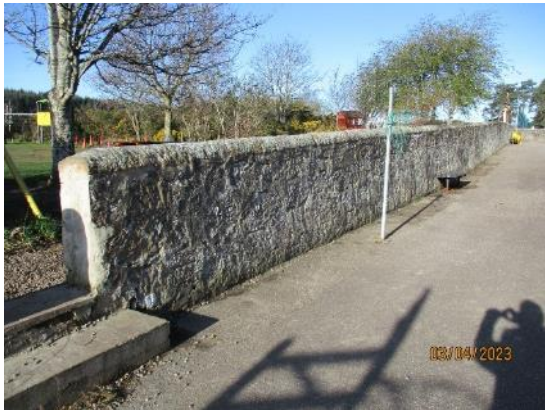
180. Natural stone playground perimeter wall

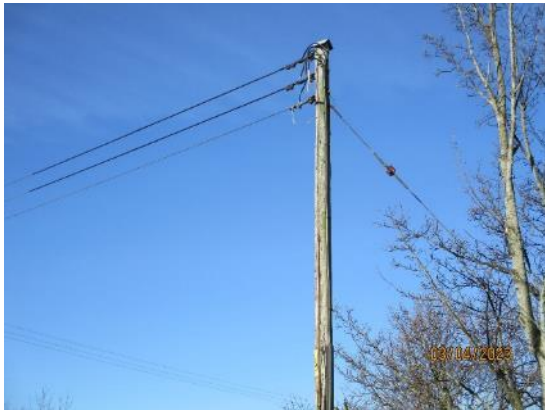
186. Timber utility pole with power lines

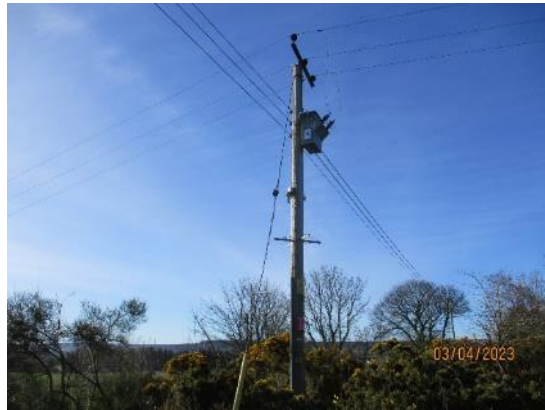
187. Timber utility pole with transformer
