# **Summary Building Condition Survey Report**

**Greenwards Primary School**

**Edgar Road, Elgin IV30 6UQ**

**28<sup>th</sup> & 29<sup>th</sup> November 2022**

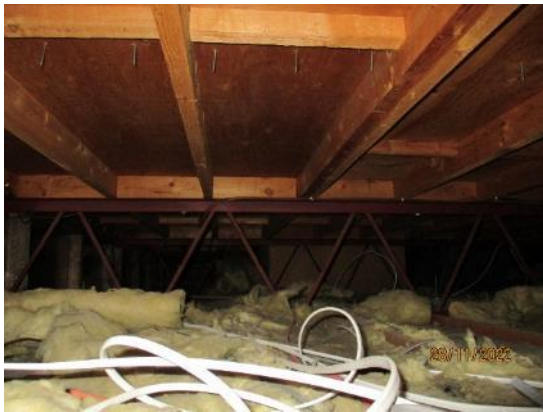
1. Steel lattice trusses and timber framed decking

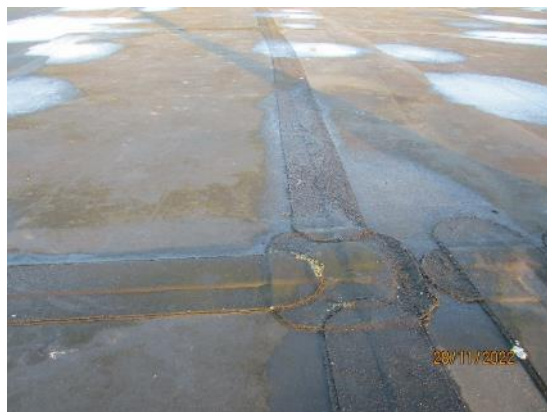
4. Previous patch repairs

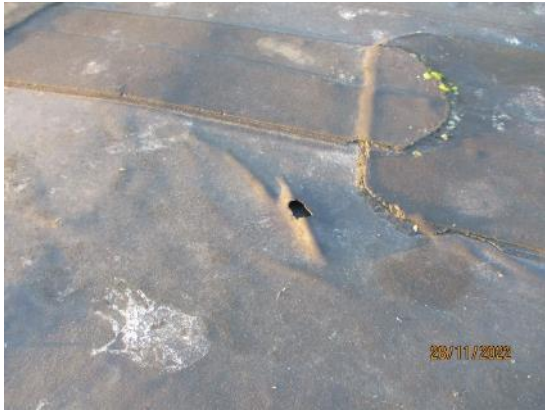
7. Holes in surface

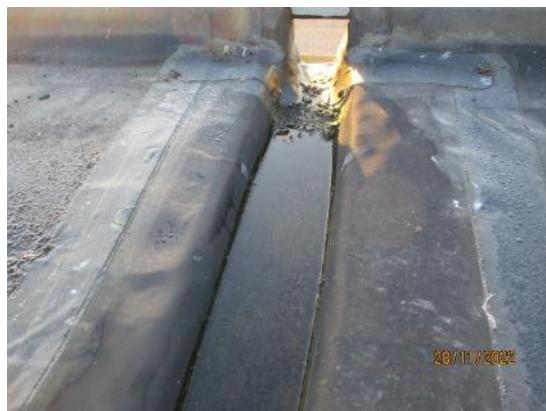
12. Box gutters blocked

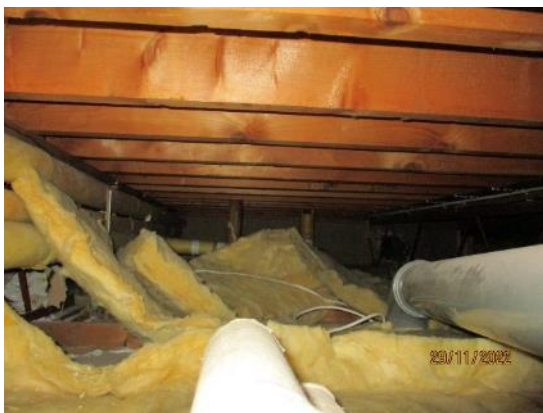
17. Thin, inadequate insulation

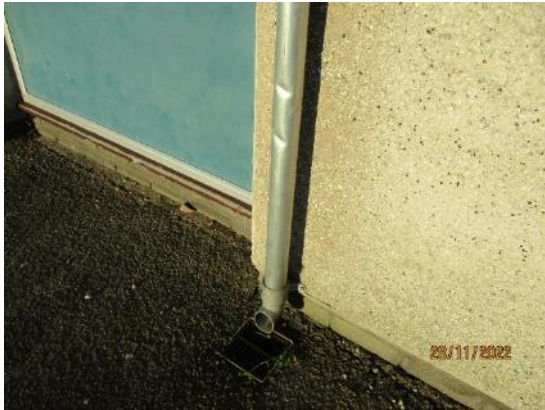
25. Minor surface damage

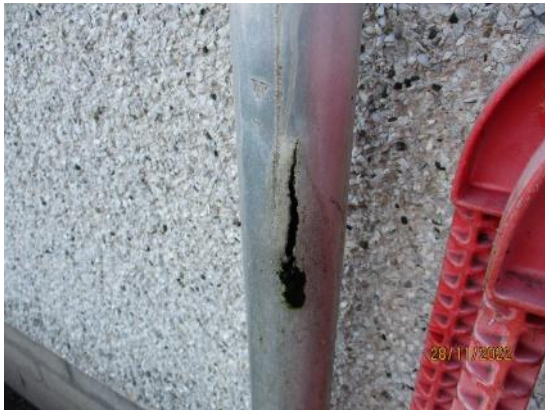
27. Split in aluminium downpipe

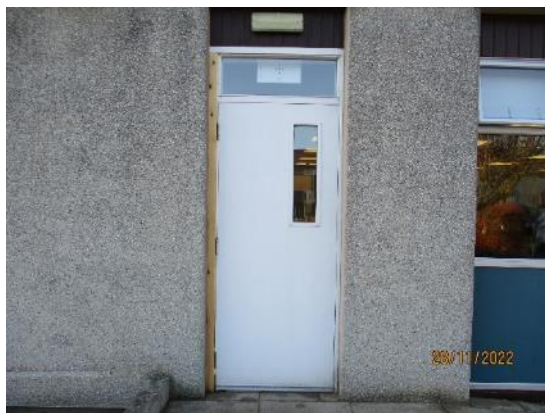
34. Timber fire exit doors

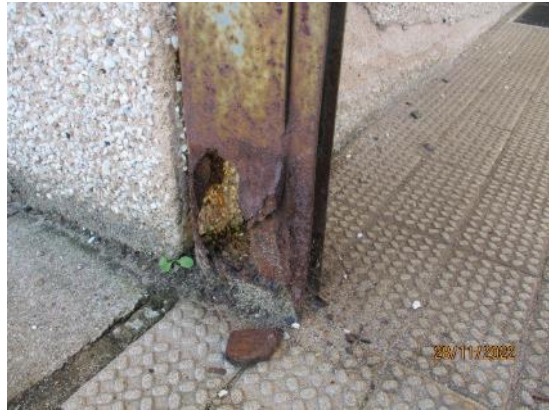
37. Extensive corrosion of steel guide rails

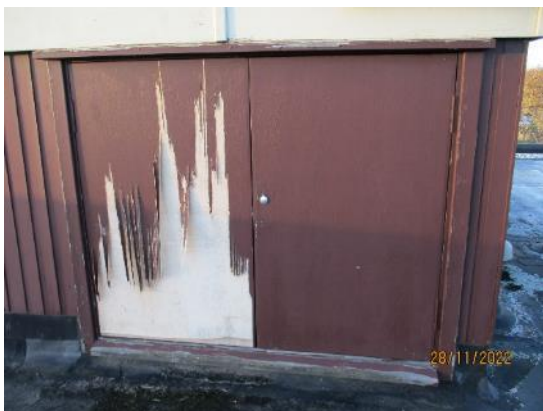
40. Timber tank house doors

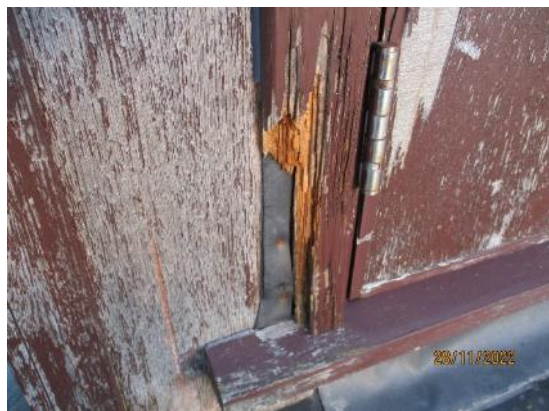
41. Rot in door frames

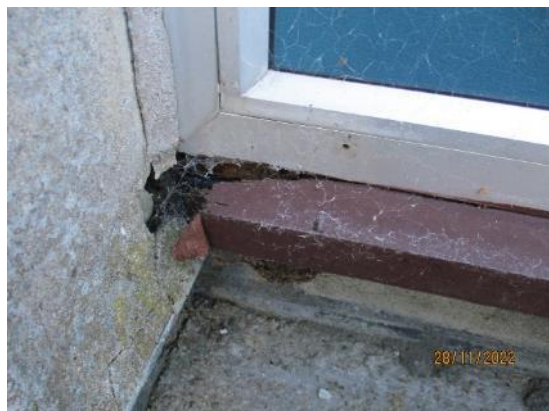
47. Rot in timber sills

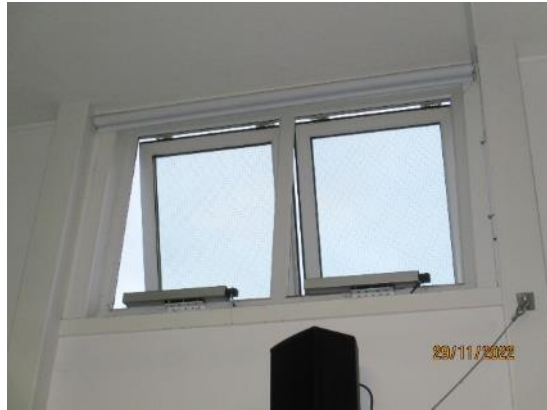
49. Electrically operated UPVC windows

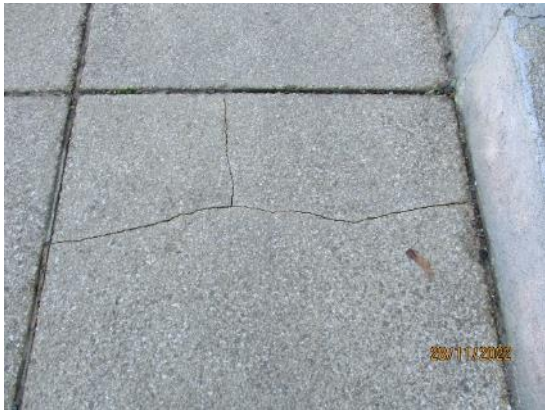
61. Broken paving slabs

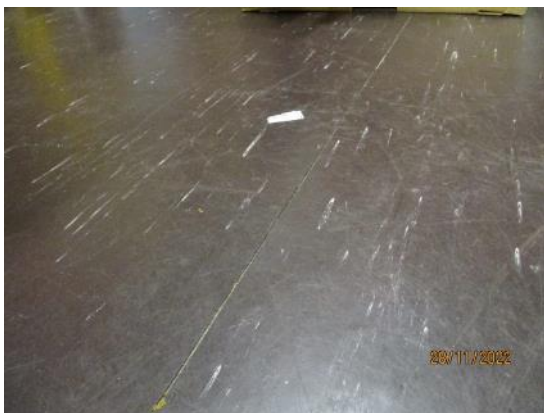
68. Sheet vinyl – open joints

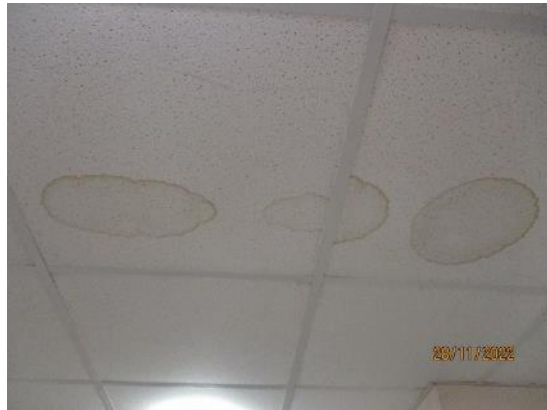
73. Water marked ceiling tiles

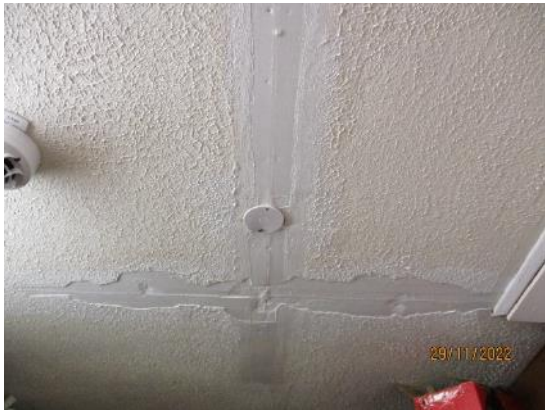
78. Damage to textured ceiling finish

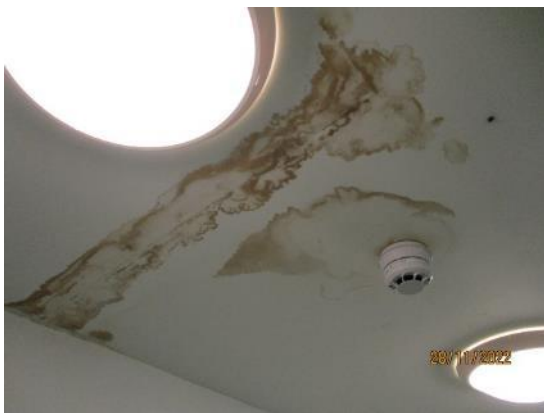
80. Water marked Plasterboard ceilings

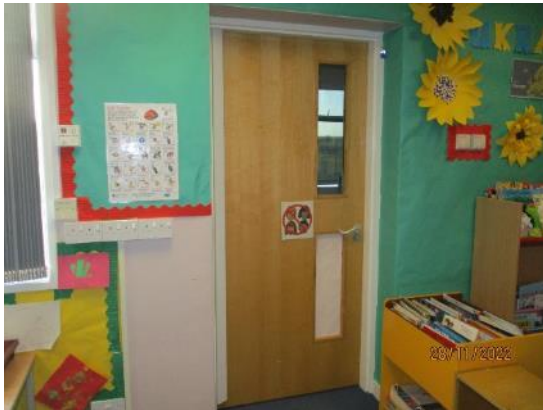
95. Veneered timber doors

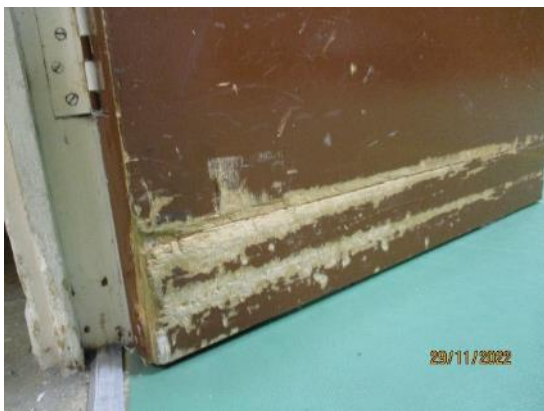
97. Damage to timber doors

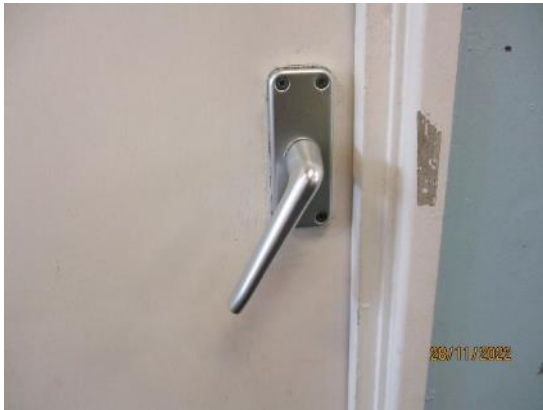
101. Faulty door handles

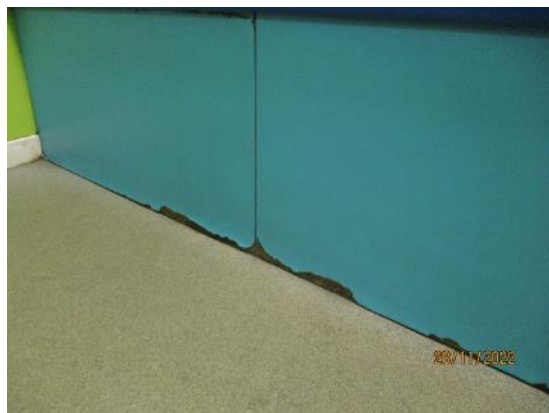
115. Damaged base units

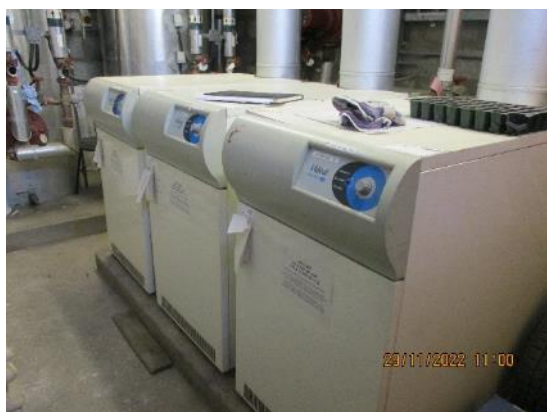
131. Gas boilers – main school plant room 1/54

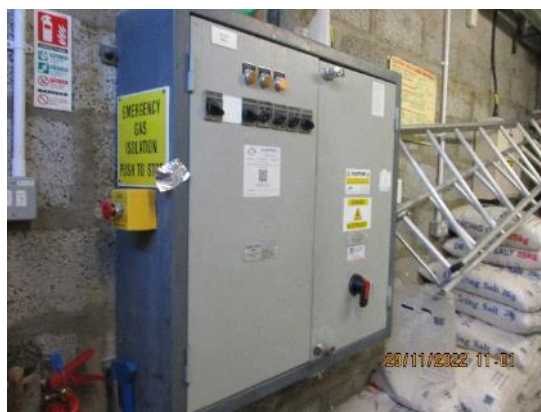
132. Heating control panel main school 1/55

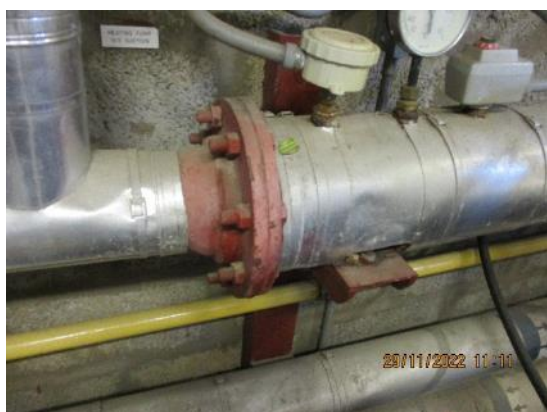
133. Heating pipework – main school 1/54

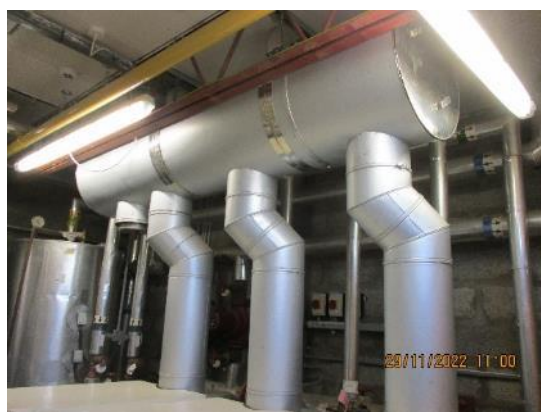
134. Boiler flues – main plant room 1/55

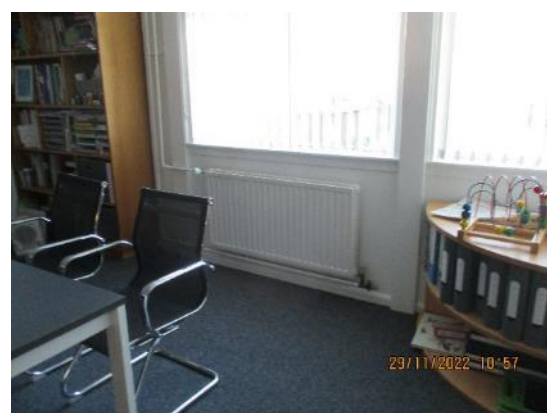
135. Radiator – steel panel. Main school 1/5

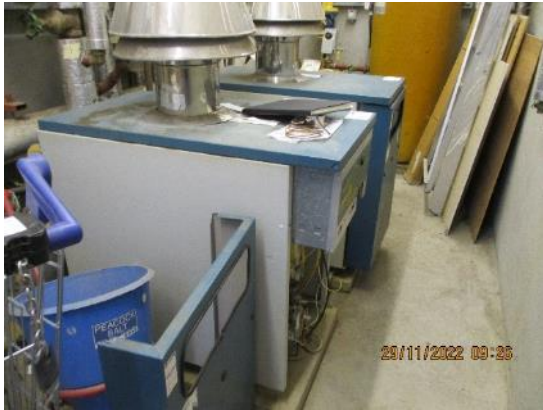
137. Boilers – SEN extension 1/54

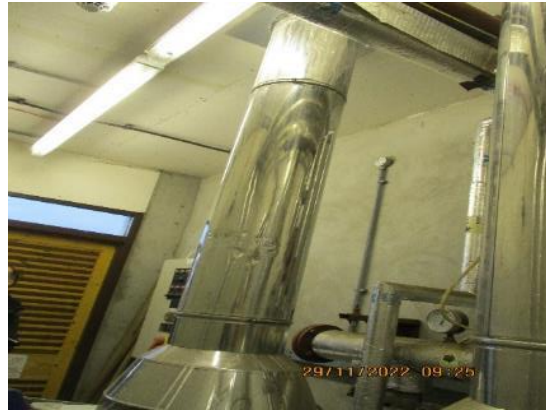
138. Flue – boilers SEN extension 1/54

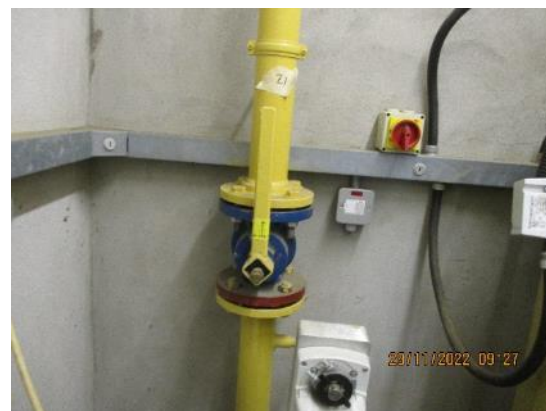
142. Gas isolation valve – SEN plant room 1-54

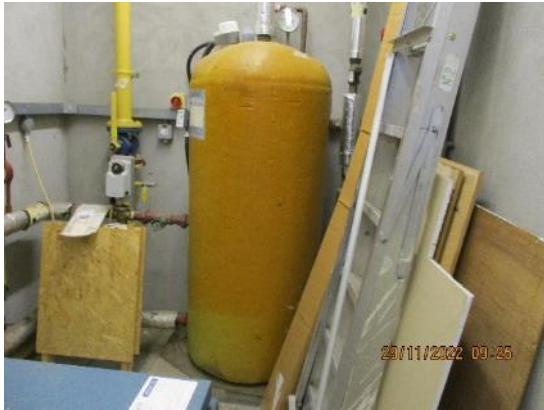
143. Hot water calorifier – SEN plant room 1/54

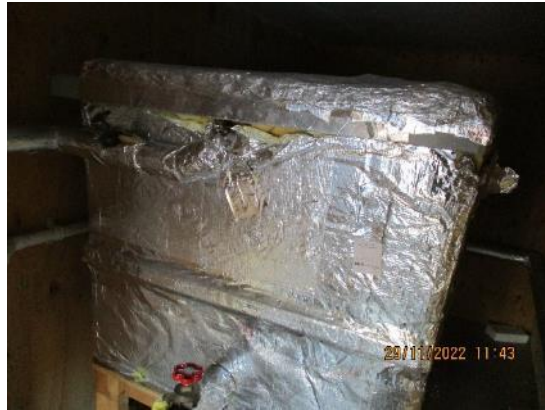
144. Cold water storage tank. SEN zone roof housing.

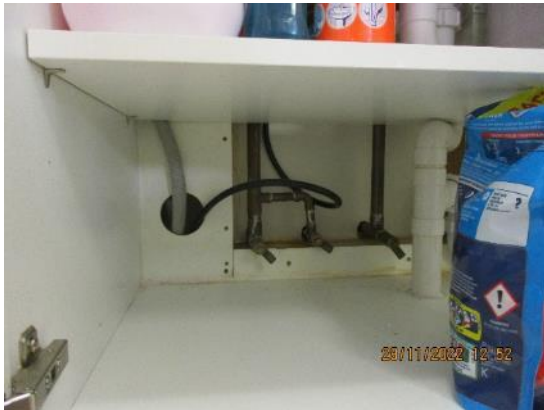
145. Pipework – hot and cold copper SEN kitchen

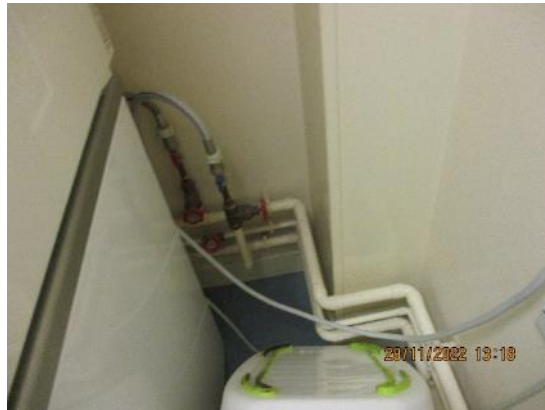
146. Pipework hot and cold. Copper – SEN laundry.

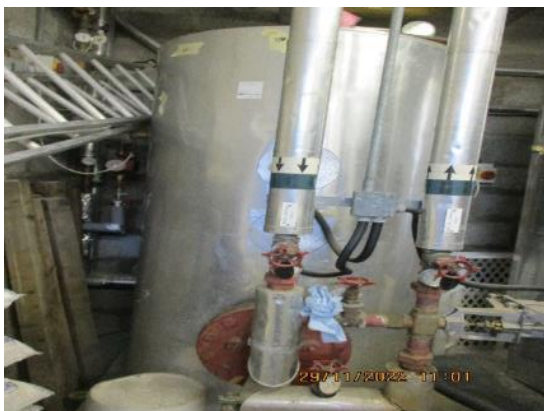
147. Hot water calorifier 1 – main school 1/55

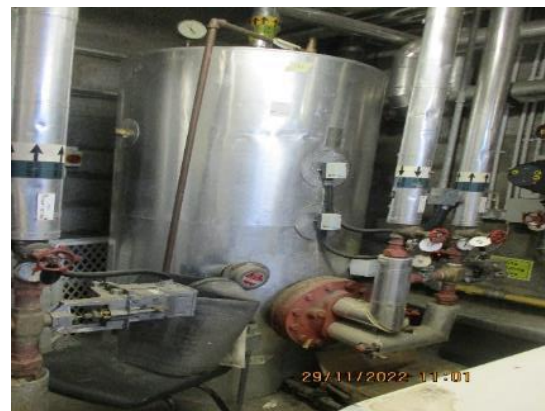
148. Hot water calorifier 2. Kitchen. Main school 1/55

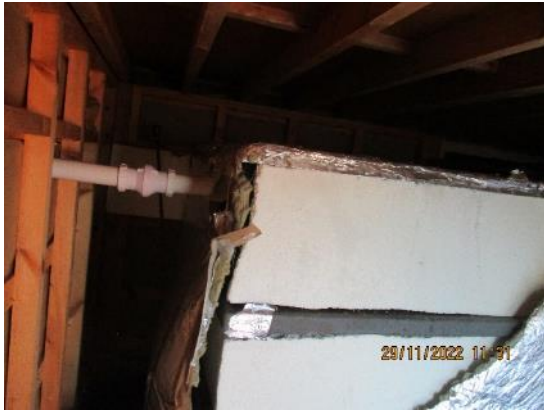
149. Cold water tank 4. Main school roof housing.

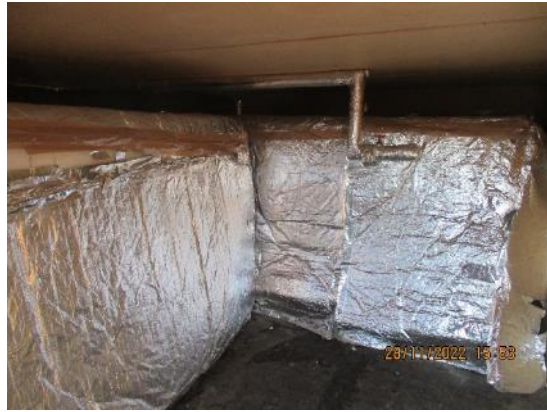
150. Cold water tanks 1+2. Main school. Roof housing.

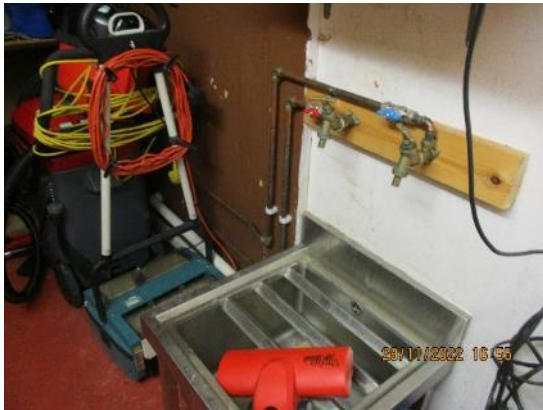
151. Pipework – hot and cold. Main school Cleaners store 1/23.

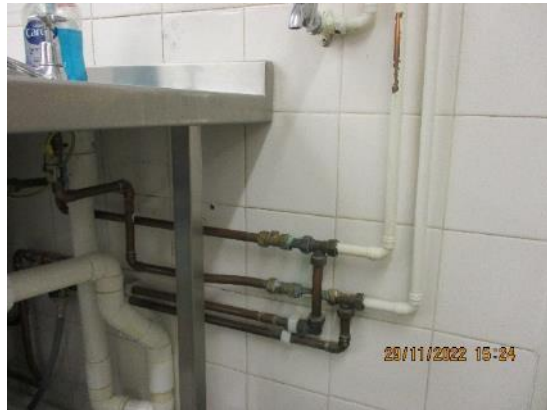
152. Pipework – hot and cold. Main school kitchen.

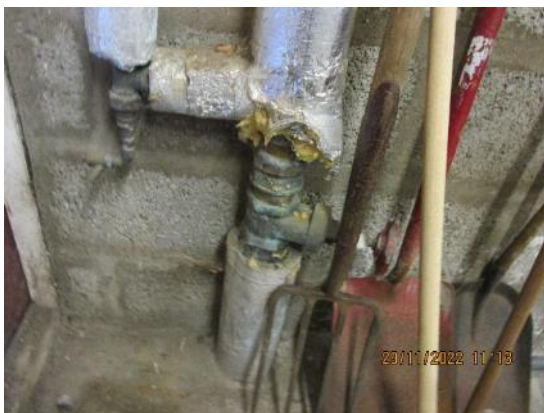
153. Pipework. Cold water mains entry to plant room 1/55

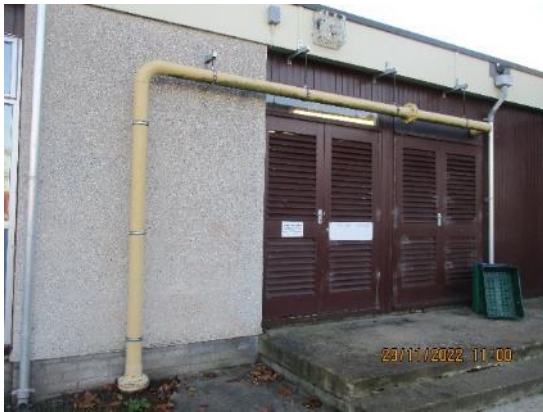
155. Gas pipe entry to main plant room 1/55

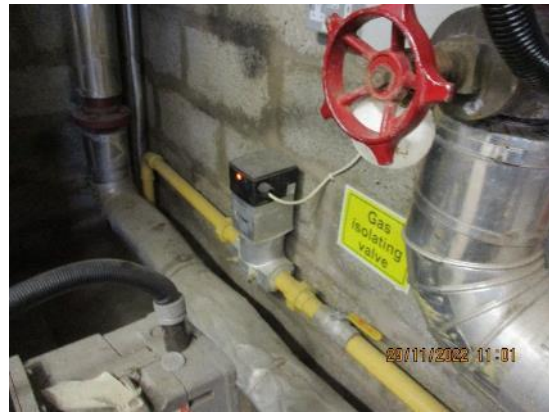
156. Gas pipework and solenoid control valve to kitchen. Located in 1/55.

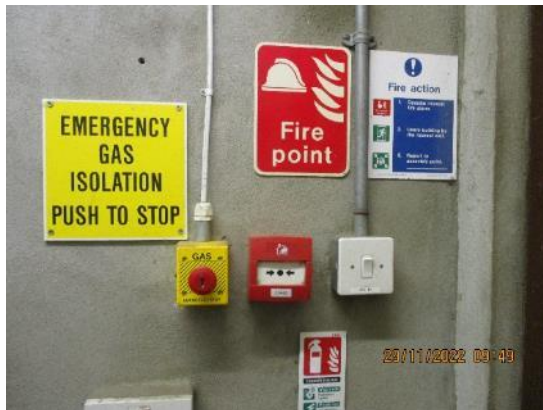
157. Gas safety stop button. Plant room 1/54

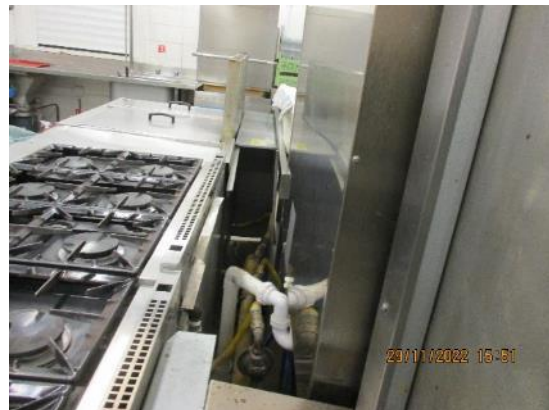
158. Gas range and pipework. Main kitchen.

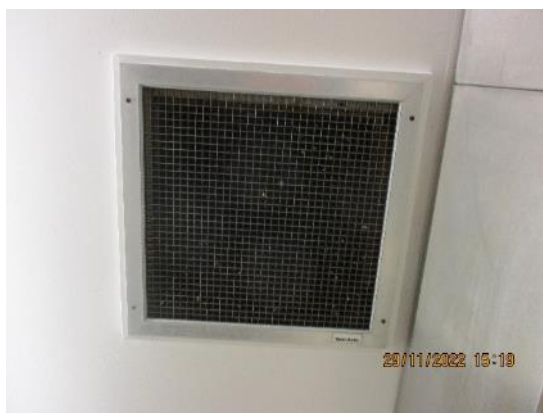
159. Extract fan. Dishwasher steam – main kitchen.

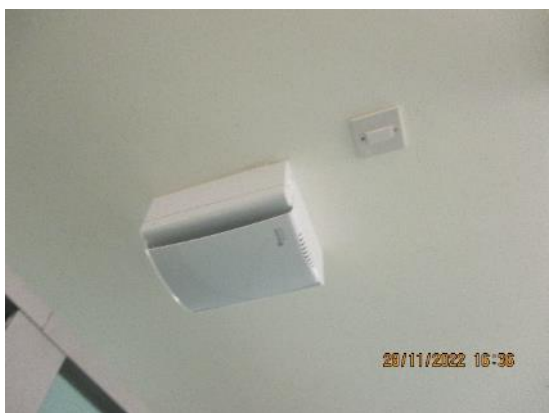
160. Extract fan. Boys toilets 1/38

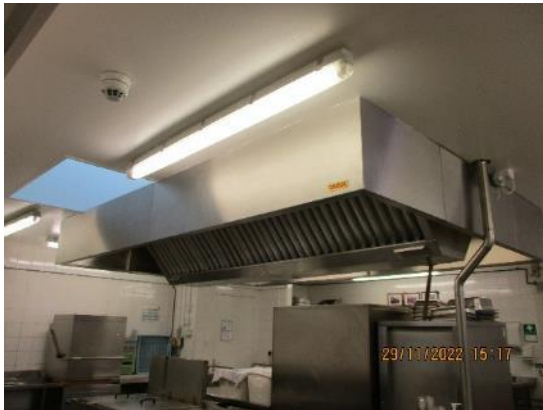
163. Extract canopy. Main kitchen.

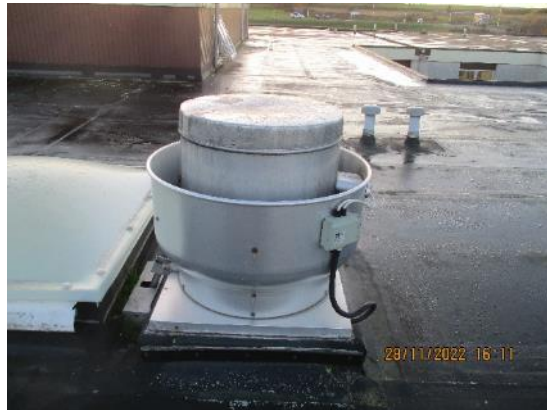
164. Extract fan. Kitchen canopy – roof mounted.

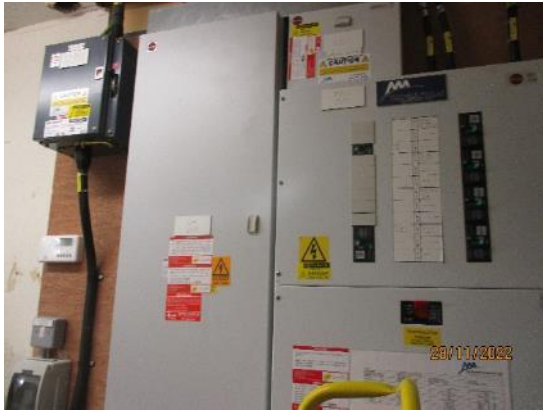
167. Distribution boards and switchgear 1/19

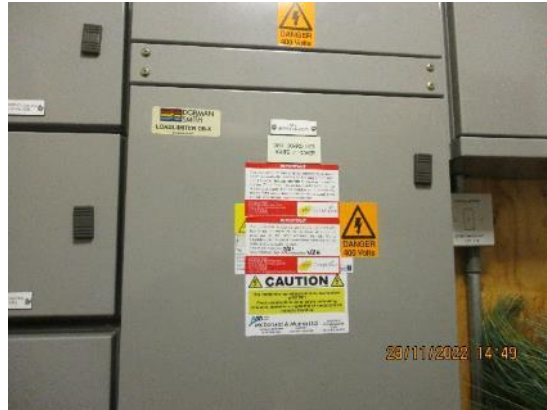
168. Distribution boards 1/41 SEN

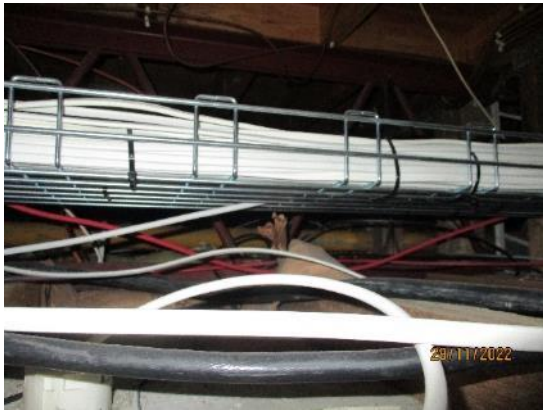
169. General wiring main school ceiling void.

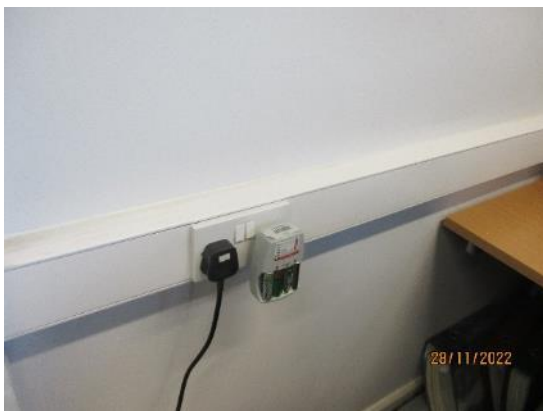
171. Sockets and dado trunking – main school typical.

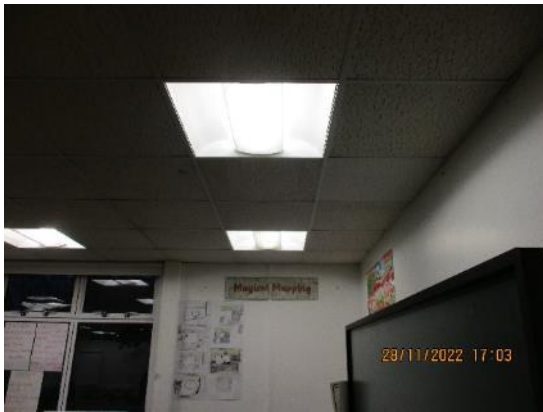
173. Lighting – classroom typical.

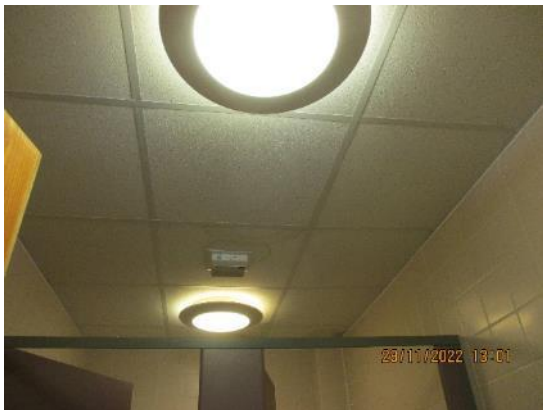
174. Lighting – store typical.

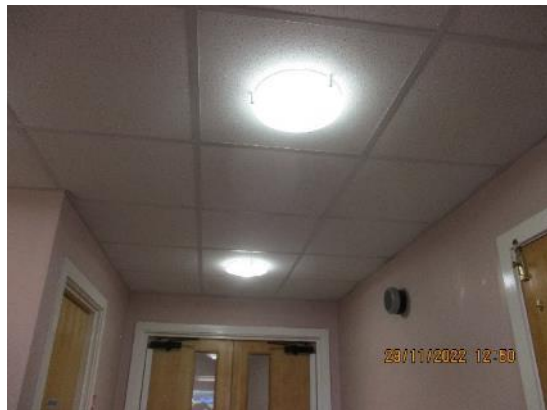
175. Lighting – toilets typical.

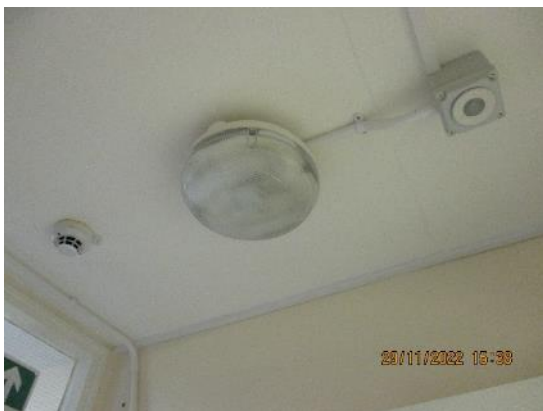
176. Lighting SEN corridor typical.

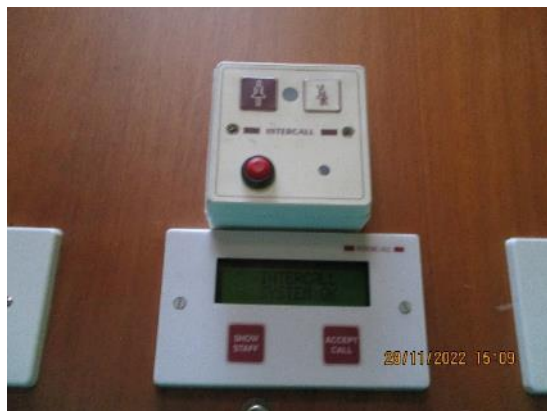
189. Intercall disabled alarm system. Pull chord SEN girls toilets.

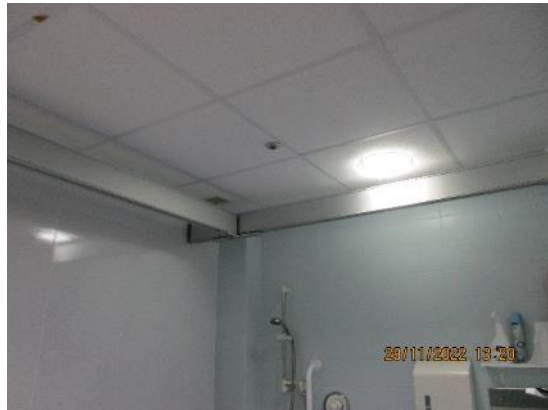
199. Hoist system SEN class 1/52

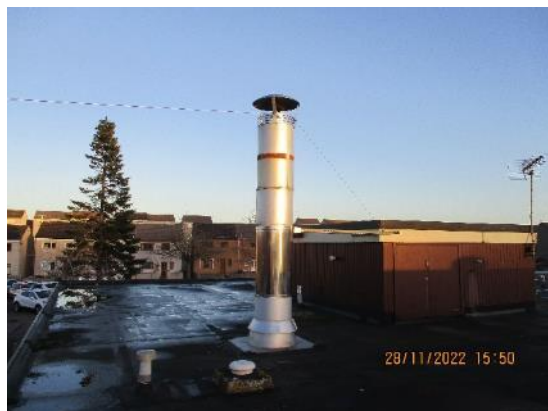
201. Roof extractor fans terminations typical

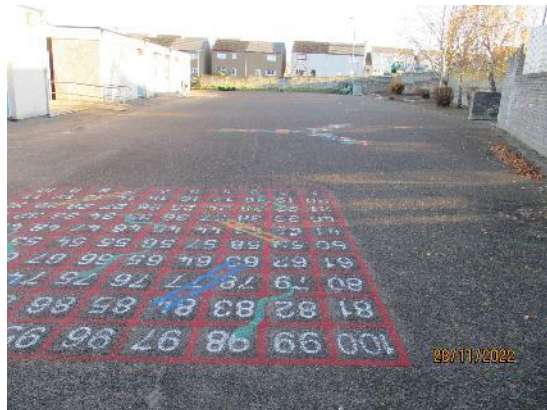
205. Front tarmacadam playground

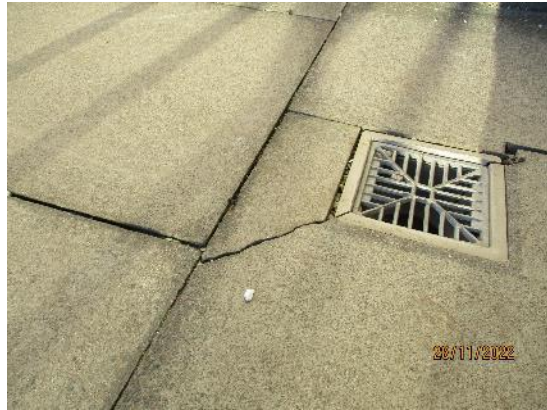
216. Broken paving slabs

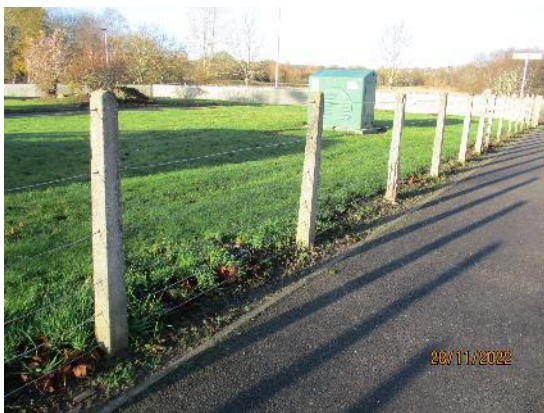
219. Concrete post and wire fence

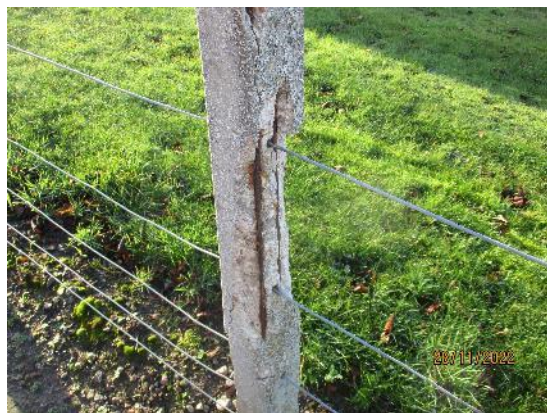
220. Damaged concrete posts

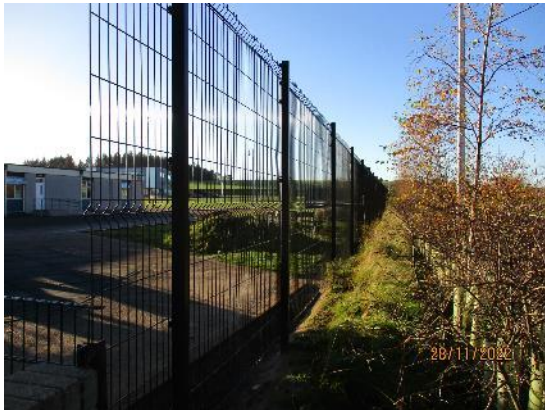
223. High metal security fencing

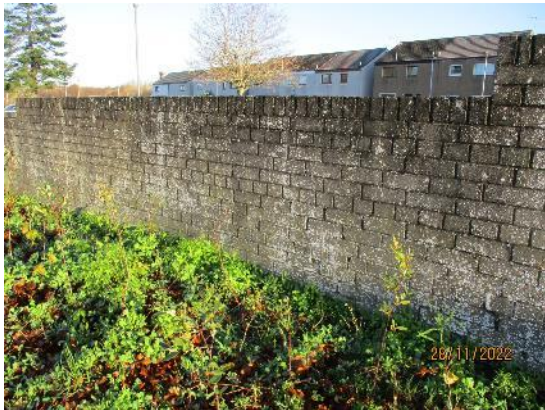
230. Damaged brick wall to rear ramp
