ARTHURS BRIDGE

Principal Inspection Report

B234M205-J-ART-STR-REP-PIR-0001

A Principal Inspection of Arthur’s Bridge was undertaken by Jacobs on the 11th February 2025. Access to the half joints, suspended and cantilever spans were obtained through the use of an underbridge unit. All elements of the structure were inspected apart from the buried foundations and waterproofing system.

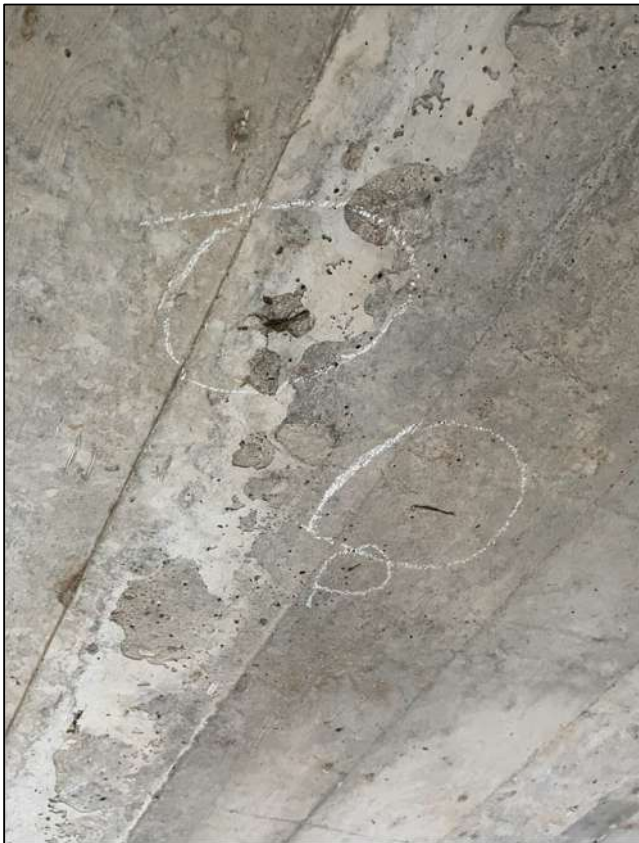
Inspection Findings:	The soffit of the bridge deck was in good condition. Localised spots of corrosion, likely from tying wire were observed, however these were rare across the whole area of the soffit. Additionally, some bird's nests were also noted on the structure.
Supporting Evidence:

<p>Fig 3. Localised spots of tying wire observed in soffit of deck</p>

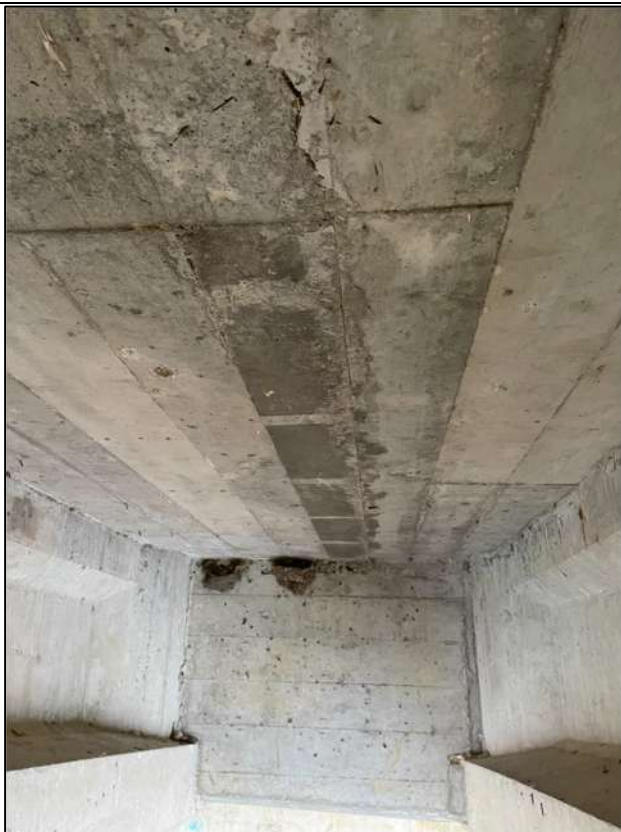
<p>Fig 4. View of soffit with bird's nest visible at crossbeam</p>		
West span	1	A	2.2
BCI: Central span	Severity 1	Extent A	Defect 2.2
East span	1	A	2.2
Defect Description:	Reinforced concrete: No spalls		
Work Required:	Remove bird's nests.		
Works Priority:	2. Recommended before next General Inspection (GI) (2 years)

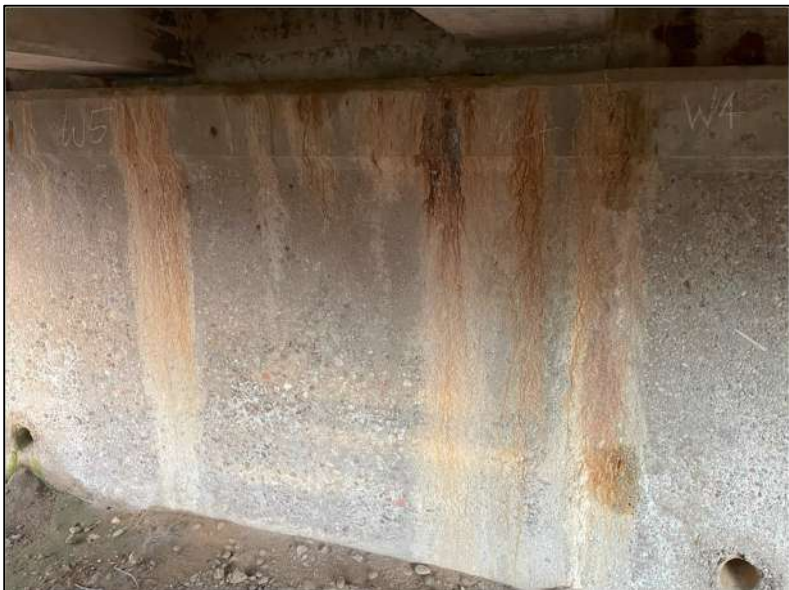
Inspection Findings:	<p>The abutments are in fair condition. There is water staining, sediment build up and dampness at the corners of each abutment. This is due to surface runoff from the road above. There is also some staining on the face of the west abutment.</p> <p>The west abutment shelf had delaminating concrete on the top surface. Additionally, the back wall had small areas of spalling, with corrosion staining visible at these locations.</p>														
Supporting Evidence:

<p>Fig 5. Staining on the west abutment</p> <p>For further photographs of this element refer to Appendix B: Annotated PI General Arrangement Drawings and Appendix C: Photographs from Principal Inspection.</p>														
BCI:	<table border="1"> <tr> <td>Severity</td> <td>2</td> </tr> <tr> <td></td> <td>3</td> </tr> </table>	Severity	2		3	<table border="1"> <tr> <td>Extent</td> <td>B</td> </tr> <tr> <td></td> <td>B</td> </tr> </table>	Extent	B		B	<table border="1"> <tr> <td>Defect</td> <td>2.5</td> </tr> <tr> <td></td> <td>14.2</td> </tr> </table>	Defect	2.5		14.2

Severity	2														
	3														
Extent	B														
	B														
Defect	2.5														
	14.2														
Defect Description:	<p>Reinforced Concrete: Early signs of delamination Waterproofing: Wet surface, drops of water falling and significant staining</p>														
Work Required:	Regular monitoring of concrete deterioration (3 monthly)														
Works Priority:	4. Monitor – Active monitoring and recording of defect.

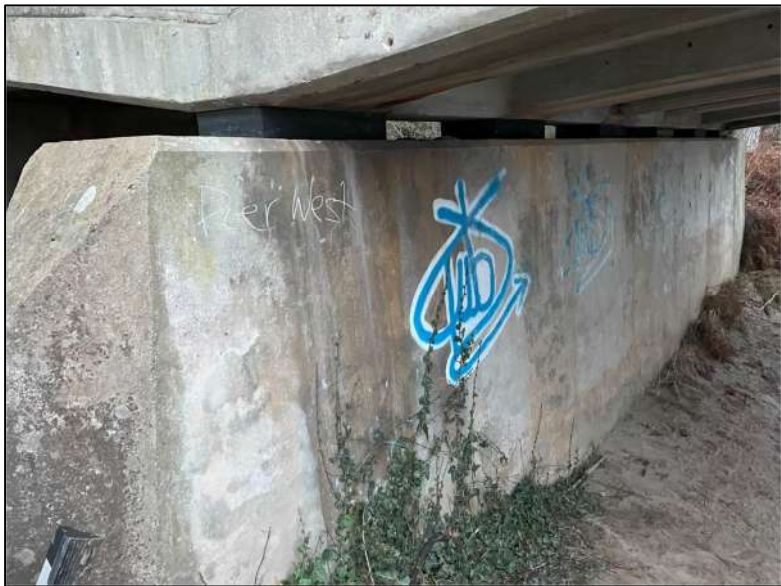
Inspection Findings:	The piers were observed to be in fair condition. Both piers have graffiti on their faces.		
Supporting Evidence:	<div style="text-align: center;">

</div> <p style="text-align: center;">Fig 6. Example of graffiti on west pier.</p> <p>For further photographs of this element refer to Appendix B: Annotated PI General Arrangement Drawings and Appendix C: Photographs from Principal Inspection.</p>		
BCI:	West span East span	Severity 1 Extent A	Defect 2.2 2.2
Defect Description:	Reinforced Concrete: No spalls		
Work Required:	Clean to remove the graffiti.		
Works Priority:	2. Recommended before next General Inspection (GI) (2 years)

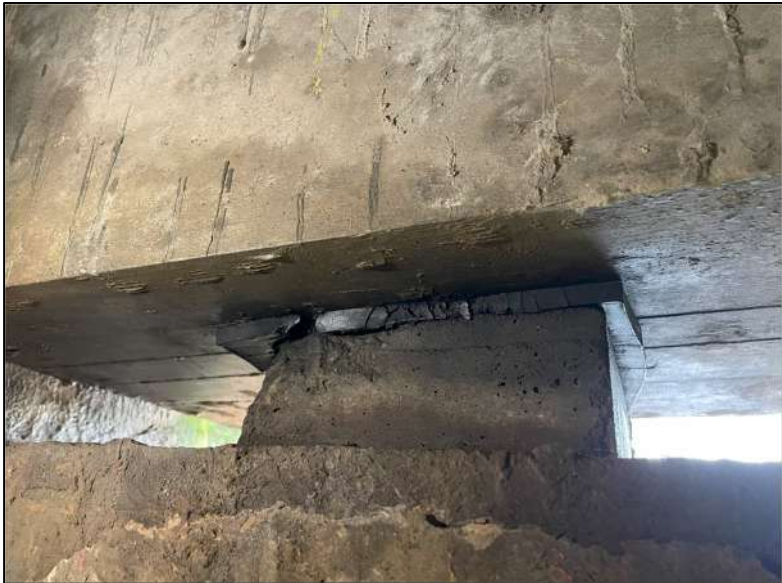
Inspection Findings:	<p>There are three different types of bearings present across the structure.</p> <p>The large elastomeric bearings at the piers are in generally good condition with some minor cracks.</p> <p>The bearings at the east half joint are elastomeric pads, these are in good condition, with no defects observed.</p> <p>The bearings at the west half joint are formed of a concrete block with a thin (10mm) elastomeric pad on top. These pads are crushed and deteriorated, with splitting and cracks easily visible. No information is available to indicate why different bearing types have been used at the west and east half joints.</p>
-----------------------------	--

<p>Fig 7. Deteriorated thin bearing pad at west half joint, crushed with cracking</p>		
<p>West span BCI: Central span East span</p>	<p>Severity</p> <p>1 4 1</p>	<p>Extent</p> <p>A D A</p>	<p>Defect</p> <p>12.4 12.4 12.4</p>
<p>Defect Description:</p>	<p>Bearing: Major breakdown</p>		
<p>Work Required:</p>	<p>Regular monitoring of bearing defects at the west half joint and impact on bridge articulation (6 monthly)</p>		
<p>Works Priority:</p>	<p>4. Monitor – Active monitoring and recording of defect.</p>

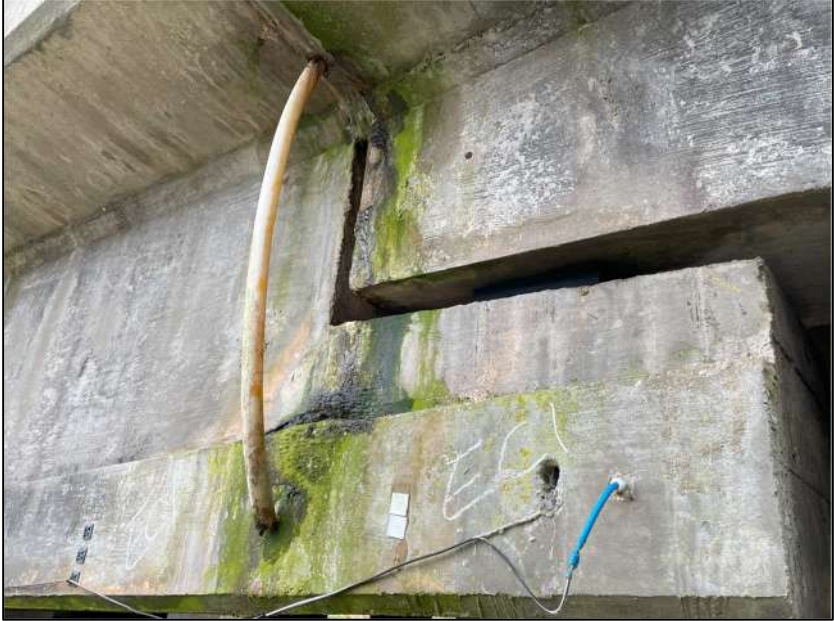
<p>Inspection Findings:</p>	<p>There are two drainage pipes at the east expansion joint, these outlet at the external faces of the structure. Algae staining was noted at both outlet points. The south drainage pipe is completely blocked by calcified sediment.</p>		
<p>Supporting Evidence:</p>

<p>Fig 8. Algae and staining at the north east drainage pipe</p>

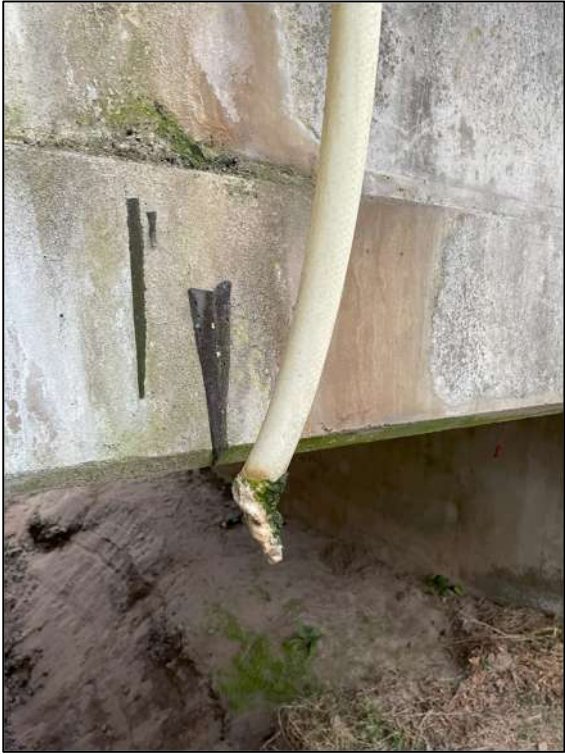
<p>Fig 9. Sediment blocking drainage pipe at south side of east expansion joint</p>		
<p>BCI</p>	<p>Severity 5</p>	<p>Extent D</p>	<p>Defect 8.1</p>

Defect Description:	Drainage: Totally blocked
Work Required:	Remove sediment from drainage pipe and unblock.
Works Priority:	2. Recommended before next General Inspection (GI) (2 years)

Task No.	Element	Works Required	Priority
001	21	Grit blast and repaint corroded elements of guardrail and baseplates.	2
	23		
002	15	Unblock south drainage pipe from structure.	2
003	03	Remove vegetation, debris and bird's nests from structure.	2
	24		
	25		
	31		
	36		
004	11	Remove the graffiti on the piers	2

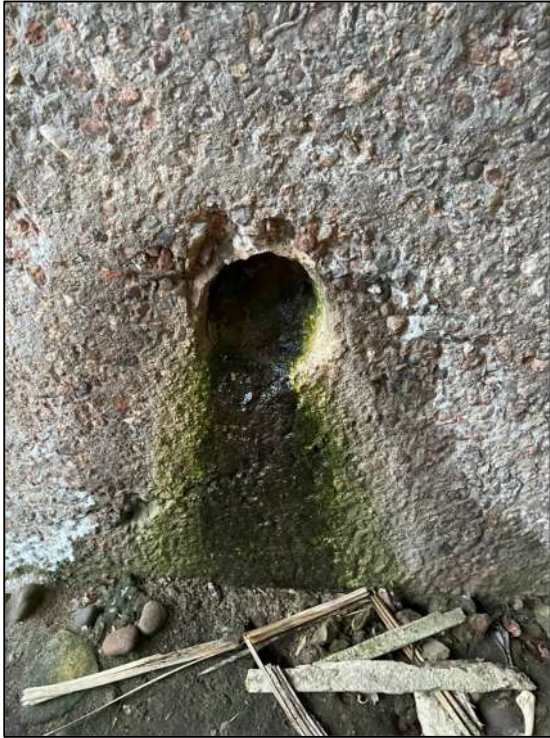
Inspection Findings:	<p>There are three weepholes in each abutment and one in the southeast wing wall. No further substructure drainage was identified. The weep holes were found to be in good condition with no evidence of blockages noted. Staining was observed on the face of the abutments below the weephole outlets.</p>		
Supporting Evidence:

BCI	Severity 2	Extent D	Defect 8.2
Defect Description:	Drainage: Causing minor staining		
Work Required:	None.		
Works Priority:	5. No action – GI and PI programme is adequate for monitoring condition.

Fig 10. Common defect of staining below outlet of weep holes

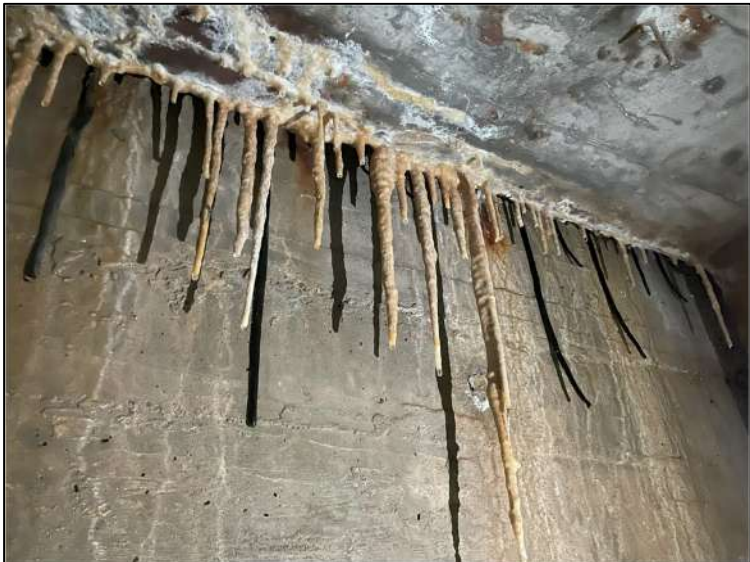
Inspection Findings:	The expansion joints have failed, causing major leakage through the structure at the half joint locations. In some places constant dripping water was observed from the joint location. This has resulted in stalactites forming in some locations and the spalling of concrete at the joint. From above the expansion joints are filled with silt and debris. The sill on each side of the joint is minorly corroded.
Supporting Evidence:

<p>Fig 11. Stalactites on soffit of deck at east expansion joint location</p>

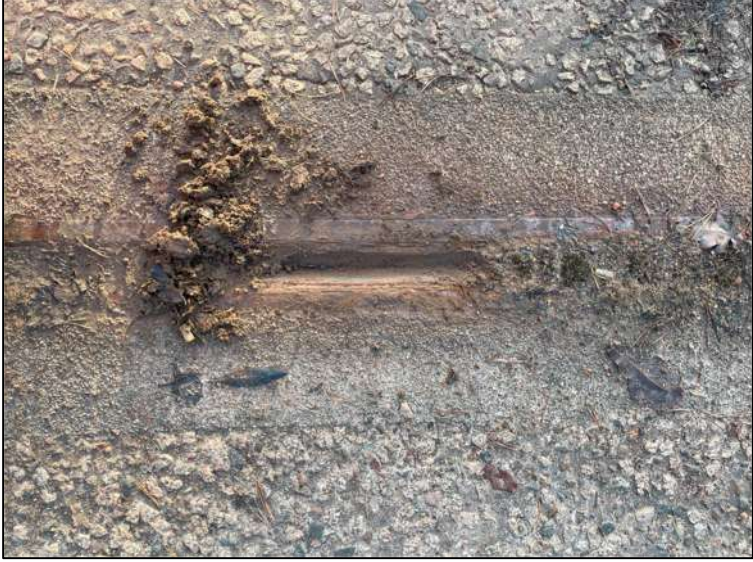
<p>Fig 12. Silt build up in the joint and minor corrosion of sills</p>		
BCI	Severity 4	Extent E	Defect 10.12
Defect Description:	Expansion Joints: Major leakage through joint causing structural damage		
Work Required:	Regular monitoring of concrete deterioration (3 monthly)		
Works Priority:	4. Monitor – Active monitoring and recording of defect.

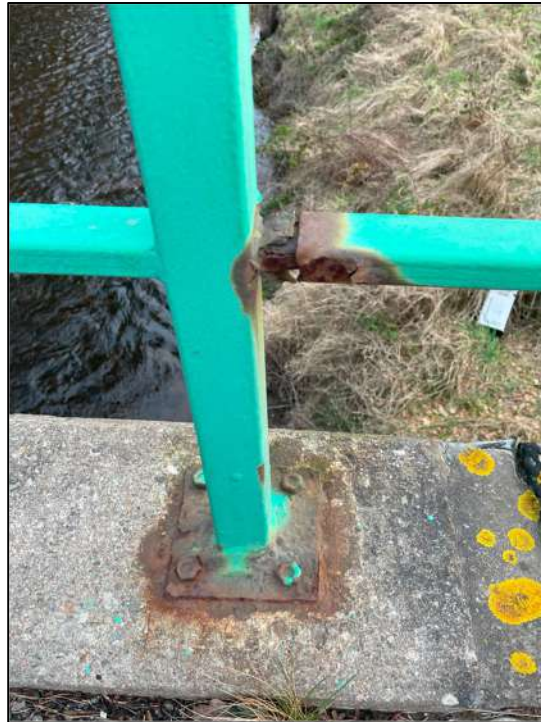
Inspection Findings:	Complete failure of the paint system was observed at the joint locations on the guardrail. This had resulted in corrosion and section loss of the guardrail section. Paint failure was also consistently noted on the parapet base plates, with corrosion of the plate and bolts. Aside from these localised areas the paint system was in fair condition.
-----------------------------	--

Fig 13. Localised paint failure at baseplates and guardrail join location

BCI	Severity 5	Extent B	Defect 4.1
Defect Description:	Paintwork and protective coating: All coats failed		
Work Required:	Grit blast and repaint the corroded guardrail and baseplates.		
Works Priority:	2. Recommended before next General Inspection (GI) (2 years)

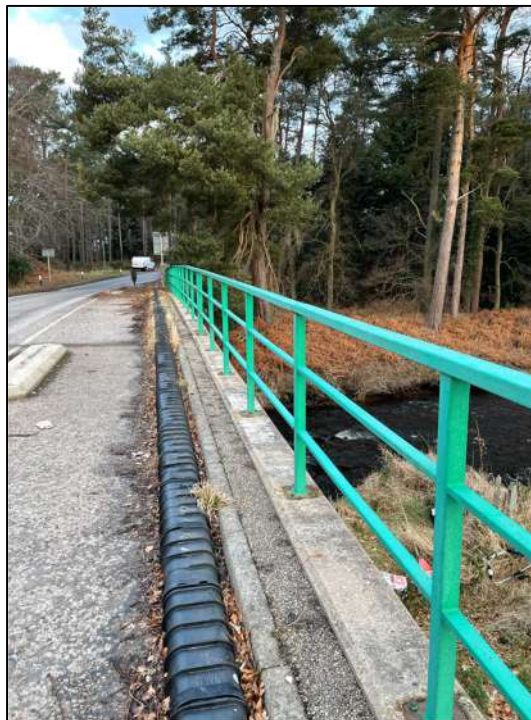
Fig 14. General view of north guardrail looking west

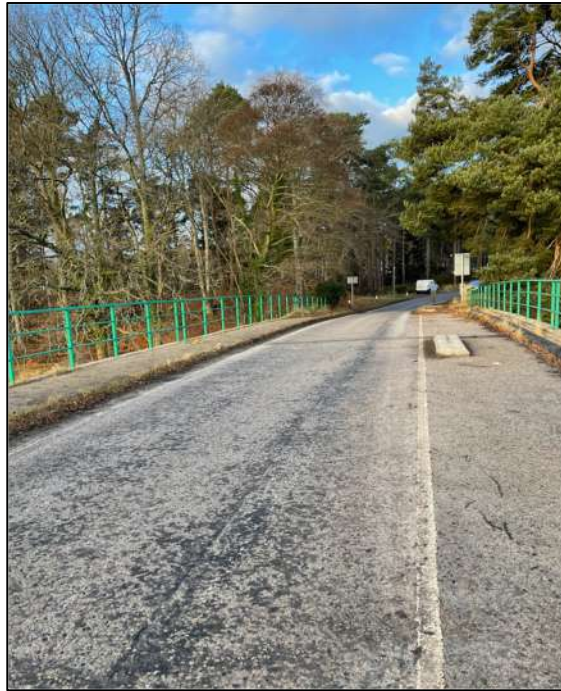
Inspection Findings:	The carriage surfacing was in good condition. There was some vegetation growth and leaf debris build up along the kerbs at either side of the carriageway.
-----------------------------	--

Fig 16. Road surface in good condition

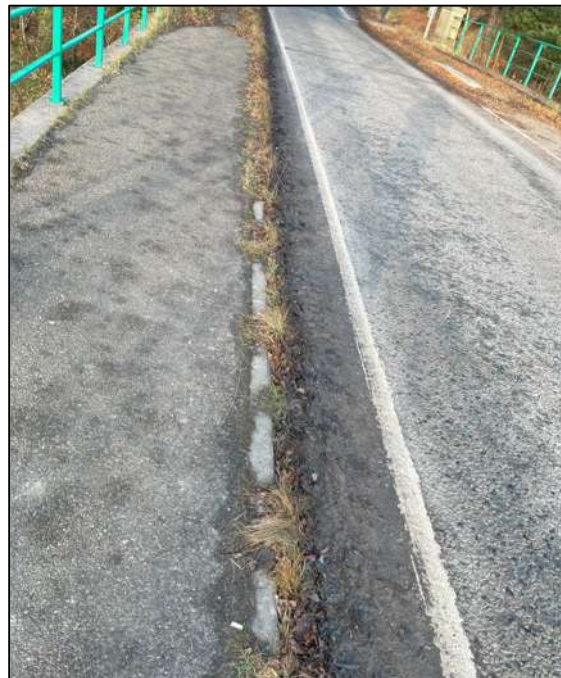
Fig 17. Vegetation along the south kerb

BCI	Severity 2 1	Extent B A	Defect 5.1 9.1
Defect Description:	Vegetation: Minor vegetation causing no structural damage Surfacing: Little to no wear/weathering		
Work Required:	Remove vegetation and debris build up.		
Works Priority:	2. Recommended before next General Inspection (GI) (2 years)

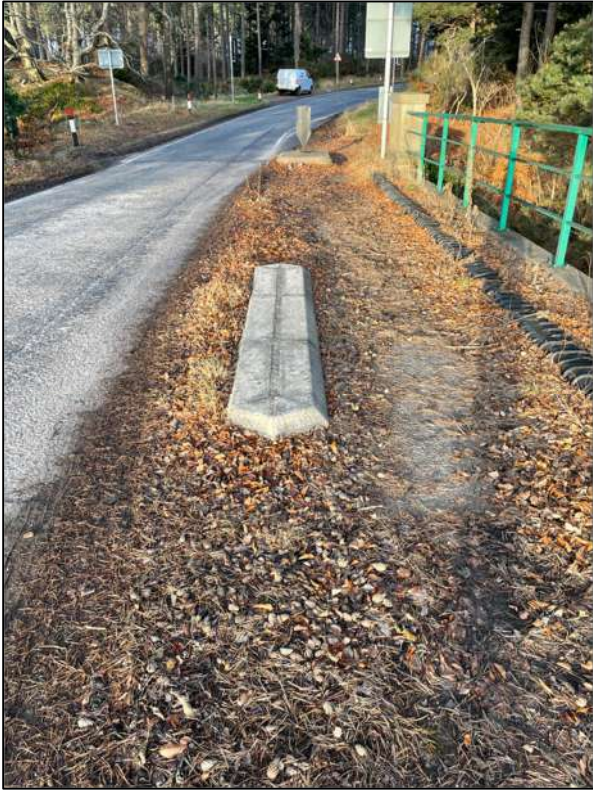
Inspection Findings:	There is a single footway running along the southern side of the structure, the surfacing of the footpath was observed to be in good condition. The footway and verge on the north side of the structure had a build up of leaves and debris.
Supporting Evidence:

<p data-bbox="630 1332 1248 1366">Fig 18. Build up of leaves and debris on north verge</p>

BCI	Severity 2 1	Extent B A	Defect 5.1 9.1
Defect Description:	Vegetation: Minor vegetation causing no structural damage Surfacing: Little to no wear/weathering		
Work Required:	Remove vegetation and debris build up.		
Works Priority:	2. Recommended before next General Inspection (GI) (2 years)

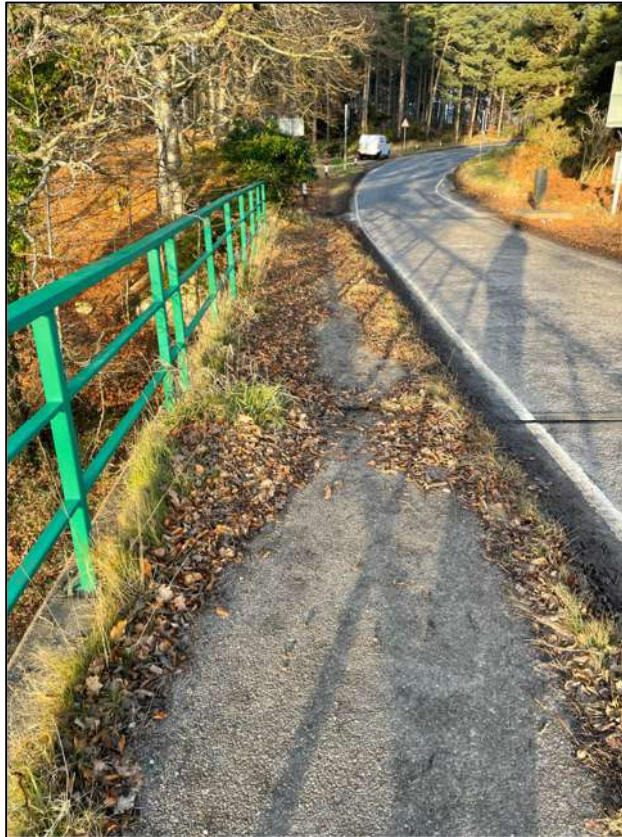
Fig 19. Build up of leaves and vegetation growth at western end of footway

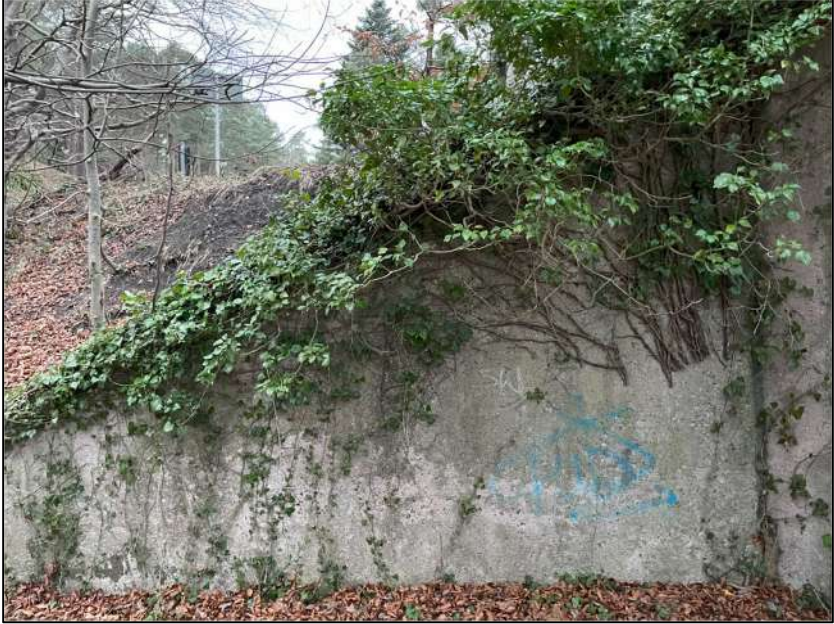
<p>Inspection Findings:</p>	<p>The wing walls were in fair condition, no structural defects were noted. However, there was a large amount of vegetation on the southwest wall. There was minor vegetation growth and staining observed on the other walls.</p>		
<p>Supporting Evidence:</p>

<p>Fig 20. Significant vegetation growth on the southwest wing wall</p>

Defect Description:	Vegetation: Significant depth/density of vegetation obscuring inspection Reinforced concrete: No spalls
Work Required:	Remove vegetation and debris build up.
Works Priority:	2. Recommended before next General Inspection (GI) (2 years)

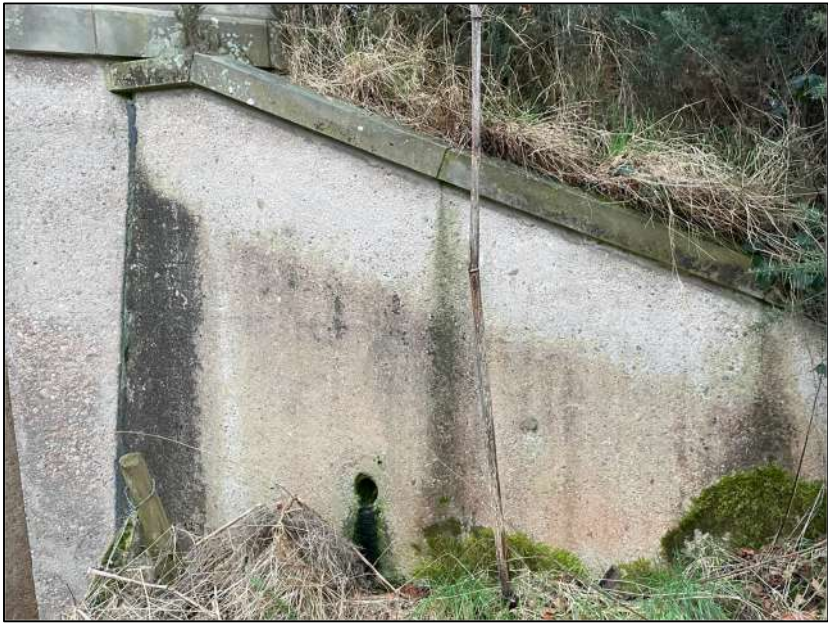
<p>Fig 21. Minor vegetation and staining observed on the southeast wall</p>		
<p>BCI</p>	<p>Severity 3 1</p>	<p>Extent C A</p>	<p>Defect 5.2 2.2</p>

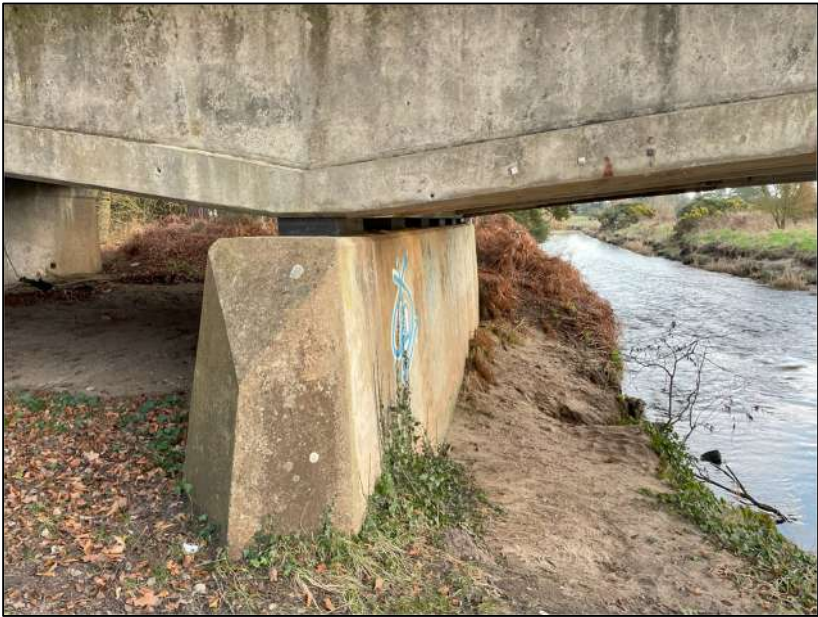
<p style="text-align: center;">Fig 22. West embankment in good condition</p>		
BCI	Severity 1	Extent A	Defect 11.1
Defect Description:	Embankments: Sound, no deformation		
Work Required:	None.		
Works Priority:	5. No action – GI and PI programme is adequate for monitoring condition.

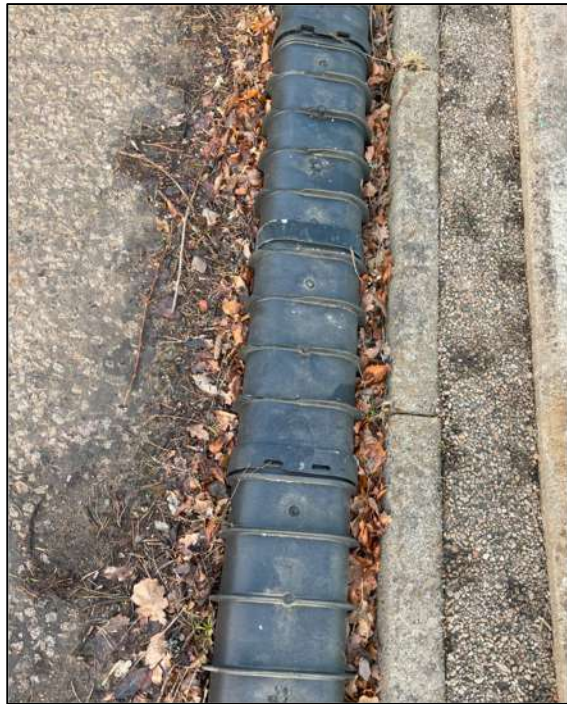
Inspection Findings:	The ducting carrying traffic light cabling was observed to be in good condition.						
Supporting Evidence:

Fig 25. Ducting carrying traffic light cabling in good condition						
BCI	Severity	1	Extent	A	Defect	NA	
Defect Description:	NA						
Work Required:	None.						
Works Priority:	5. No action – GI and PI programme is adequate for monitoring condition.

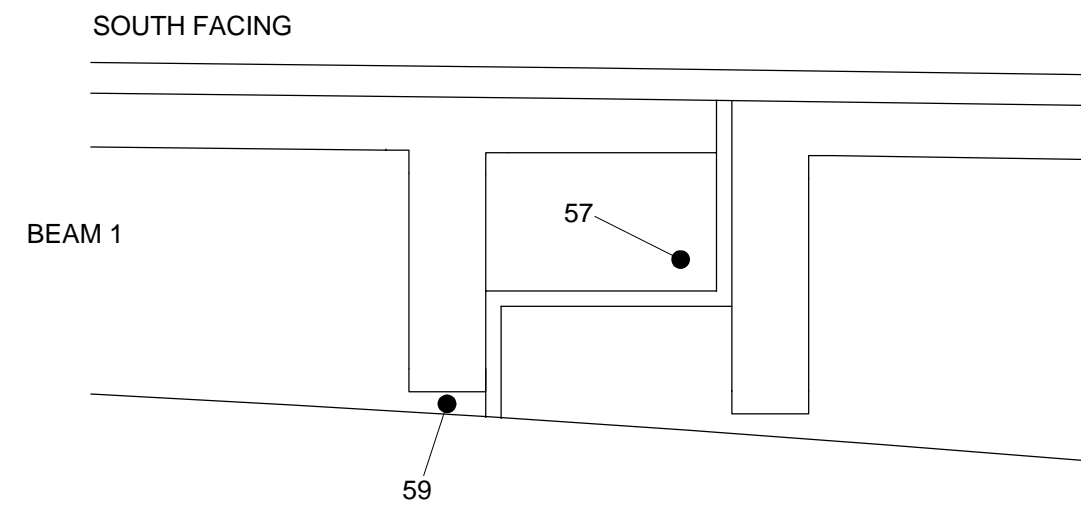
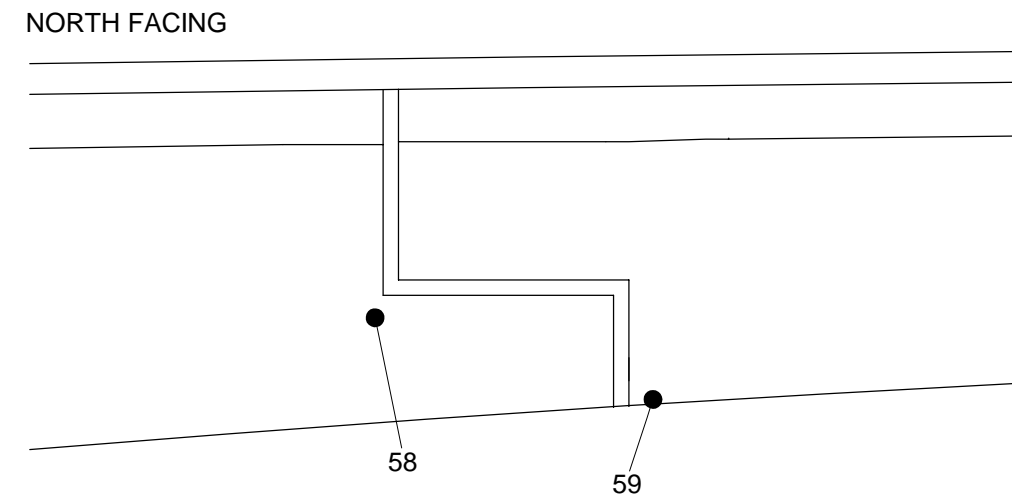
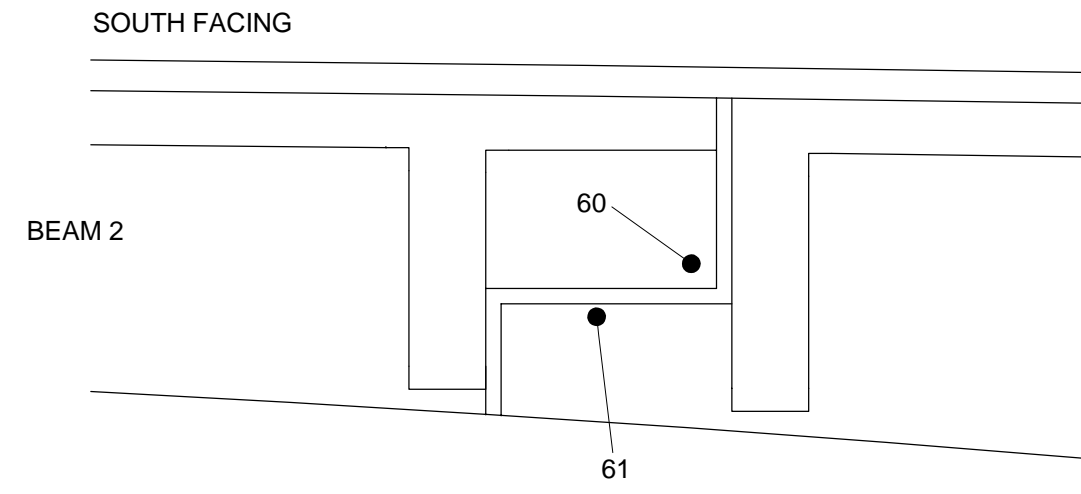
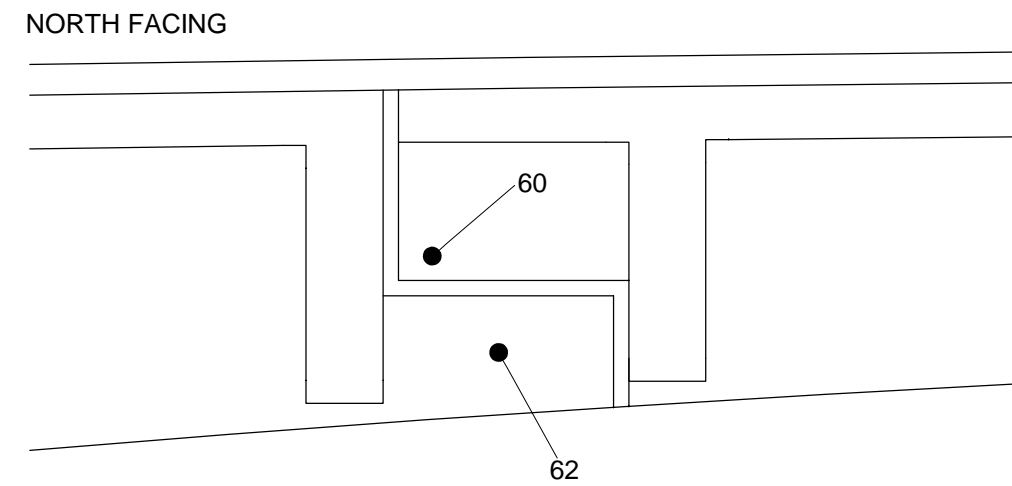
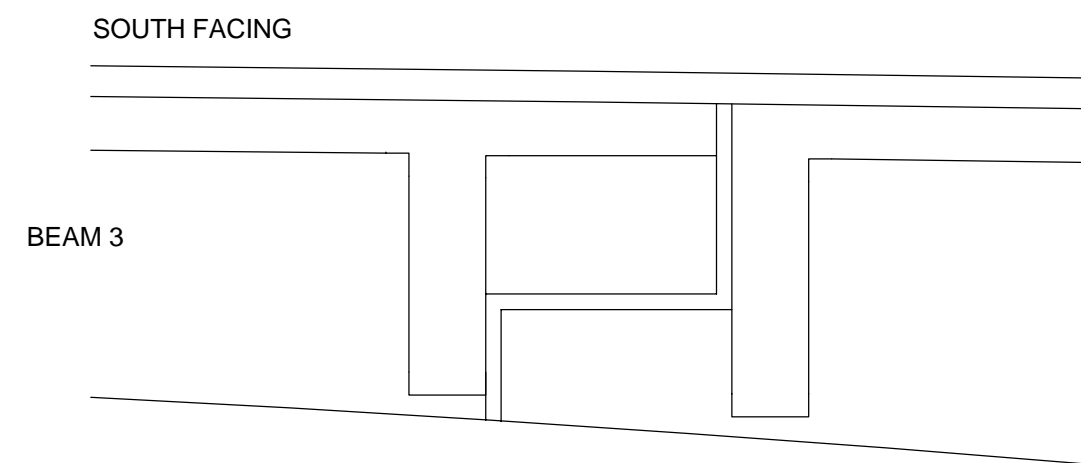
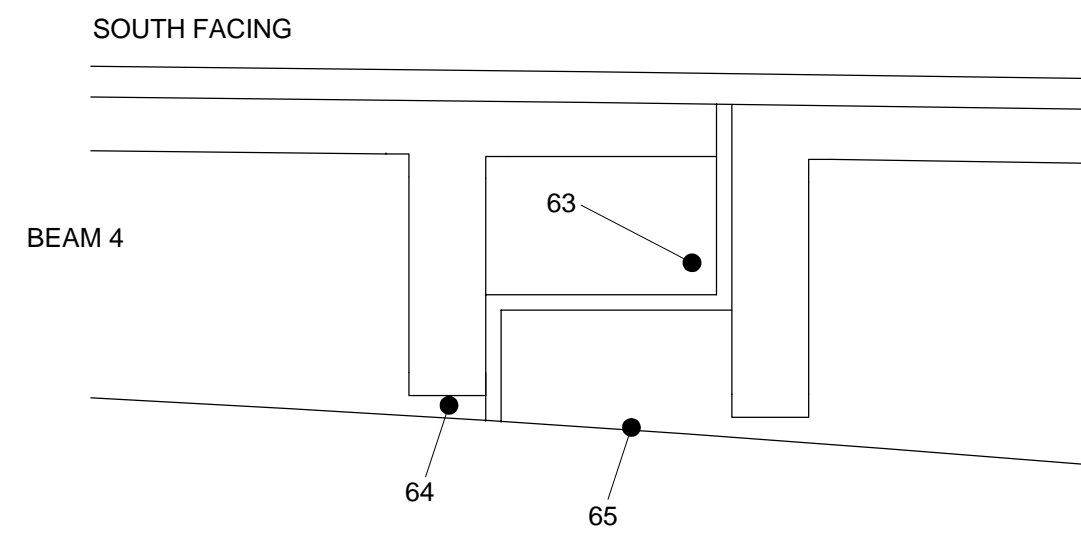
EAST HALF JOINT

Defect Number	Span	Beam Number	Size	Description	Photograph Number
57	Half joint east	Beam 1 (south facing)	550 x 400 x 60 mm	Spalling on face and corner with exposed and corroded reinforcement	57
58	Half joint east	Beam 1 (north facing)	NA	Water ingress, active water dripping and green mould on outside face	58
59	Half joint east	Beam 1 (north and south facing)	600 x 100 x 110 mm	Spalling of soffit end of suspended span, end links exposed, one completely protruding and sheared, badly corroded	59
60	Half joint east	Beam 2 (south and north facing)	340 x 450 x 140 mm	End face link exposed, whole face is cracked with corner spalled on both sides of beam	60
61	Half joint east	Beam 2 (south facing)	750 x 220 mm	Spalling concrete indicated by cracking, bursting off corner	61
62	Half joint east	Beam 2 (north facing)	350 x 490 x 40 mm	Spalled concrete on side face of beam, exposed and severely corroded reinforcement	62

63	Half joint east	Beam 4 (south and north facing)	600 x 460 x 160 mm	End face corner cracked and spalling, full width of beam	63
64	Half joint east	Beam 4 (south facing)	600 x 70 x 80	Spalling and cracking of soffit end of suspended span, end links exposed (B)	64
65	Half joint east	Beam 4 (south facing)	1800 x 180 x 80 mm	Spalling of bottom corner of beam, reinforcement exposed and corroded (D)	65
66	Half joint east	Beam 4 (north facing)	1000 x 100 x 100 mm	Bottom corner spalling off, cracking	66
67	Half joint east	Beam 4 (north facing)	NA	Delaminated face of beam	67
68	Half joint east	Beam 4 (north facing)	150 x 90 x 150 mm	Top corner wedge cracked and beginning to spall	68
69	Half joint east	Beam 5 (south and north facing)	600 x 150 x 60 mm	Spalling of corner of end suspended span, saturated and dripping	69
70	Half joint east	Beam 5 (south facing)	600 mm long	Crack 100 mm below top edge of beam, bursting off corner	70

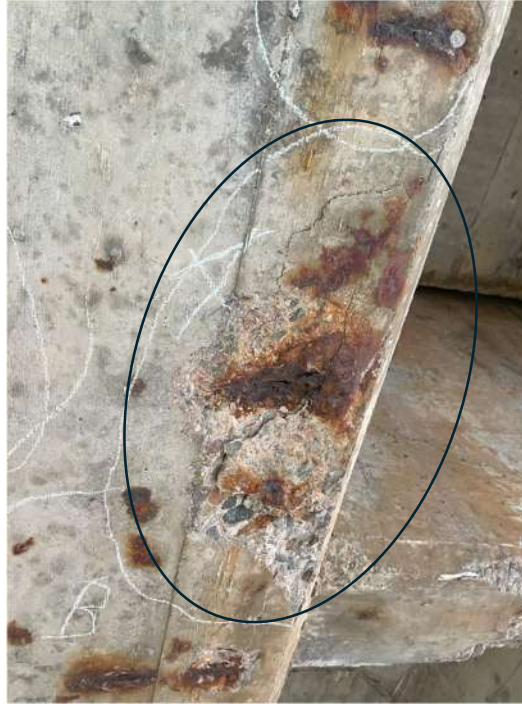
Photograph 5: Beam 2, cantilever span west, cracking and staining on bottom face

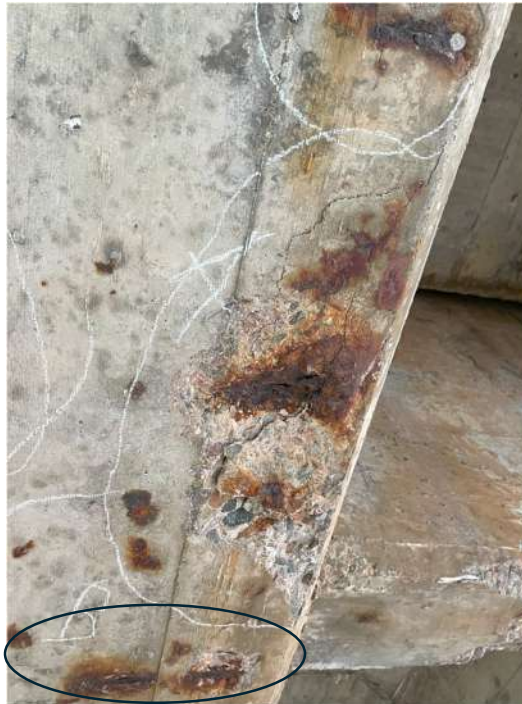
Photograph 6: Beam 2, cantilever span west, defect on bottom face of cantilever

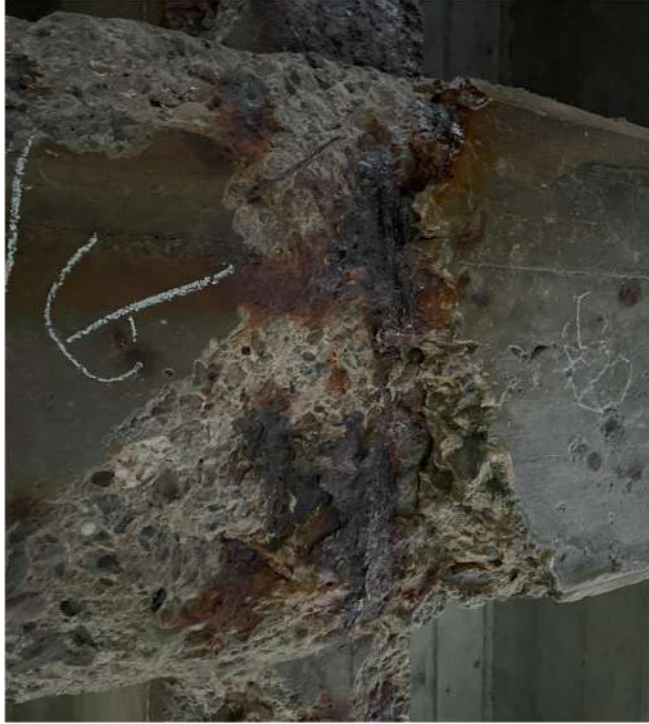
Photograph 29: Beam 5, cantilever span east, spall between crossbeams

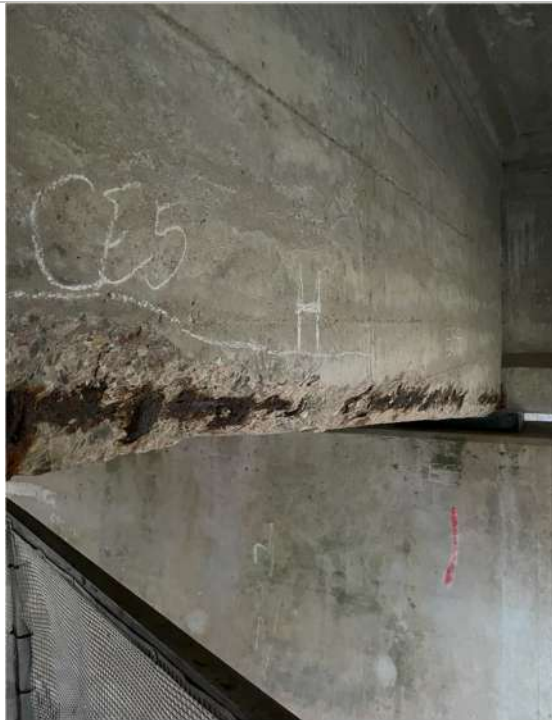
Photograph 30: Beam 5, cantilever span east, spall along bottom corner of beam, longitudinal reinforcement and links exposed

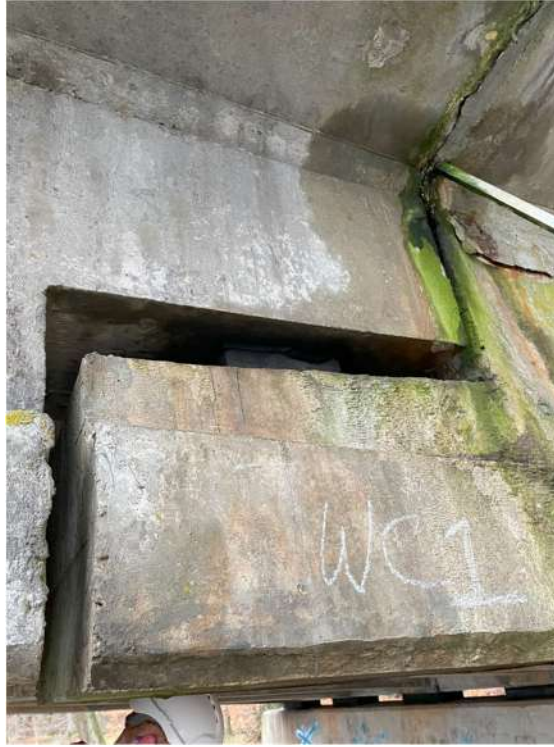
Photograph 41: Beam 1 (north facing), half joint west, Water ingress, damp and green mould on outside face

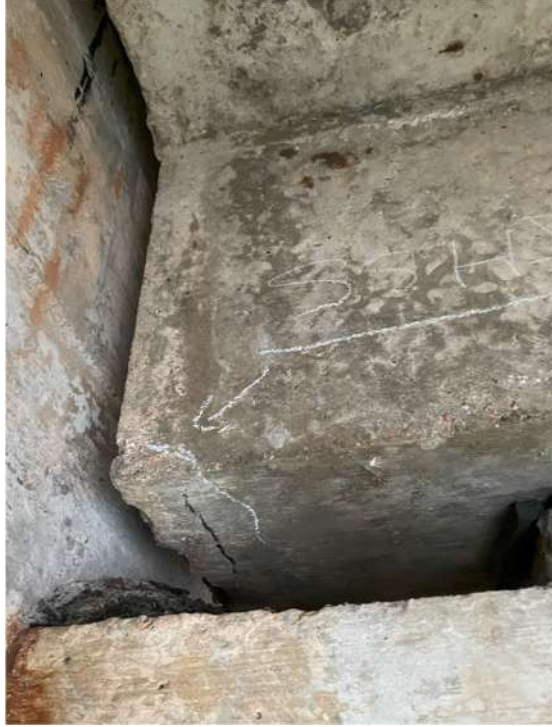
Photograph 43: Beam 2 (south facing), half joint west, crack and spalling

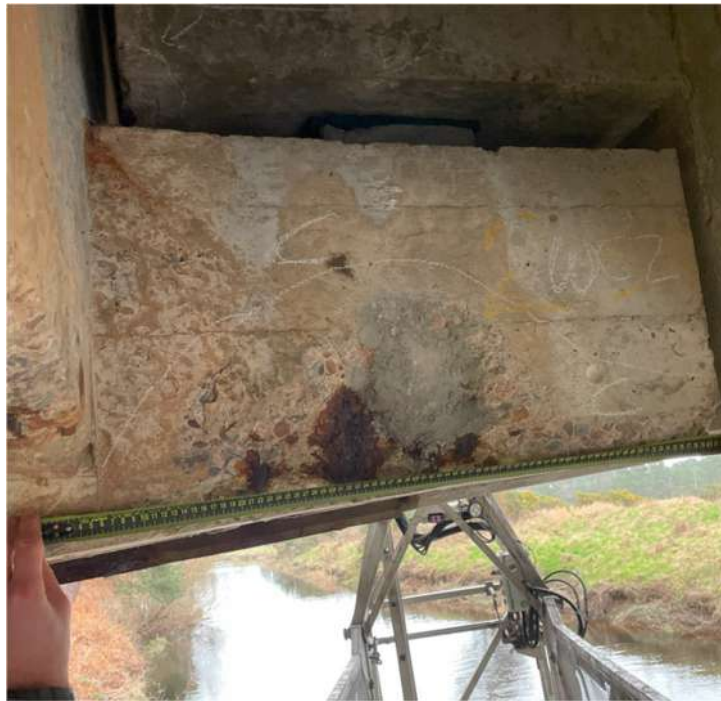
Photograph 44: Beam 2 (south facing), half joint west, loss of bottom corner section

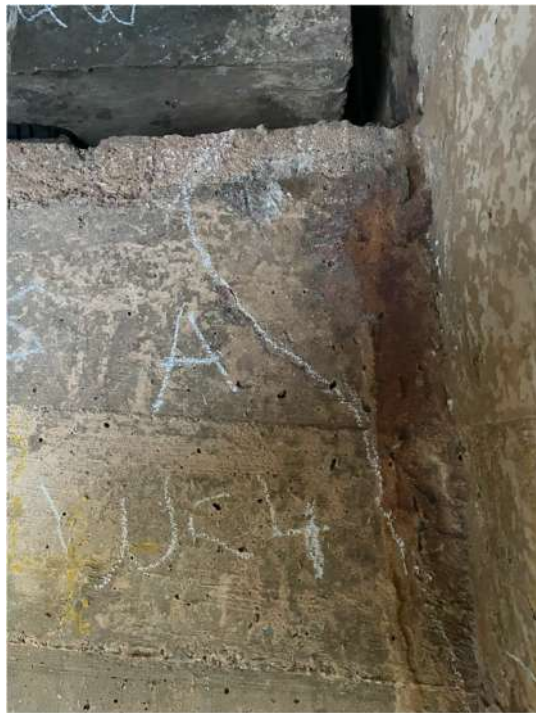
Photograph 48: Beam 4 (north facing), half joint west, hollow sounding and delamination

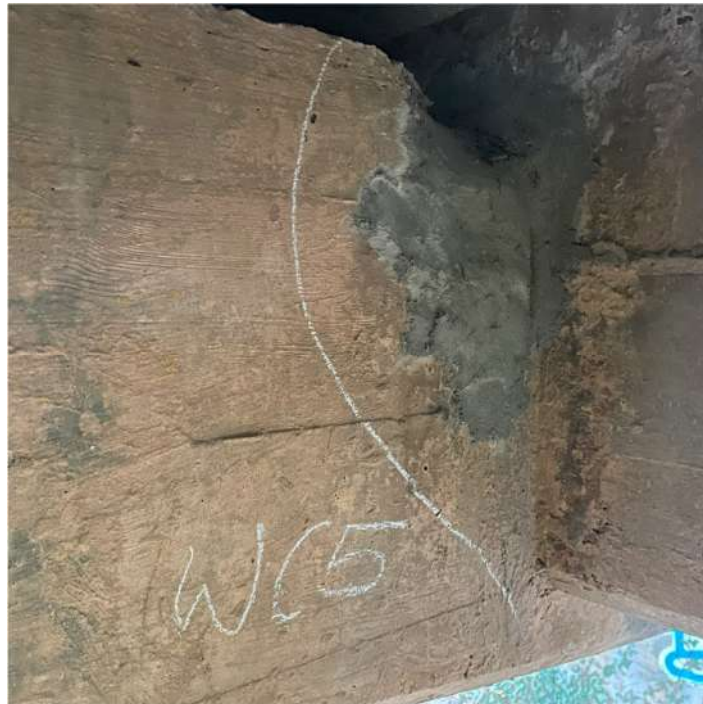
Photograph 52: Beam 5 (north facing), half joint west, area of missing concrete previous repair patch

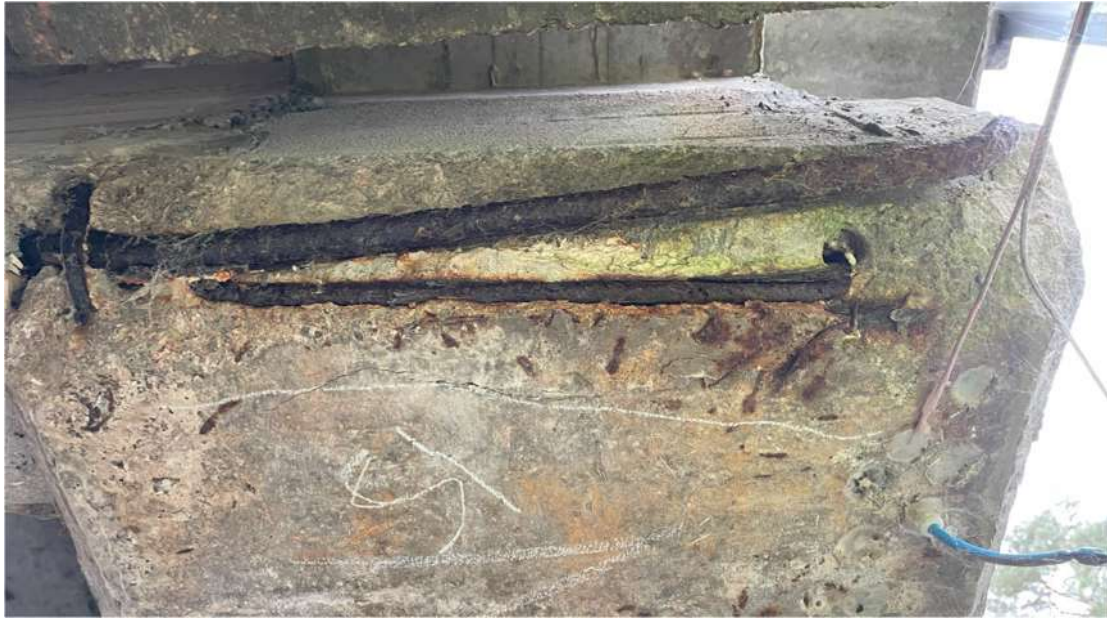
Photograph 59: Beam 1 (north and south facing), half joint east, end links exposed, one completely protruding and sheared

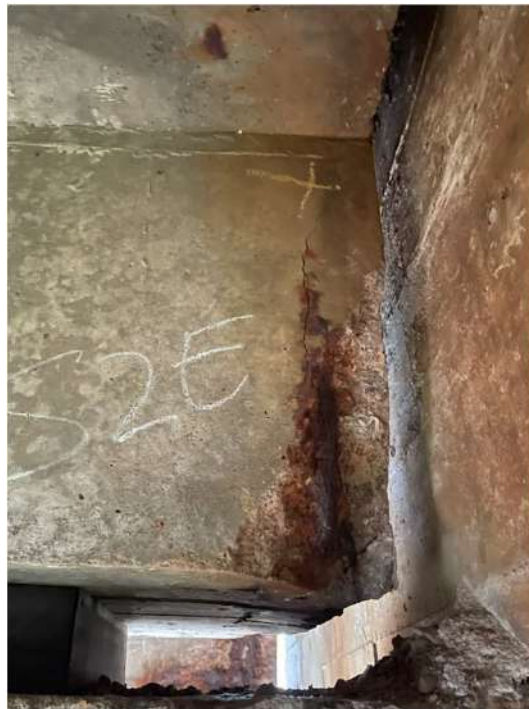
Photograph 60: Beam 2 (north and south facing), half joint east, end face link exposed, whole face is cracked with corner spalled

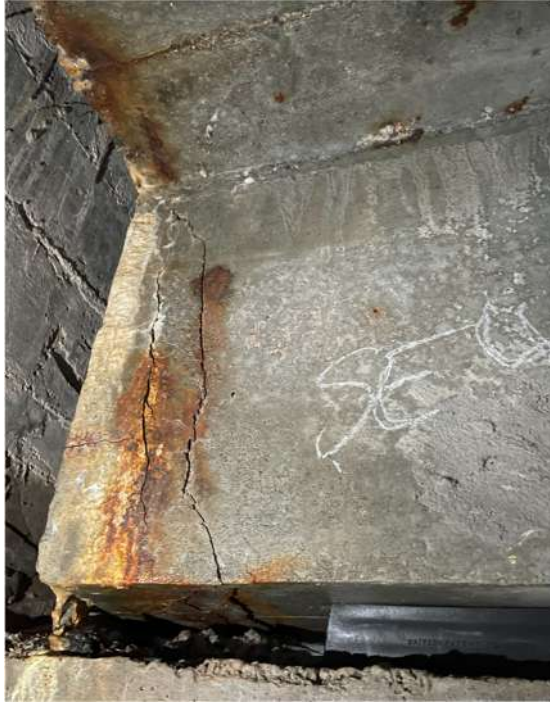
Photograph 63: Beam 4 (south and north facing), half joint east, end face corner cracker and spalling

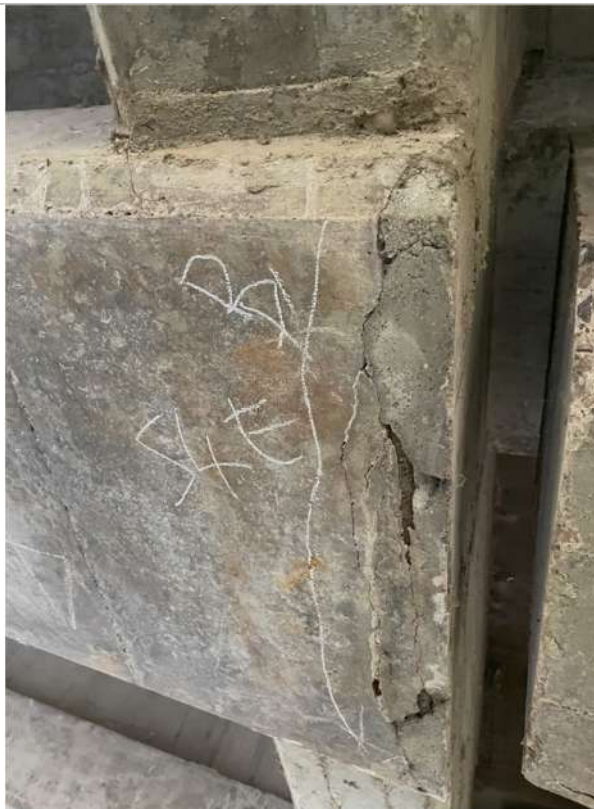
Photograph 64: Beam 4 (south facing), half joint east, spalling and cracking of soffit end of suspended span

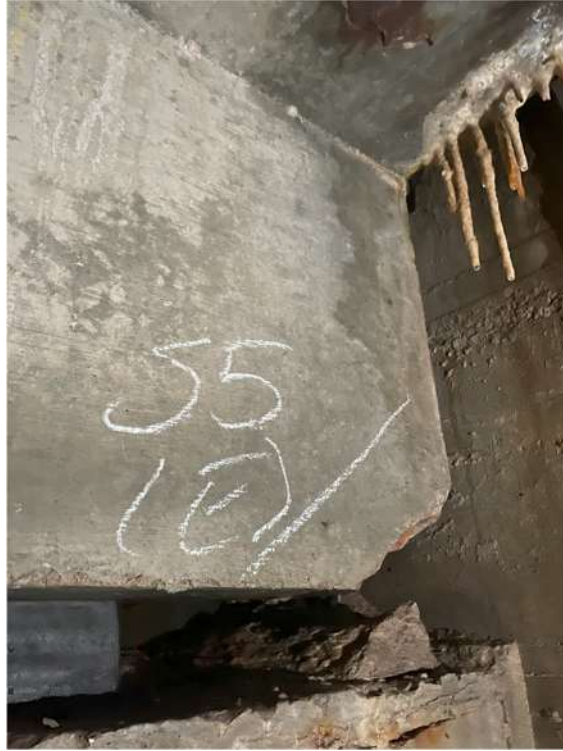
Photograph 69: Beam 5 (south and north facing), half joint east, spalling of corner, saturated and dripping

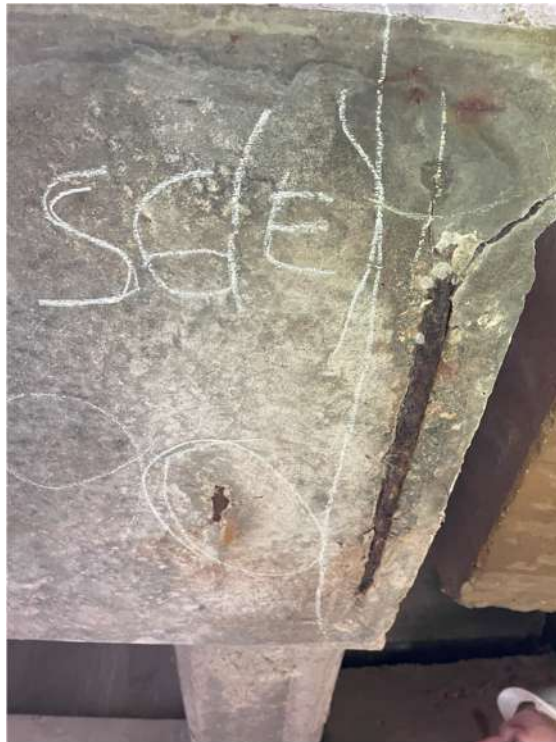
Photograph 74: Beam 6 (south and north facing), half joint east, spalling of soffit, end links exposed and corroded
