ARTHURS BRIDGE

Principal Inspection Report

B234M205-J-ART-STR-REP-PIR-0001

A Principal Inspection of Arthur’s Bridge was undertaken by Jacobs on the 11th February 2025. Access to the half joints, suspended and cantilever spans were obtained through the use of an underbridge unit. All elements of the structure were inspected apart from the buried foundations and waterproofing system.

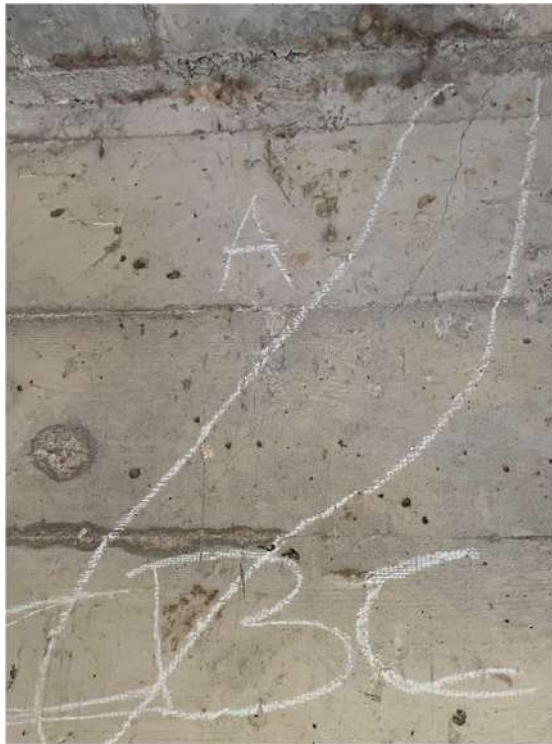
Defect Number	Span	Beam Number	Size	Description	Photograph Number
76	Central cross beam	Beam 2 – Beam 3 (both faces)	400 mm long, 0.45 mm thick crack	Hairline crack, starting from soffit of deck and is on a diagonal, visible on both sides of cross beam	76
77	West pier, east face	Beam 1 – Beam 2	220 x 220 x 40 mm	Spalling in area of large aggregate, some corrosion staining	77
78	West pier, east face	Beam 3 – Beam 4	250 x 230 x 60 mm	Spalled concrete with cracks extending from spall	78
79	East pier, west face	Beam 4 – Beam 5	NA	Hairline crack with corrosion staining	79
80	East pier, west face	Beam 5 – Beam 6	440 x 180 x 40 mm	Concrete spalling, some corrosion staining	80
81	East and west abutment	Abutment corners	NA	Staining and seepage at all corners, residue build up	81
82	West abutment	Top of abutment	NA	Delamination of top of abutment	82
83	West abutment	Back face of abutment between beams	300 x 140 mm	Delamination and general corrosion stains between beams, multiple spots	83

Photograph 76: Beam 2 – Beam 3 (both faces), central cross beam, hairline crack on diagonal from soffit of deck

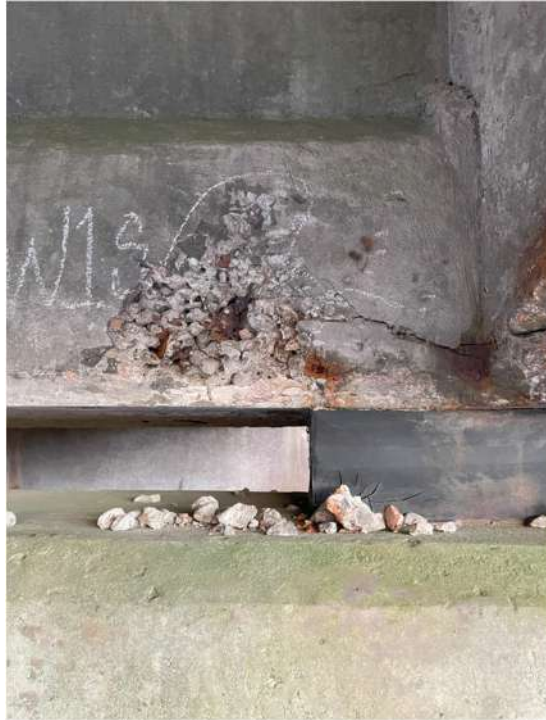
Photograph 77: Beam 1 – Beam 2, west pier, east face, spalling in area of large aggregate

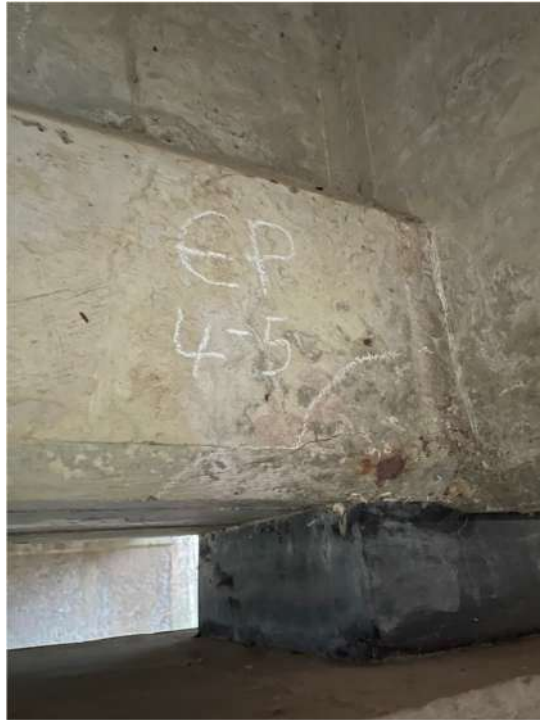
Photograph 79: Beam 4 – Beam 5, east pier, west face, hairline crack with corrosion staining

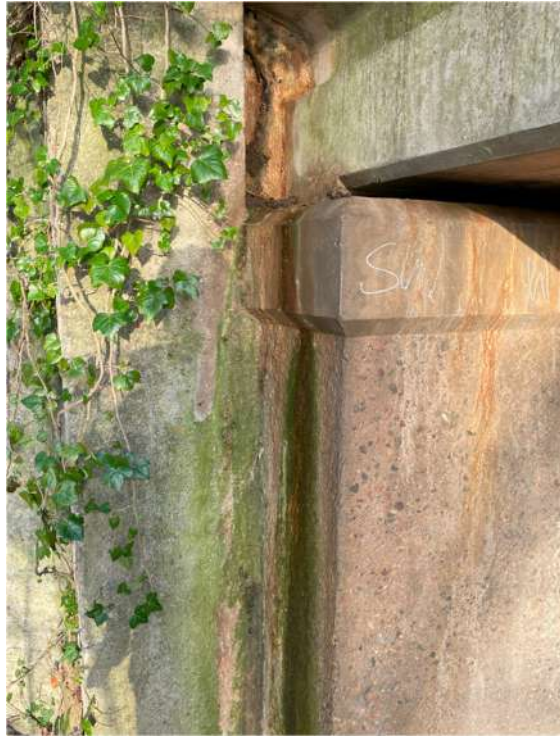
Photograph 81: Abutment corners, east and west abutment, staining and seepage, residue build up
