## GRANT LODGE, ELGIN FABRIC INSPECTION REPORT

AUGUST 2012

Address of Property:	Grant Lodge, Elgin
Date of Inspection:	21 <sup>st</sup> August 2012
Weather Conditions at Time of Inspection:	Dry and bright
Inspection Carried Out By:	Pinny Neill, Architect and Ian Fraser, Associate, LDN Architects llp, 29 St Leonards Road, Forres IV36 1EN

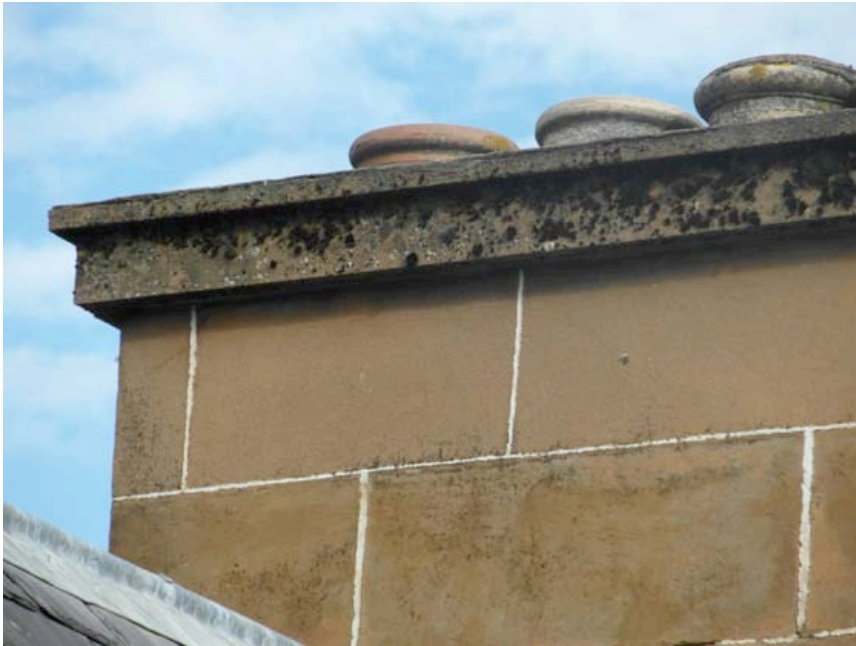
Photograph 029: The chimney stacks (4no.) are of dressed ashlar regularly coursed surmounted by the double stepped moulded stone coping.
