# DUFFTOWN CLOCK TOWER, THE SQUARE, DUFFTOWN

## CONDITION SURVEY

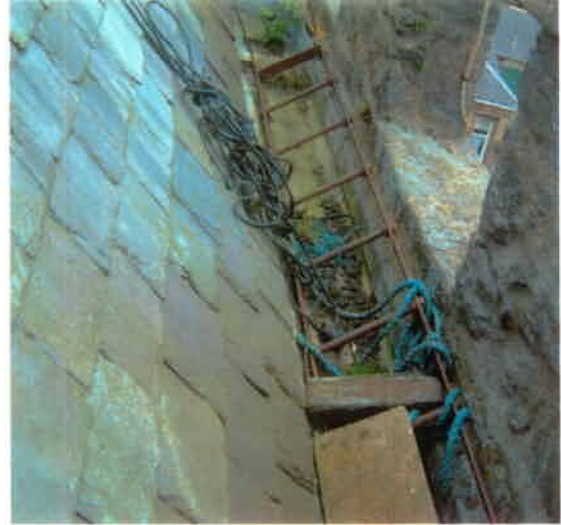
**Photo 2 – East Roof Gutter**

Flat, lead covered roof beneath bell with lead roof and timber canopy above bell. Lead to tower roof in poor condition, cracked and causing moisture penetration to roof timbers.  
Slated pitched sections in good condition, lead gutters below good, some debris in gutters. Flagpole base to S.E. corner cracked. Gutter outlets require to be cleared, and debris removed from the flat lead gutters. The store turrets to the four corners are generally in fair condition, with slight vegetation growth and minor repointing required.

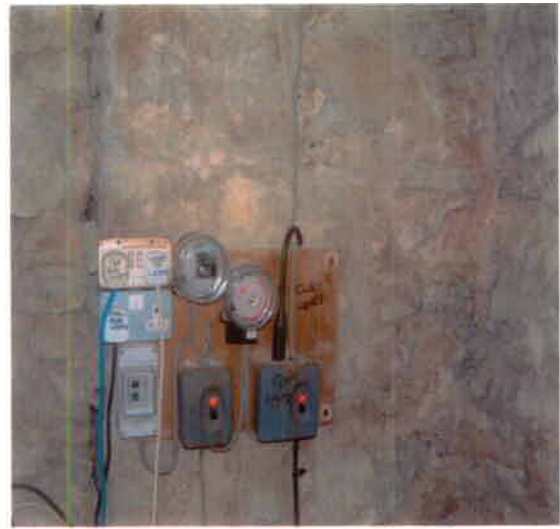
**Photo 26 – Electrics to First Floor**

<b>1<sup>ST</sup> FLOOR</b>	
<b>Ceiling</b>	70% plaster remaining although much of this is cracked. 95% lath cracking. Some joist ends have been spliced at north wall. Central pendant light fitting.
<b>North Wall (Photos 26 &amp; 27)</b>	Pointing required to infilled arch area. Electrics mounted on board on wall to right of previous opening / archway.
<b>West Wall</b>	75% of lath & plaster remaining, wallpapered – should be removed prior to repointing. “Nu-weather” integrated stove with fire and surround. Stonework exposed in NW corner with a number of areas of missing stonework / pointing and a large hole penetrating 600mm through stone wall (Photo 31). Glistening residue to pointing in NW corner indicative of water ingress.
<b>South Wall (Photo 28)</b>	Lath and plaster all intact. Double Belfast sink with lead wastepipe in timber sink unit. (Photos 32 & 33). Single glazed timber sash & case window with perspex panes in poor condition and in need of replacement. (Photos 29 and 30)

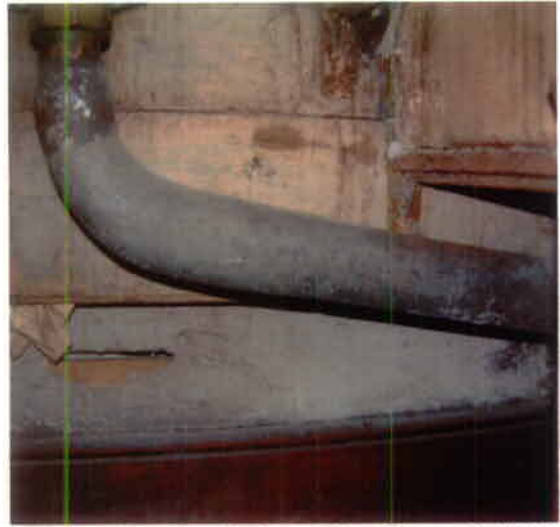
**Photo 32 – Lead Waste Pipe Beneath Sink**

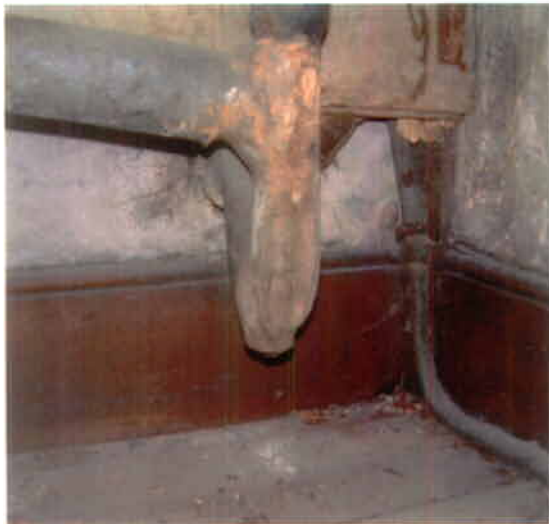
**Photo 33 – Lead Pipework Below Sink**

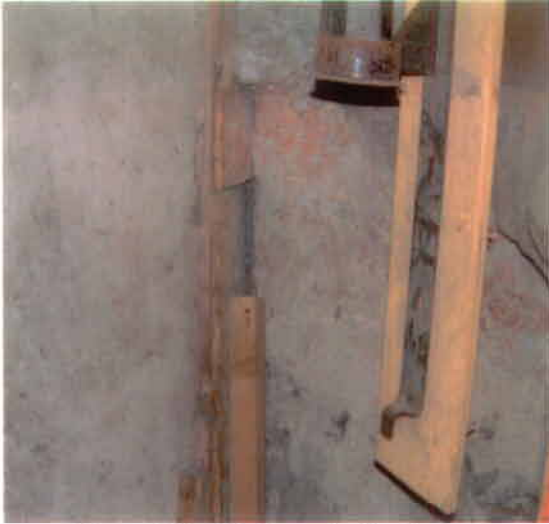
Photo 37 – Understair Cupboard

Stone floor and walls (photo 37)

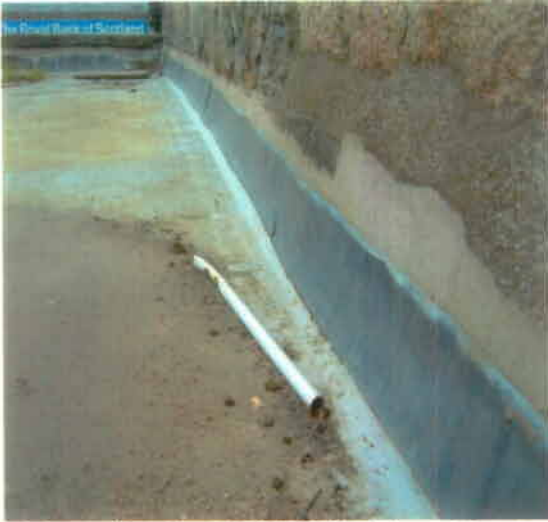
**Photo 43 – Roof / Wall Flashing – North Elevation**

Renewed in 2002 with “Dryseal” GRP finish in good condition (Photos 43 – 45, 57 & 58)  
Cement to turret at NE corner cracked.

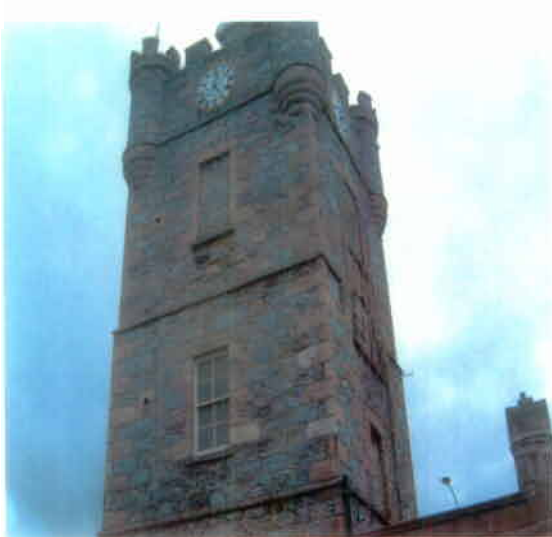
**Photo 53 – East Elevation**

Stonework and pointing good – vegetation growth to string course below clock face.  
Large sash and case timber window at First Floor level in fair condition and decoration. (Photo 51).  
Small timber casement window at Ground Floor level in fair condition – top pane cracked.
