# **Summary Building Condition Survey Report**

**St Thomas Primary School  
Chapel Street Keith AB55 5AL**

**10<sup>th</sup> January 2024**

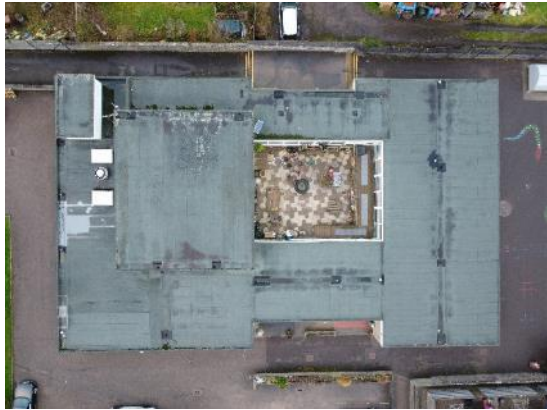
1. Aerial photo of roofs

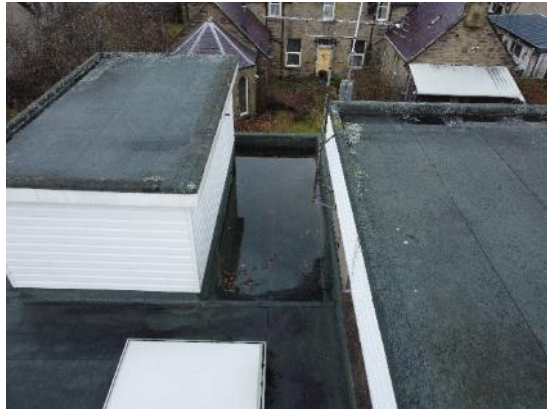
2. Tank House roof (left)

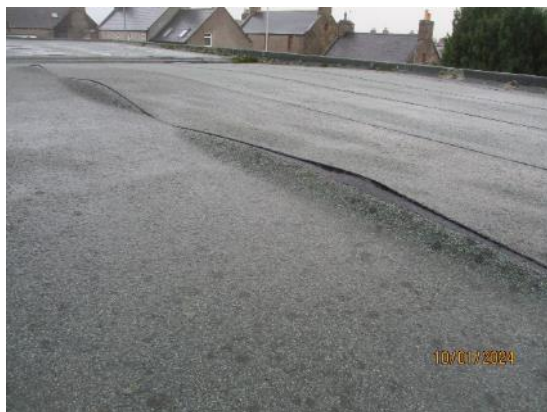
6. Raised seams in felt roofing

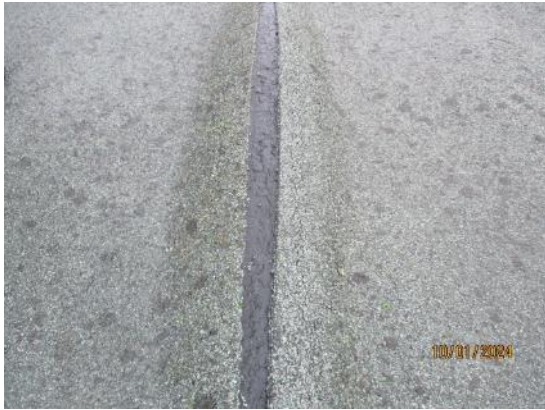
7. Open seams in felt roofing

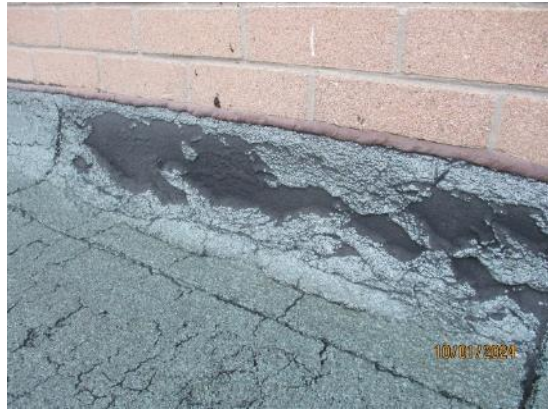
8. Surface erosion of felt flashings

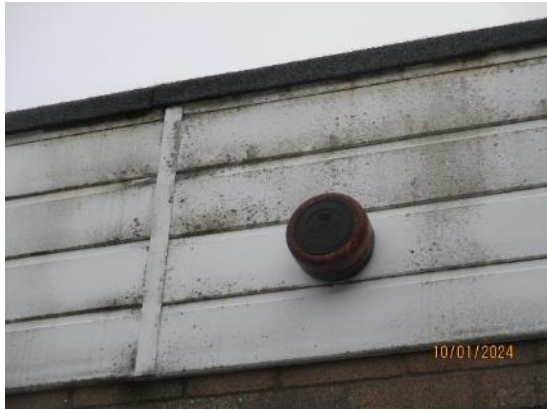
13. UPVC fascias to main building

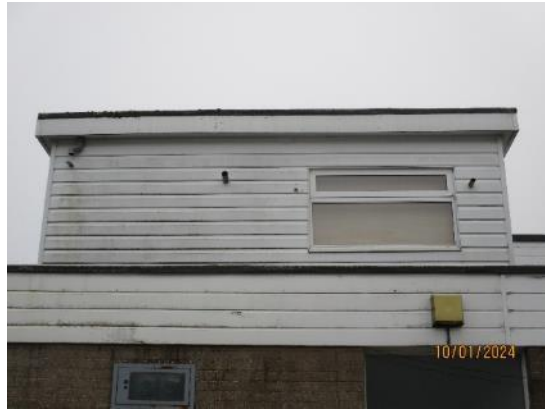
14. UPVC cladding to Tank House

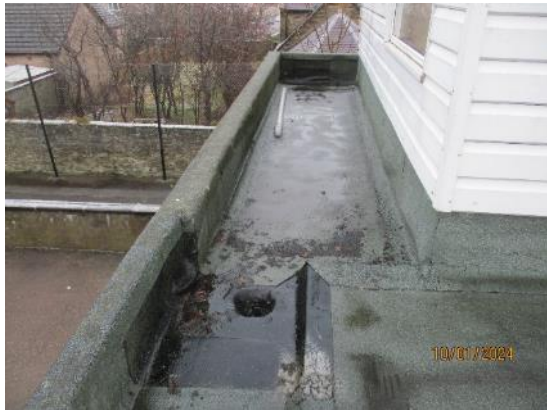
15. Felt box gutters and outlets

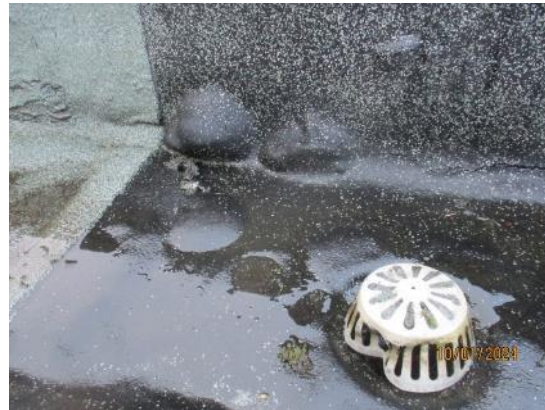
16. Blistered previous repairs

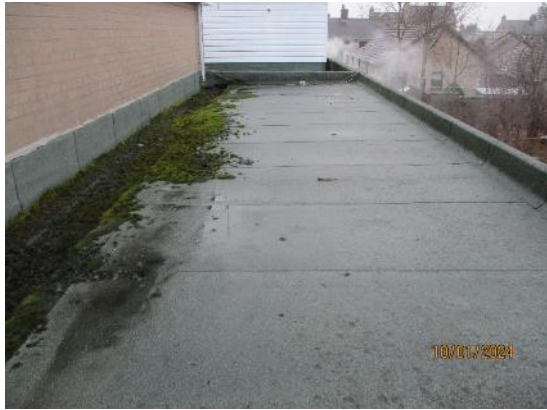
19. Blocked box gutters

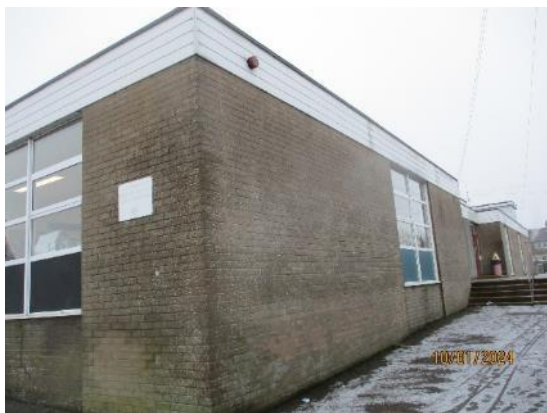
23. Brick external structure

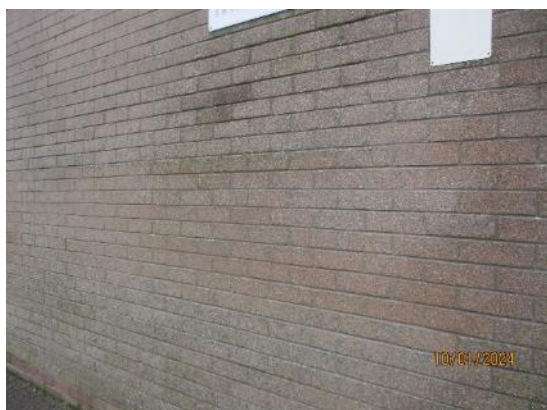
31. Facing brick external finish

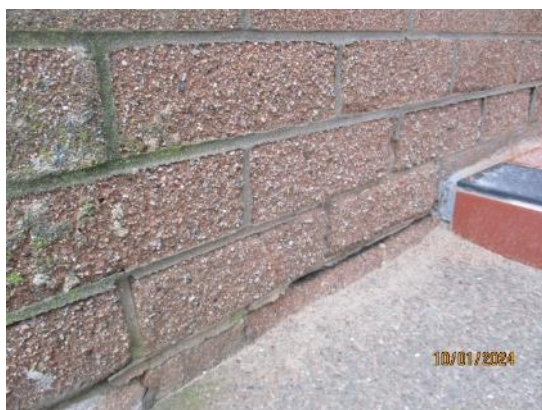
32. Isolated surface erosion

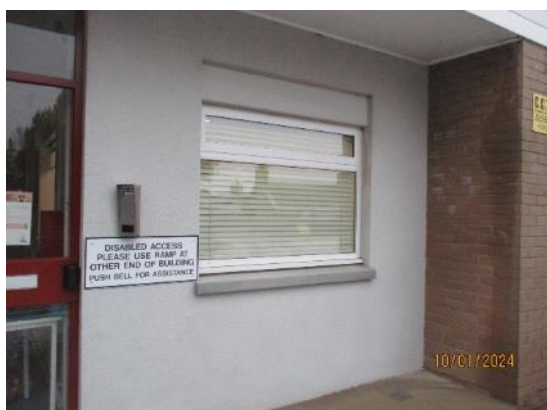
33. Textured paint finish to rendered walls

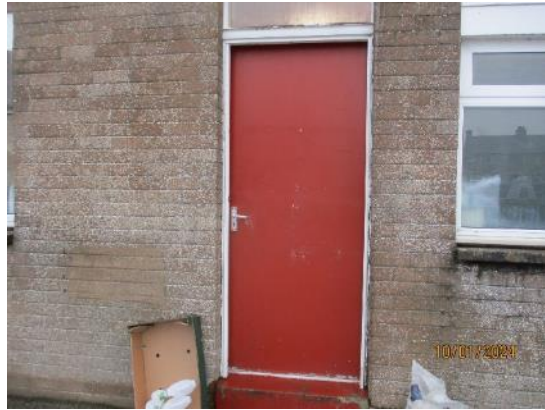
38. Timber service doors

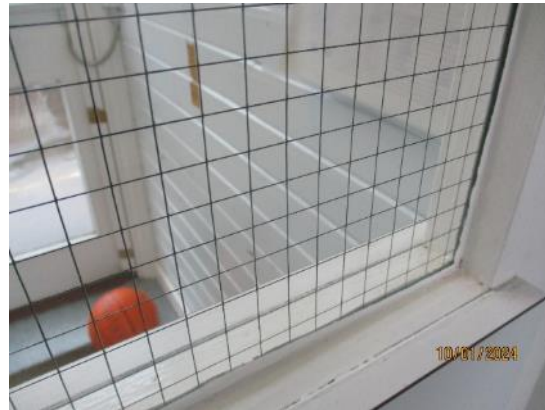
40. Georgian wired glass to external doors

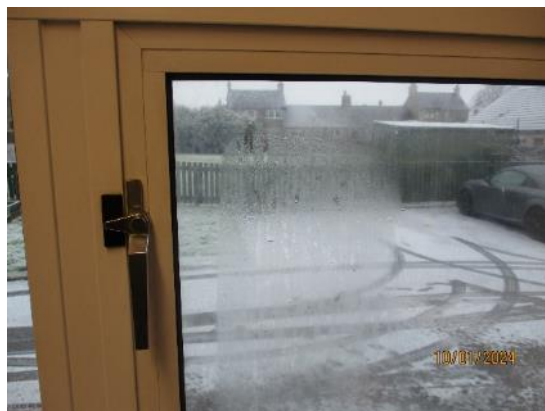
48. Fogged double glazed units

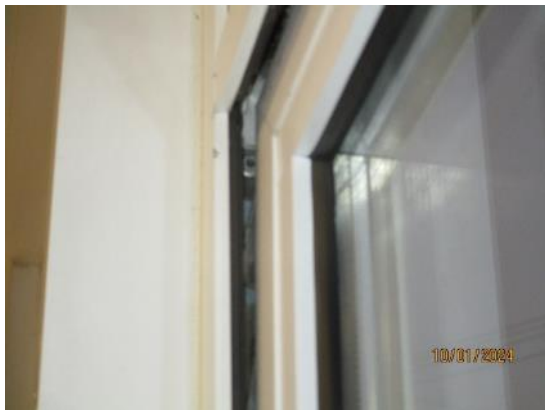
51. Typical hinge mechanism

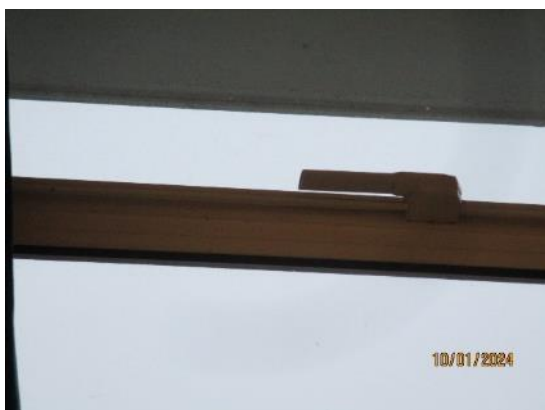
52. Faulty mechanism not sealing when closed

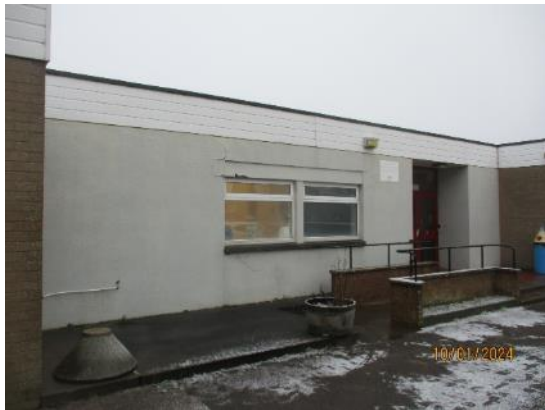
55. Flaking paint on rendered wall

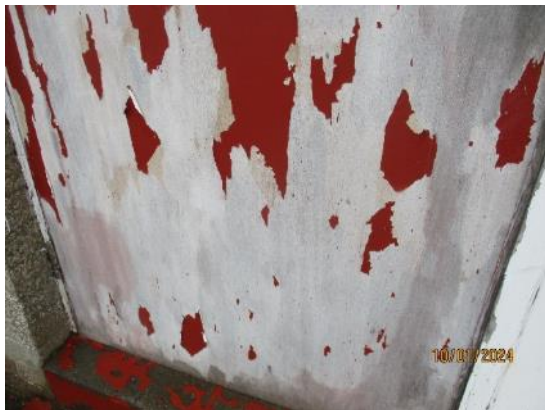
57. Timber external doors peeling

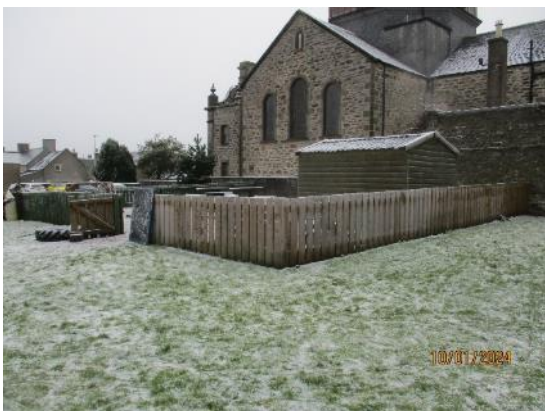
59. Bare timber fencing

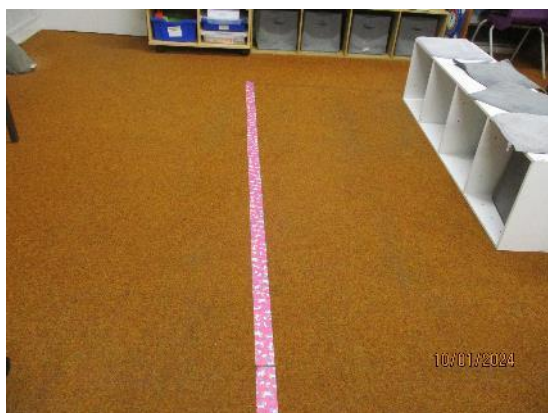
71. Repairs to damaged carpet

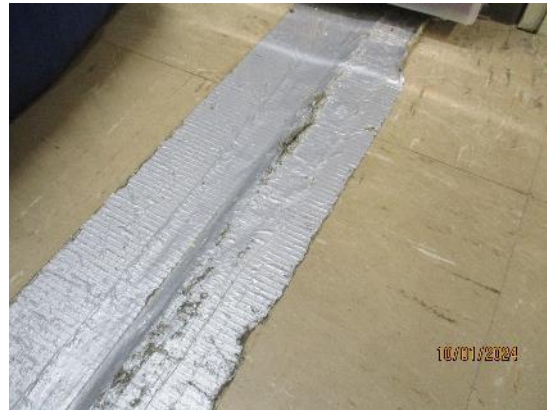
76. Tape repair to vinyl tiles

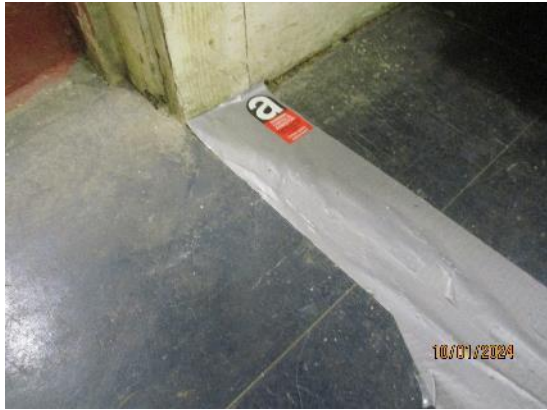
79. Tape repair to vinyl tiles

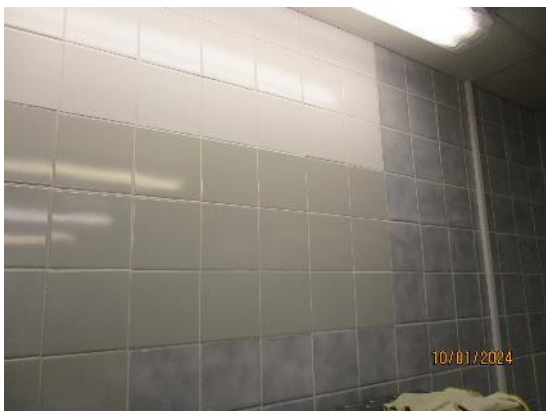
100. Ceramic tiles with patch repairs

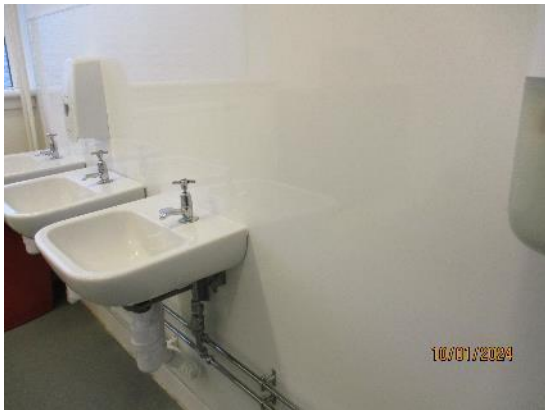
102. Wetwall, half height in pupil toilets

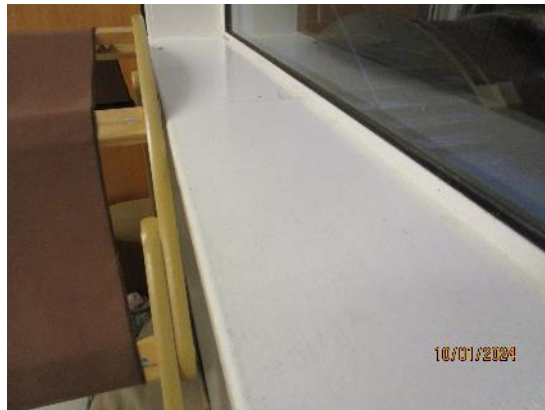
103. Timber window sills blistered and water marked

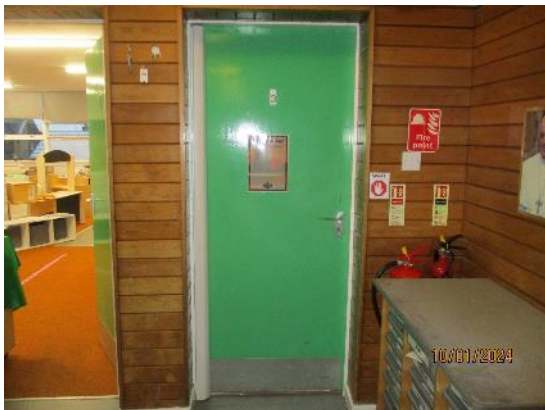
104. Timber hollow core classroom doors

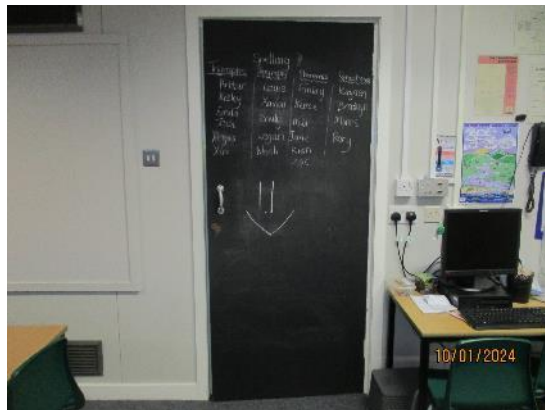
105. Timber hollow core store doors

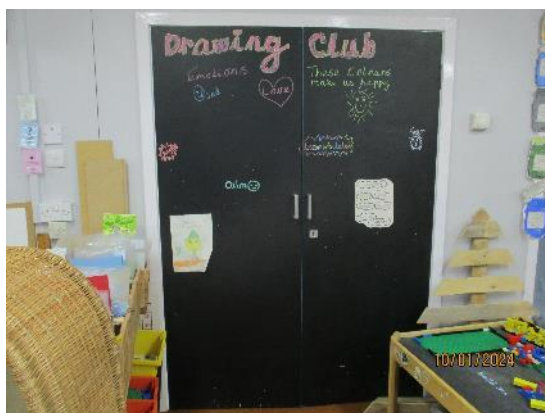
106. Timber hollow core double doors

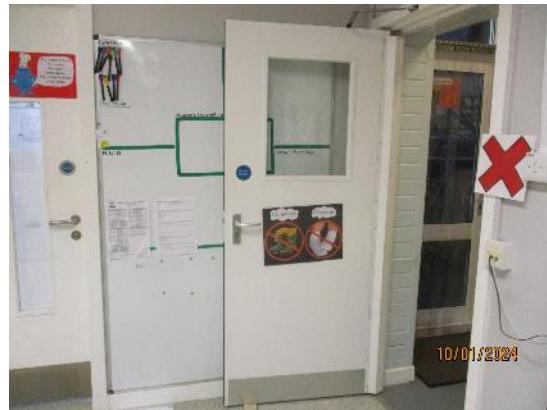
109. Timber solid core fire doors

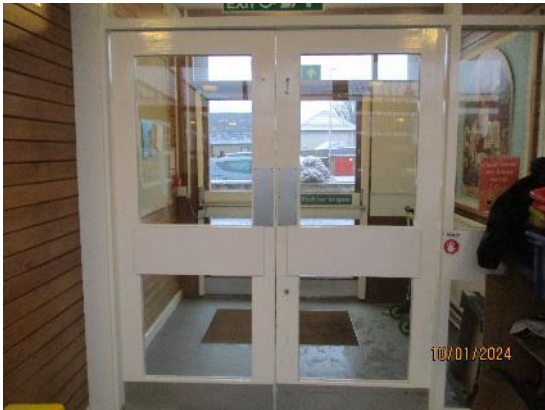
110. Timber double doors

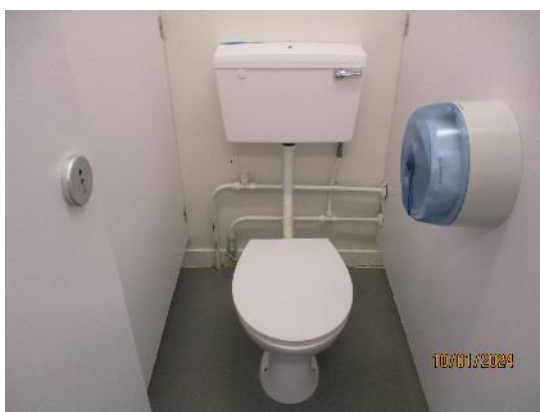
117. Pupil toilets with PVC cisterns

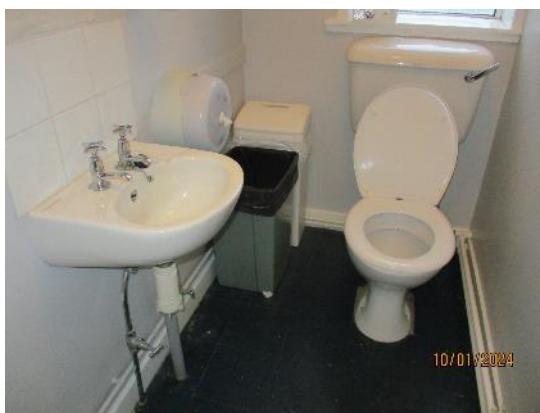
119. Staff toilets with china cisterns

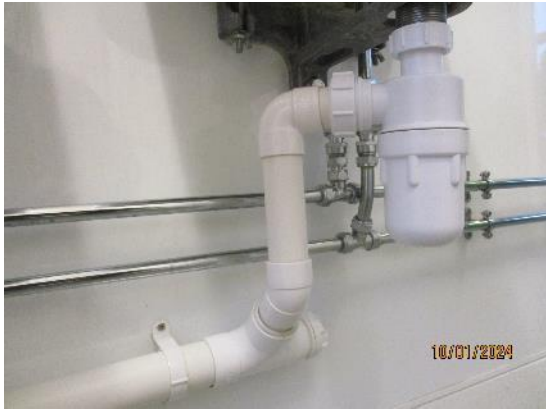
126. PVC waste pipes

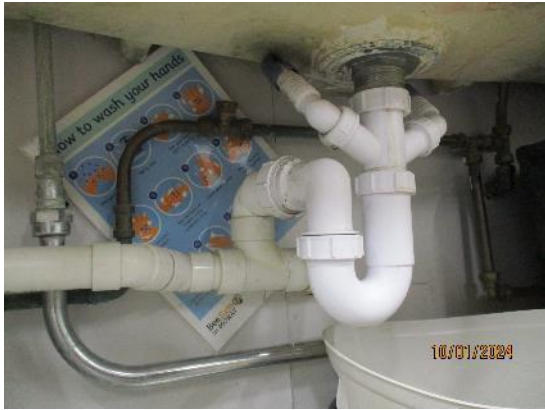
137. PVC waste pipes

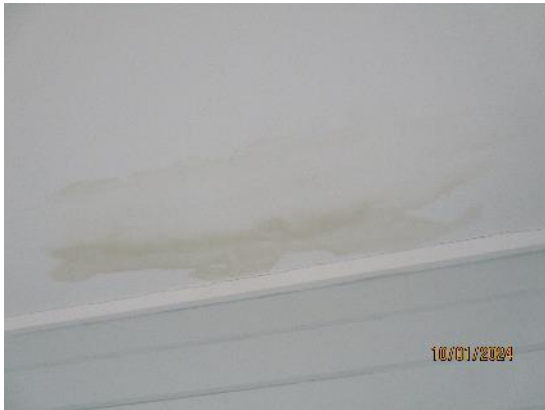
138. Watermarked plasterboard ceilings

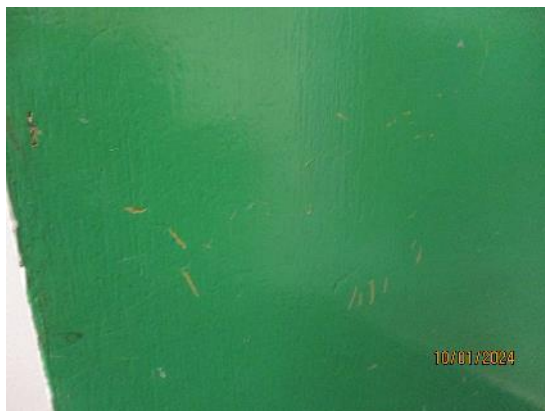
140. Scratched timber doors

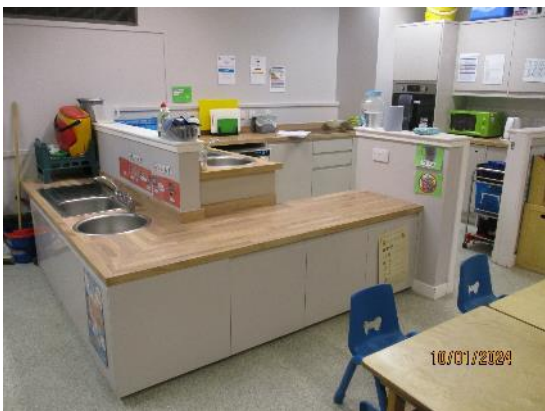
146. Kitchen units - Nursery

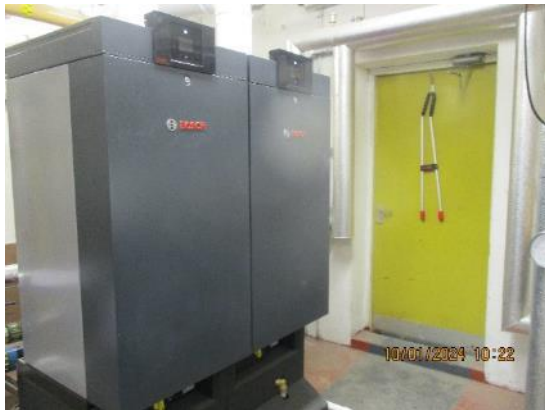
149. Natural gas high efficiency boilers

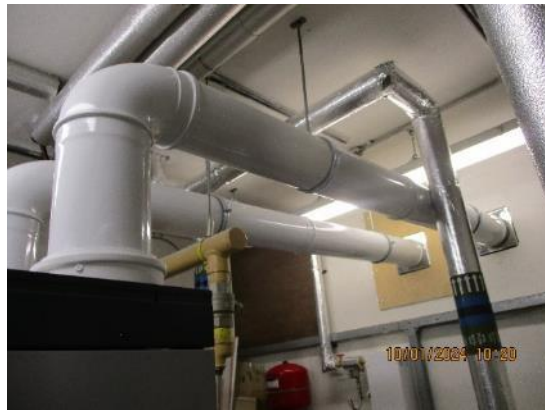
150. Boiler individual flue pipes

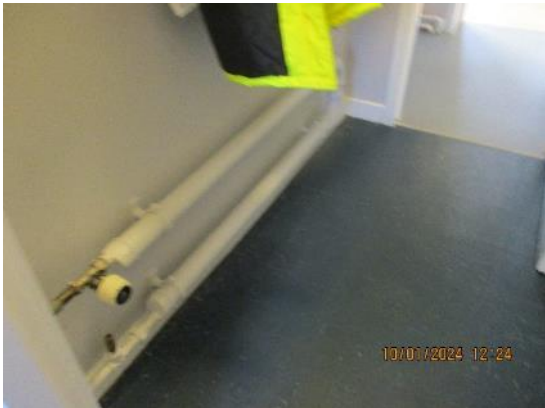
151. Heating system pipework in staff toilet.

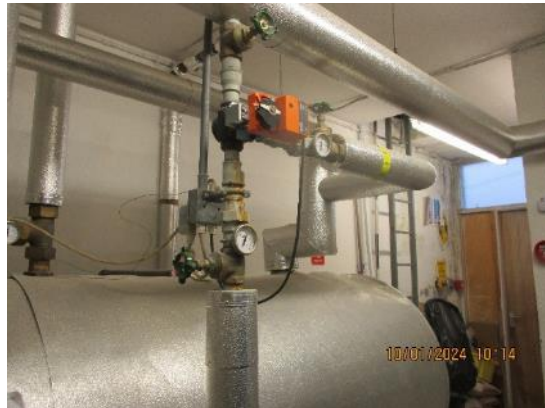
152. Heating primary pipework – boiler house.

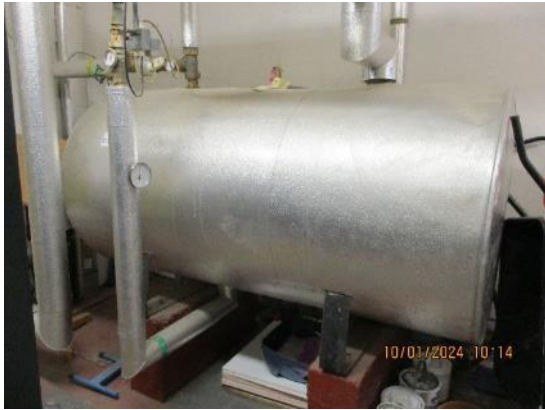
155. Hot water storage calorifier boiler house.

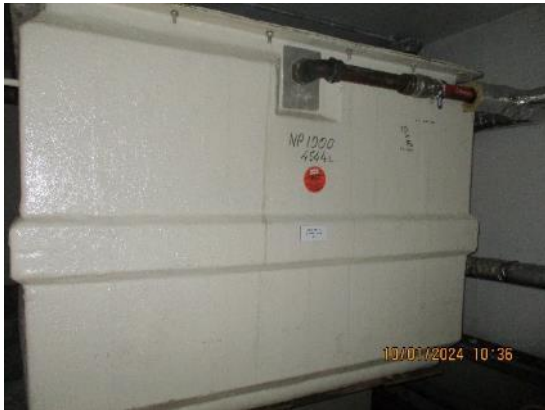
157. Cold water storage tank – above boiler house.

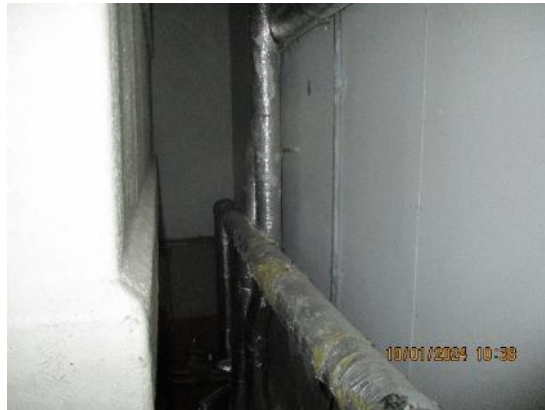
158. Cold water pipework in tank room.

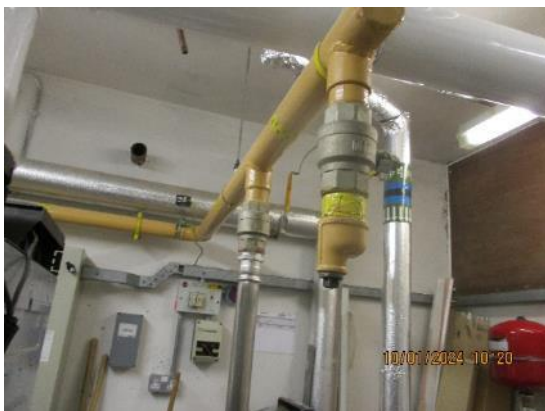
159. Gas supply pipework at boilers.

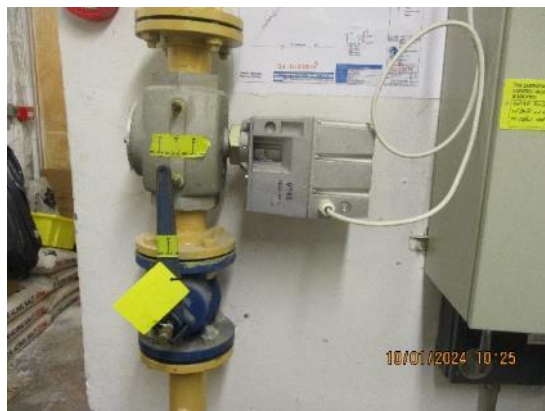
160. Gas supply main solenoid valve. Boiler house.

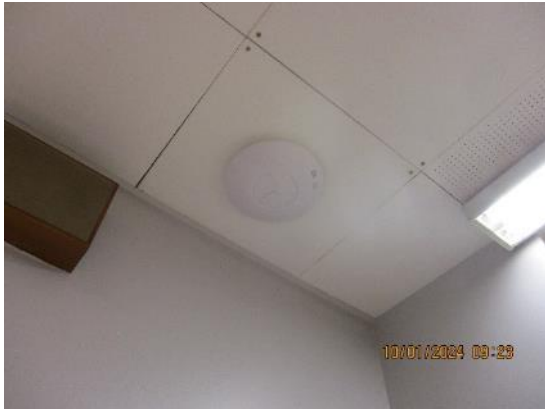
161. Extract fan – nursery kitchenette 1/15

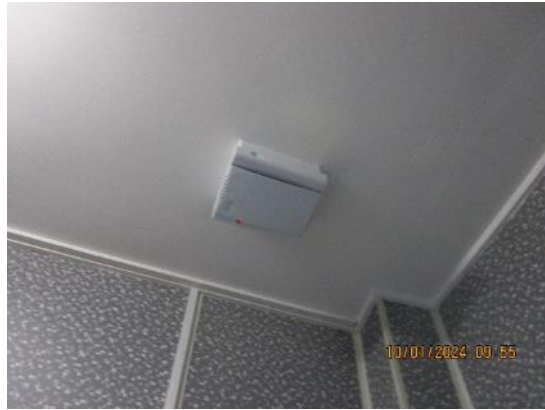
162. Extract fan access toilet 1/19

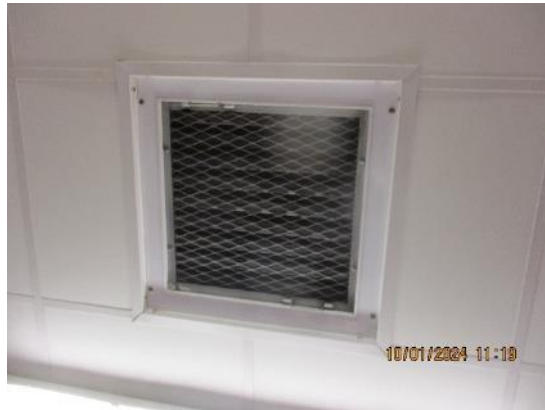
164. Kitchen extract internal grille.

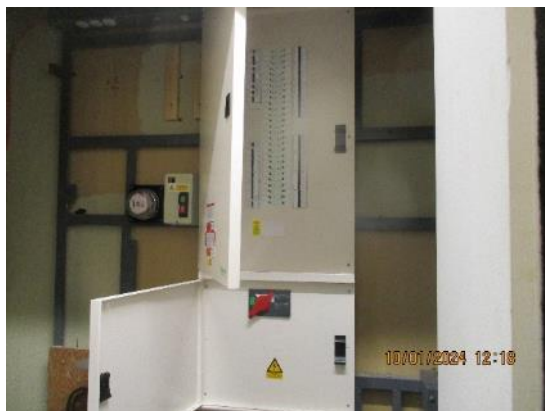
165. Main swiychboard – distribution 1/6 Cupoard

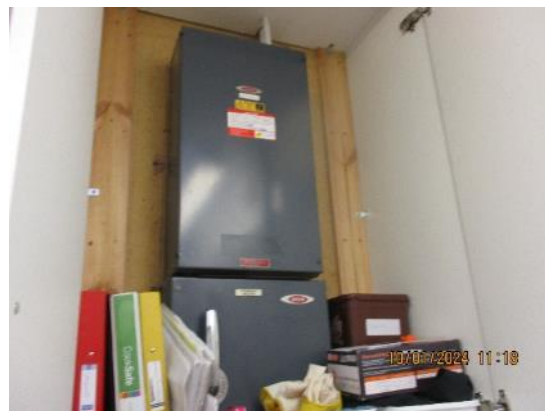
166. DB and isolator – kitchen cupboard.

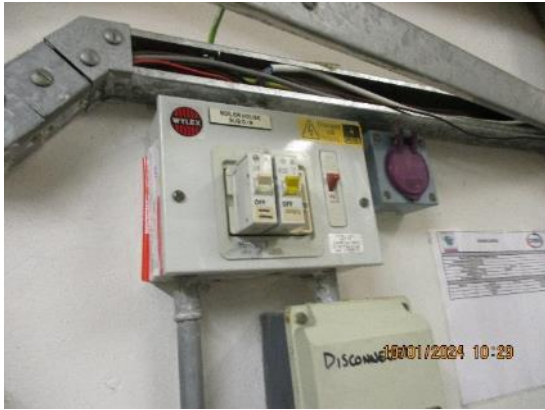
167. DB – 2 way 1 phase – boiler house.

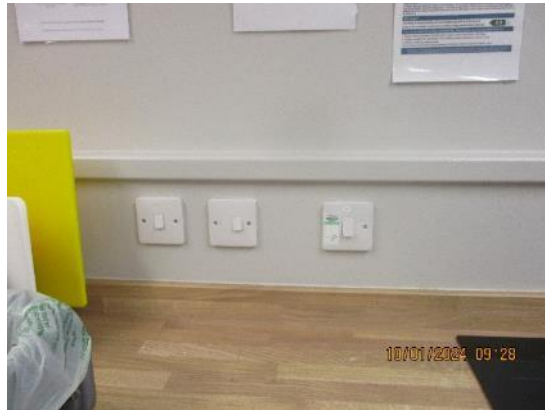
170. Switches – new nursery typical.

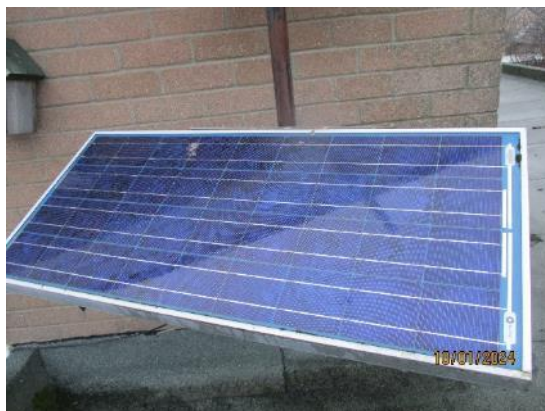
171. Solar PV panel – roof mounted.

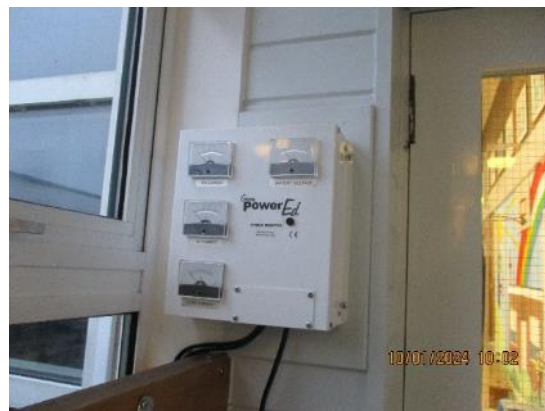
172. Solar panel voltage monitoring unit. 1/16 corridor

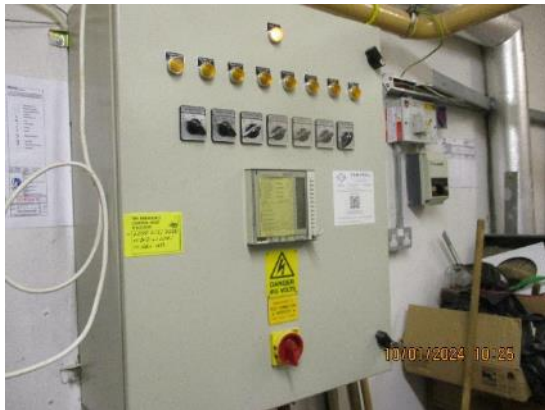
173. Control panel – heating system. Boiler house.

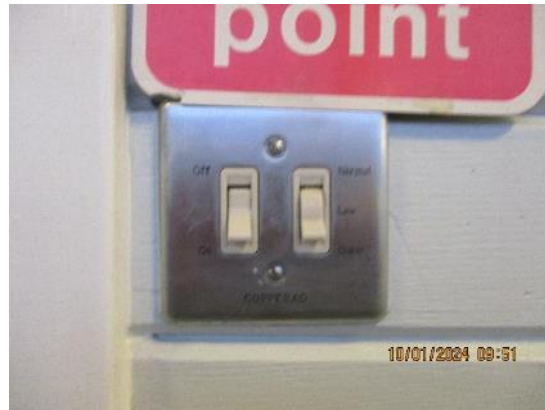
174. Convactor heater – switch control typical.

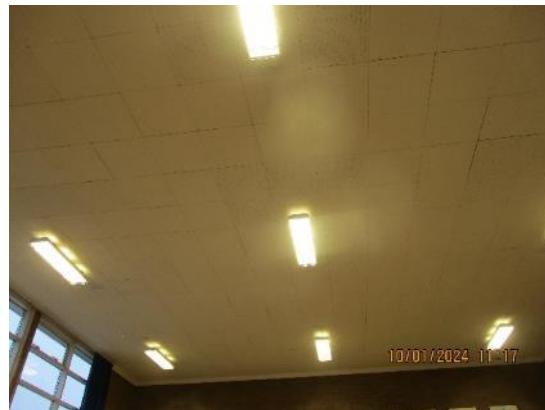
176. Lighting – main hall. 1/21

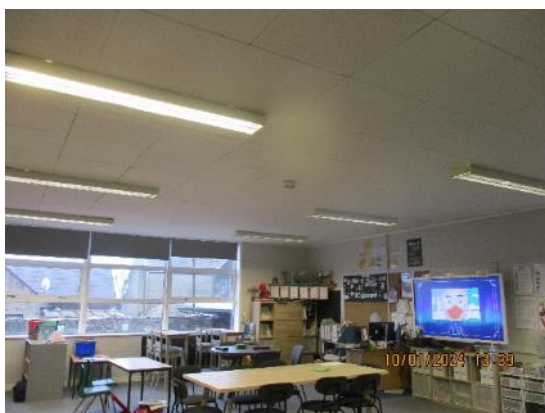
177. Lighting – classroom typical. 1/13

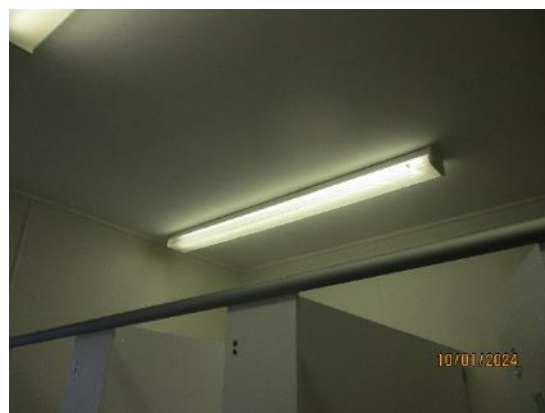
178. Lighting – girls toilet 1/10

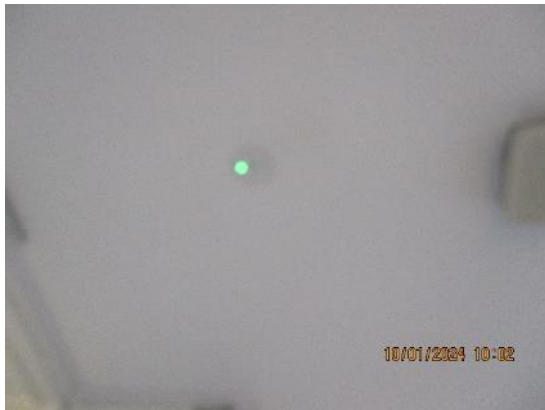
179. Emergency LED lighting. Nursery corridor 1/16

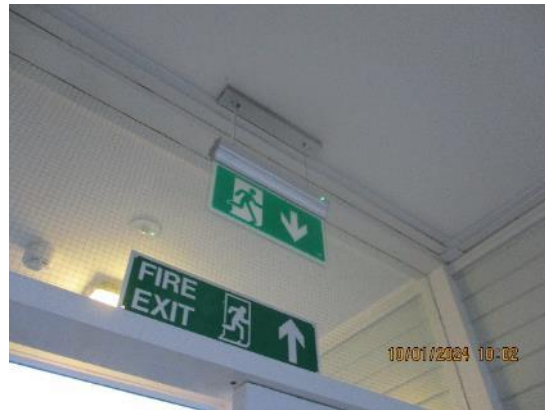
180. Emergency exit sign light 1/16 to 1/20 lobby.

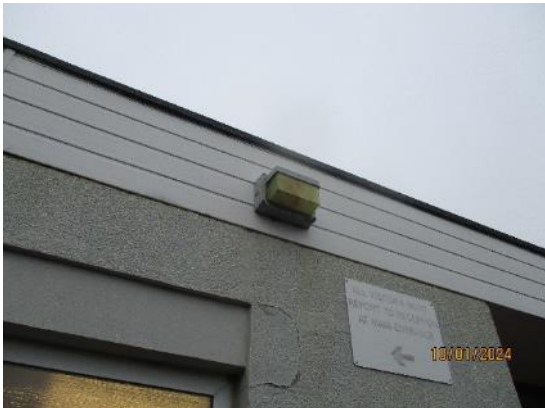
181. External lighting typical.

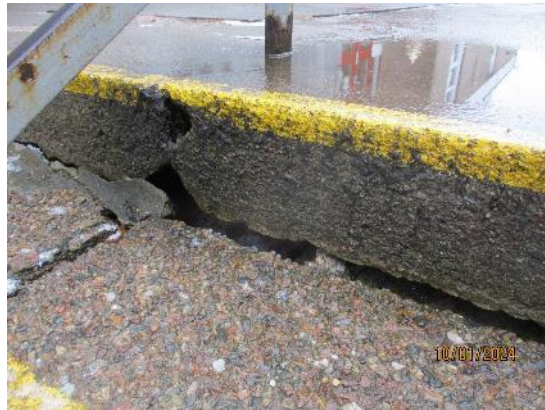
206. Gaps in concrete steps

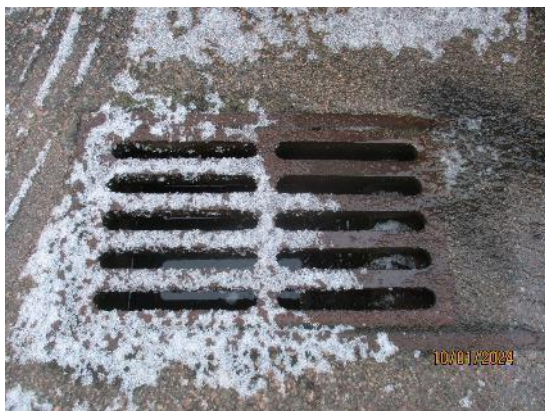
232. Car park road gully drainage

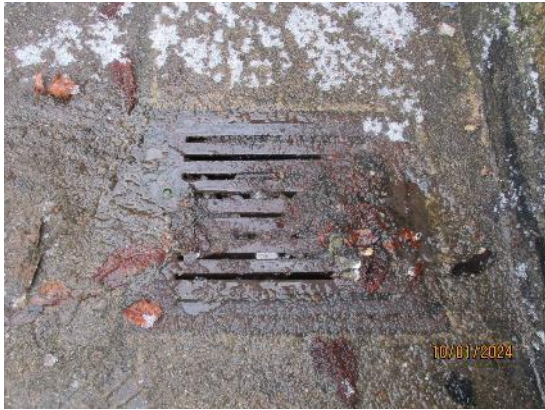
233. Playground drainage partially blocked
