# **BRIDGE INSPECTION REPORT**

**Client:**  
**Moray Council**

**Site:**  
**Broom of Moy**

Date of Inspection: 15<sup>th</sup> January 2004  
Report Date: 11<sup>th</sup> February 2004

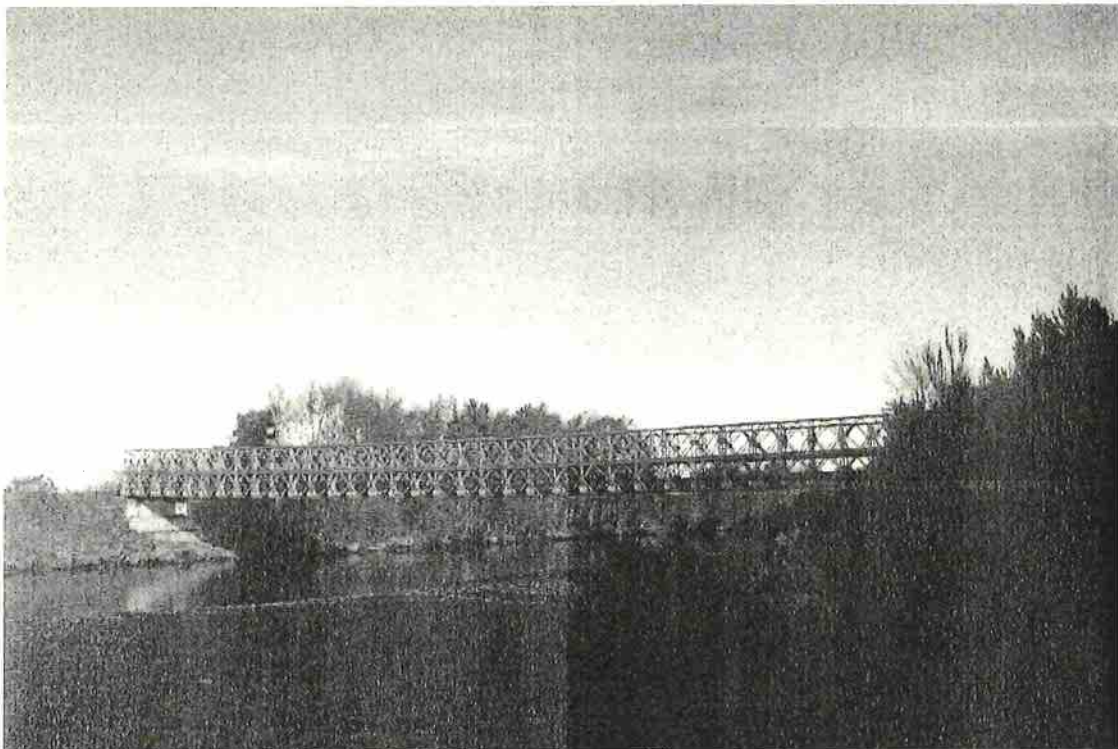
Bridge looks to be in a reasonable condition, there are no major signs of corrosion on the steelwork and all major components are still present.  
Some of the timber decking has rotted away leaving holes in the timber chesses.  
A sag of 300mm approx is present in the bridge.

Showing deflection of the bridge
