# **Summary Building Condition Survey Report**

**Botriphnie Primary School  
Drummuir, Keith AB55 5JF**

**28<sup>th</sup> August 2023**

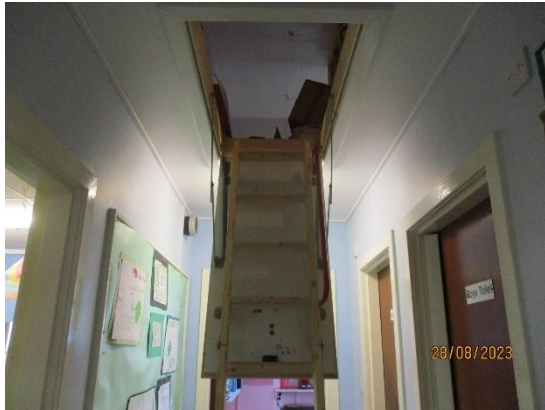
1. Access to water tank

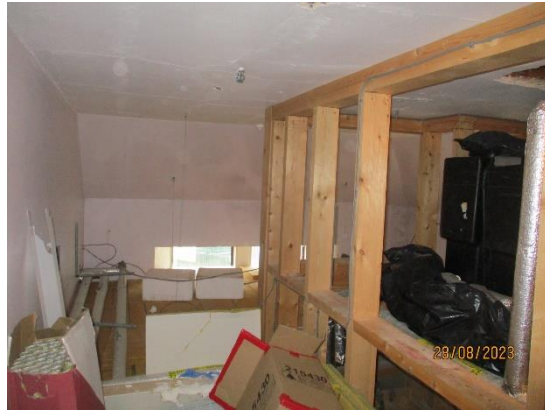
2. Roof void below structure

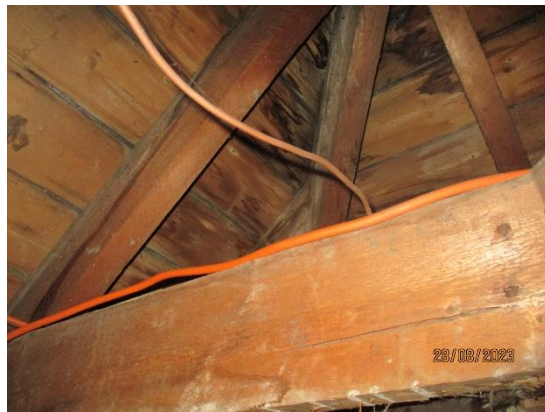
4. Evidence of rainwater penetration

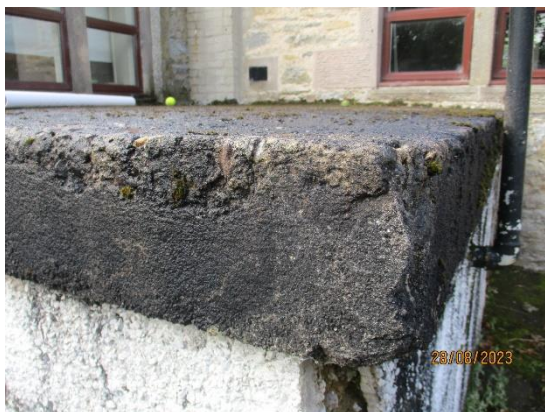
5. Concrete slab roof over boiler room

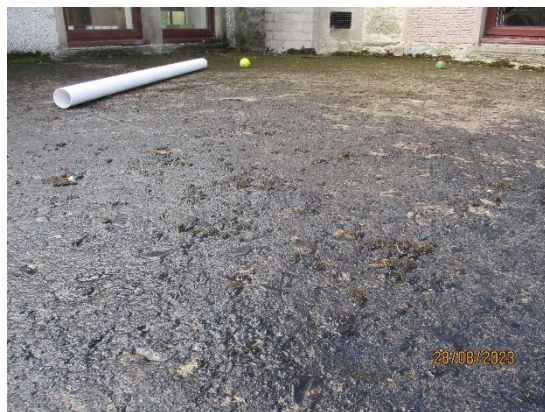
6. Concrete slab surface

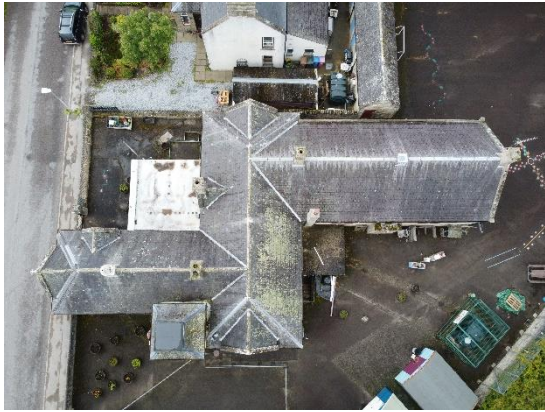
7. Overview of slated roof

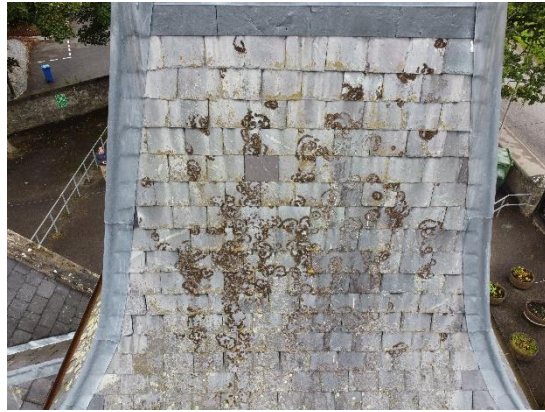
8. Slated roof to belltower

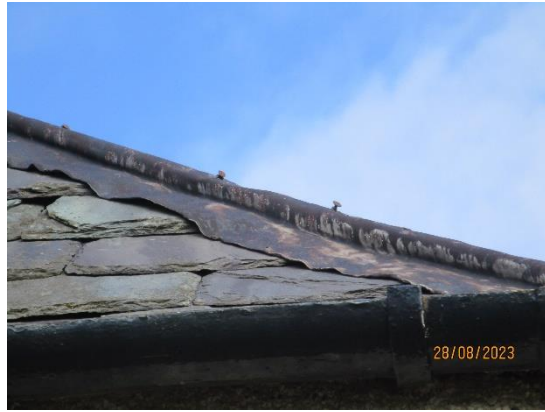
- Ridge and skew pointing requires repair.
- Zinc hips are in poor condition and insecure.
- Isolated slipped and broken slates.
- GRP roof is blistered and not adequately draining.
- Chimney pots are open and partially blocked with vegetation
- All 5 redundant chimney pots need to be capped and ventilated.
- Stone chimneys require isolated re-pointing.
- The flashing to the boiler flue is not adequately dressed around the flue.
- Cast iron gutters are misaligned, broken and leaking.
- Windows have defective glazing seals and isolated blown glazing units.
- External timber doors are a poor fit in the frame with wet rot.
- Lath & plaster ceilings are damaged and cracked.
- Timber floors are uneven suggesting defective boards/joists.

14. Nails protruding from zinc hip

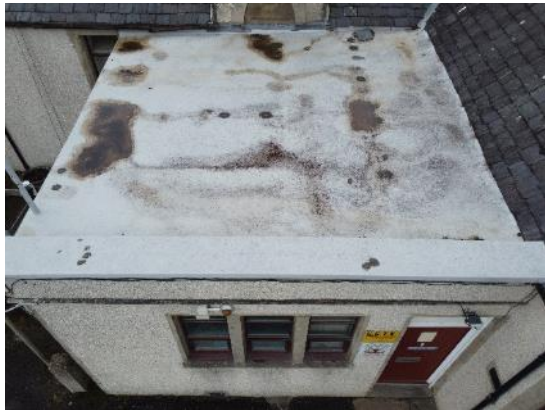
15. GRP roof to Reception

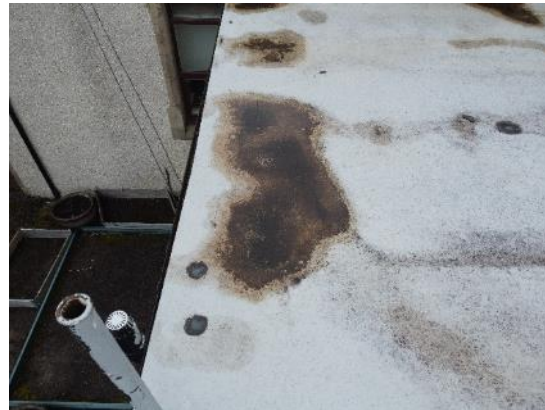
16. Blistered GRP roof with ponding

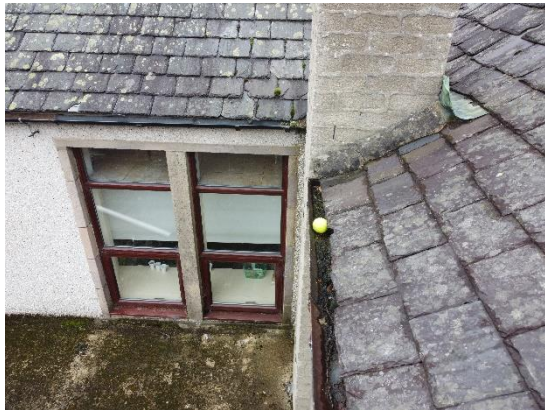
21. Gutters with isolated blockages

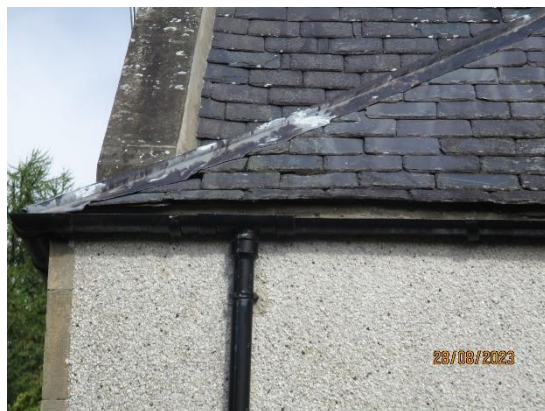
24. Gutter not aligned with roof surface

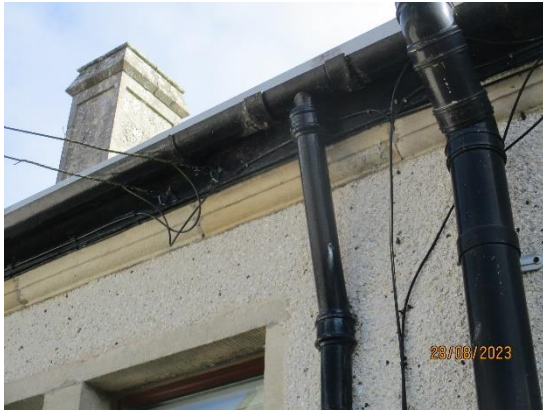
25. Cast iron downpipes

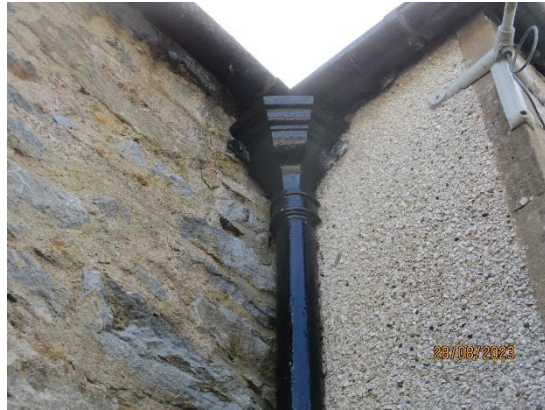
26. Cast iron hopper head and downpipe

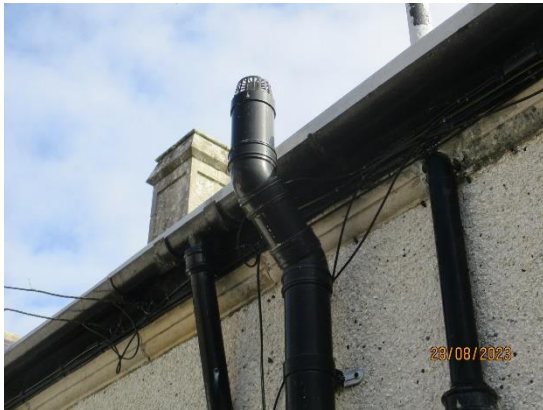
27. UPVC soil vent pipe

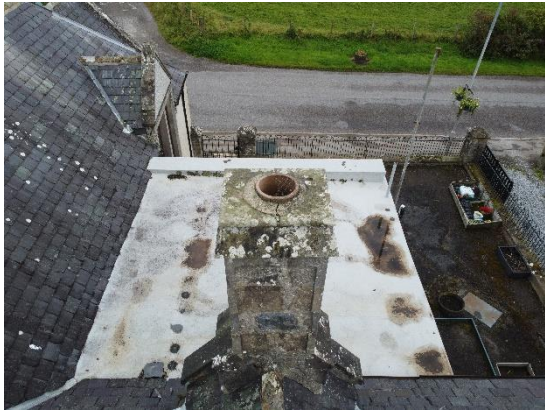
31. Open flues require capping and venting

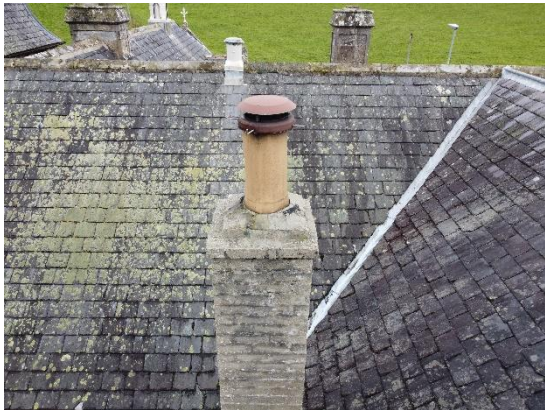
33. Boiler chimney stack

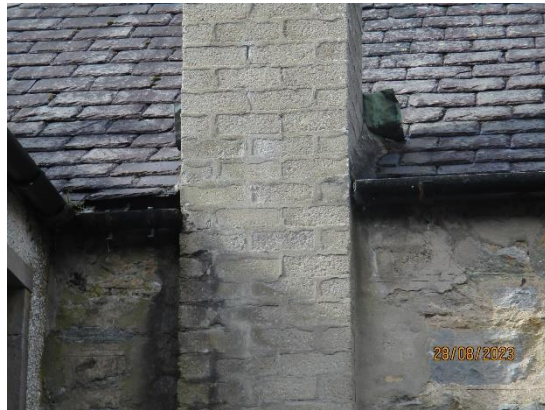
34. Brick boiler flue

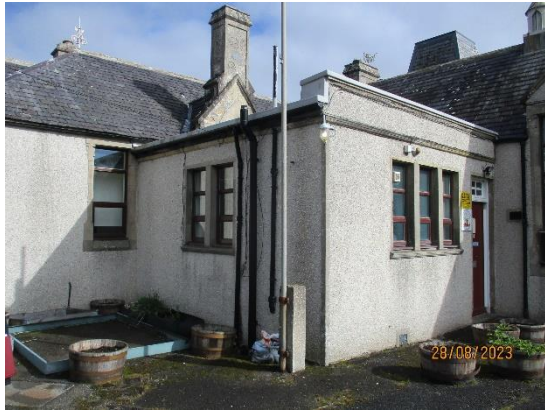
37. Metal flag pole fixed to concrete post

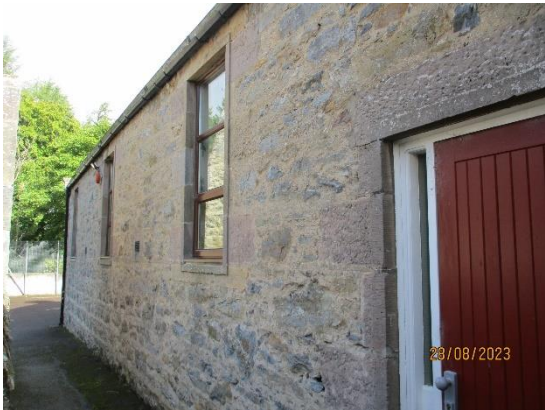
39. Stone walls to main school building

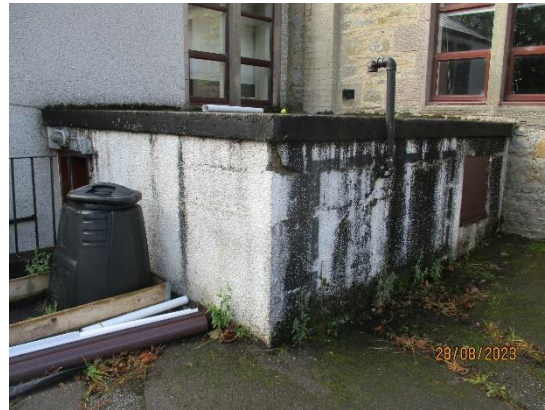
40. Blockwork walls – Reception & Boiler Room

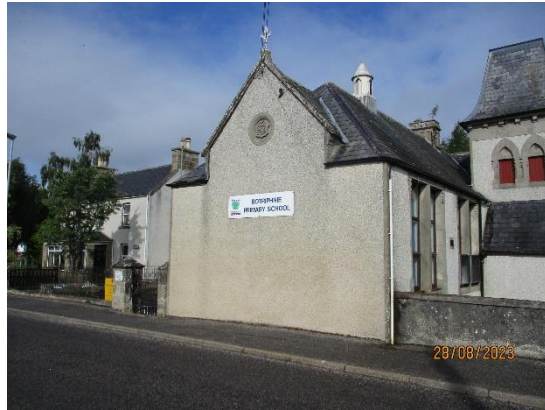
44. Stone with roughcast finish to south wing

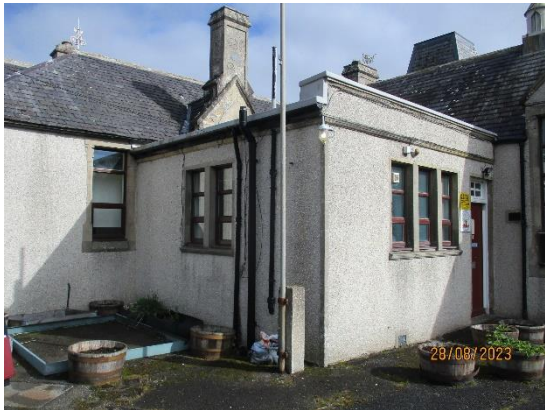
45. Masonry with roughcast finish to Reception

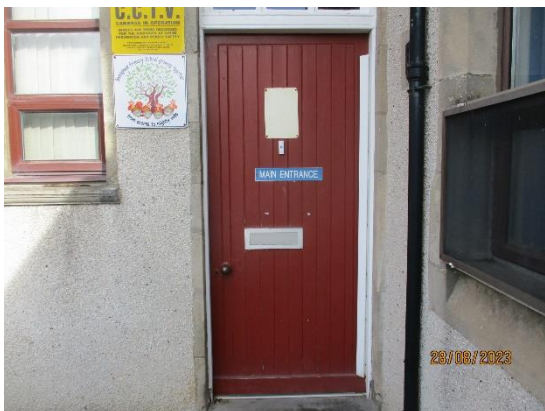
47. Timber front entrance door

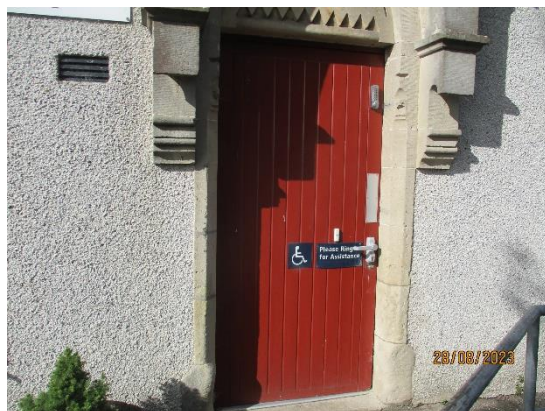
48. Timber side entrance from playground

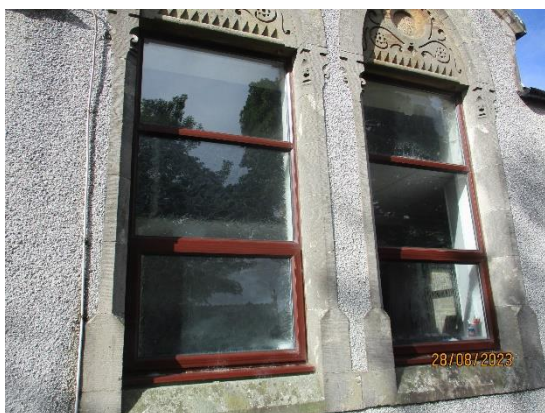
54. Typical UPVC windows

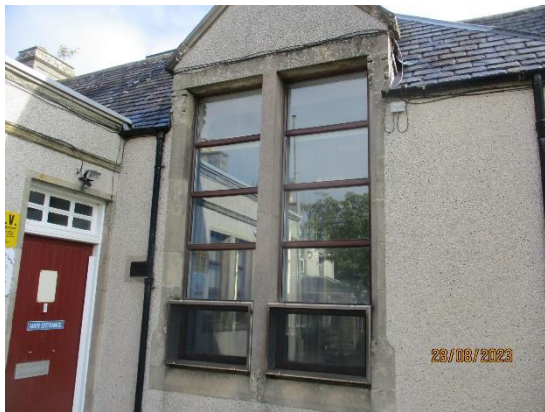
57. Large UPVC windows

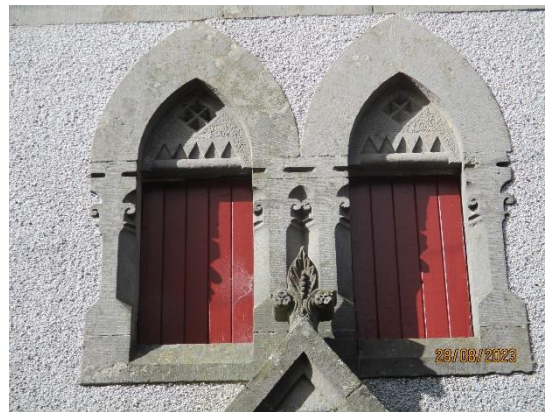
58. Timber screens to Belltower

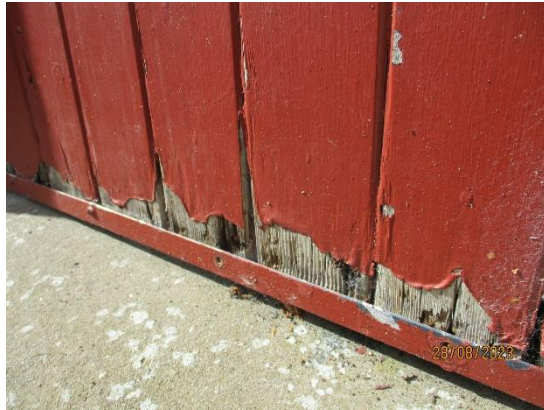
62. Peeling paint to timber doors

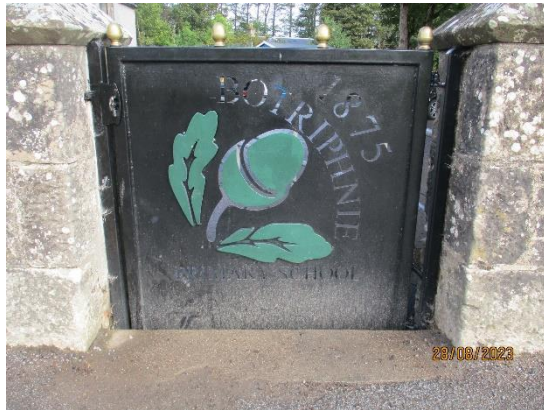
64. Painted metal gates

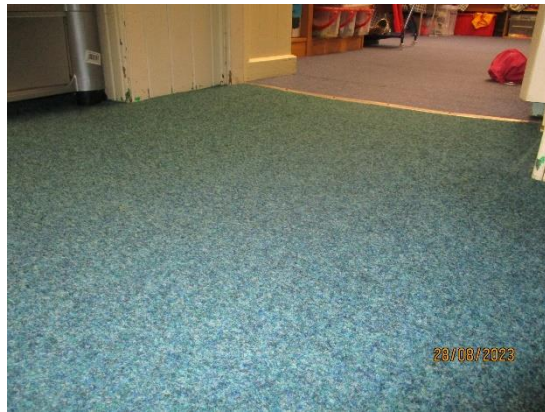
67. Uneven suspended timber floors

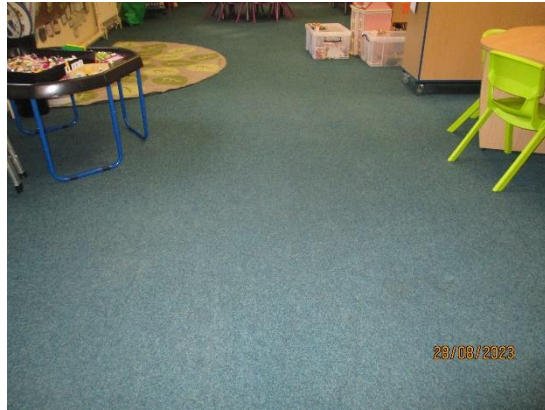
73. Carpet to classroom floors

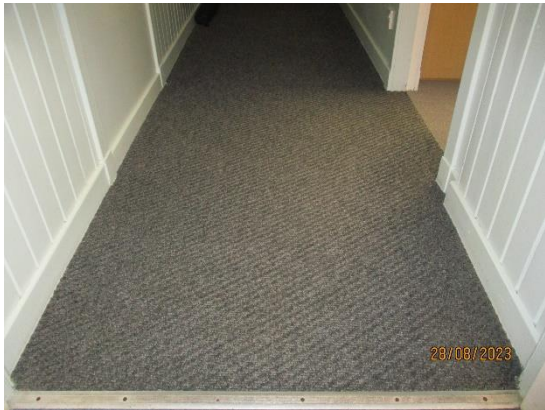
74. Heavy duty carpet to entrance corridor

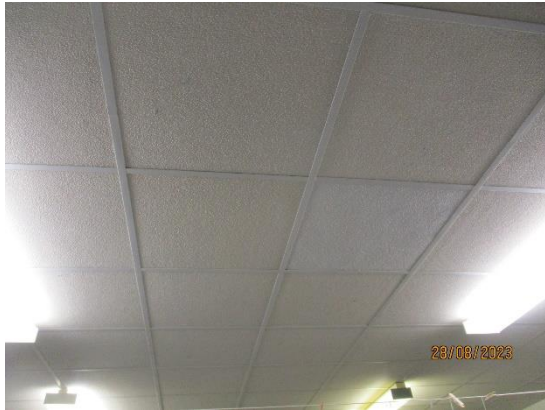
78. Suspended ceiling tiles

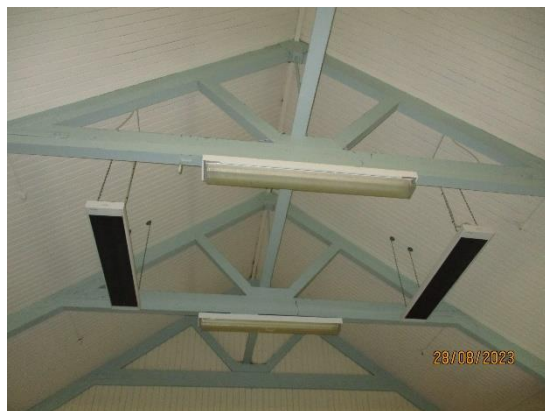
83. Timber linings to Hall ceiling (1/6)

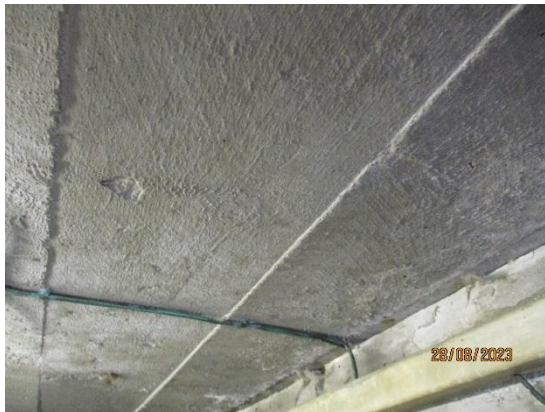
84. Concrete ceiling to the Boiler Room

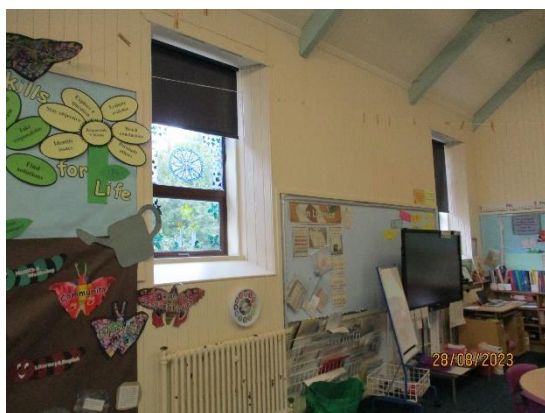
87. Timber linings to Hall

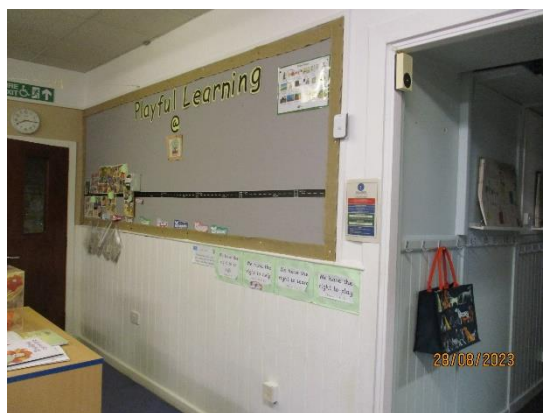
88. Low level timber linings to circulation areas

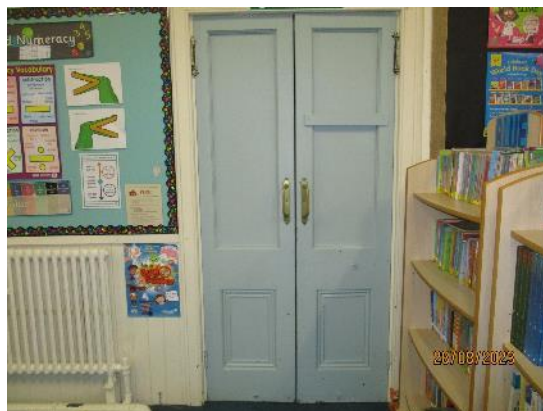
94. Timber panelled double doors

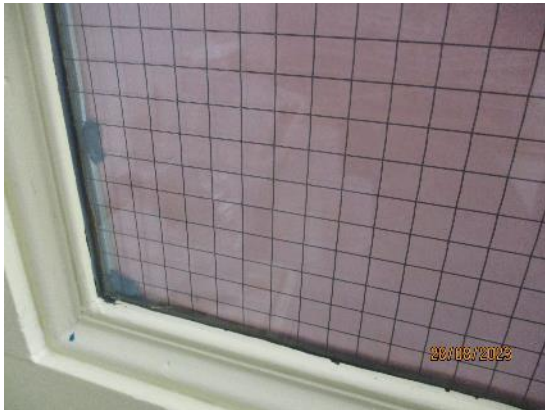
97. Georgian wired glazing to doors

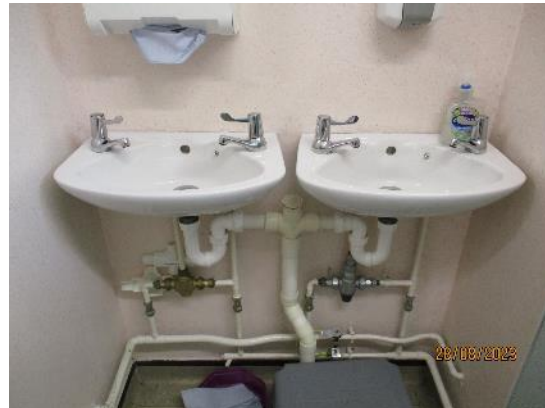
104. Typical wall hung basins

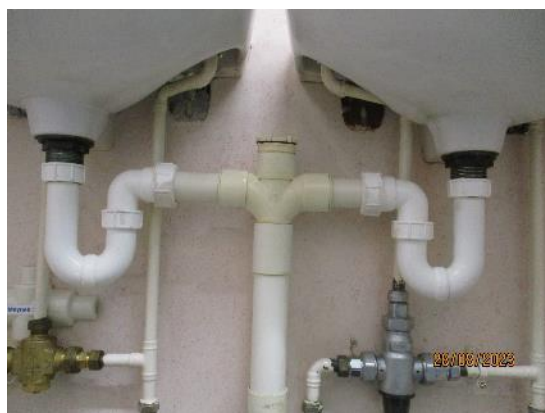
106. PVC waste pipes

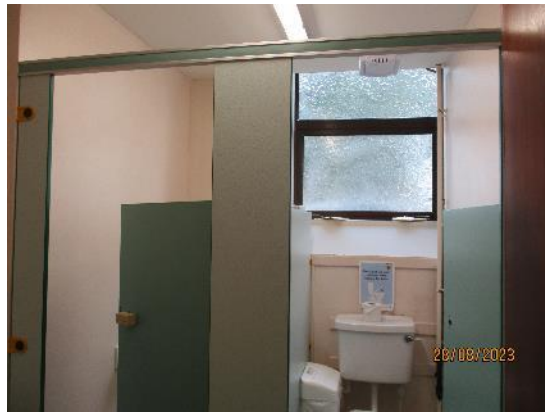
108. Composite panel toilet cubicles

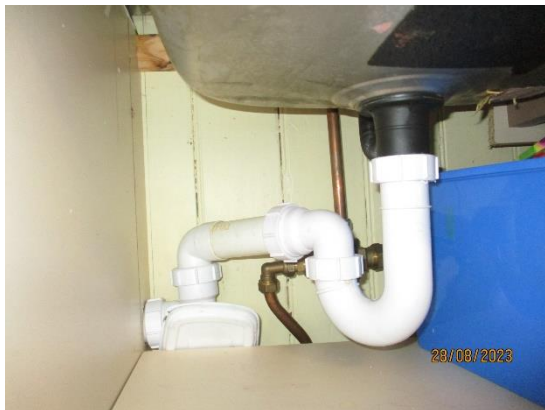
115. PVC waste pipes

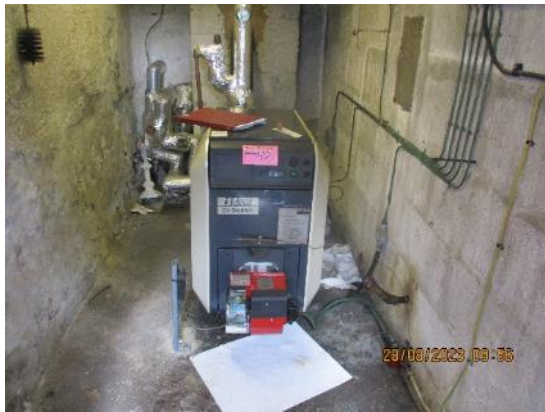
127. Oil system boiler. Basement plant room 0/14.

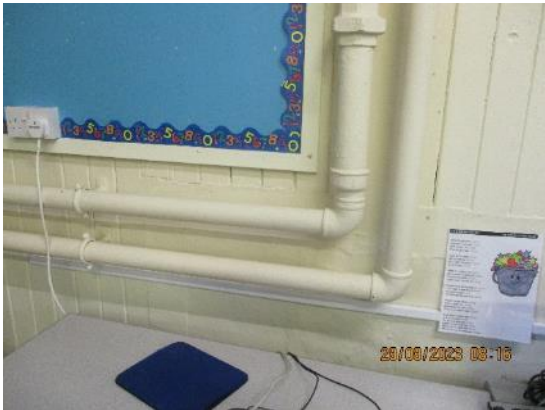
129. Heating system distribution pipework class 1/6.

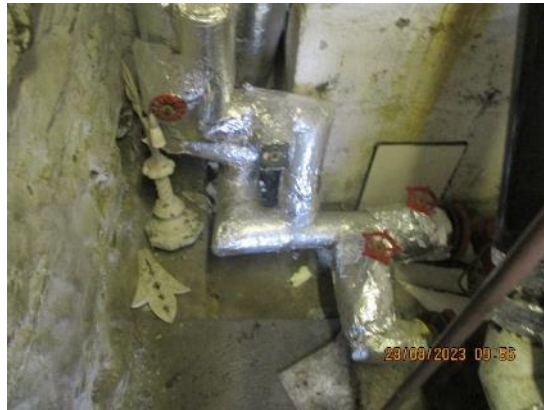
130. Heating system pipework in plant room 0/14.

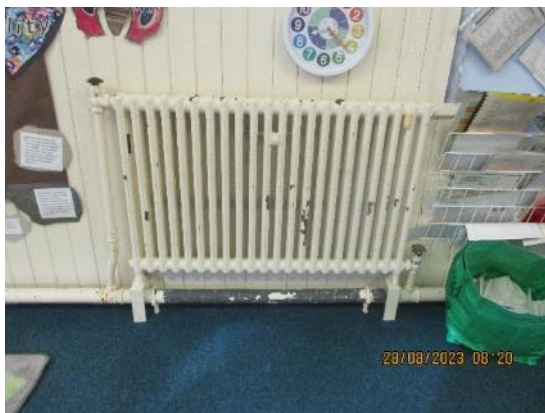
131. Cast iron radiator classroom 1/5.

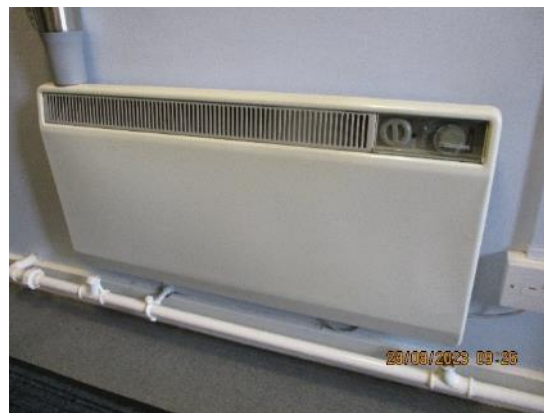
132. Electric convector heater corridor 1/7.

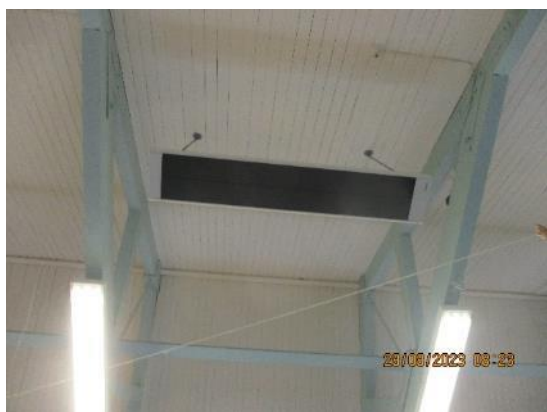
133. Radiant ceiling panel heater classroom 1/6.

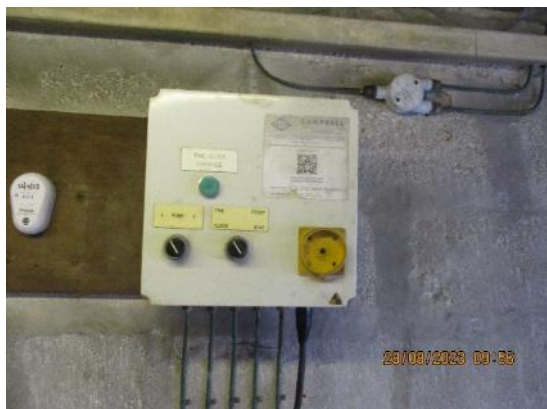
135. Heating control panel 0/14.

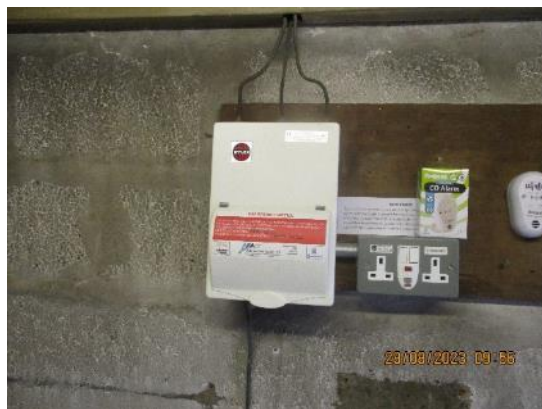
136. Distribution board – heating system. 0/14 supply.

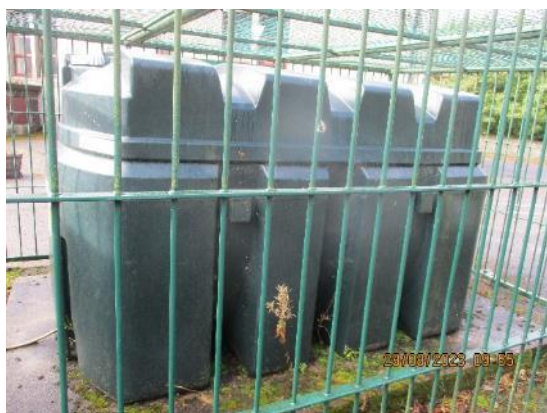
137. External oil storage and supply tank.

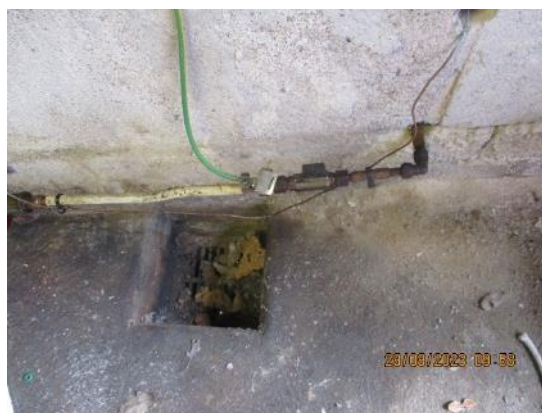
138. Oil supply pipe to appliance 0/14.

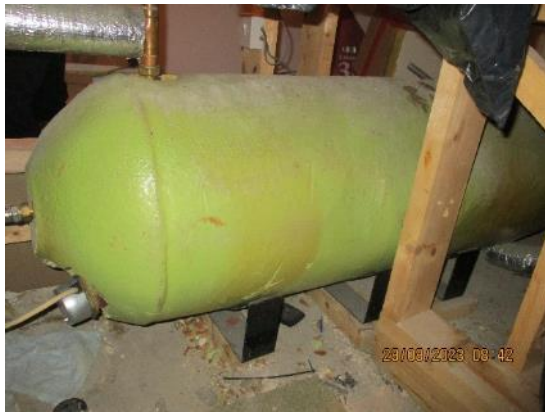
139. Hot water cylinder – attic space above 1/7.

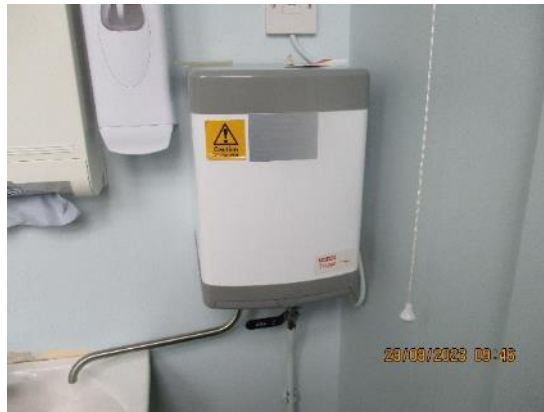
140. Electric point of use water heater 1/2 toilet.

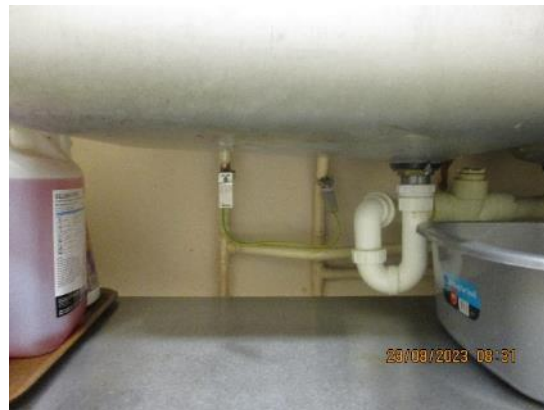
142. Hot water pipework typical.

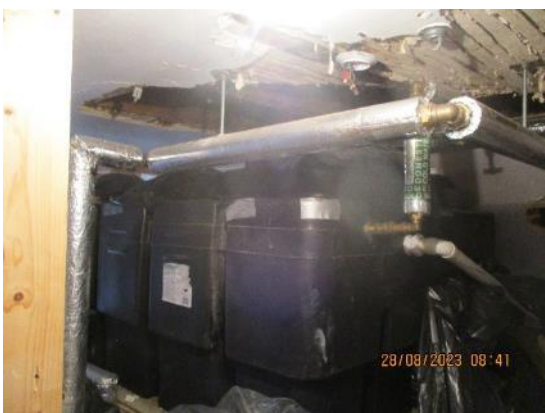
143. Cold water tanks – attic space above 1/7.

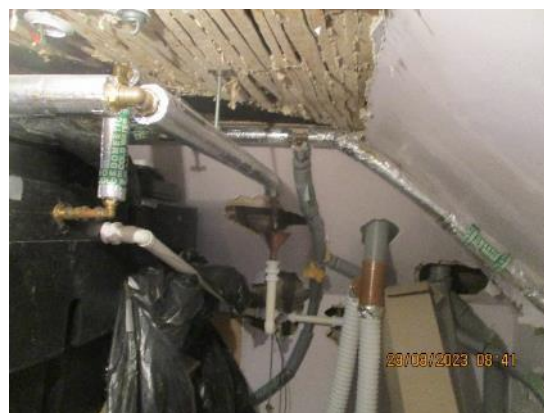
144. Cold water pipework attic above 1/7.

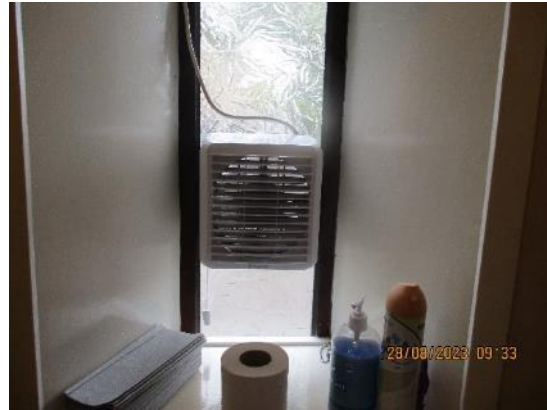
146. Extract fan staff toilet 1/11.

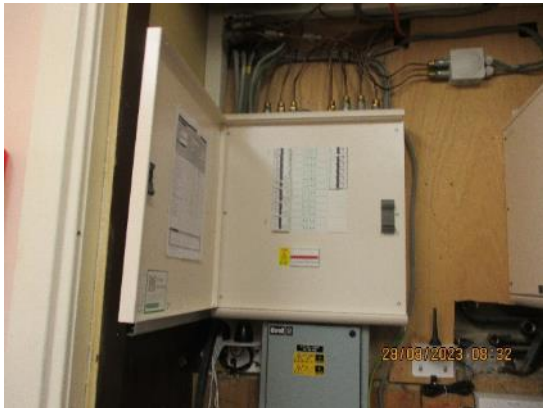
147. Distribution board L+P cupboard 1/19.

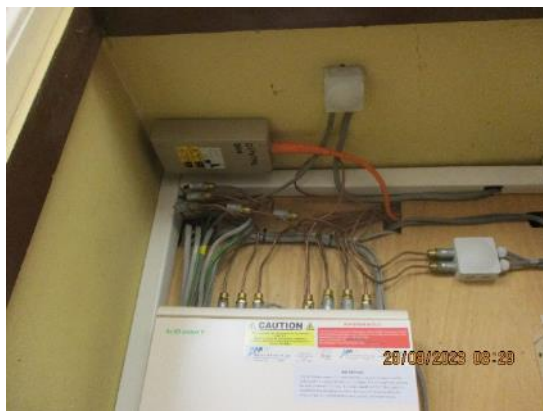
149. General wiring from L+P DB cupboard 1/19.

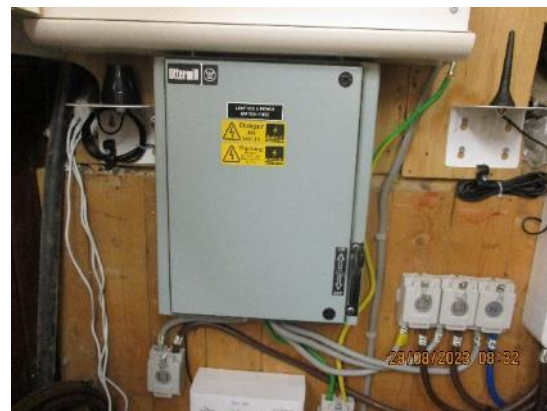
150. Fused isolator cupboard 1/19.

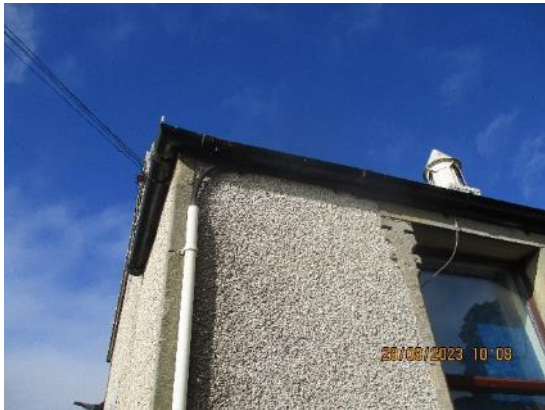
153. Incoming power supply in white PVC pipe.

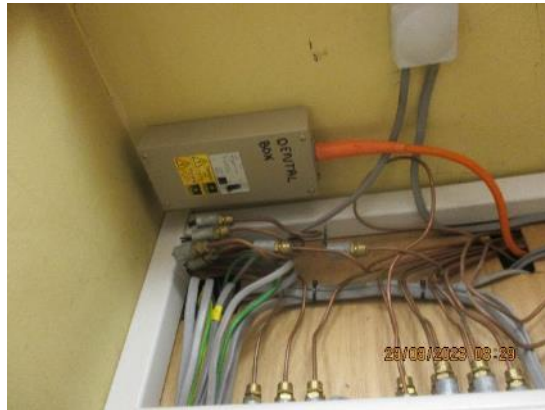
154. RCD unit – dentist box 1/19. (redundant)

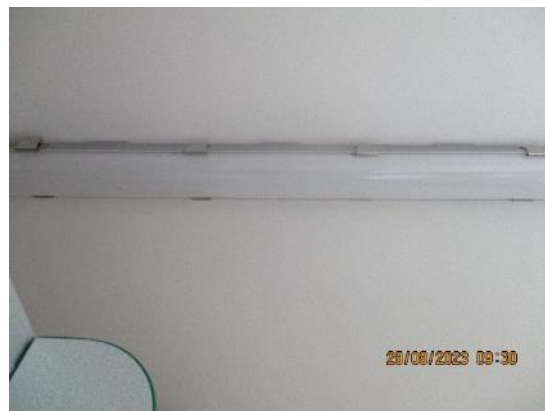
156. Lighting girls toilets 1/9.

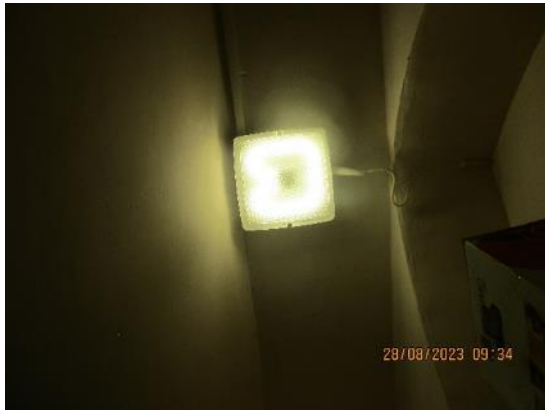
159. Lighting staff toilet 1/11.

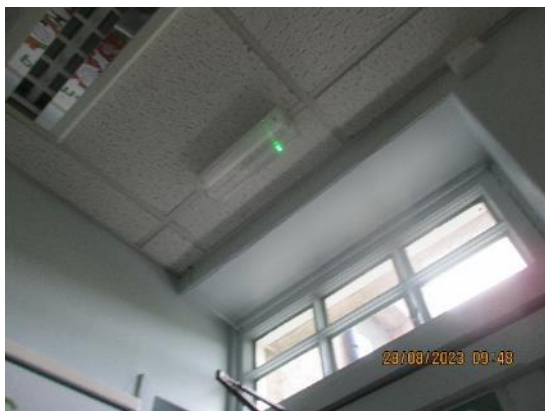
161. Emergency lighting main entrance 1/1.

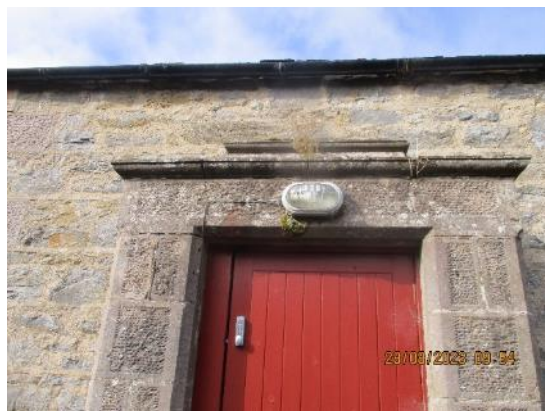
162. External lighting east wall.

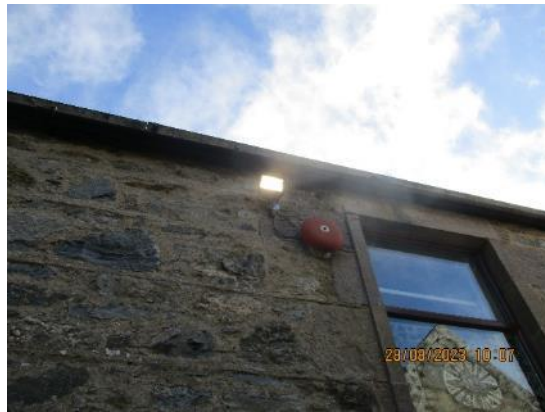
164. External flood light west wall,

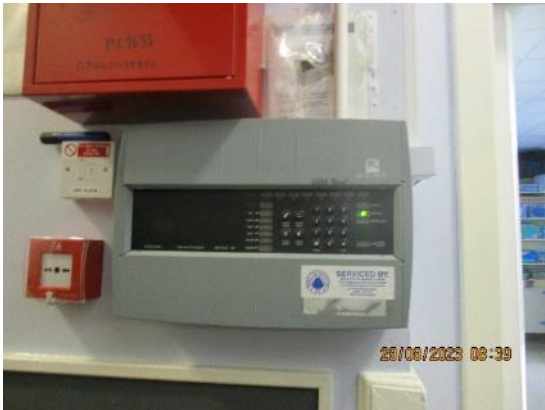
165. Fire alarm system control panel 1/7.

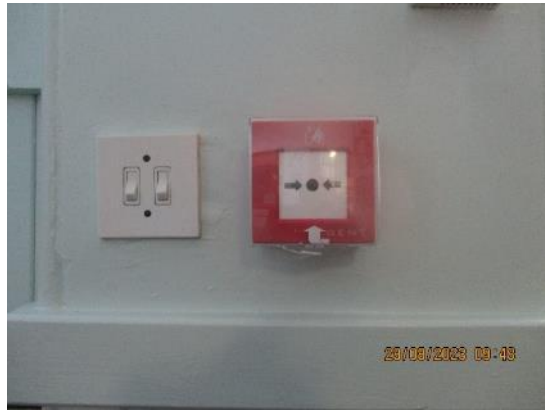
166. Fire alarm call point 1/1.

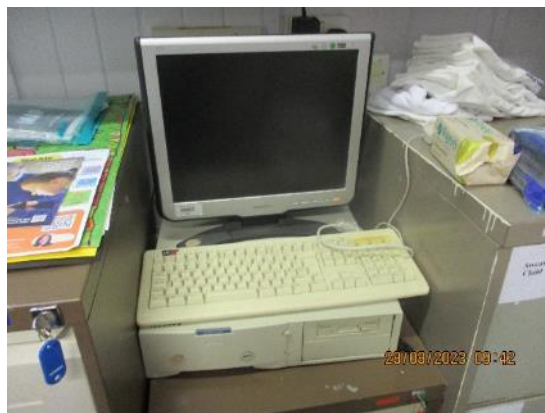
One CCTV camera is installed at the front main entrance door, with monitor and desktop processing unit located in the reception office. This is currently defective and site staff report it has not been operational for a number of years.

168. CCTV monitor and desktop – office 1/3.

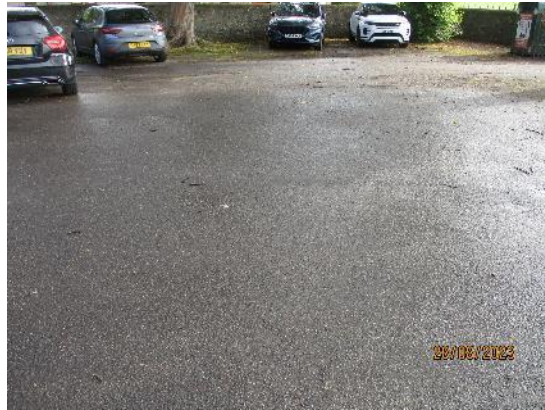
- Tarmacadam car park pot holed with surface erosion.
- Tarmacadam playground has damaged and cracked surface.
- Personnel and vehicle metal gates are in poor condition and life expired.
- Stone perimeter walls require repointing.

170. Tarmac car park

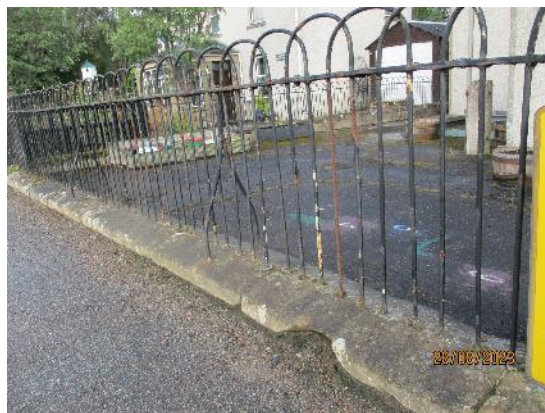
180. Metal hoop fencing

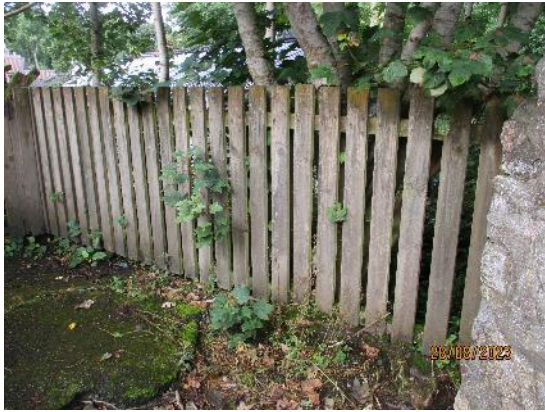
181. Timber boarded fencing

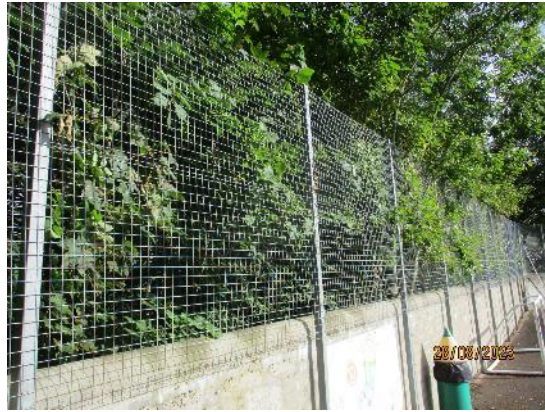
182. Chain link fencing

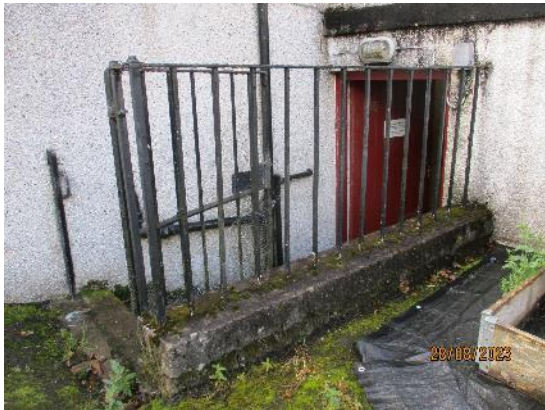
183. Metal bar fencing

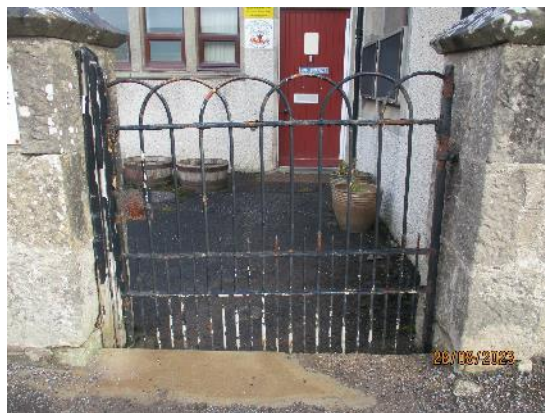
186. Metal hoop main entrance gate

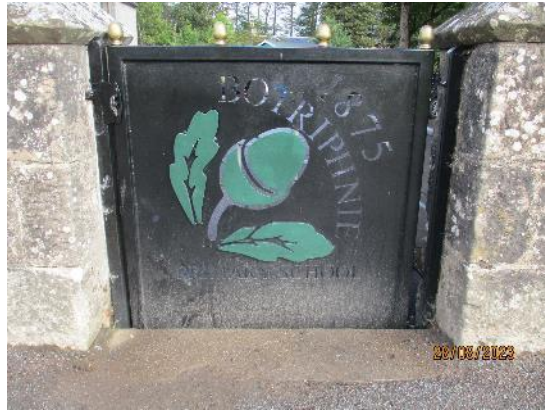
188. Steel plate gate to side entrance

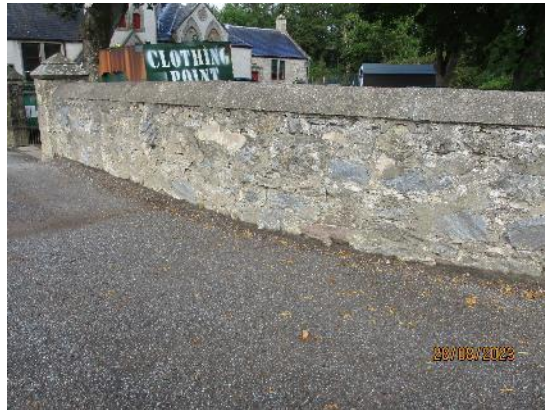
190. Natural stone wall to perimeter

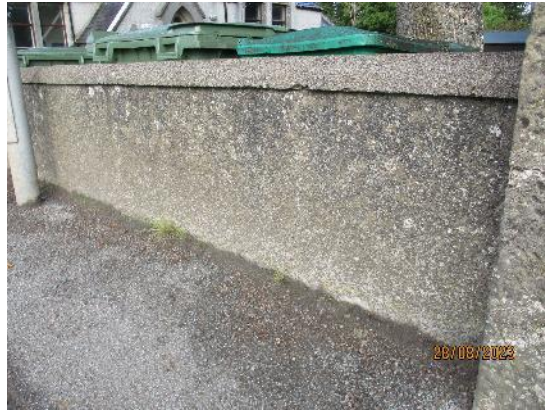
194. Masonry roughcast wall

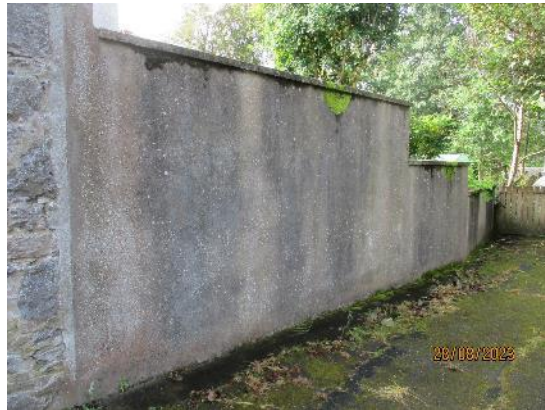
196. Masonry and smooth render wall

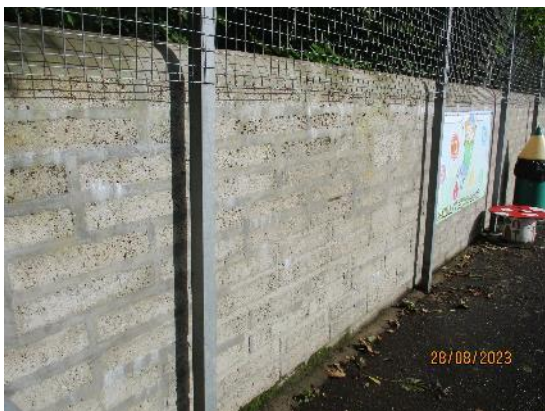
197. Concrete block retaining wall

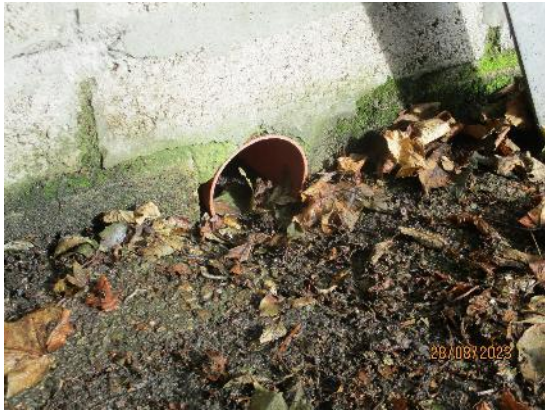
199. Playground surface water drainage by wall ducts

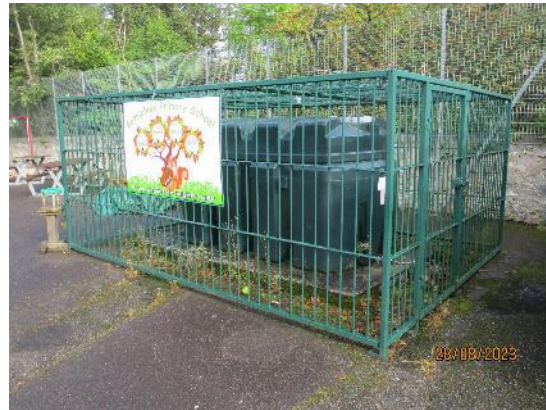
202.Oil tank enclosure
