# **Summary Building Condition Survey Report**

**Keith Grammar School and Leisure Centre  
School Road, Keith AB55 5GS**

**9<sup>th</sup> to 12<sup>th</sup> October 2023 and 22<sup>nd</sup> to 25<sup>th</sup> January 2024**

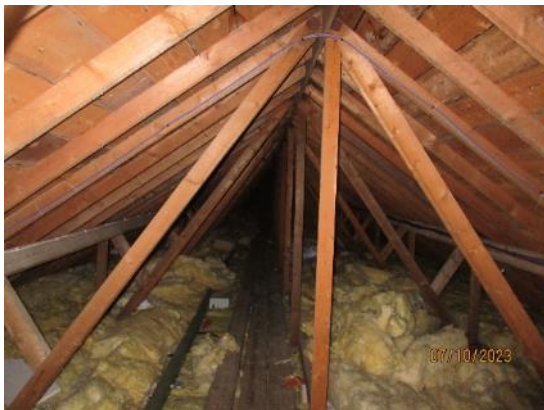
5. School timber pitched roof

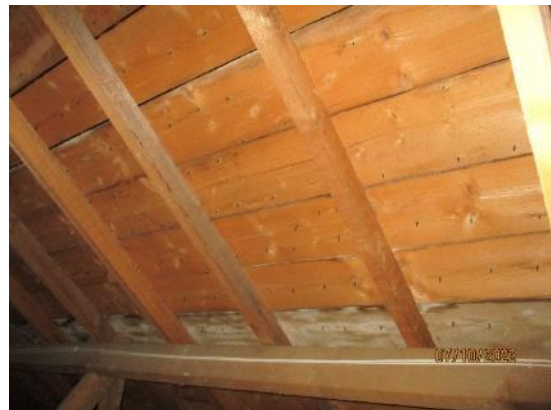
6. Timber sarking boards

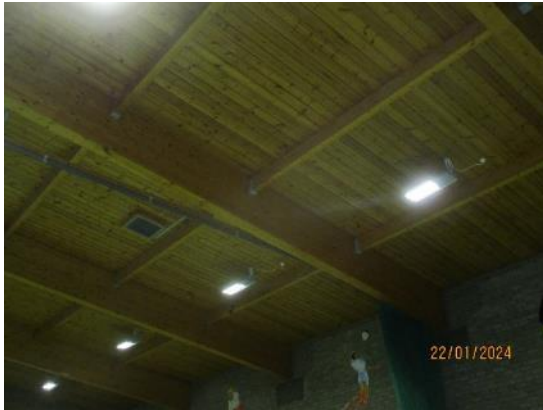
7. Glulam beams – Games Hall

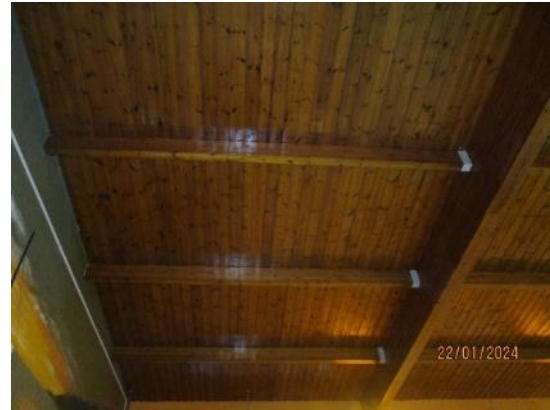
8. Glulam beams – Swimming Pool

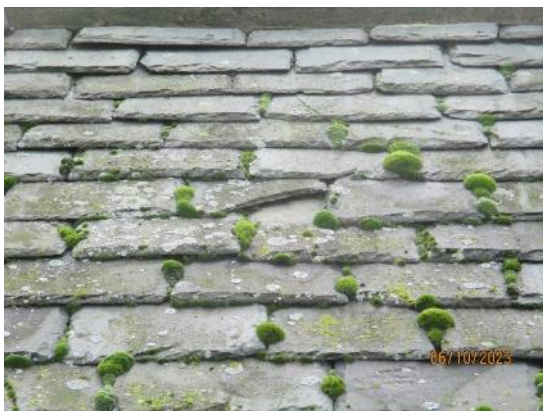
11. Slipped and broken slates

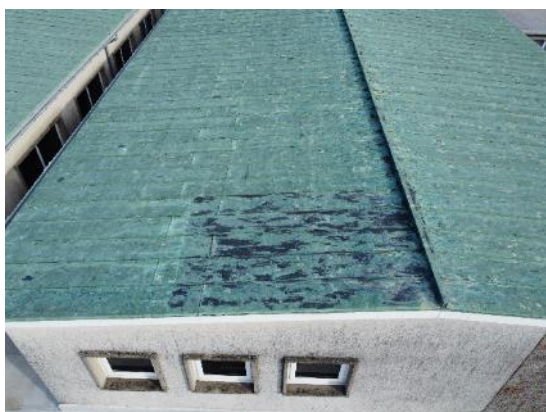
13. Surface discolouration of copper roofs

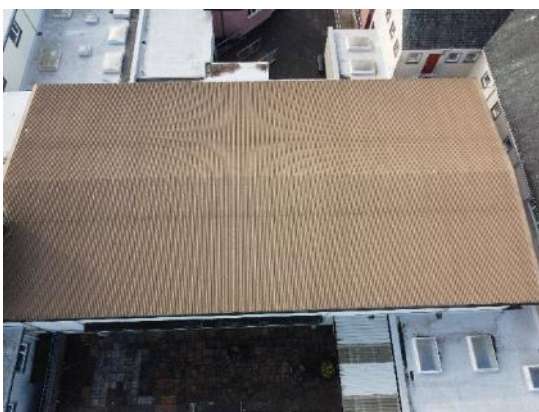
14. Metal profile roof to Hall and Stage

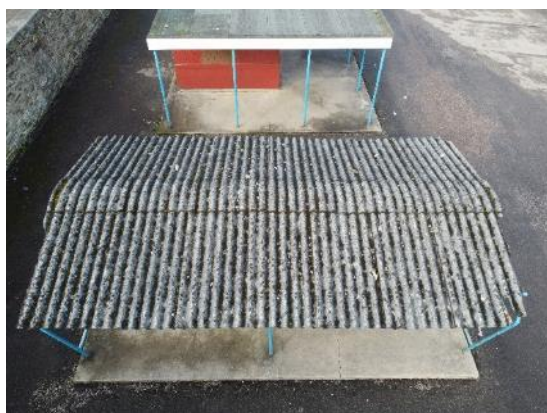
17. Asbestos roofs to Store and Cycle Shelter

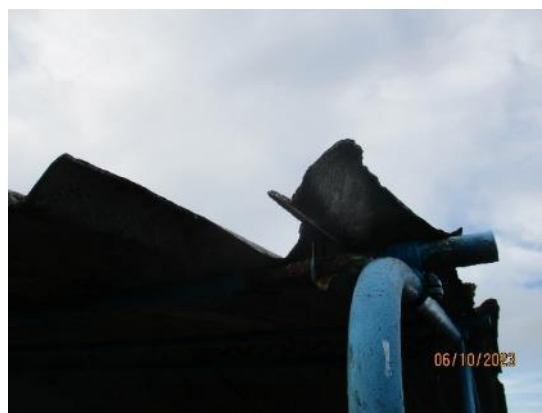
18. Damaged asbestos roofs

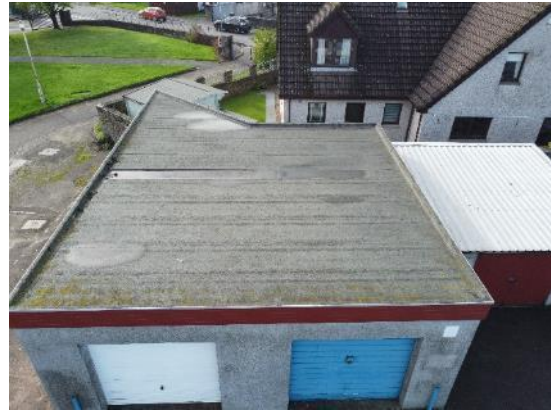
20. Mineral felt to Shelter and Garage

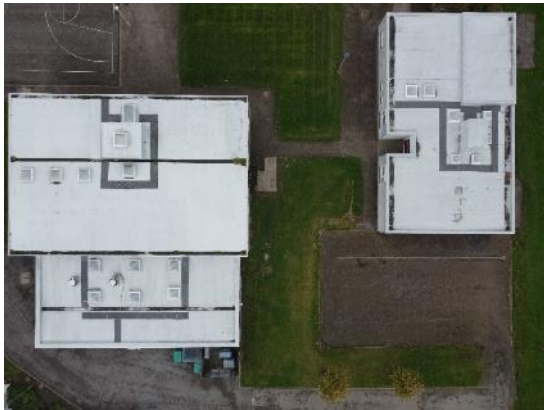
21. Single ply membrane to Blocks K and M

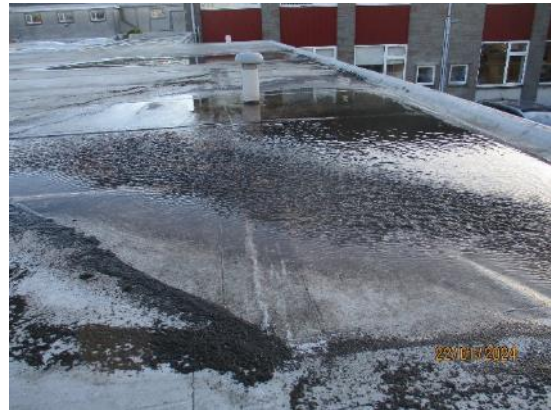
22. Single ply to Leisure Centre - Ponding

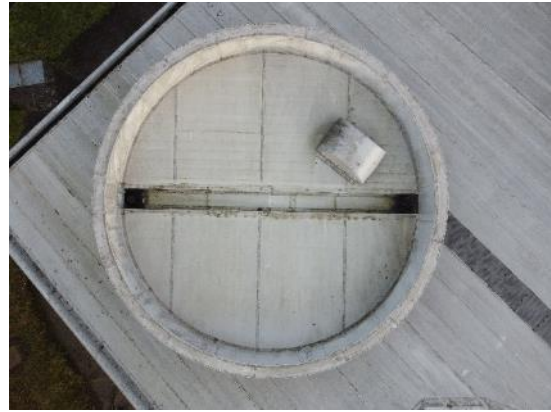
26. Circular roof above Meeting Room

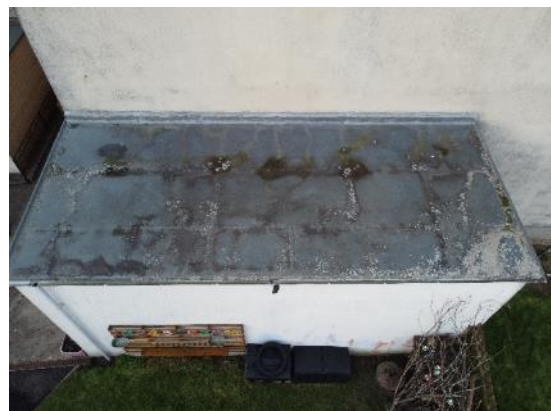
30. GRP roof above Games Hall Store

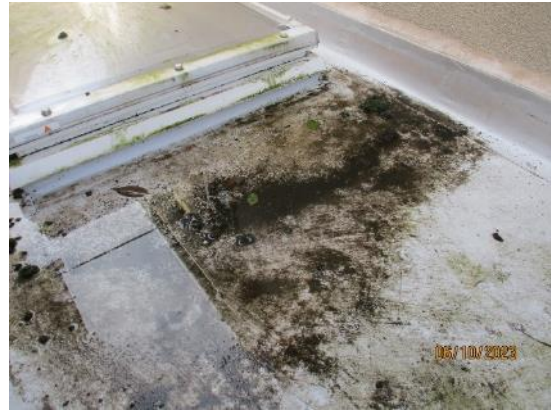
32. SPM roofs ponding

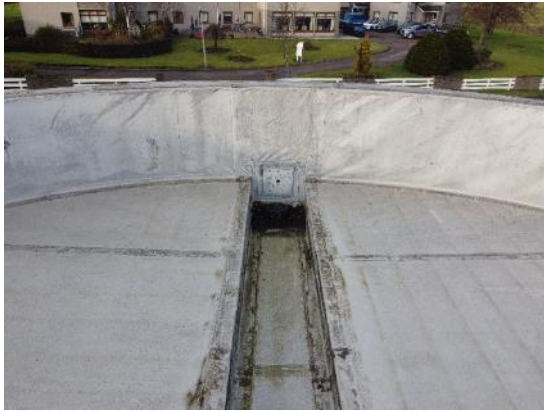
37. SPM box gutter above Meeting Room

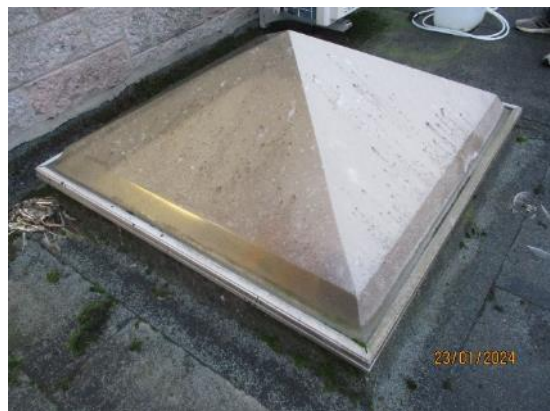
42. GRP rooflights to Leisure Centre

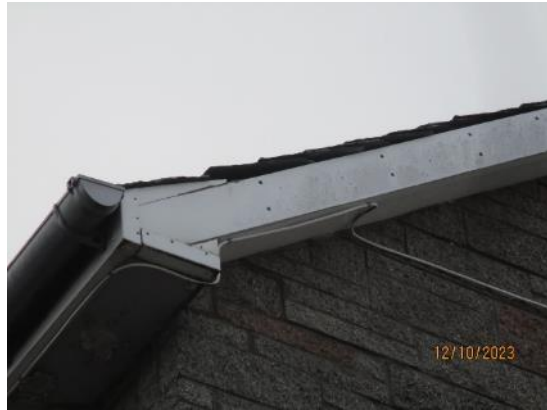
44. PVC fascia and barge boards - School

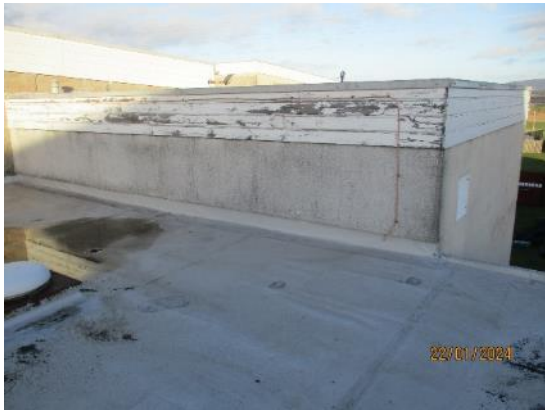
45. Timber fascia boards - School

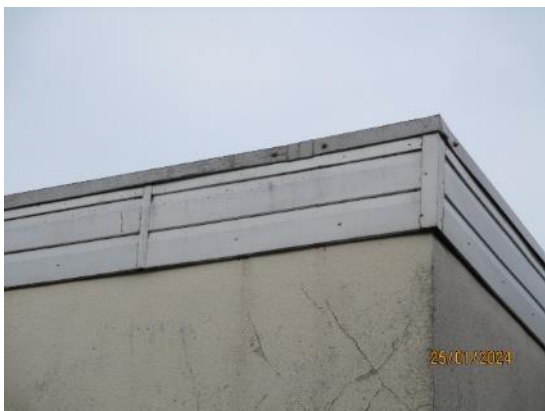
47. PVC fascia boards – Leisure Centre

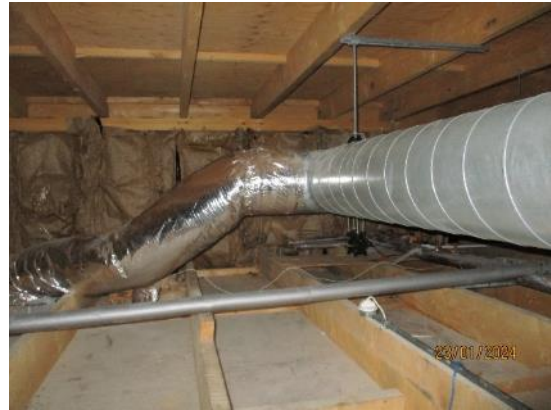
50. Lack of insulation above Sauna

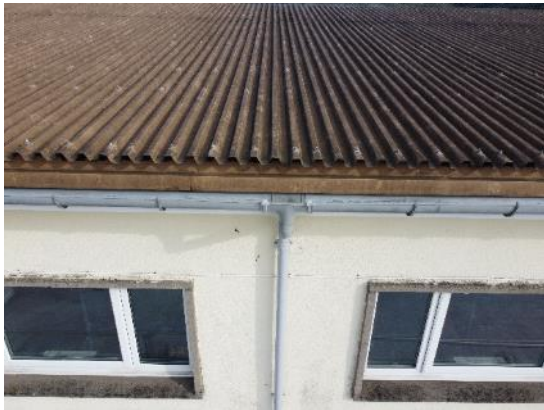
51. UPVC gutters - School

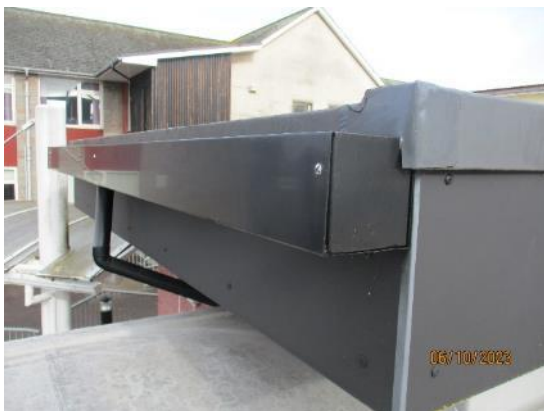
53. Metal box gutters to new entrance

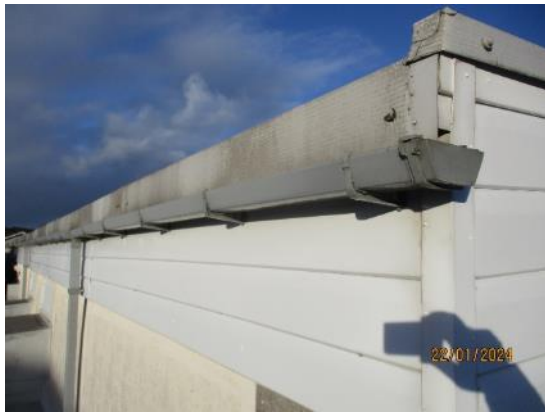
55. UPVC gutters – Leisure Centre

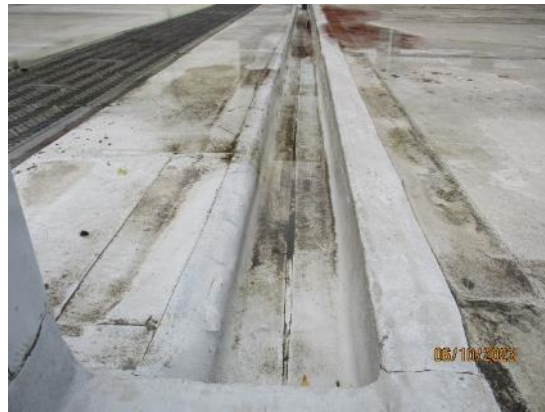
56. SPM box gutters - School

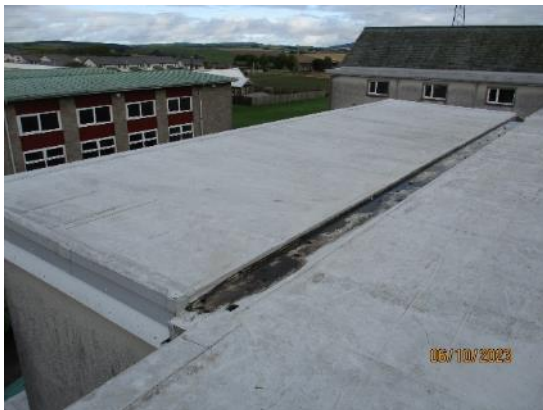
57. SPM box gutters need cleaning

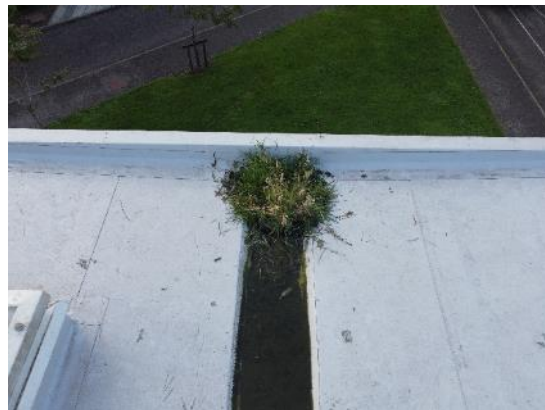
58. Box gutters and outlets blocked

- Mineral felt and GRP roofs are reaching the end of their useful life.
- Balloon gratings are missing from most downpipes.
- UPVC downpipes are insecure and missing.
- Box gutters and the valley gutter are partially blocked with poor drainage.
- Timber fascia boards have wet rot and poor decoration.
- Roughcast and brick walls are cracked.
- Concrete steps to external doors are broken.
- External decoration is overdue.
- Internal hollow core doors are worn with surface damage.
- Sheet vinyl floor coverings have open joints.
- Carpets are worn and soiled.

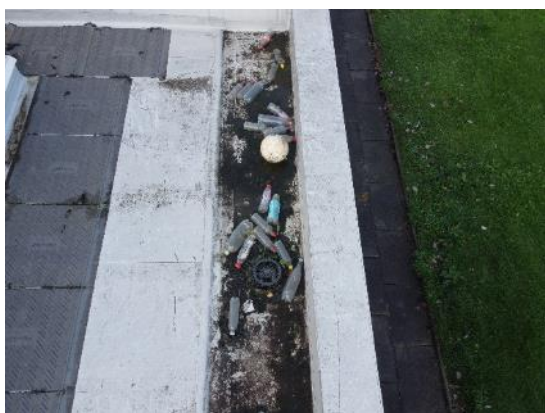
59. Block M – blocked box gutters

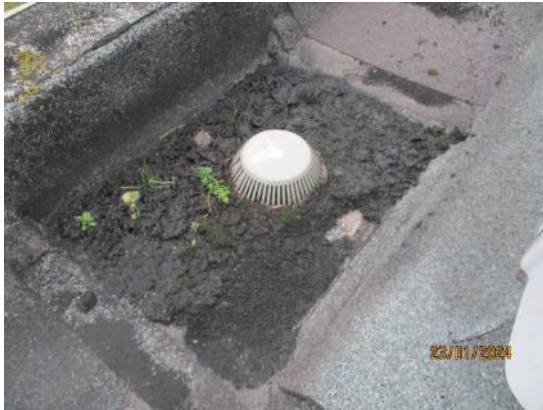
61. Felt box gutters blocked – Leisure Centre

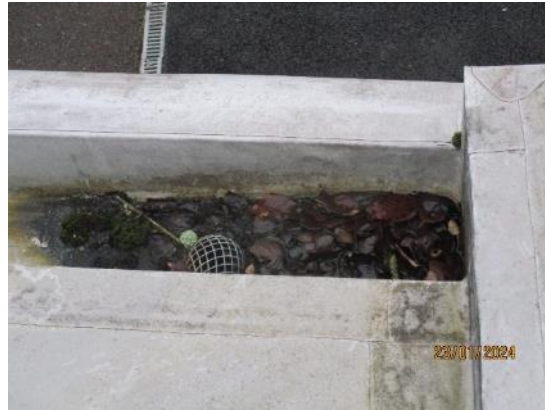
62. SPM box gutters part blocked -Leisure Centre

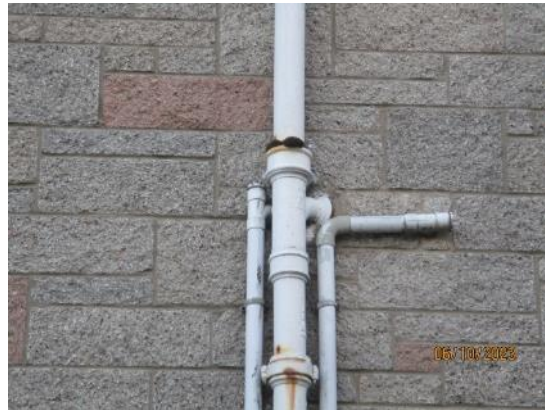
64. Cast iron downpipes leaking - School

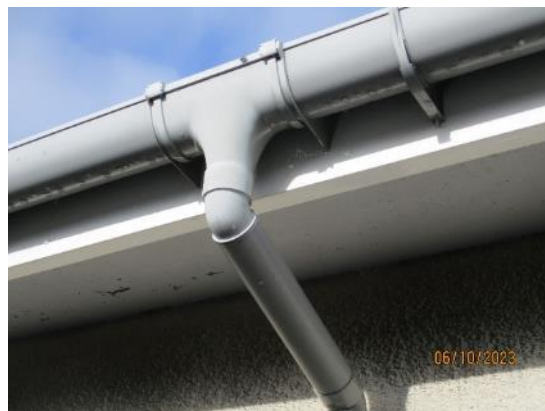
66. UPVC downpipes - School

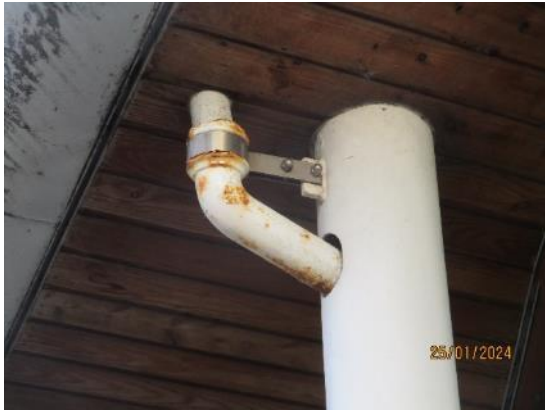
67. Cast iron downpipes – Leisure Centre

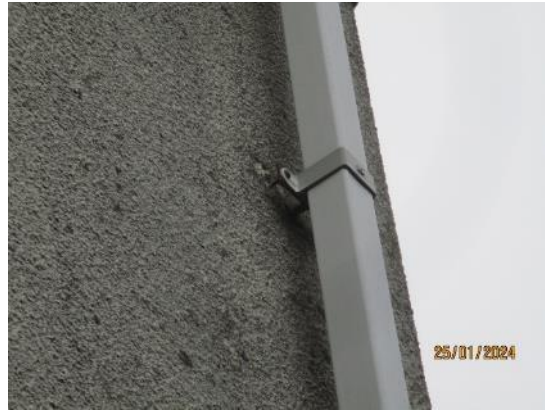
68. UPVC downpipes insecure – Leisure Centre

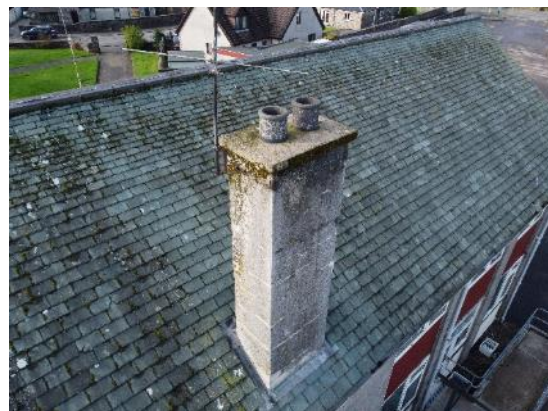
72. Masonry chimney stack

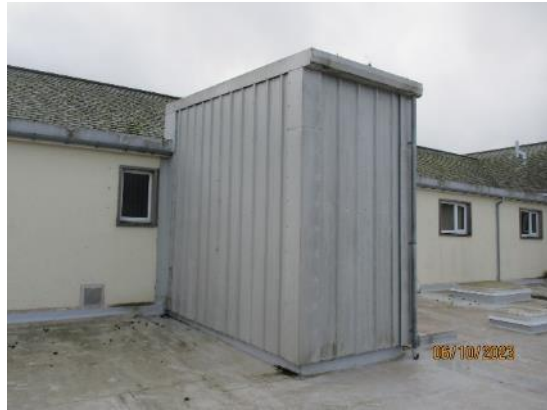
86. Metal profile lift enclosure

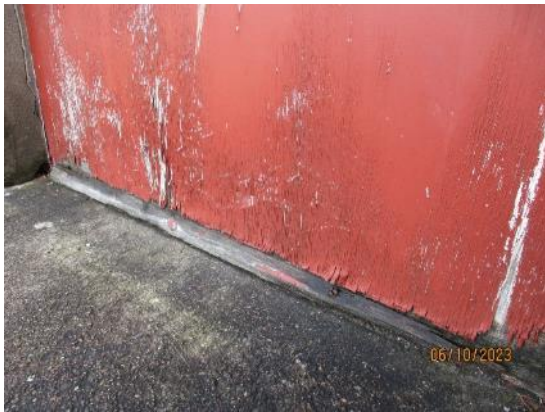
96. Solid core timber fire escape doors

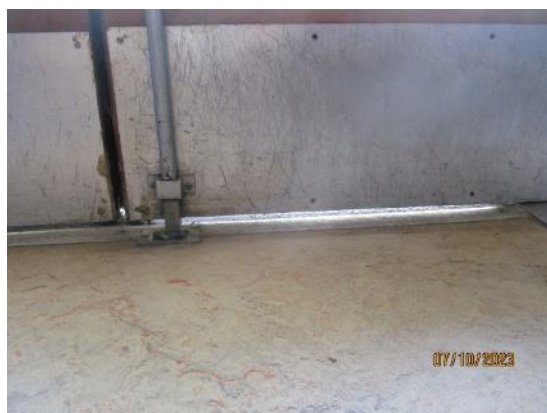
101. Timber double fire escape doors

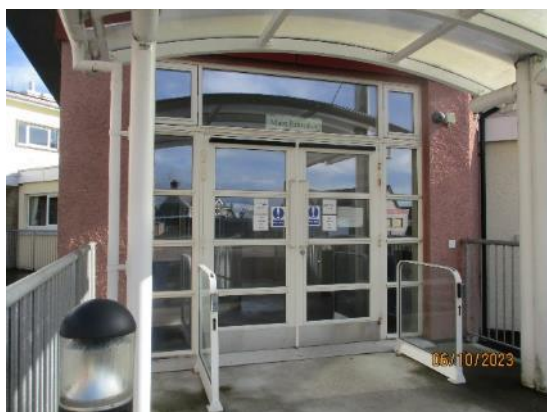
102. Gaps around external doors

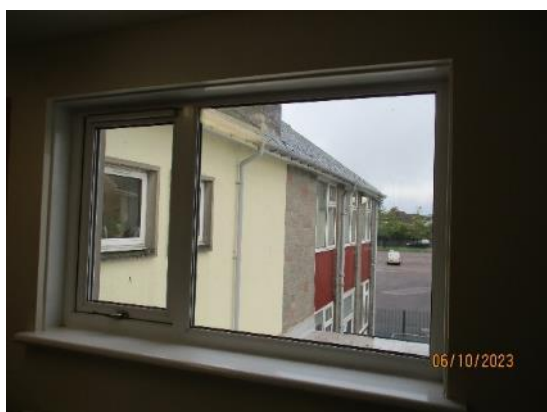
110. PVC medium windows - School

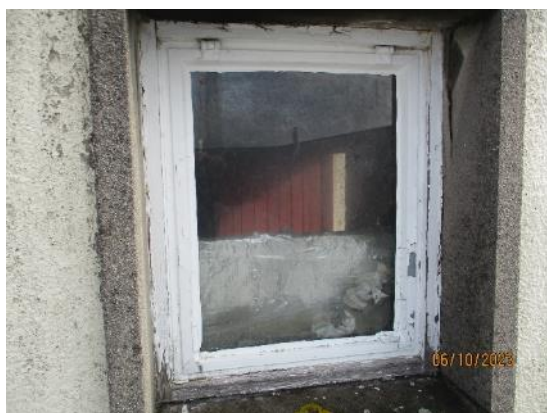
112. PVC large windows - School

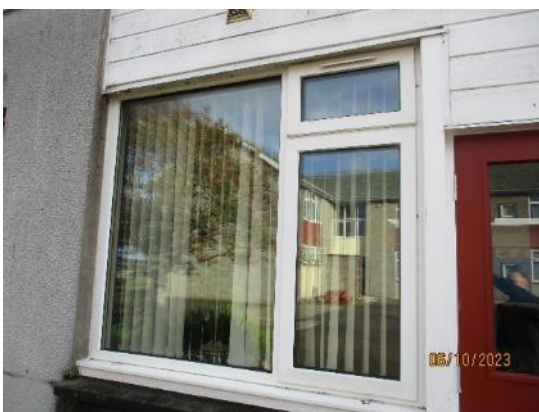
115. Powder coated large windows – Block K

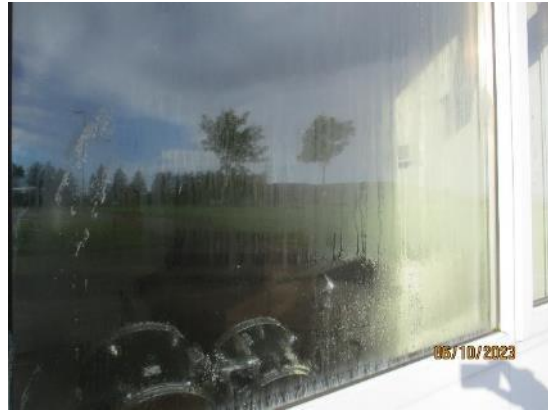
121. Double glazed windows

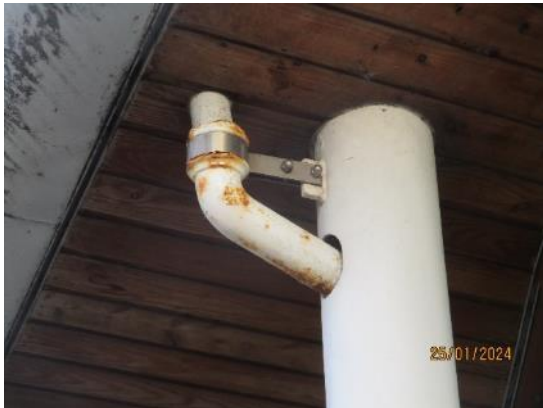
127. Cast iron downpipes

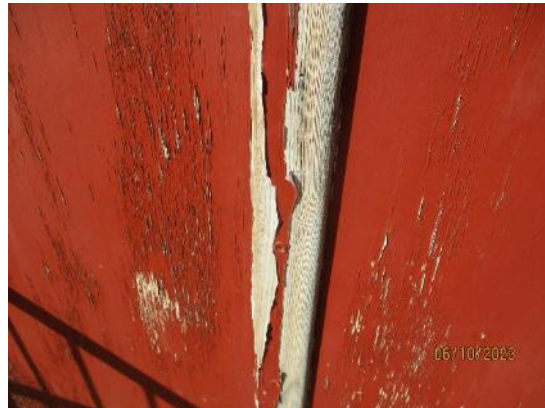
128. Timber external doors

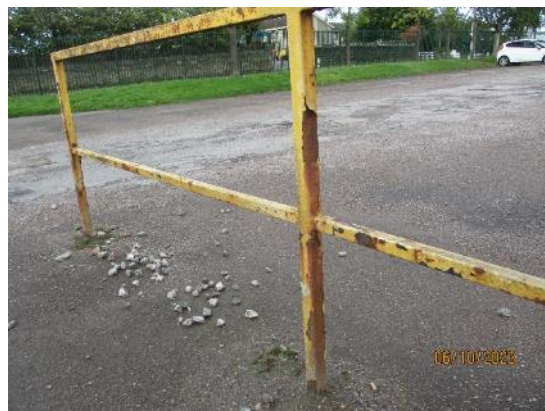
130. Metal separation rails

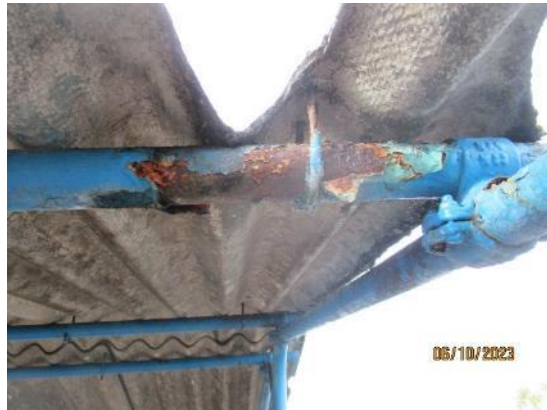
134. Metal frames to outbuildings

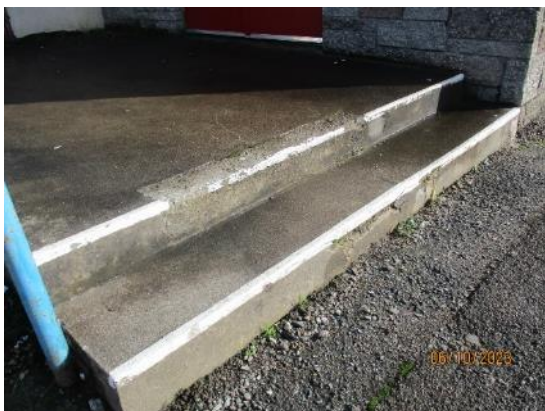
135. Concrete steps to fire exits

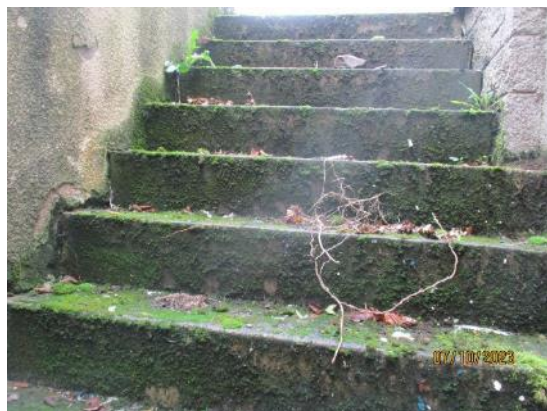
136. Concrete steps to boiler room

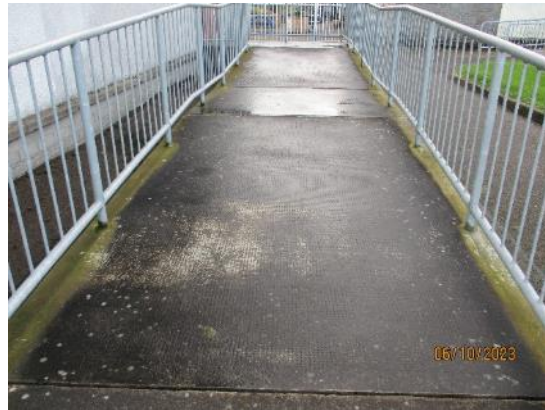
140. Concrete ramps to fire exits

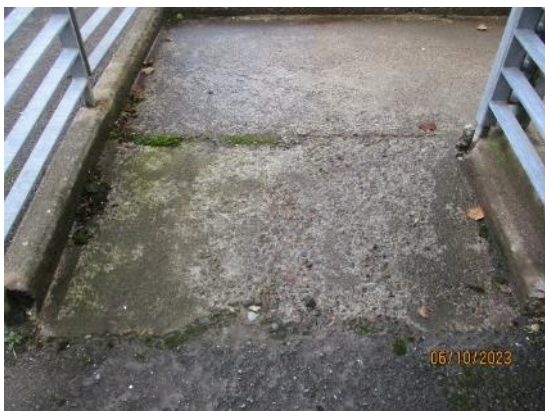
- Tarmacadam car park is patched and pot holed.
- Paving slab and concrete footpaths are broken and uneven.
- Concrete ramps eroding and require resurfacing.
- Tarmacadam footpath at the Leisure Centre is damaged by tree roots.
- Surface water drainage partially blocked.
- Timber post & wire perimeter fence is partially collapsed.
- Stone boundary walls require repointing.
- Stone wall to neighbouring property is leaning towards the car park.
- Outbuilding asbestos roofs broken and leaking.

141. Surface erosion of concrete ramps

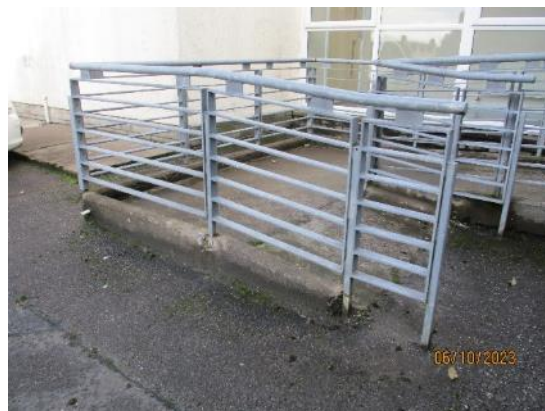
142. Galvanised tubular guard rails

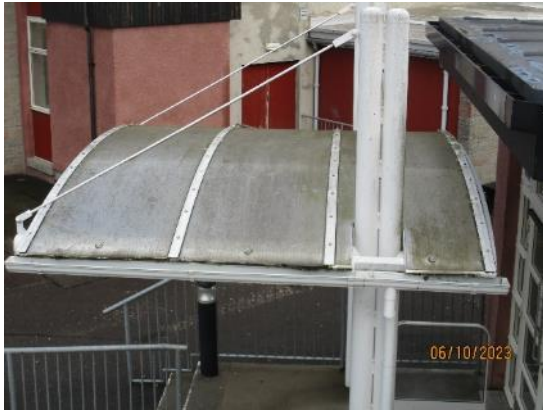
143. Polycarbonate canopy to new entrance

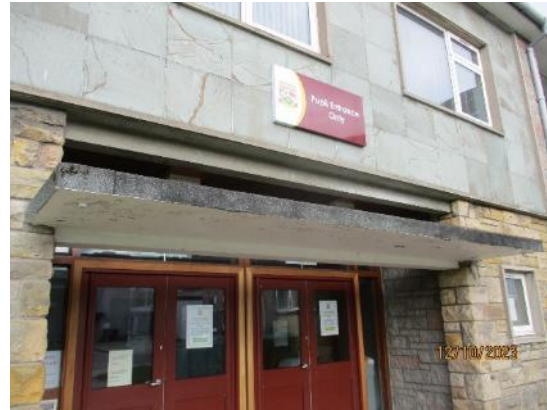
144. Concrete/felt canopy to pupil entrance

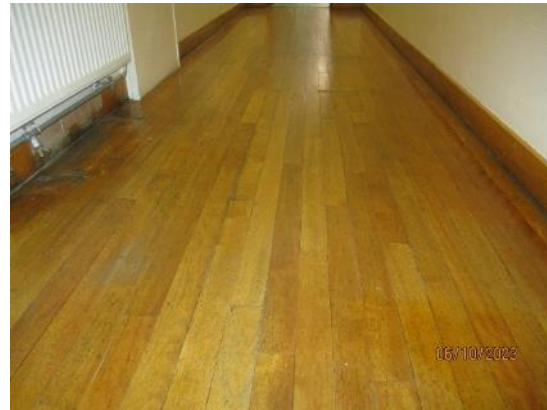
146. Noisy timber floating floors

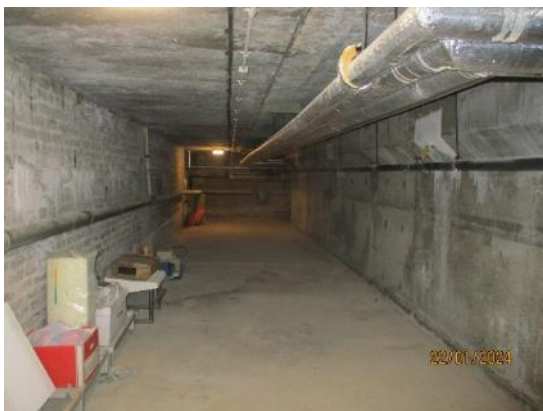
147. Suspended concrete floor around pool

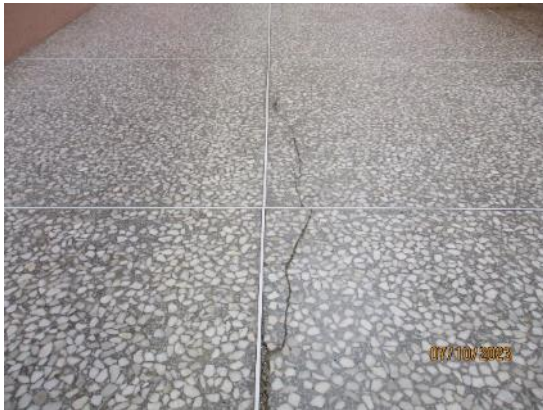
157. Terrazzo tile with isolated damage

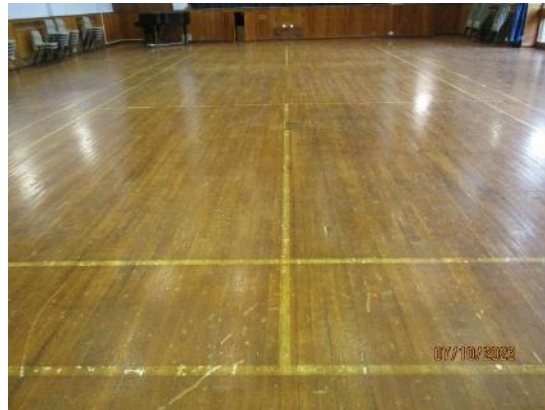
158. Timber floor boards

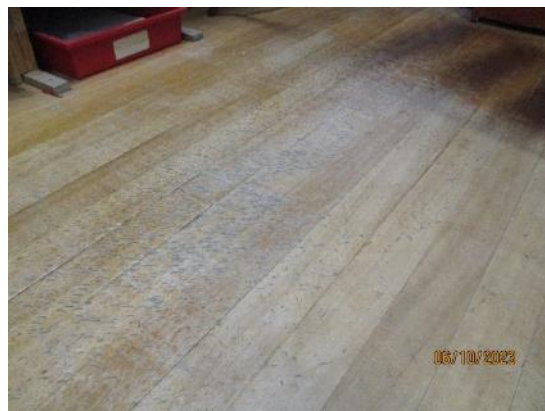
160. Timber boards to store rooms

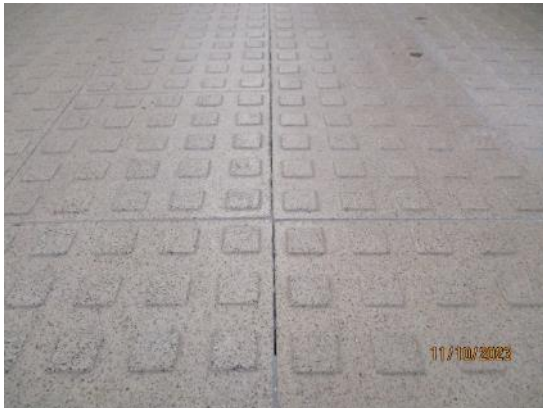
162. Isolated re-grouting required

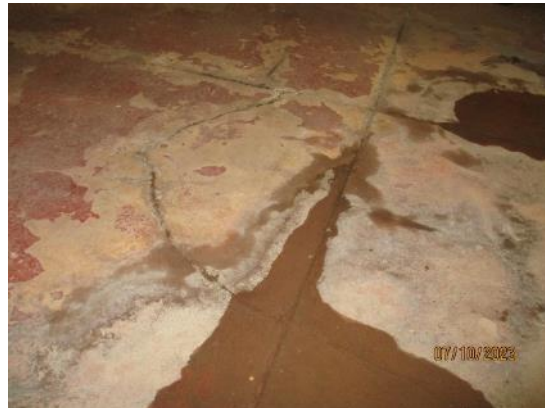
163. Painted concrete floors

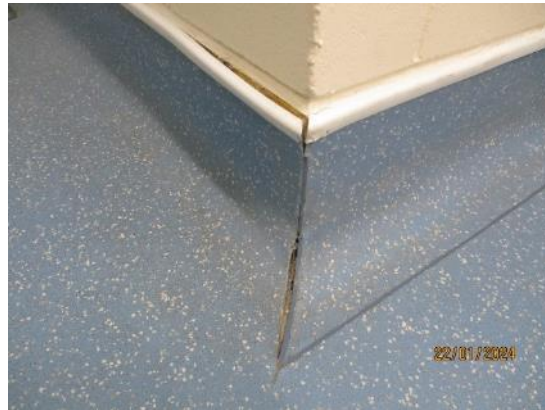
169. Peeling skirting and open joints

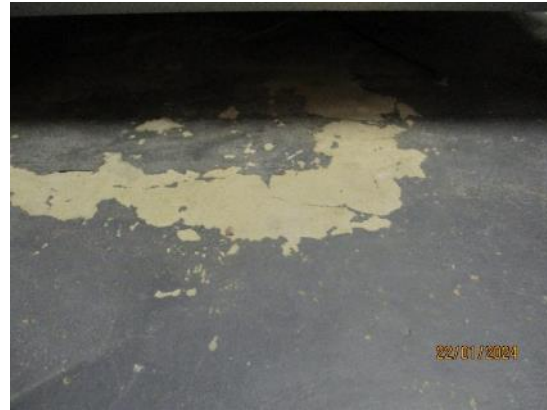
173. Painted concrete floors

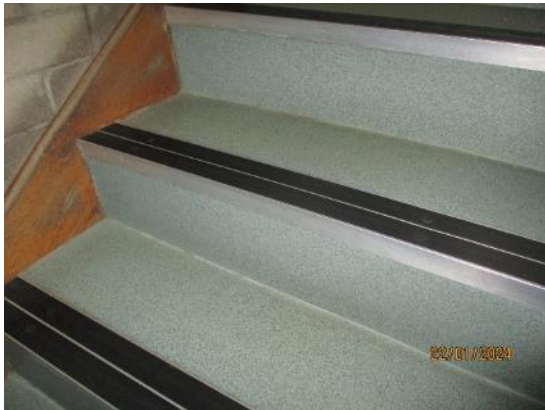
186. Vinyl treads and risers – Leisure Centre

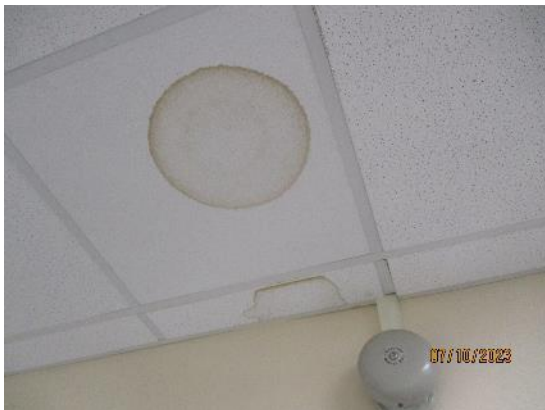
196. Watermarked ceiling tiles

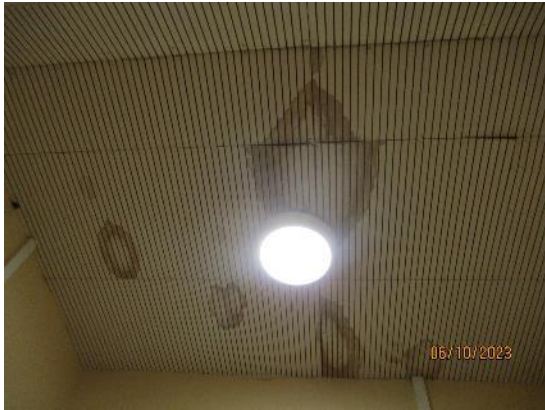
200. Water marked fibre ceiling tiles

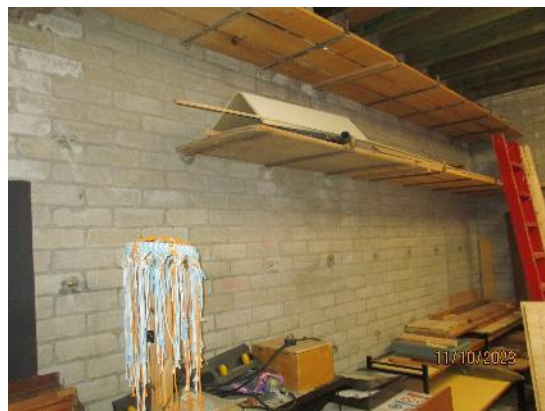
216. Masonry/plaster walls - School

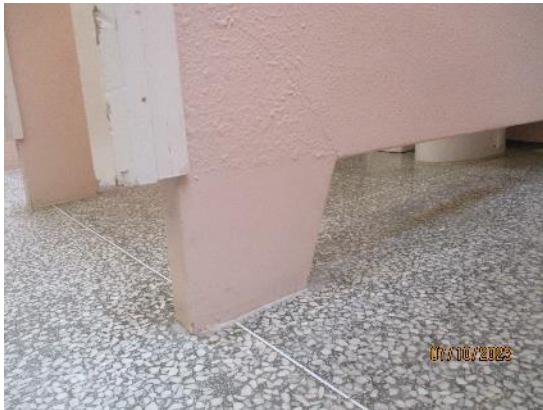
219. Terrazzo partitions in Toilets/Changing Rooms

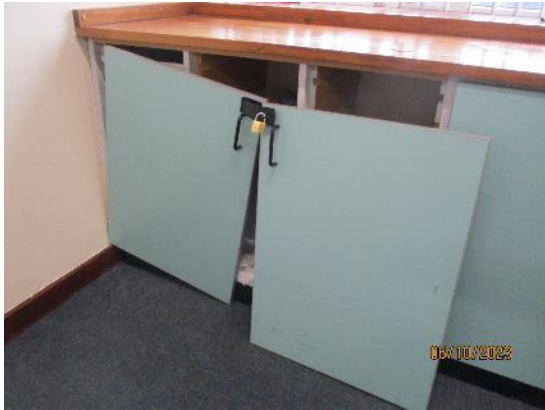
342. Collapsing base units

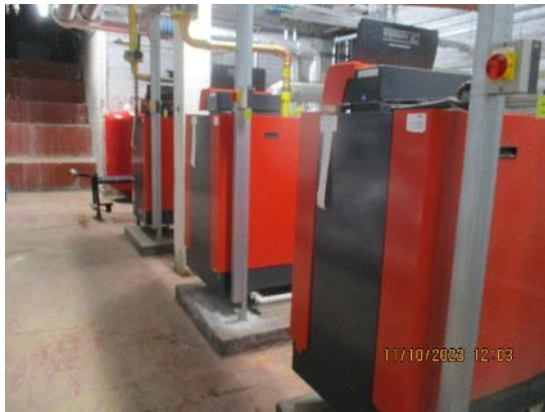
350. 3 no. natural gas fired boilers.

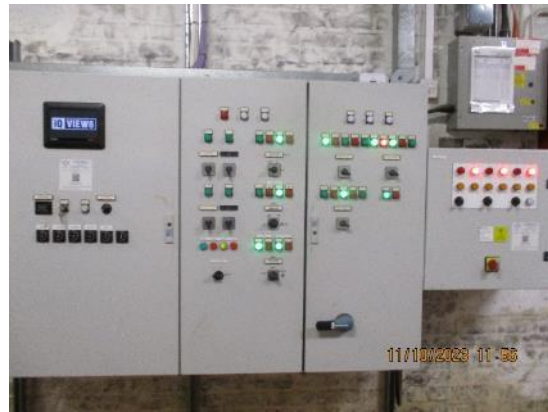
351. BEMS main control panel.

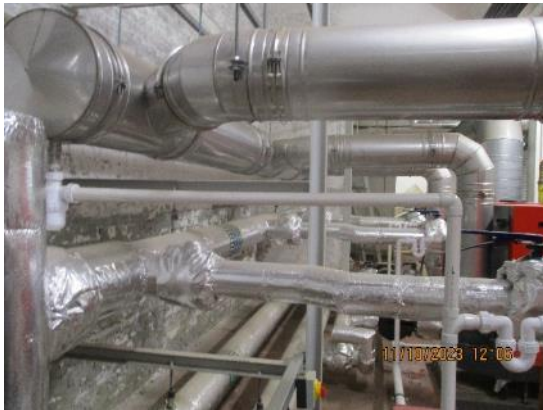
352. Heating system pipework main school plant room.

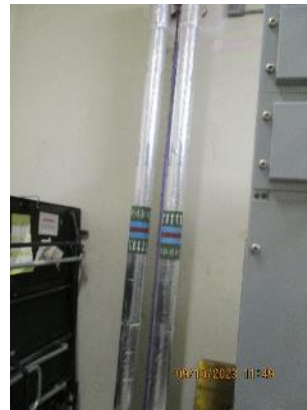
353. Heating pipework main school internal.

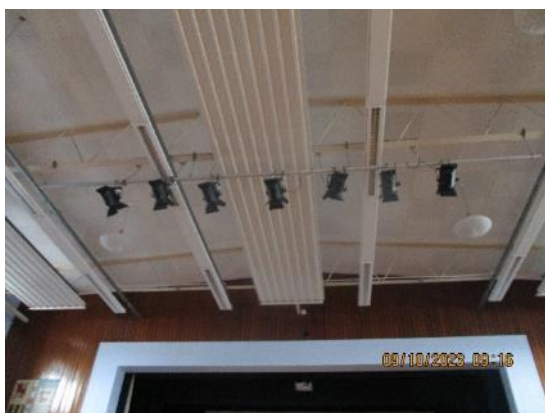
354. Ceiling mounted radiators main assembly hall.

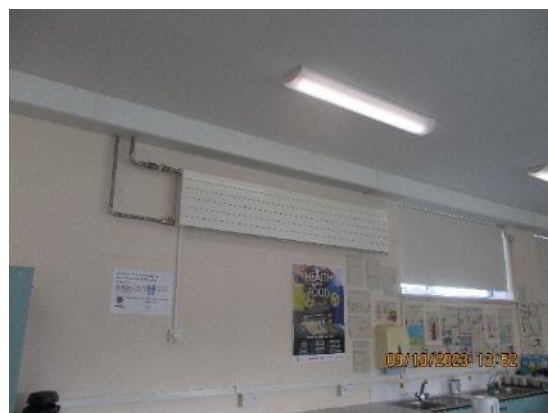
355. High level wall mounted radiator main school.

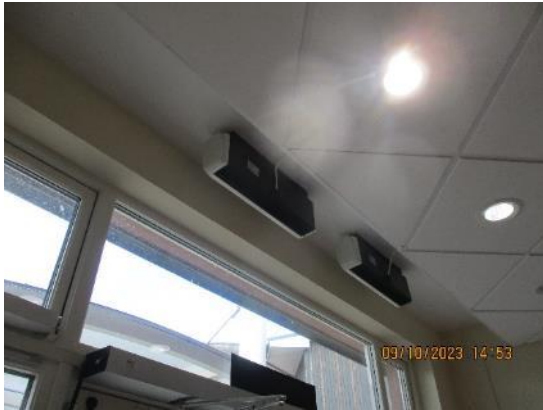
356. Electric fan over door heaters main school.

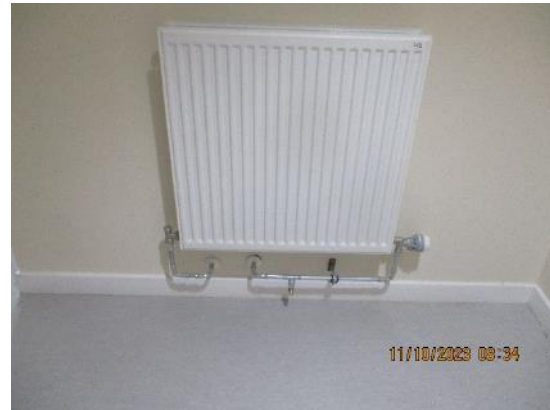
359. Steel panel radiator Main school typical.

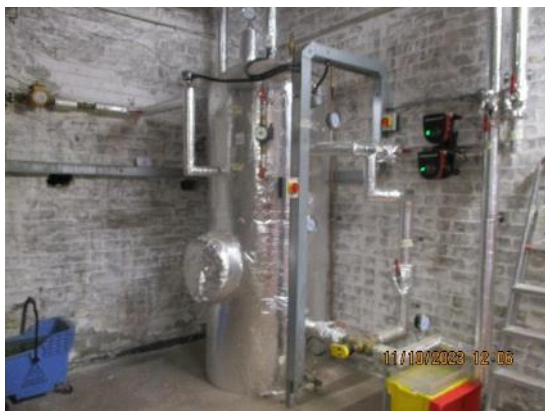
360. Hot water storage calorifier main school.

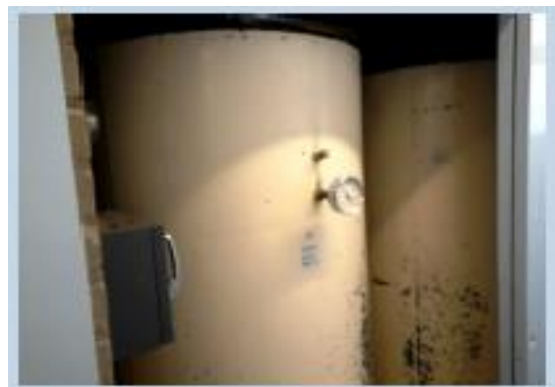
361. Hot water calorifiers kitchen block

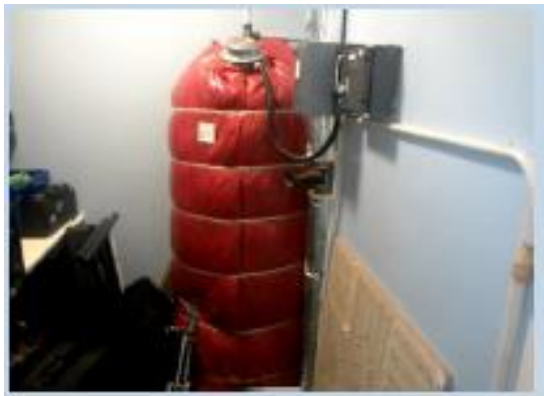
362. Hot water storage cylinder Music block

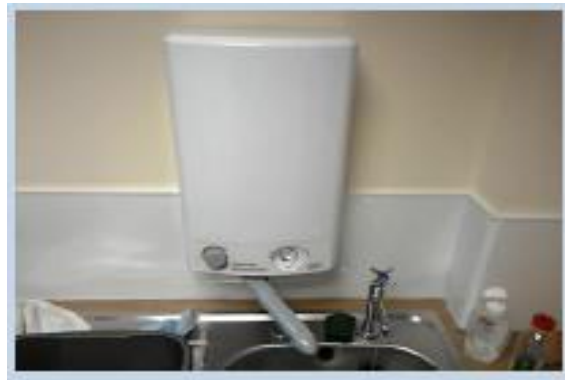
363. Point of use water heater main school.

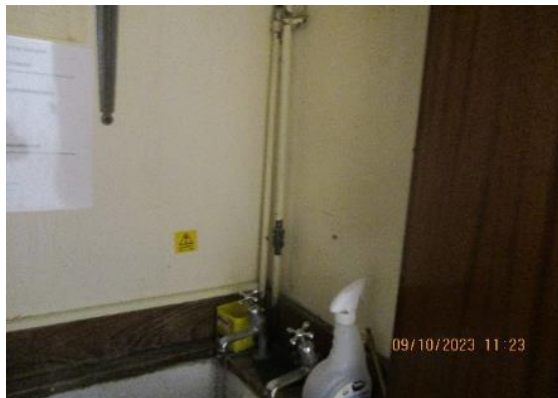
364. Hot water copper pipework main school.

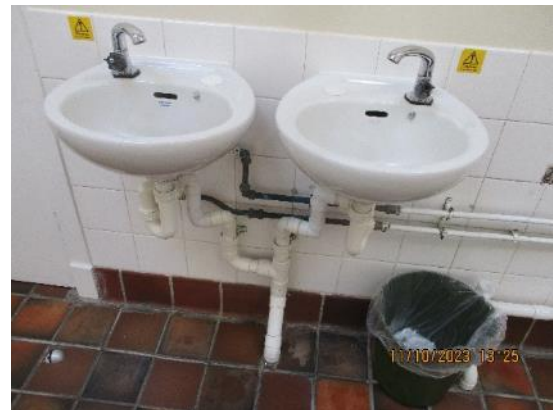
365. Hot water copper pipework M Block typical.

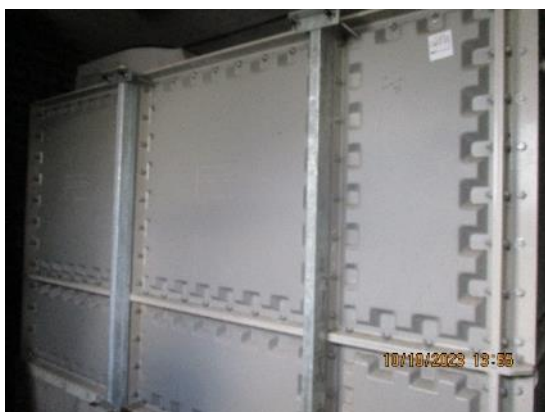
366. Cold water tanks main school.

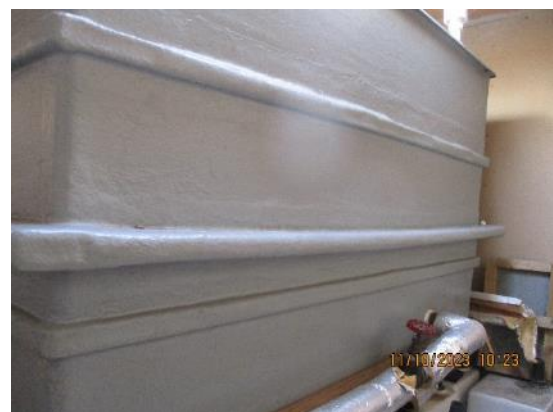
367. Cold water tank K Block

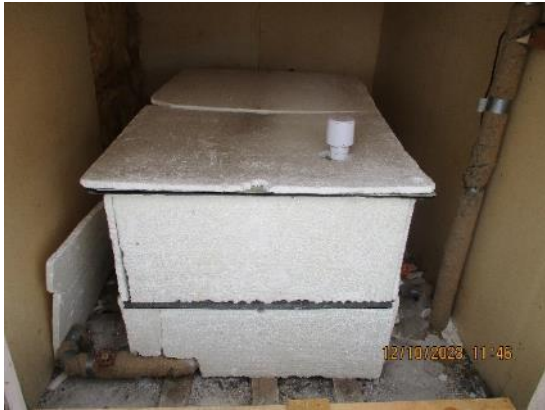
368. Cold water tank – M Block roof.

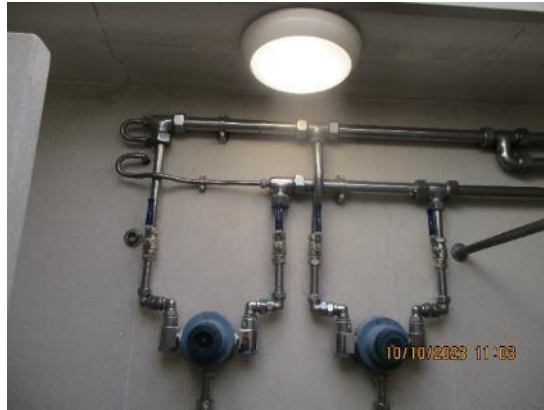
369. Cold water pipework Main school

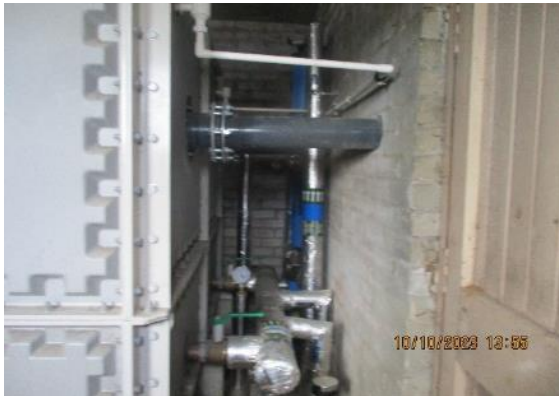
370. Cold water pipework at main school tank.

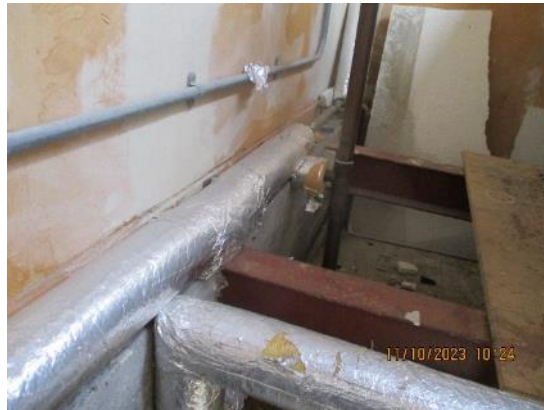
371. Cold water pipework K block tank room.

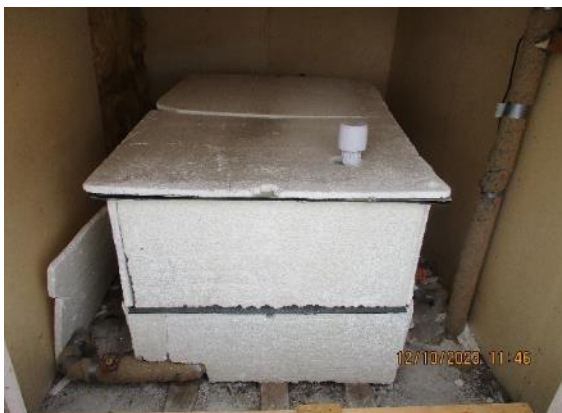
372. Cold water pipework M block tank room.

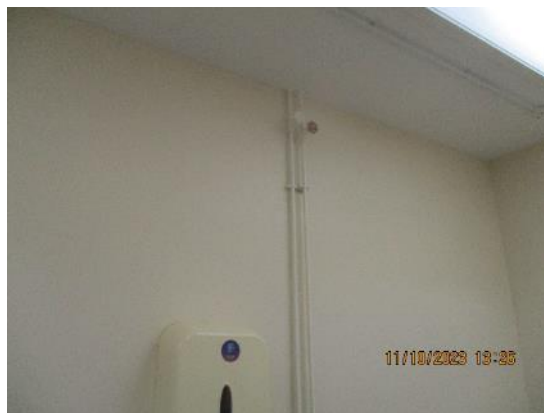
373. Cold water pipework – M Block typical.

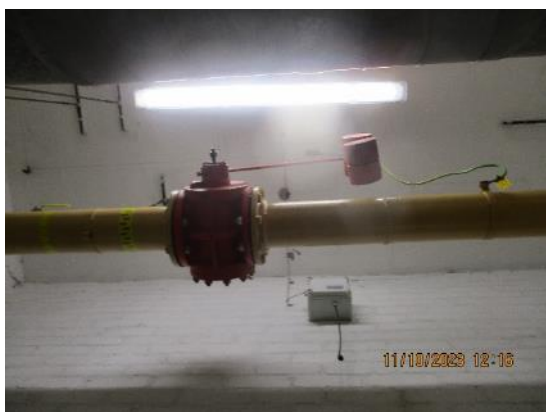
374. Gas supply pipework entering plant room with weighted drop isolation valve.

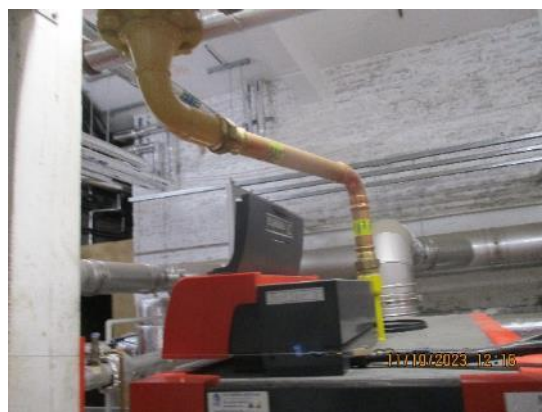
375. Gas supply pipework to boilers.

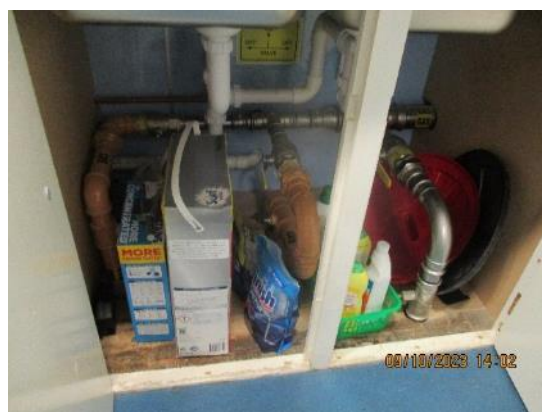
377. Gas pipework entering HE and science departments

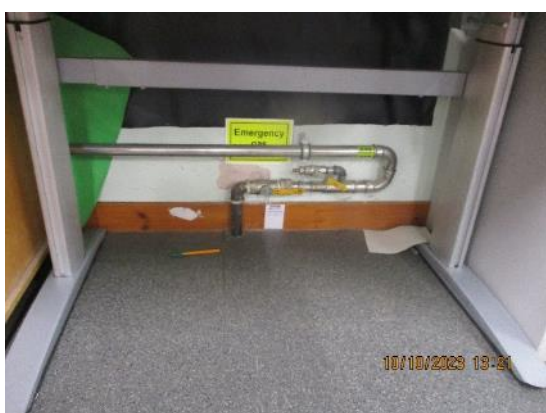
378. Gas supply pipework entering science class.

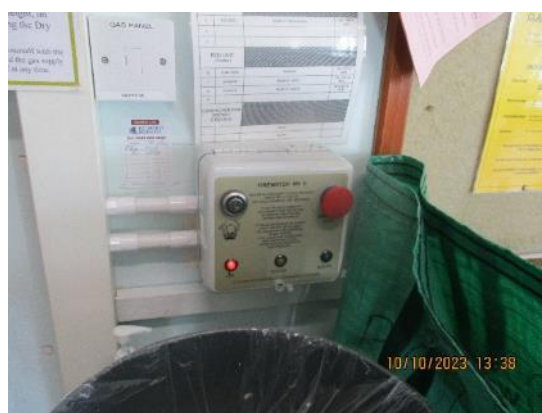
379. Gas safety room control panel typical.

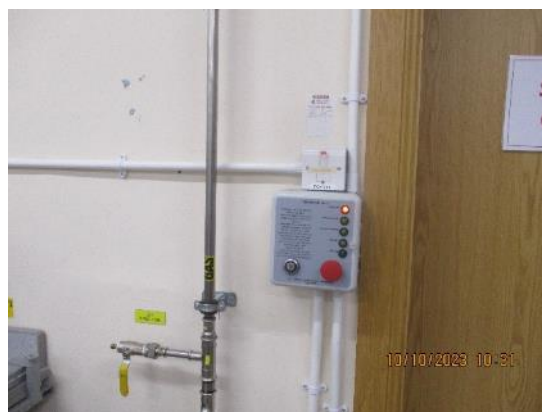
381. Gas safety control panel technology class.

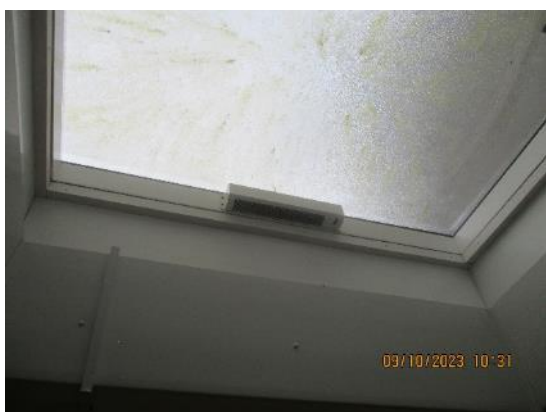
382. Extract fan in rooflight typical – main school.
