# **Summary Building Condition Survey Report**

**Keith Grammar School and Leisure Centre  
School Road, Keith AB55 5GS**

**9<sup>th</sup> to 12<sup>th</sup> October 2023 and 22<sup>nd</sup> to 25<sup>th</sup> January 2024**

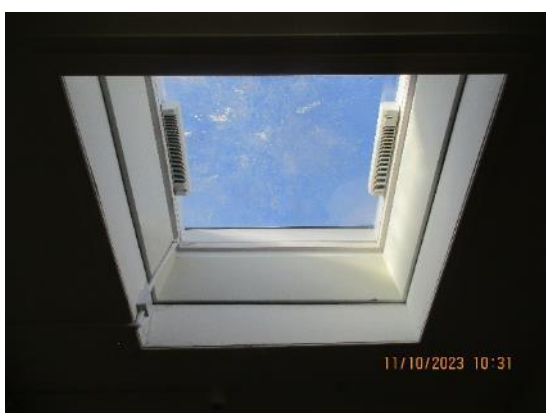
384. Extract fans in roof light K Block.

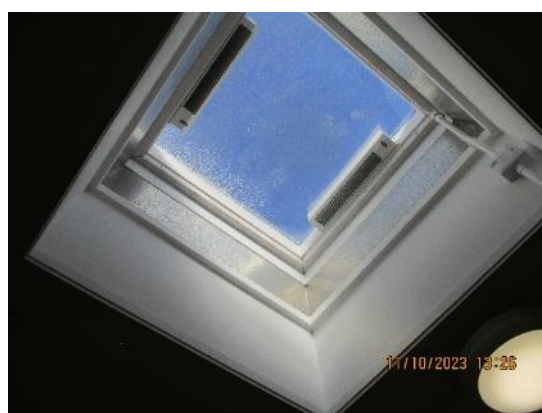
385. Extract fans in rooflights – M block.

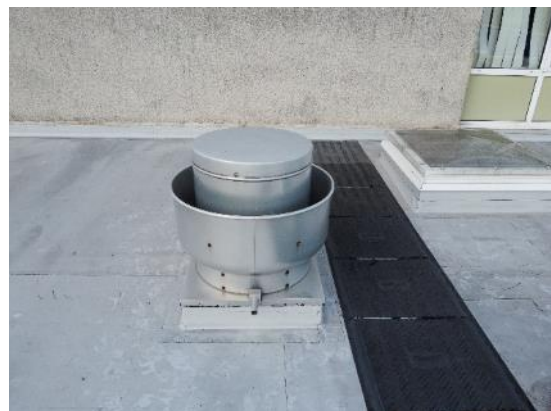
391. Kitchen canopy extract fan – K Block roof.

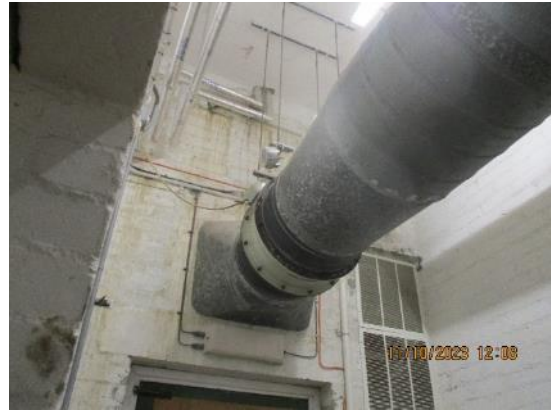
393. Supply fan and ductwork – plant room main school.

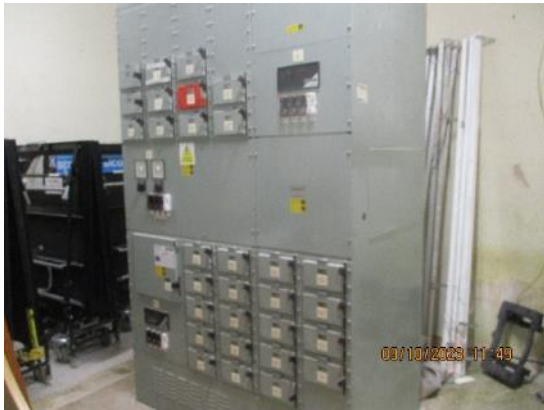
394. Main switchboard – incomer main school 1/67

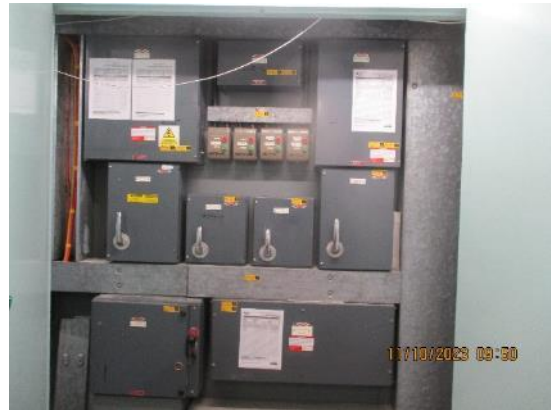
395. Switchgear and busbar – K Block.

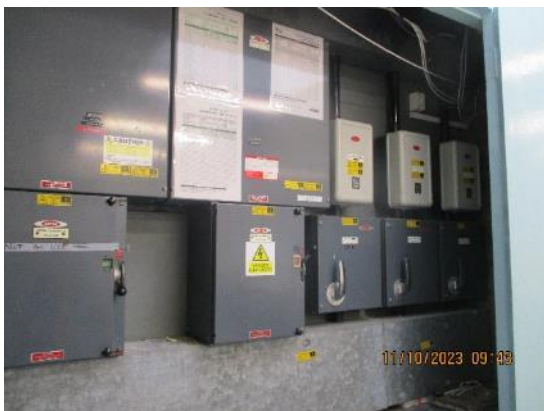
396. Switchgear – kitchen block.

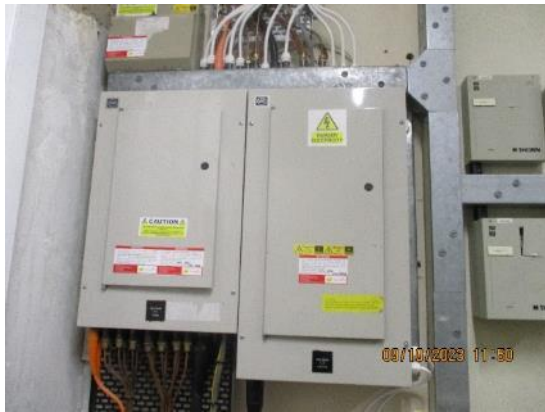
398. Distribution boards – Main school typical

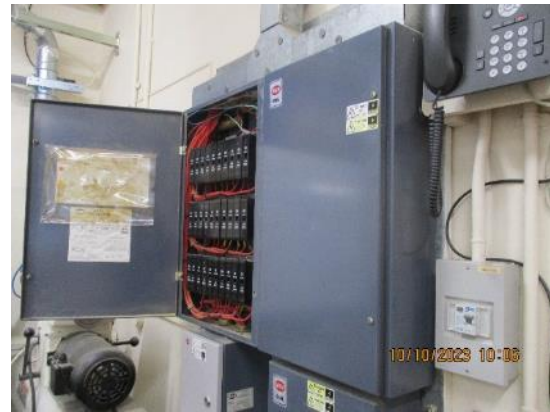
399. Distribution boards – woodwork class main school.

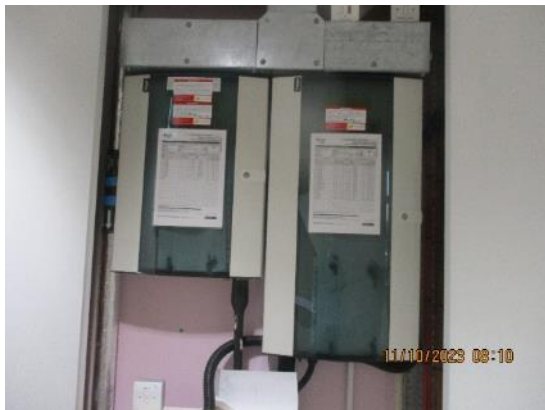
400. Distribution boards – Art dept main school.

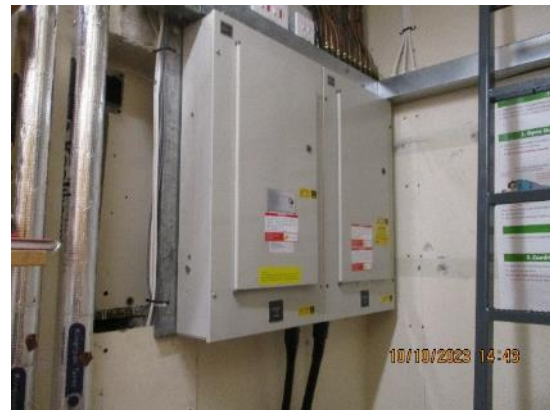
401. Distribution boards – science dept main school.

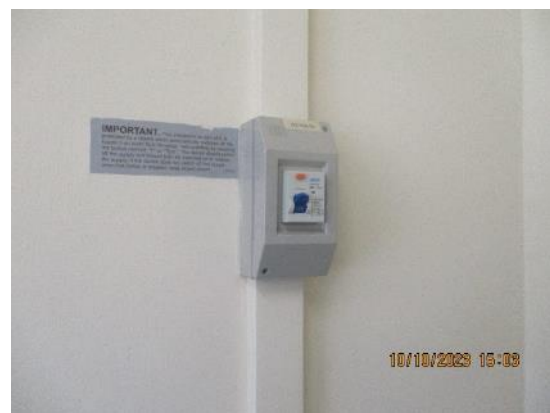
403. 32A RCD – classroom typical.

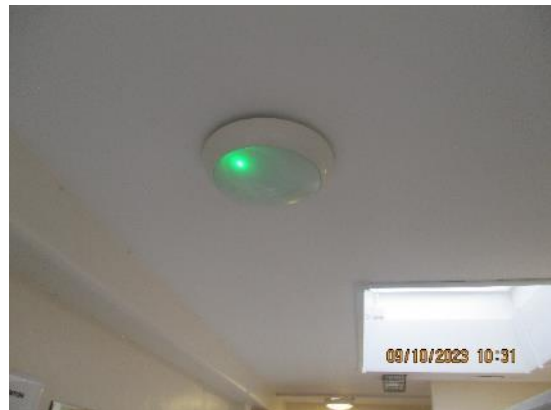
407. Lighting 1/74 girls toilets main school.

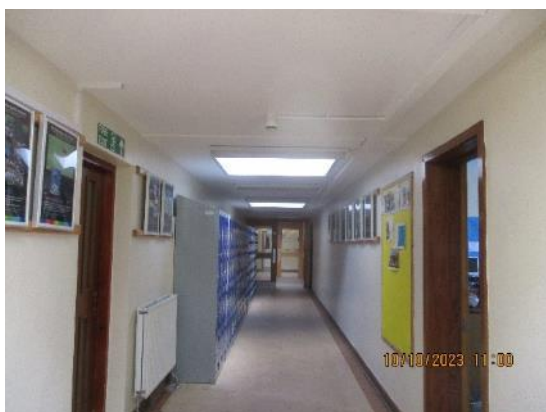
410. Lighting – corridor of main school typical.

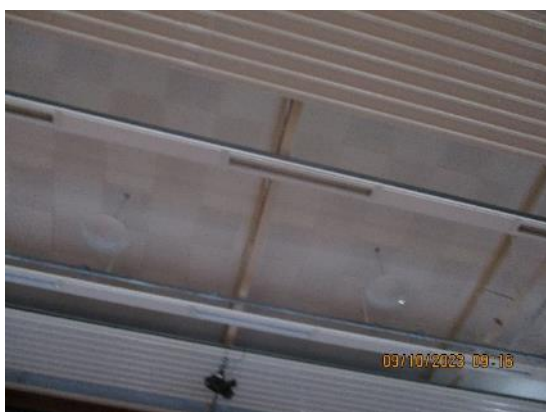
412. Lighting – assembly hall 1/66 main school.

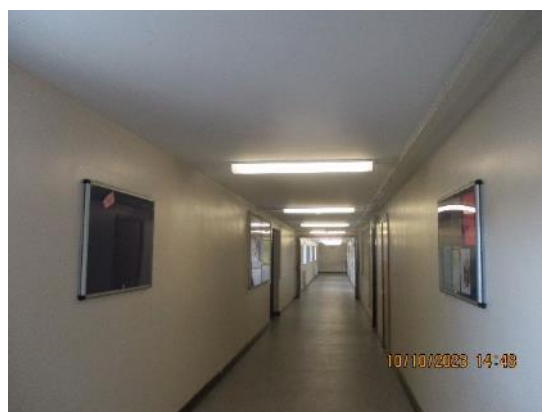
413. Lighting – upstairs corridor main school.

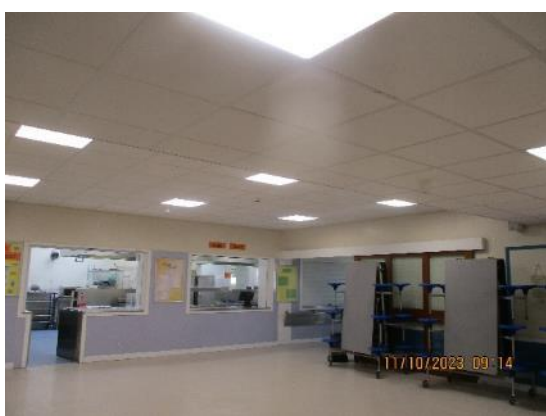
414. Lighting – K Block dining room.

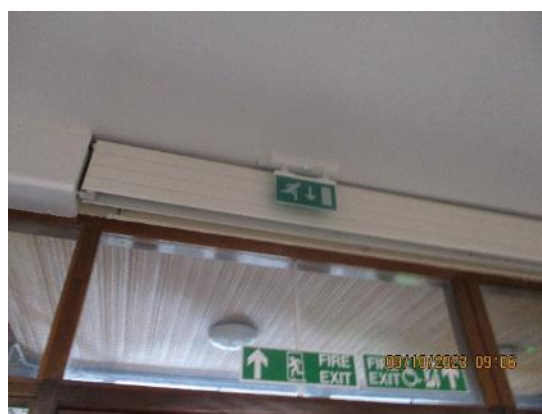
417. Emergency exit lighting main school.

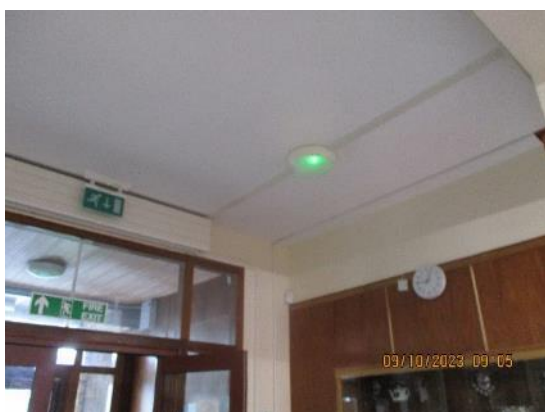
418. Emergency lighting main school.

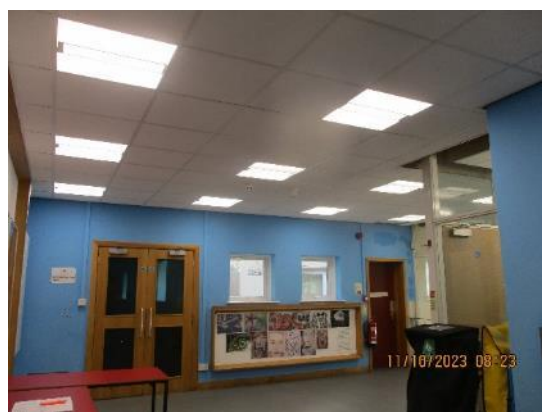
419. Lighting incorporating emergency fittings K Block upstairs.

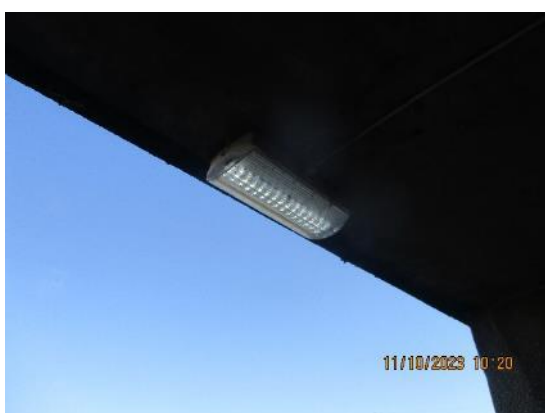
420. External lighting – K block entrance.

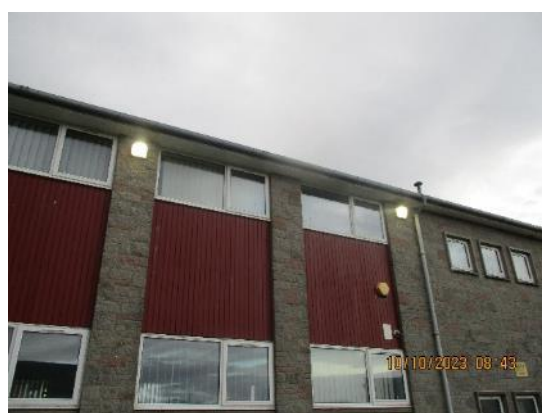
- External building lighting is in poor condition and is not LED.
- General internal lighting in areas is in poor condition and is not LED.
- The air handling unit serving upstairs is in bad condition and has exceeded its useful life.
- Some roof mounted extract fans have exceeded their anticipated life and are in poor condition.
- Areas of general wiring has exceeded its anticipated life.
- Large percentage of electrical switchgear has exceeded its useful life and does not contain modern circuit protection devices.
- Heating panels in the sports hall have exceeded their anticipated life and are in poor condition.

421. External lighting main school building.

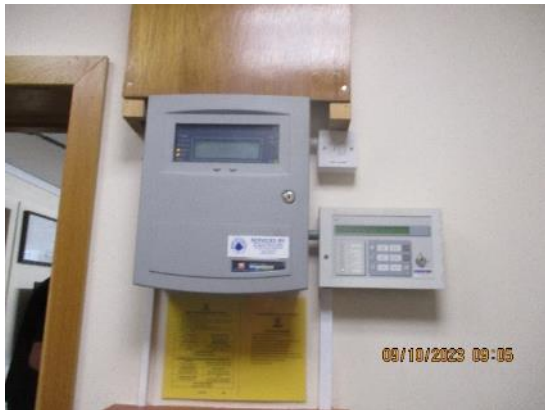
422. Fire alarm control panel 1/2 corridor main school.

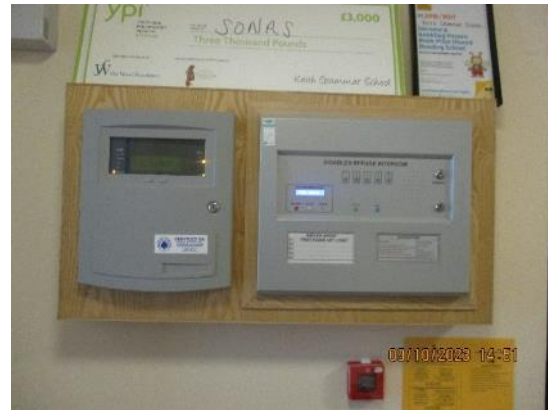
423. Fire alarm control panel new reception corridor.

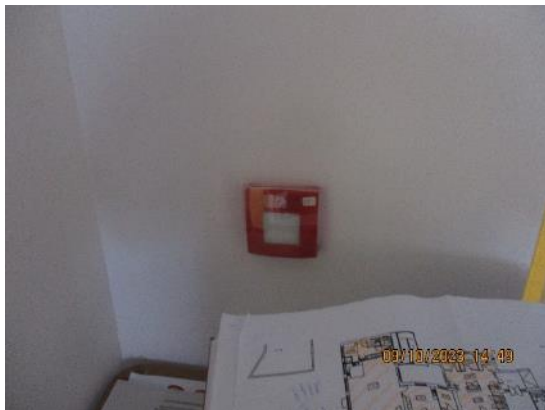
424. Fire alarm call point typical.

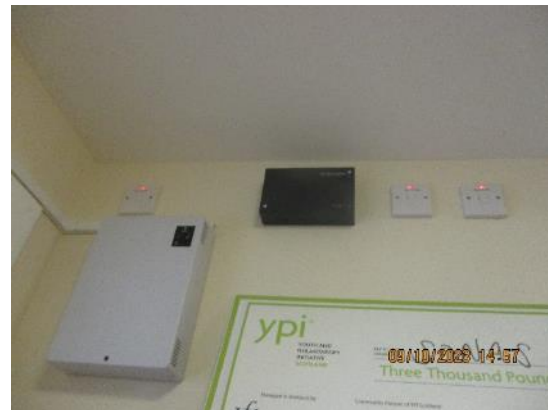
425. Fire alarm interface for reception security door.

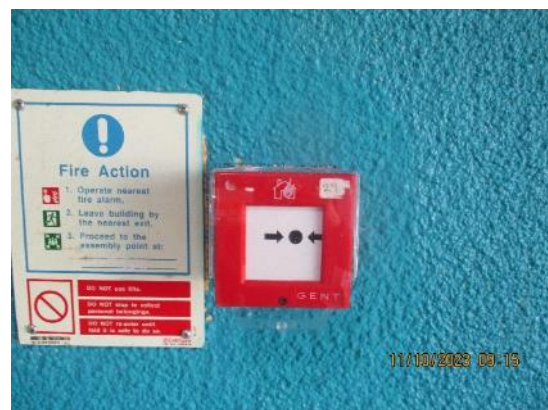
427. Fire alarm call point K block.

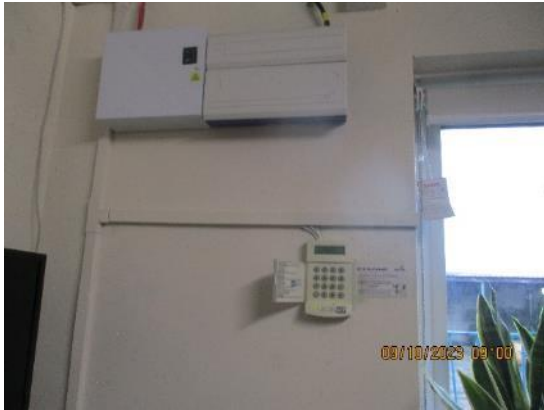
428. Intruder alarm keypad janitors office 1/70

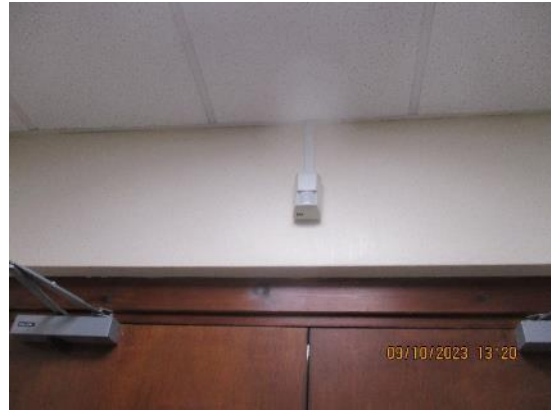
429. Intruder alarm PIR typical.

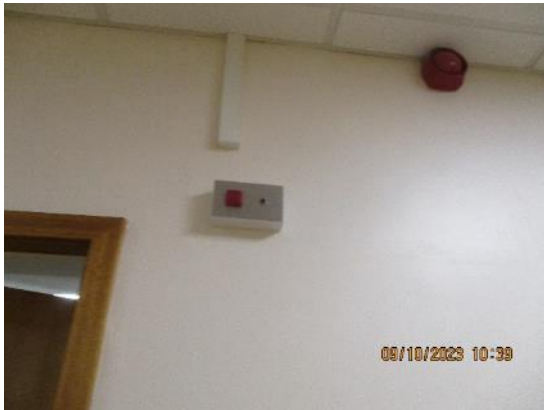
430. Disabled toilet alarm alert unit. 1/76 Toilet

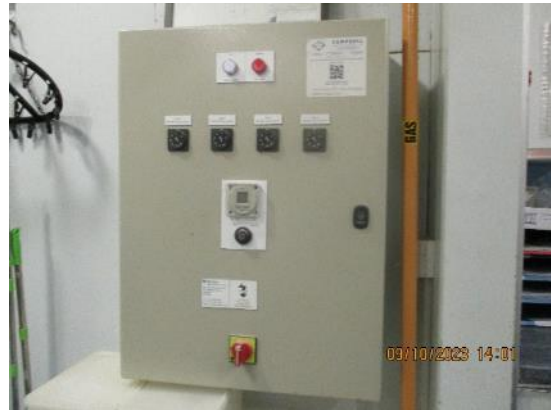
431. BEMS control panel/outstation. Main school.

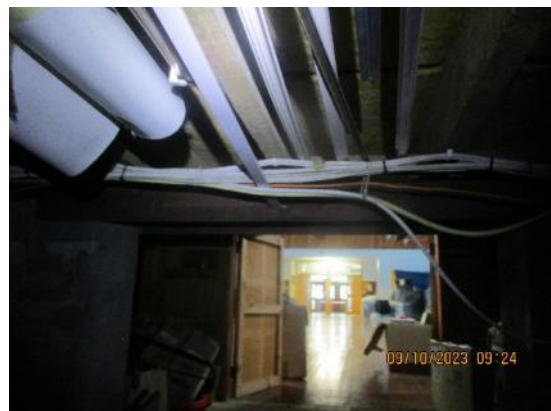
433. General wiring under stage.

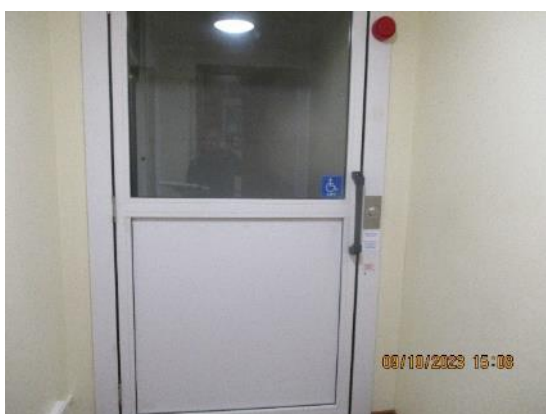
434. Platform lift 1/116 – front view.

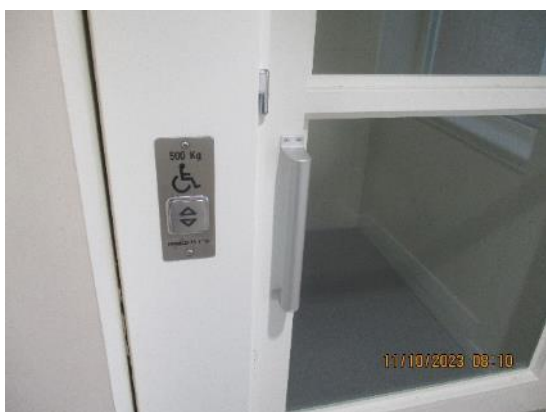
436. Platform lift 2 – front view.

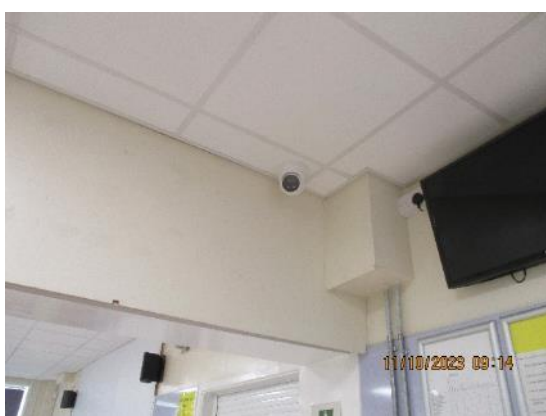
438. CCTV camera – dining room K block

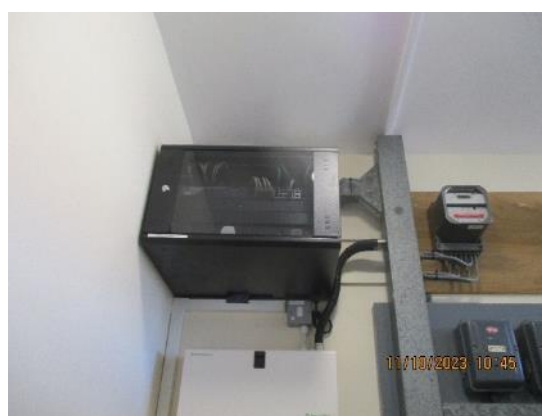
439. CCTV distribution cabinet – K block

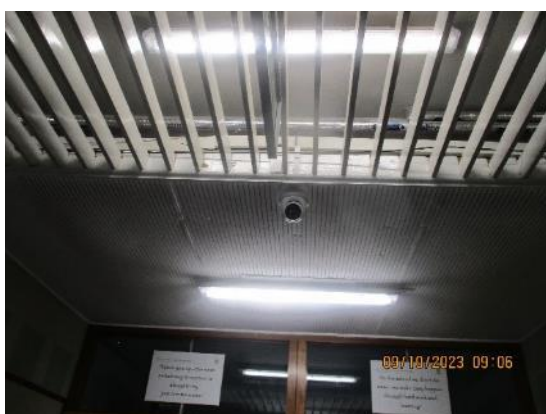
440. CCTV camera entrance lobby main building.

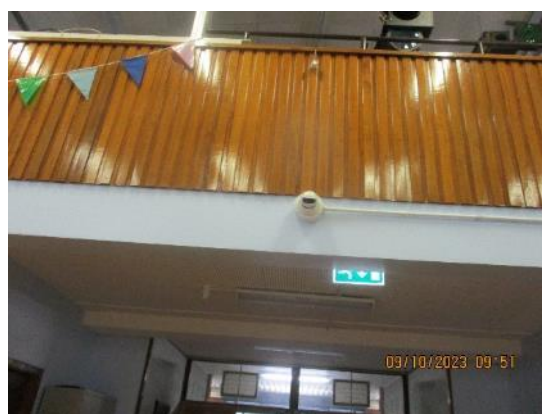
441. CCTV camera assembly hall main building.

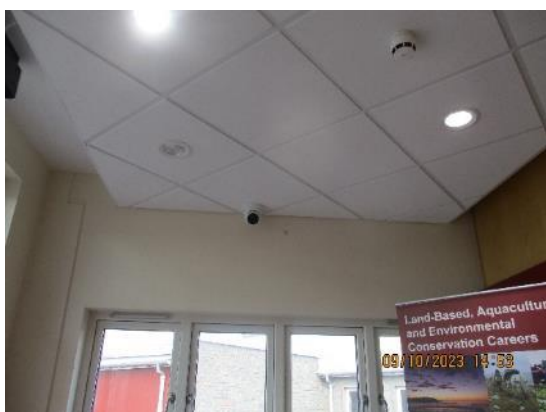
442. CCTV camera ASN dept main building.

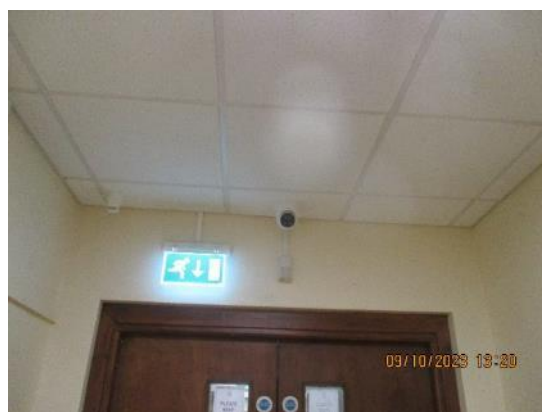
443. CCTV camera internal corridor main building.

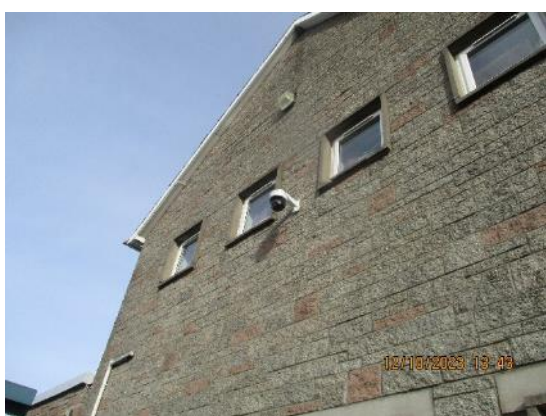
444. CCTV camera external. Main building.

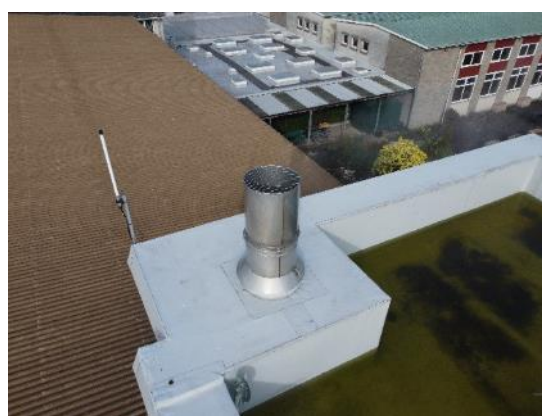
445. Boiler chimney termination roof view.

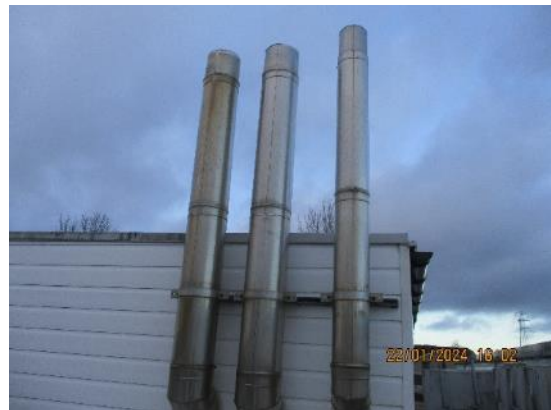
447. Gas boiler flue pipe terminations

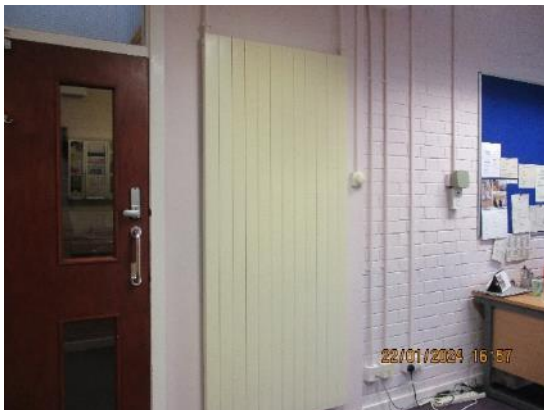
448. Steel panel radiator office 1/4

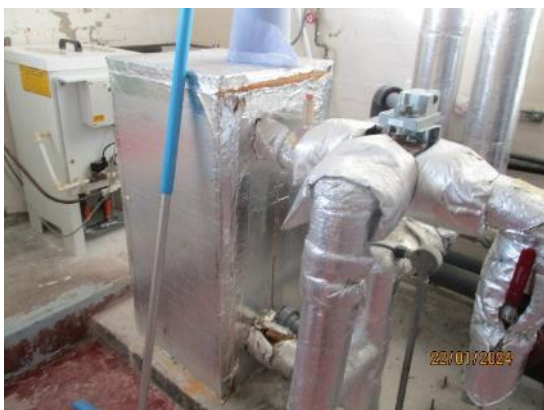
450. Heating pipework and pool plate heat exchanger

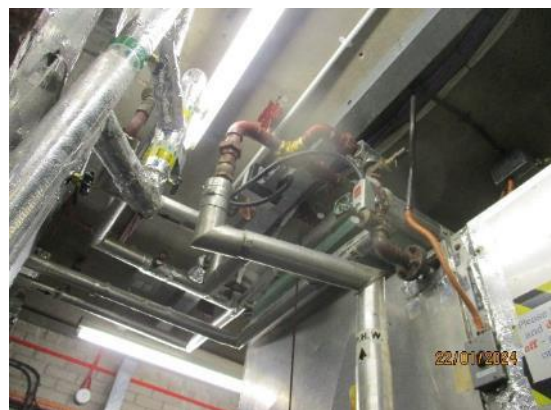
451. Heating pipework plant room 1/7

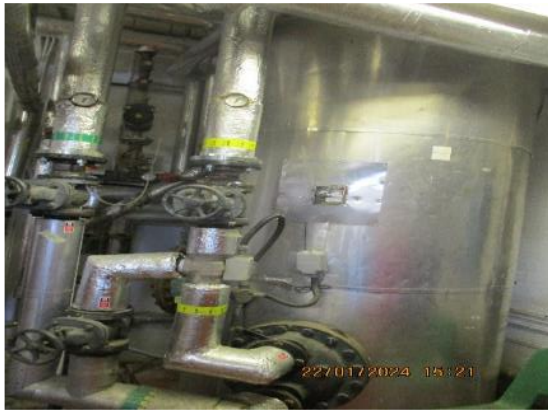
452. Hot water calorifier and pipework

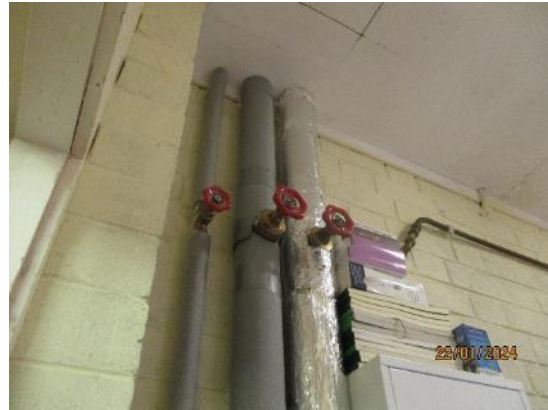
453. Hot water pipework - typical

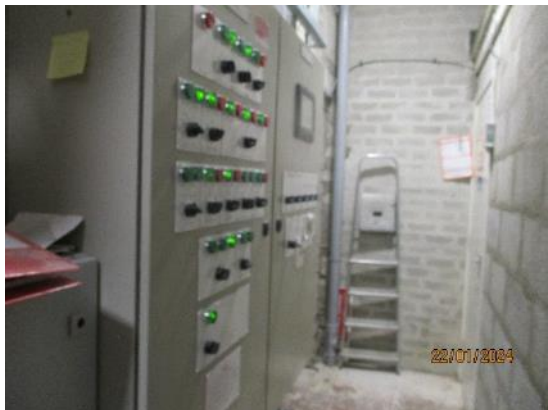
454. Main BMS control panel

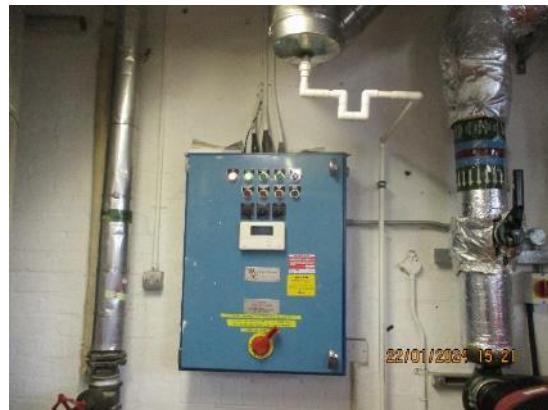
455. Control panel – boiler house

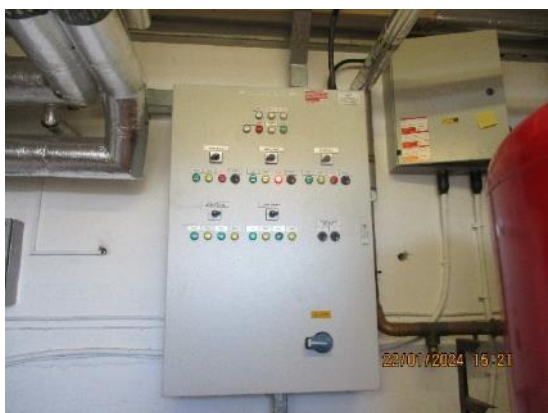
456. Control panel – boilers and pumps

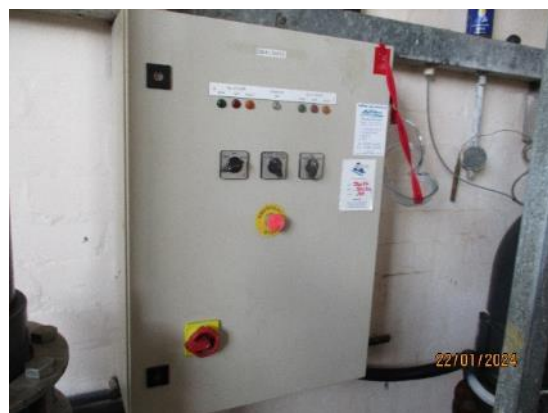
457. Control panel – pool pumps.

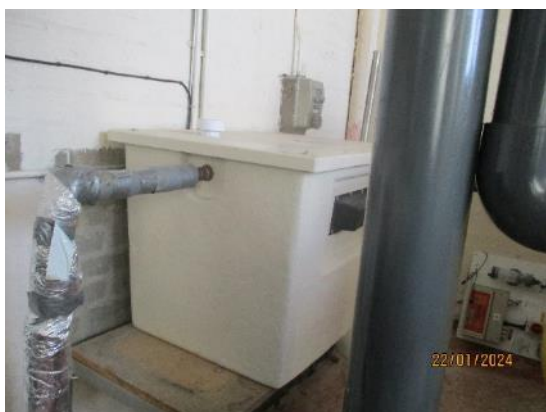
458. Cold water storage tank – pool systems top up.

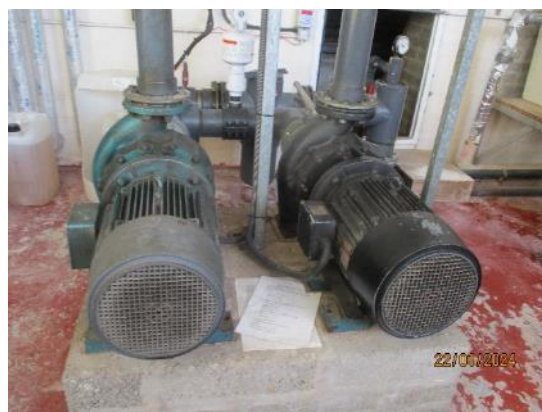
459. Pool system pumps and pipework.

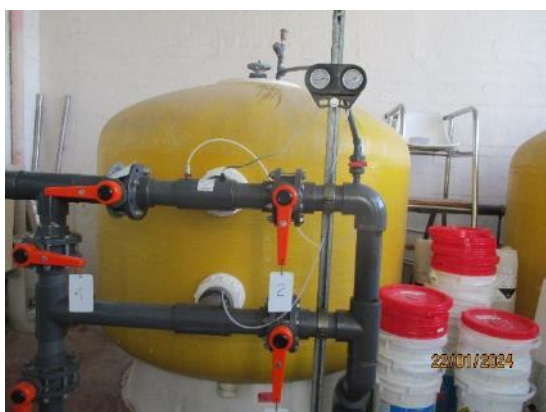
460. Sand filter vessels and pipework – pool systems.

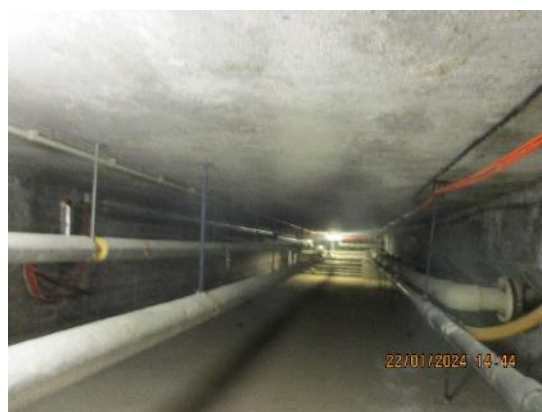
461. Pipework in service duct under pool.

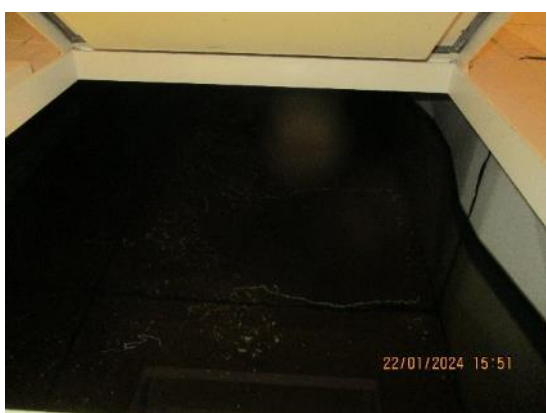
462. Cold water storage tank internal view.

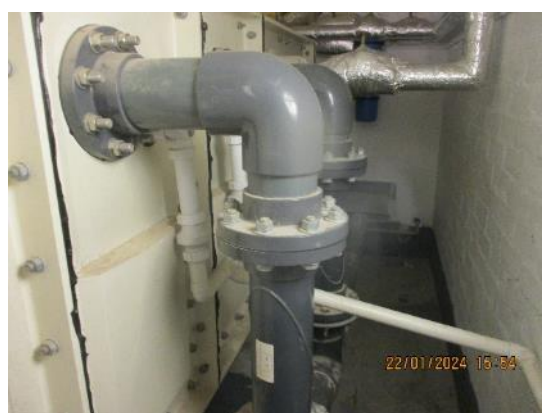
463. Cold water storage tank external view.

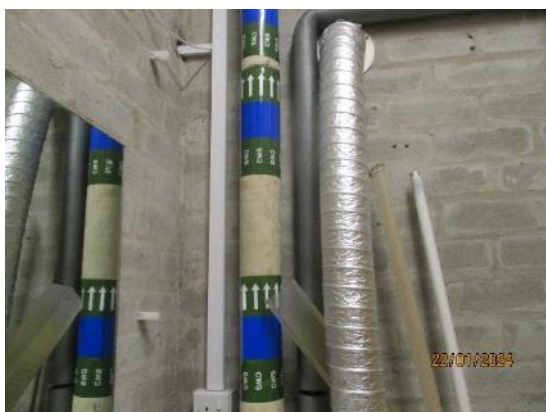
464. Cold water service pipework typical.

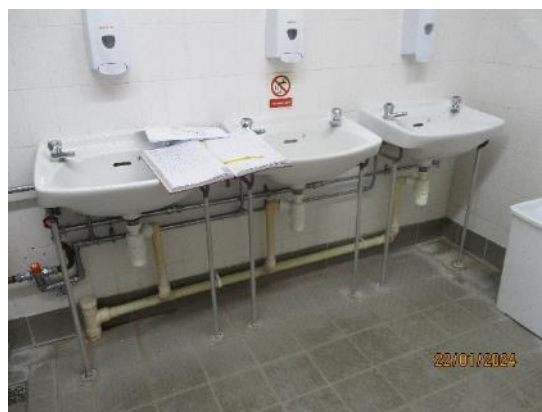
465. Cold water distribution pipework typical.

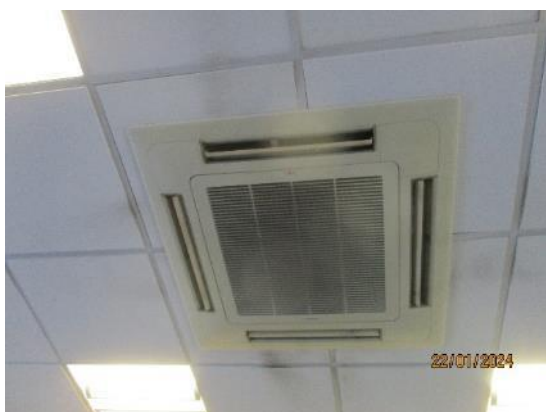
466. Air conditioning unit fitness room.

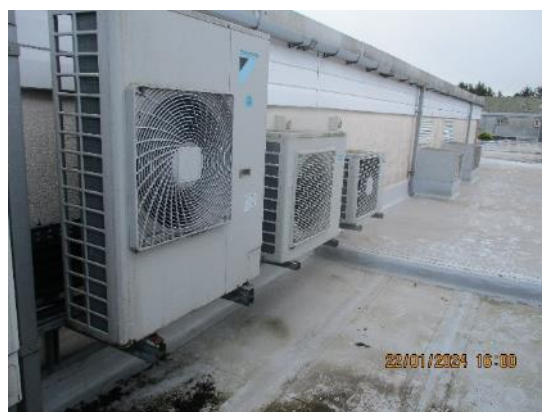
467. Air conditioning external units on roof.

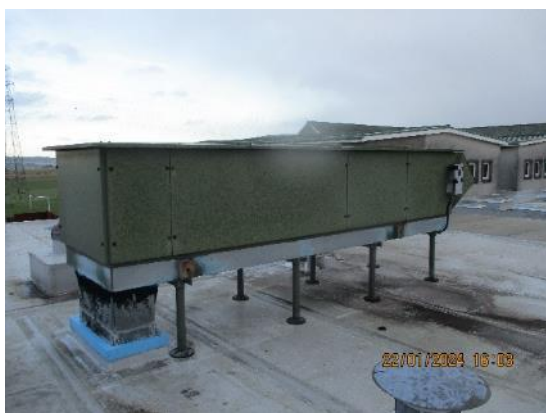
468. Air handling unit on roof.

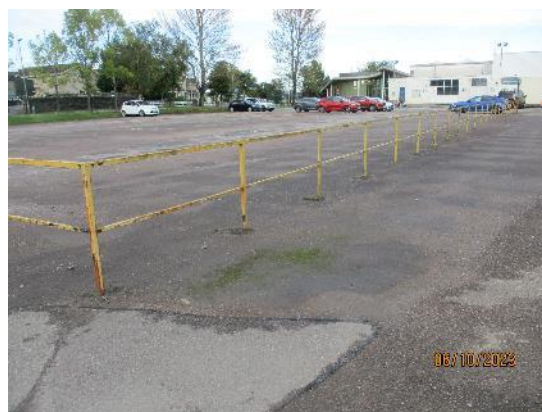
513. Metal bar separation in car park

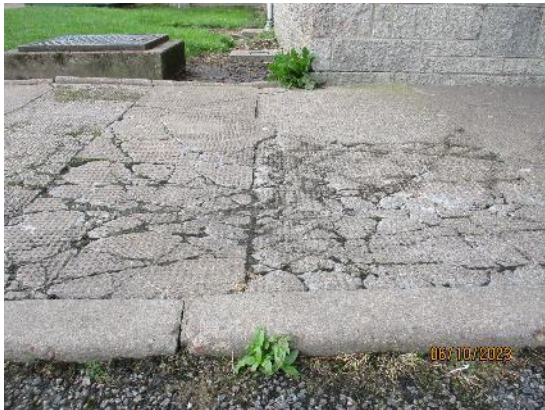
520. Concrete paths sunken

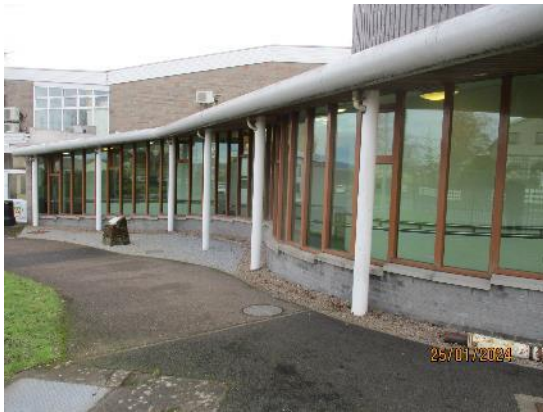
- Tarmacadam car park is patched and pot holed.
- Paving slab and concrete footpaths are broken and uneven.
- Concrete ramps eroding and require resurfacing.
- Tarmacadam footpath at the Leisure Centre is damaged by tree roots.
- Surface water drainage partially blocked.
- Timber post & wire perimeter fence is partially collapsed.
- Stone boundary walls require repointing.
- Stone wall to neighbouring property is leaning towards the car park.
- Outbuilding asbestos roofs broken and leaking.

525. Tarmacadam cracked by tree roots

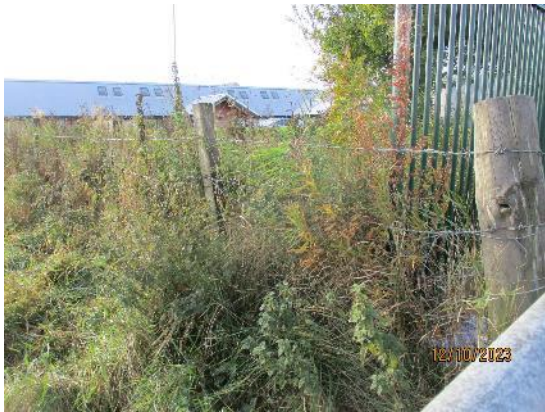
530. Timber post and rail fence leaning

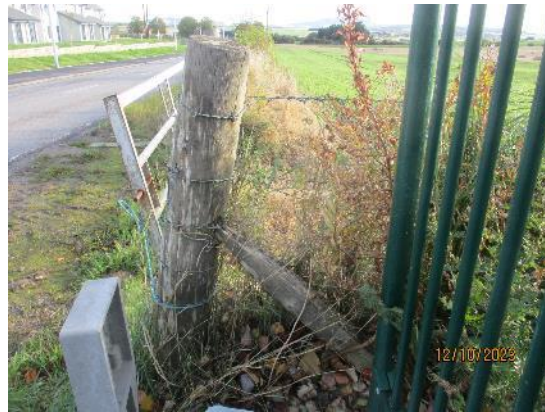
531. Timber strainer leaning

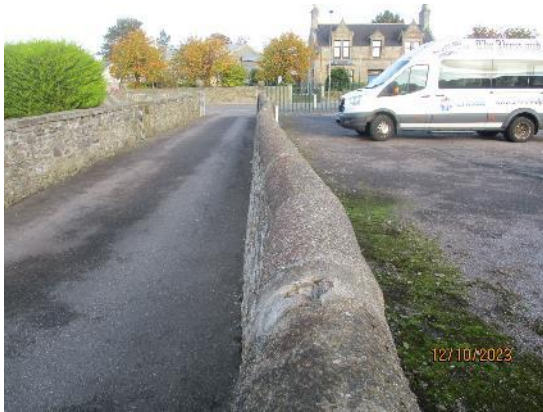
542. Retaining wall to neighbour, leaning

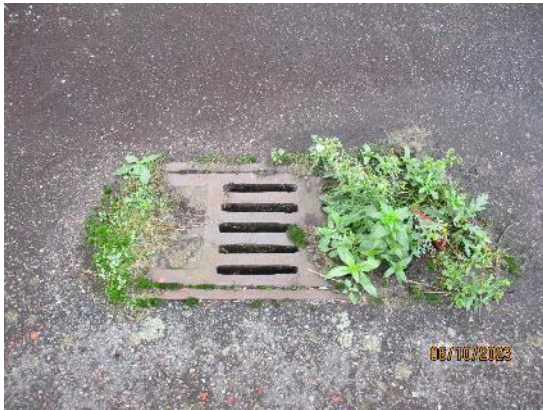
544. Surface water drainage, part blocked

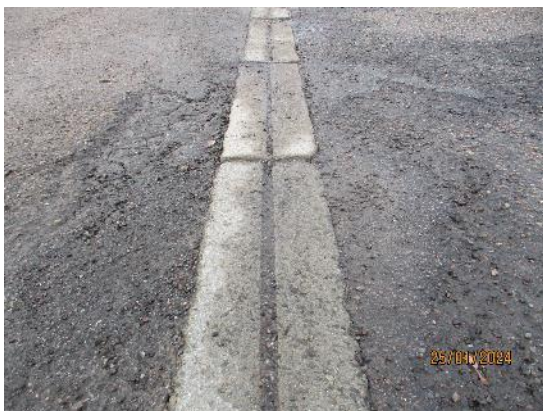
546. Channel gullies blocked – Leisure Centre

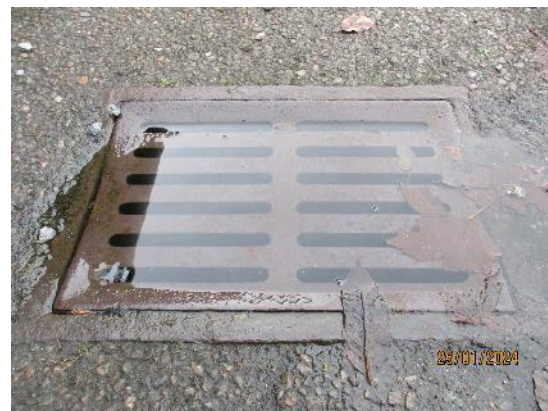
547. Road gullies blocked

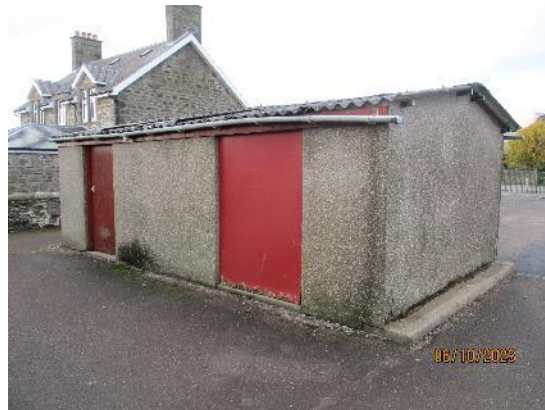
551. Brick external store with asbestos roof

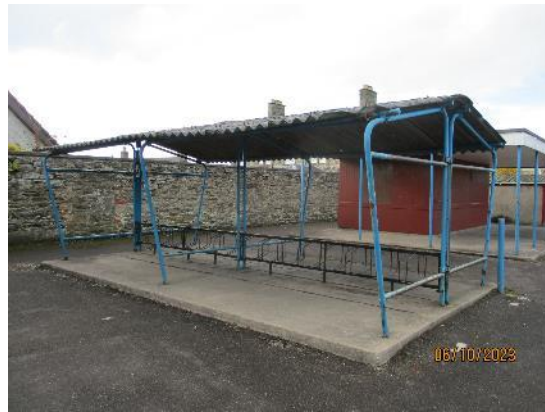
555. Bike shelter with asbestos roof

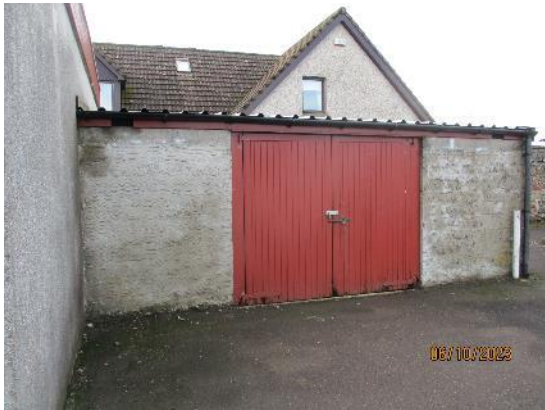
556. External store with metal profile roof

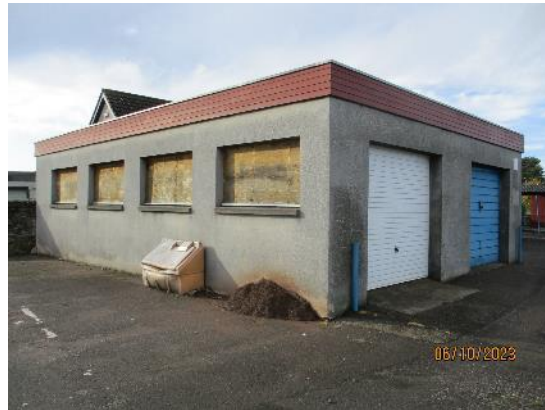
557. Brick garages with felt roof

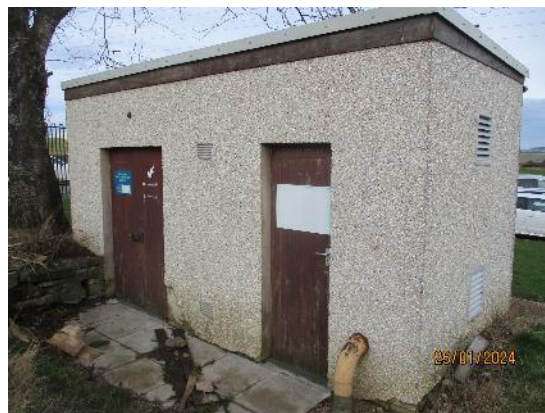
559. Gas meter house with metal profile roof
