# **Summary Building Condition Survey Report**

**Rothiemay Primary School  
Main Street, Rothiemay AB54 7LT**

**25<sup>th</sup> September 2023**

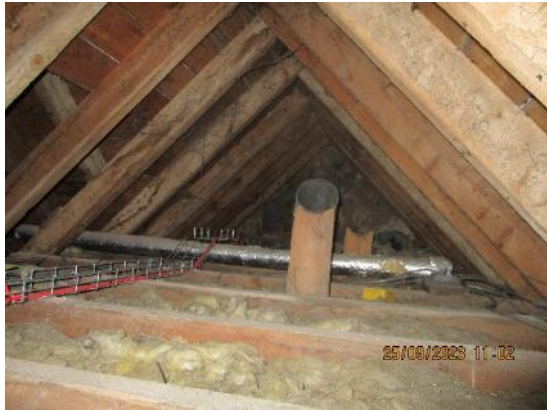
1. Timber trussed roof above two storey part

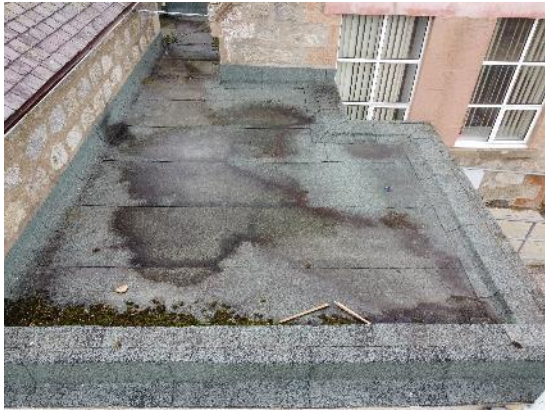
7. Felt roof above Boy's toilets

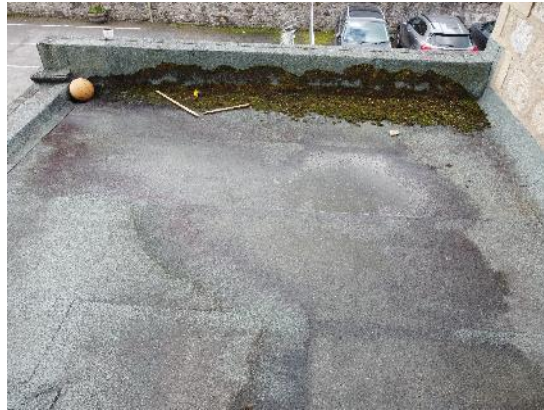
8. Sunken area ponding

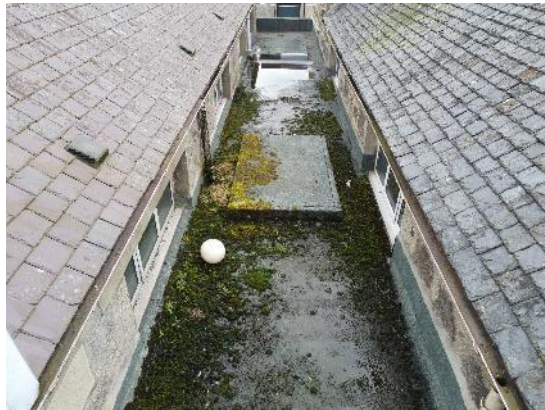
9. Felt roof above corridor

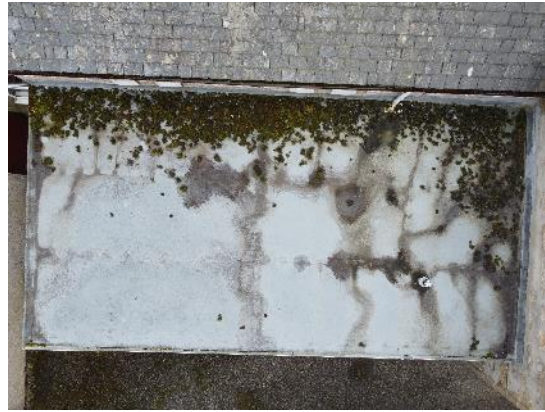
14. GRP roof above Kitchen and entrance

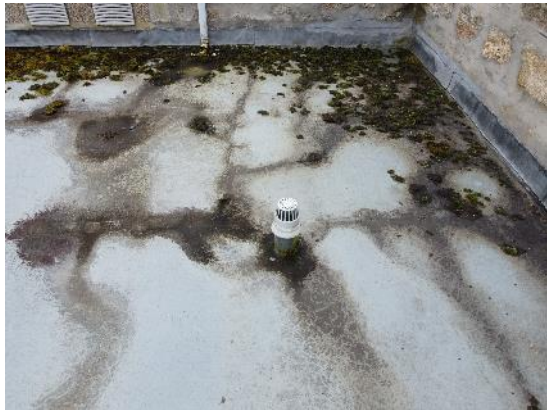
15. GRP roof blistering and crazing

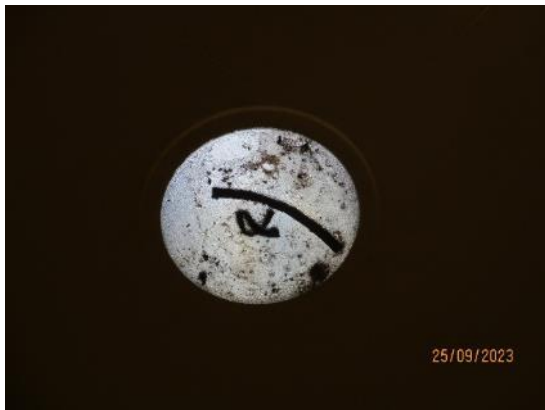
21. Cleaning of sunpipes required

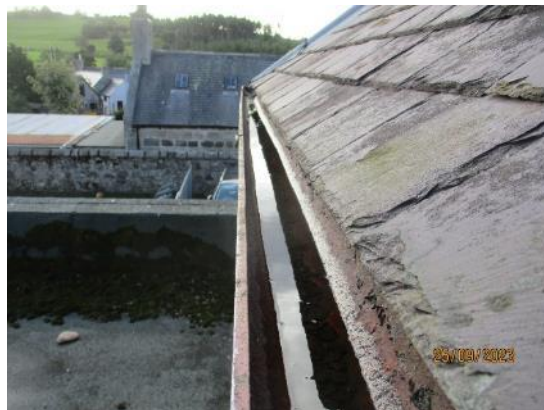
22. Cast iron gutters ponding

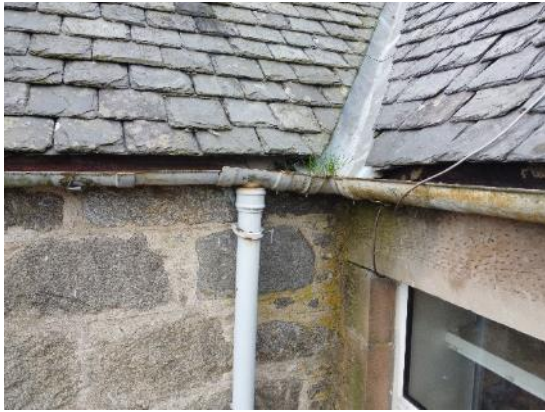
25. Miss-aligned gutters and vegetation

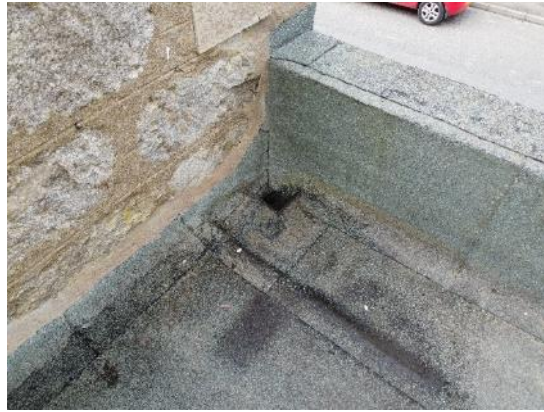
26. Rainwater outlet from felt flat roof

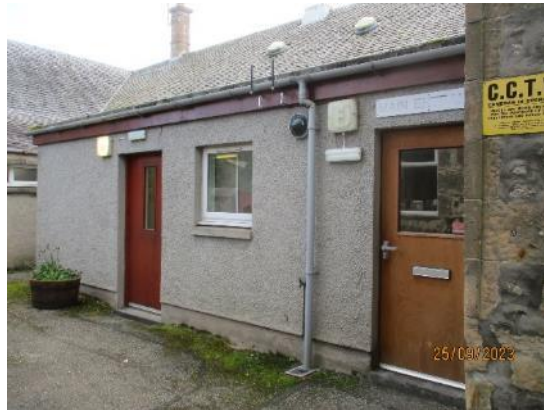
28. UPVC gutter and downpipe

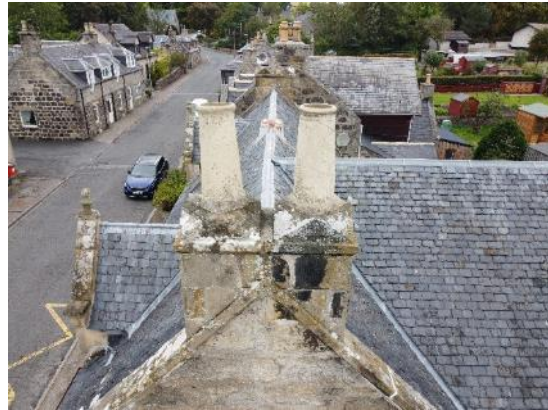
32. Stone chimney stack

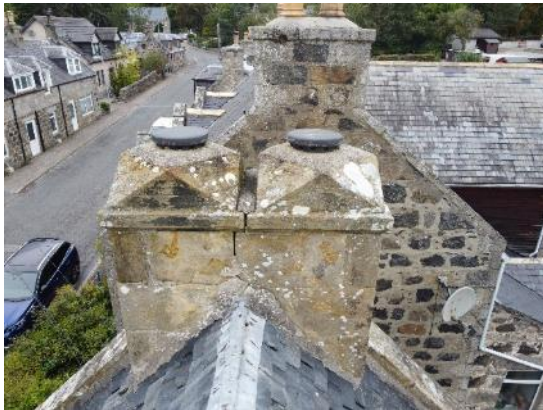
33. Capped and ventilated chimney stack

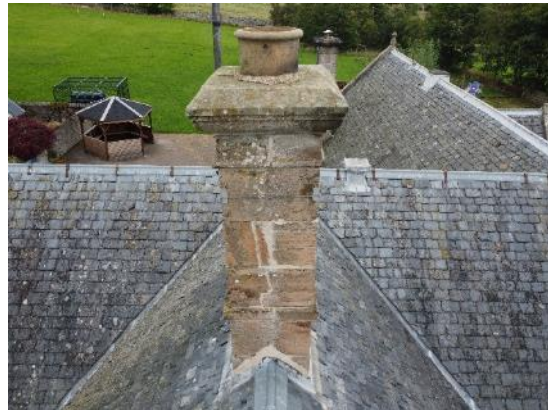
34. Eroded stone chimney stack

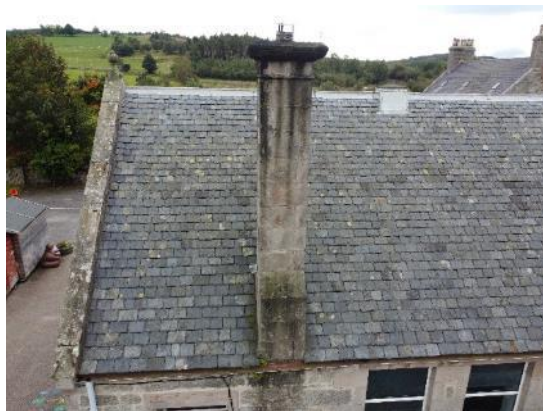
35. Stone boiler flue

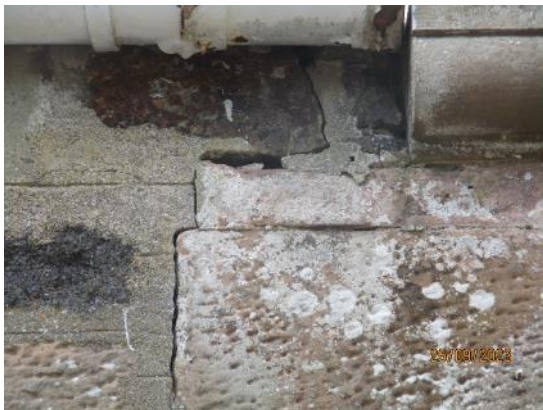
45. Isolated repointing required

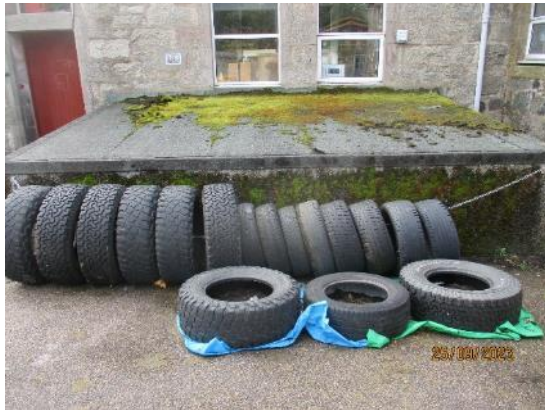
51. Roughcast walls to Boiler Room

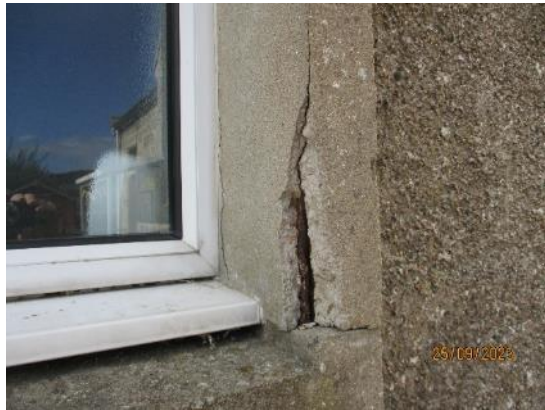
52. Exposed reinforcement to window surrounds

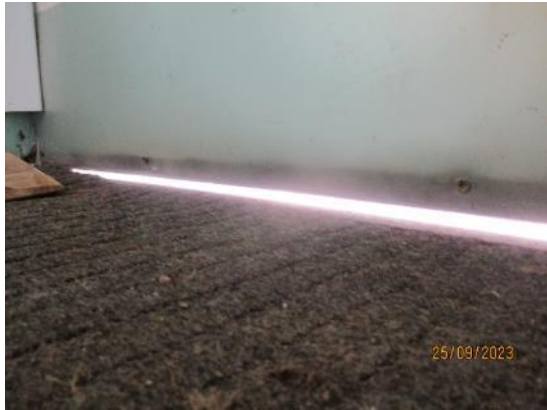
55. Daylight visible around external doors

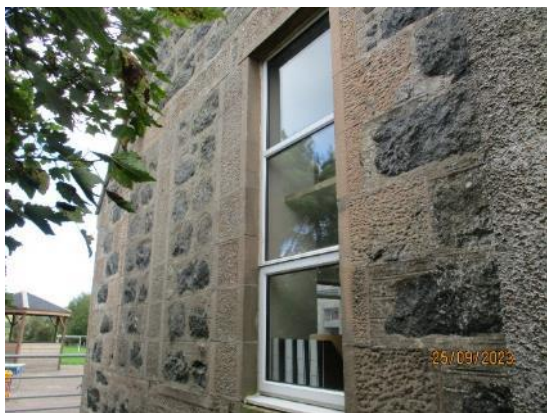
59. Large UPVC windows

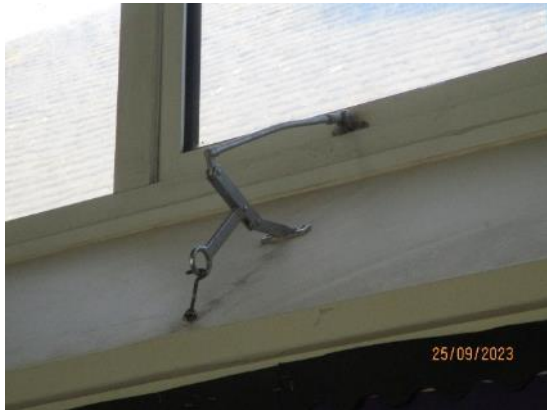
63. High level winding mechanism

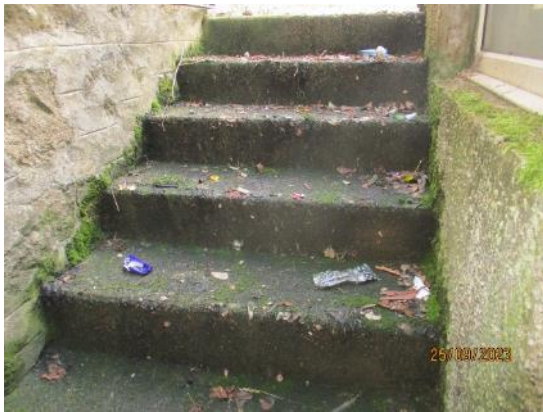
73. Concrete steps to Boiler Room

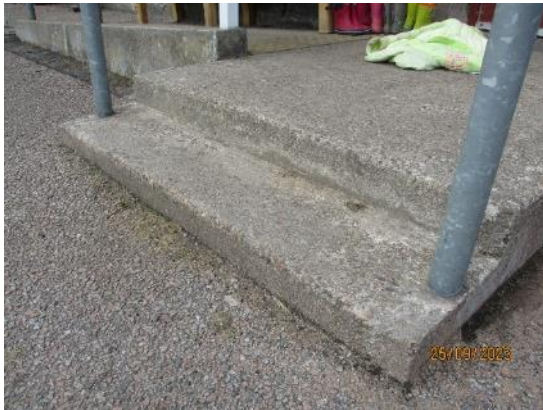
75. Concrete steps to Play Group entrance

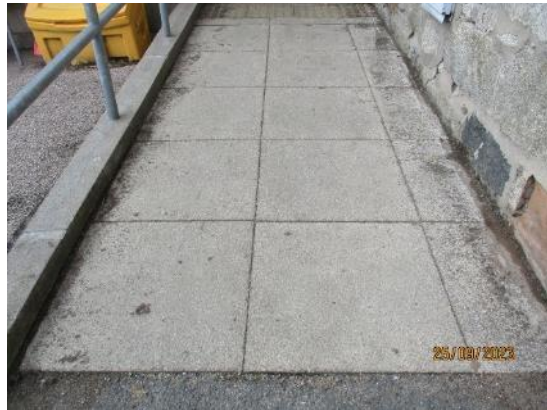
76. Paving slab ramps

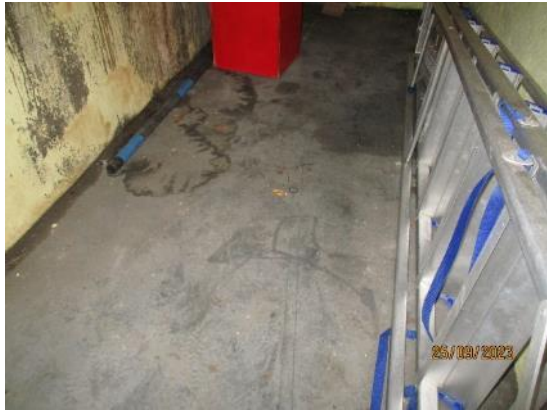
91. Concrete floor in Boiler Room

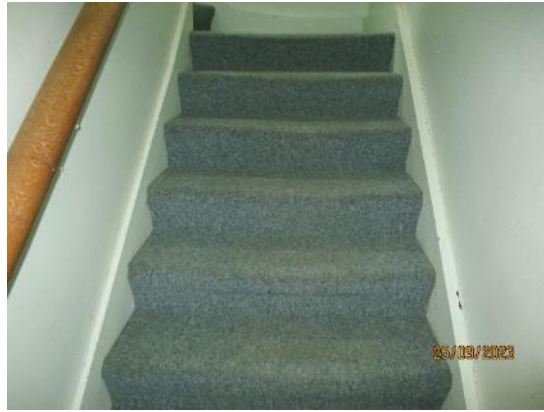
92. Timber stair to first floor

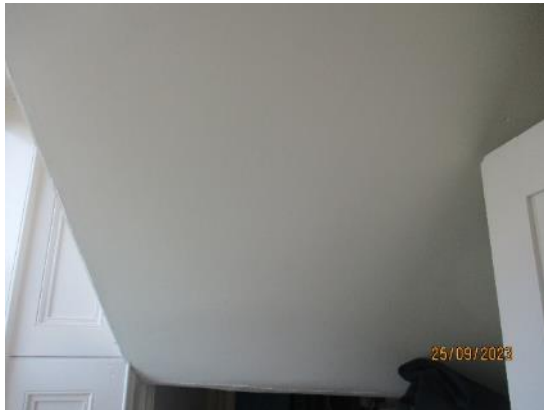
94. Lath & plaster soffit

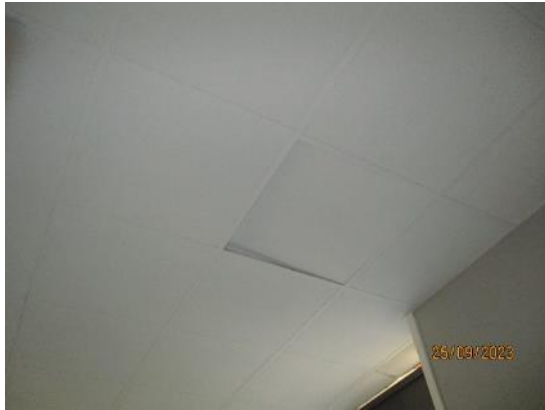
96. Suspended ceiling tiles

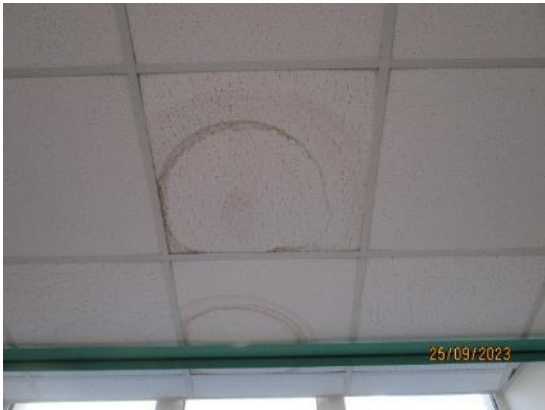
98. Water marked suspended ceiling tiles

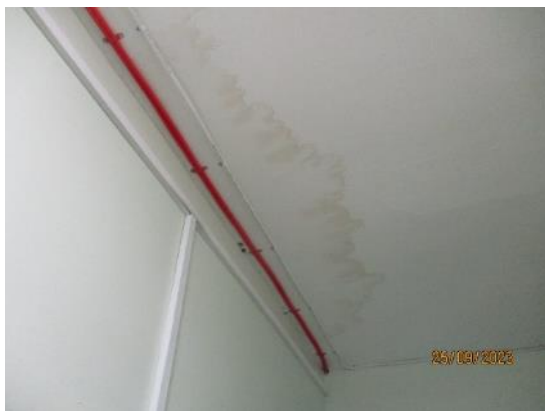
100. Watermarked plasterboard ceilings

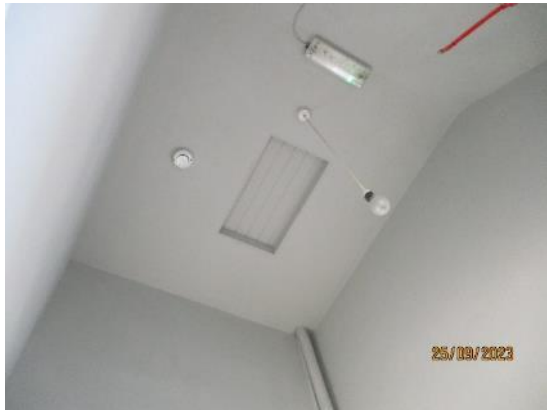
104. Lath & plaster ceilings

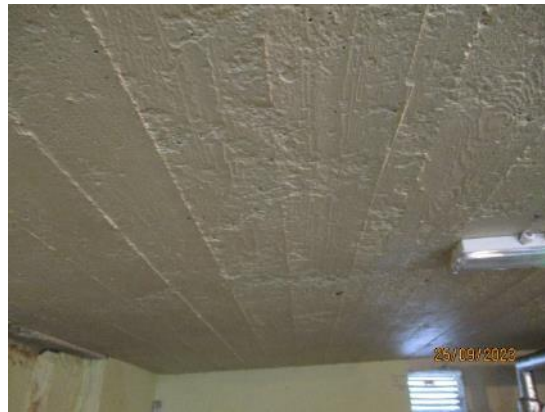
109. Concrete ceiling to Boiler Room

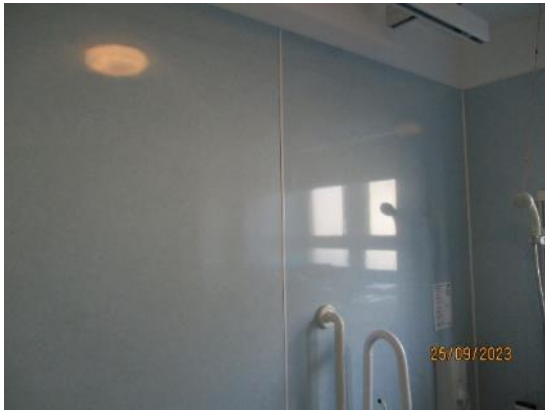
116. Wetwall in Shower Room

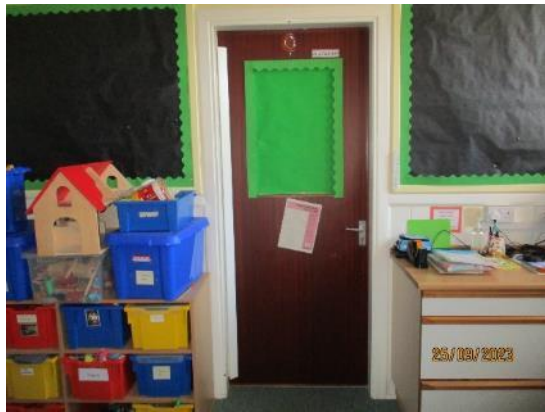
121. Timber veneered doors to classrooms

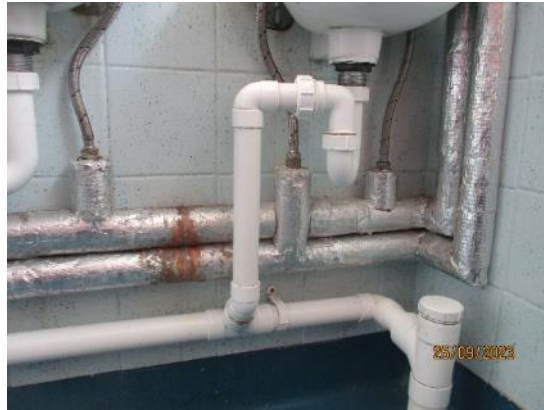
133. UPVC waste pipes

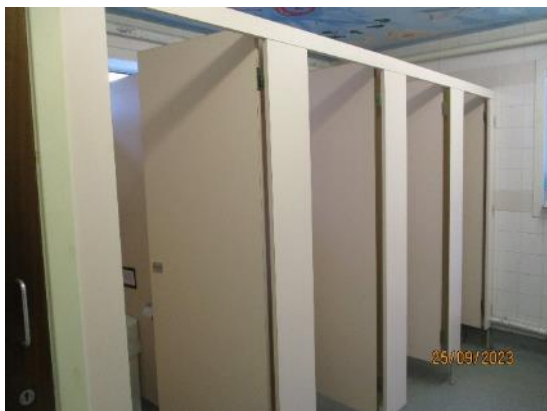
136. Composite panel toilet cubicles

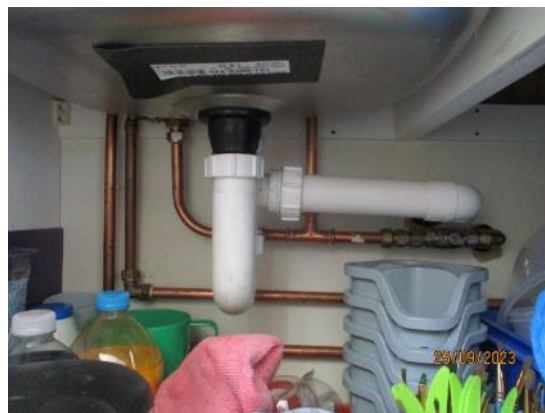
143. UPVC waste pipes

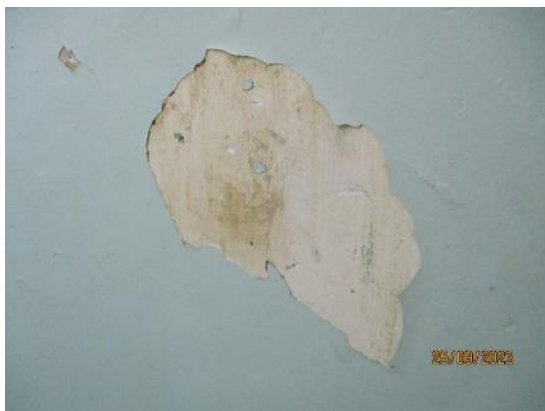
148. Lath & plaster walls

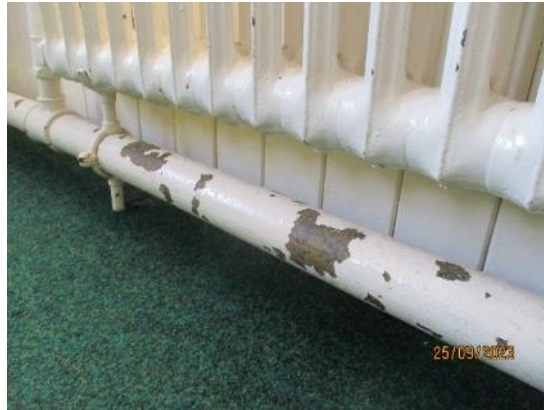
151. Metal heating equipment

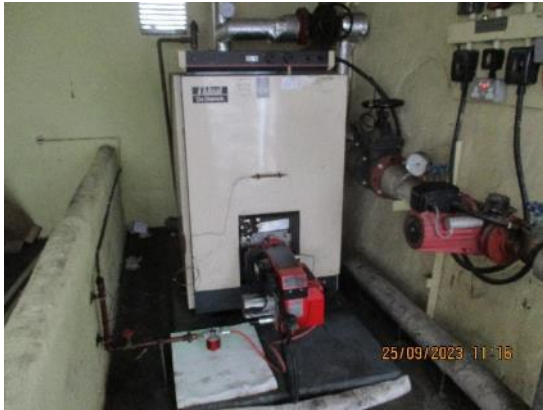
- The heating system is life expired and should be considered for replacement, including the boiler which is reaching the end of its useful life.
- No intruder alarm system is installed.
- The CCTV system is defective, with components missing.
- Internal general wiring is life expired due to age and should be considered for replacement.
- Internal electrical distribution boards are reaching the end of their useful life.
- Cold water, hot water and heating pipework insulation is in poor condition with sections of pipework uninsulated.
- Internal fluorescent tube general lighting is life expired and should be considered for replacement.
- No electronic security systems are installed on external entrance doors.

160. Oil boiler – heating system.

- Provide access to all roof voids.
- Install an intruder alarm system.
- Alter control strategy for extract fans in toilets with motion sensors installed to enable and disable fans.
- Upgrade the heating system and controls.
- Replace general wiring.
- Upgrade internal lighting to incorporate energy saving controls.
- Install electronic door access security systems to external doors.
- Repair or replace the CCTV system.

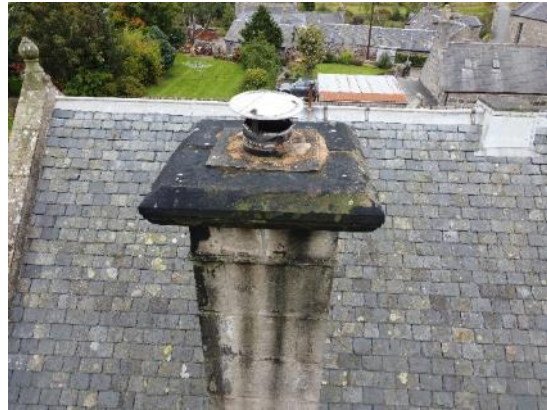
161. Oil boiler flue termination

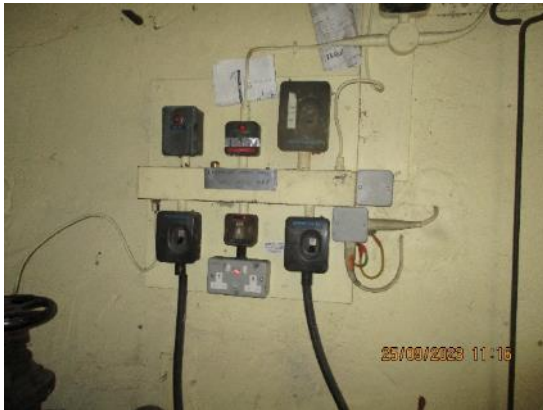
162. Heating system controls – boiler house.

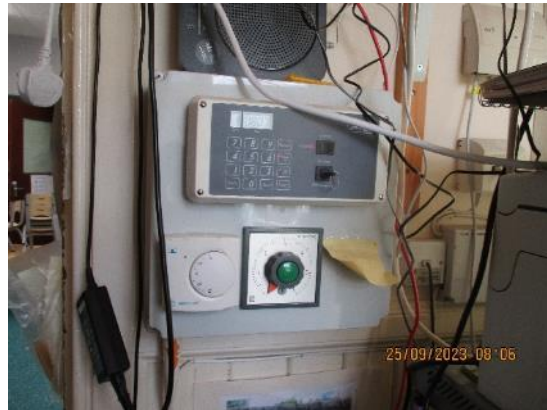
163. Heating programmer – nursery store room.

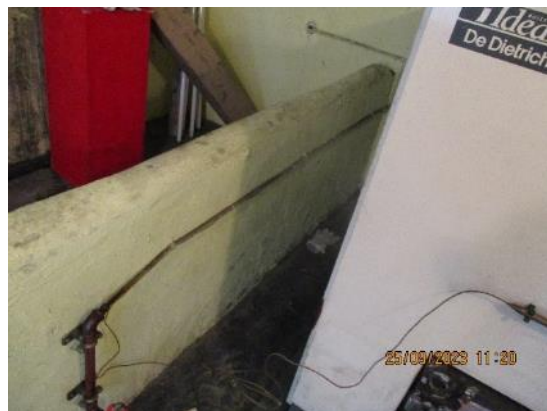
165. Oil supply pipework to boiler.

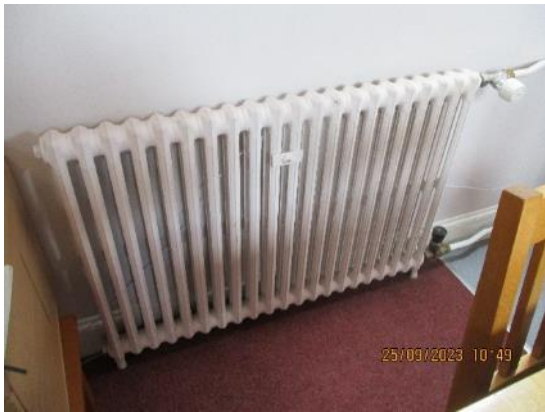
166. Cast iron section radiator staff room 2-23

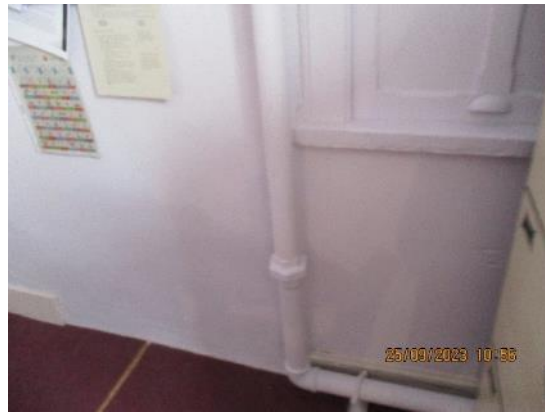
167. Heating system distribution pipework typical.

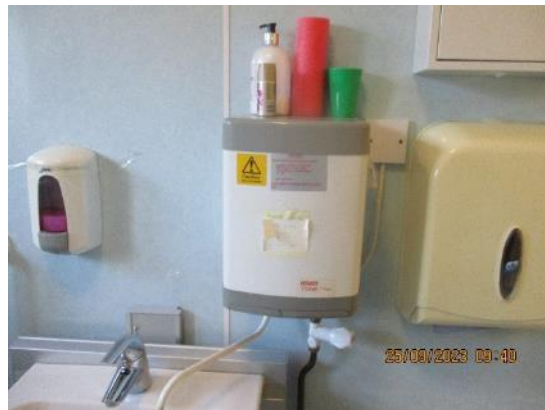
169. Point of use water heater. Access toilet.

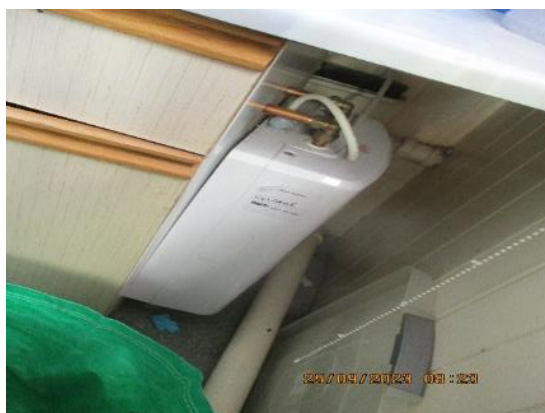
170. Point of use water heater – classroom typical.

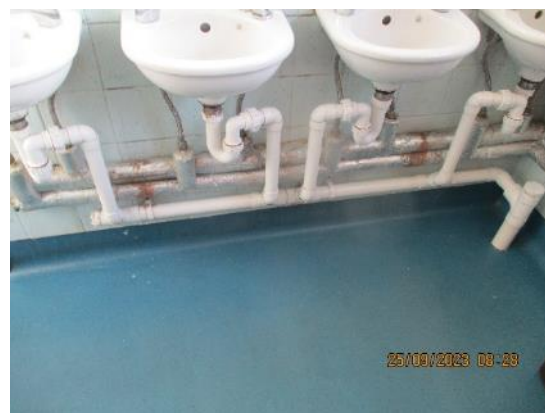
171. Pipework – hot and cold / boys toilets.

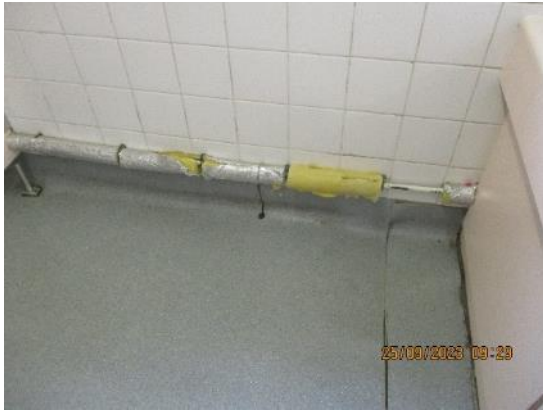
172. Pipework – cold water / girls toilets.

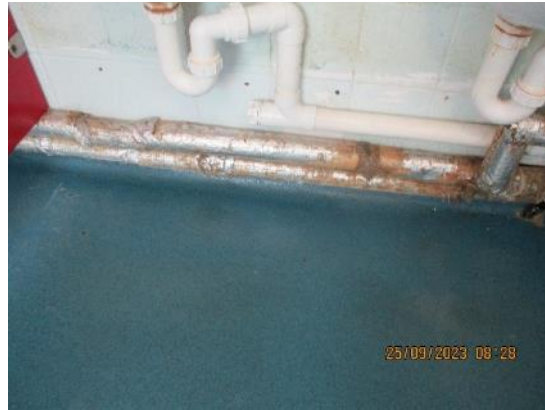
173. Pipework – hot and cold boys toilets.

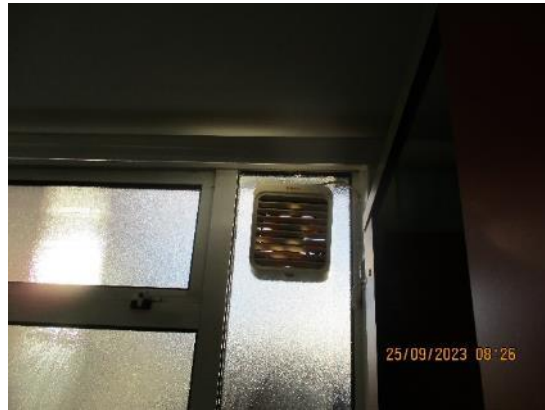
175. Extract fan – boys toilets.

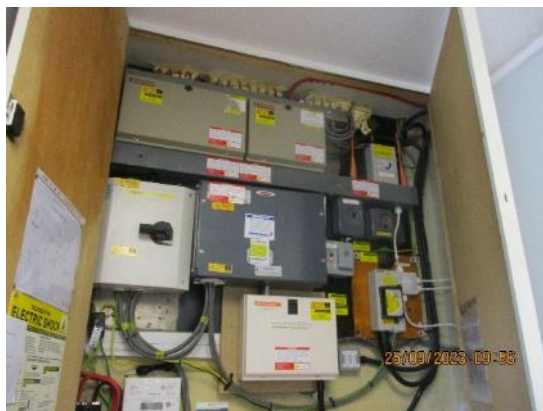
176. Switchgear and distribution boards – reception office cupboard.

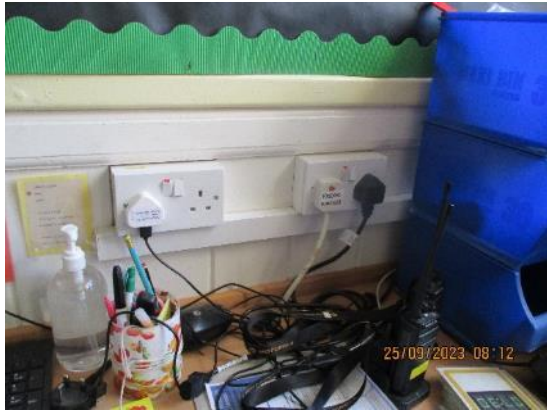
178. Sockets and plastic trunking typical.

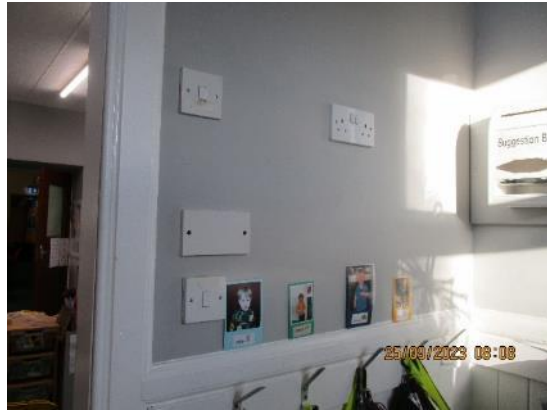
179. Sockets and switches typical.

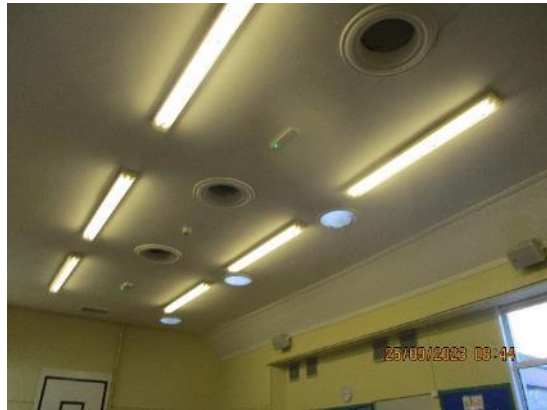
180. Lighting – library.

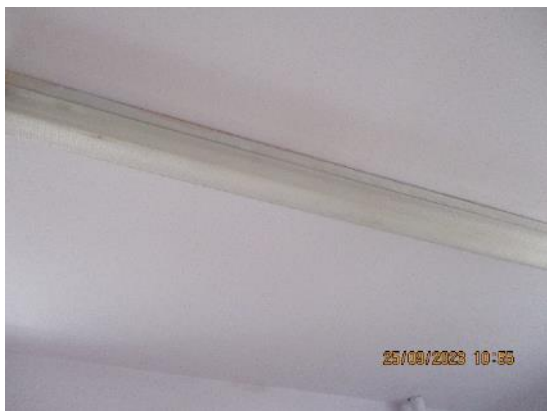
181. Lighting – GP hall.

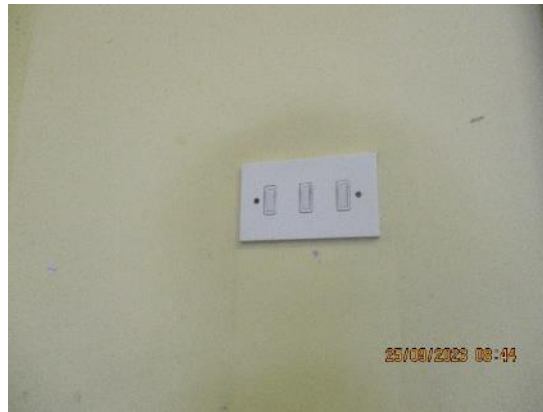
184. Lighting – access corridor typical.

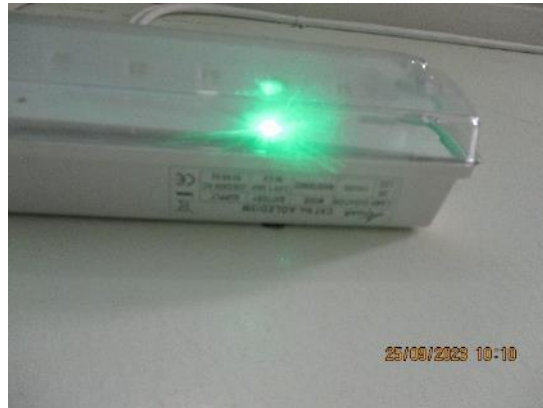
186. Emergency exit sign light internal typical.

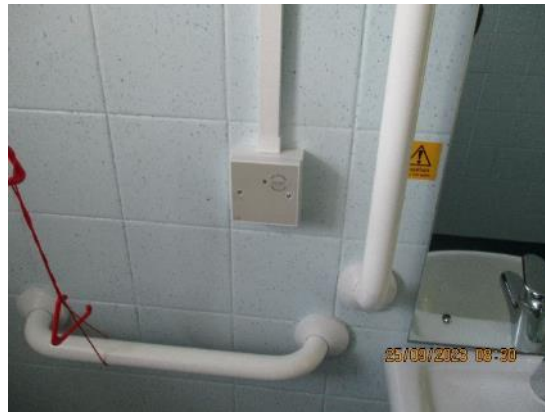
196. Disabled toilet alarm system panel access toilet.

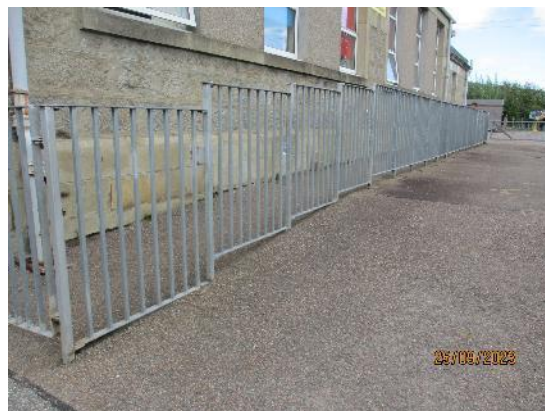
207. Galvanised bar separation fencing

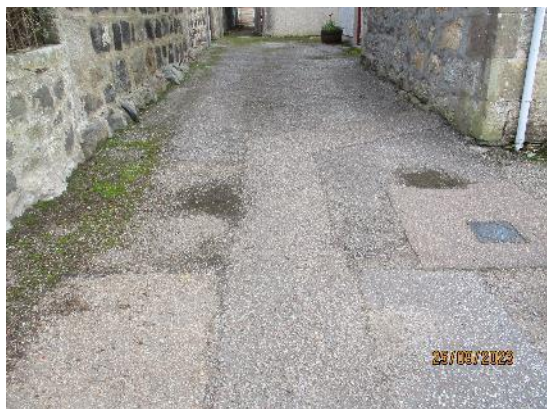
210. Tarmacadam entrance footpath

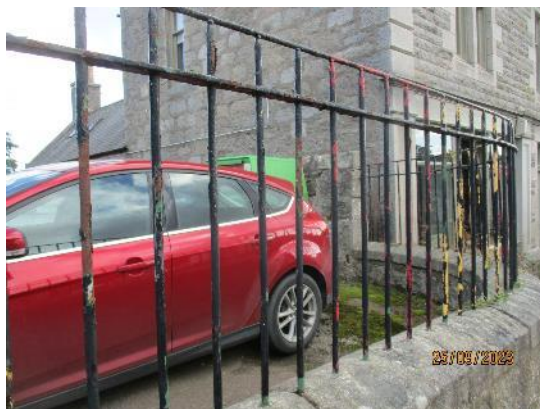
211. Metal railings above stone wall

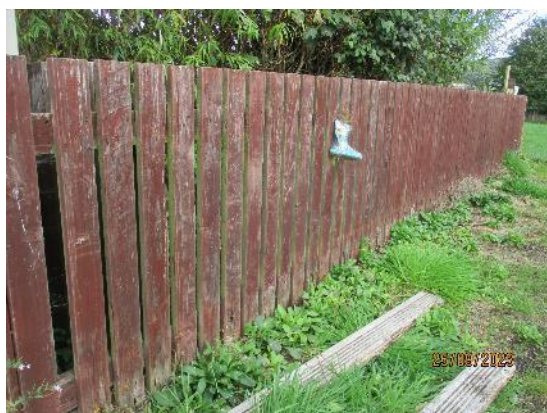
212. Timber boarded fencing

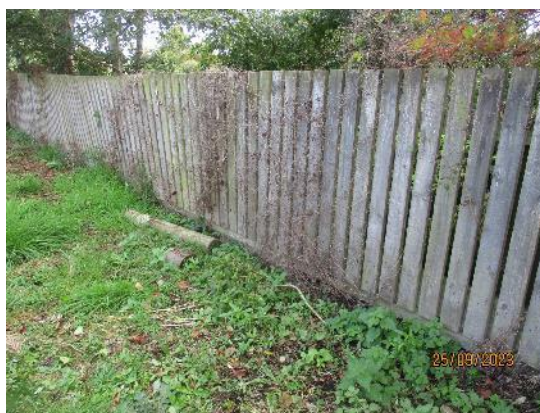
213. High timber boarded fencing

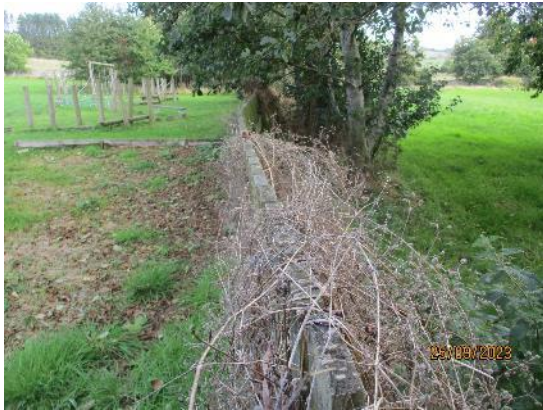
- Surface water drainage is part blocked.
- Timber fencing and gates are reaching the end of their useful life.
- Perimeter stone walls require isolated repointing.
- The stone wall to the sports field has a slight lean and cracked corner joint.

214. Leaning timber boarded fencing

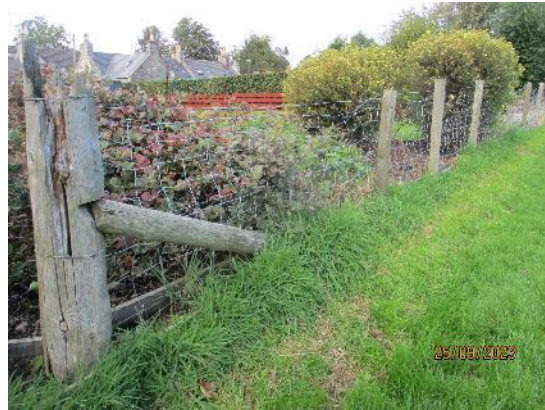
215. Timber post & wire fencing

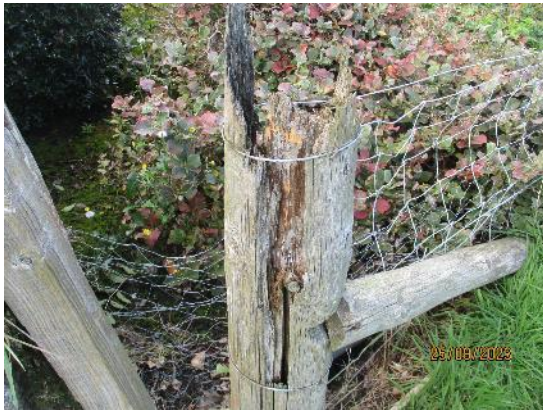
216. Rotten/leaning timber posts

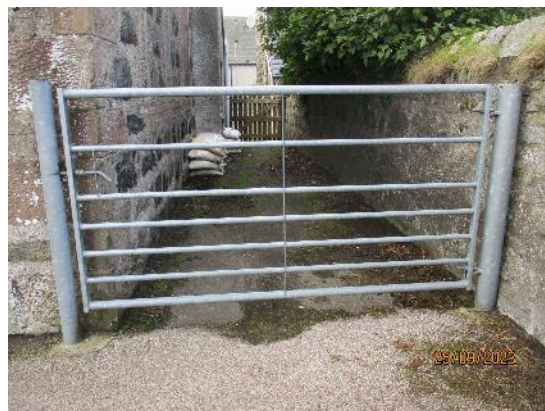
219. Galvanised rail gate

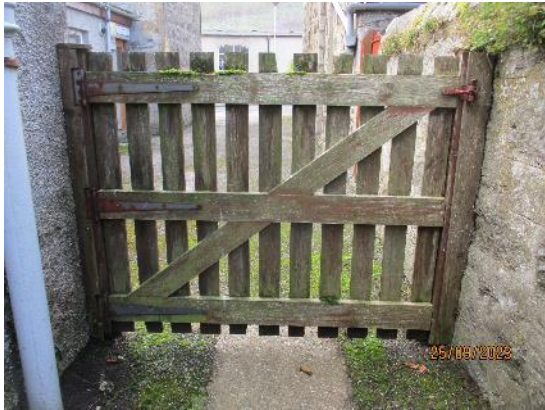
220. Timber boarded gates

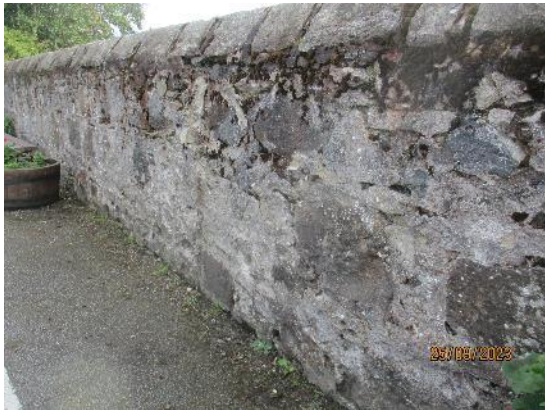
222. Natural stone perimeter walls

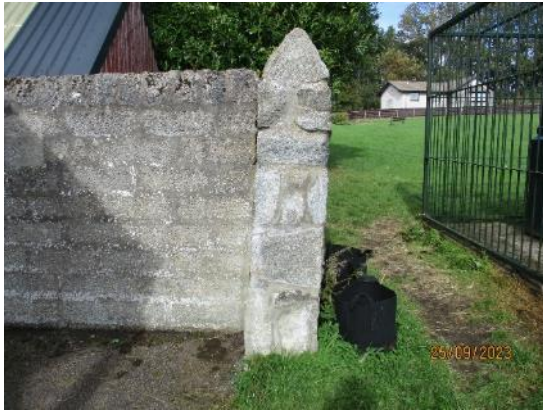
226. Stone wall to sports field - leaning

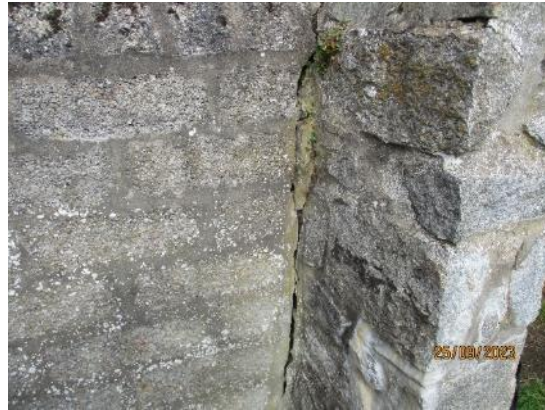
227. Open joint with adjacent block wall

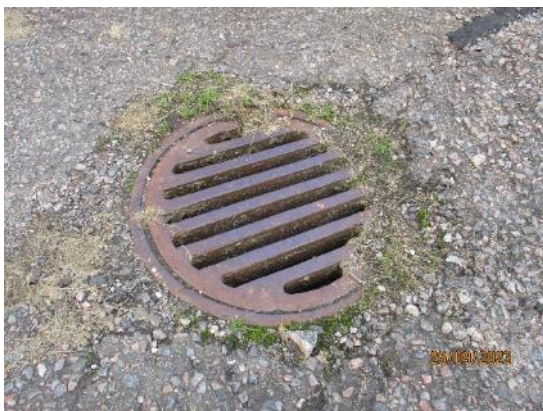
230. Part blocked drainage to car park

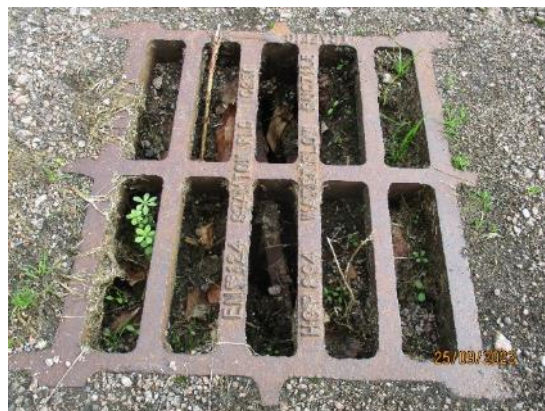
231. Part blocked drainage to playground

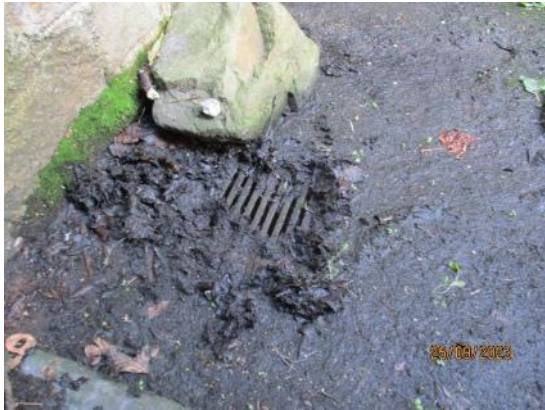
232. Blocked drainage outside Boiler Room
