# **Summary Building Condition Survey Report**

**Newmill Primary School  
Middle Brae, Keith AB55 6US**

**11<sup>th</sup> September 2023**

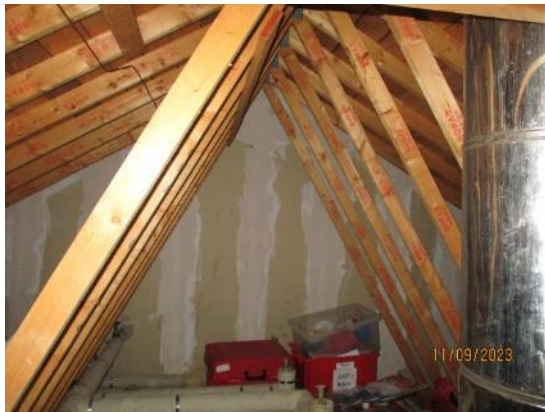
1. Timber trusses to all roofs

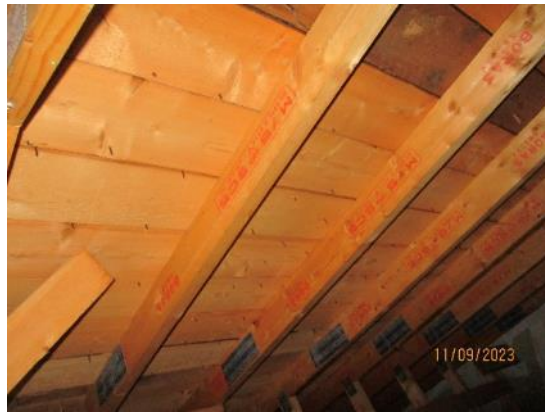
2. Timber sarking boards

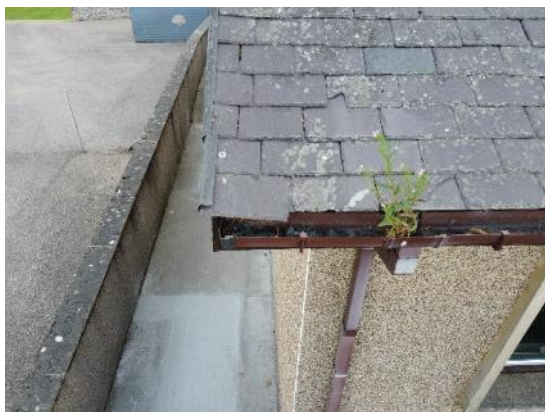
5. Slipped and broken slates

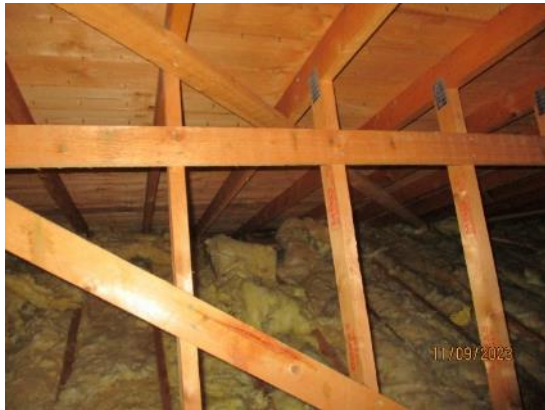
15. Mineral fibre insulation laid over ceilings

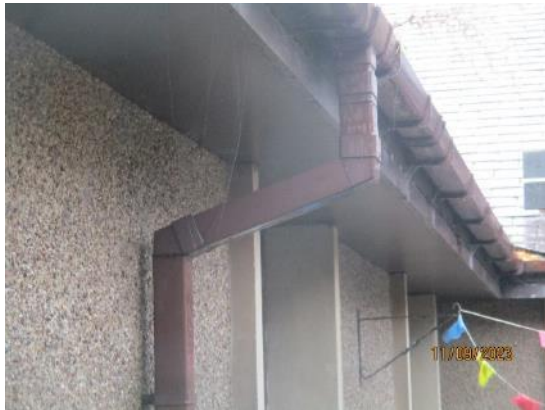
21. UPVC rainwater downpipes

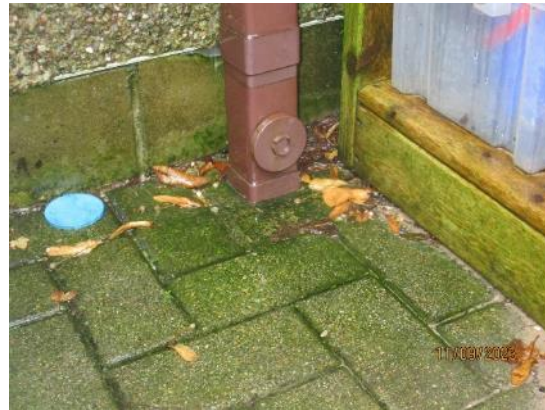
22. Downpipes blocked and leaking

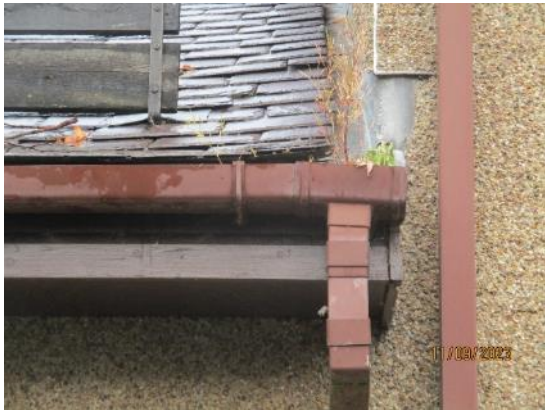
27. Vegetation in gutters

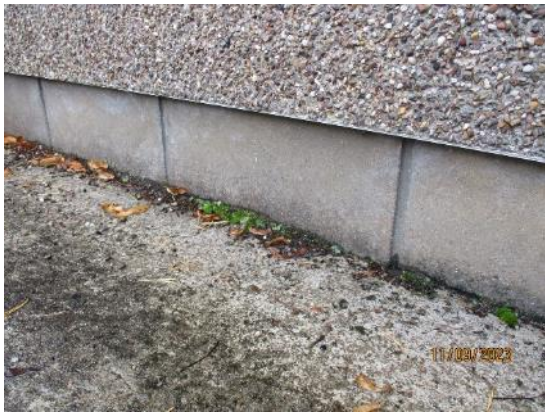
31. Dressed blockwork underbuilding

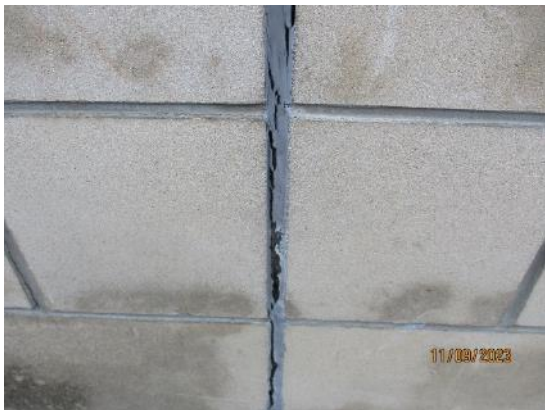
33. Expansion joints require resealing

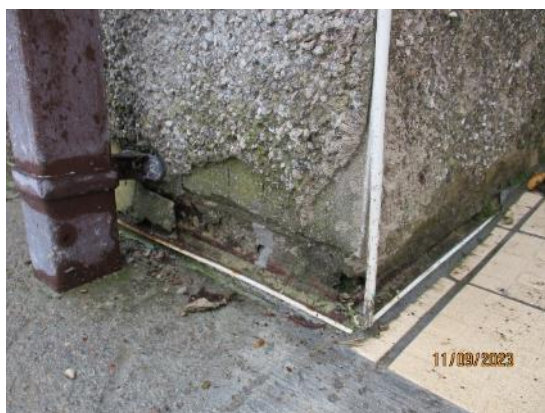
35. Damaged roughcast finish

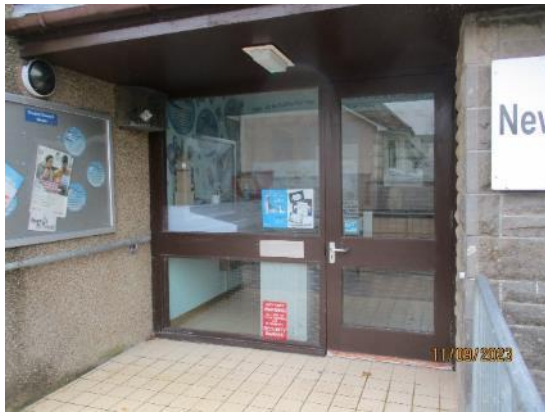
37. Timber entrance screen

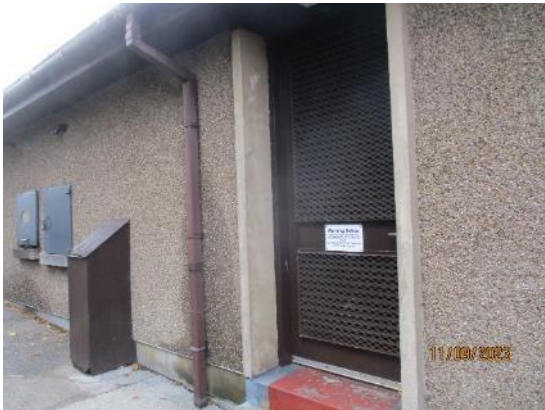
39. Timber door to Boiler Room

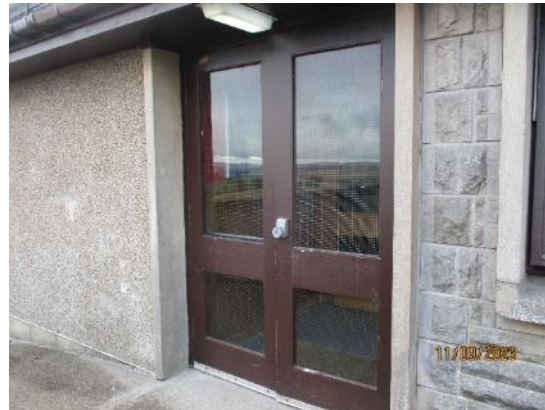
40. Double timber doors

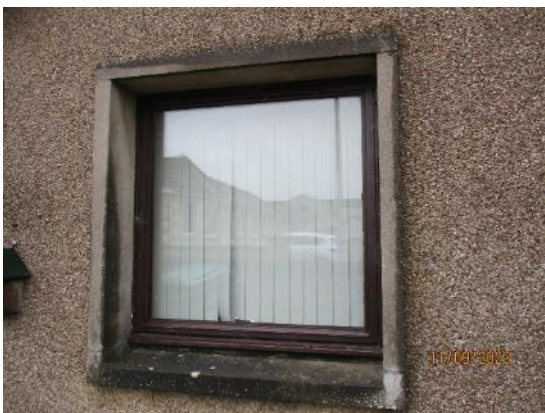
41. Timber windows to most elevations

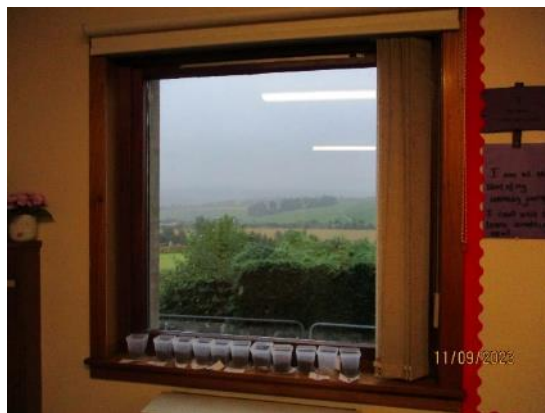
42. Internal view of timber windows

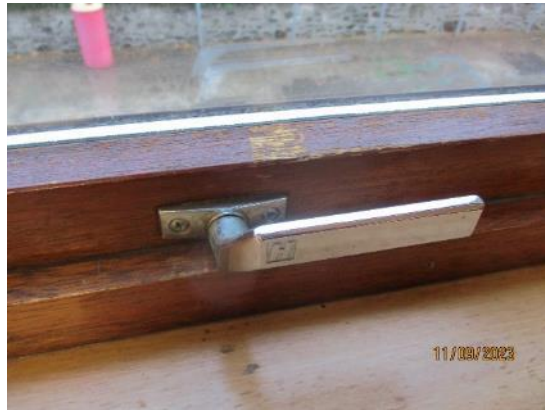
46. Lever handles to timber windows

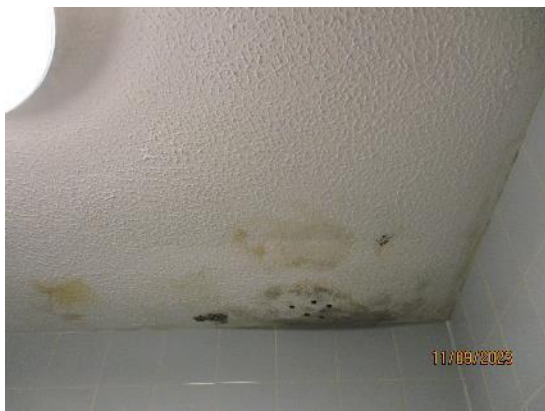
103. Water damaged plasterboard ceilings

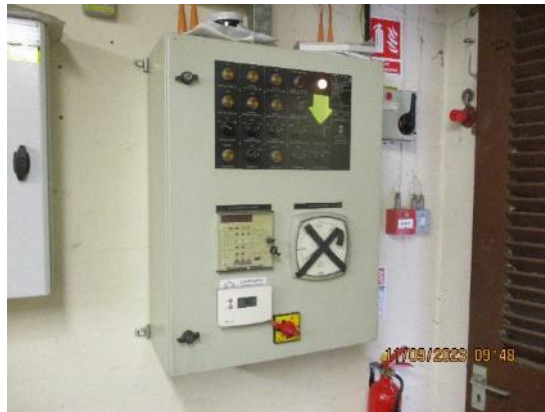
- The oil tank and oil supply pipework and controls are life expired and in poor condition.
- All electrical extract fans fitted in toilets are life expired and in poor condition.
- The school heating system controls and control panel are life expired and in poor condition.
- Heating pipework is only partly insulated.
- Hot water pipework is only partly insulated.
- Cold water pipework is only partly insulated.
- Electrical convector heaters installed are life expired and in poor condition.
- General wiring and wiring accessories are life expired.
- General lighting is life expired with exception of class 1/13.
- Building external lighting is life expired with exception of new LEDs.
- No intruder alarm system is installed.
- The CCTV system is basic and nearing the end of its useful life.
- The fire alarm system is manual type only and has no detectors incorporated.

113. Heating system control panel. 1/19

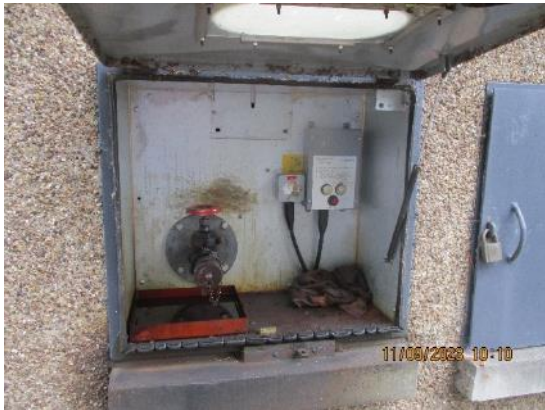
120. Oil tank filling point and fill alarm system. 1/20

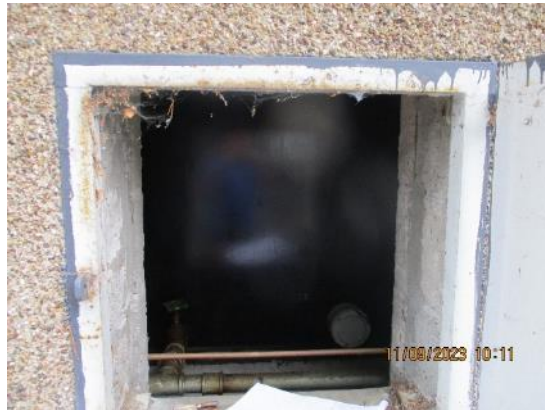
121. Oil tank in bunded room. 1/20.

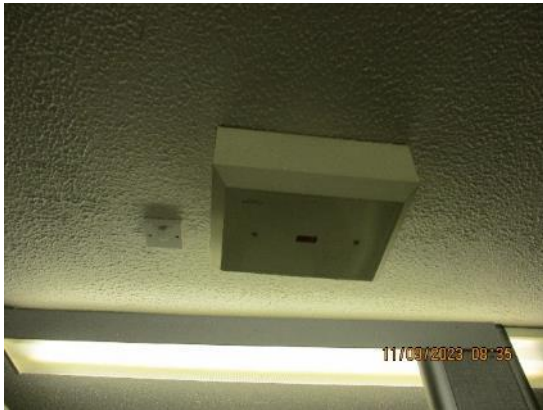
126. Extract fan boys toilets 1/16.

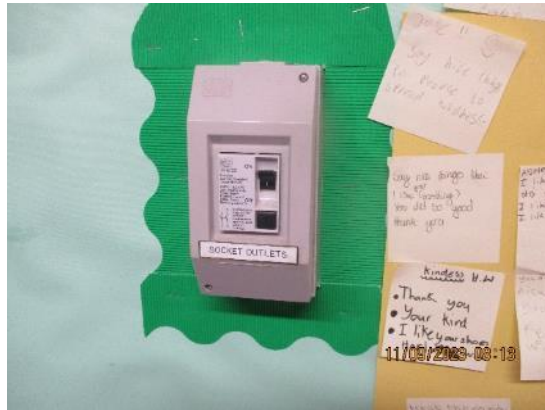
133. Classroom socket RCD unit. 1/13

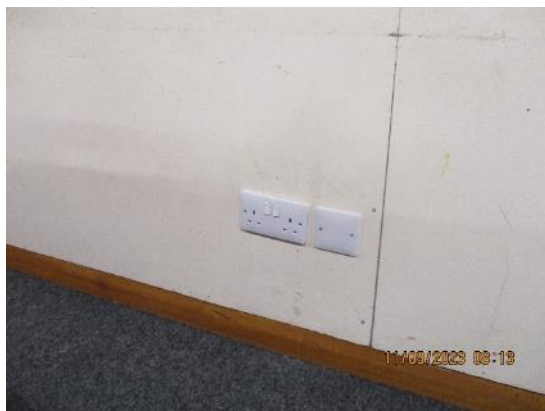
134. Flush fitted wiring accessories typical.

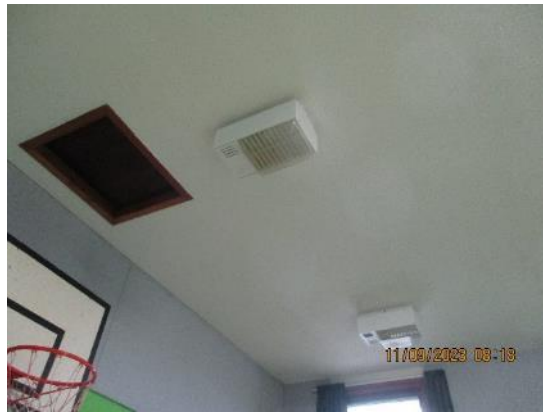
137. Lighting – main hall 1/18.

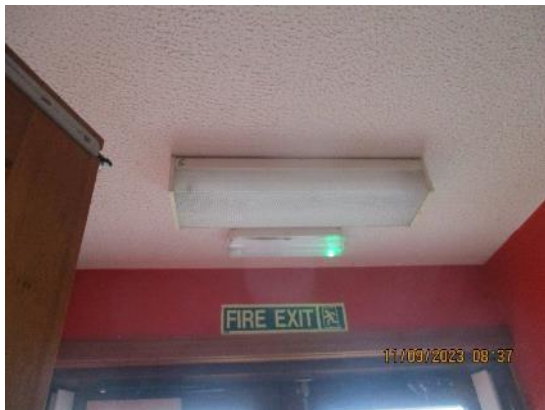
138. Lighting boys toilets 1/16.

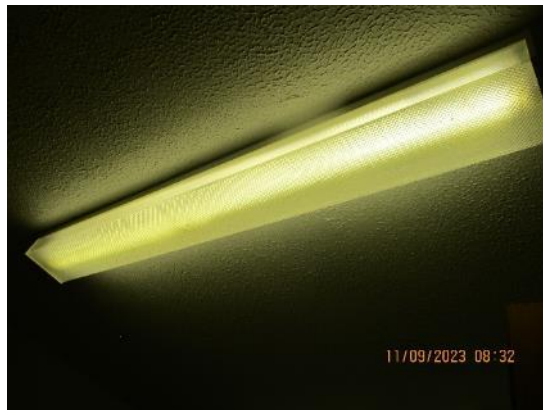
139. Lighting girls toilets 1/15.

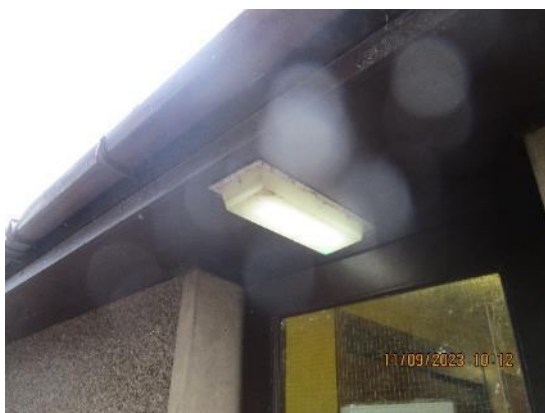
140. External maintained emergency light.

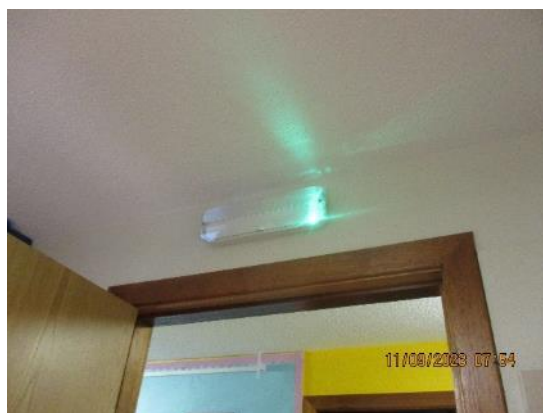
141. Emergency lighting office 1/3.

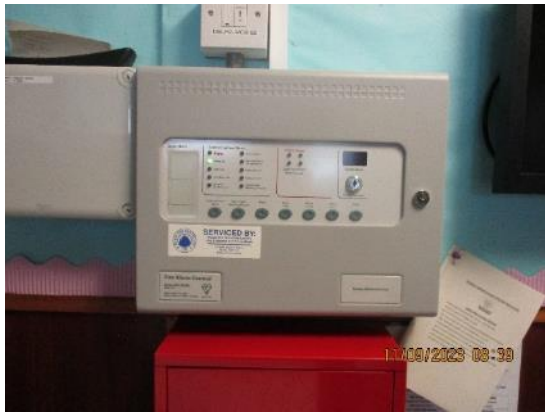
142. Fire alarm call point.

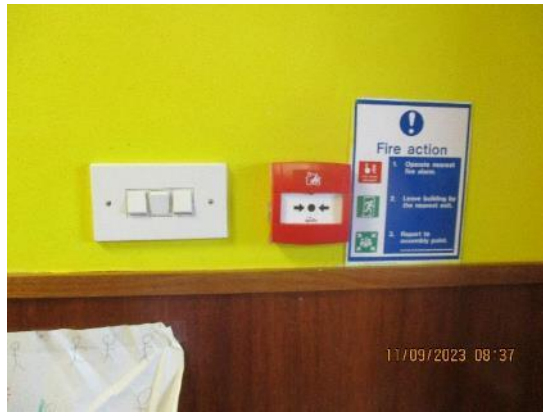
143. Fire alarm call point typical.

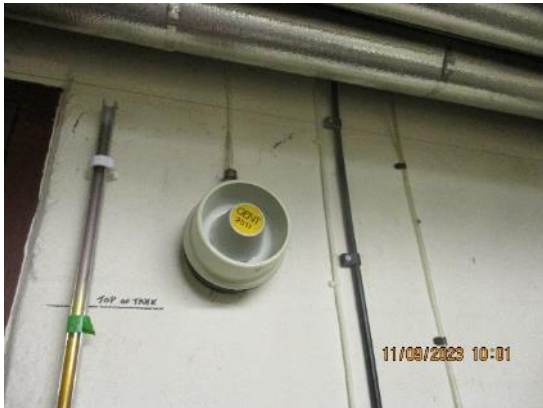
144. Fire alarm bell – typical. Boiler house 1/19.

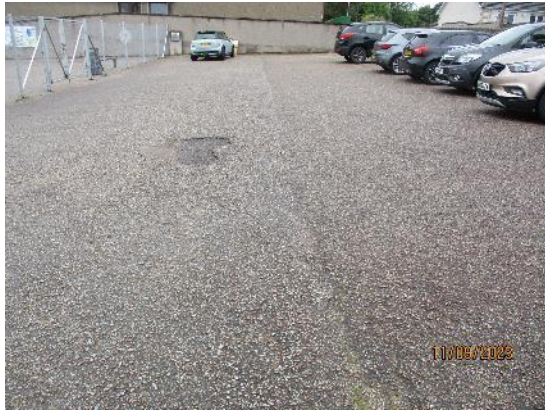
- Car park tarmacadam surface is eroded and potholed.
- Front concrete path is heavily eroded.
- Concrete ramps and footpaths are uneven/trip hazards.
- Concrete steps to the playing field are cracked and uneven.
- The metal frame of the chain link gate to the playground is corroded.
- Stone perimeter walls require repointing.
- The blockwork retaining wall to the car park requires roughcast repairs.

155. Eroded car park entrance

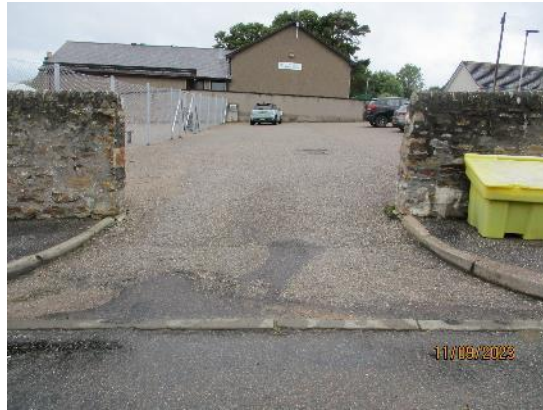
156. Potholed car park

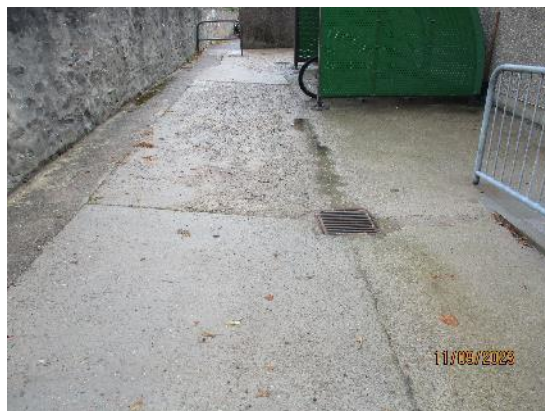
165. Eroded concrete to front entrance

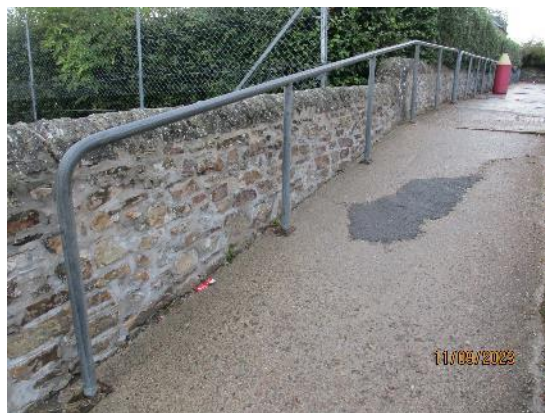
177. Galvanised rail to boundary wall

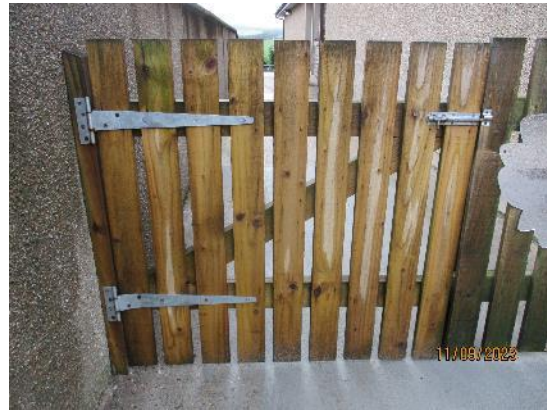
181. Timber boarded gates to both sides

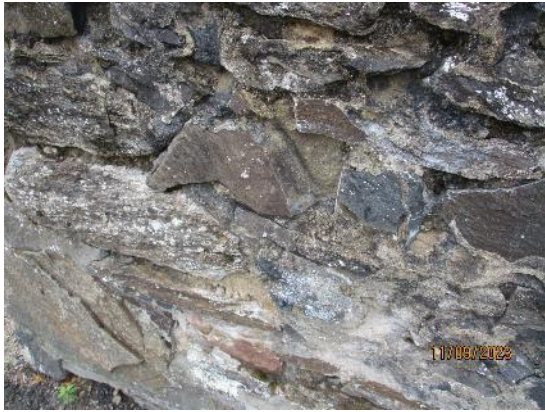
184. Stone walls require isolated repointing

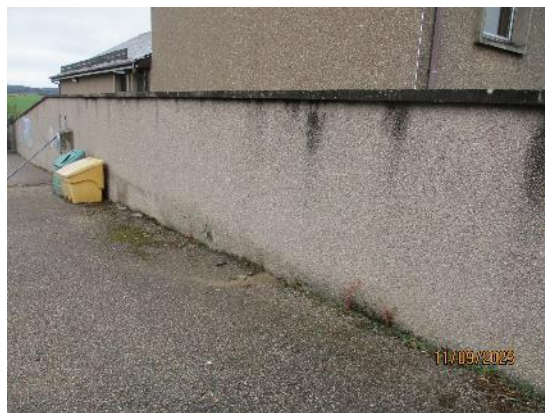
189. Retaining wall with roughcast surface

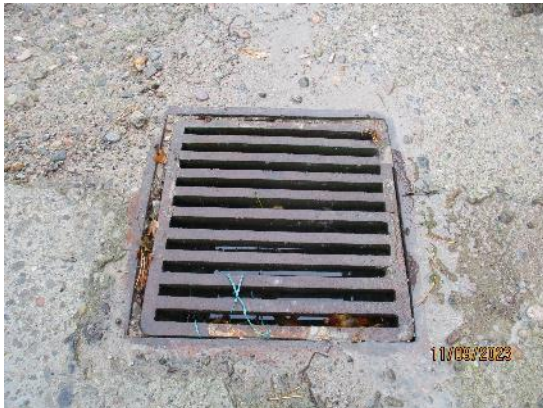
192. Surface water pot gullies
