| PROJECT :<br>MORAY COUNCIL<br>HARBOUR INSPECTIONS | | | | |
| TITLE :<br>HOPEMAN HARBOUR - 2020<br>SURVEY AREA | | | | |

The Moray Council engaged Arch Henderson to undertake an inspection of Hopeman Harbour which was to include principle structural assets above and below the water line. Assets were to include sea walls, piers, jetties, quays, slipways and steps. At Hopeman these assets are constructed from masonry in the original parts of the harbour or from insitu concrete in areas where the harbour has historically been extended. No historic drawings of the structures are available and the assessment of defects is based on comparison with adjacent areas and archive photographs. Arch Henderson has no knowledge and has made no assessment into the load bearing capacities of the structures which would require further analysis.

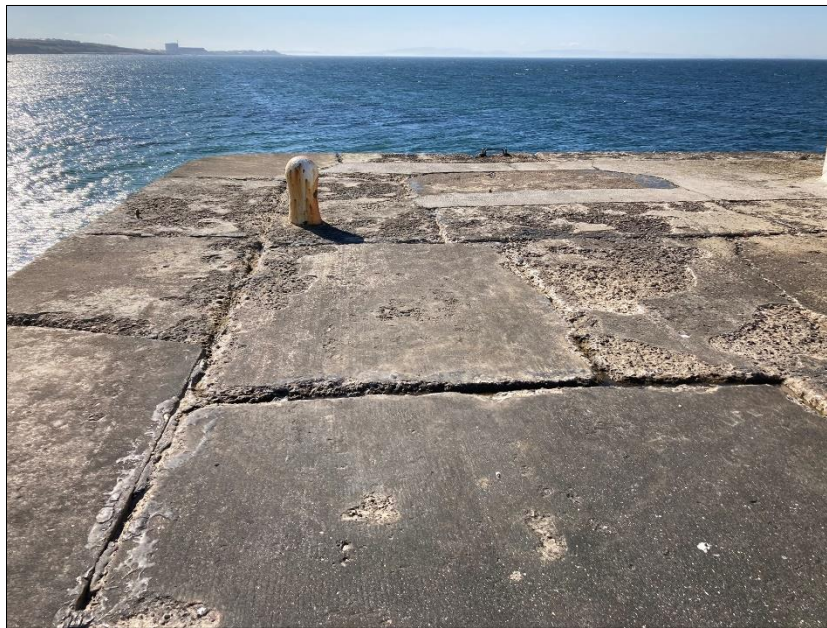
| Ref. | Element | Observation | Photo Reference | Comments |
|---|---|---|---|---|
| 08 | Deck | Section of deck slab abraded and joints open. | Photo 7<br>3925 | Sections of damaged area may cause trip hazard. |

Photo 7: North pier deck.

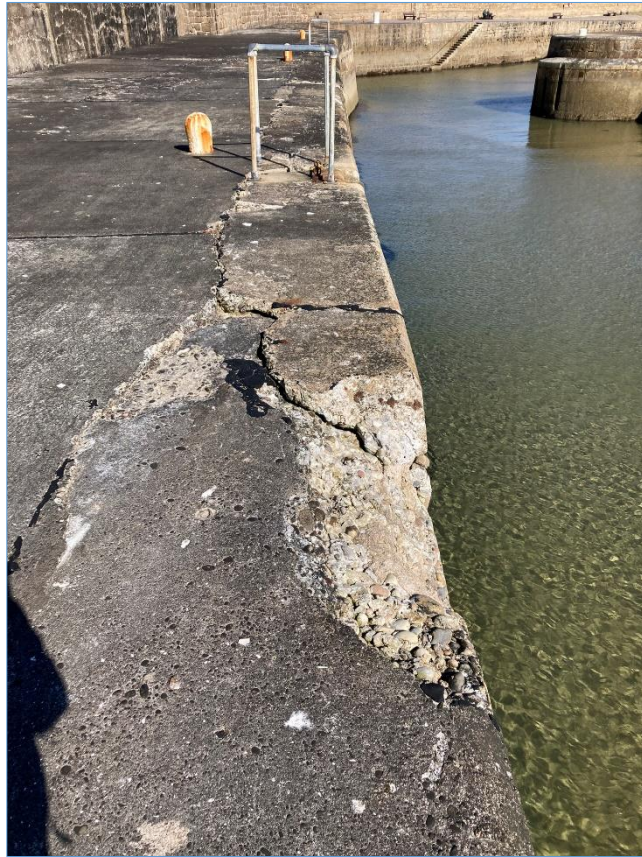
| Ref. | Element | Observation | Photo Reference | Comments |
|---|---|---|---|---|
| 09 | Cope | Sections of cope damaged and broken. Approx 1.0 x 1.0 x 0.15 deep. | Photo 9<br>3929<br>3930 | Sections of damaged cope may cause trip hazard. |

Photo 9: North Pier Cope.

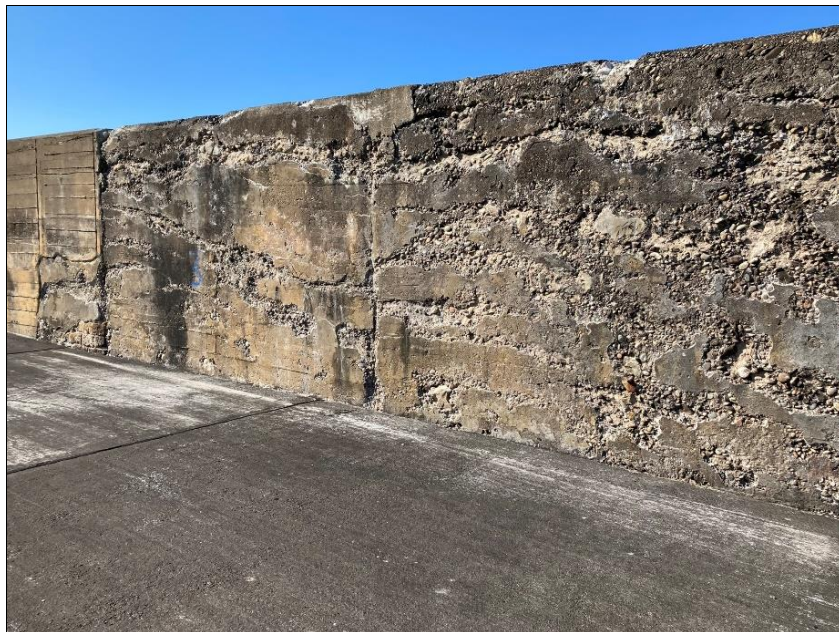
| Ref. | Element | Observation | Photo Reference | Comments |
|---|---|---|---|---|
| 11 | Inside Face parapet Wall | Inside face of parapet wall badly abraded and cracked. | Photo 10<br>3933<br>3934 | Condition of wall appears to have deteriorated since previous inspection. |

Photo 10: North Pier Parapet Wall.

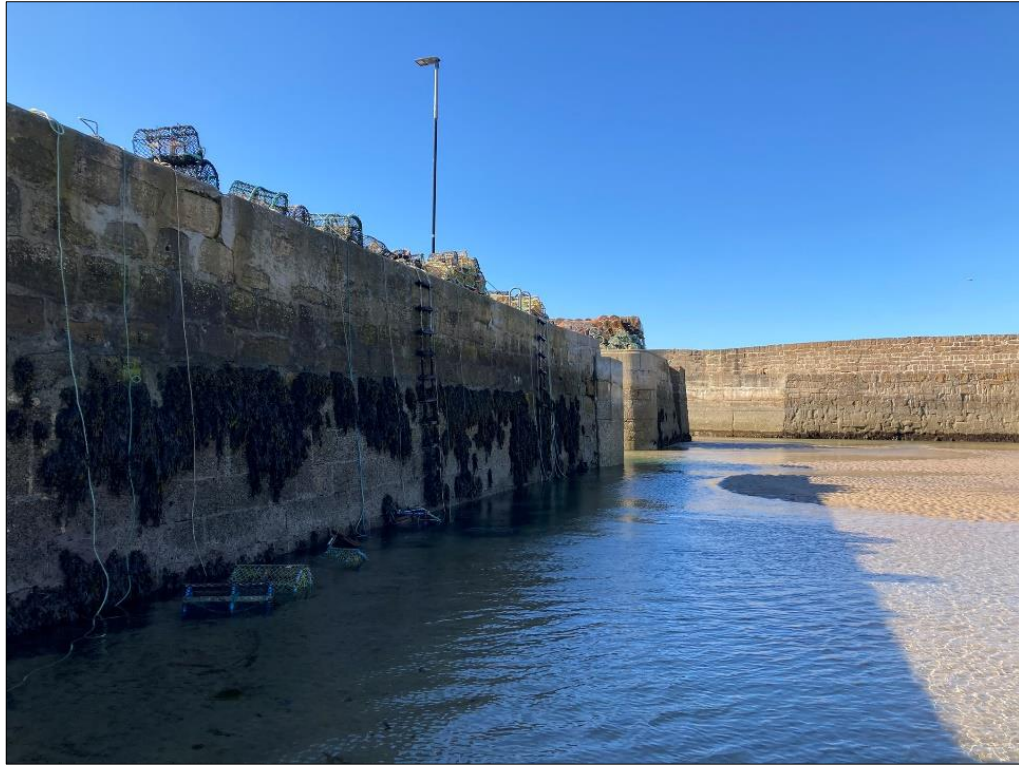
Photo 20: Central pier roundhead.

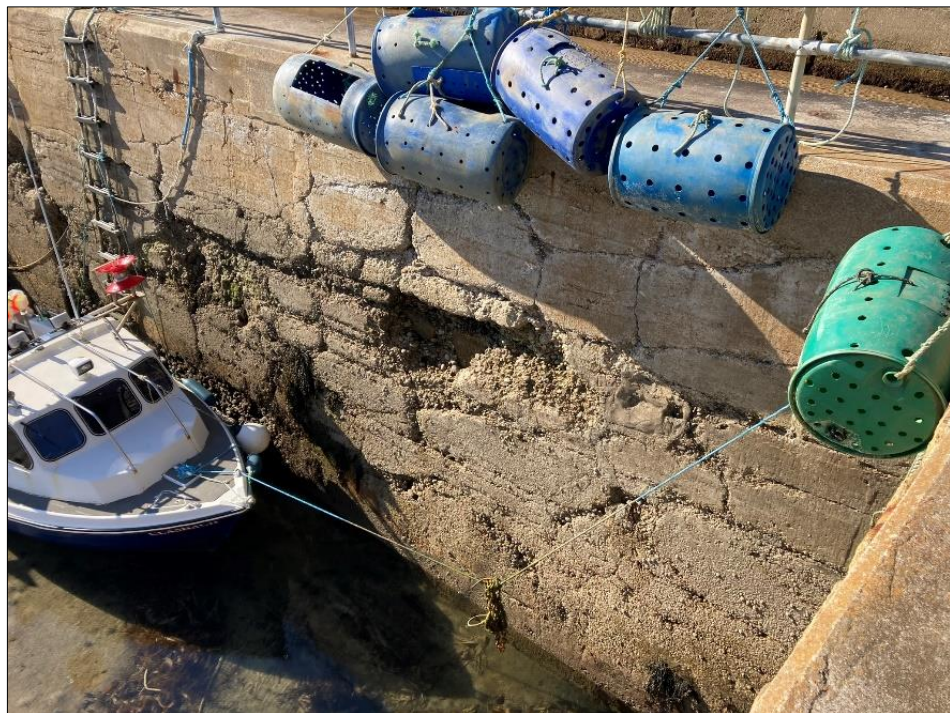
Photo 23: South Pier west end.

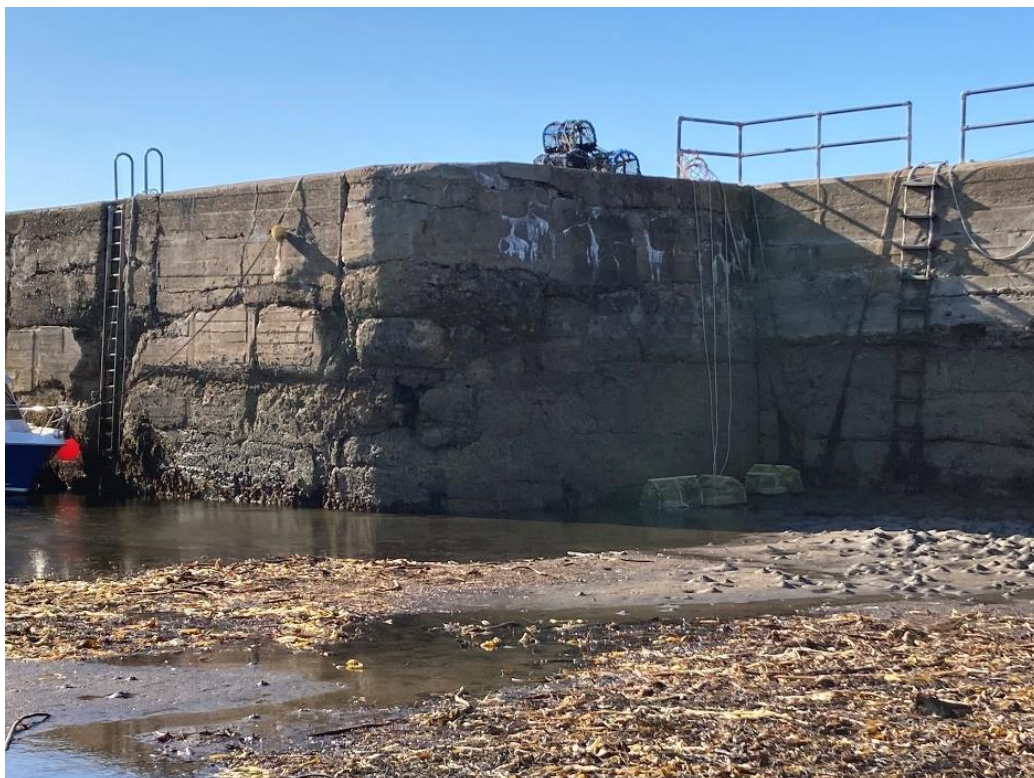
Photo 25: South Pier Quay Wall inner basin face.

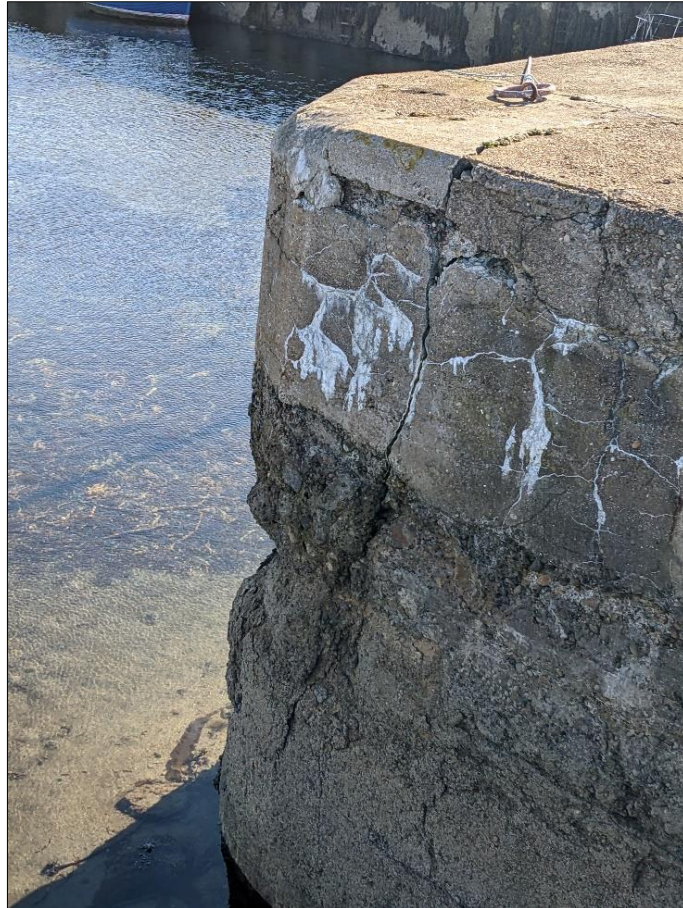
Photo 26: South Pier west corner inner basin.

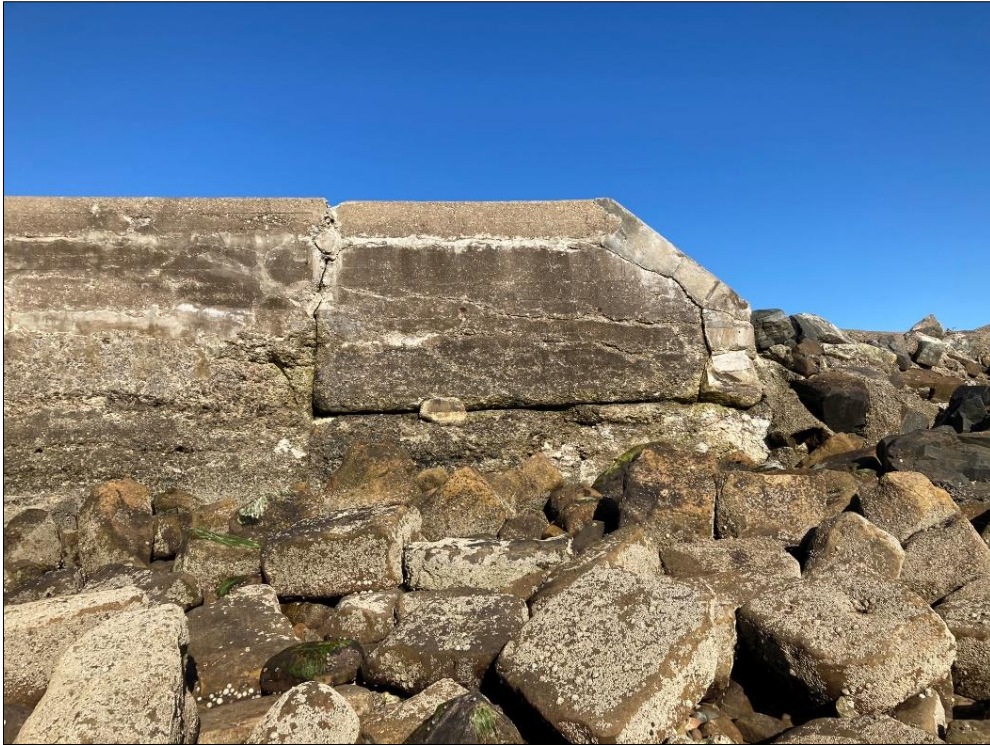
Photo 28: Rock armour south end of West Pier.

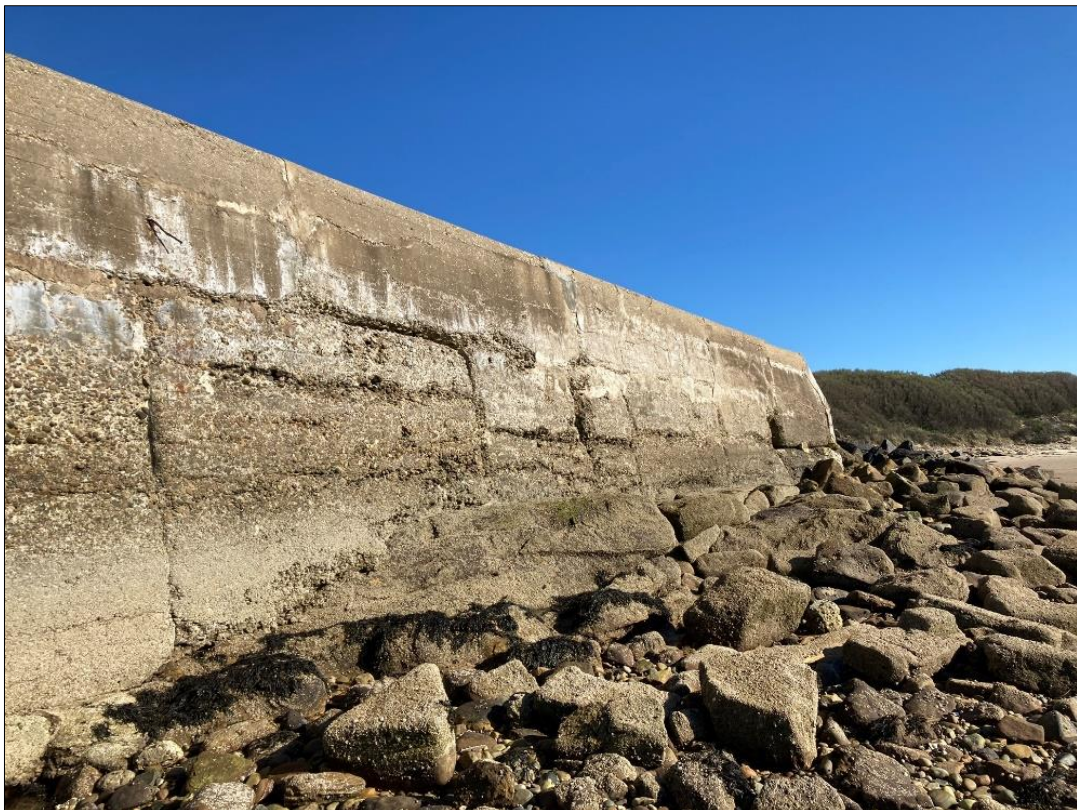
Photo 29: Parapet wall south end of West Pier.

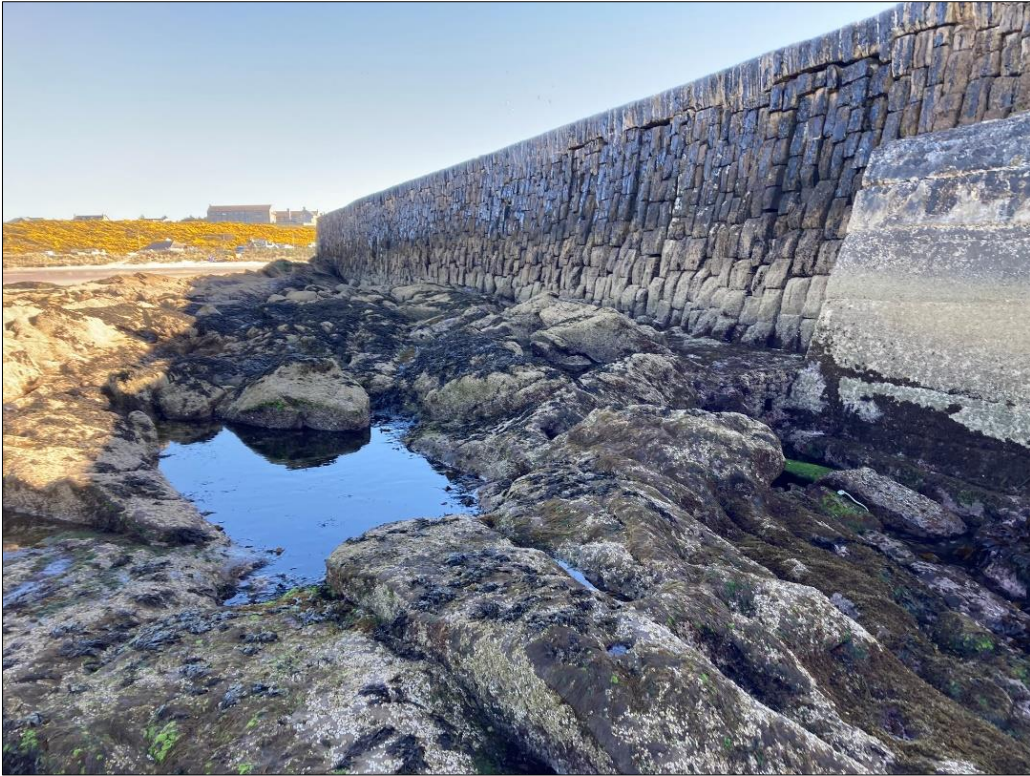
Photo 30: Parapet Wall south end of West Pier.

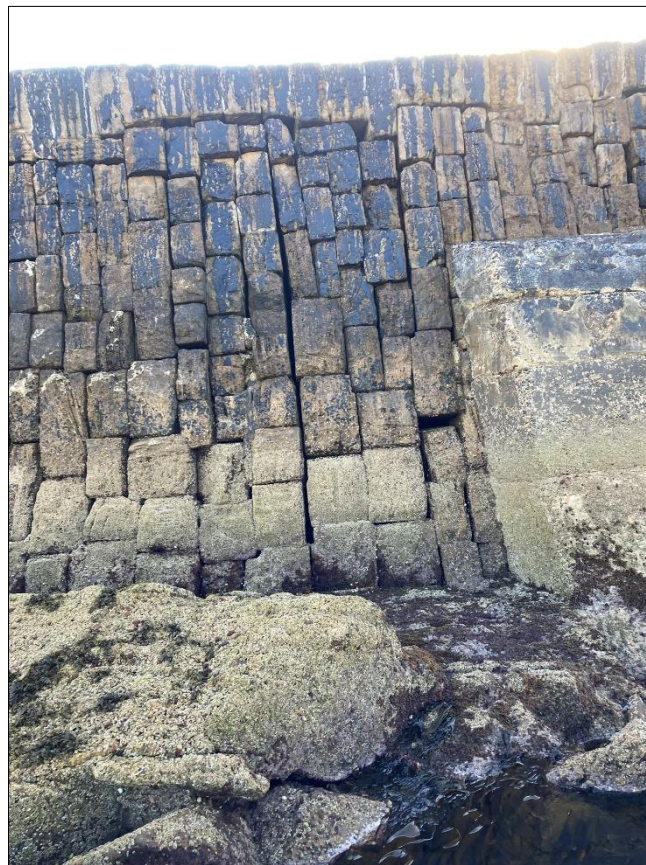
Photo 31: Outer Face of East Pier

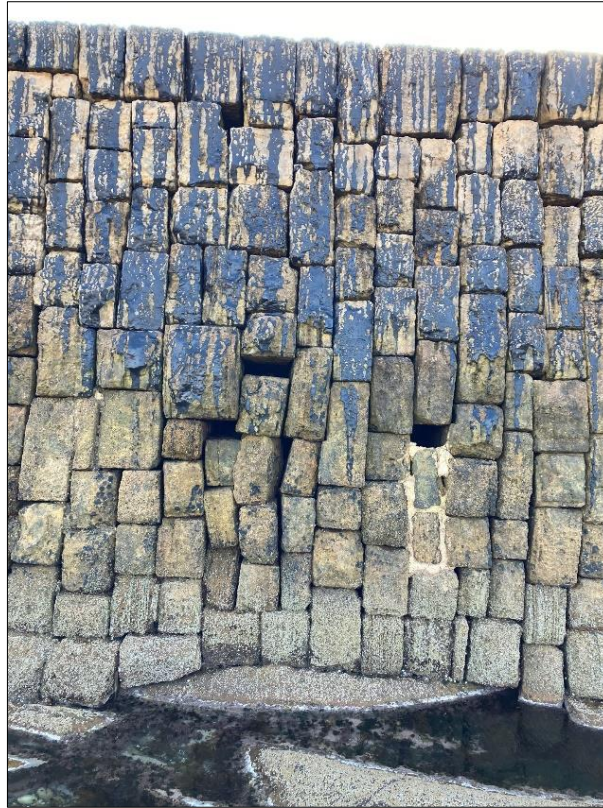
Photo 32: Outer face of East Pier.
