# **Summary Building Condition Survey Report**

**Crossroads Primary School**

**Grange, Keith AB55 6LX**

**26<sup>th</sup> October 2022**

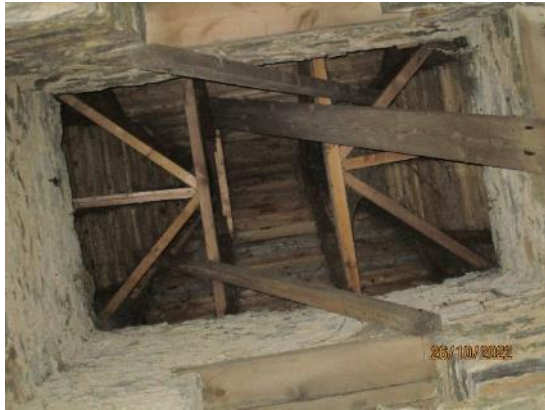
1. Bell tower roof structure

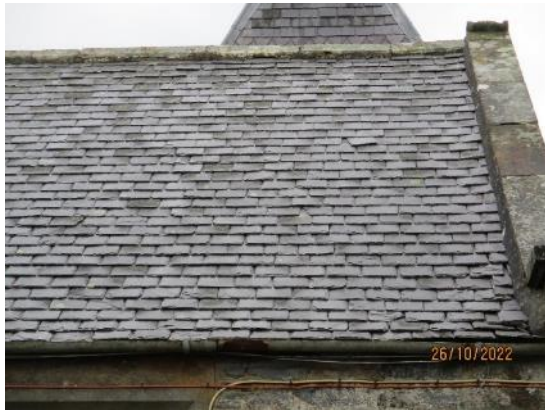
3. Slate to old building

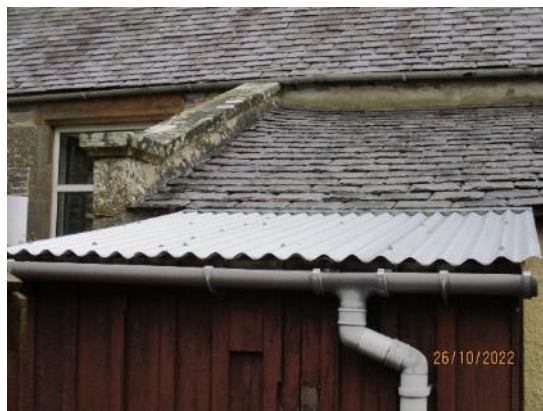
6. Metal profile lean-to roof

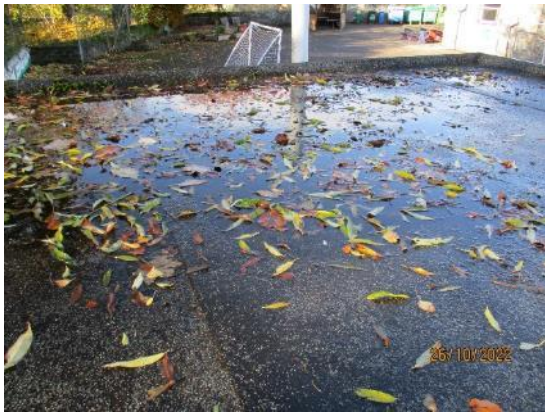
7. Felt roof to teaching block

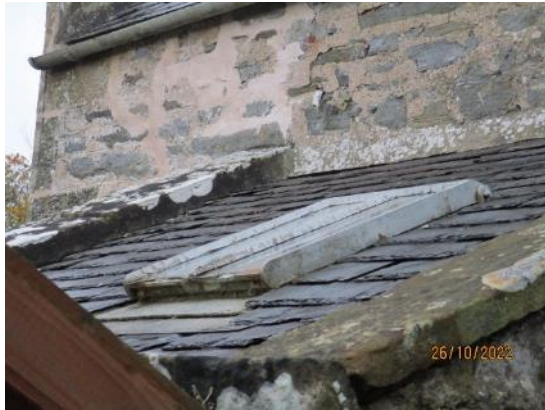
13. Metal skylight to old building

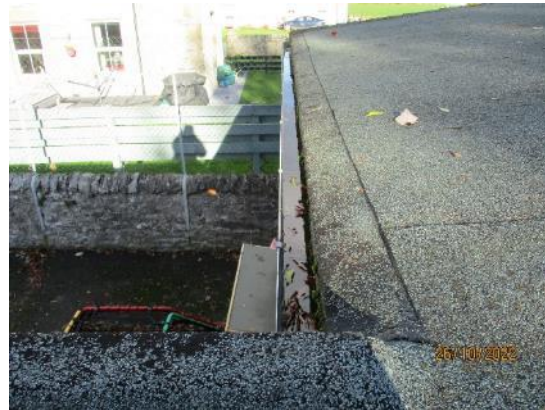
16. Poor fall and standing water

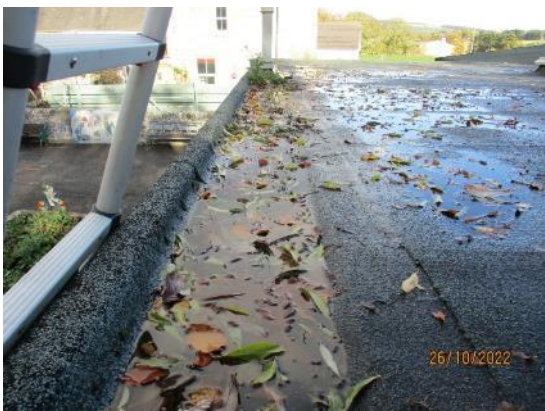
17. Felt box gutters blocked

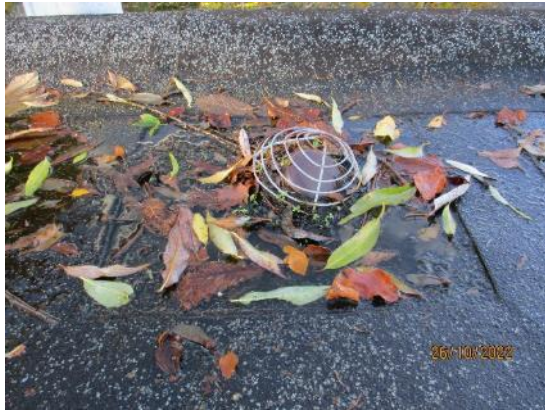
19. Blocked rainwater outlets

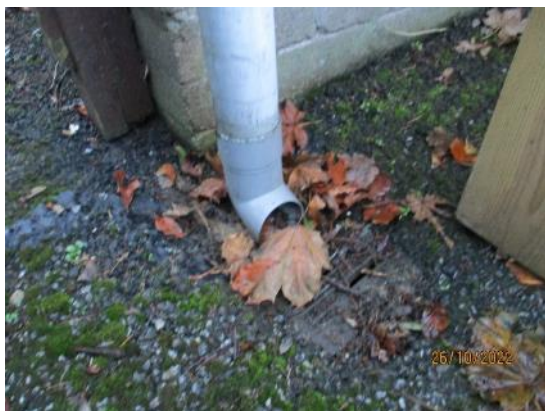
23. UPVC rainwater downpipes

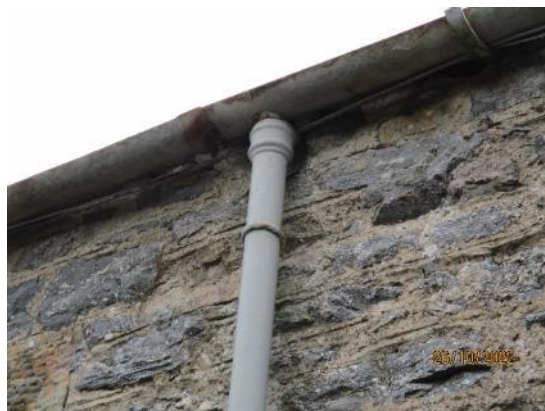
24. Cast iron rainwater downpipes

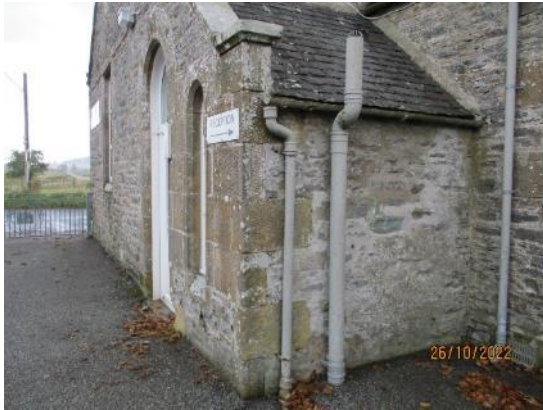
25. UPVC soil vent pipe

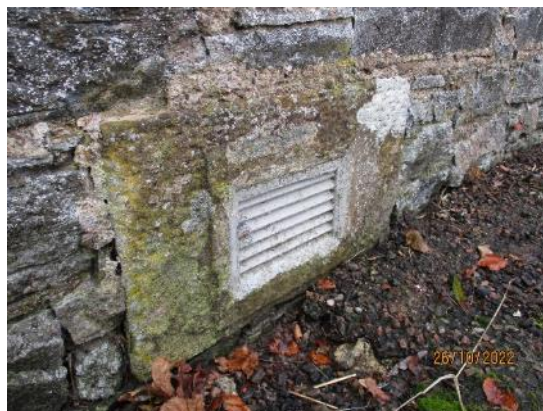
30. Ground level – Old building

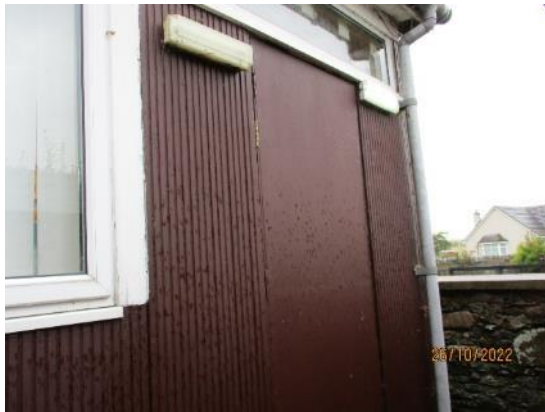
37. Timber fire escape doors

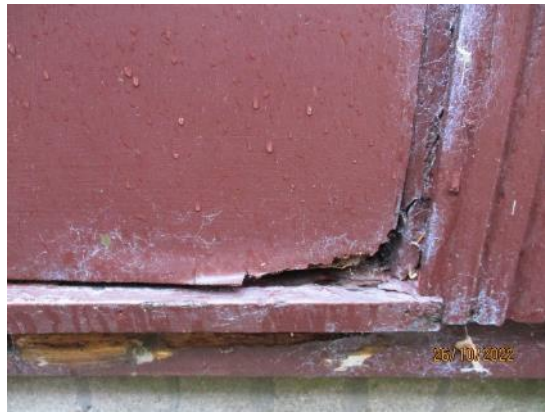
38. Timber decay in doors

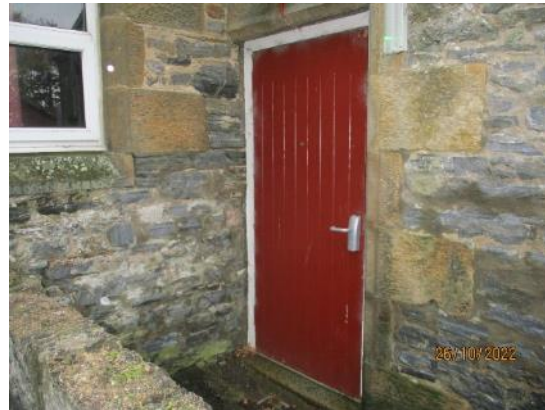
40. Timber fire escape door

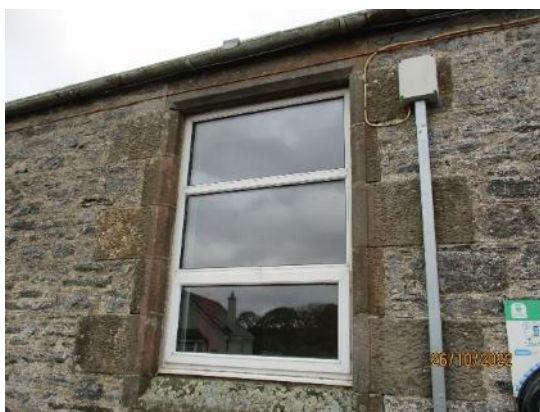
44. UPVC windows – old block

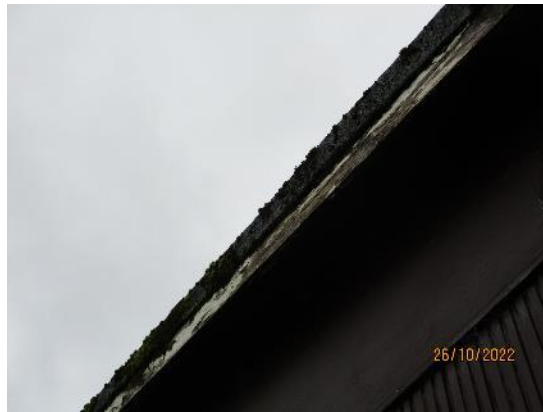
50. Timber fascia boards peeling

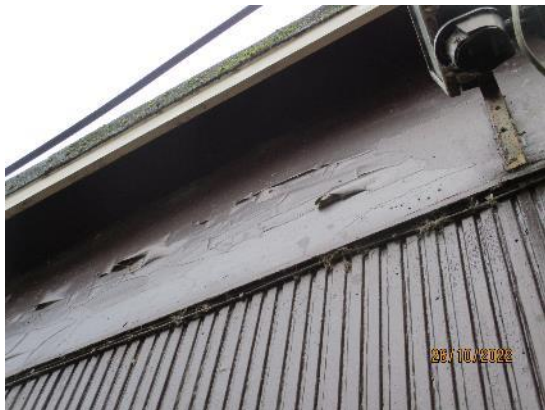
51. Timber cladding flaking and peeling

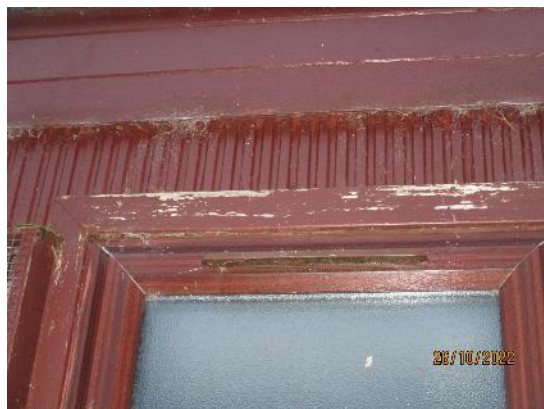
52. Window surrounds peeling

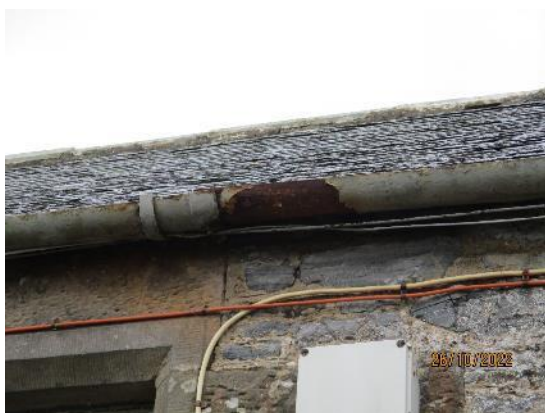
53. Cast iron peeling

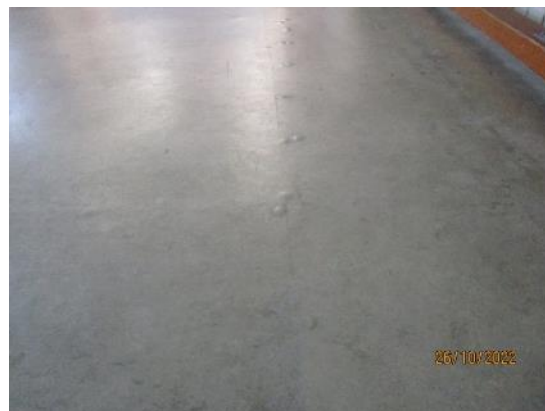
59. Uneven timber suspended floor – Old building

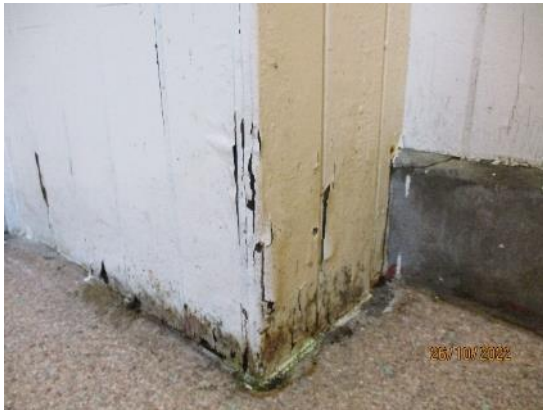
84. Timber decay in linings

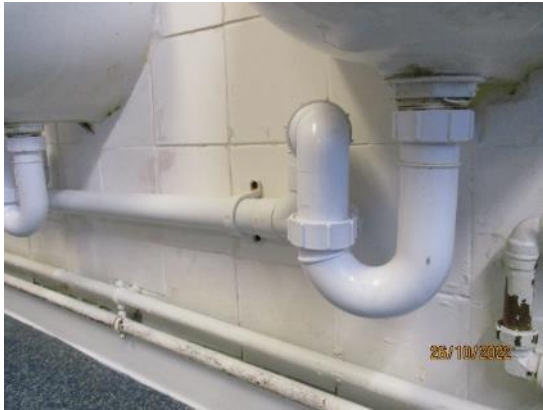
88. Copper waste pipes

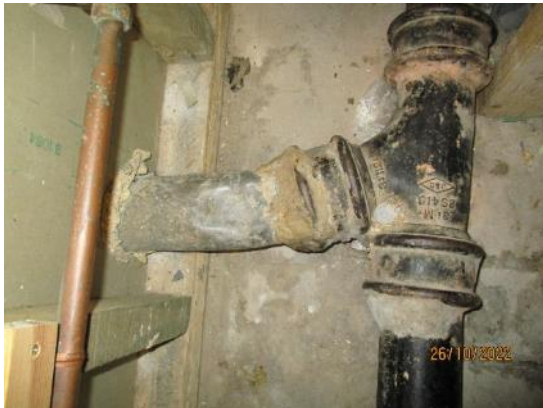
90. Damaged lead waste pipes

- Replace lead connections to cast iron waste pipes.
- Increase field of CCTV cameras to cover more of site and both buildings.
- Install intruder alarm systems in both buildings.

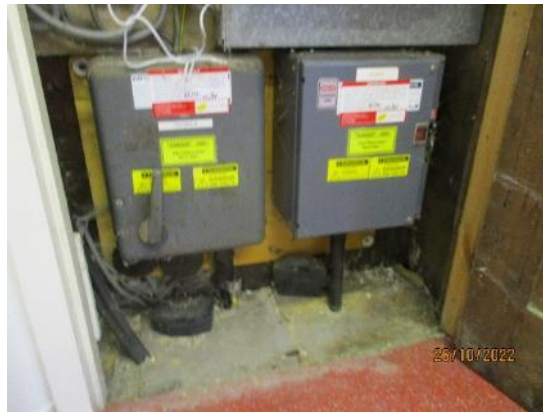
118. Switchgear – main switches old building.

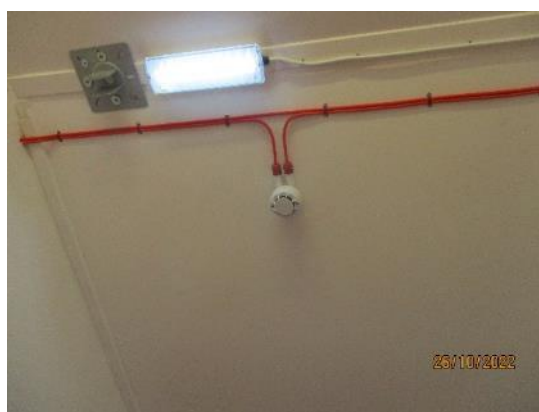
130. Fire detector head and wiring class block typical

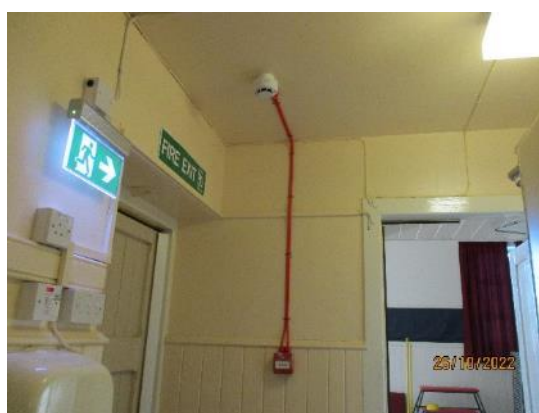
134. Fire alarm devices and wiring old building typical

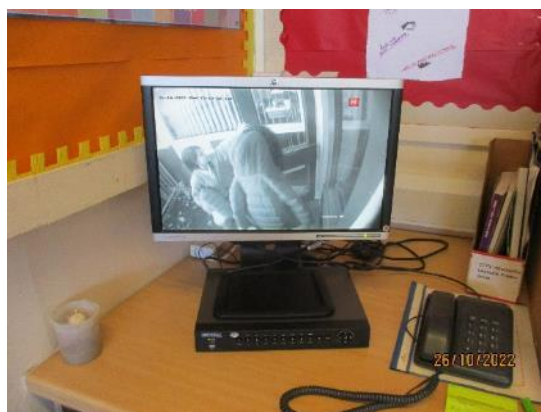
136. CCTV monitor and processor classroom 2

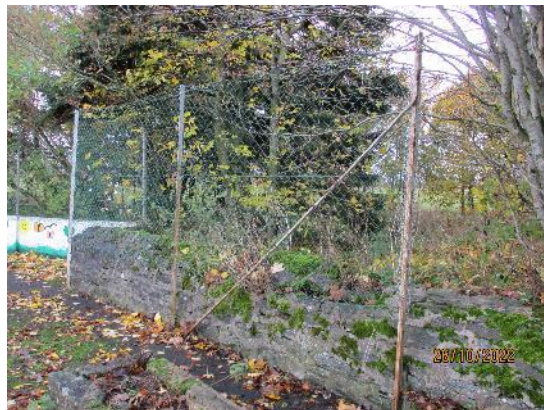
144. High chainlink fencing

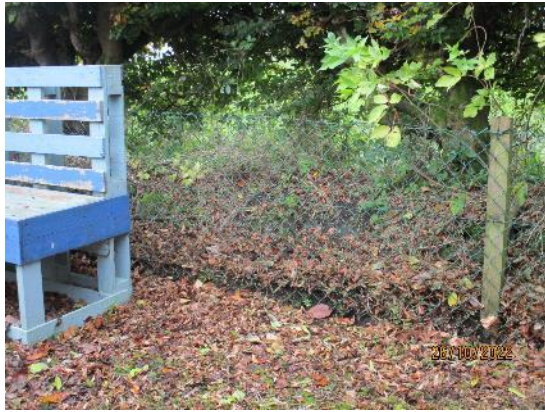
147. Low level chainlink fencing

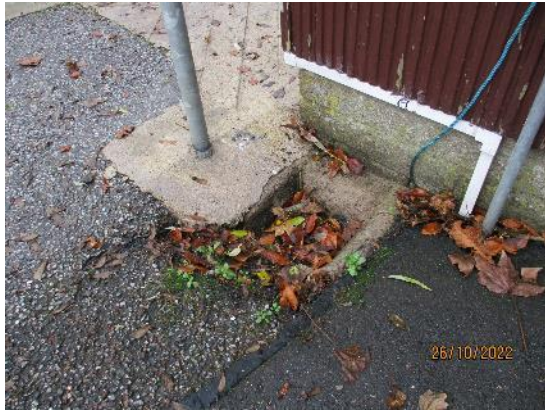
153. Blocked surface water drainage
