# Moray Council

## Inspection/Defect Report

**Date Range:-** From 01/06/2025 To 30/06/2026  
**Street :-** 26301301 - B9015 from Garmouth Road in Mosstodloch to South Road in  
**Street Inspection History**

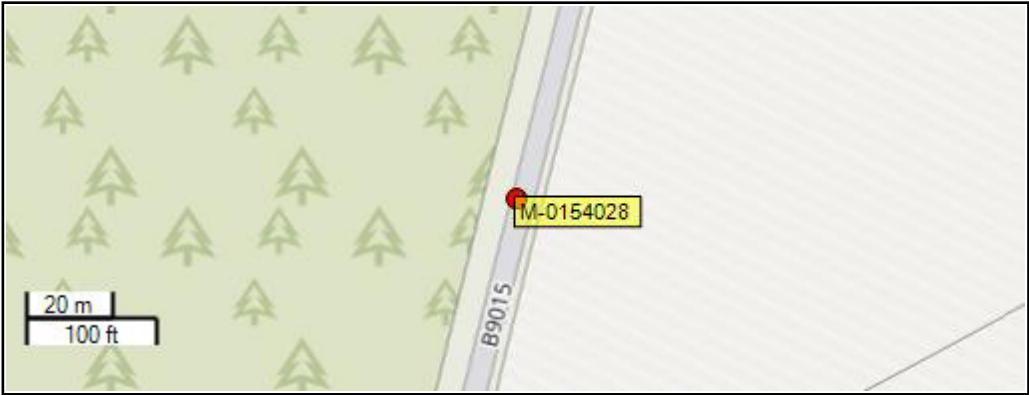
**Instruction Reference:** M-0154028  
**Instruction Created:** 17/06/2025 15:14:00  
**Instruction Status :** **Works Complete**  
**Inspection:** Safety Inspection Area W07 - 06 (Jun) on the 17th of June 2025  
**Item Type:** Carriageway  
**Item Detail:** Pothole  
**Defect Category:** P3 - 30 working days  
**Issued Date:** 17/06/2025 15:14  
**Target Date:** 29/07/2025 15:14  
**Completion Date:** 30/06/2025 14:11  
**Location Description:** From Mosstodloch: 160m after the Riding Centre access road, northbound side of the carriageway.  
**Description of Works:** E&C Pothole - 459mm x 400mm x 35mm

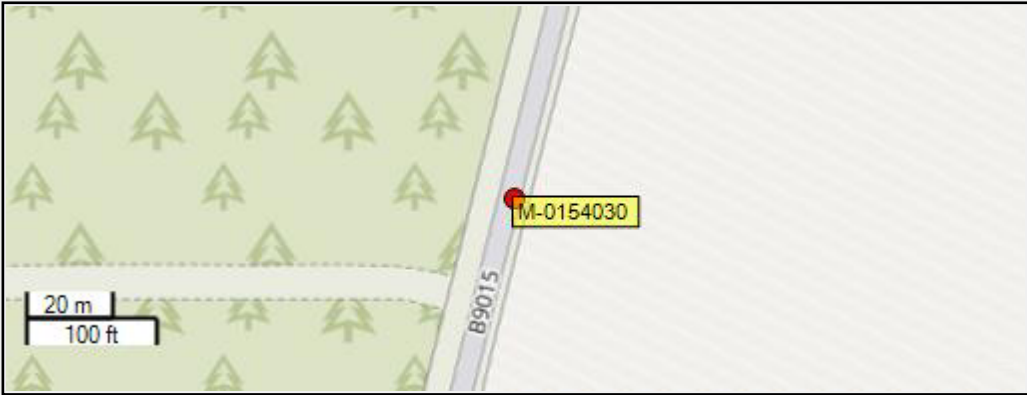
**Instruction Reference:** M-0154030  
**Instruction Created:** 17/06/2025 15:18:00  
**Instruction Status :** *Works Complete*  
**Inspection:** Safety Inspection Area W07 - 06 (Jun) on the 17th of June 2025  
**Item Type:** Carriageway  
**Item Detail:** Carriageway Defects  
**Defect Category:** P3 - 30 working days  
**Issued Date:** 17/06/2025 15:18  
**Target Date:** 29/07/2025 15:18  
**Completion Date:** 30/06/2025 13:49  
**Location Description:** From Mosstodloch: 350m after the Riding Centre access road, southbound side of the carriageway.  
**Description of Works:** E&C Pothole and 2 Patches- 300mm x 200mm x 40mm, 1m x 300mm a d 600mm x 150mm

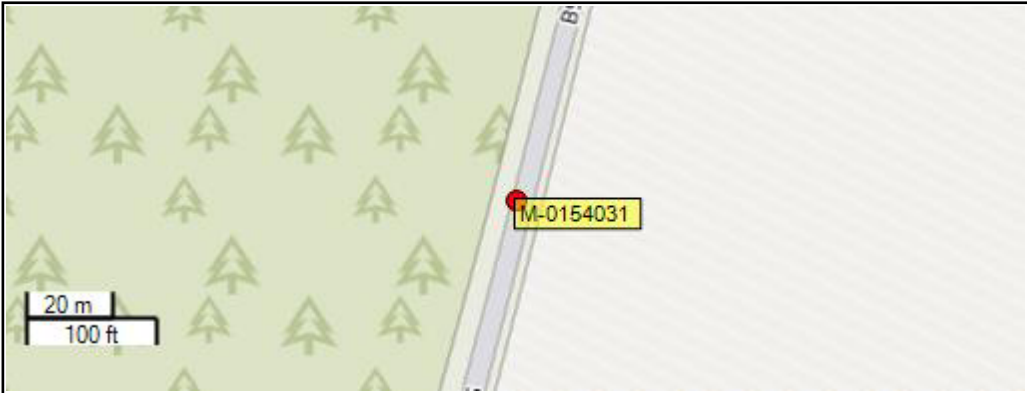
**Instruction Reference:** M-0154031  
**Instruction Created:** 17/06/2025 15:23:00  
**Instruction Status :** *Works Complete*  
**Inspection:** Safety Inspection Area W07 - 06 (Jun) on the 17th of June 2025  
**Item Type:** Carriageway  
**Item Detail:** Pothole  
**Defect Category:** P3 - 30 working days  
**Issued Date:** 17/06/2025 15:23  
**Target Date:** 29/07/2025 15:23  
**Completion Date:** 30/06/2025 13:49  
**Location Description:** From Mosstodloch: 575m after the Riding Centre access road, northbound side of the carriageway.  
**Description of Works:** E&C Pothole -500mm x 400mm x 35mm

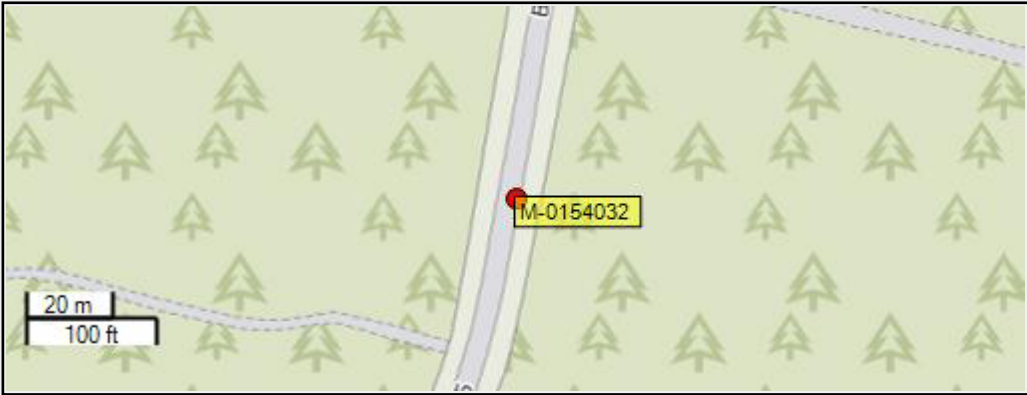
**Instruction Reference:** M-0154032  
**Instruction Created:** 17/06/2025 15:27:00  
**Instruction Status :** *Works Complete*  
**Inspection:** Safety Inspection Area W07 - 06 (Jun) on the 17th of June 2025  
**Item Type:** Carriageway  
**Item Detail:** Pothole  
**Defect Category:** P3 - 30 working days  
**Issued Date:** 17/06/2025 15:27  
**Target Date:** 29/07/2025 15:27  
**Completion Date:** 30/06/2025 13:45  
**Location Description:** From Mosstodloch: 175m after the layby, at the double bend, northbound side of the carriageway.  
**Description of Works:** E&C small Pothole

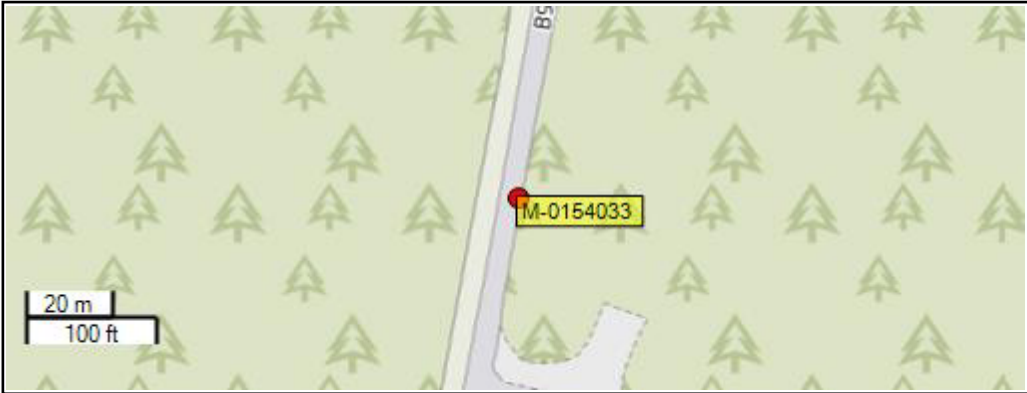
**Instruction Reference:** M-0154033  
**Instruction Created:** 17/06/2025 15:30:00  
**Instruction Status :** *Works Complete*  
**Inspection:** Safety Inspection Area W07 - 06 (Jun) on the 17th of June 2025  
**Item Type:** Carriageway  
**Item Detail:** Carriageway Defects  
**Defect Category:** P3 - 30 working days  
**Issued Date:** 17/06/2025 15:30  
**Target Date:** 29/07/2025 15:30  
**Completion Date:** 30/06/2025 13:33  
**Location Description:** From Mosstodloch: 270m after the layby, both sides of the carriageway.  
**Description of Works:** E&C 5 Patches - 1.1m x 400mm and 4 small Patches.

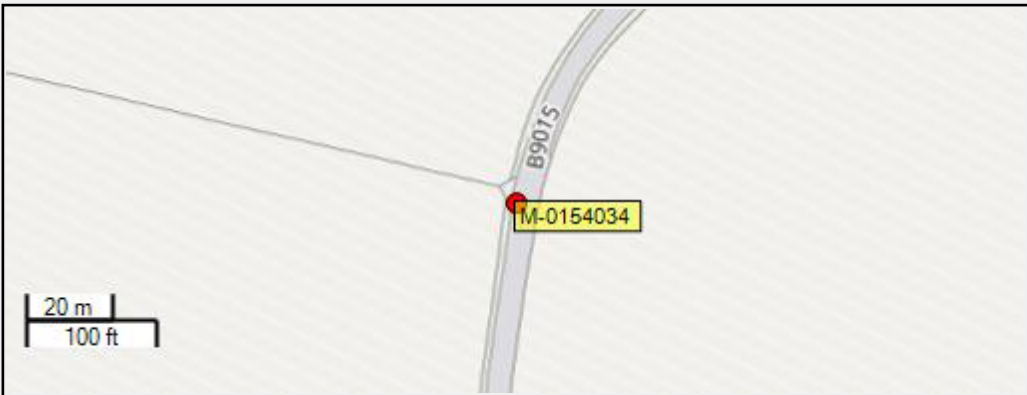
**Instruction Reference:** M-0154034  
**Instruction Created:** 17/06/2025 15:44:00  
**Instruction Status :** *Works Complete*  
**Inspection:** Safety Inspection Area W07 - 06 (Jun) on the 17th of June 2025  
**Item Type:** Carriageway  
**Item Detail:** Pothole  
**Defect Category:** P3 - 30 working days  
**Issued Date:** 17/06/2025 15:44  
**Target Date:** 29/07/2025 15:44  
**Completion Date:** 30/06/2025 13:24  
**Location Description:** From Mosstodloch: 385m after Laughhill access rd, northbound side of the carriageway

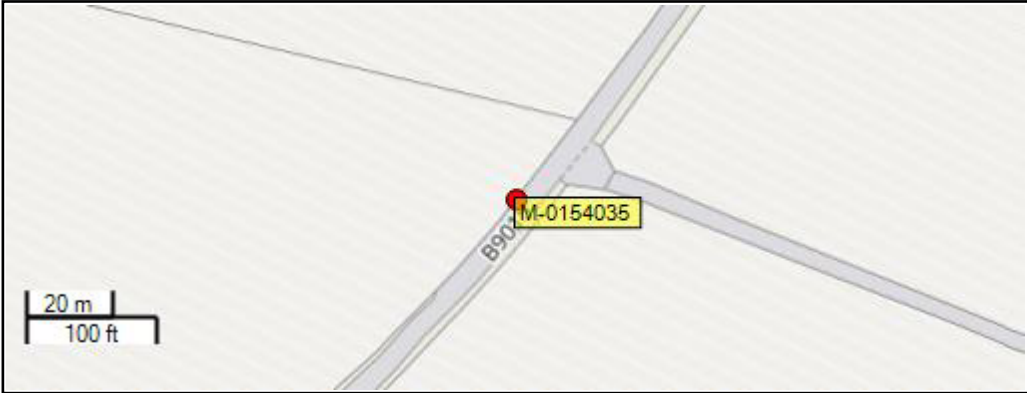
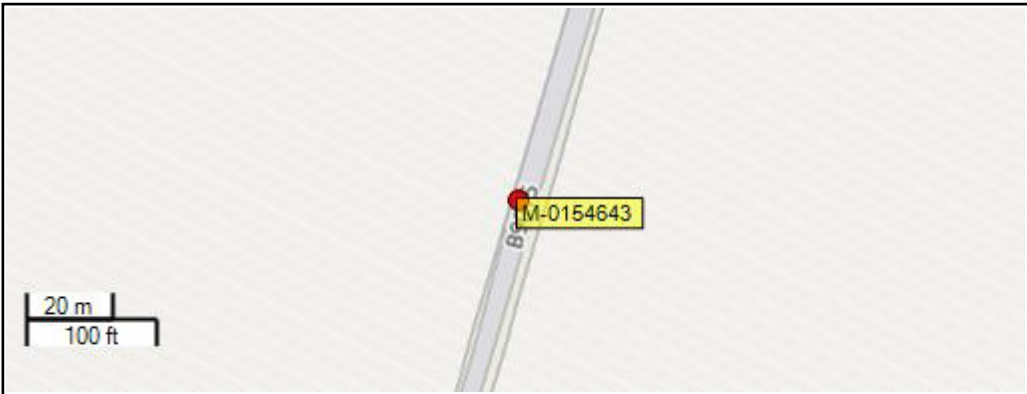
**Description of Works:** E&C 2 Potholes - 2 x 400mm x 300mm x 30mm and 2 Patches - 2m x 100mm and 250mm x 200mm

**Instruction Reference:** M-0154035  
**Instruction Created:** 17/06/2025 15:48:00  
**Instruction Status :** *Works Complete*  
**Inspection:** Safety Inspection Area W07 - 06 (Jun) on the 17th of June 2025  
**Item Type:** Carriageway  
**Item Detail:** Carriageway Defects  
**Defect Category:** P3 - 30 working days  
**Issued Date:** 17/06/2025 15:48  
**Target Date:** 29/07/2025 15:48  
**Completion Date:** 30/06/2025 13:17

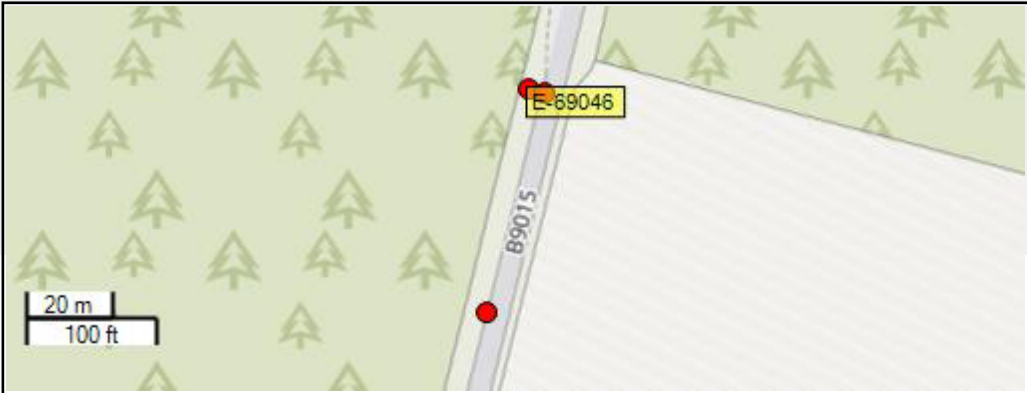
**Enquiry Reference:** E-69046  
**Enquiry Created:** 20/08/2025 15:49:15  
**Enquiry Status :** *Investigation (In-Office)*  
**Item Type:** Traffic Sign  
**Item Detail:** Corroded Pole  
**Location Description:** Just before layby on north bound approach to bends  
**Enquiry Comments:** Pole is rusted through in places.

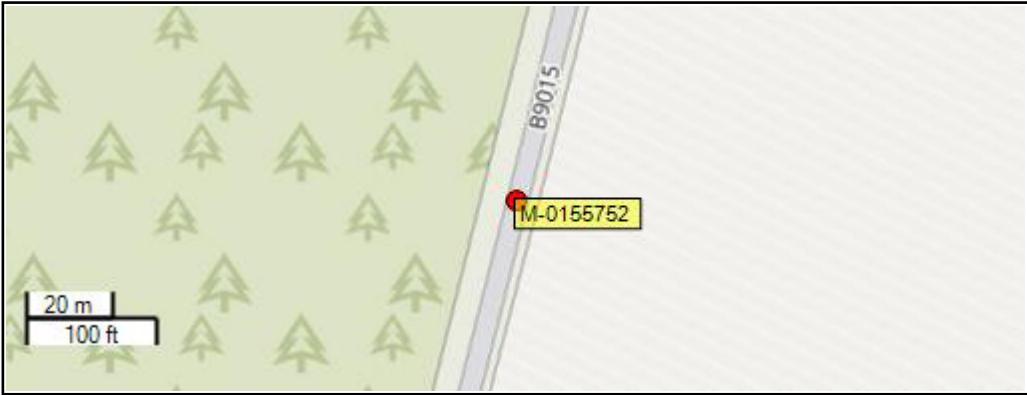
**Instruction Reference:** M-0155752  
**Instruction Created:** 26/08/2025 15:11:00  
**Instruction Status :** *Works Complete*  
**Item Type:** Carriageway  
**Item Detail:** Carriageway Defects  
**Defect Category:** P3 - 30 working days  
**Issued Date:** 26/08/2025 15:11  
**Target Date:** 07/10/2025 15:11  
**Completion Date:** 05/09/2025 12:29  
**Location Description:** From Mosstodloch:  
365m after the Riding Centre access road - 65m x 500mm.  
490m after the Riding Centre access road - 40m x 400mm.  
670m after the Riding Centre access road - 20m x 400mm.  
780m after the Riding Centre access road - 30m x 400mm.  
**Description of Works:** Jetpatch the carriageway edge damage.

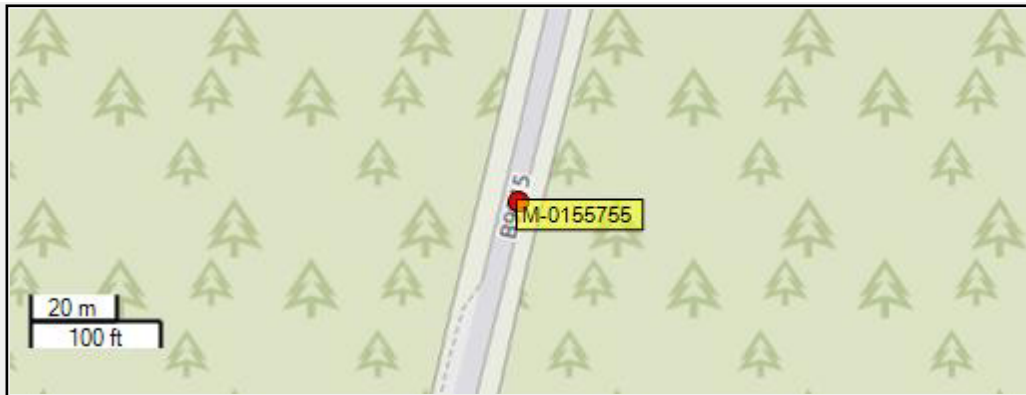
**Location Description:** From Mosstodloch: Between the parking place and Spey Cottage. Both sides of the carriageway and the centre at the double bend.

**Description of Works:** Jetpatch the carriageway damage - Approximately 90m. Marked

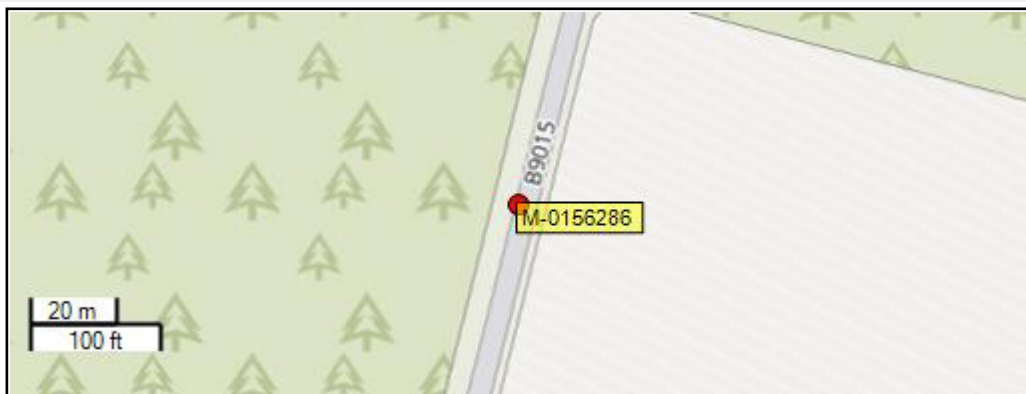
**Item Detail:** Over-run damage

**Location Description:** From Mosstodloch: Between the Riding Centre access and the double bends.

**Description of Works:** Pull the verge back, to the the edge of the carriageway, where required.

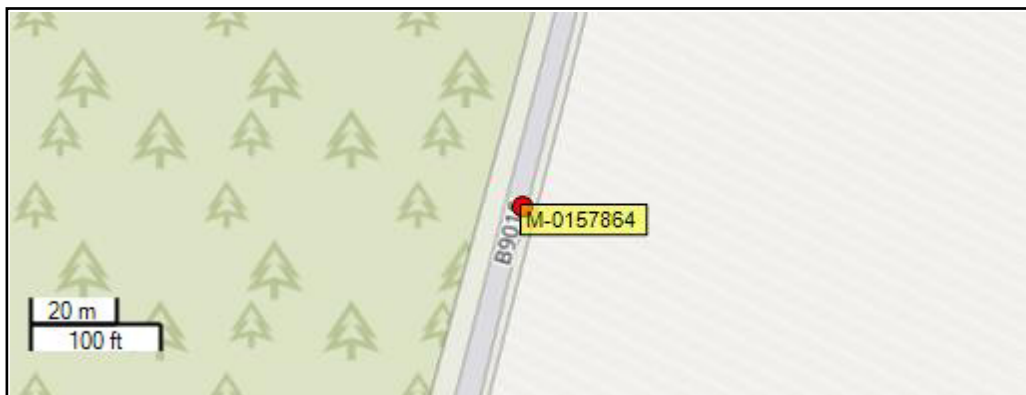
**Location Description:** From Mosstodloch: 545m after the Riding Centre access, southbound side of the carriageway.

**Description of Works:** E&C edge Patch - 1.5m x 500m, incorporating a 500mm x 300mm x 35mm edge pothole

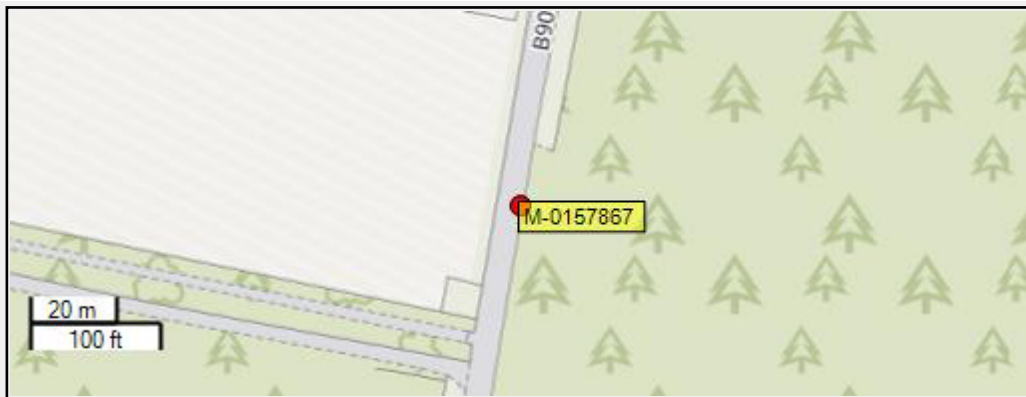
**Location Description:** From Mosstodloch: From the Drum Lodge access, for 30m, southbound side of the carriageway.

**Description of Works:** E&C 8 edge patches - 4m x 500mm, 3m x 500mm, 3 x 1m x 500mm, 3 x 500mm x 500mm,

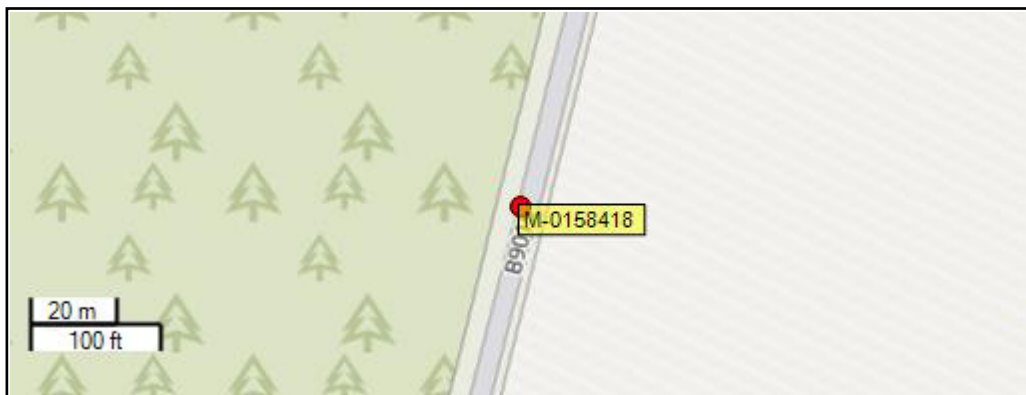
**Item Detail:** Pothole

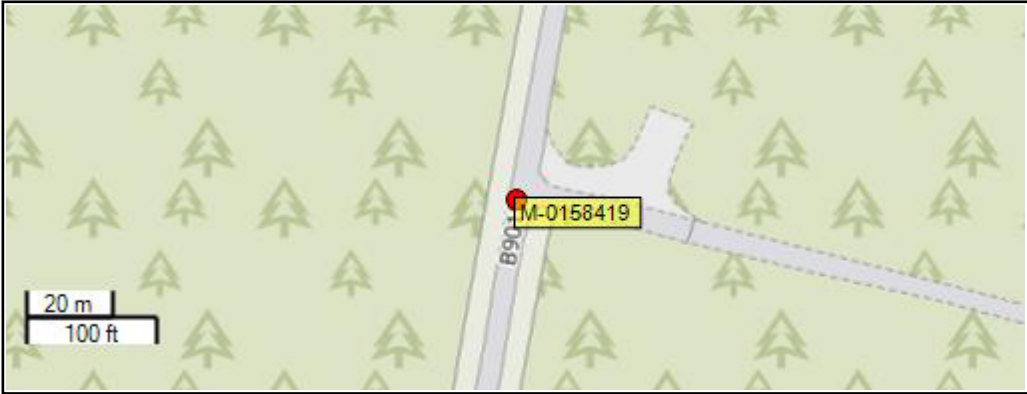
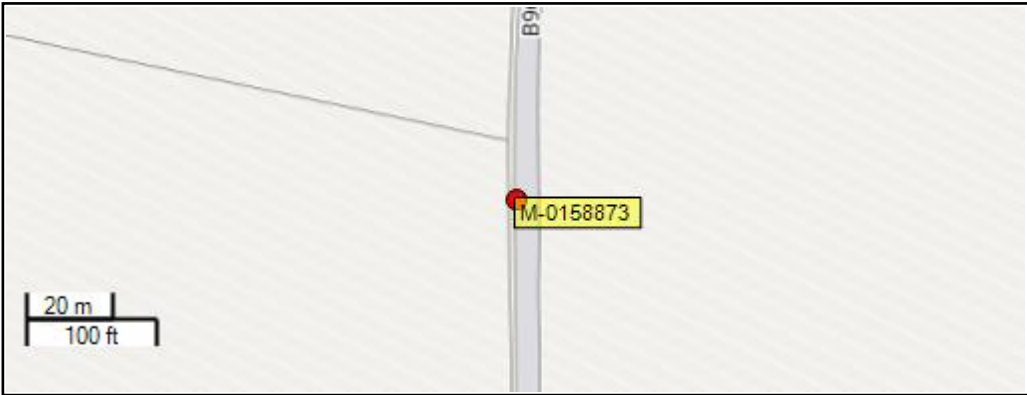
**Location Description:** From Mosstodloch: 480m after the Riding Centre access road, northbound side of the carriageway.

**Description of Works:** Cold Tar Pothole - 700mm x 400mm x 55mm

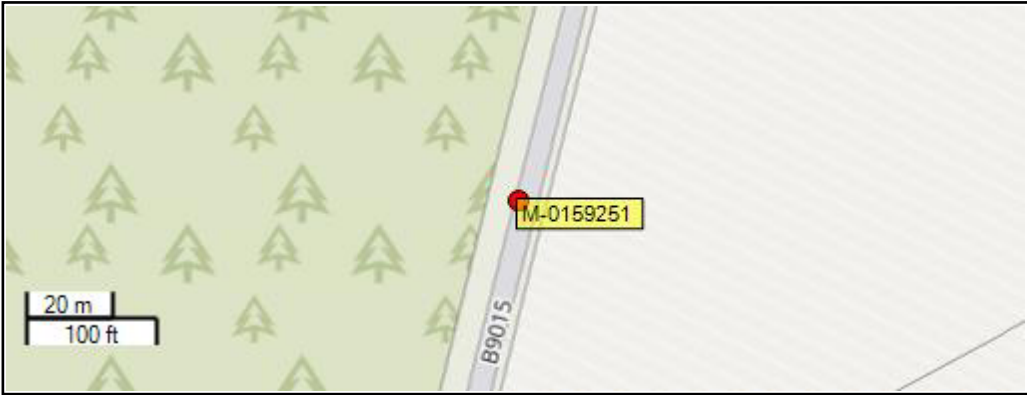
**Instruction Reference:** M-0159251  
**Instruction Created:** 03/02/2026 11:02:00  
**Instruction Status :** *Works Complete*  
**Inspection:** Safety Inspection Area W07 - 02 (Feb) on the 3rd of February 2026  
**Item Type:** Carriageway  
**Item Detail:** Pothole  
**Defect Category:** P3 - 30 working days  
**Issued Date:** 03/02/2026 11:02  
**Target Date:** 17/03/2026 11:02  
**Completion Date:** 06/02/2026 11:49  
**Location Description:** From Mosstodloch: 115m after the Riding Centre access road, northbound side of the carriageway and 1 patch on the opposite side of the carriageway.  
**Description of Works:** E&C Pothole - 400mm x 300mm x 40mm and E&C 1 patch

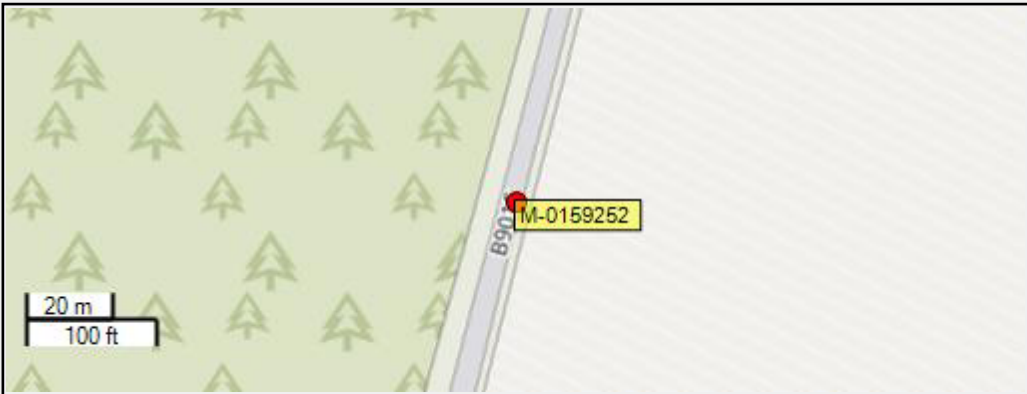
**Instruction Reference:** M-0159252  
**Instruction Created:** 03/02/2026 11:12:00  
**Instruction Status :** *Works Complete*  
**Inspection:** Safety Inspection Area W07 - 02 (Feb) on the 3rd of February 2026  
**Item Type:** Carriageway  
**Item Detail:** Pothole  
**Defect Category:** P3 - 30 working days  
**Issued Date:** 03/02/2026 11:12  
**Target Date:** 17/03/2026 11:12  
**Completion Date:** 04/02/2026 14:48  
**Location Description:** From Mosstodloch: 415m after the Riding Centre access road, northbound side of the carriageway.  
**Description of Works:** E&C 1 Pothole - 900mm x 250mm x 40mm and 1 edge patch - 1m x 400mm

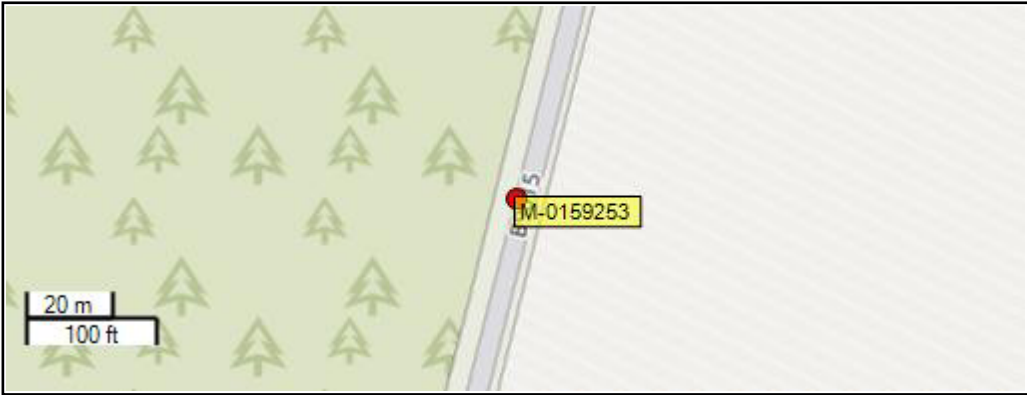
**Instruction Reference:** M-0159253  
**Instruction Created:** 03/02/2026 11:16:00  
**Instruction Status :** *Works Complete*  
**Inspection:** Safety Inspection Area W07 - 02 (Feb) on the 3rd of February 2026  
**Item Type:** Carriageway  
**Item Detail:** Pothole  
**Defect Category:** P3 - 30 working days  
**Issued Date:** 03/02/2026 11:16  
**Target Date:** 17/03/2026 11:16  
**Completion Date:** 04/02/2026 14:41  
**Location Description:** From Mosstodloch: 495m after the Riding Centre access road, northbound side of the carriageway.  
**Description of Works:** E&C edge Pothole - 700mm x 300mm x 35mm

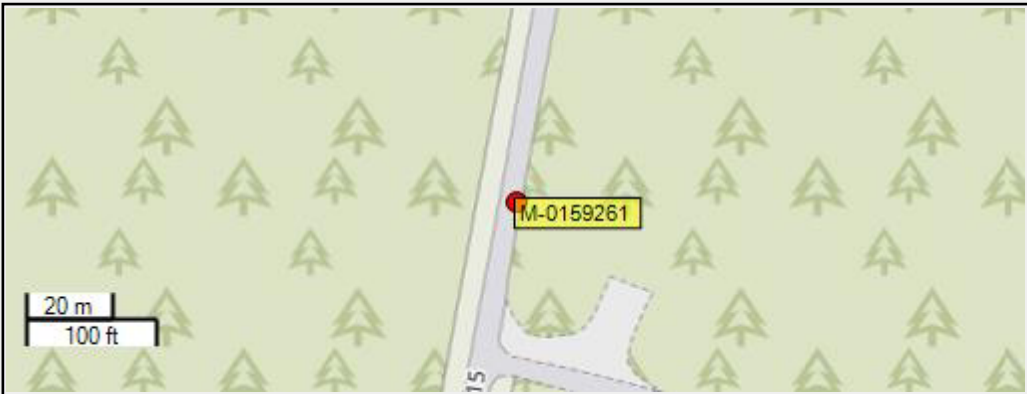
**Instruction Reference:** M-0159261  
**Instruction Created:** 03/02/2026 11:54:00  
**Instruction Status :** *Works Complete*  
**Inspection:** Safety Inspection Area W07 - 02 (Feb) on the 3rd of February 2026  
**Item Type:** Carriageway  
**Item Detail:** Carriageway Defects  
**Defect Category:** P3 - 30 working days  
**Issued Date:** 03/02/2026 11:54  
**Target Date:** 17/03/2026 11:54  
**Completion Date:** 04/02/2026 14:25  
**Location Description:** From Garmouth: 45m after Spey Cottage, southbound side of the carriageway.  
**Description of Works:** E&C 8 small Patches

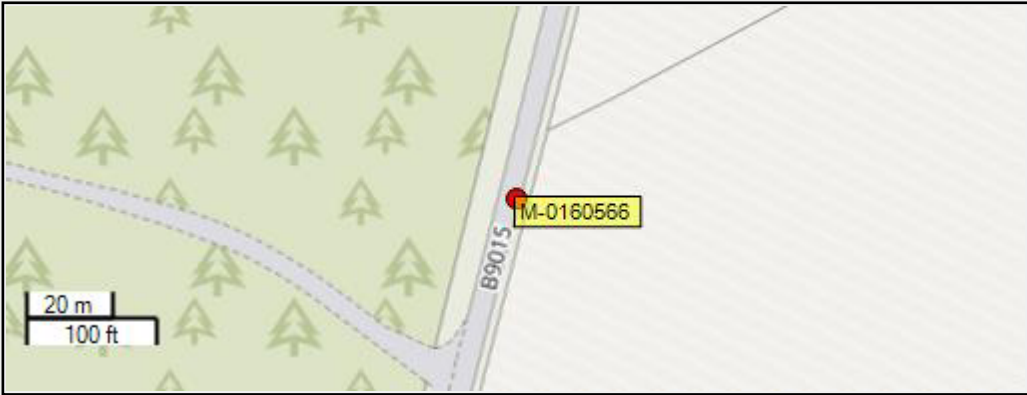
**Instruction Reference:** M-0160566  
**Instruction Created:** 03/03/2026 14:57:00  
**Instruction Status :** *Works Complete*  
**Inspection:** Safety Inspection Area W07 - 03 (Mar) on the 3rd of March 2026  
**Item Type:** Carriageway  
**Item Detail:** Carriageway Defects  
**Defect Category:** P3 - 30 working days  
**Issued Date:** 03/03/2026 14:57  
**Target Date:** 15/04/2026 14:57  
**Completion Date:** 09/03/2026 13:59  
**Location Description:** From Mosstodloch: 35m after the Riding Centre access road, southbound side of the carriageway.  
**Description of Works:** E&C 6 Patches - 3 x 500mm x 300mm. 3 x 300mm x 300mm

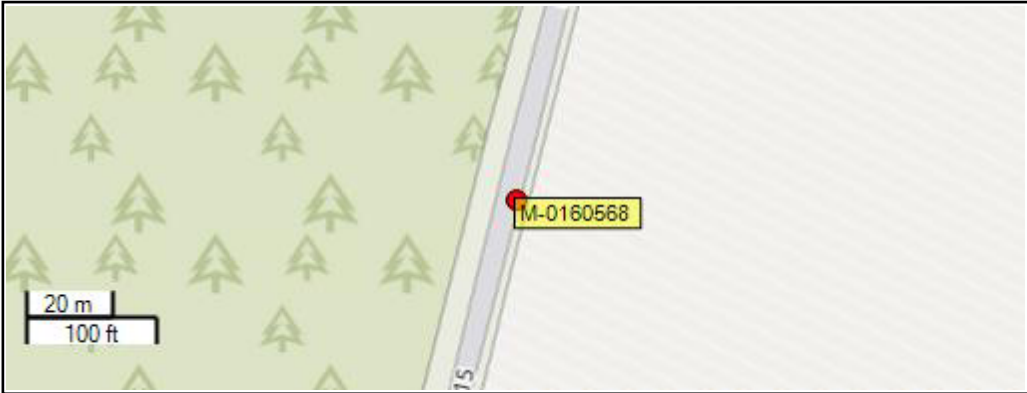
**Instruction Reference:** M-0160568  
**Instruction Created:** 03/03/2026 15:04:00  
**Instruction Status :** *Works Complete*  
**Inspection:** Safety Inspection Area W07 - 03 (Mar) on the 3rd of March 2026  
**Item Type:** Carriageway  
**Item Detail:** Pothole  
**Defect Category:** P3 - 30 working days  
**Issued Date:** 03/03/2026 15:04  
**Target Date:** 15/04/2026 15:04  
**Completion Date:** 09/03/2026 14:03  
**Location Description:** From Mosstodloch: 370m after the Riding Centre access road, southbound side of the carriageway.  
**Description of Works:** E&C Pothole - 500mm x 300mm

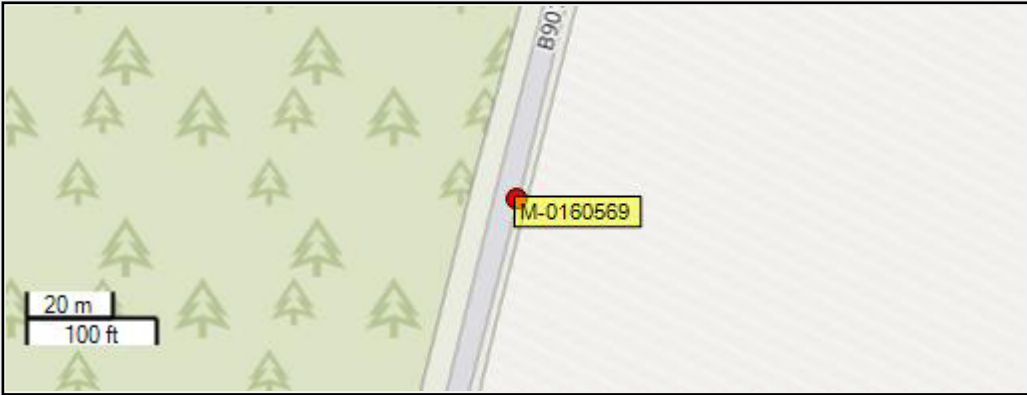
**Instruction Reference:** M-0160569  
**Instruction Created:** 03/03/2026 15:06:00  
**Instruction Status :** *Works Complete*  
**Inspection:** Safety Inspection Area W07 - 03 (Mar) on the 3rd of March 2026  
**Item Type:** Carriageway  
**Item Detail:** Pothole  
**Defect Category:** P3 - 30 working days  
**Issued Date:** 03/03/2026 15:06  
**Target Date:** 15/04/2026 15:06  
**Completion Date:** 09/03/2026 14:08  
**Location Description:** From Mosstodloch: 390m after the Riding Centre access road, southbound side of the carriageway.  
**Description of Works:** E&C Pothole - 600mm x 350mm x 35mm

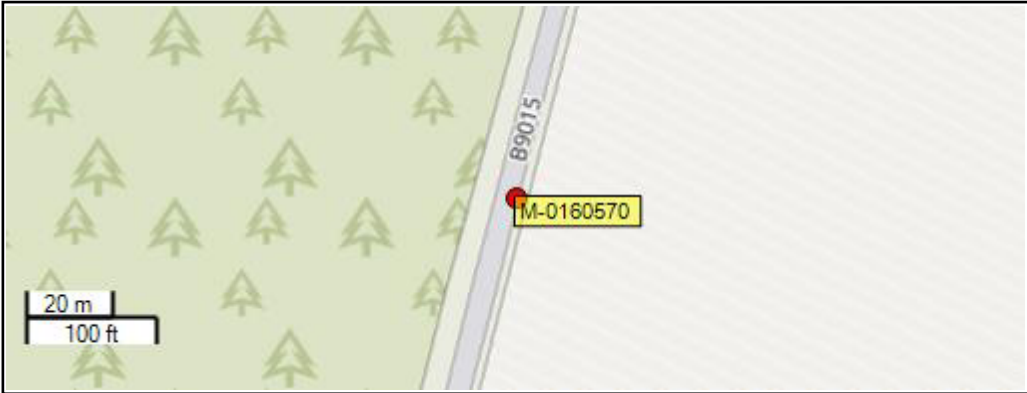
**Instruction Reference:** M-0160570  
**Instruction Created:** 03/03/2026 15:08:00  
**Instruction Status :** *Works Complete*  
**Inspection:** Safety Inspection Area W07 - 03 (Mar) on the 3rd of March 2026  
**Item Type:** Carriageway  
**Item Detail:** Pothole  
**Defect Category:** P3 - 30 working days  
**Issued Date:** 03/03/2026 15:08  
**Target Date:** 15/04/2026 15:08  
**Completion Date:** 09/03/2026 10:39  
**Location Description:** From Mosstodloch: 420m after the Riding Centre access road, southbound side of the carriageway.  
**Description of Works:** E&C Pothole - 1m x 300mm x 30mm and 2 small Patches.

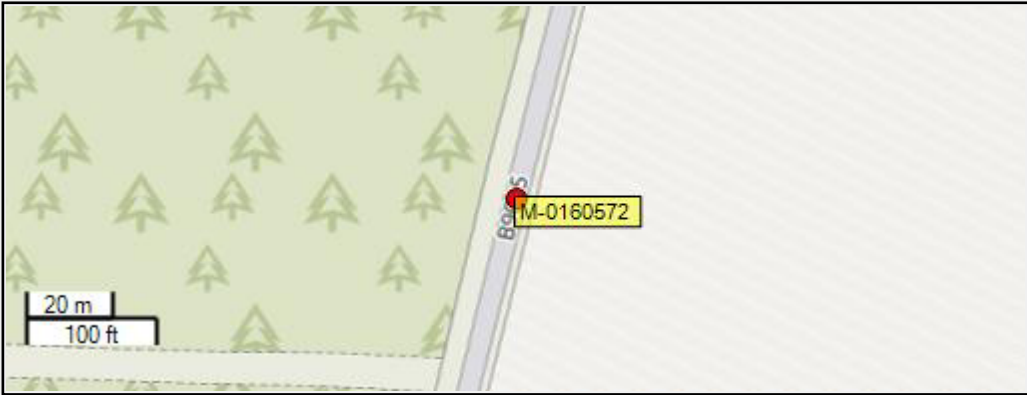
**Instruction Reference:** M-0160572  
**Instruction Created:** 03/03/2026 15:11:00  
**Instruction Status :** *Works Complete*  
**Inspection:** Safety Inspection Area W07 - 03 (Mar) on the 3rd of March 2026  
**Item Type:** Carriageway  
**Item Detail:** Pothole  
**Defect Category:** P3 - 30 working days  
**Issued Date:** 03/03/2026 15:11  
**Target Date:** 15/04/2026 15:11  
**Completion Date:** 09/03/2026 10:43  
**Location Description:** From Mosstodloch: 575m after the Riding Centre access road, centre of the carriageway.  
**Description of Works:** E&C Pothole - 500mm x 350mm x 40mm

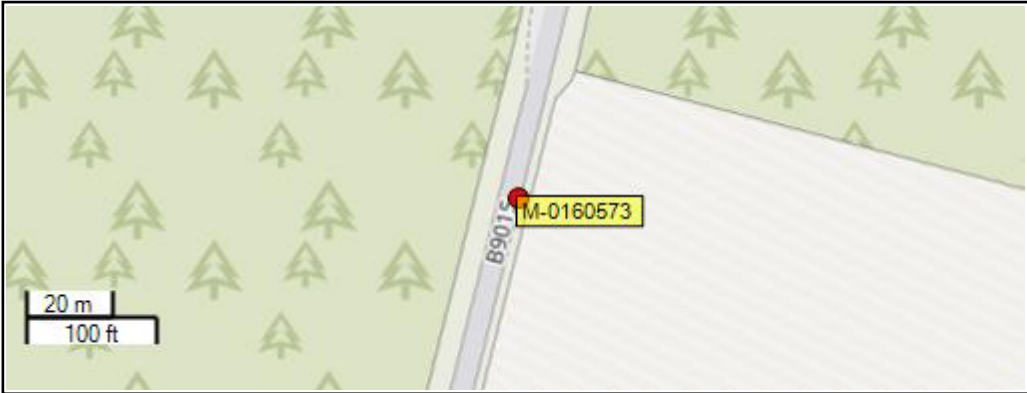
**Instruction Reference:** M-0160573  
**Instruction Created:** 03/03/2026 15:14:00  
**Instruction Status :** *Works Complete*  
**Inspection:** Safety Inspection Area W07 - 03 (Mar) on the 3rd of March 2026  
**Item Type:** Carriageway  
**Item Detail:** Carriageway Defects  
**Defect Category:** P3 - 30 working days  
**Issued Date:** 03/03/2026 15:14  
**Target Date:** 15/04/2026 15:14  
**Completion Date:** 09/03/2026 10:51  
**Location Description:** From Mosstodloch: 665m after the Riding Centre access road, southbound side of the carriageway.  
**Description of Works:** E&C 2 edge Patches - 3m x 400mm and 500mm x 400mm.

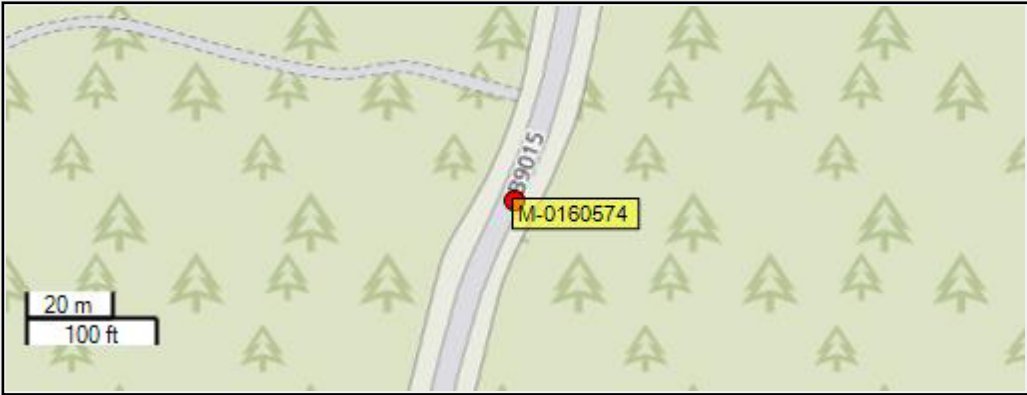
**Instruction Reference:** M-0160574  
**Instruction Created:** 03/03/2026 15:21:00  
**Instruction Status :** *Works Complete*  
**Inspection:** Safety Inspection Area W07 - 03 (Mar) on the 3rd of March 2026  
**Item Type:** Carriageway  
**Item Detail:** Pothole  
**Defect Category:** P3 - 30 working days  
**Issued Date:** 03/03/2026 15:21  
**Target Date:** 15/04/2026 15:21  
**Completion Date:** 09/03/2026 10:59  
**Location Description:** From Mosstodloch: 100m after the layby, at the double bends, centre of the carriageway  
**Description of Works:** E&C 2 Potholes - 2 x 400mm x 300mm x 35mm

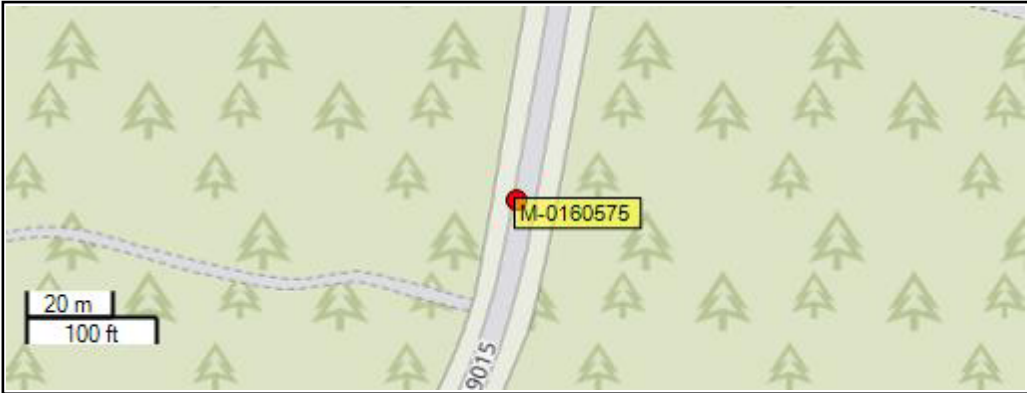
**Instruction Reference:** M-0160575  
**Instruction Created:** 03/03/2026 15:24:00  
**Instruction Status :** *Works Complete*  
**Inspection:** Safety Inspection Area W07 - 03 (Mar) on the 3rd of March 2026  
**Item Type:** Carriageway  
**Item Detail:** Pothole  
**Defect Category:** P3 - 30 working days  
**Issued Date:** 03/03/2026 15:24  
**Target Date:** 15/04/2026 15:24  
**Completion Date:** 09/03/2026 11:00  
**Location Description:** From Mosstodloch: 140m after the layby, northbound side of the carriageway  
**Description of Works:** E&C a small Pothole

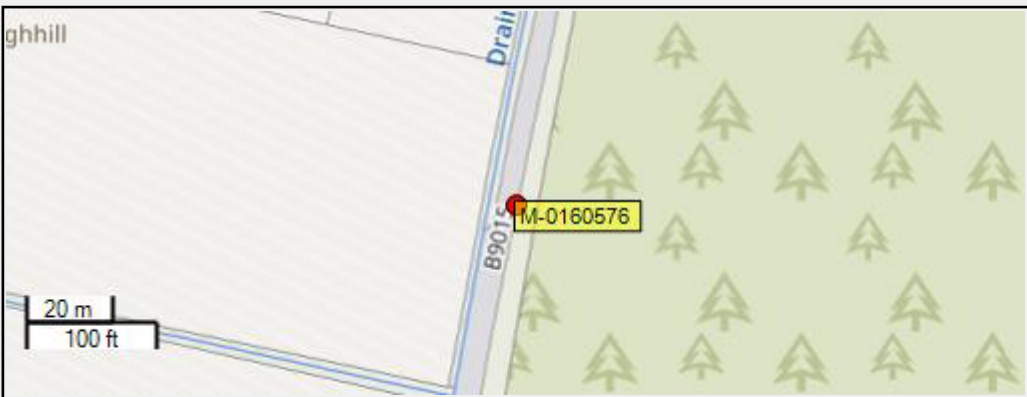
**Instruction Reference:** M-0160576  
**Instruction Created:** 03/03/2026 15:31:00  
**Instruction Status :** *Works Complete*  
**Inspection:** Safety Inspection Area W07 - 03 (Mar) on the 3rd of March 2026  
**Item Type:** Carriageway  
**Item Detail:** Carriageway Defects  
**Defect Category:** P3 - 30 working days  
**Issued Date:** 03/03/2026 15:31  
**Target Date:** 15/04/2026 15:31  
**Completion Date:** 09/03/2026 11:13  
**Location Description:** From Mosstodloch: 200m after the Spey Cottage access road, southbound side of the carriageway.

**Description of Works:** E&C the carriageway edge patches - totalling 15m x 400mm

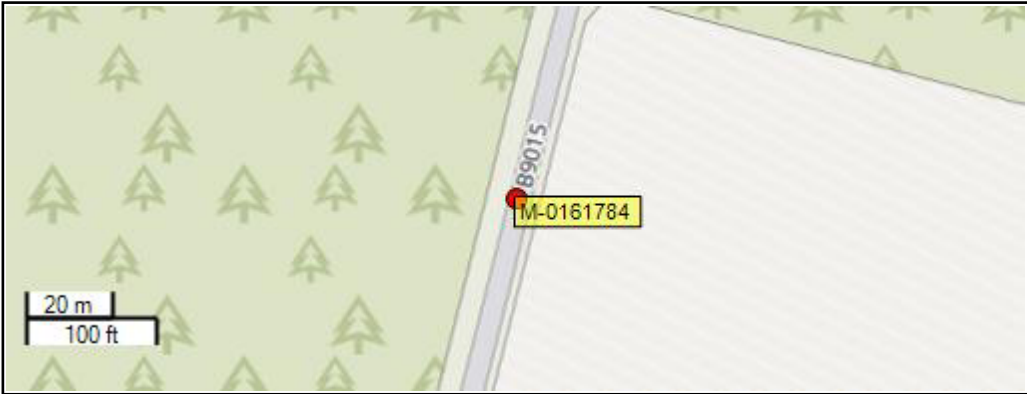
**Location Description:** From Mosstodloch: 640m after the Riding Centre access road, northbound side of the carriageway.

**Description of Works:** Cold Tar Pothole - 1m x 650mm x 60mm

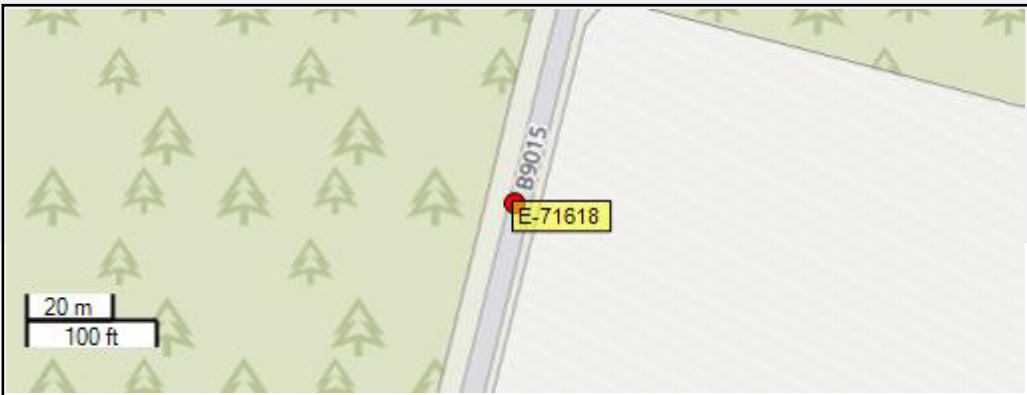
**Location Description:** B9015 from Garmouth Road in Mosstodloch to South Road in Garmouth : About 1 mile north of Mosstodloch.

Fault Details  
Fault Area: Road Surface  
Fault Type: Pothole  
Subcategory Fault Type:  
Further Fault Details: Large pothole on B9015 Mosstodloch to Garmouth. About 1 mile north of Mosstodloch, just before the double bend in the woods.
