# **Summary Building Condition Survey Report**

**Alves Primary School  
1 Main Road, Alves IV30 8UR**

**9<sup>th</sup> and 10<sup>th</sup> of May 2022**

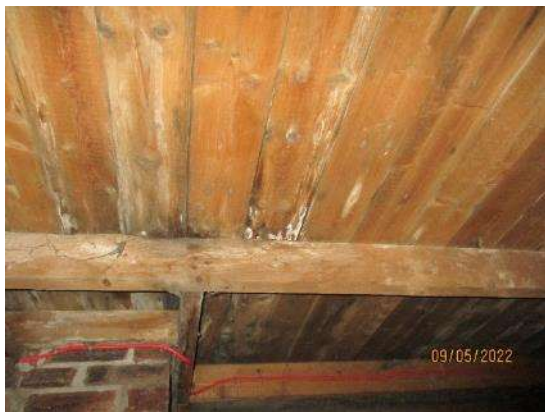
3. Teaching south minor water marking

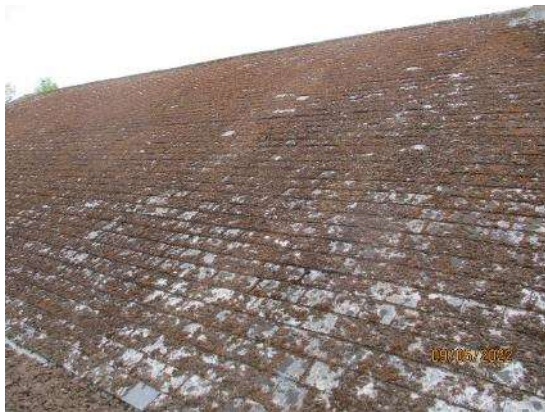
- Asbestos tiles have extensive moss growth to the East aspect.
- The GRP roof above the staff toilet has a significant hole and extensive blistering.
- External walls to classrooms 1 and 2 have extensive, significant cracking.
- Plaster and plasterboard ceilings have significant cracking.
- Internal walls also have significant cracking.
- Concrete floors to classrooms 1 and 2 have dropped by approx. 25mm.
- Internal doors are dated, glazing is single glazed and ironmongery is defective.

15. Extensive moss growth

- Replacement of asbestos cement tiles.
- Underpinning of classrooms 1 & 2 to prevent further movement.
- Expansion of the field of CCTV cameras to increase security.
- Installation of an intruder alarm system in the dining block to increase security.
- Review of requirement for mechanical ventilation in toilet rooms.
- Upgrade of controls for mechanical fans and lighting for energy saving purposes.
- Upgrade of lighting in both buildings due to age and condition.
- Upgrade of heating and associated plumbing systems in both buildings due to age and condition and for energy saving and reduction of carbon emission purposes.
- Installation of a sump pump system within the dining room block basement boiler house, as it is below ground level and has potential to flood.

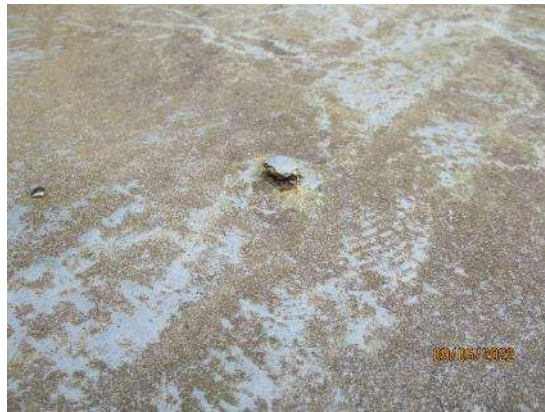
20. Fixings punching through GRP surface

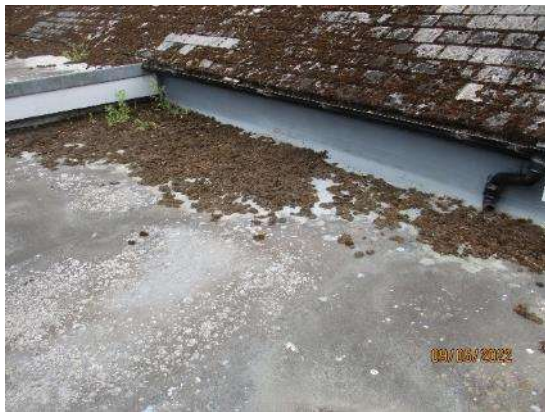
21. Moss and vegetation on flat roofs

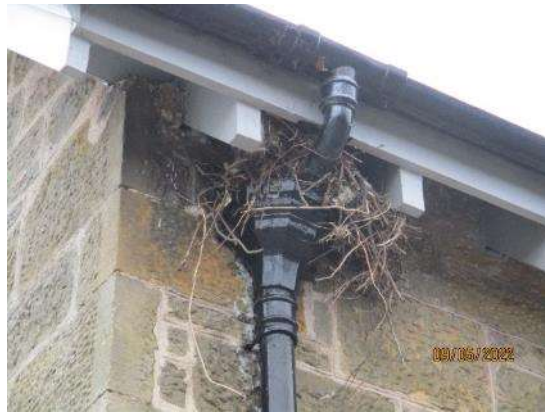
32. Birds nest in hopper head

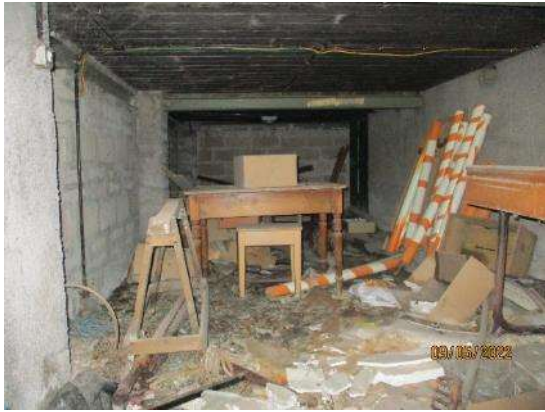
49. Below floor – Teaching south

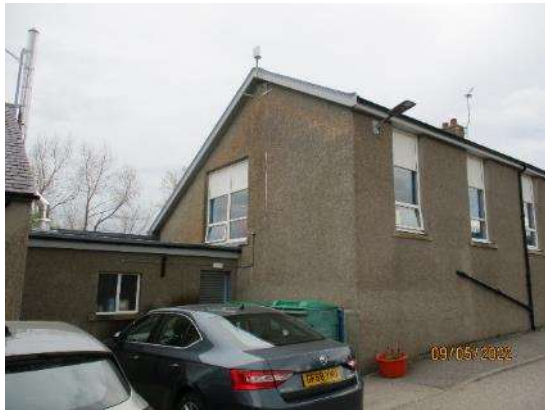
52. Roughcast – Teaching south

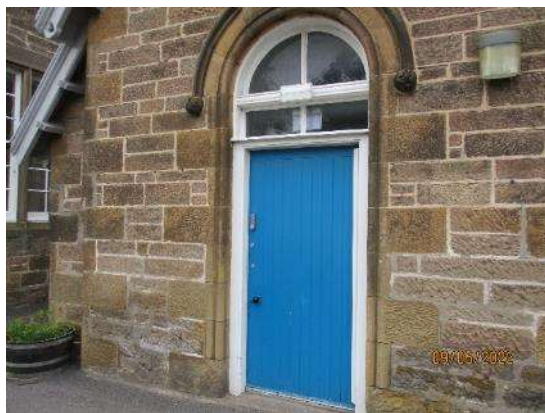
53. Timber single doors

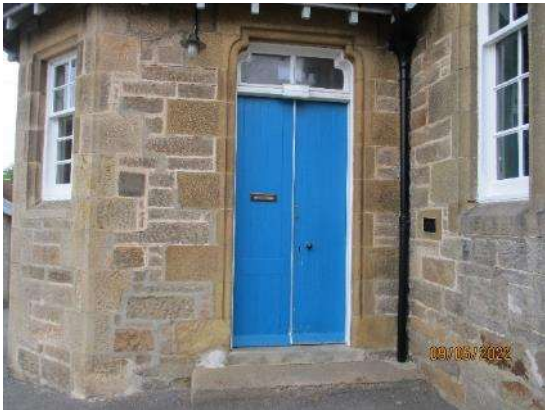
57. Timber double doors

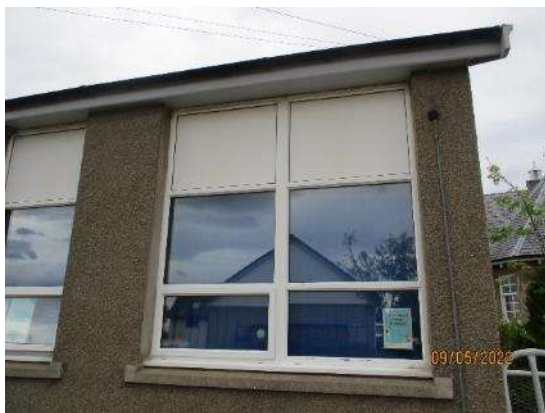
59. UPVC windows

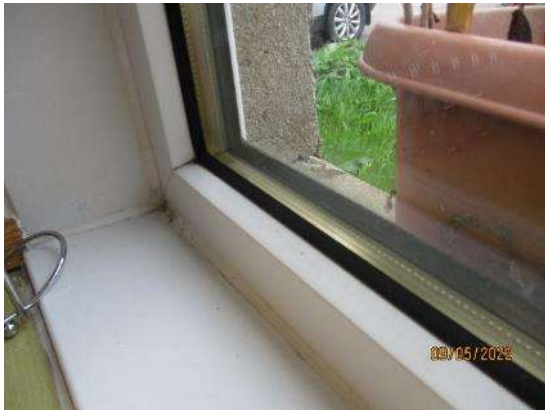
69. Double glazing to Teaching block

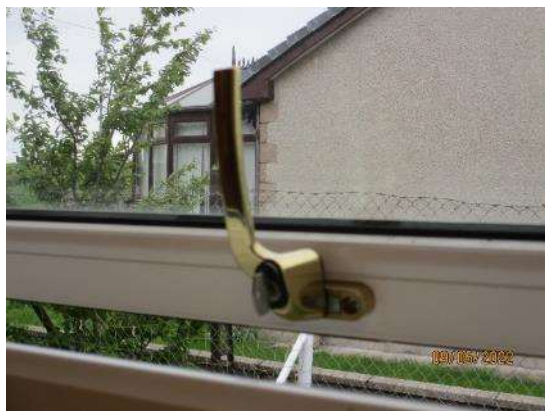
71. UPVC window ironmongery

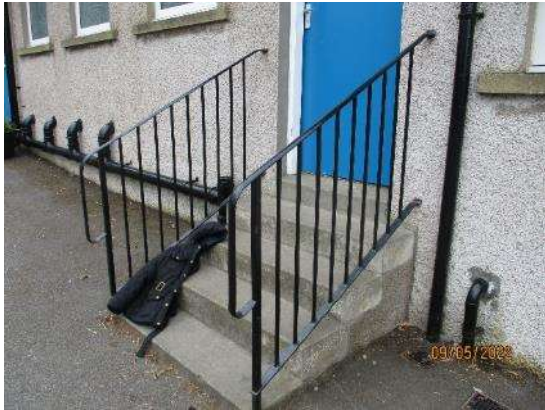
72. Concrete steps

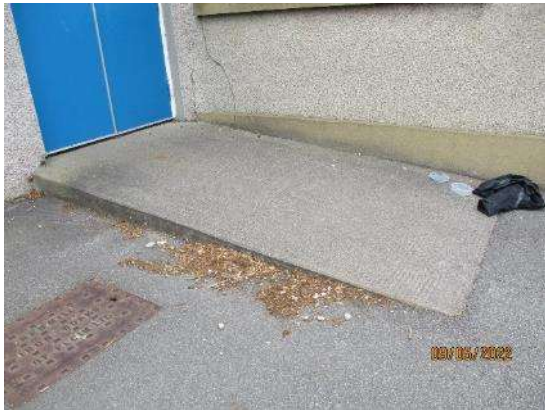
74. Concrete ramps

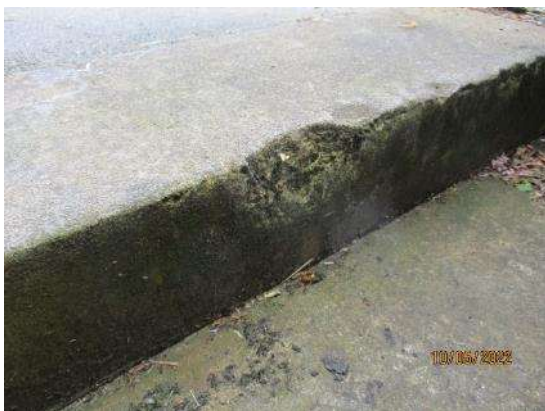
76. Chipped nosings

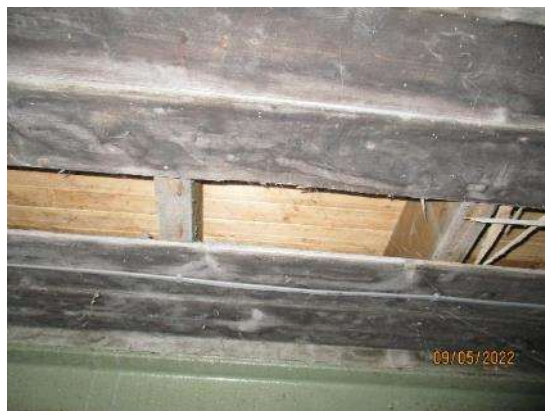
83. Timber suspended floor

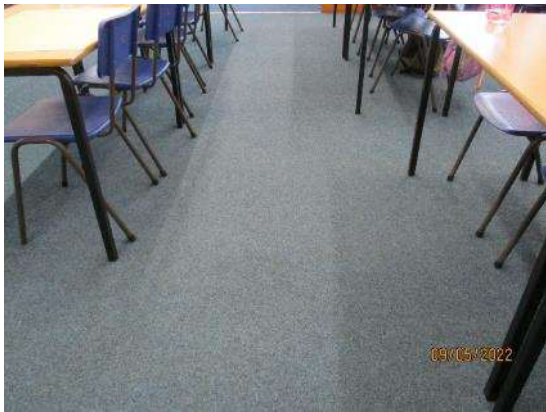
84. Carpet floor finish

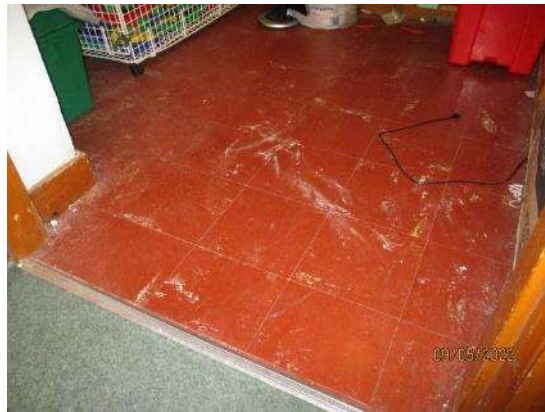
85. Vinyl tiles

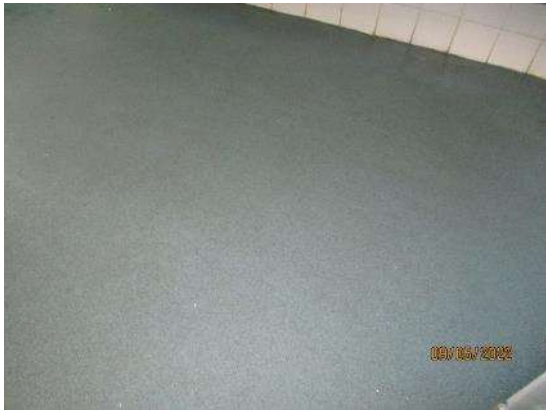
86. Sheet vinyl

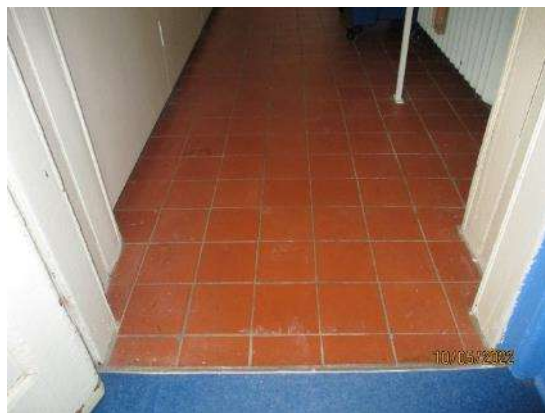
89. Quarry tile flooring

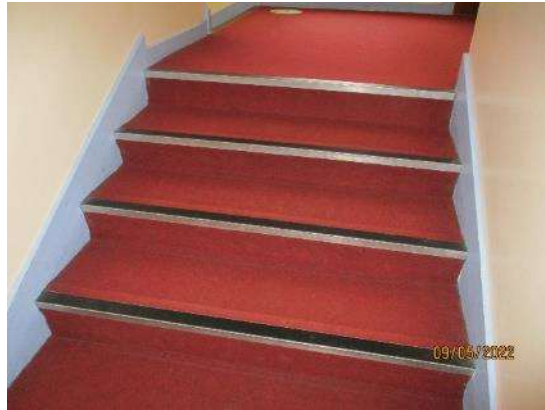
91. Steps to Teaching corridor

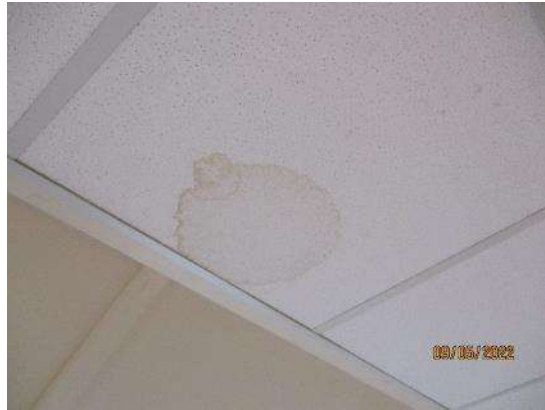
96. Water marked

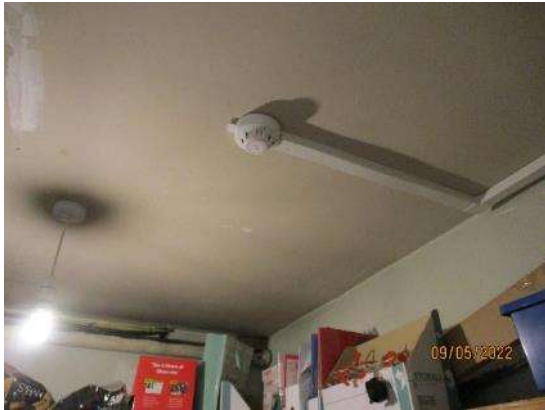
101. Plasterboard ceilings

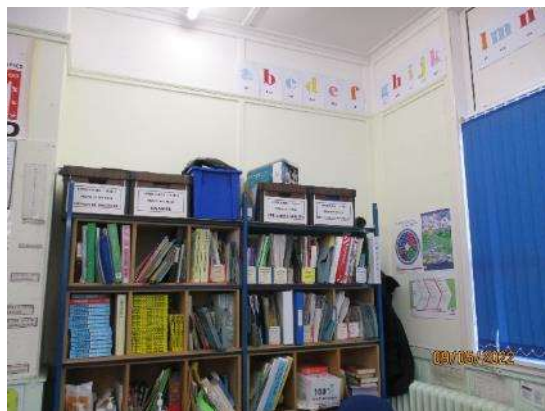
106. Plasterboard walls

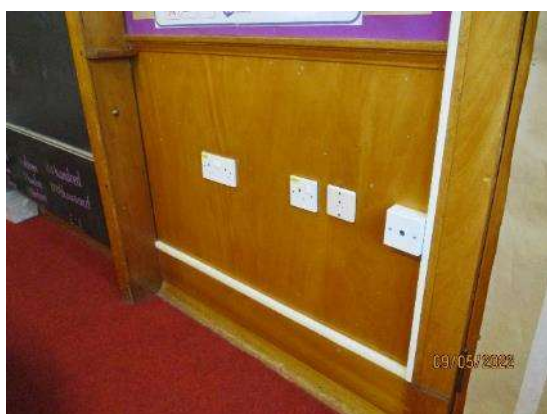
107. Timber panelling

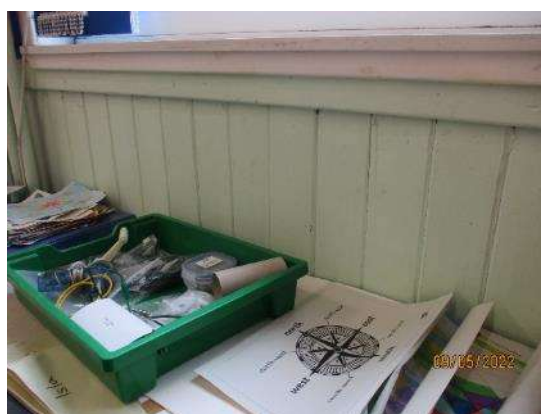
108. Timber linings

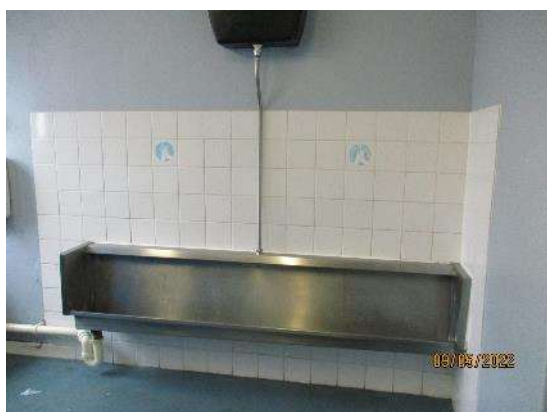
109. Ceramic wall tiles

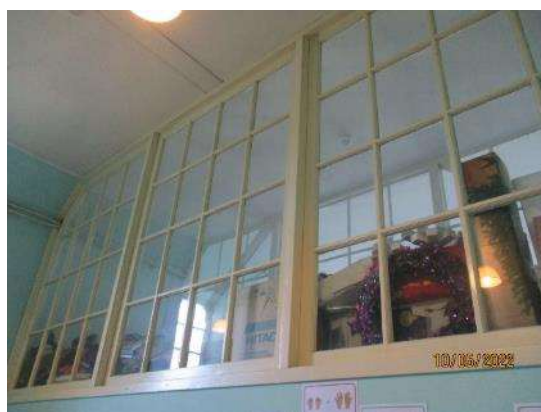
110. Internal glazed screens

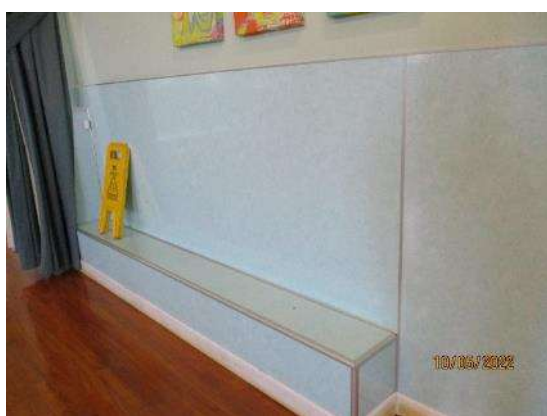
111. Wet wall

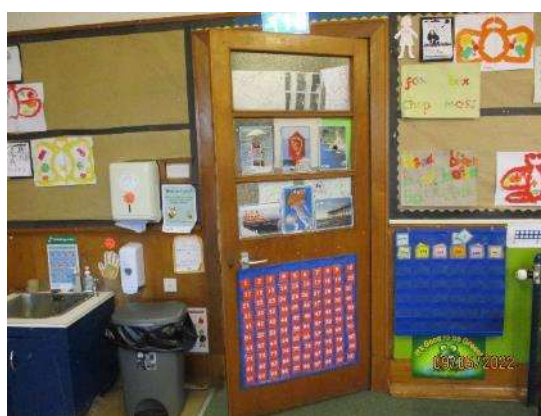
112. Timber classroom doors

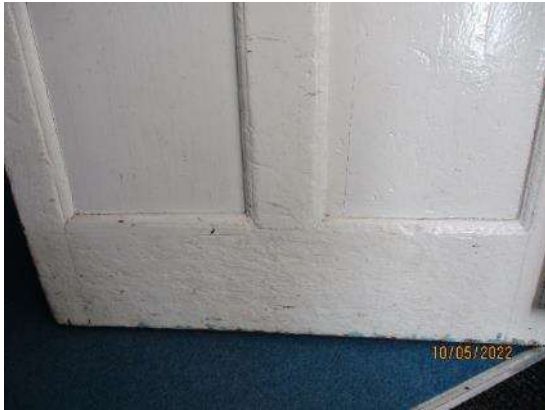
113. Timber panelled doors

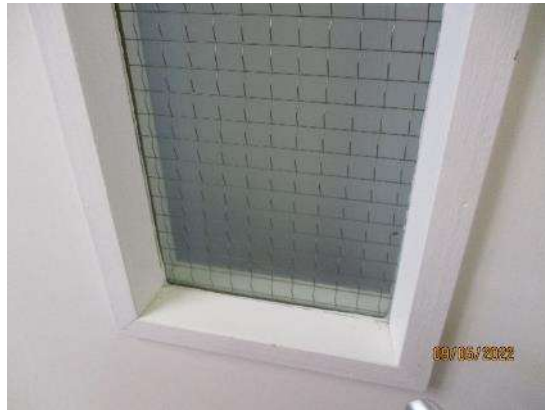
116. Georgian wired glass

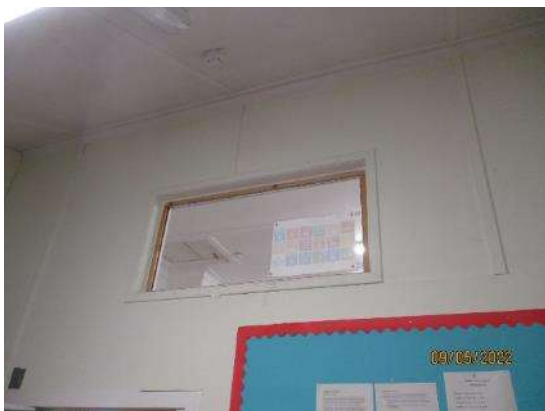
117. Borrowed lights

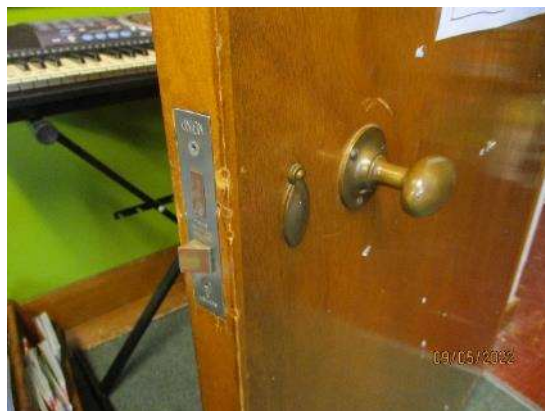
118. Brass door ironmongery

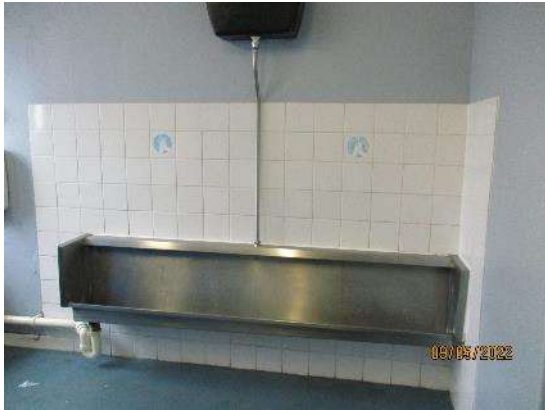
119. Wall hung urinal

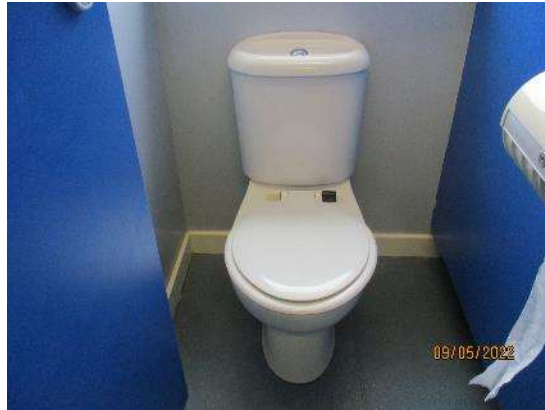
120. Typical WC

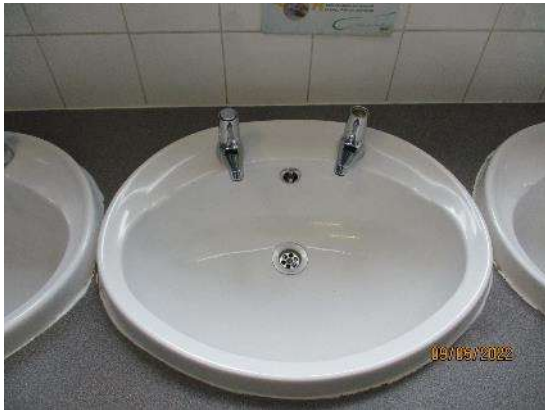
121. Vanity basins

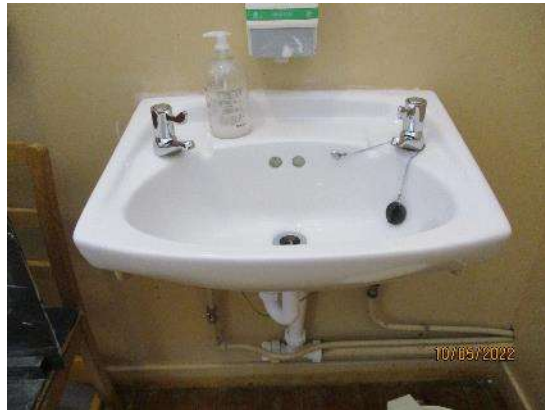
122. Wall hung basins

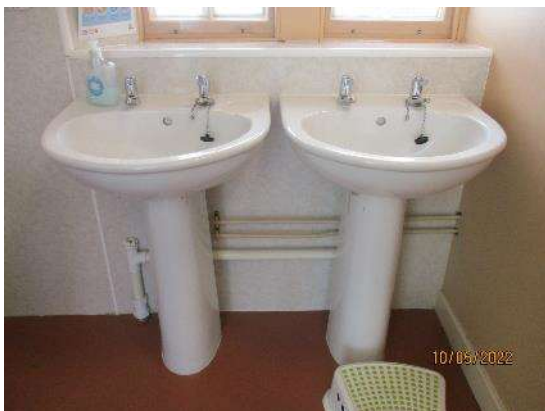
123. Pedestal basins

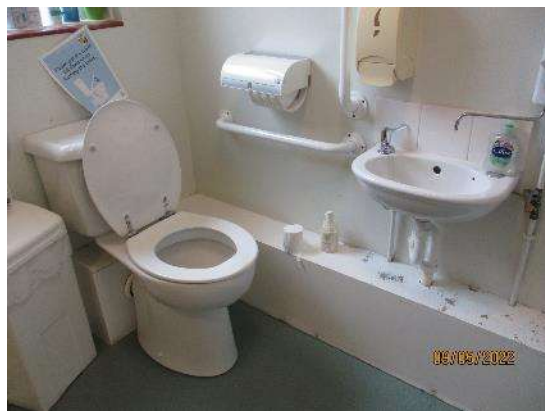
124. Accessible toilet

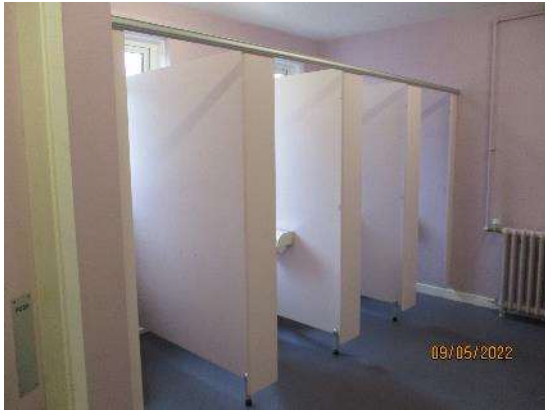
125. Cubicle partitions

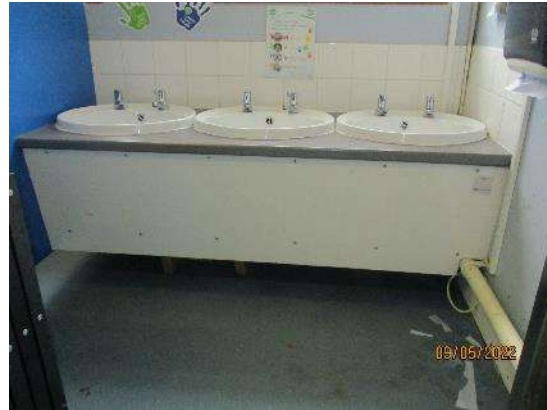
126. Vanity base units

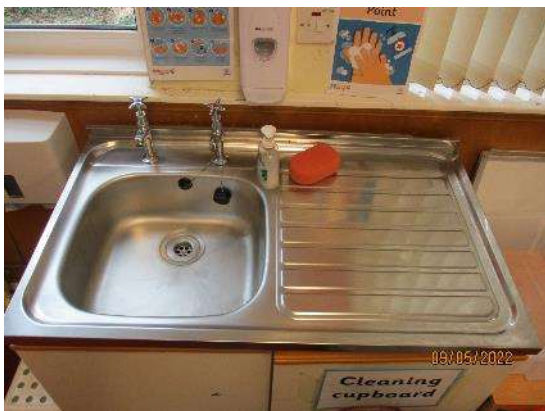
128. Stainless steel sinks

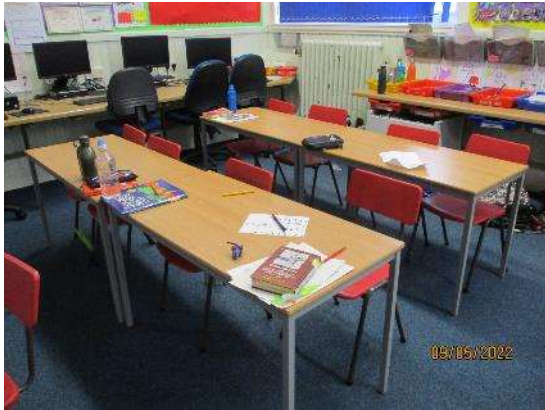
130. Classroom tables and chairs

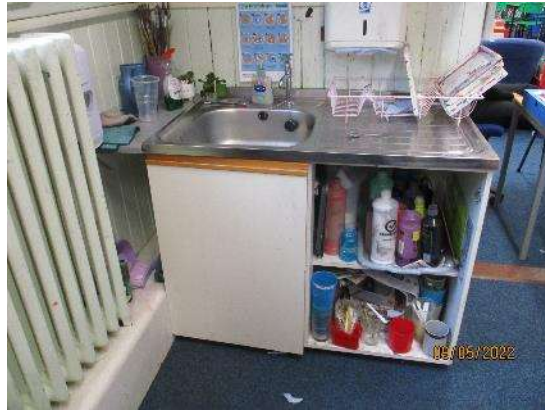
131 Sink base units

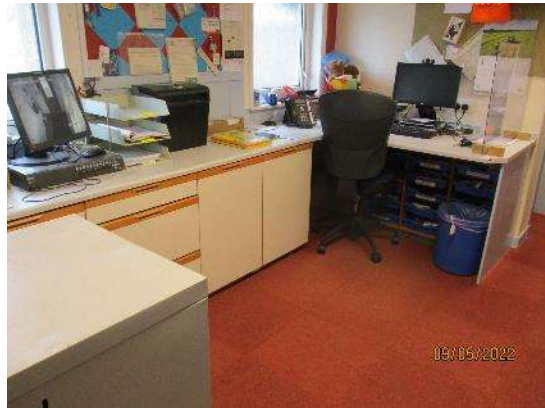
133. Reception furniture

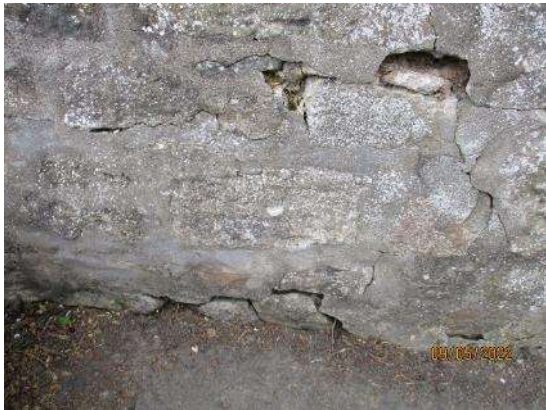
214. Pointing required

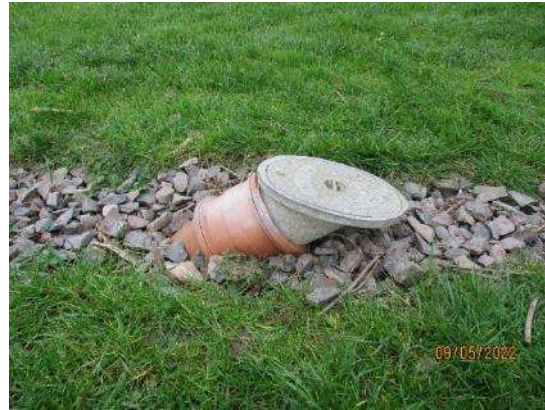
- Rodding eyes and manhole covers are loose and raised above ground level.

219. Rodding eyes above ground level
