# **Summary Building Condition Survey Report**

**Andersons Primary School  
High Street, Forres IV36 1DB**

**31<sup>st</sup> January & 1<sup>st</sup> February 2022**

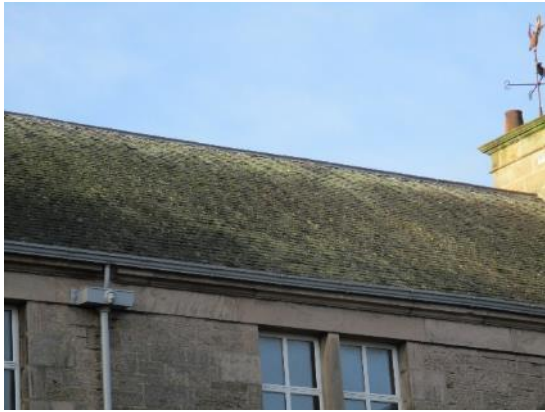
1. Slated roofs

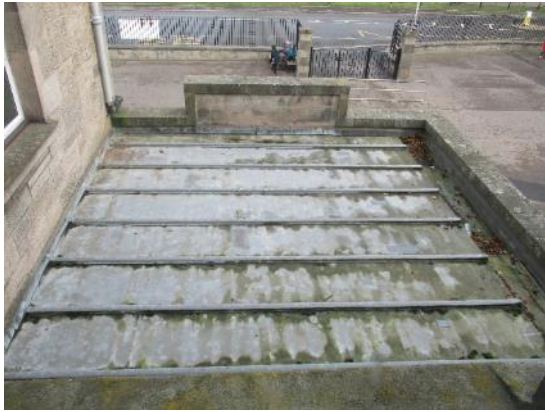
2. Flat lead roofs

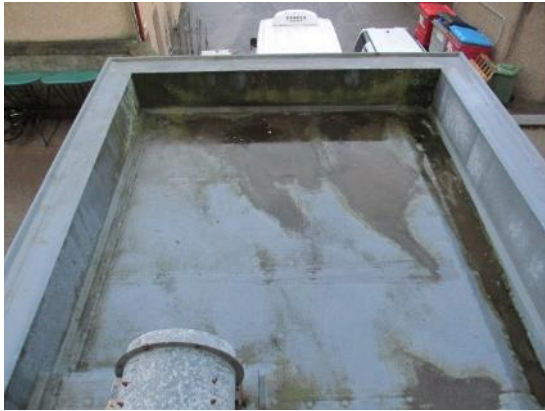
4. GRP roofs

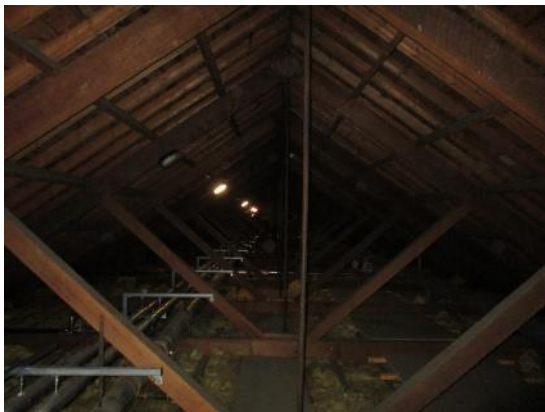
5. Pitched roof structure

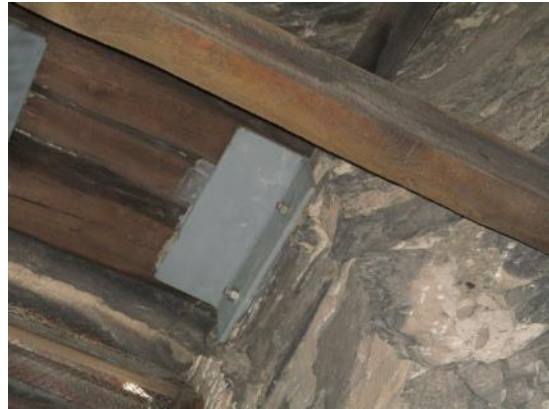
8. Steel supports

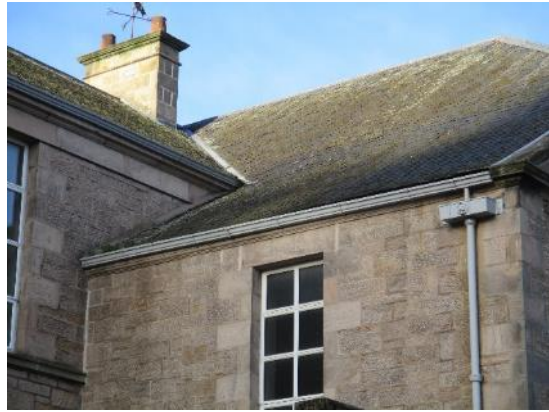
14. Cast iron ogee gutters

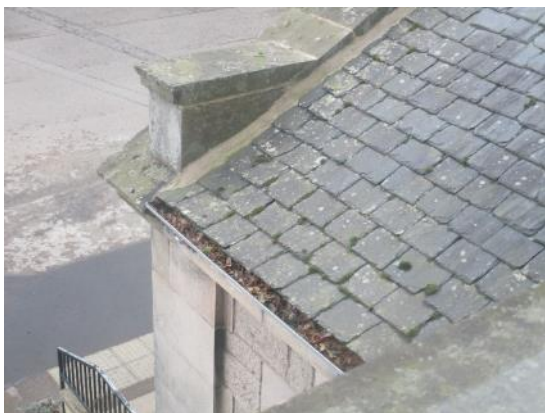
17. Leaves in gutters

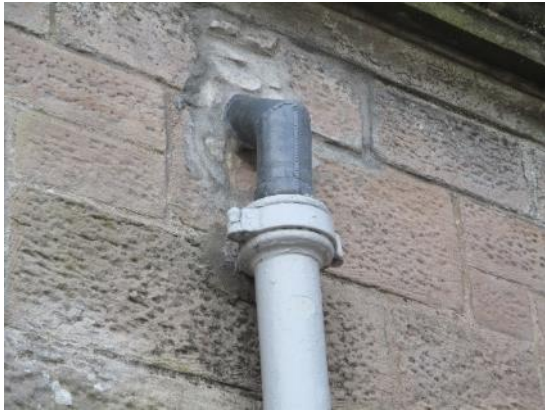
19. Lead outlets from flat roofs

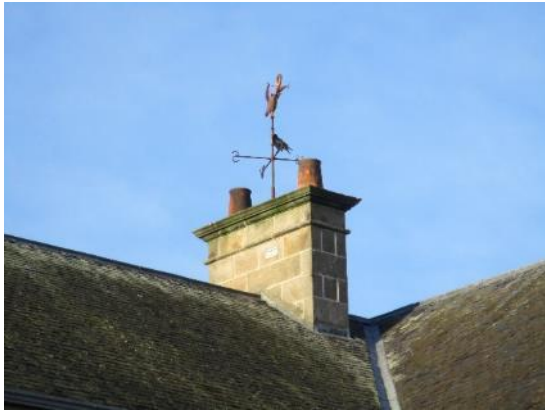
25. North chimney and weather vane

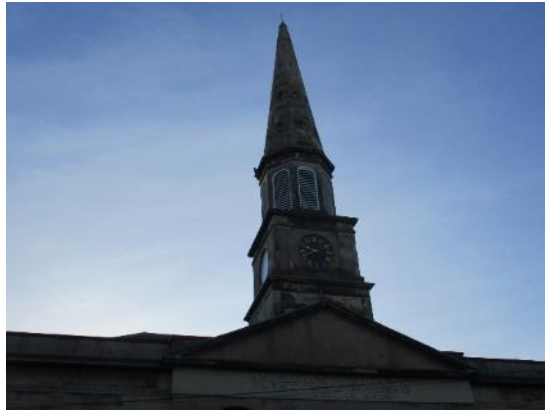
26. Steeple to north elevation

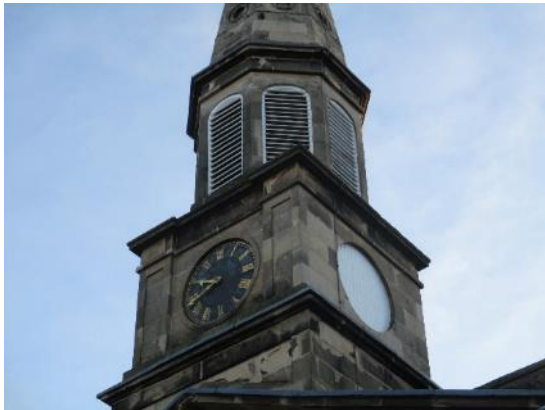
27. Timber louvres and clock

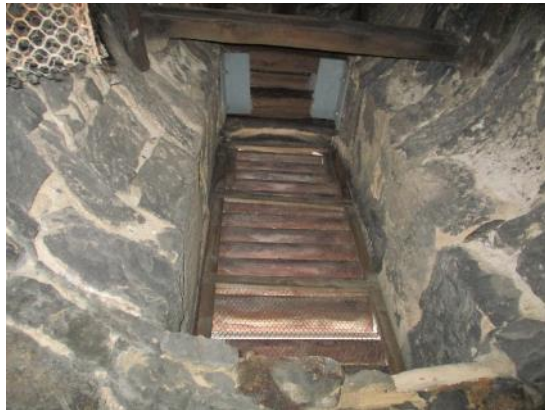
28. Louvres internally

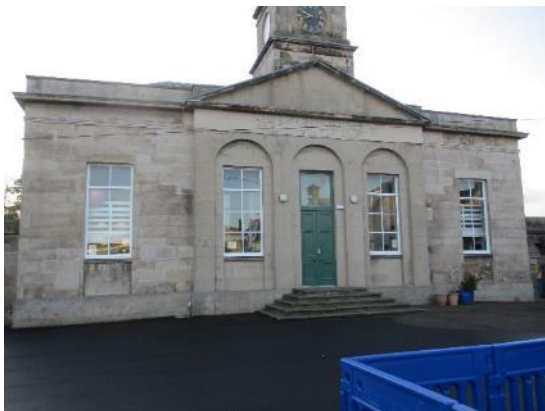
29. External masonry

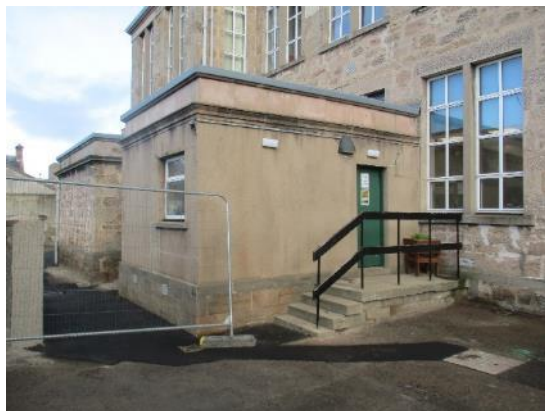
30. Kitchen roughcast extension

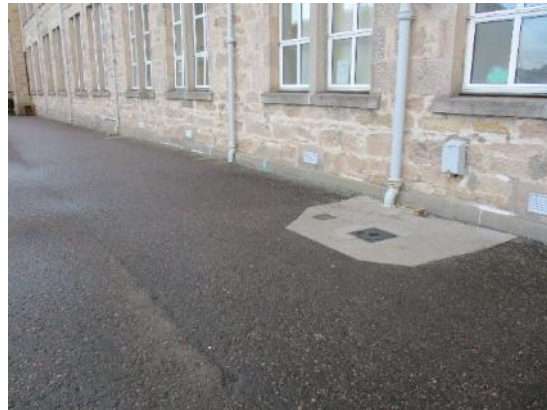
35. Ground level to the west elevation

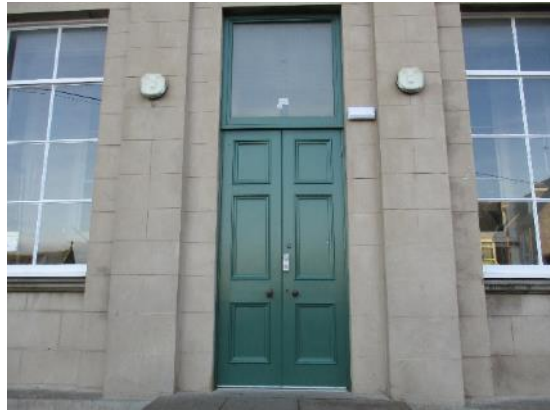
39. Timber panelled external doors

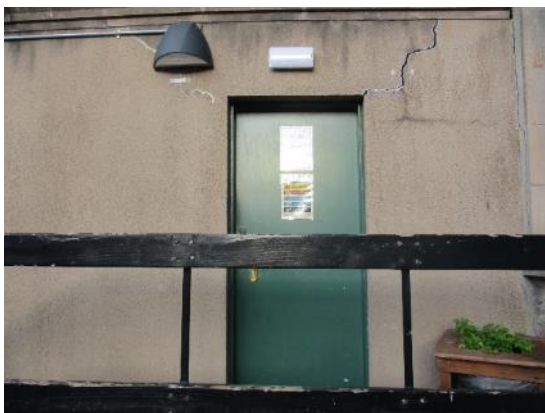
42. Kitchen side door

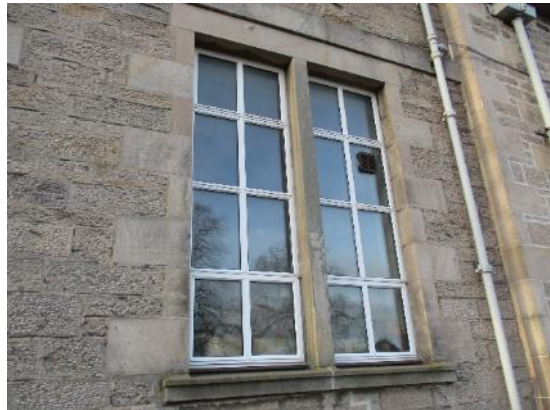
46. Timber window sills

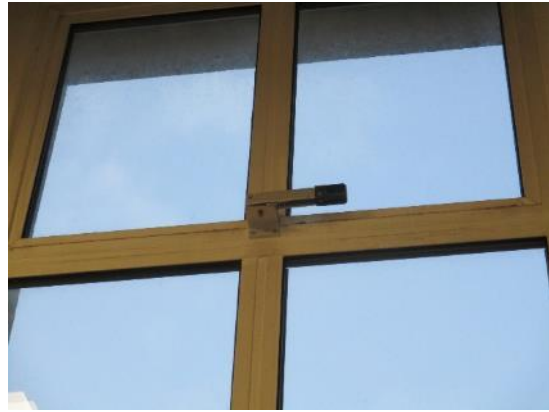
50. Window mechanisms stiff to operate

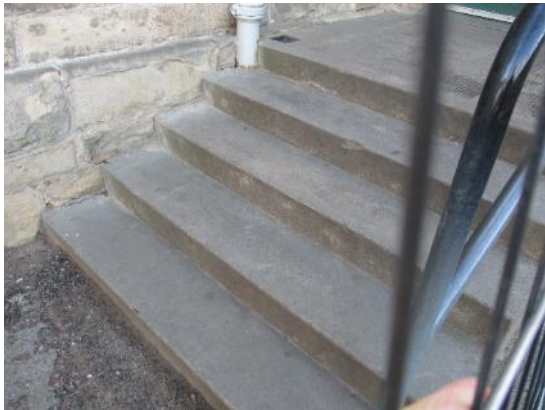
59. Damaged steps to Kitchen side door

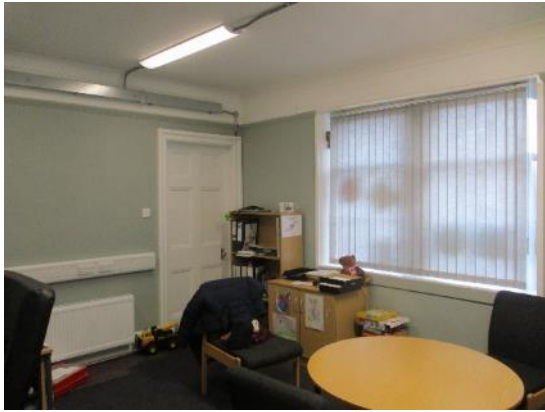
63. Repairs to plasterboard

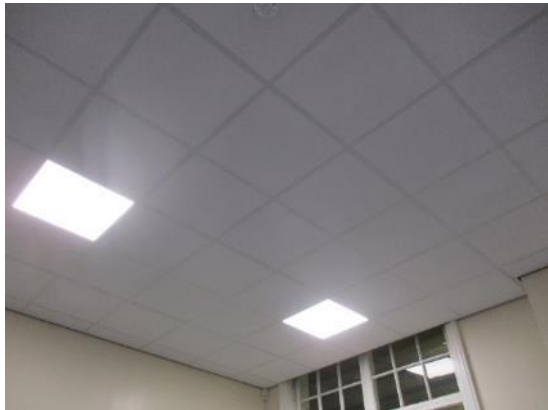
66. Water marked suspended ceiling

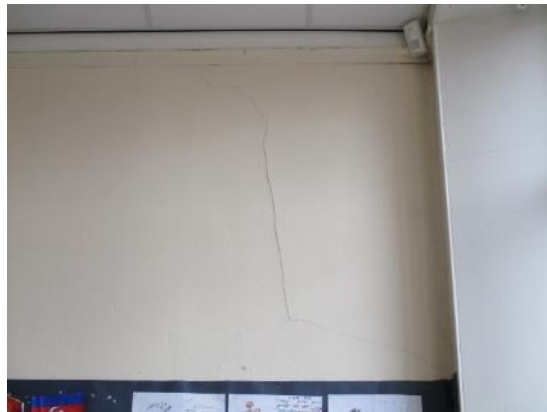
71. Isolated cracking

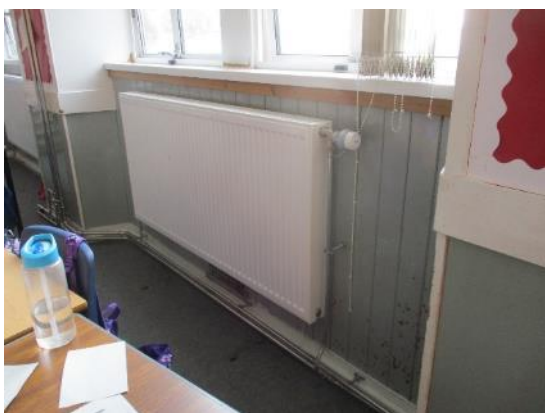
73. Plasterboard walls - Water damage

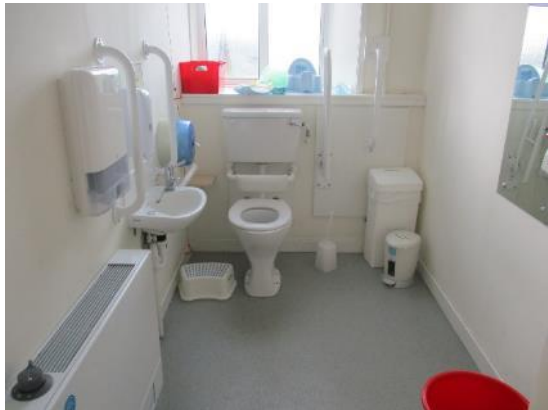
102. Accessible toilet

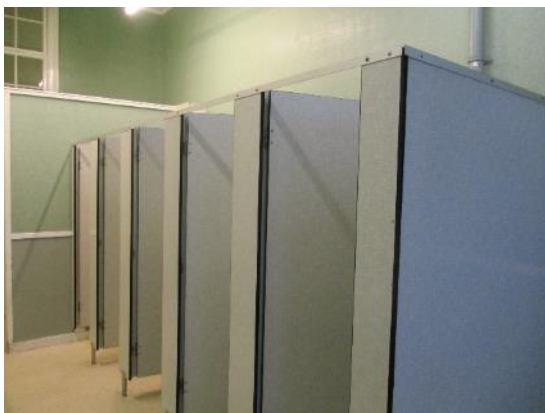
103. Cubicle partitions

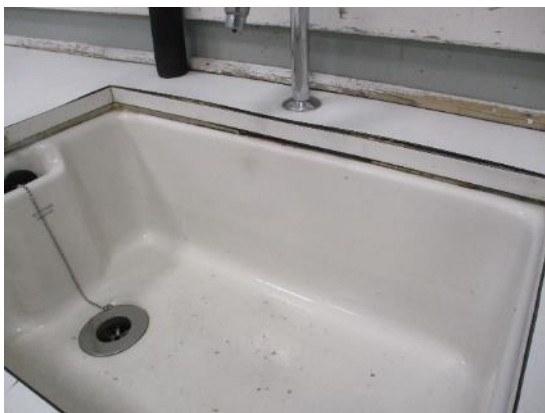
109. Classroom butler sinks

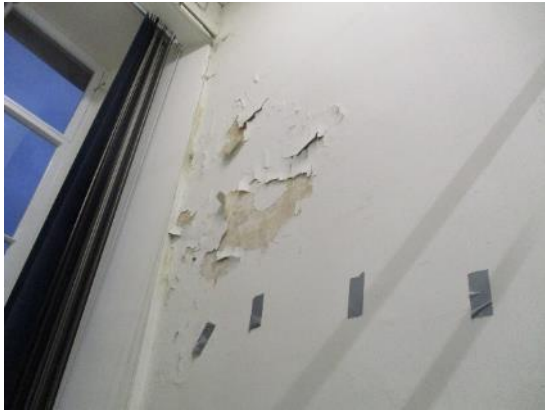
111. Peeling paint

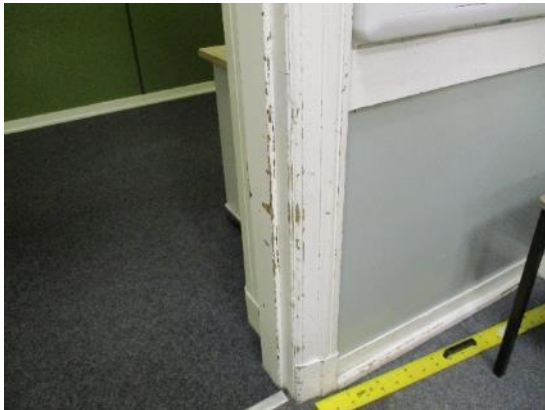
113. Joinery items

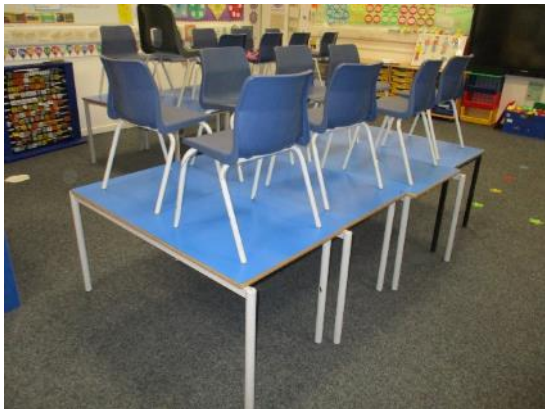
114. Classroom furniture

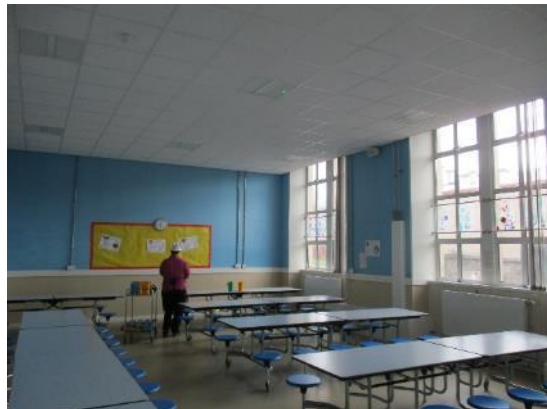
115. Social furniture

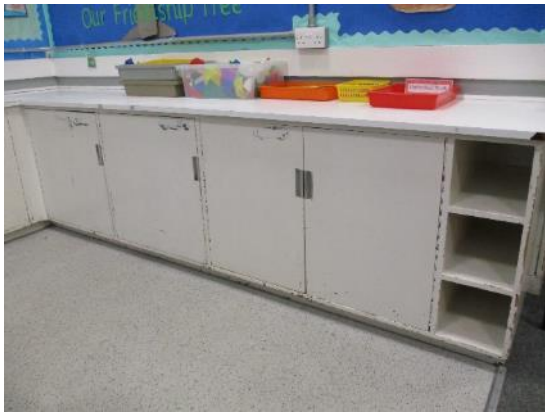
116. Classroom base units

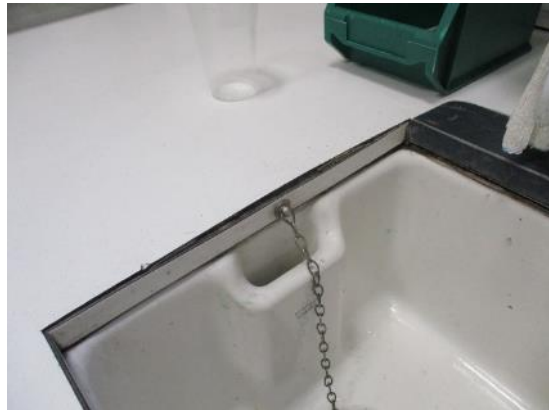
117. Laminating worktops

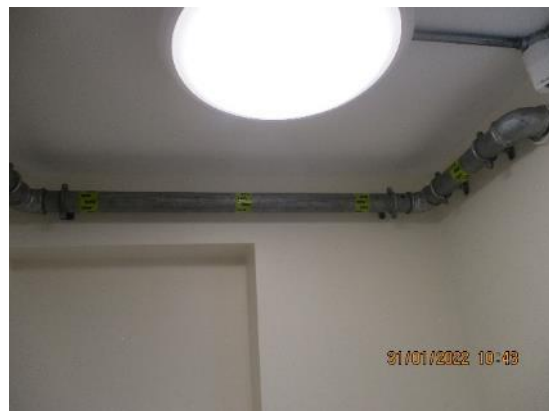
130. Gas supply (part) to kitchen internal 1/33

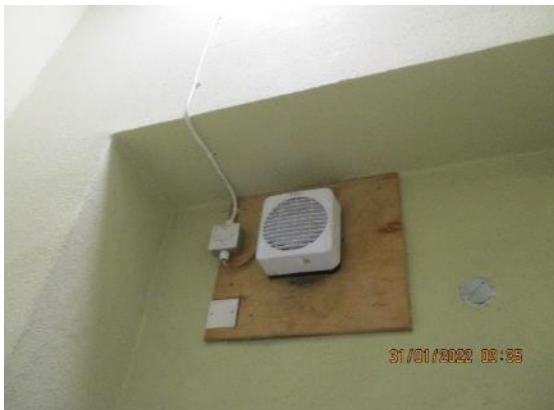
133. General extract mechanical ventilation 1/2a

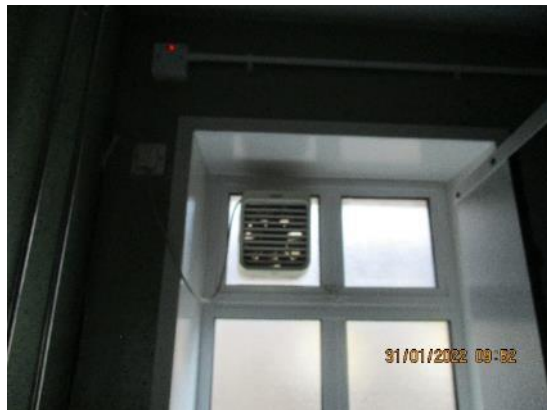
134. General extract mechanical ventilation 1/5

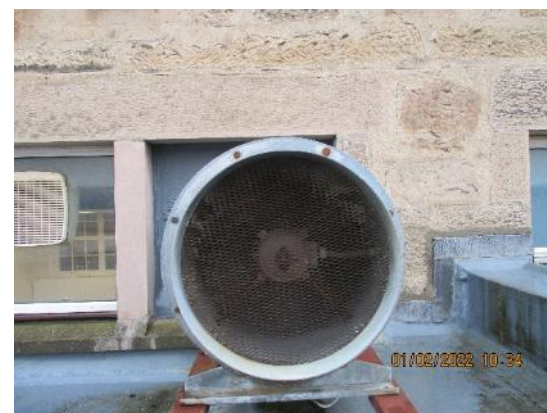
136. Specialist extract mechanical ventilation kitchen fan 1/11

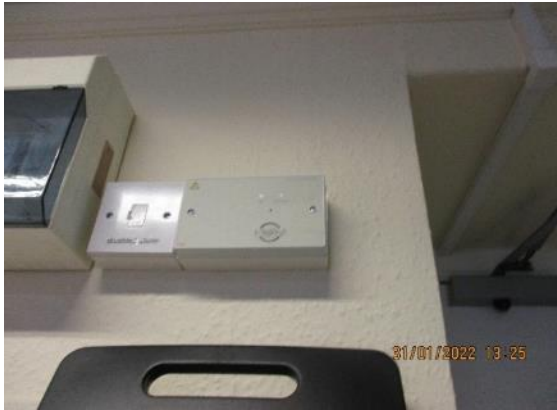
155. Disabled alarm system receiver unit - reception

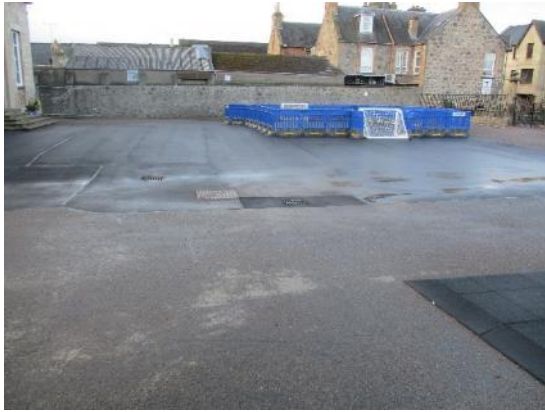
161. Tarmacadam playground

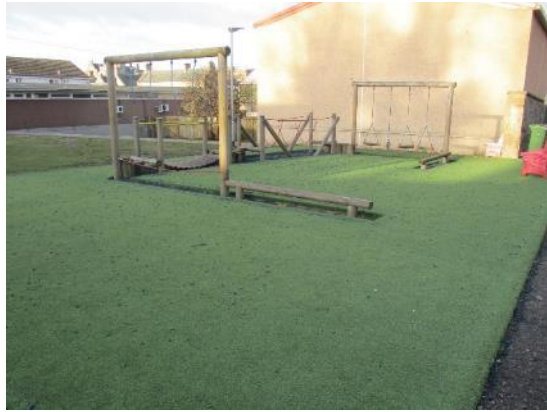
162. Log playground equipment

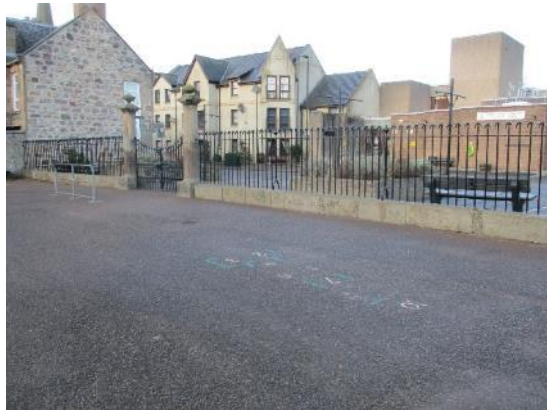
164. Cast iron railings (Listed)

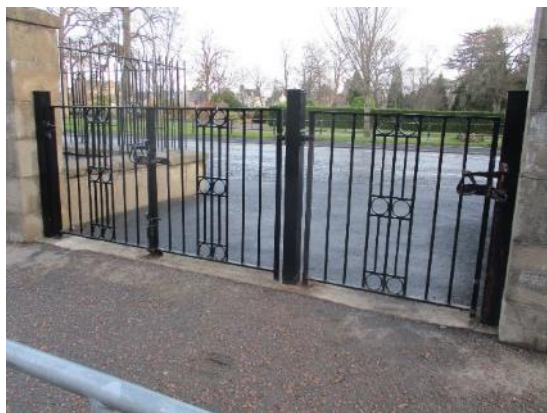
166. East gate

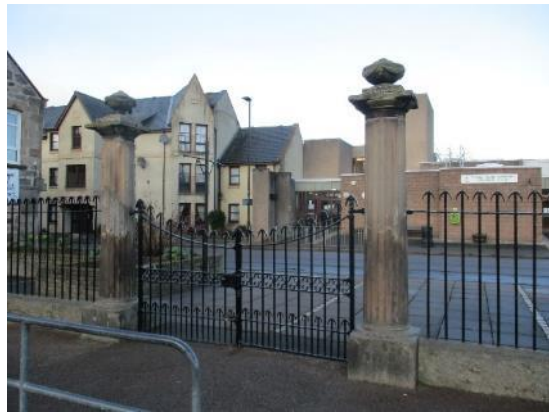
- Gate piers have exposed reinforcement and require repair (Cat B Listed).
- Perimeter wall surface cracking and efflorescence, cracked and broken coping stones.
- Gas supply pipe exiting the main gas meter has no mechanical protection and has evidence of being used to climb on.

168. Stone gate pillars (Listed)

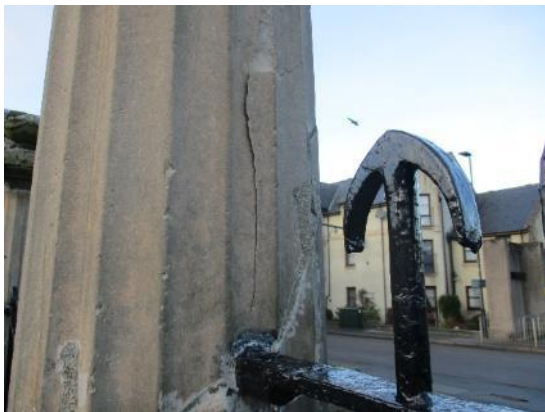
169. Stone cracking

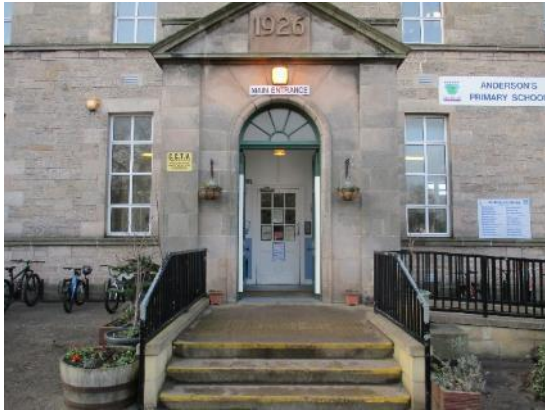
173. Signage
