# **Summary Building Condition Survey Report**

**Applegrove Primary School  
Orchard Road, Forres IV36 1PJ**

**21<sup>st</sup> & 22<sup>nd</sup> February 2022**

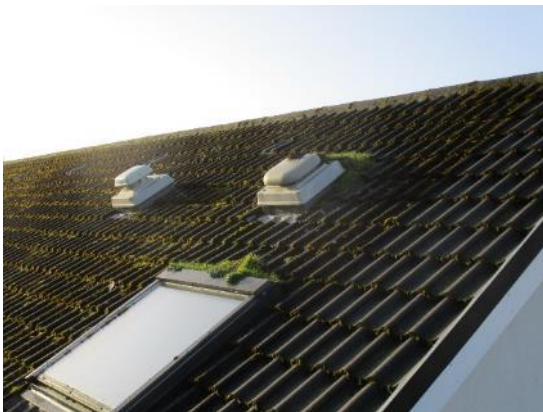
5. Extensive moss growth

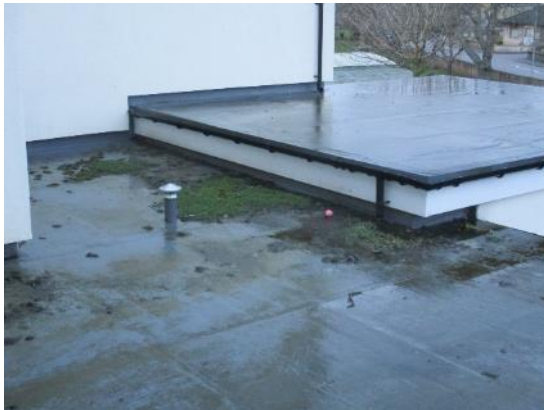
9. Moss and vegetation

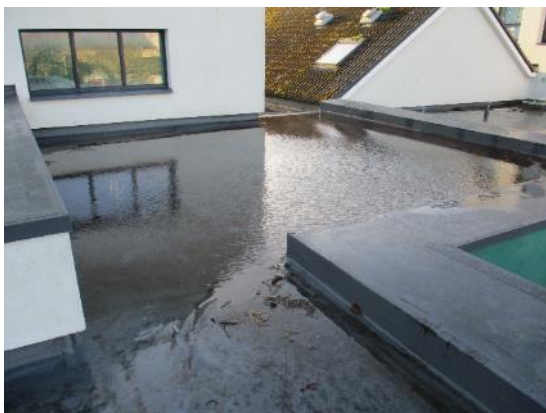
11. Flooding in isolated areas

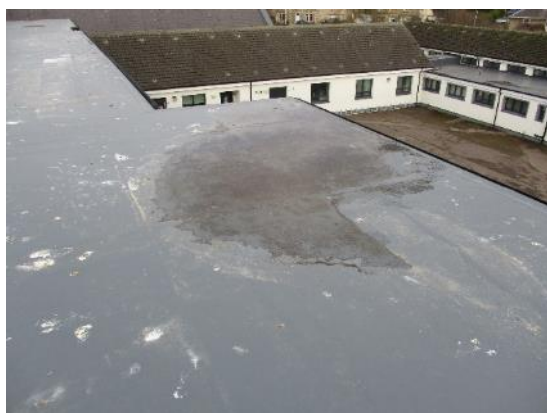
17. Isolated ponding

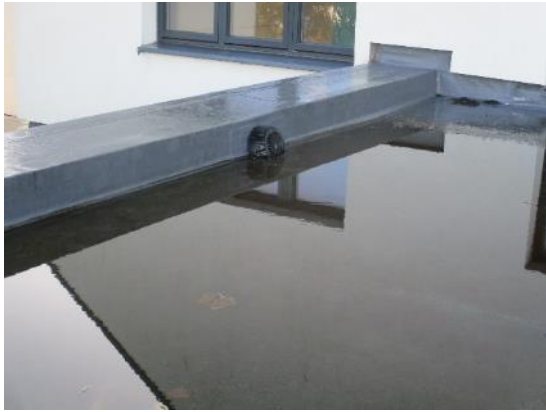
25. Flooding

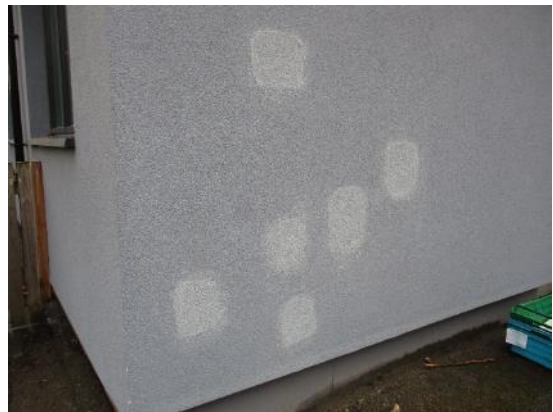
34. Previous repairs

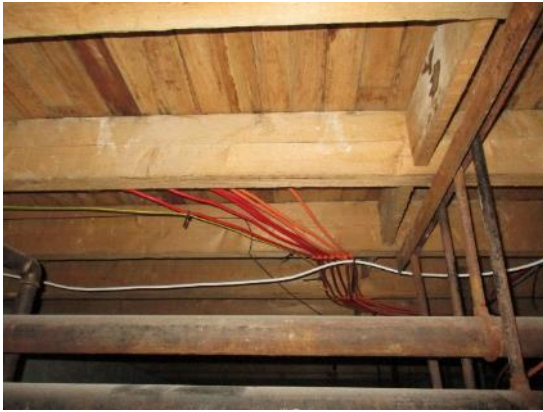
49. Suspended timber floor

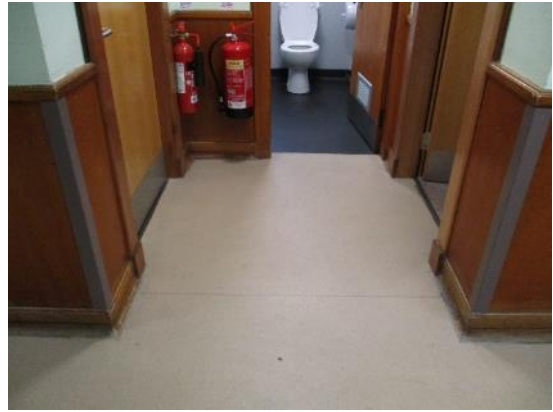
50. Sheet vinyl flooring

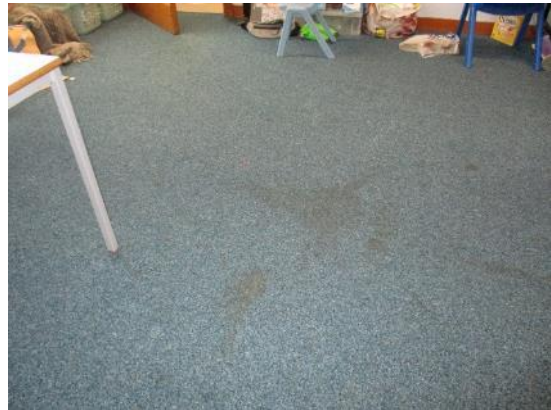
52. Soiled carpet flooring

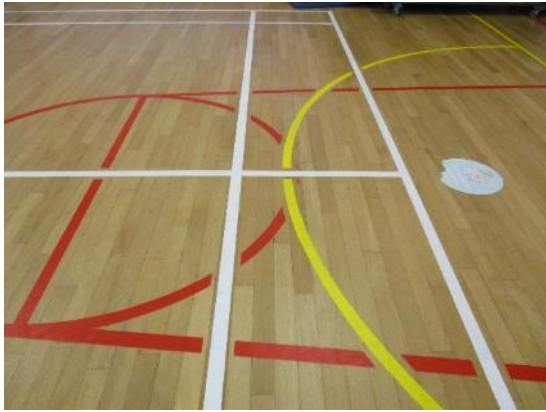
55. Timber boarded Gym

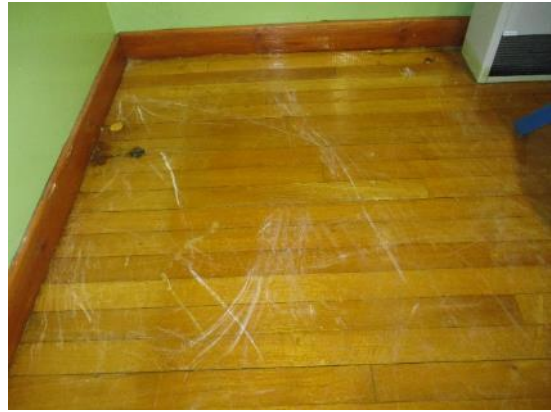
56. Timber floor – Assembly & Stage

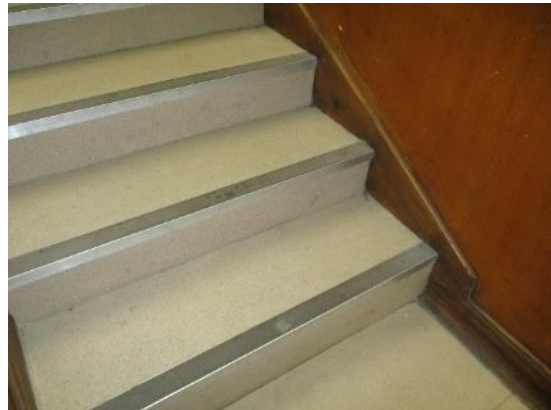
64. Vinyl treads to Stage

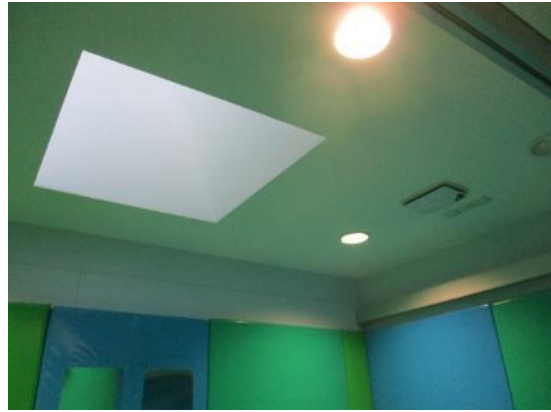
68. Plasterboard ceilings

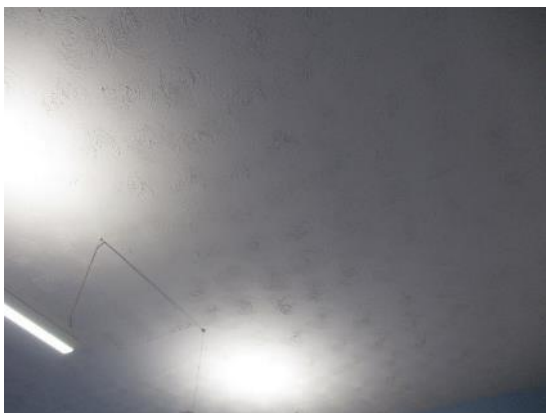
71. Textured ceilings

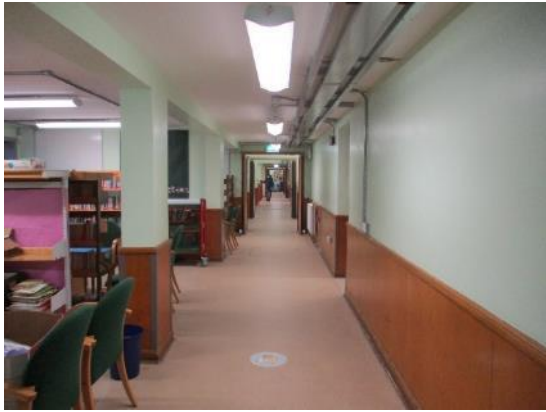
73. Plastered walls

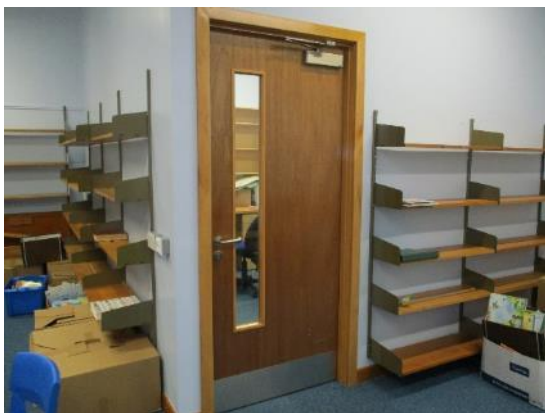
83. Replacement doors

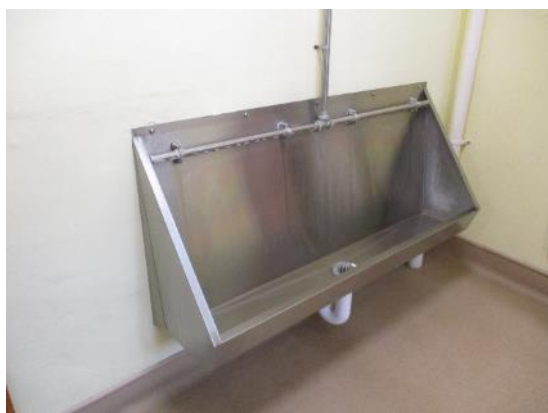
89. Stainless steel urinal

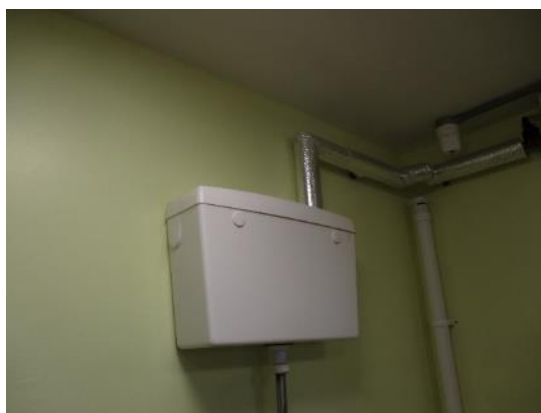
90. High level composite cistern

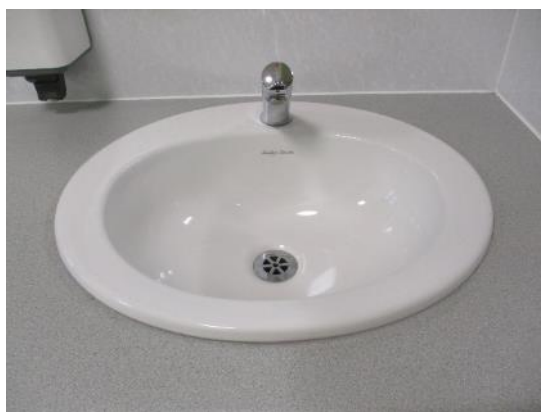
92. Vanity basin with motion tap

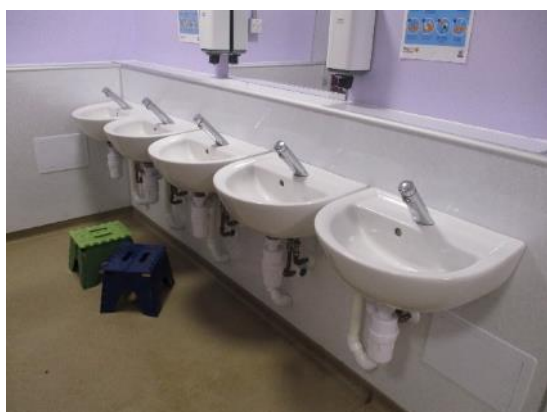
93. Wall hung basins with motion taps

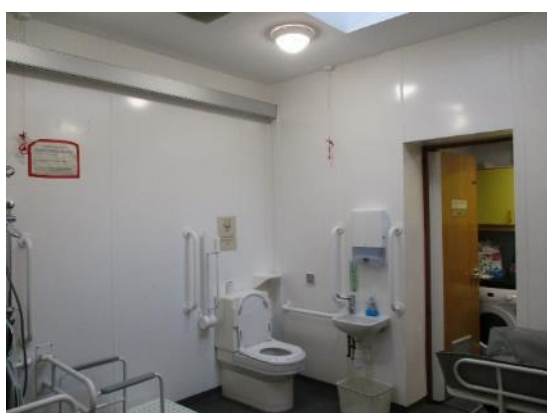
95. SEN accessible toilet

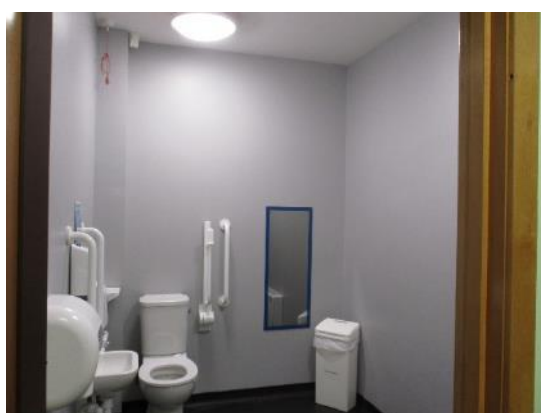
96. Pupil accessible toilet

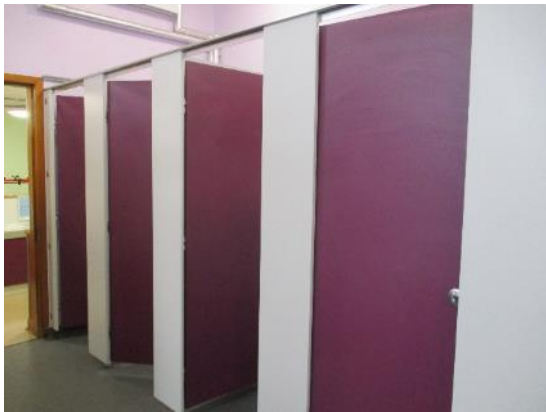
97. Cubicle partitions

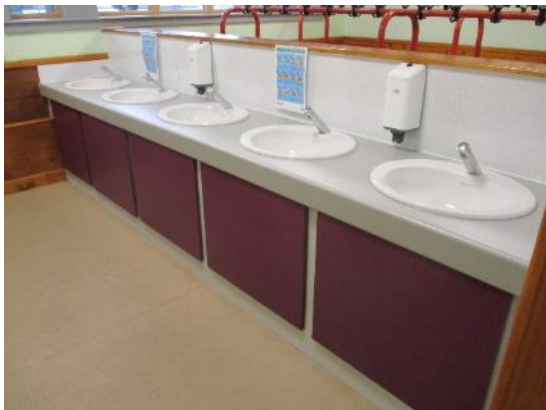
99. Vanity units

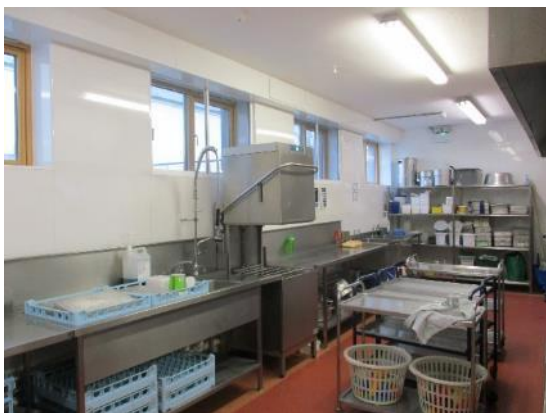
101. Commercial kitchen

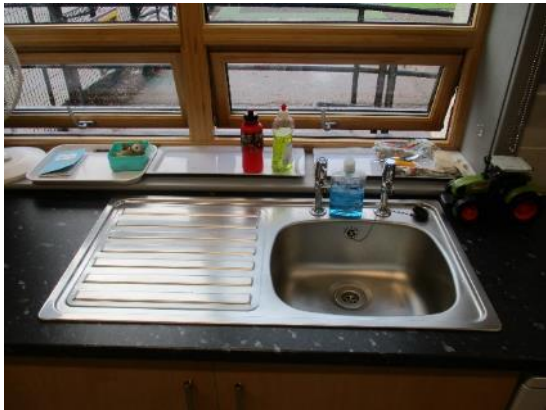
105. Typical stainless steel sink

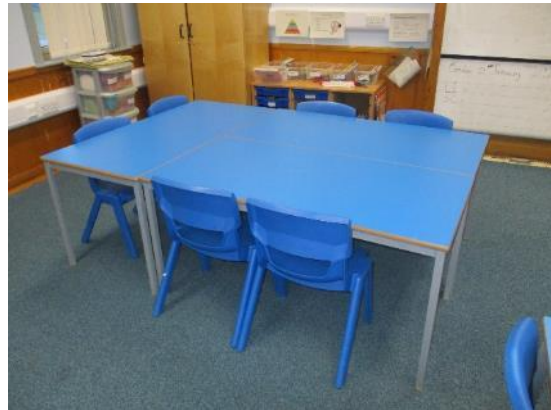
106. Classroom furniture

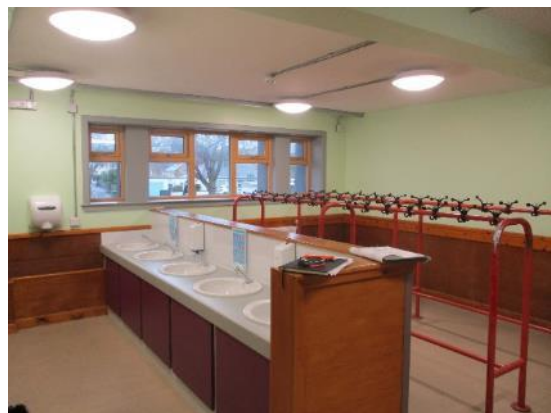
108. Cloakroom rails

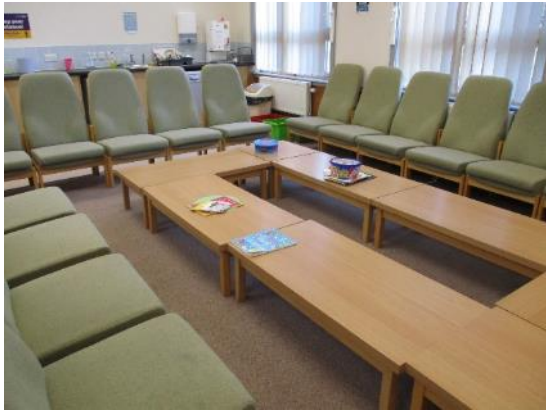
109. Staff room furniture

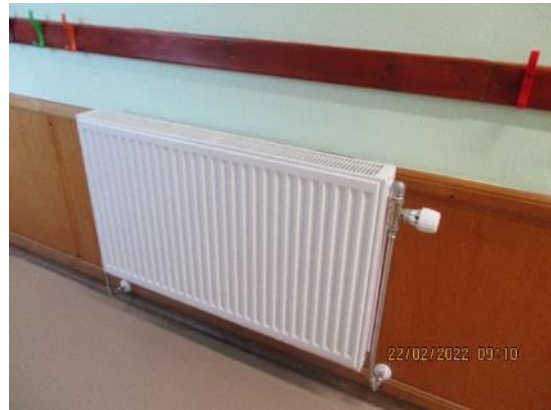
114. Radiator example

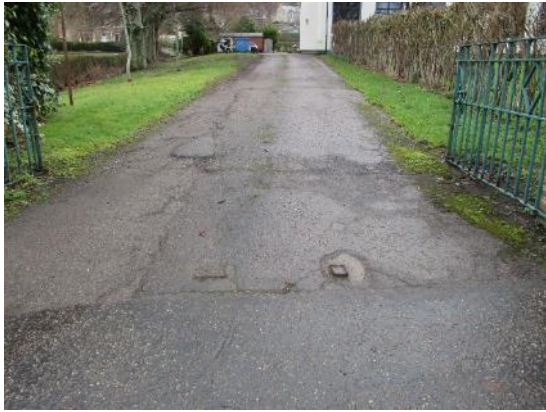
160. Surface damage and flooding

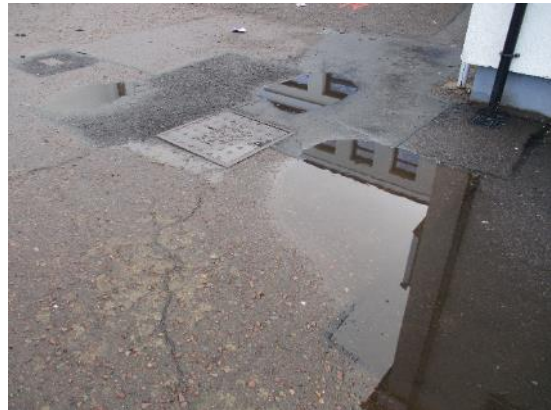
162. Isolated ponding

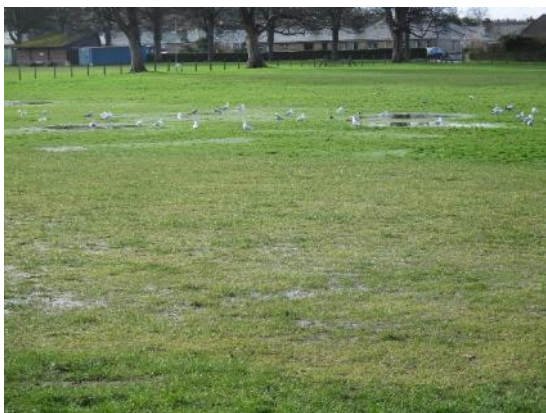
- Tarmacadam paths at gated entrances are cracked and breaking up.
- Entrance gates have significant corrosion.
- The playing field floods and required improved drainage.

175. Playing field flooding
