# Summary Building Condition Survey Report

**Dallas Primary School**  
**Knockando Road, Dallas IV36 2SA**

**24<sup>th</sup> May 2022**

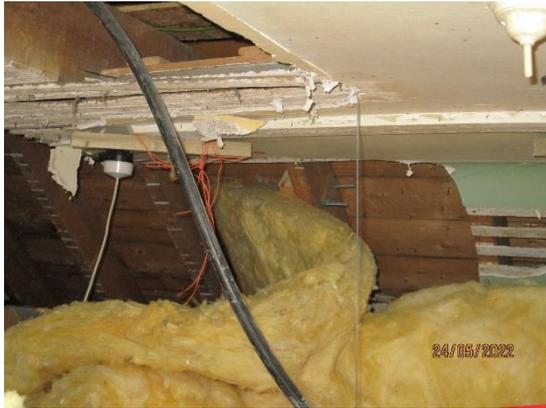
1. Main roof structure

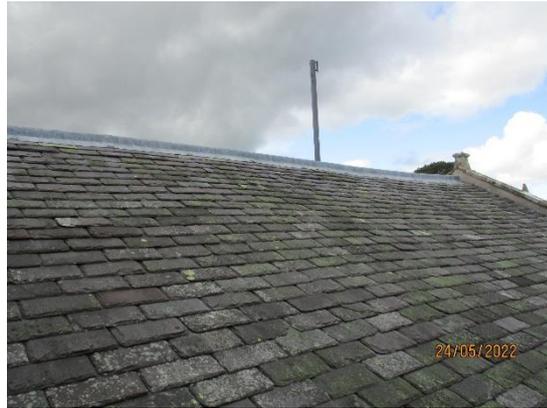
2. Slight sag in roof structure

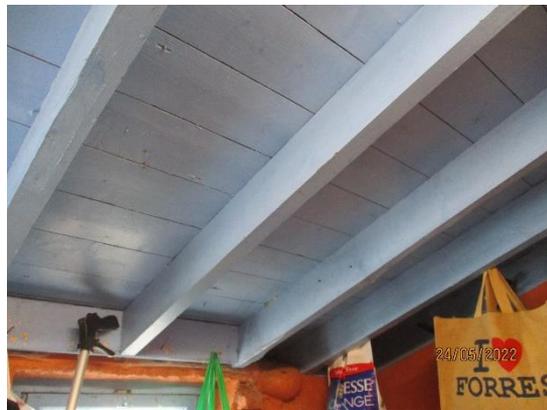
4. External stores roof structure

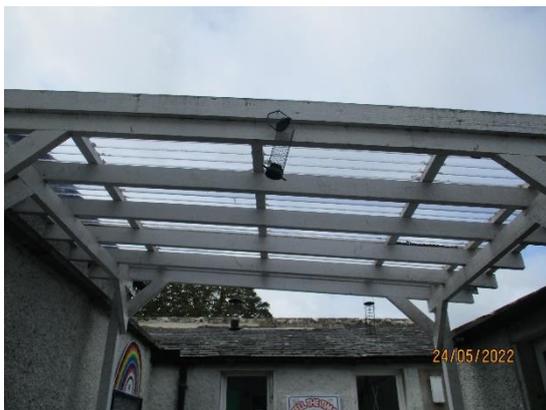
5. Pergola roof structure

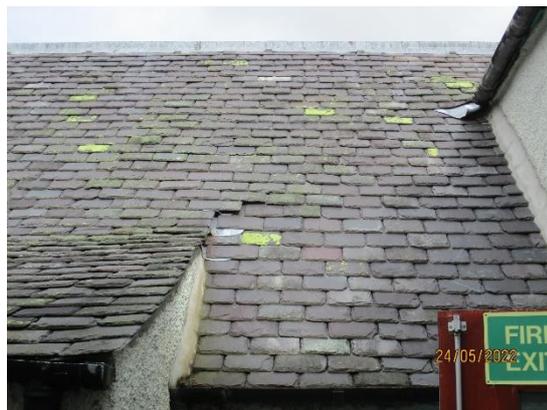
6. Slated roof

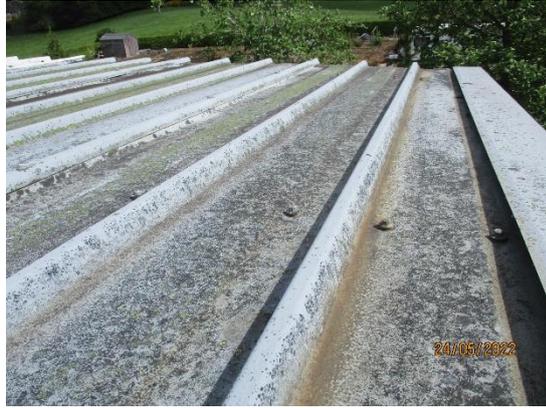
8. Metal profiled roofs

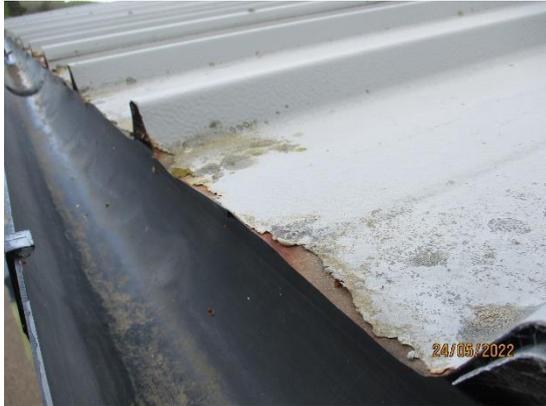
- Water penetration above the corridor to pupil toilets.
- Cut edge corrosion to profiled metal roof coverings.
- Capping and ventilation of the chimney stacks to be confirmed.
- Fascia boards have early signs of wet rot and paint is peeling.
- Several windows have defective double glazed units
- Several ceiling tiles are damaged and watermarked.
- Carpet tiles are worn, soiled and lifting.
- Inadequate underfloor ventilation to some rooms.
- Creaking floor boards in several areas.

9. Cut edge corrosion

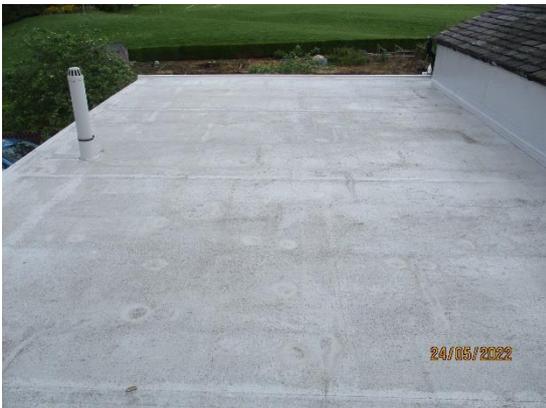
11. Single ply membrane above pupil toilets

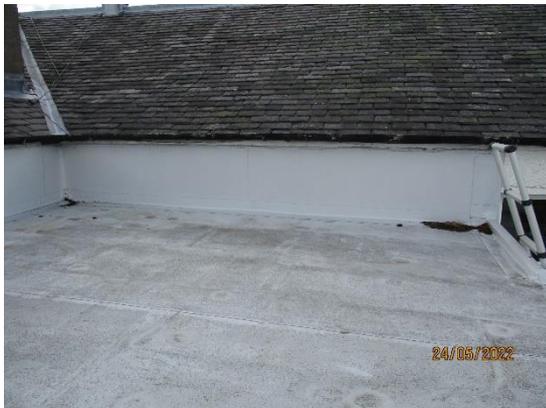
12. Upstand to adjacent walls

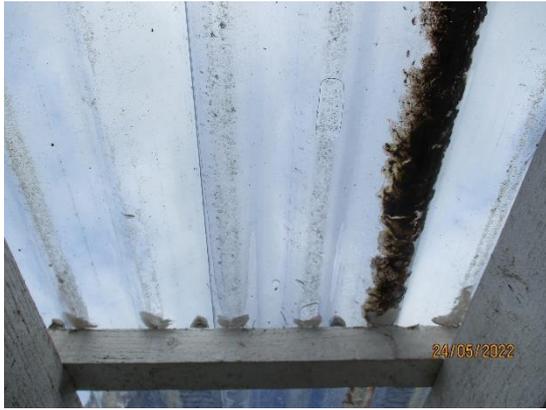
13. Corrugated Perspex roof

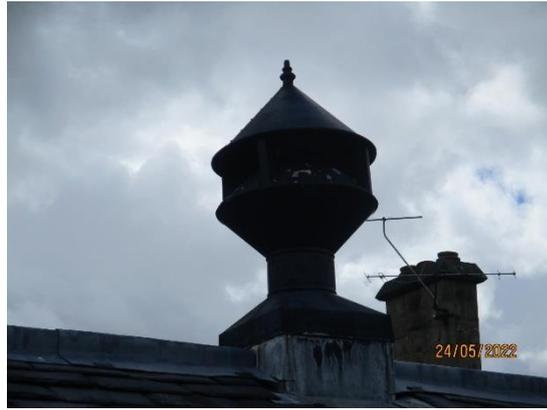
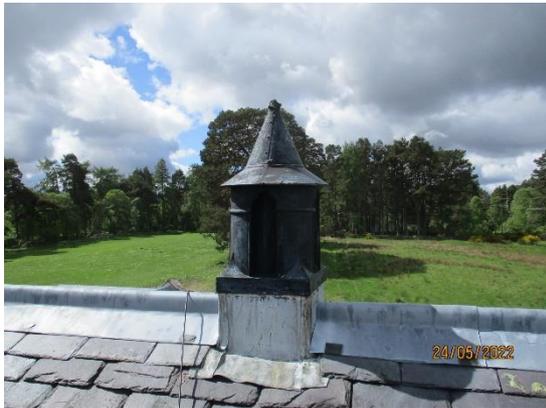
14. Roof vents

15. Roof vents

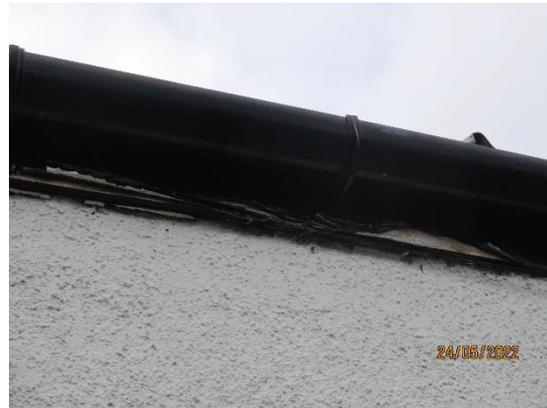
16. Timber fascia boards

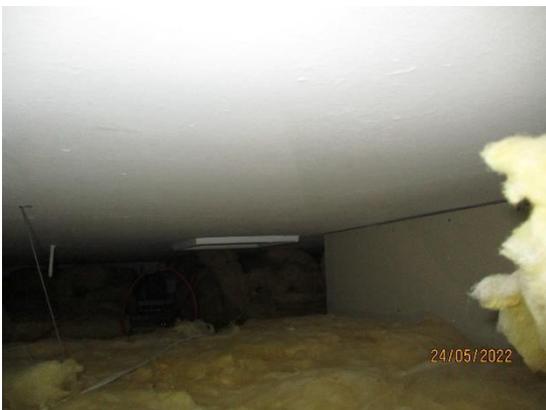
17. Insulation laid over suspended ceilings

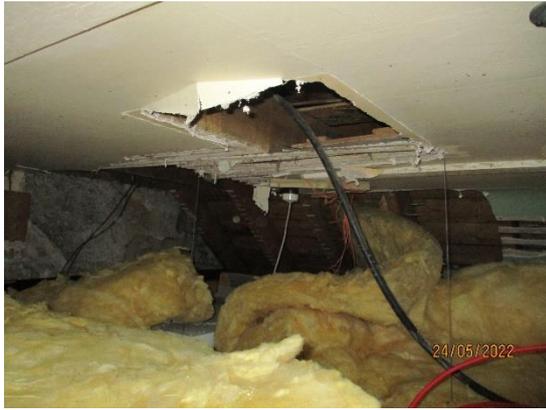
19. Disturbed insulation

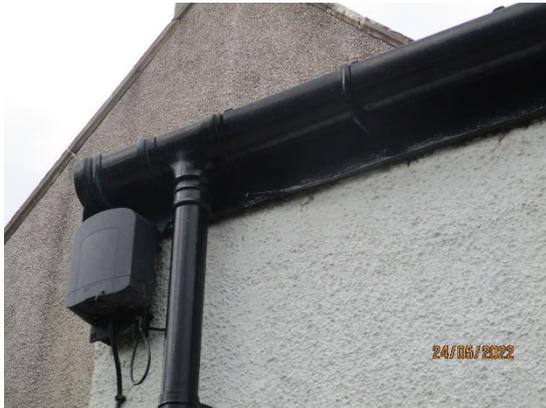
21. UPVC half round gutters

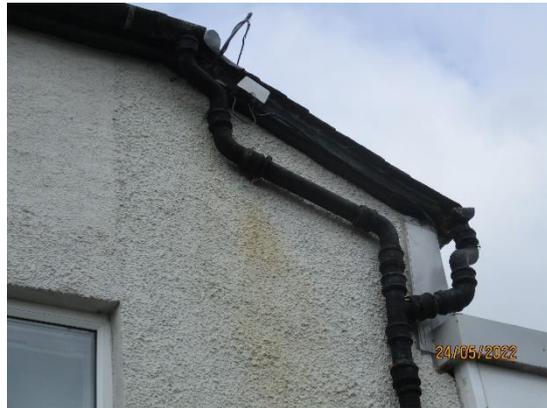
22. Cast iron downpipes

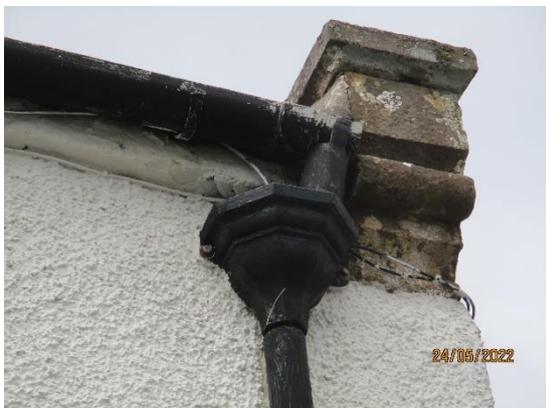
23. Cast iron hopper heads

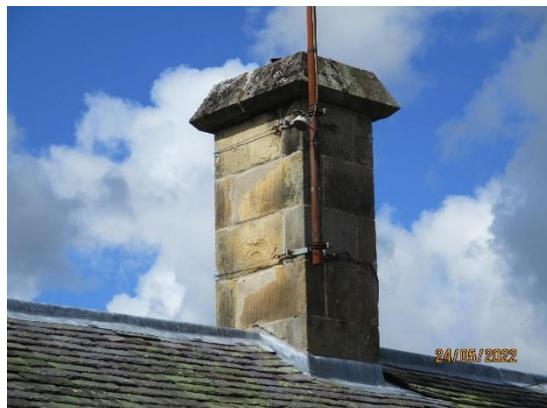
24. Stone chimney

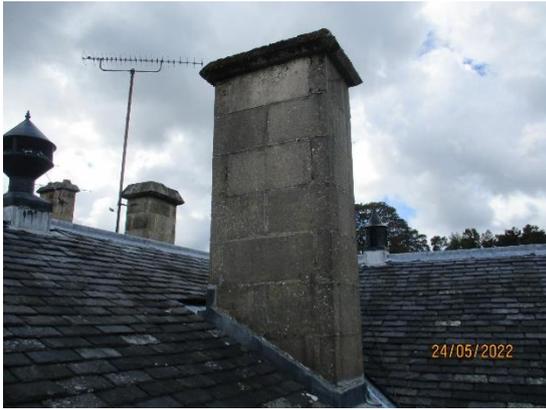
25. Masonry chimney

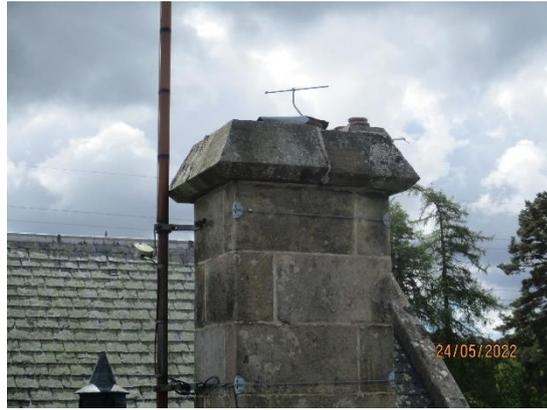
26. Capping of pots/flues

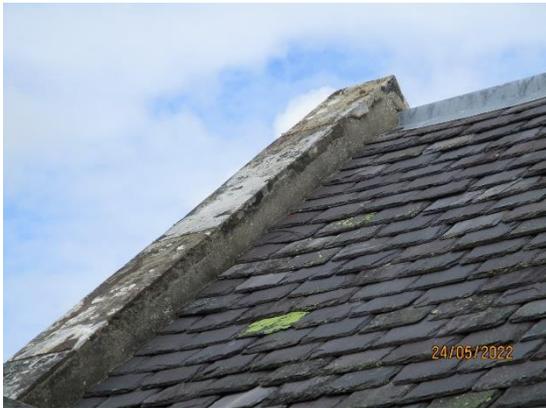
27. Pointed skew stones

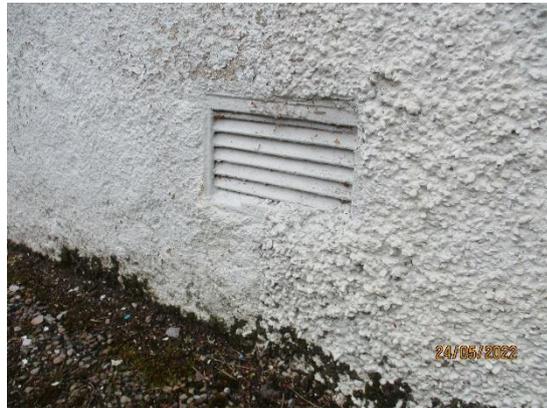
28. Underfloor ventilation

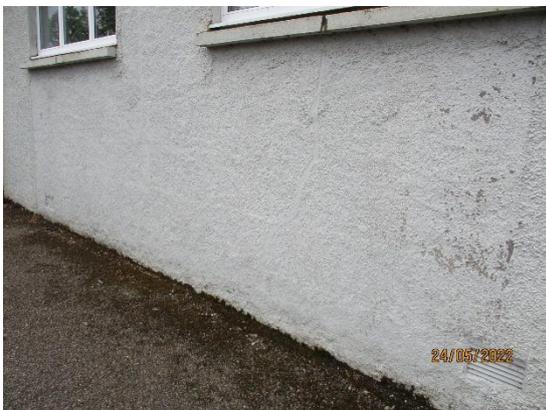
29. Roughcast walls

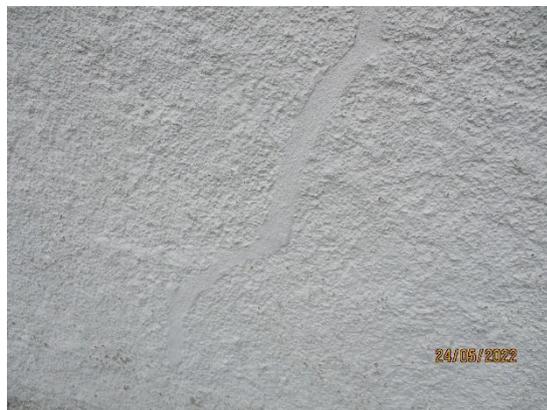
30. Evidence of previous repairs

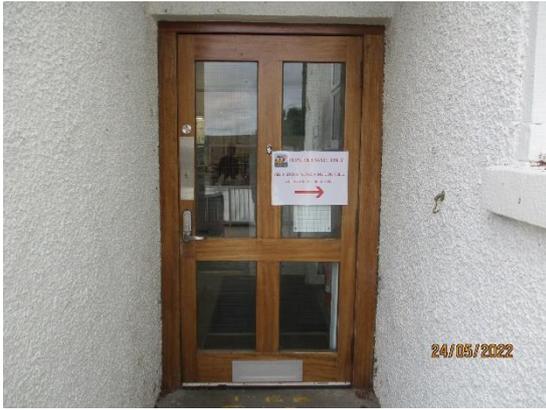
31. External timber doors

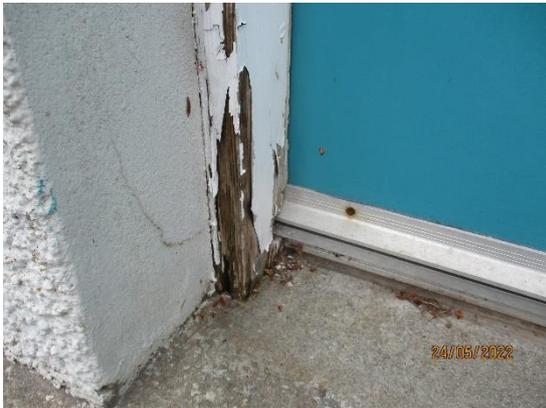
33. Rot in timber frame

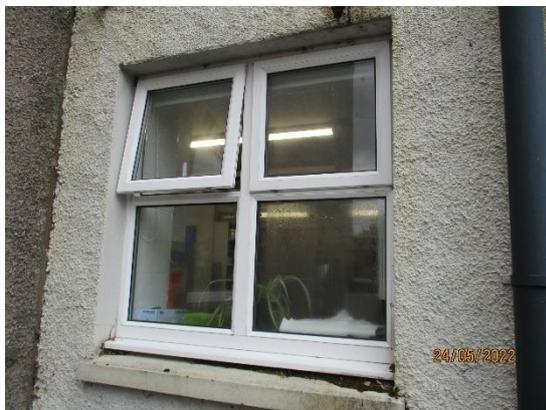
35. Standard UPVC windows

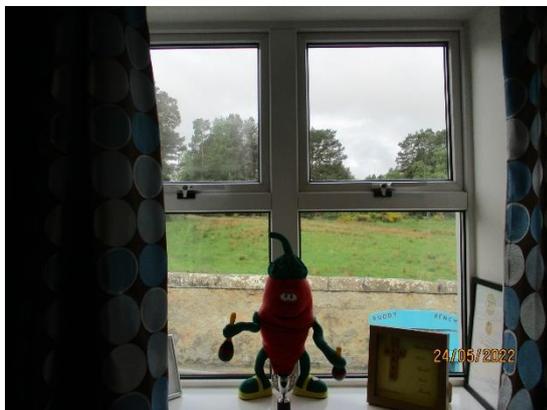
36. Windows internally

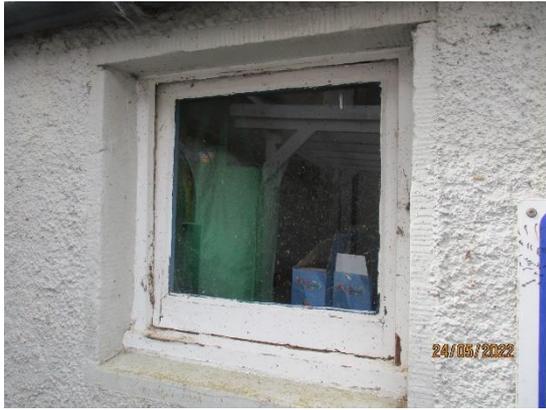
37. Timber windows to external stores

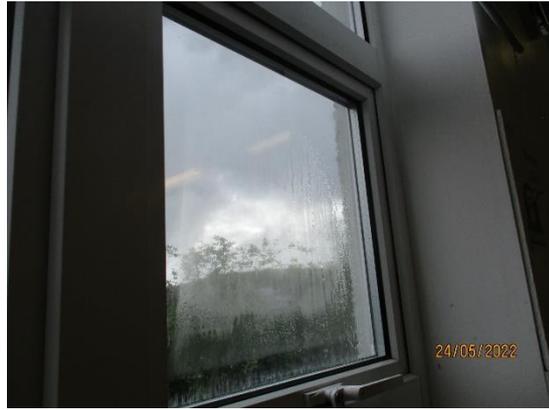
38. Failed double glazing unit

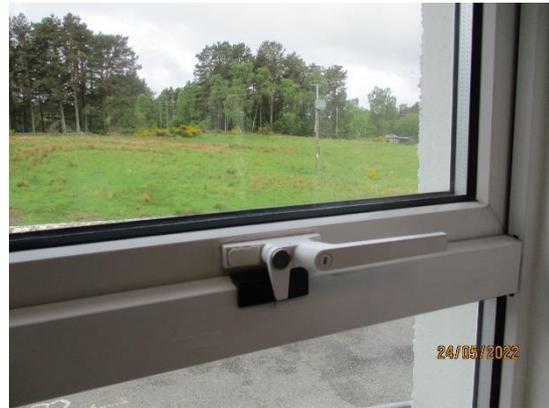
40. Typical locking handle

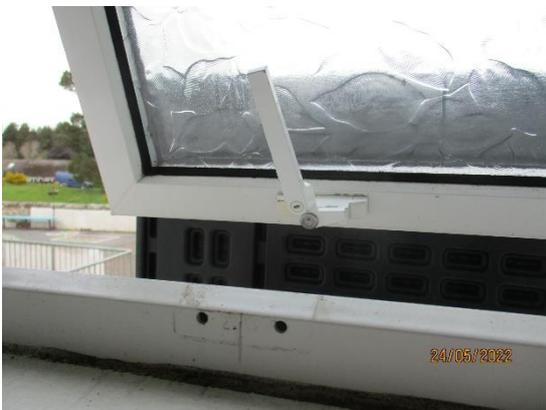
41. Missing ironmongery

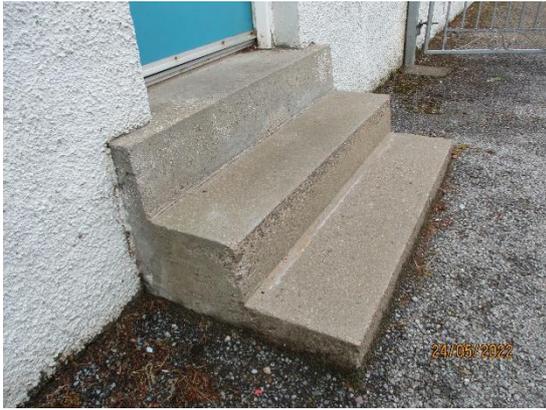
42. Concrete steps to Kitchen

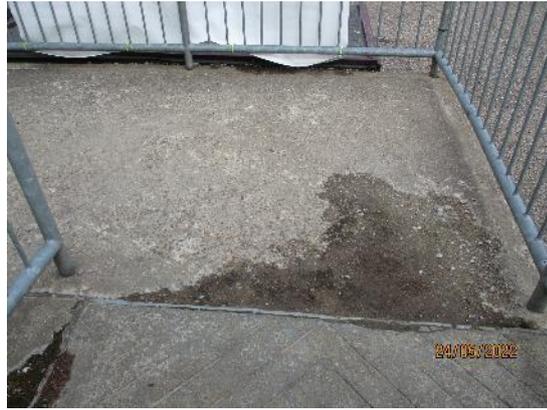
- Concrete ramps are cracked and spalling.
- Roughcast is spalling from the perimeter wall.

43. Concrete ramps

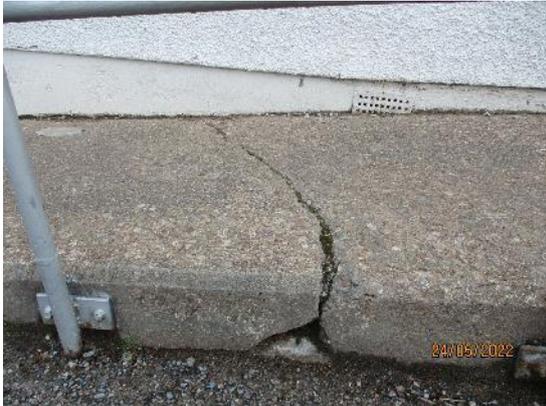
44. Cracked ramp

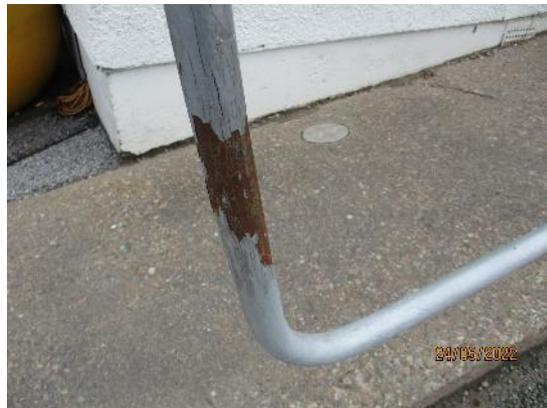
47. Peeling, flaking paint

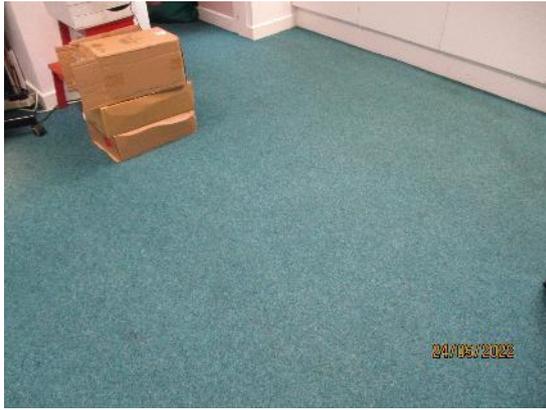
48. Soiled carpet

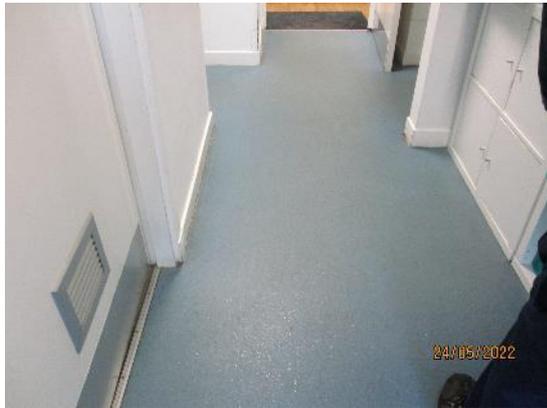
51. Sheet vinyl

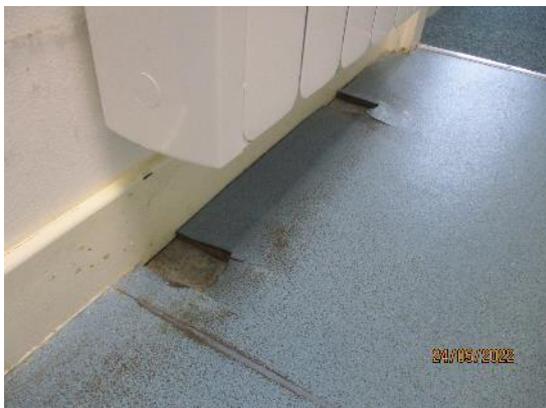
52. Holes and soiled vinyl flooring

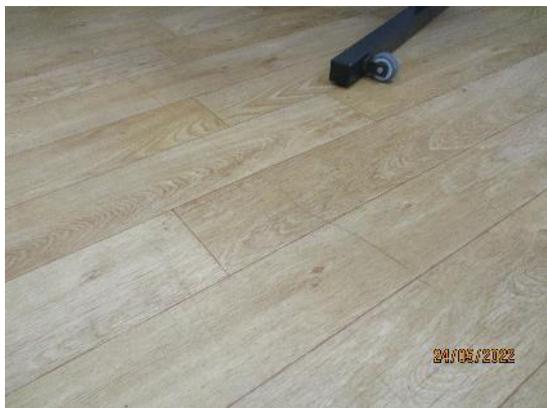
53. Sheet vinyl flooring

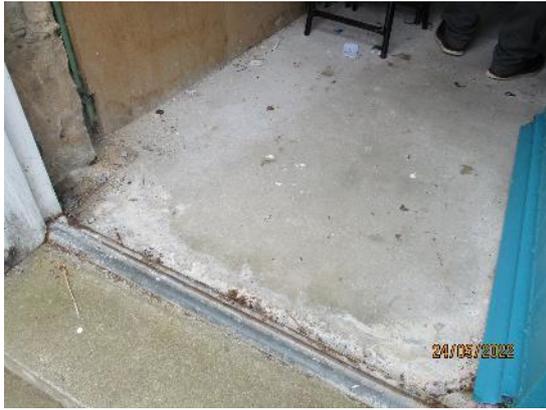
54. Concrete floor (Switch Gear Room)

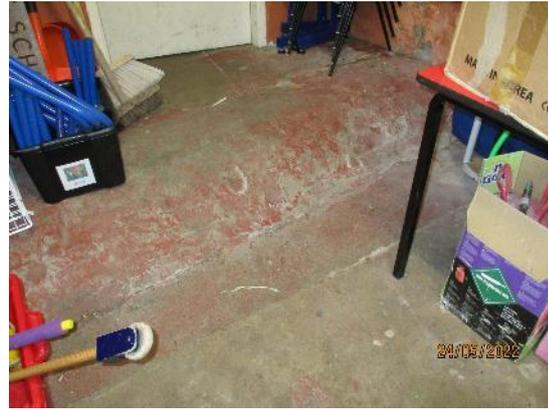
55. Concrete floor (External Stores)

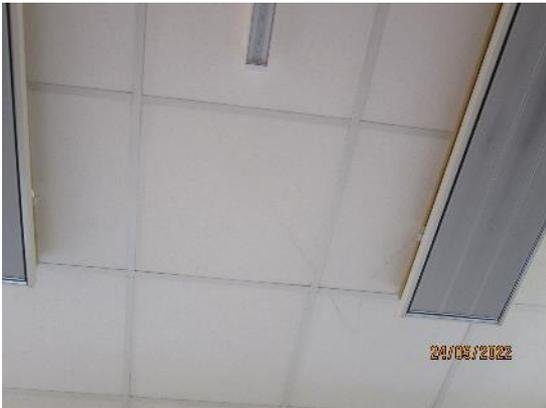
56. Suspended ceiling tiles

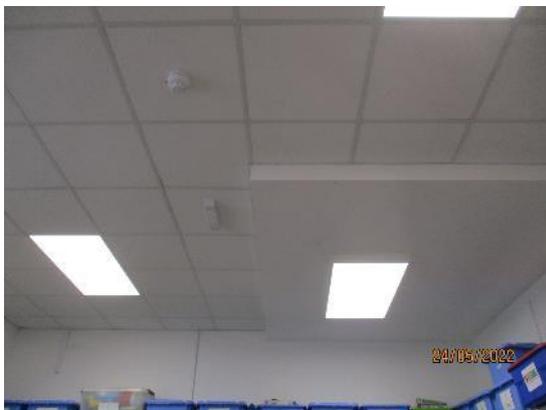
58. Suspended ceiling tiles / Plasterboard

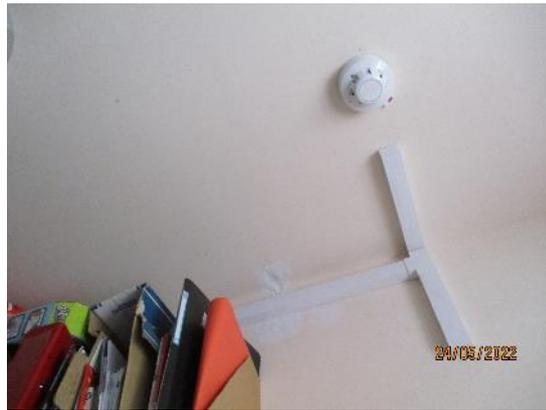
61. Repairs to plasterboard ceilings

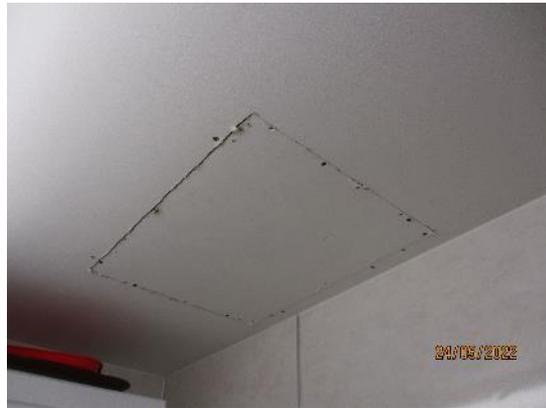
63. Access patch in plasterboard ceiling

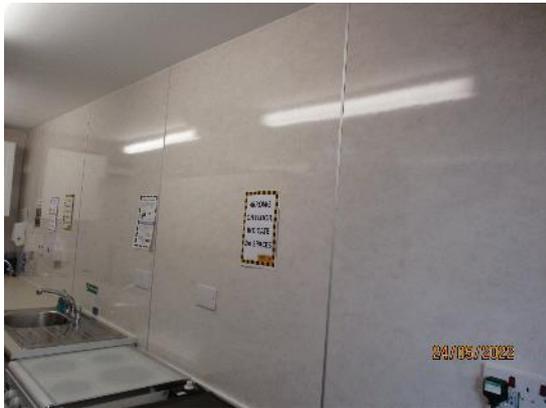
68. Wetwall (Kitchen)

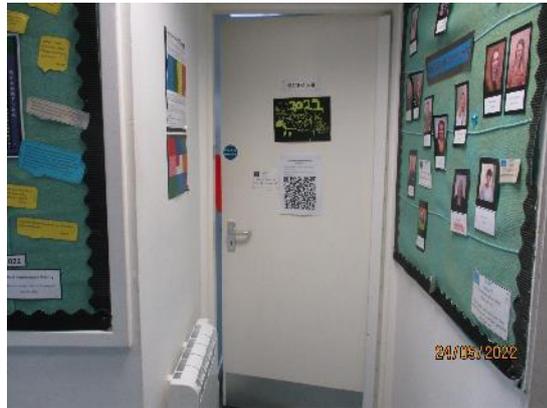
69. Timber internal doors

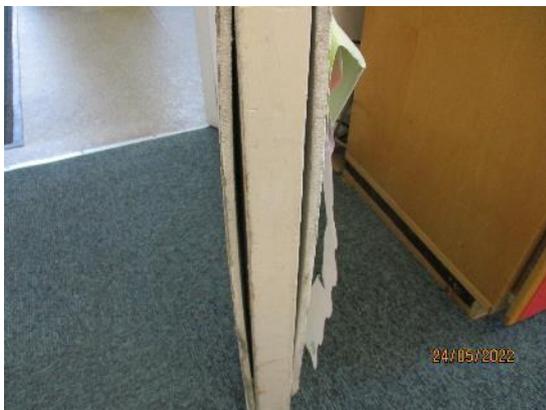
70. Faced with fire retardant board

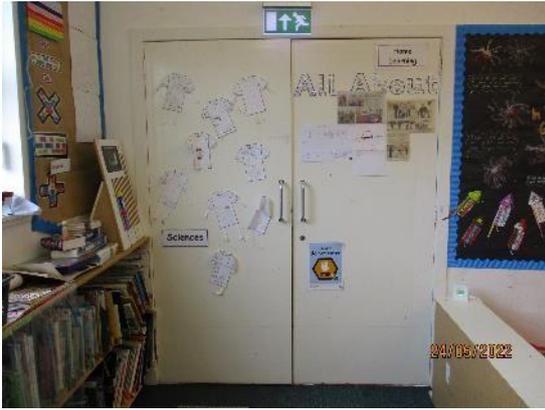
72. Timber double doors

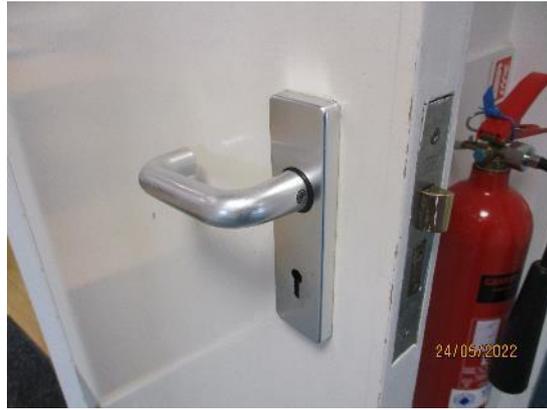
73. Aluminium lever handles

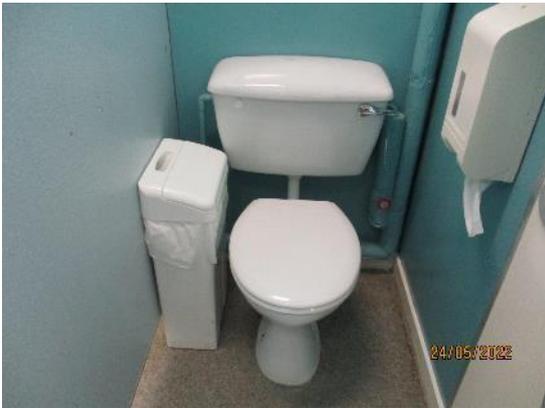
74. Typical WC

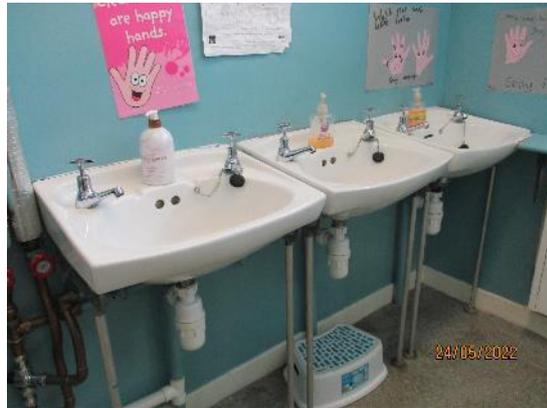
75. Wall hung basins

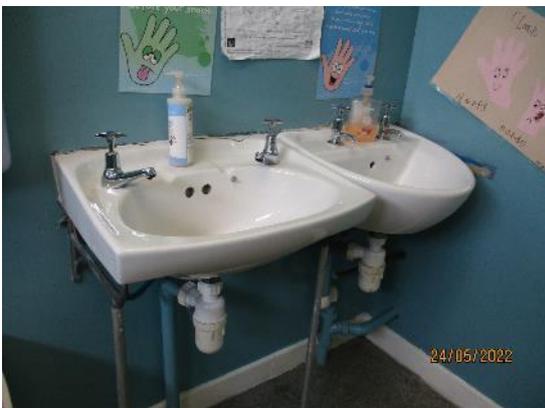
76. Miss-matched basins

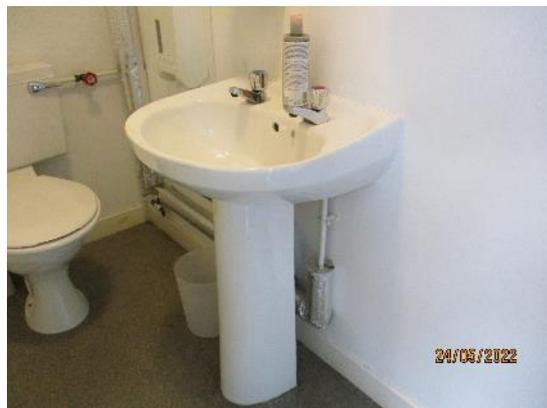
77. Pedestal basin (Staff Toilet)

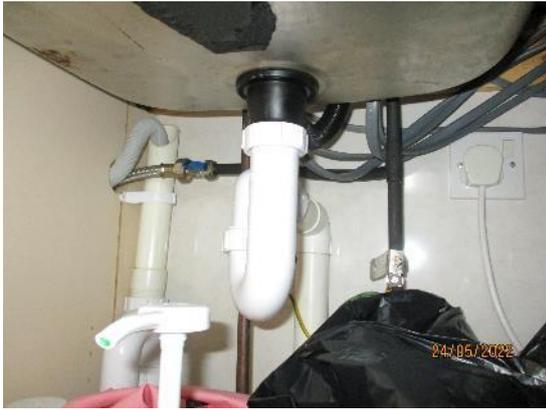
78. PVC waste pipes

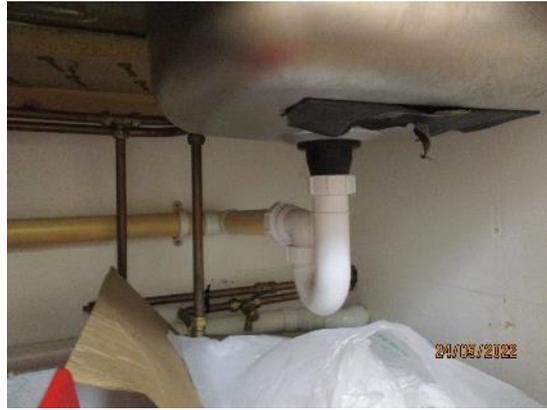
79. New to old PVC waste pipes

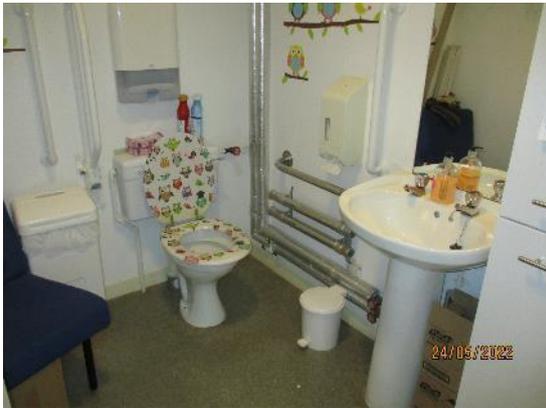
80. Accessible toilet

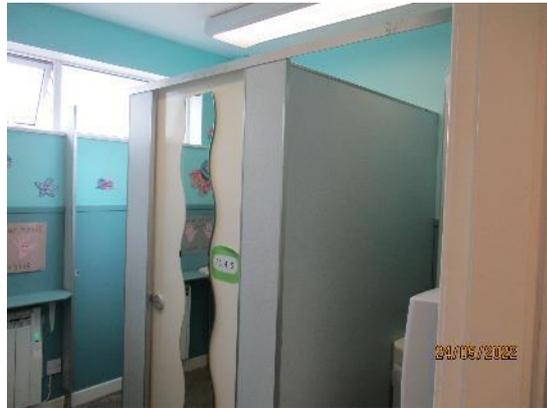
81. Cubicle partitions

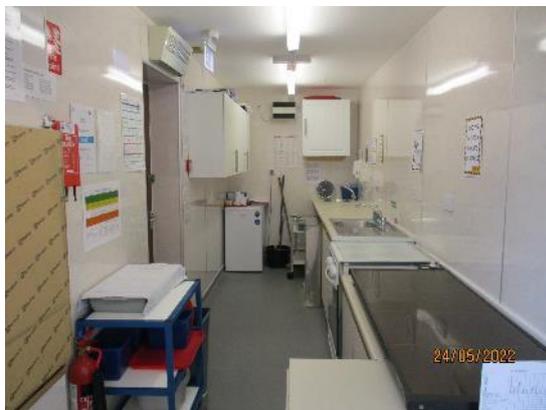
82. Commercial kitchen

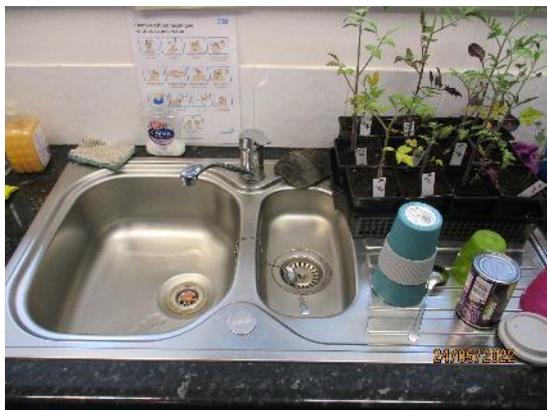
83. Stainless steel sinks

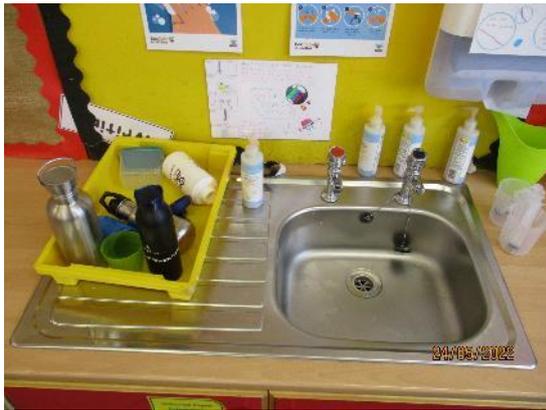
84. Classroom stainless steel sinks

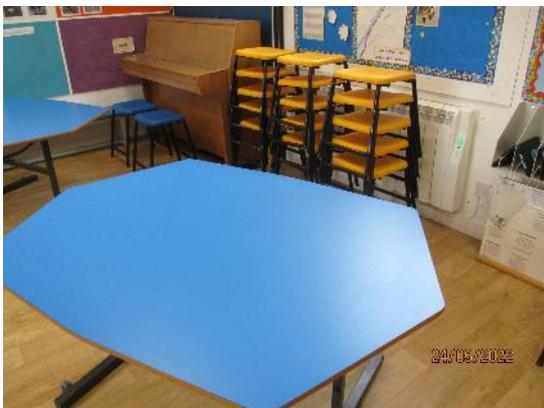
87. Classroom furniture

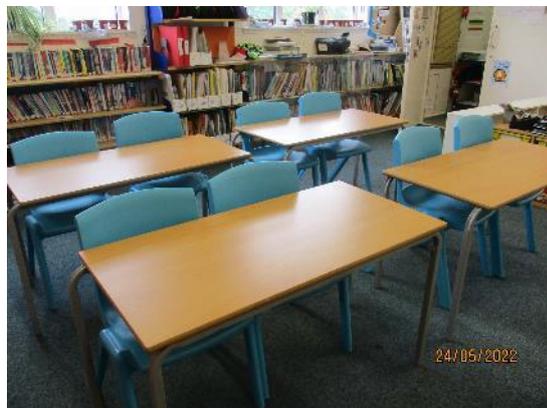
88. Tables and chairs

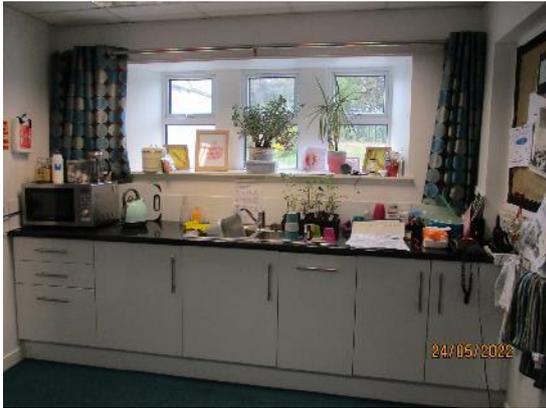
89. Kitchen base units

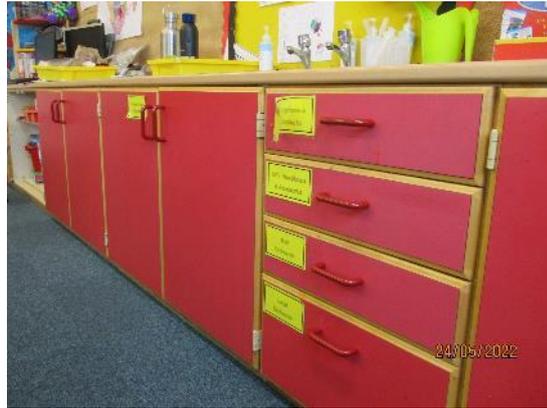
90. Classroom base units

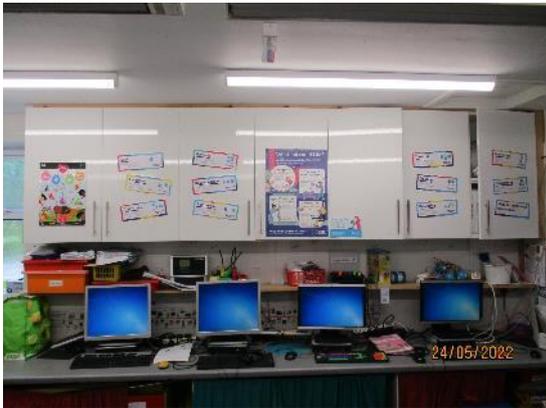
91. Classroom wall units

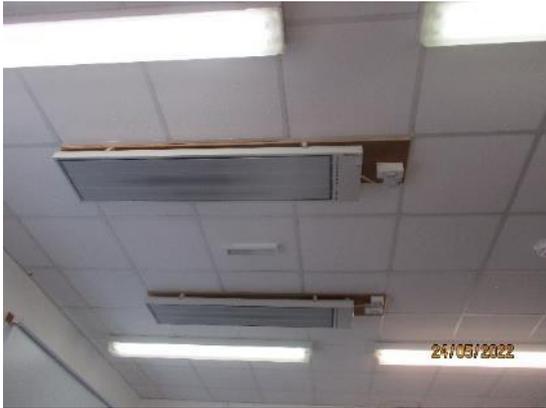
92. Electric ceiling radiant heater panels. Classroom.

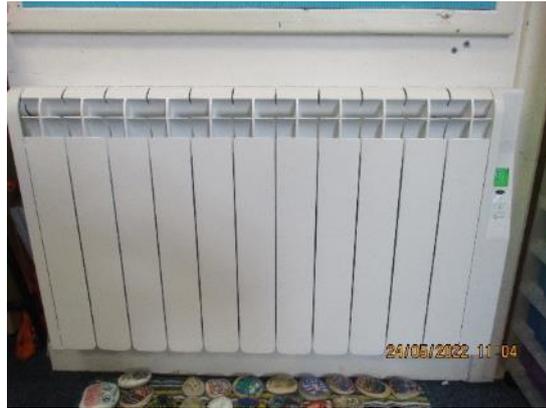
93. Electric radiator – classroom.

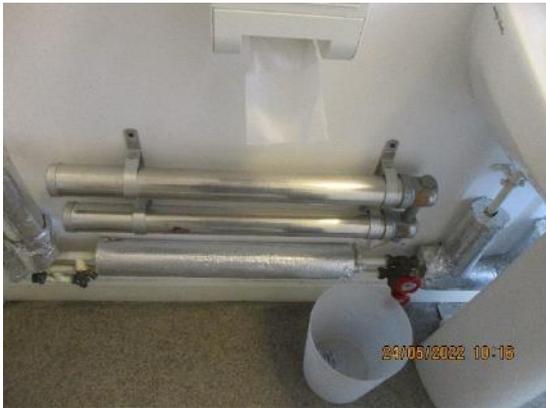
94. Electric tube heaters – Toilet.

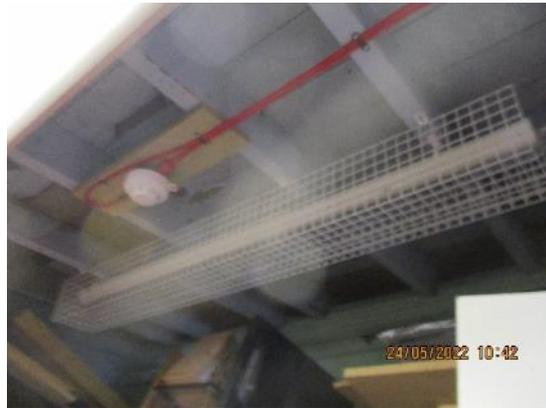
95. Electric tube heaters. External store.

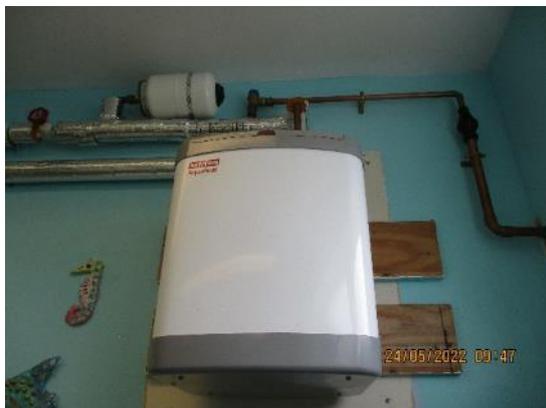
- The electric installation is reaching the end of its useful life.
- Some point of use electrical water heaters are reaching the end of useful life.
- External lighting is in poor condition and showing evidence of water ingress.
- The current CCTV system installation is not useable due to defects and removal of the external camera.
- Areas of hot and cold water pipework are uninsulated.
- A percentage of internal lighting is dated and reaching the end of its useful life.

96. Water heater – electric. Girls toilets.

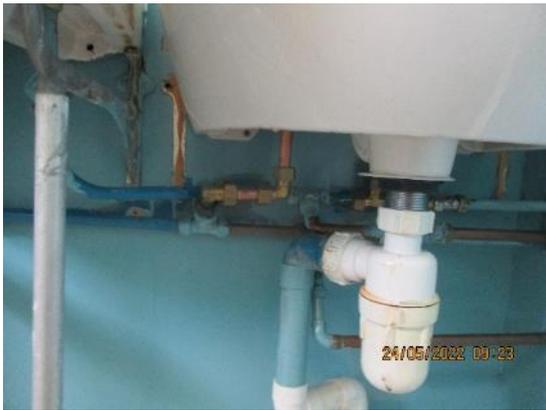
97. Water heater – electric. Staff toilet typical.

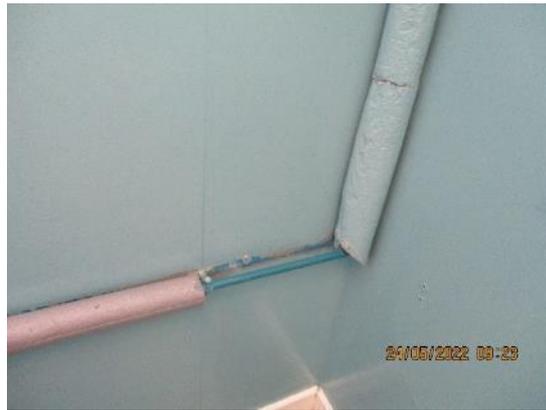
98. Pipework – copper. Cold water/boys toilets.

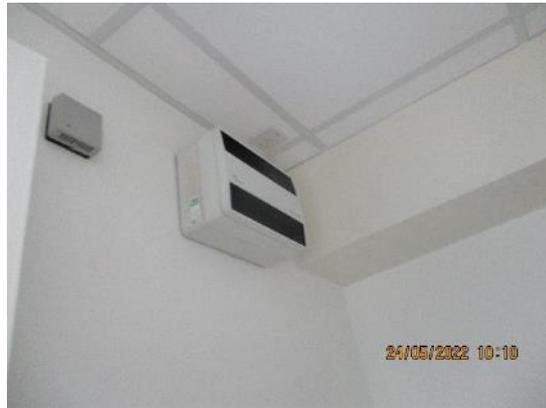
100. Extract fan – electric. Kitchen.

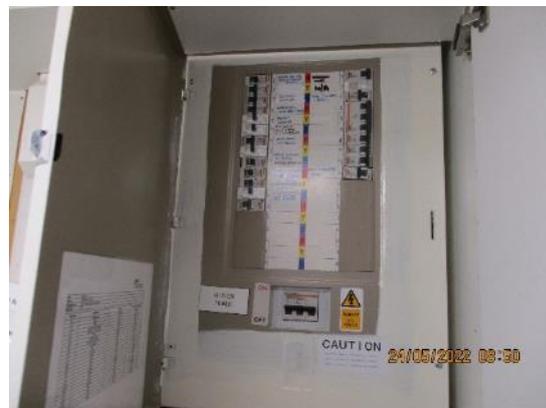
102. Main distribution board – switchgear room 1-20.

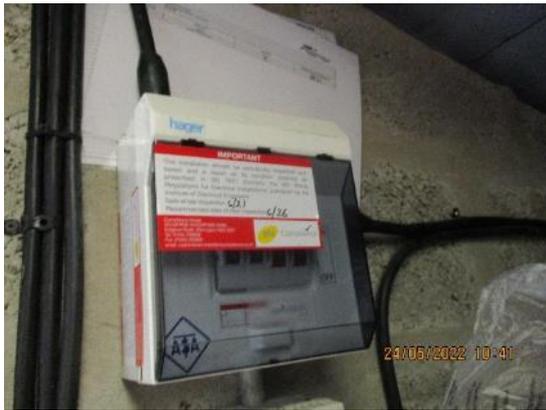
103. Distribution board. Power and lighting. Class 1-9

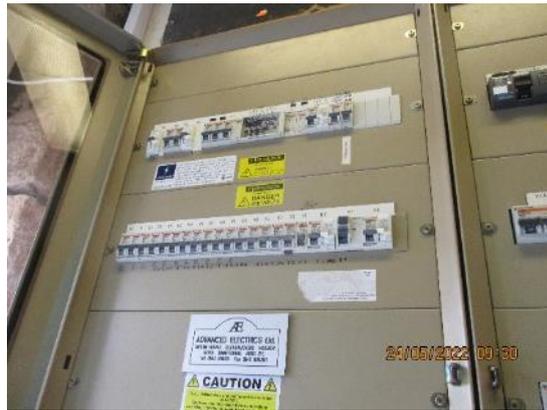
104. Consumer unit. External store 1-22.

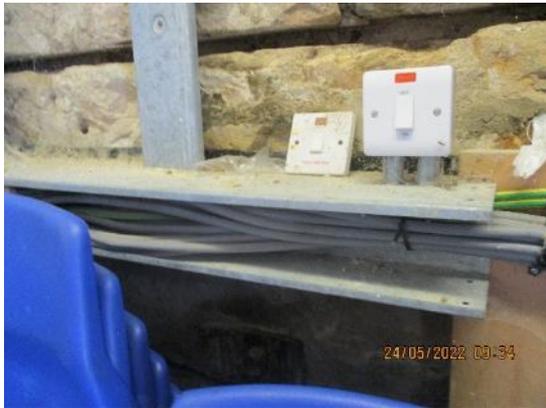
105. DB lighting and power. Main switchgear room. 1-20

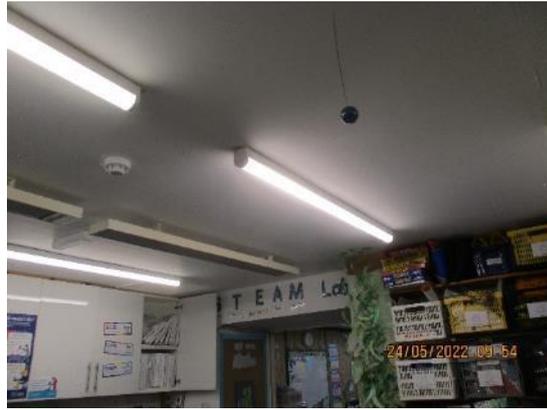
110. Lighting – HT office 1-17.

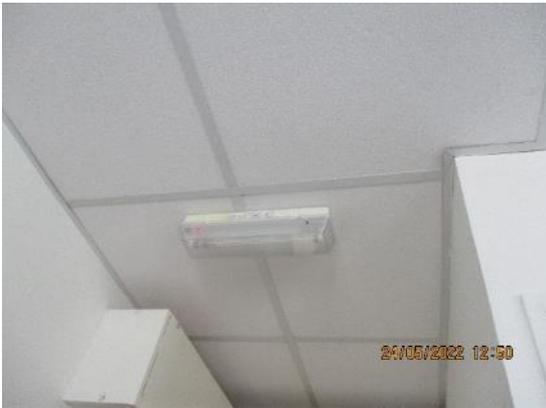
111. Lighting –classroom.

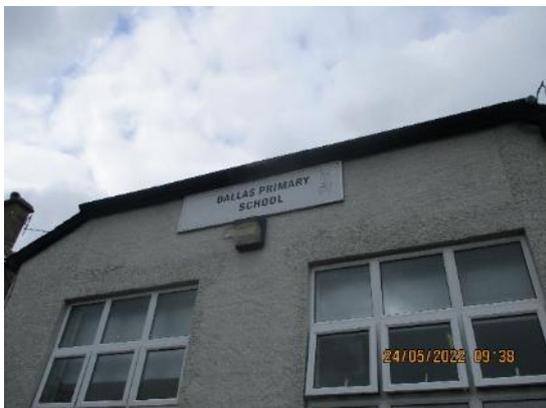
113. Emergency light. External fire escape typical.

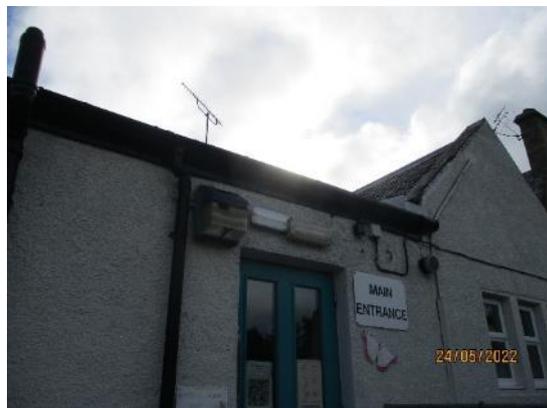
114. External lighting – typical.

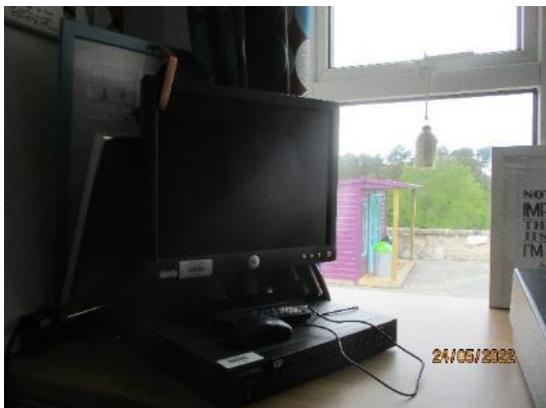
125. Comms cabinet – HT office.

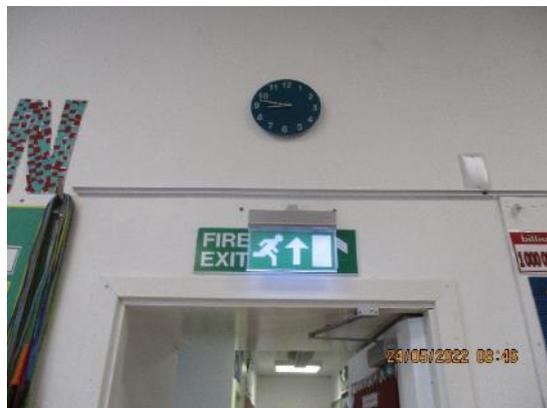
At the time of the survey, the CCTV camera that had been installed previously at the main entrance had been removed for reasons of previous repair or due to being defective. The viewing monitor and recorder unit located in the head teachers' office is also currently not connected or able to be used.

126. CCTV monitor and recorder. (Unused)

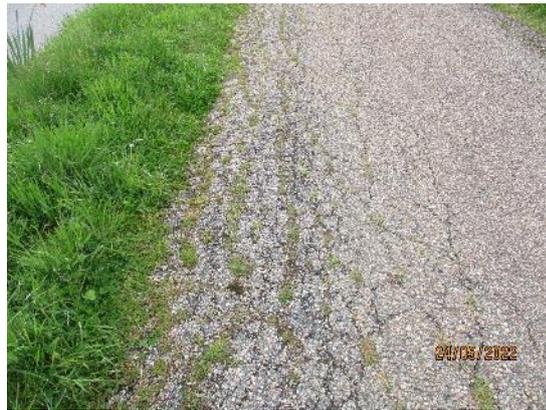
129. Crumbling edge

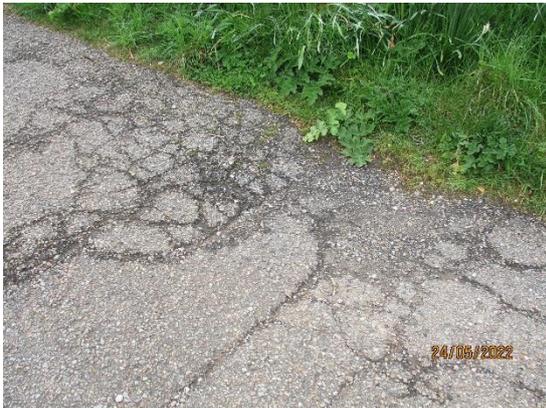
130. Cracked surface

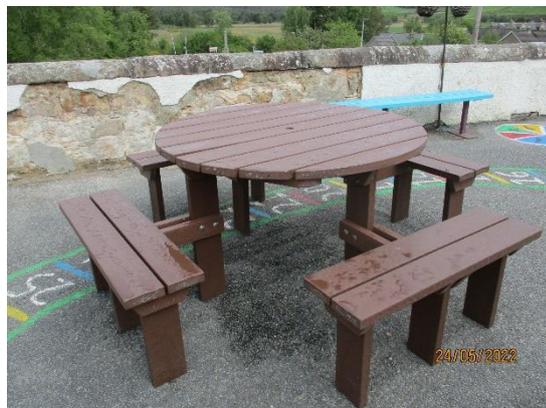
133. Playground equipment

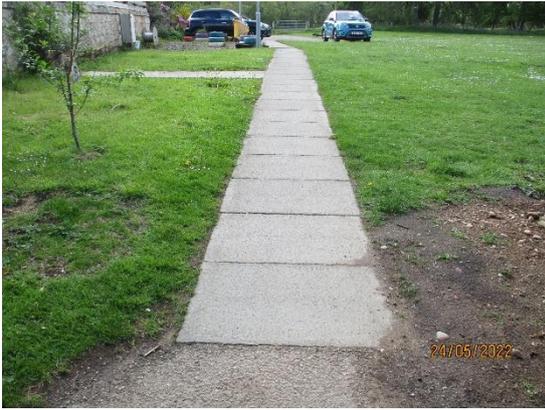
134. Paving slab footpaths

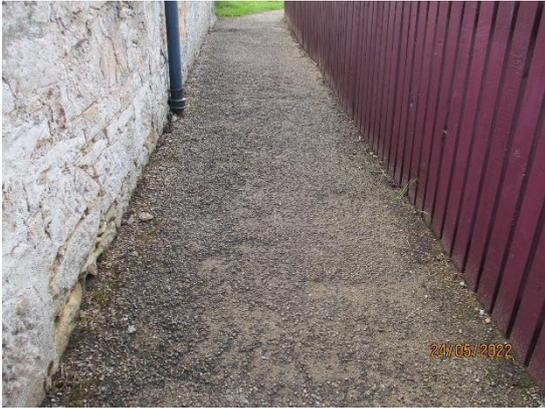
136. Tarmacadam footpath

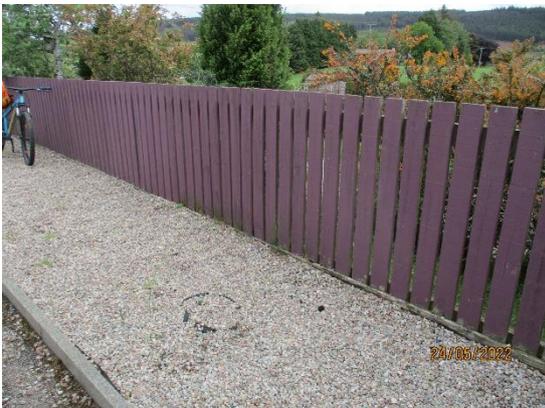
138. Timber boarded fence

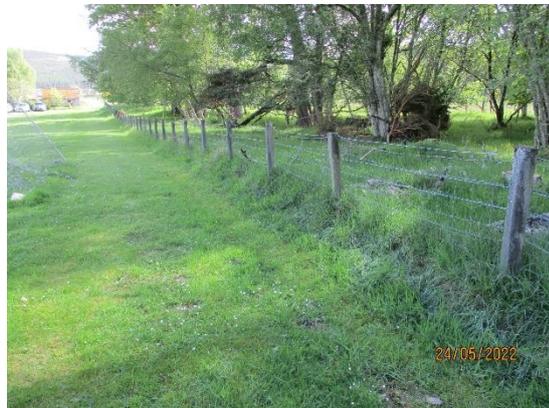
139. Post and wire fence (sports field)

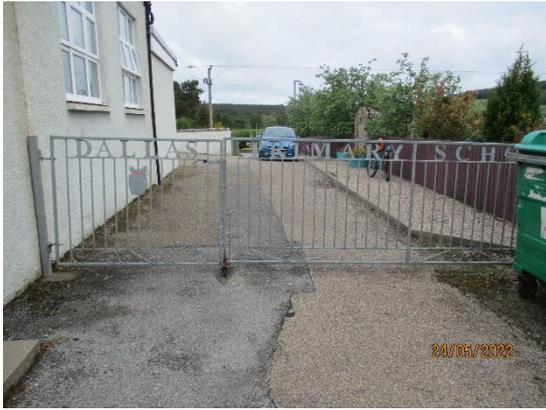
140. Galvanised vehicle gates

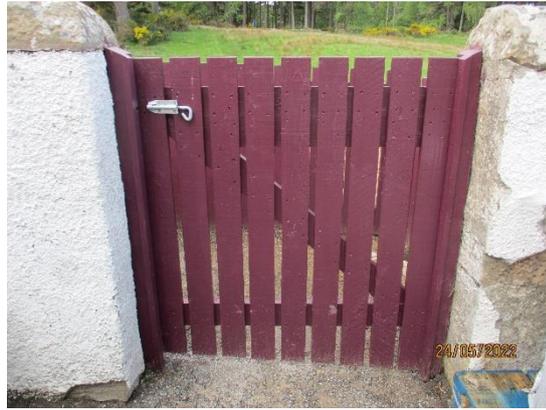
141. Timber pedestrian gates

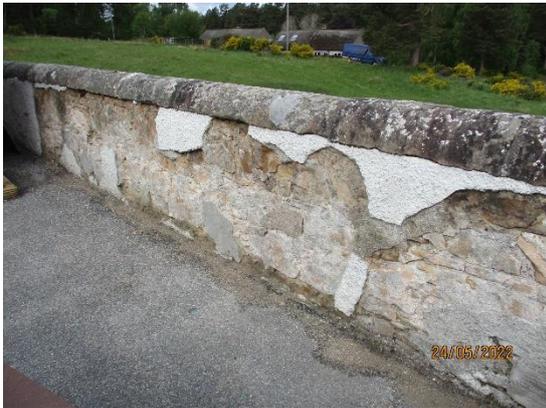
142 Stone perimeter wall

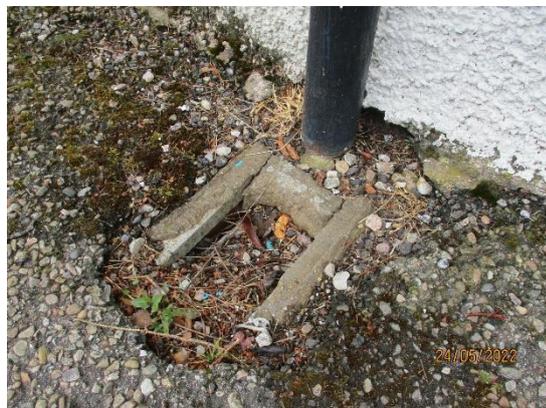
145. Back inlet gullies - blocked

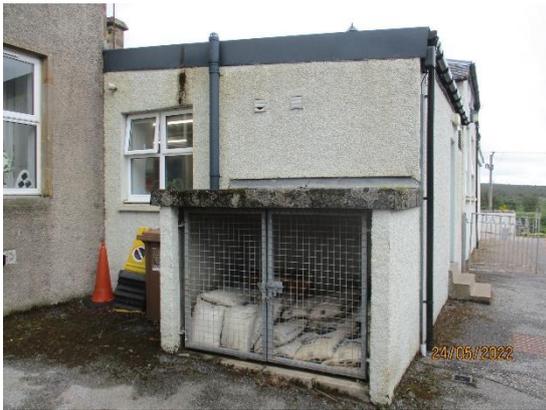
146. Bin store
