# Summary Building Condition Survey Report

**Dallas Primary School**  
**Knockando Road, Dallas IV36 2SA**

**24<sup>th</sup> May 2022**

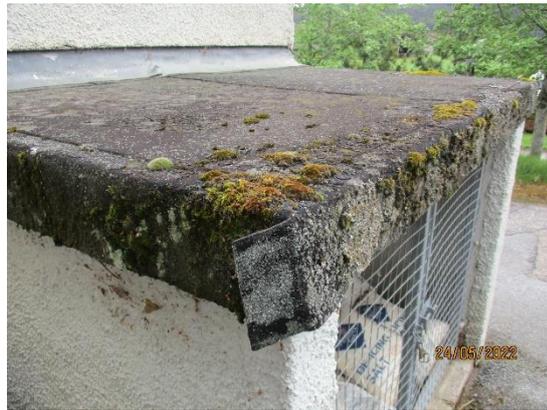
147. Felt roof
