# **Summary Building Condition Survey Report**

**Dyke Primary School**

**Dyke IV36 2TF**

**5<sup>th</sup> October 2021**

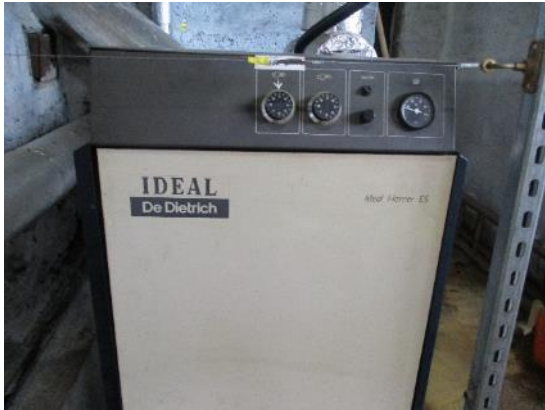
- Heat source, heating system and controls have exceeded useful life and due to age and condition are at risk of imminent significant failure.
- CCTV system is basic and non-maintained. Was defective at time of inspection and requires replacement.

31. Oil boiler

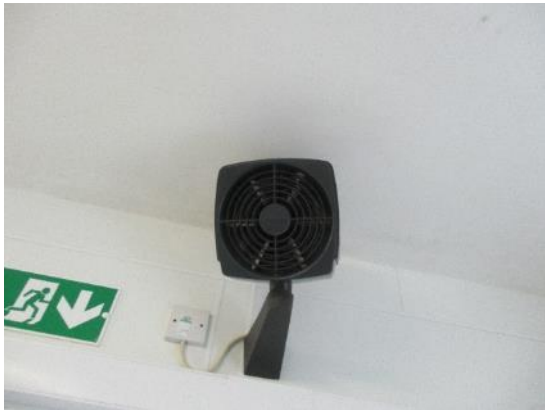
33. Kitchen – Fan heater

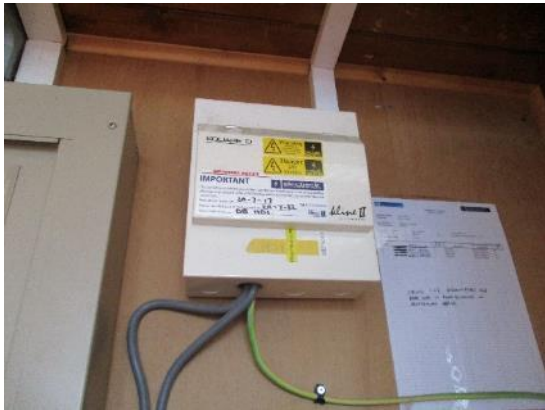
- External surface water drainage was blocked in a number of locations.
- Internal and external lighting is in poor condition.
- Building wiring and power distribution boards for small power systems are in poor condition and have exceeded useful life.

58. Main school consumer unit.
