Summary Building Condition Survey Report

Kinloss Primary School
Burghead Road, Kinloss IV36 3SX

14th & 15th March 2022

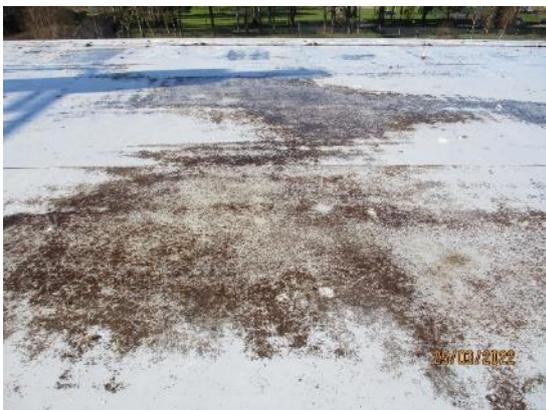
5. Surface silt and debris

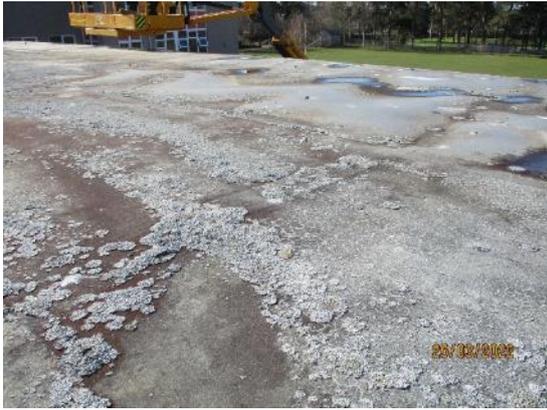
- Fibreglass roof covering to single and two storey roofs is blistering and is extensively covered with lichen.
- Bird spikes/deterrent requires replacement.
- Rooflights are damaged and reaching the end of their useful life.
- Double glazing seals are bulging on a number of double glazed units.
- Floor finishes are generally poor, vinyl is very poor.
- Assembly Hall floor seal is blistering and damaged.
- Classroom sinks and worktops are dated and in poor condition.
- Sanitary ware is generally dated and in poor condition.

7. Extensive lichen on the surface

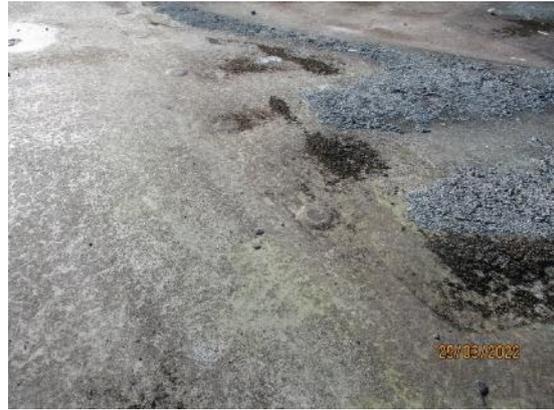
8. Seams visible

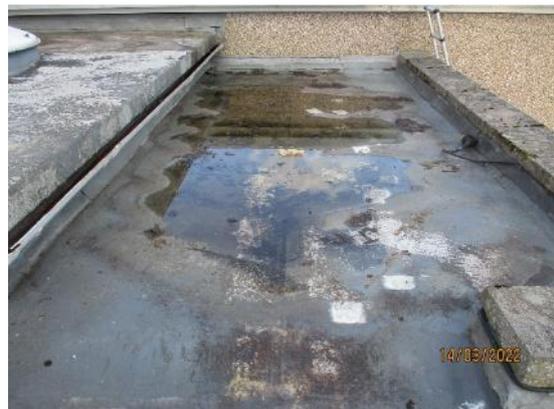
10. Rainwater ponding

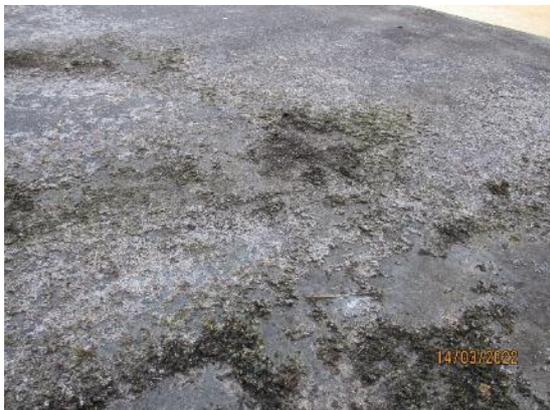
11. Extensive lichen on the surface

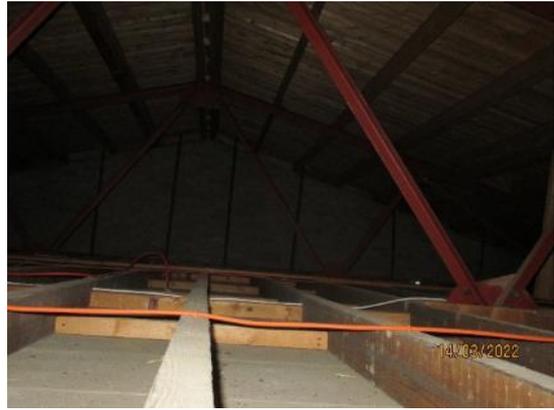
26. Lack of insulation above Dining Room

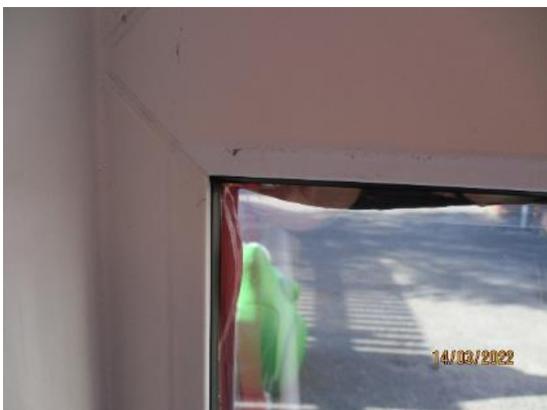
41. Double glazing seals bulging

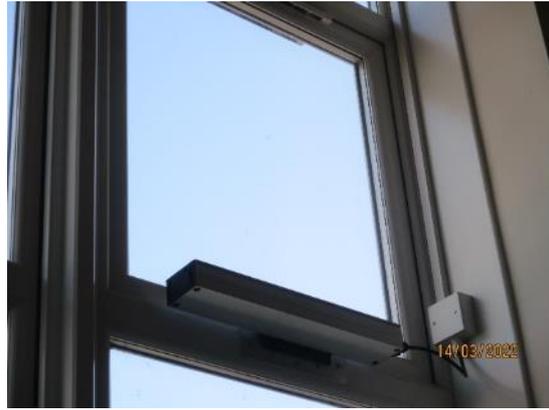
44. Remote window winders

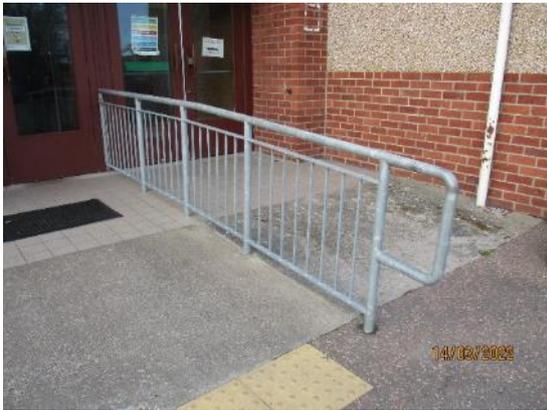
45. Entrance ramp and handrail

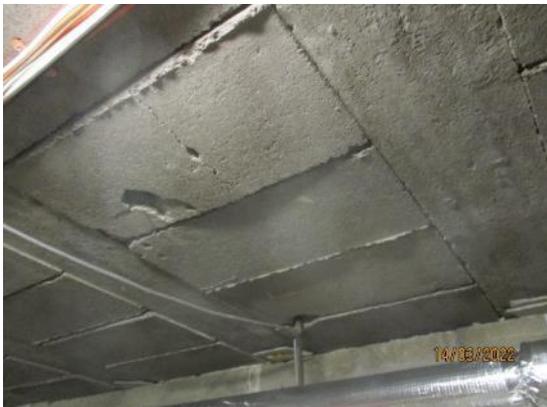
46. Beam & block floors

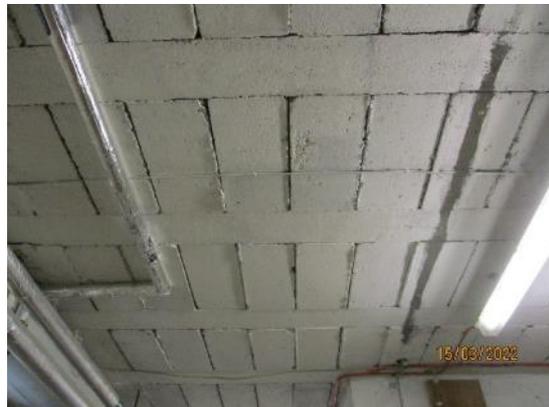
47. Basement ceiling

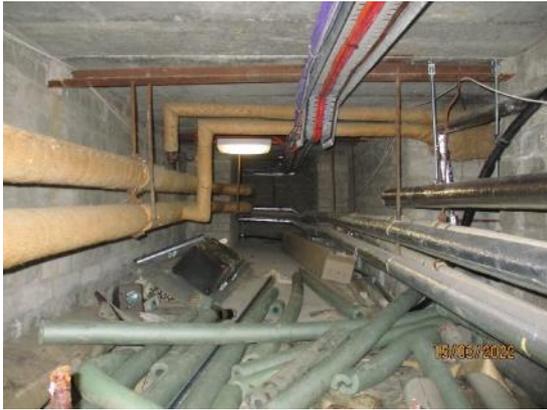
48. Suspended concrete above service ducts

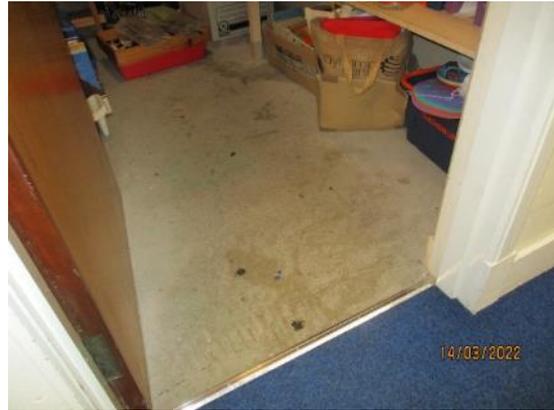
49. Concrete screed

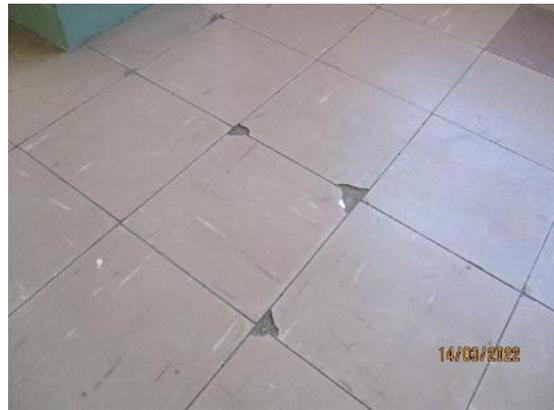
51. Vinyl tiles

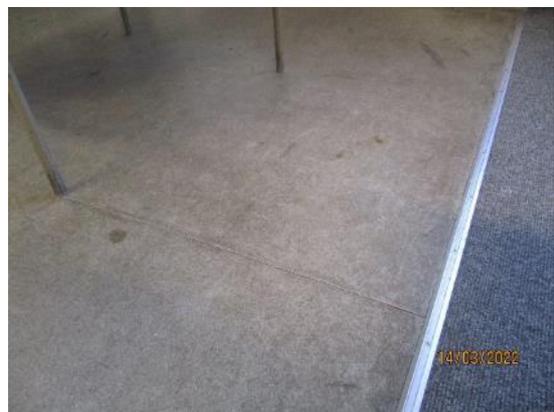
53. Sheet vinyl

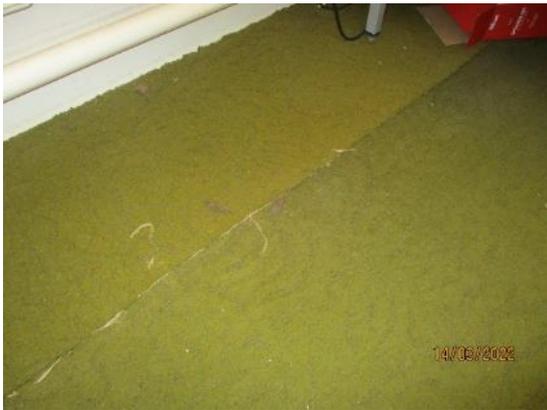
54. Carpet

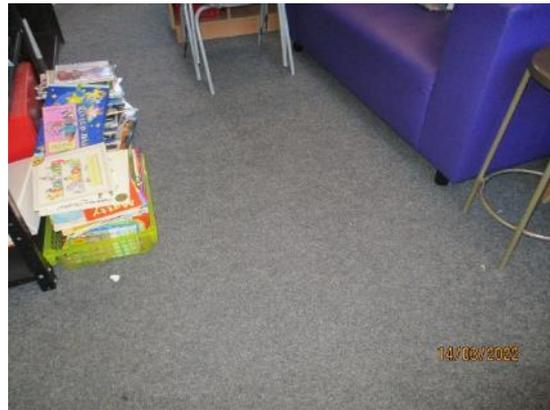
55. Contract grade carpet

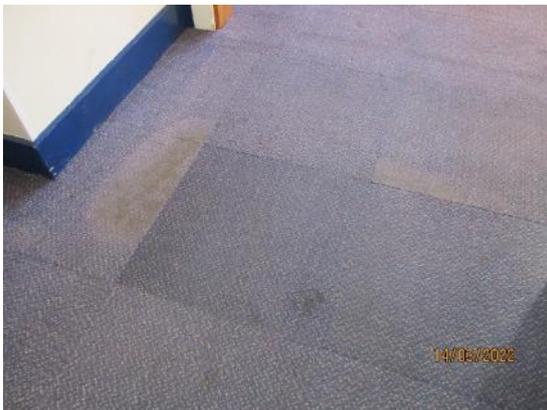
56. Carpet tiles

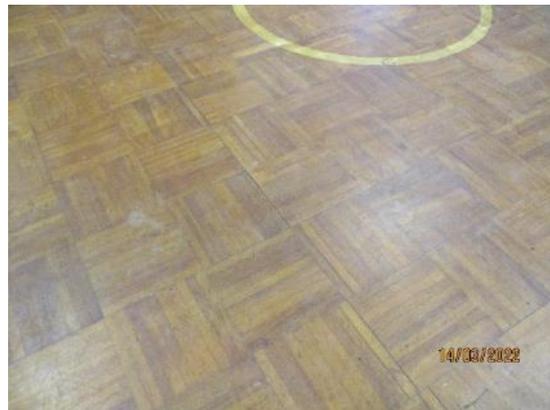
57. Parquet flooring – Assembly Hall

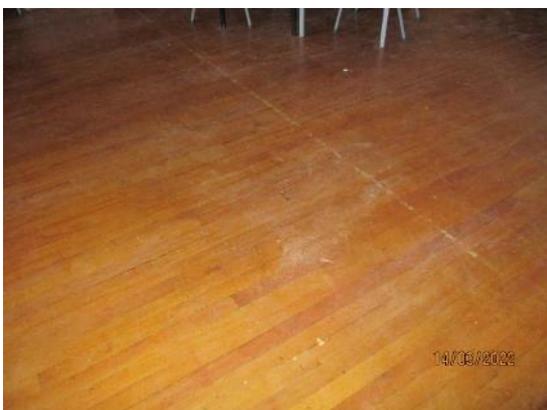
58. Timber boarding - Stage

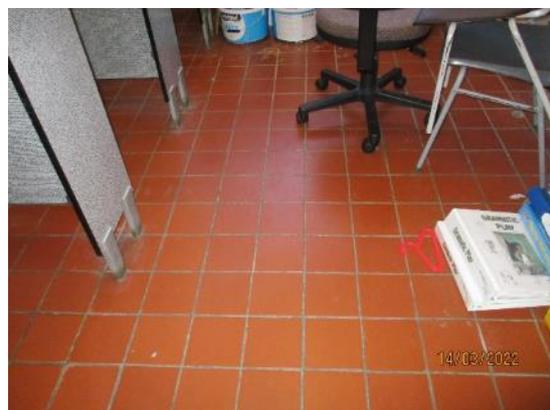
59. Quarry tile - Toilets

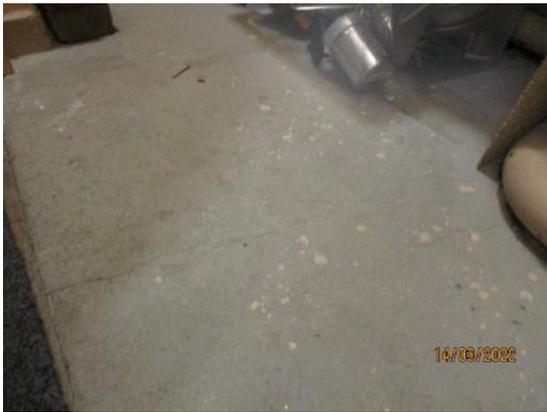
60. Concrete screed

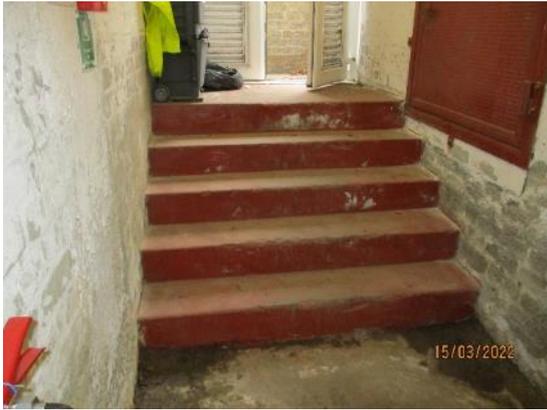
67. Chipped nosings

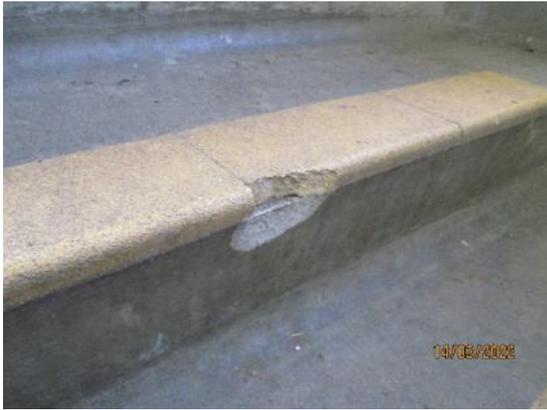
72. Chipped tactile nosing

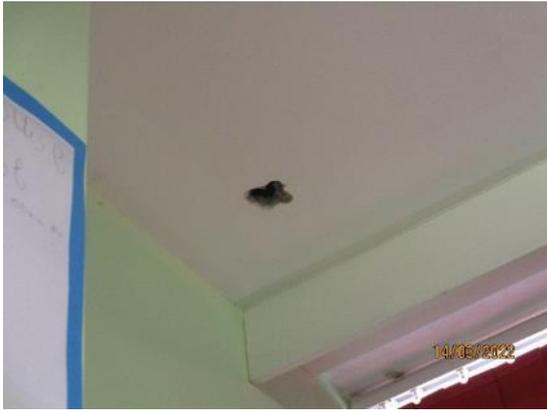
77. Previous services

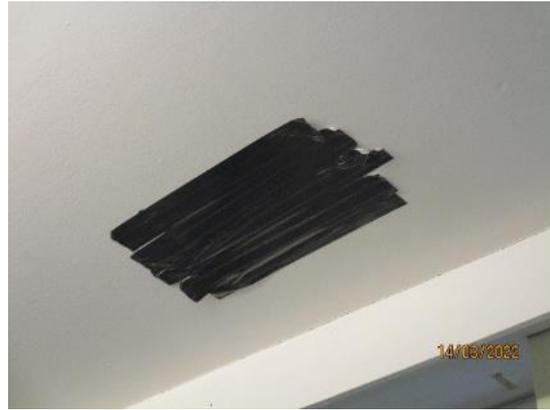
78. Taped repairs

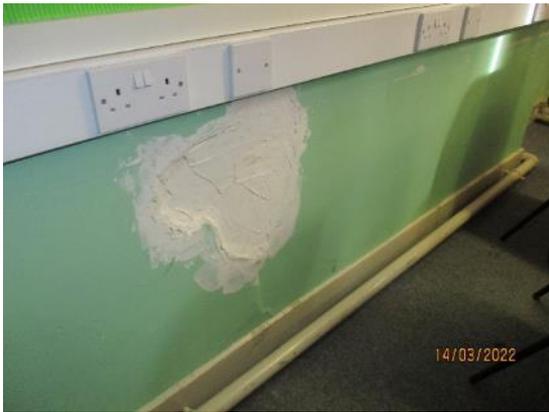
83. Previous repairs

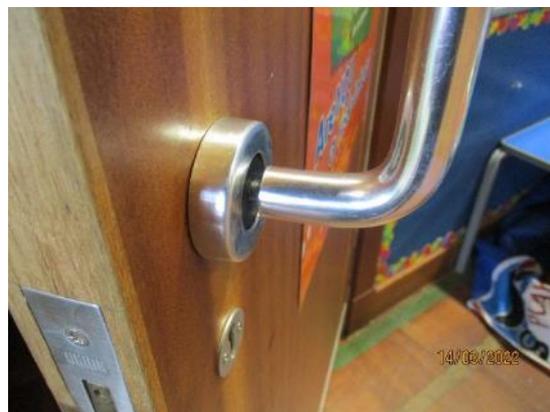
88. Ironmongery repairs

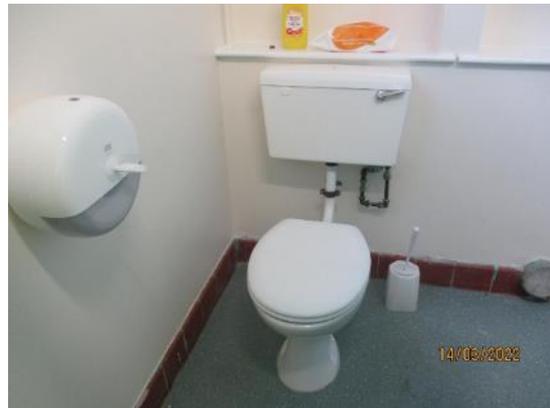
92. Typical WC

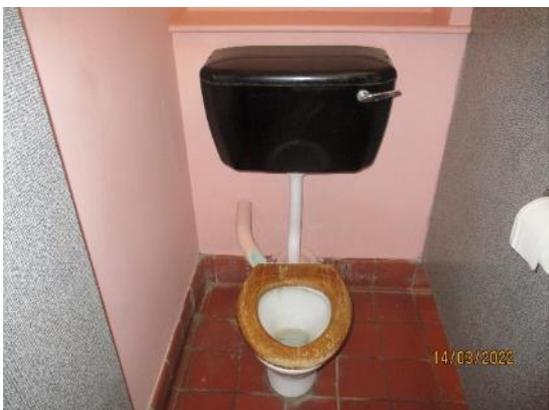
93. Dated WC

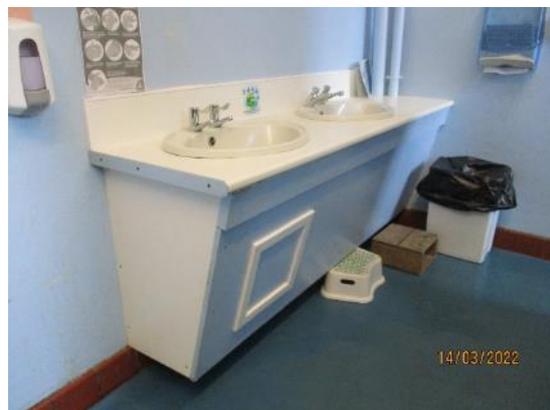
94. Vanity basins

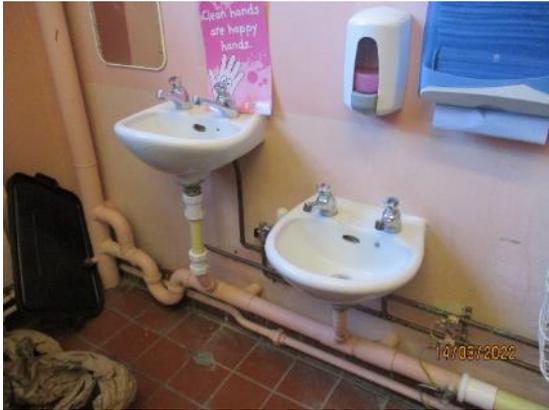
95. Wall hung wash hand basins

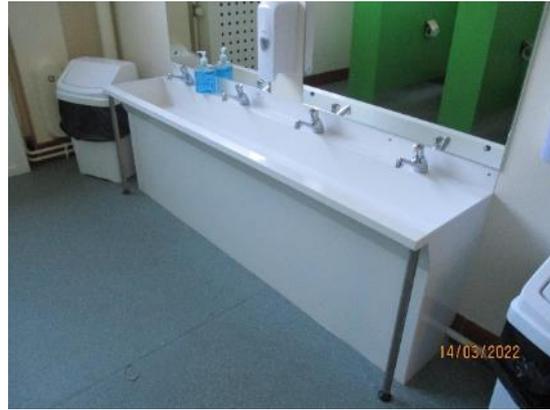
96. Composite trough basin - Nursery

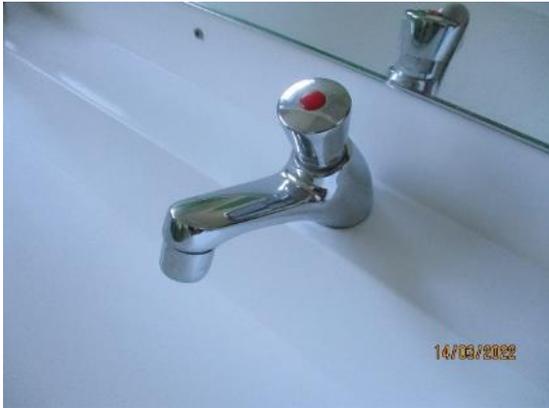
97. Typical tap

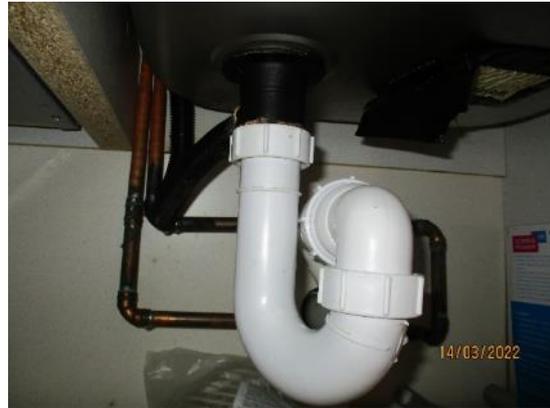
98. Copper supplies and PVC waste pipes

- Hot water distribution pipework is life expired, in poor condition and poorly insulated and should be considered for replacement.
- Cold water distribution pipework is life expired, in poor condition, poorly insulated and should be considered for replacement.

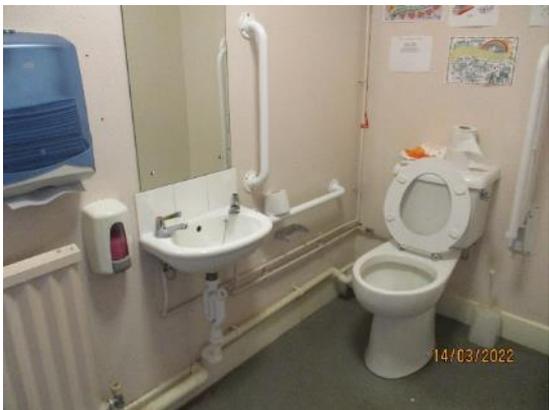
99. Accessible toilet

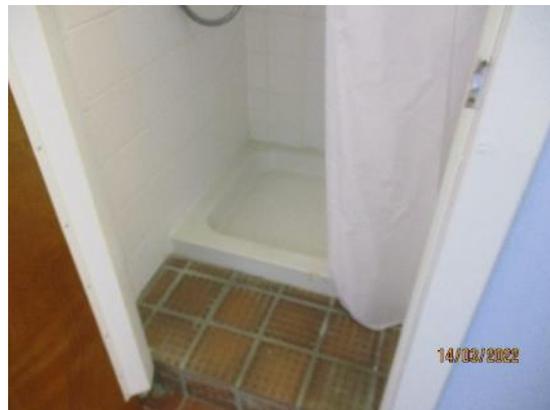
100. Shower tray

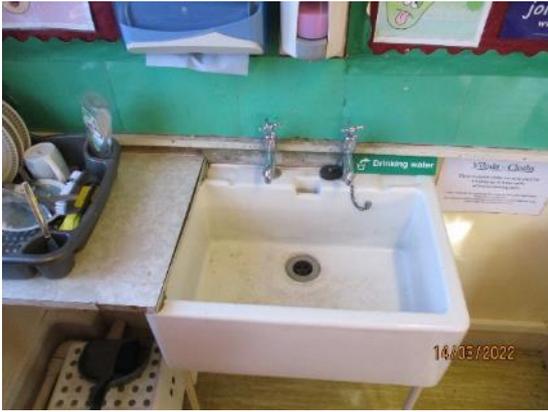
101. Classroom butler sinks

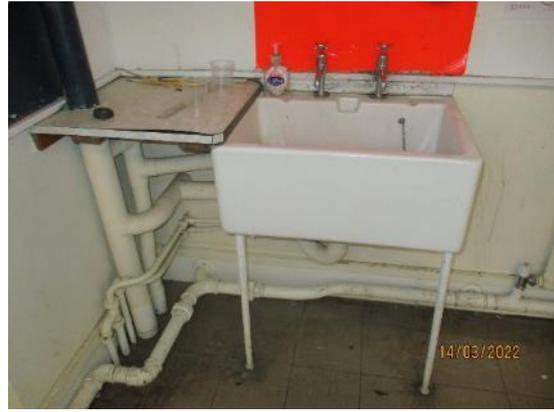
102. Adjacent worktop

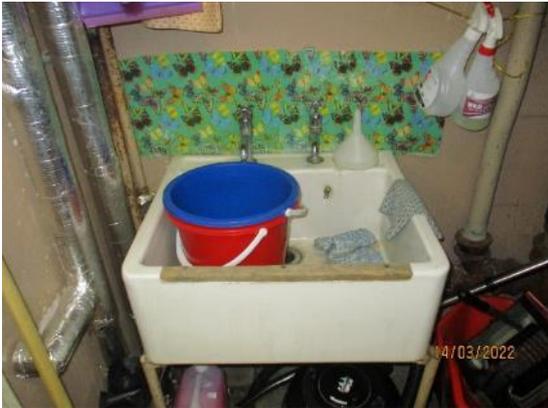
103. Cleaners butler sinks

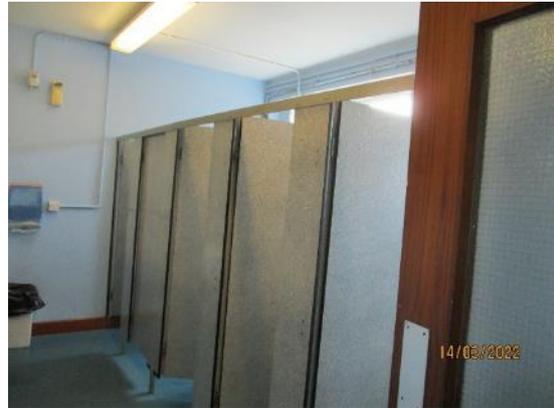
104. WC cubicles

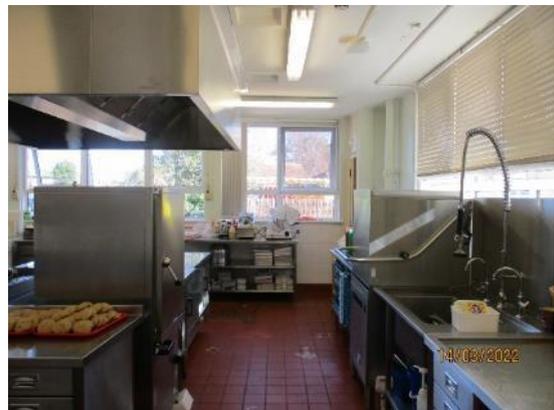
106. Commercial kitchen

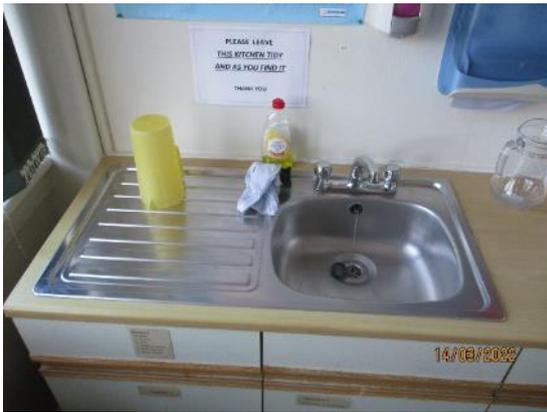
107. Stainless steel sinks

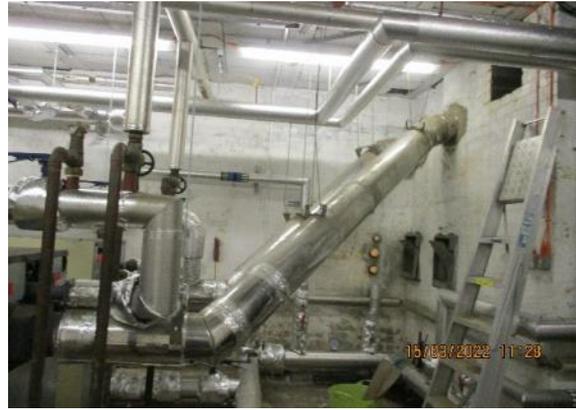
117. Oil boiler flues into brick chimney.

- Oil boilers are reaching the end of their useful life, in poor condition and should be considered for replacement.
- The Hot water calorifier is life expired and should be considered for replacement within part of scope of heating upgrades.

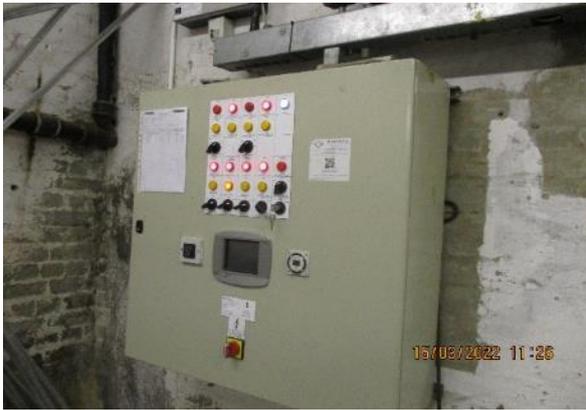
118. Heating BMS control panel.

- Trend building management system is life expired and should be considered for upgrade/replacement within part of scope of heating upgrades.
- Electrical distribution boards are nearing the end of their useful life and should be considered for replacement.

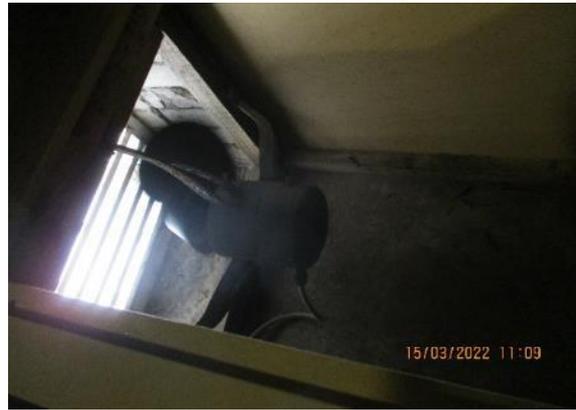
119. Boiler house air supply fan.

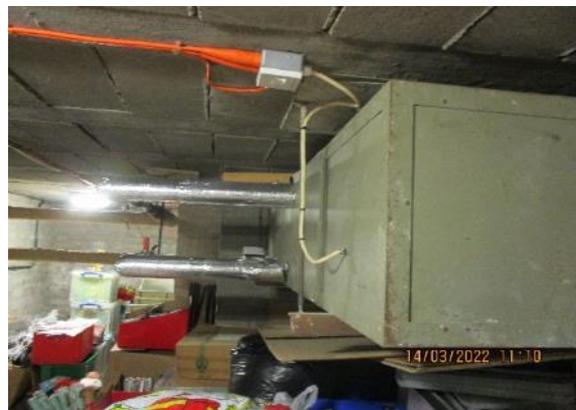
121. Heating convector under stage.

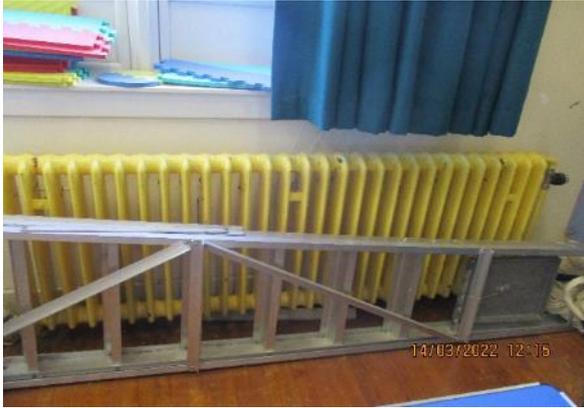
122. Radiator Cast iron column GP hall.

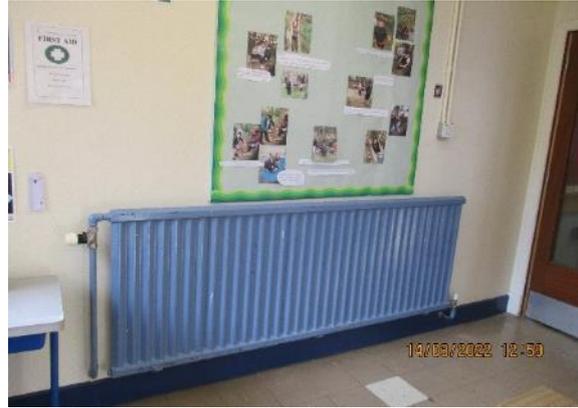
123. Radiator steel panel access corridor.

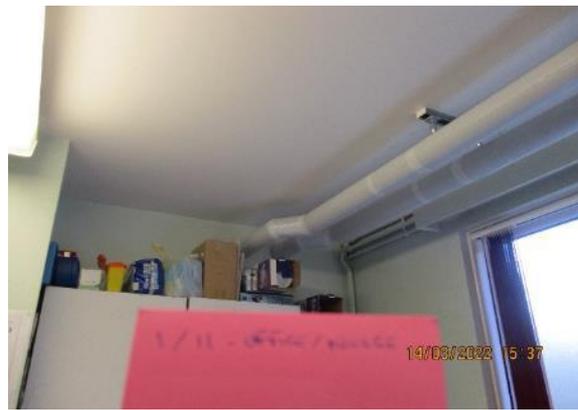
125. Pipework new heating.

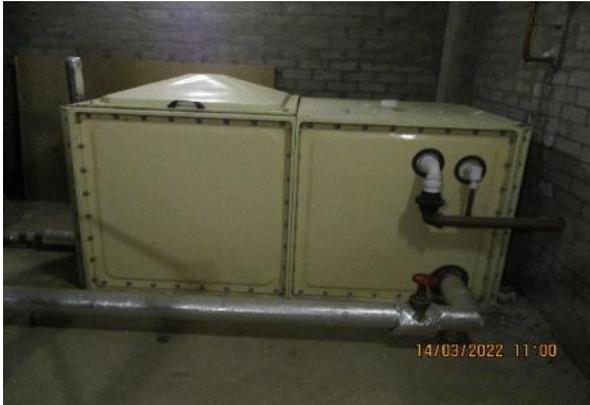
128. Cold water storage tank – Tower block.

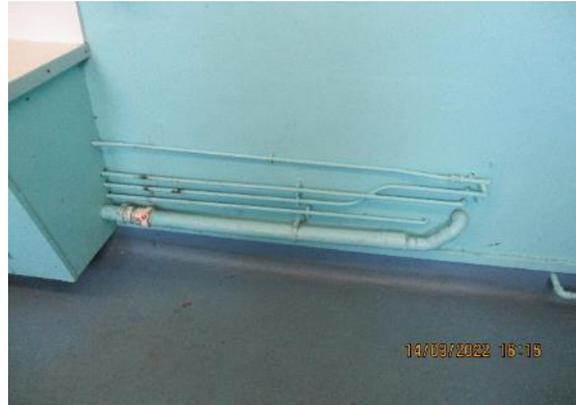
129. Cold water pipework boys toilets.

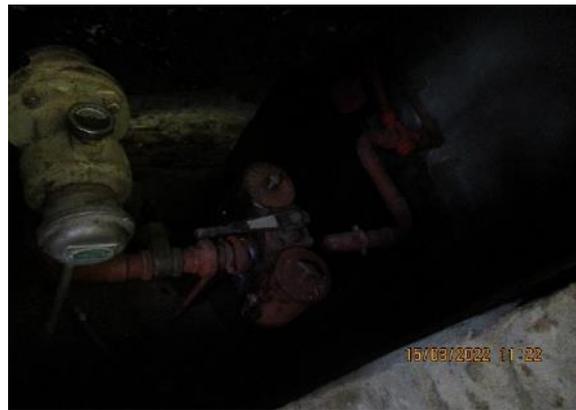
131. Oil supply control and shut off valves.

- Oil storage tank and distribution pipework is life expired, in poor condition and should be considered for replacement within part of scope of heating upgrades.

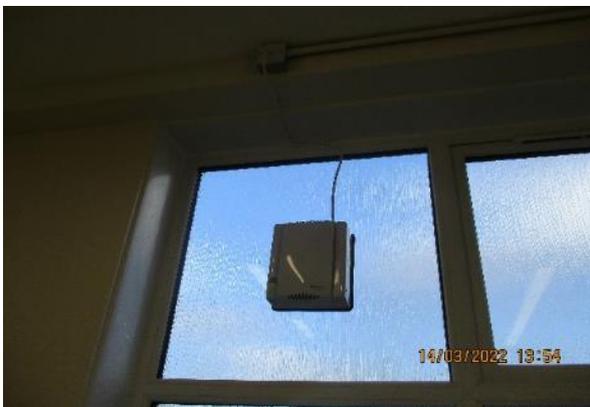
132. Extract fan – toilet window.

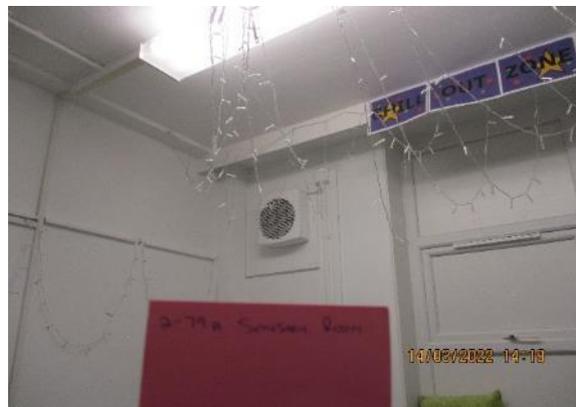
133. Extract fan – sensory room.

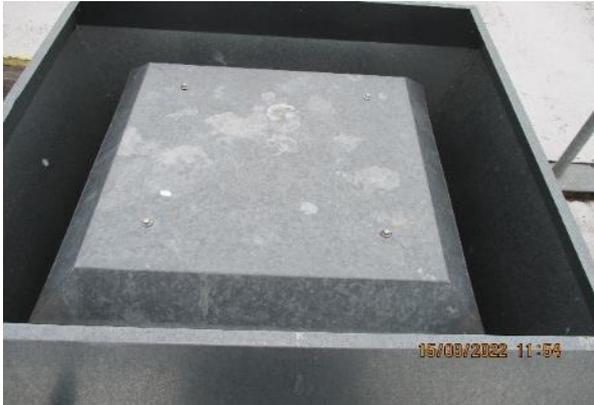
134. Kitchen canopy extract. Roof mounted.

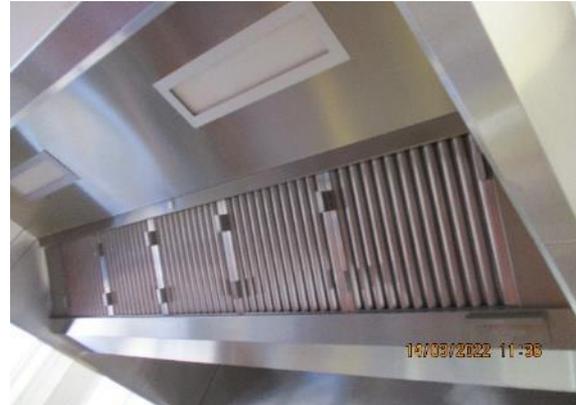
135. Kitchen extract stainless steel canopy.

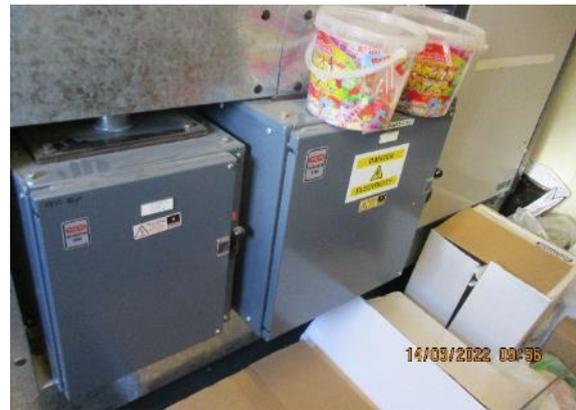
137. Main switchboard isolators.

- Main switchboard is life expired and should be considered for replacement.

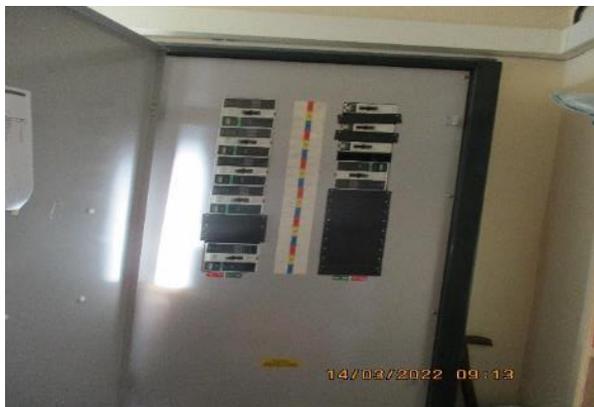
138. Distribution board Lighting and power.

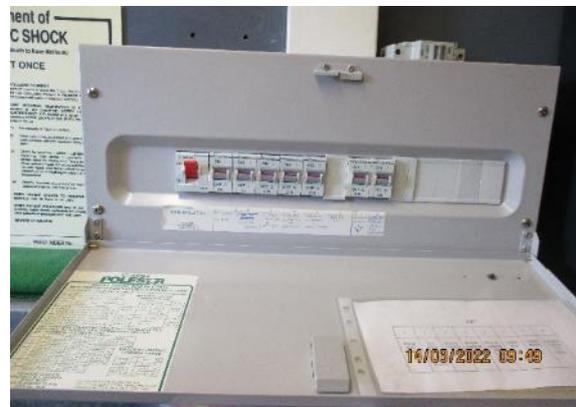
139. Consumer Unit power.

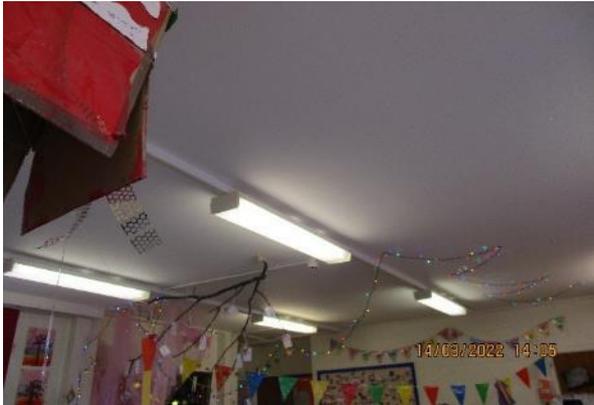
140. Lighting – classroom.

- Internal lighting is nearing the end of its useful life and should be considered for replacement and upgrade to LED types with energy saving controls.
- Wiring accessories – sockets and switches are nearing the end of their useful life, are in poor condition and should be considered for replacement.
- Building external lighting is in poor condition, life expired and should be considered for replacement and to incorporate lux sensors.
- Fire alarm devices are life expired and should be considered for replacement.

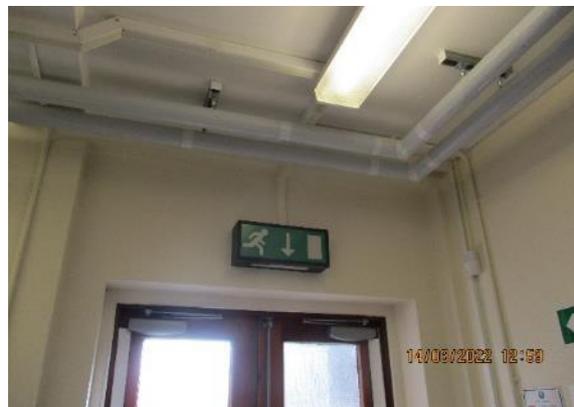
145. Emergency exit illuminated sign. Non maintained.

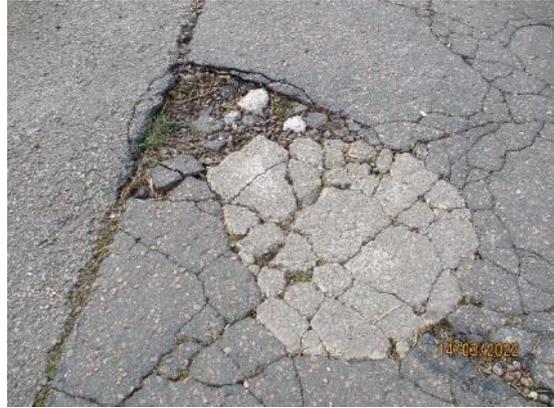
- Access road and car park, surface erosion, cracking and pot holed.
- Investigate sunken drainage routes in the playground.
- Missing and damaged Perspex cladding to the Bike Shelters.

165. Tarmacadam breaking up

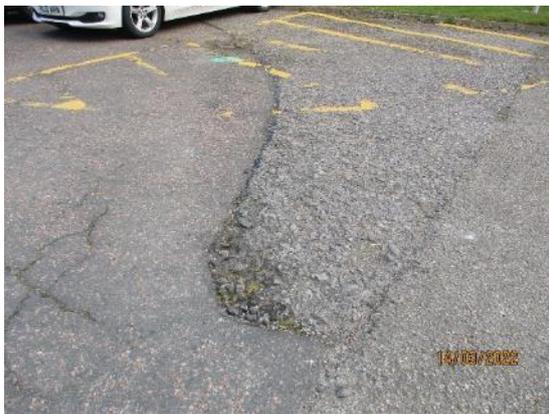
166. Previous patches

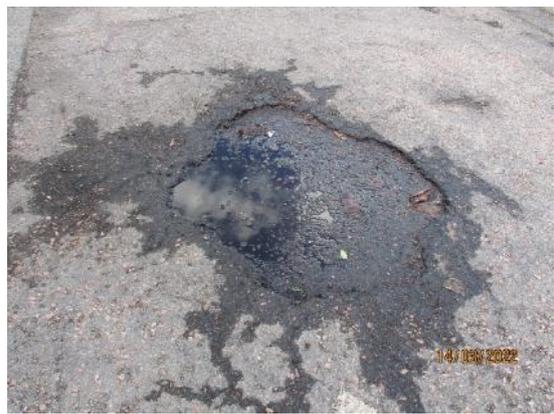
167. Potholed

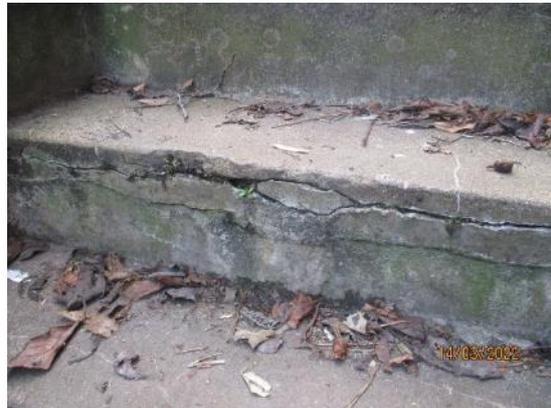
173. Concrete steps breaking up

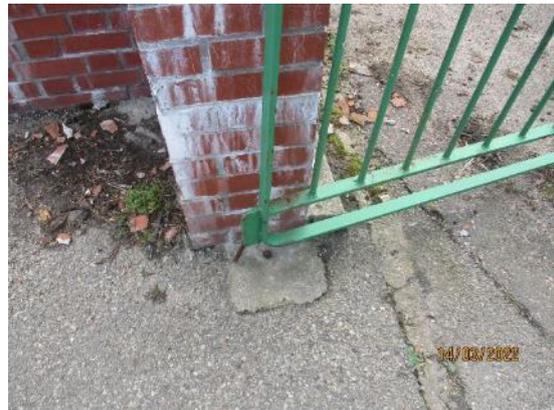
179. Gates not operational

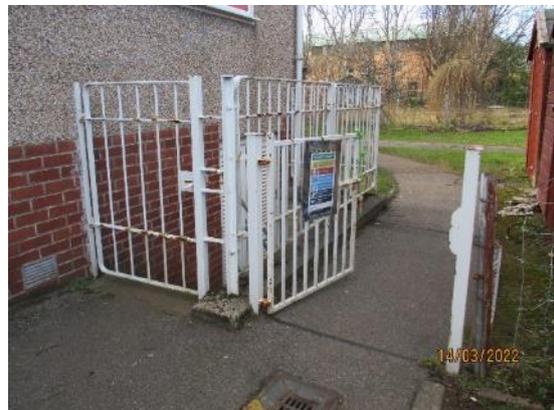
180. Galvanised gate to playground

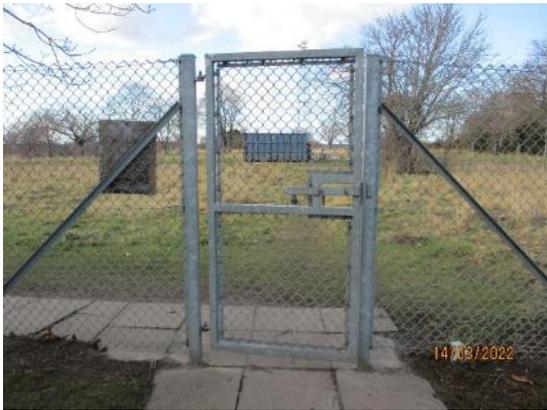
181. Metal gates at Boiler House

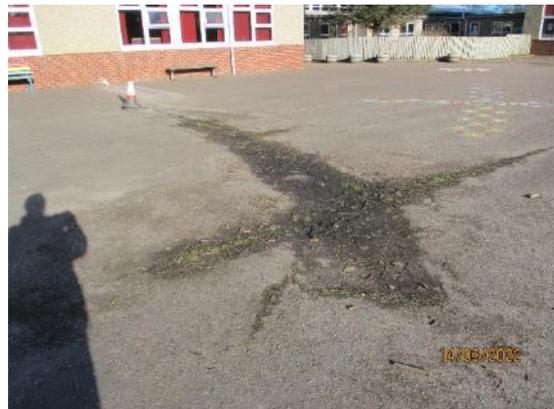
184. Road gully surface water drainage

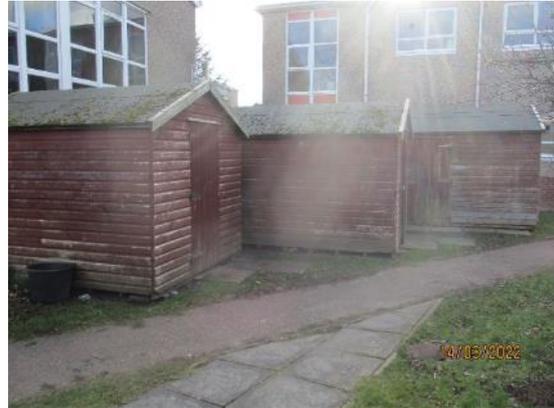
190. Timber sheds

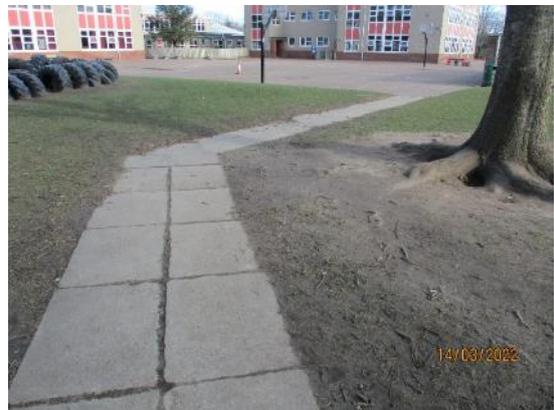
192. Landscaping to front

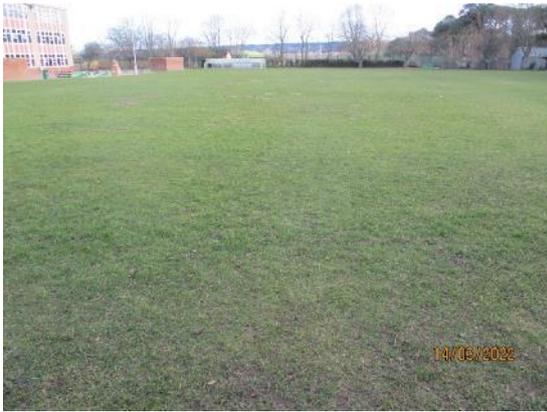
193. Landscaping to rear

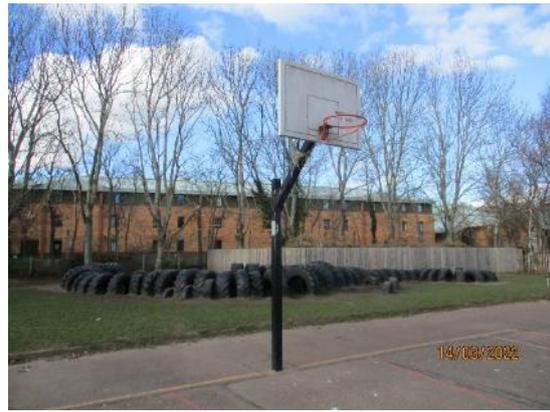
194. Sports field
