# **Summary Building Condition Survey Report**

**Logie Primary School**

**Dunphail IV36 2QG**

**7<sup>th</sup> October 2021**

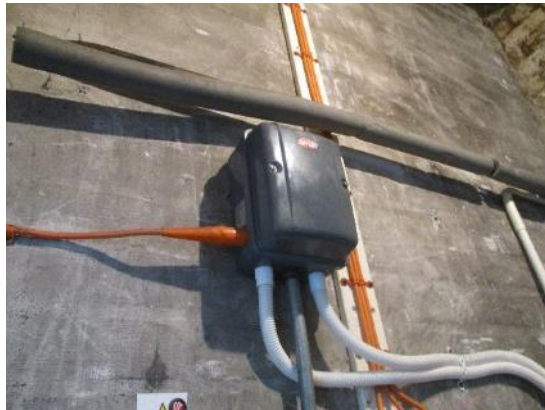
69. General wiring

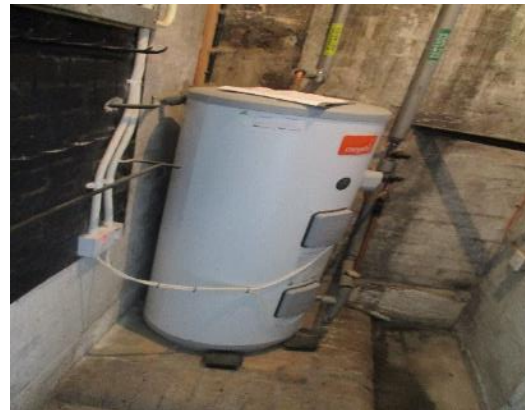
70. Unvented hot water storage cylinder

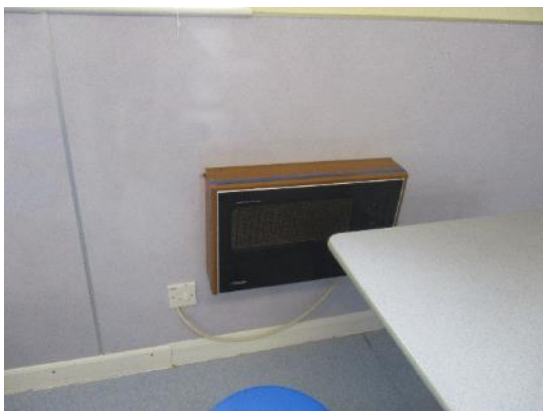
71. Dining hall convector heater

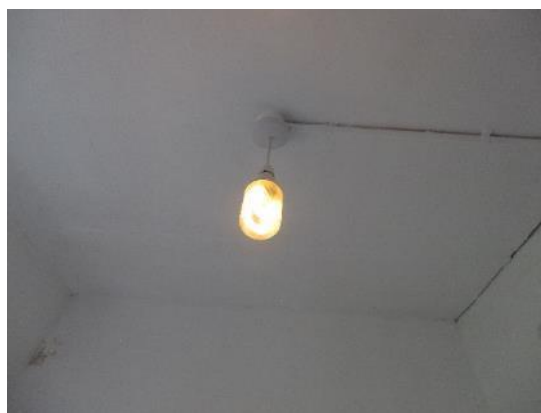
78. Store pendant light.
