# **Summary Building Condition Survey Report**

**Pilmuir Primary School  
Pilmuir Road, Forres IV36 1HD**

**30<sup>th</sup> & 31<sup>st</sup> March 2022**

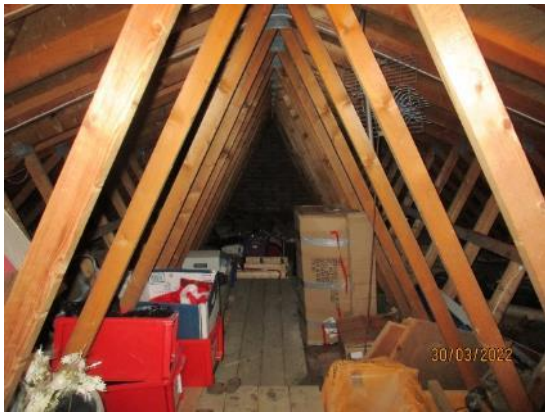
1. School pitched roof structure

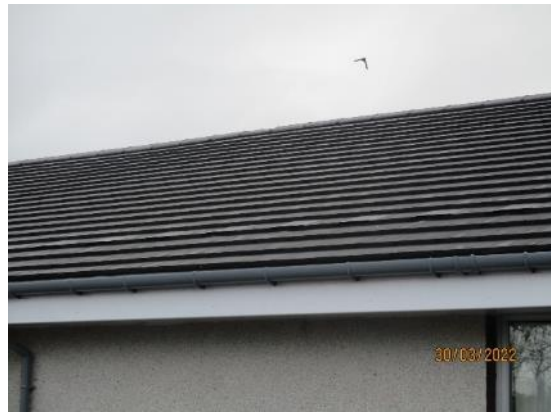
2. Concrete tile

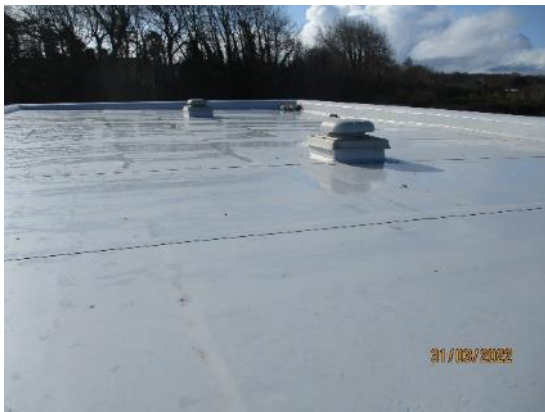
3. Single ply membrane – Games Hall

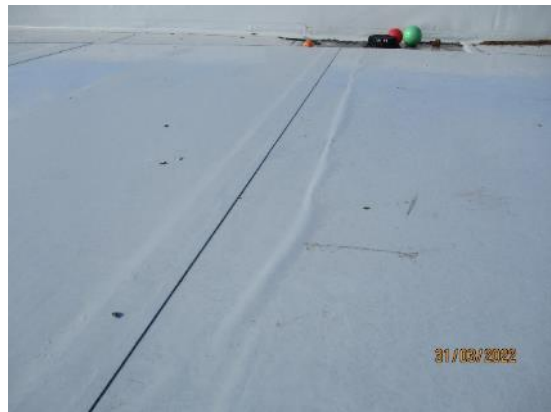
4. Surface wrinkles

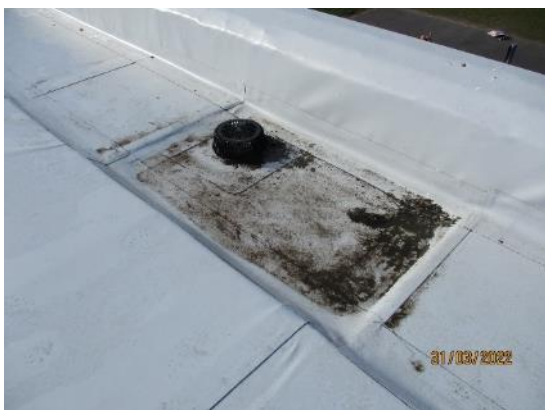
5. Rainwater outlet

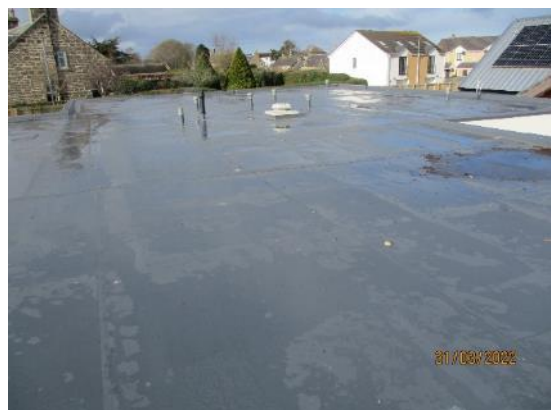
6. Single ply membrane - Annexe

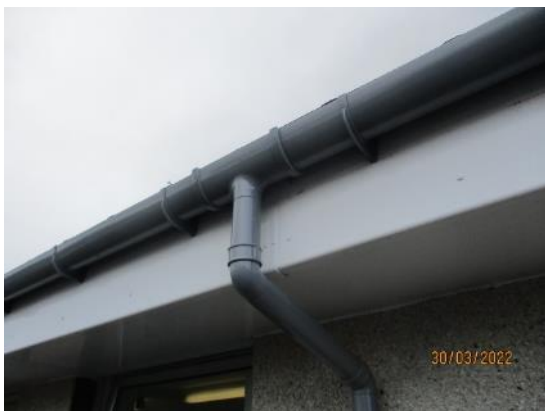
11. PVC gutters

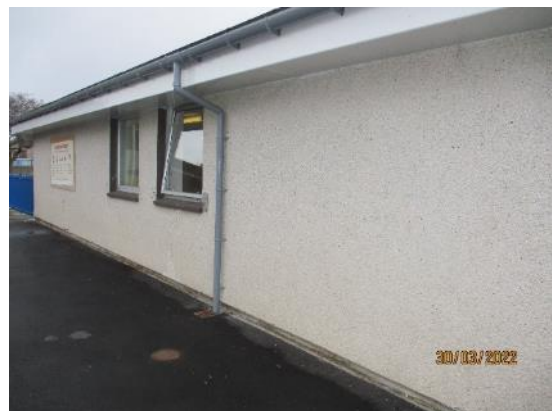
12. PVC downpipes

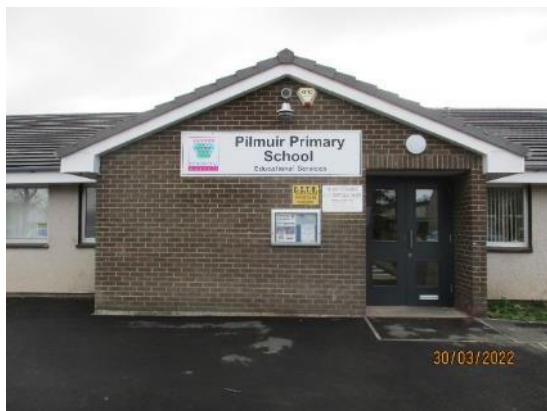
17. Facing brick

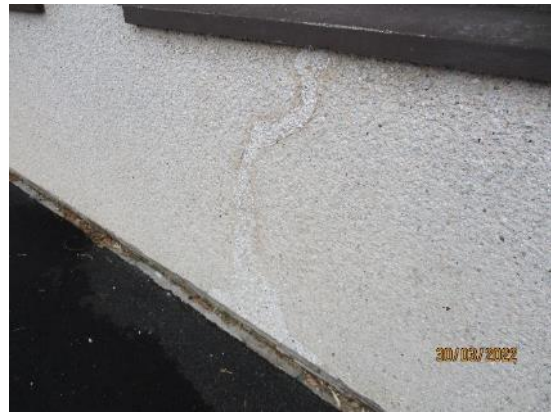
20. Roughcast repairs

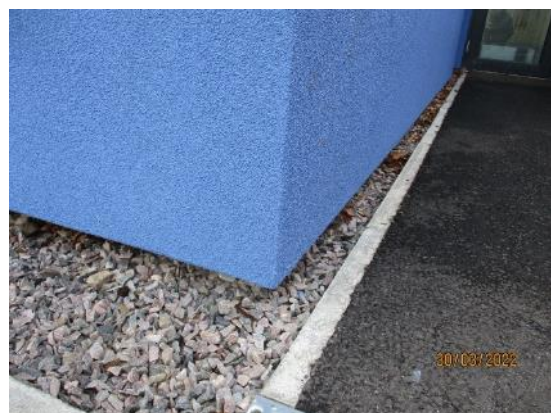
24. External insulation

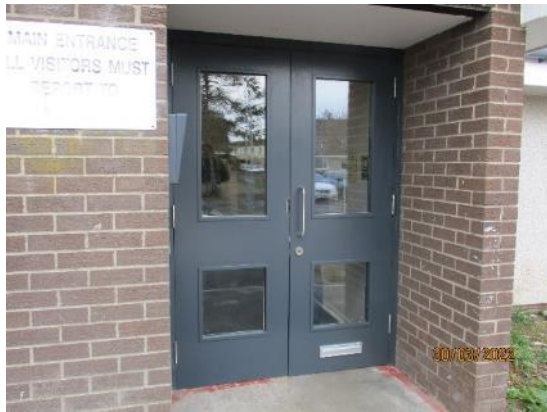
25. Entrance doors

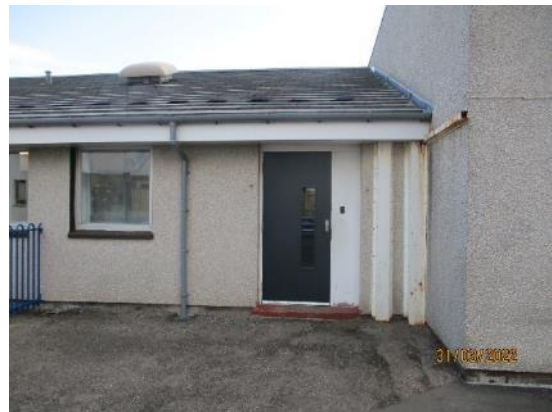
28. Single exit door

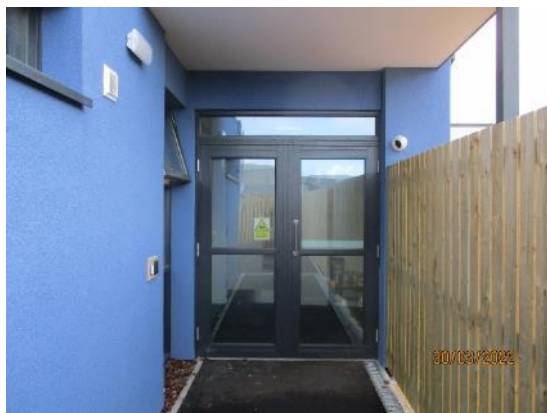
29. Annexe entrance door

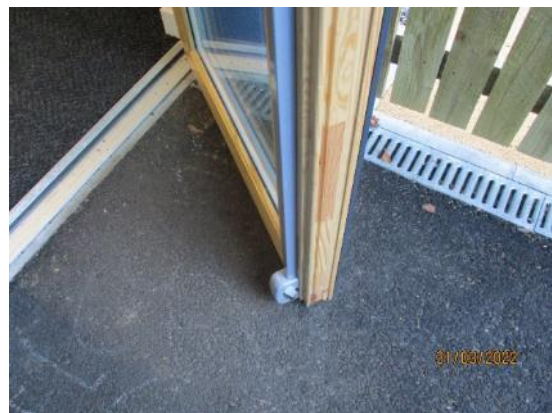
30. Timber doors with aluminium face

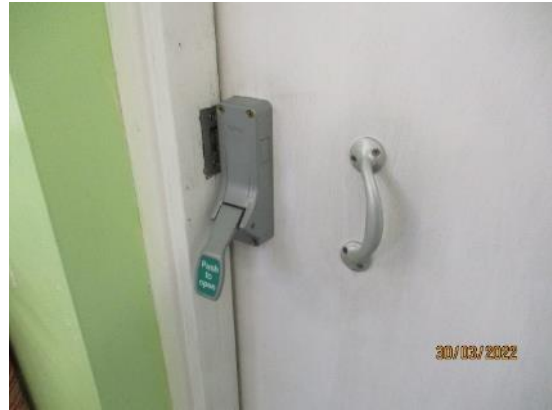
32. Fire exit push pad

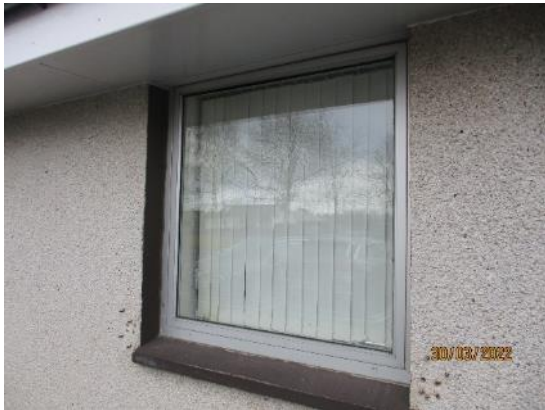
33. Typical aluminium window

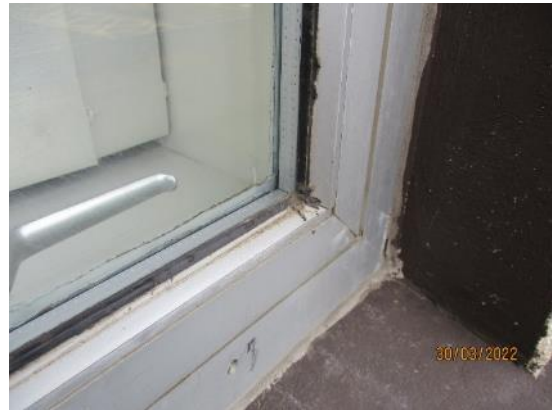
34. Failing seals

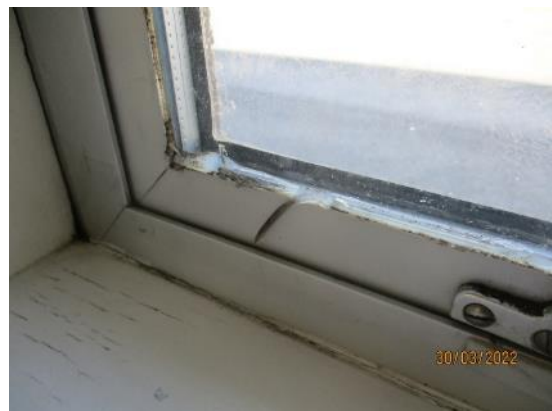
36. Repaired seals

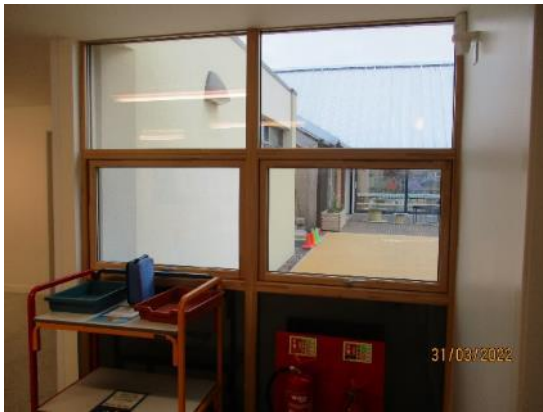
37. Annexe windows

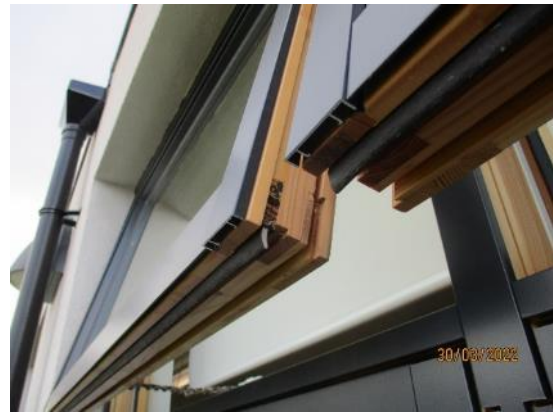
38. Timber with aluminium face

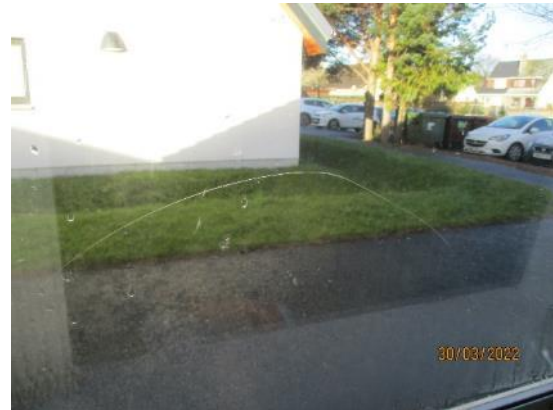
40. Scratched glass – Primary School

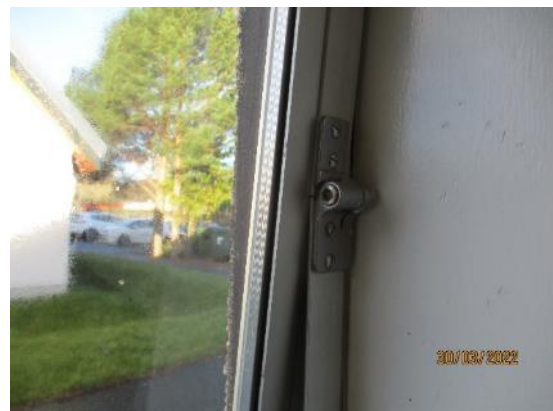
42. Centre pivot ironmongery

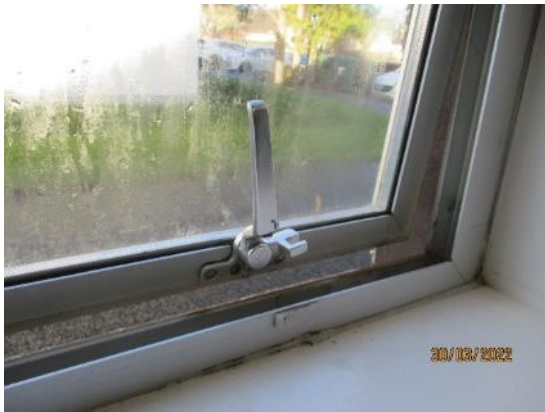
43. Lever handles – Primary School

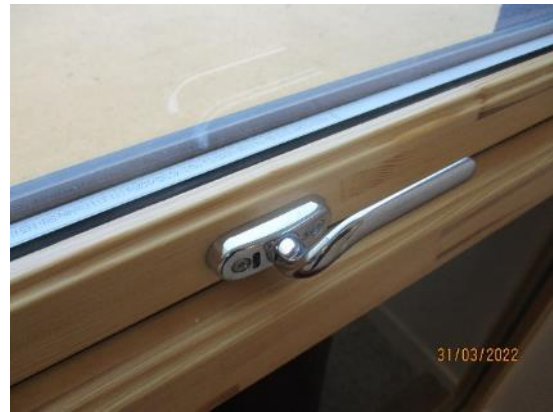
44. Lever handles - Annexe

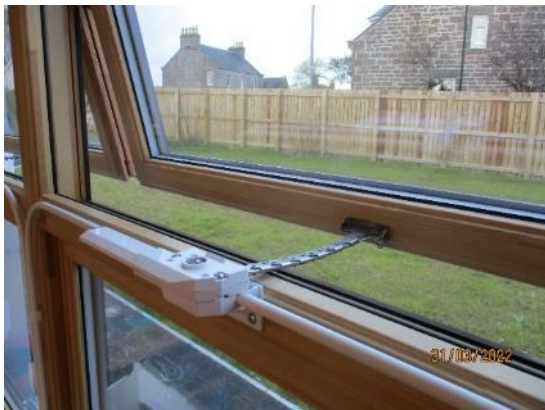
45. High window mechanism

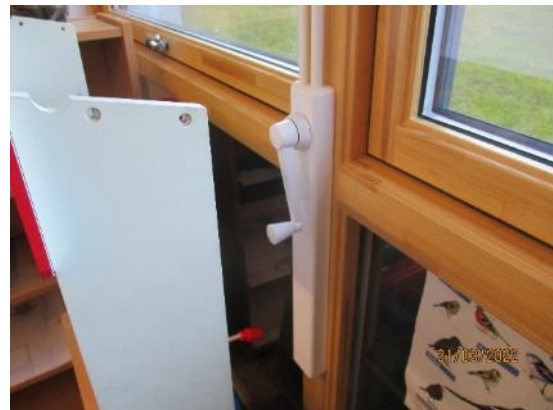
46. Winding handle for high level windows

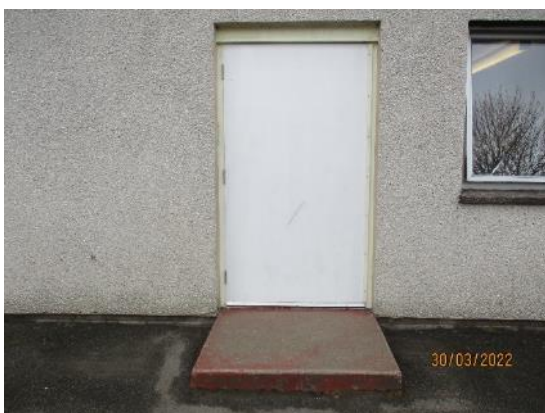
47. Concrete step

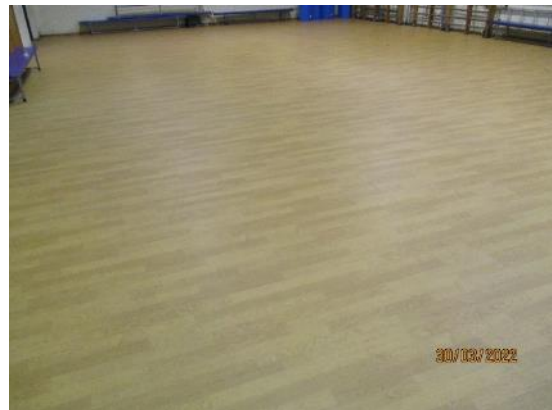
51. Sheet vinyl in Gym Hall

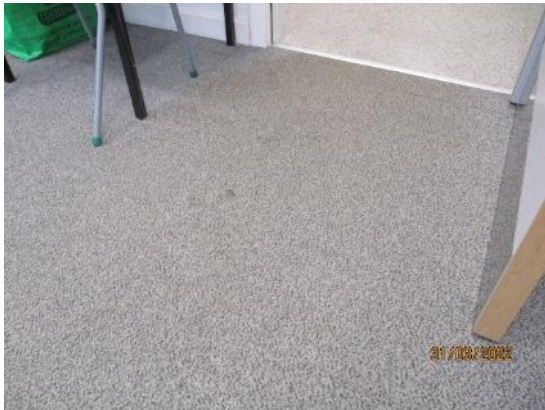
56. Carpet tiles in the Annexe

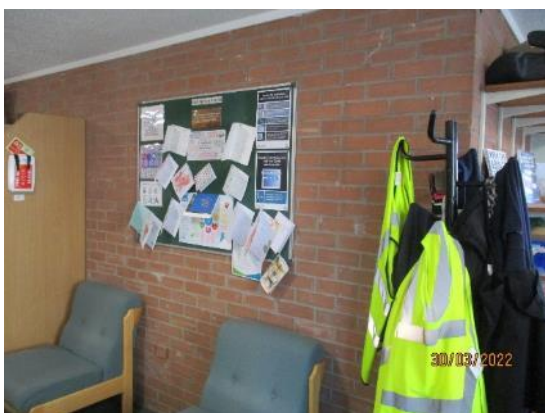
64. Facing brickwork

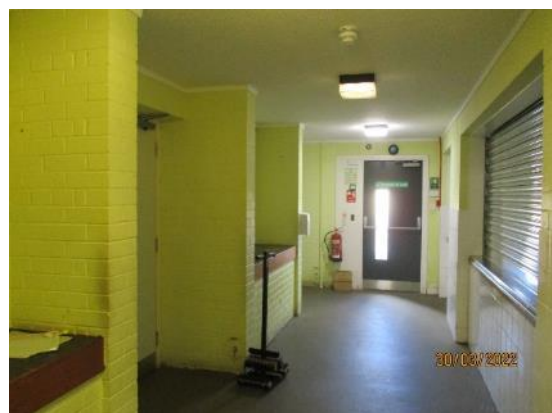
65. Painted brickwork

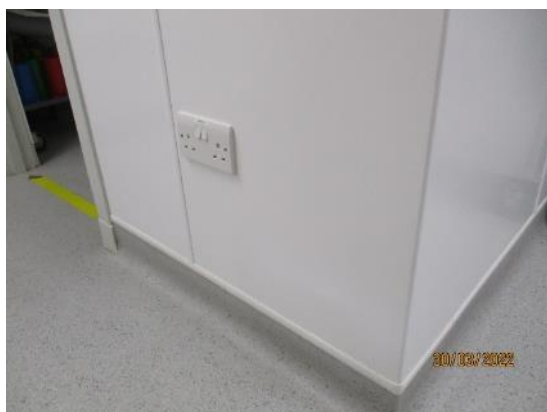
66. Wetwall

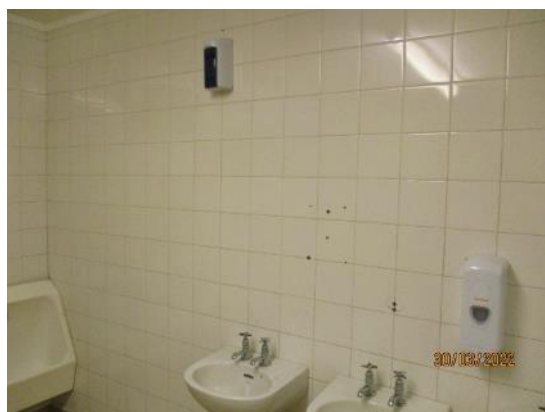
67. Ceramic wall tiles

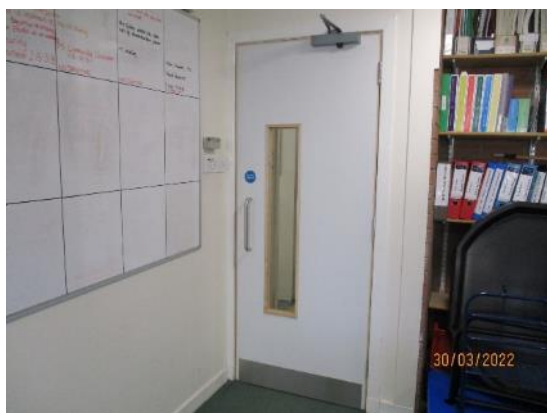
70. PVC faced doors

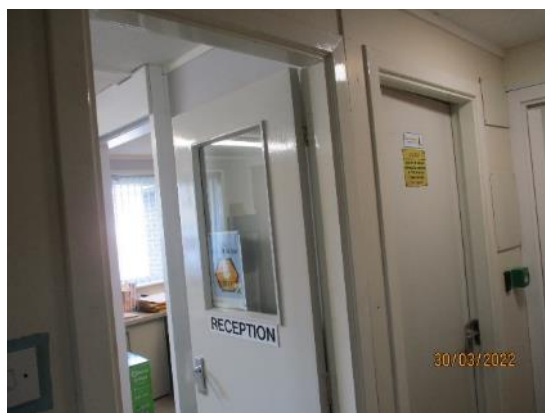
71. Timber doors

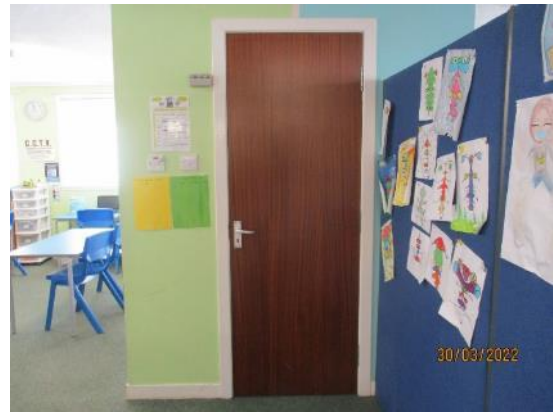
73. Lightweight veneered doors

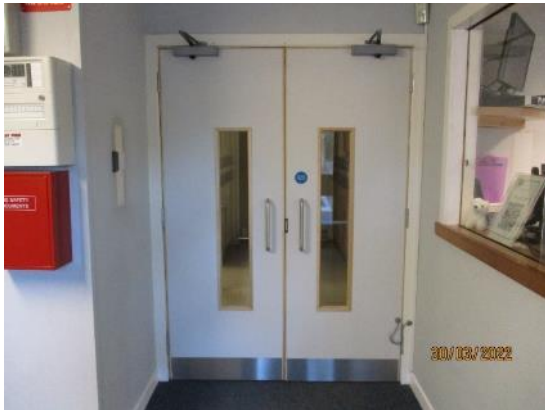
74. PVC faced double doors

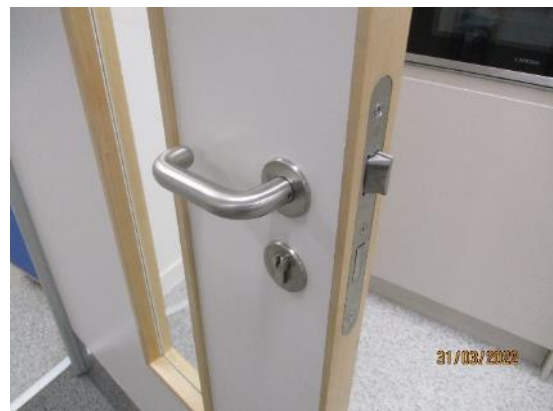
77. Annexe ironmongery

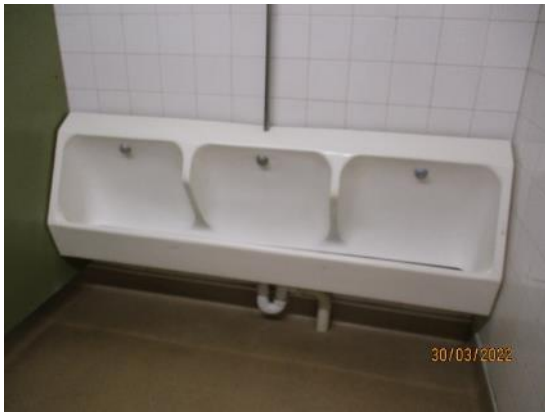
78. Composite urinals

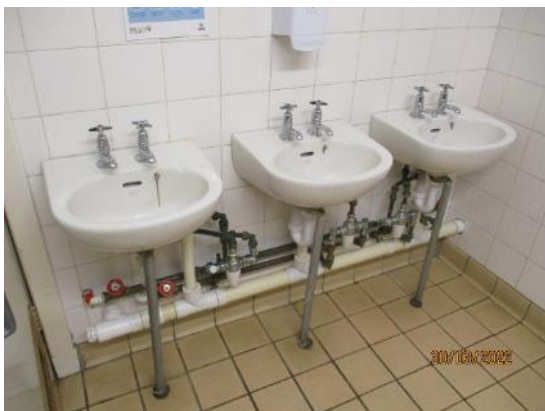
82. Typical Primary wall hung basins

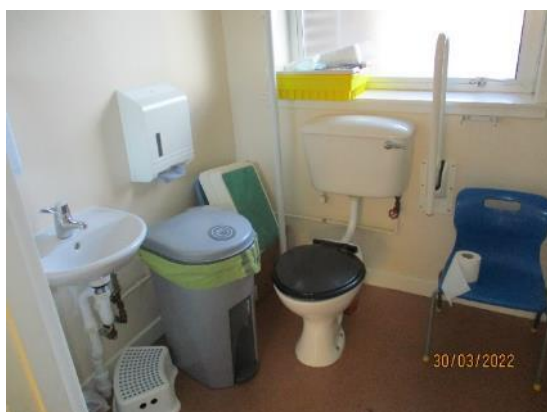
86. Primary accessible toilet

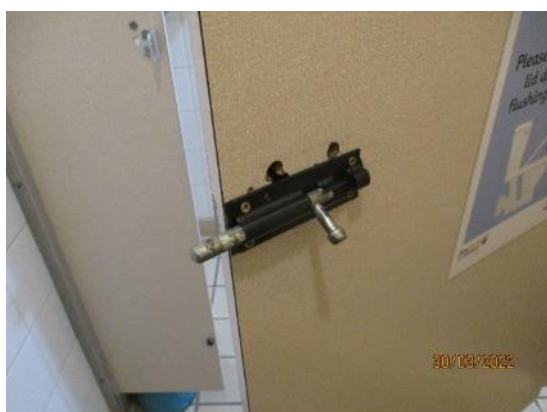
90. Replacement ironmongery

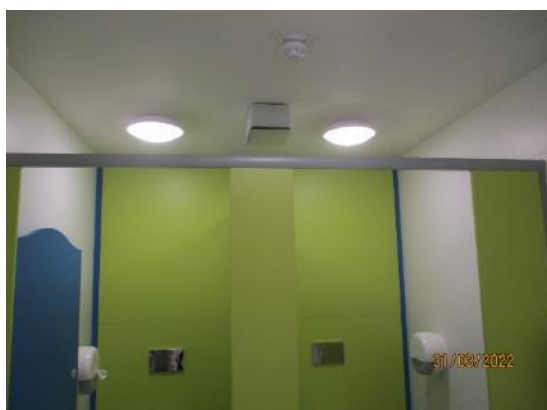
92. Annexe cubicle partitions

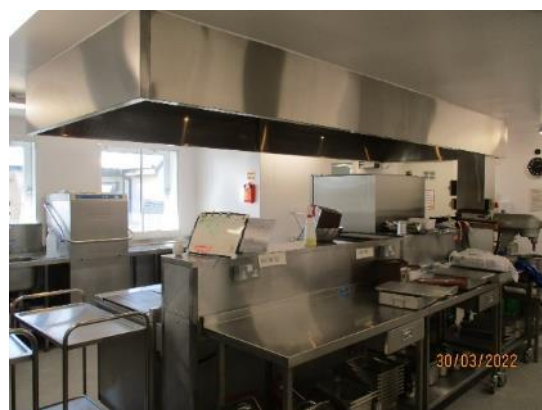
93. Commercial kitchen units

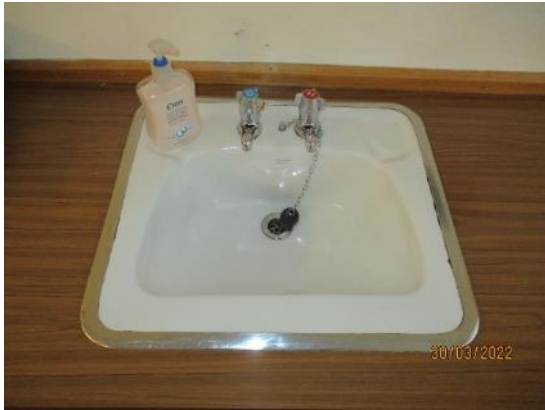
96. Composite inset sink

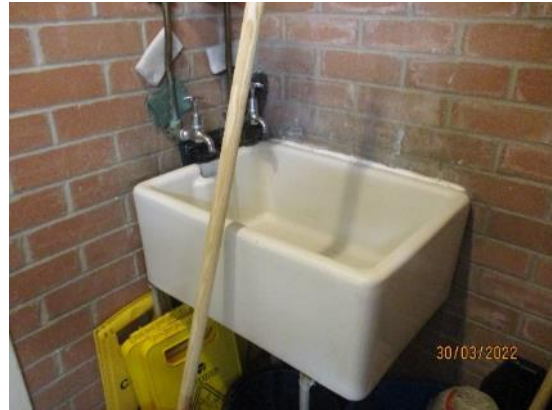
97. Cleaners Butler sinks

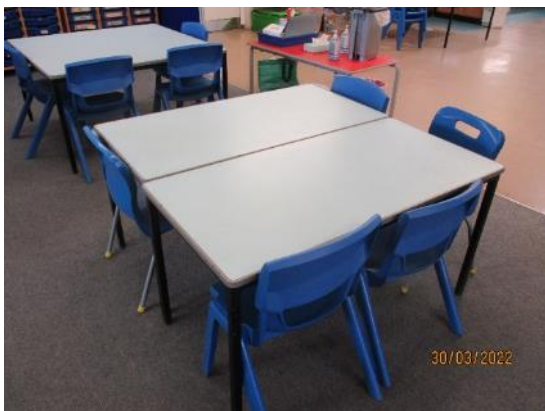
99. Classroom furniture

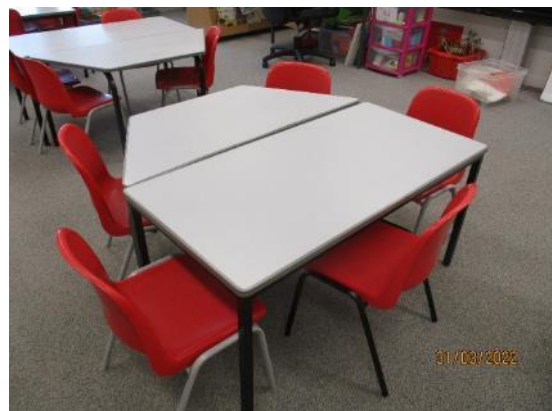
100. Annexe classroom furniture

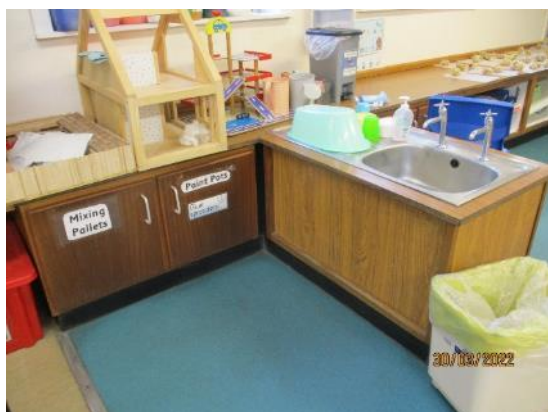
101. Sink base units

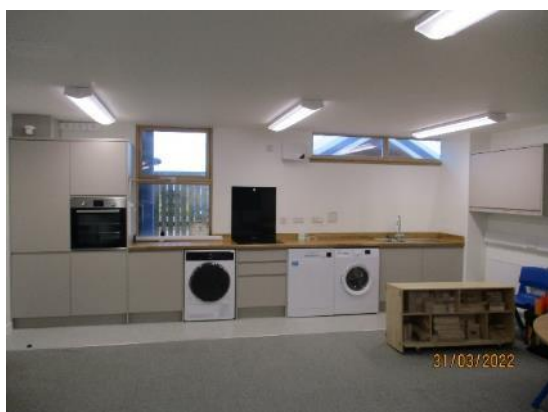
103. Kitchen units in the Annexe

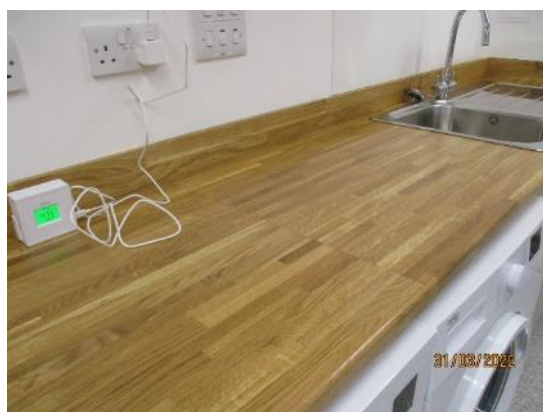
104. Annexe worktops

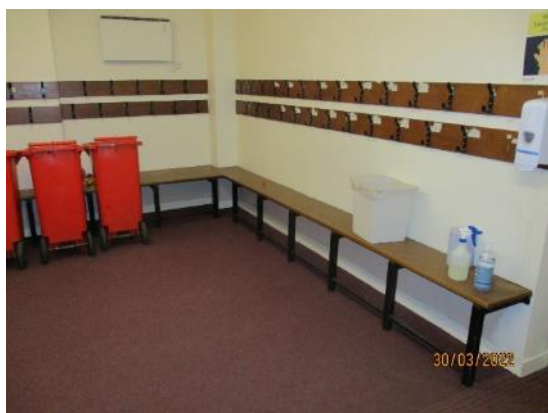
105. Cloakroom furniture

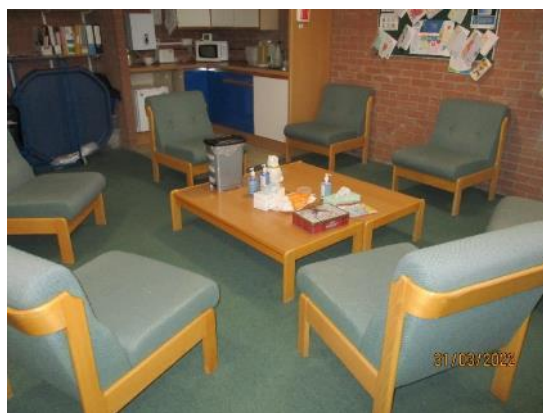
106. Staff room furniture

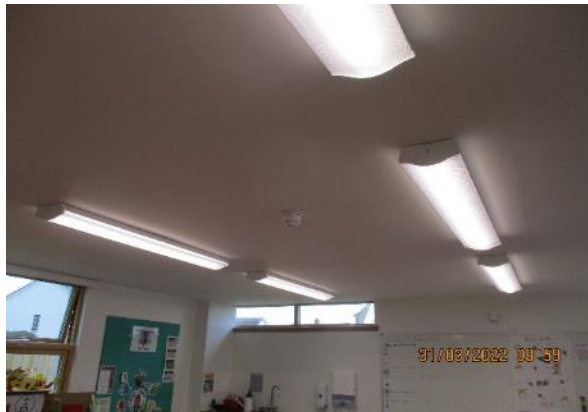
- Watermarked ceilings and taped joints failing.
- Floor finishes worn and soiled.
- Sanitary ware dated, cubicle partitions laminating.
- Existing lighting is dated throughout and should be considered for upgrade to LED type with energy saving controls.

149. Lighting classroom

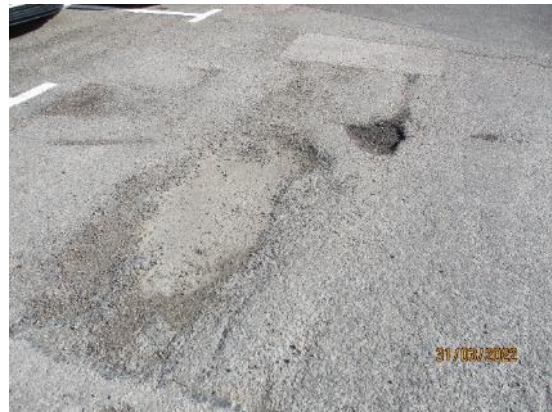
- Stone wall to East boundary crumbling, requires repair and repointing.
- Concrete posts to chain link fence leaning and require stabilised.
- Access road and car park, tarmacadam breaking up and potholed.

168. Potholes

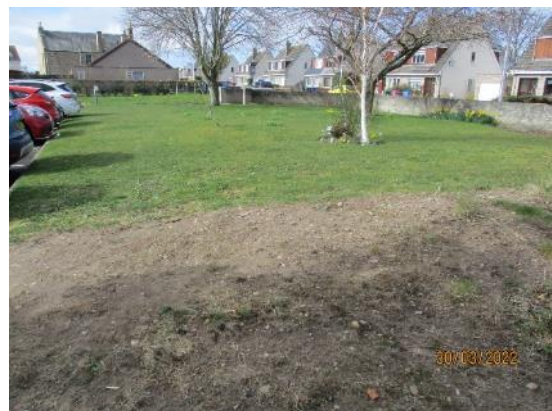
183. Road gully car park drainage

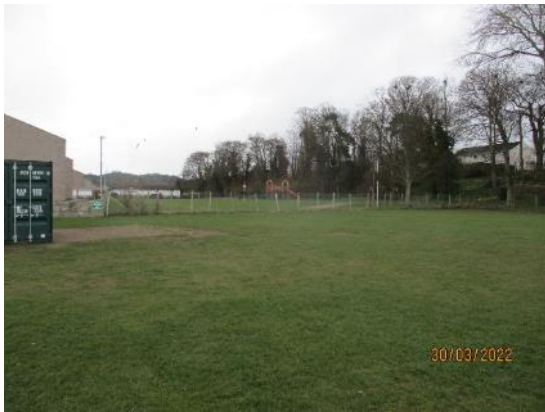
184. Landscaping – grass and trees

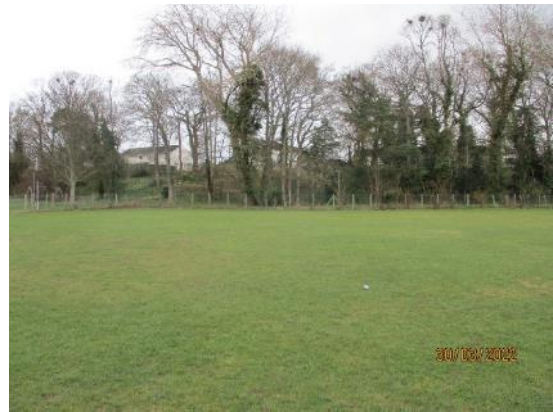
185. Playing field
