# **Summary Building Condition Survey Report**

**Cluny Primary School  
South Pringle Street, Buckie AB56 1PX**

**25<sup>th</sup> and 26<sup>th</sup> April 2022**

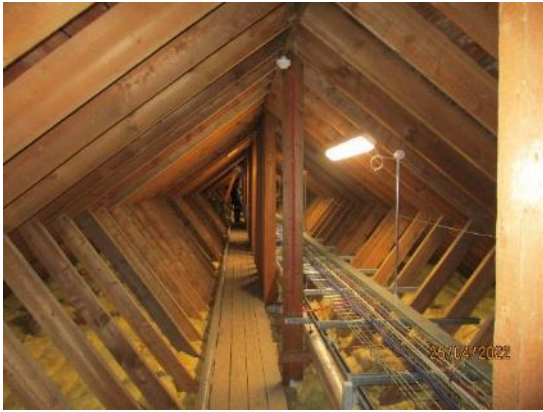
1. Main school, pitched roof

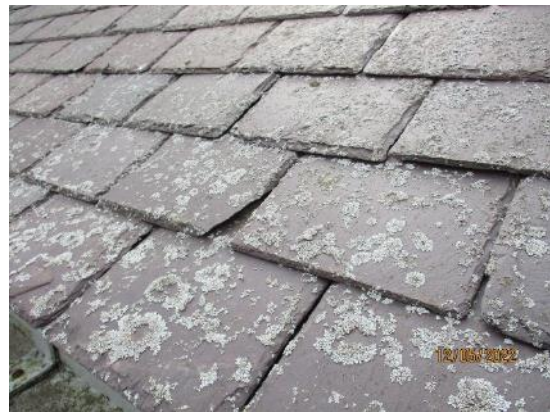
4. Slated roofs

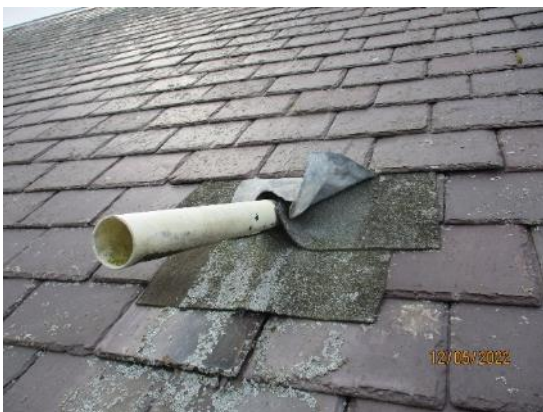
5. Slates and lead flashings

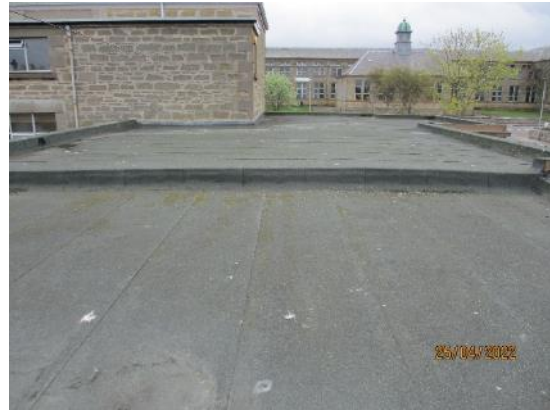
8. Mineral felt to single storey flat roofs

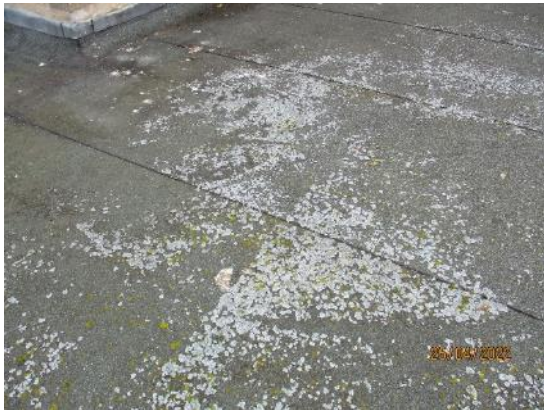
9. Lichen on the surface of felt roofs

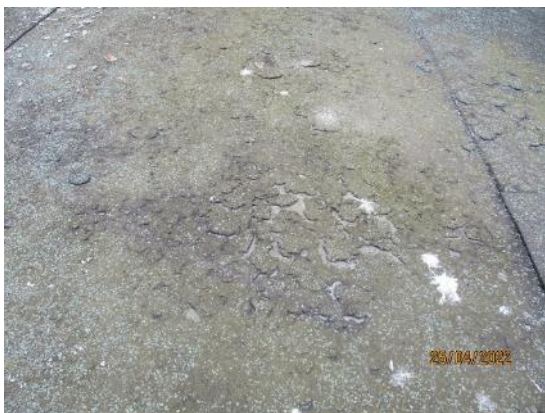
11. Felt surface crazing

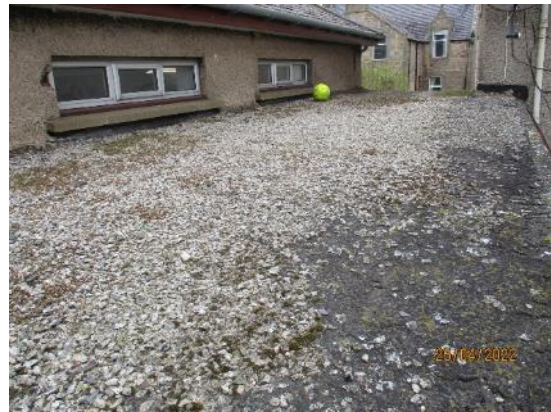
14. Dining Hall felt roof

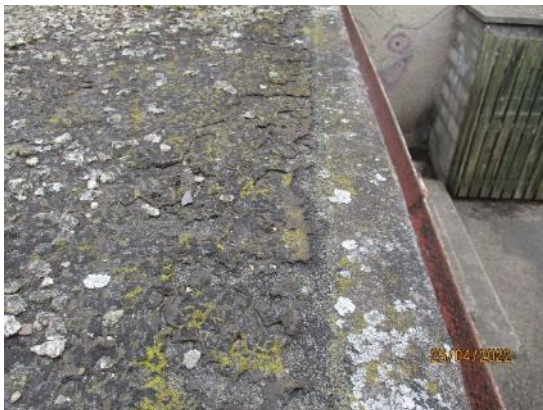
15. Felt cracking and crazing

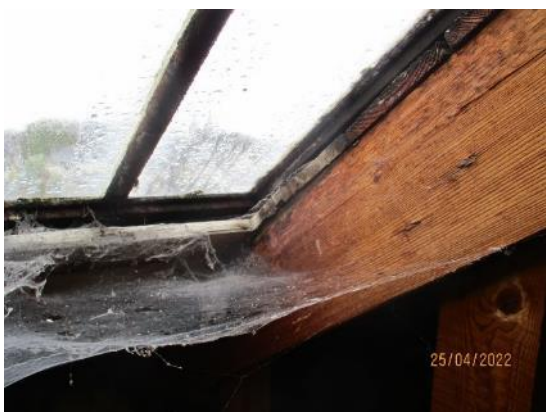
19. Skylight internally

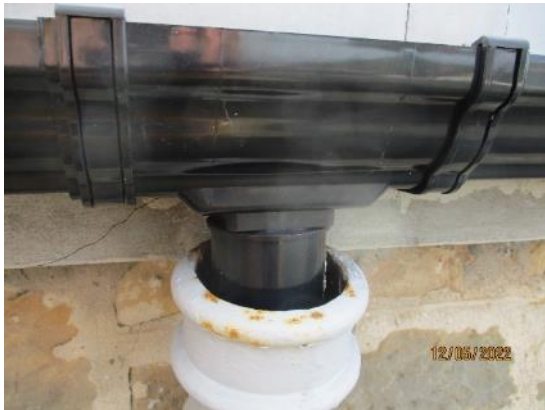
27. UPVC ogee gutter outlets

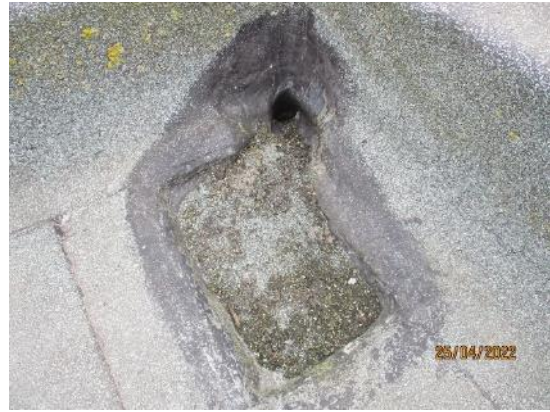
32. Small outlets to felt roofs

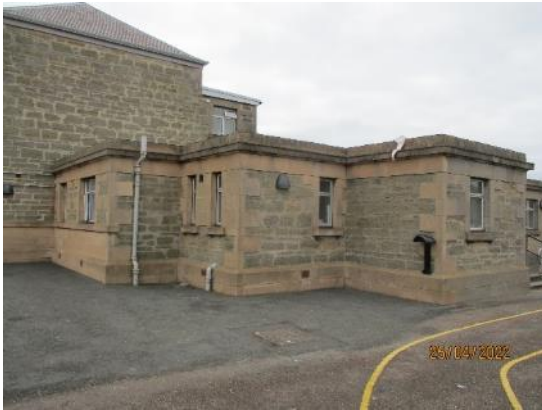
37. Stone walls to main school

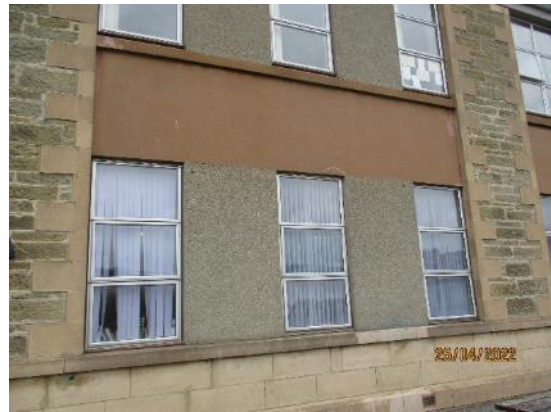
44. Render and roughcast panels

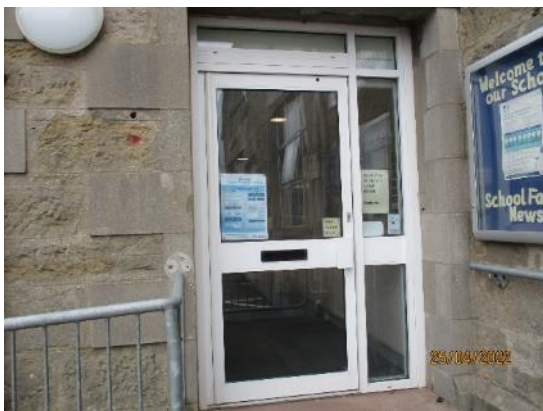
47. Main entrance

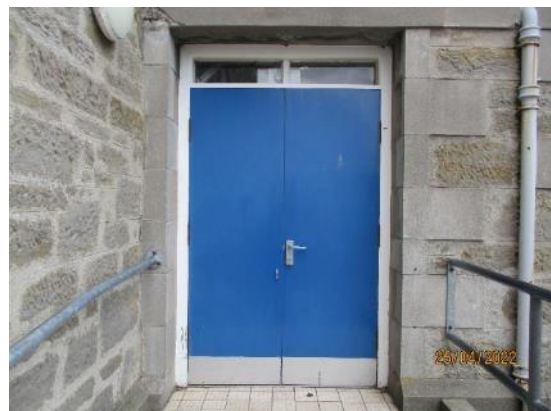
48. Timber double doors

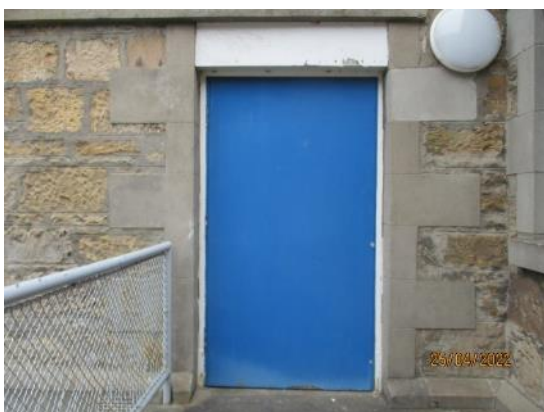
49. Single timber doors

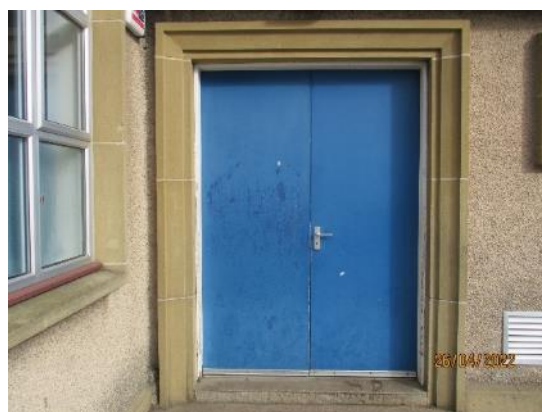
52. Dining Hall timber double doors

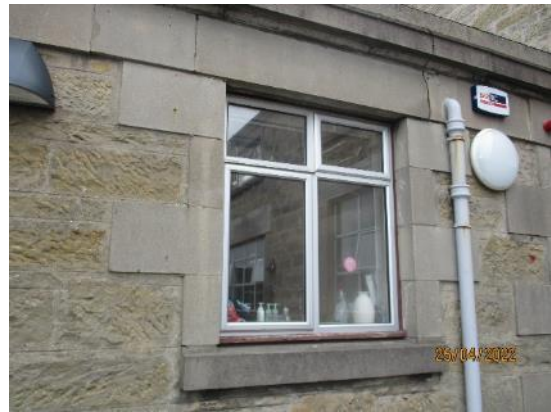
56. Standard aluminium windows

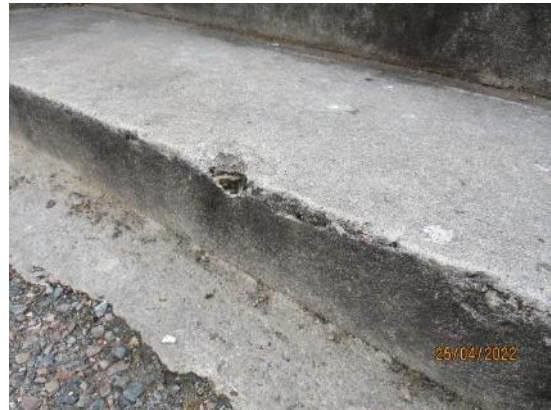
69. Chipped nosings

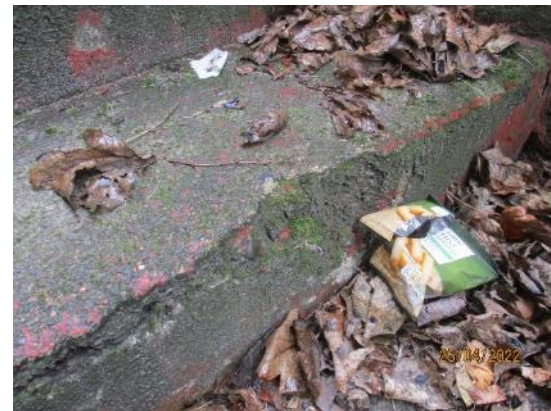
71. Chipped nosings

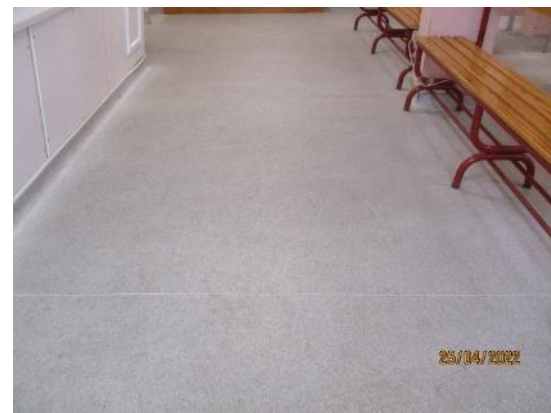
77. Soiled sheet vinyl

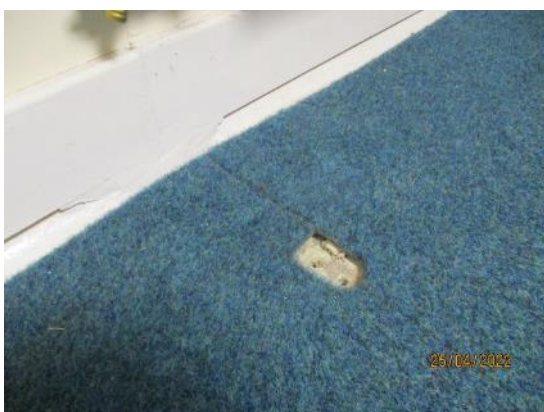
80. Holes in carpet

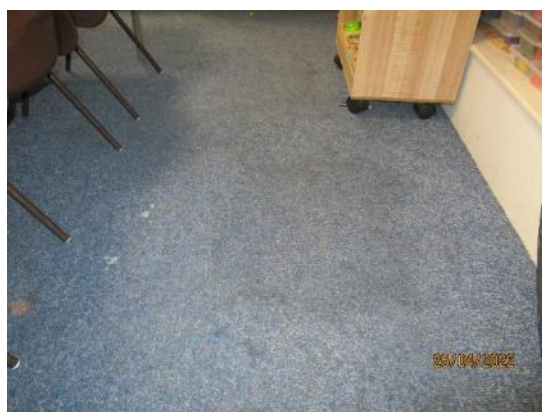
81. Soiled and stained carpets

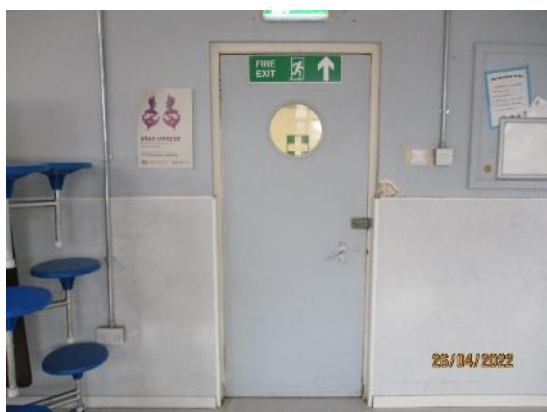
115. Timber doors in Dining Room

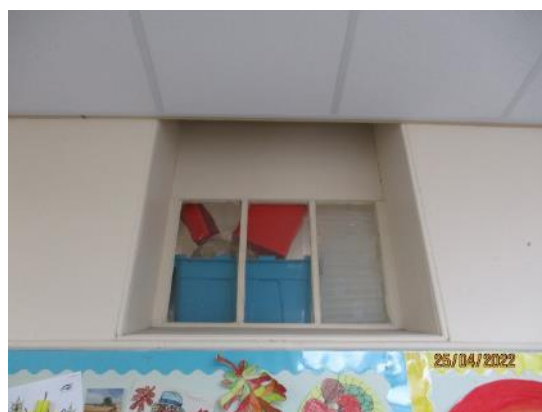
116. Borrowed lights to classrooms

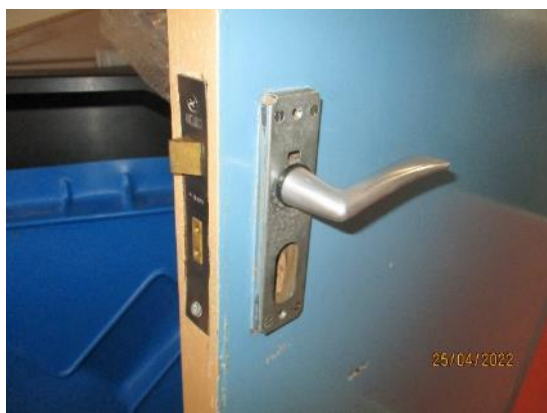
117. Defective ironmongery

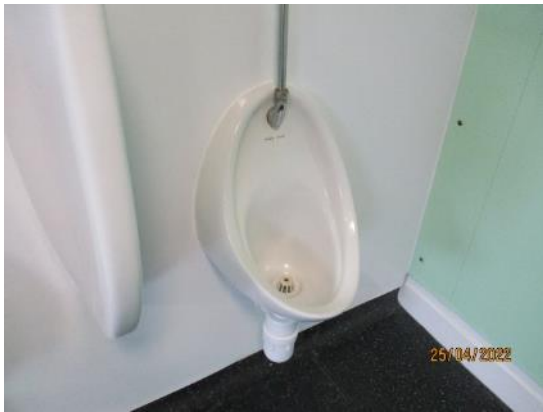
119. Individual urinals

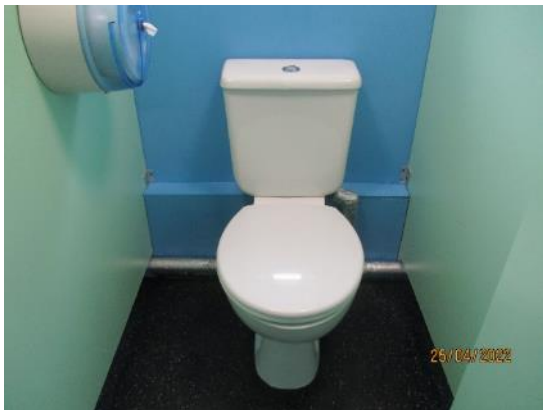
121. Typical WC

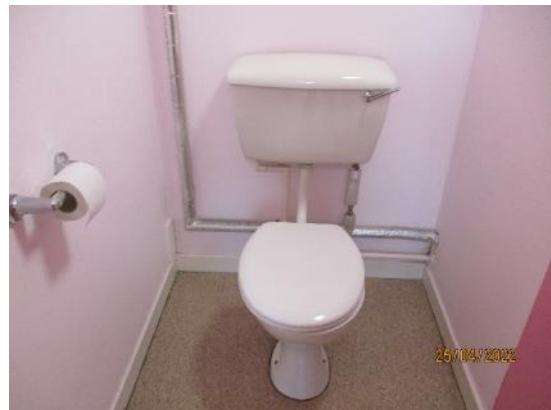
122. Older WC's

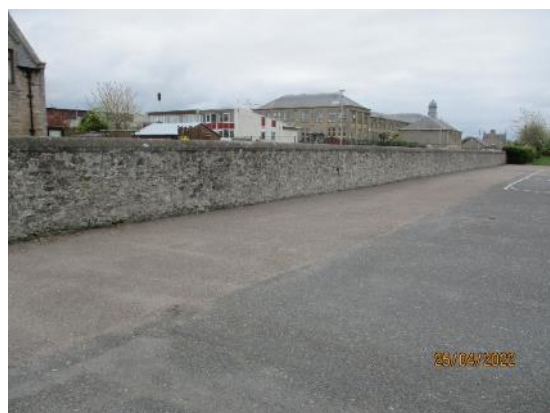
236. Natural stone wall
