# **Summary Building Condition Survey Report**

**Cullen Primary School  
Old Church Road, Cullen AB56 4UZ**

**7<sup>th</sup> June 2022**

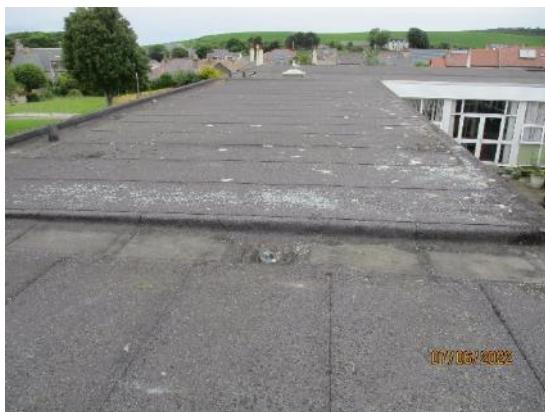
5. Steps in felt roofing

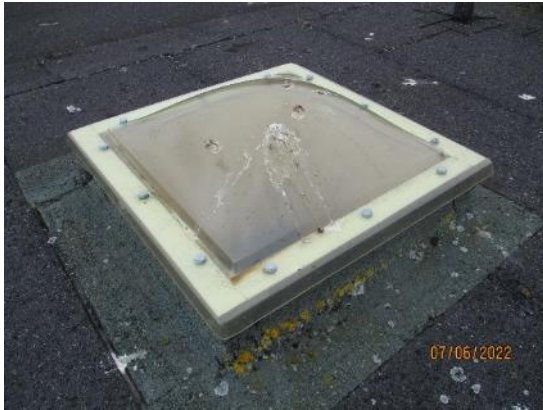
7. Rooflights

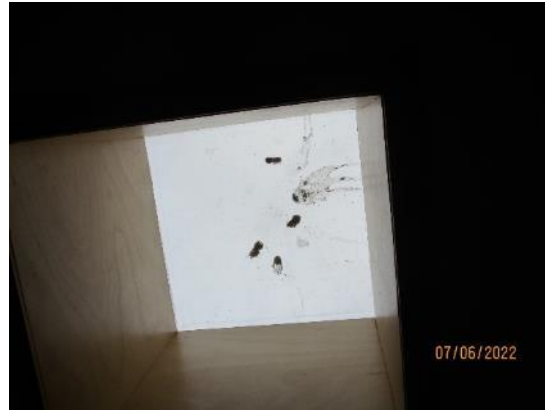
8. Rooflight internally

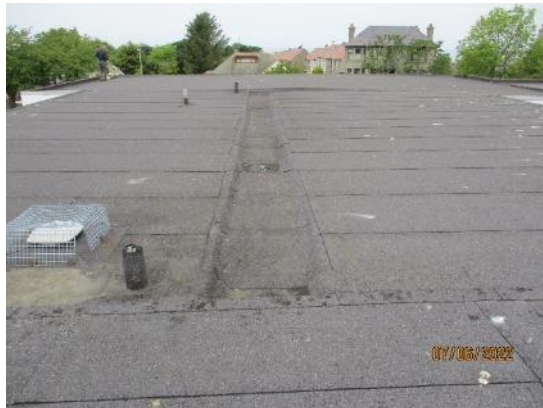
9. Box gutters

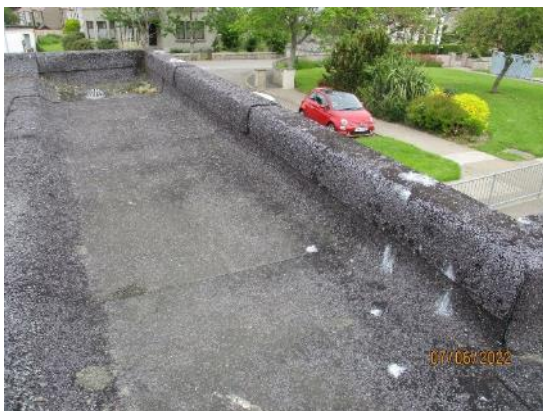
11. Perimeter box gutters

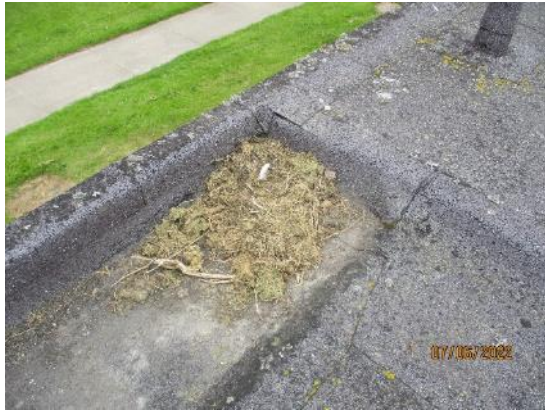
13. Birds nests and debris

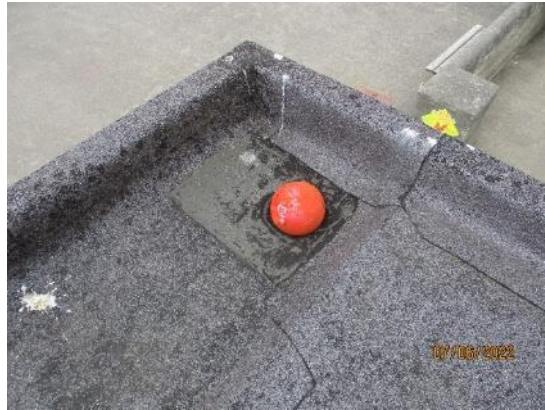
14. Outlet blockages

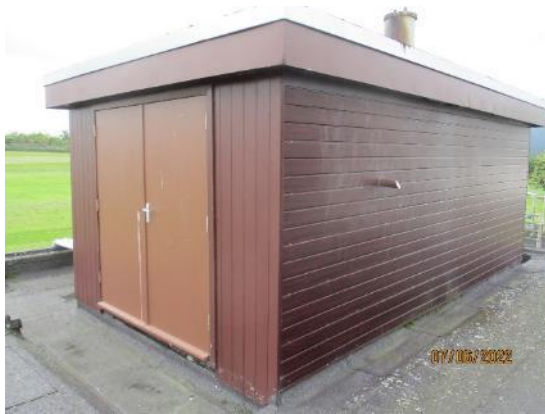
19. Timber boarding

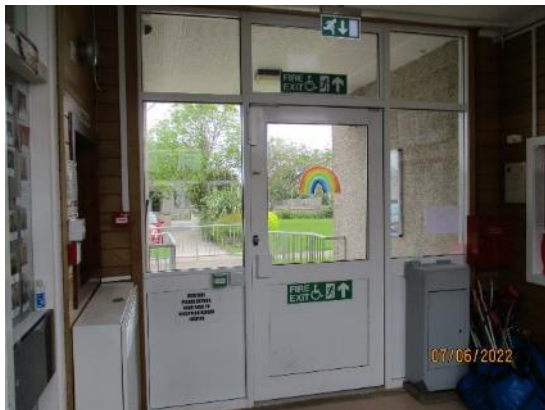
21. Entrance door and screen

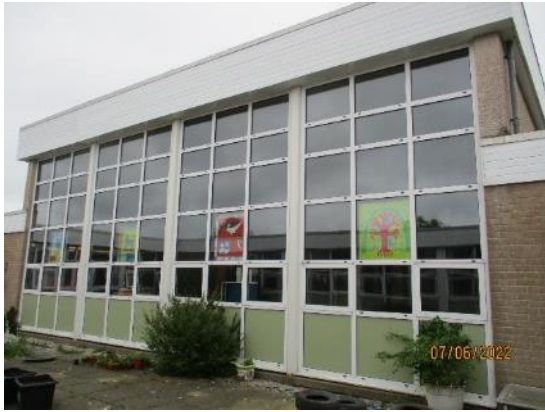
25. Large glazed screen

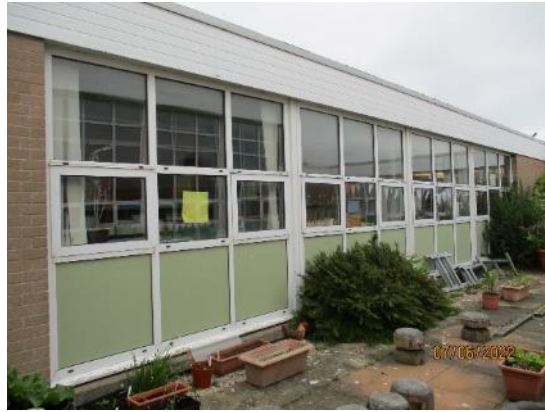
26. Courtyard windows

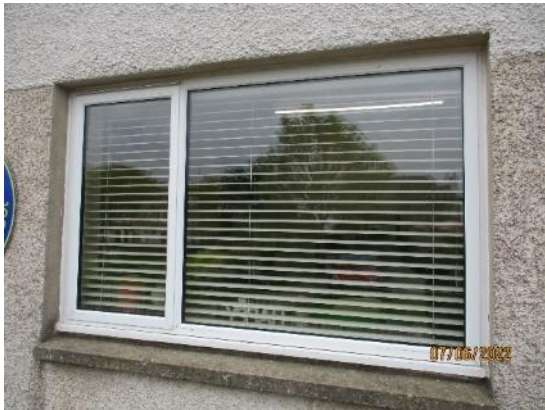
27. Standard window

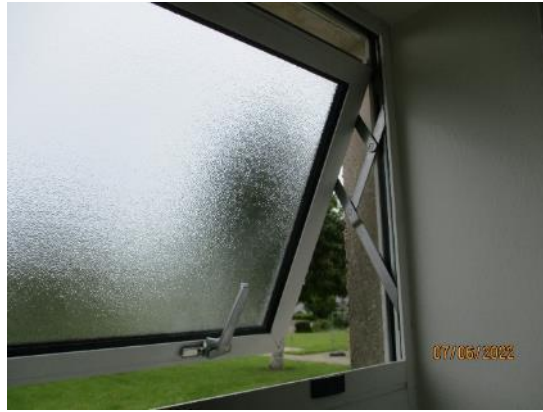
32. Friction hinge mechanism

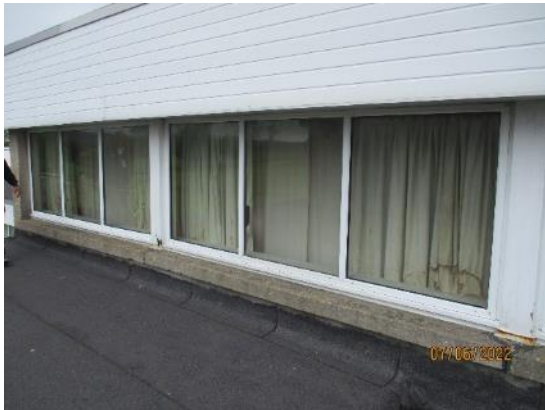
33. Games Hall high level windows

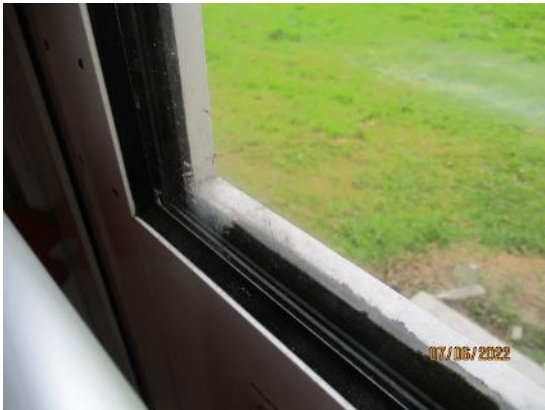
39. Double glazing units

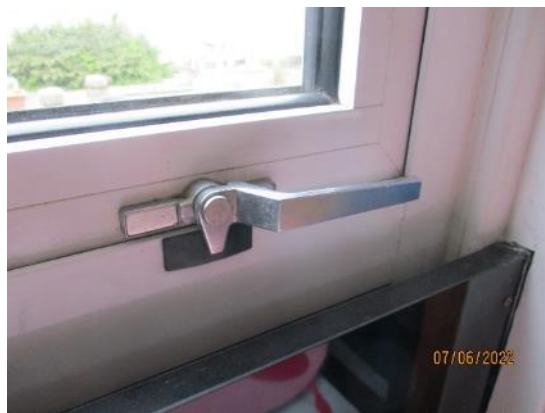
42. Lever handles

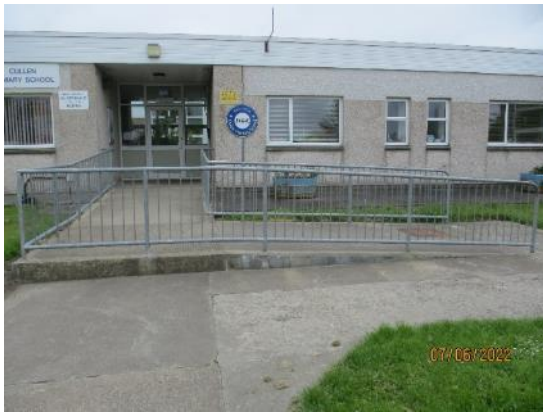
43. Entrance ramps

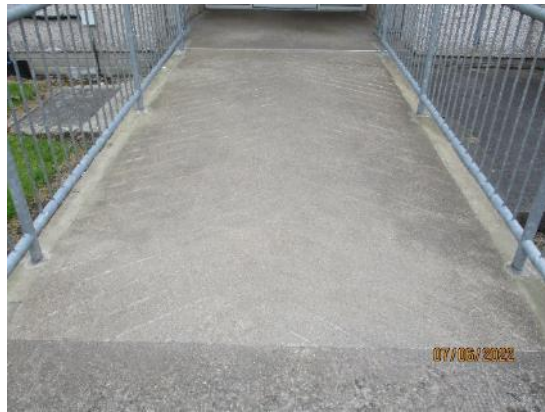
44. Concrete ramp

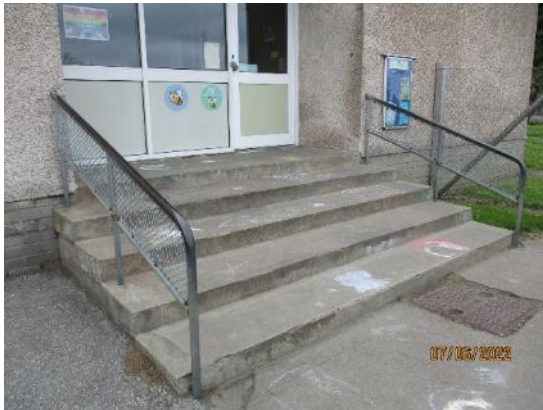
45. Steps to side

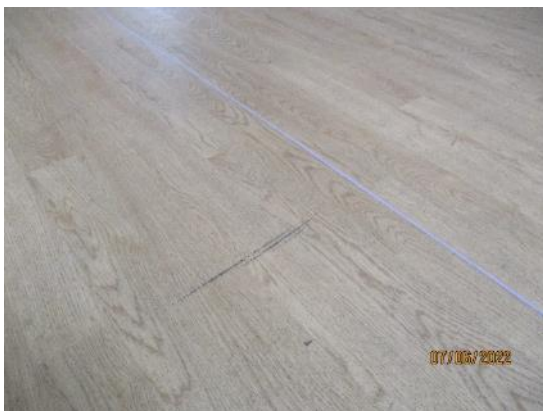
47. Sheet vinyl to Games Hall floor

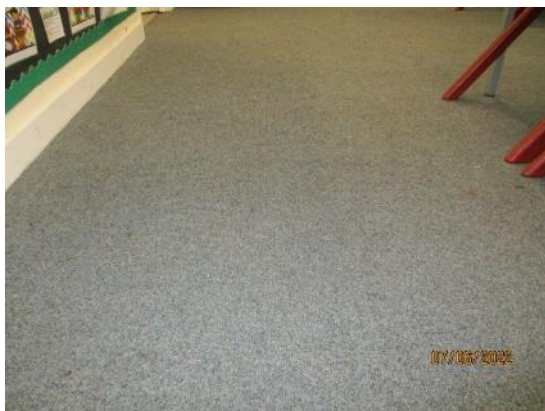
53. Classroom carpet

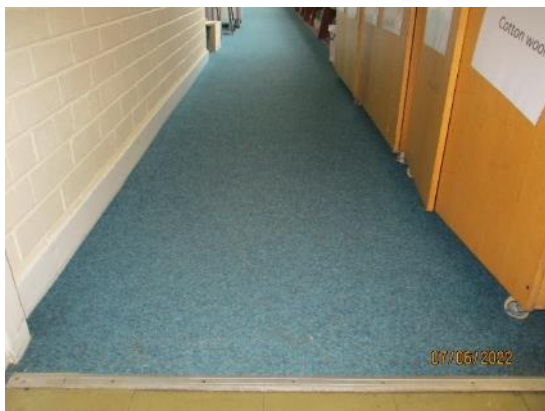
54. Corridor carpet

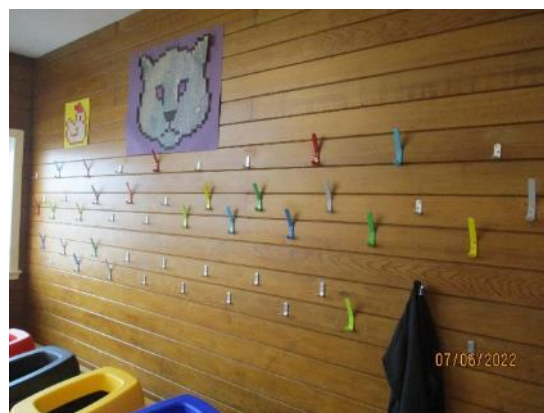
65. Timber linings

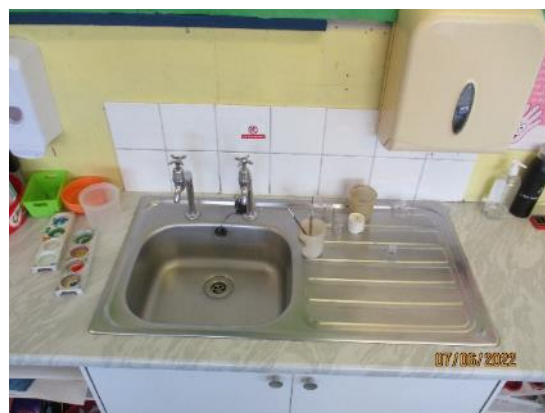
71. Ceramic tiled splashbacks

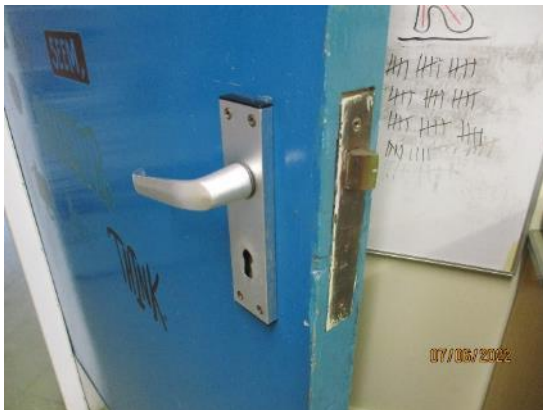
80. Aluminium lever handles

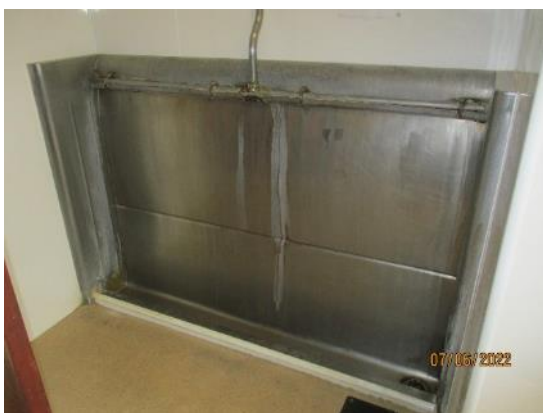
81. Stainless steel trough urinals

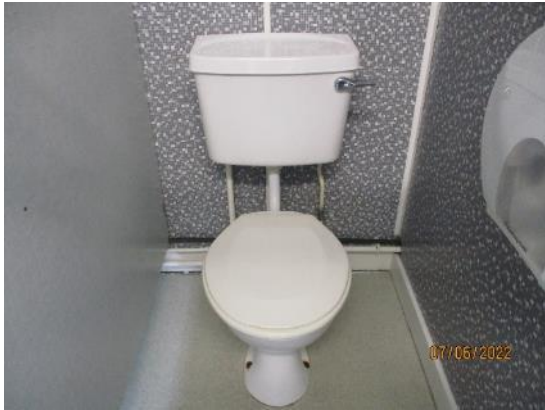
83. Typical WC

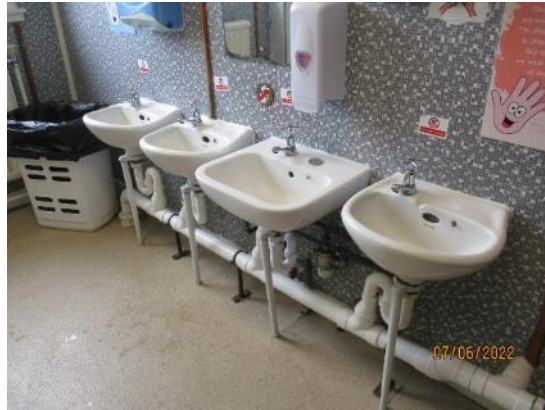
84. Variety of wall hung basins

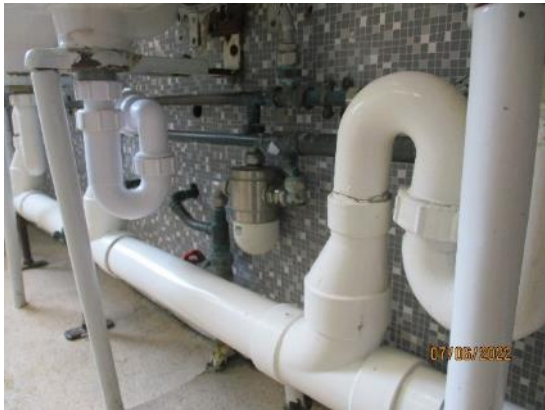
85. PVC waste pipes

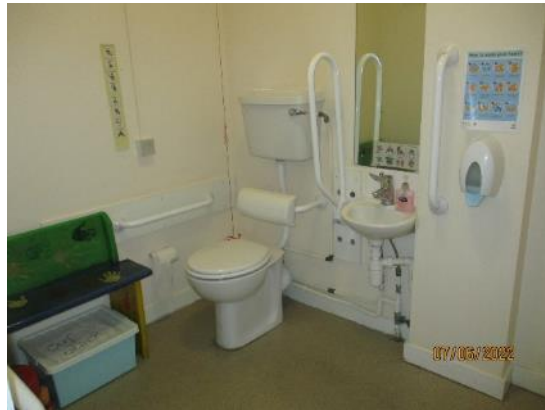
86. Accessible toilet

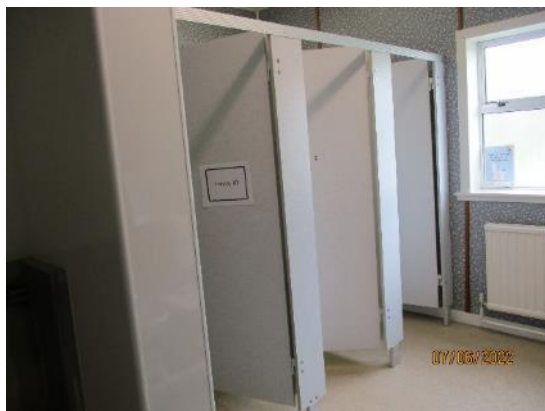
87. Composite cubicle partitions

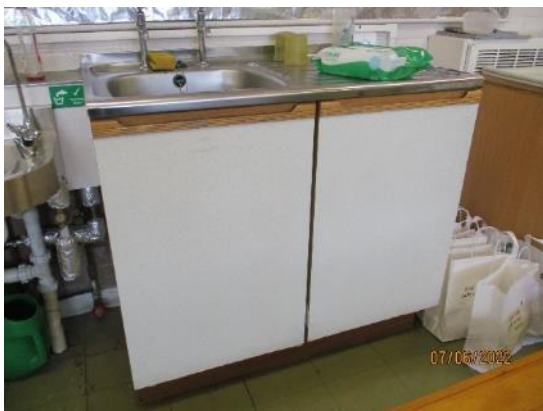
99. Dated sink base units

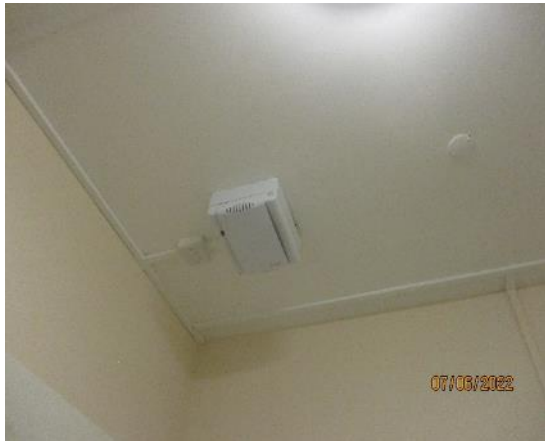
115. Extract fan boys toilets 1-23

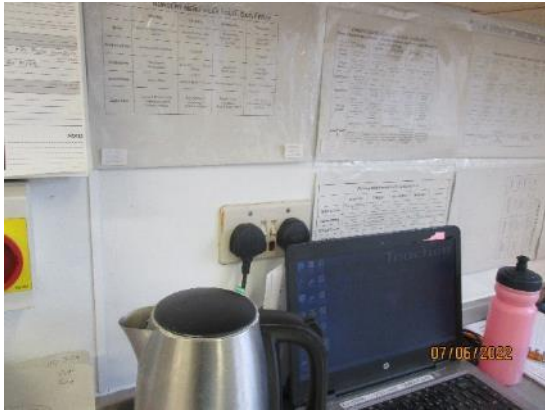
124. Distribution board. Power – kitchen 1/17

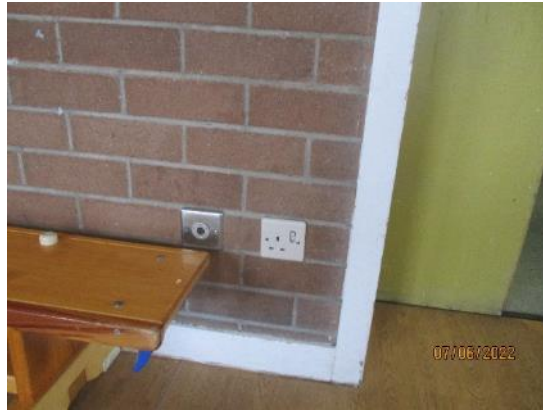
125. Sockets – kitchen 1/17

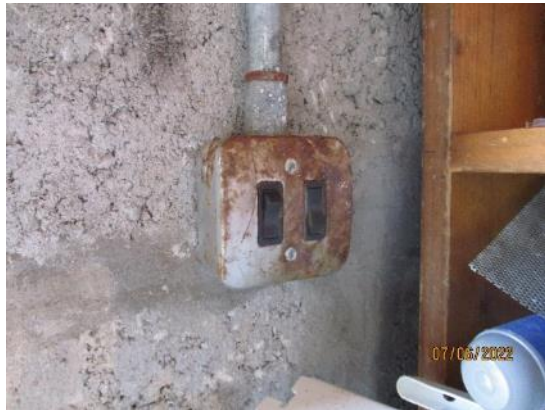
126. Socket – gym hall 1/16

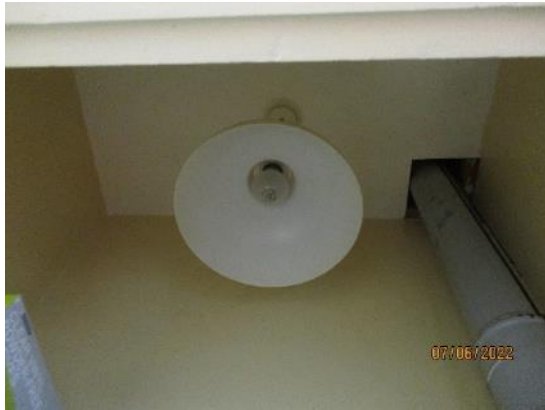
130. Lighting – typical toilet.

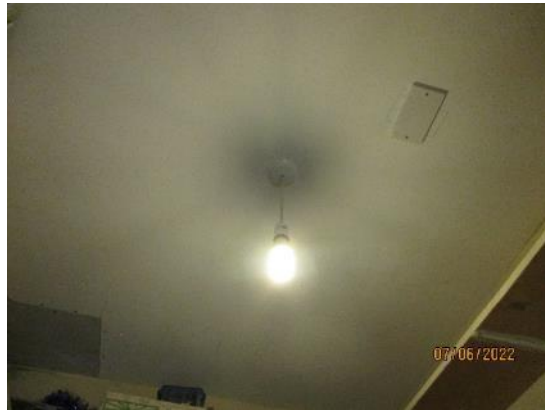
133. Lighting – external store example.

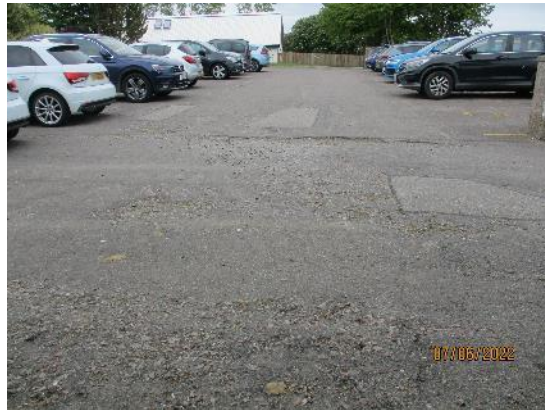
158. Previous patching

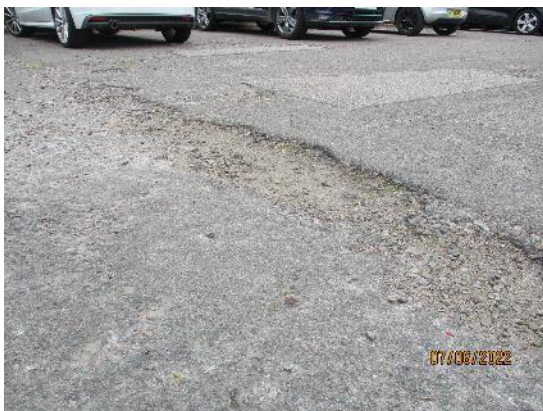
- Tarmacadam car park and rear access road is potholed and breaking up.
- Areas of concrete footpaths are breaking up.
- Precast concrete slab footpaths are damaged and uneven.
- Masonry wall to front has several open cracks.
- Timber sheds are dilapidated.

159. Deep ruts

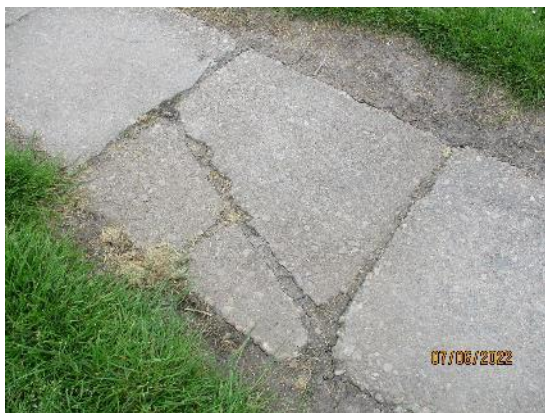
170. Cracked and uneven

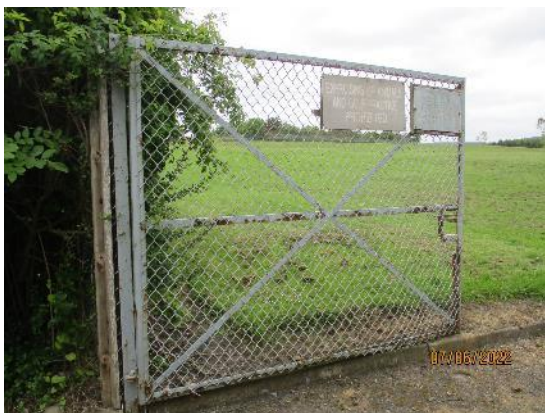
176. Timber rot and flaking paint
