# **Summary Building Condition Survey Report**

**Findochty Primary School  
Burnside Street, Findochty AB56 4QW**

**11<sup>th</sup> & 12<sup>th</sup> July 2022**

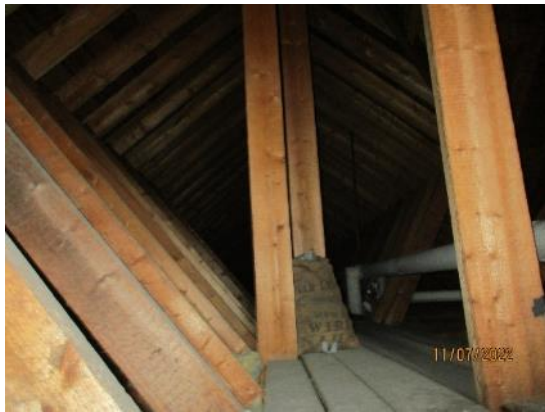
1. Timber trusses

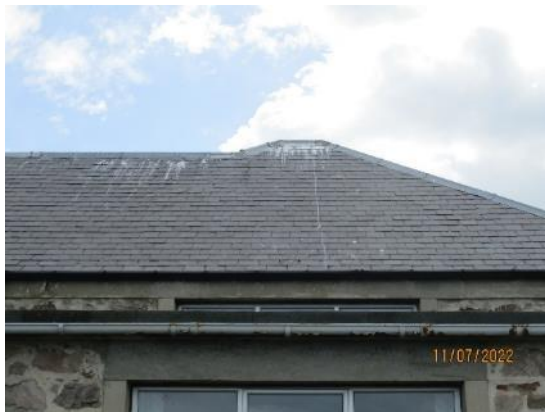
3. Slate to Main School

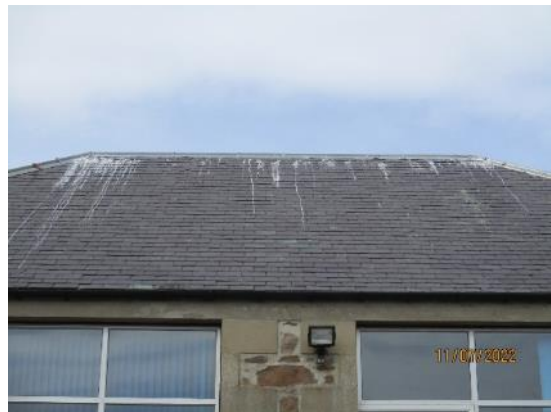
4. Slate to Games Hall

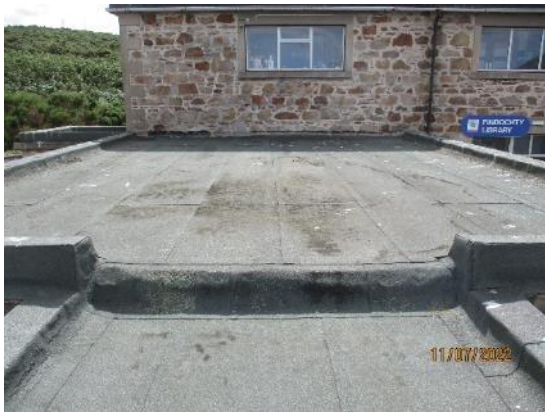
7. Felt roof above Reception

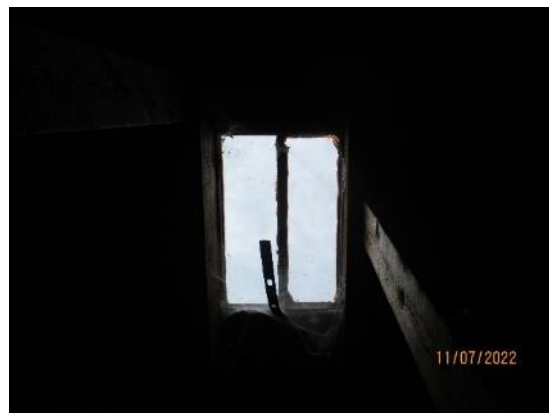
12. Damaged ironmongery

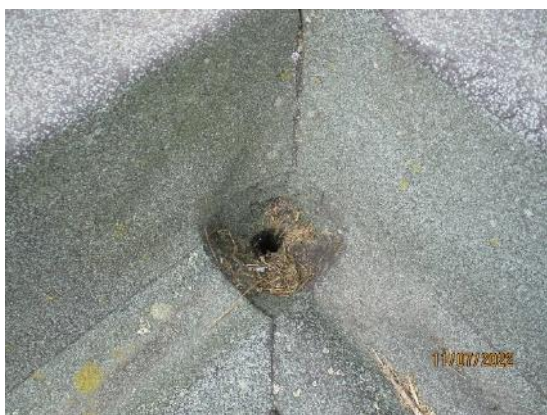
19. Very small flat roof outlets

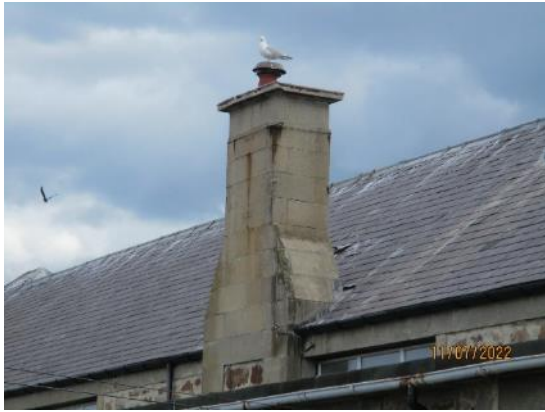
25. Stone chimney with single pot

- Replacement of the HORSAs hut with an appropriate external storage building.
- Investigate the chimney capping / venting.
- Upgrade the Commercial Kitchen wall and ceiling finishes, to wetwall.

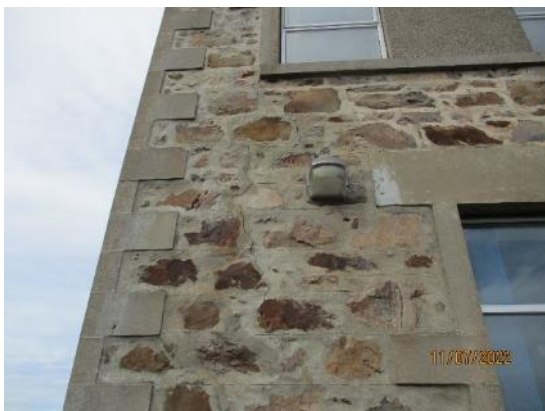
28. Natural stone external walls

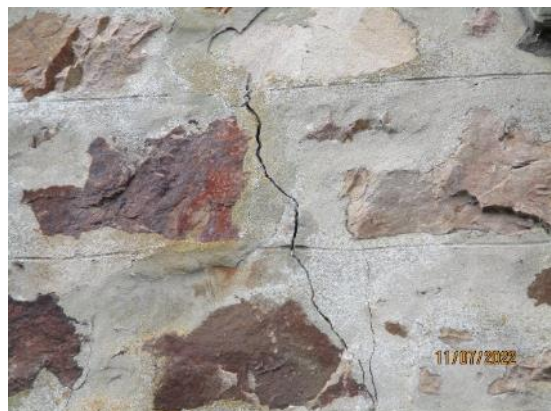
29. Vertical cracking

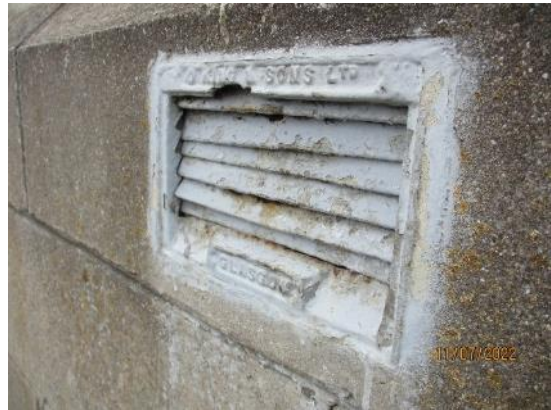
33. Damaged vents

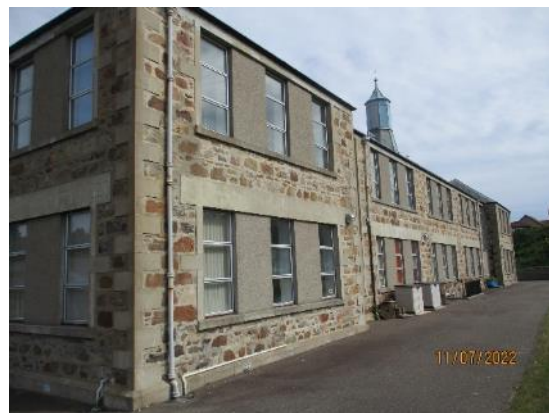
35. Natural stone external finish

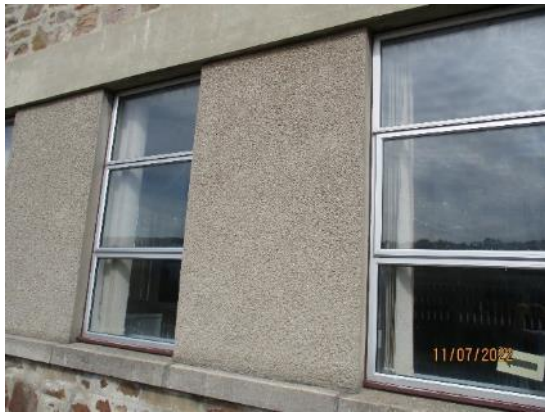
36. Roughcast panels between windows

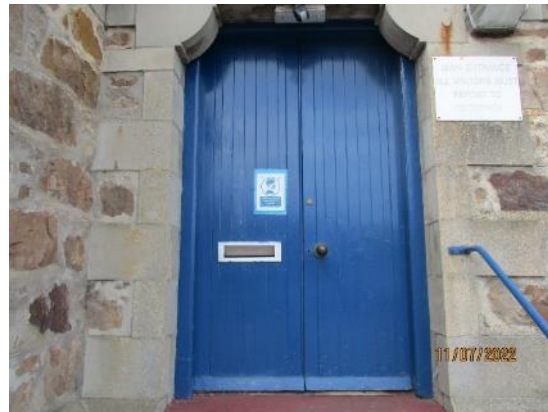
37. Timber front entrance doors

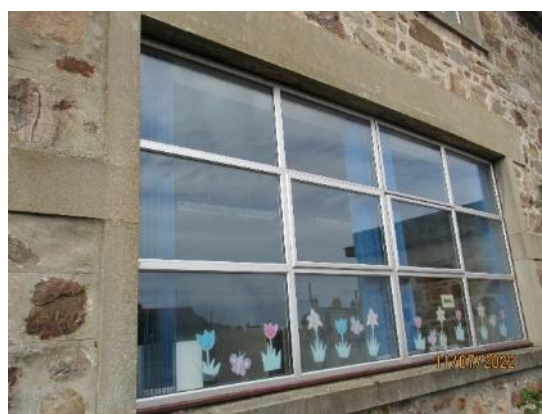
43. Large aluminium windows

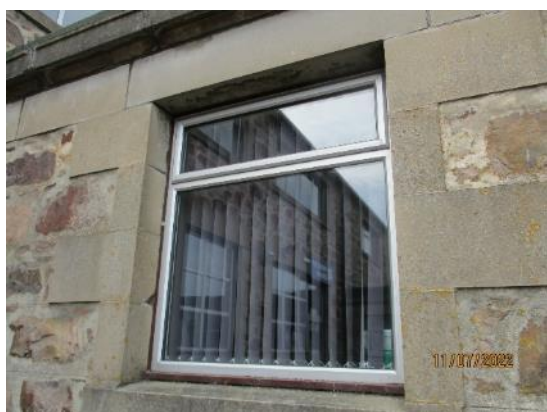
44. Standard aluminium windows

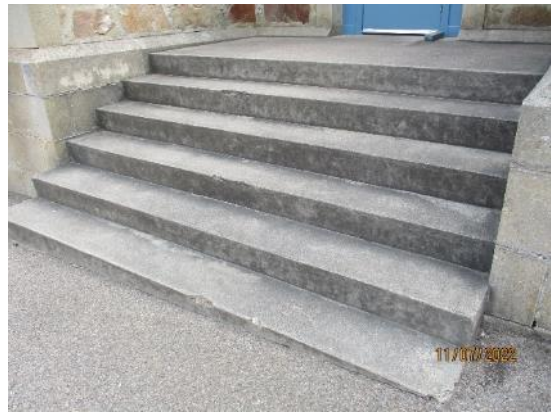
55. Concrete steps to Nursery entrance

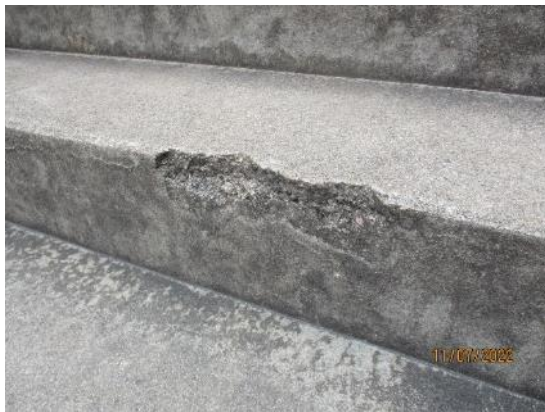
56. Chipped nosings

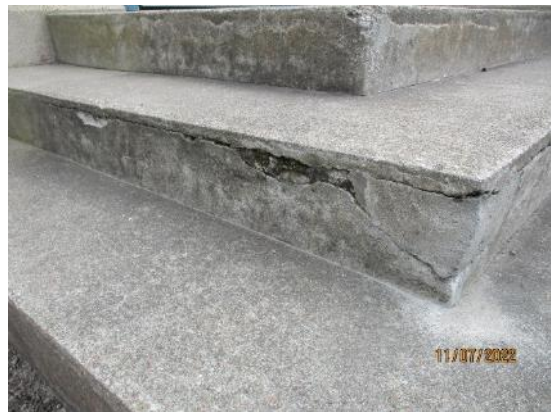
57. Cracked steps

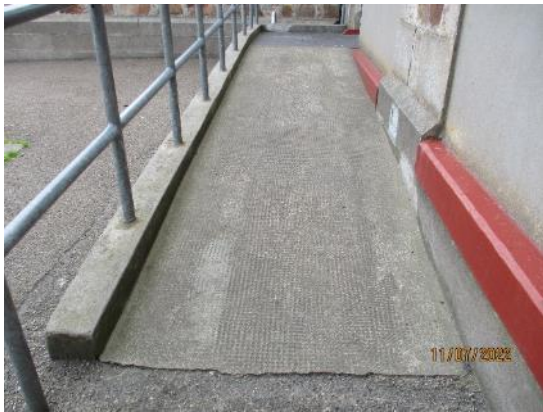
60. Concrete ramps

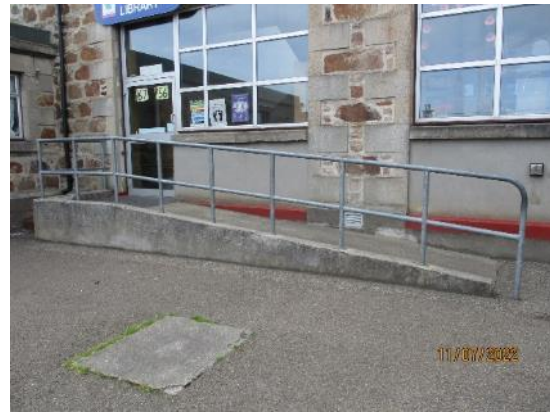
61. Galvanised tubular rails

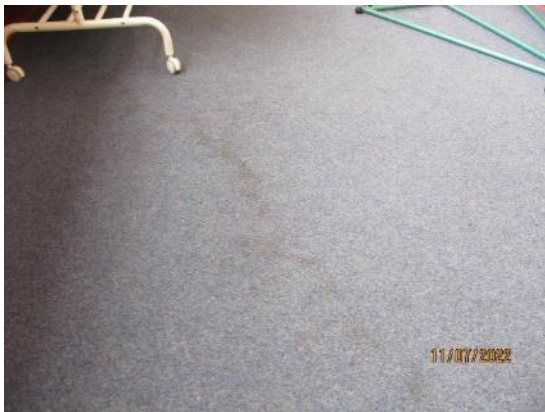
68. Soiled carpets

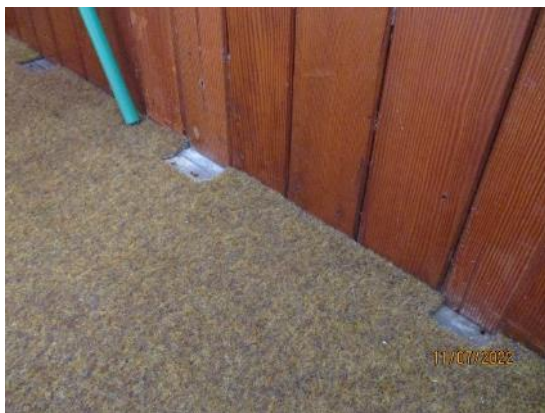
70. Holes in carpet

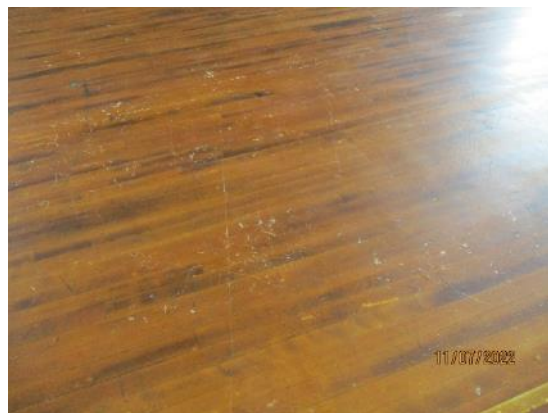
71. Timber sports floor in Games Hall

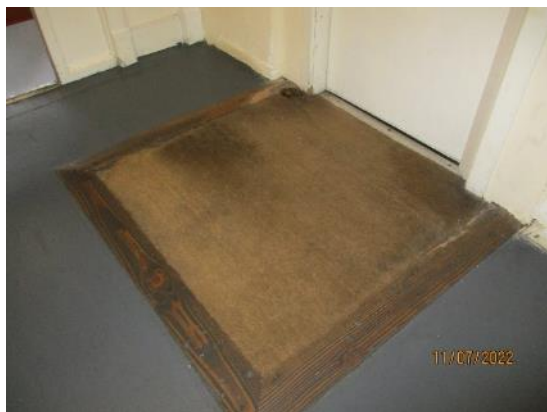
74. Timber frame to coconut matting

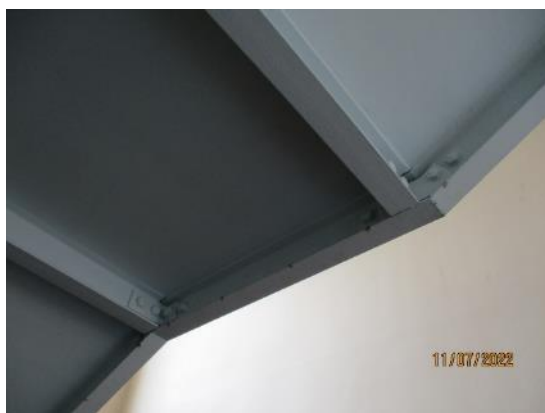
77. Steel support

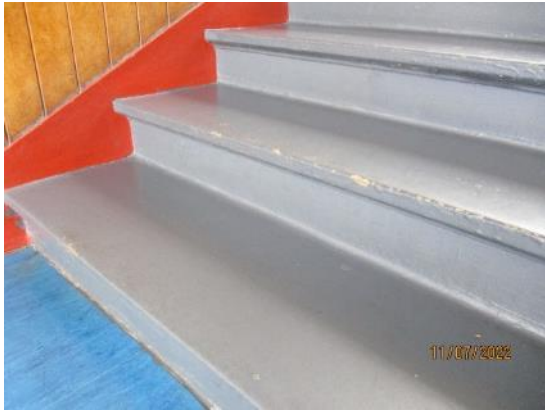
78. Painted concrete treads

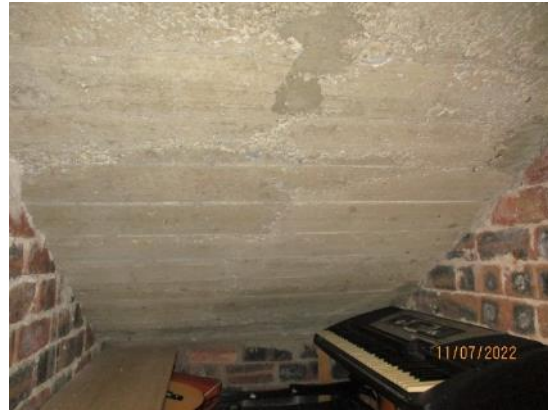
79. Concrete soffits

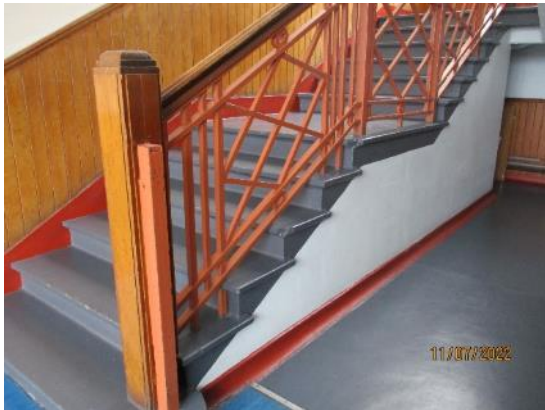
80. Timber balustrades

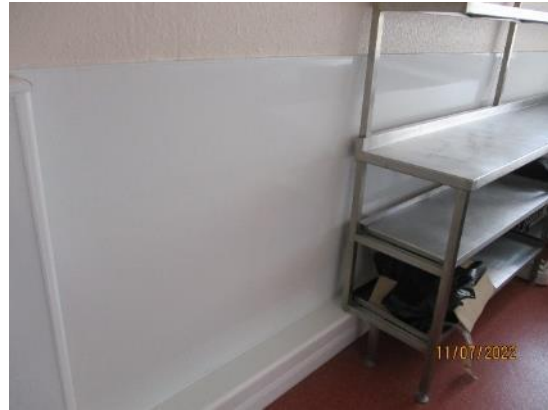
97. Wet wall to various walls

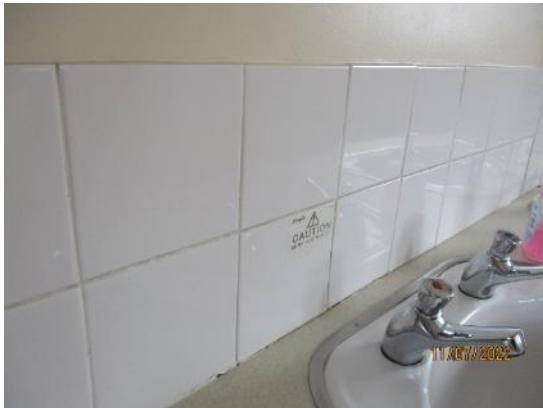
98. Ceramic tile splashbacks

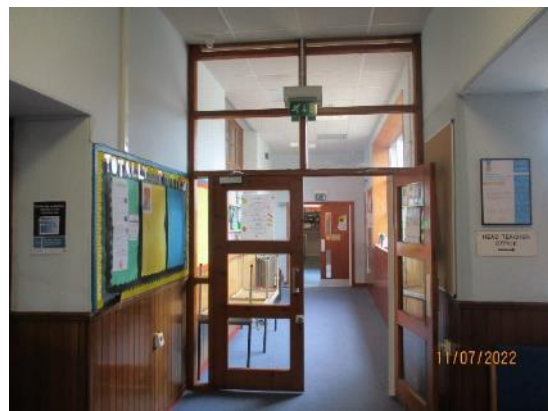
101. Timber doors and screens

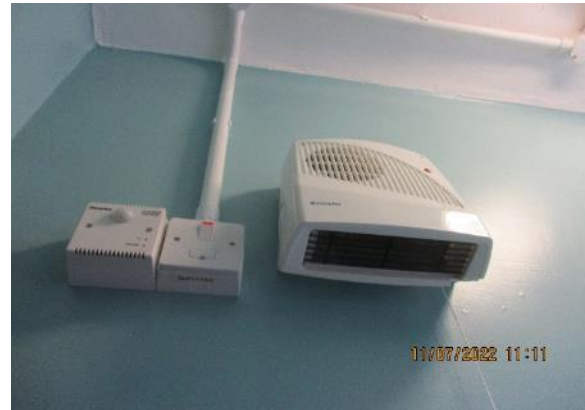
146. Electric fan heater. Gents toilet. 1/21a

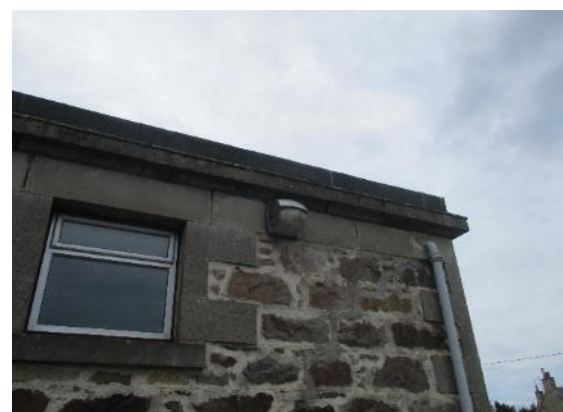
- External lights are showing signs of corrosion and approaching the end of their useful life.
- Electric point of use water heaters are in poor condition and approaching the end of their useful life.
- Electric convector heaters in the boys and girls toilets are in poor condition.

170. External light. Typical bulkhead / wall packette.

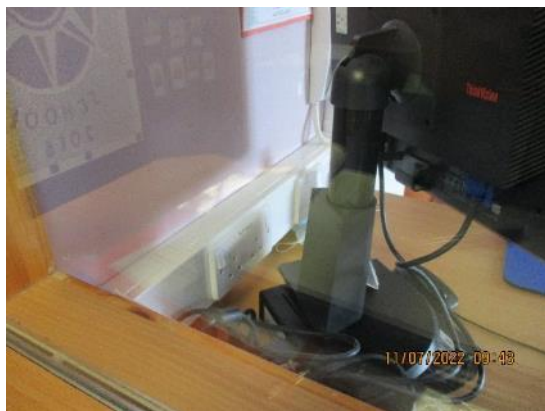
183. CCTV monitor – reception office.

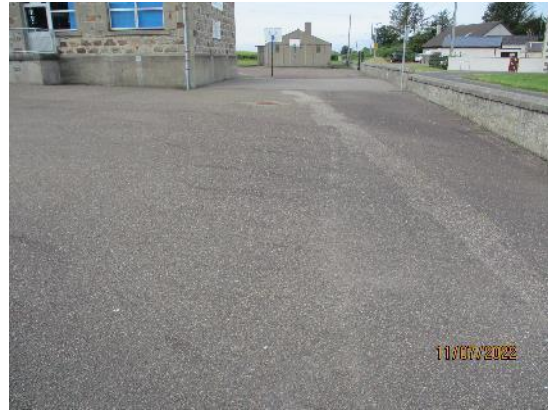
186. Tarmacadam playground

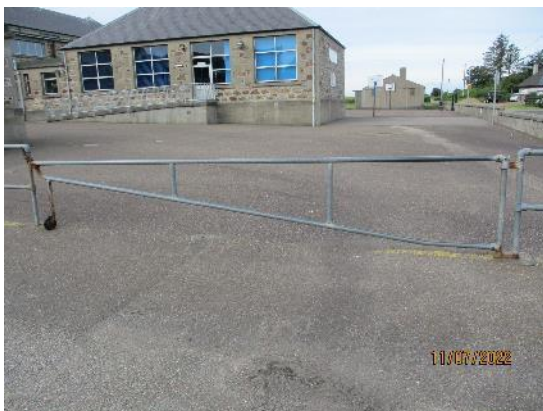
195. Tubular rail gate

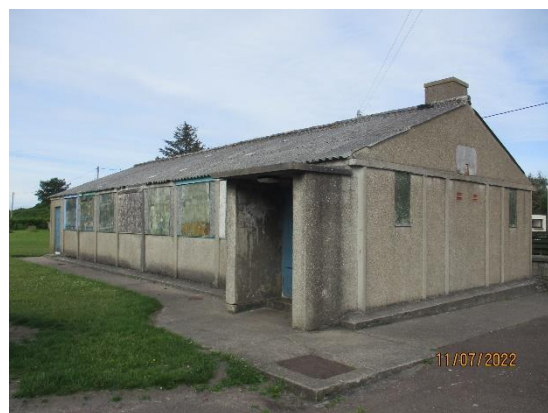
- The HORSIA hut is boarded up, is no longer in use and has exceeded its useful life.
- The concrete coping to the front wall is cracked and spalling.
- The cover of the inspection chamber in the playground is corroded and raised.
- The basketball stands are corroded and the backboards are laminating.
- There are large depressions in the surface of the sports field, at the goal mouths.

210. HORSА hut (boarded up)

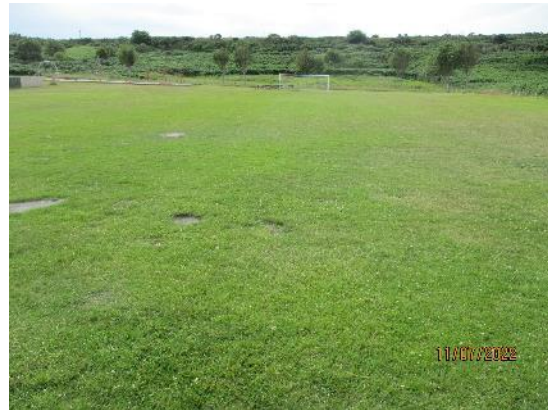
220. Sports field grass

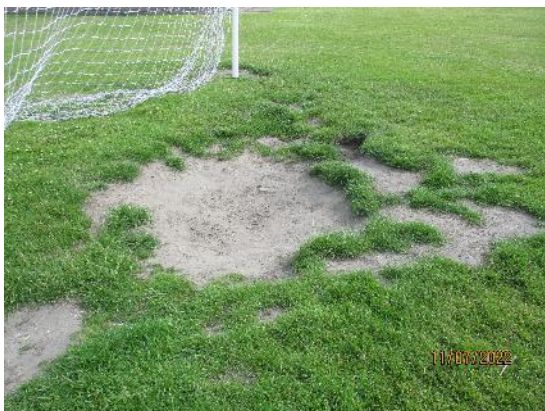
221. Deep depressions at goal mouths
