# **Summary Building Condition Survey Report**

**Millbank Primary School  
McWilliam Crescent, Buckie AB56 1LU**

**18<sup>th</sup> & 19<sup>th</sup> July 2022**

Z00445 / ADC & NS

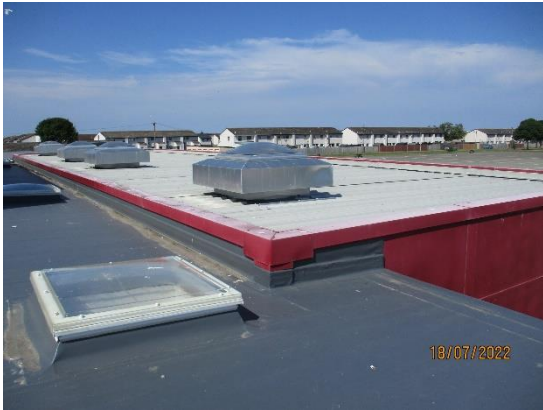
1. Metal profile roof

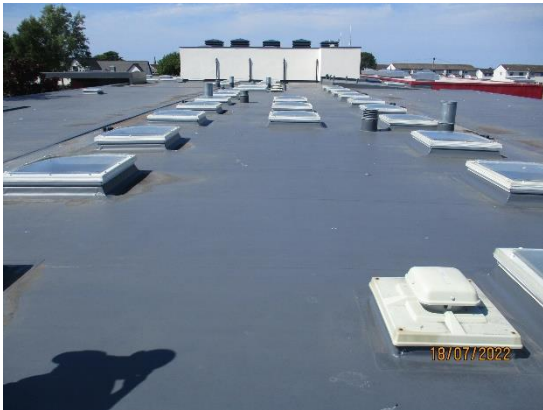
3. Single ply membrane

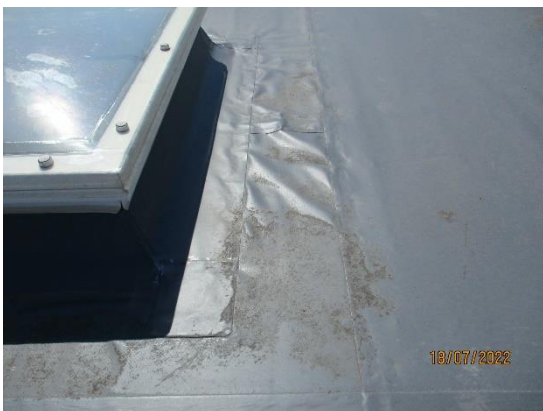
5. Wrinkled single ply membrane

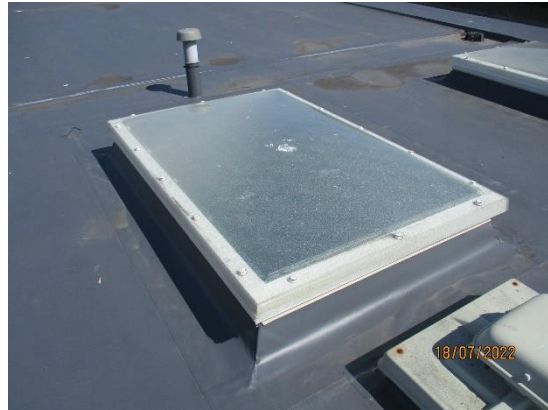
8. Obscure rooflights

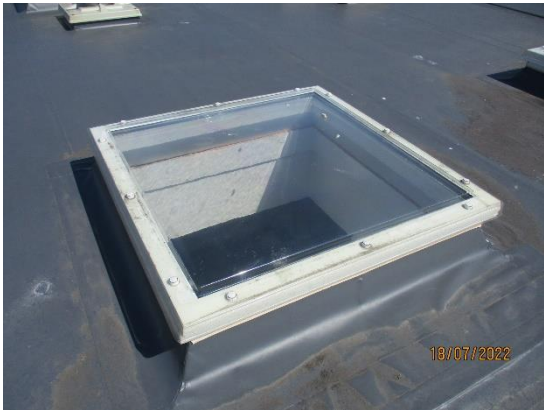
9. Clear rooflights

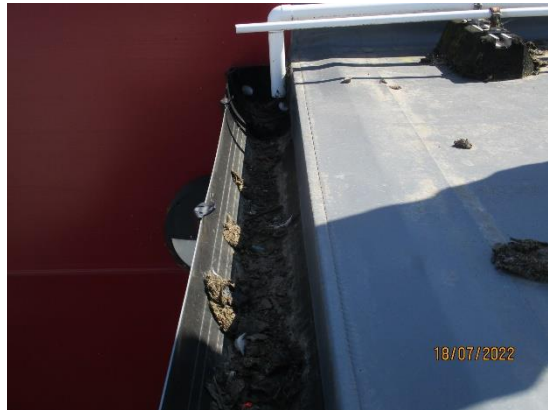
10. UPVC gutter to shallow pitched roofs

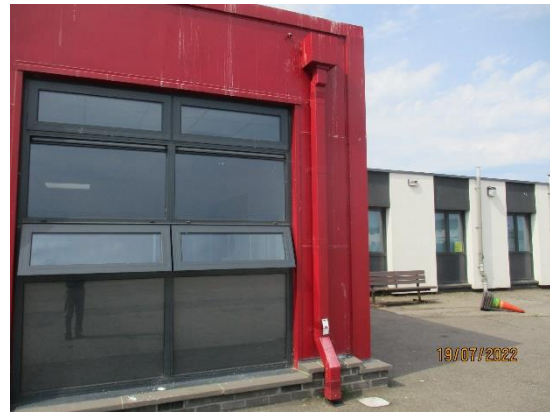
20. Metal hopper heads and downpipes

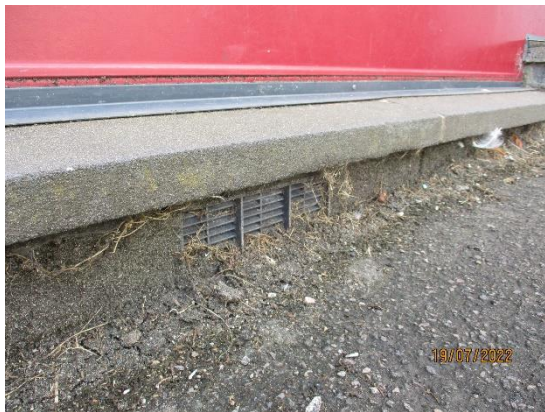
21. Ground level at pods extension

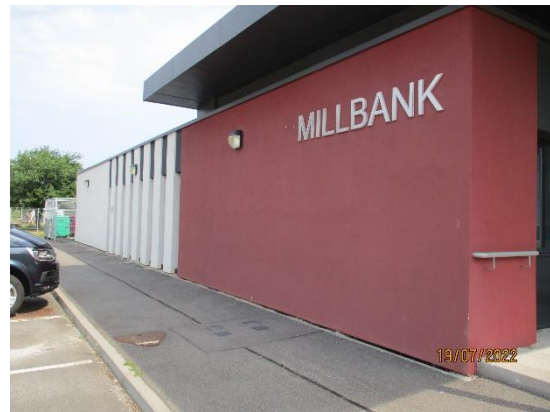
22. External insulation

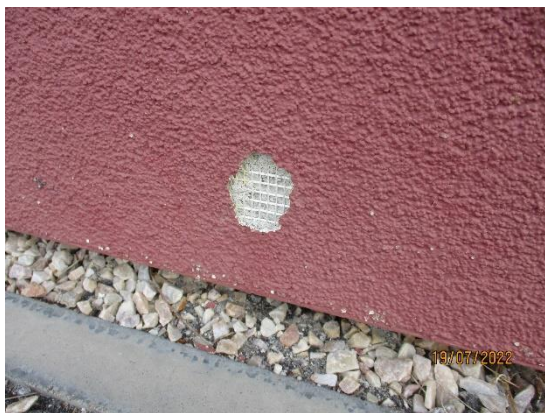
23. Damage to external insulation

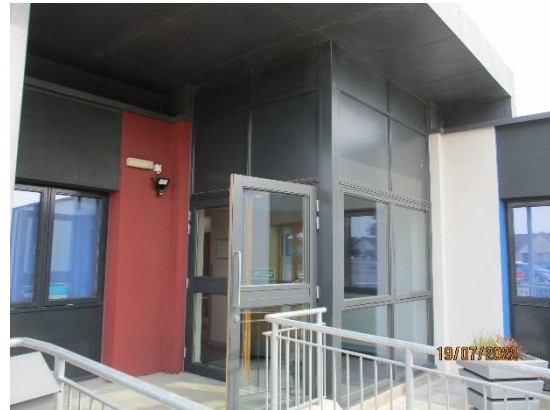
28. Main entrance door

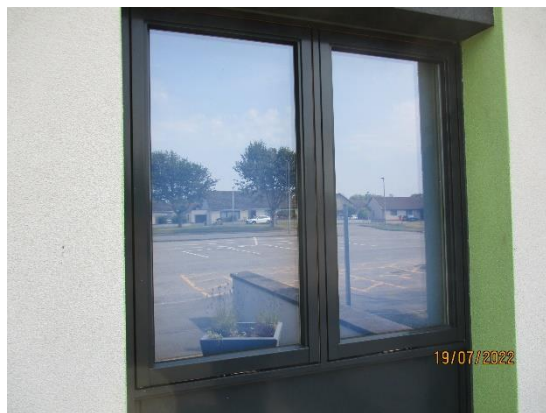
36. Typical window

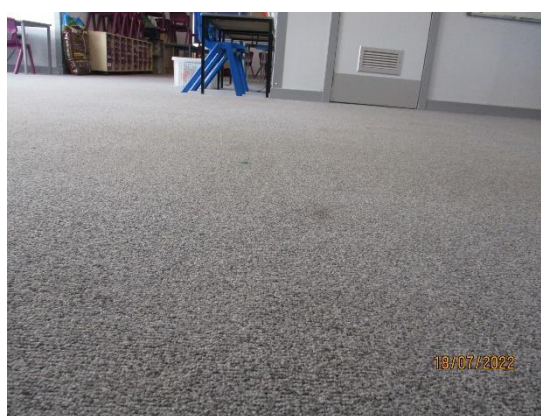
53. Ridge in concrete floor

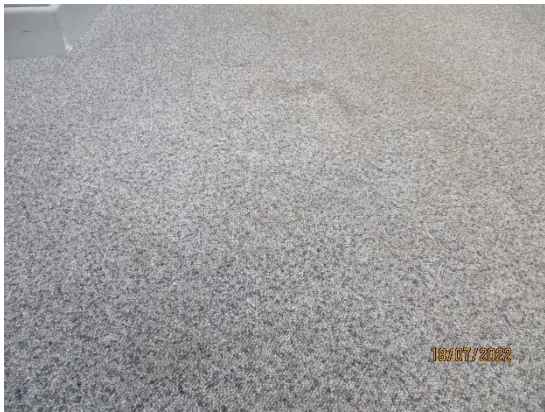
60. Soiled carpet/carpet tiles

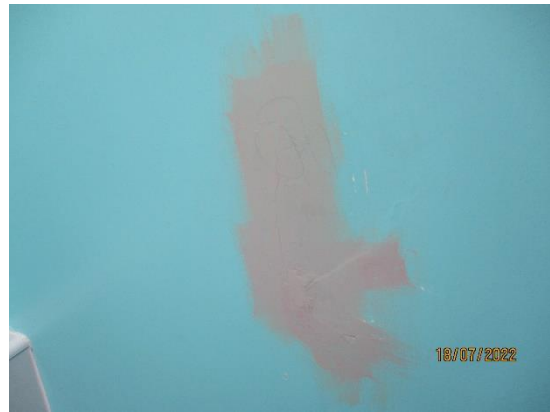
83. Previous repairs

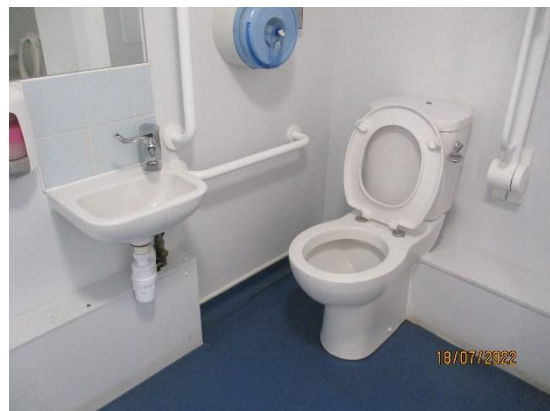
99. Accessible toilets

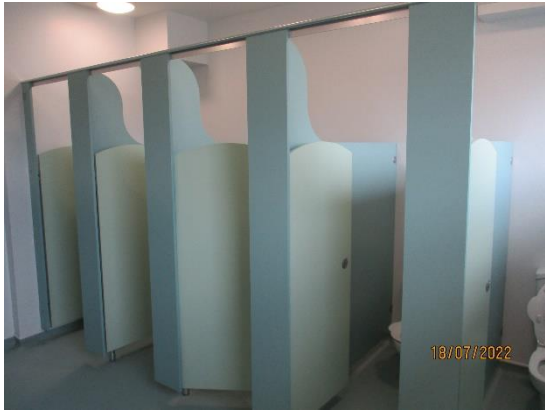
100. Cubicle partitions

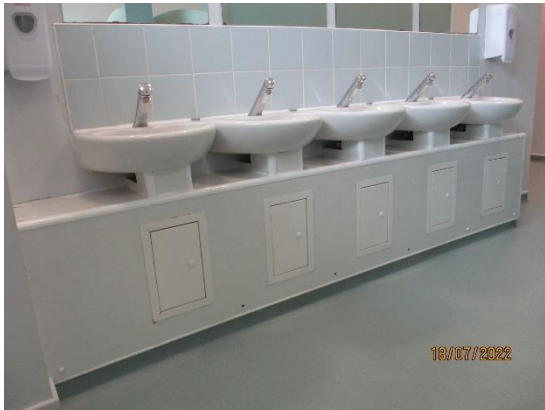
102. Vanity base units

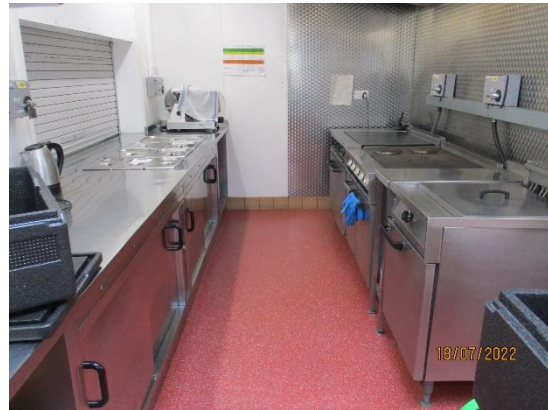
103. Commercial kitchen.

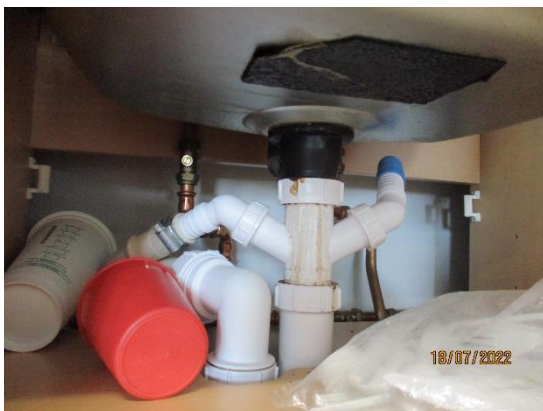
109. PVC waste pipes

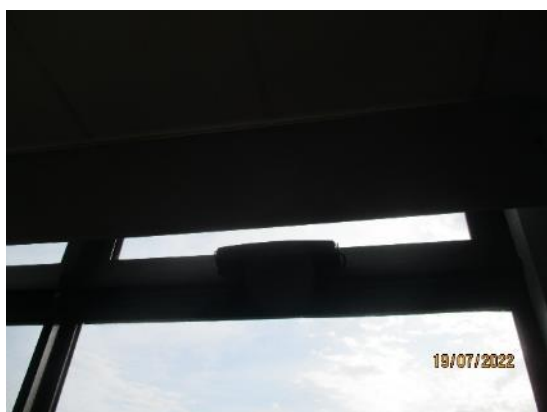
155. Automatic Ventilation Units. Hall ceiling mounted.

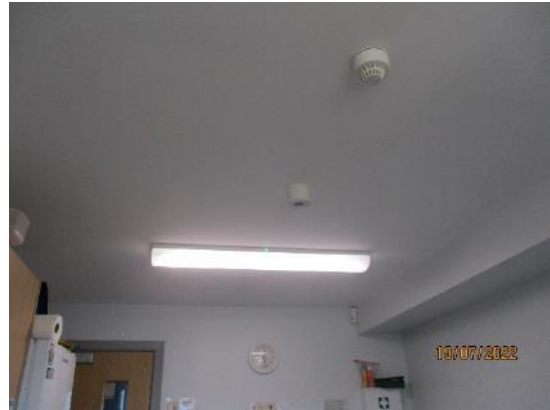
166. Lighting – main school corridor.

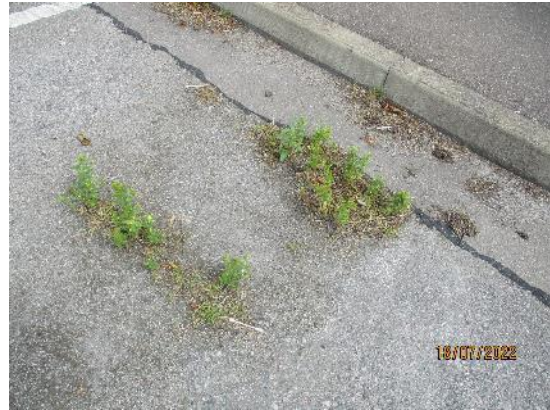
- Tarmacadam car park – surface erosion, potholes and surface vegetation.
- Car park drainage, partially blocked.
- Playground surface – previous repairs, cracking and surface vegetation.
- Playground drainage, partially blocked.
- Nursery grass playground, worn and missing grass.
- Holes in Nursery paving slabs.
- Sunken tarmacadam in Nursery playground.

197. Vegetation in car park

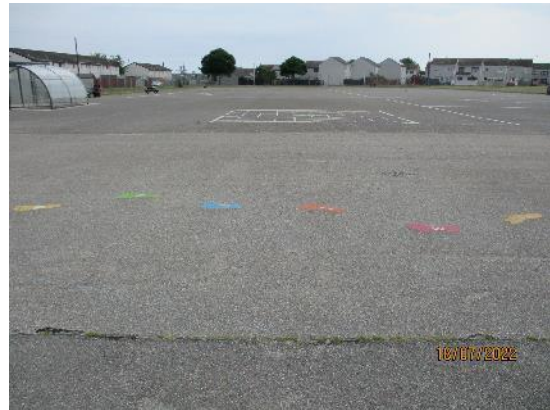
199. Tarmacadam playground

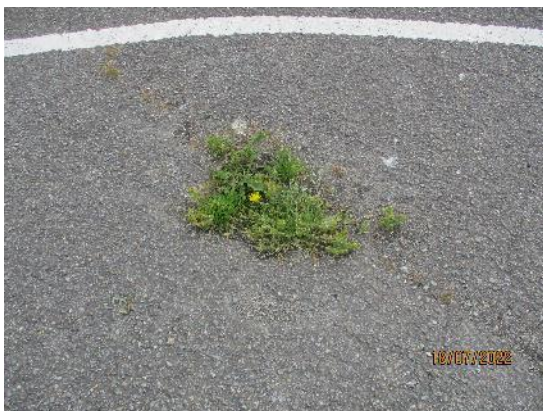
200. Vegetation in playground

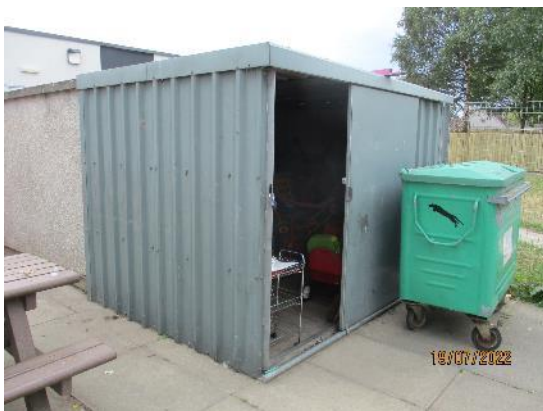
224. Metal shed

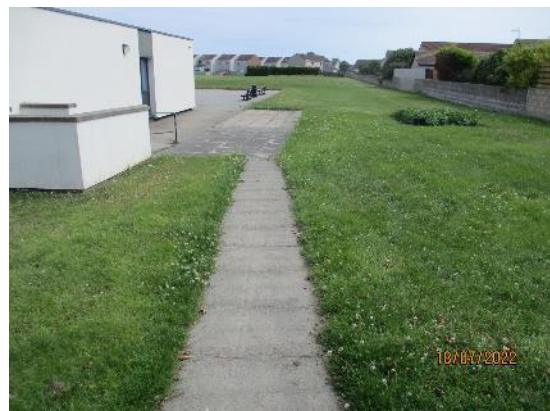
225. Landscaping to perimeter

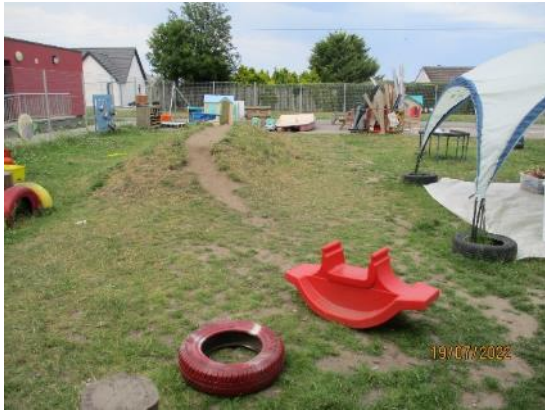
226. Nursery landscaping

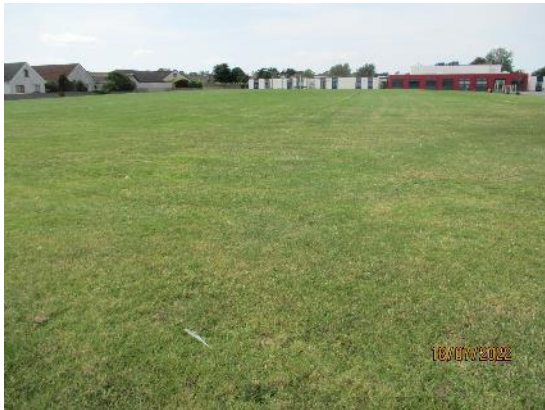
228. Grass sports field

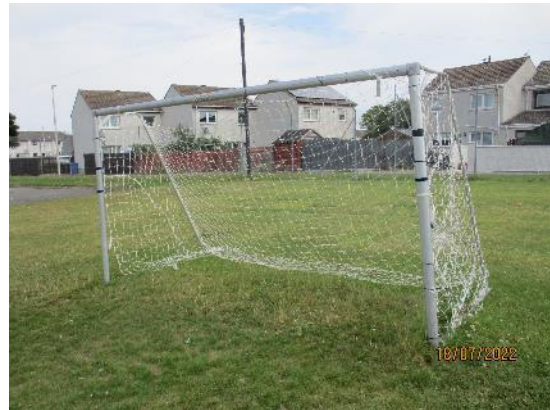
229. Goal posts
