# **Summary Building Condition Survey Report**

**Portessie Primary School  
School Road, Portessie AB56 1TN**

**24<sup>th</sup> & 25<sup>th</sup> August 2022**

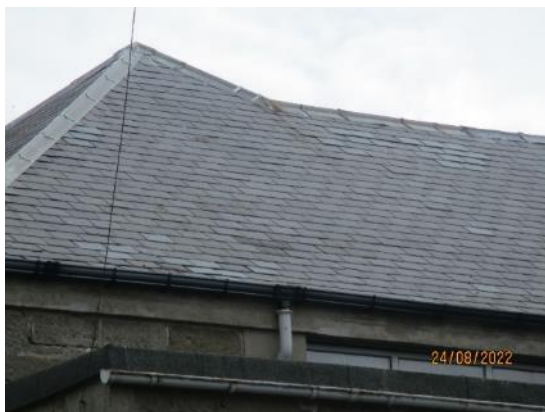
5. Main school slated roof

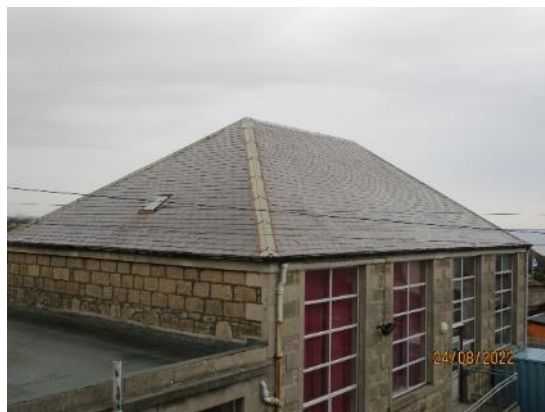
6. Games Hall slated roof

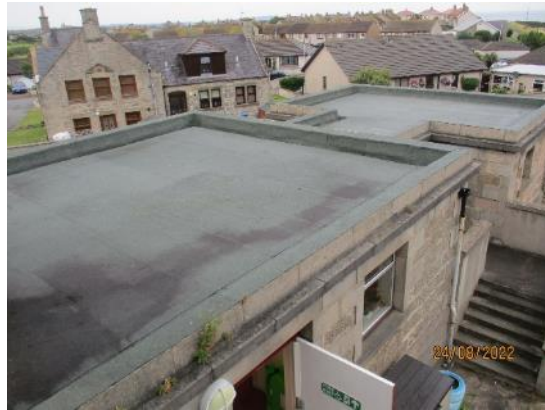
- Isolated slipped and broken slates, ridge and hip capping has surface corrosion.
- The metal skylight above the Games Hall is corroded and has broken glass.
- Felt roofing has exceeded its useful life.
- Cast iron gutters and downpipes are cracked and corroded.
- Aluminium windows are reaching the end of their useful life.
- Several double glazing units are fogged and obscure.
- Timber external doors have rot in the frames and at the base of the doors.
- Concrete steps are slipped, cracked and broken.
- External decoration is overdue.
- Plaster ceilings and walls have isolated cracking.
- Polystyrene sheeting to store 1/19 ceiling.
- Timber suspended floorboards are uneven and creek.
- Carpets and some sheet vinyl floors are soiled and worn.
- Internal classroom timber doors are twisted with cracked and broken glazing.

8. Felt covered flat roofs

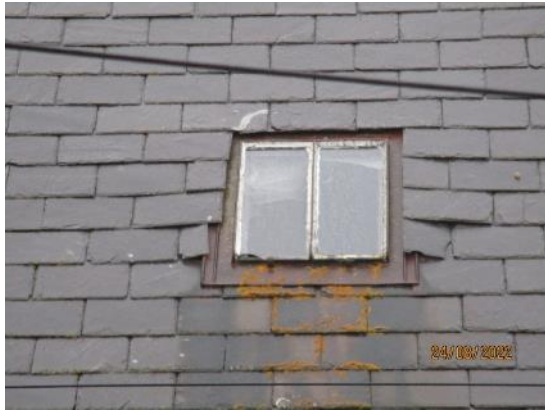
13. Metal skylight above Games Hall

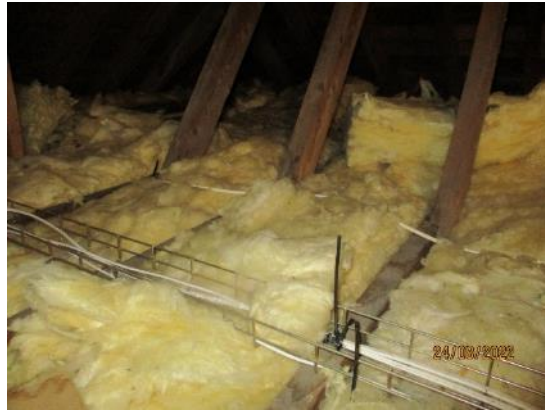
14. Mineral fibre insulation to main school

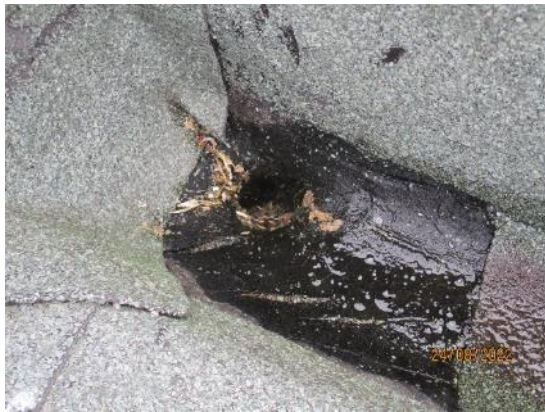
19. Narrow outlets from flat roofs

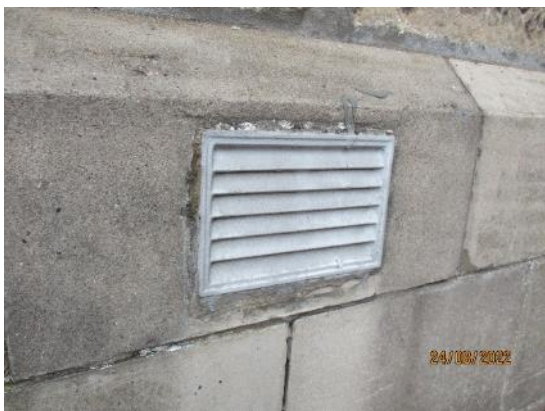
29. Underfloor ventilation

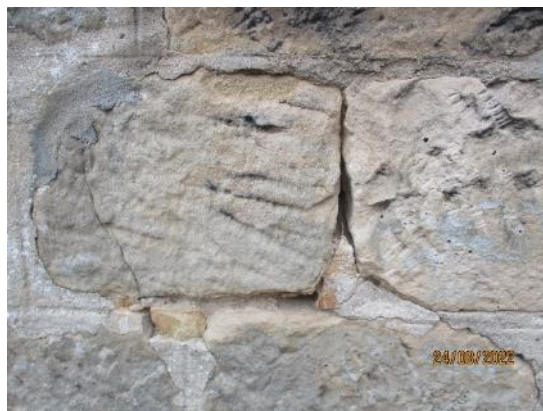
30. Re-pointing required

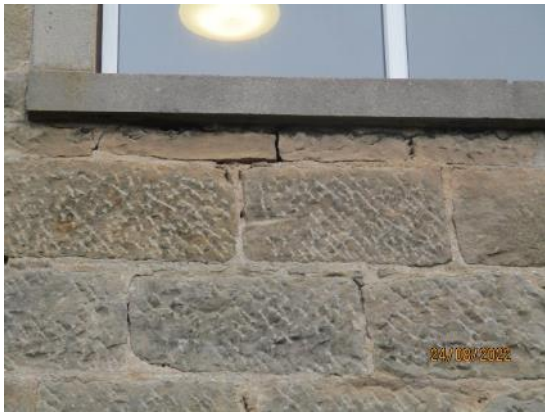
31. Re-pointing required

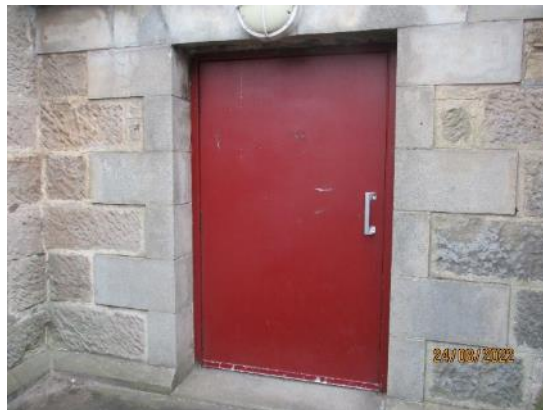
34. Timber fire escape door

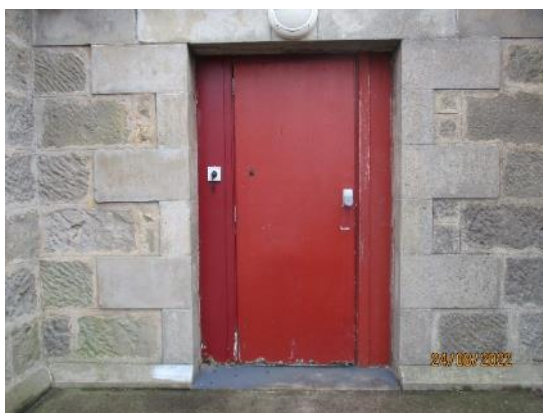
36. Timber fire escape door

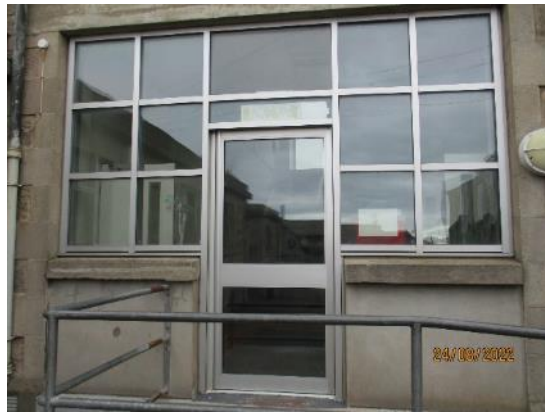
38. Aluminium framed doors

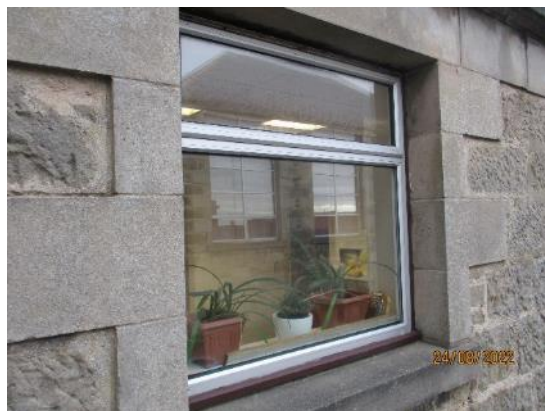
42. Standard aluminium framed windows

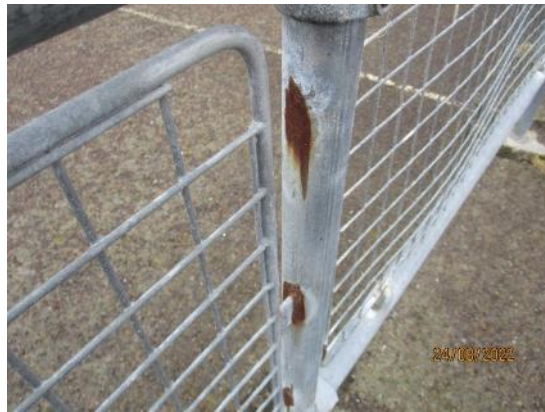
56. Galvanised fencing

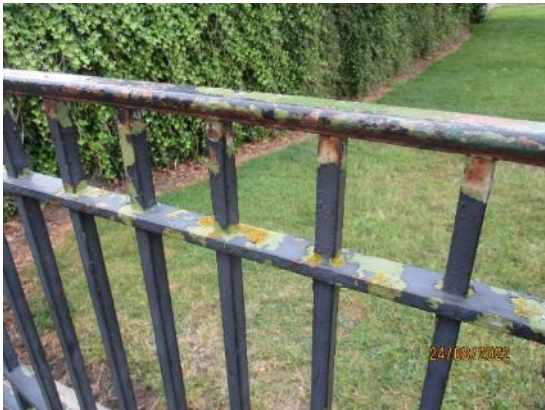
59. Metal railings

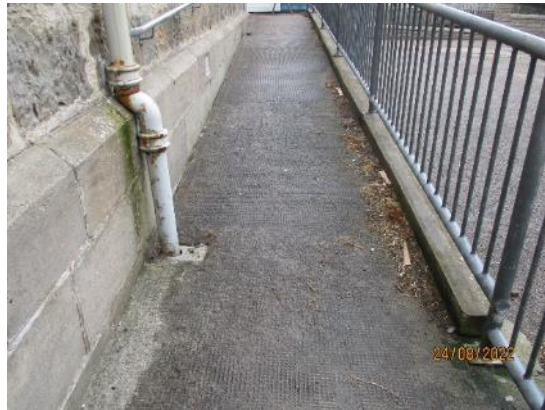
65. Concrete ramps

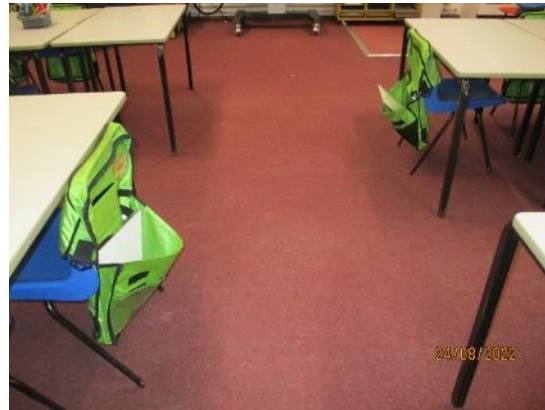
77. Carpet floor covering

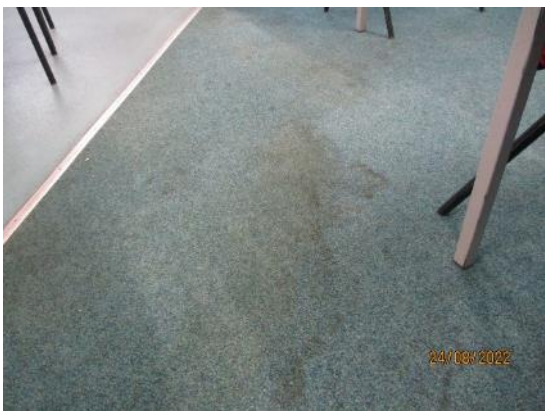
78. Soiled carpet

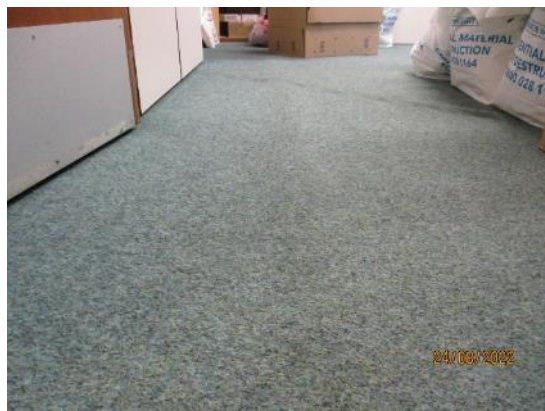
79. Wrinkled, stretched carpet

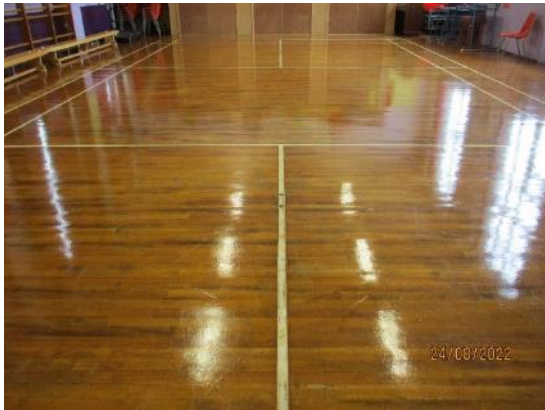
82. Games Hall timber floor

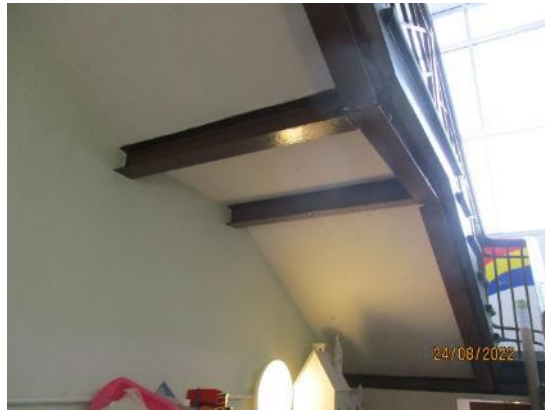
94. Broken steps

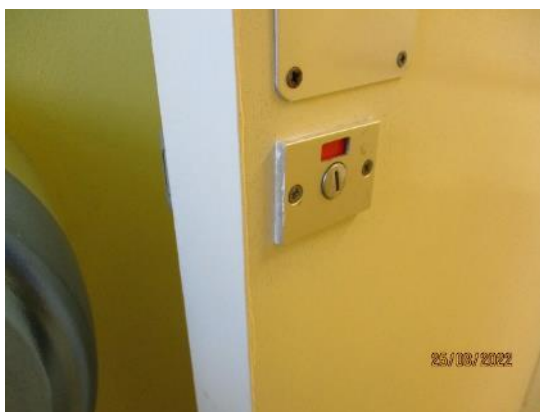
146. Faulty toilet indicator bolts

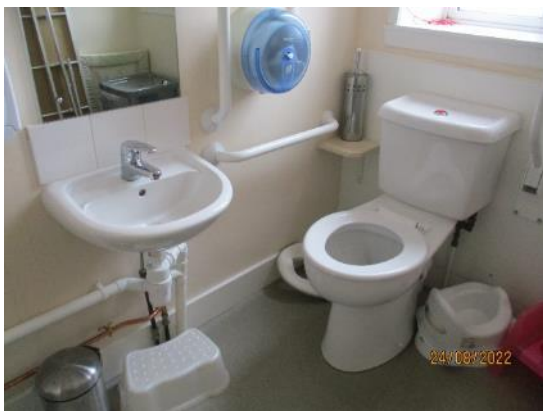
155. Accessible toilet

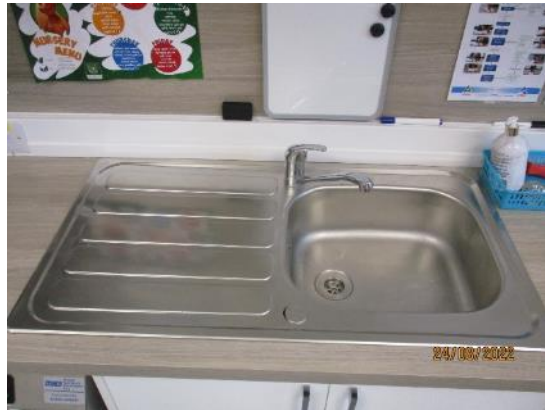
166. Stainless steel sinks

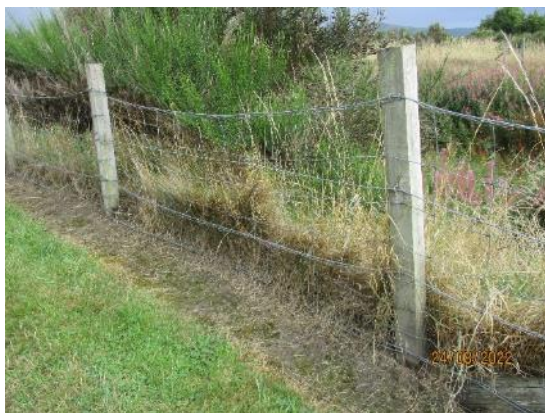
241. Timber fence to Nursery playground

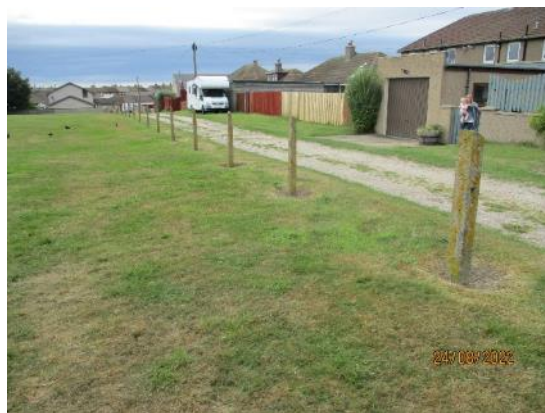
242. Timber post & wire fence to sports field

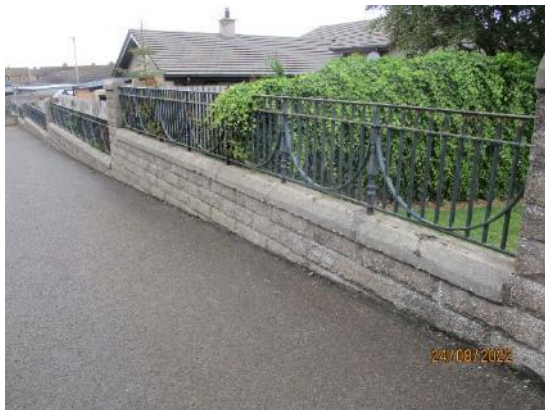
245. Metal railings above block walls

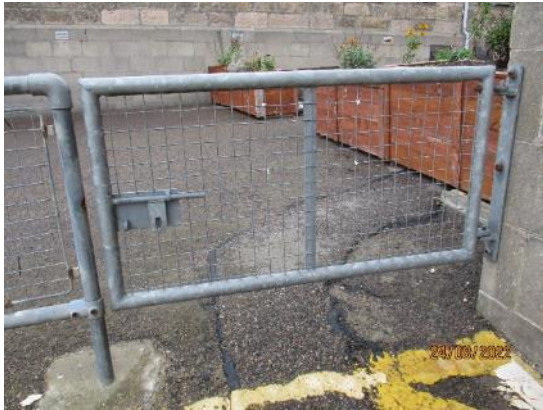
249. Tubular rail vehicle gate

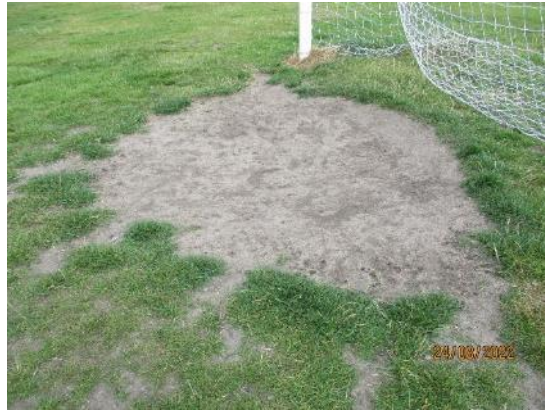
263. Sports field grass
