# **Summary Building Condition Survey Report**

**Portgordon Primary School  
Richmond Terrace, Portgordon AB56 5RA**

**13<sup>th</sup> September 2022**

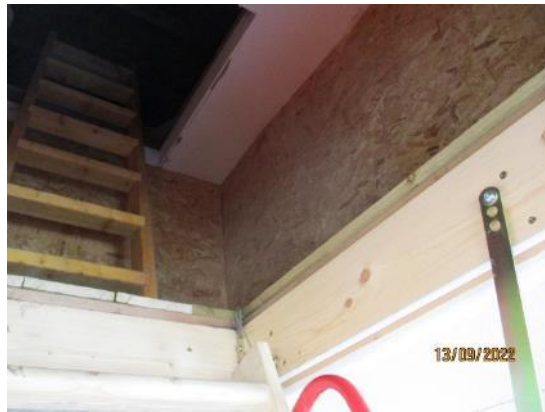
2. Recessed roof space access

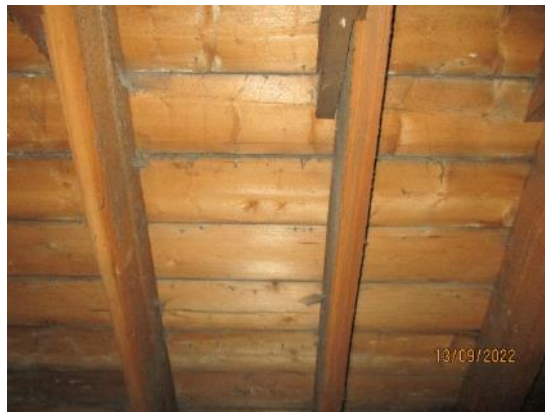
4. Sarking boards

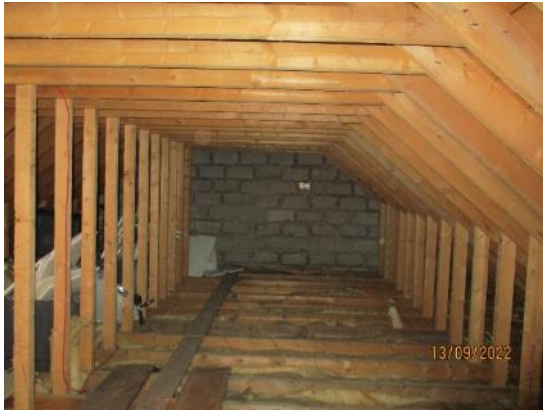
7. Roof structure

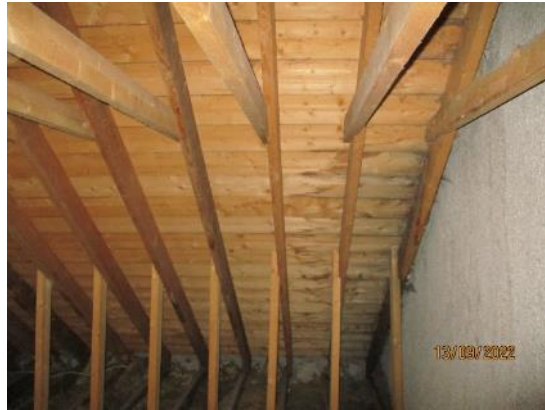
8. Sarking boards

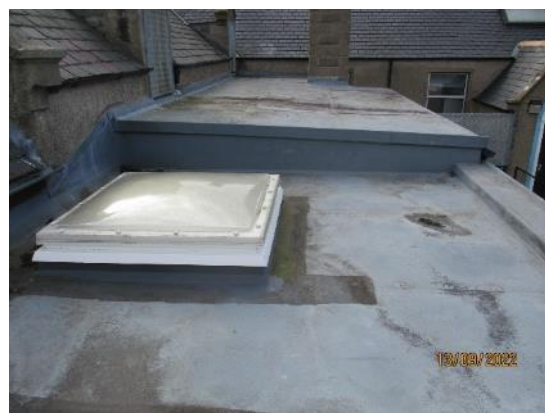
18. GRP roof above Kitchen

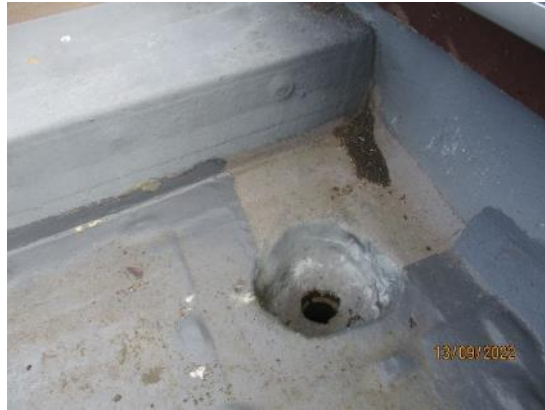
20. GRP roof outlet

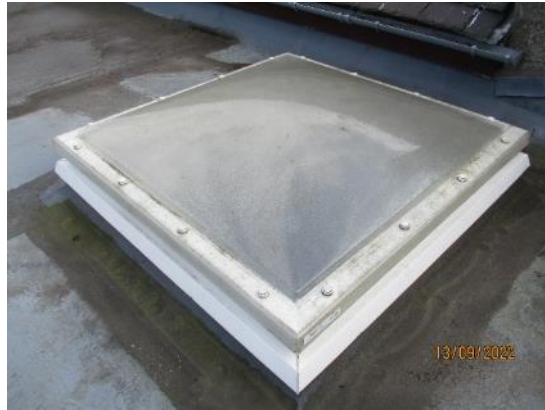
26. GRP domed rooflights

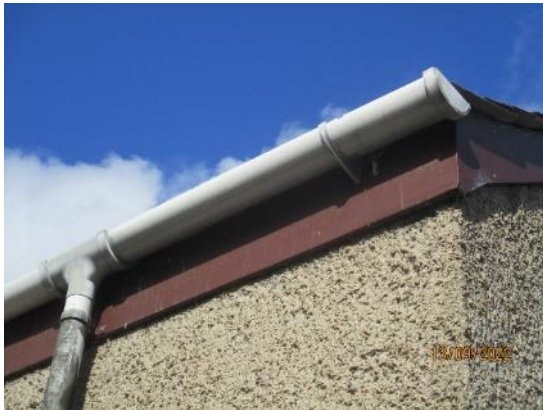
33. UPVC gutters

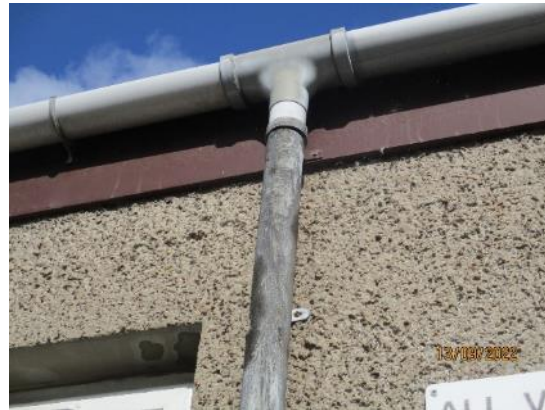
40. UPVC downpipes

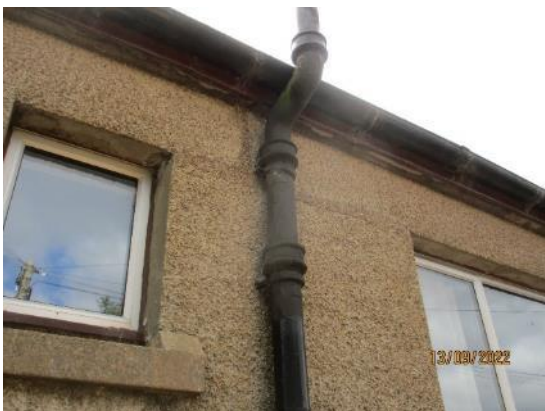
41. Cast iron SVP's

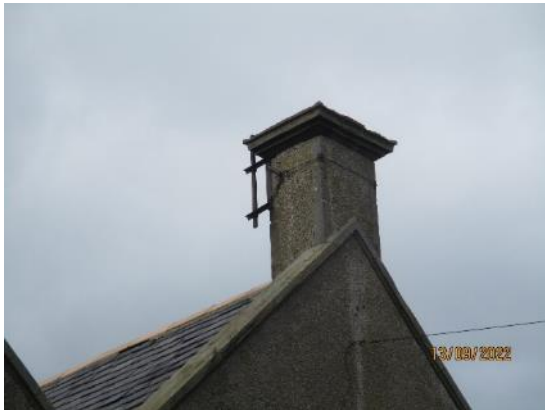
45. Roughcast chimney

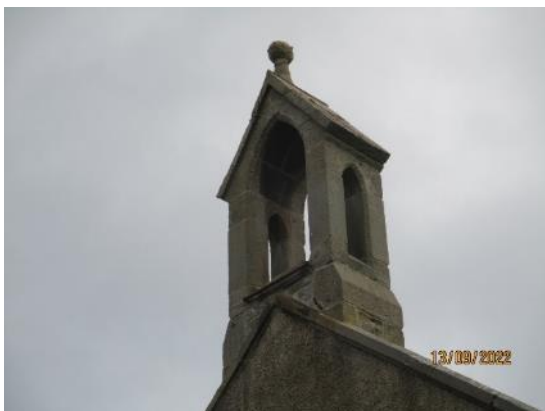
48. Redundant bell tower (no bell)

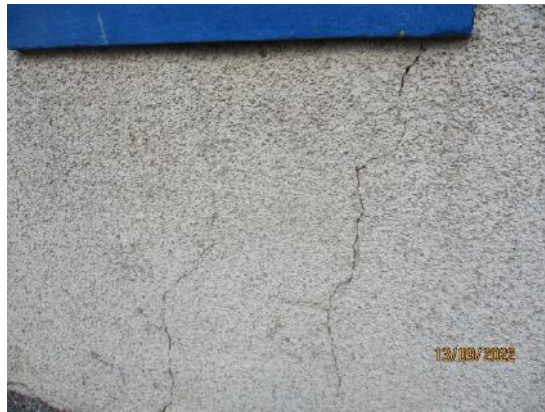
55. Cracking of roughcast finish

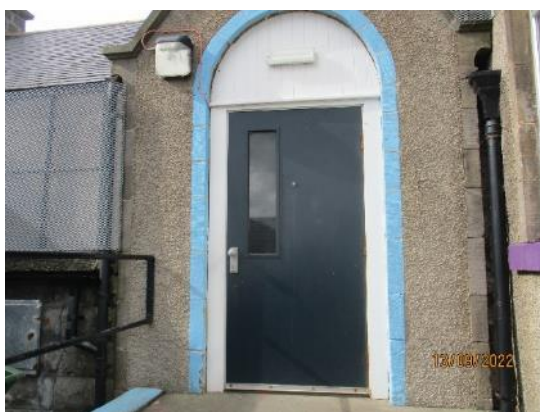
63. Timber front entrance door

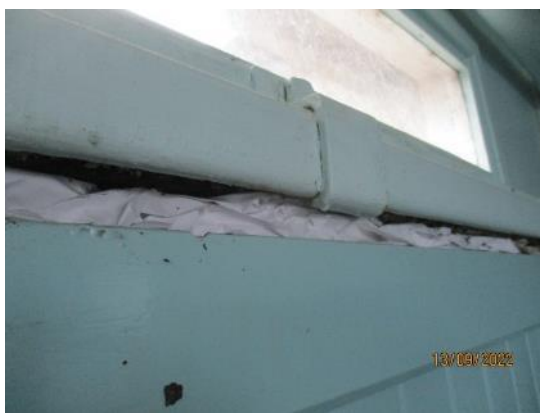
65. Redundant door to Boys Toilet

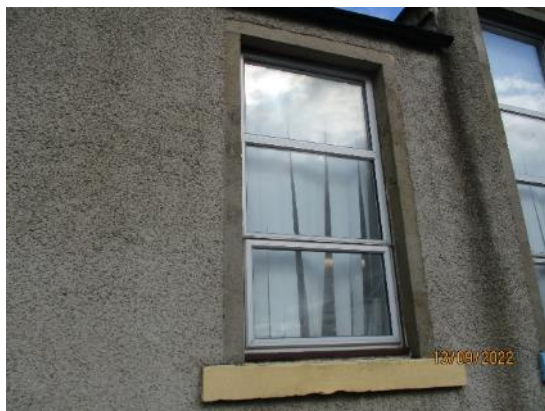
70. Large aluminium windows

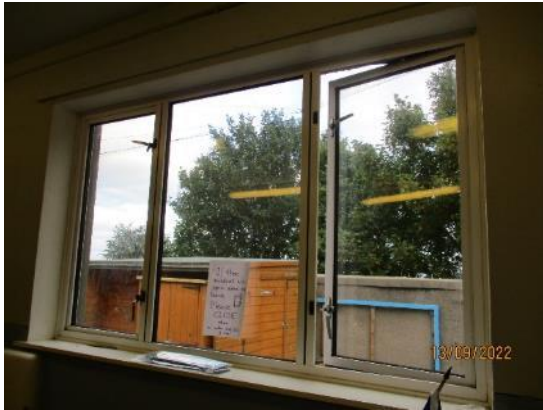
72. Failed sealant below window sills

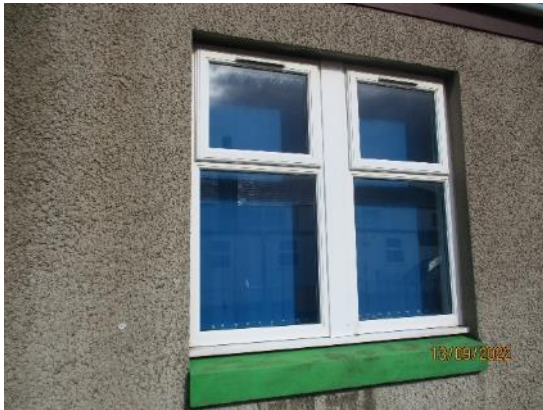
74. Windows taped where seals have failed

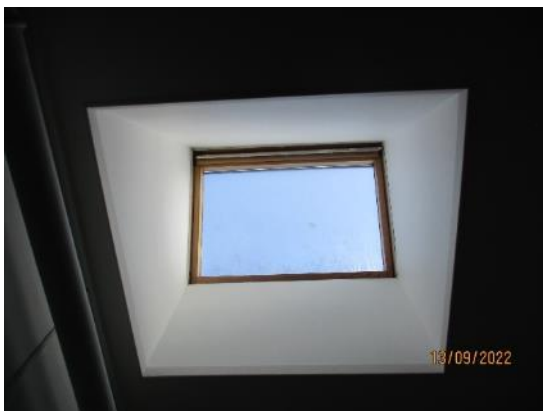
76. Velux windows

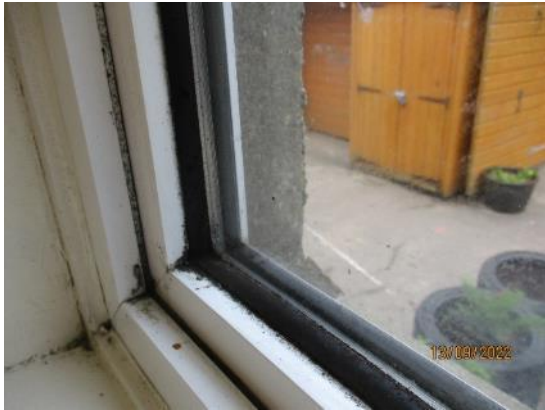
78. Failing solar film

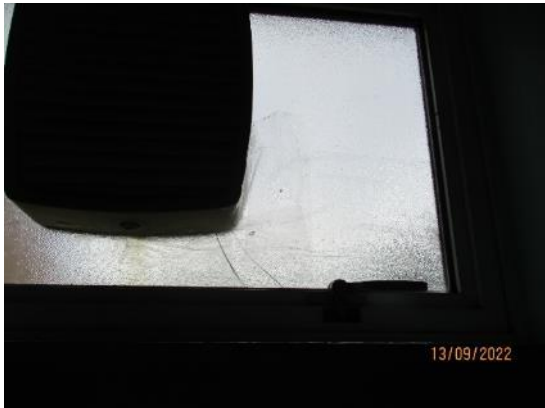
80. Fogged double glazing units

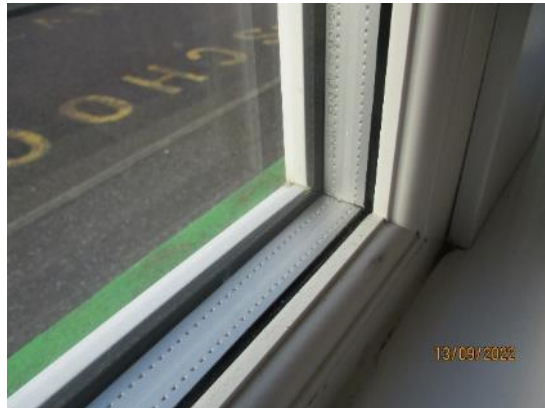
81. Broken glass

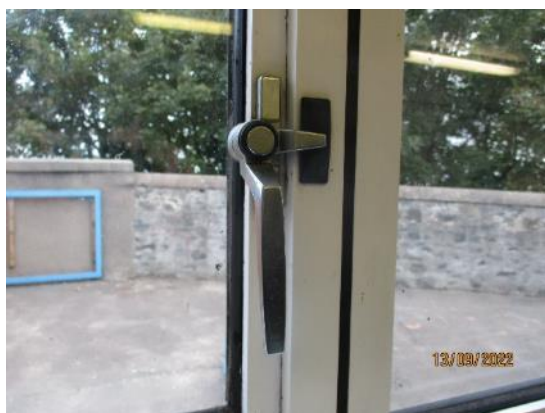
82. Double glazing to uPVC windows

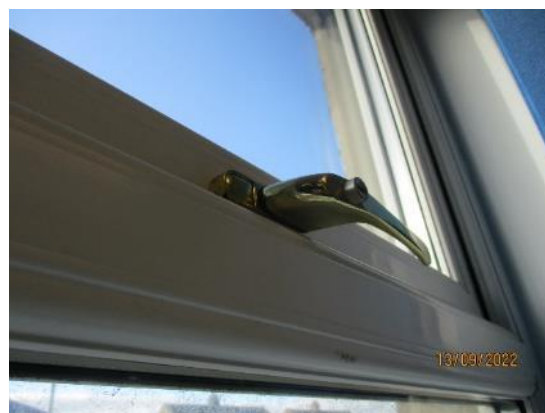
83. Window lever handles

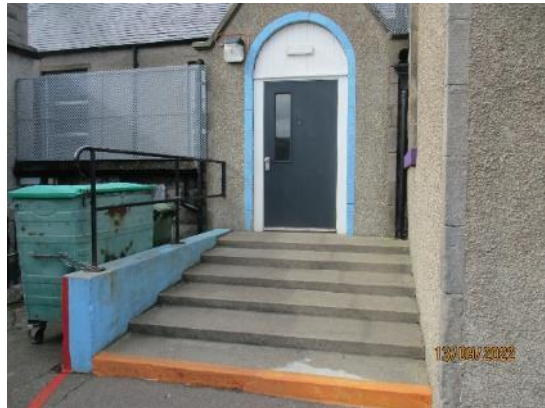
87. Concrete steps

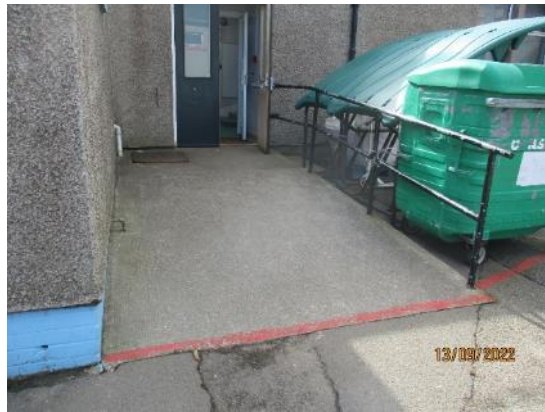
91. Concrete ramp to front entrance

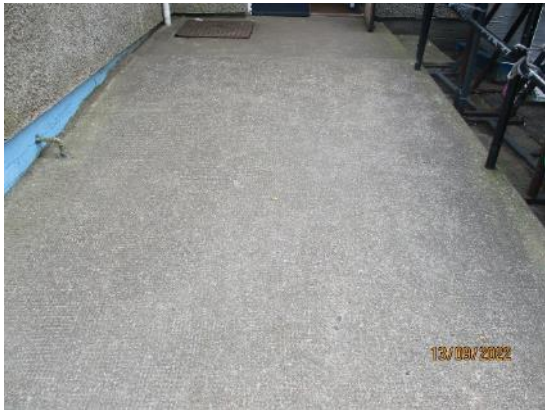
92. Concrete ramp to Nursery

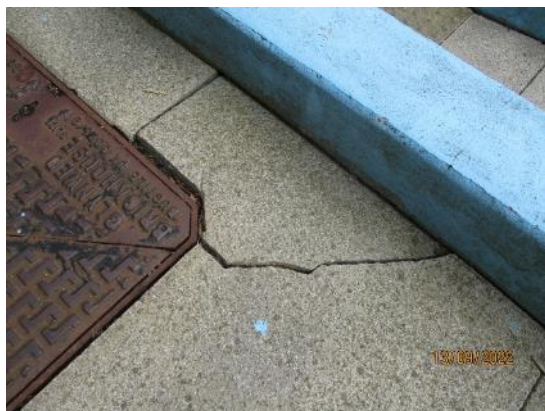
94. Paving slab ramp

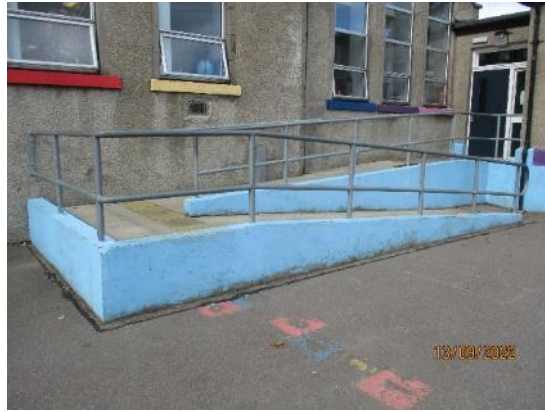
97. Guard rails

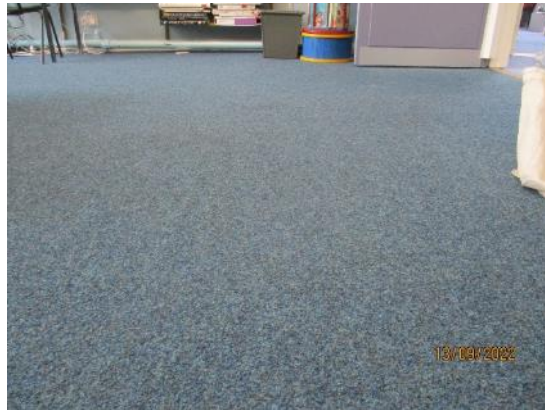
99. Sloping timber floors

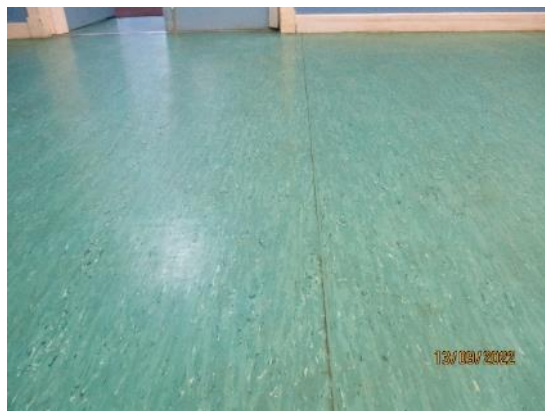
101. Sheet vinyl flooring

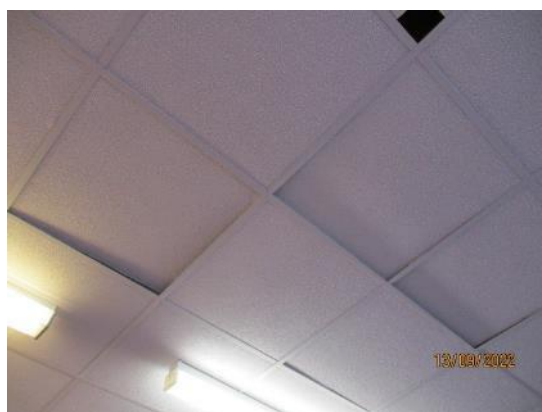
116. Suspended ceiling tiles

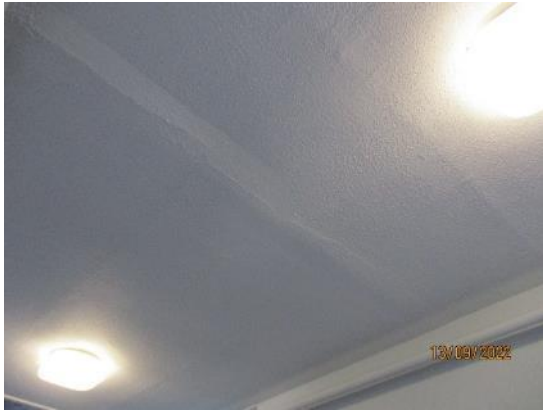
119. Plasterboard ceilings – failed taped joints

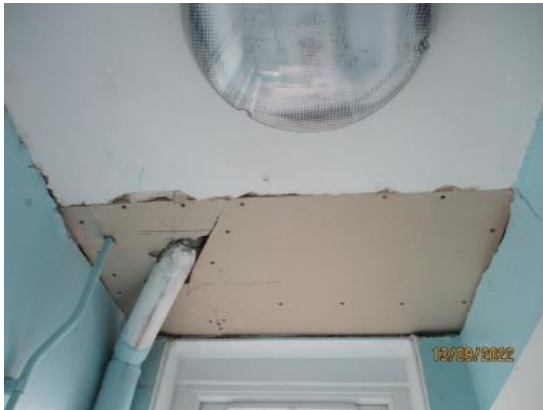
121. Plasterboard repairs

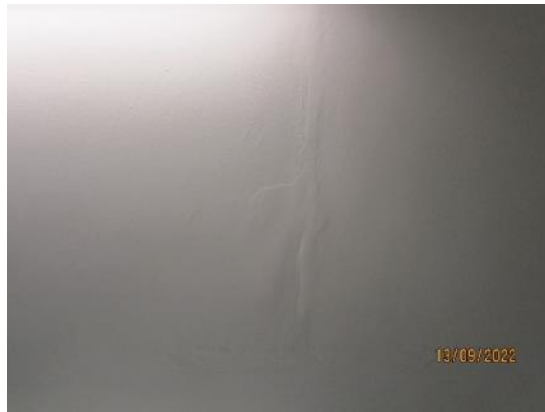
126. Repairs to plaster ceilings

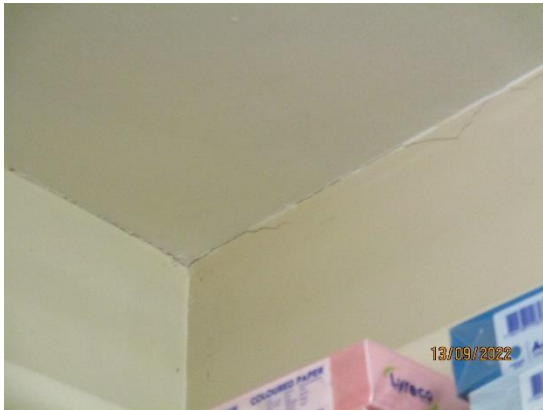
133. Cracks at high level

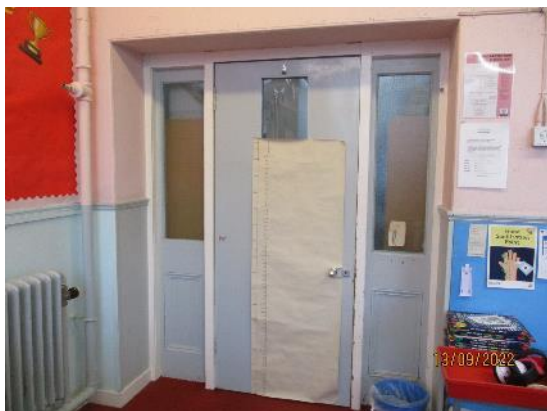
156. Classroom doors and screens

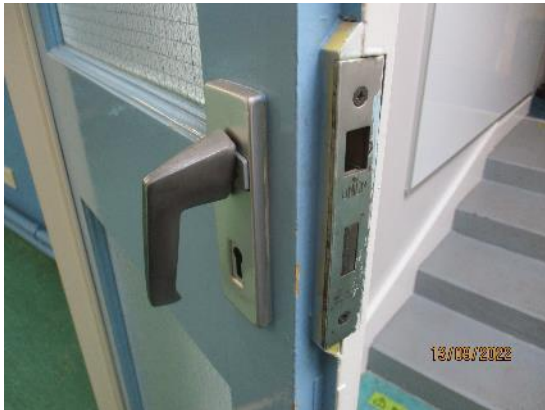
159. Door ironmongery (various)

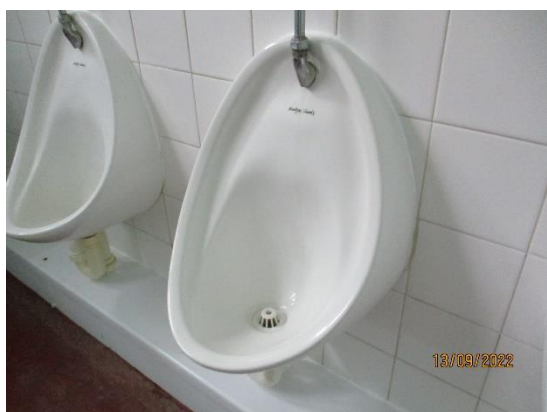
165. Individual urinals

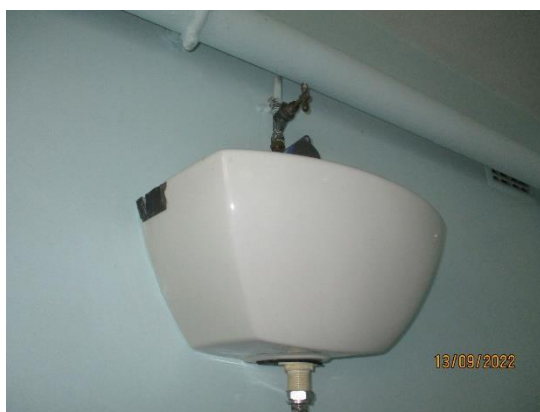
166. China cistern

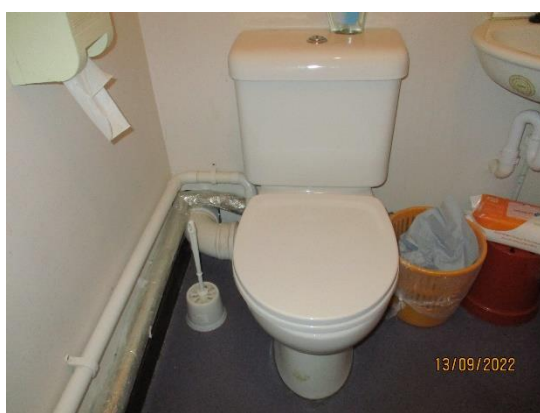
168. Staff WC

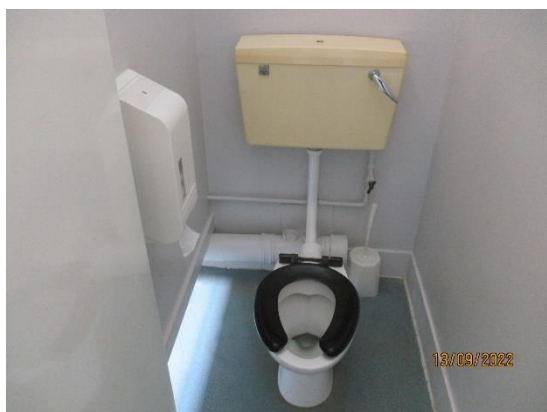
169. Nursery WC

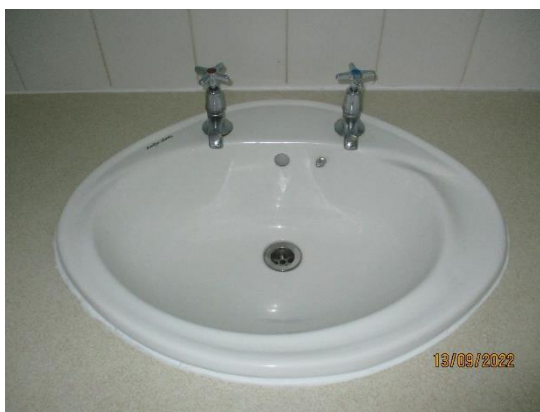
170. Boys vanity basins

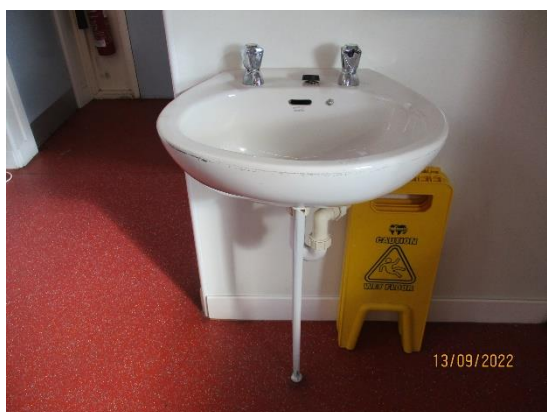
171. Wall hung basins (various)

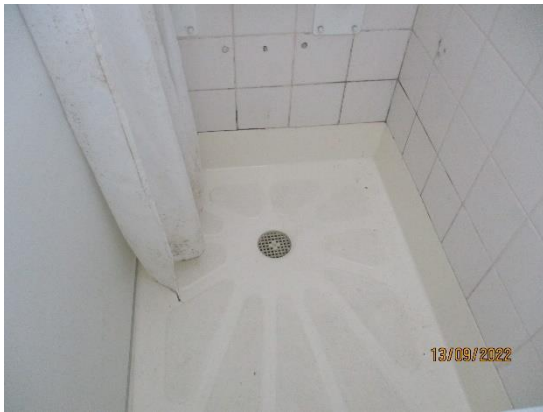
175. PVC shower tray

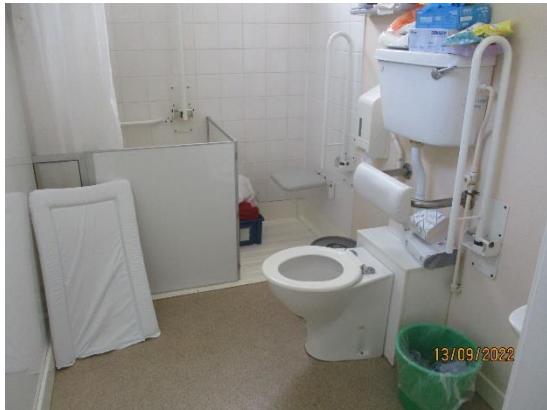
178. Accessible toilet

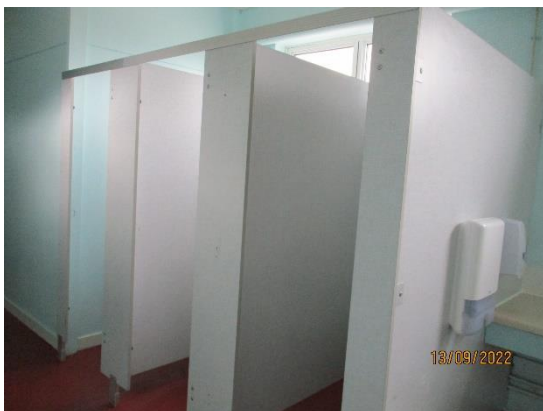
179. Cubicle partitions

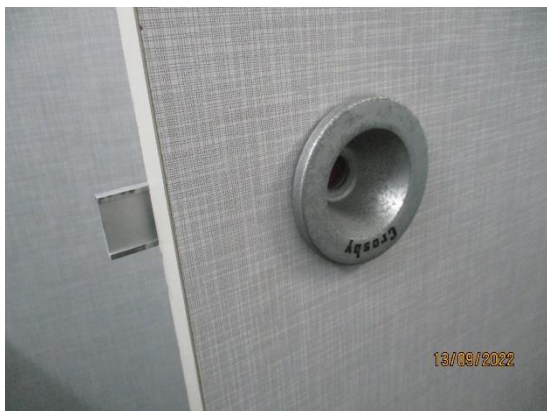
180. Indicator bolts

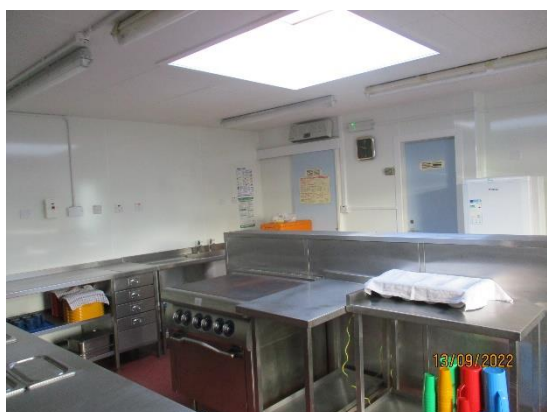
183. Commercial kitchen

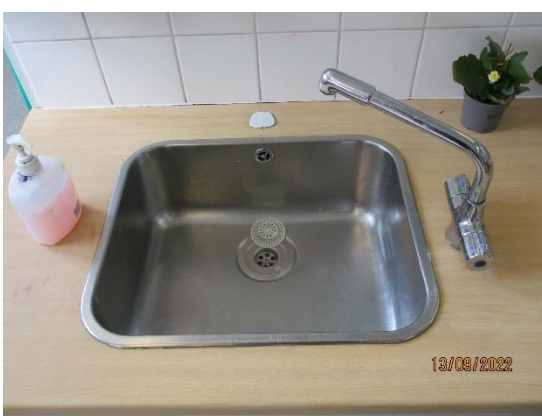
186. Inset stainless steel sinks

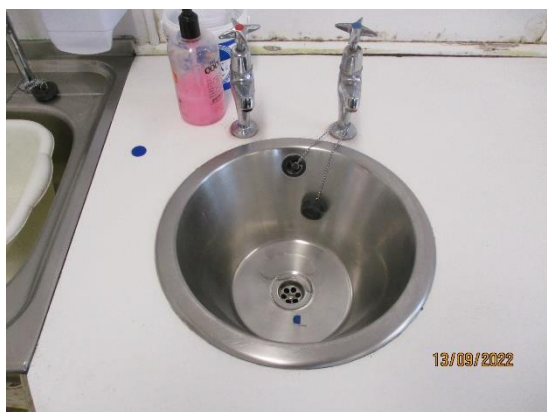
187. Hand wash sinks

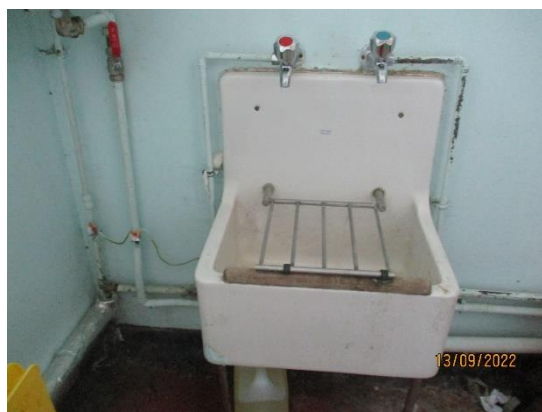
188. Cleaners butler sink

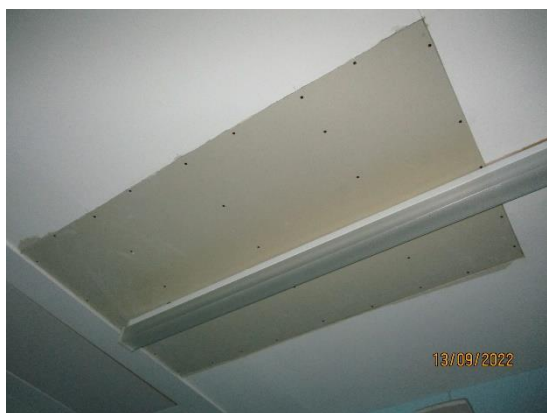
190. Previous repairs

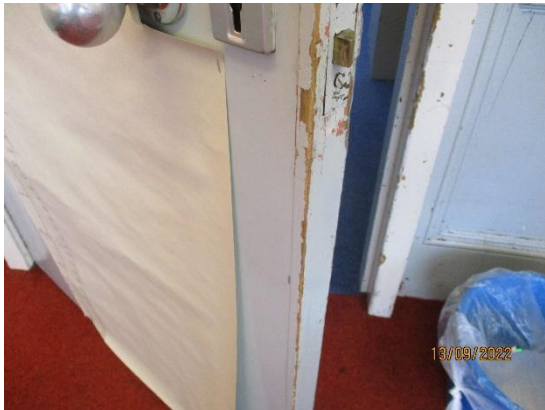
194. Scraped and chipped

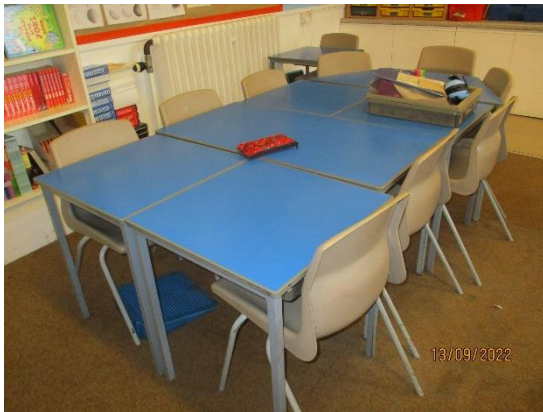
198. Classroom tables and chairs

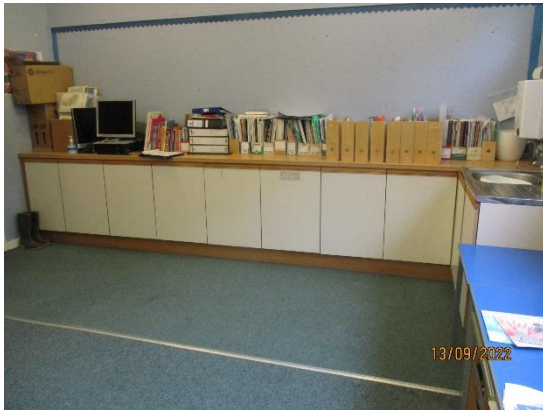
200. Base units and worktops

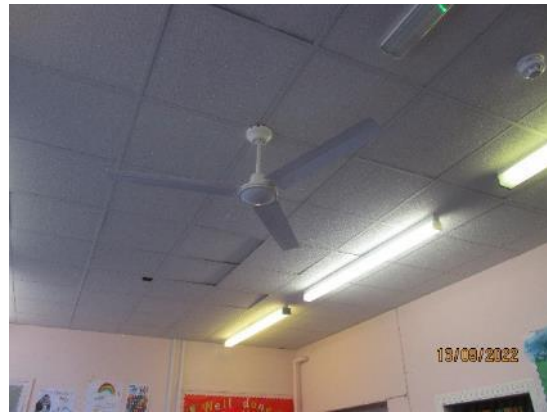
223. De stratification class fan typical.

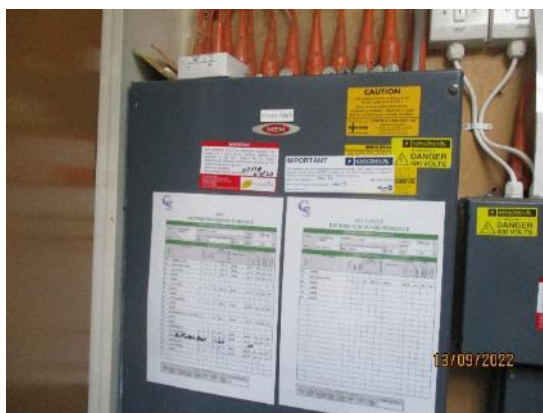
226. Distribution boards

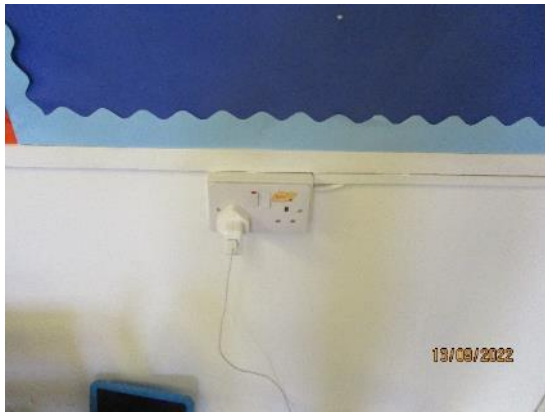
228. Sockets – typical.

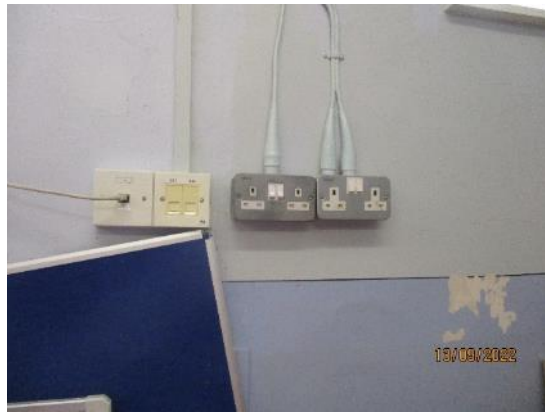
229. Sockets – playgroup room 1/11

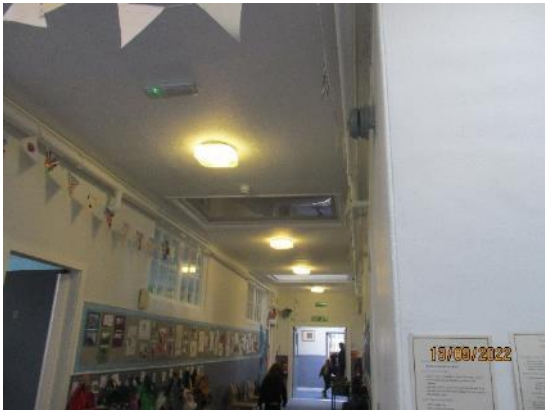
230. Lighting – corridor typical.

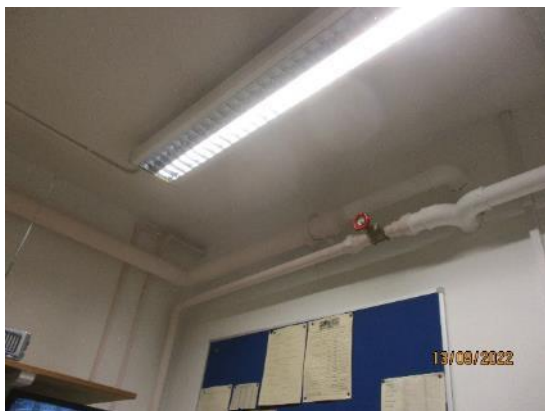
232. Lighting – reception office.

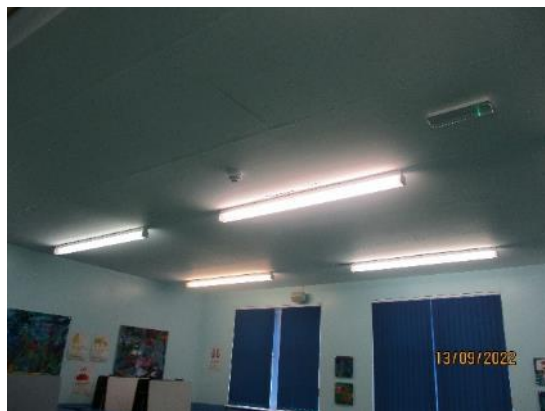
233. Lighting – dining hall.

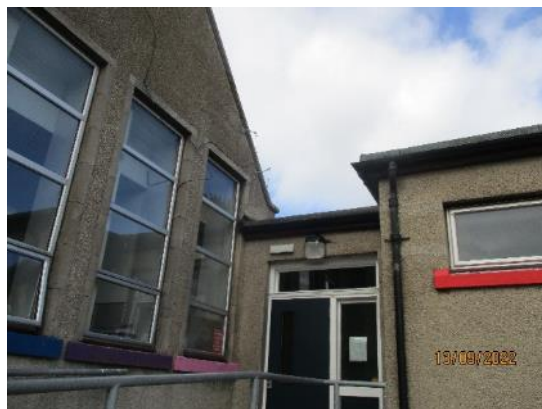
237. External lighting.

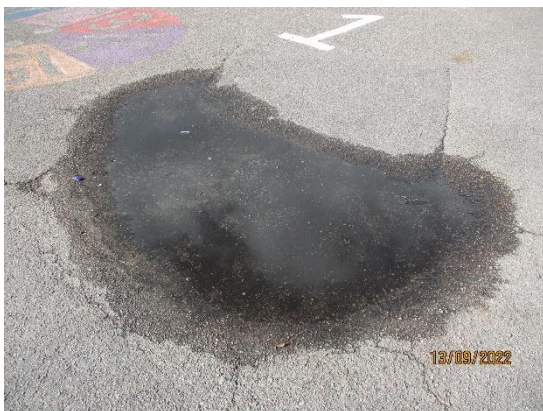
256. Sunken surface

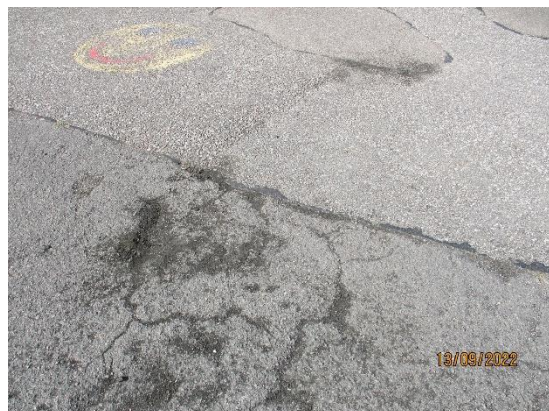
257. Surface cracking

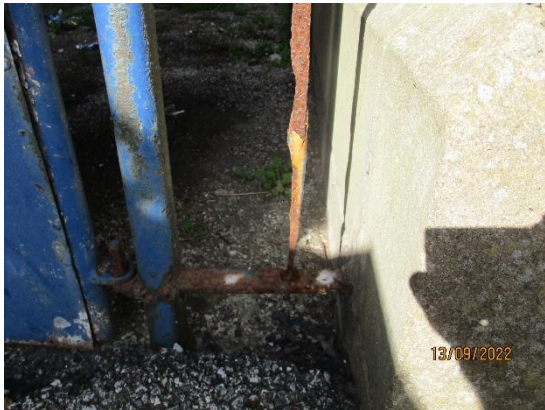
272. Extensive corrosion

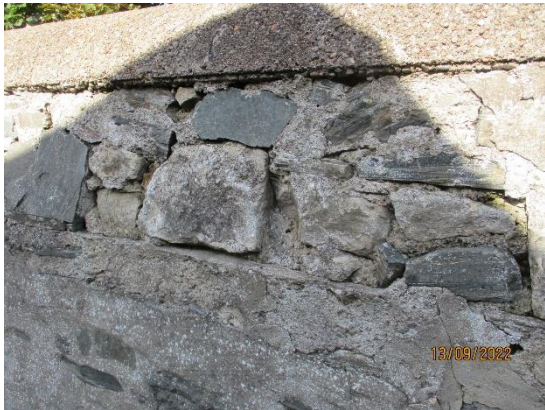
- Cracks, potholes and surface erosion of tarmacadam car park and playground.
- Cracked, spalling render and missing pointing, to perimeter walls.

278. Missing pointing

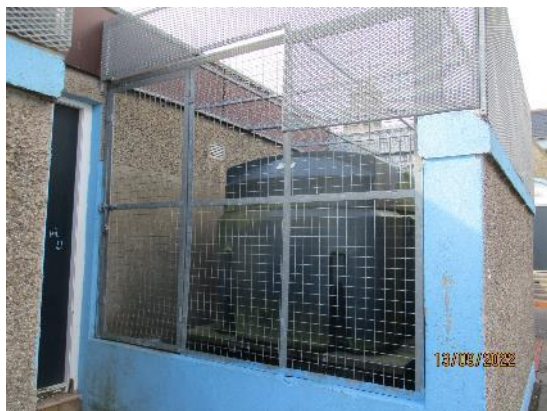
287. Oil tank enclosure

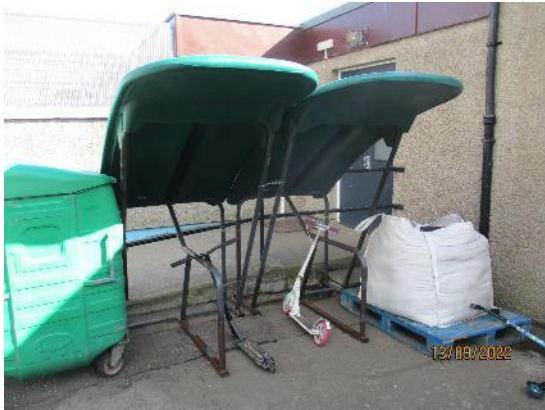
288. Bike shelters

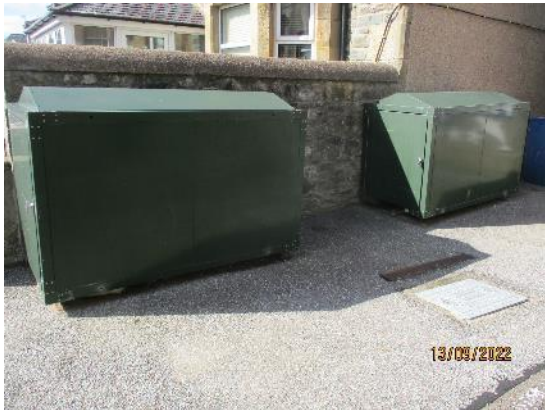
290. Bike lock-ups

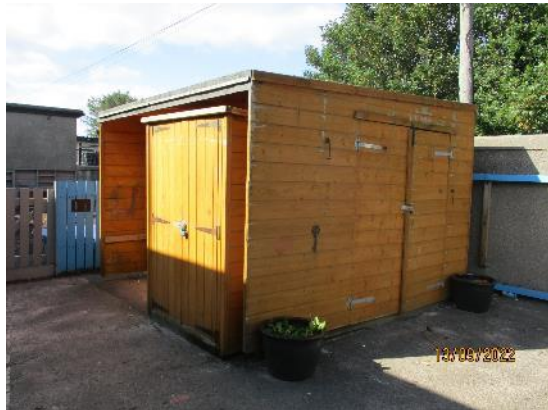
291. Timber shed
